Photo Log of the Lower Boise River
Ada and Canyon Counties, Idaho
August 13, 2008

This photo log will document the appearance of the Lower Boise River on the date August 13, 2008. This log begins at the bridge on Eagle Road on the south channel of the Lower Boise River and the photos will run downstream to the mouth of the River where the Lower Boise enters the Snake River. Each photo site will give a latitude and longitude position where the photos were taken. The latitude and longitude was obtained through the use of a Garmin hand-held GPS unit at the time the photos were taken.

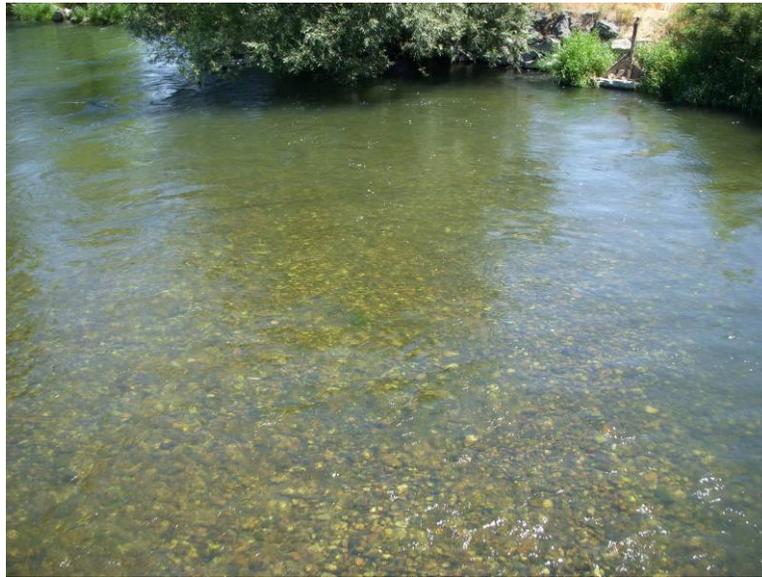
1. South Channel of the Lower Boise River on Eagle Road.
N 43⁰ 40.496' W 116⁰ 21.237'

The Lower Boise River splits into a north channel and a south channel at eagle. The West Boise Wastewater Treatment Plant discharges just upstream of this crossing on Eagle Road.

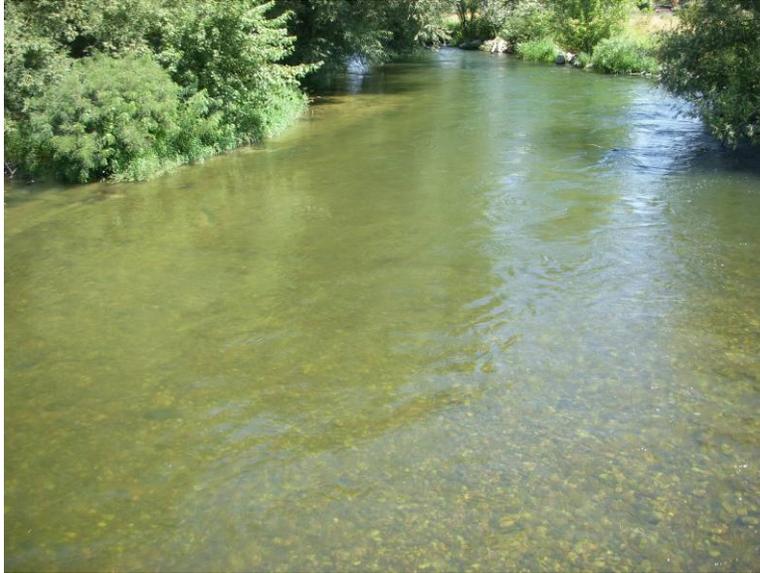
2. South Channel of the Lower Boise River on Eagle Road.
N 43⁰ 40.517' W 116⁰ 21.217'

This photo was taken from the bridge on Eagle Road looking upstream. The water appeared to be clear on this day, in this location.

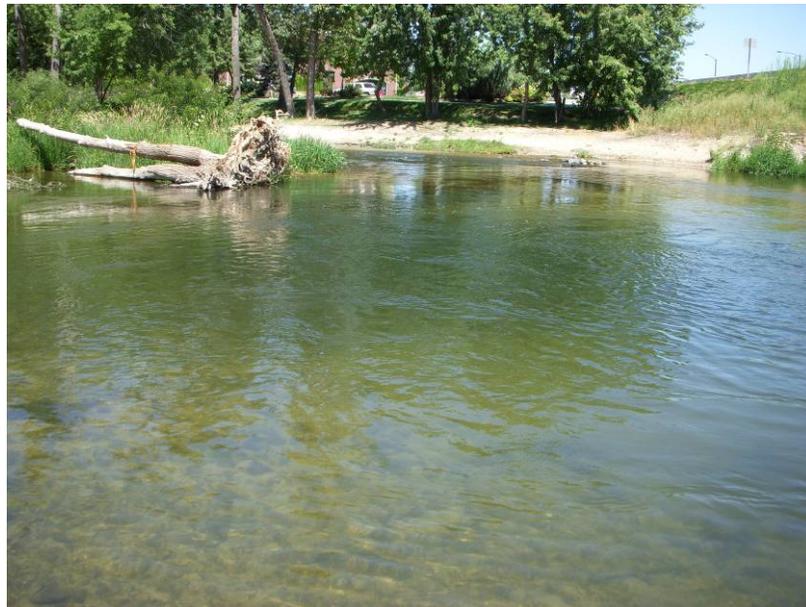
3. North Channel of the Lower Boise River on Eagle Road.
N 43⁰ 41.175' W 116⁰ 21.274'

This photo was taken standing on the bank of the river looking across, downstream of the bridge. The water was clear with some vegetation visible.

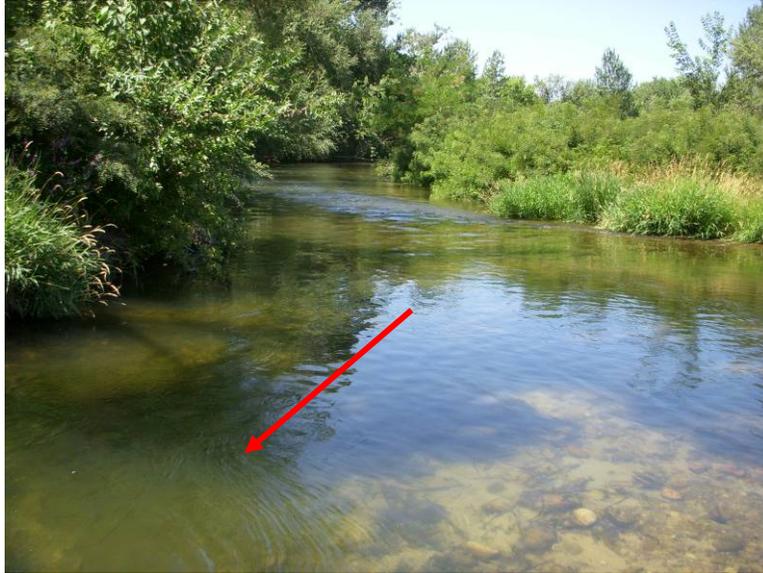
4. North Channel of the Lower Boise River on Eagle Road.
N 43⁰ 41.175' W 116⁰ 21.274'

This photo was taken standing on the bank of the river looking downstream near the bridge. The water was clear with some vegetation visible. The arrow is pointing at some vegetation in the channel.

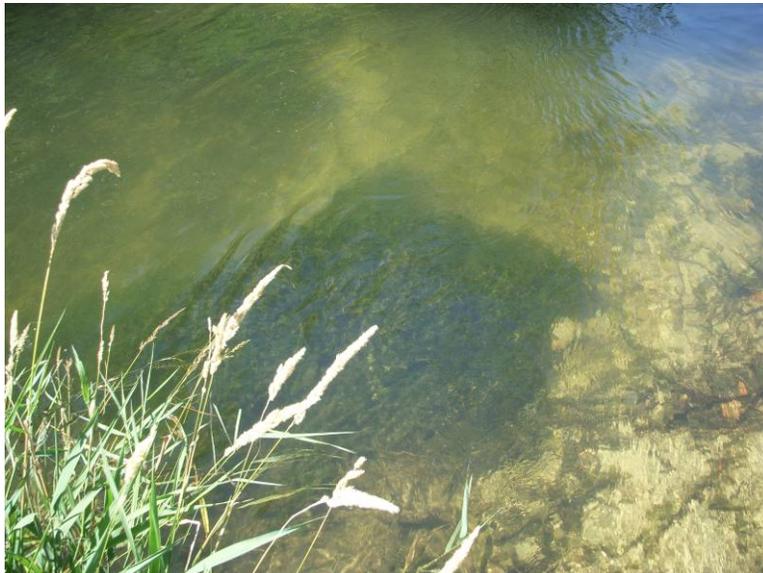
5. North Channel of the Lower Boise River on Eagle Road.
N 43⁰ 41.175' W 116⁰ 21.274'

This photo shows a weed bed in a sheltered small bay along the channel in this location.

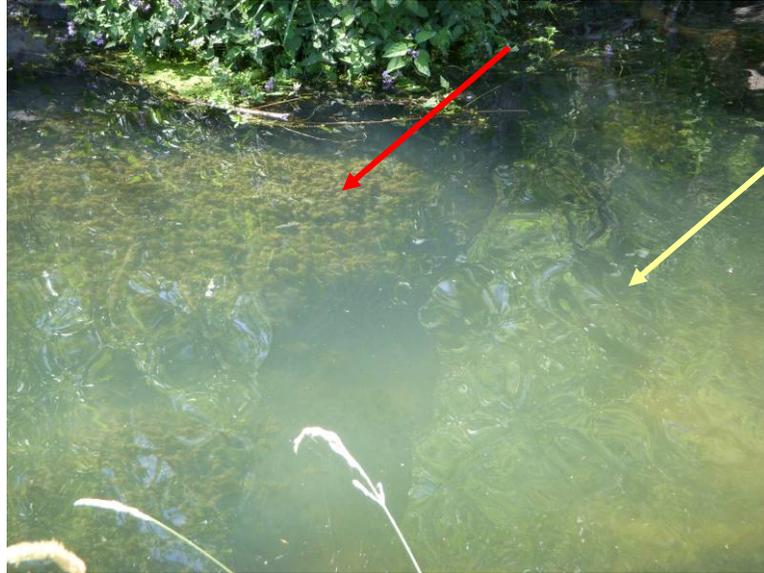
6. North Channel of the Lower Boise River on Eagle Road.
N 43⁰ 41.175' W 116⁰ 21.274'

This photo shows a weed bed in a sheltered small bay along the channel in this location. The red arrow points to a macrophyte bed and the yellow arrow points to what appears to be algae in the water.

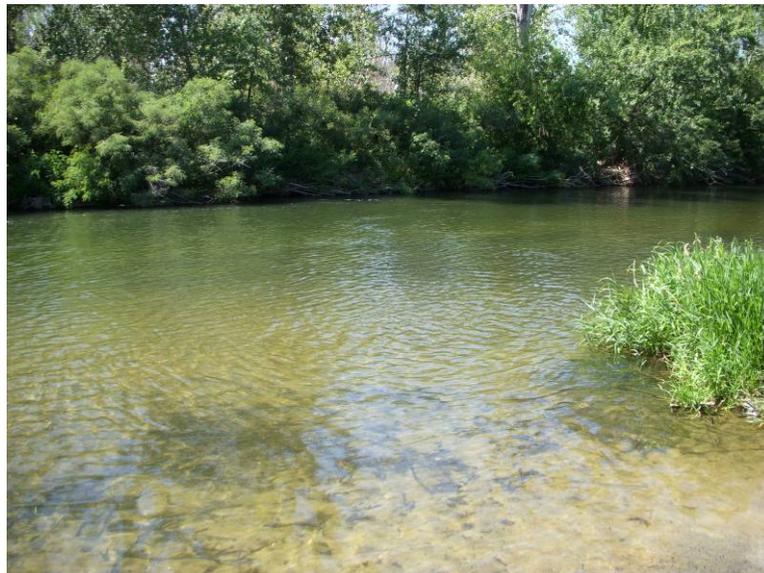
7. Lander Street Bridge on the Lower Boise River. N 43⁰ 41.311' W 116⁰ 24.806'

This photo was taken standing under the Lander Street Bridge on the Lower Boise River. The water in this photo appeared to be clear. The dark material in the water in the foreground was dead vegetation, sticks, etc.

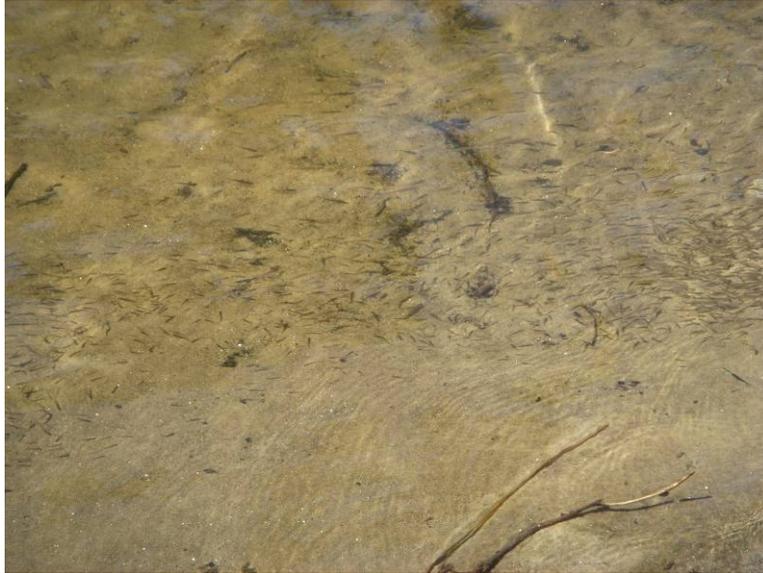
8. Lander Street Bridge on the Lower Boise River. N 43⁰ 41.311' W 116⁰ 24.806'

There was a large number of tiny fish swimming in the shallow water at this location. They don't show up very well in this photo.

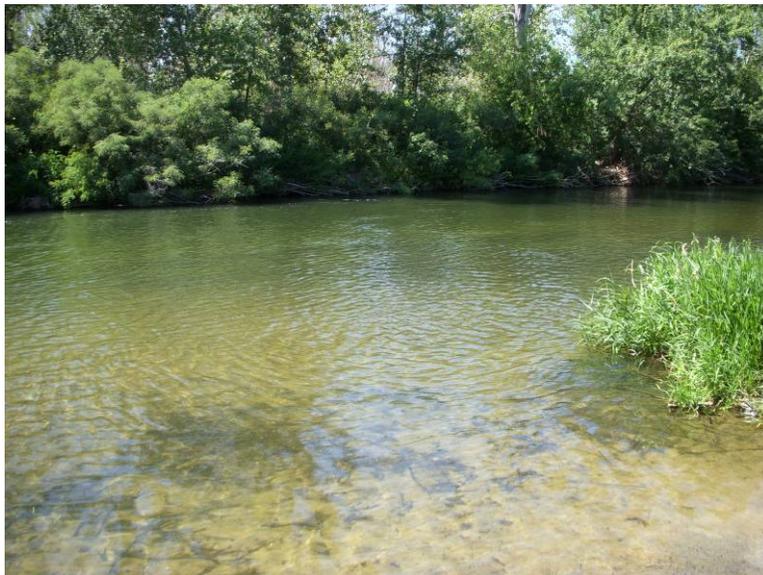
9. Lander Street Bridge on the Lower Boise River. N 43⁰ 41.311' W 116⁰ 24.806'

This photo was taken from the same location as the previous photos, looking downstream.

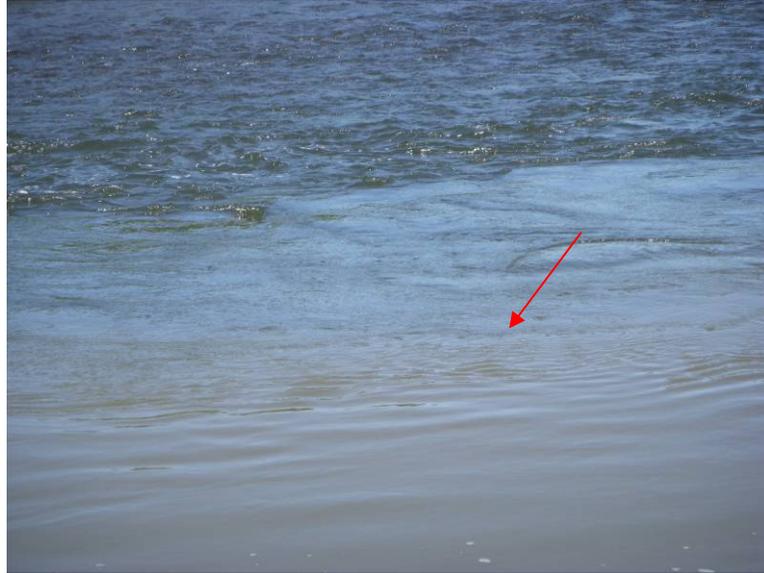
10. Sportsman Access where 15-Mile Creek enters Lower Boise River. N $43^{\circ} 41.209'$ W $116^{\circ} 35.615'$

This photo was taken standing near the confluence of 15-Mile Creek and the Lower Boise River. The turbid water in the foreground is from the creek. See Arrow.

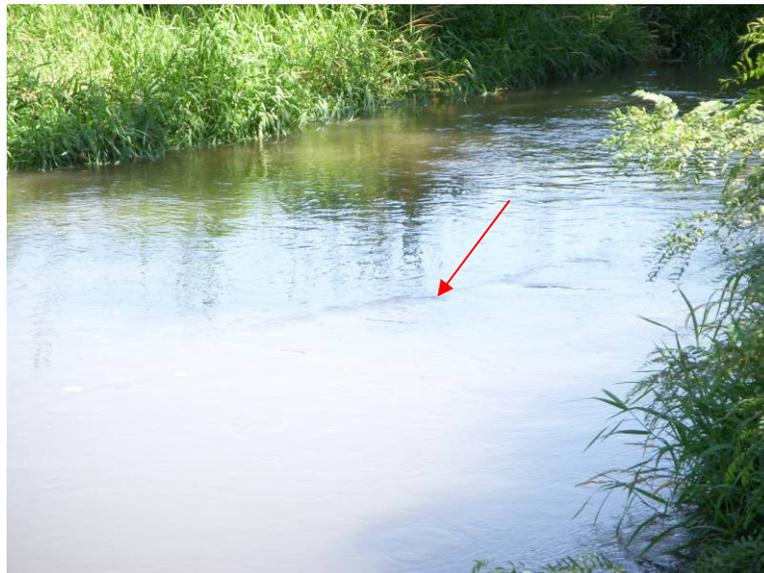
11. Sportsman Access where 15-Mile Creek enters Lower Boise River. N $43^{\circ} 41.209'$ W $116^{\circ} 35.615'$

This is another photo of 15-Mile Creek and the Lower Boise River. The turbid water in the foreground is from the creek. See Arrow.

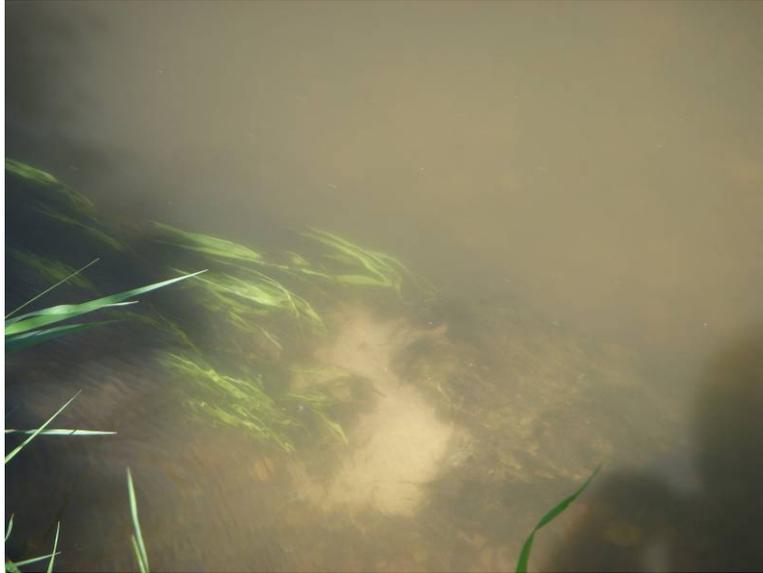
12. Sportsman Access where 15-Mile Creek enters Lower Boise River. N 43⁰ 41.209' W 116⁰ 35.615'

This photo shows a close up of the turbid water coming from the creek with some vegetation growing on the substrate in the Lower Boise River.

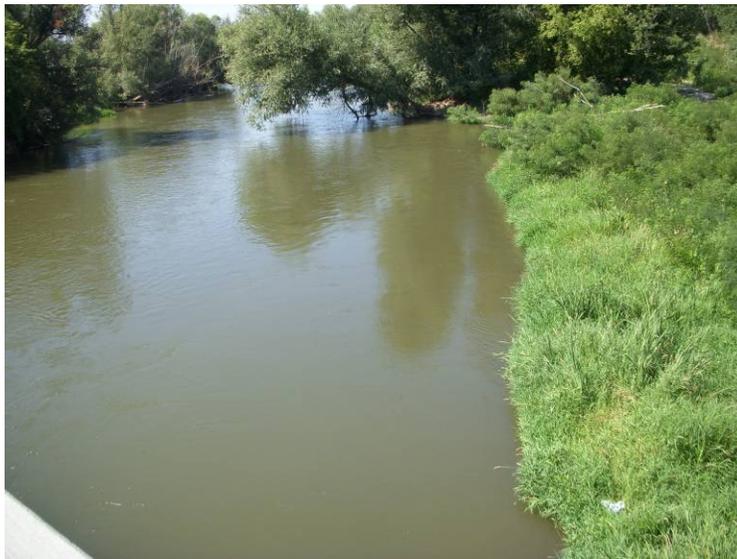
13. Lower Boise River from the bridge at Notus, Idaho. N 43⁰ 43.335' W 116⁰ 47.881'

This photo was taken from the bridge looking downstream at Notus. The water appeared to be turbid at this location.

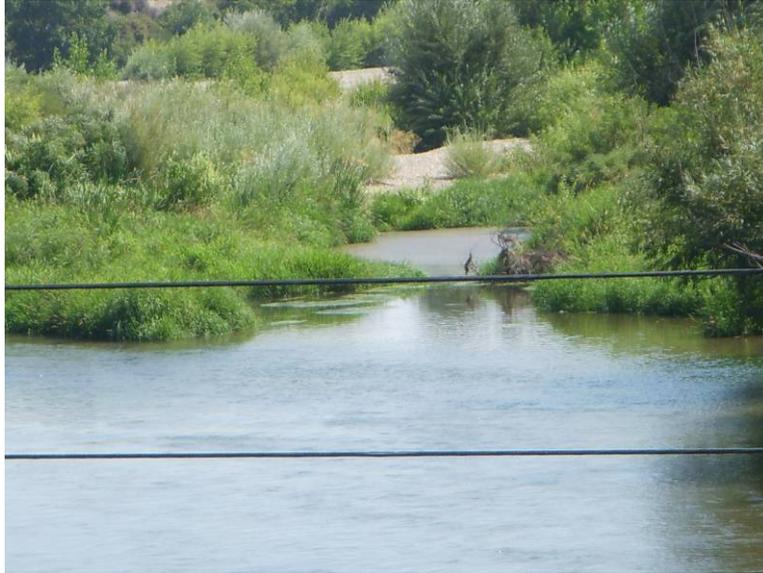
14. Lower Boise River from the bridge at Notus, Idaho. N 43⁰ 43.335' W 116⁰ 47.881'

In this picture, the Lower Boise River is in the foreground with a opening to a side channel. The side channel appeared to be full of vegetation.

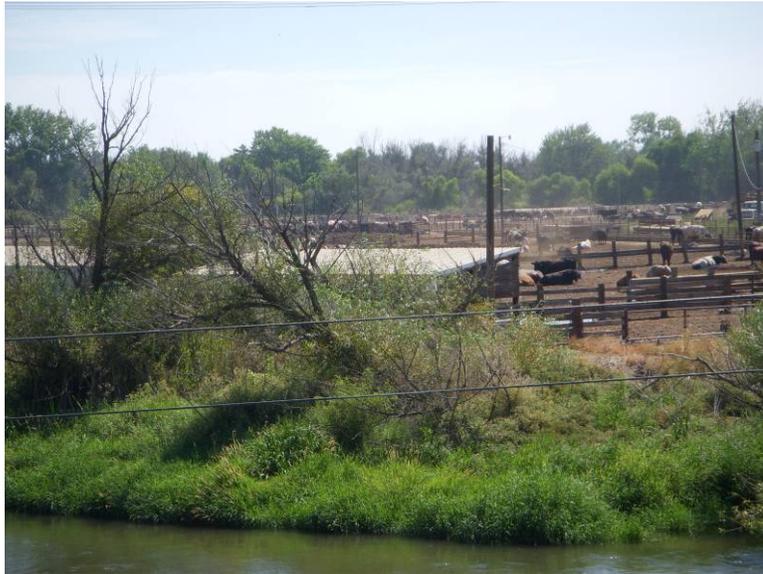
15. Lower Boise River from the bridge at Notus, Idaho. N 43⁰ 43.335' W 116⁰ 47.881'

This photo was taken from the bridge looking upstream at Notus. This feedlot was located near the bank of the river.

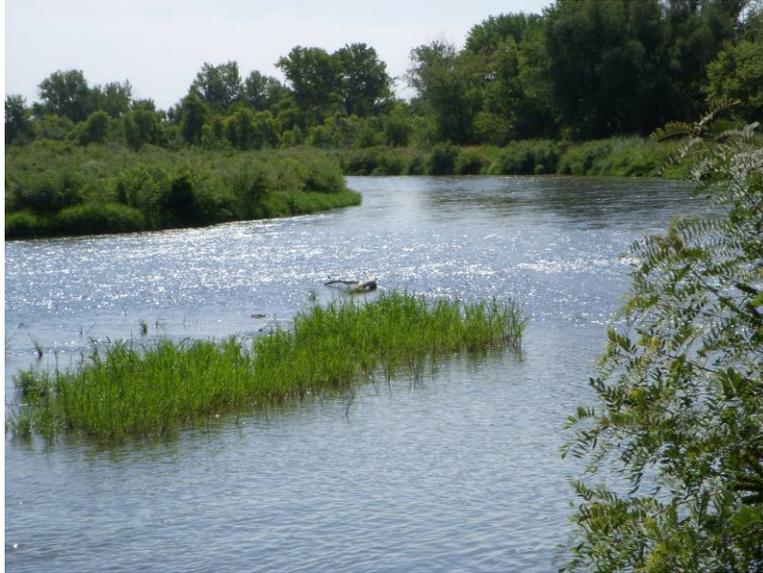
16. Lower Boise River approx. 1 mile upstream of the Parma Gage. N 43⁰ 46.699' W 116⁰ 58.355'

This photo was taken from the road looking upstream above Parma, Idaho. The water appeared to be turbid at this location. The vegetation in the center of the channel is growing from what appears to be deposited sediment in the channel.

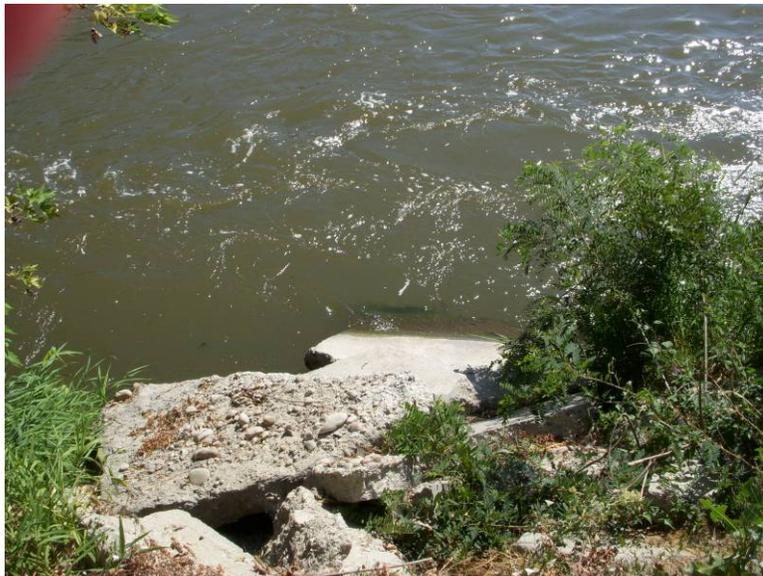
17. Lower Boise River approx. 1 mile upstream of the Parma Gage. N 43⁰ 46.699' W 116⁰ 58.355'

This photo shows the turbidity in the water at this location.

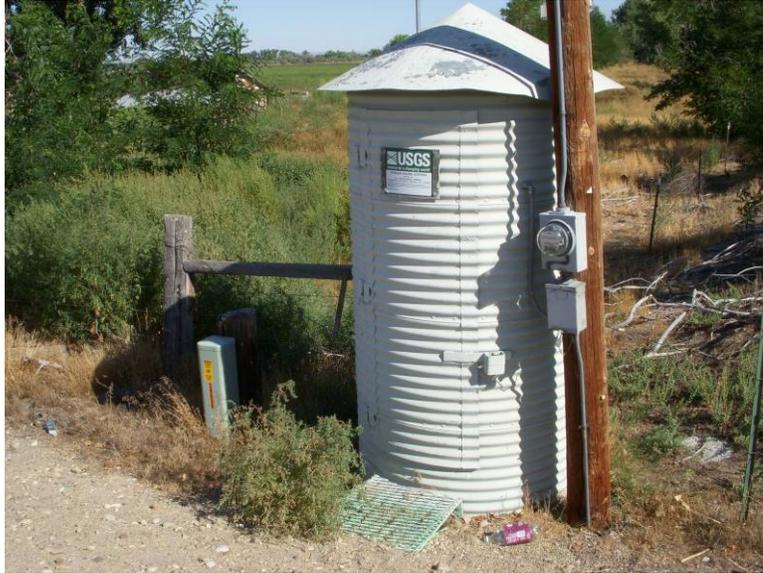
18. Lower Boise River at the Parma Gage. N 43⁰ 46.899' W 116⁰ 58.372'

This picture shows the Parma Gauge on the Lower Boise River near the Bridge at Parma.

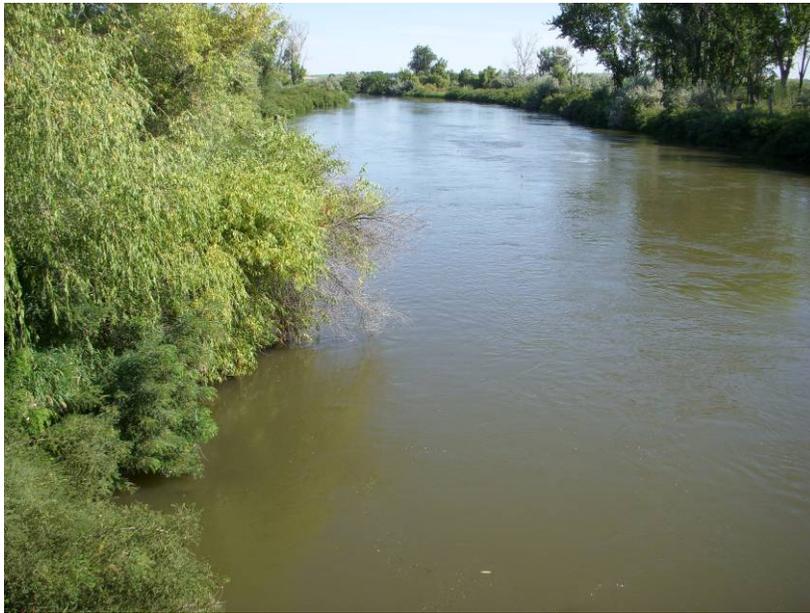
19. Lower Boise River at the Parma Gage. N 43⁰ 46.899' W 116⁰ 58.372'

This picture shows the Lower Boise River, looking downstream on the bridge at Parma. The water in this location appeared to be very turbid and it was impossible to see the substrate on the bottom of the river.

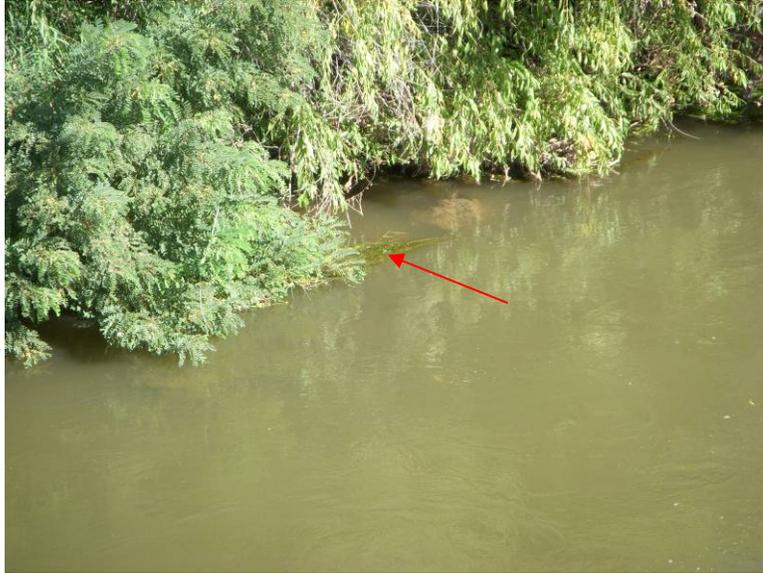
20. Lower Boise River at the Parma Gage. N 43⁰ 46.899' W 116⁰ 58.372'

This picture shows some vegetation growing near the riparian vegetation along the banks of the Lower Boise River near the Bridge at Parma.

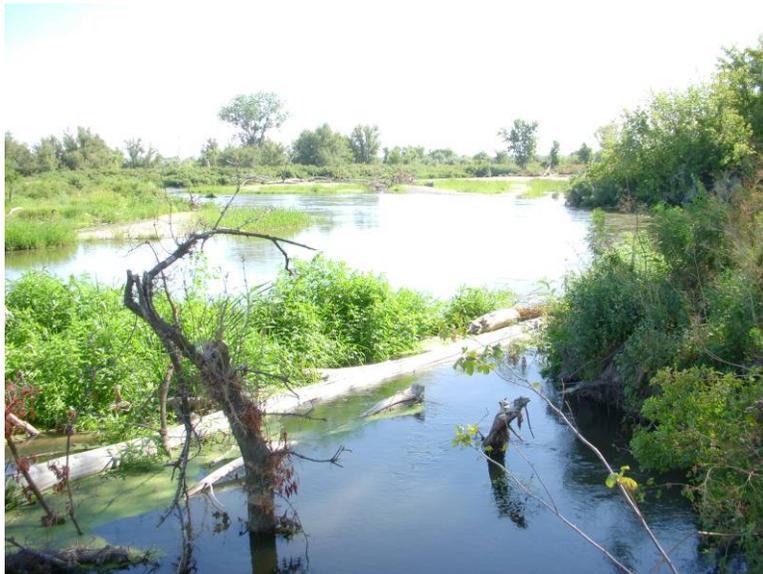
21. Sportsman Access Mouth of the Lower Boise River. N 43⁰ 48.852' W 117⁰ 01.294'

This picture was taken standing at the mouth of the Lower Boise River looking upstream. Vegetation was growing around a log jam near the mouth.

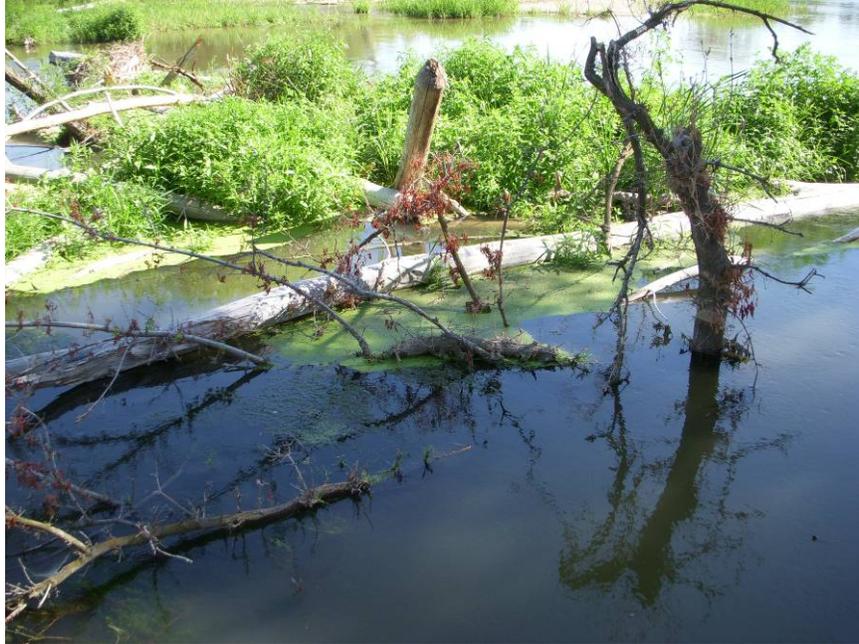
22. Sportsman Access Mouth of the Lower Boise River. N 43⁰ 48.852' W 117⁰ 01.294'

This picture was taken standing at the mouth of the Lower Boise River looking upstream. Vegetation was growing around a log jam near the mouth. Note the algae and what appears to be lemna (sp).

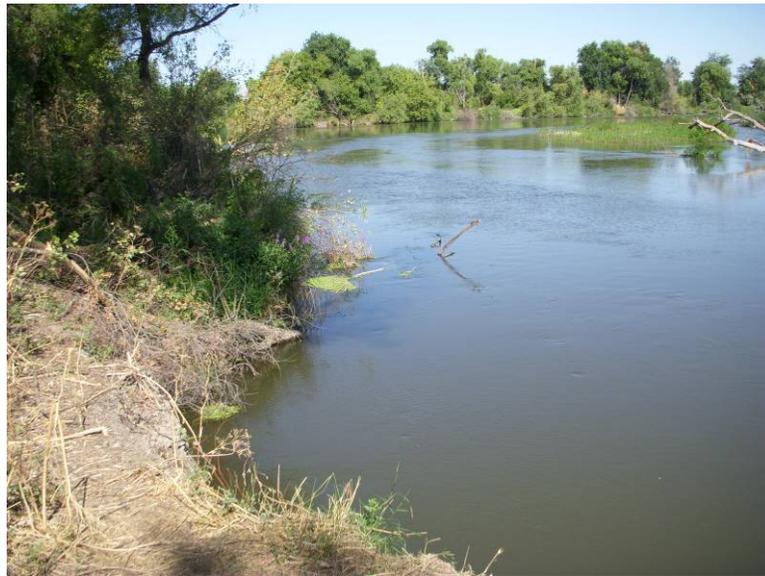
23. Sportsman Access Mouth of the Lower Boise River. N 43⁰ 48.852' W 117⁰ 01.294'

This picture was taken standing at the mouth of the Lower Boise River looking downstream to the Snake River.

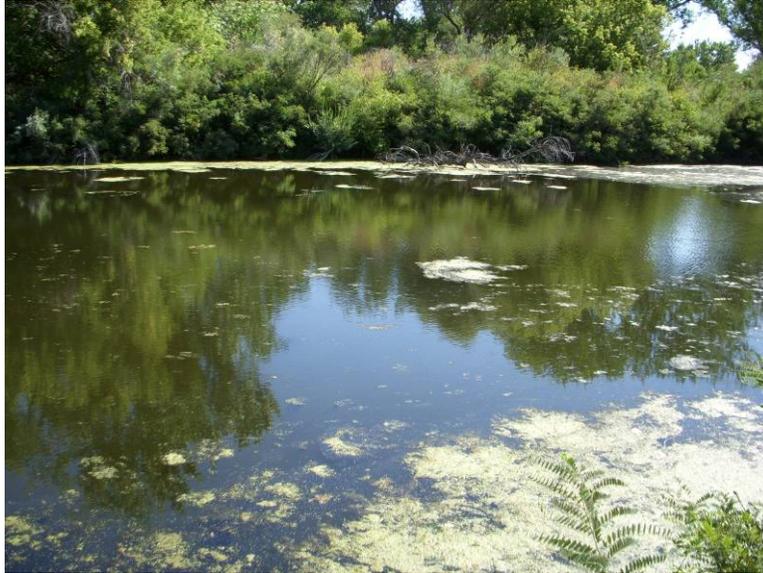
24. Lower Boise River side channel approximately 100 ft. from the mouth of the river. N 43⁰
48.722' W 117⁰ 01.331'

This picture was taken standing on a side channel very near the mouth of the river.
Vegetation was thick in the side channel and the water appeared to be very eutrophic.

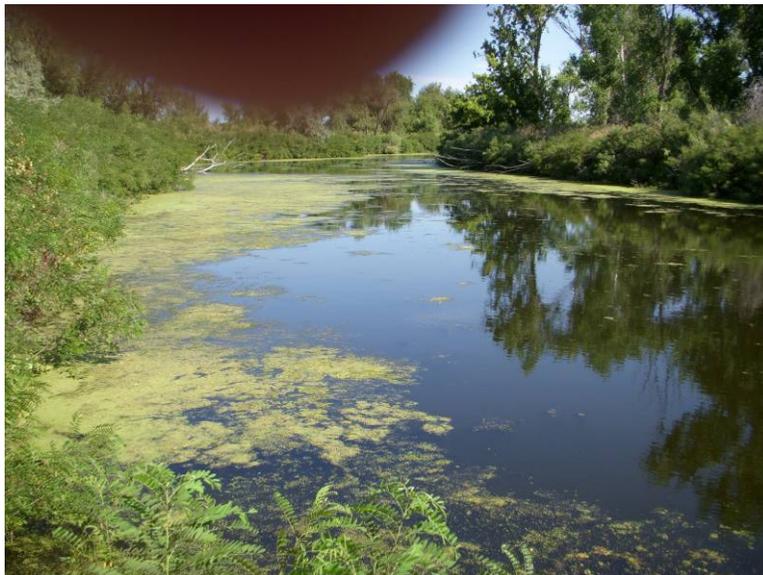
25. Lower Boise River side channel approximately 100 ft. from the mouth of the river. N 43⁰
48.722' W 117⁰ 01.331'

This picture was taken standing on a side channel looking towards the mouth of the river.
Vegetation was thick in the side channel and the water appeared to be very eutrophic.

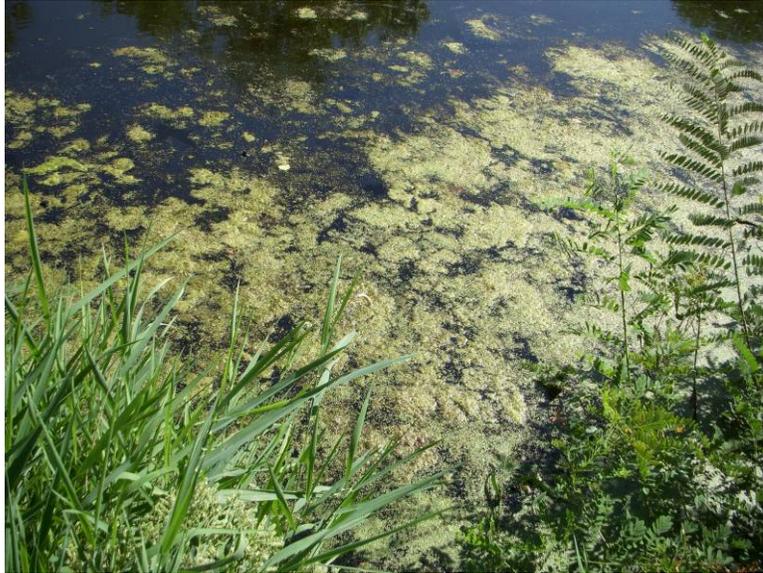
26. Lower Boise River side channel approximately 100 ft. from the mouth of the river. N 43⁰ 48.722' W 117⁰ 01.331'

This picture was taken standing on a side channel very near the mouth of the river. This is a closer view of the filamentous algae and other vegetation in the side channel.

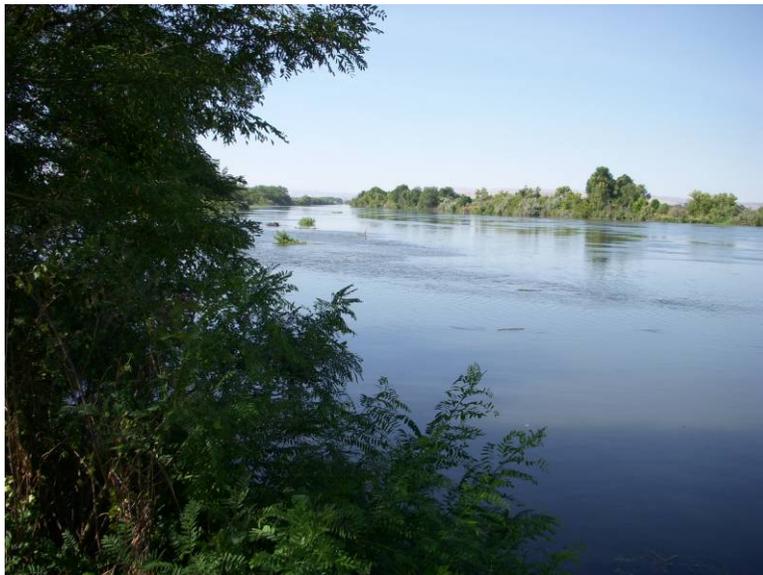
27. Snake River at Old Fort Boise approximately 1-2 miles downstream from the mouth of the Lower Boise River. N 43⁰ 49.335' W 117⁰ 01.183'

This section of the Snake River had lots of aquatic vegetation and the water was turbid.

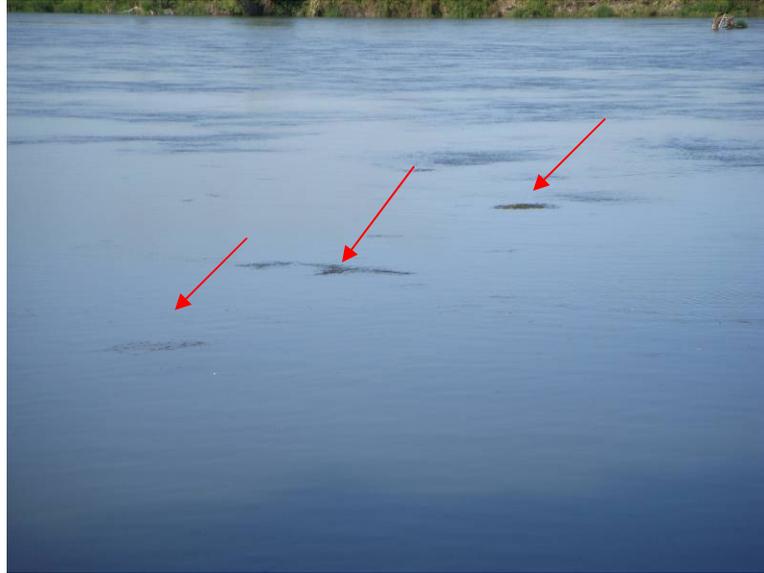
28. Snake River at Old Fort Boise approximately 1-2 miles downstream from the mouth of the Lower Boise River. N 43⁰ 49.335' W 117⁰ 01.183'

This photo shows floating mats of vegetation on the Snake River.

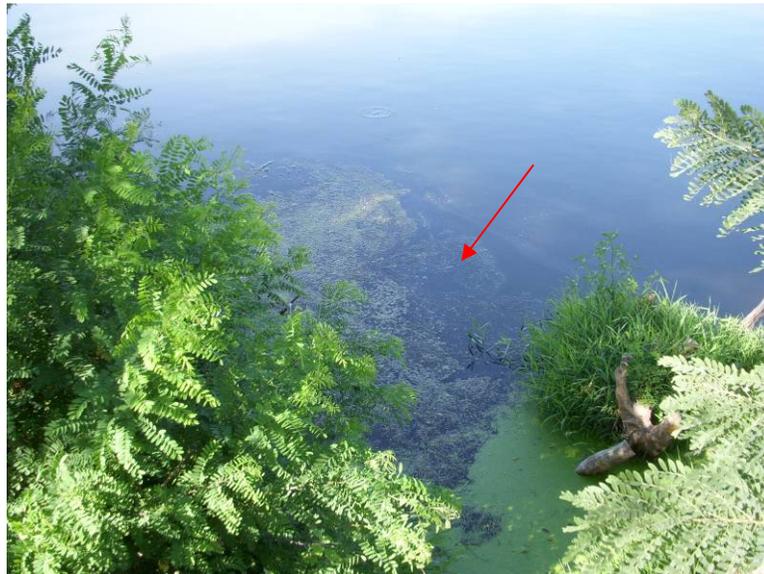
29. Snake River at Old Fort Boise approximately 1-2 miles downstream from the mouth of the Lower Boise River. N 43⁰ 49.335' W 117⁰ 01.183'

Aquatic vegetation was growing thick along the bank of the Snake River in this location.
