**Red Water Pond Road Removal Action
Church Rock Site, McKinley County, NM
Rio Algom Mining LLC**

**Conestoga Rovers & Associates Ltd.
and SENES Consultants Limited**

February 2013

RE: Red Water Pond Road (RWPR) Removal Action - Final Report

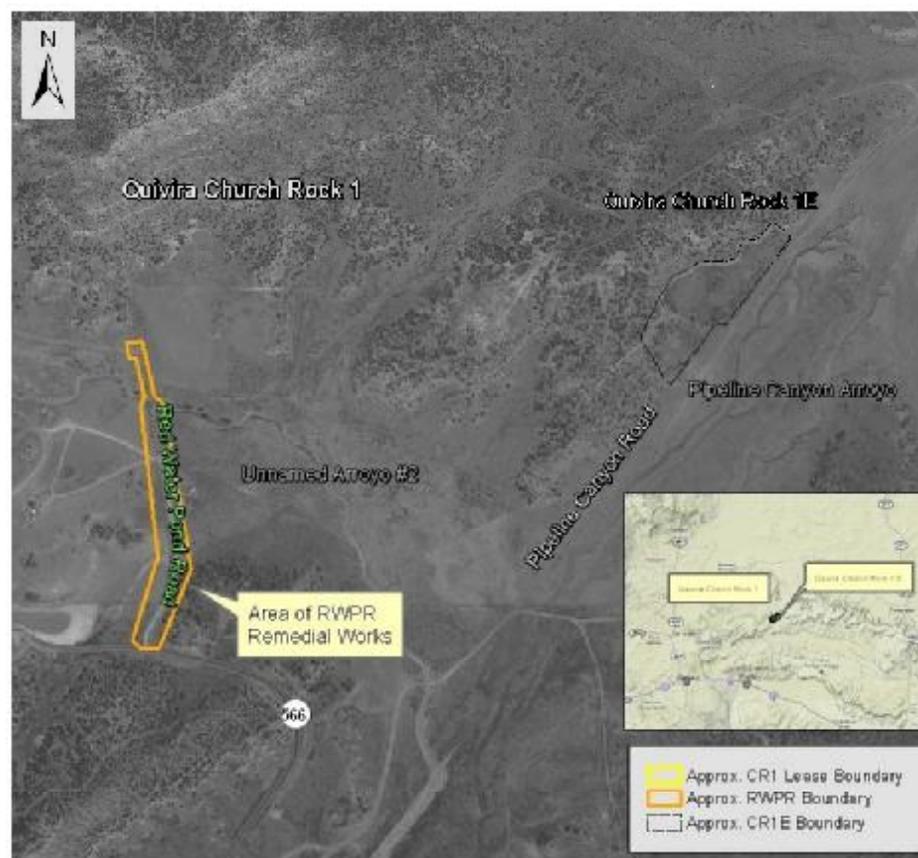
Figure 1.1 General Location of RWPR

In addition to the 1800 feet of roadway work carried out under the UOA, some earthworks were also carried out north of the bridge over the Unnamed Arroyo No.2 that generally included some excavation, regrading, and wear surface placement on the RWPR and the entrance to the CR1 site. Excavated soils and debris from the RWPR area were relocated and stored at the CR1 site in accordance with the UAO requirements. Figure 1.1 is an approximate area of the RWPR Removal Action.

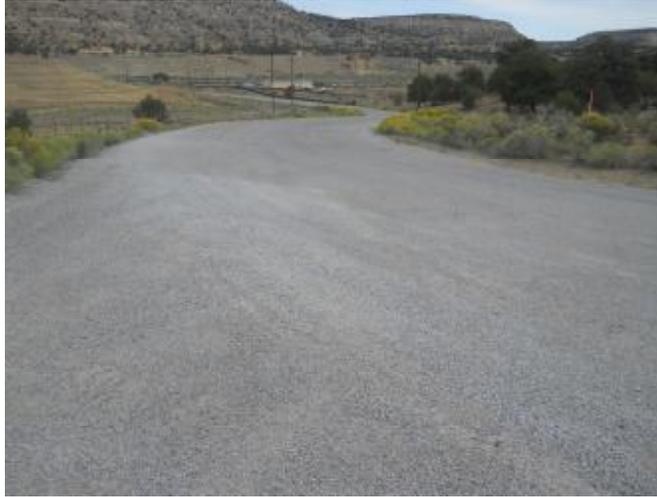
Photograph 1 - Red Water Pond Road Area – Pre-reclamation (looking N)

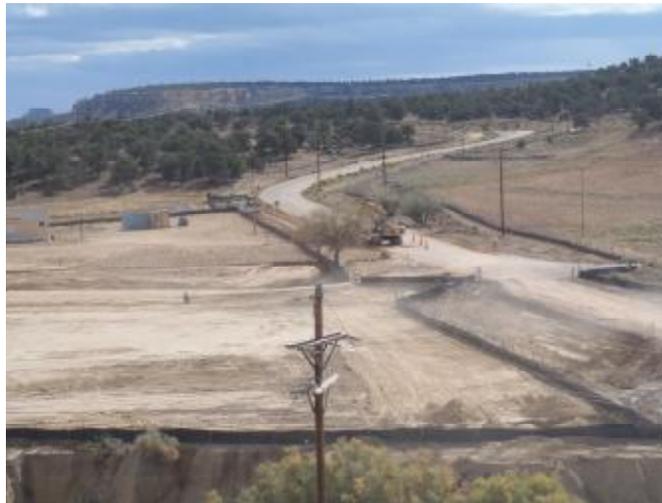
Photograph 2 – Red Water Pond Road Area – Looking S from CR1

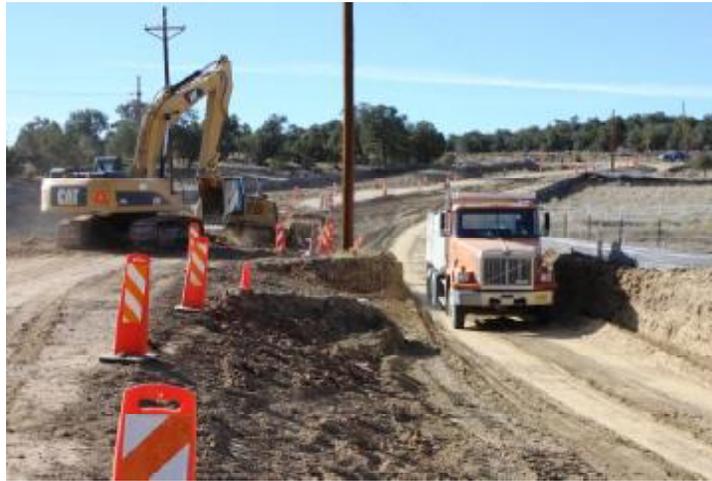
Photograph 3 – West side of RWPR Area at Culvert 1

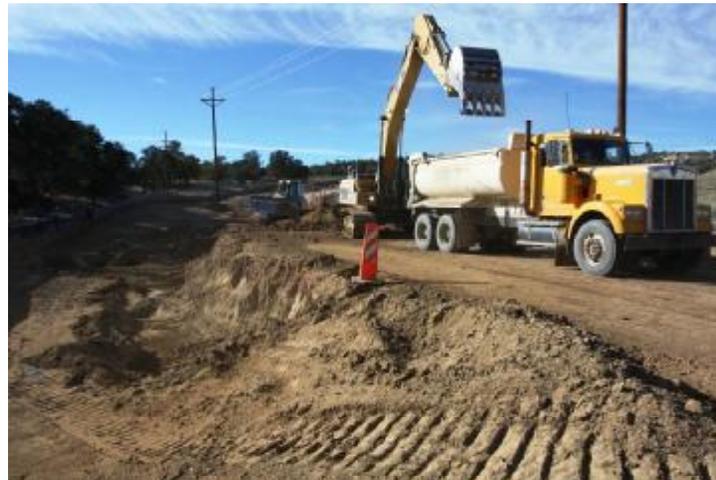
Photograph 4 – Cut on east shoulder of RWPR Area above culvert (looking S)

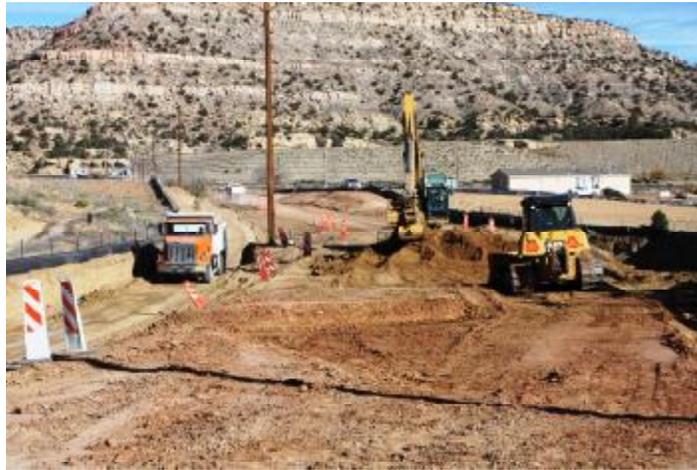
Photograph 5 – Road removal (looking N)

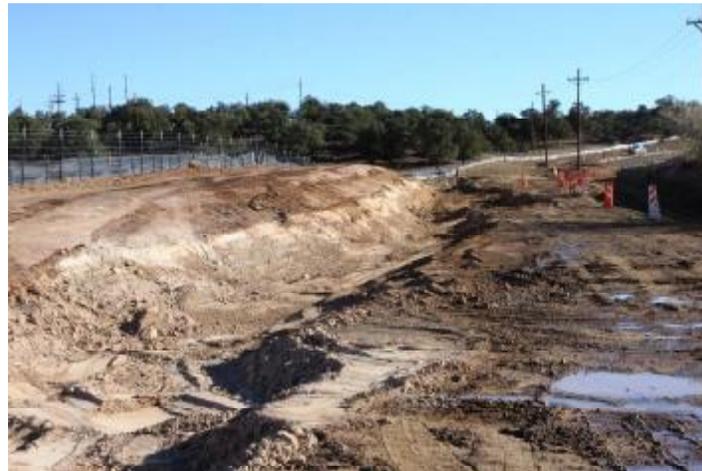
Photograph 6 - East shoulder of RWPR Area below Culvert No. 1 (looking S)

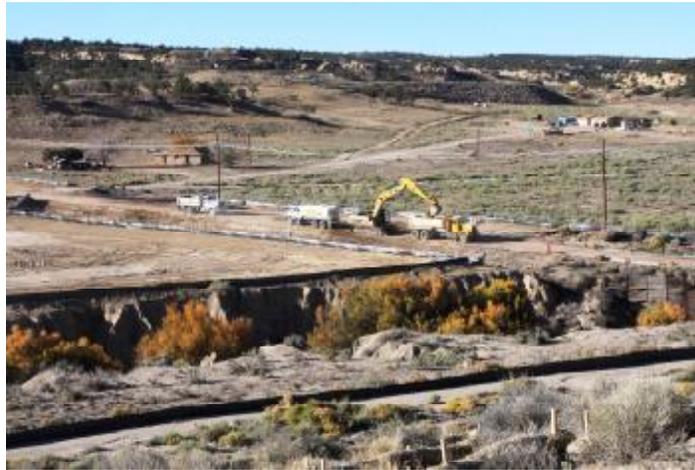
Photograph 7 – Excavation of road south of bridge

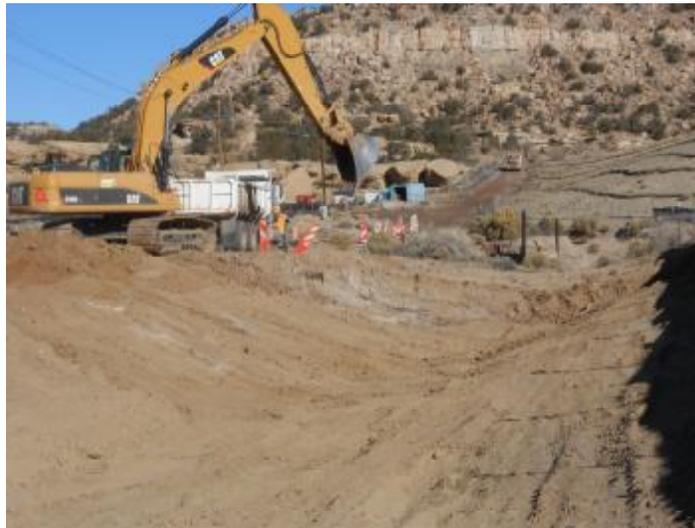
Photograph 8 – Excavation of east shoulder of RWPR Area above arroyo

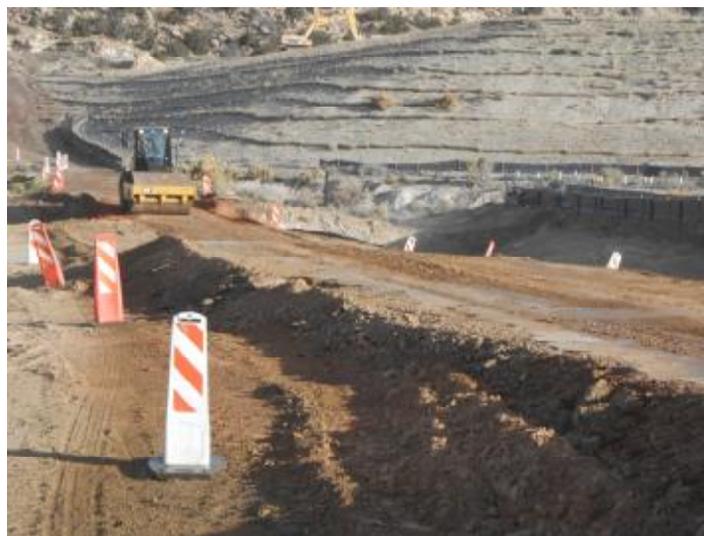
Photograph 9 – Making the road traffic worthy before weekend shutdown

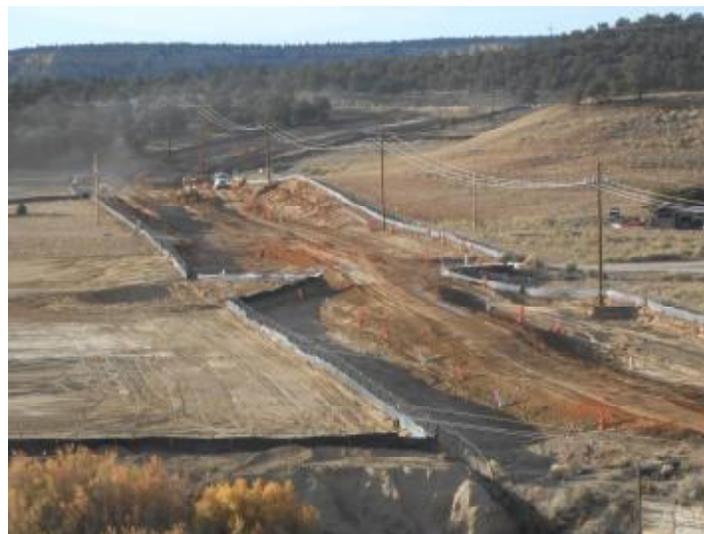
Photograph 10 – View of RWPR and shoulder excavation (looking S)

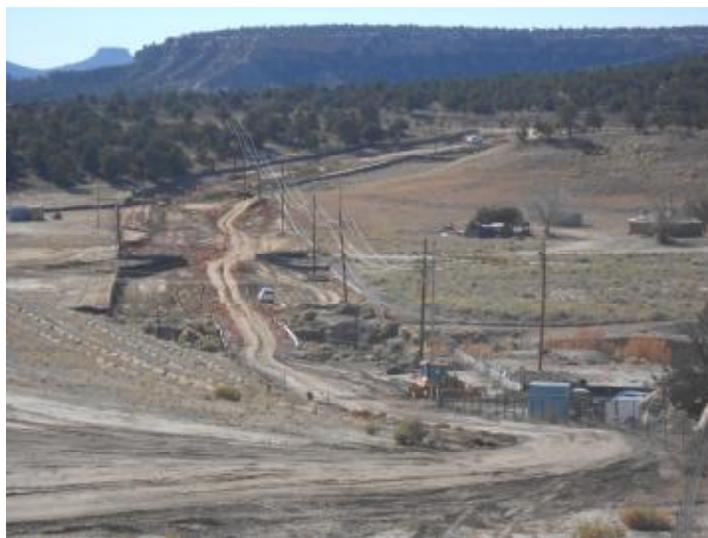
Photograph 11 – Final road excavation prior to fill placement (looking S)

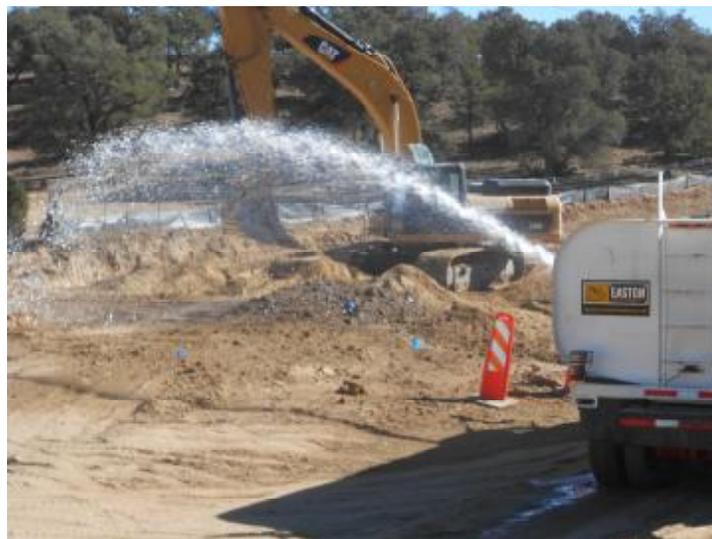
Photograph 12 – Dust control measures

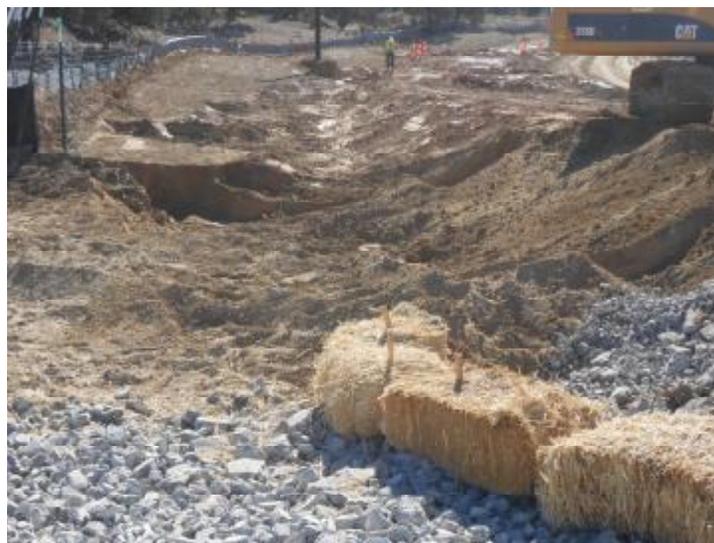
Photograph 13 – Excavation of east shoulder drainage to outlet of Culvert 1

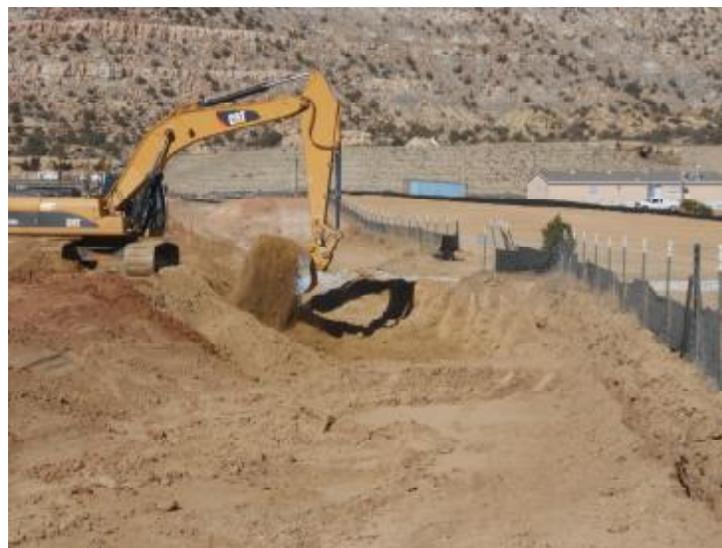
Photograph 14 – Final shoulder excavation above Culvert 1

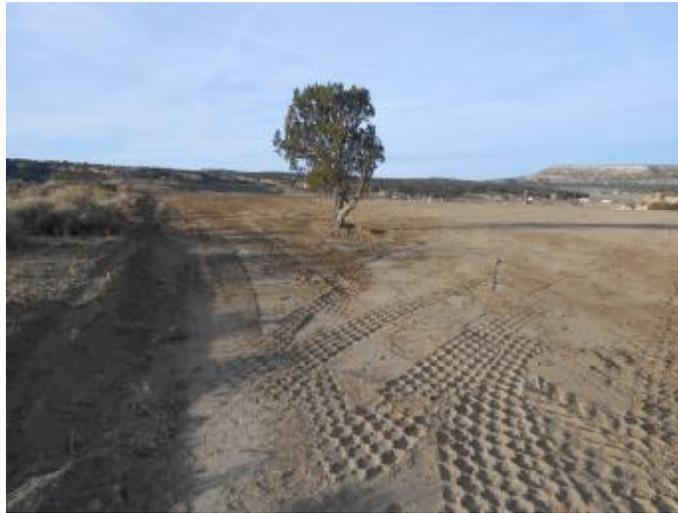
Photograph 15 – Disposal material site at CR-1

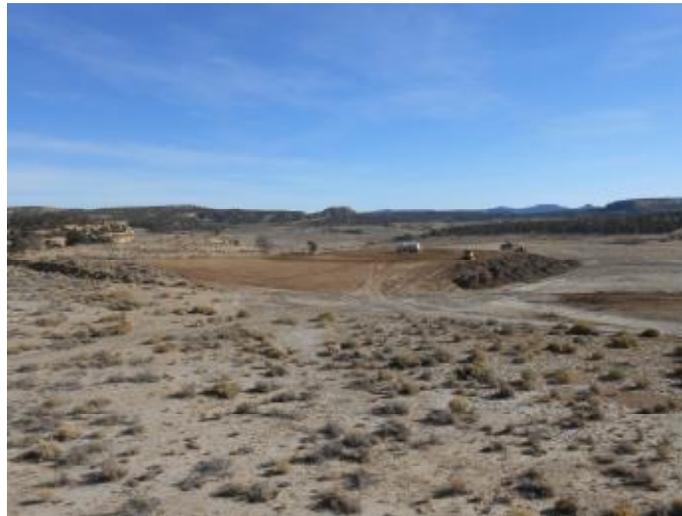
Photograph 16 – Disposal area at CR-1 (looking SE)

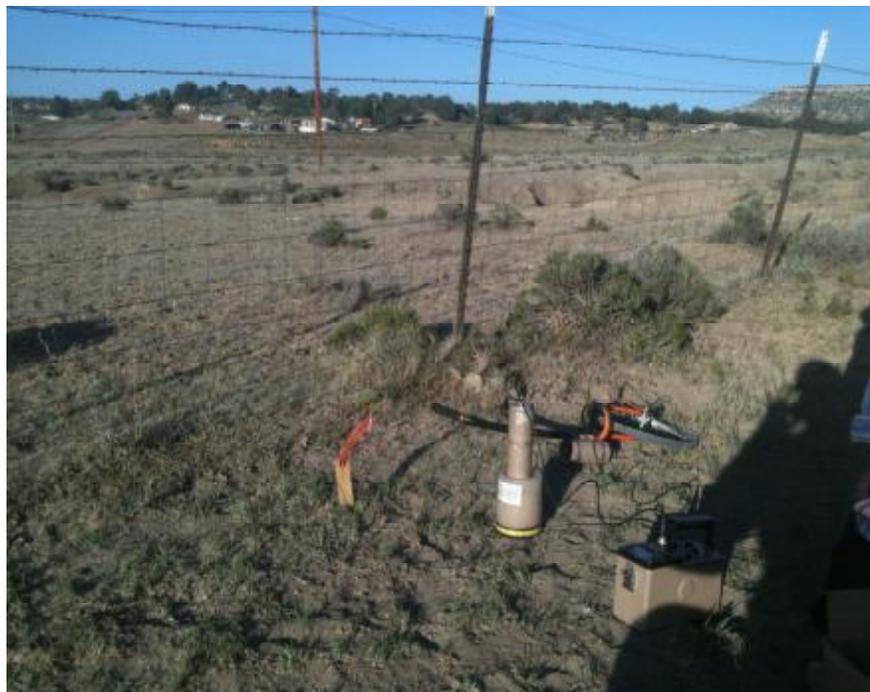
Figure B1-1 Check Location for Ludlum 2221

A specific on-site location was chosen to perform the function range check, daily background and daily function checks for the Ludlum 2221 with 44-10 used for gamma radiation levels at the site to minimize differences in readings due to background radiation.

Note: Picture was taken in May 2012 (This location used in October 2012 during RWPR Remediation).

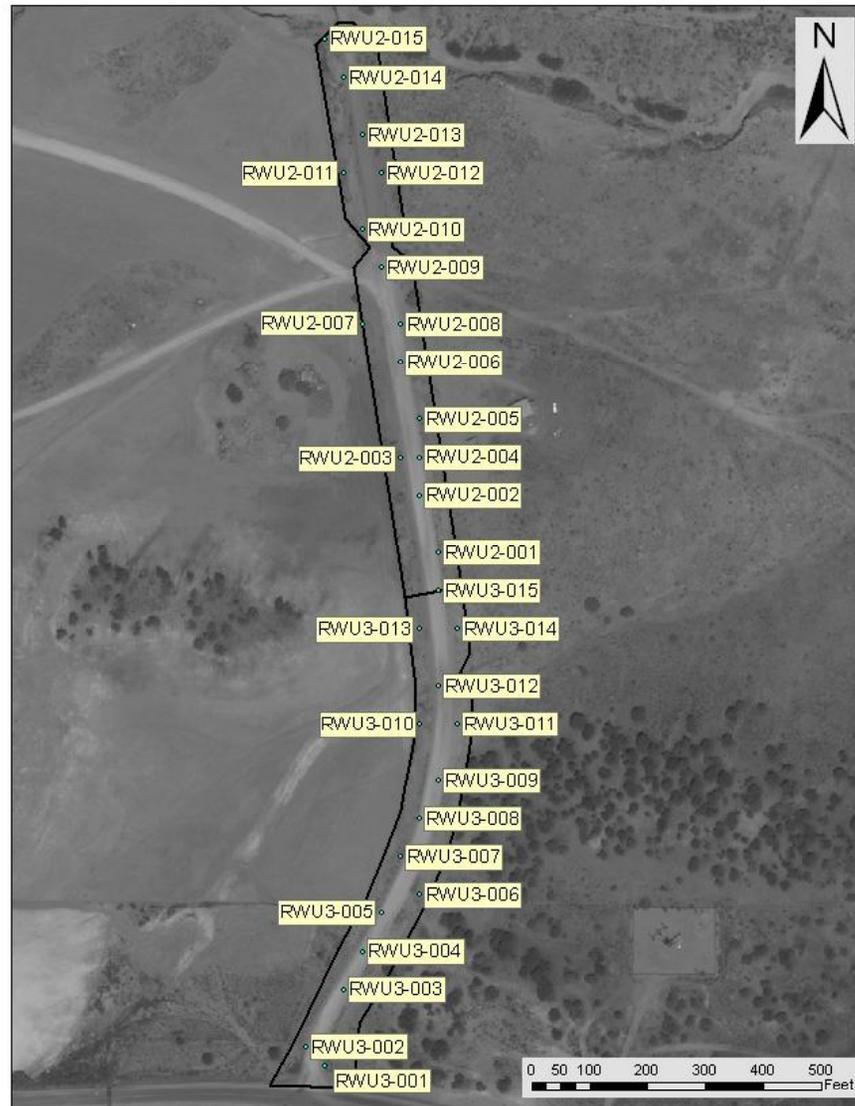
Plate B2-1 Confirmatory Soil Sample Locations

Plate B2-1 in Appendix B shows the random soil sampling locations were specified for the two survey units south of the Unnamed Arroyo #2 Bridge with an intended number of fifteen (15) samples per survey unit. A five-spot composite sample of the 0 to 6 inch layer was collected from selected 10 m by 10 m blocks from the center sample plus four locations 1 meter inside each of the corners as per the approved Work Plan (SENES, 2012).

Soil sampling locations were specified for the two survey units south of the Unnamed Arroyo #2 bridge with an intended number of fifteen (15) samples per survey unit. A five-spot composite sample of the 0 to 6 inch layer was collected from selected 10 m by 10 m blocks from the center sample plus four locations 1 meter inside each of the corners. At each of the five locations, a grab sample of about 2 pounds was collected from the top 0 to 6 inch soil horizon and was placed in a stainless steel mixing pole. Many samples had variation in the type of soil ranging from sandy materials, to loose shales to soils with a high silt content.

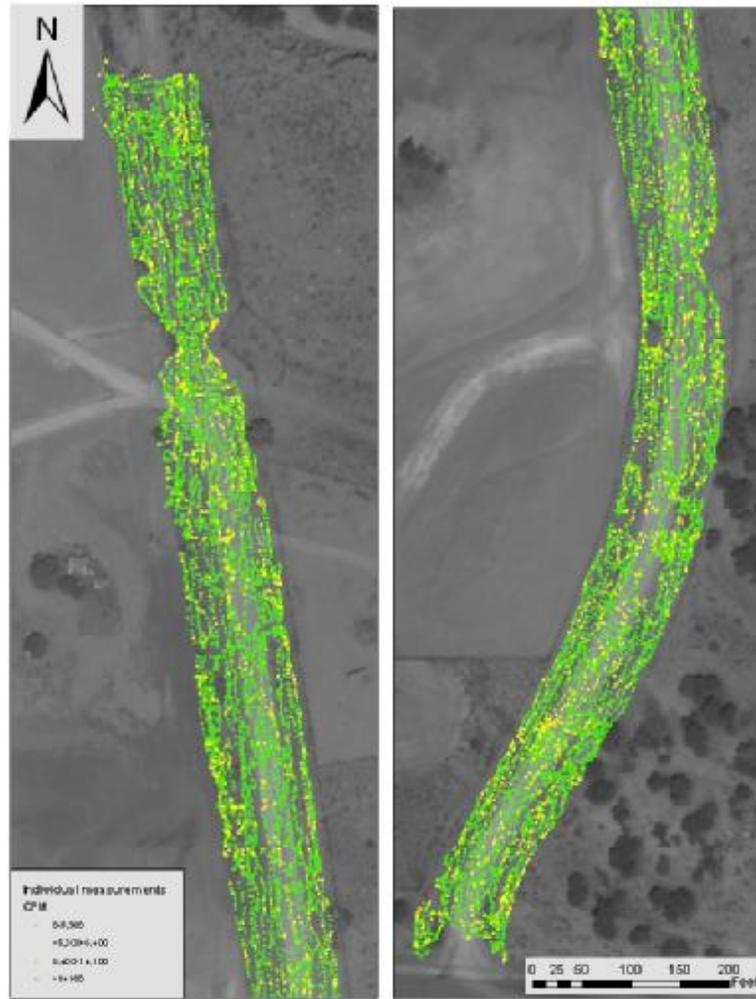
Plate B2-2 Individual Gamma Radiation Count Rates Following Remediation

Table B2-6 shows the summary statistics of the scanning gamma radiation measurements used for verification. All blocks within the remediated area met the field verification criteria

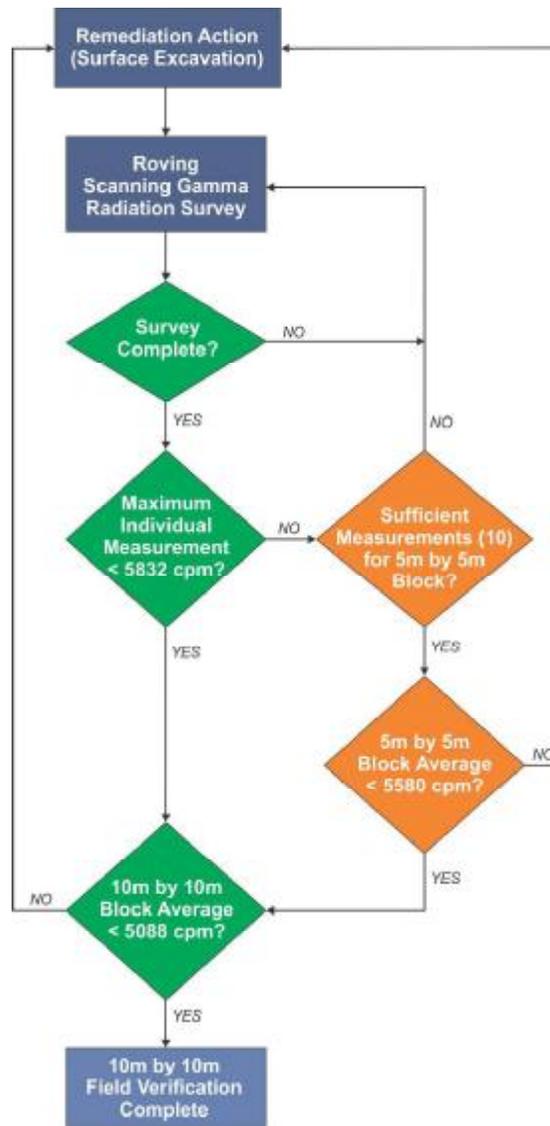
Figure B3-1 Logic for Field Verification Assessment Using Gamma Radiation Measurements

For final reporting purposes, a soil sampling program was conducted to confirm that the soil criterion was met. The MARSSIM Wilcoxon test indicated that the two survey units below the Unnamed Arroyo #2 bridge met the UAO criterion and the assessment using gamma radiation was confirmed.

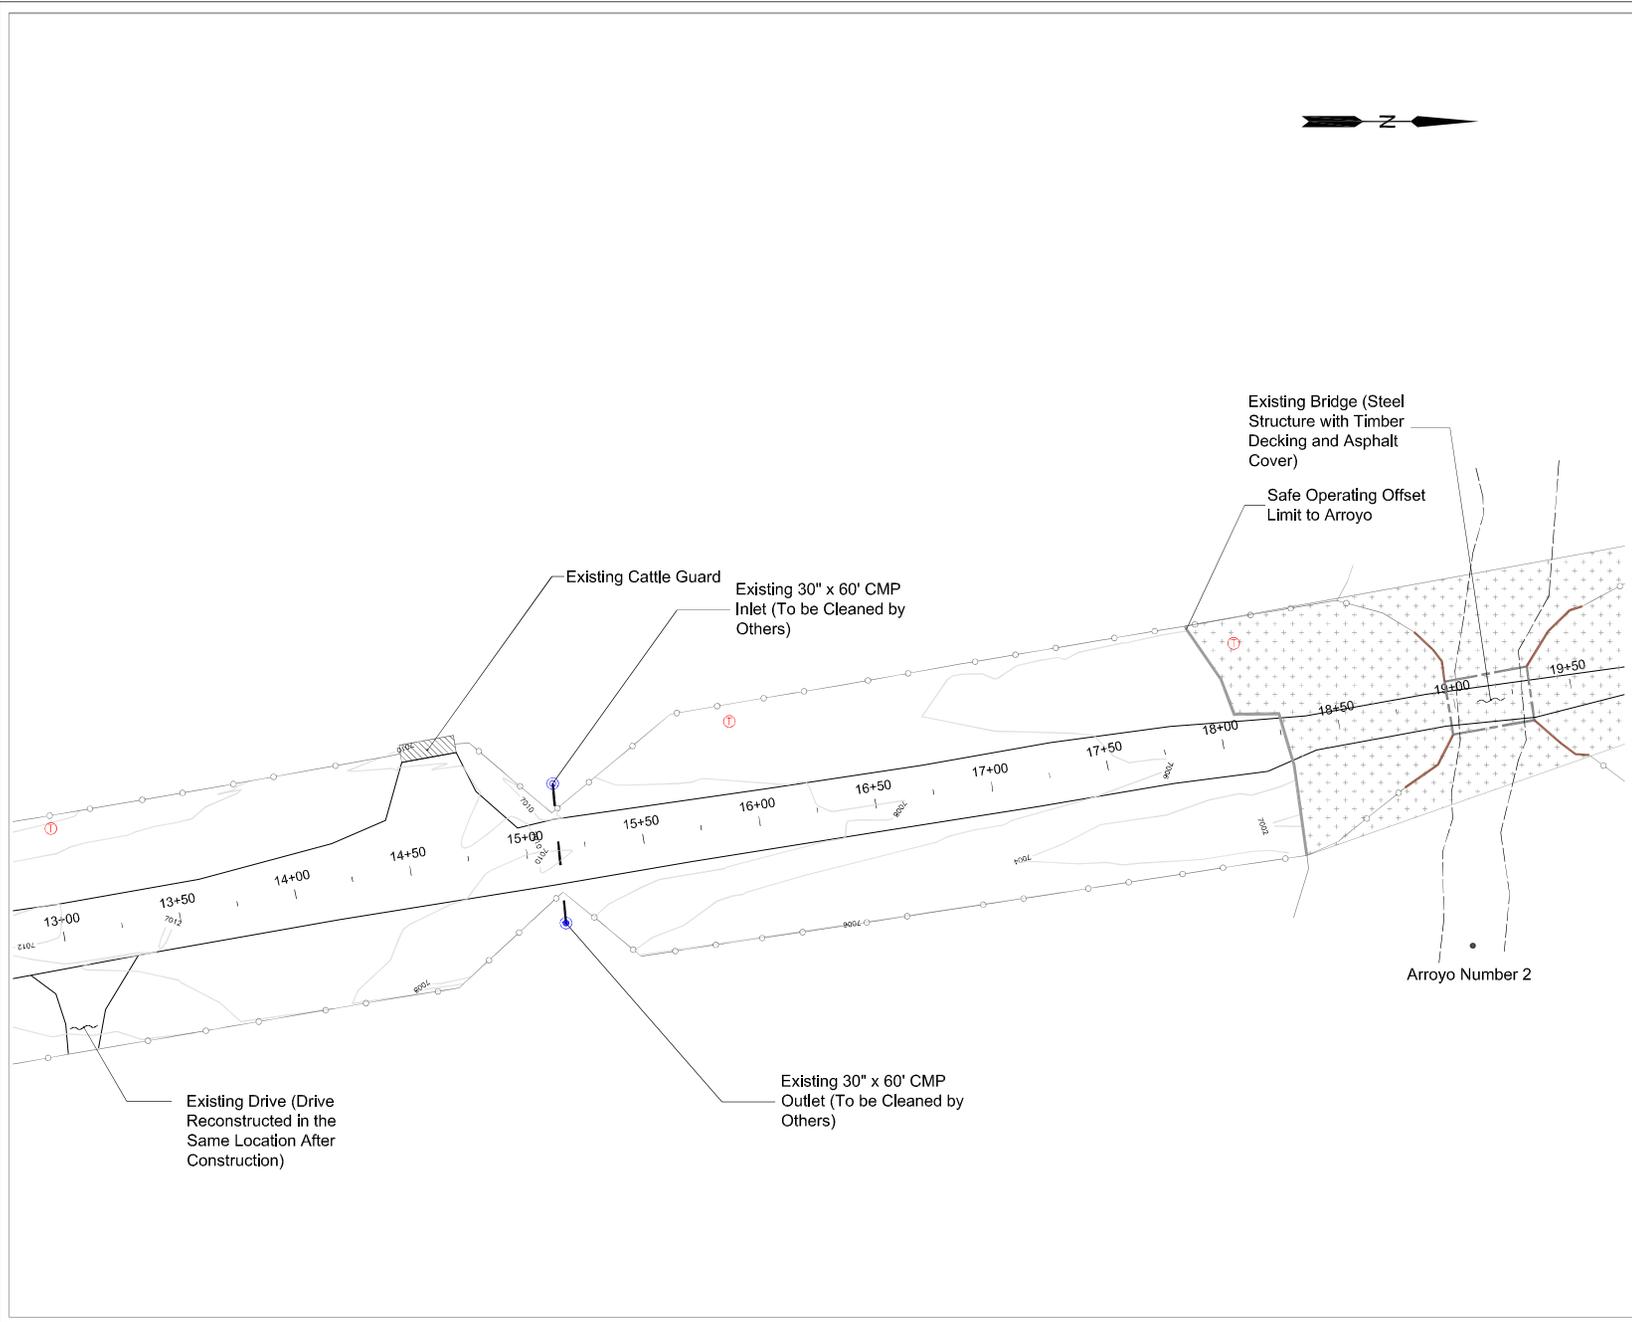
The existing storm water conveyance culvert (Culvert No. 1) was removed and replaced with a 30 inch culvert. The captured drainage water tied into the outlet drainage riprap work completed by UNC on the Eastern Drainage. An additional 24 inch culvert was installed in the road shoulder that collects water upgradient in the east shoulder of the road and drains into the No. 1 culvert outlet channel. The surface water conveyance controls as constructed are shown on Drawings AB 3 and AB 4 of the As Built drawings (see Appendix C).

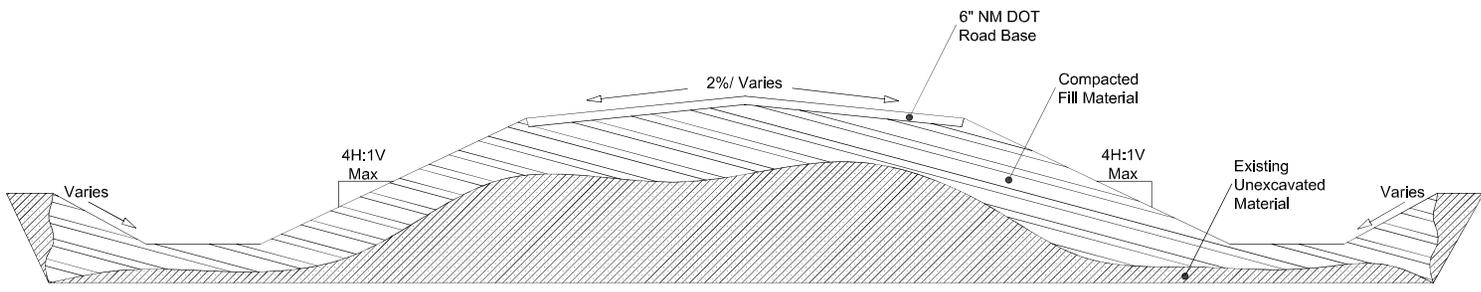
Typical Road Cross Section Detail
(Exaggerated and Not To Scale)

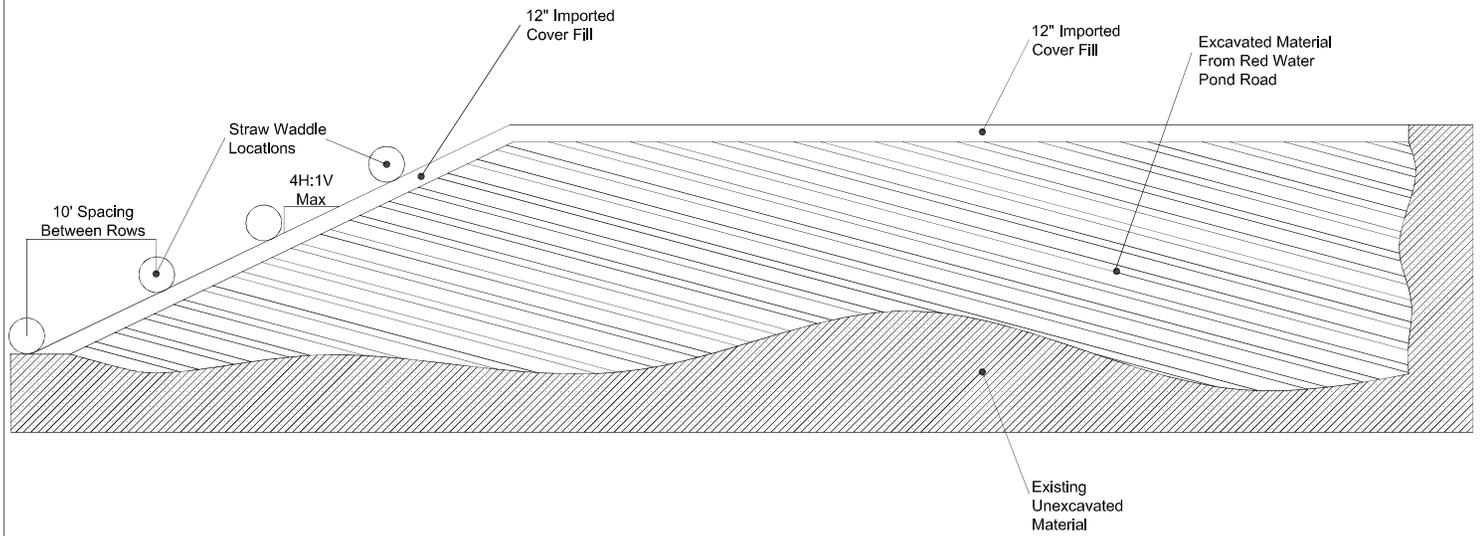
Disposal Area Cap Cross Section Detail
(Exaggerated and Not To Scale)
