APPENDIX J
Construction Photos

MUSCOY OPERABLE UNIT REMADAL DESIGN
WA NO. 014 - RDRD. 09JS

I - 215 AND BNSF UNDERCROSSING
SAN BERNARDINO, CALIFORNIA

PHOTO LOG - JOBSITE

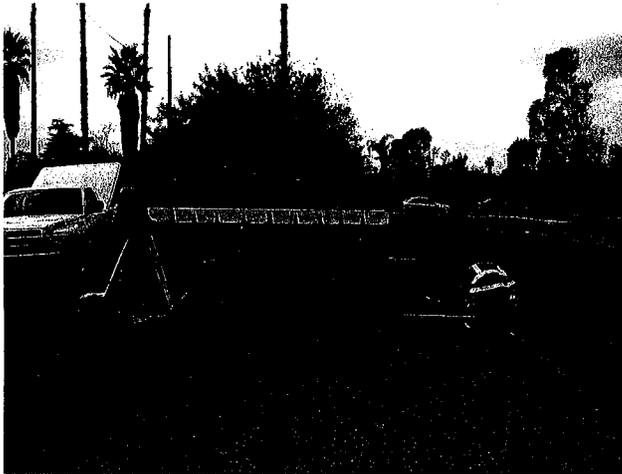
06-Dec-04 (Photo No. 4)
Jobsite before jack and bore construction starts on W. 10th Street, center of street. Started survey staking and layout of 20-inch DIP and Bore pit.

Jobsite before Jack and Bore construction starts on W. 10TH Street, center of street started survey staking and layout of 20 inch DIP and Bore pit.

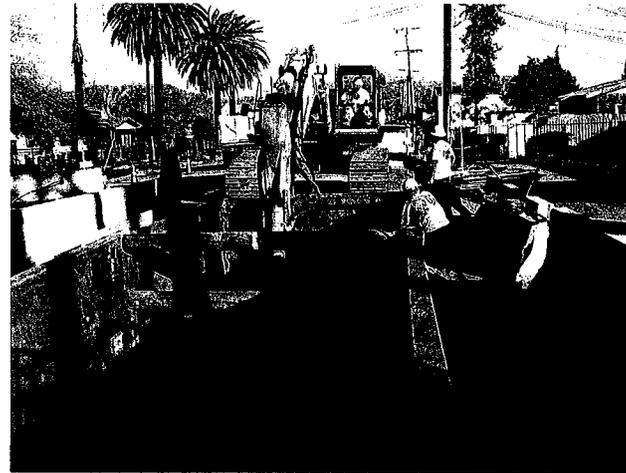
10-Dec-04 (Photo No. 21)
Setting the shoring boxes into location on East half of bore pit and installing lockpins to lock shoring boxes together.

Setting the shoring boxes into location on East half of Bore pit and installing lockpins to lock shoring boxes to each other.

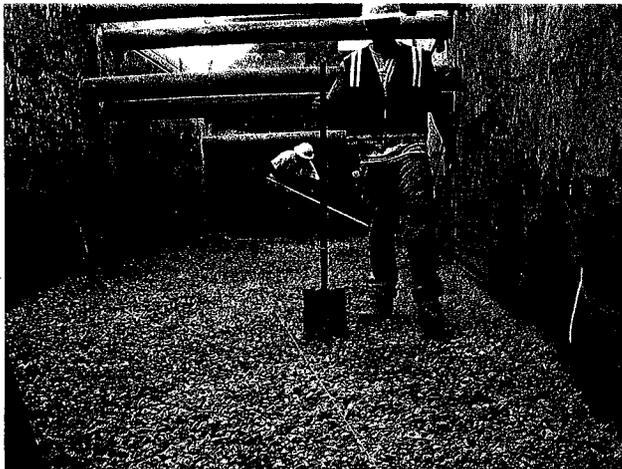
13-Dec-04 (Photo No. 25)
Fine grading the gravel on the bottom of the bore pit for working surface for bore equipment.

Fine grading the gravel on the bottom of the Bore pit for working surface for Bore equipment.

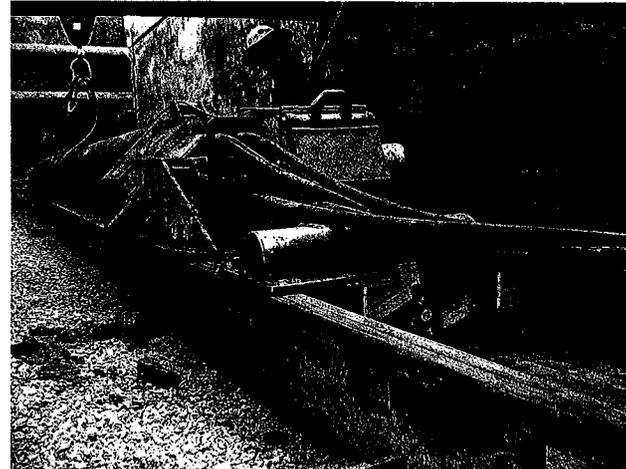
21-Dec-04 (Photo No. 35)
Continuing to set the auger and steel casing in place to connect to the Jack and Bore equipment at W. 10th Street bore pit.

Continuing to set the auger and steel casing in place to connect to the Jack and Bore equipment at W. 10TH Street Bore pit.

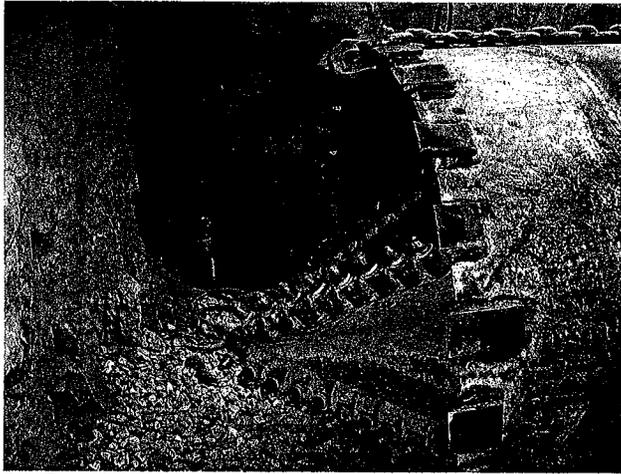
21-Dec-04 (Photo No. 37)
Cutting heads of both the 36-inch steel casing and the 32-inch auger before the jack and bore operation starts at W. 10th Street.

Cutting heads of both the 36 inch steel casing and the 32 inch auger before the Jack and Bore operation starts at W. 10TH Street.

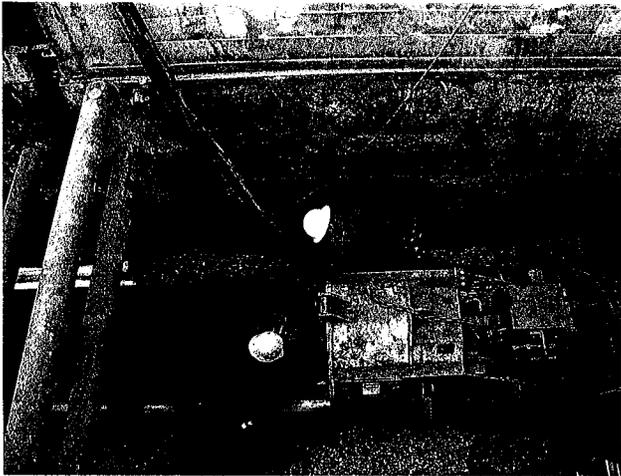
22-Dec-04 (Photo No. 46)
Connecting the auger inside the 36-inch steel casing to the jack and bore rig at W. 10th Street.

Connecting the auger inside the 36 inch steel casing to the Jack and Bore rig at W. 10TH Street.

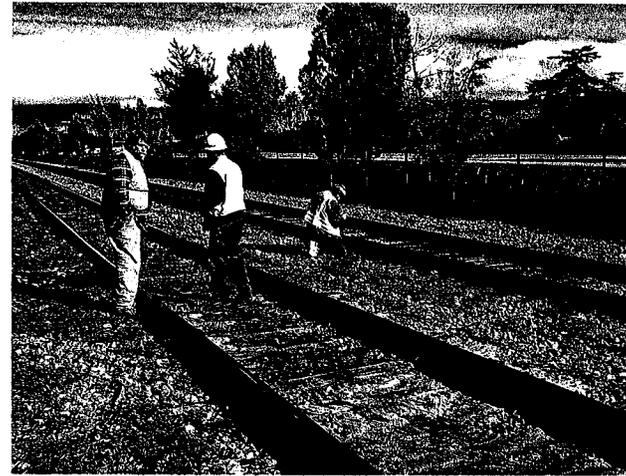
30-Dec-04 (Photo No. 59)
Setting survey markers on the BNSF Railroad tracks before the jack and bore operation bores under the Railroad property.

Setting survey markers on the BNSF Railroad tracks before the Jack and Bore operation bores under the Railroad property.

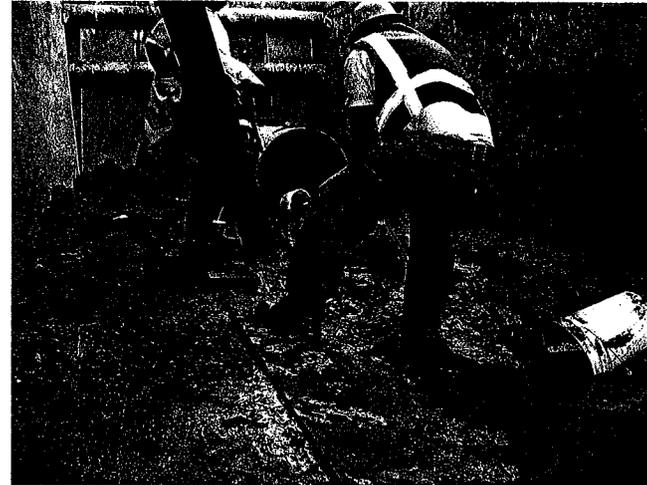
15-Jan-05 (Photo No. 65)
Continuing to clean 36-inch casing, removing saturated soils and water with hand buckets in the W. 10th Street bore pit.

Continuing to Clean 36 inch casing removing Saturated soils and water with hand buckets in the Bore pit at W. 10TH Street.

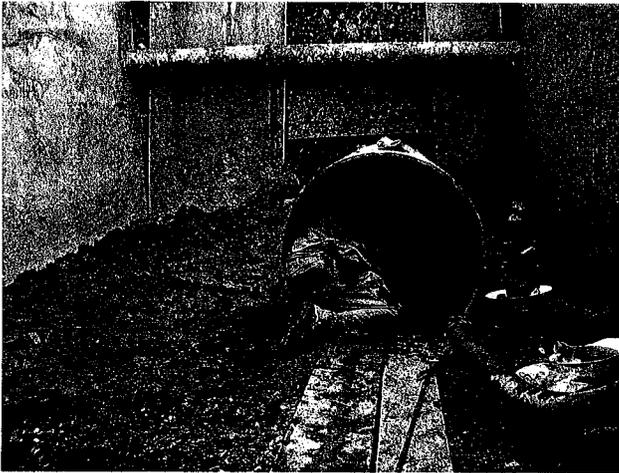
17-Jan-05 (Photo No. 66)
Started to pressure grout the outside edge of the 36-inch steel casing starting at the receiving pit working to the W. 10th Street bore pit.

Started to pressure grout the outside edge of the 36 inch steel casing starting at the receiving pit working to the Bore pit at W. 10TH Street.

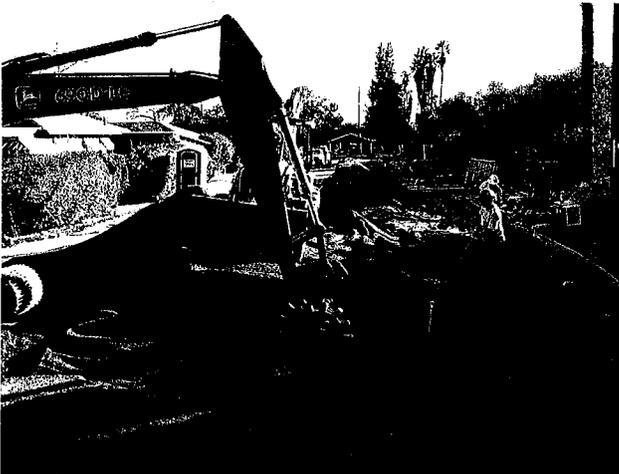
19-Jan-05 (Photo No. 71)
Shoring was removed from the bore pit and backfilled and compacted with imported base material at W. 10th Street.

- I - 215 and BNSF Undercrossing
19-Jan-05
Station No. 148+25
Looking South
Photo No. 71 CD No.3
Shoring was removed from the Bore pit and and backfilled and compacted with imported base material at W. 10YH Street.

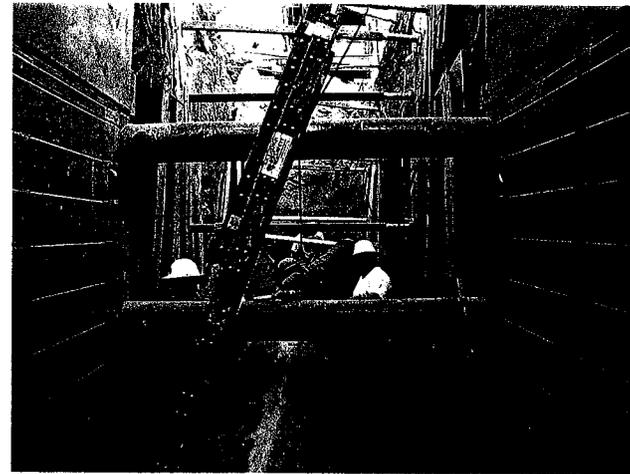
25-Jan-05 (Photo No. 76)
Continuing to level and weld the 20-foot joints of 36-inch steel casing in the trench line at W. 10th Street.

Continuing to level and weld the 20 foot joints of 36 inch steel casing in trench line at W. 10TH Street.

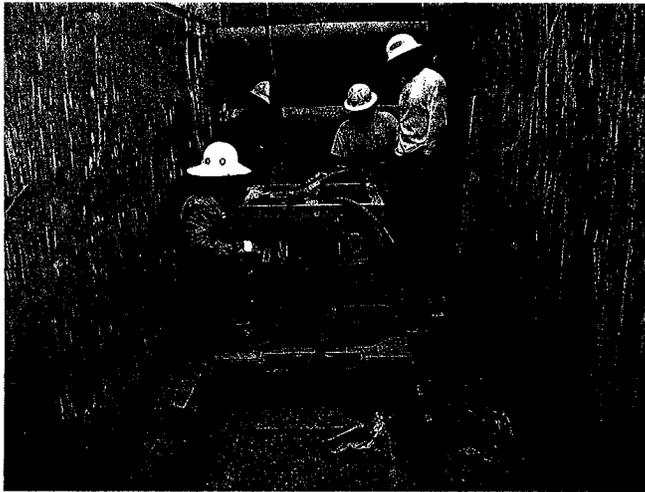
31-Jan-05 (Photo No. 81)
Continuing to push the 20-inch DIP carrier pipe with jacking equipment in the 36-inch casing in jacking pit at W. 10th Street.

Continuing to push the 20 inch DIP carrier pipe with Jacking equipment in the 36 inch casing in Jacking pit at W. 10TH Street.

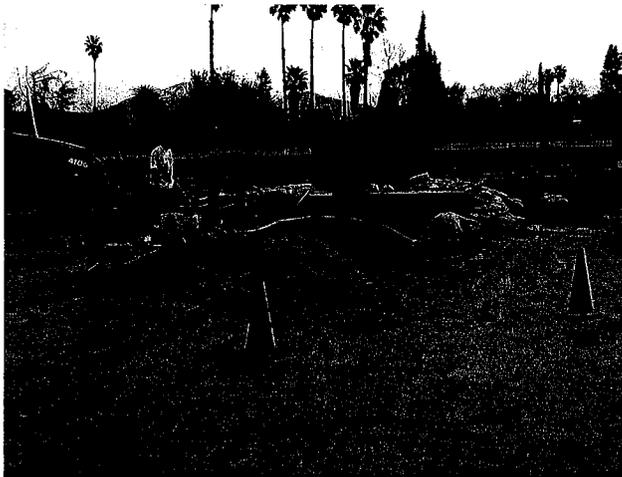
05-Feb-05 (Photo No. 94)
Performed the pressure test and chlorinating of the 20-inch DIP carrier pipe at the receiving pit at N. I Street and W. 10th Street.

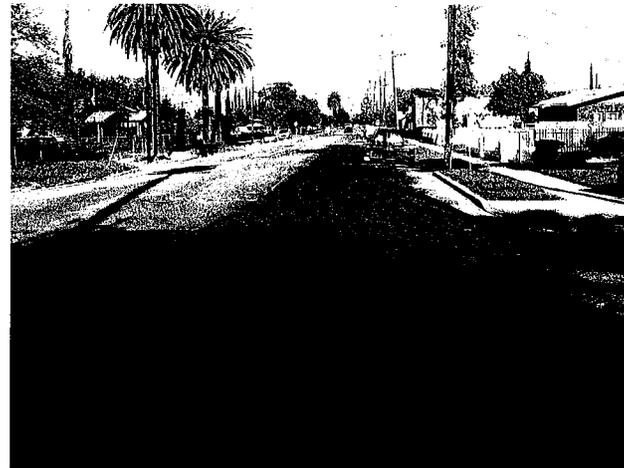
06-Apr-05 (Photo No. 102)
Jack and bore completed site, bore pit location at W. 10th Street.
