**Halaco Superfund Site: EPA testing results on The Nature Conservancy property in Oxnard, California**

SOLID MATRIX SAMPLING AND ANALYSIS RESULTS FOR THE  
NCL-EAST AND NCL-NORTH AREAS  
HALACO SUPERFUND SITE  
REMEDIAL INVESTIGATION  
OXNARD, CALIFORNIA

EPA CONTRACT NO. EP-S9-08-04  
EPA TASK ORDER NO. 015-RIRI-09X6  
CH2M HILL PROJECT NO. 385135

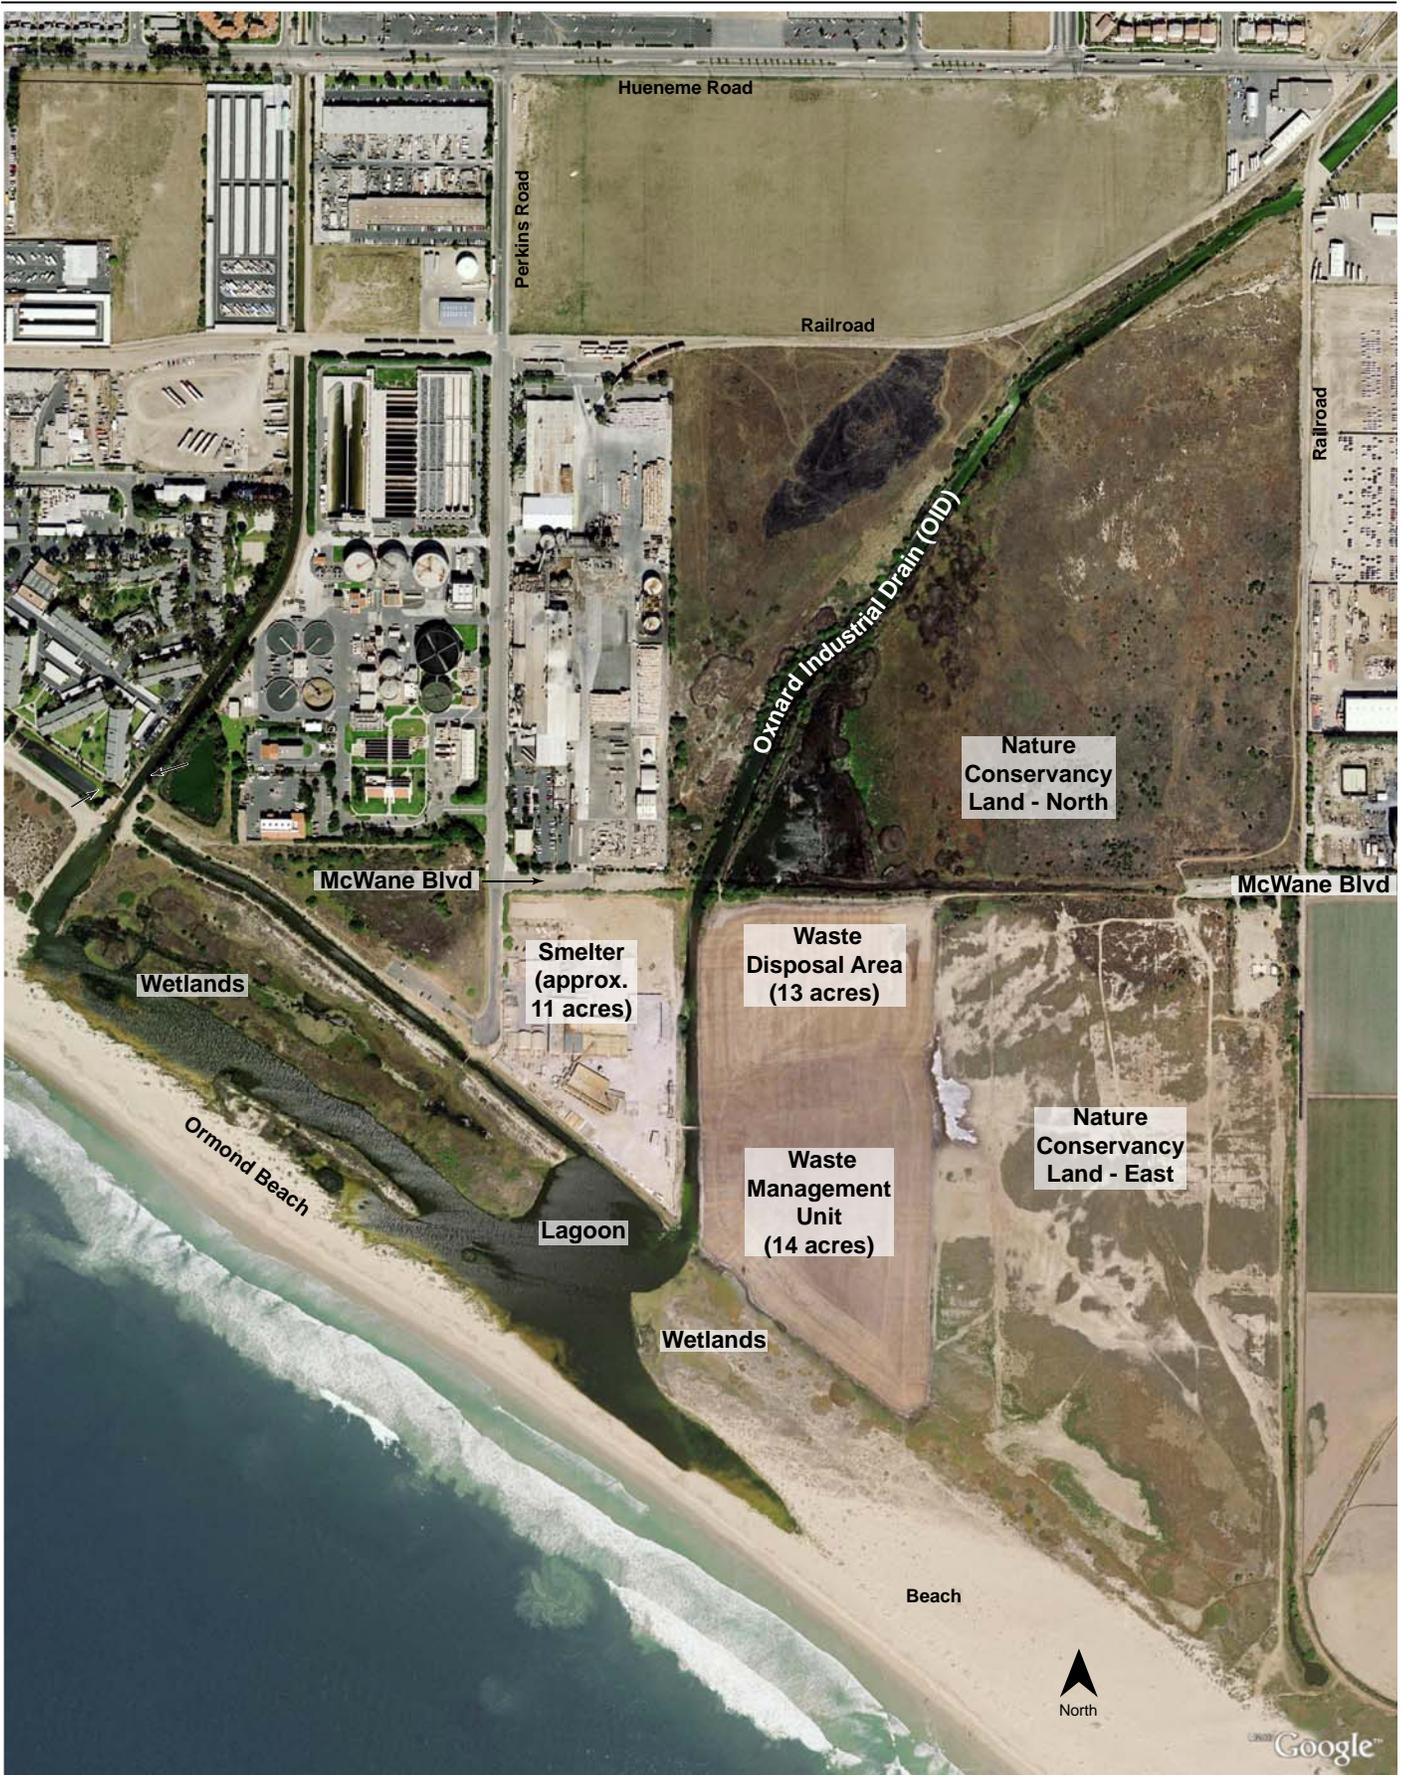
**FIGURE 1**  
 Halaco Superfund Site Areas  
*Halaco Site Remedial Investigation*  
 Oxnard, California

In 2006 and 2007, two removal actions were completed to address immediate Site risks while EPA evaluated the Site for placement on the NPL. The first removal action, completed by the property owners between August 2006 and February 2007, included the removal of drums and other hazardous substances from the Site. A second, EPA-funded removal action was completed in 2007 to stabilize and secure the Site and limit offsite migration of contaminated wastes. It included re-grading the waste pile to reduce the steepness of the slopes, placing matting on the slopes to reduce erosion, stabilizing the banks along the lower portion of the OID, removing an estimated 9,000 cubic yards of waste from the smelter area, removing an estimated 7,600 cubic yards of material from a wetland area adjacent to the Halaco property, and installing more than 6,000 feet of fencing around the perimeter of the Waste Management Area. See the “Team 9” report (2008) for additional details. Figure 1 is an aerial photo of the Site after the second removal action was completed.

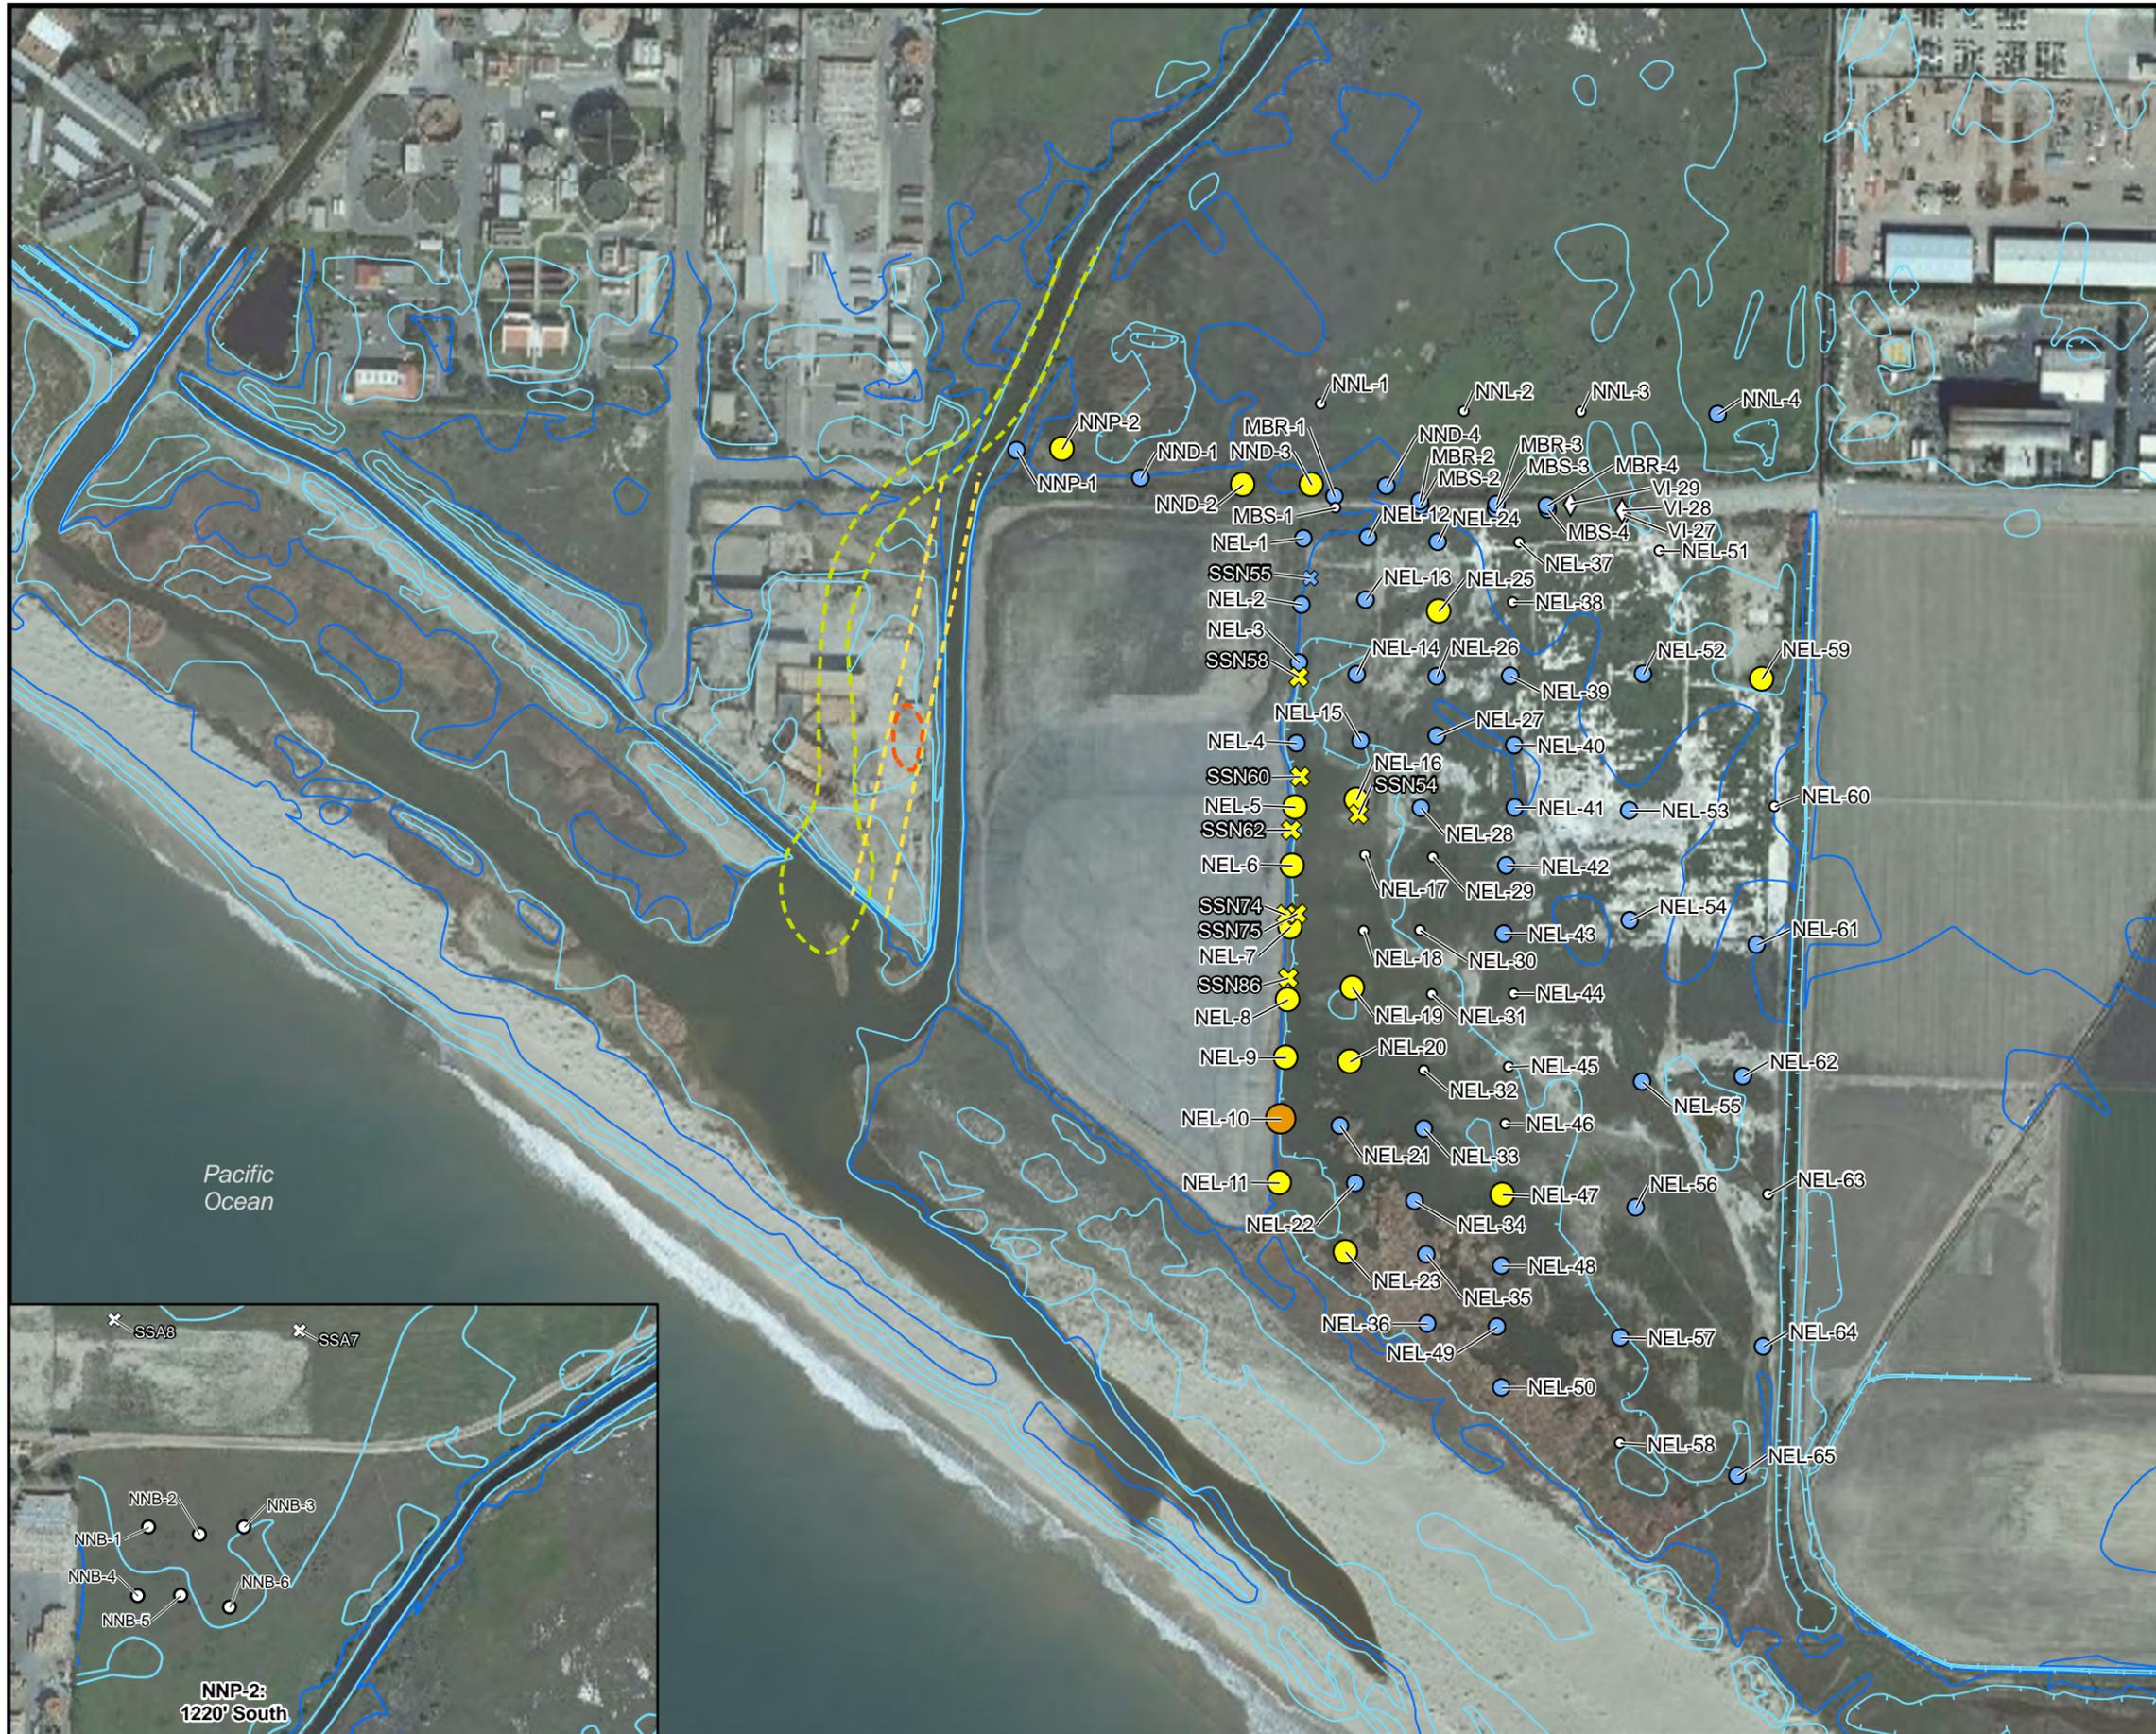
**FIGURE 4a**  
**Lead Solid Matrix Concentrations,**  
**NCL East and North, Surface Samples**  
 HALACO SITE REMEDIAL INVESTIGATION  
 OXNARD, CALIFORNIA

The highest concentrations of Halaco’s waste material are found closest to the Waste Management Area as indicated by the yellow and orange symbols in Figure 4a. This is consistent with the Integrated Assessment data that were collected from an area within 200 feet of the Waste Management Area (and shown in the figure with an “x” symbol). The high concentrations are generally found in the lower elevation areas in the western

Evidence of Halaco's waste material was also found immediately north of the WDA as indicated by the blue and yellow symbols in Figure 4a. The presence of Halaco's waste in this area was not known prior to the 2009-2010 sampling effort.

Evidence of waste material was not found to the north of the WDA in surface or subsurface samples NNL-1 through NNL-4. One exception is that the eastern-most surface sample (NNL-4) appears to be slightly elevated as indicated by the blue symbol in Figure 4a. This may be an area where waste materials settled from historical wind erosion from the Waste Management Area.

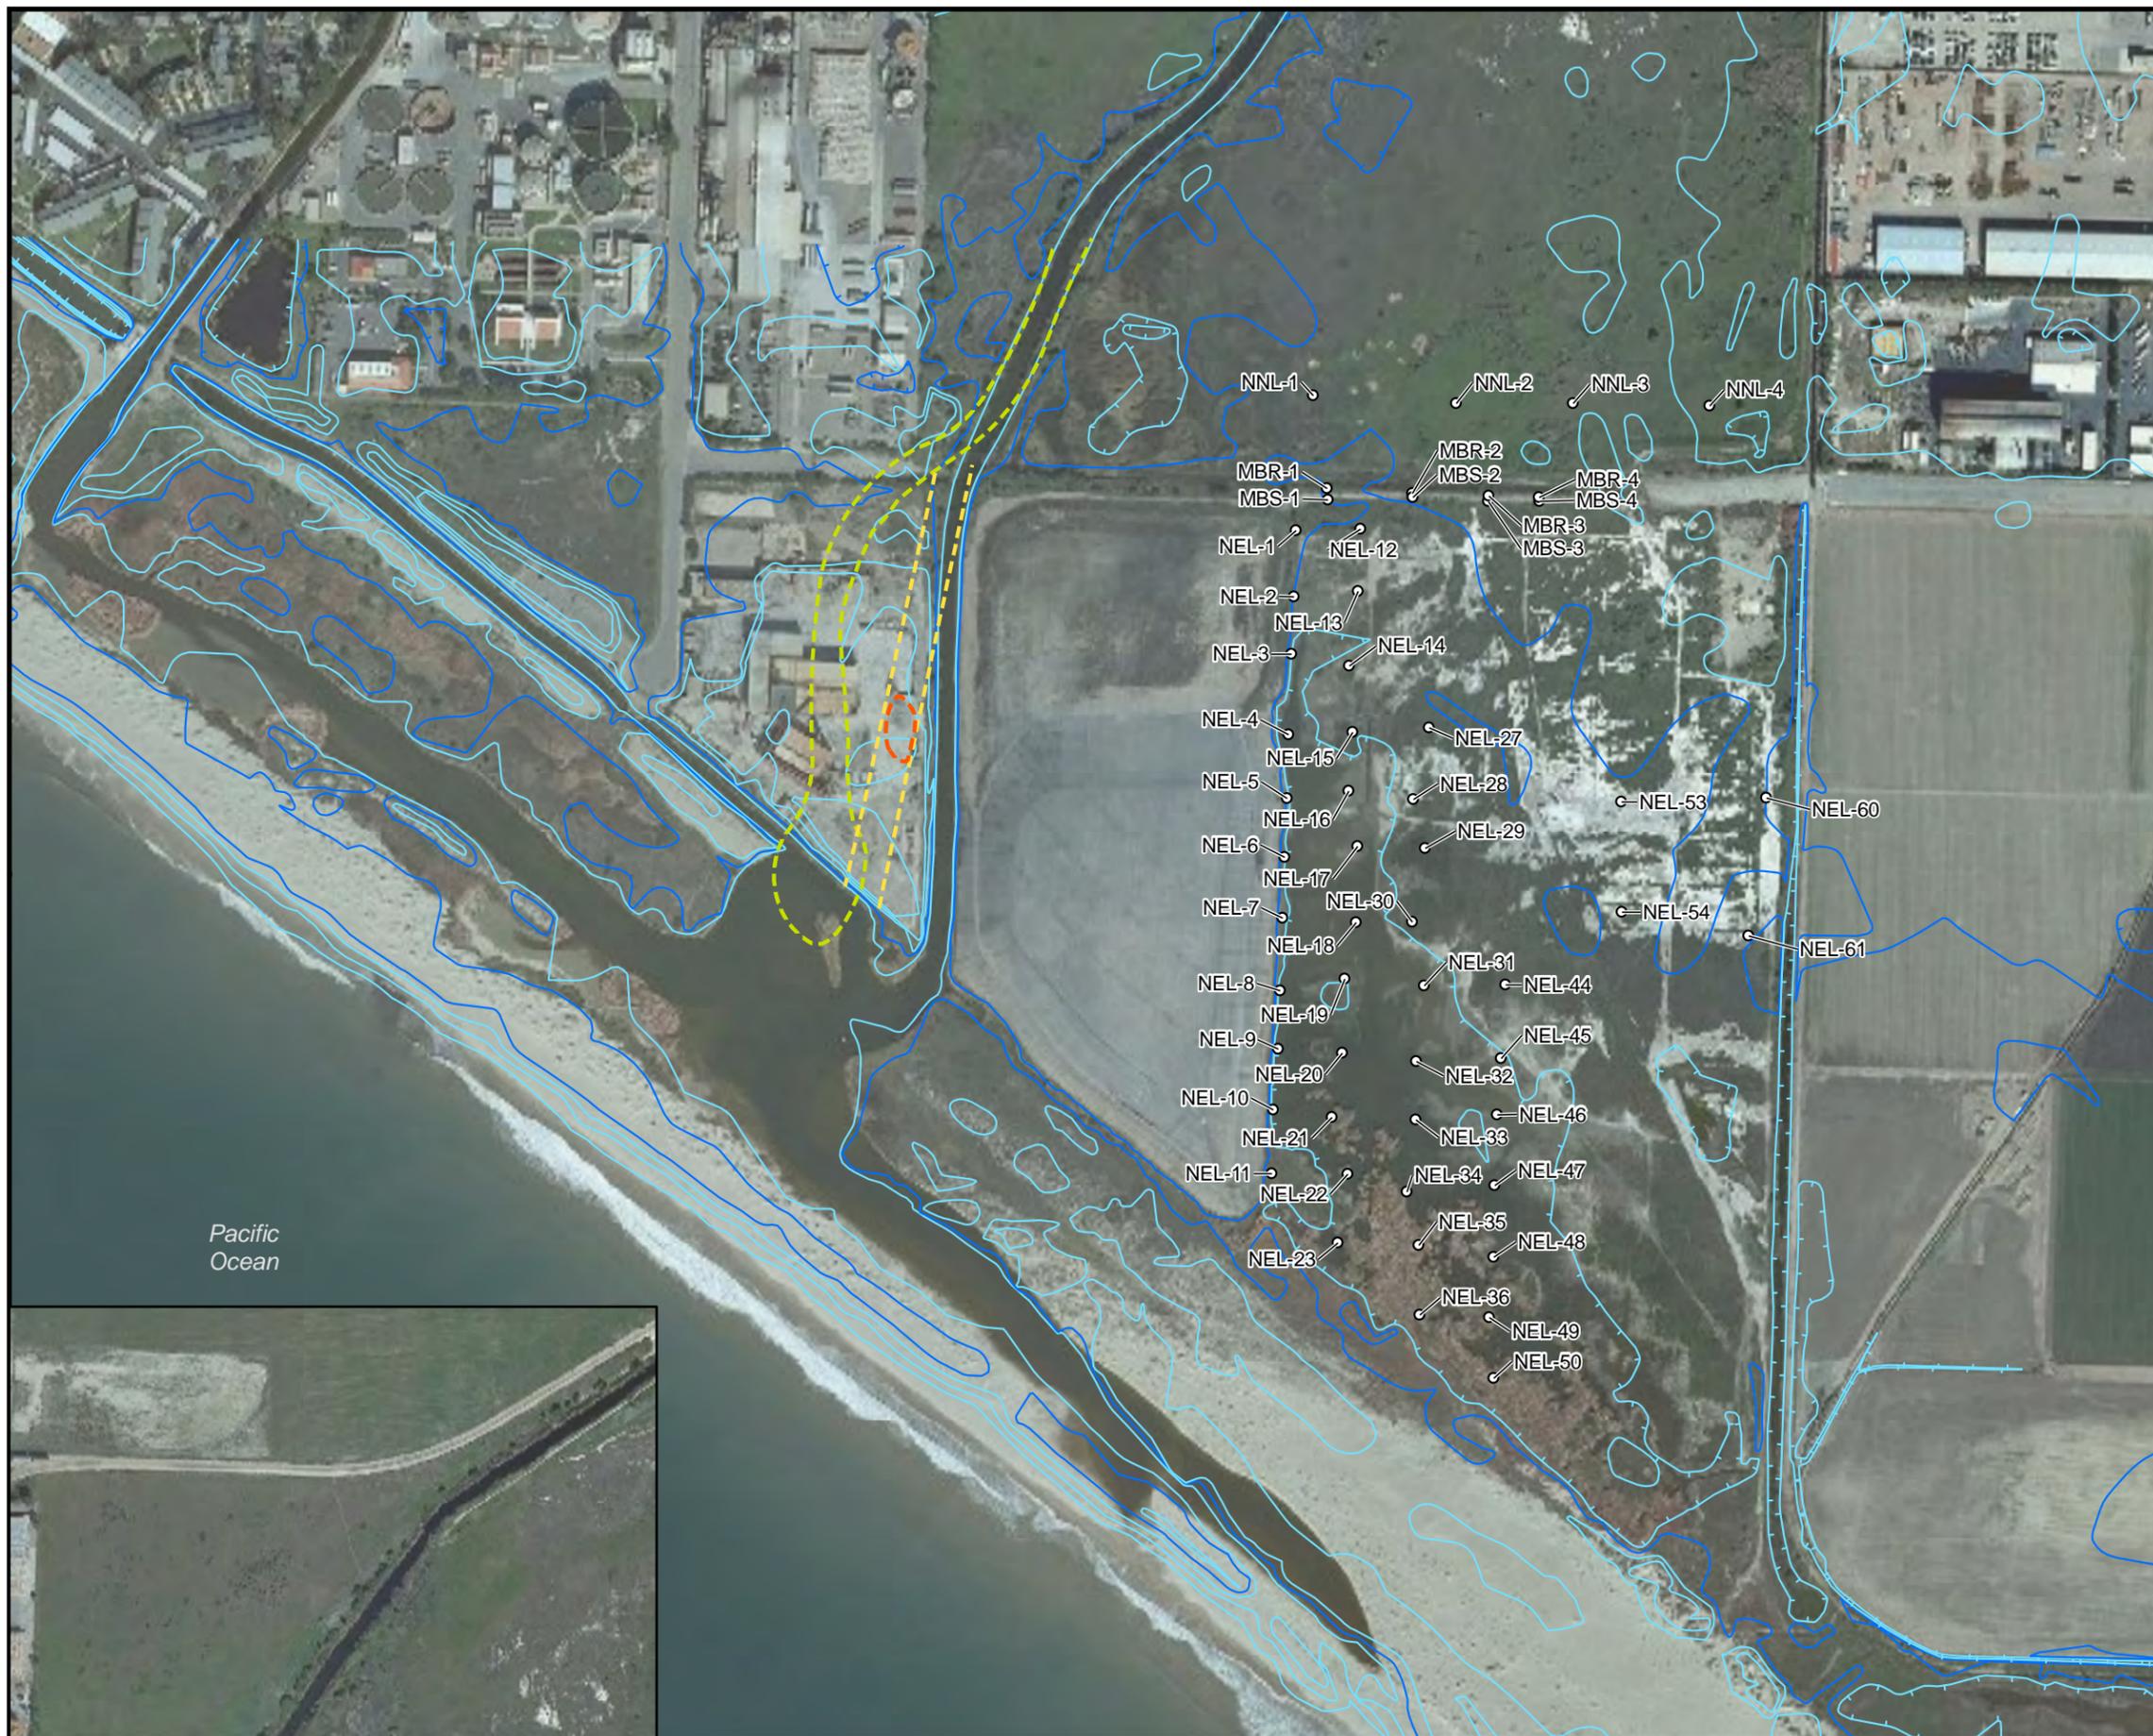
**FIGURE 5b**  
**Thorium 232 Solid Matrix Activities,**  
**NCL East and North, B Interval**  
 HALACO SITE REMEDIAL INVESTIGATION  
 OXNARD, CALIFORNIA

As shown in Figures 5a and 5b, radionuclide activities do not appear to be elevated in the majority of the NCL-East or NCL-North areas. The figures depict the Th 232 activities, which are below 2 pCi/g for both surface and subsurface soils, except for a limited number of samples near the WMU. These include one surface sample slightly above 5 pCi/g (SSN58) and three samples between 2 and 5 pCi/g (SSN54, SSN75, SSN86). Except for these four samples, the activities in the NCL areas are within the range of background conditions.
