Final Remedial Investigation Report

Casmalia Resources Superfund Site
 Casmalia, California

**cis-1,2-Dichloroethene Groundwater Concentrations
 Upper HSU Zone 1 Area
 Remedial Investigation Sampling**

FIGURE	G-25
SHEET:	1 OF 1
REVISION NUMBER:	0
DATE:	January 2011

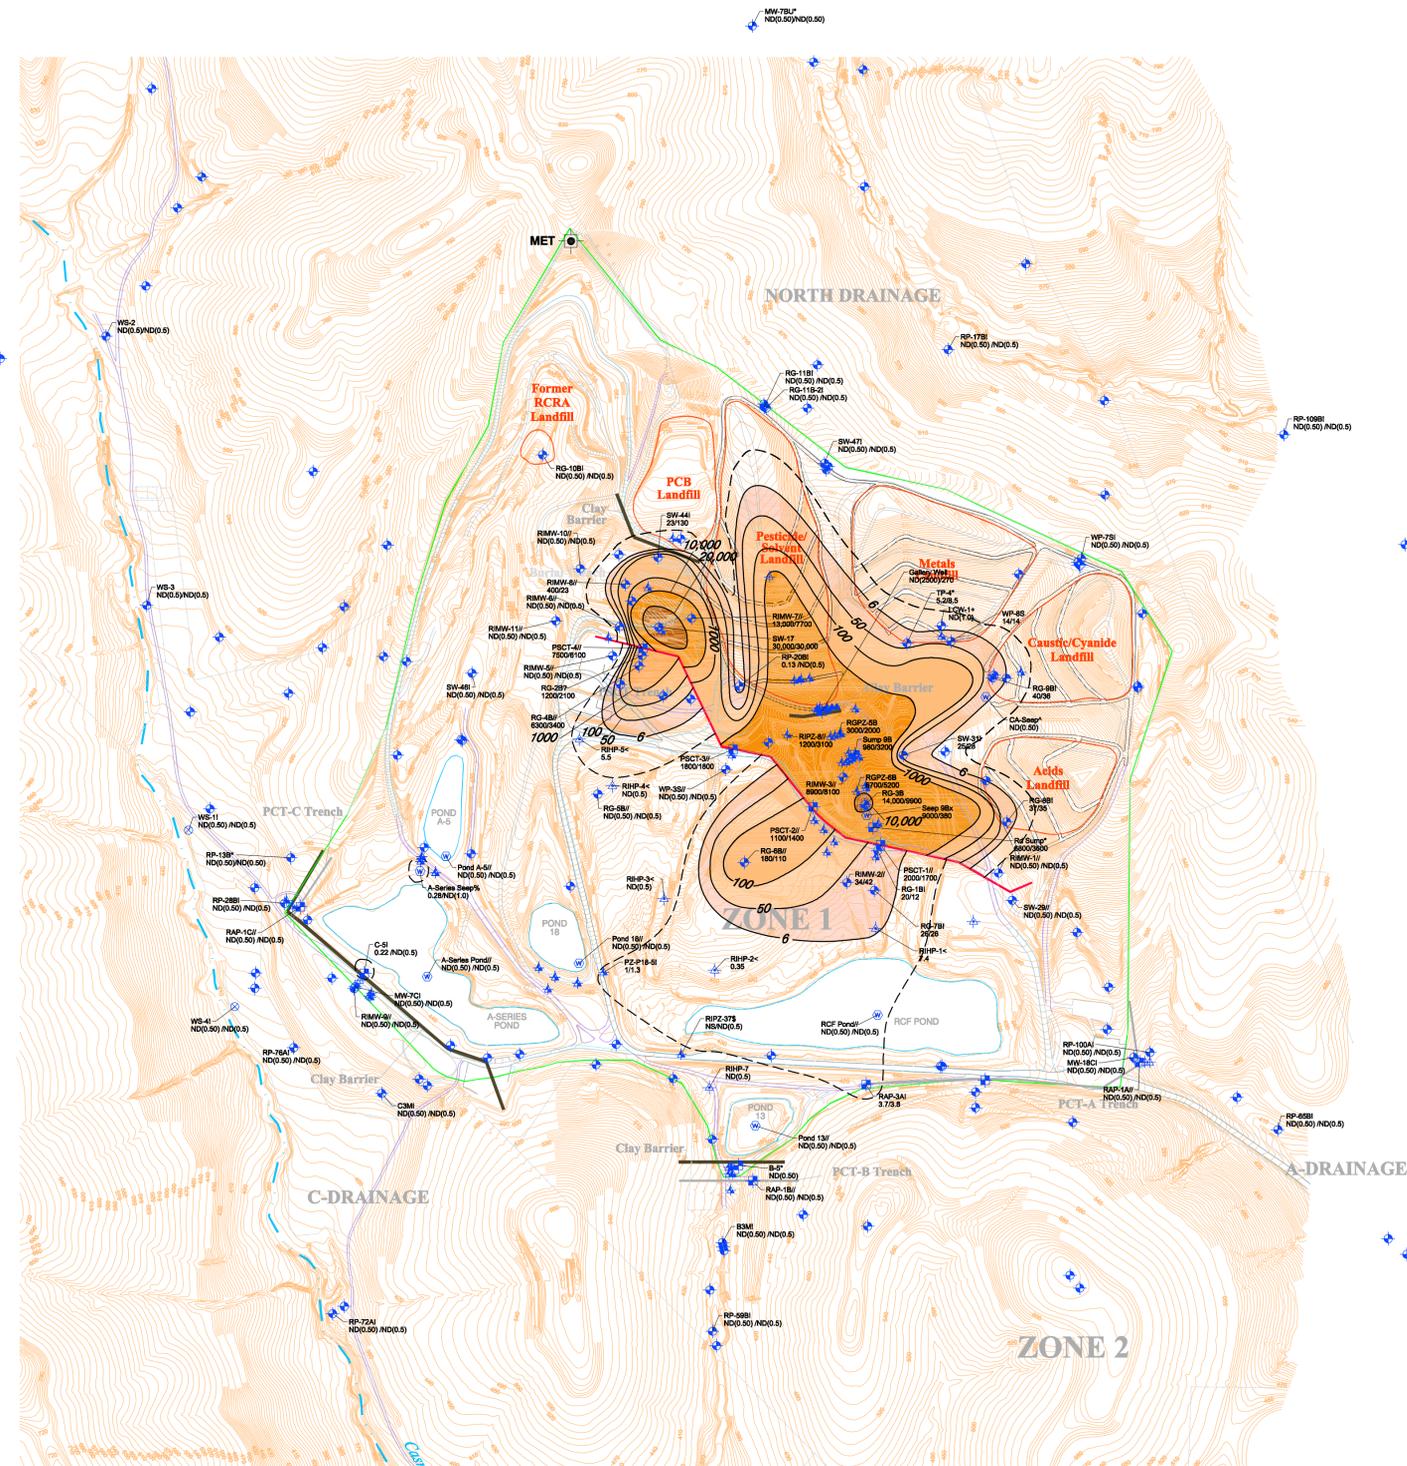
The widths of the clay barriers, PSCT, and PCT trenches are exaggerated for presentation purposes.

Zone 1 boundary (green) is approximate and includes the area within the facility boundary.
