FINAL
SUBAREA 7 ROUND 2 ADDENDUM
TO THE FINAL FSP FOR SOIL SAMPLING
SANTA SUSANA FIELD LABORATORY SITE
AREA IV RADIOLOGICAL STUDY

TO: Andrew Bain, EPA Region 9 RPM
FROM: T. Stewart Williford, P.G., HGL
THROUGH: L. Steven Vaughn, R.G., HGL Project Manager
Rene R. Rodriguez, P.E., HGL Deputy Project Manager
CC: Mary Aycock, EPA Region 9 RPM
Yarissa Martinez, P.E., EPA Region 9 RPM
Shiann-Jang Chern, Ph. D., P.E., EPA Region 9 RPM
Gregg Dempsey, Technical Advisor
DATE: July 6, 2012
SUBJECT: Subarea 7 Round 2 Addendum to the Final Field Sampling Plan for Soil Sampling

CONTRACT NO: EP-S7-05-05
TASK ORDER NO: 0038

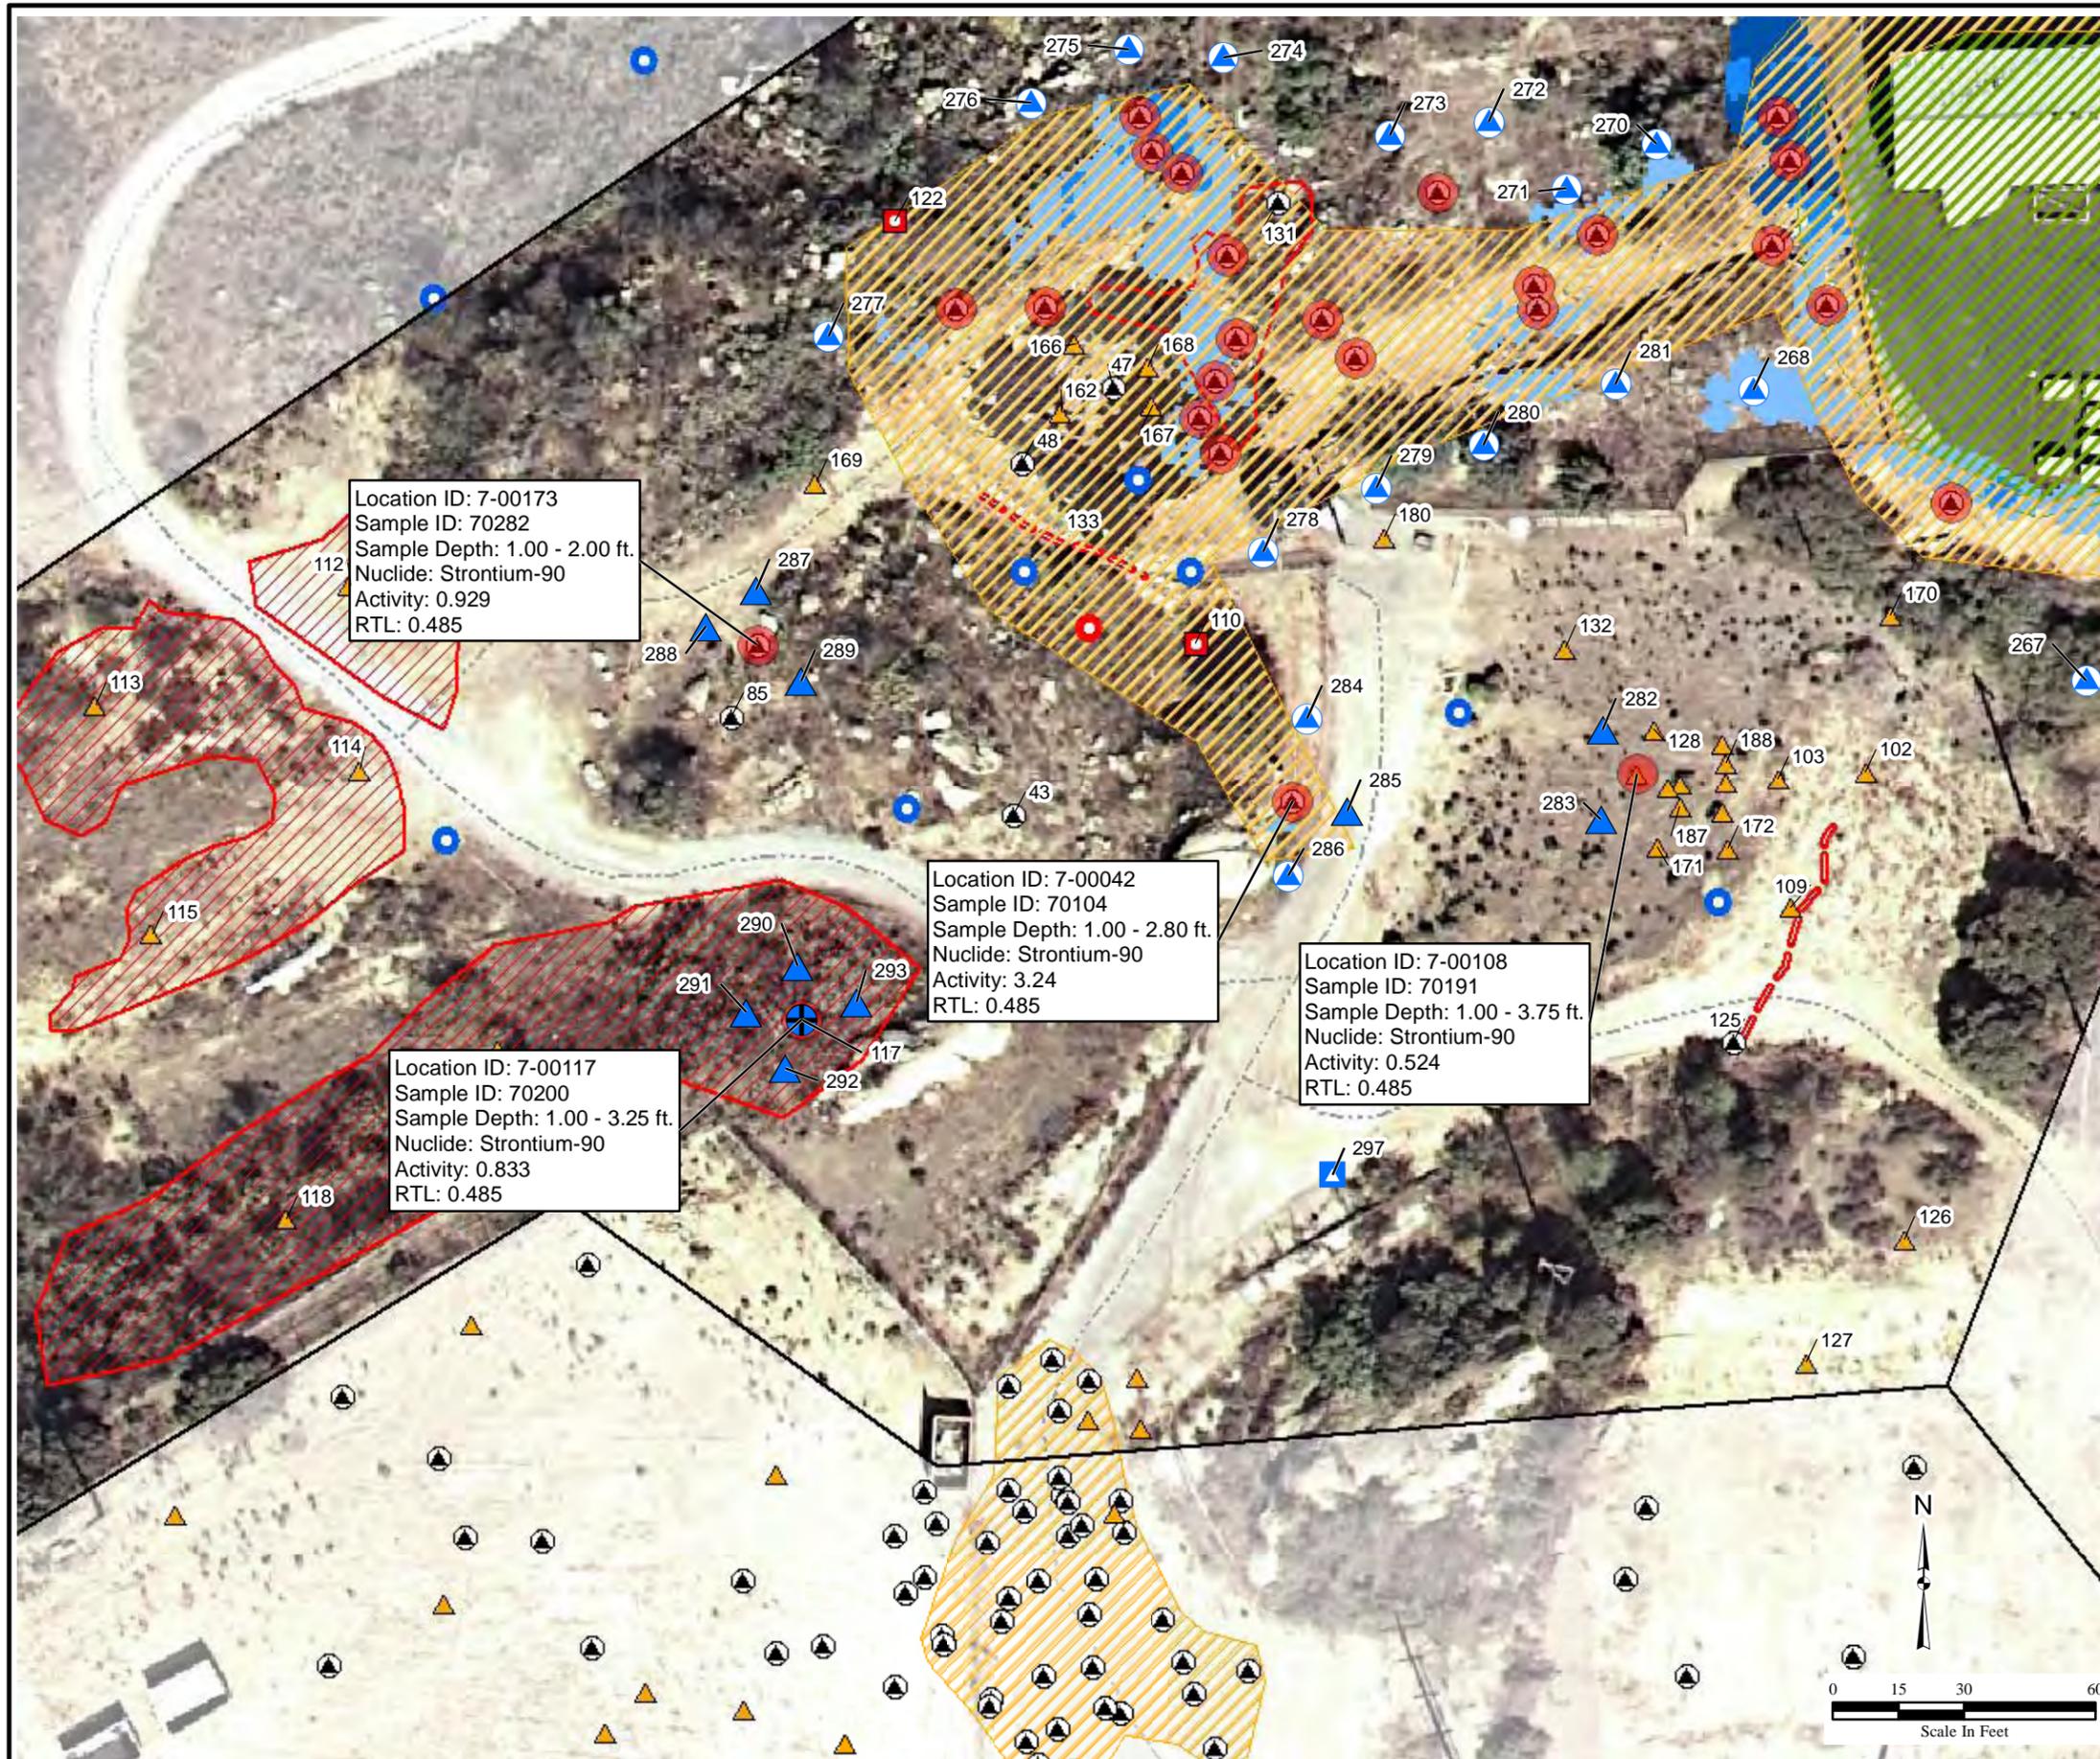
Figure 12
Southern Portion
Subarea 7, Round 2
Santa Susana Field Laboratory

Location ID: 7-00120
 Sample ID: 70205
 Sample Depth: 1.00 - 5.00 ft.
 Nuclide: Strontium-90
 Activity: 0.517
 RTL: 0.485
