Subject: **2014 Annual Progress Report – Former Fairchild Buildings 13, 19, and 23**
Middlefield-Ellis-Whisman (“MEW”) Area
Mountain View, California

**2014 ANNUAL PROGRESS REPORT
FORMER FAIRCHILD
BUILDINGS 13, 19, AND 23
MOUNTAIN VIEW, CALIFORNIA**

**2014 Annual Progress Report
Former Fairchild Buildings 13, 19, and 23
Middlefield-Ellis-Whisman Study Area
Mountain View, California**

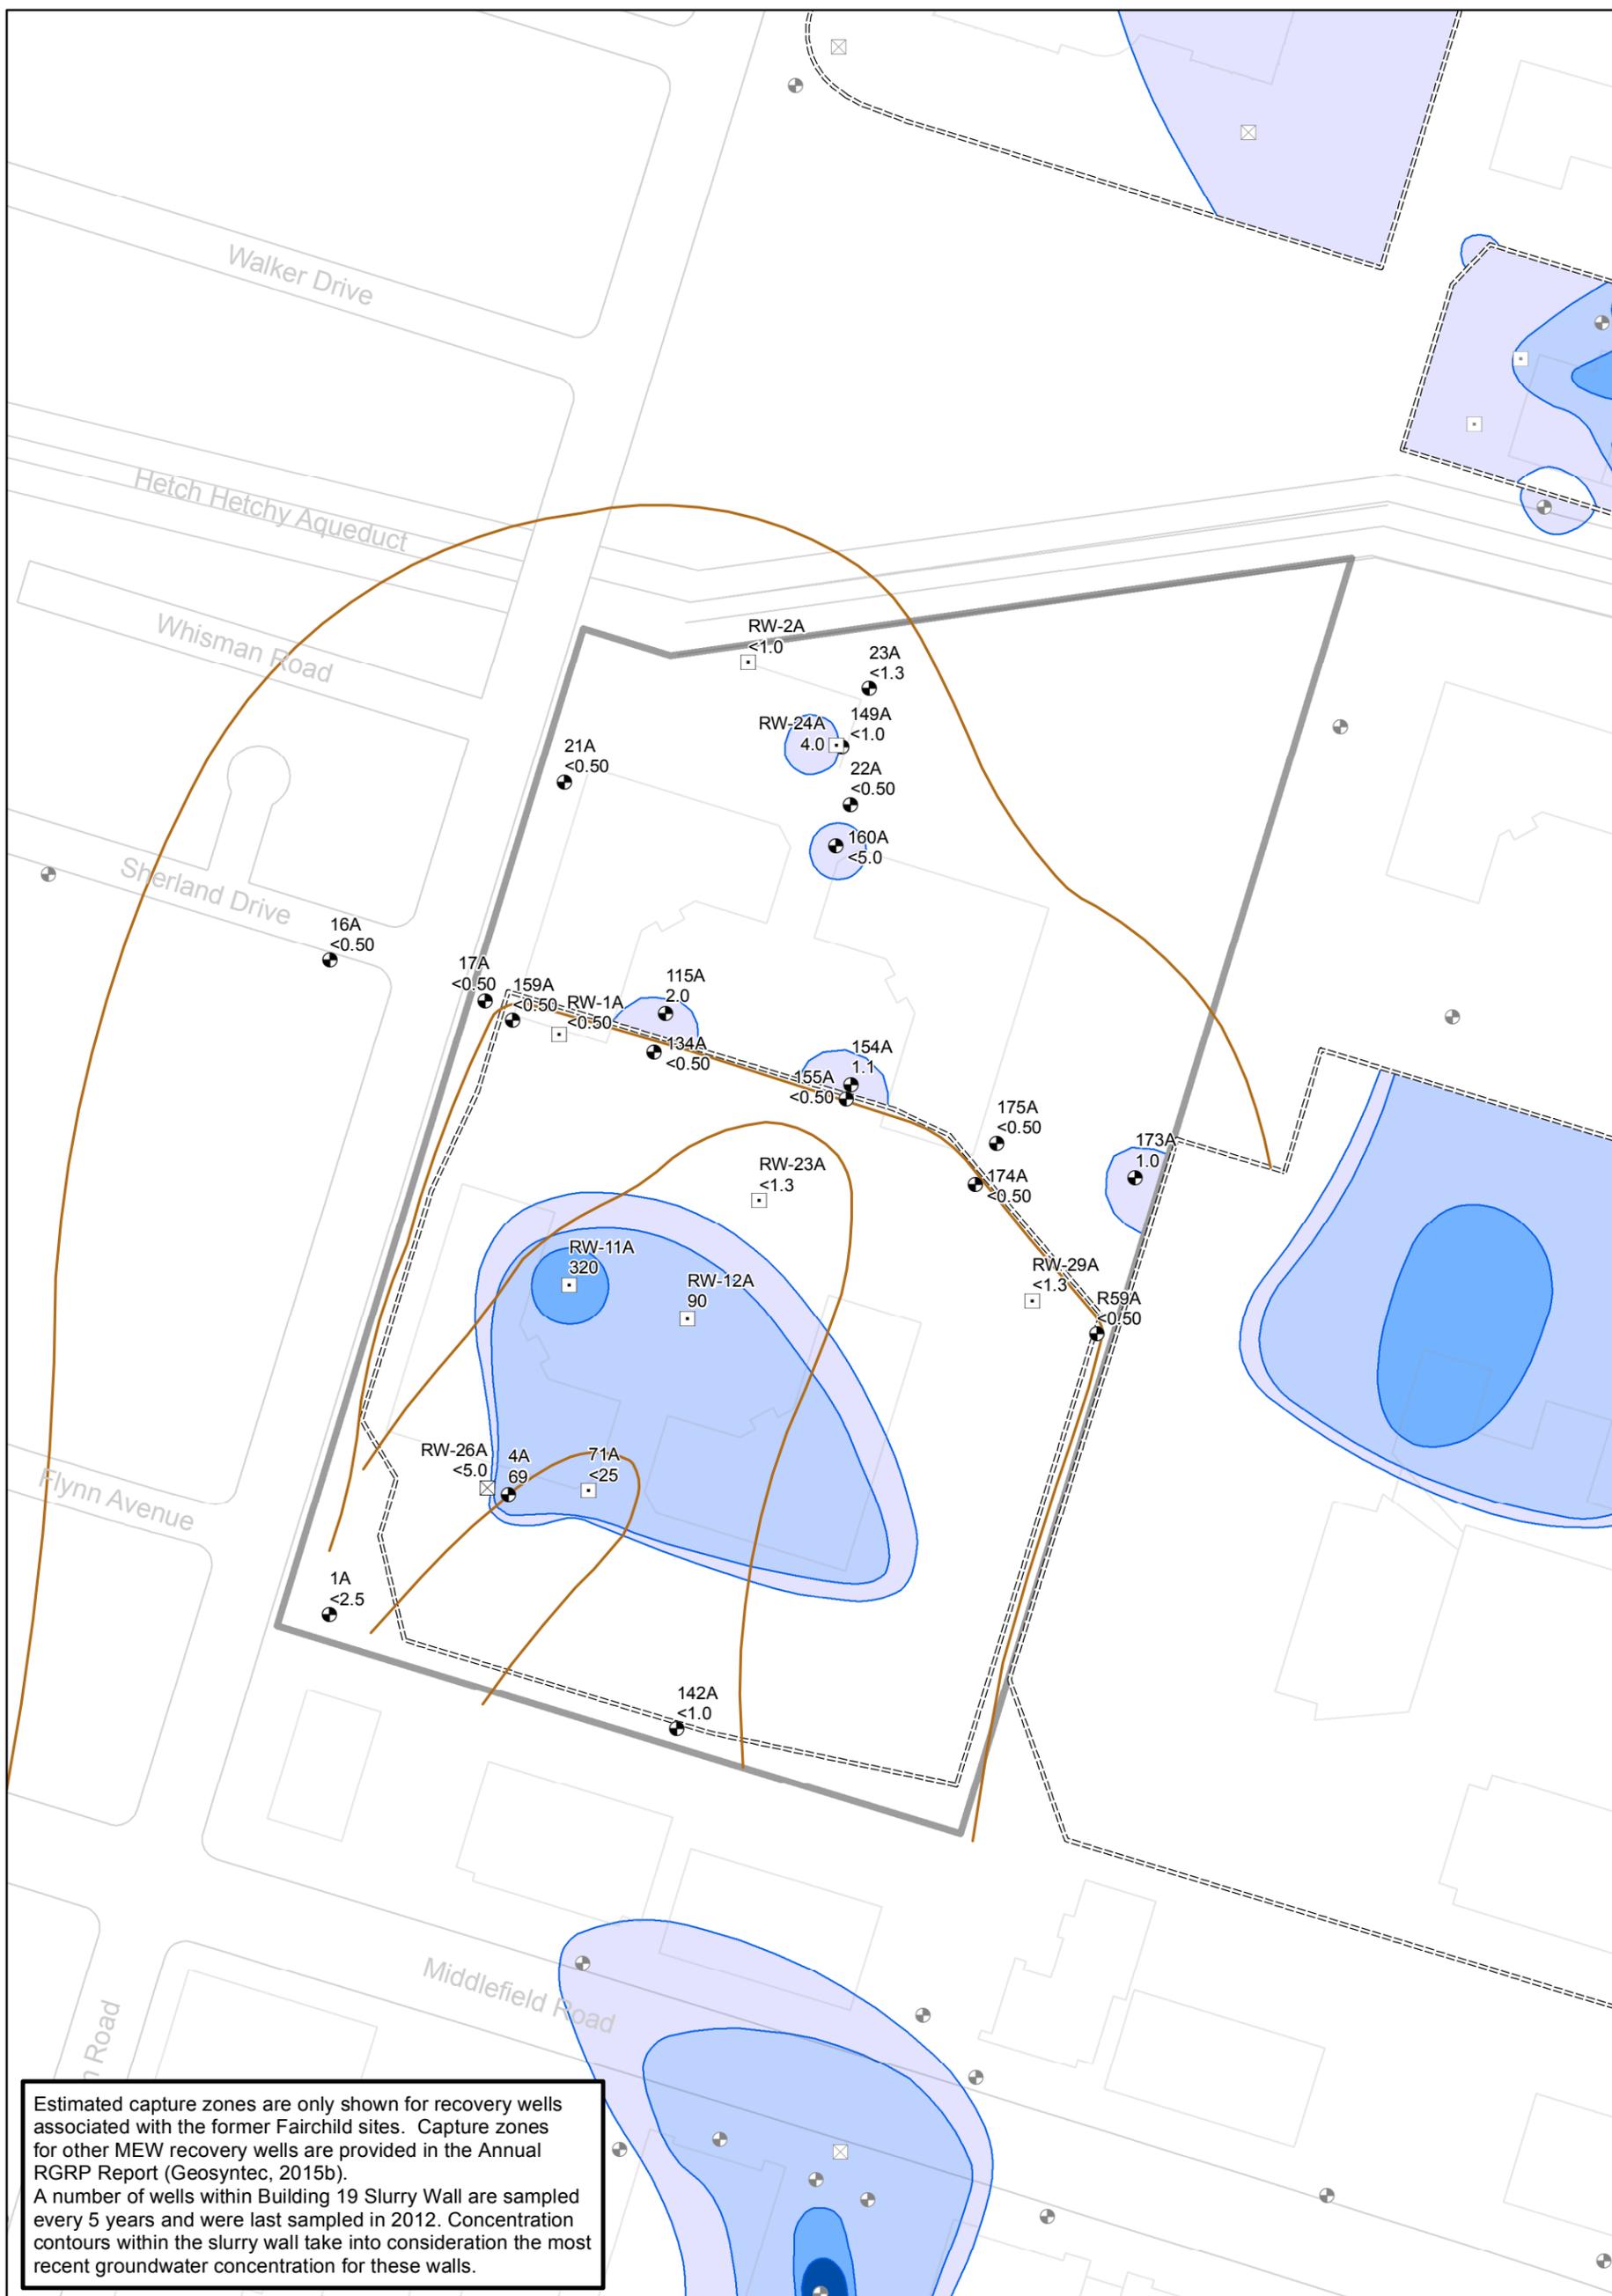
14

- Figure 14: A Zone cDCE Concentrations and Estimated Capture Zones, September/October 2014**
- Figure 15: A Zone VC Concentrations and Estimated Capture Zones, September/October 2014**

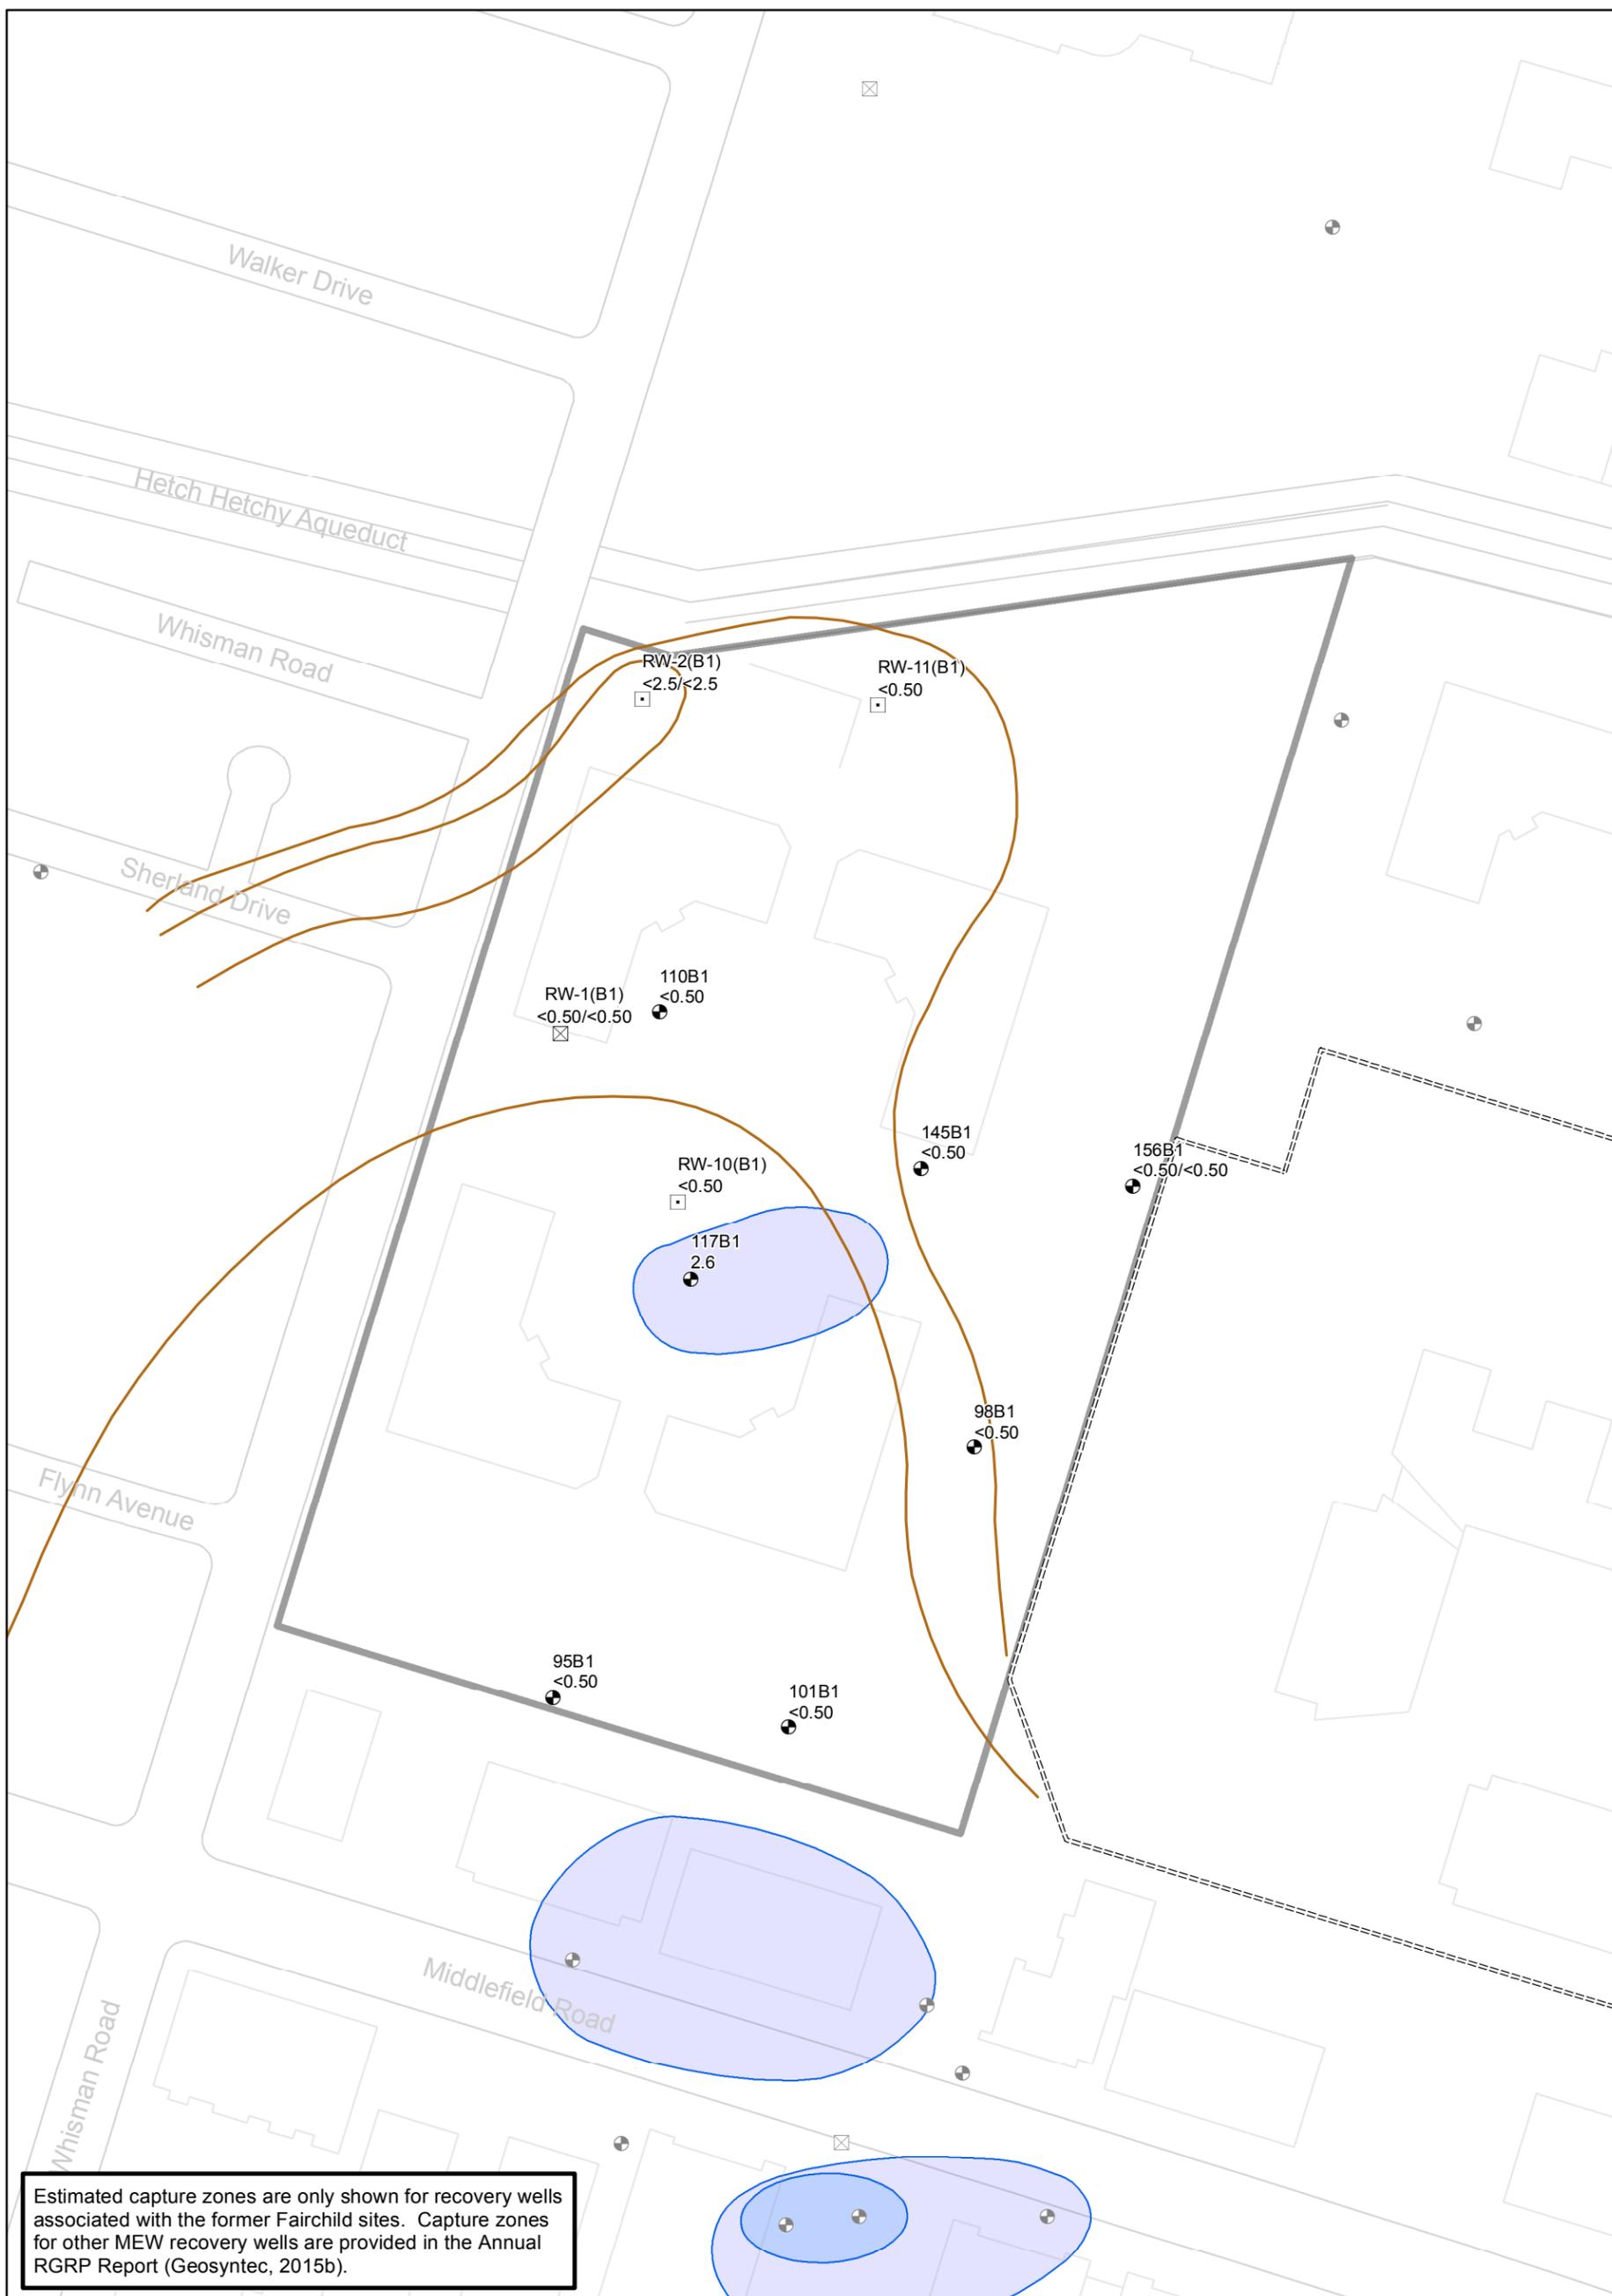
18

- Figure 18: B1 Zone cDCE Concentrations and Estimated Capture Zones, September/October 2014**
- Figure 19: B1 Zone VC Concentrations and Estimated Capture Zones, September/October 2014**
