**FIGURE W-3**  
**Cut-Fill Map**  
**1987 Versus 1998**  
**Site Topography**  
 Final Remedial Investigation Report  
 Casmalia Resources Superfund Site  
 January 2011

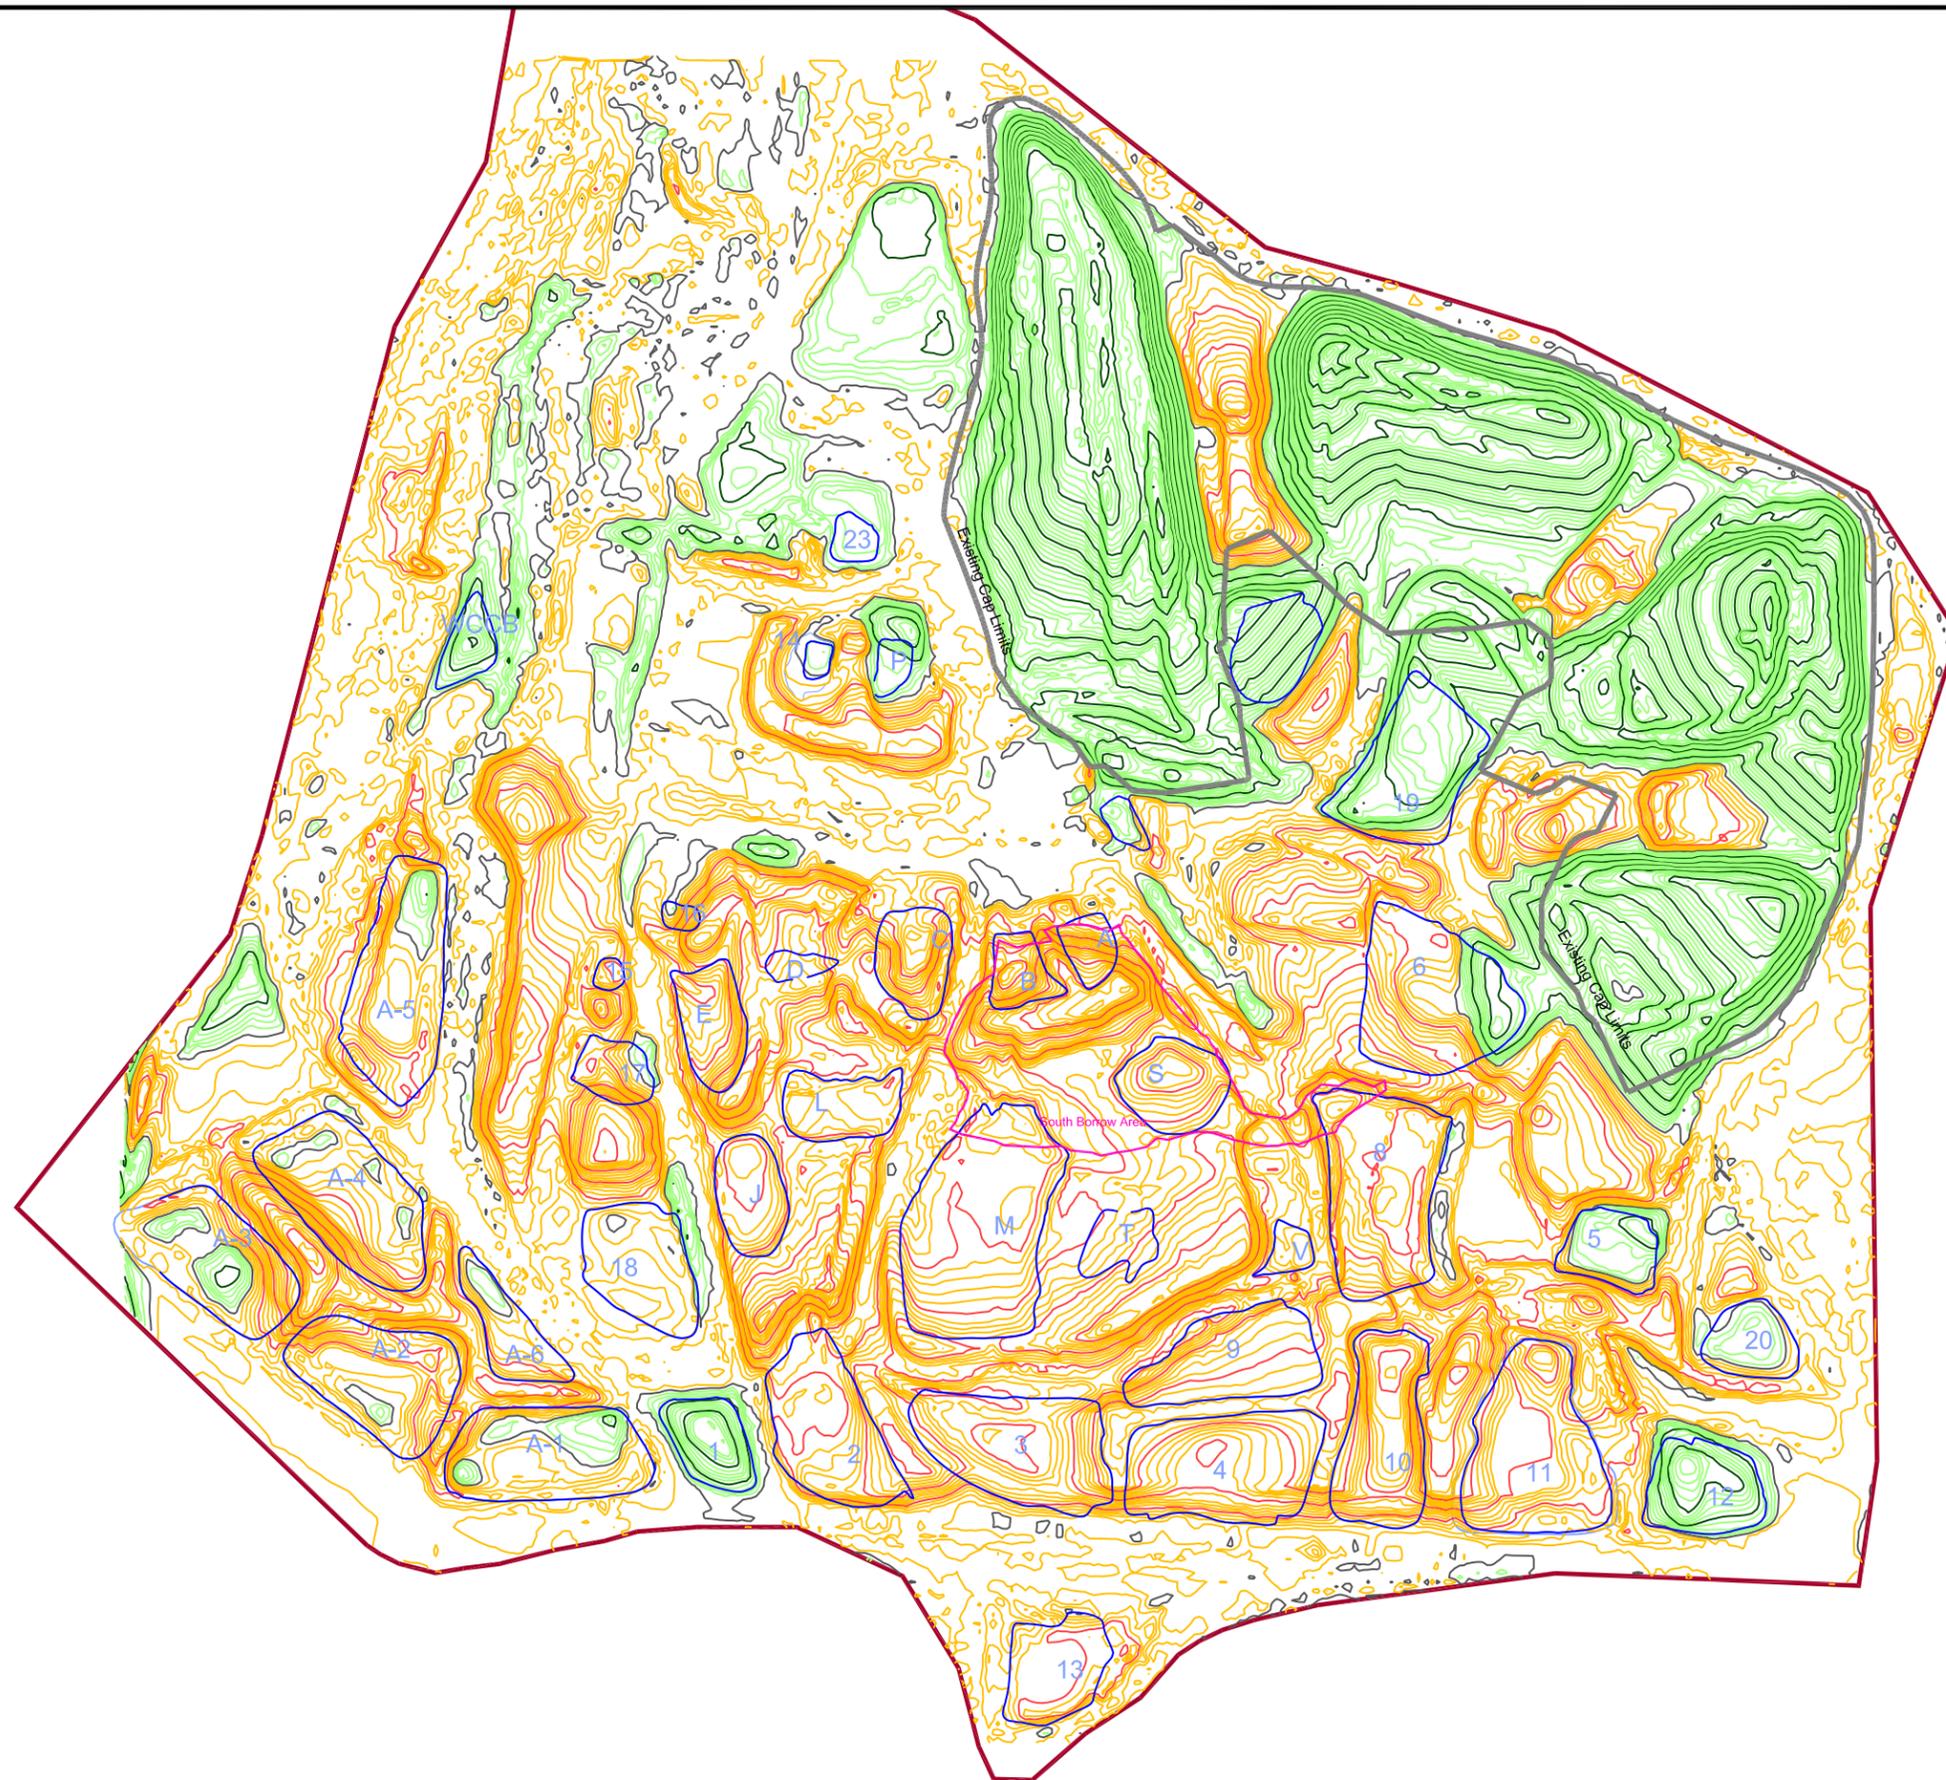
- Existing cap limits
- Major (10') contour intervals, 10' to 90'
- Minor (2') contour intervals
- Zero-line
- Minor (-2') contour intervals
- Major (-10') contour intervals, -10' to -50'
- M Approximate location of former pond/pad

Note: South Borrow Area reflects 1987 vs. 2002 topography
