## 2009 ANNUAL PROGRESS REPORT

**Former Fairchild Buildings 1-4  
515/545 Whisman Road and 313 Fairchild Drive  
Middlefield-Ellis-Whisman Area  
Mountain View, California**

**2009 ANNUAL PROGRESS REPORT**  
**for**  
**Former Fairchild Buildings 1- 4**  
**515/545 Whisman Road and 313 Fairchild Drive**  
**Middlefield-Ellis-Whisman Area**  
**Mountain View, California**

**USEPA, Region 9, Superfund Division**  
75 Hawthorne Street  
San Francisco, California 94105

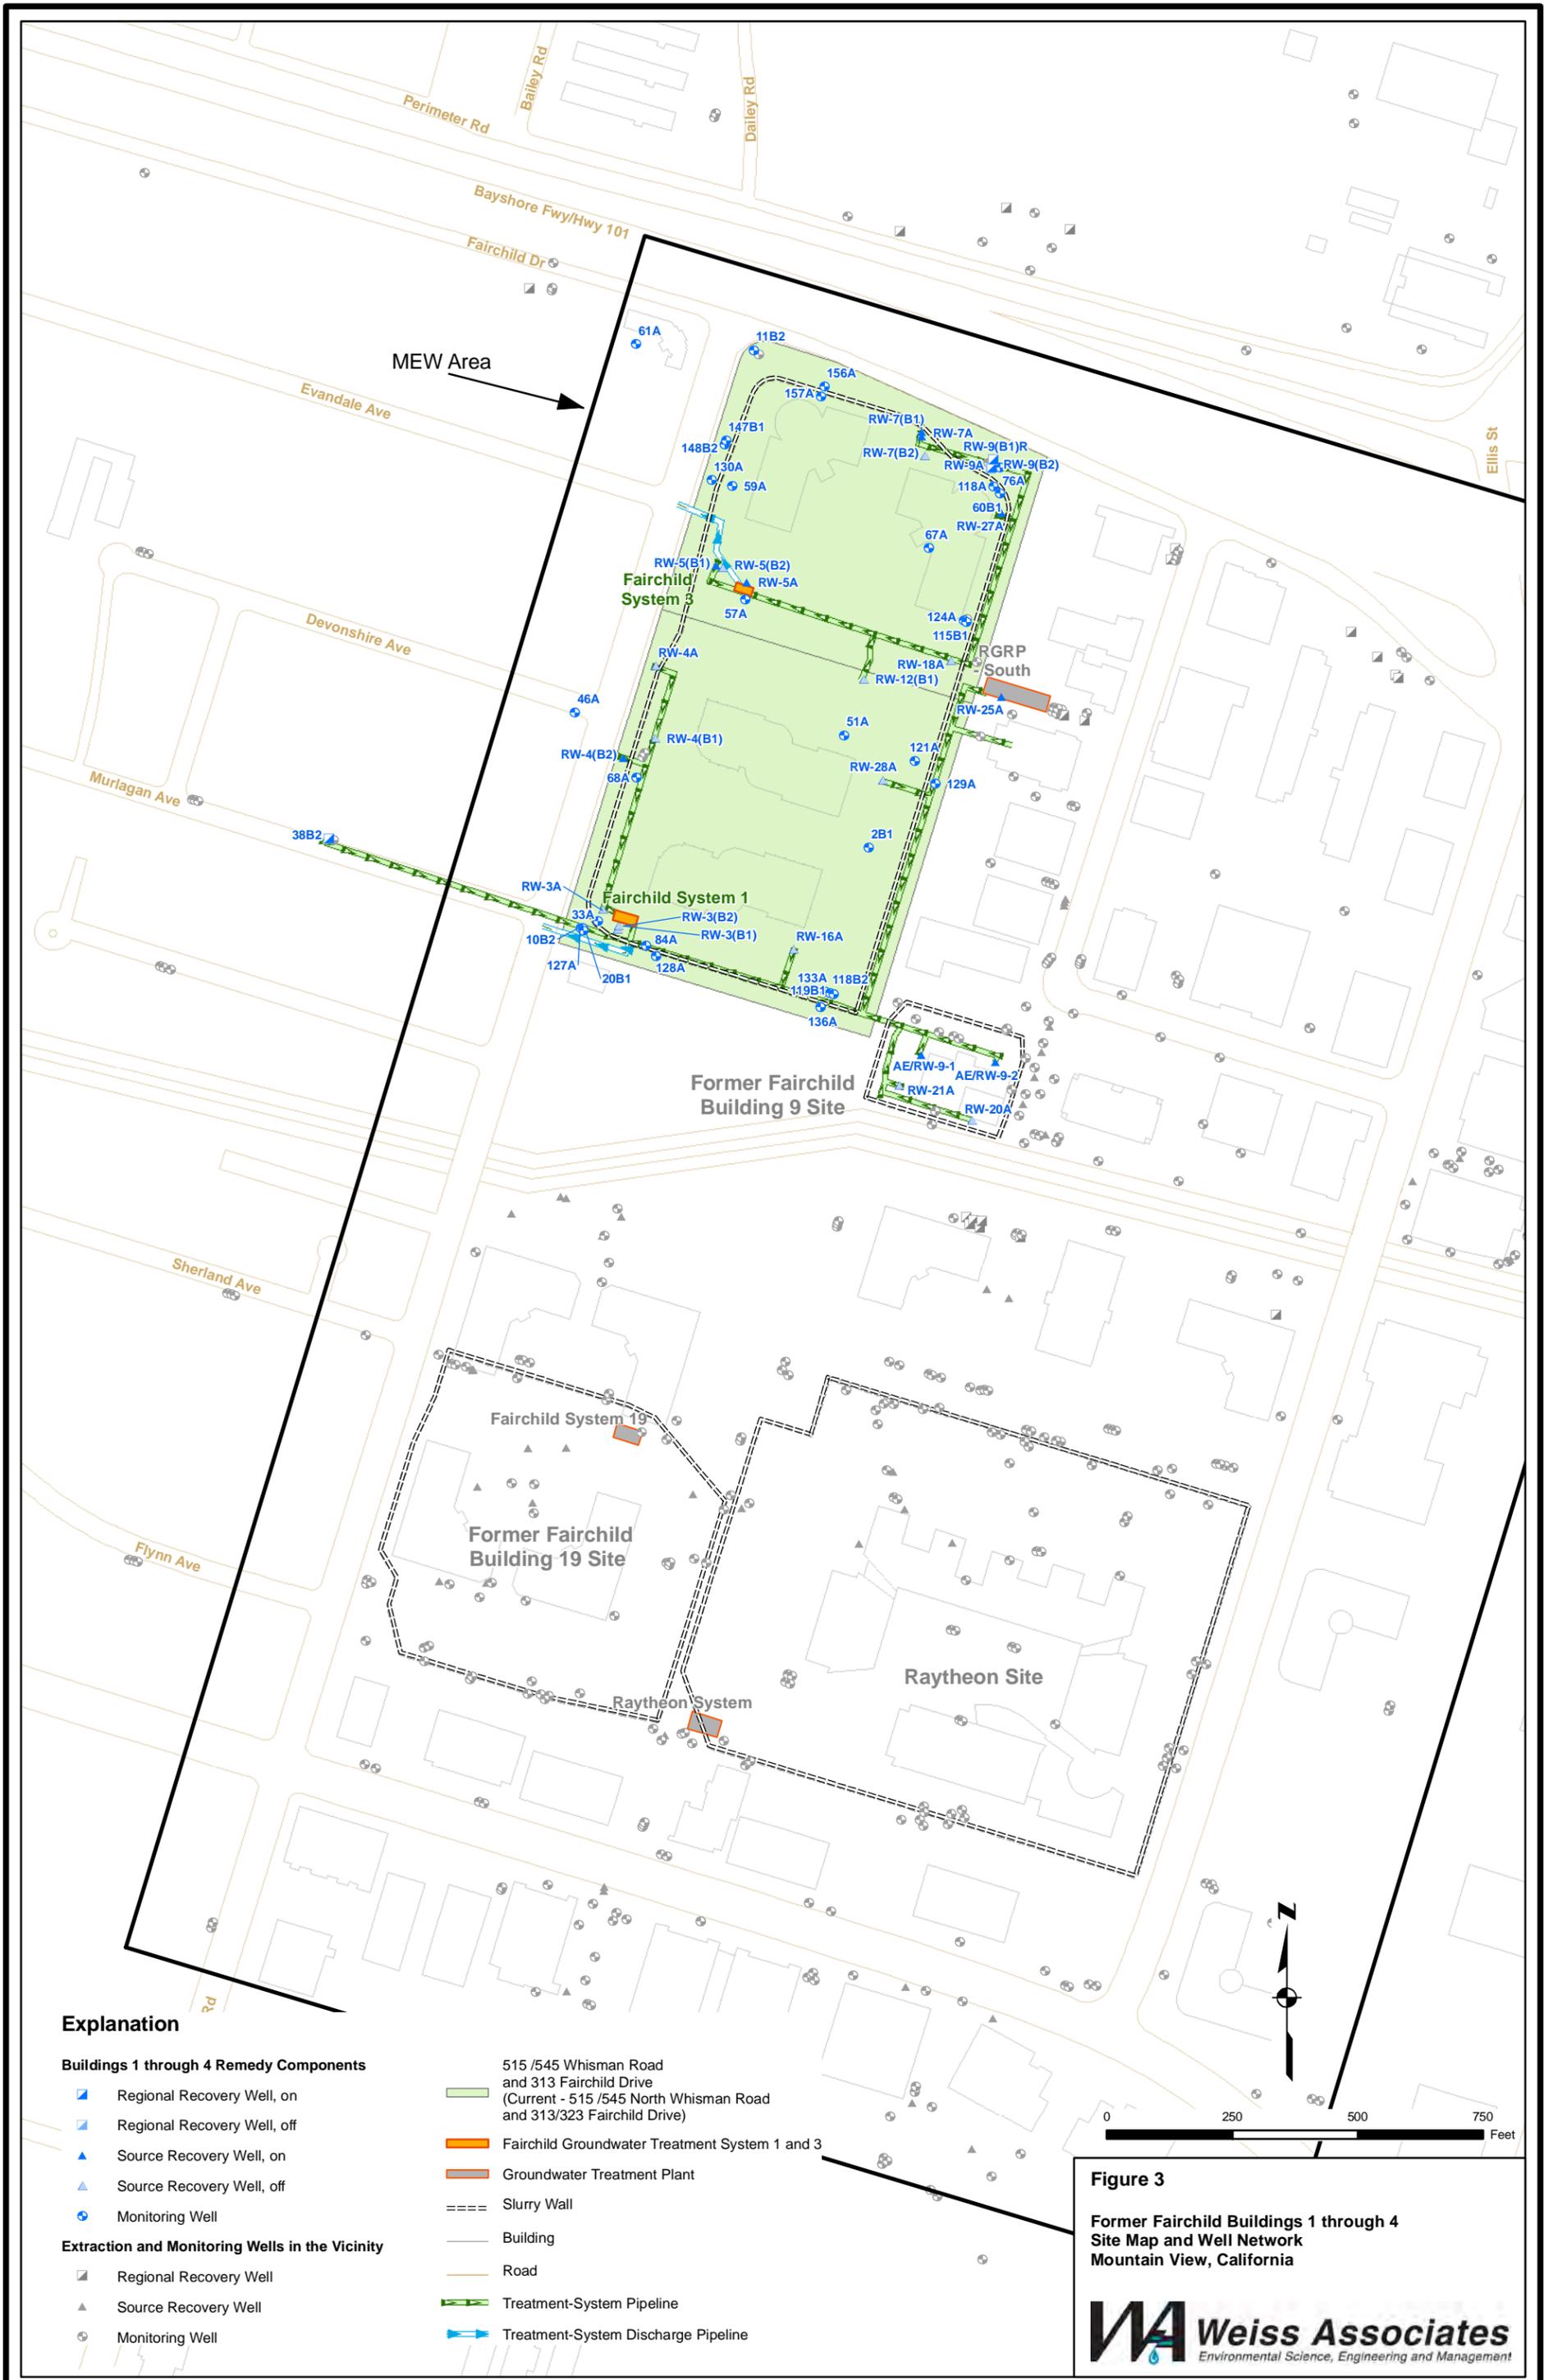
**Figure 3**

**Former Fairchild Buildings 1 through 4 Site Map and Well Network Mountain View, California**

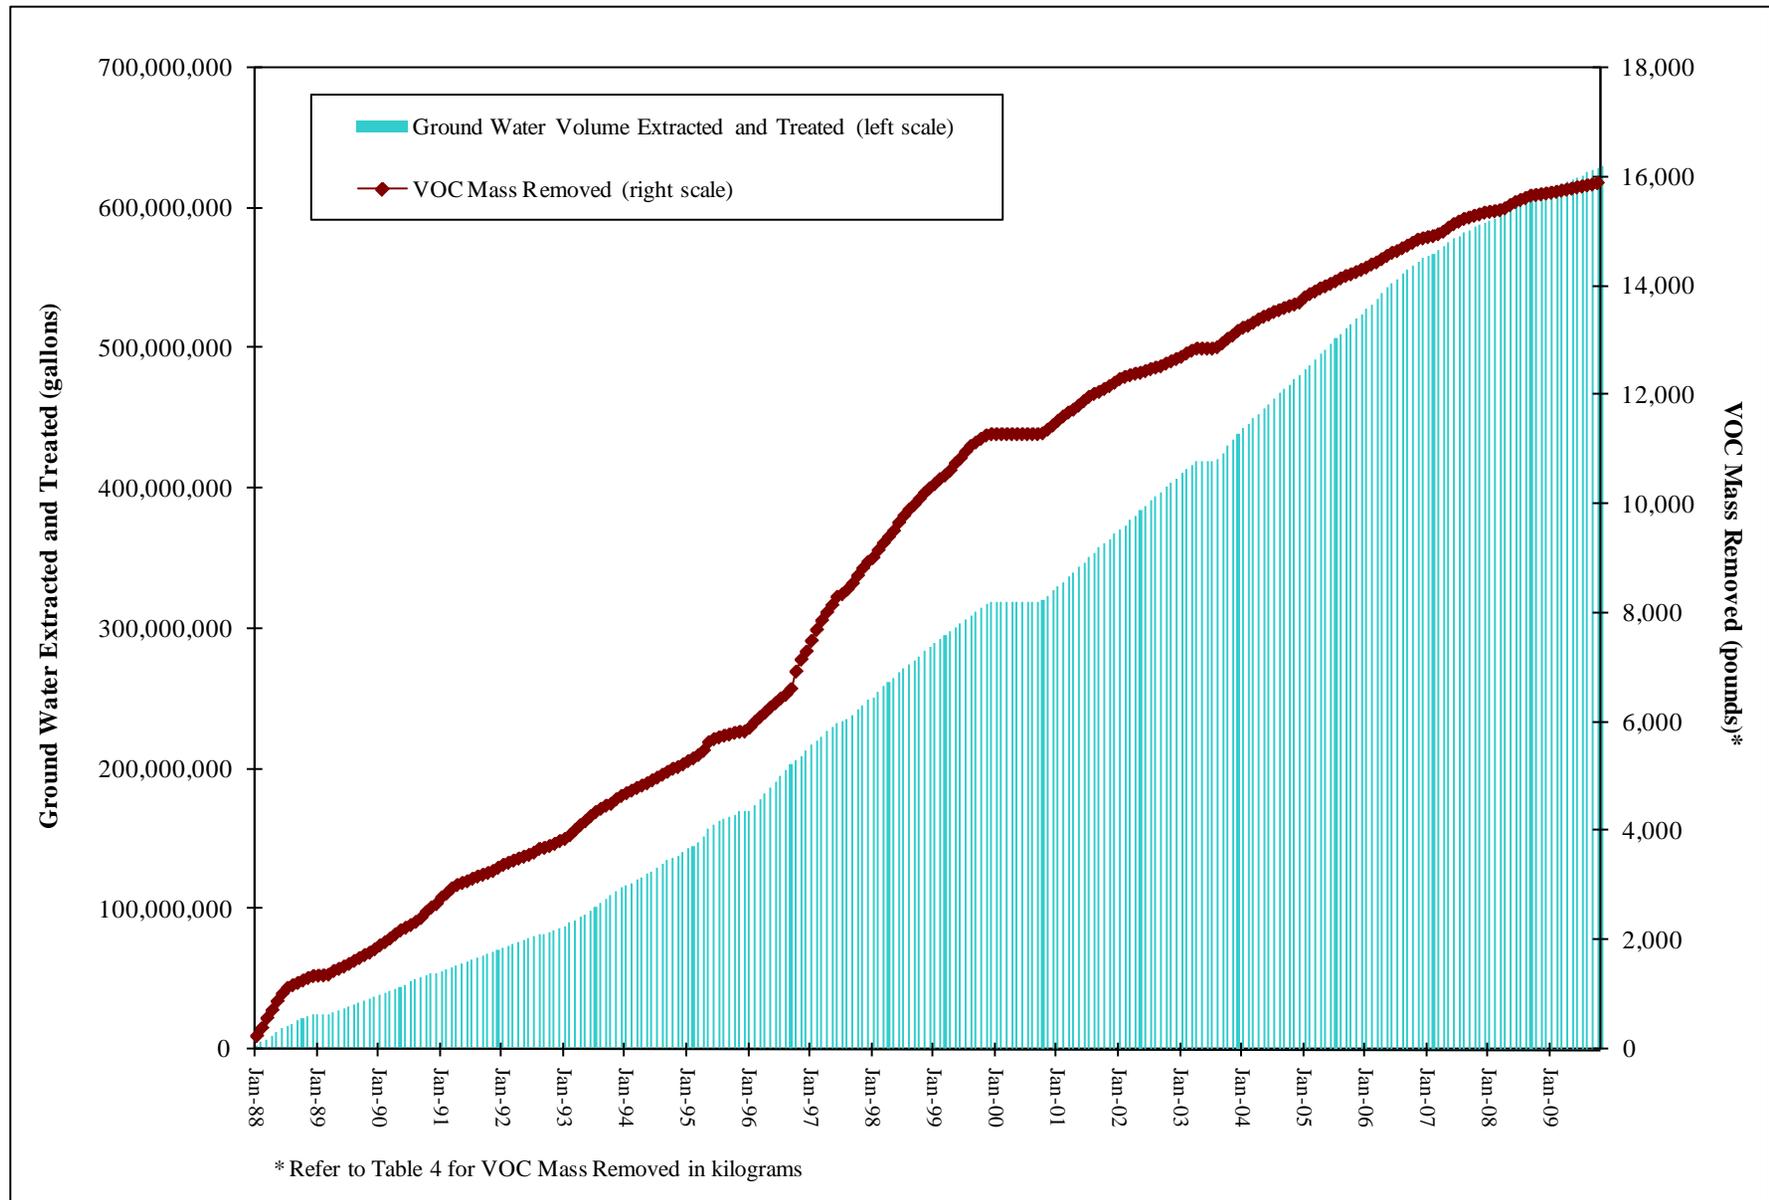
Figure 4. Cumulative Groundwater and VOC Mass Removal Summary, Fairchild System 1, 515/545 Whisman Road, Mountain View, California.

Approximately 34.3 million gallons of groundwater were treated and 505 pounds of VOCs were removed by the Site treatment systems during 2009. From January 1 through December 31, 2009, Site Treatment Systems 1 and 3 operated on a nearly continuous basis (97% and 99%, respectively), and no significant problems related to system operations were noted in 2009.

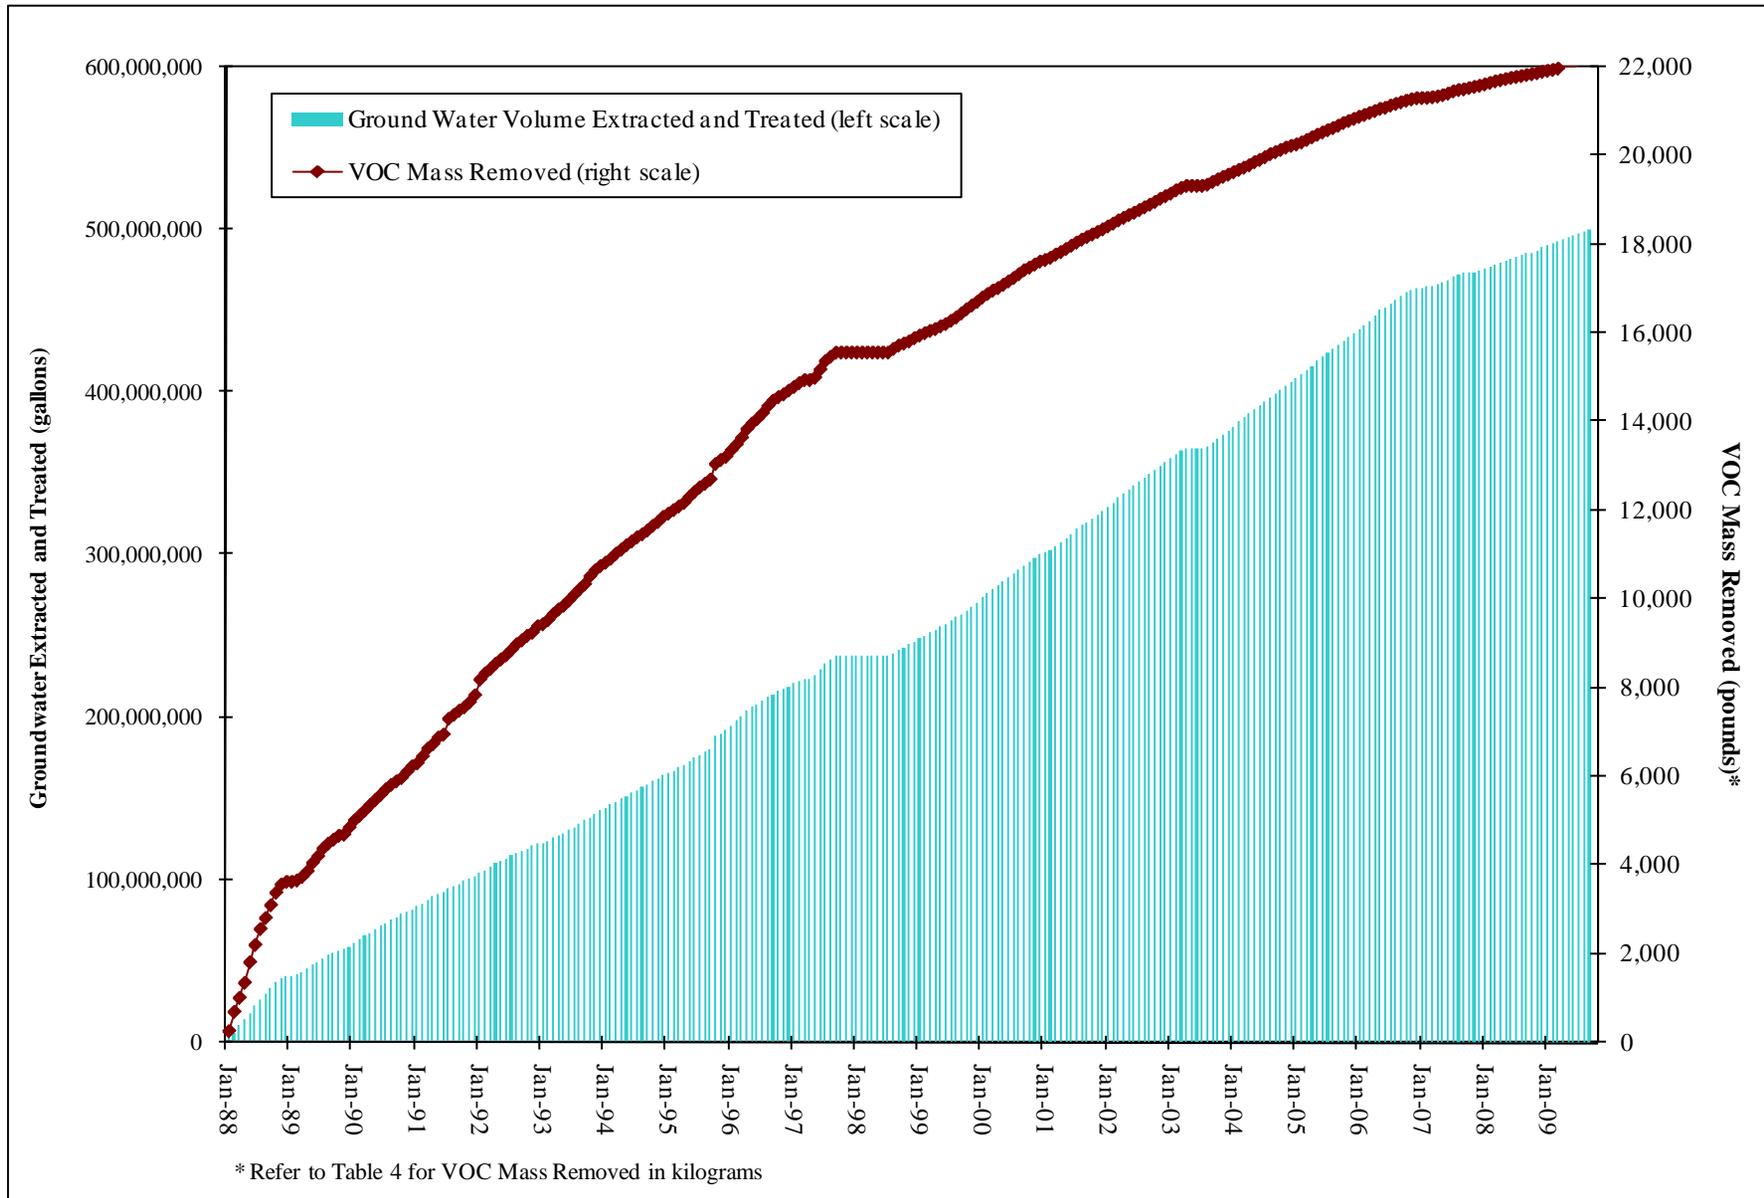
Figure 5. Cumulative Groundwater and VOC Mass Removal Summary, Fairchild System 3, 313 Fairchild Drive, Mountain View, California.

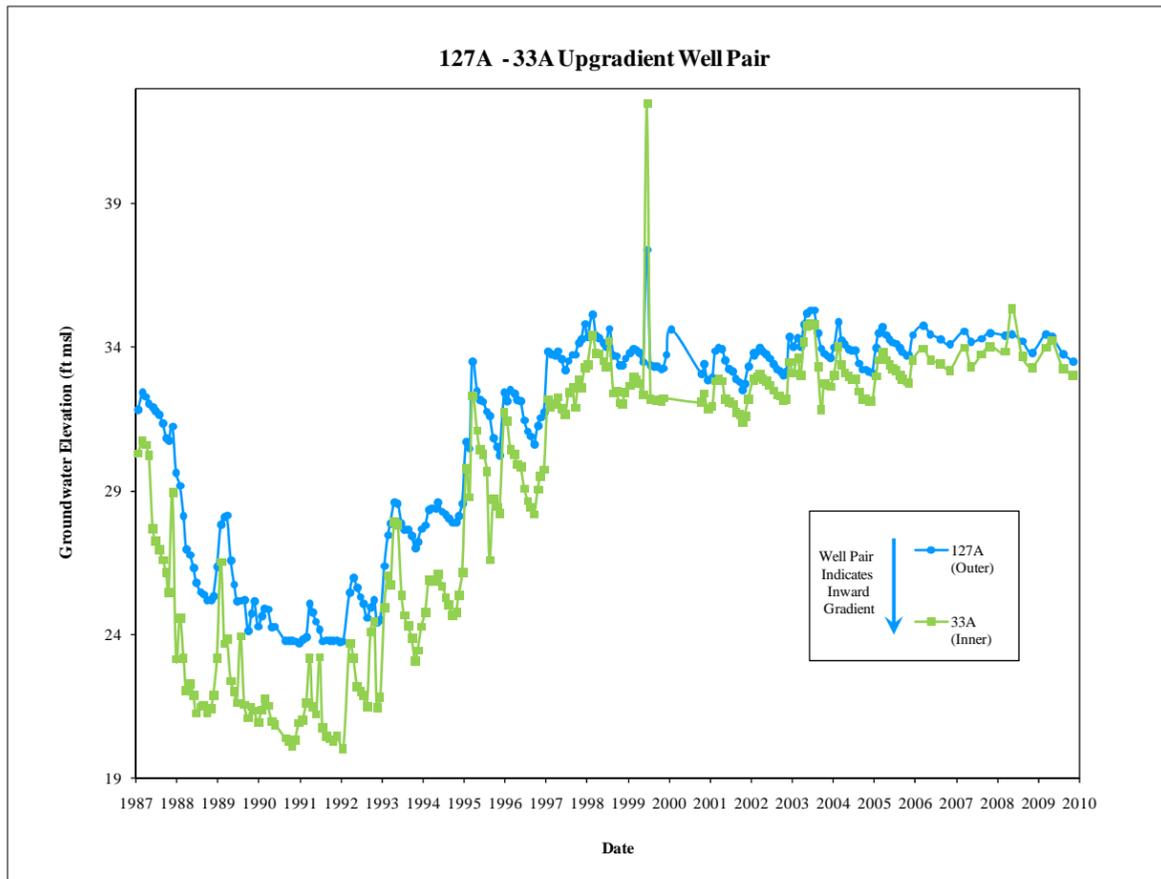
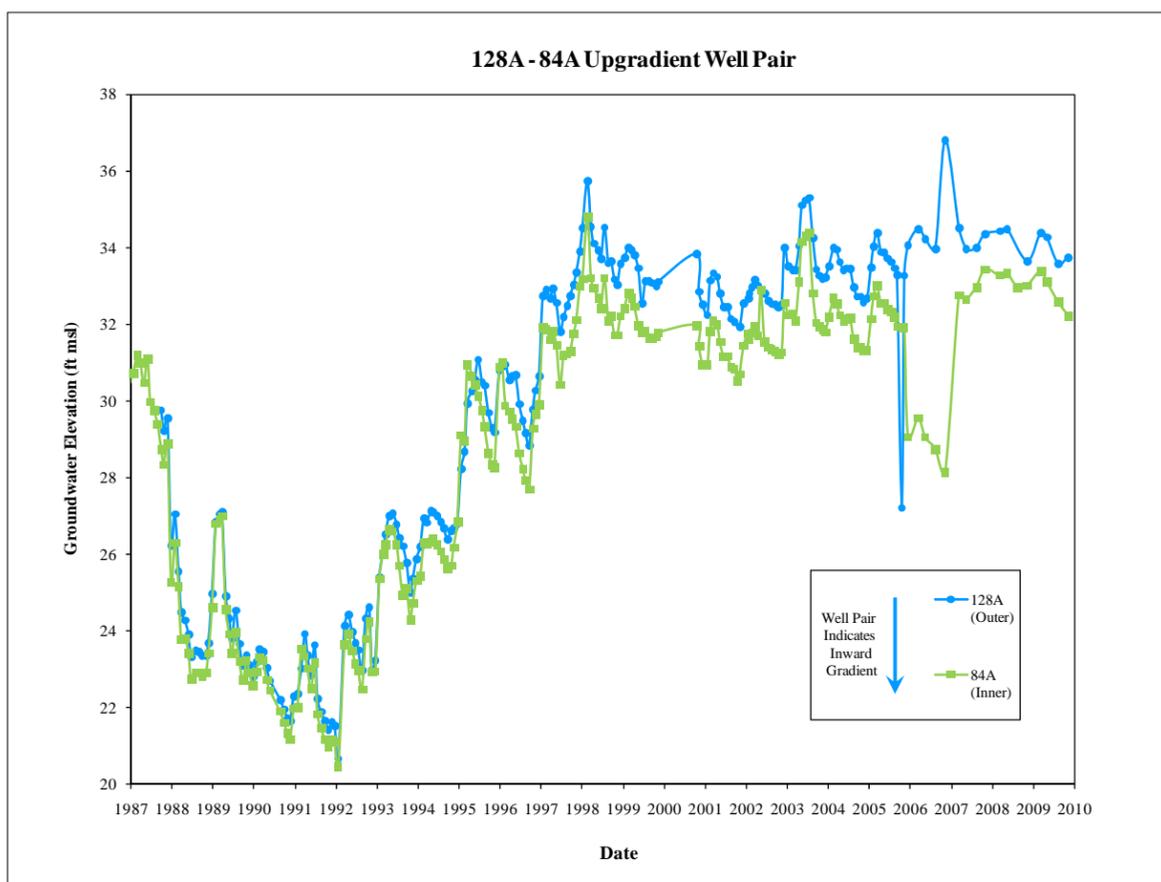
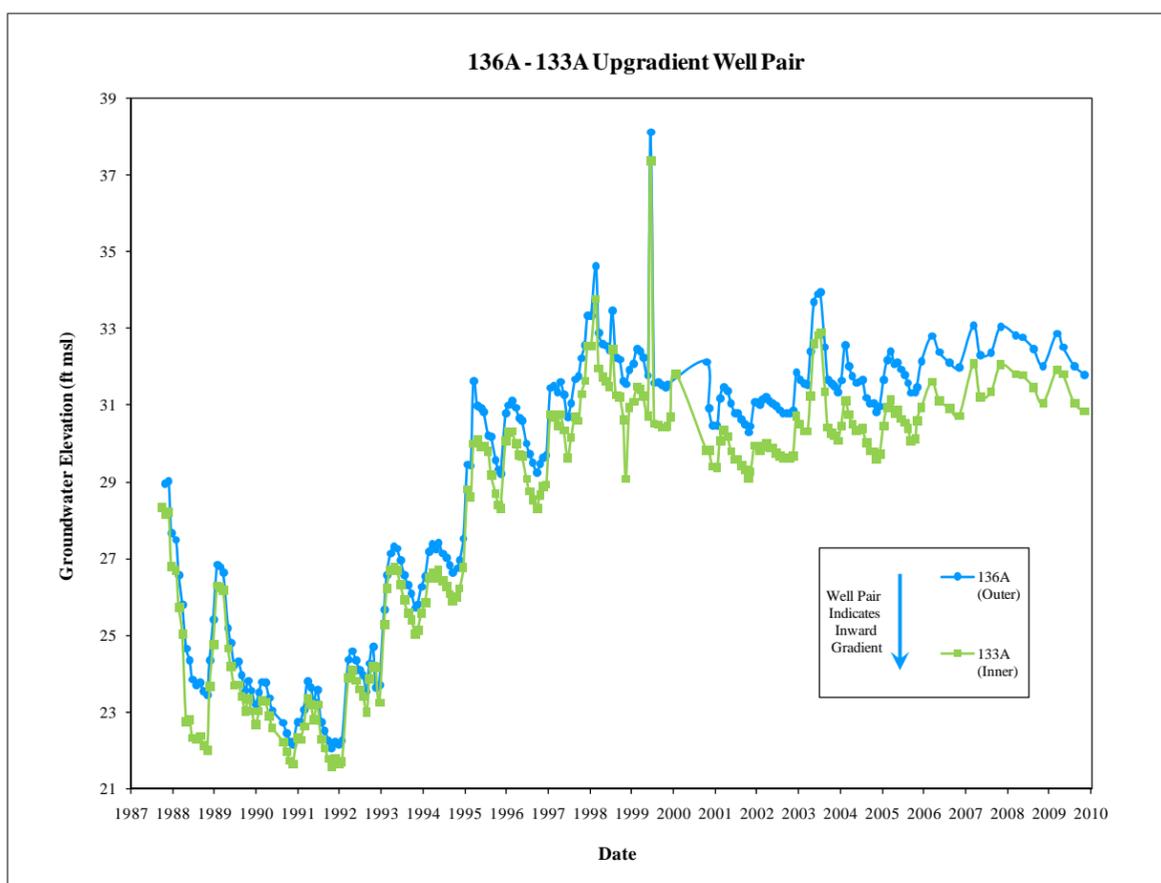
Figure 6. Hydrographs – Groundwater Elevation Measurements, Slurry Wall Well Pairs – Upgradient Wells, Buildings 1-4, MEW Fairchild Site, Mountain View, California

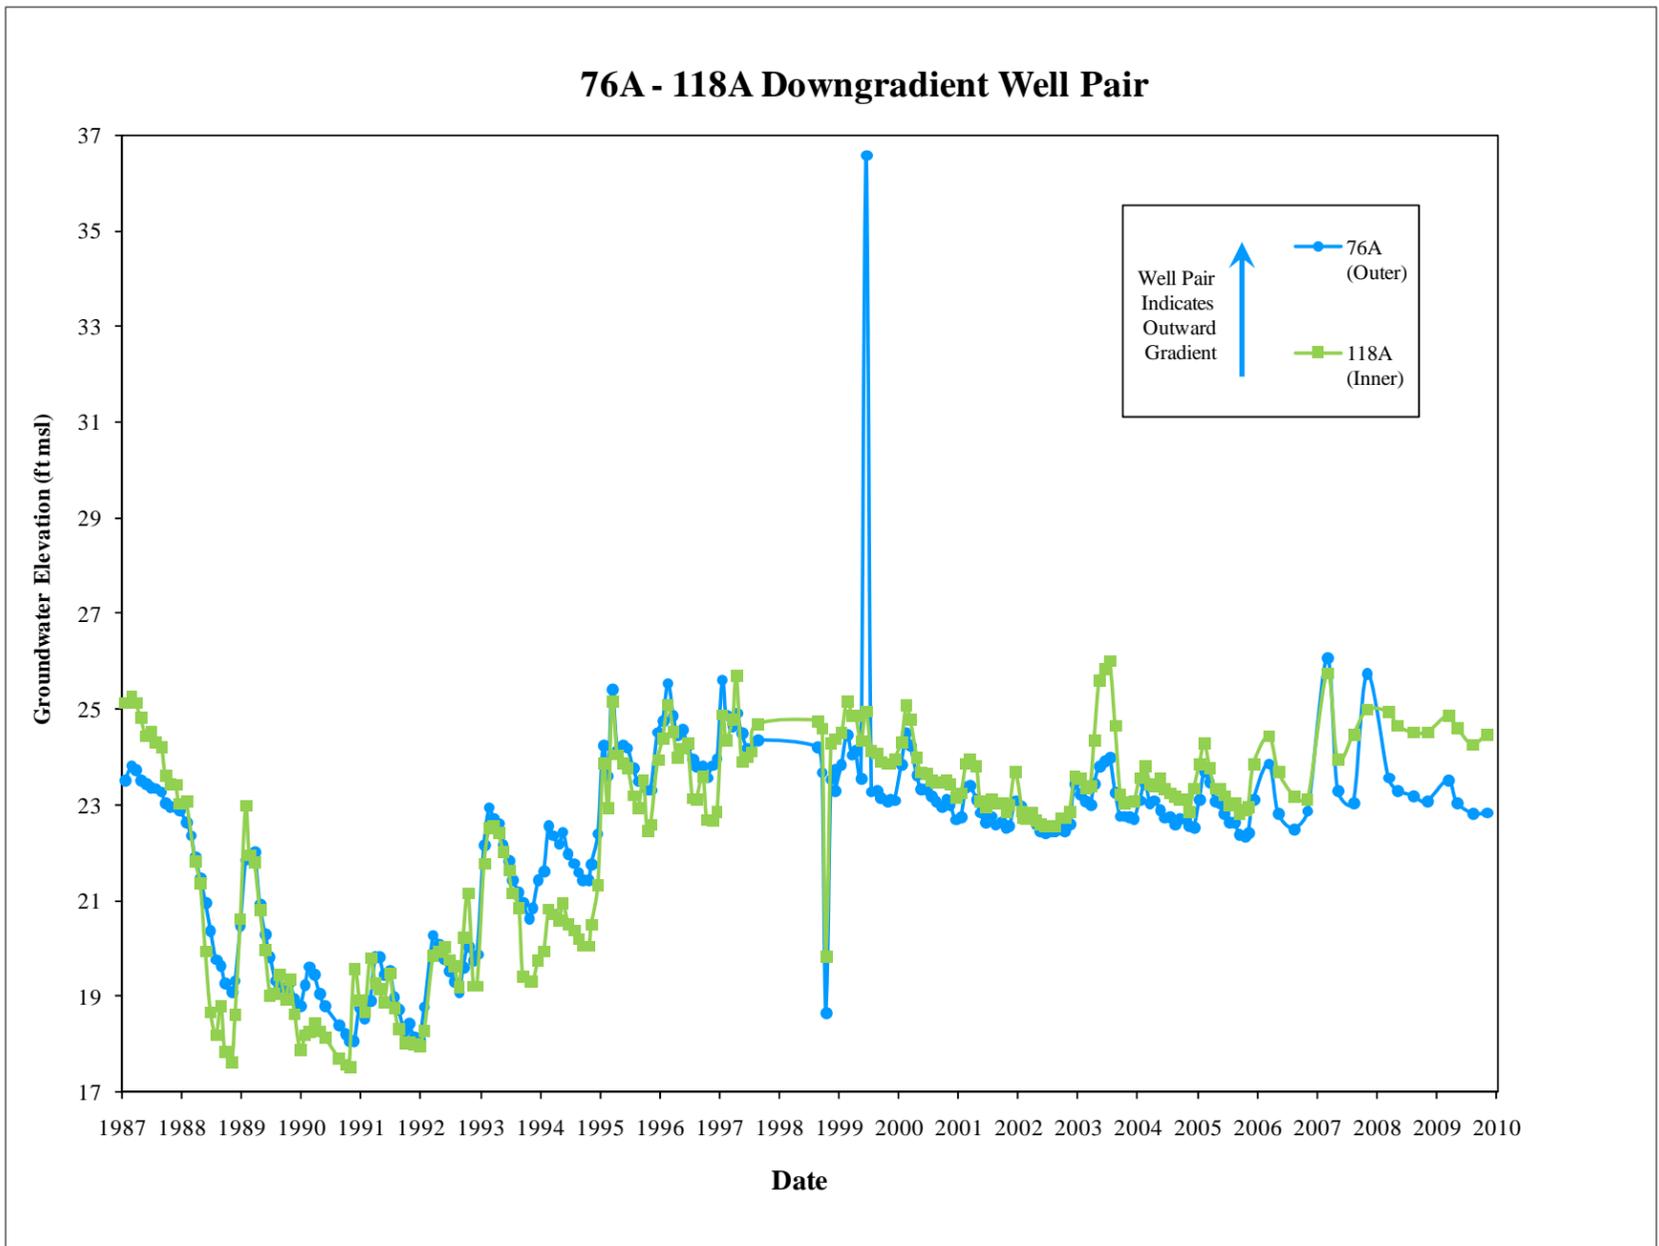
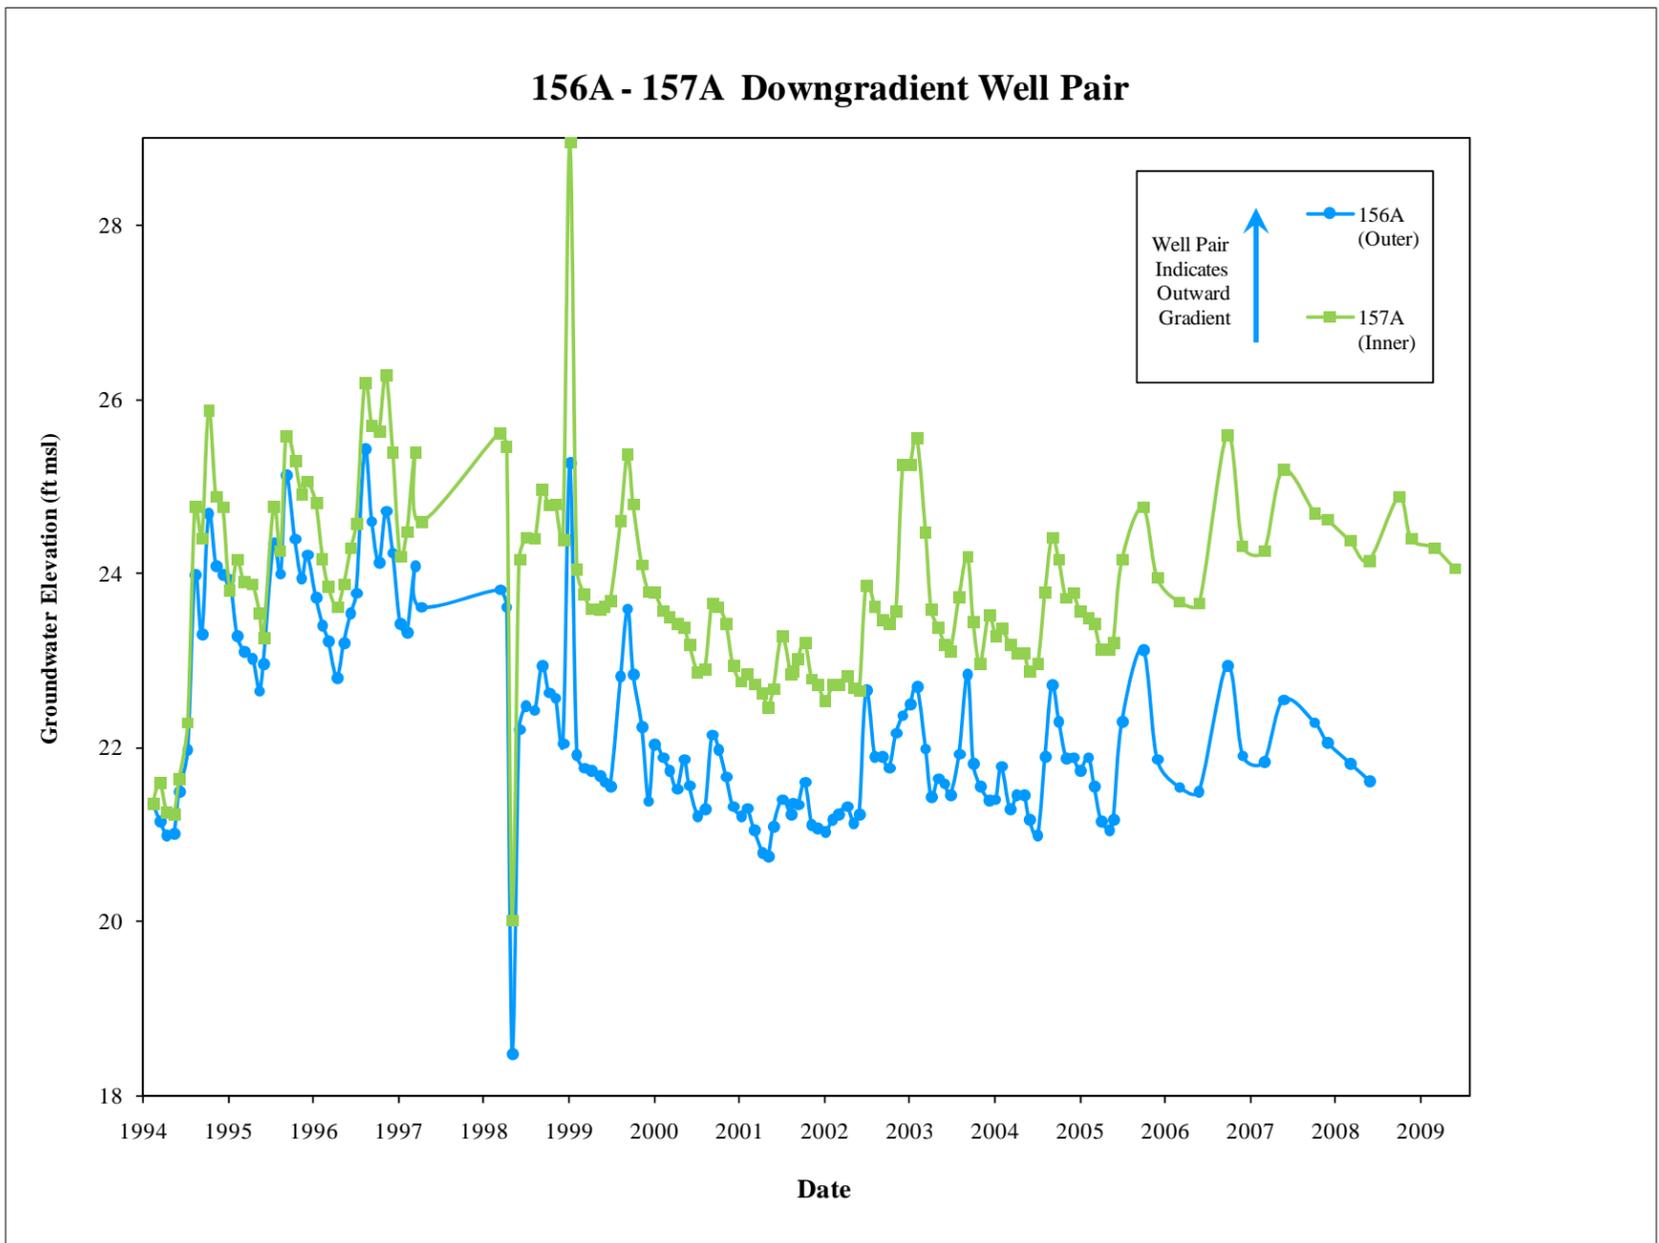
Figure 7. Hydrographs – Groundwater Elevation Measurements, Slurry Wall Well Pairs – Downgradient Wells, Buildings 1-4, MEW Fairchild Site, Mountain View, California

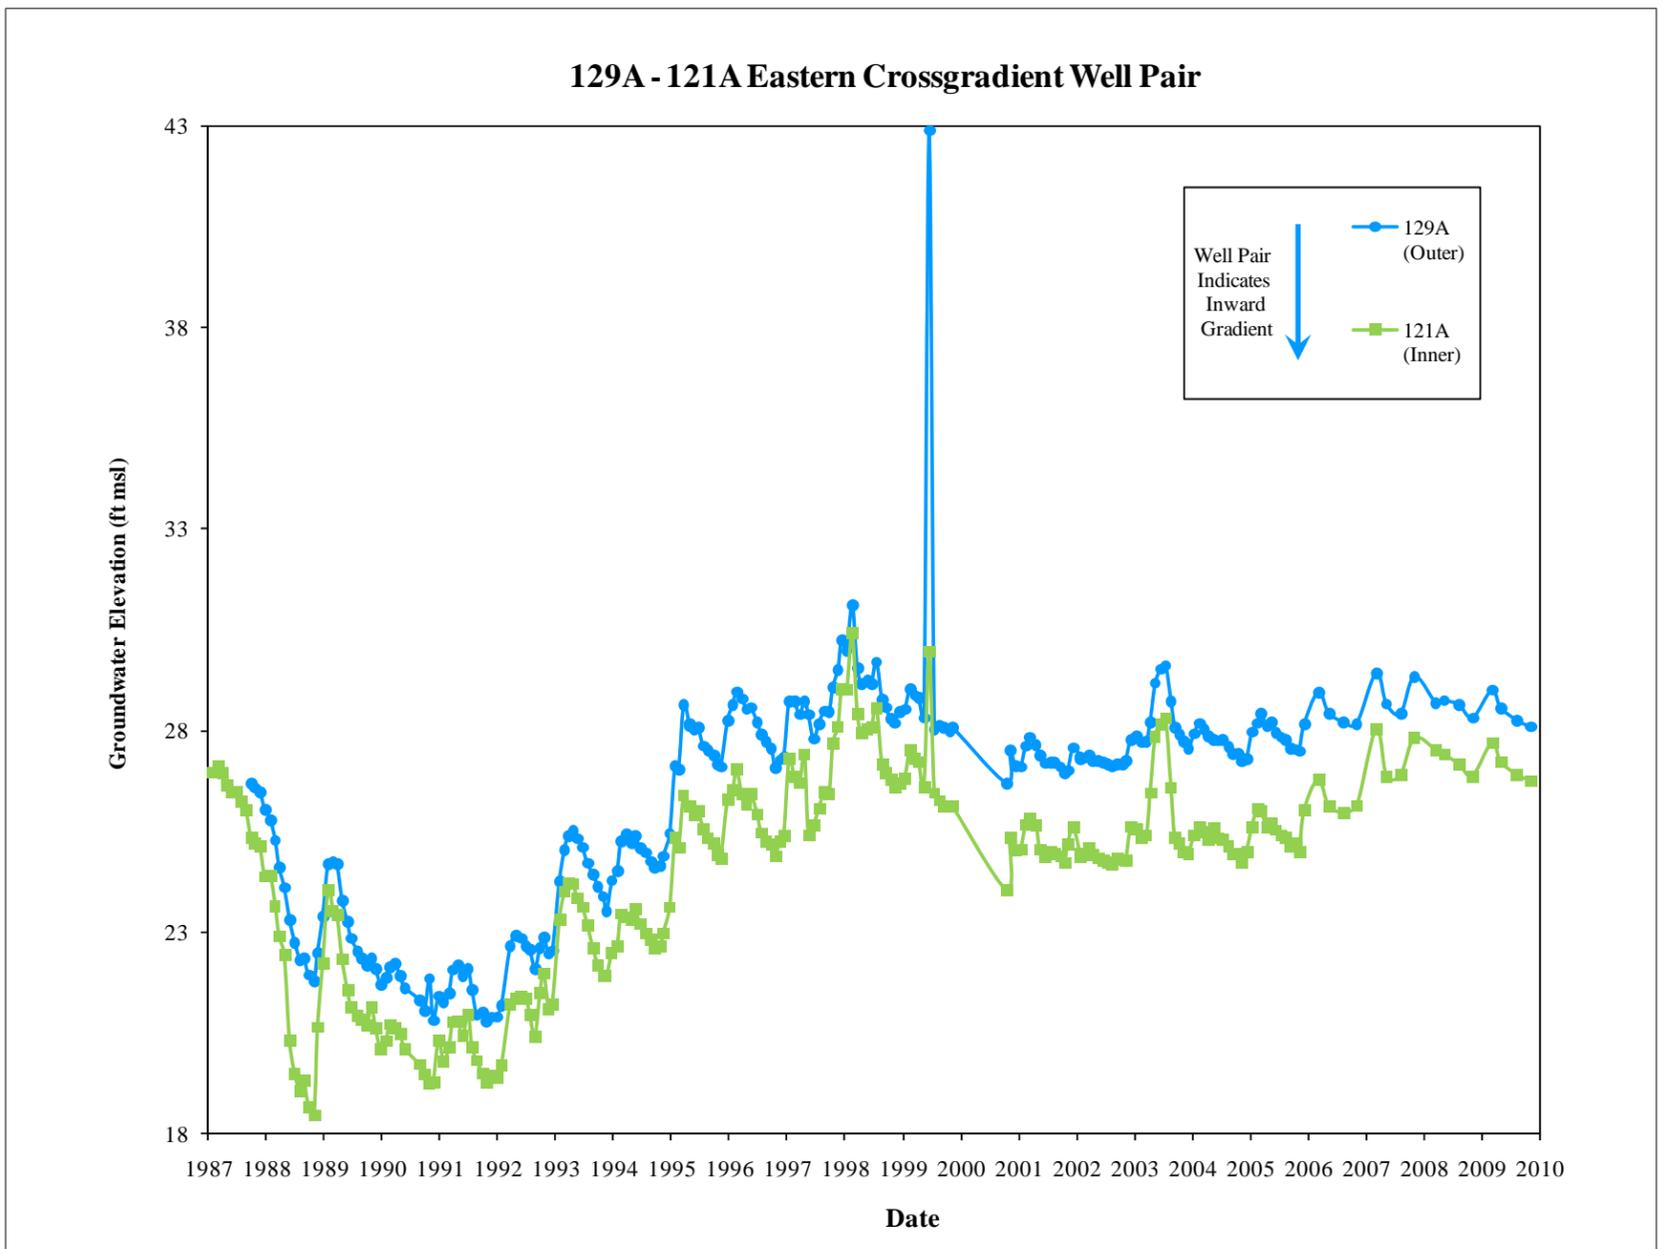
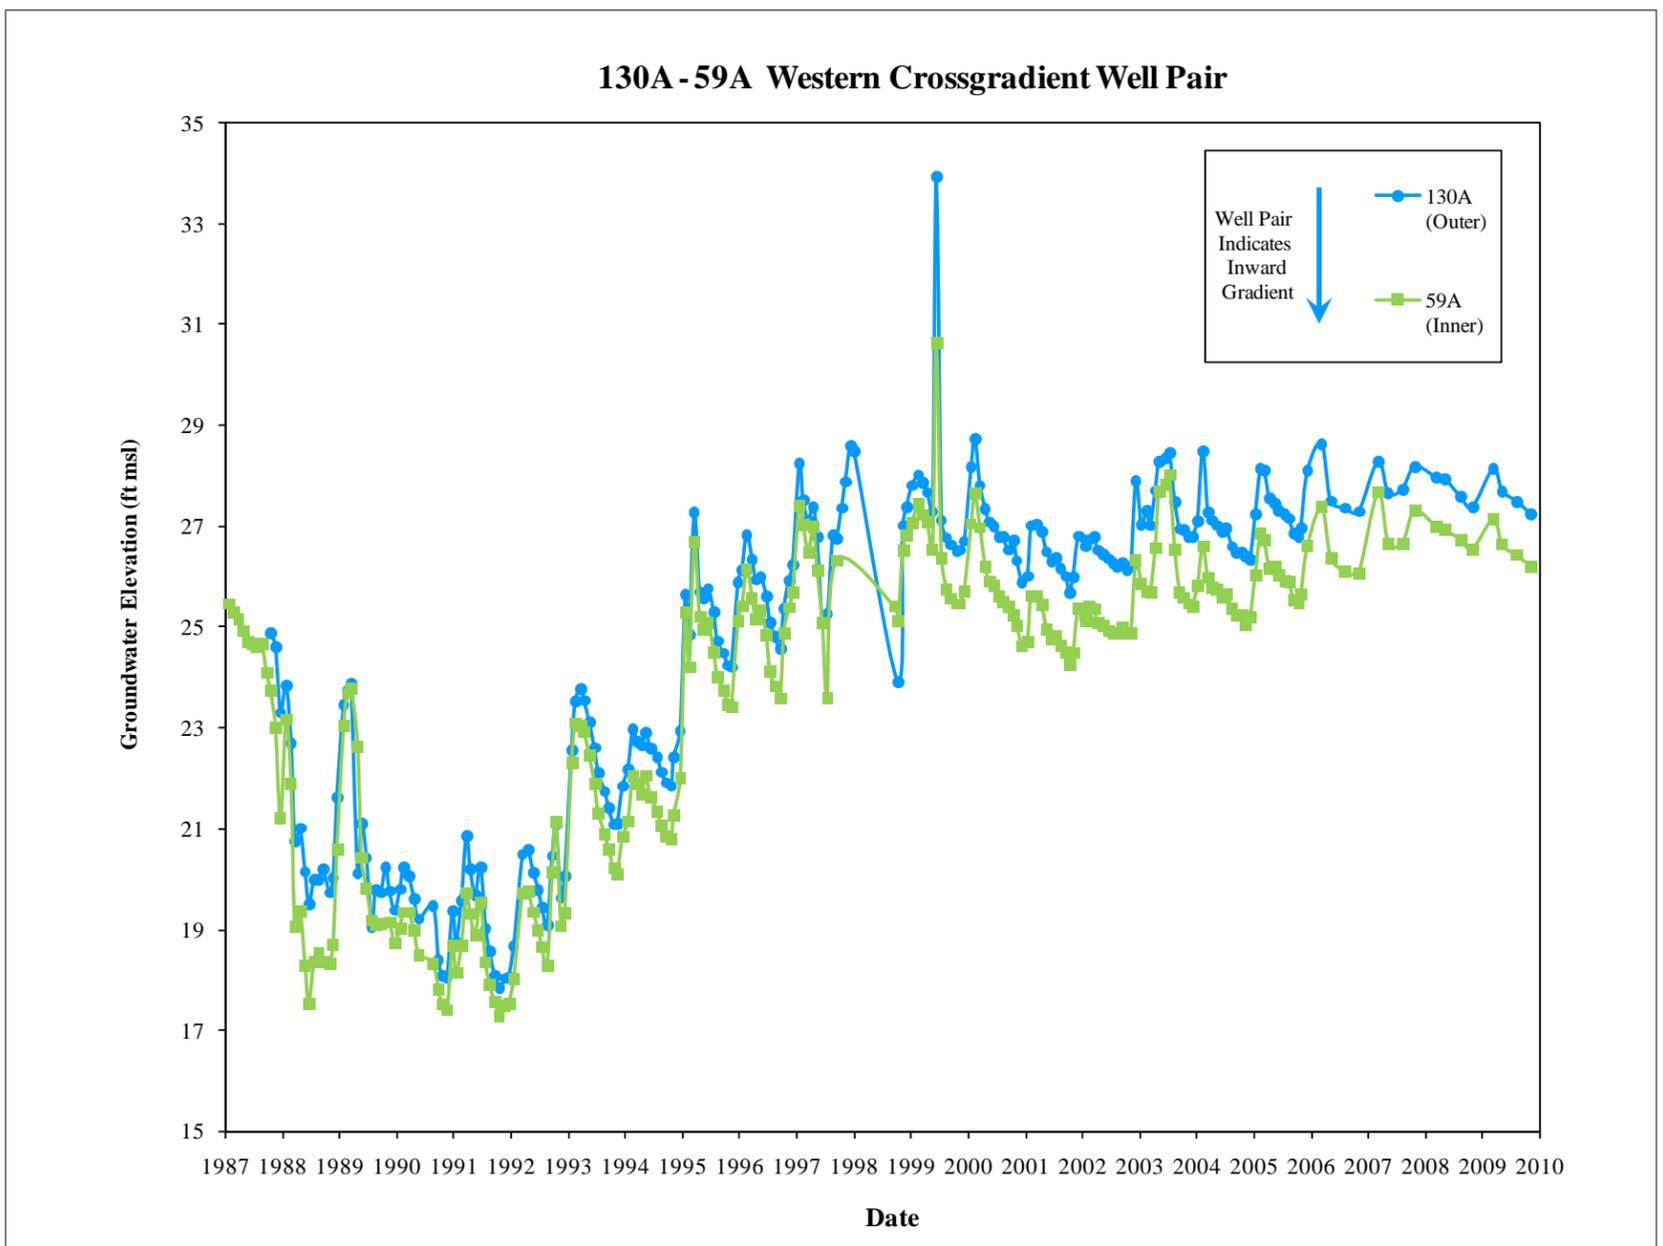
Figure 8. Hydrographs – Groundwater Elevation Measurements, Slurry Wall Well Pairs – Crossgradient Wells, Buildings 1-4, MEW Fairchild Site, Mountain View, California

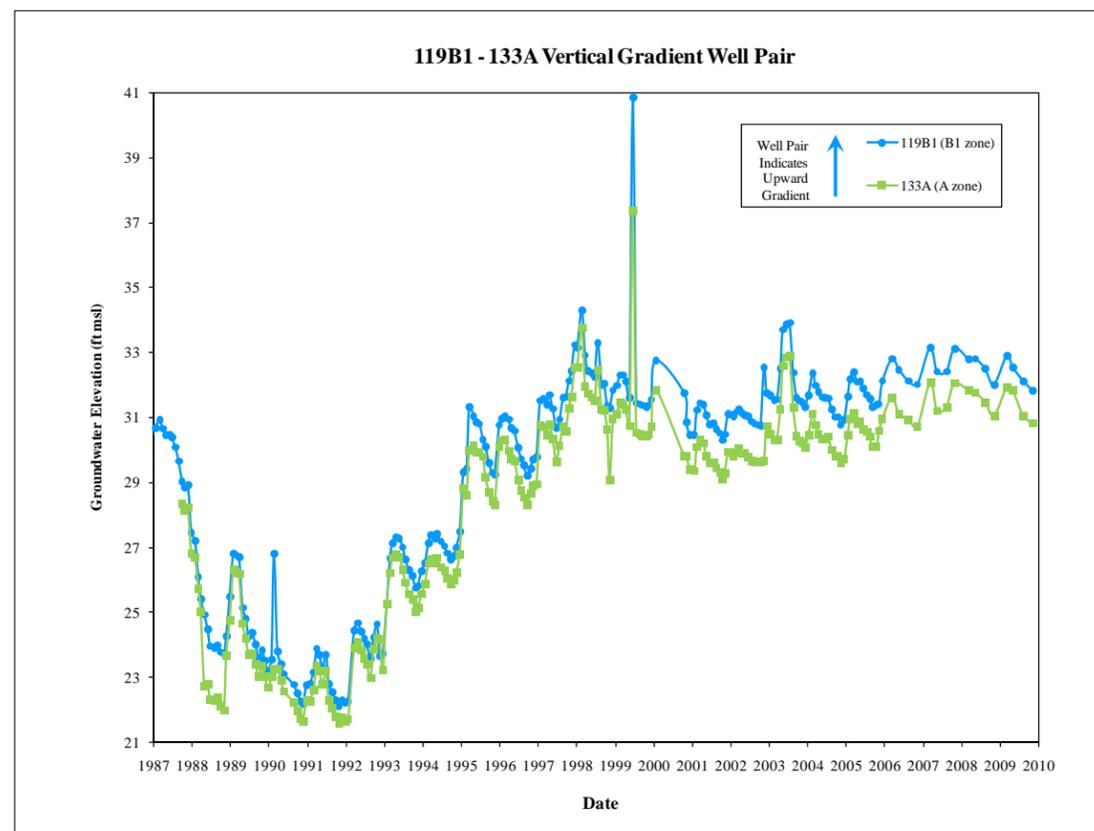
Figure 9. Hydrographs – Groundwater Elevation Measurements, Slurry Wall Well Pairs – Vertical Gradient Wells, Buildings 1-4, MEW Fairchild Site, Mountain View, California

**In general, vertical gradients across the B and deeper water-bearing zones are upward. Upward vertical gradients are typical from the B- to A-zone, but downward vertical gradients are observed at a few locations.**
