## 2009 ANNUAL PROGRESS REPORT

**Former Fairchild Buildings 1-4  
515/545 Whisman Road and 313 Fairchild Drive  
Middlefield-Ellis-Whisman Area  
Mountain View, California**

**2009 ANNUAL PROGRESS REPORT**  
**for**  
**Former Fairchild Buildings 1- 4**  
**515/545 Whisman Road and 313 Fairchild Drive**  
**Middlefield-Ellis-Whisman Area**  
**Mountain View, California**

**USEPA, Region 9, Superfund Division**  
75 Hawthorne Street  
San Francisco, California 94105

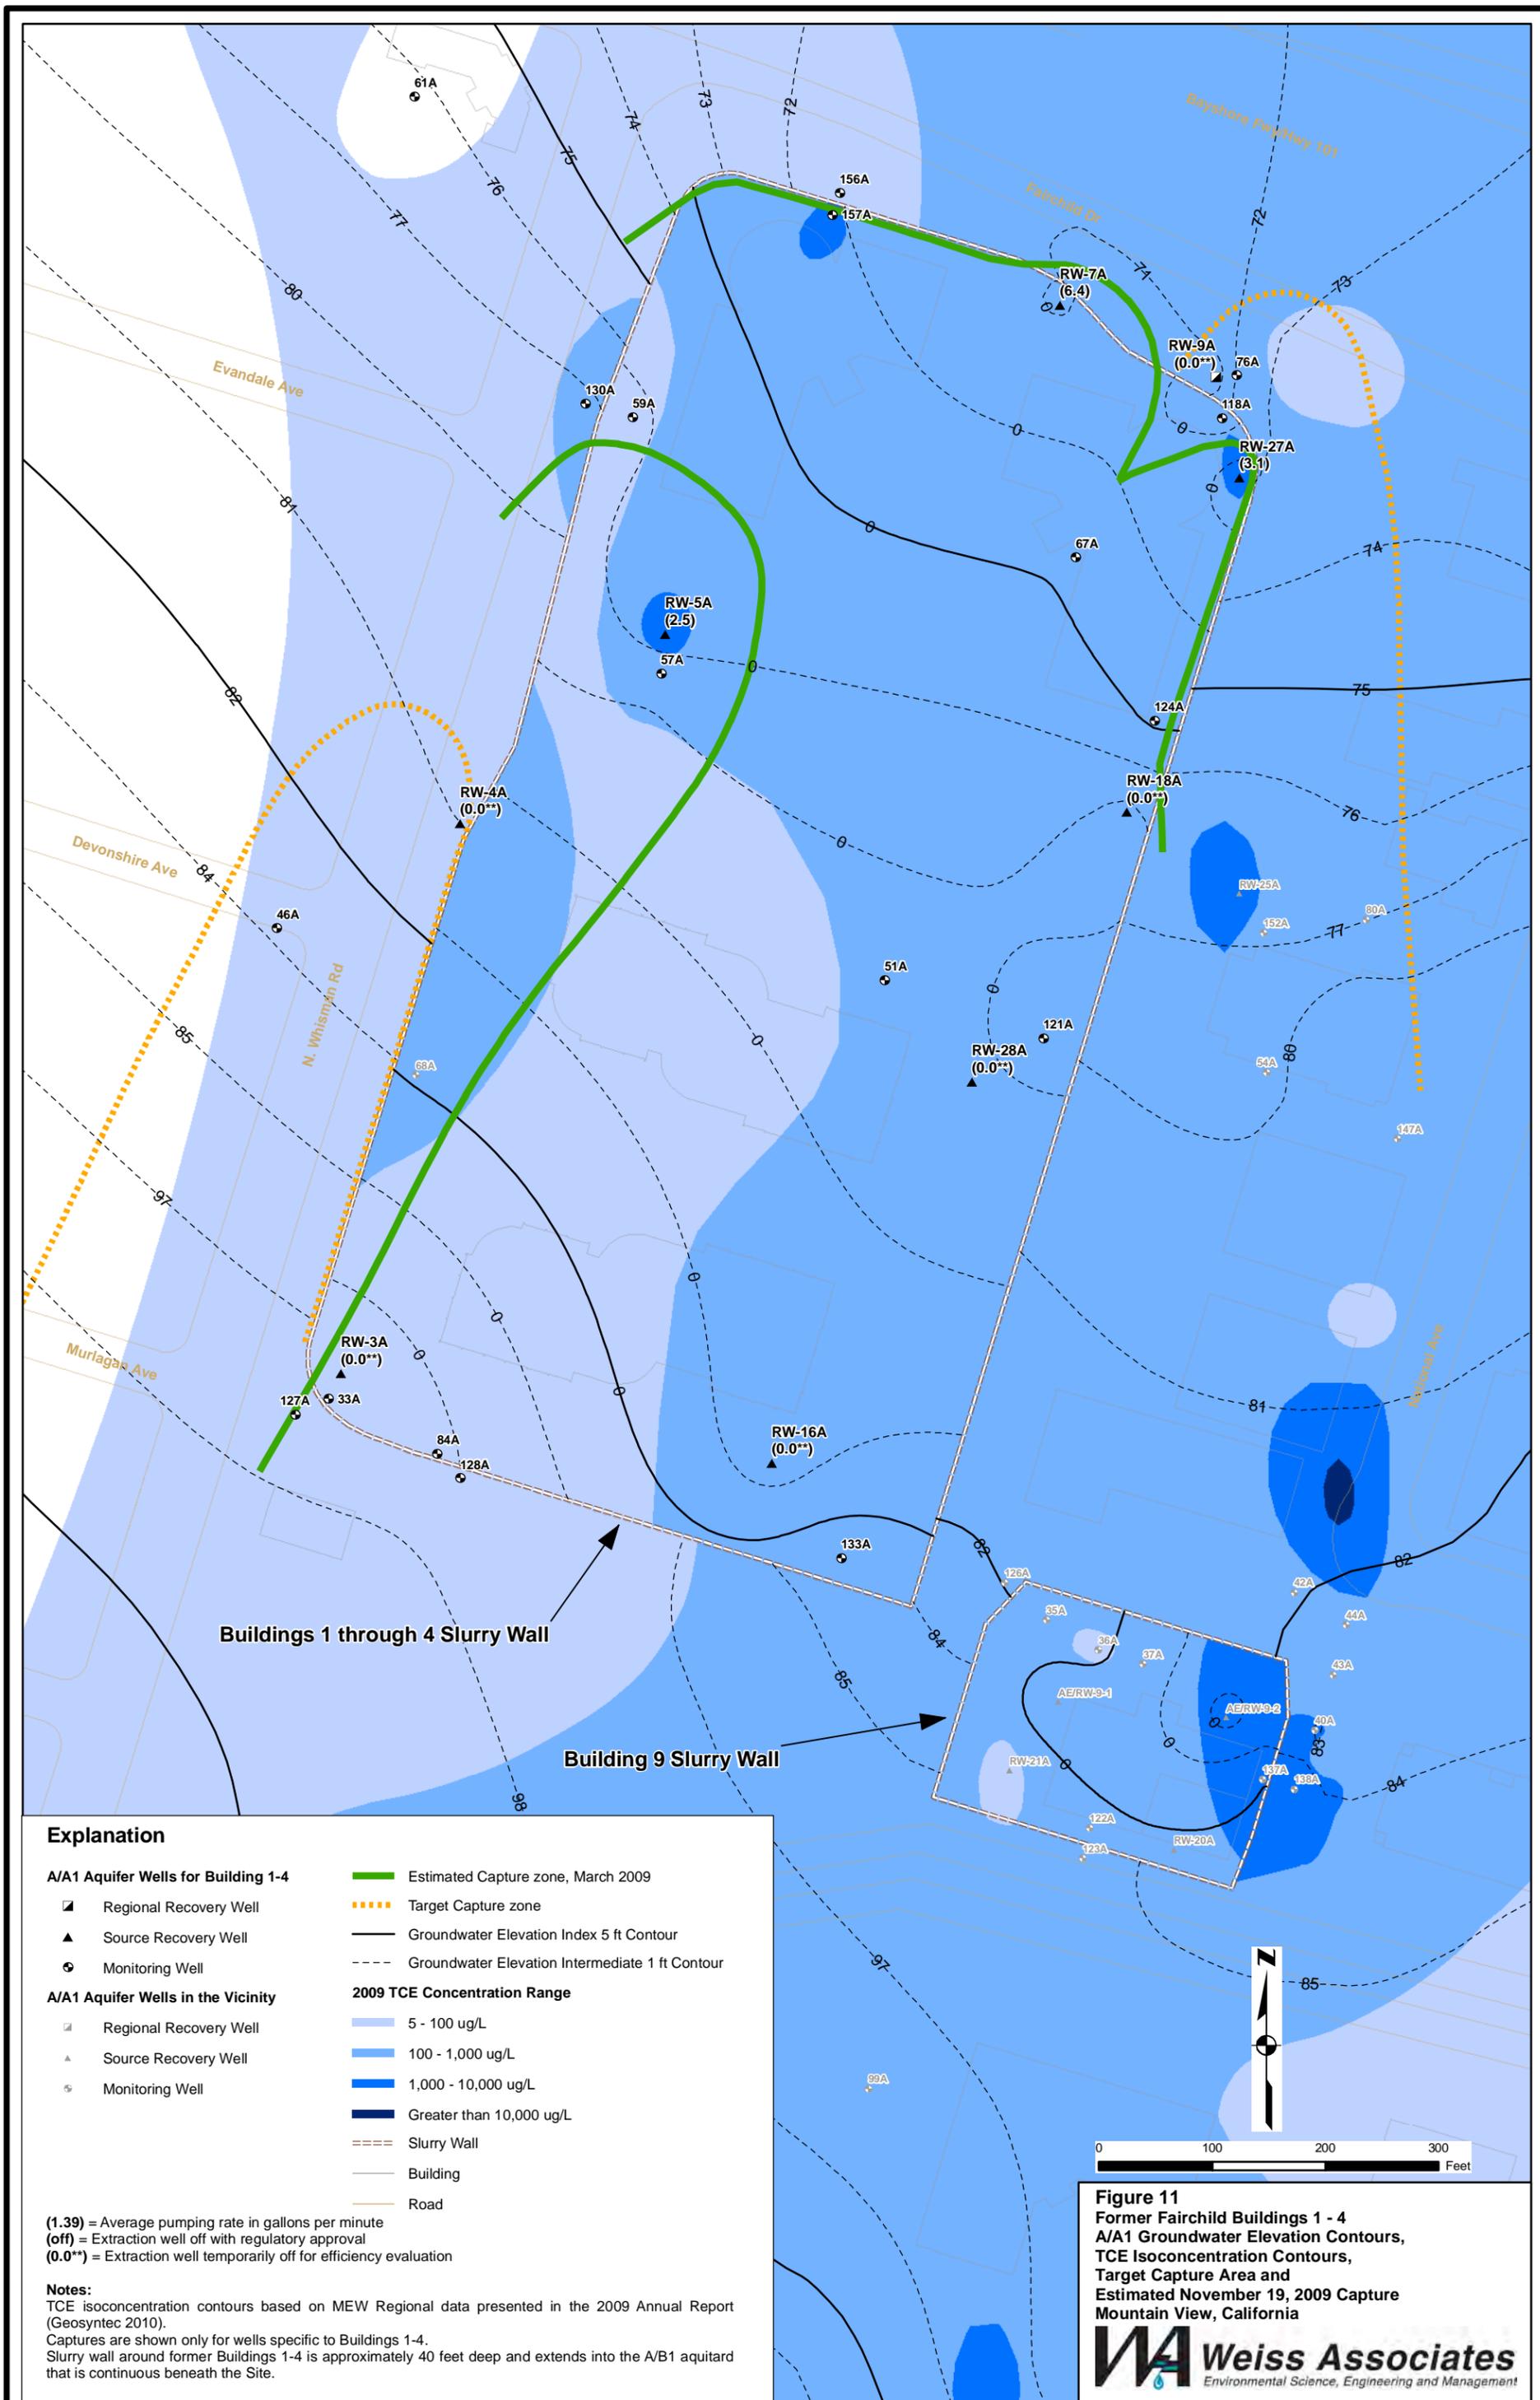
**Notes:**  
 TCE isoconcentration contours based on MEW Regional data presented in the 2009 Annual Report (Geosyntec 2010).  
 Captures are shown only for wells specific to Buildings 1-4.  
 Slurry wall around former Buildings 1-4 is approximately 40 feet deep and extends into the A/B1 aquifer that is continuous beneath the Site.

**Figure 11**  
 Former Fairchild Buildings 1 - 4  
 A/A1 Groundwater Elevation Contours,  
 TCE Isoconcentration Contours,  
 Target Capture Area and  
 Estimated November 19, 2009 Capture  
 Mountain View, California

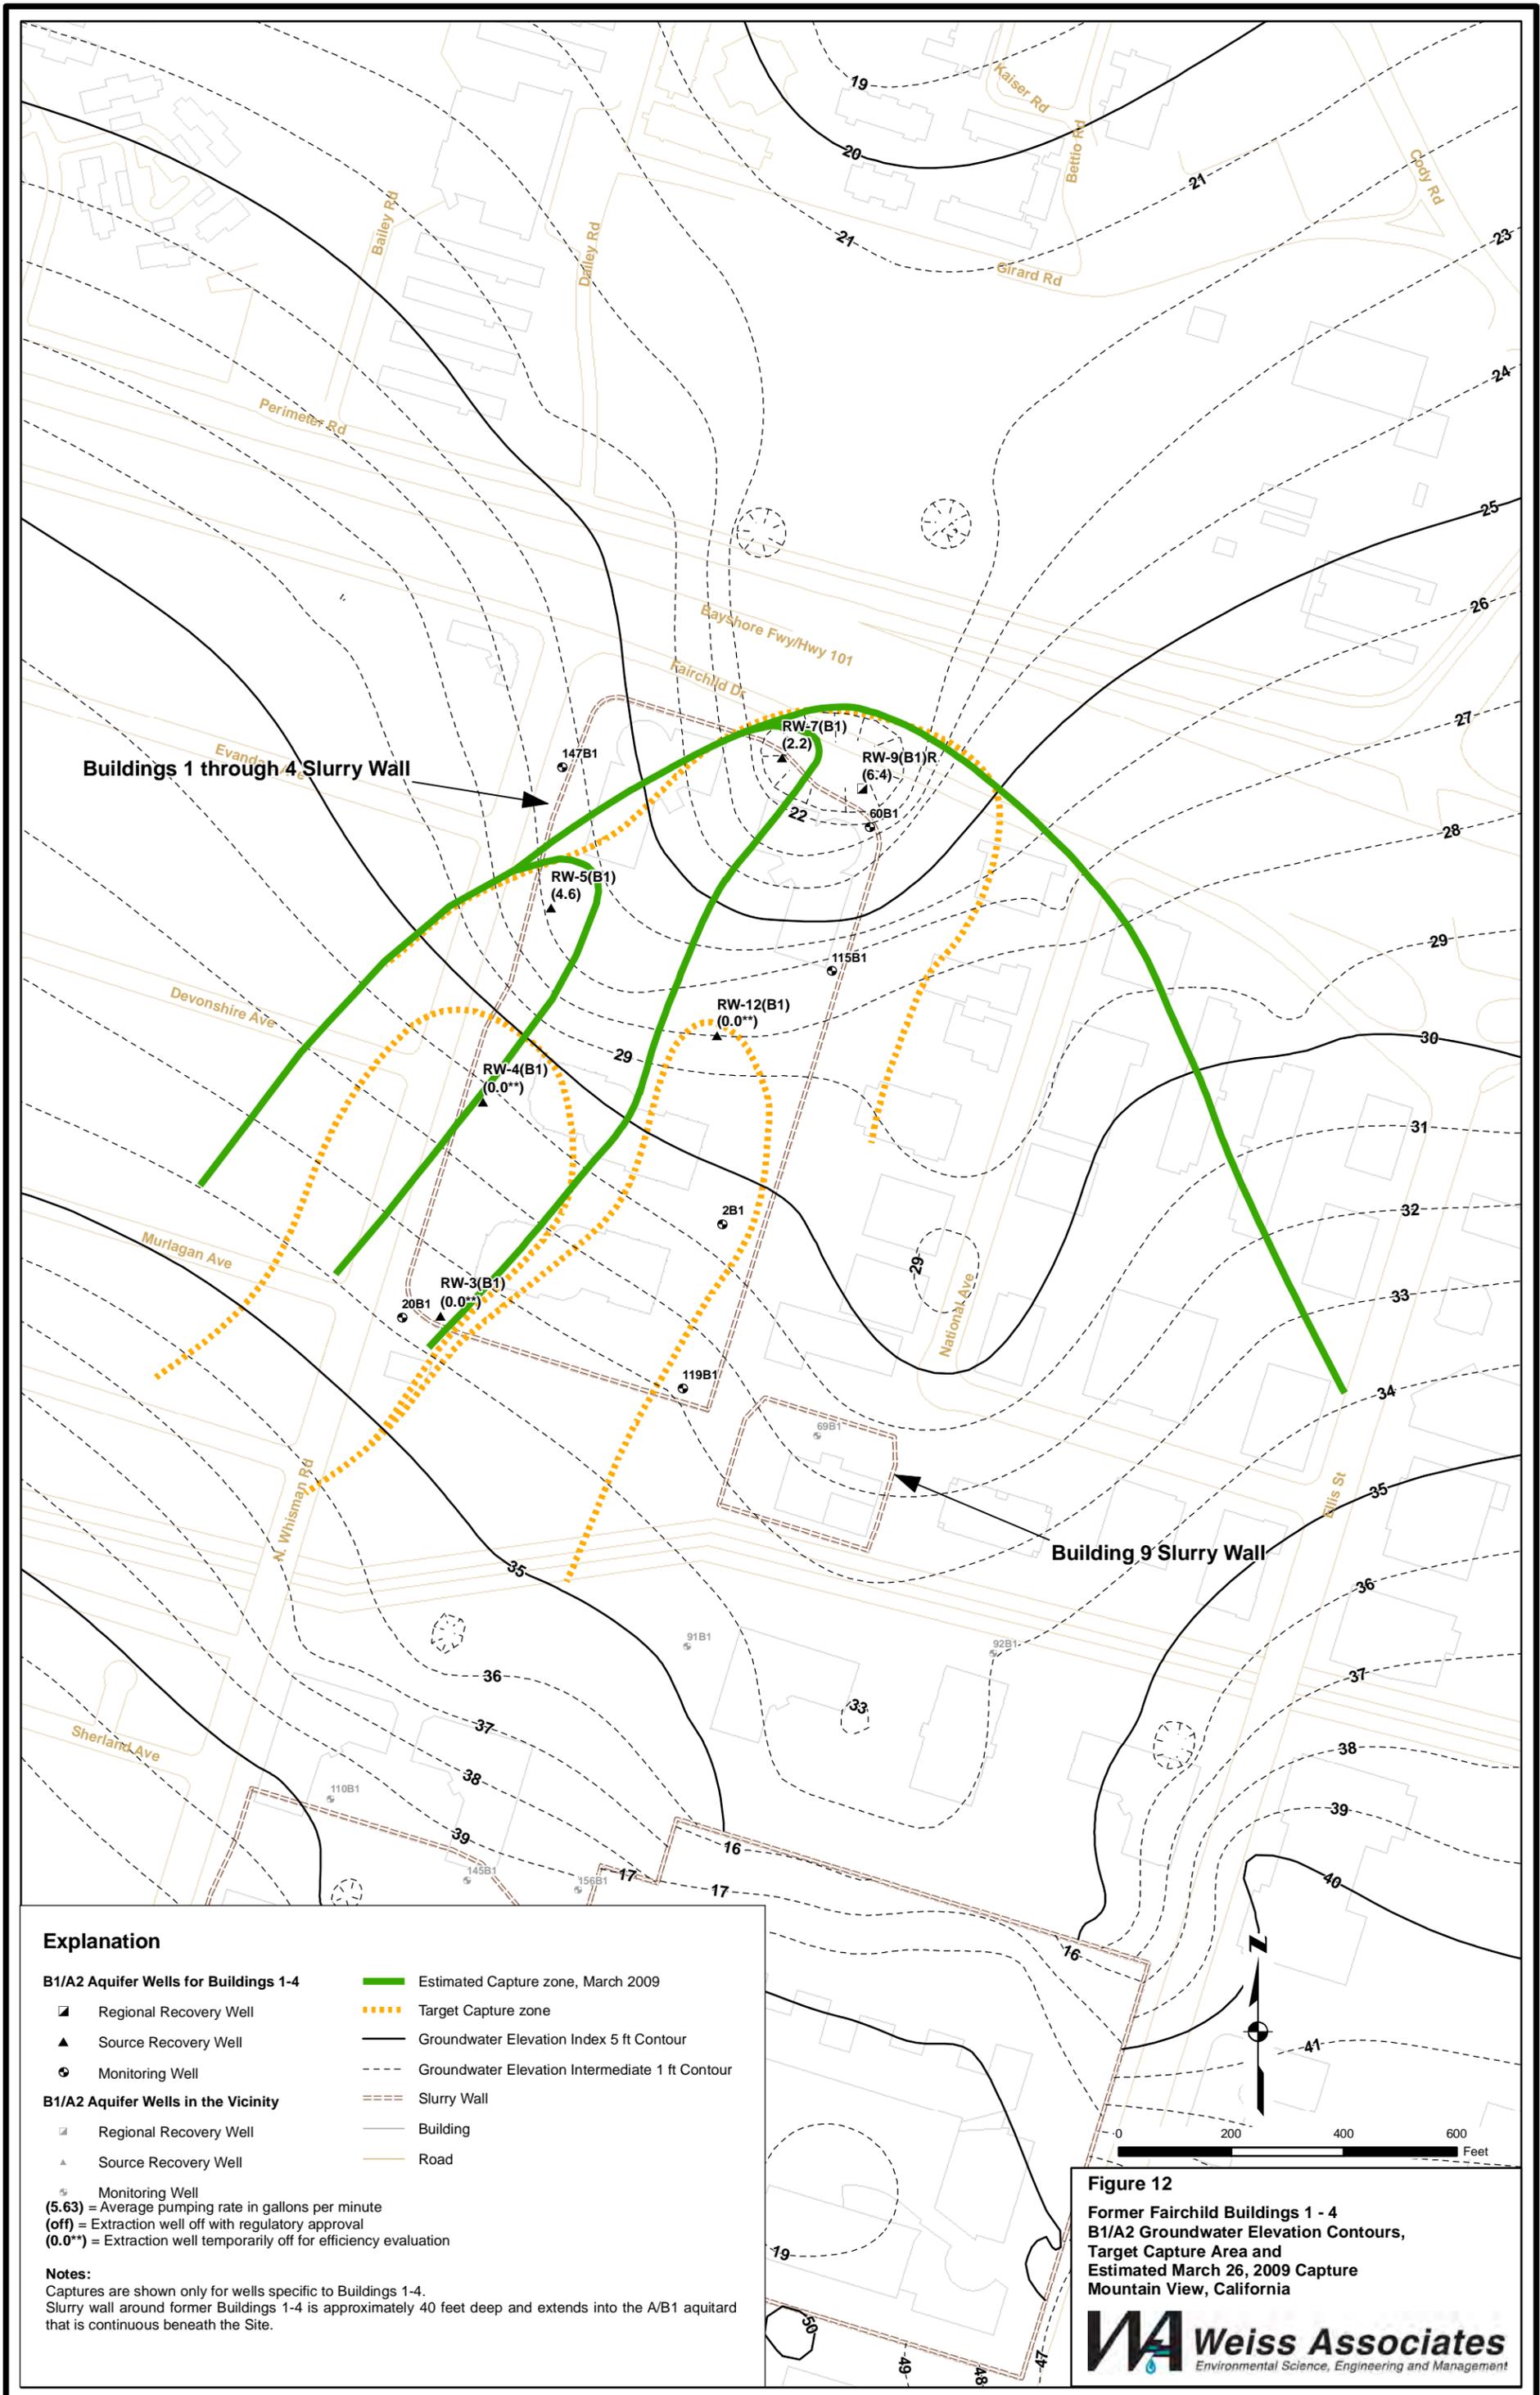
**Former Fairchild Buildings 1 - 4  
 B1/A2 Groundwater Elevation Contours,  
 Target Capture Area and  
 Estimated March 26, 2009 Capture  
 Mountain View, California**

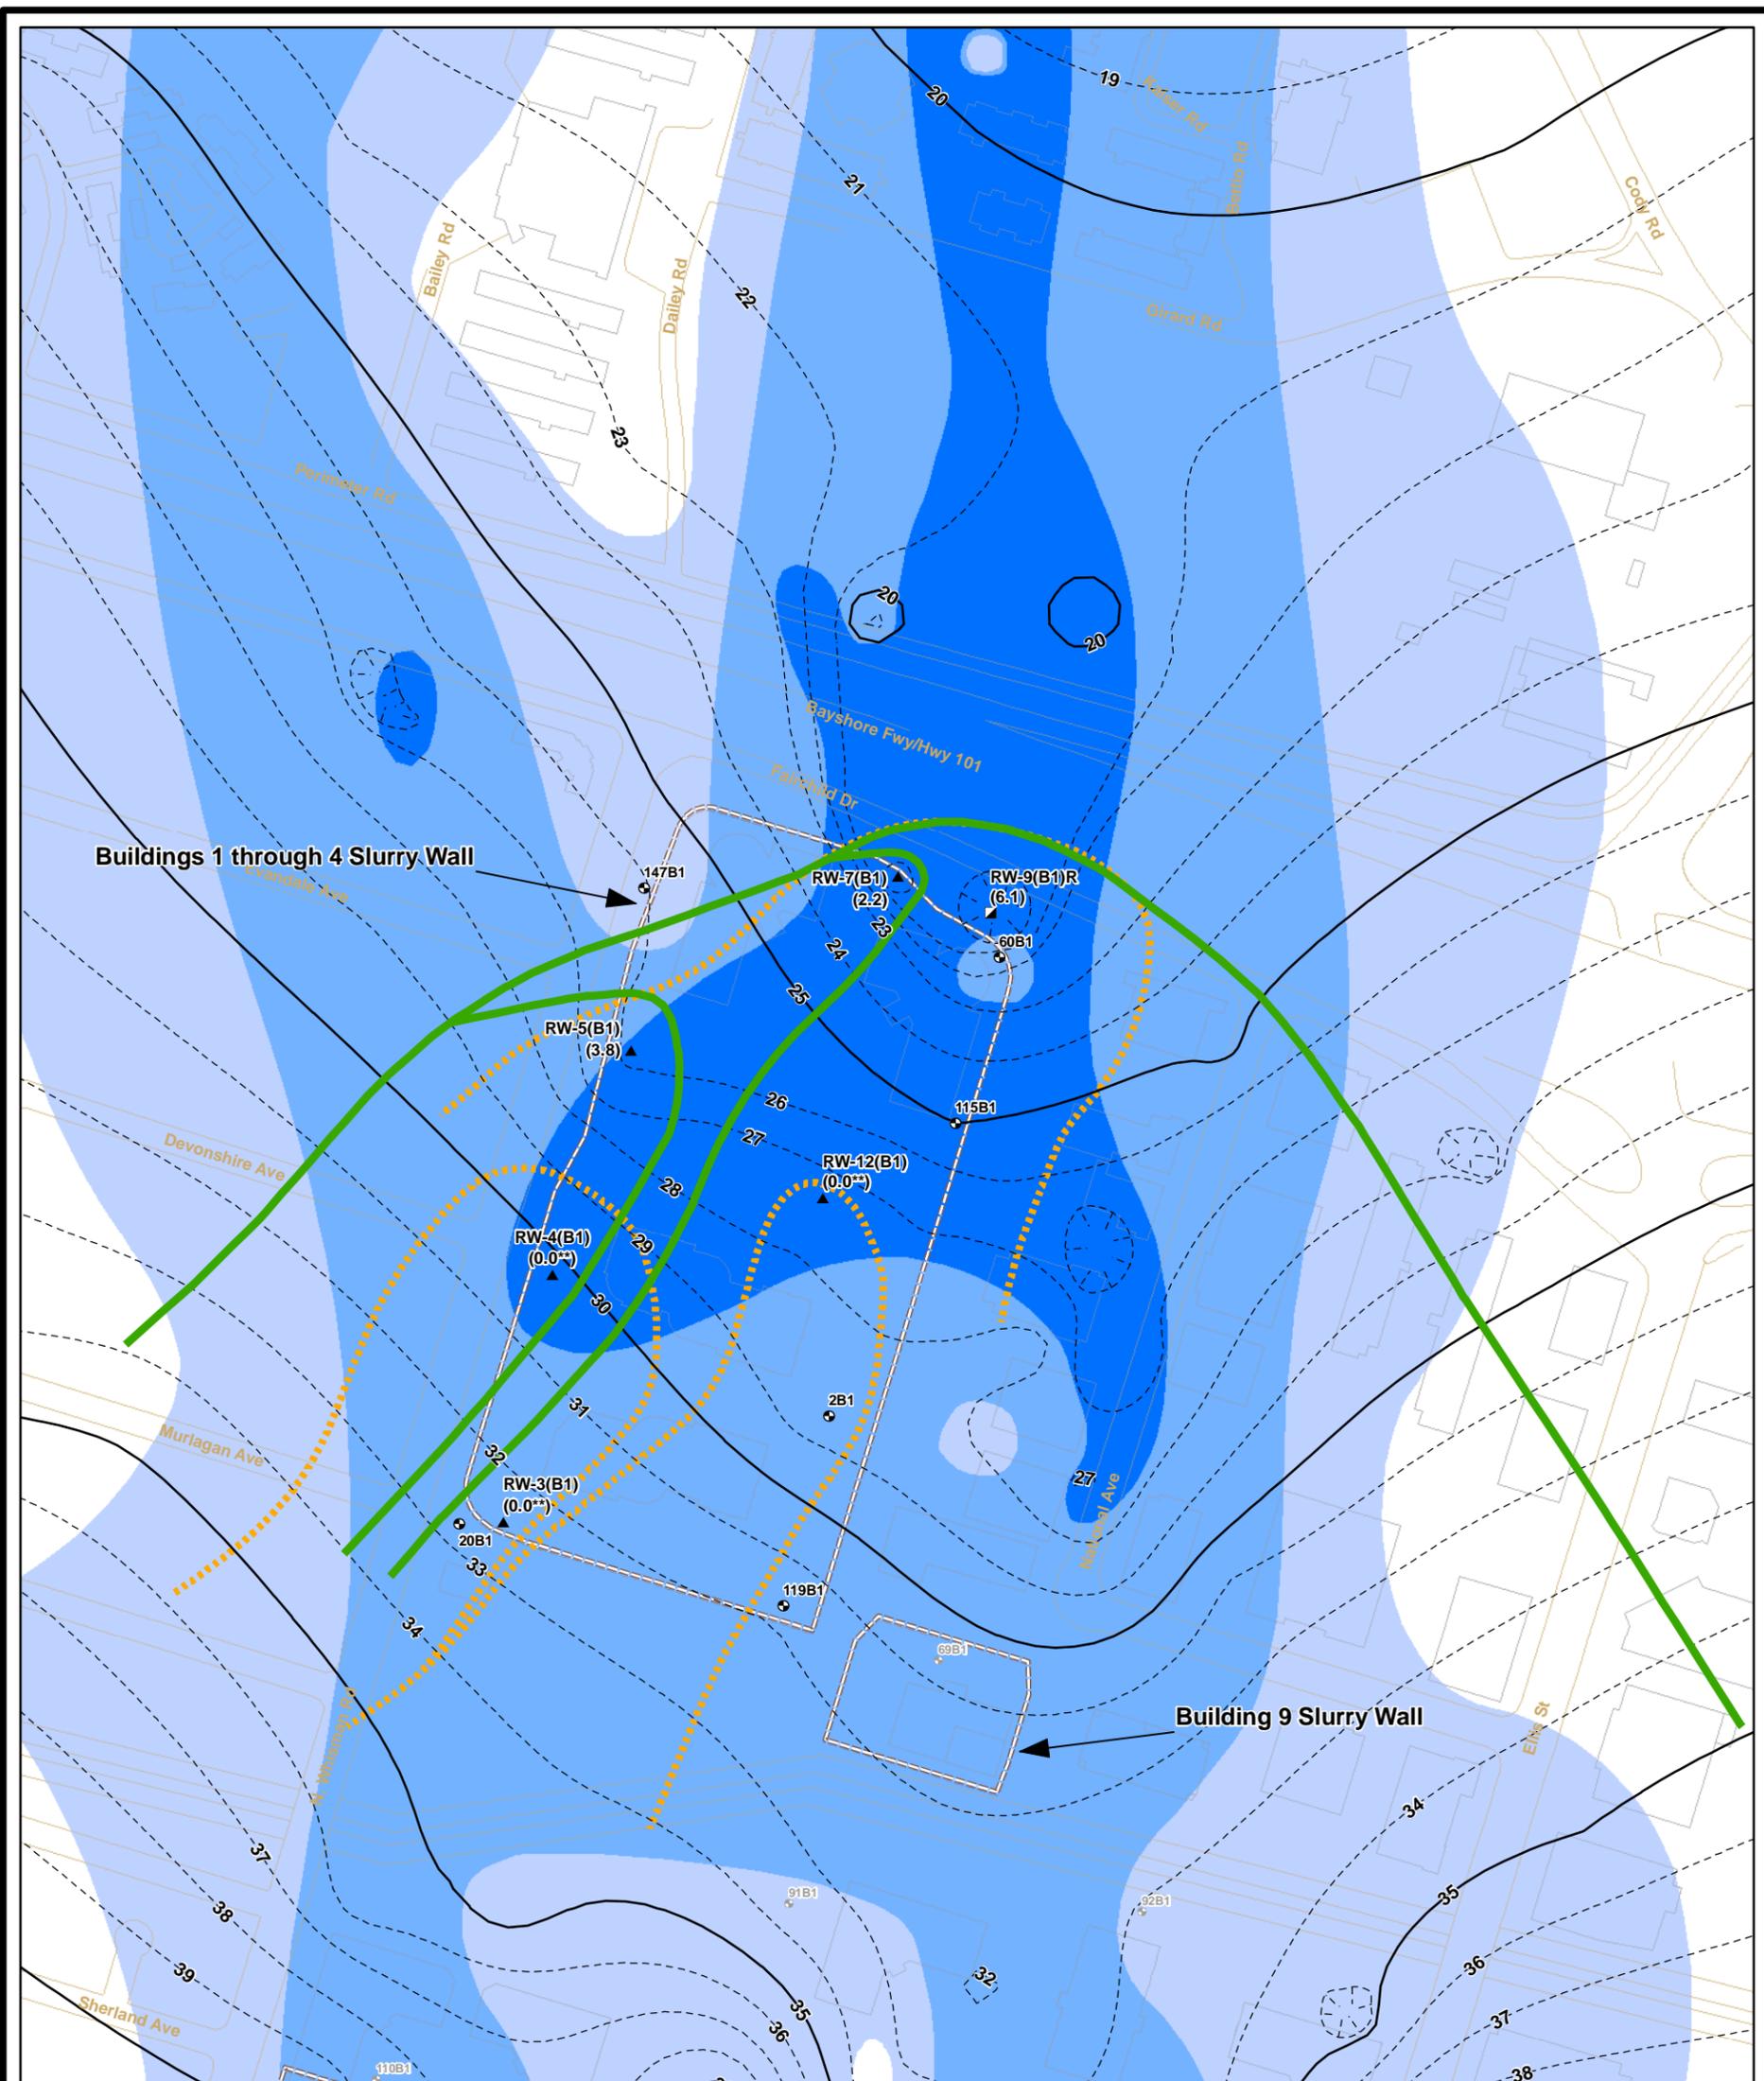
**Figure 13**  
 Former Fairchild Buildings 1 - 4  
 B1/A2 Groundwater Elevation Contours,  
 TCE Isoconcentration Contours,  
 Target Capture Area and  
 Estimated November 19, 2009 Capture  
 Mountain View, California

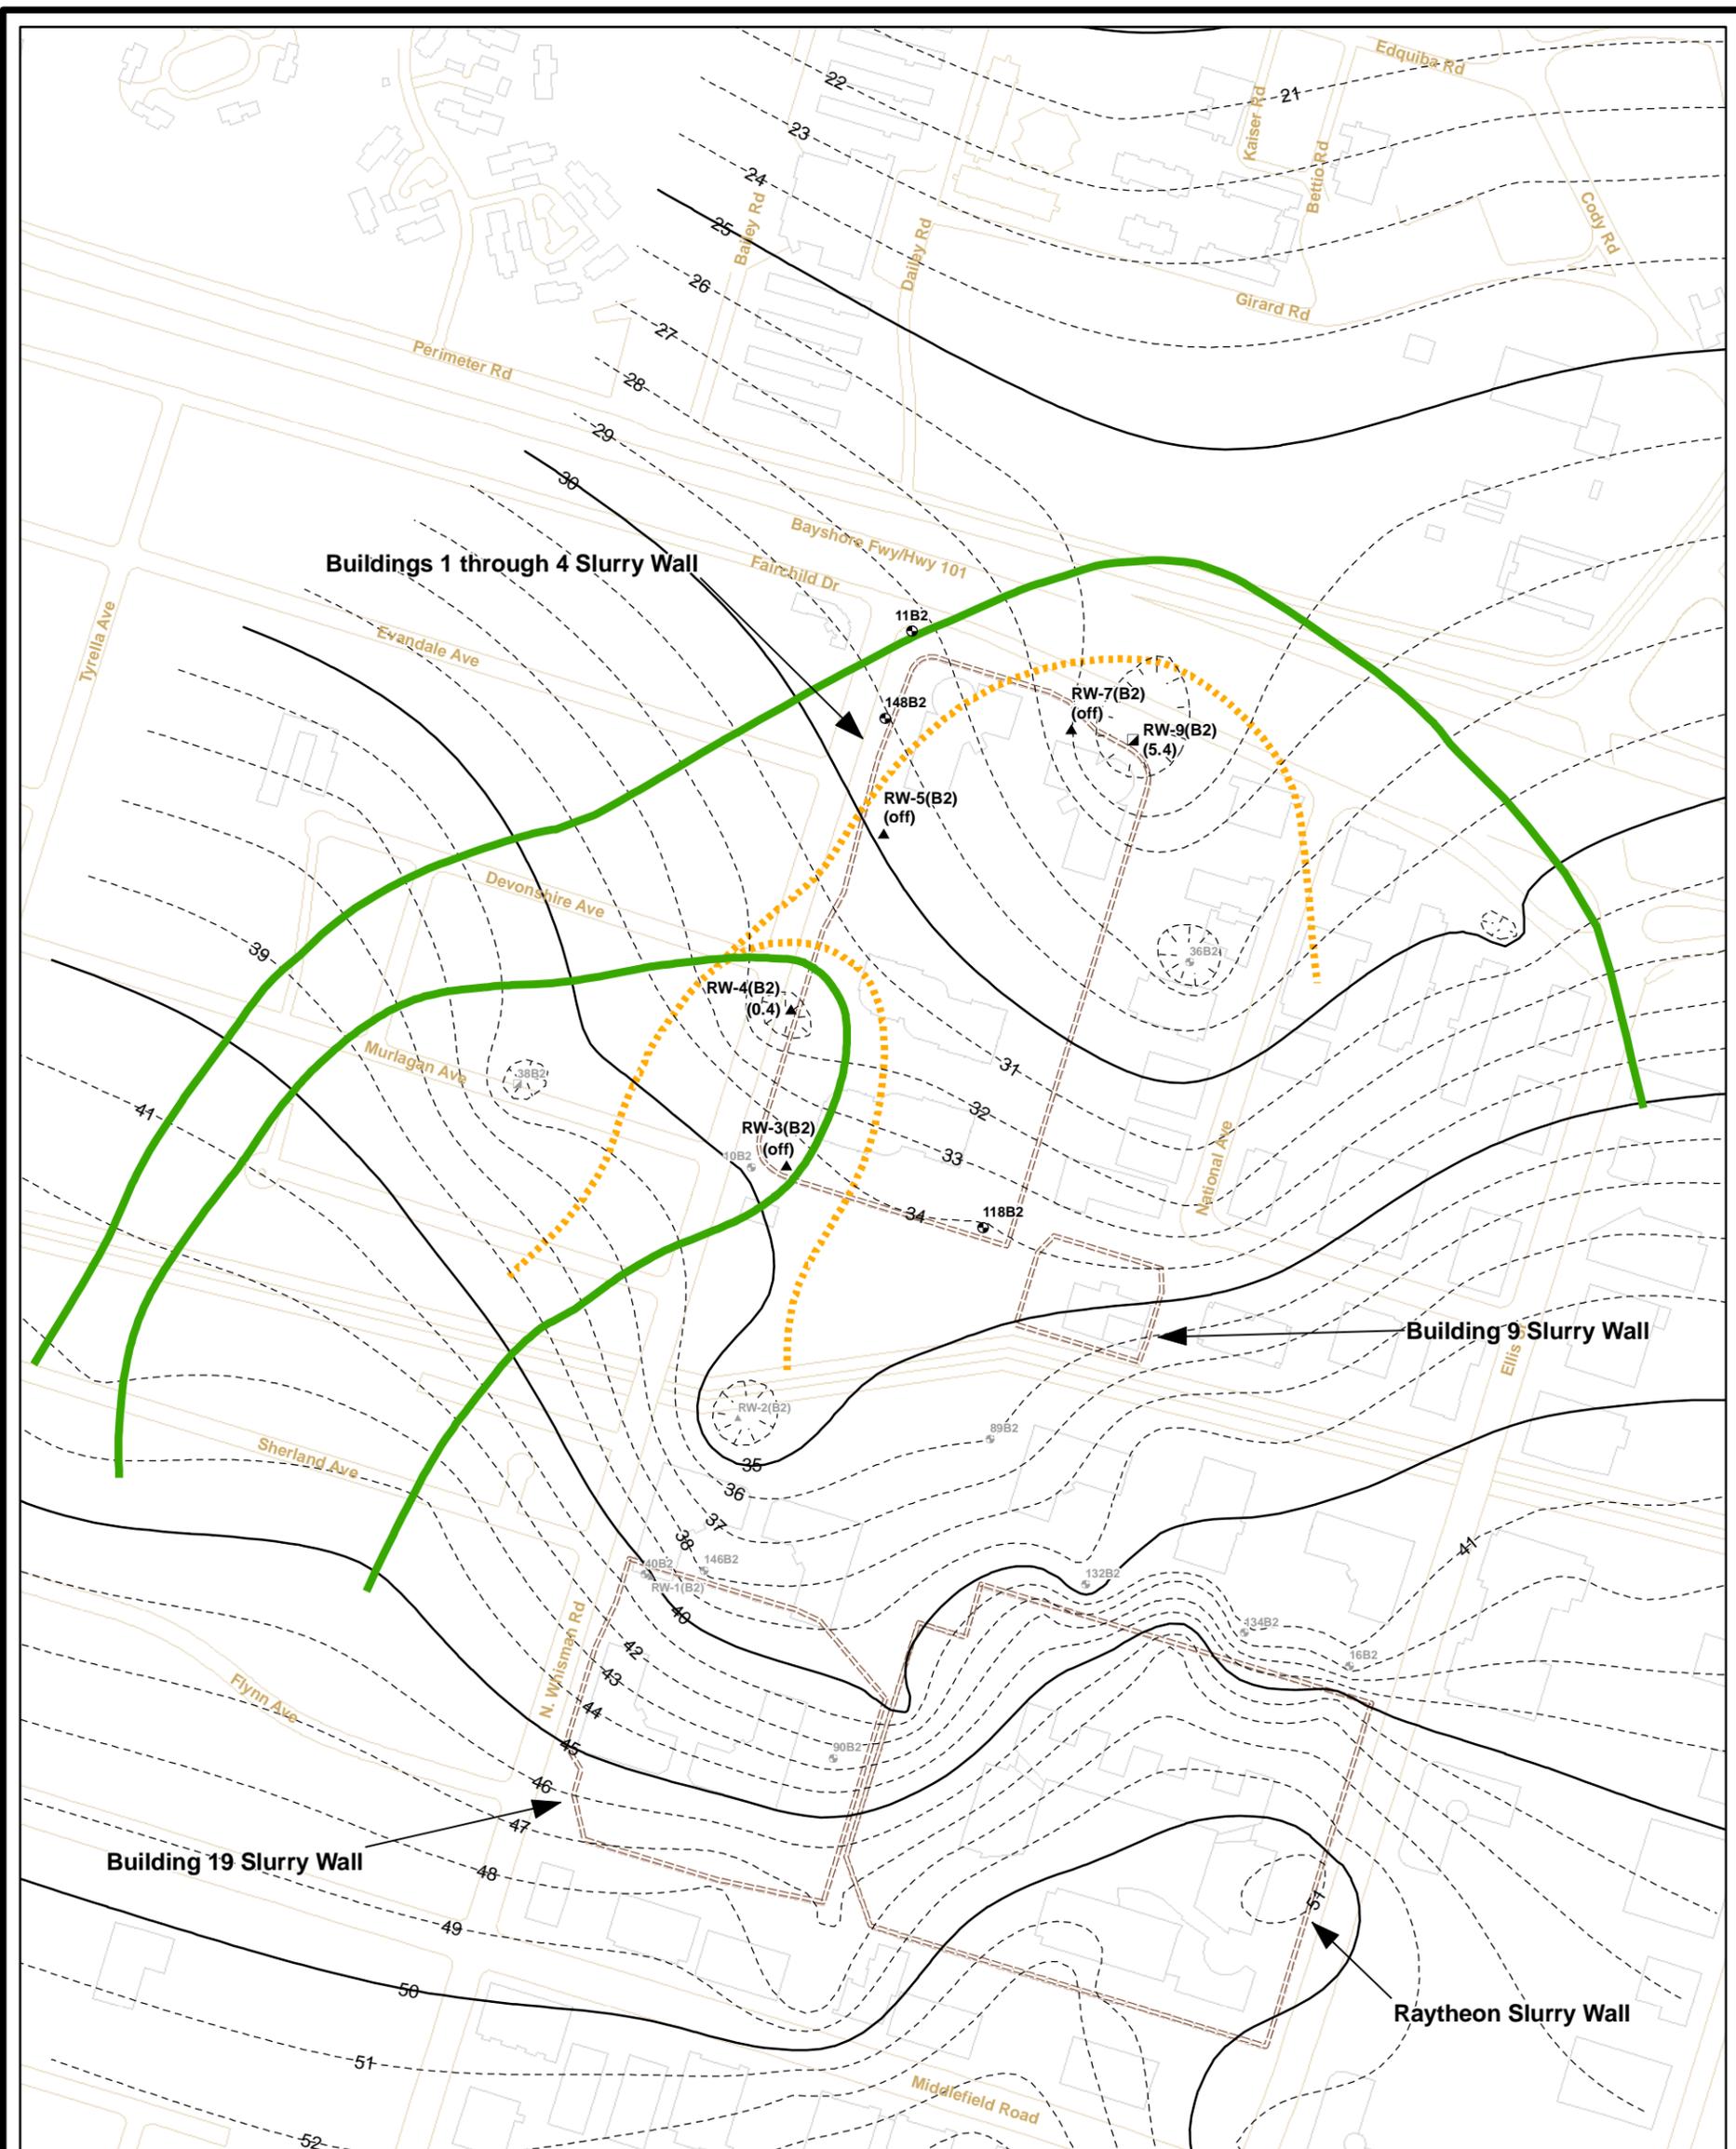
**Figure 14**  
 Former Fairchild Buildings 1 - 4  
 B2 Groundwater Elevation Contours,  
 Target Capture Area and  
 Estimated March 26, 2009 Capture  
 Mountain View, California

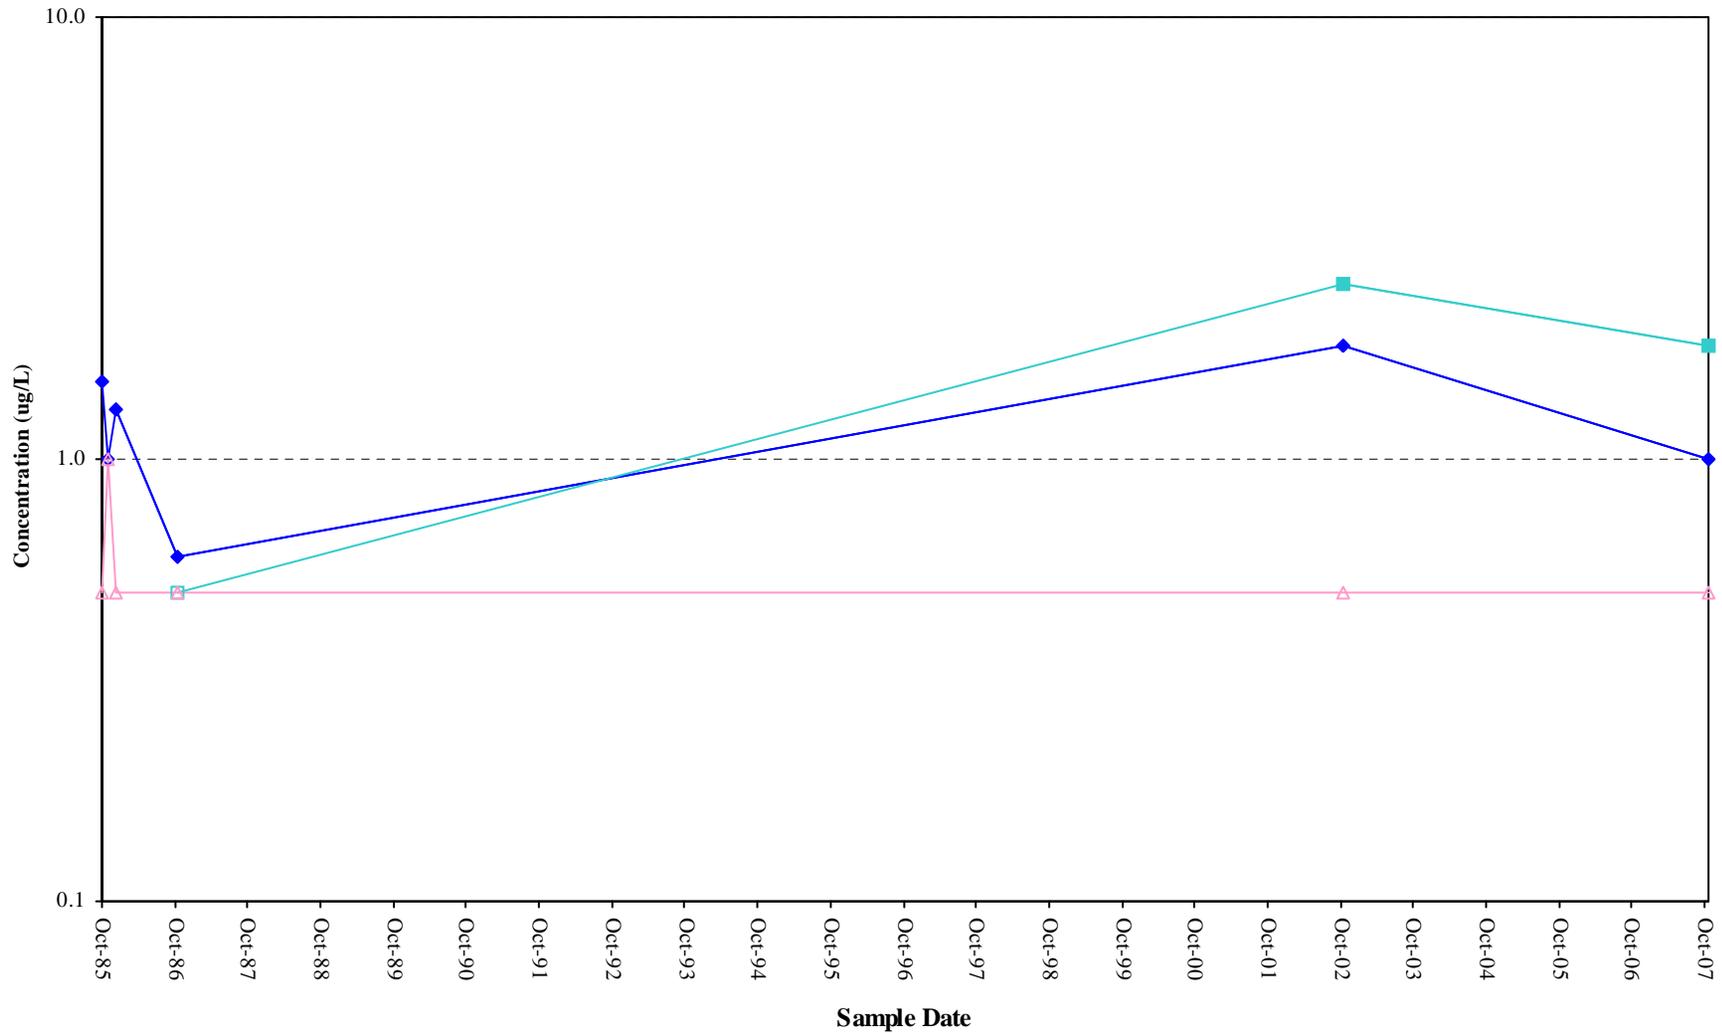
### Well 84A VOCs vs. Time

- ◆ TCE
- cis-1,2-DCE
- ▲ Vinyl Chloride

Analytes not detected above the reported detection limit (RDL) shown as open chart symbols at the RDL.

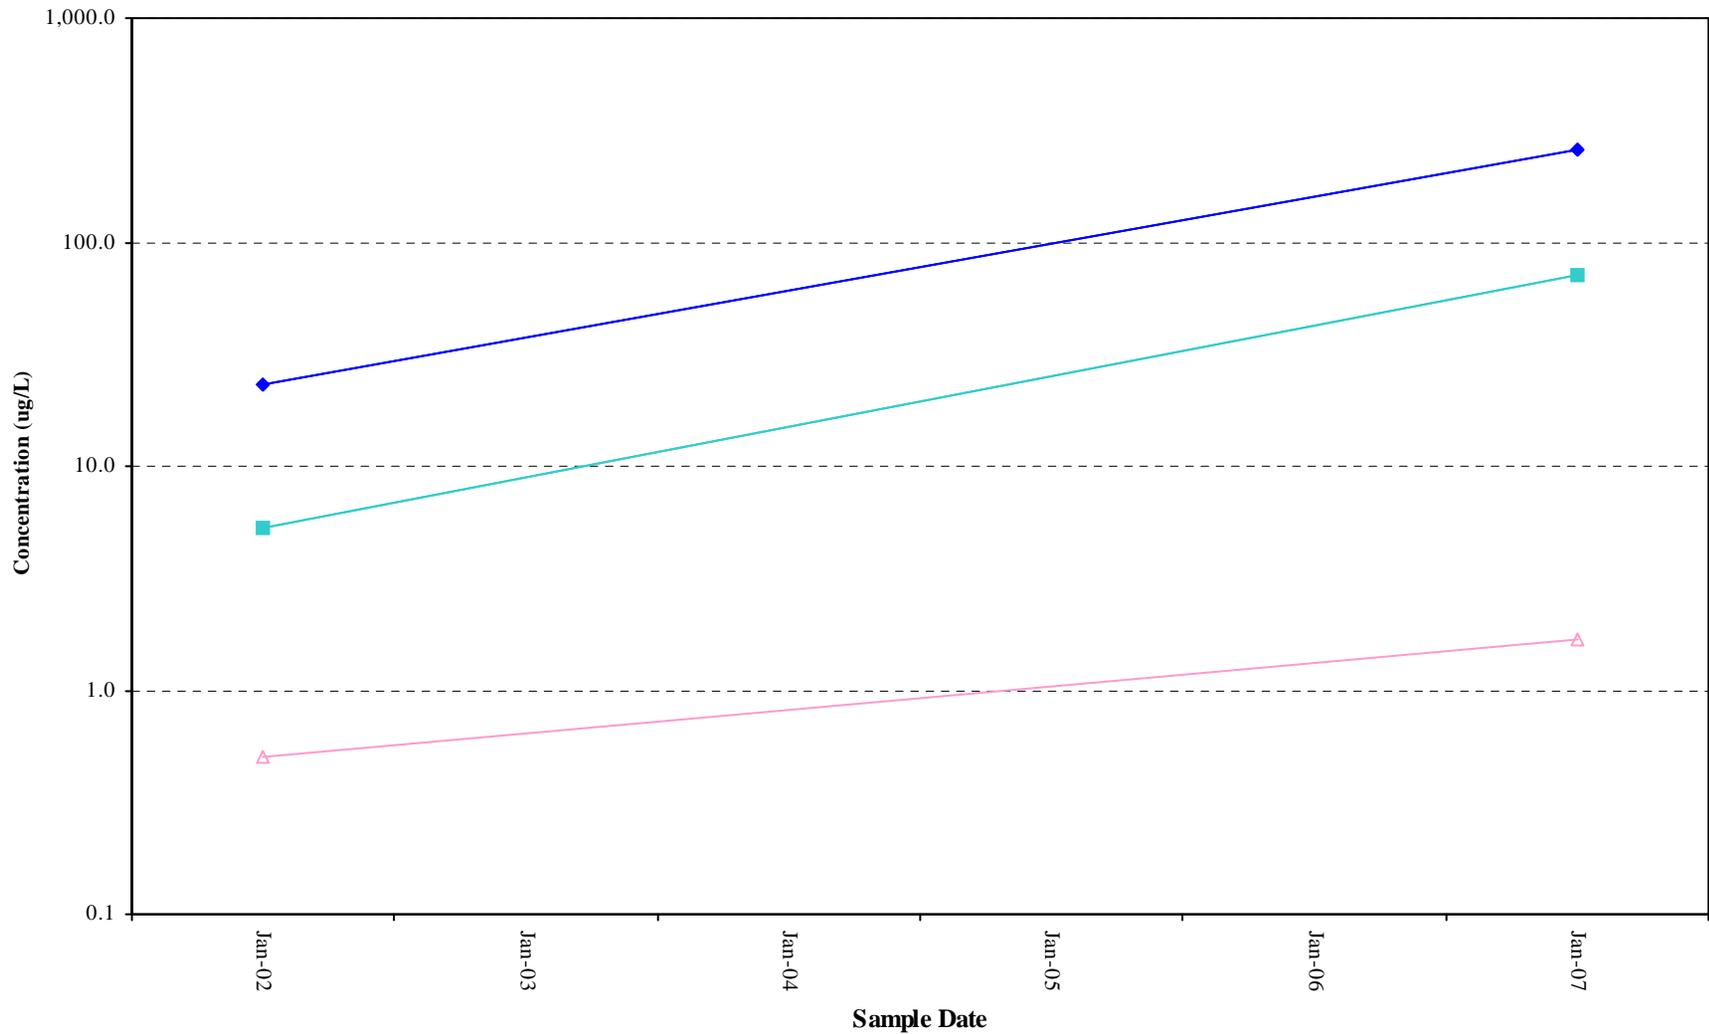
### Well 133A VOCs vs. Time

◆ TCE  
■ cis-1,2-DCE  
△ Vinyl Chloride

Analytes not detected above the reported detection limit (RDL) shown as open chart symbols at the RDL.
