2011 Oversight Summary Report Leviathan Mine Superfund Site Alpine County, California

May 2012

**Burleson Consulting, Inc.
950 Glenn Drive, Suite 245
Folsom, California 95630**

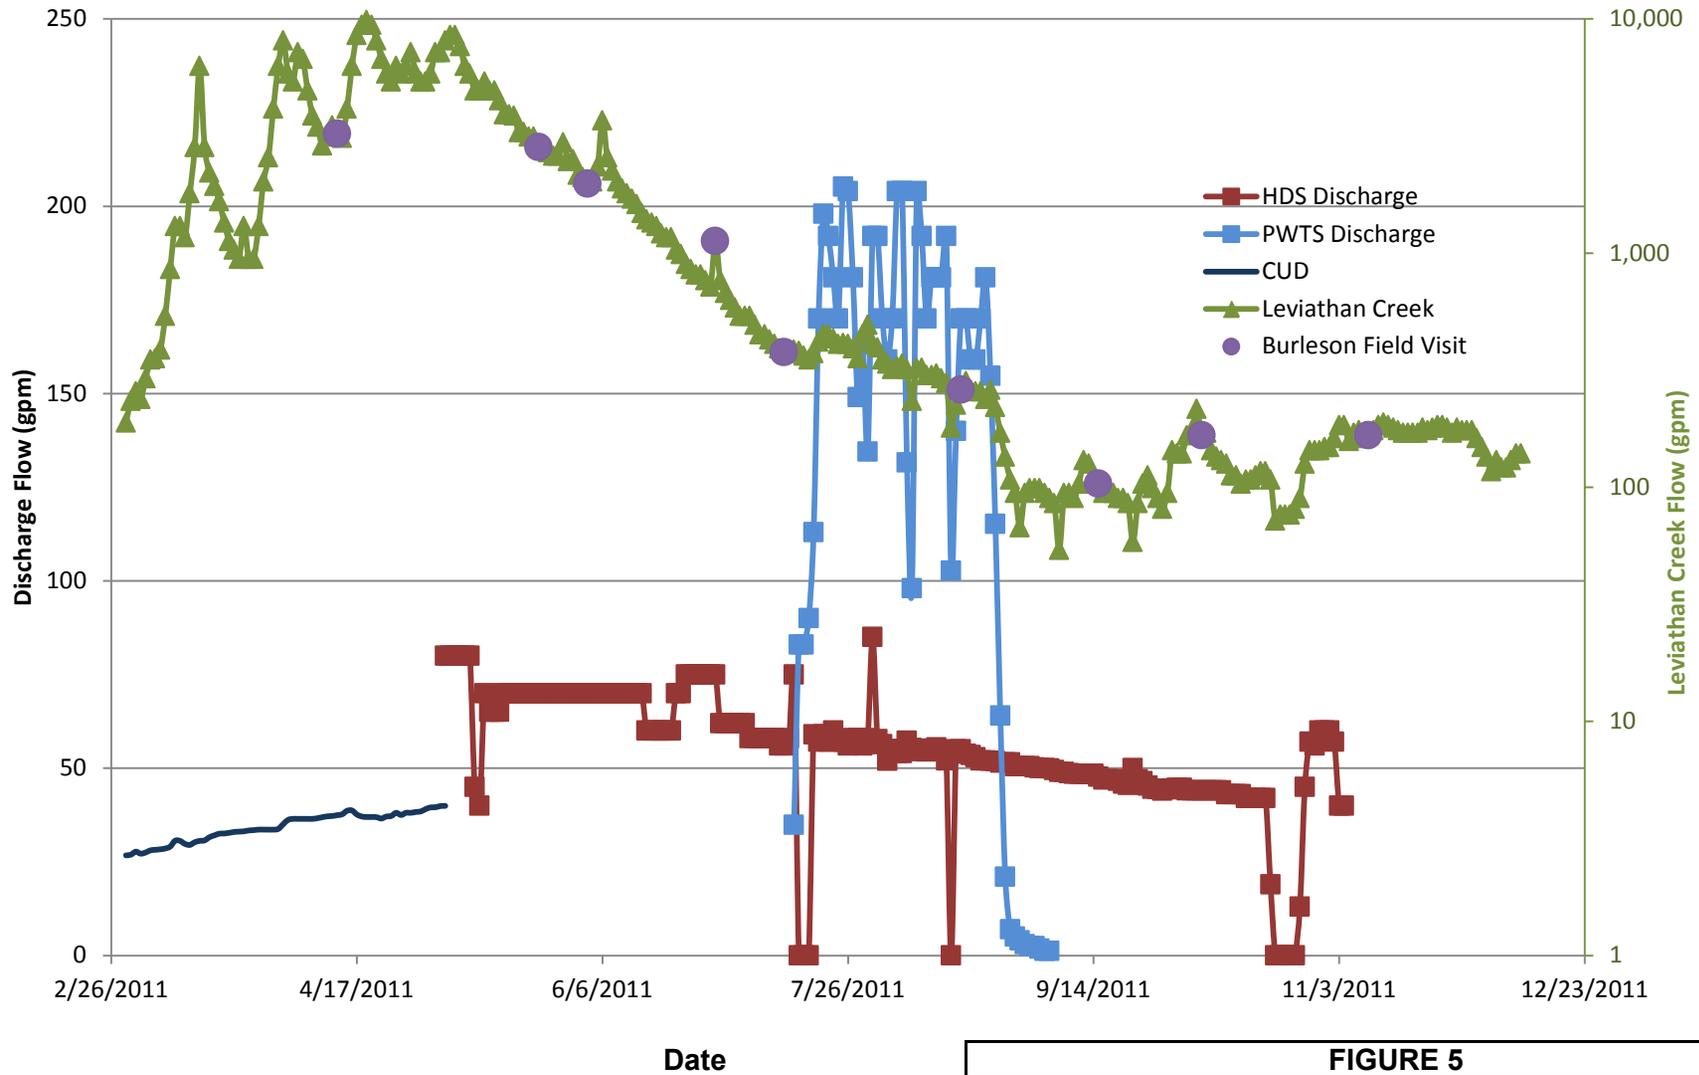
FIGURE 5
TREATMENT SYSTEM DISCHARGE AND
FLOW AT STATION 15 (LEVIATHAN CREEK)
LEVIATHAN MINE SUPERFUND SITE
ALPINE COUNTY, CALIFORNIA

CUD and Leviathan Creek flow rates are from the U.S. Geological Survey 2011 Flow & CDFG
 Recent Daily Water for California, Accessed online at: <http://waterdata.usgs.gov/ca/nwis/current?type=flow>

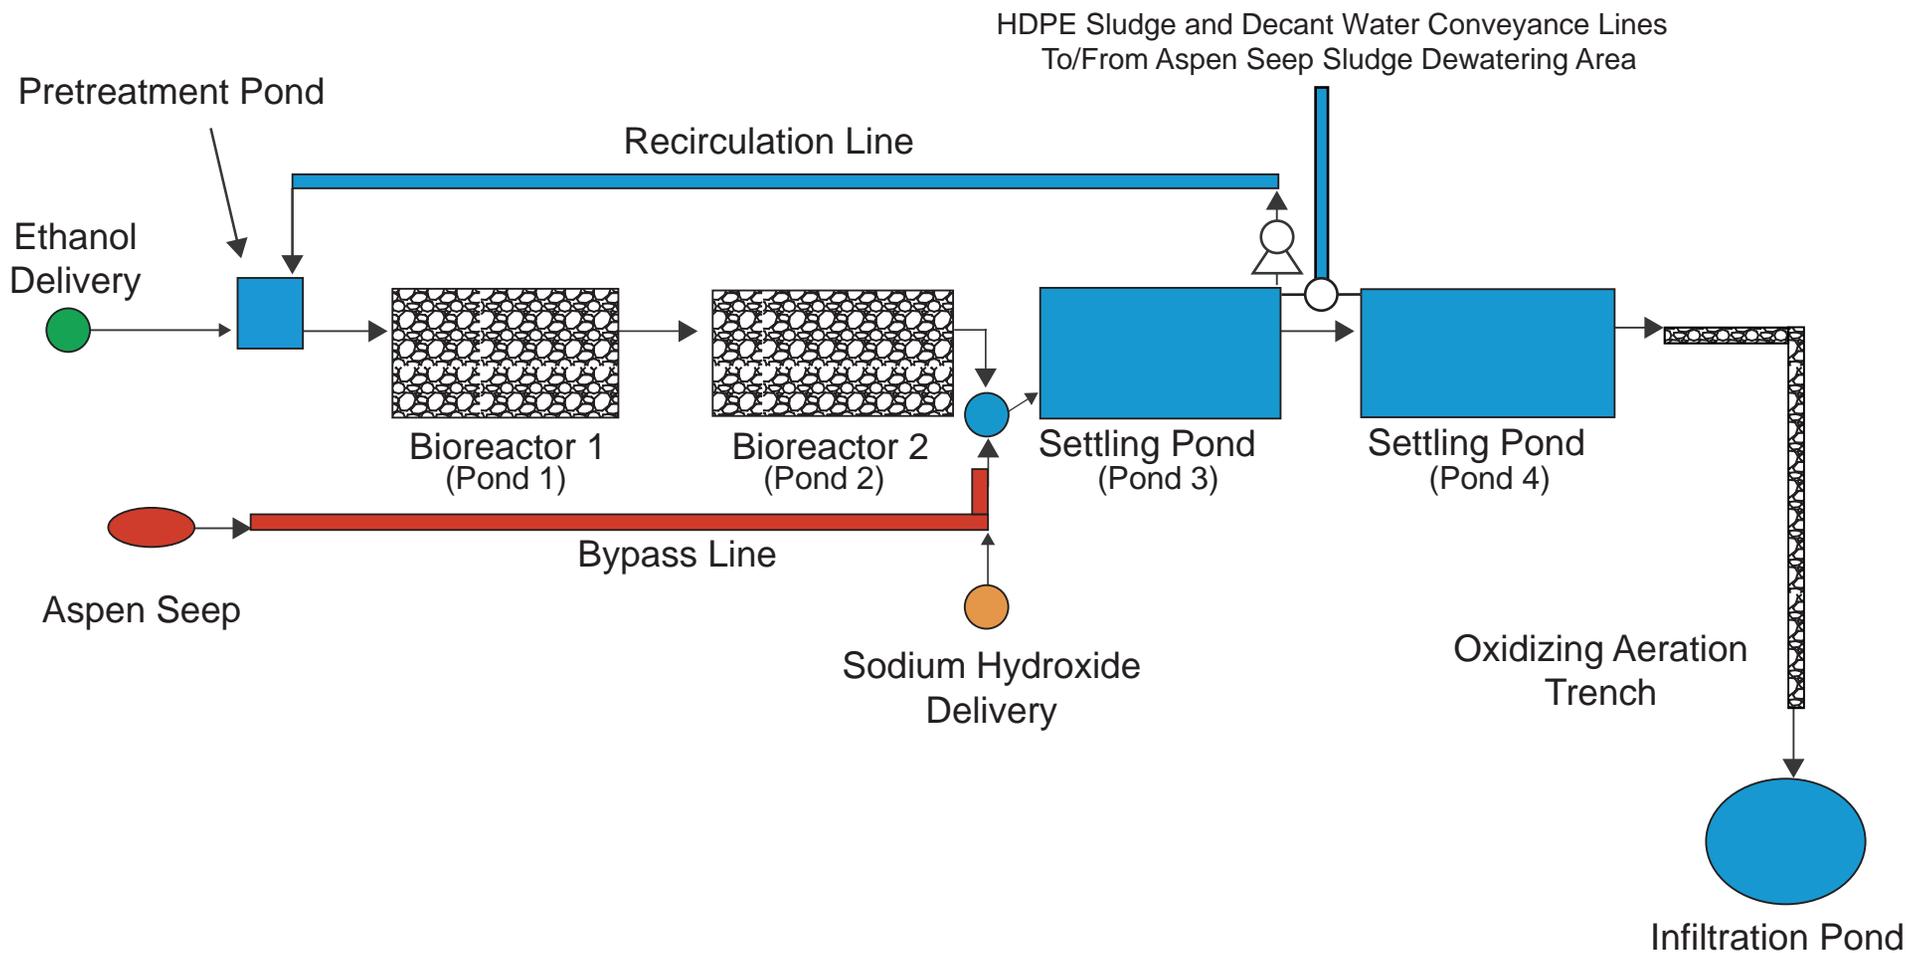
FIGURE 6

**ASPEN SEEP BIOREACTOR
OPERATION WITH RECIRCULATION
LEVIATHAN MINE SUPERFUND SITE
ALPINE COUNTY, CALIFORNIA**

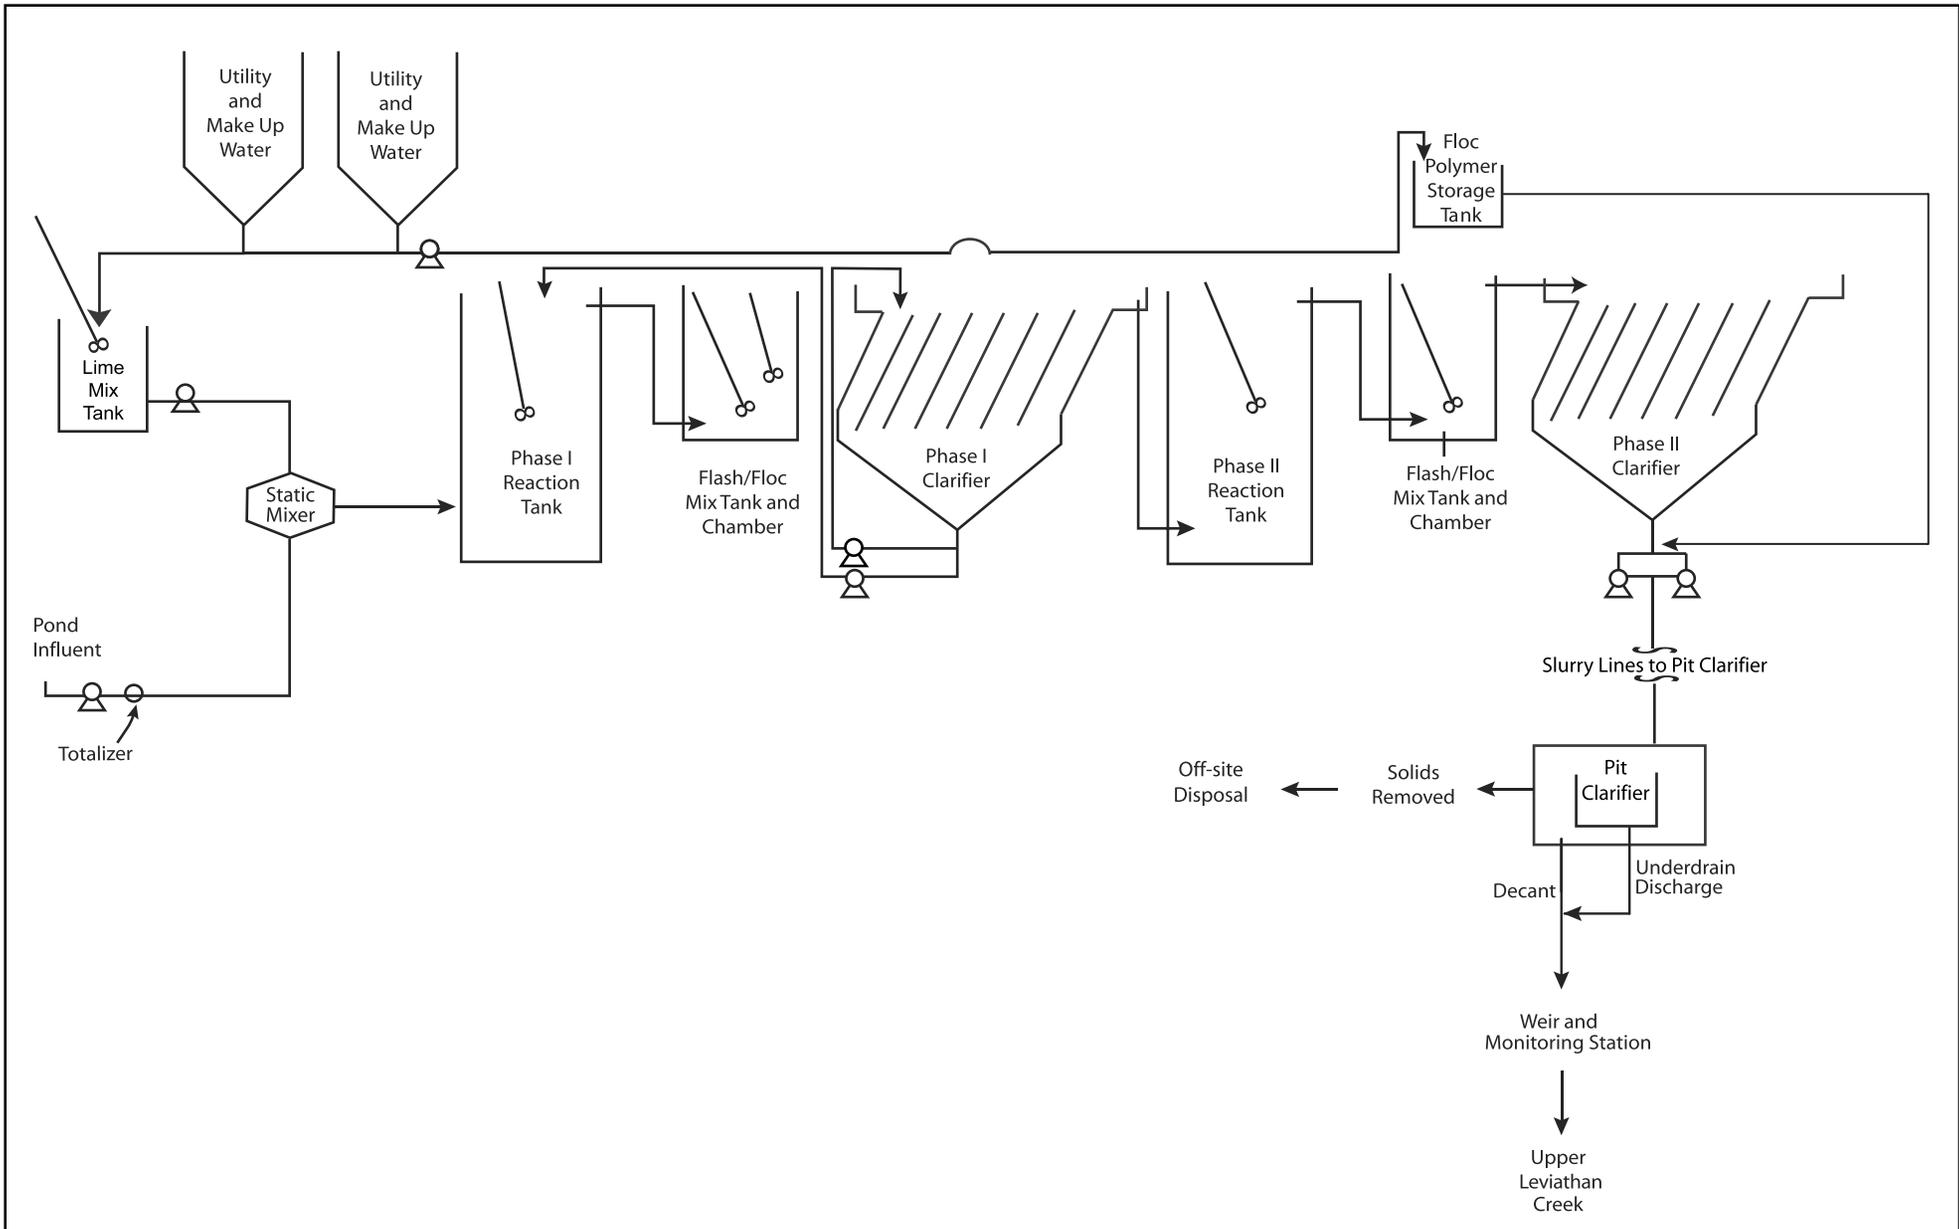
FIGURE 10

**POND 1 LIME TREATMENT PLANT
PROCESS FLOW DIAGRAM
LEVIATHAN MINE SUPERFUND SITE
ALPINE COUNTY, CALIFORNIA**

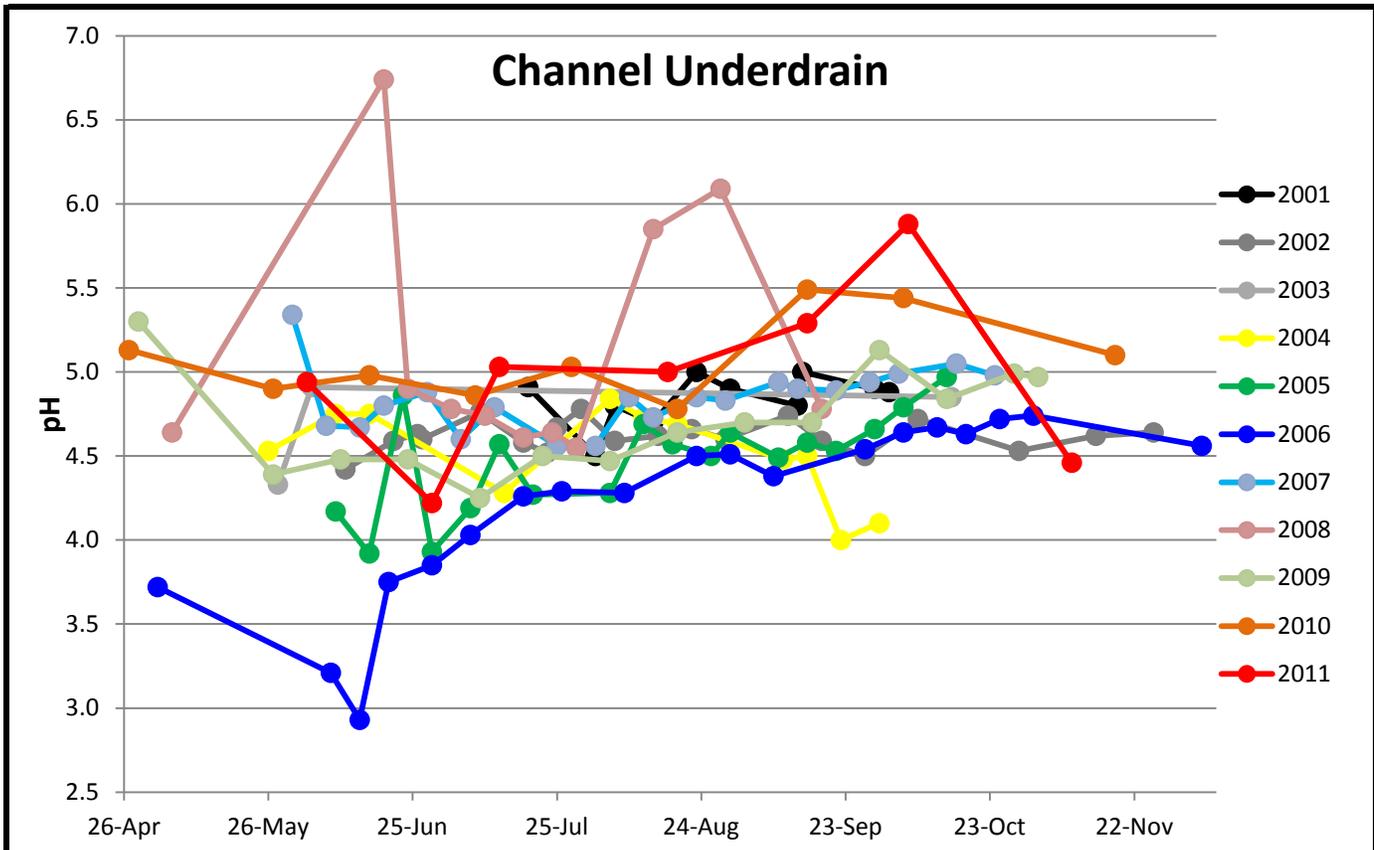
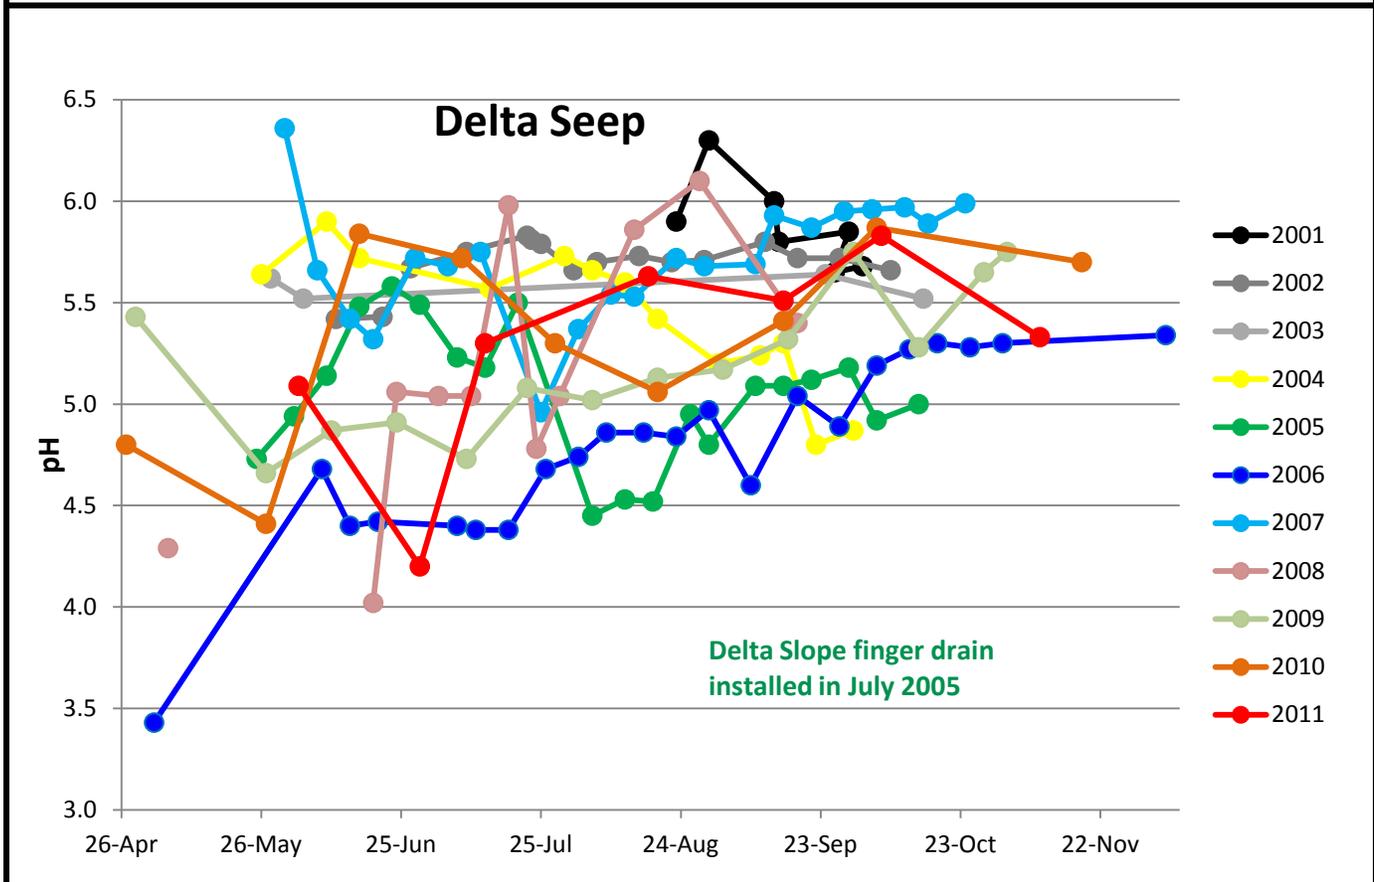
FIGURE 15
CUD AND DELTA SEEP pH
LEVIATHAN MINE SUPERFUND SITE
ALPINE COUNTY, CALIFORNIA

Note:
Delta Seep data since July 2005 represent the mixture of seepage and discharge from the Delta Slope finger drain.

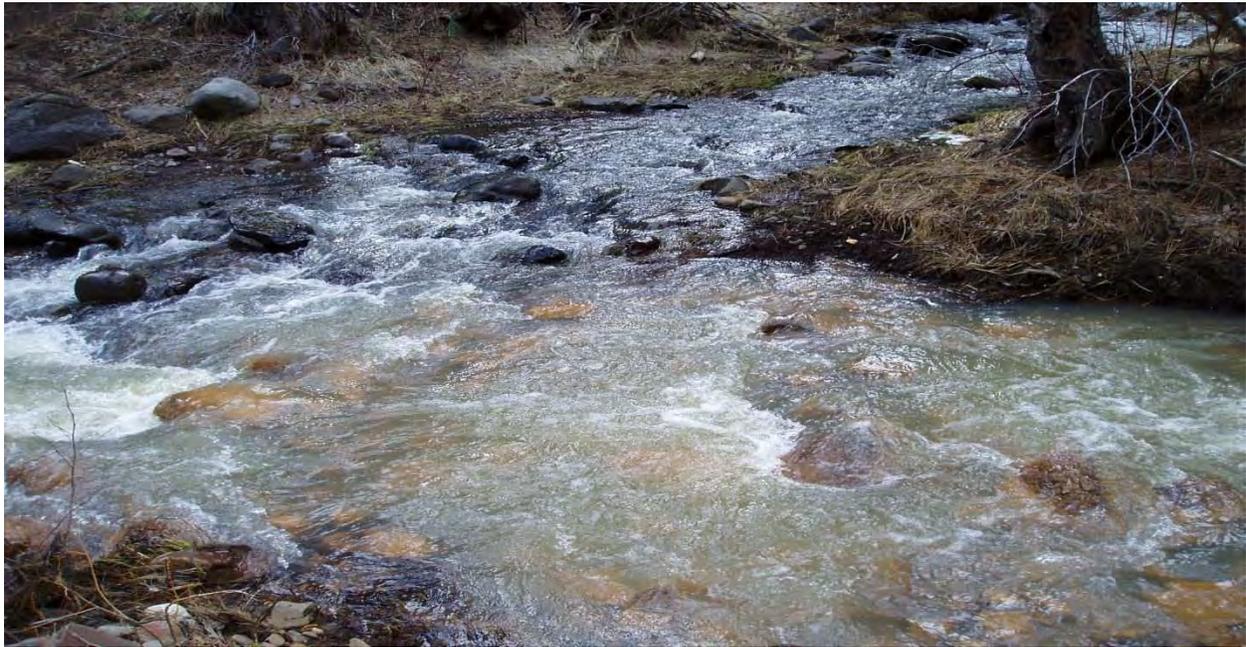
Mountaineer Creek (top creek) and Leviathan Creek, before capture of Channel Underdrain and Delta Seep, April 13, 2011

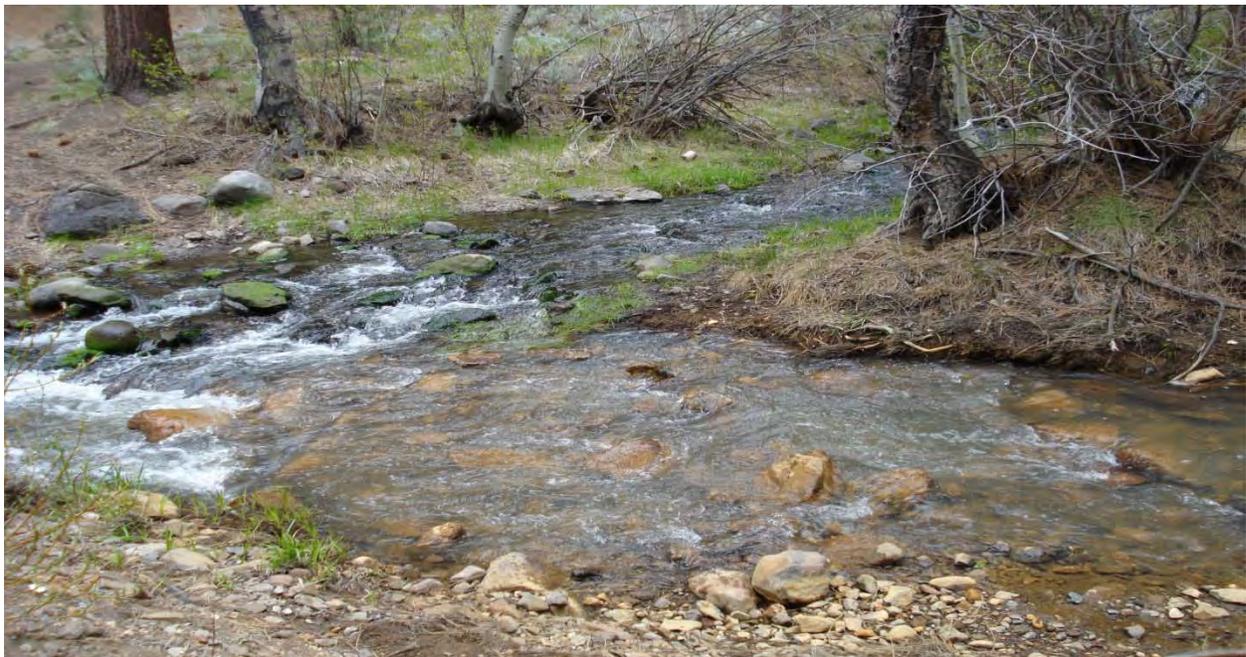
Mountaineer Creek (top creek) and Leviathan Creek, after capture and treatment of Channel Underdrain and Delta Seep, June 3, 2011

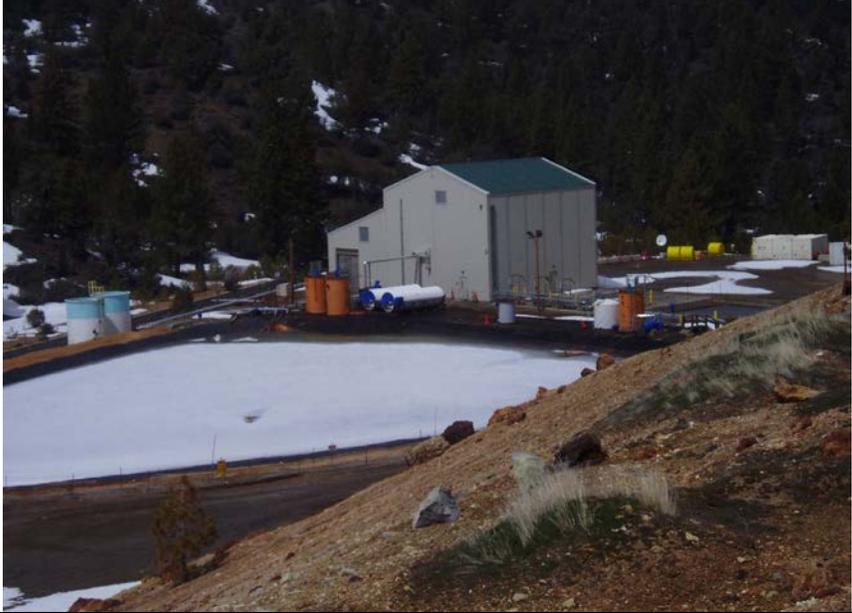
Photo Number	Photo Description	Photo
B-1	View of Pond 4 before the 2011 treatment season. Note ice/snow covering Pond 4. View to northwest. April 13, 2011

The water in Pond 4 before treatment in 2011 was a combination of (1) treated water left at the end of the treatment season in 2010; (2) direct precipitation that fell on the pond through the winter; and (3) acid drainage that may have discharged into Pond 4 from the influent standpipe, which was found to be a minor source of contamination in previous years (Brown and Caldwell 2002). Photographs B-1 and B-2 in Appendix B show Pond 4 before treatment began in 2011.

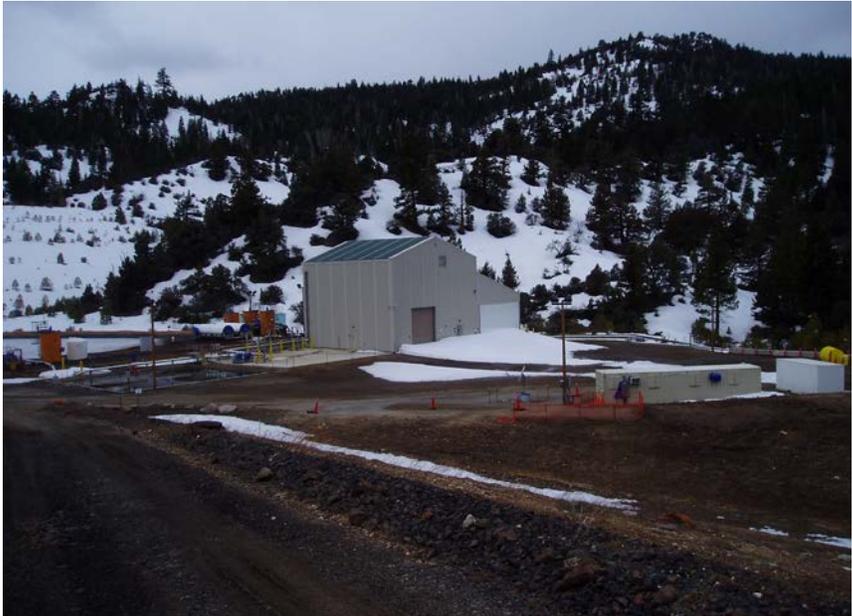
A photograph showing a large, rectangular pond covered in a layer of white snow and ice. In the background, there is a large, light-colored industrial building with a green roof. The surrounding area is a mix of dirt, gravel, and some sparse vegetation. The sky is overcast.
B-2	View of Pond 4 before the 2011 treatment season. View to southwest. May 27, 2010

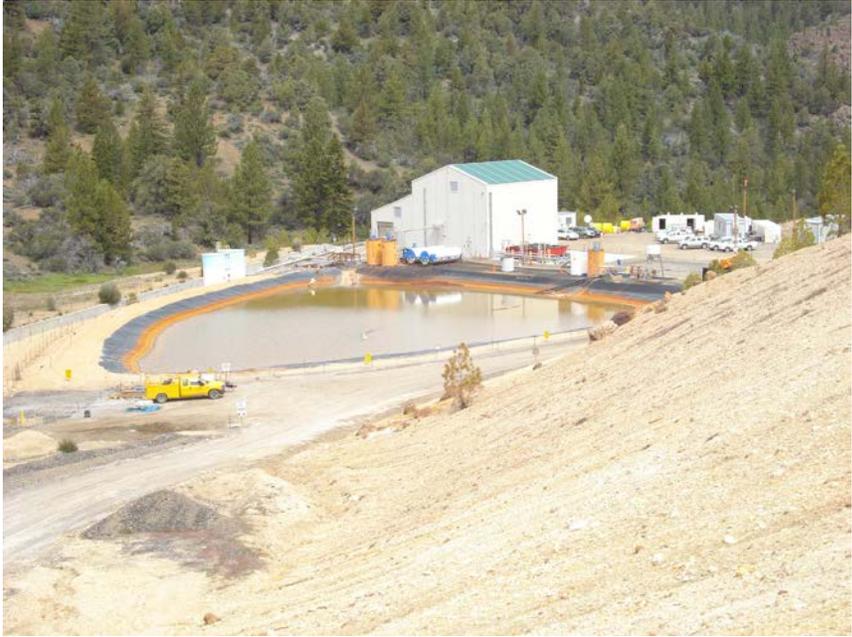
Photo Number	Photo Description	Photo
<p style="text-align: center;">B-3</p>	<p>View of HDS at Pond 4. Note orange sludge rim around pond. View to Northwest.</p> <p>June 3, 2011</p>

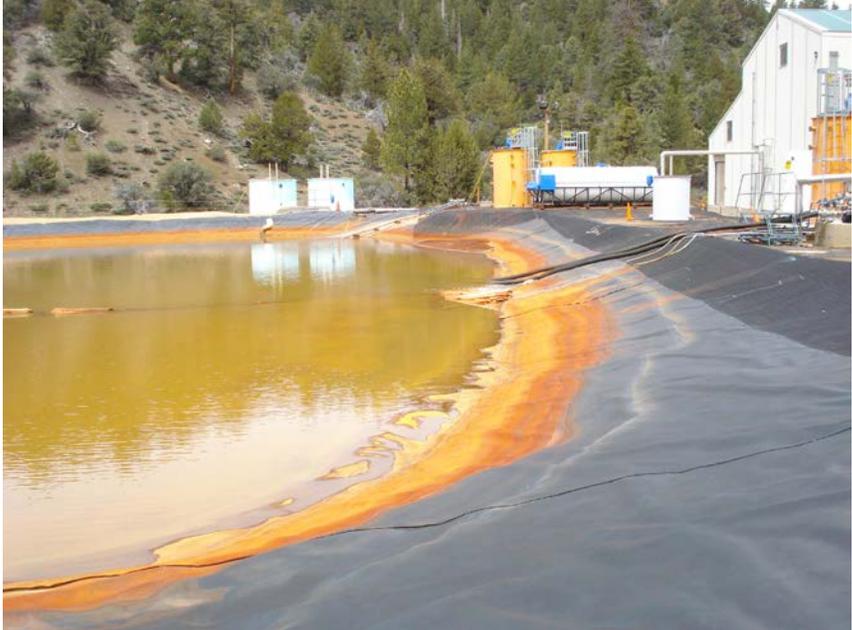
<p style="text-align: center;">B-4</p>	<p>Pond 4 before sludge removal started.</p> <p>June 3, 2011</p>

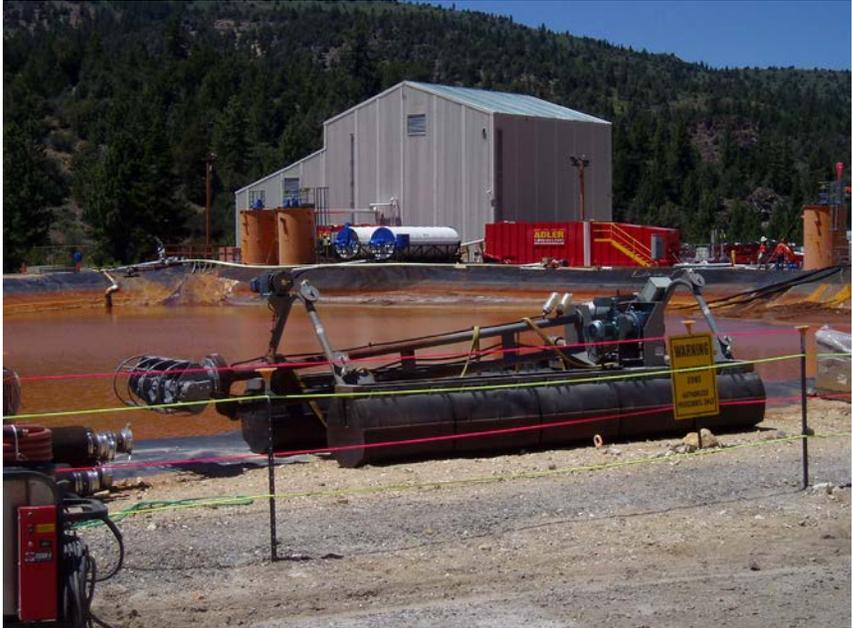
Photo Number	Photo Description	Photo
<p style="text-align: center;">B-5</p>	<p>Floating Dredge before use to remove sludge at Pond 4. View to Northwest.</p> <p>July 13, 2011</p>

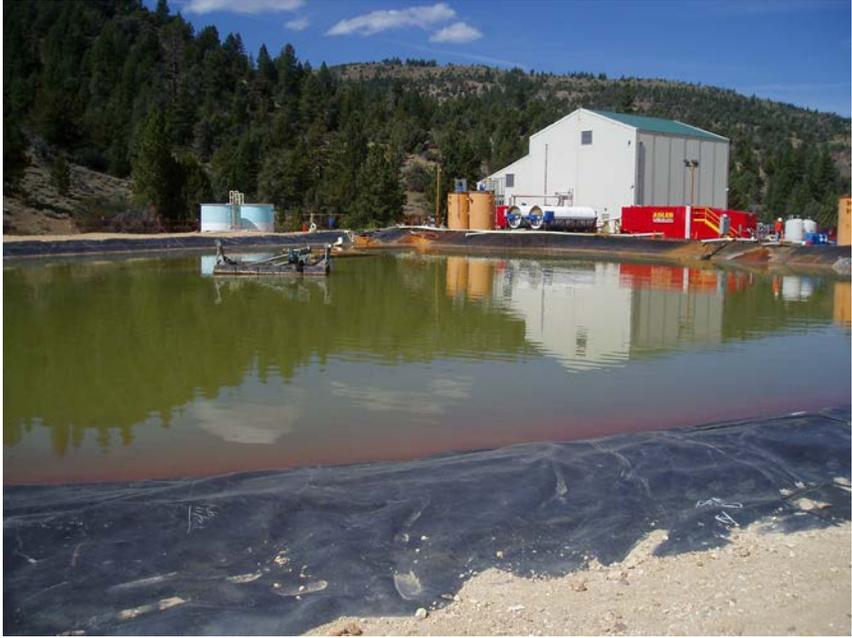
<p style="text-align: center;">B-6</p>	<p>Floating dredge operating at Pond 4. View to Northwest. Note red tank, this was used to store captured CUD and DS flows prior to treatment during sludge removal.</p> <p>September 15, 2011</p>

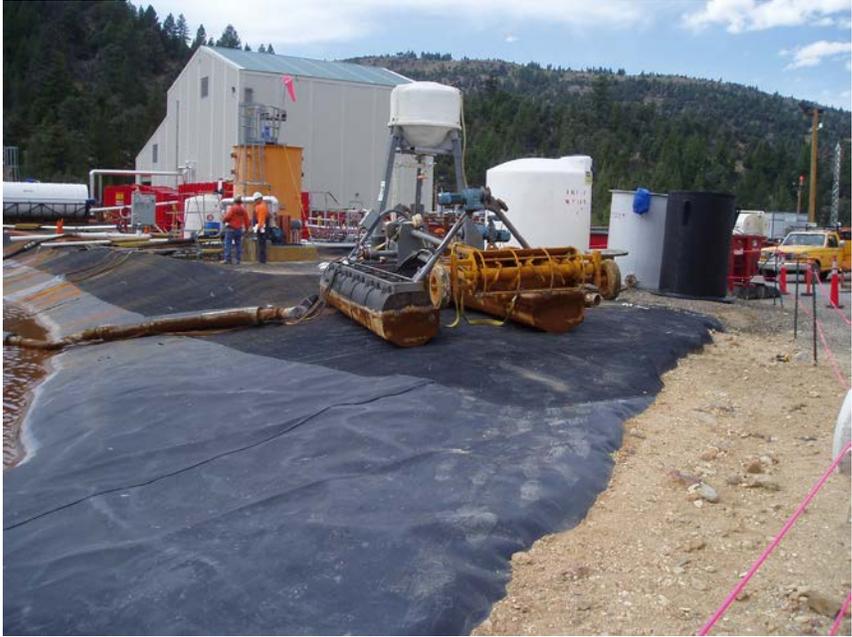
Photo Number	Photo Description	Photo
<p style="text-align: center;">B-7</p>	<p>Dredge after use to remove sludge at Pond 4.</p> <p>September 29, 2011</p>

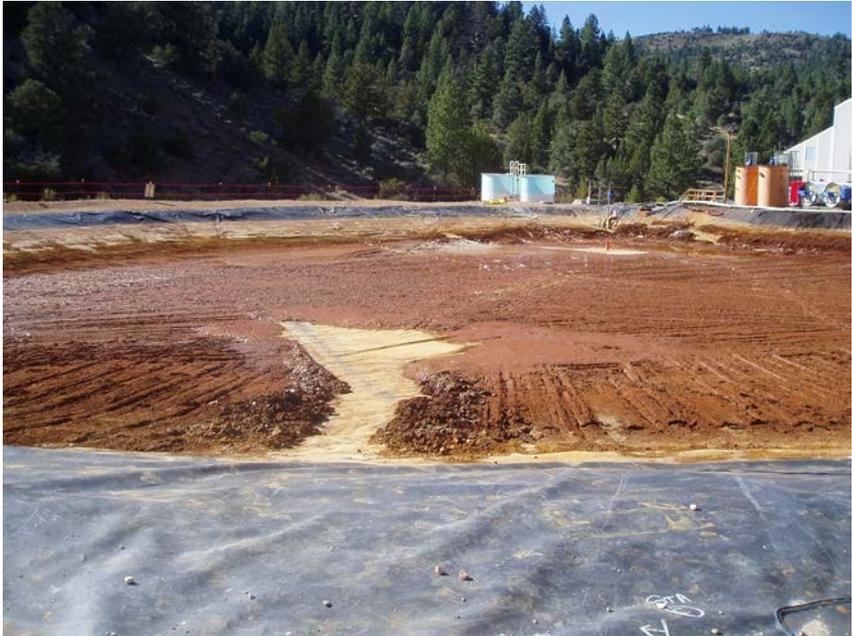
<p style="text-align: center;">B-8</p>	<p>Pond 4 after sludge removal. View to north.</p> <p>October 19, 2011</p>

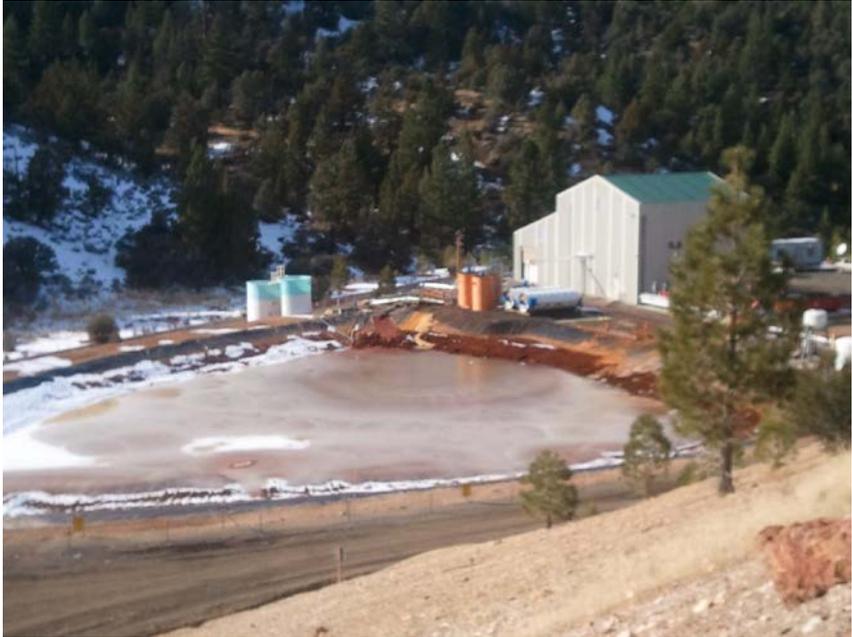
Photo Number	Photo Description	Photo
<p style="text-align: center;">B-9</p>	<p>View of Pond 4 and winterized HDS plant. View to Northwest.</p> <p>November 9, 2011</p>

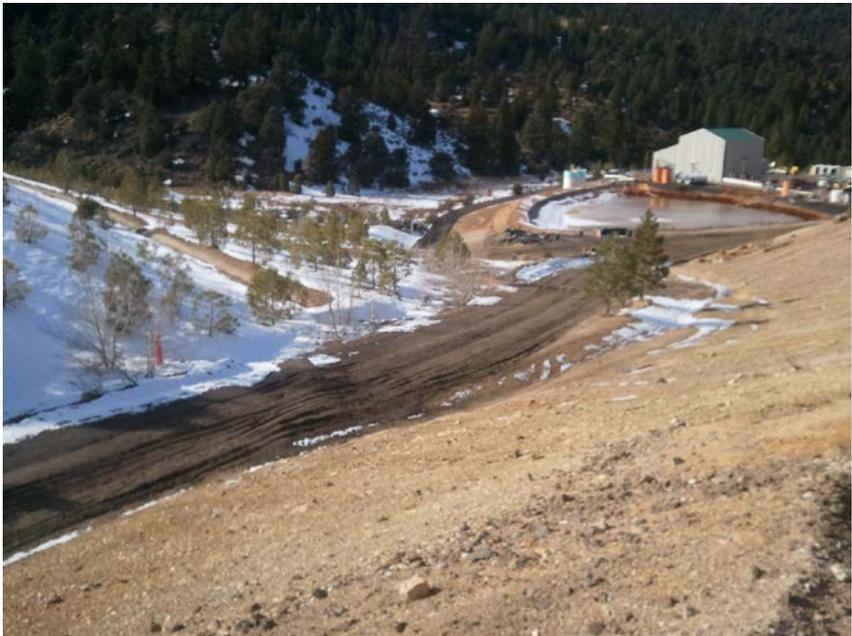
<p>An aerial photograph showing a large, circular, brownish pond (Pond 4) in the foreground. In the background, there is a large white industrial building with a green roof (the winterized HDS plant). The surrounding area is a mix of snow-covered ground and bare earth, with some trees visible in the distance.</p>
<p style="text-align: center;">B-10</p>	<p>Water bars along the Upper Road.</p> <p>November 9, 2011</p>

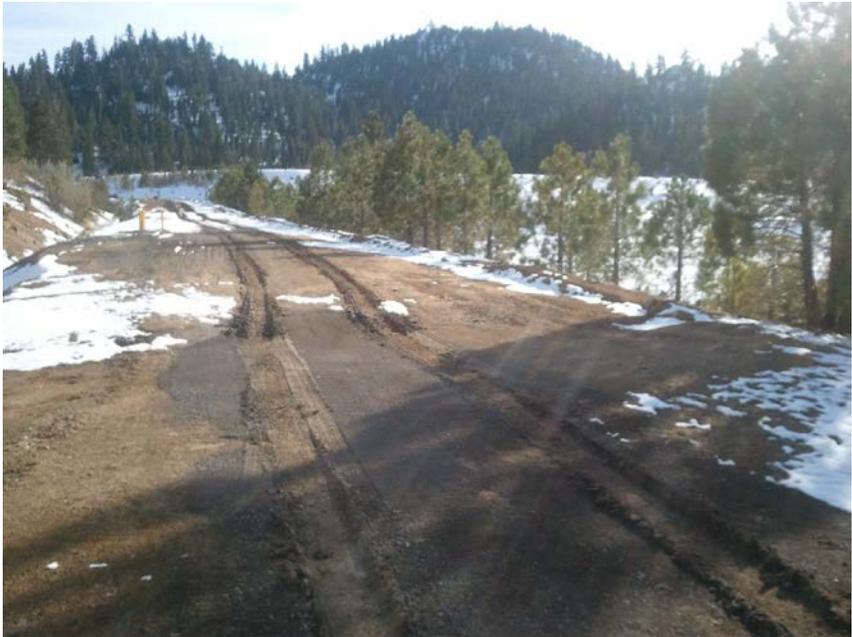
Photo Number	Photo Description	Photo
B-11	Water Dip across the Crusher Road. November 9, 2011

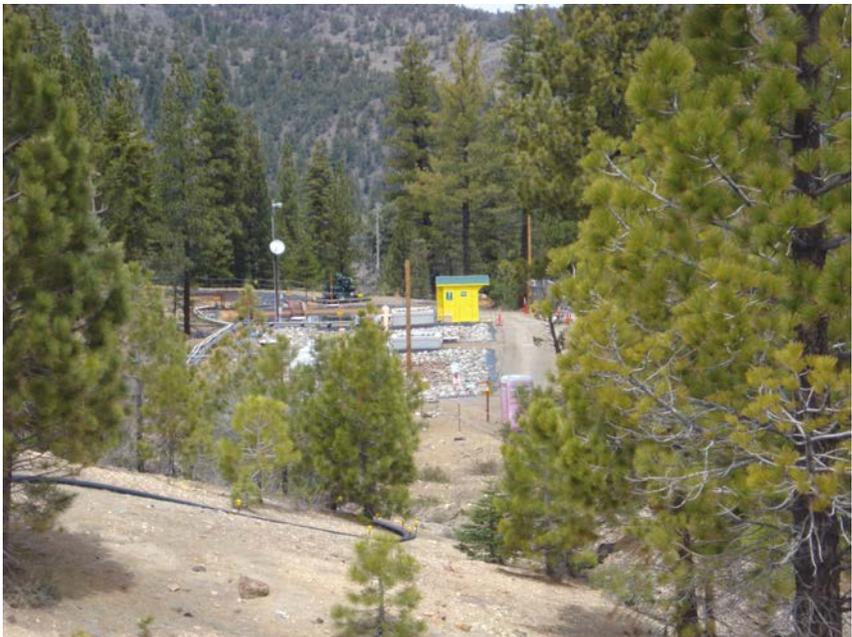
B-12	Aspen Seep Bioreactor overview. View to Northwest. June 3, 2011

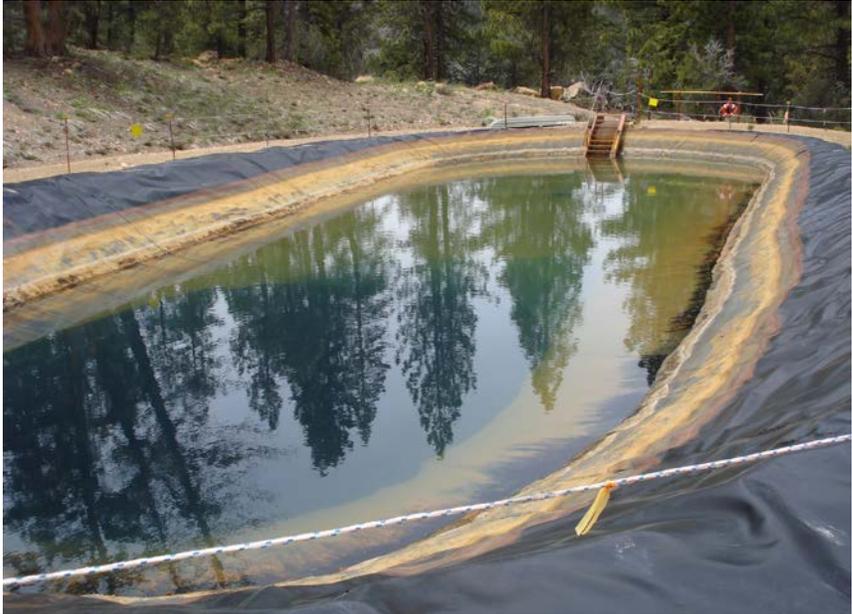
Photo Number	Photo Description	Photo
<p style="text-align: center;">B-13</p>	<p>Aspen Seep Bioreactor Settling Pond. Note black sludge in middle-left. View to West.</p> <p>June 3, 2011</p>

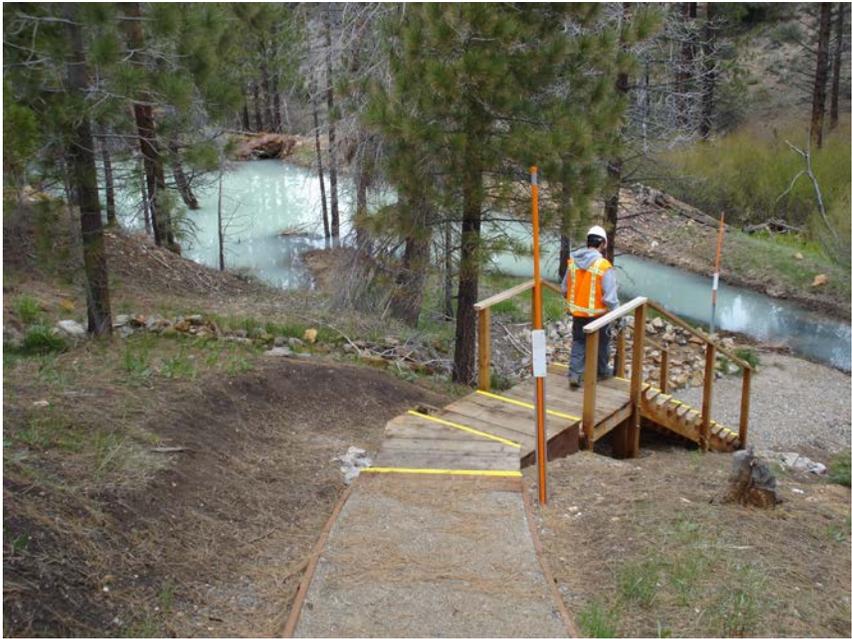
<p style="text-align: center;">B-14</p>	<p>Aspen Seep Bioreactor infiltration pond. View to North.</p> <p>June 3, 2011</p>

Discharge of ASBR effluent from the infiltration pond to Aspen Creek continued during 2011. Discharge seeps through the downslope infiltration pond berm into Aspen Creek. Water also

overflows from the northeastern corner of the infiltration pond down a steep slope into Aspen Creek.

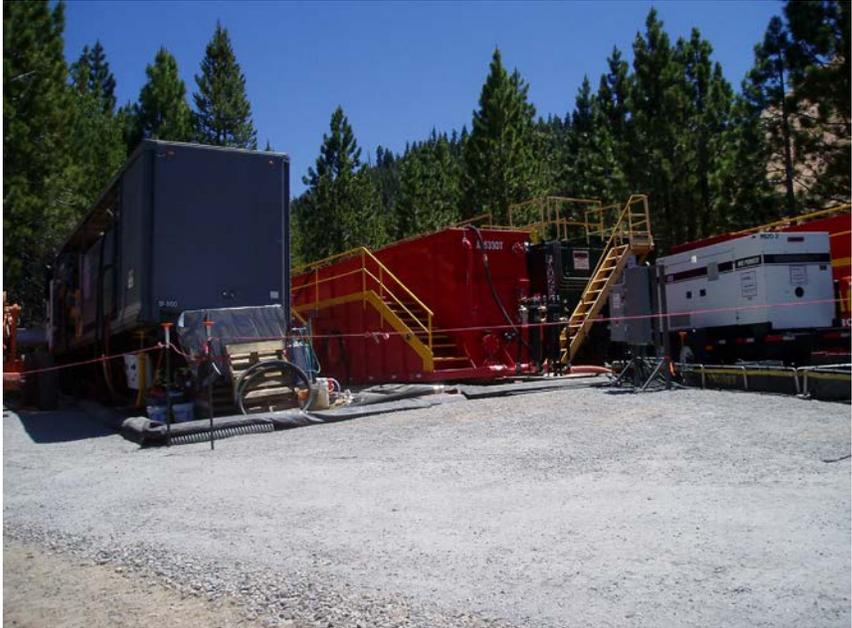
Photo Number	Photo Description	Photo
<p style="text-align: center;">B-15</p>	<p>Aspen Seep Bioreactor sludge dewatering equipment. View to Northeast.</p> <p>July 13, 2011</p>

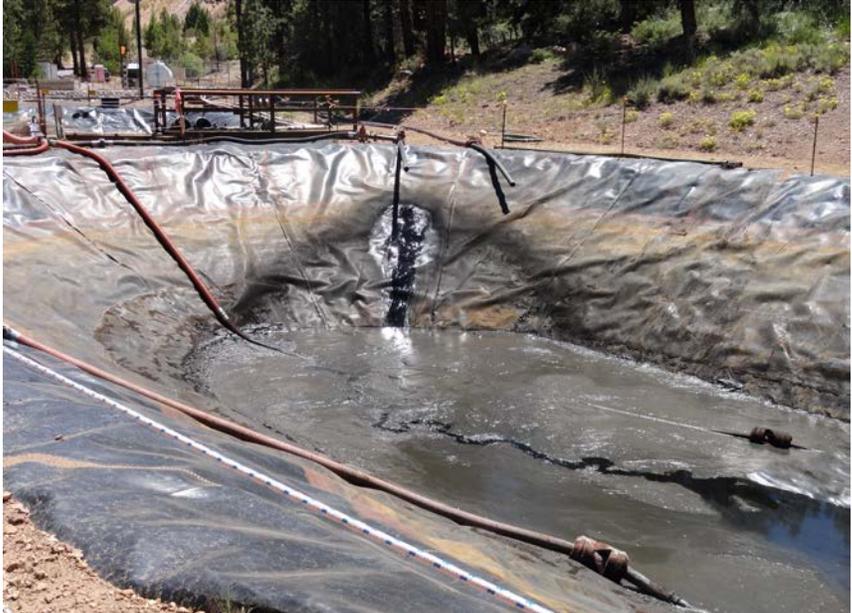
<p>A photograph showing industrial equipment for sludge dewatering. In the foreground, there is a large, dark-colored rectangular tank or container. To its right, a red structure with yellow stairs and railings is visible. Further right, a white piece of equipment with a yellow ladder is partially seen. The ground is gravel, and the background consists of a dense forest of tall evergreen trees under a clear blue sky.</p>
<p style="text-align: center;">B-16</p>	<p>Aspen Seep Bioreactor settling pond prepared for sludge removal.</p> <p>August 18, 2011</p>

<p>A photograph of a settling pond. The pond is lined with a silver, reflective material, likely a geomembrane. The water in the pond is dark and murky. Several large, brown pipes or hoses are connected to the pond, with one pipe extending into the water. The pond is situated in a wooded area with trees and a dirt embankment in the background.</p>

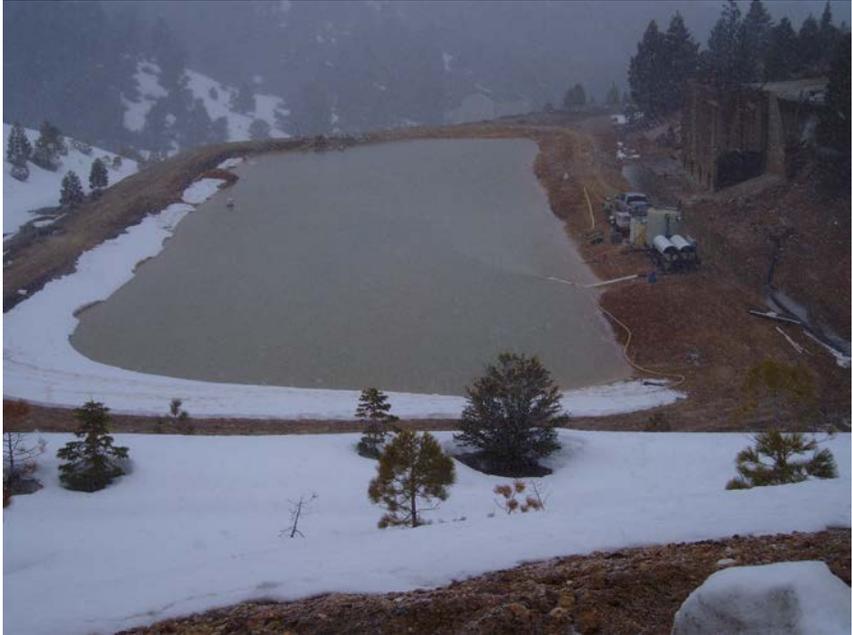
Photo Number	Photo Description	Photo
<p style="text-align: center;">B-17</p>	<p>RCTS at Pond 3. View to West</p> <p>April 13, 2011</p>

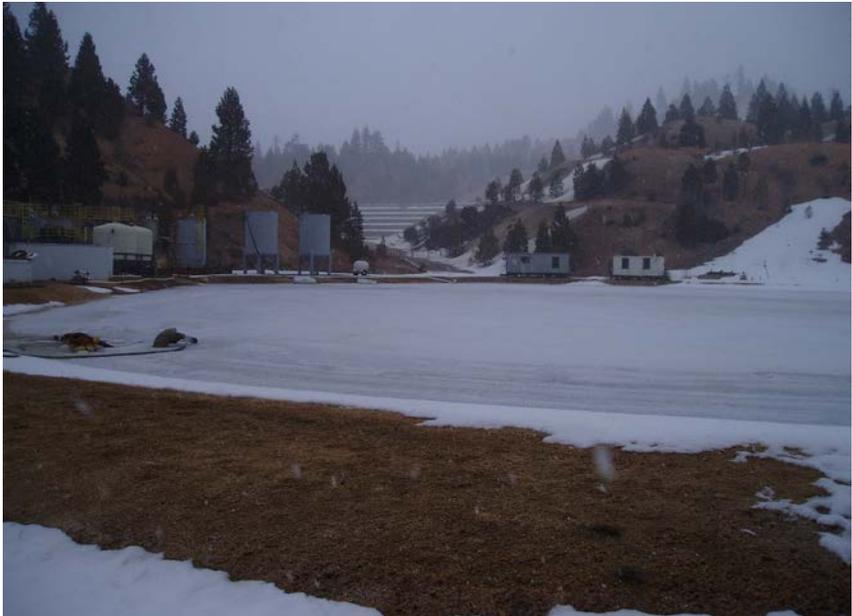
<p style="text-align: center;">B-18</p>	<p>Pond 1 water source (middle left) during spring season treatment. View to Northeast.</p> <p>April 13, 2011</p>

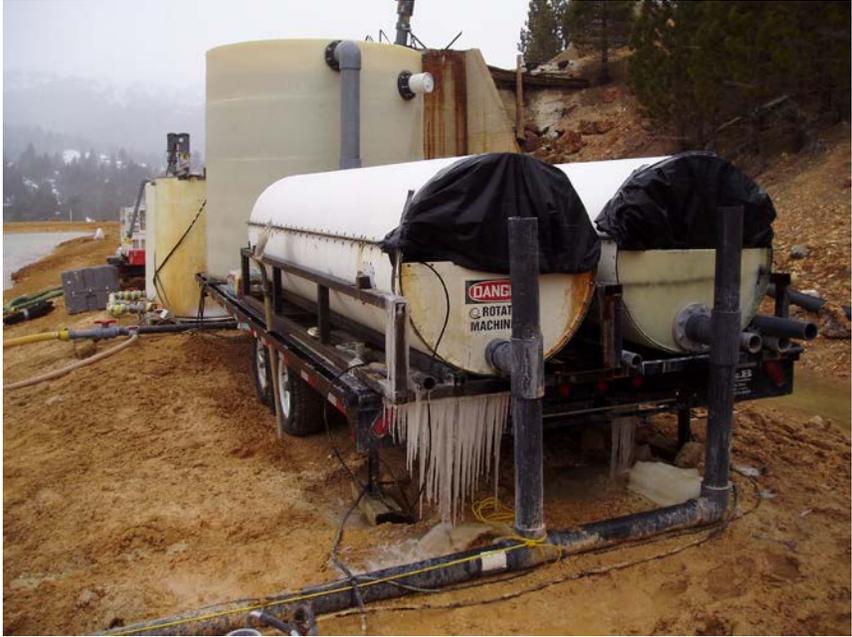
Photo Number	Photo Description	Photo
<p style="text-align: center;">B-19</p>	<p>Rotating Cylinder Treatment System at Pond 3 during spring season treatment. View to West.</p> <p>April 13, 2011</p>

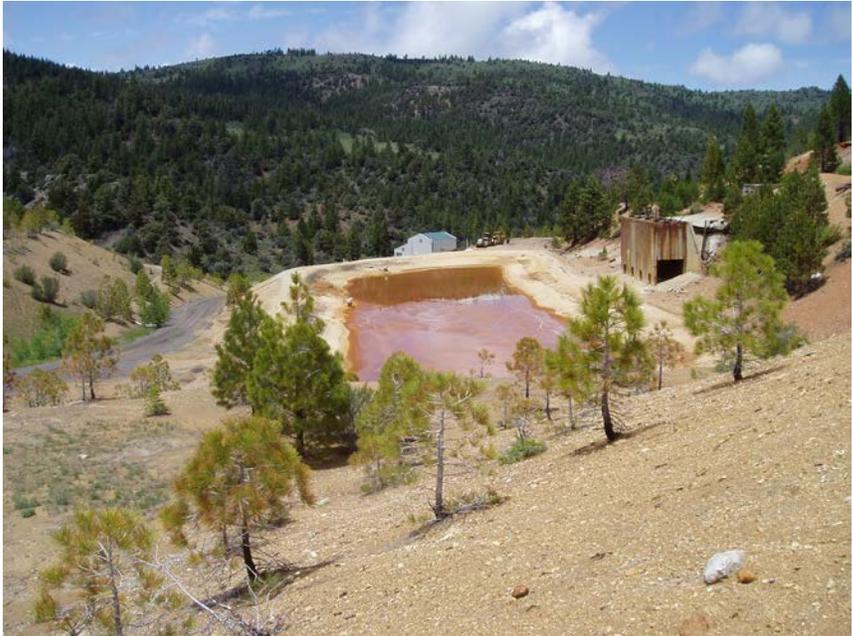
<p style="text-align: center;">B-20</p>	<p>Pond 3 after spring season treatment was completed. View to West.</p> <p>June 29, 2011</p>

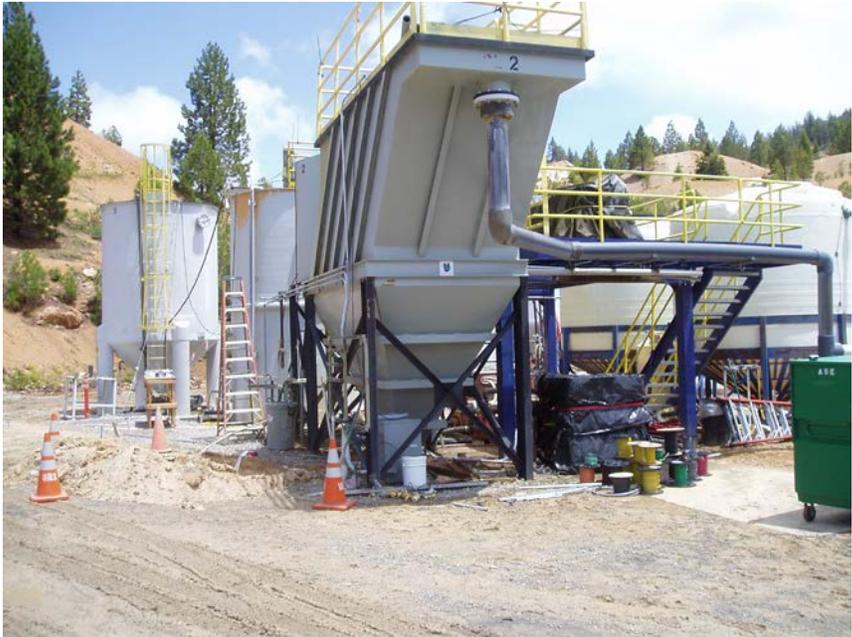
Photo Number	Photo Description	Photo
<p>B-21</p>	<p>Pond water treatment system during mobilization. View to Northeast.</p> <p>June 29, 2011</p>
