2011 Oversight Summary Report Leviathan Mine Superfund Site Alpine County, California

May 2012

**Burleson Consulting, Inc.
950 Glenn Drive, Suite 245
Folsom, California 95630**

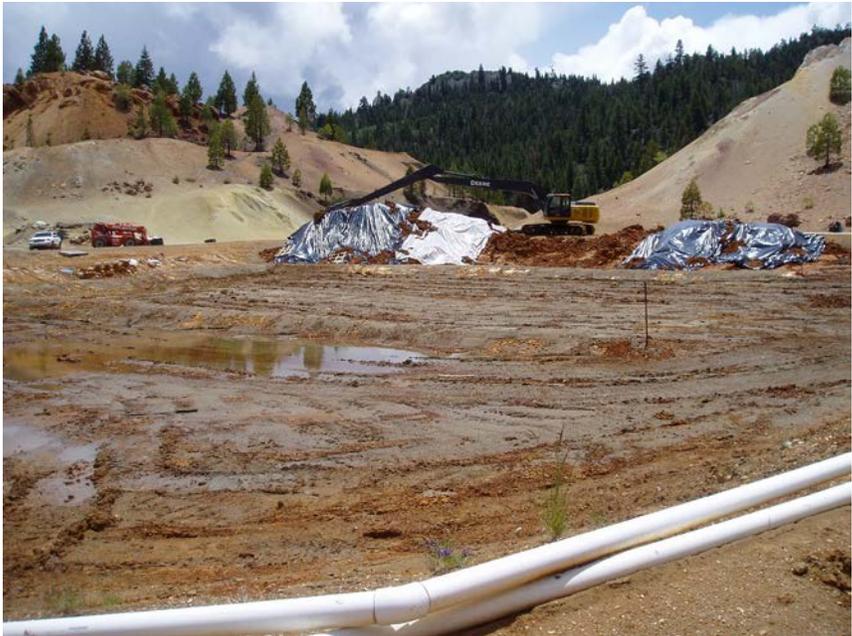
<p>B-22</p>	<p>Sludge Removal at the Pit Clarifier before start of Pond water treatment</p> <p>June 29, 2011</p>

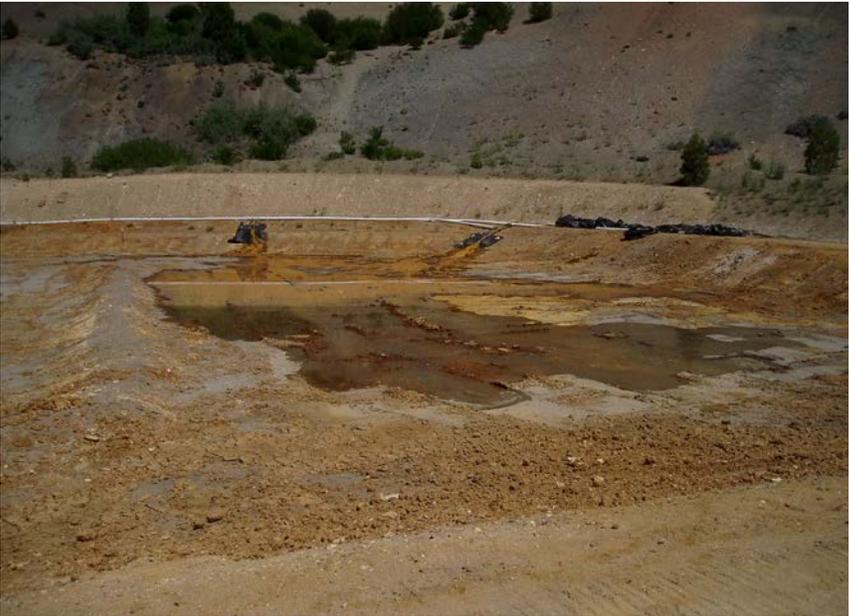
Photo Number	Photo Description	Photo
B-23	<p>First discharge of effluent to the Pit Clarifier. View to West.</p> <p>July 13, 2011</p>

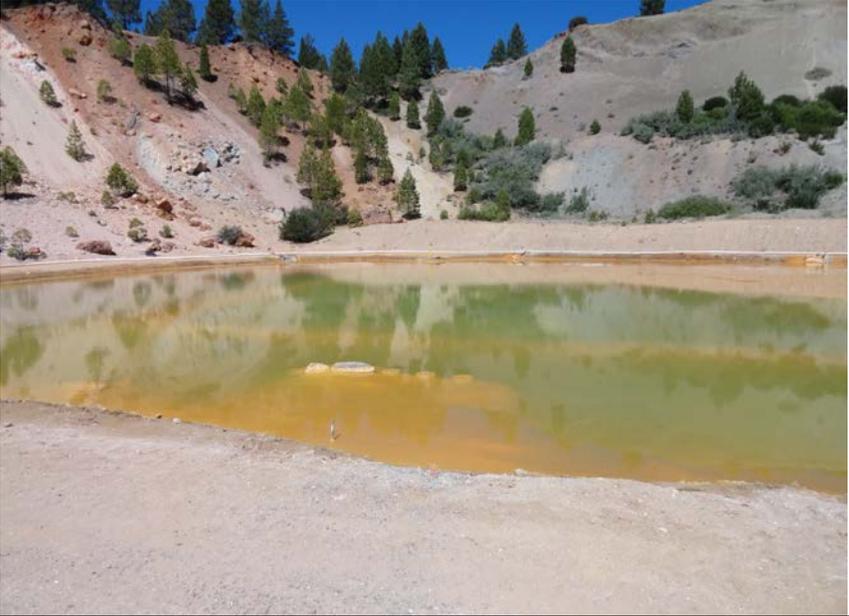
B-24	<p>Pit Clarifier with piccolo drain in foreground. View to West.</p> <p>August 18, 2011</p>

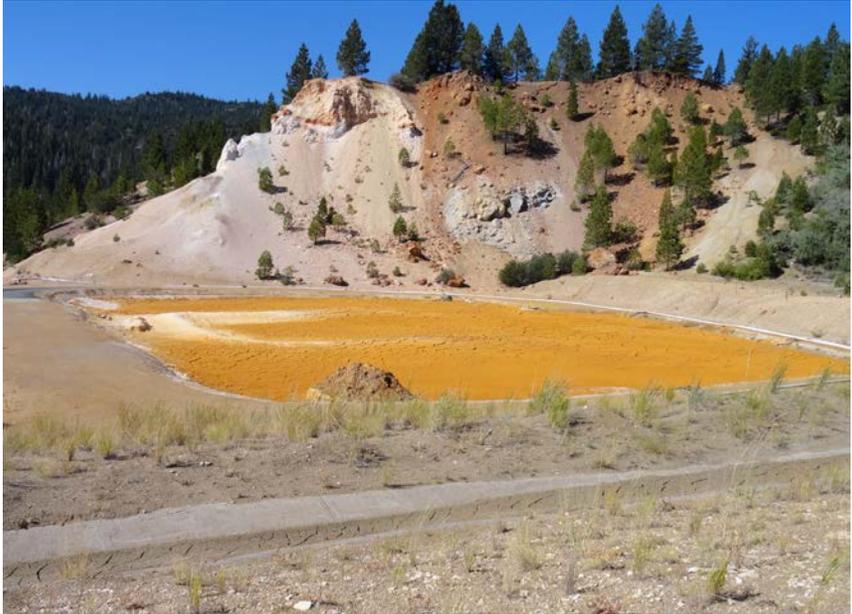
Photo Number	Photo Description	Photo
<p style="text-align: center;">B-25</p>	<p>Pit Clarifier after pond water treatment completion. View to Southwest.</p> <p>September 15, 2011</p>

- Seasonal pond water treatment activities are complete. The Pond Water Treatment System (PWTS) at Pond 1 appeared to be winterized. URS personnel were not observed on-site.
- The Pit Clarifier was dry and a small volume of water was flowing through the Pit Clarifier weir box.

The seasonal pond water treatment activities are complete. The PWTS appeared to be winterized with valves covered in plastic, and enclosures in place over control panels. URS personnel were not observed on-site. Water was not visible in the Pit Clarifier and the surface of the solids is crossed by cracks. About four gallons per minute of water continues to drain through the Pit Clarifier weir box.

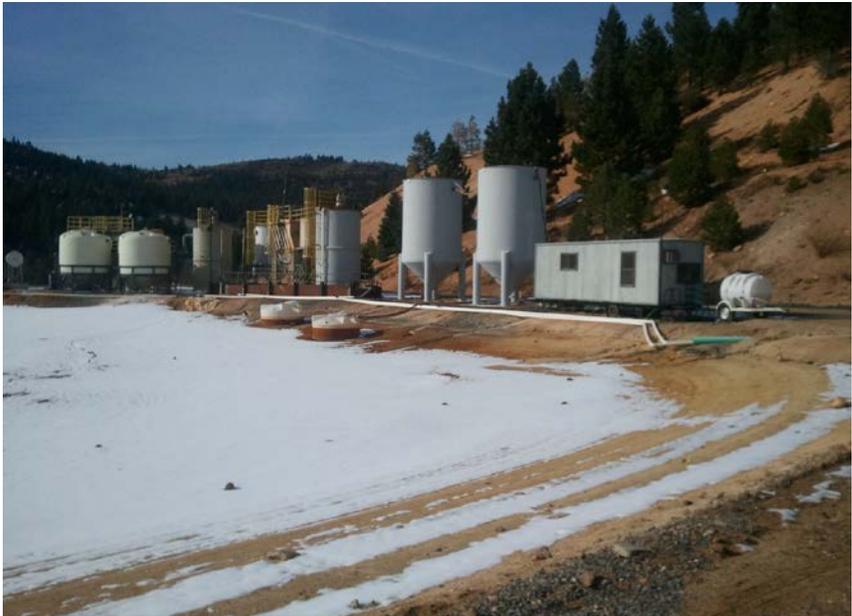
<p style="text-align: center;">B-26</p>	<p>Winterized pond water treatment system. View to northwest.</p> <p>November 9, 2011</p>

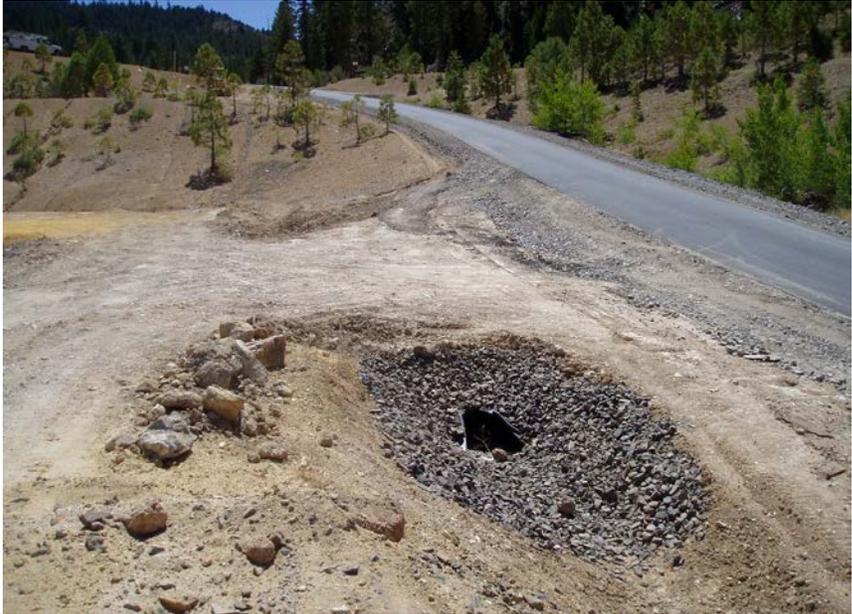
Photo Number	Photo Description	Photo
B-27	New pavement on Upper Road and repaired culvert at entrance to Pond 3. View to southeast. August 17, 2011

Road paving occurred from mid to late July and included grading the road surfaces, installing concrete V-ditches along paved reaches of road, lime treating the road surface, and placing the asphalt-concrete pavement. Access road paving included paving about 0.75 miles of access road from near the California access gate to the vicinity of the Pond 3 entrance, and including the area around Pond 1 and the road into the Pit. The gate to the pit was replaced with a wider double gate, and a truck turnaround area was provided in the pit. Drainage improvements included installing 6 drop box inlets, 375 feet of 12-inch high density polyethylene (HDPE) culverts, removal and replacing 900 linear feet of concrete V-ditch, and adding about 1,160 feet of new concrete V-ditch. Photographs B-27 and B-28 in Appendix B show some of the paving completed during 2011.

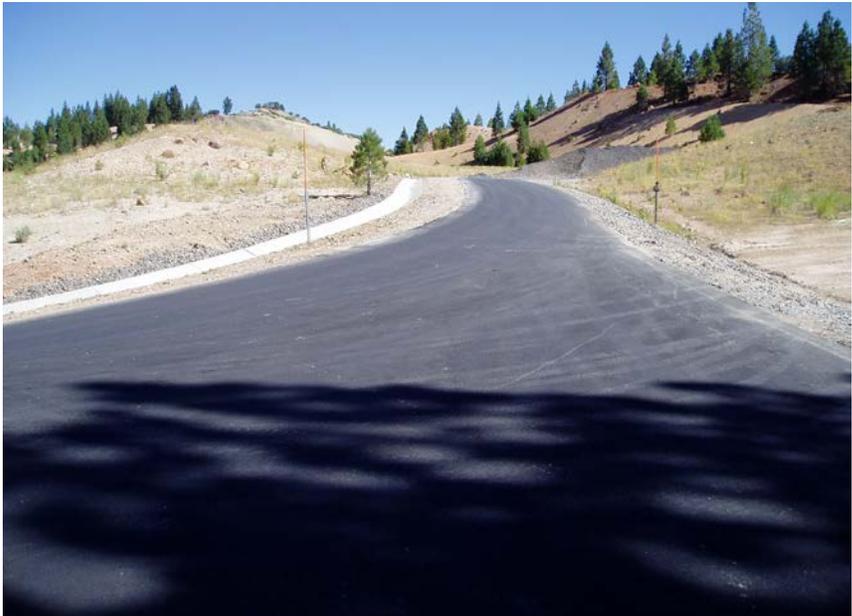
B-28	New pavement and concrete V-ditch along entrance road above (to southeast of) Pond 1. View to North. August 17, 2011

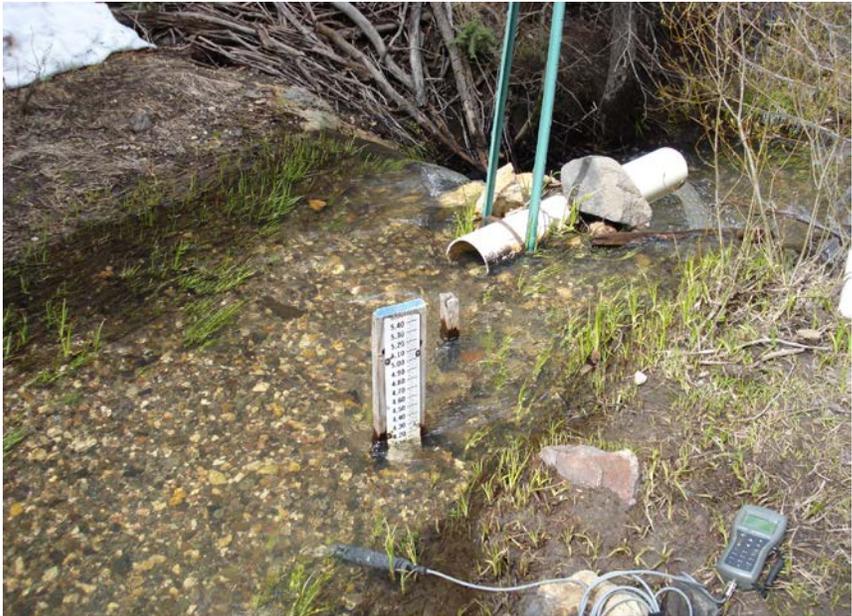
Photo Number	Photo Description	Photo
<p style="text-align: center;">B-29</p>	<p>Station 1 at Leviathan Creek. View to West.</p> <p>June 3, 2011</p>

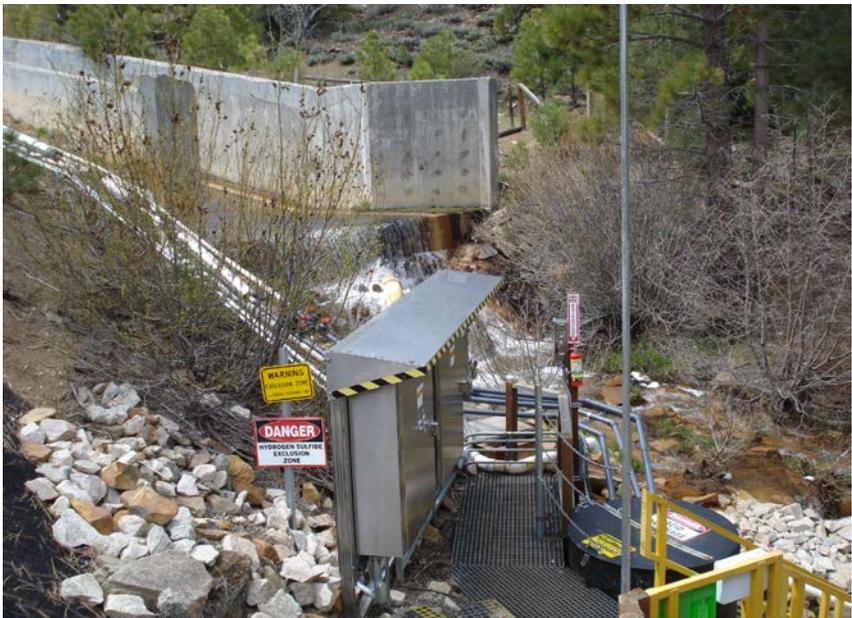
<p>A photograph showing a water level gauge (a vertical ruler with markings from 0.00 to 5.00) placed in a shallow stream. A surveying instrument (a total station) is visible in the foreground, connected to the gauge by a cable. The stream is surrounded by rocks and some vegetation.</p>
<p style="text-align: center;">B-30</p>	<p>End of Leviathan Creek concrete channel at Channel Underdrain. View to South.</p> <p>June 3, 2011</p>

<p>A photograph showing the end of a concrete channel where water is flowing into a metal structure. The structure has a yellow and black striped top. There are two safety signs: a yellow one that says 'WARNING' and a red one that says 'DANGER HYDROGEN SULFIDE EXCLUSION ZONE'. The area is rocky and has some vegetation.</p>

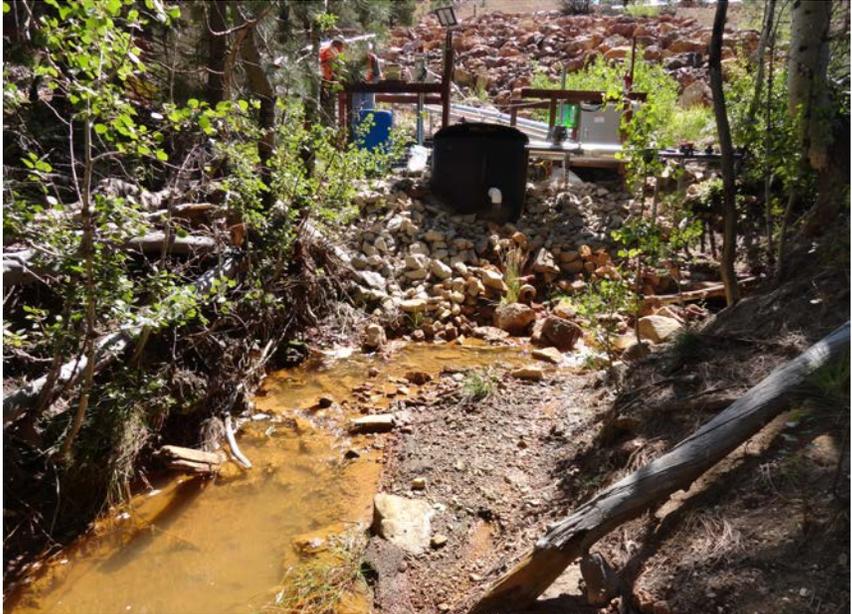
Photo Number	Photo Description	Photo
B-31	Delta Seep collection tank at Leviathan Creek. View to southeast. September 15, 2011

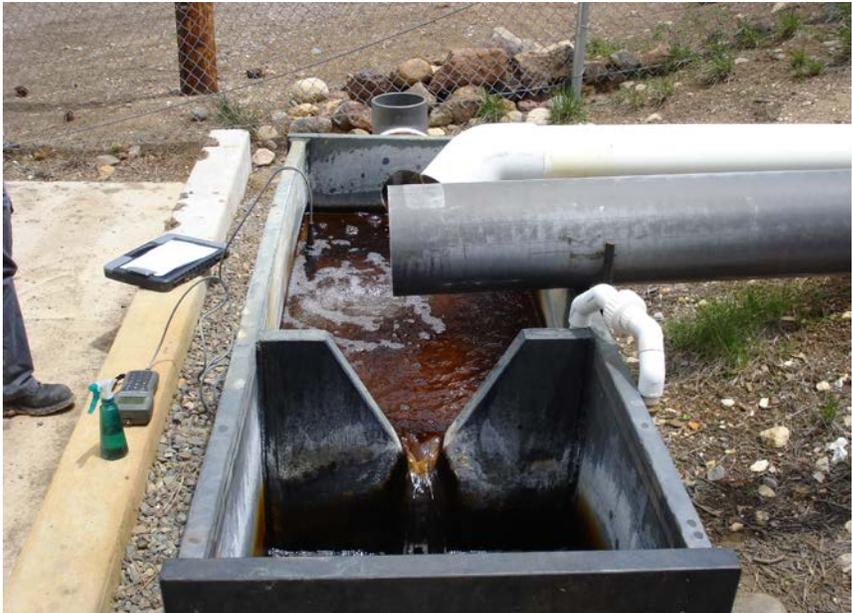
B-32	Aspen Seep Weir Box. View to Northeast. June 3, 2011

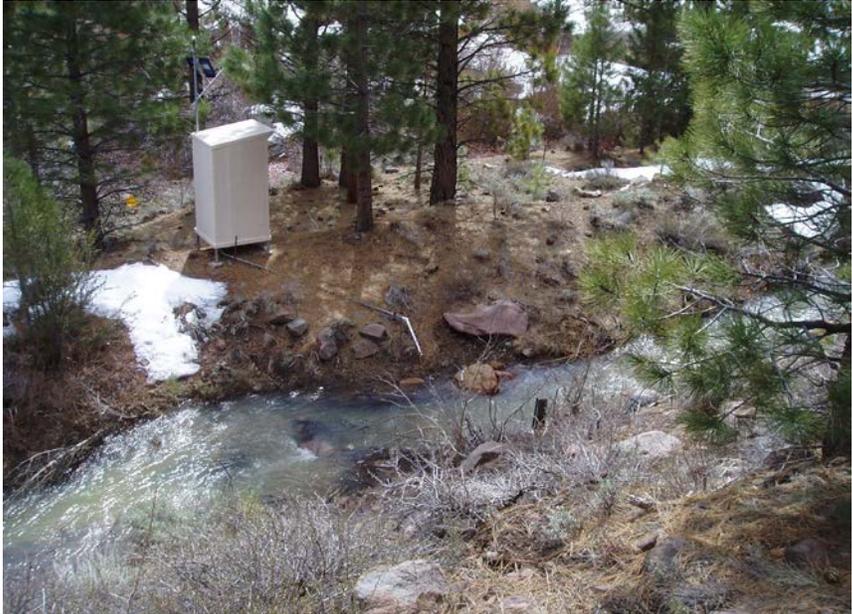
Photo Number	Photo Description	Photo
B-33	Station 15 at Leviathan Creek. View to Southeast. April 13, 2011

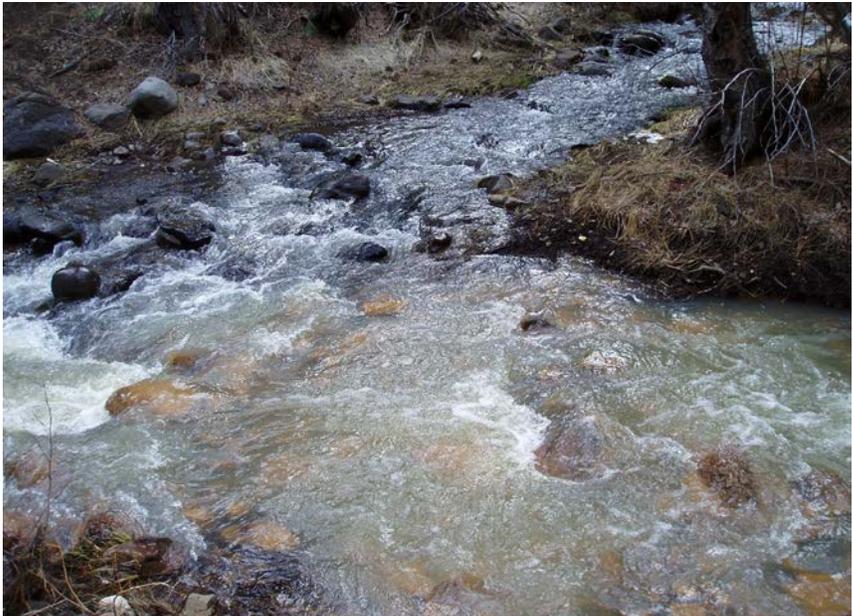
B-34	Confluence of Leviathan Creek (foreground) with Mountaineer Creek. View to East. April 13, 2011

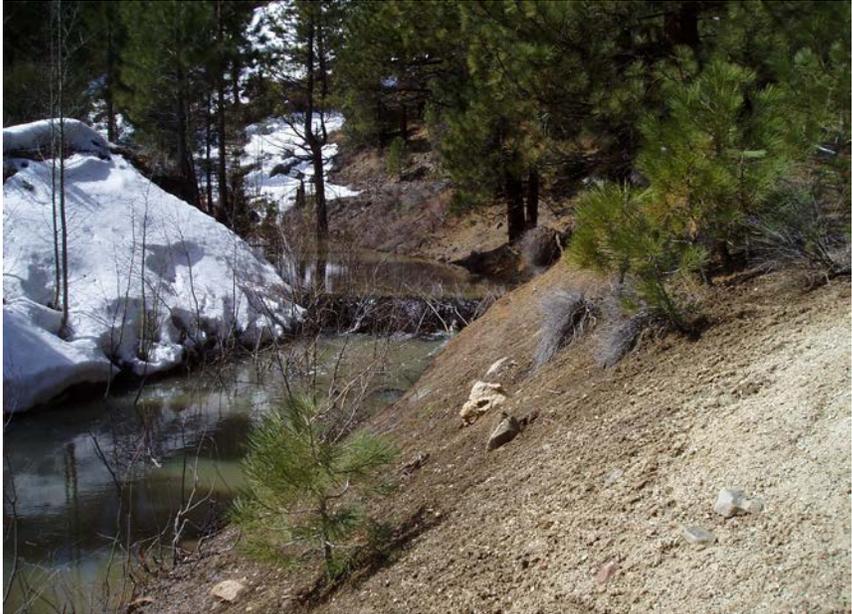
Photo Number	Photo Description	Photo
<p style="text-align: center;">B-35</p>	<p>Lower Beaver Dam. View to South.</p> <p>April 13, 2011</p>

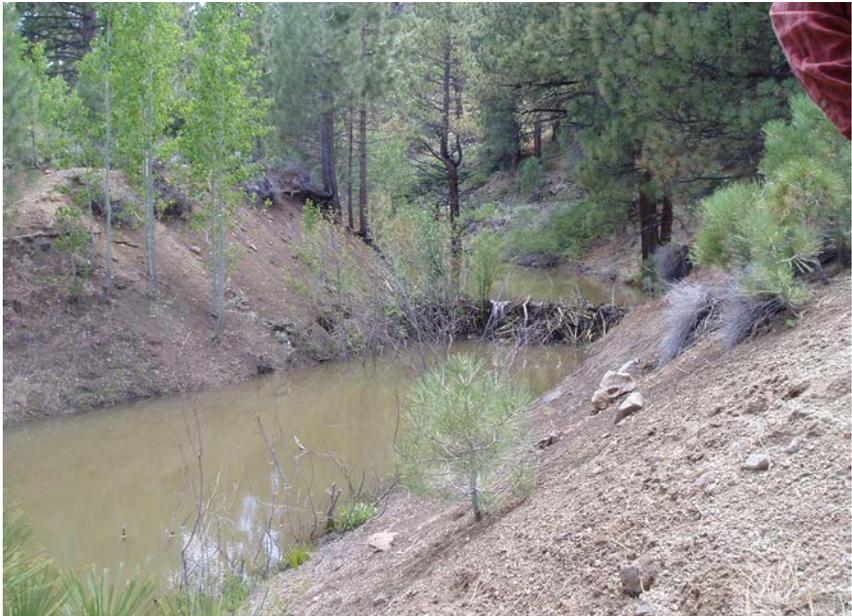
<p style="text-align: center;">B-36</p>	<p>Lower Beaver Dam. View to South.</p> <p>June 29, 2011</p>

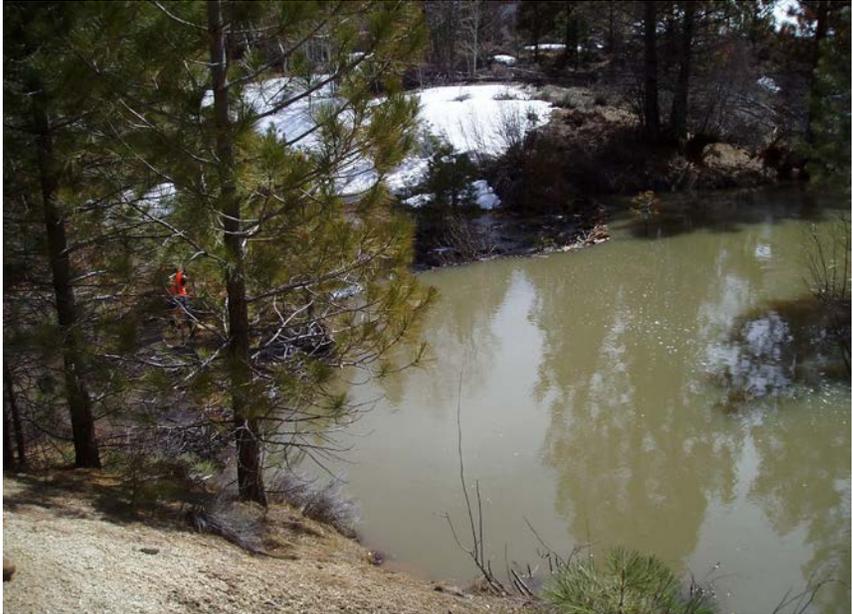
Photo Number	Photo Description	Photo
B-37	Main Beaver Dam. View to West. April 13, 2011

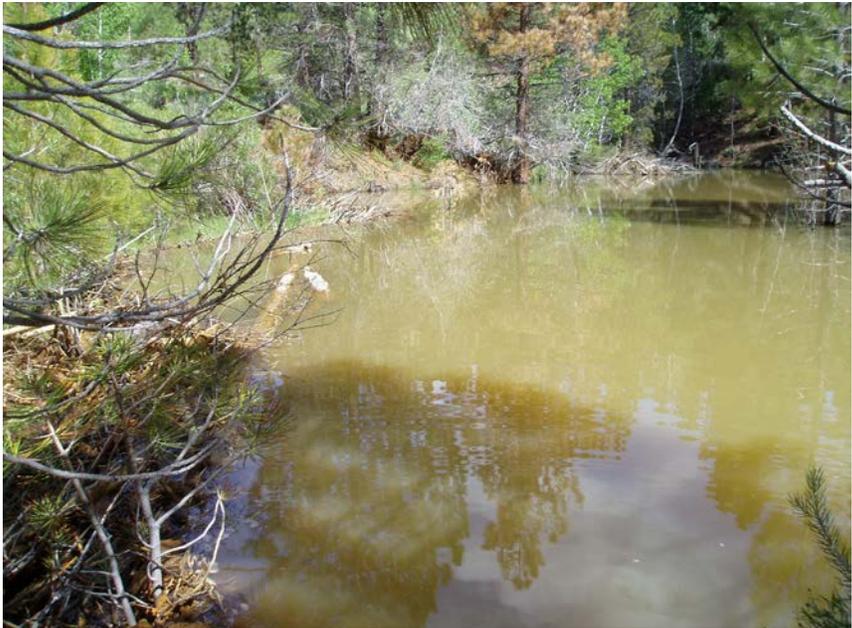
A photograph showing a beaver dam in a forested area. The water is murky and brown. There are snow patches on the ground in the background. The trees are mostly evergreens.
B-38	Main Beaver Dam. View to West. June 29, 2011

A photograph showing a beaver dam in a forested area. The water is murky and brown. There are dense evergreen trees and some bare branches in the foreground. The dam is visible in the background.

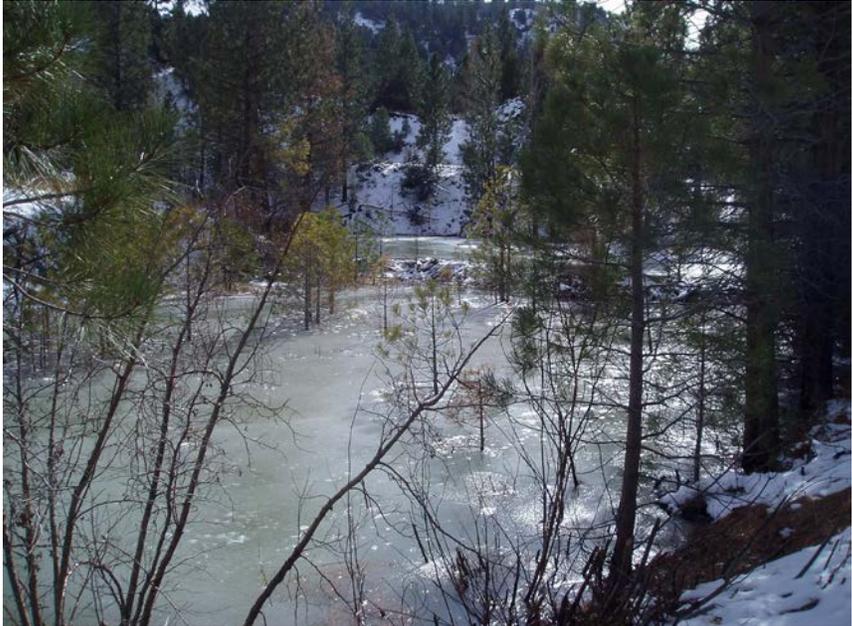
Photo Number	Photo Description	Photo
B-39	Main Beaver Dam. View to Southwest. November 9, 2011
