This Data Review Technical Memorandum highlights existing groundwater conditions and the status of site cleanup at NIBW and SIBW.

ITSI prepared this Data Review Technical Memorandum summarizing the evaluation of the groundwater contamination concentrations and groundwater elevations for NIBW and SIBW as part of the First FYR. This Data Review Technical Memorandum compares the groundwater data since the time of the respective RODs as an appendix to the Five Year Review Report. Final conclusions and recommendations are presented in the Five Year Review Report.

**Data Review Technical Memorandum**  
 TCE Concentration  
 North Indian Bend Wash Superfund Area  
 Scottsdale, Arizona

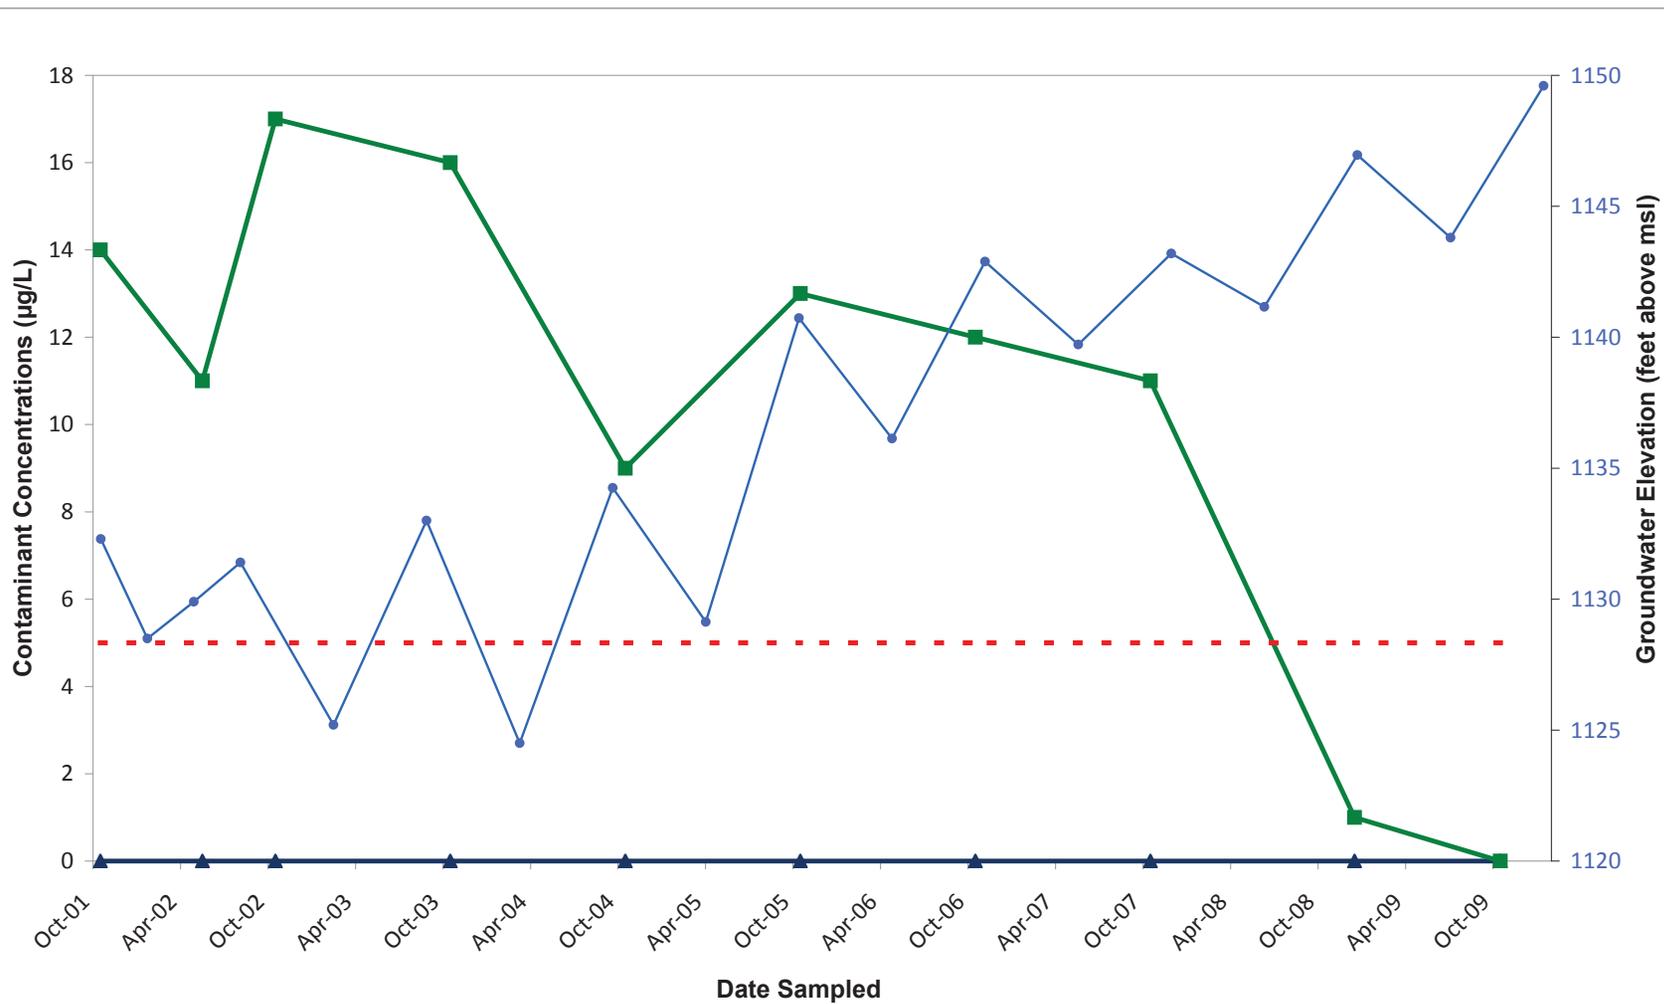
**Figure 2-3A**  
NIBW D-1UA  
Upper Alluvial Unit  
October 2001 - October 2009

Note For analytes not detected above the laboratory reporting limits, the concentration was plotted as zero

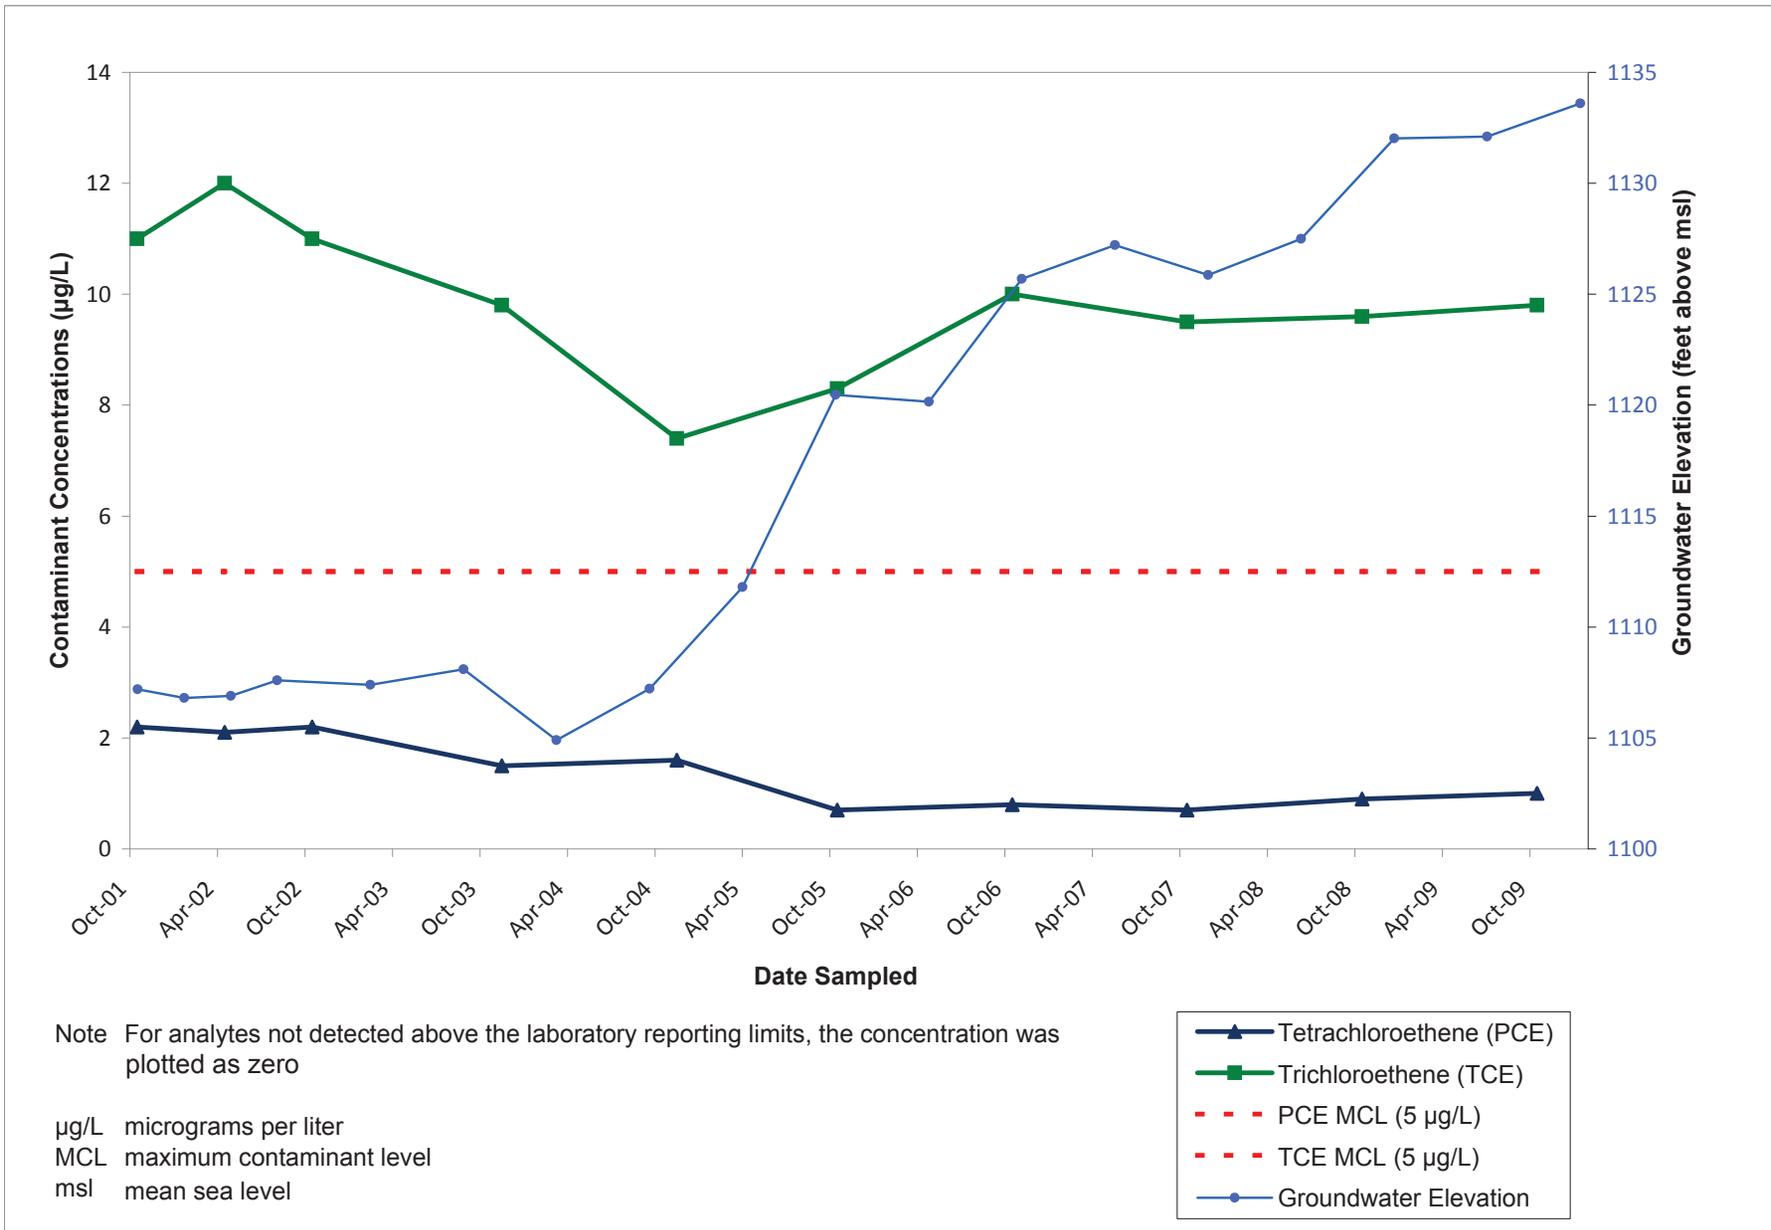
**Figure 2-3B**  
 NIBW E-5UA  
 Upper Alluvial Unit  
 October 2001 - October 2009

**Data Review Technical Memorandum**  
 Concentrations and Water Levels for NIBW Over Time  
 North Indian Bend Wash Superfund Area  
 Scottsdale, Arizona

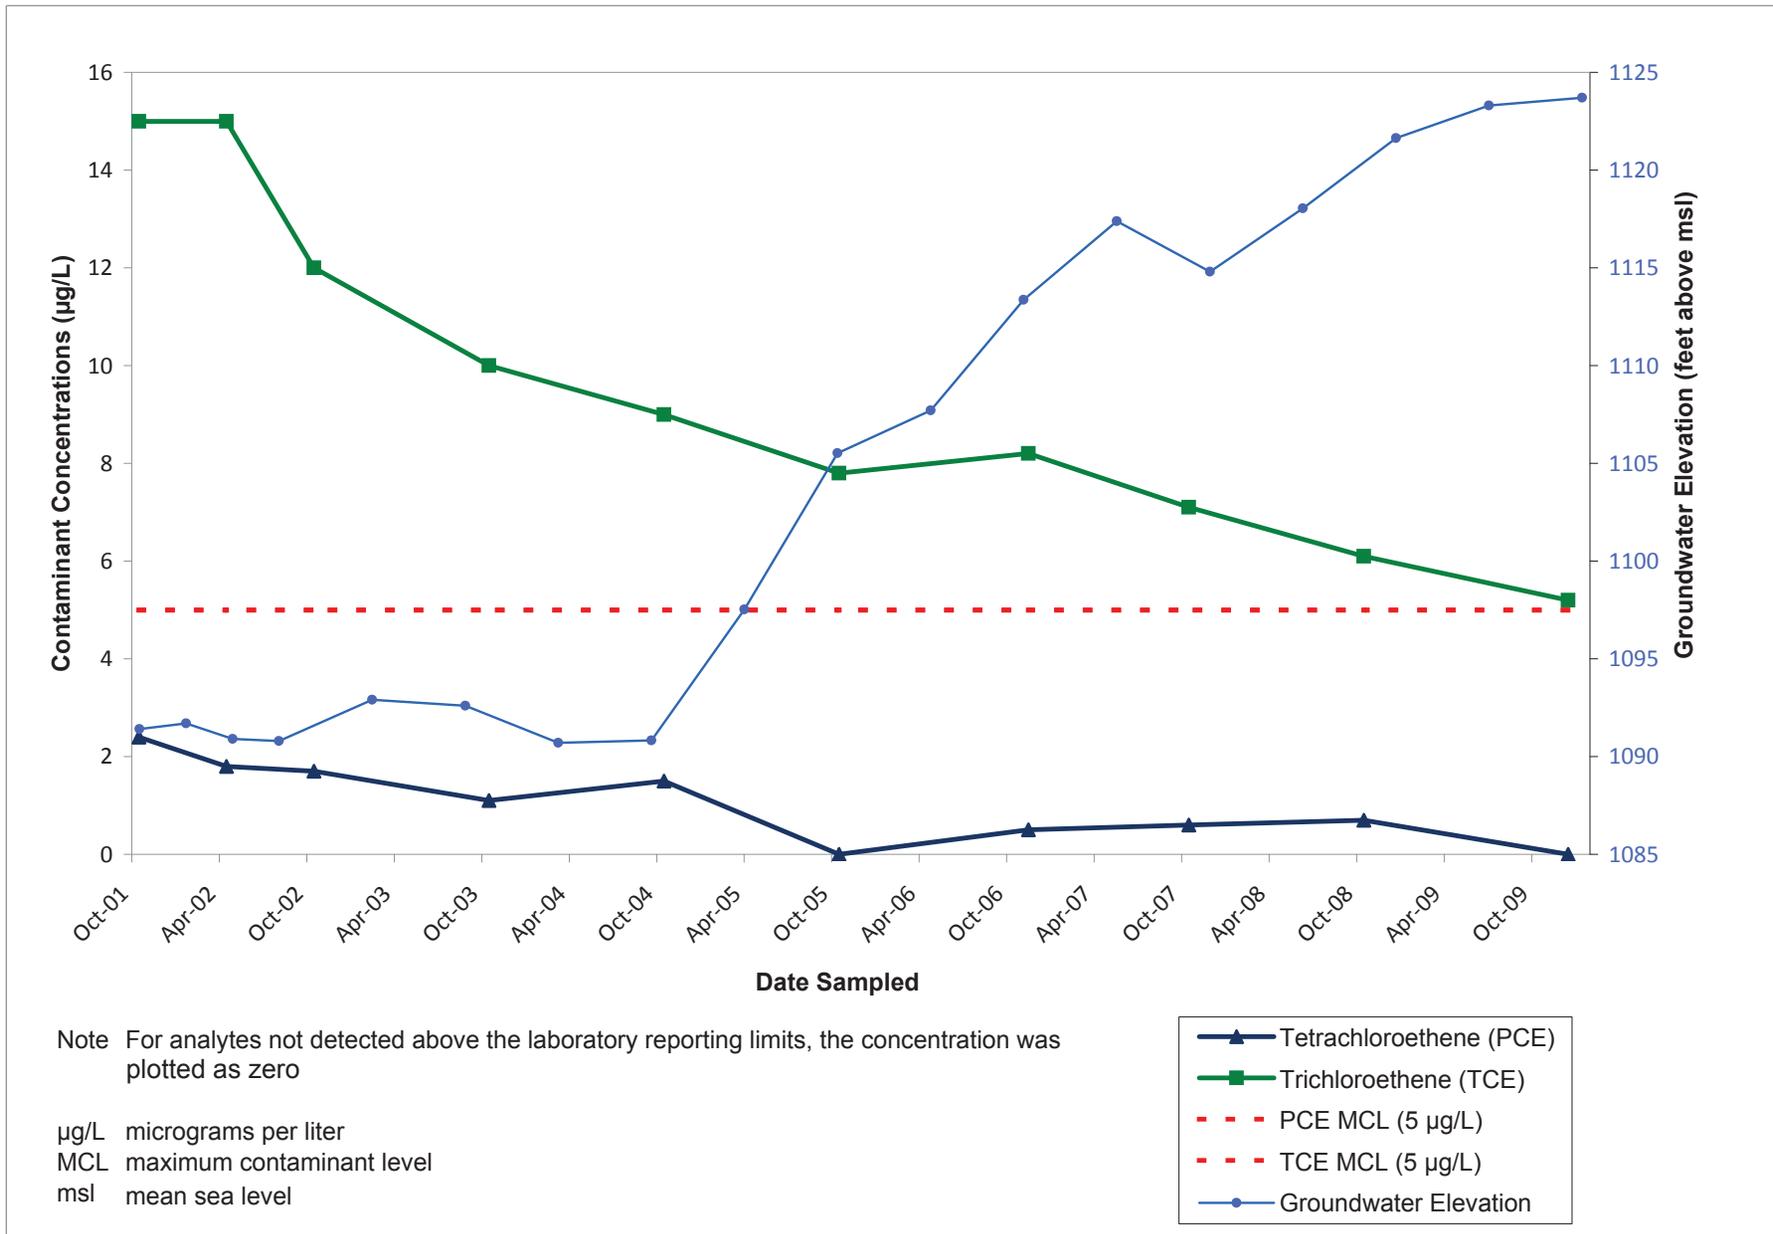
**Figure 2-3C**  
 NIBW PG-5UA  
 Upper Alluvial Unit  
 October 2001 - October 2009

**Data Review Technical Memorandum**  
 Concentrations and Water Levels for NIBW Over Time  
 North Indian Bend Wash Superfund Area  
 Scottsdale, Arizona

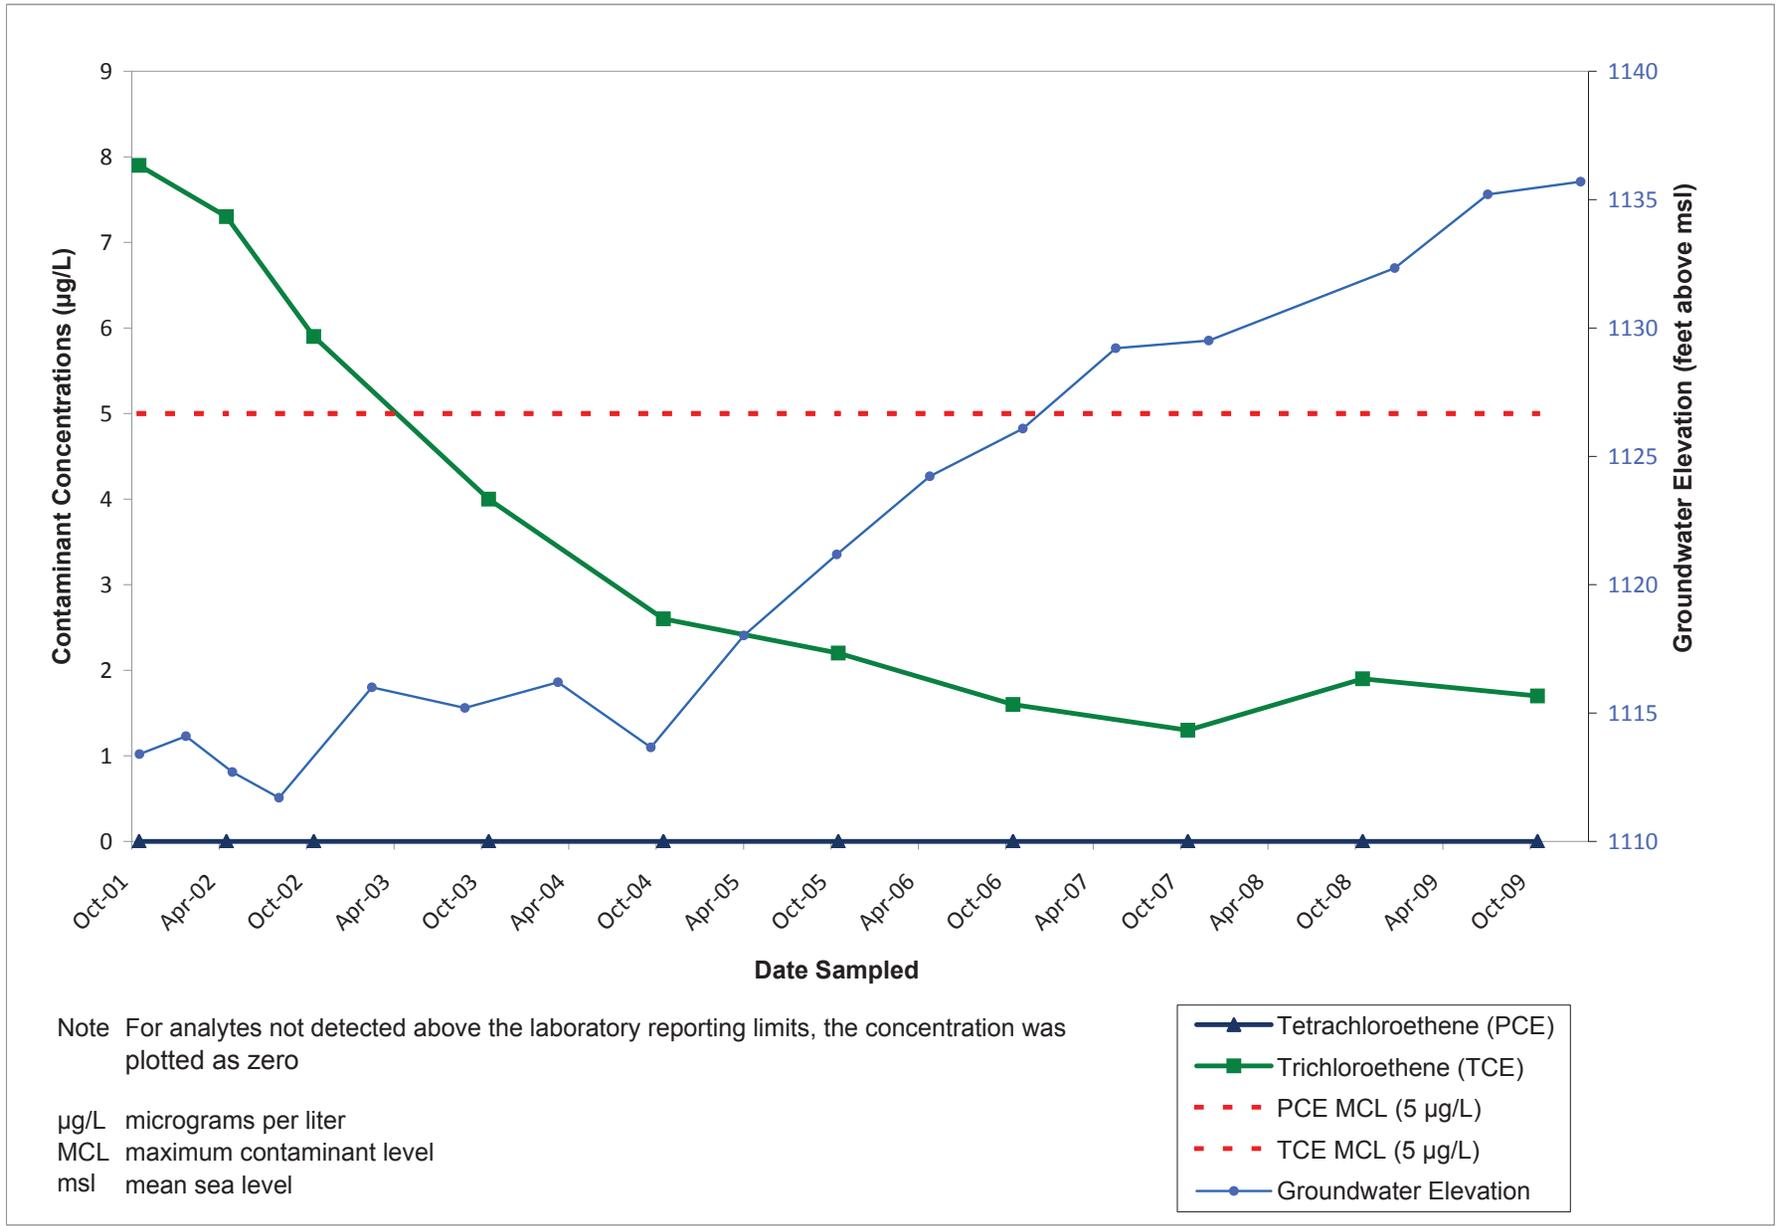
**Figure 2-3D**  
NIBW PG-10UA  
Upper Alluvial Unit  
October 2001 - October 2009

**Data Review Technical Memorandum**  
Concentrations and Water Levels for NIBW Over Time  
North Indian Bend Wash Superfund Area  
Scottsdale, Arizona

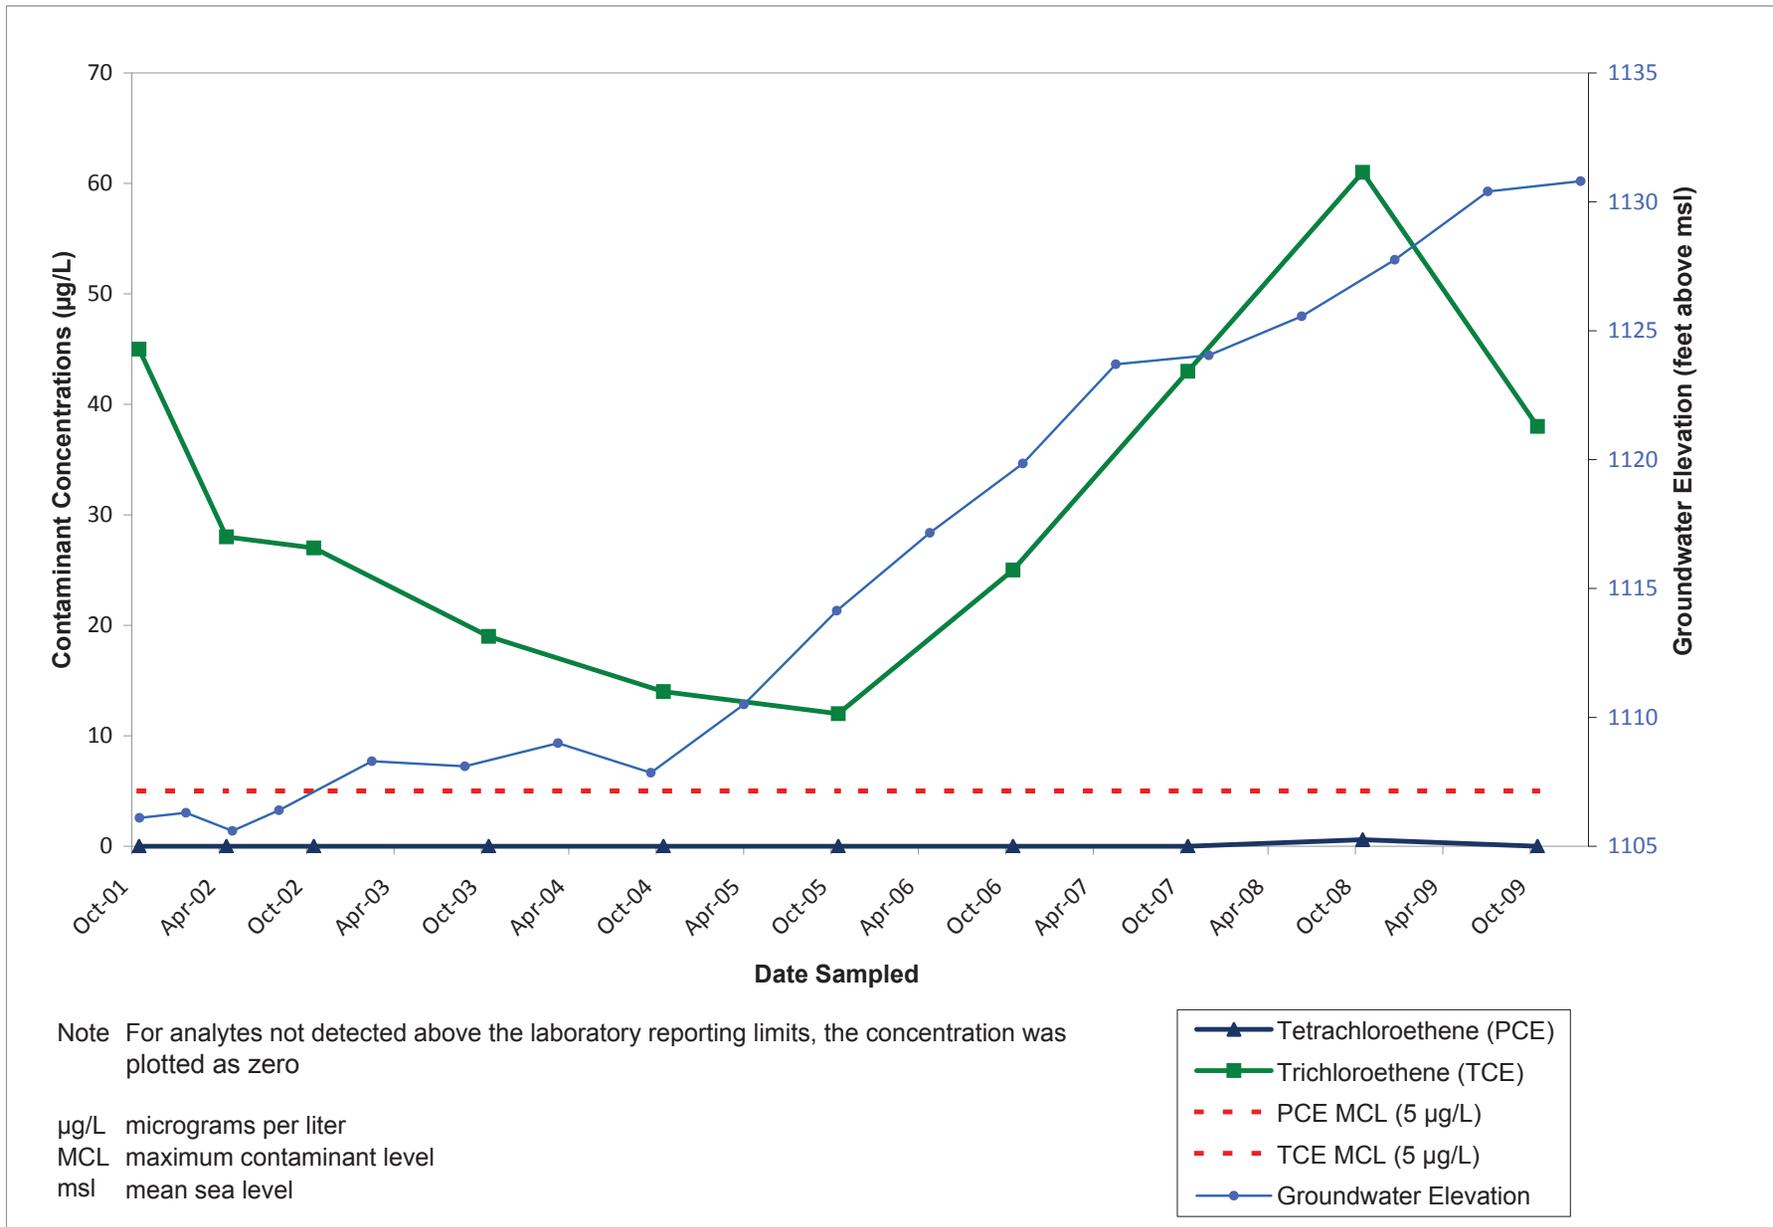
**Figure 2-3E**  
NIBW PG-31UA  
Upper Alluvial Unit  
October 2001 - October 2009

**Data Review Technical Memorandum**  
Concentrations and Water Levels for NIBW Over Time  
North Indian Bend Wash Superfund Area  
Scottsdale, Arizona

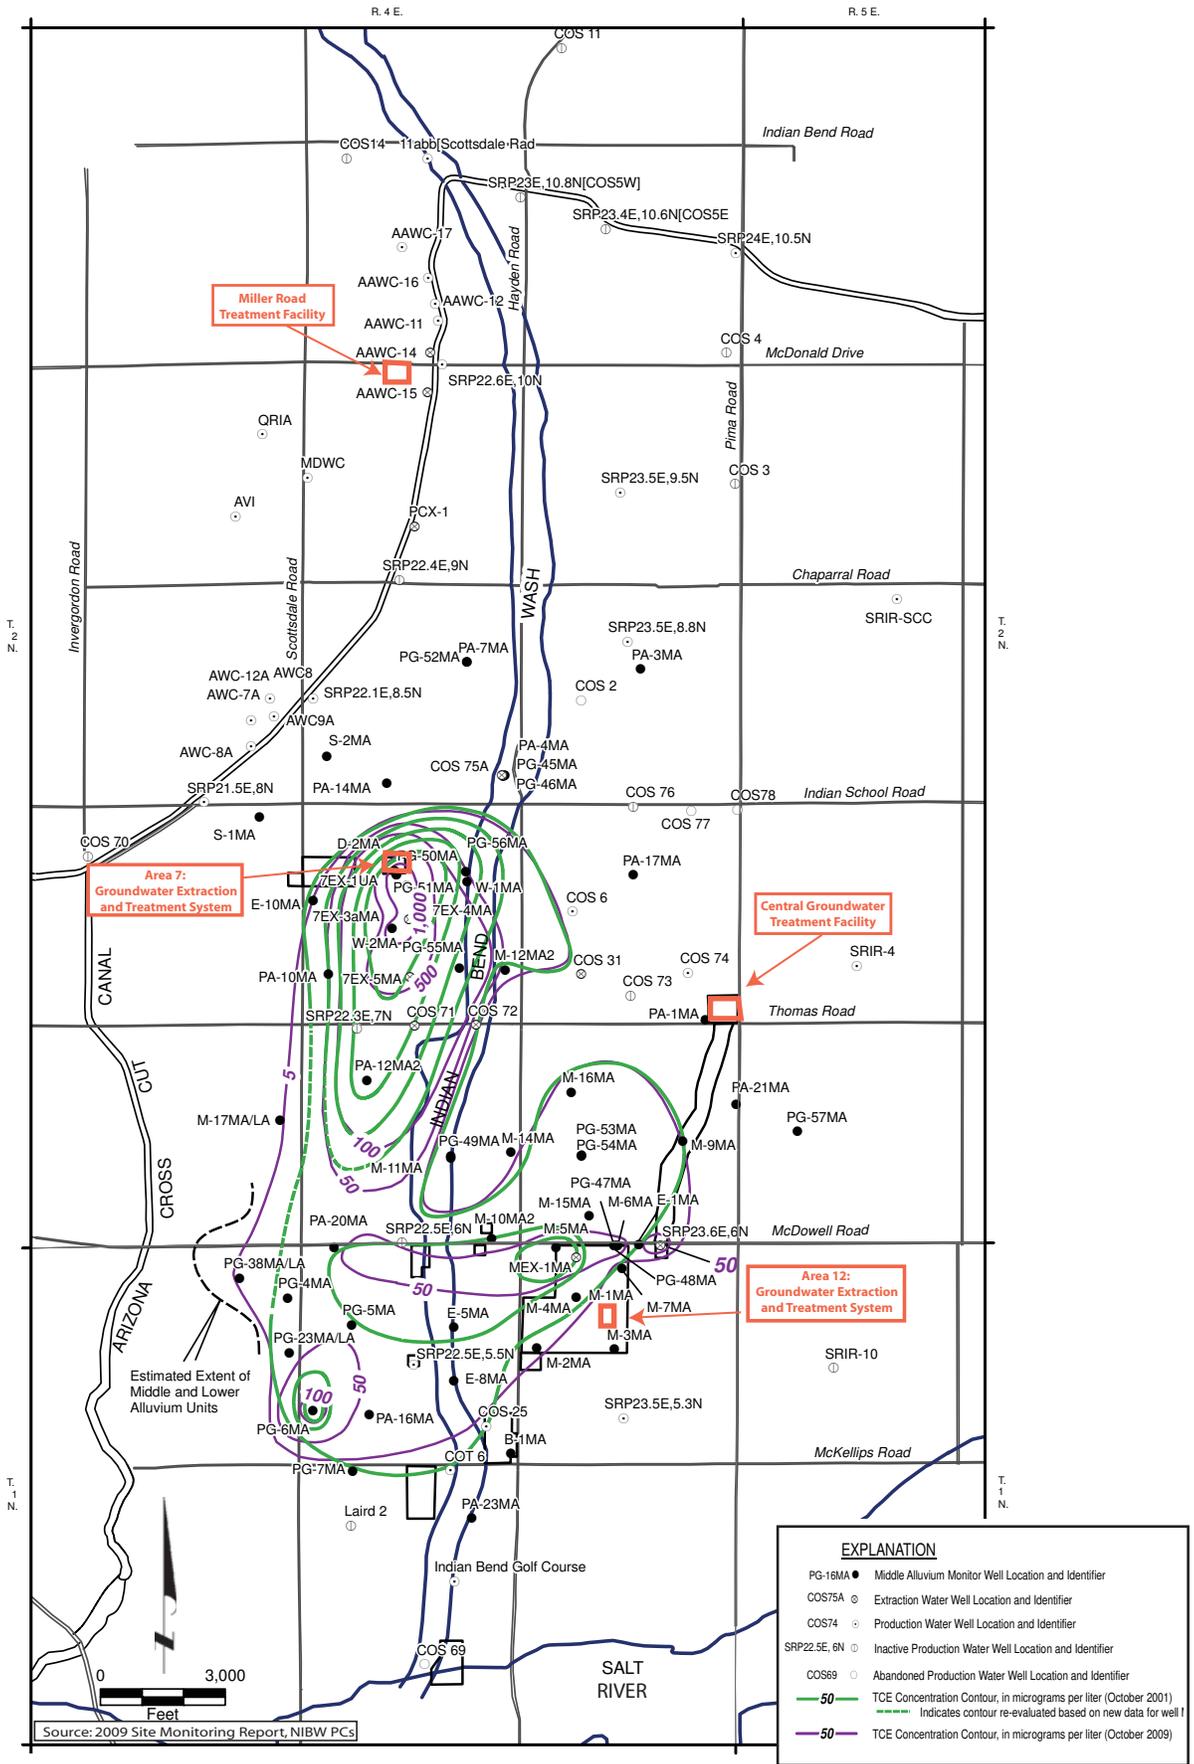
**Figure 2-5**  
 Middle Alluvial Unit Wells  
 October 2001 and October 2009

EXPLANATION	
PG-16MA ●	Middle Alluvium Monitor Well Location and Identifier
COS75A ○	Extraction Water Well Location and Identifier
COS74 ○	Production Water Well Location and Identifier
SRP22.5E,6N ○	Inactive Production Water Well Location and Identifier
COS69 ○	Abandoned Production Water Well Location and Identifier
—50—	TCE Concentration Contour, in micrograms per liter (October 2001)
—50—	Indicates contour re-evaluated based on new data for well 1
—50—	TCE Concentration Contour, in micrograms per liter (October 2009)

Changes in TCE concentrations in the MAU groundwater observed over the past eight years (October 2001 to October 2009) are generally small. The overall footprint of the TCE plume in the MAU is generally stable, with the western boundary expanding slightly in the area of PG-38MA/LA. Figures 2-6A through 2-6I show trend plots for TCE (and PCE) concentrations and groundwater elevations at selected representative wells in the MAU at the NIBW Site. In October 2001, the total TCE plume size was approximately 2,122 acres. In October 2009, the total TCE plume size was approximately 2,280 acres, an increase of approximately 7 percent.

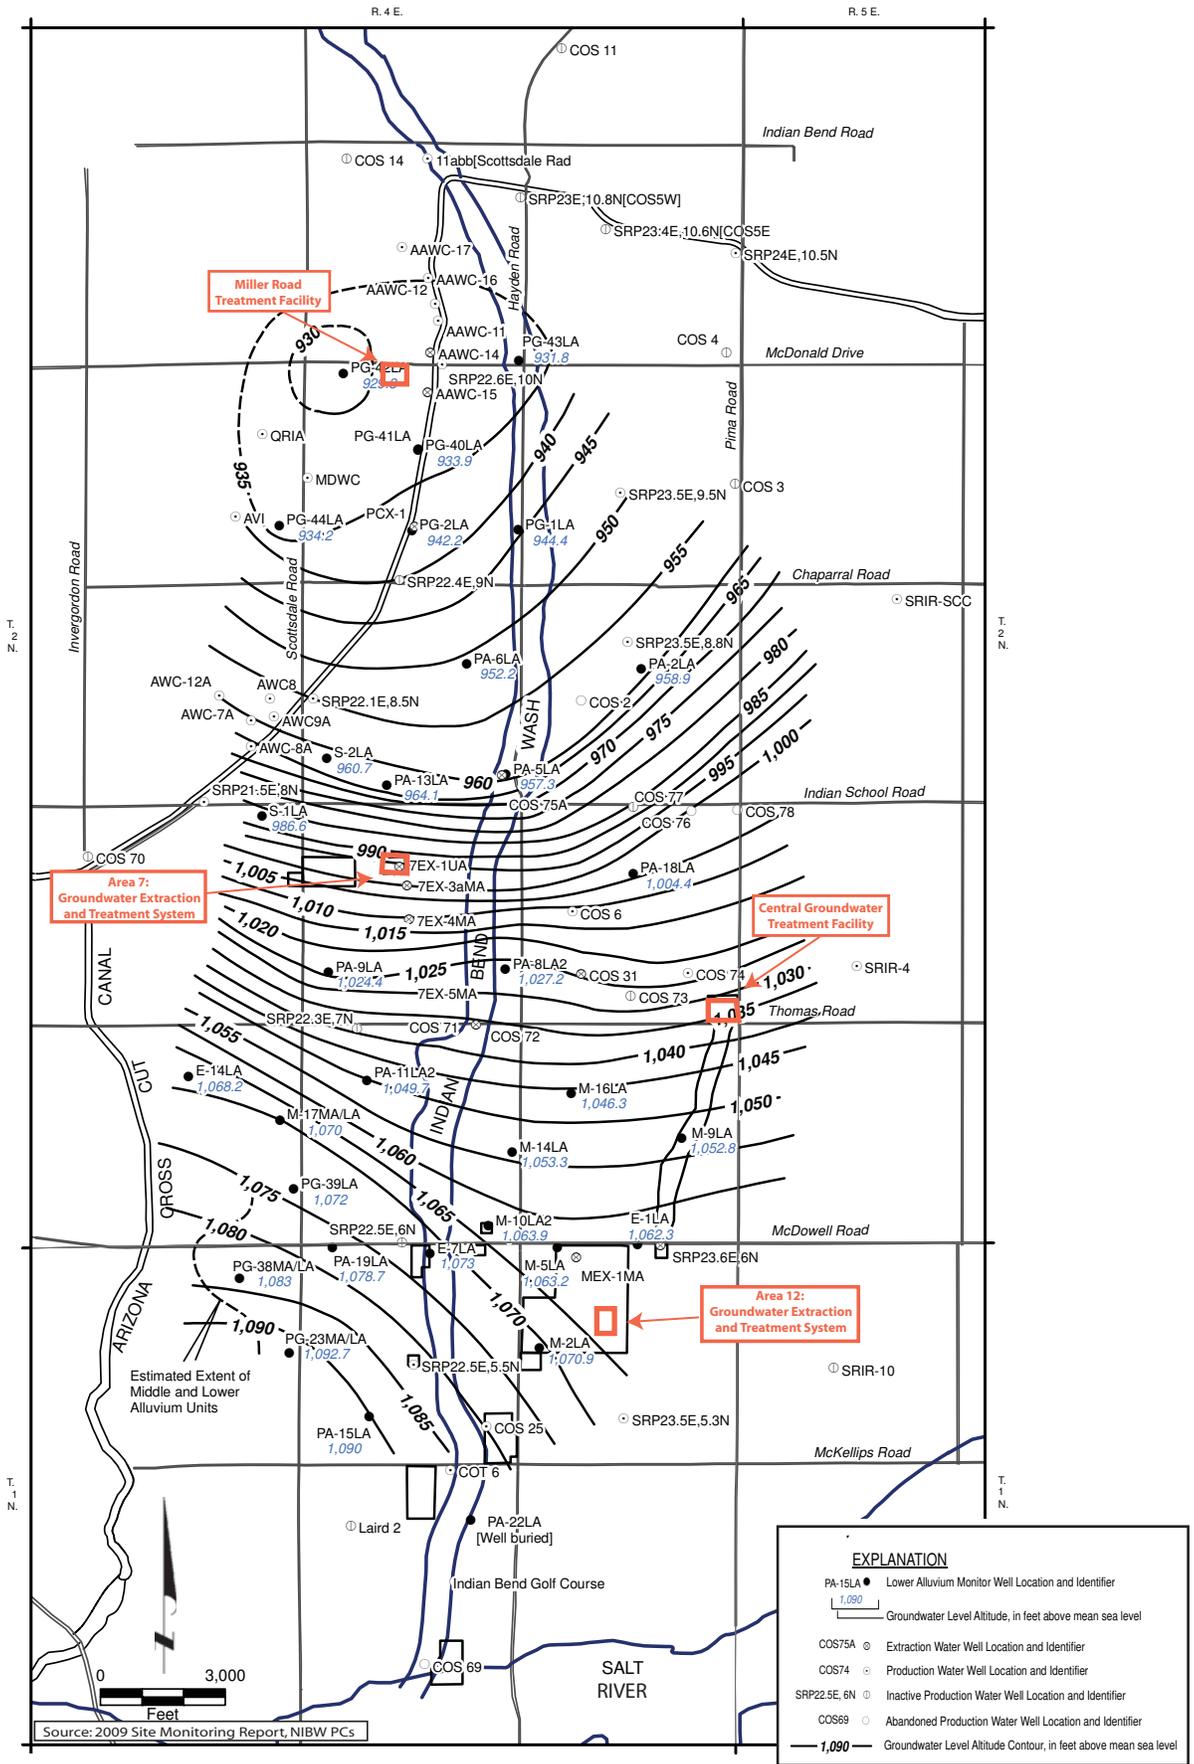
**Figure 2-7**  
 Lower Alluvial Unit Wells  
 October 2009

**Data Review Technical Memorandum**  
 Groundwater Elevation Contours  
 North Indian Bend Wash Superfund Area  
 Scottsdale, Arizona

Groundwater elevation data for NIBW were reviewed with respect to each alluvial unit during the period of October 2001 through October 2009 and general trends were observed.

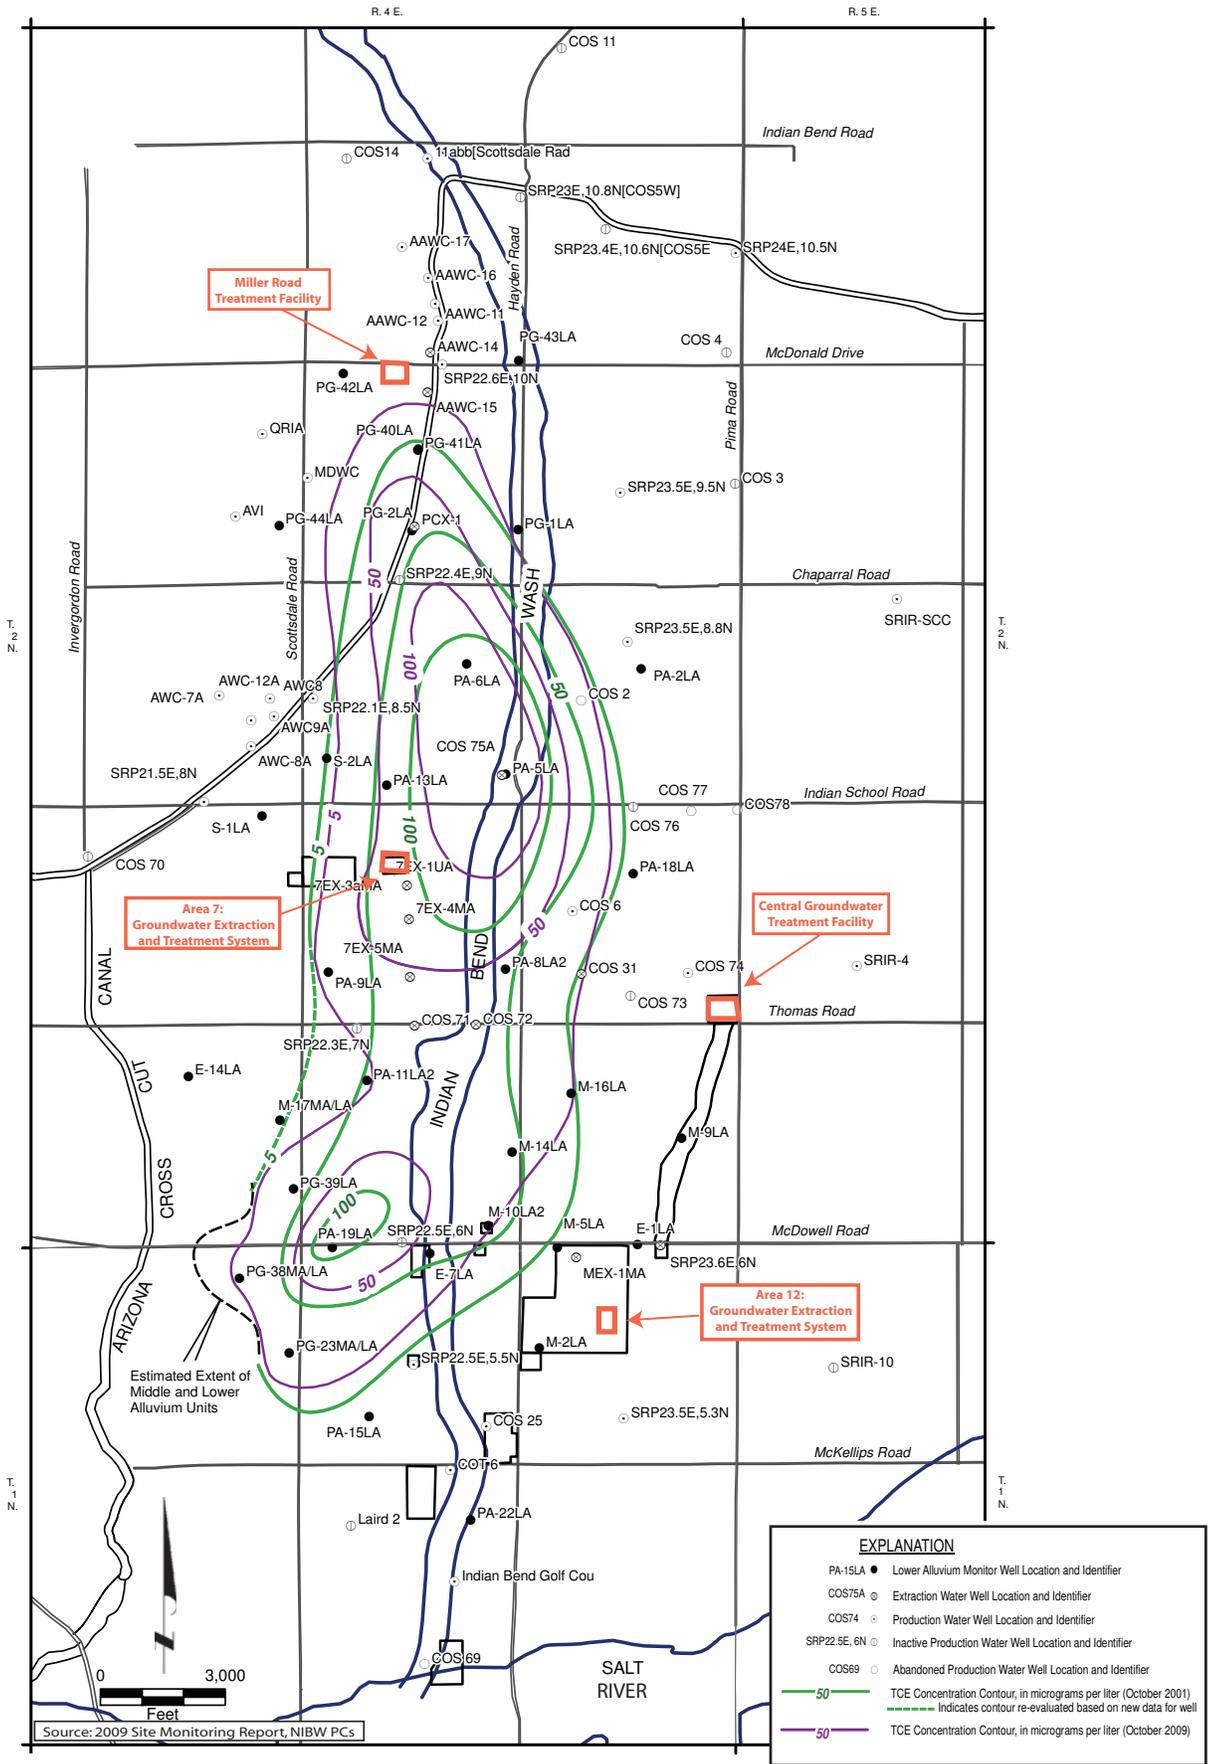
**Figure 2-8**  
 Lower Alluvial Unit Wells  
 October 2001 and October 2009

EXPLANATION	
PA-15LA ●	Lower Alluvium Monitor Well Location and Identifier
COS75A ○	Extraction Water Well Location and Identifier
COS74 ○	Production Water Well Location and Identifier
SRP22.5E, 6N ○	Inactive Production Water Well Location and Identifier
COS69 ○	Abandoned Production Water Well Location and Identifier
— 50 —	TCE Concentration Contour, in micrograms per liter (October 2001)
- - - 50 - - -	Indicates contour re-evaluated based on new data for well
— 100 —	TCE Concentration Contour, in micrograms per liter (October 2009)

Changes in TCE concentrations in the LAU groundwater observed over the eight-year period between October 2001 and October 2009 are generally small, although TCE concentrations have decreased at some locations within the plume. Decreases observed in the southern part of the NIBW Site in the LAU and along the centerline of the plume (e.g., PA-19LA and PG-23MA/LA) are likely attributed to mass removal at extraction wells and influx over time of UAU and MAU groundwater with progressively lower concentrations of TCE. Increases observed to the north (PA-6LA, PG-2LA, and PG-40LA) are attributable to the migration of the LAU mass towards extraction well PCX-1 and the MRTF extraction wells, as intended by the remedy and shown by the increase in TCE concentrations at the influent of extraction well PCX-1. Figures 2-9A through 2-9G illustrate TCE (and PCE) concentration and groundwater elevation trend plots for selected representative wells in the LAU at the NIBW Site.

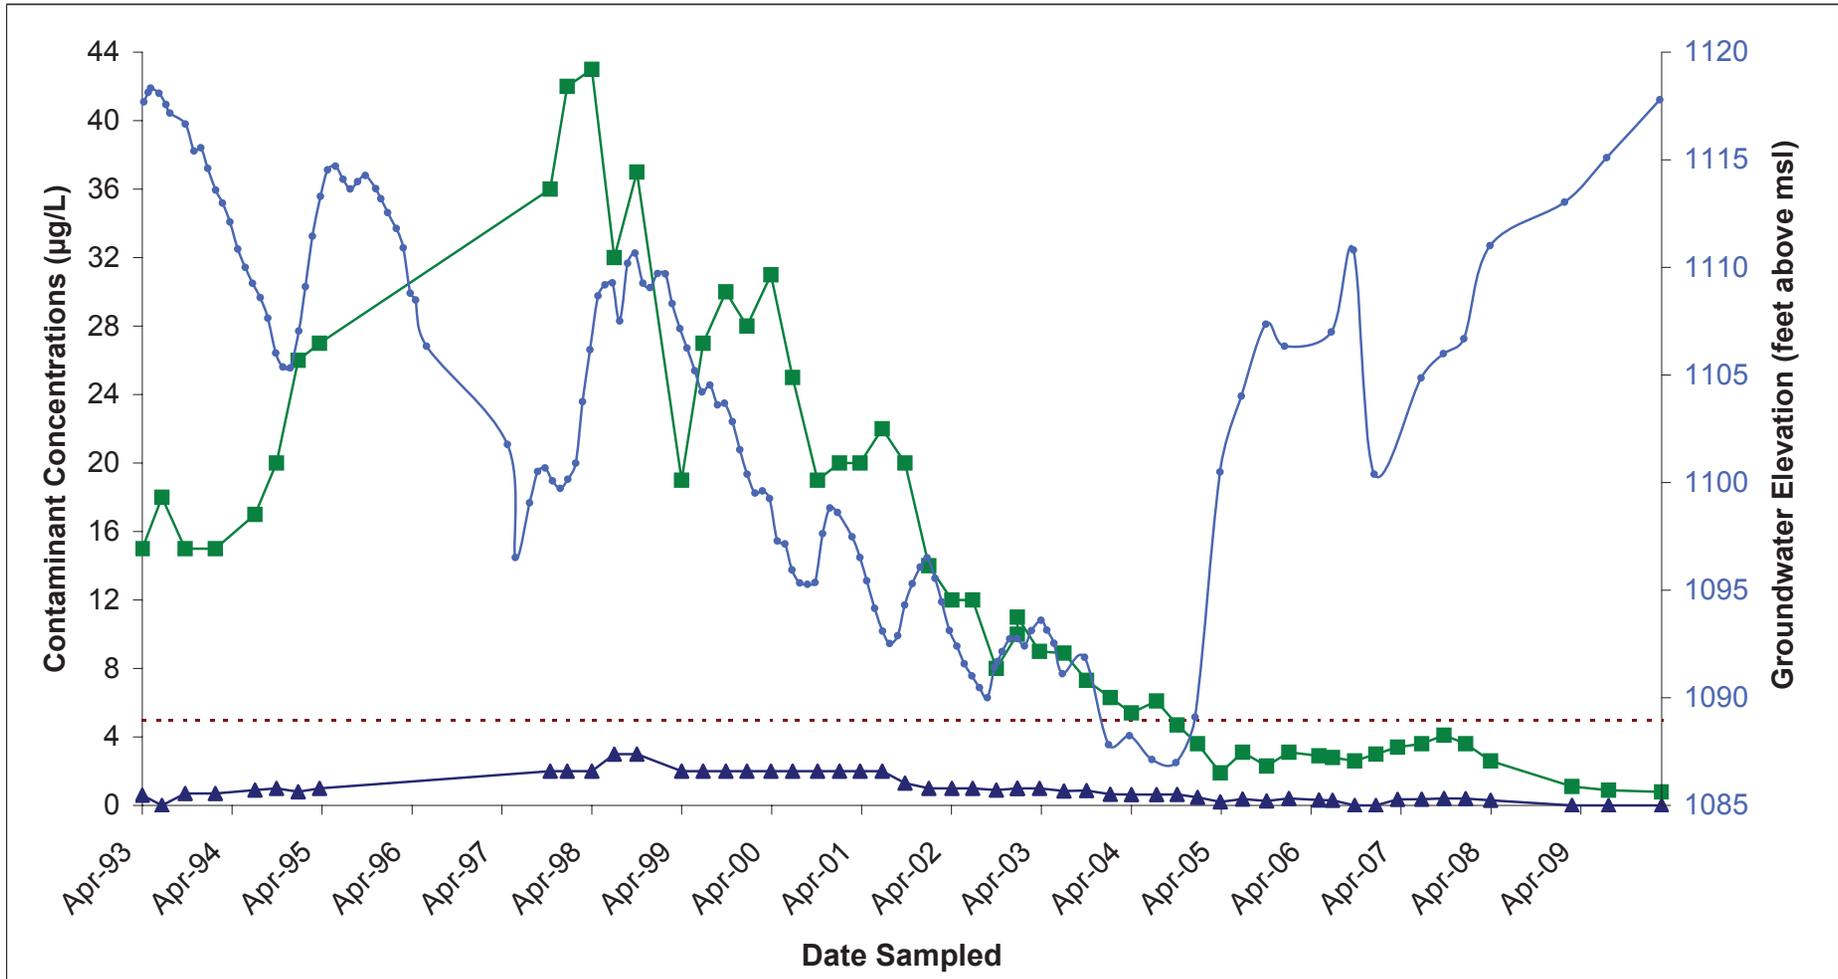
**Figure 3-4**  
SIBW-28U  
Western Plume  
March 1993- March 2010

Note For analytes not detected above the laboratory reporting limits, the concentration was plotted as zero

Statistically decreasing trends were found for TCE in the following wells: SIBW-13MC, SIBW-56MC and SIBW-58MC in the eastern plume and SIBW-28U in the western plume, with absolute values of Kendal tau coefficient closer to 0.5 than 1.0. Two wells in the central plume, SIBW-38U and SW-1, have statistically decreasing PCE trends. While only six of the 19 wells were statistically decreasing, the rest of the wells selected as part of this data review have had COC concentrations consistently below the MCL for several years; therefore, the rate of decrease in COC concentrations is not great enough to obtain a Kendall tau value representative of a statistically decreasing trend.

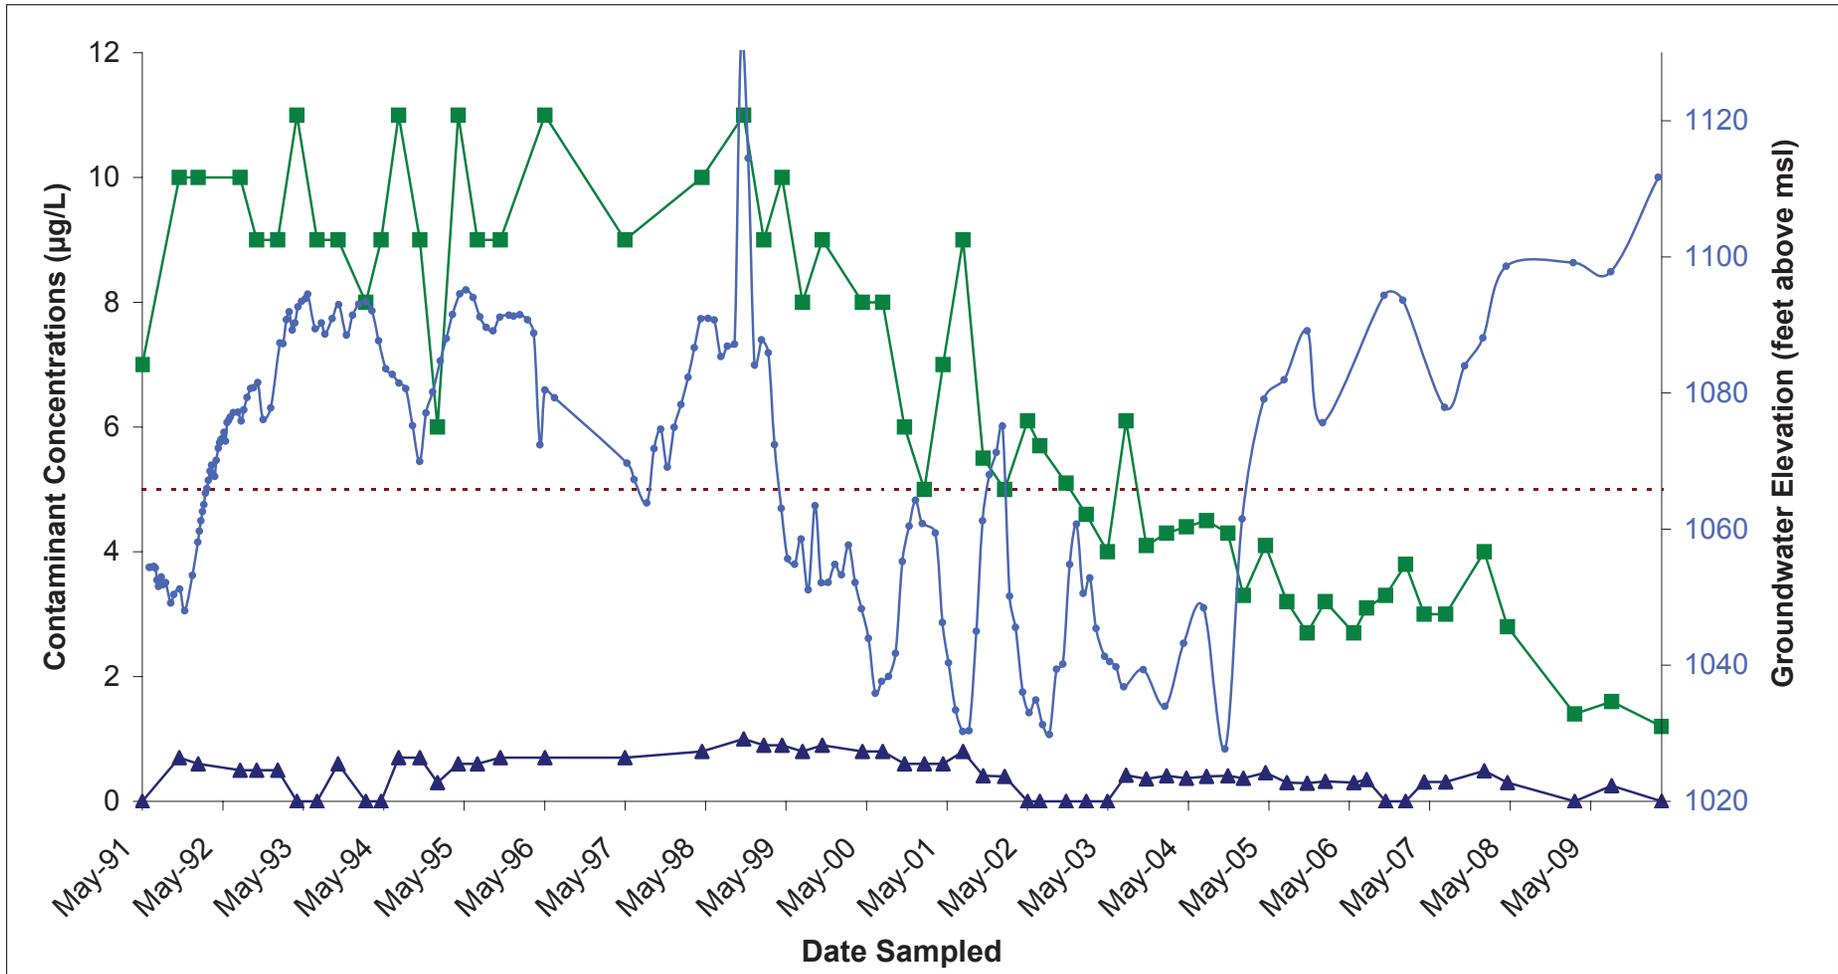
**Figure 3-6B**  
SIBW-13MC  
Eastern Plume  
June 1991- March 2010

Note For analytes not detected above the laboratory reporting limits, the concentration was plotted as zero
