This Data Review Technical Memorandum highlights existing groundwater conditions and the status of site cleanup at NIBW and SIBW.

ITSI prepared this Data Review Technical Memorandum summarizing the evaluation of the groundwater contamination concentrations and groundwater elevations for NIBW and SIBW as part of the First FYR. This Data Review Technical Memorandum compares the groundwater data since the time of the respective RODs as an appendix to the Five Year Review Report. Final conclusions and recommendations are presented in the Five Year Review Report.

**Data Review Technical Memorandum**  
 TCE Concentration  
 North Indian Bend Wash Superfund Area  
 Scottsdale, Arizona

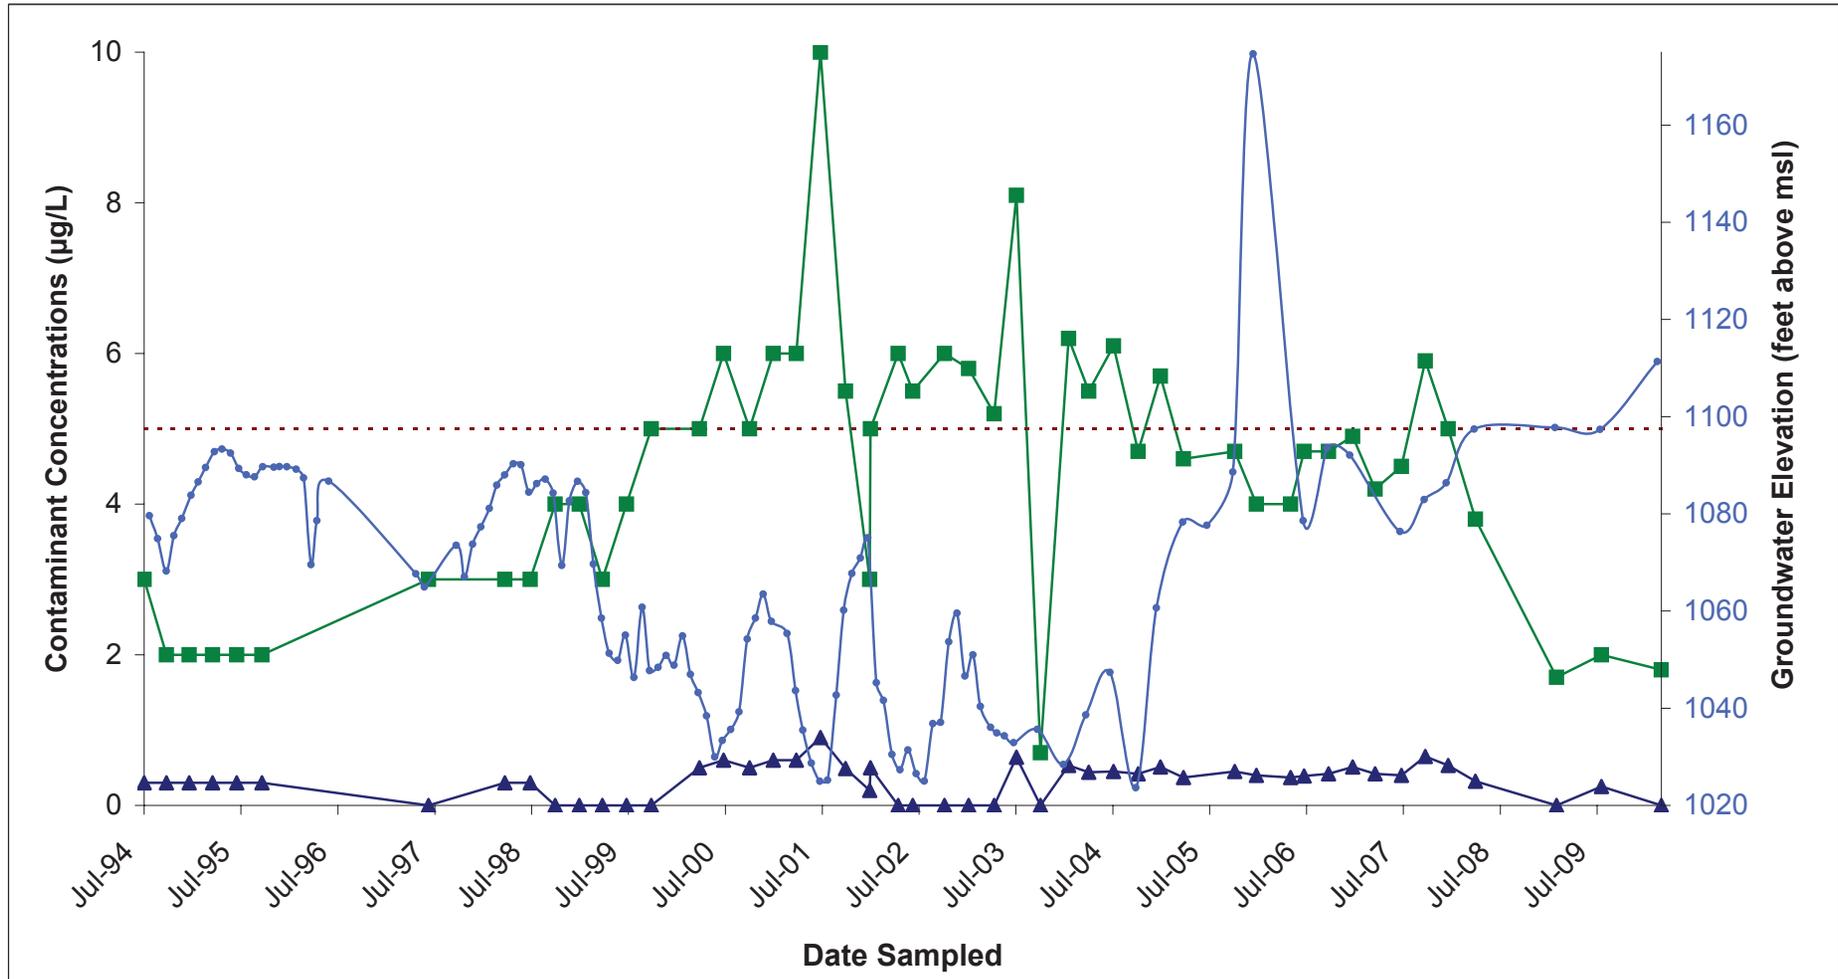
**Figure 3-6C**  
SIBW-56MC  
Eastern Plume  
July 1994 - March 2010

Note For analytes not detected above the laboratory reporting limits, the concentration was plotted as zero

Statistically decreasing trends were found for TCE in the following wells: SIBW-13MC, SIBW-56MC and SIBW-58MC in the eastern plume and SIBW-28U in the western plume, with absolute values of Kendal tau coefficient closer to 0.5 than 1.0. Two wells in the central plume, SIBW-38U and SW-1, have statistically decreasing PCE trends. While only six of the 19 wells were statistically decreasing, the rest of the wells selected as part of this data review have had COC concentrations consistently below the MCL for several years; therefore, the rate of decrease in COC concentrations is not great enough to obtain a Kendall tau value representative of a statistically decreasing trend.

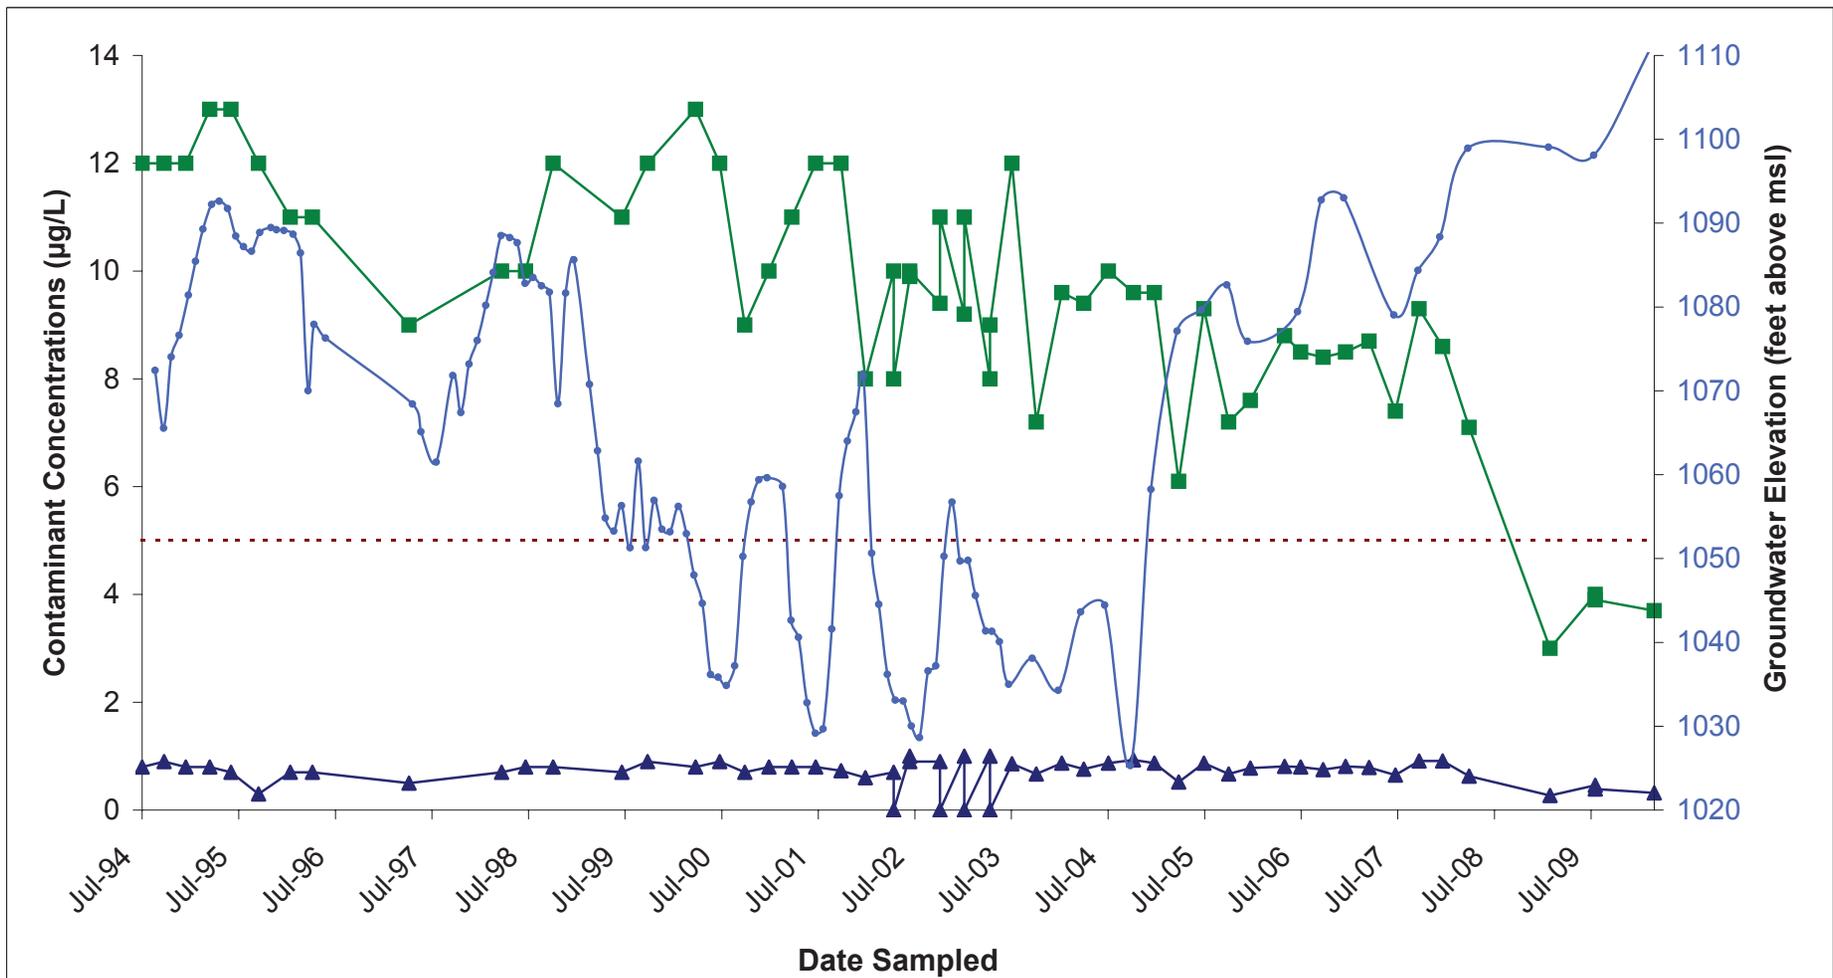
**Figure 3-6D**  
SIBW-58MC  
Eastern Plume  
July 1994 - March 2010

Note For analytes not detected above the laboratory reporting limits, the concentration was plotted as zero

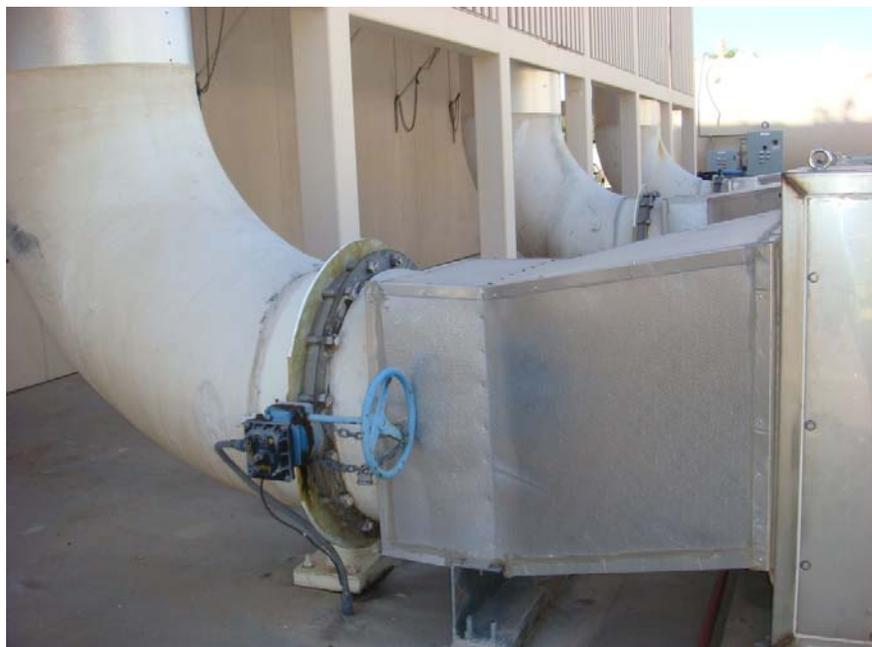
**Description:** Air stripper  
process air outlet duct and inlet  
to gas-fired process air heaters  
(used for humidity control).
