THIRD FIVE-YEAR REVIEW REPORT

South Bay Asbestos Superfund Site ALVISO, SAN JOSE, CALIFORNIA

September 2010

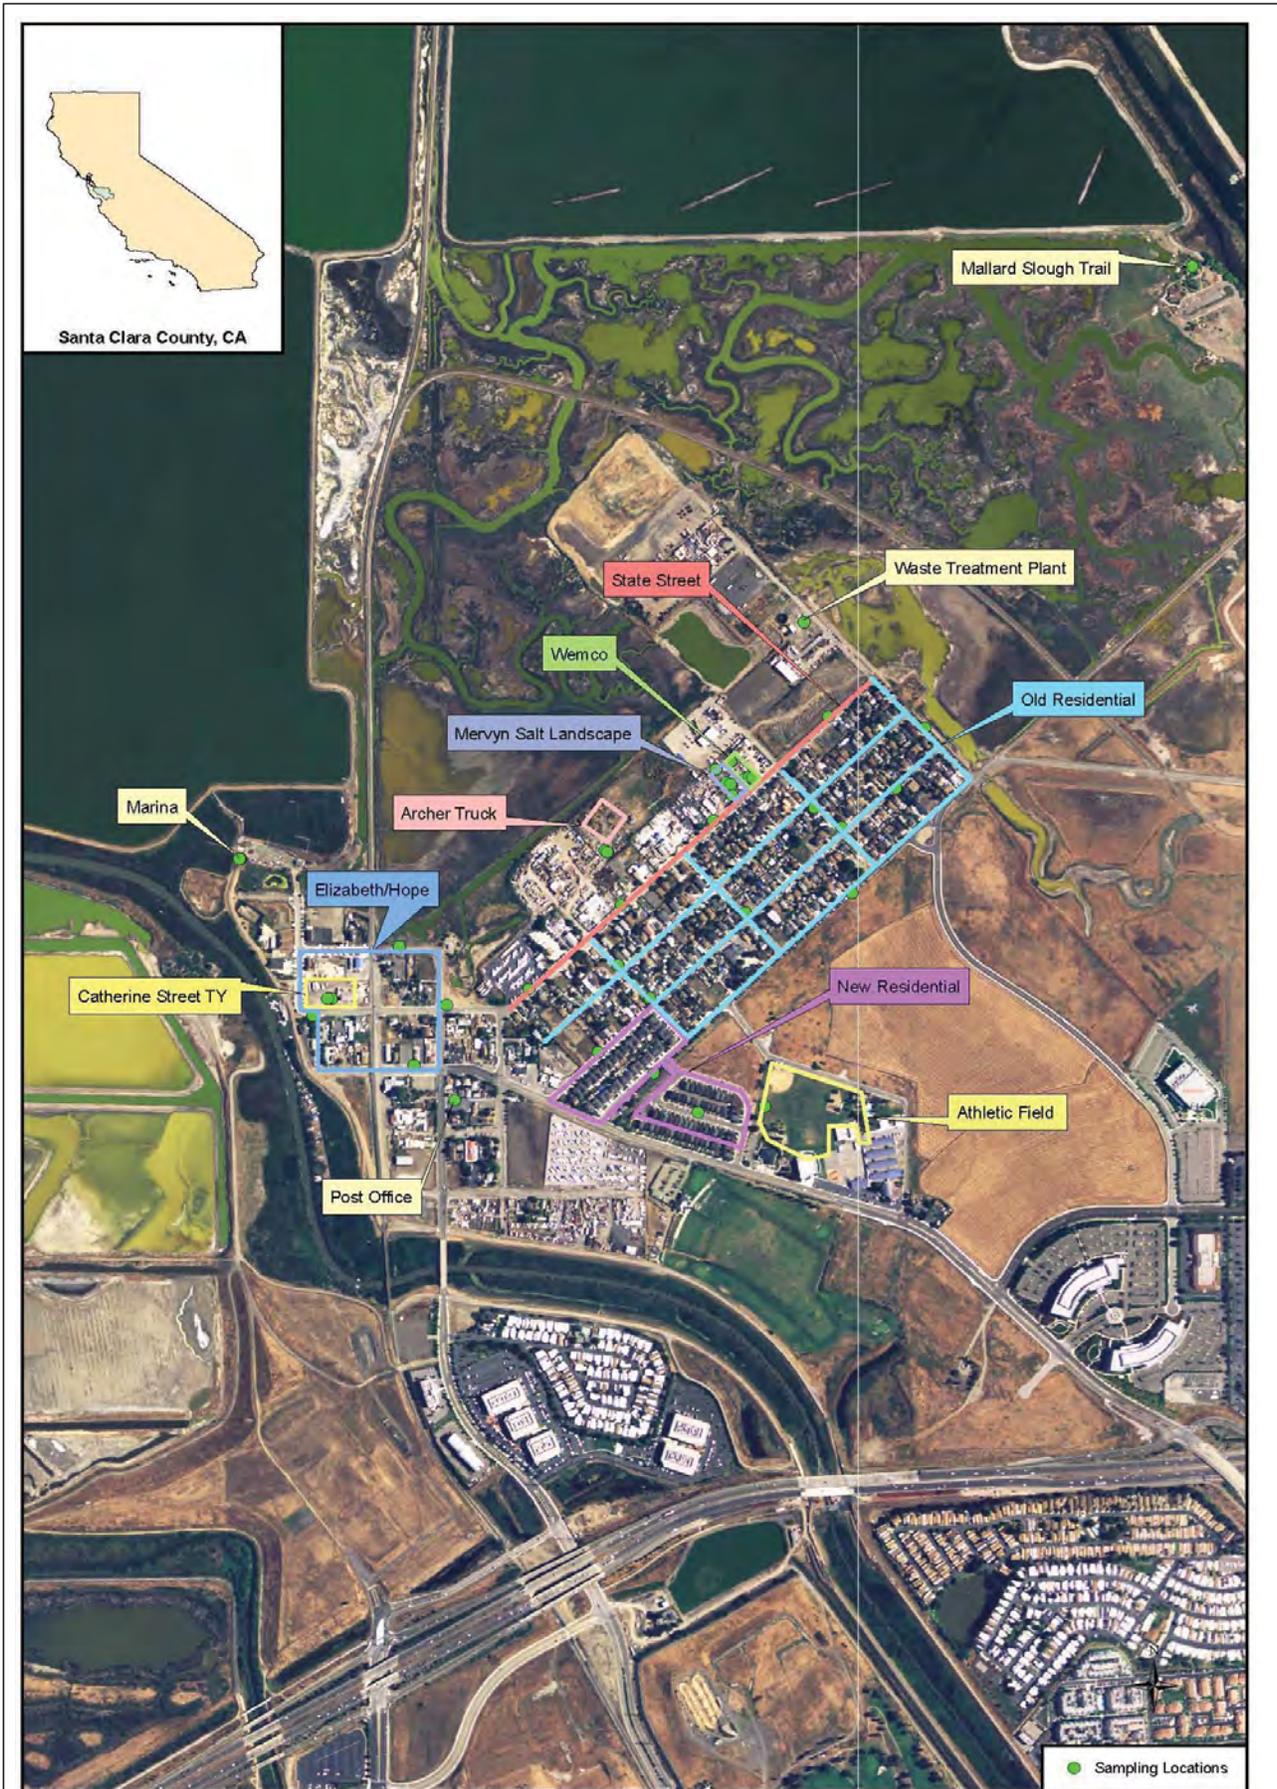
Figure 3
 Activity-Based Sampling Air Sampling Locations
 August 2007
 South Bay Asbestos
 Third Five-Year Review Report
 Alviso, California

This section summarizes the results of the activity-based air sampling and the soil sampling that occurred in 2007. ABS was used to measure personal asbestos exposures during typical outdoor and recreational activities. A full presentation of all asbestos sampling results can be found in the sampling and analytical report (Lockheed Martin, 2009). The results of the risk evaluation are presented in the *Asbestos Exposure Assessment and Risk Evaluation Summary Report* (EPA, 2010).

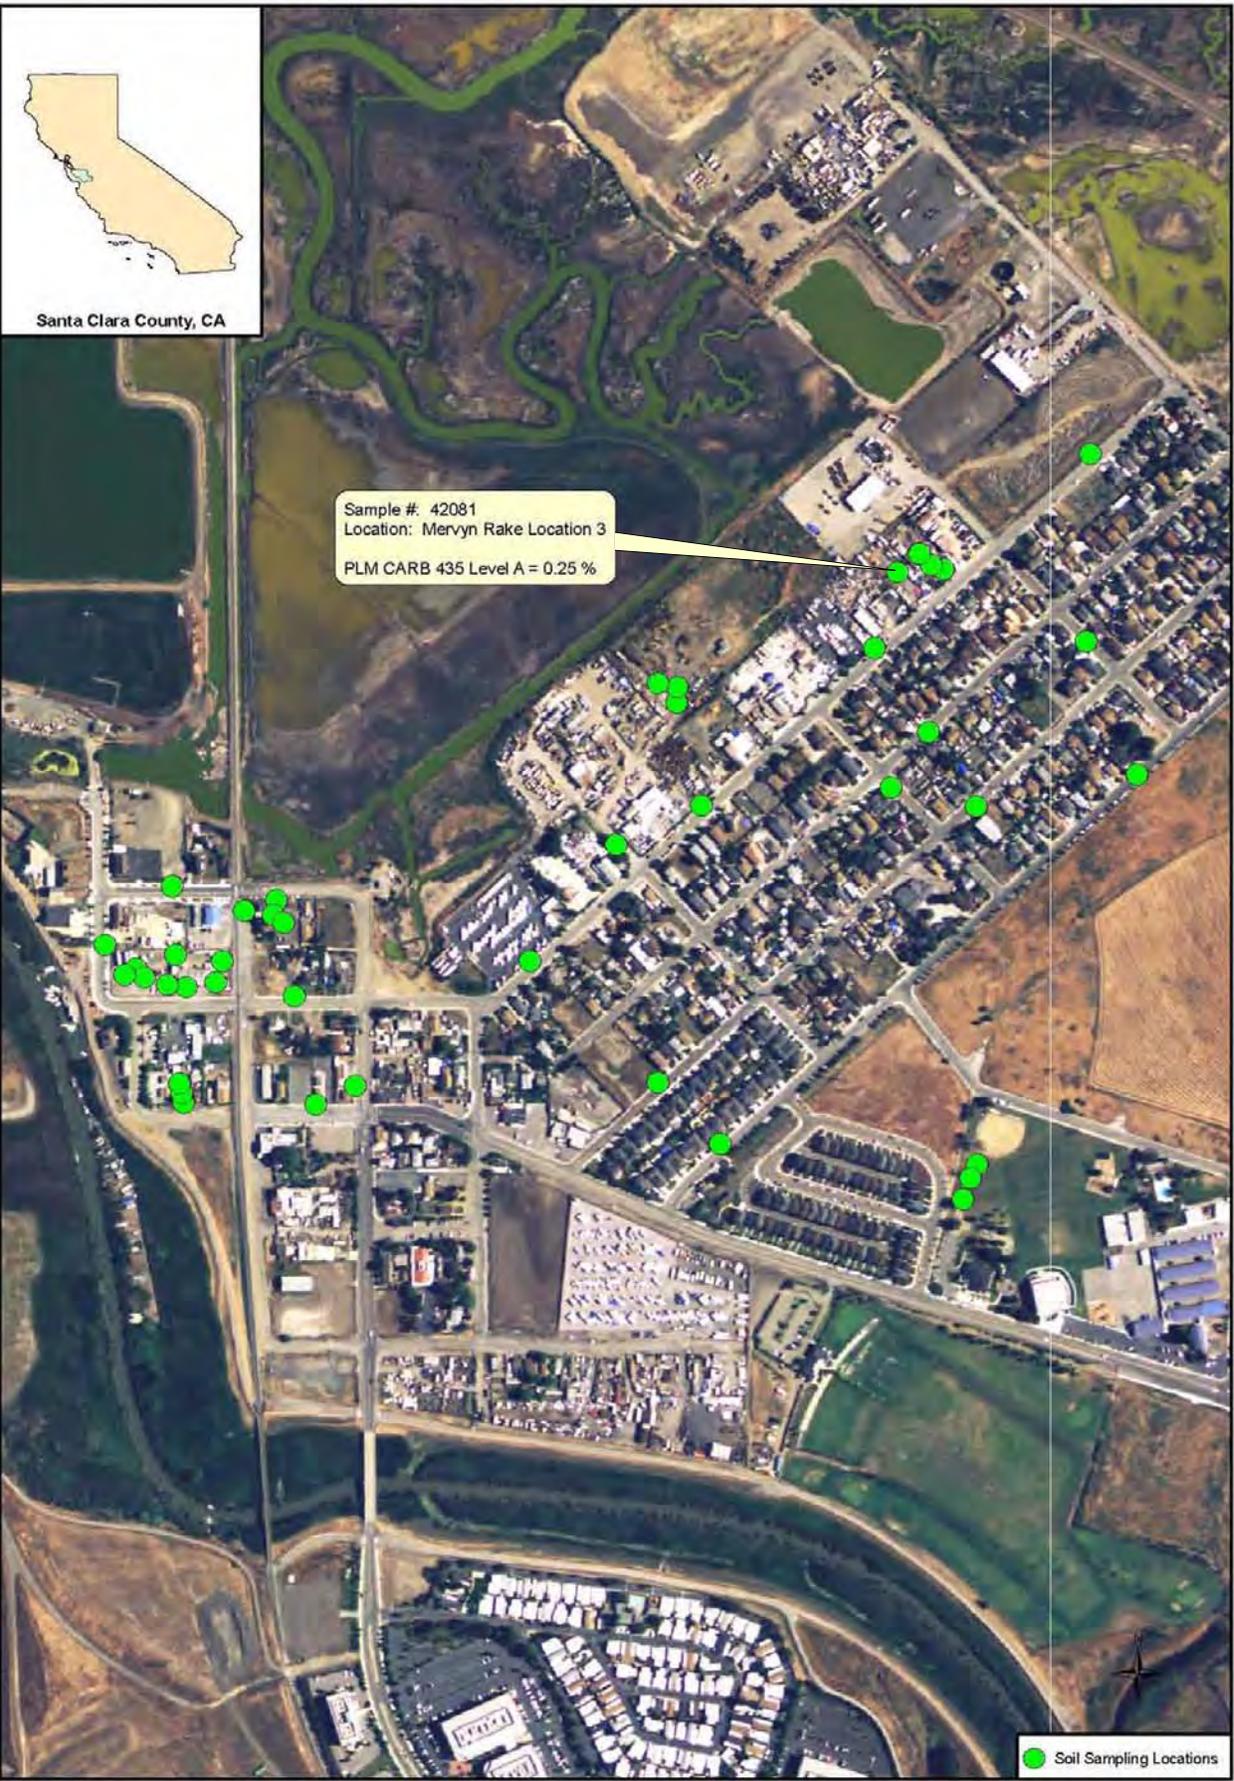
Figure 4
 Activity-Based Sampling Soil Sampling Locations
 August 2007
 South Bay Asbestos
 Third Five-Year Review Report
 Alviso, California

All soil samples except one were non-detect for asbestos at the analytical sensitivity of 0.25% (Lockheed Martin, 2009). Figure 4 illustrates all soil sampling locations and indicates the location of the single positive sample (#42081) which measured 0.25%. The data for the soil particle size and soil moisture content are described further in the *Asbestos Exposure Assessment using ABS Report* (Lockheed Martin, 2009).

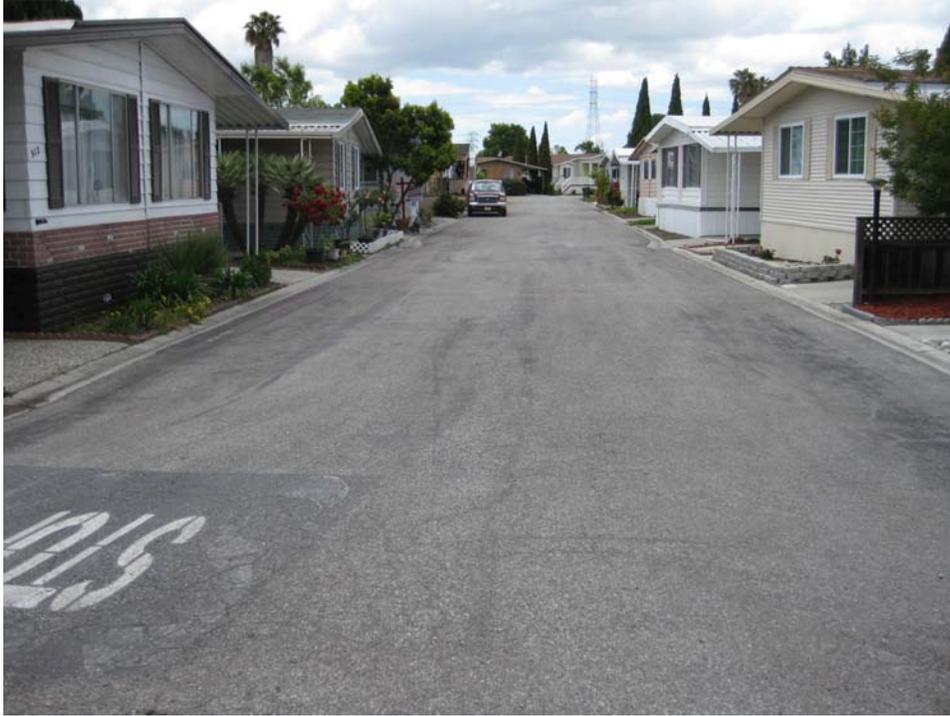
Photograph 1: View of Summerset Mobile Estates, which is located over the Santos Landfill and has paved roadways, trailer homes, driveways, and landscaped areas.

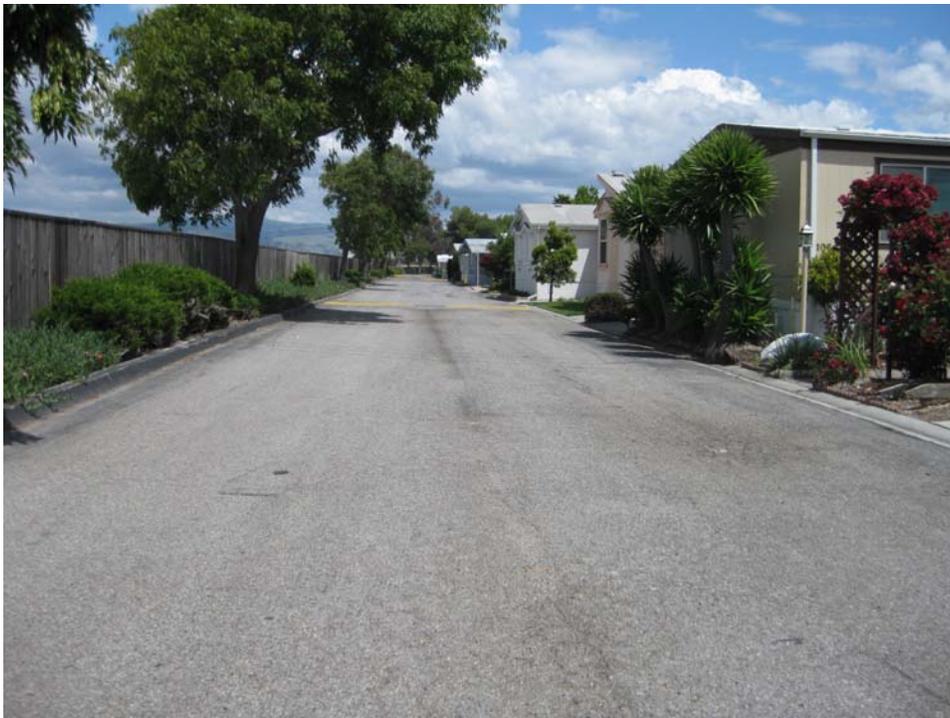
Photograph 2: View of northern property boundary of the Summerset Mobile Estates portion of the Santos Landfill.

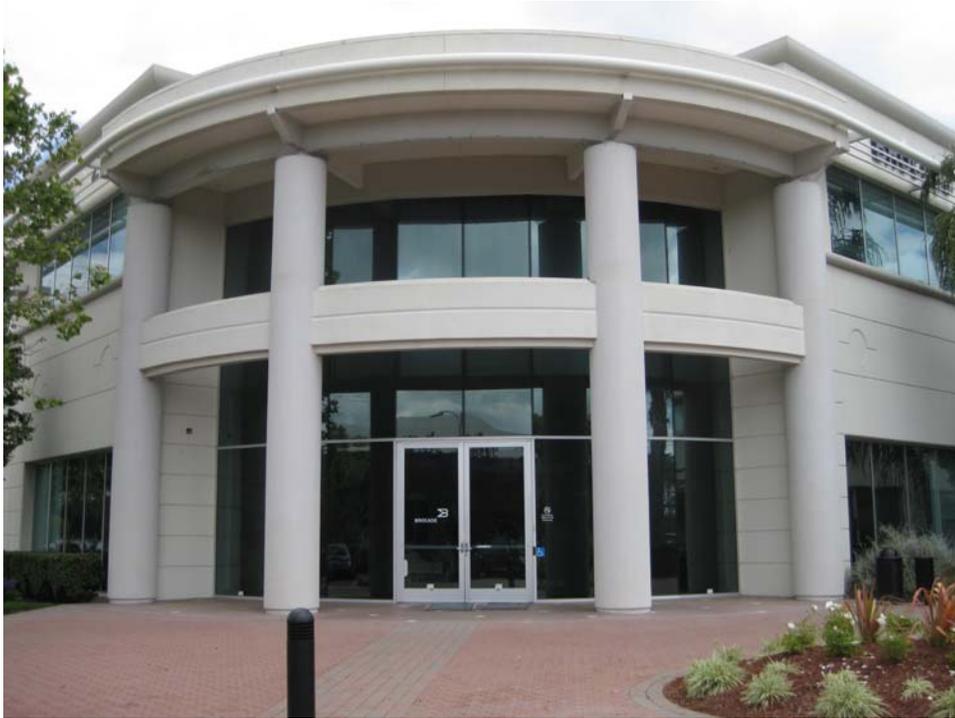
Photograph 3: View of one of the buildings located in the Bixby Tech Park portion of the Santos Landfill.

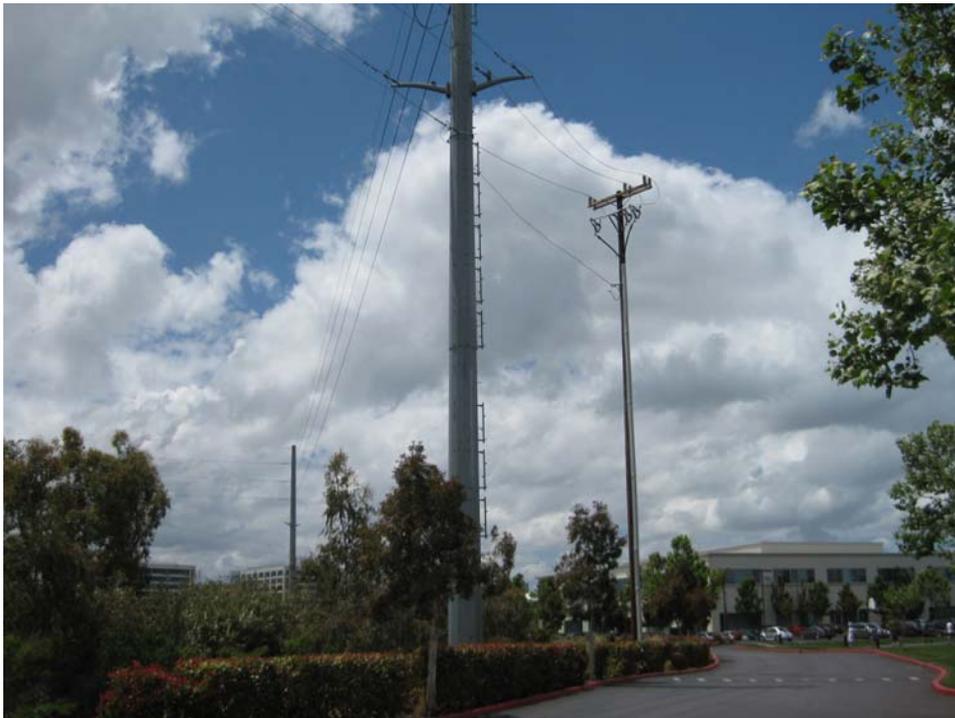
Photograph 4: View of the utility pole (right) installed during the PG&E trenching project in July 2009.

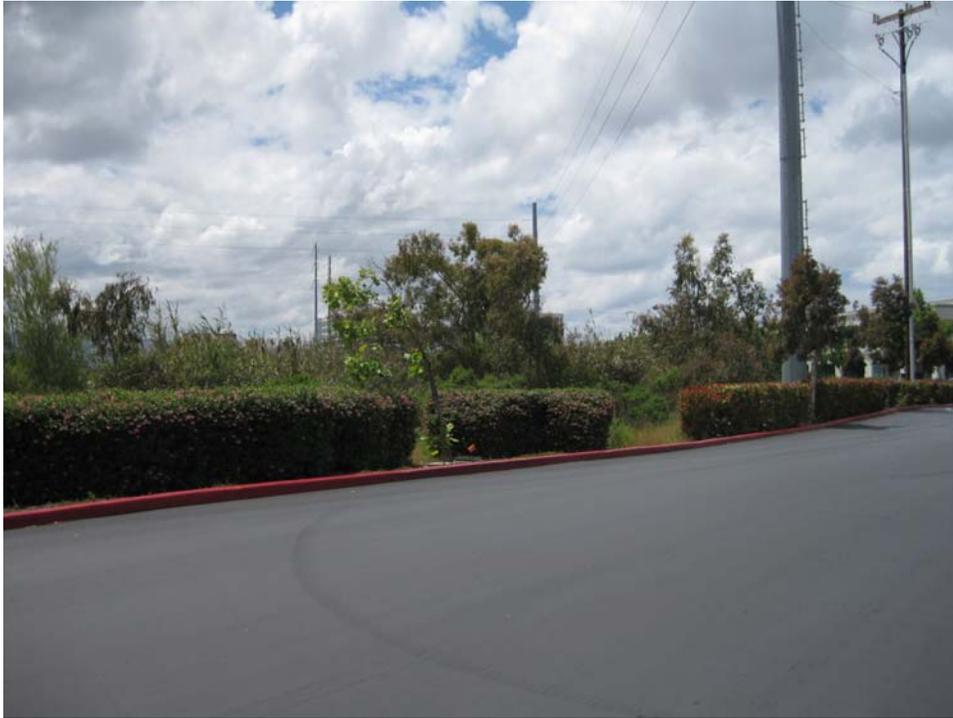
Photograph 5: View of parking lot where the utility trench was excavated during the PG&E project. The asphalt parking lot has since been re-paved.

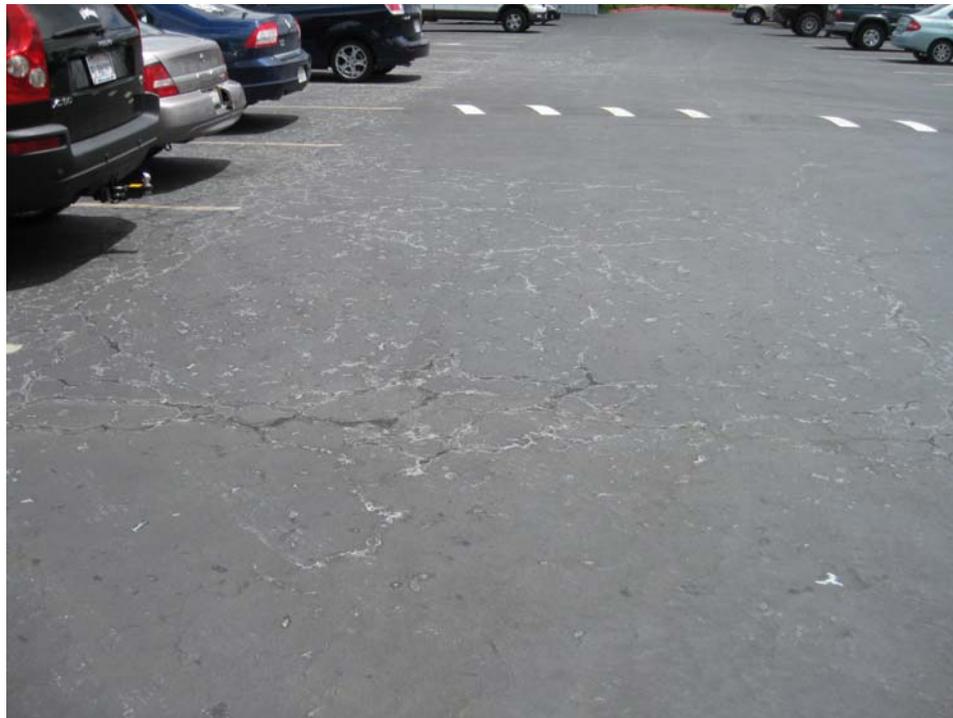
Photograph 6: View of cracks and white residue present within the northeastern portion of the parking lot for Bixby Technology Park.

EPA has no information regarding the project O&M costs for maintenance of the landfill caps since there have been no significant maintenance activities required during the past five years. All inspections have revealed the caps are in good condition with minor asphalt crack repairs conducted at a minimal cost.

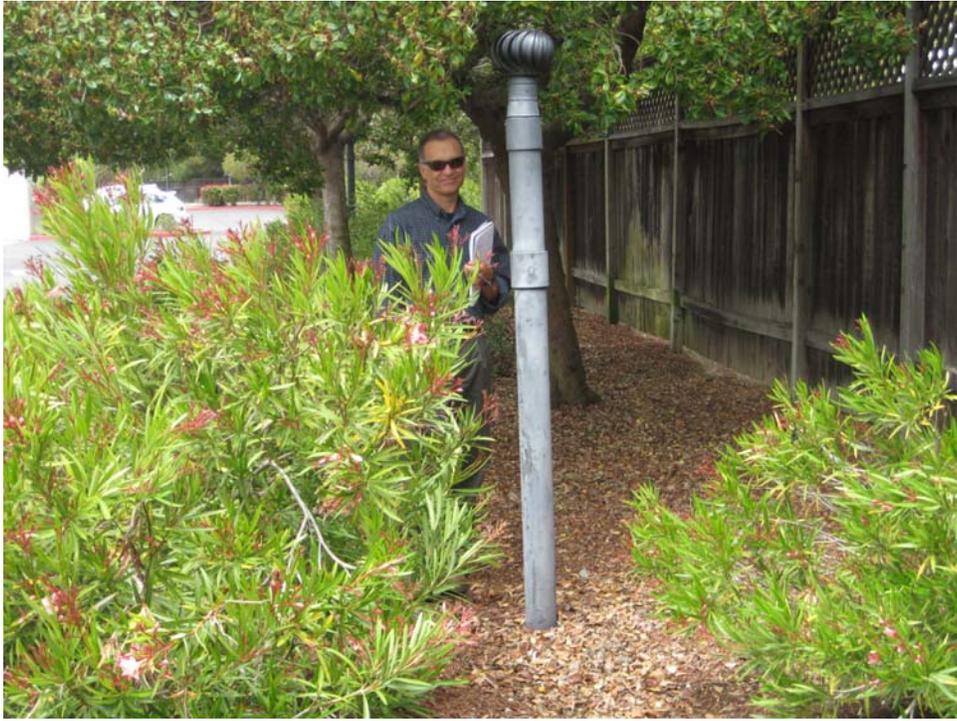
Photograph 7: View of one of the subsurface gas landfill monitoring probe located on the northern property boundary of the Bixby Technology Park.

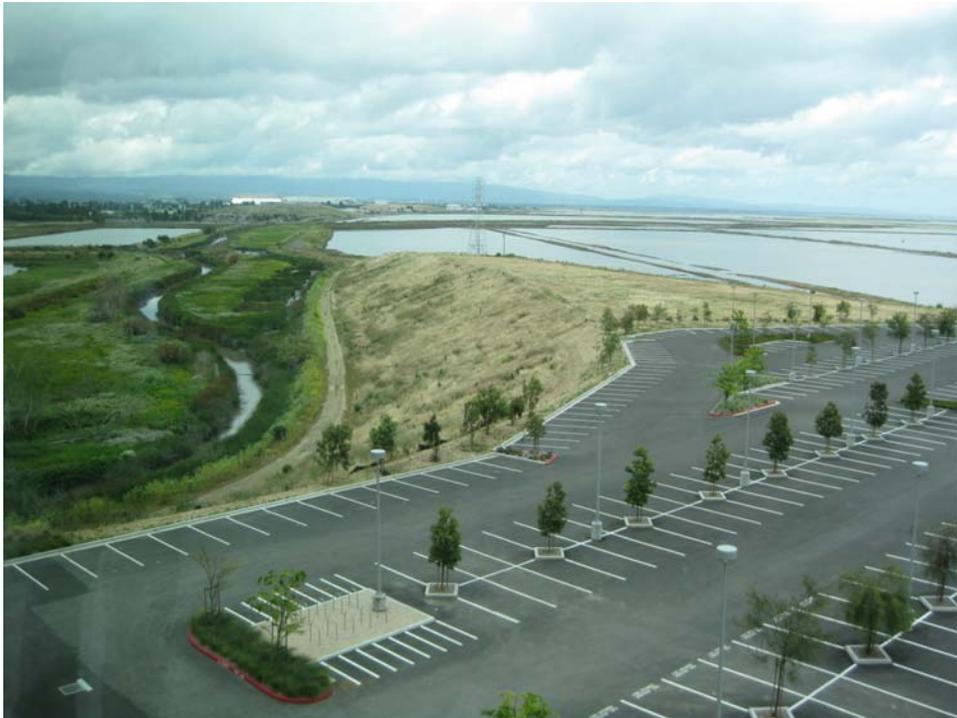
Photograph 8: View facing northwest of the asphalt parking lot on the Marshland Landfill/Legacy America Center. The photograph was taken from the sixth floor of the building onsite. The salt ponds can be seen in the distance.

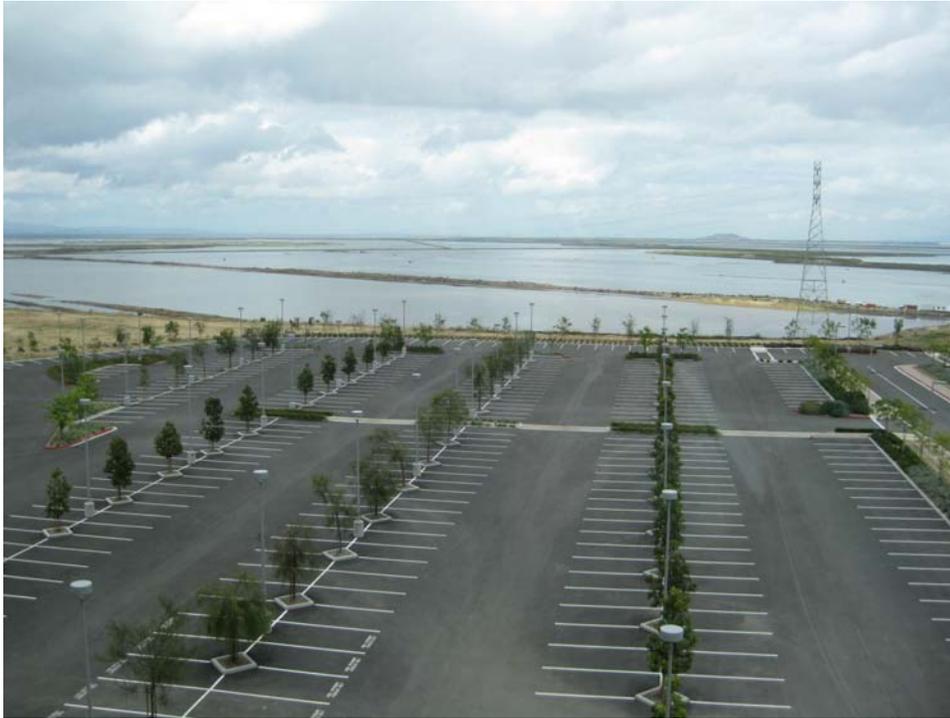
Photograph 9: View facing north of the asphalt parking lot on the Marshland Landfill/Legacy America Center. The photograph was taken from the sixth floor of the building onsite. The salt ponds can be seen in the distance.

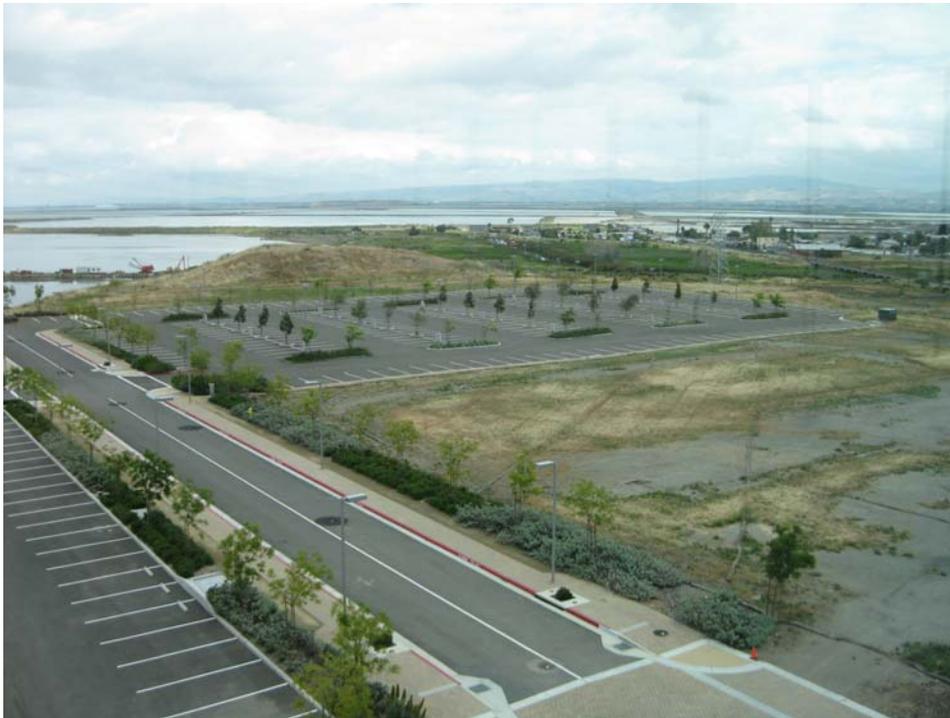
Photograph 10: View facing northeast of the asphalt parking lot on the Marshland Landfill/Legacy America Center and the portion of the property that will be developed in the future. The photograph was taken from the sixth floor of the building onsite.

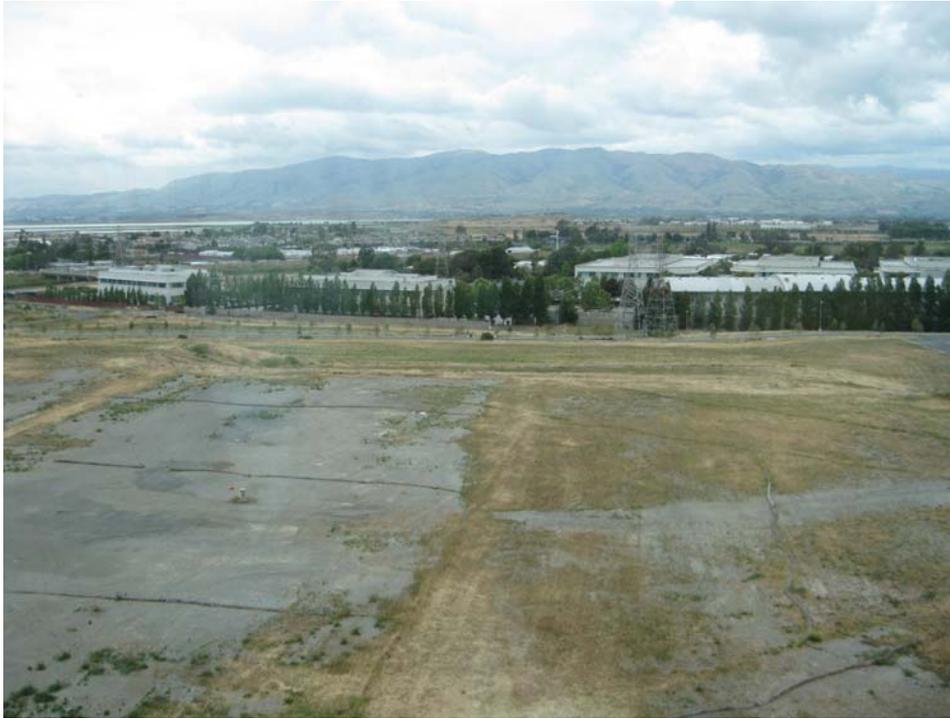
Photograph 11: View facing east of the Marshland Landfill/Legacy America Center and the portion of the property that will be developed in the future. The photograph was taken from the sixth floor of the building onsite.

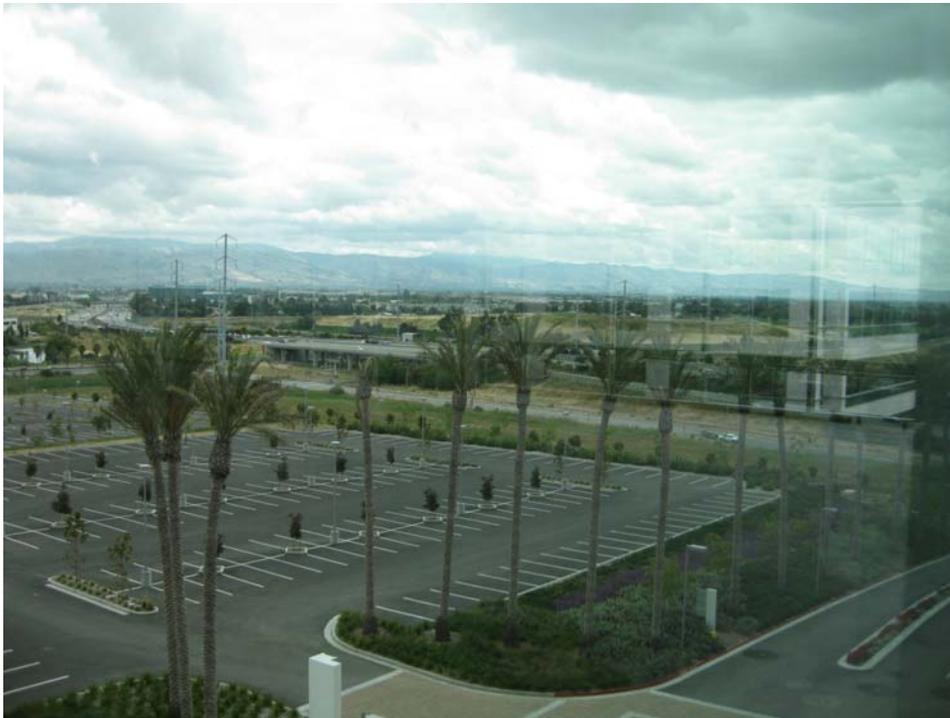
Photograph 12: View facing southeast of the asphalt parking lot on the Marshland Landfill/Legacy America Center. Highway 237 can be seen in the distance. The photograph was taken from the sixth floor of the building onsite.

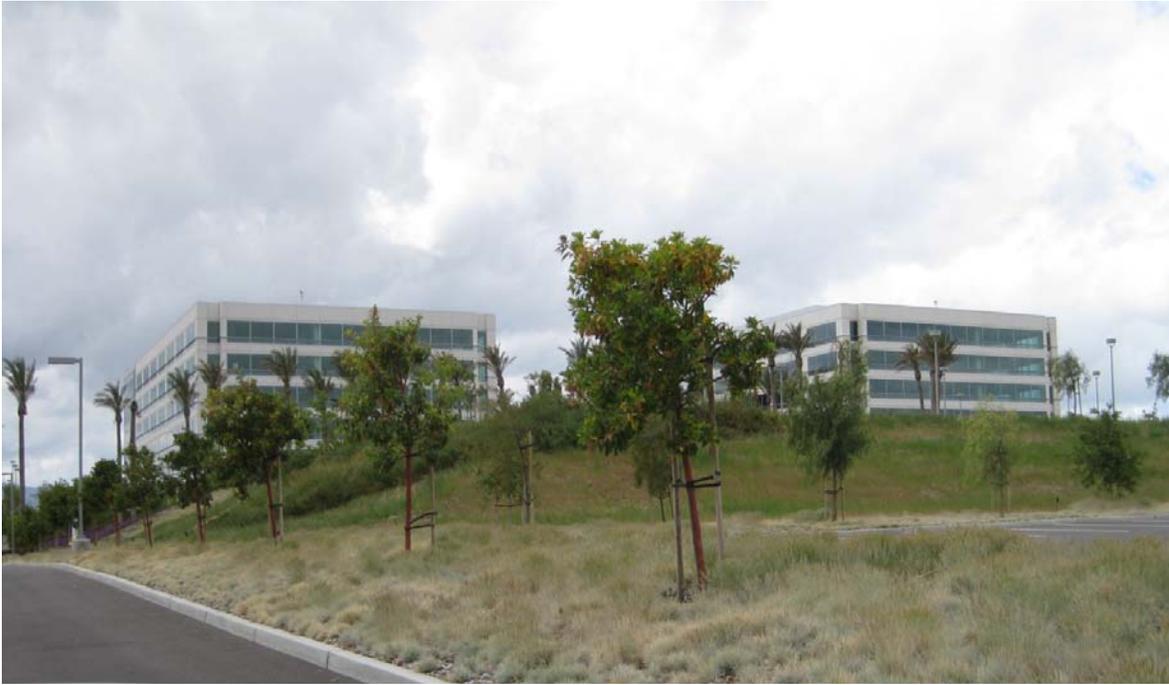
Photograph 13: View facing northeast of the two six-story buildings built on the Marshland Landfill/Legacy America Center property between 2007 and 2009.

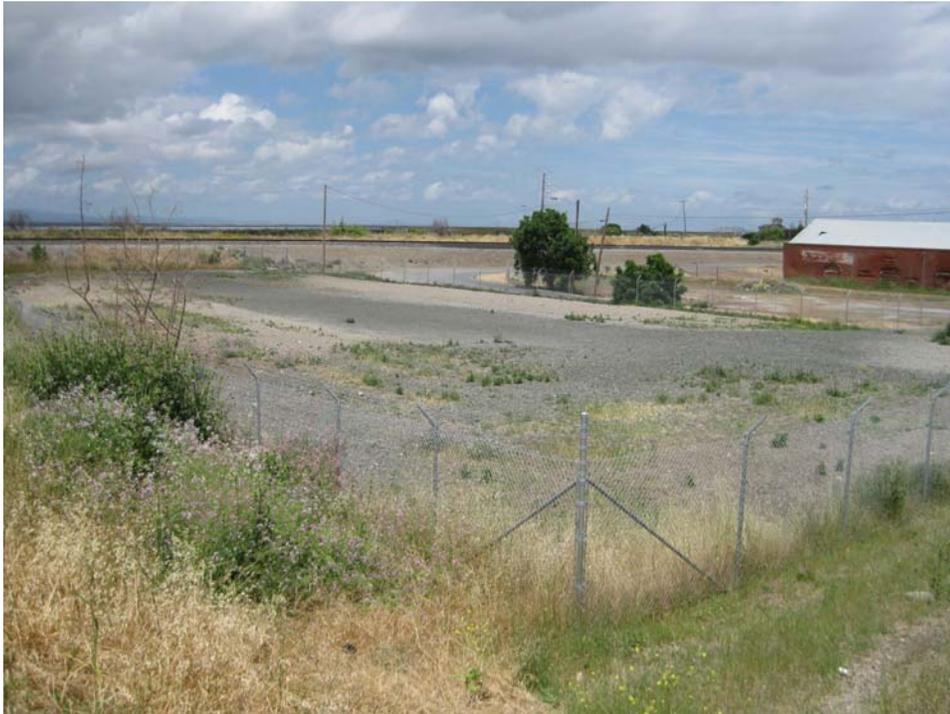
Photograph 14: View facing northwest of the western portion of the Sainte Claire Landfill, which is located on the west side of Gold Street.

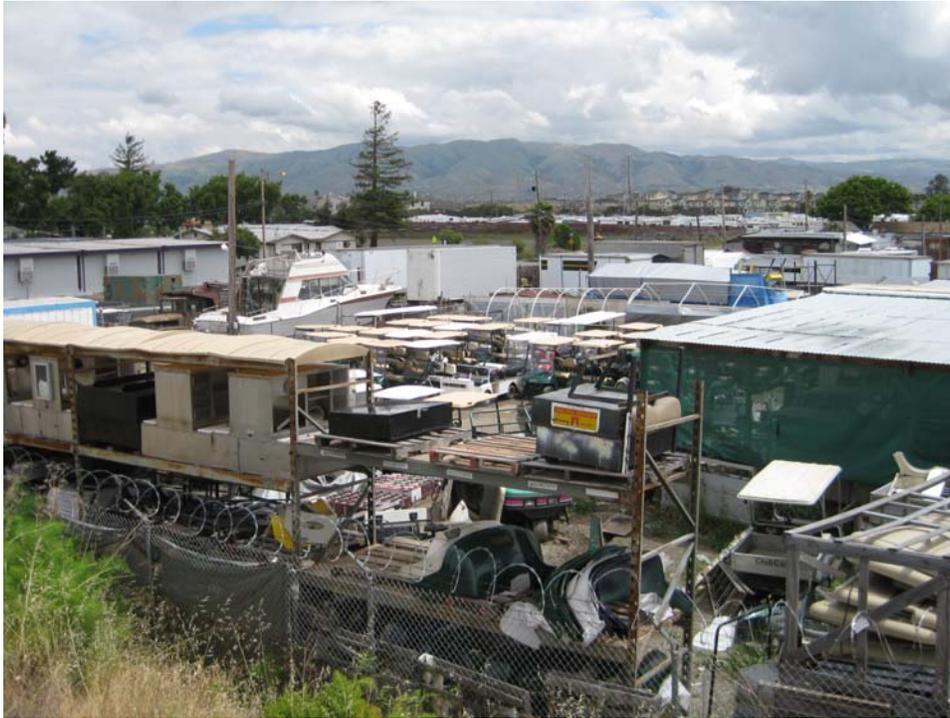
Photograph 15: View facing northeast of the eastern portion of the Sainte Claire Landfill, which is located on the east side of Gold Street. This property is occupied with Mel's General Repair and is used as a storage area.

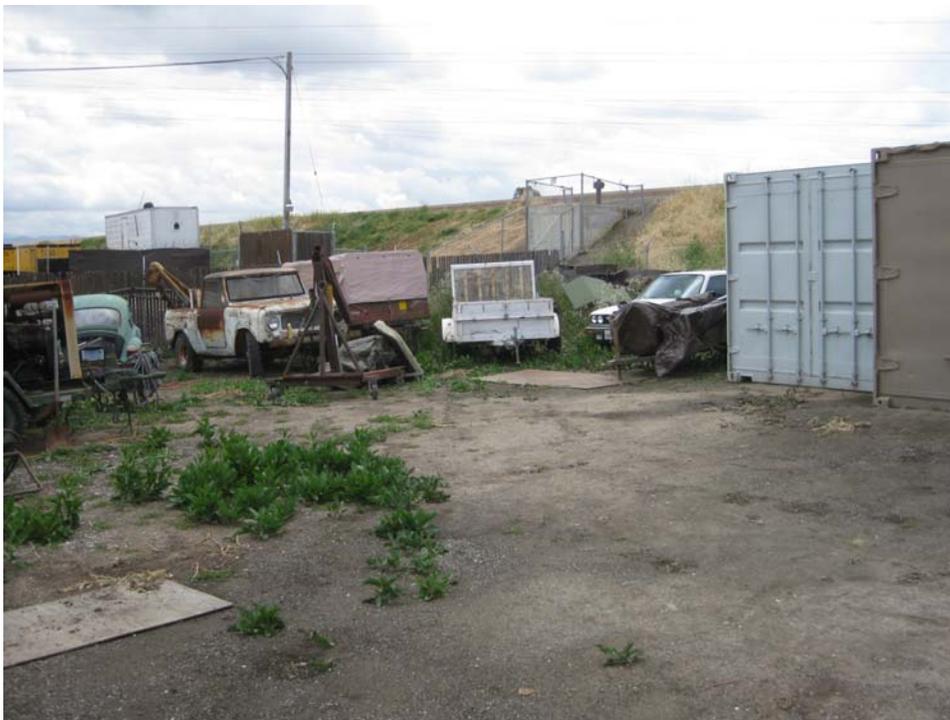
Photograph 16: View facing southeast of the interior portion of Mel's General Repair. The Guadalupe River Levee can be seen in the background.

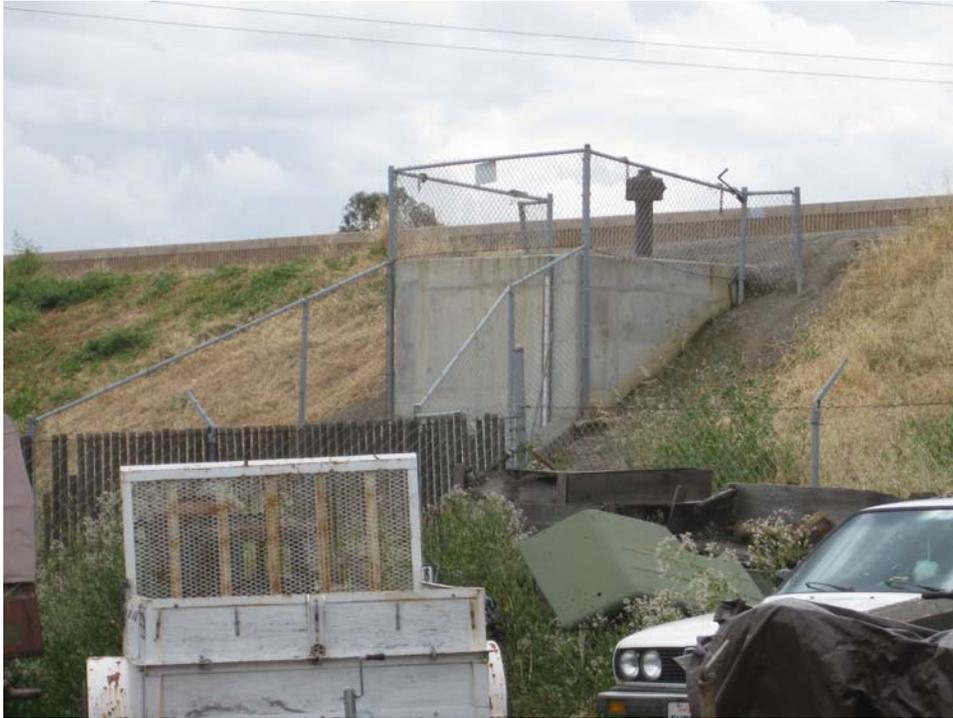
Photograph 17: View facing southeast of the levee outfall within the Guadalupe River Levee.

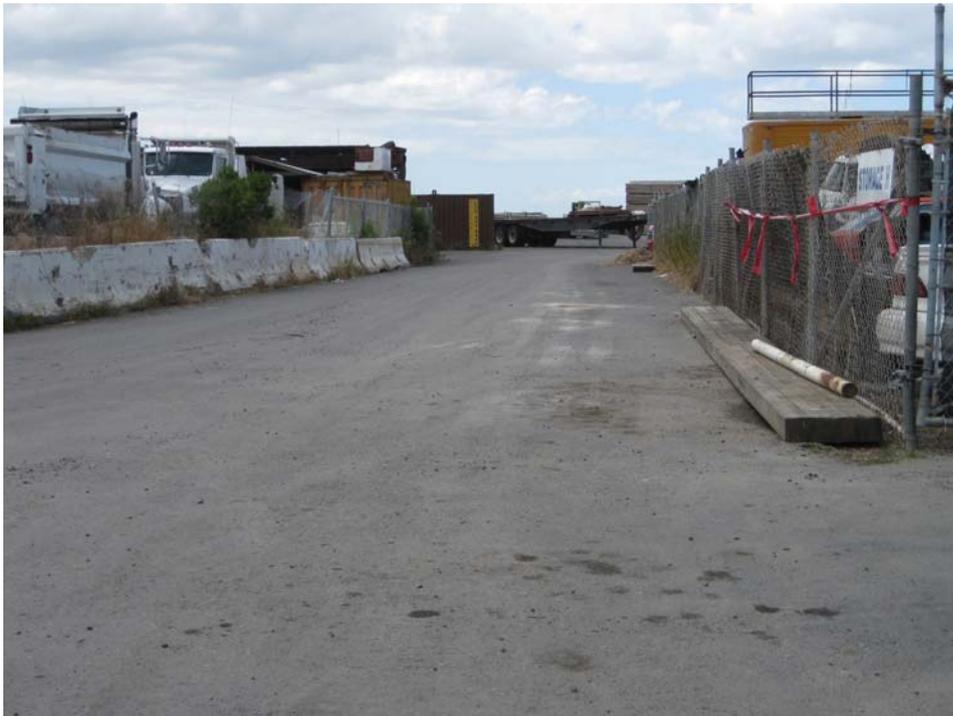
Photograph 18: View of the Archer Street entrance of one of the trucks yards.
