South Refinery at Time of Sale to Midland

Midland's Process and Storm Water Treatment System

Areas Addressed under the UAO for
“visual contamination” within the
Coke Pond Excavation, Coke Pond Expansion,
and SAOC 5-1

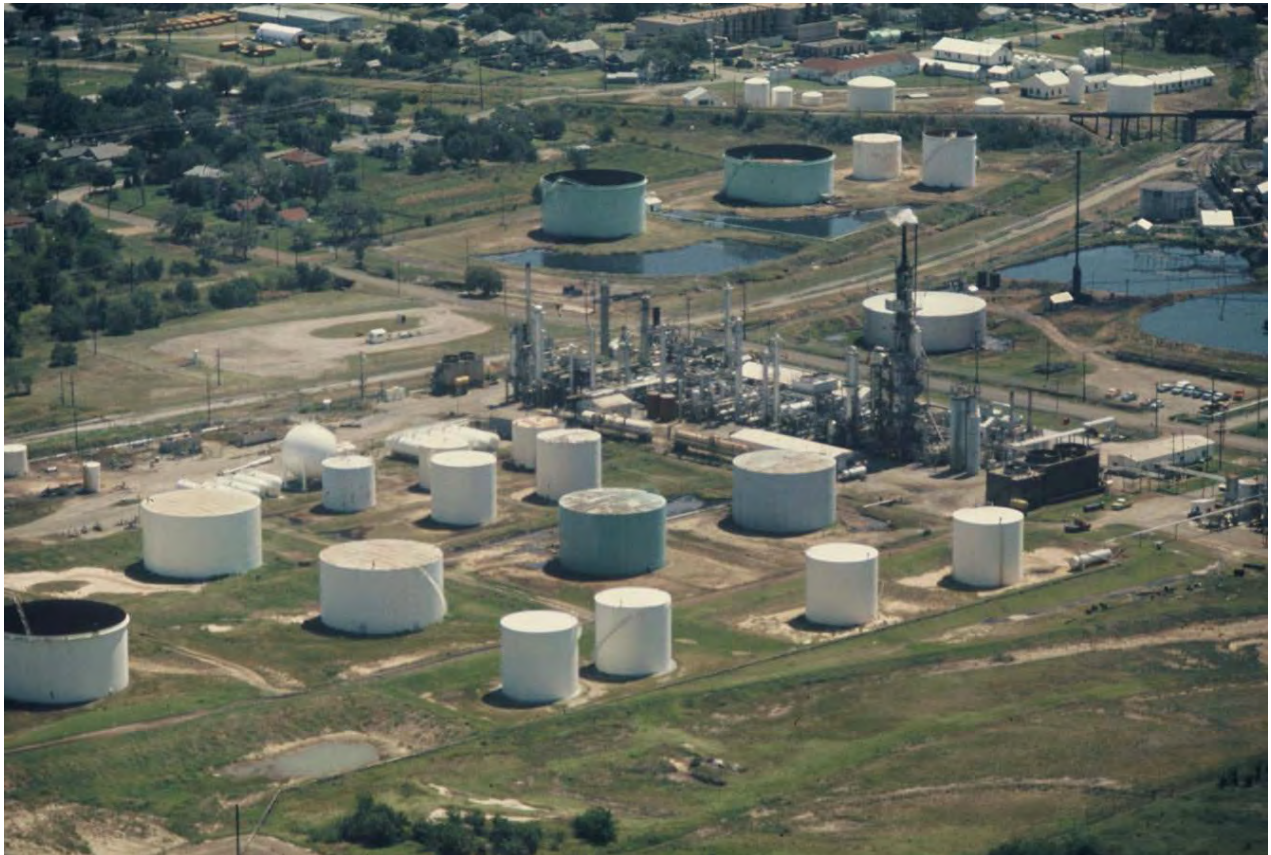
FIGURE
4

Aerial Photograph North Refinery (Late 1960s)

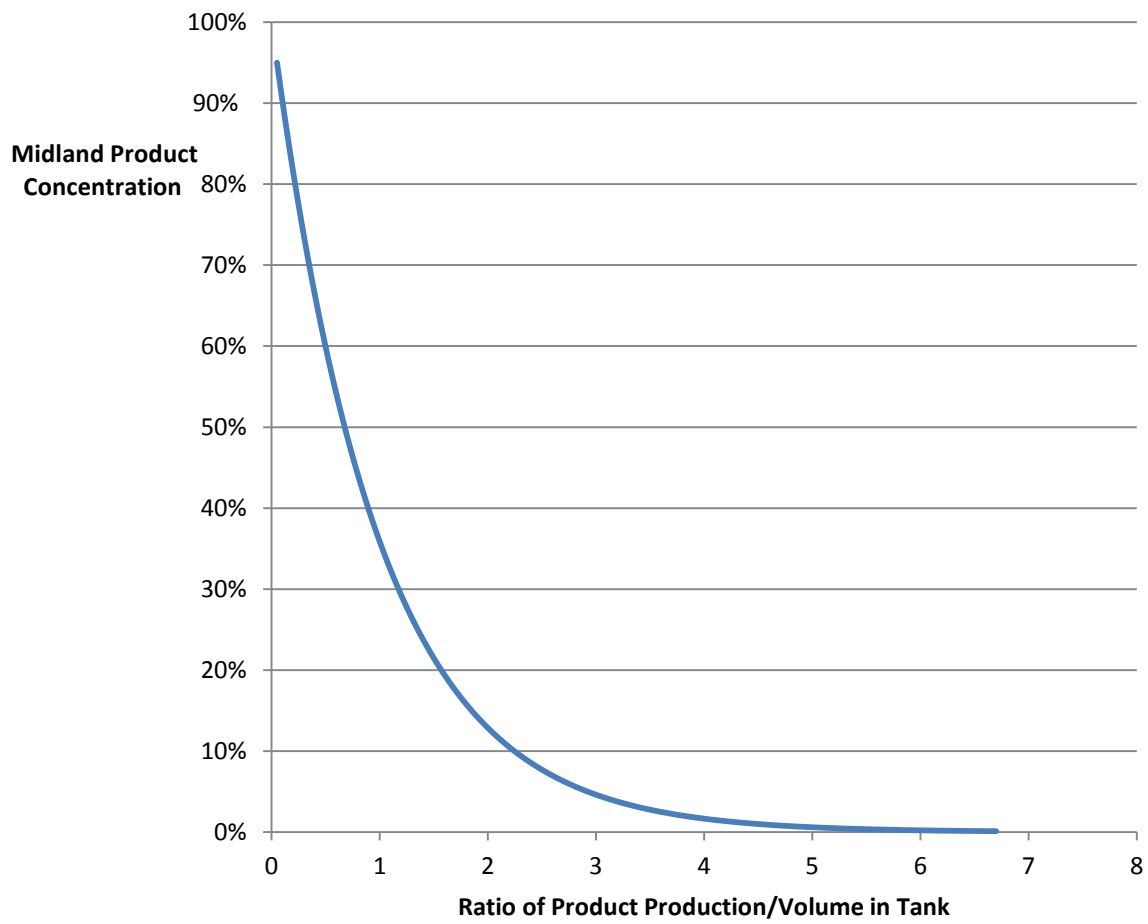
FIGURE
6

Midland Product Remaining In Tank

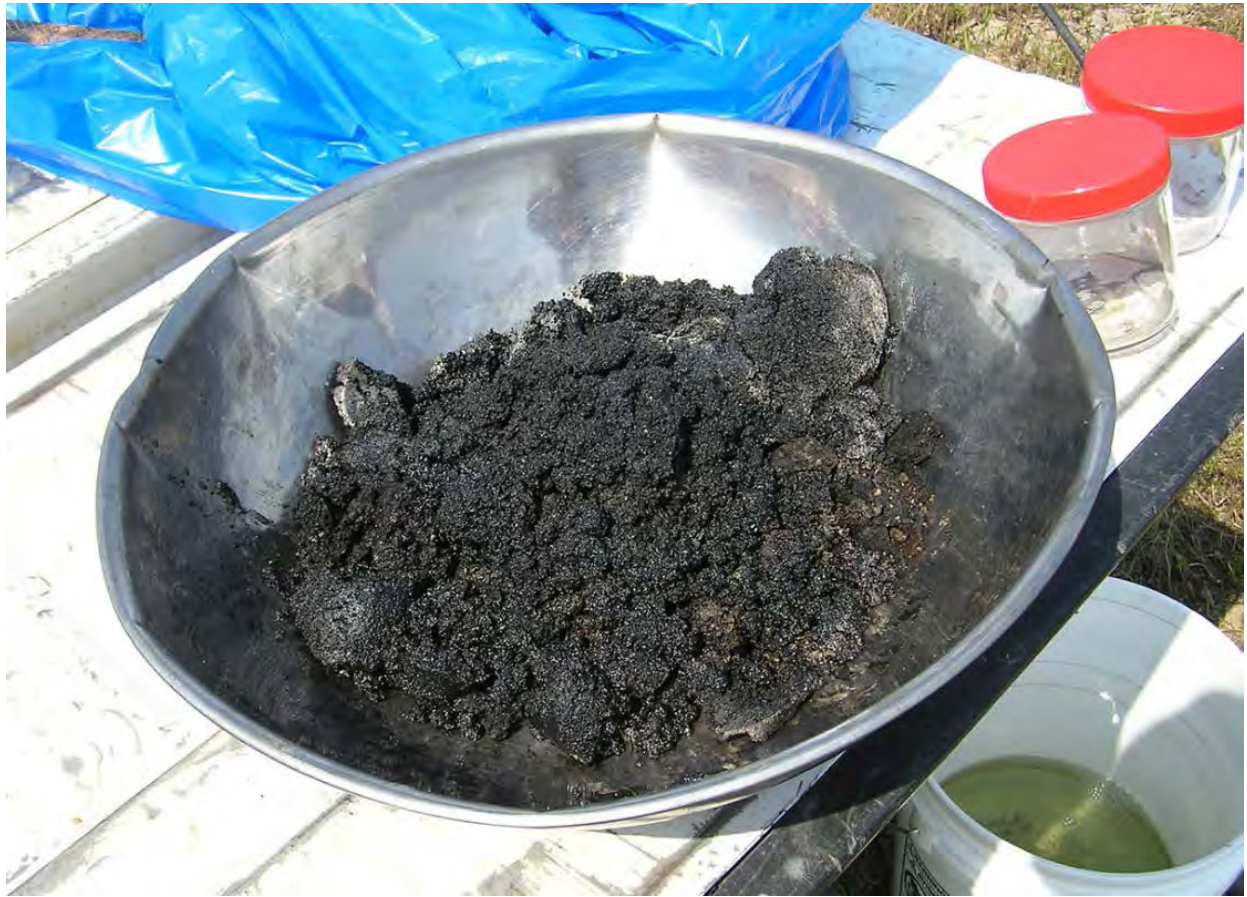
FIGURE
10

Photograph - Coke Fines Removed from Coke Pond

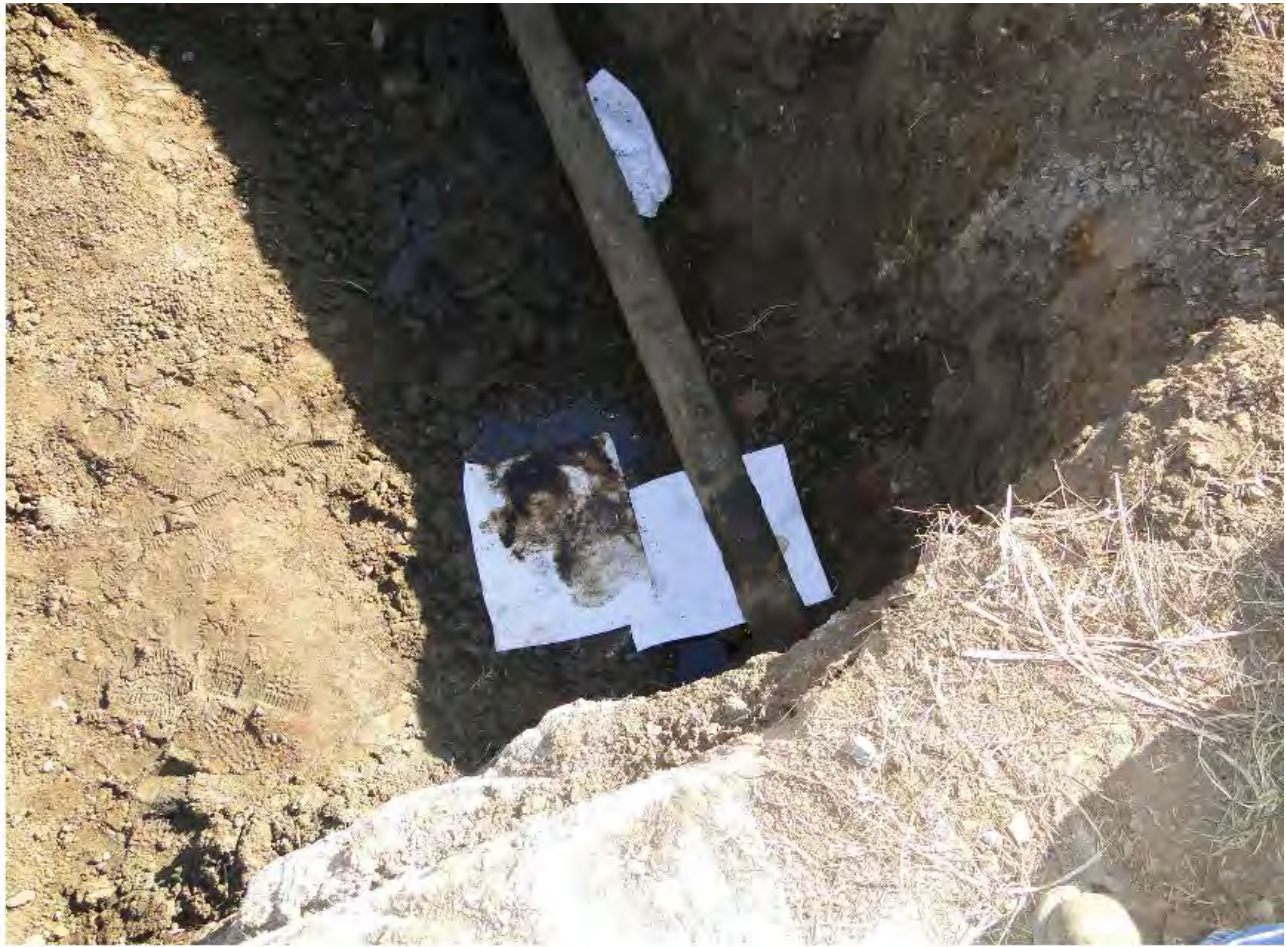
FIGURE
15

Photograph - Leaking Buried Pipe under Former Crude Stills

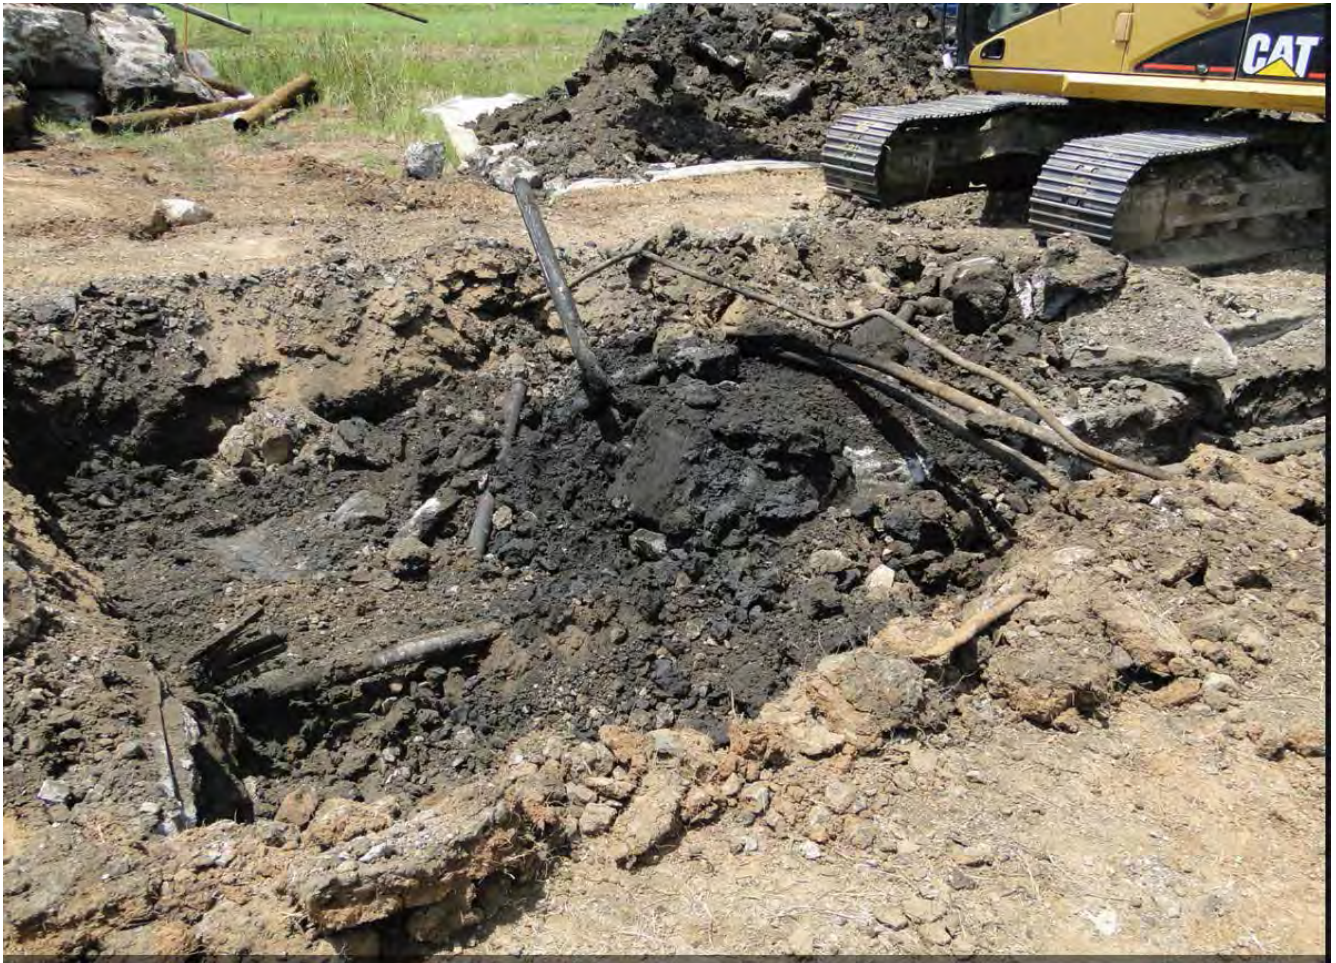
FIGURE
16

Photograph - "Visual contamination" from "Rats Nest" of
Leaking Buried Piping under Former Crude Stills

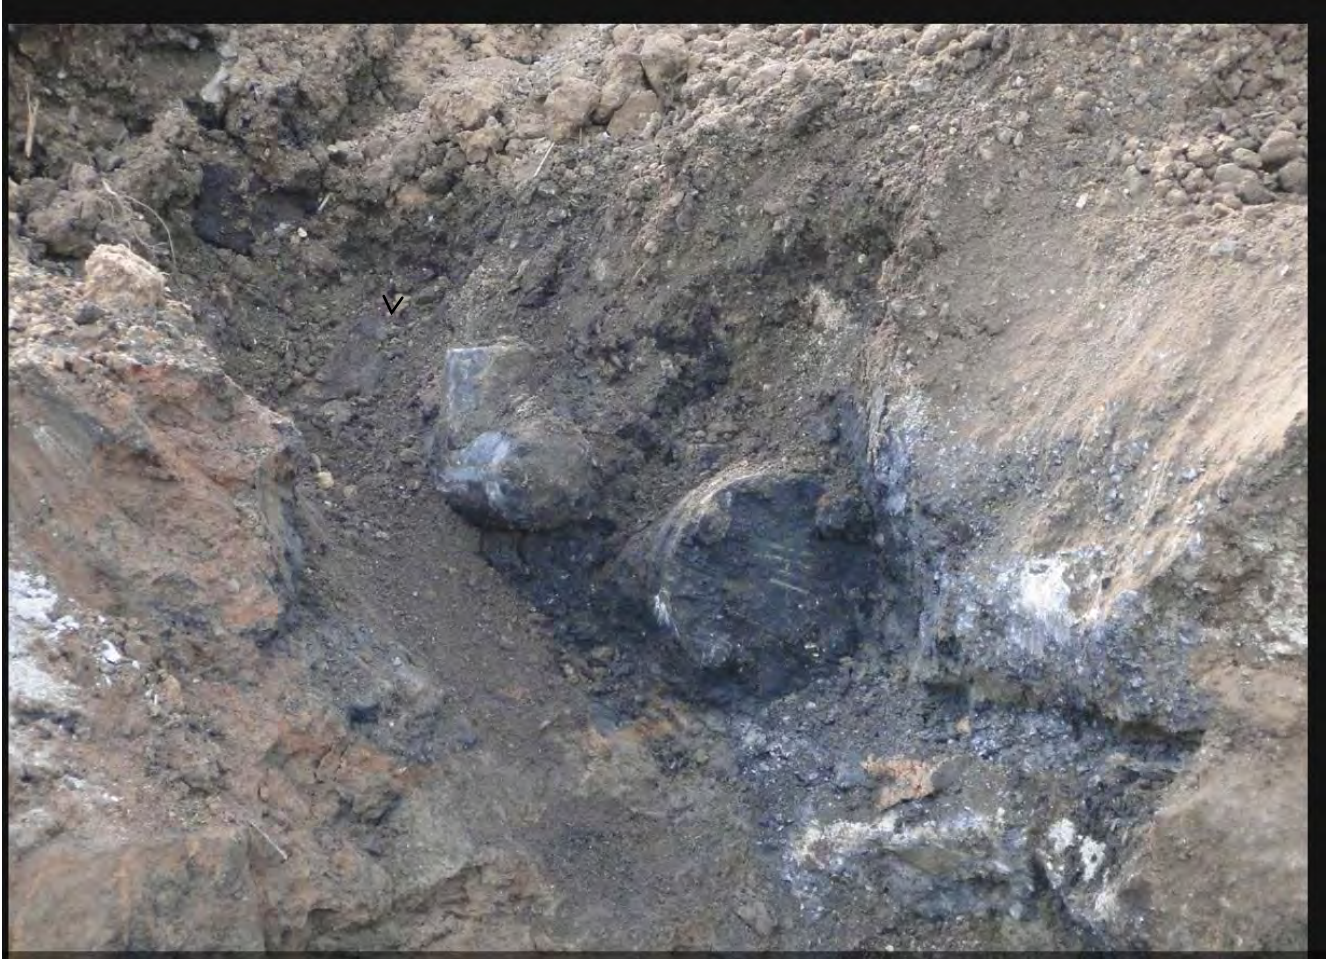
FIGURE
17

Photograph - "Visual contamination" from
Leaking pre WWII Threaded Pipe "T"

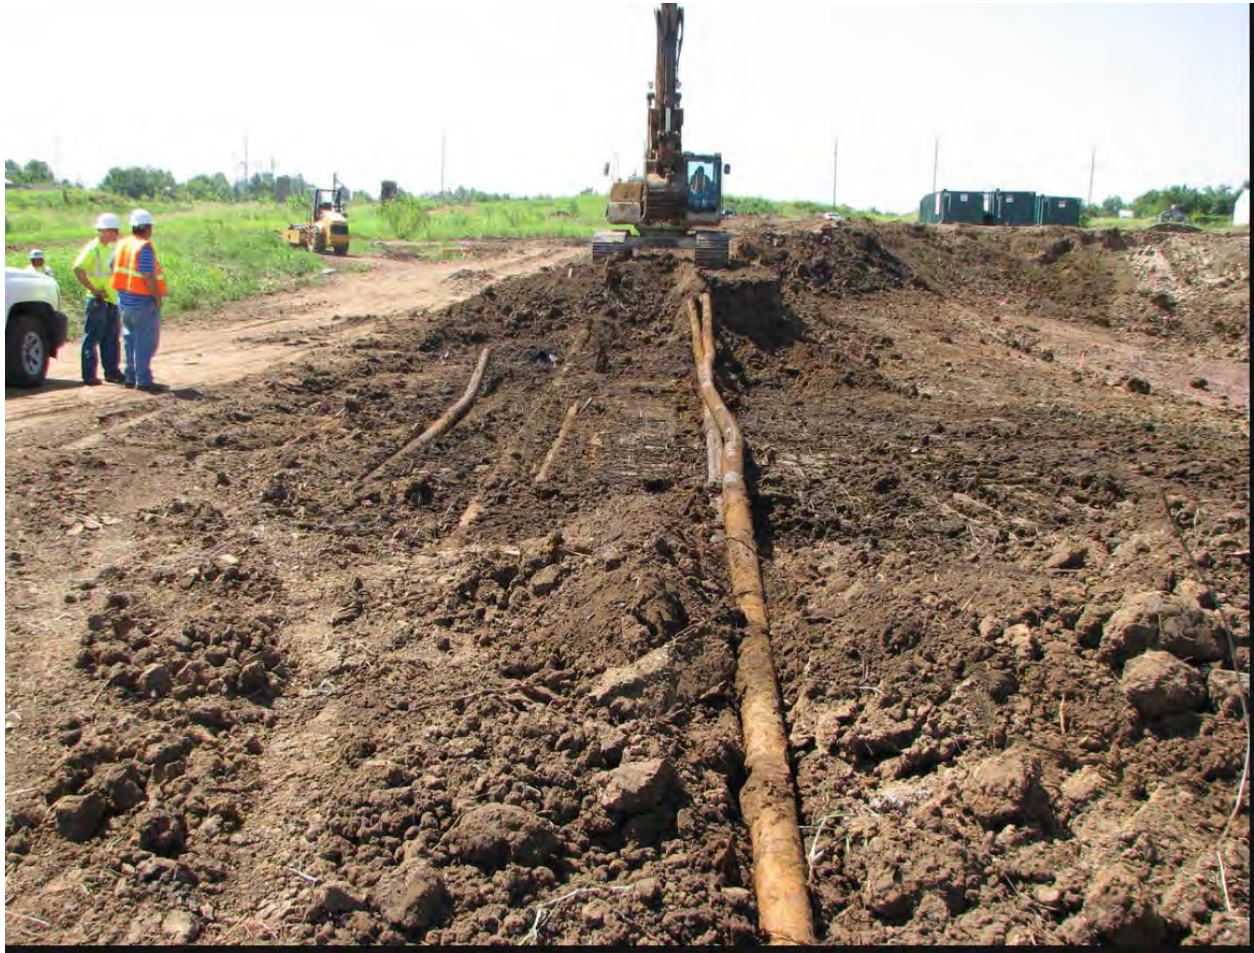
FIGURE
19

Photograph - Buried North/South Pipe-way under East Berm of Coke Pond

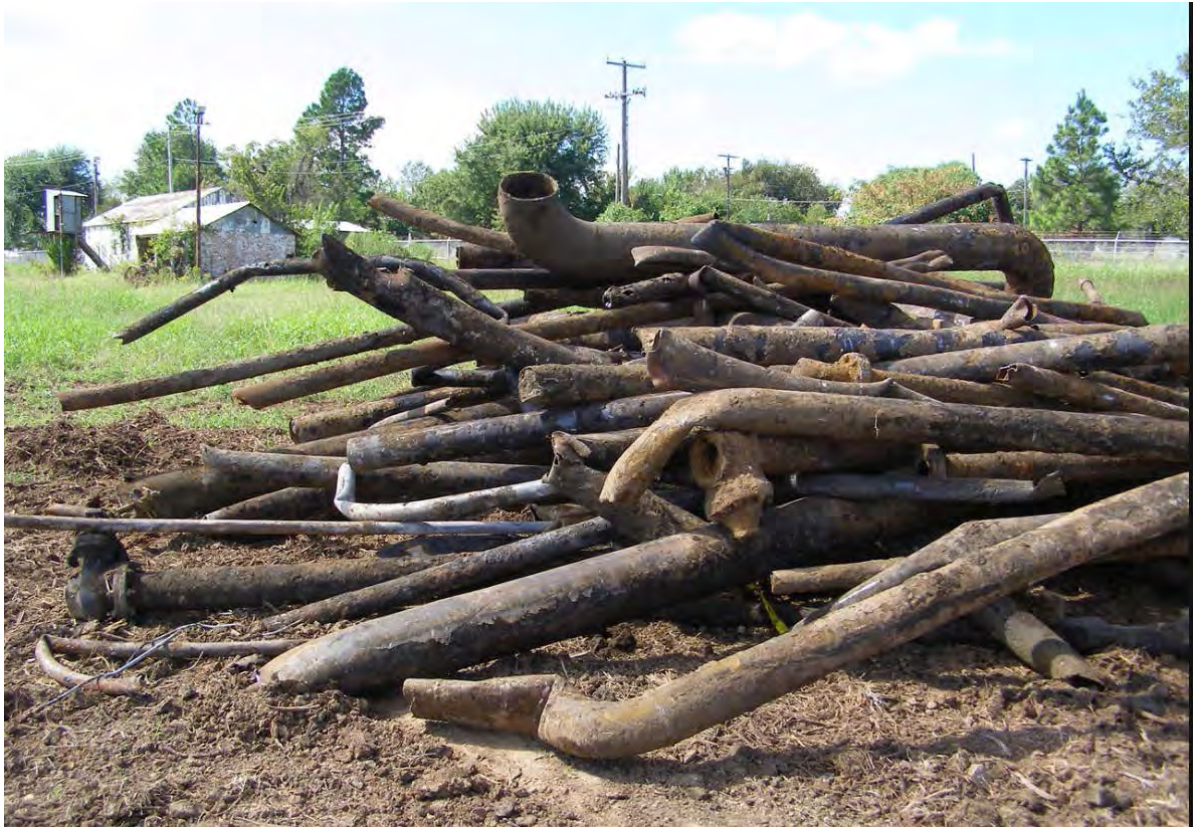
FIGURE
20

Photograph - Buried Pipe Dug up from Around Coke Pond Expansion Area
