UNITED STATES ENVIRONMENTAL PROTECTION AGENCY

Subj: Inspection Report
Springfield Regional Wastewater Treatment Facility

- A. *Facility Name:* Springfield Regional Wastewater Treatment Facility
- B. *Facility Location:* 190 M St Extension
Agawam, MA 01001
- C. *Facility Contacts:* Josh, Schimmel, Executive Director, Springfield Water and Sewer Commission
(413) 452-1333, josh.schimmel@waterandsewer.org
- Mickey Nowak, Operator, Suez North America
(413) 246-3915, Mickey.Nowak@suez-na.com
- D. *NPDES ID Number:* MA0101613

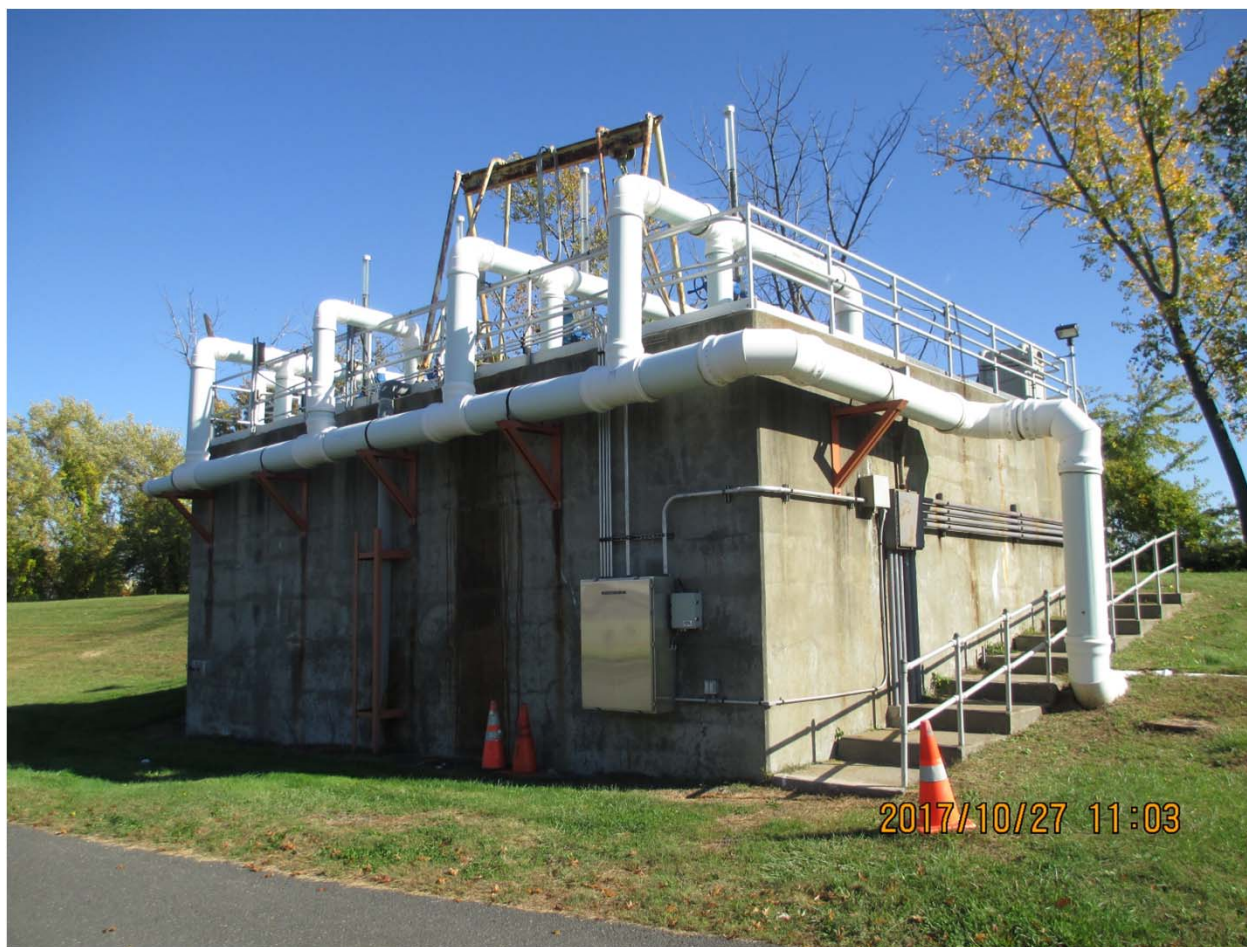
Number	Area	Subject
3	Influent Structure	Influent Structure exterior - plant side

The inspection team visited the Influent Structure (Photos 3 - 6). The Influent Structure is located on the facility side of a berm along the Connecticut River.

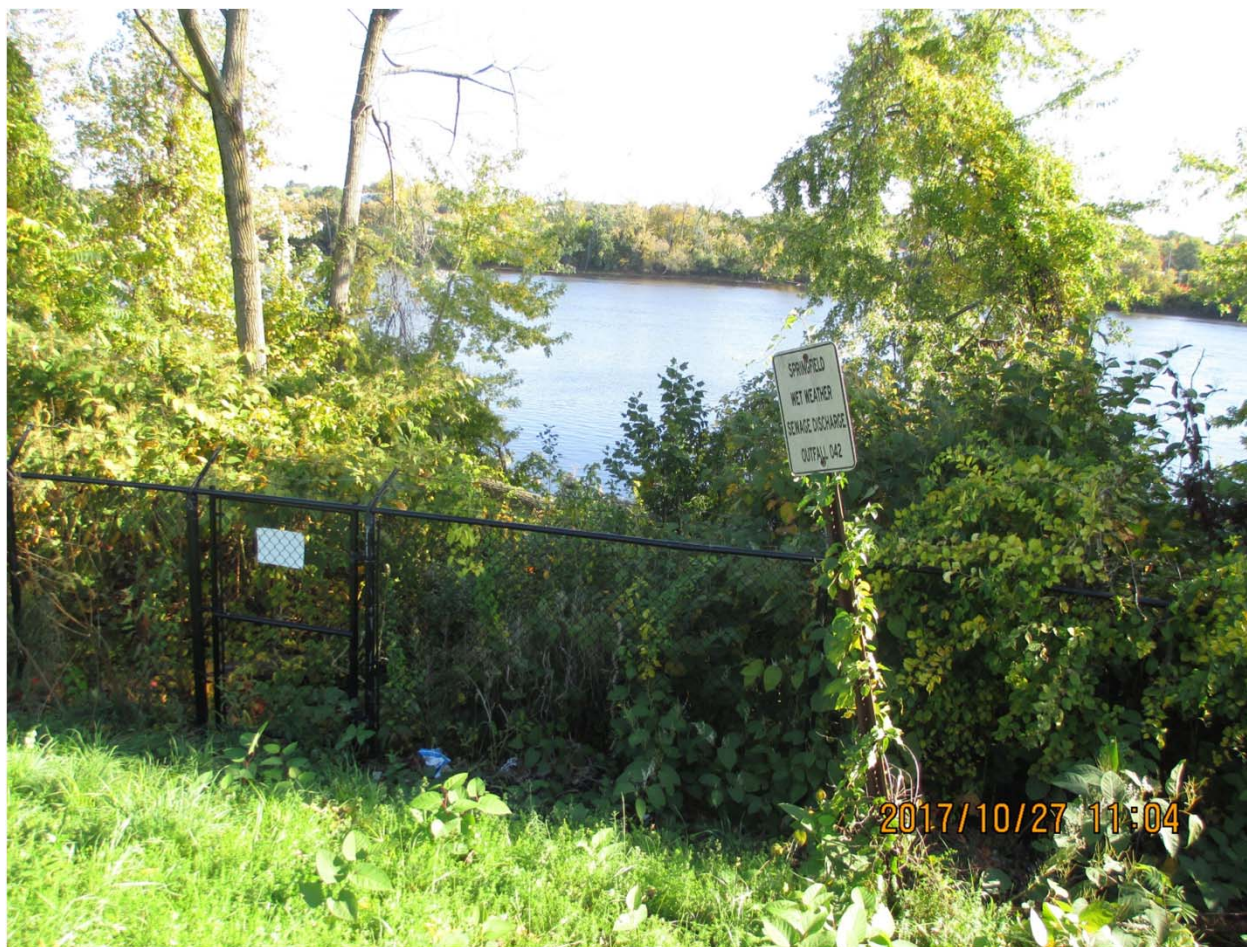
Number	Area	Subject
4	Influent Structure	Influent bypass discharge location

A sign was observed showing the location of the influent bypass outfall (Photo 4). Facility representatives stated that no sign was posted for boaters along the river near the outfall. Facility representatives stated that it would be challenging to install a sign above high flow elevations. Facility representatives stated that they have experienced theft and vandalism of signs on the Springfield side of the river.

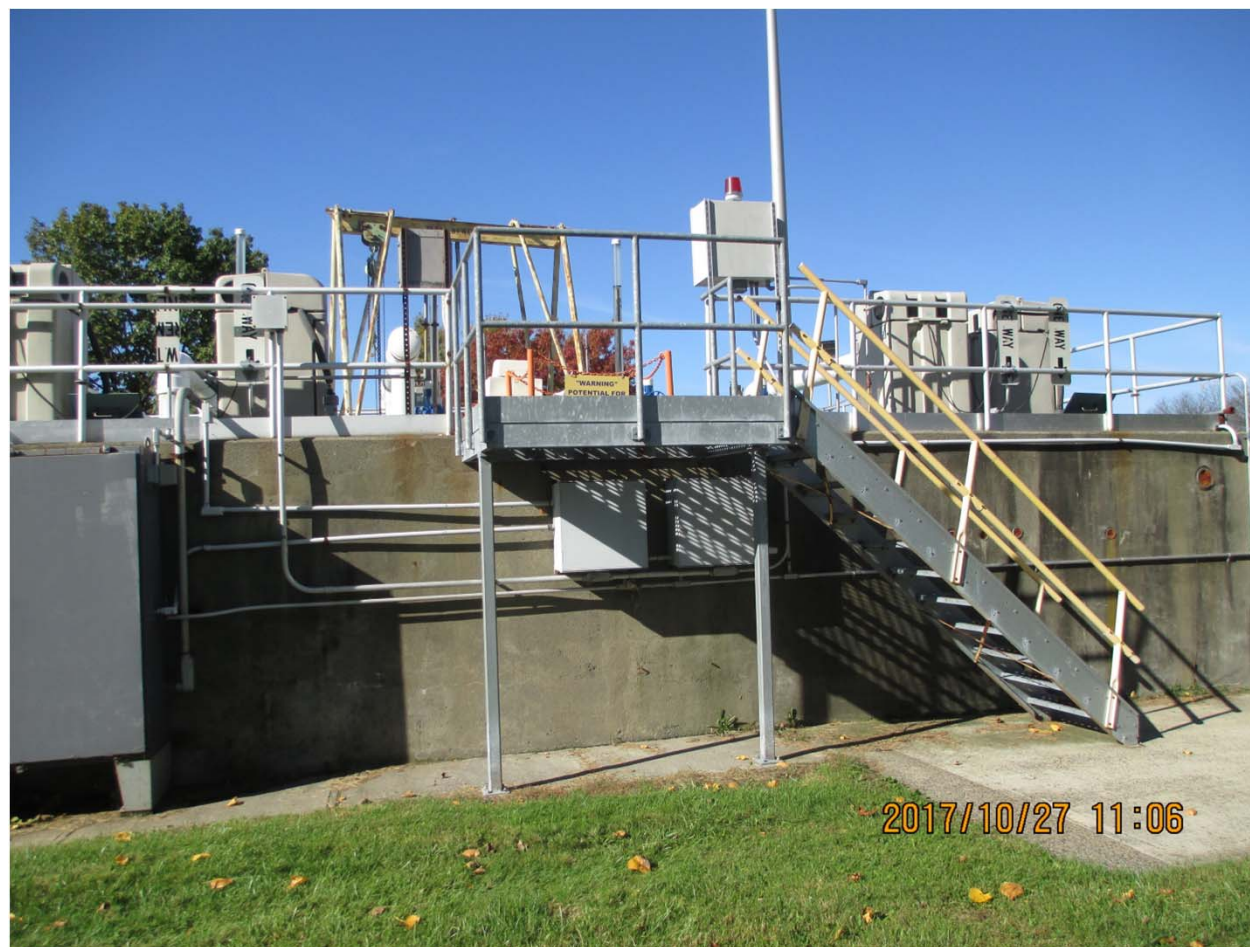
Number	Area	Subject
5	Influent Structure	Influent Structure exterior - river side

An influent bypass flow meter control panel and alarm were observed on the river side of the Influent Structure (with a red light on top; Photo 5). The chamber conveying flow to the influent bypass overflow was observed (Photo 6). Facility representatives stated that flows are measured using an ultrasonic measurement of bypass flow over a weir. The ultrasonic device is calibrated regularly, but the facility has not attempted to verify flow measurements using depth and velocity meters installed on the discharge pipe. Facility representatives stated that the measurement of height over a weir is more accurate than depth and velocity meters on the discharge pipe would be and that installation of such meters would be impractical.

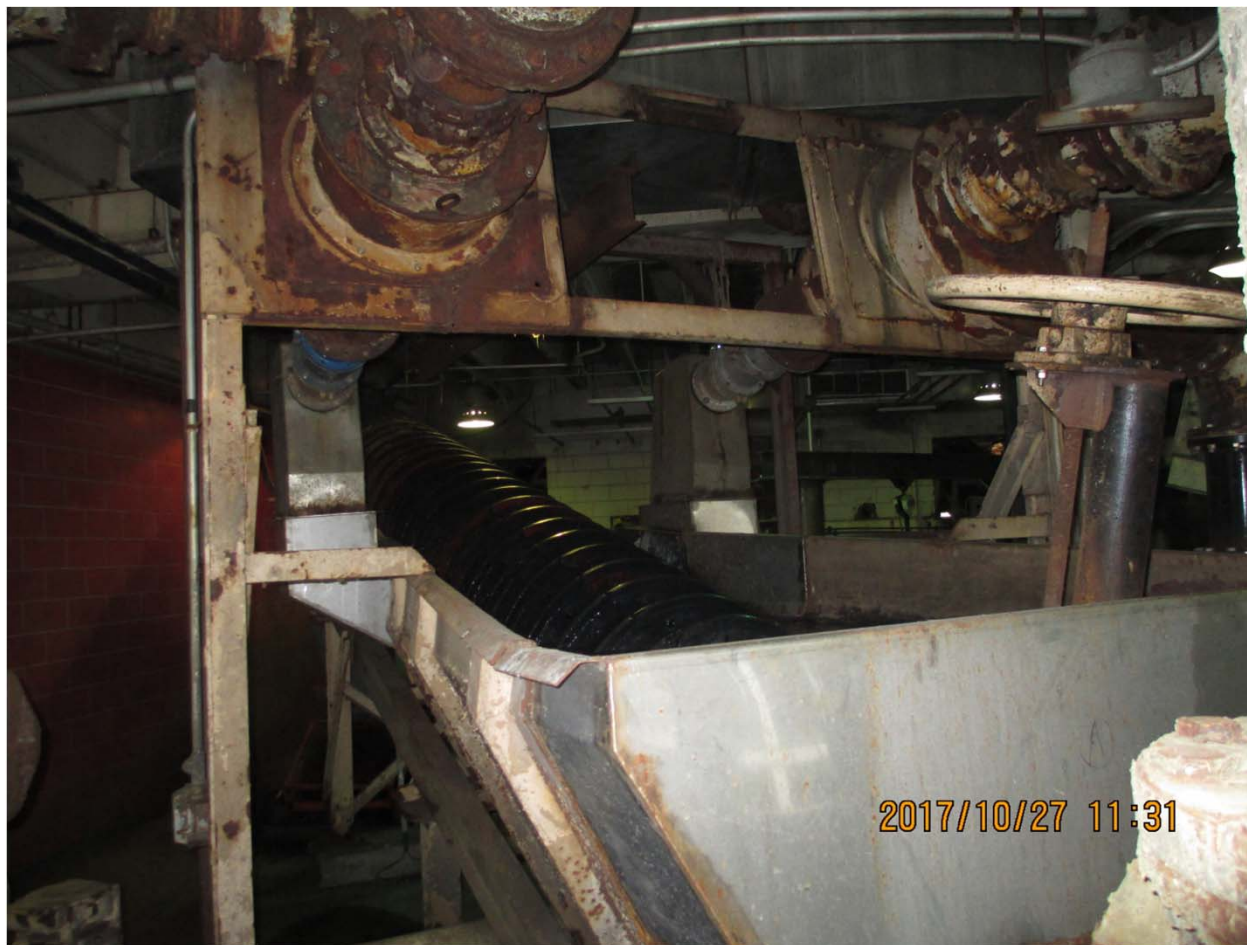
Number	Area	Subject
7	Screening Building	Archimedes screw to grit cyclone separator

The grit cyclone separator was observed (Photo 7). The grit cyclone separator receives grit and sludge from the primary clarifiers.

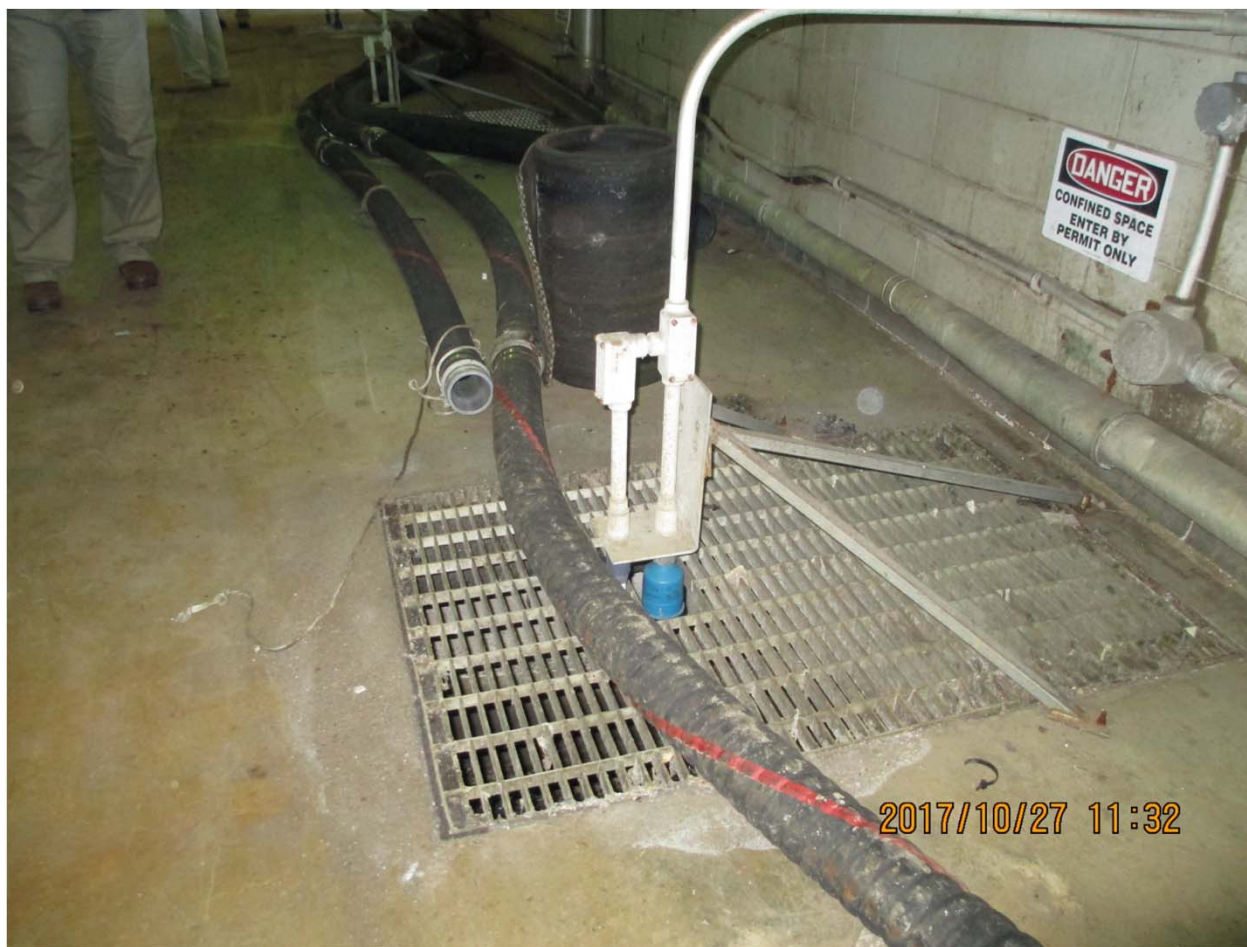
Number	Area	Subject
8	Screening Building	Influent flow metering

The influent flow meters were observed (Photo 8). Facility representatives stated that these are regularly calibrated by a third-party.

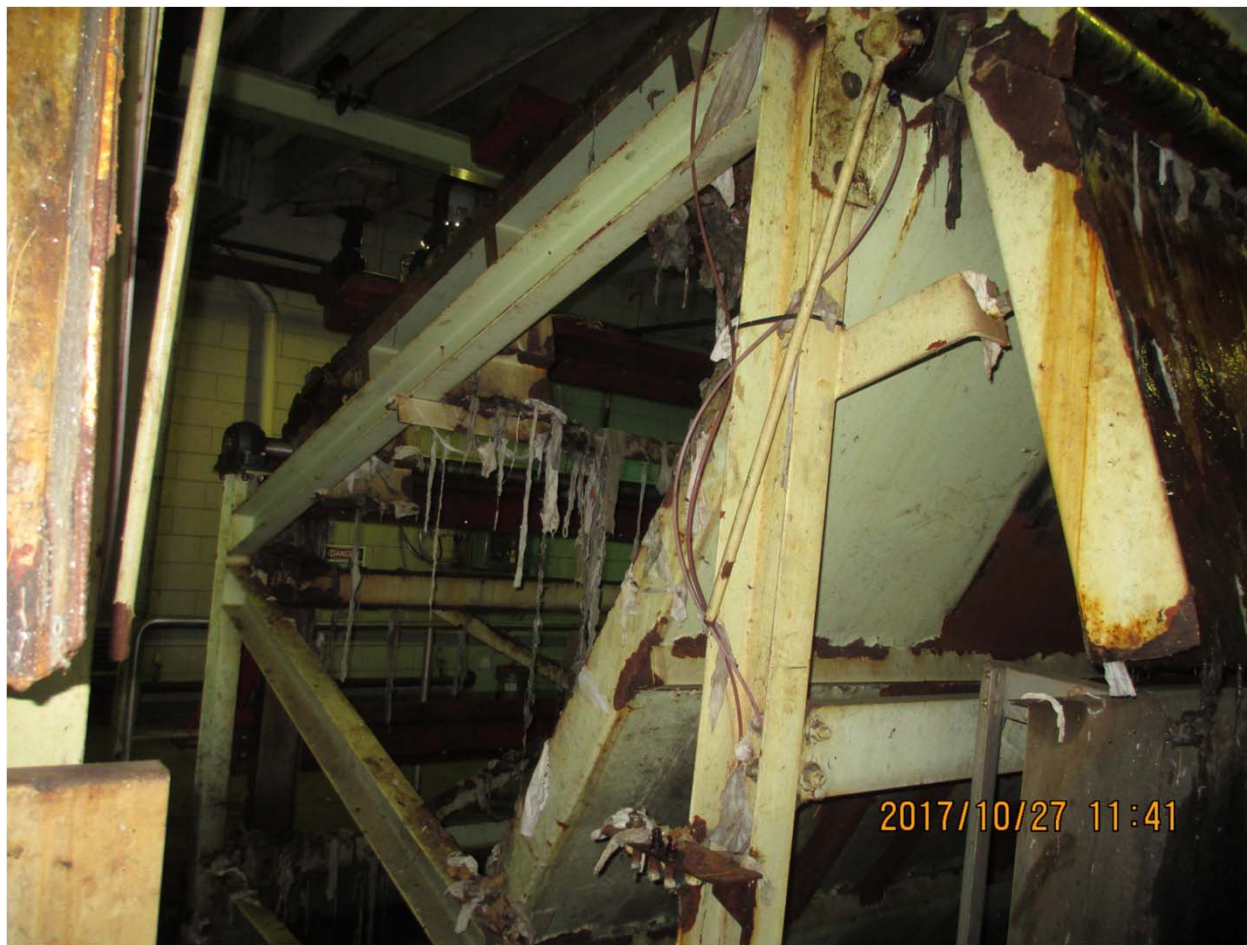
Number	Area	Subject
9	Screening Building	Bar rack

Facility representatives stated that since 2000, the facility has added additional rakes to the bar screens and changed the screen spacing from 1-inch to ½-inch.

Facility representatives stated that in February 2017, the bar screens were clogged with excessive rags and leaves and the influent bypass was activated with a flow of less than 180 MGD.

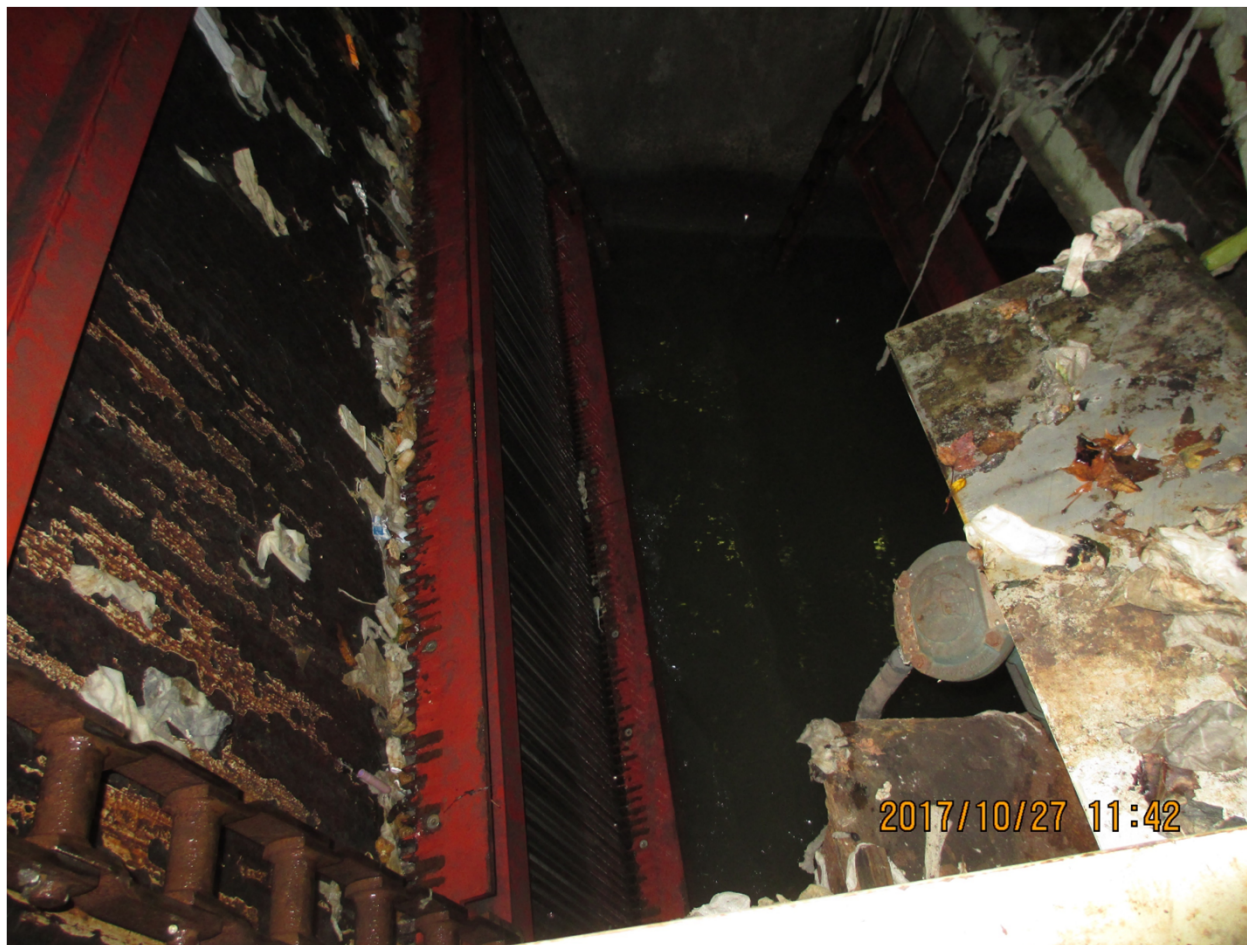
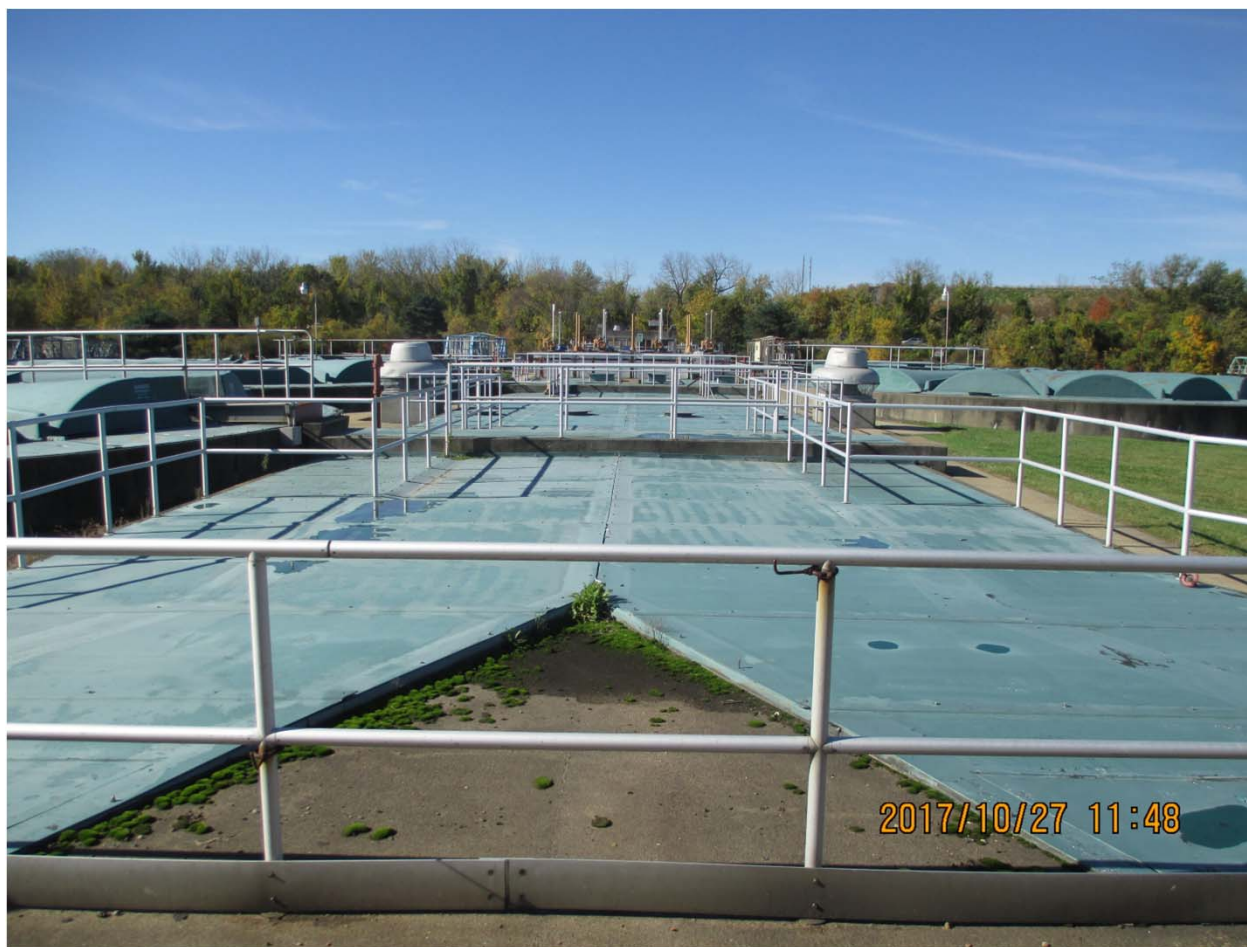
Number	Area	Subject
11	Primary Treatment	Channels to primary

Channels convey flows from the Screening Building to the primary clarifiers (Photo 11).

Facility representatives stated that it had rained approximately four inches on the night of October 24, 2017. Flows to the facility had exceeded 180 MGD and the influent bypass had been activated. Large amounts of solids had flowed into primary clarifiers and the facility was still in the process of removing solids and restoring normal operations.

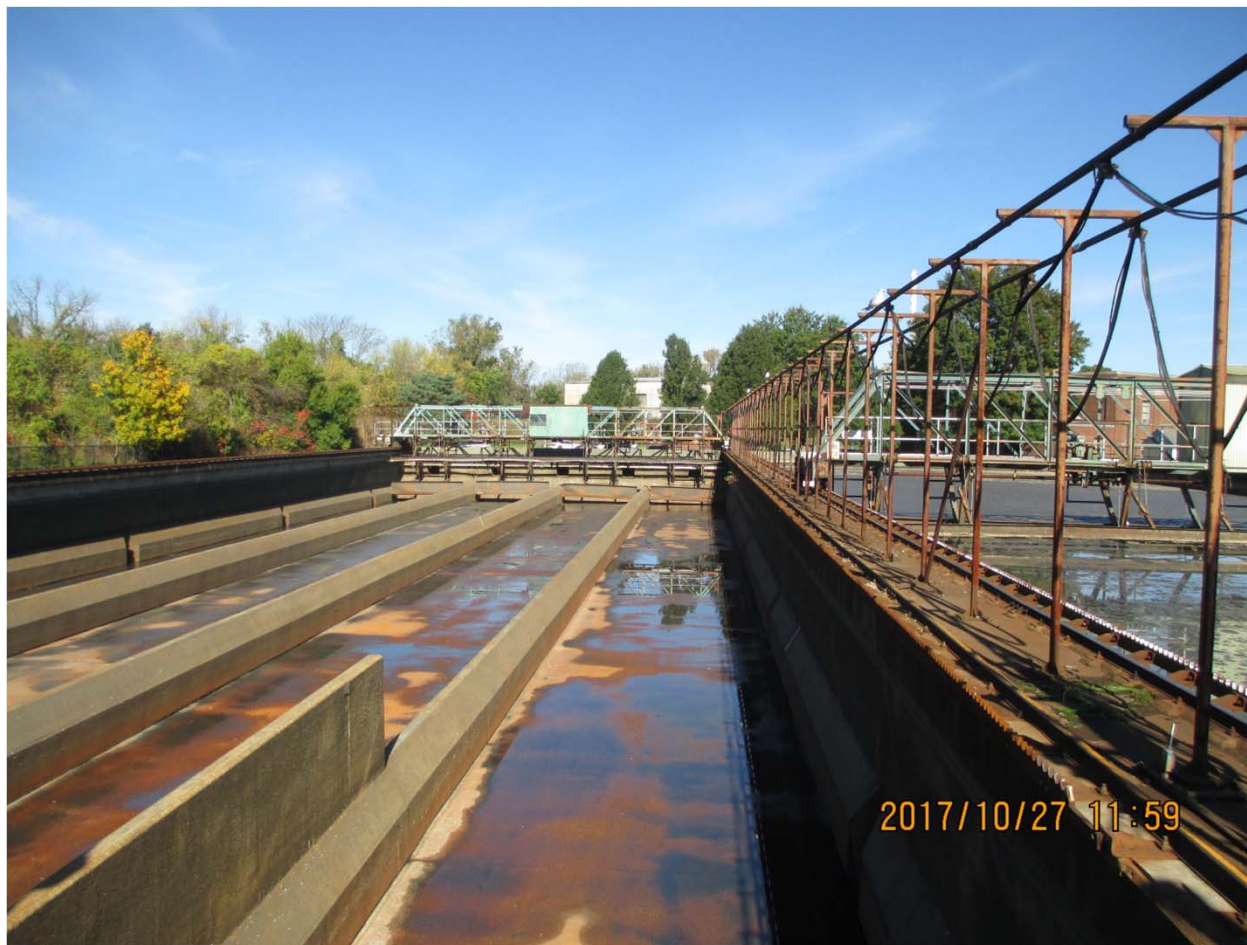
Number	Area	Subject
12	Primary Treatment	Primary basin (out of service)

Sludge and grit are removed from the bottom of the clarifiers and scum is skimmed from the top of the clarifiers by traveling bridges. The traveling bridges traveled on cog tracks (Photo 12).

During high flows, the traveling bridges are not able to keep up with solids removal. During the storm, shorter passes are made with the traveling bridges to keep the influent end clear of solids. Following a storm, the height of the traveling bridge blade is raised to allow for gradual removal of accumulated solids from the entire clarifier.

Facility representatives stated that the traveling bridges require frequent maintenance. Only three of the four primary clarifiers are in service at any one time to allow for maintenance. Traveling bridges must be rebuilt using custom-fabricated parts approximately every six months.

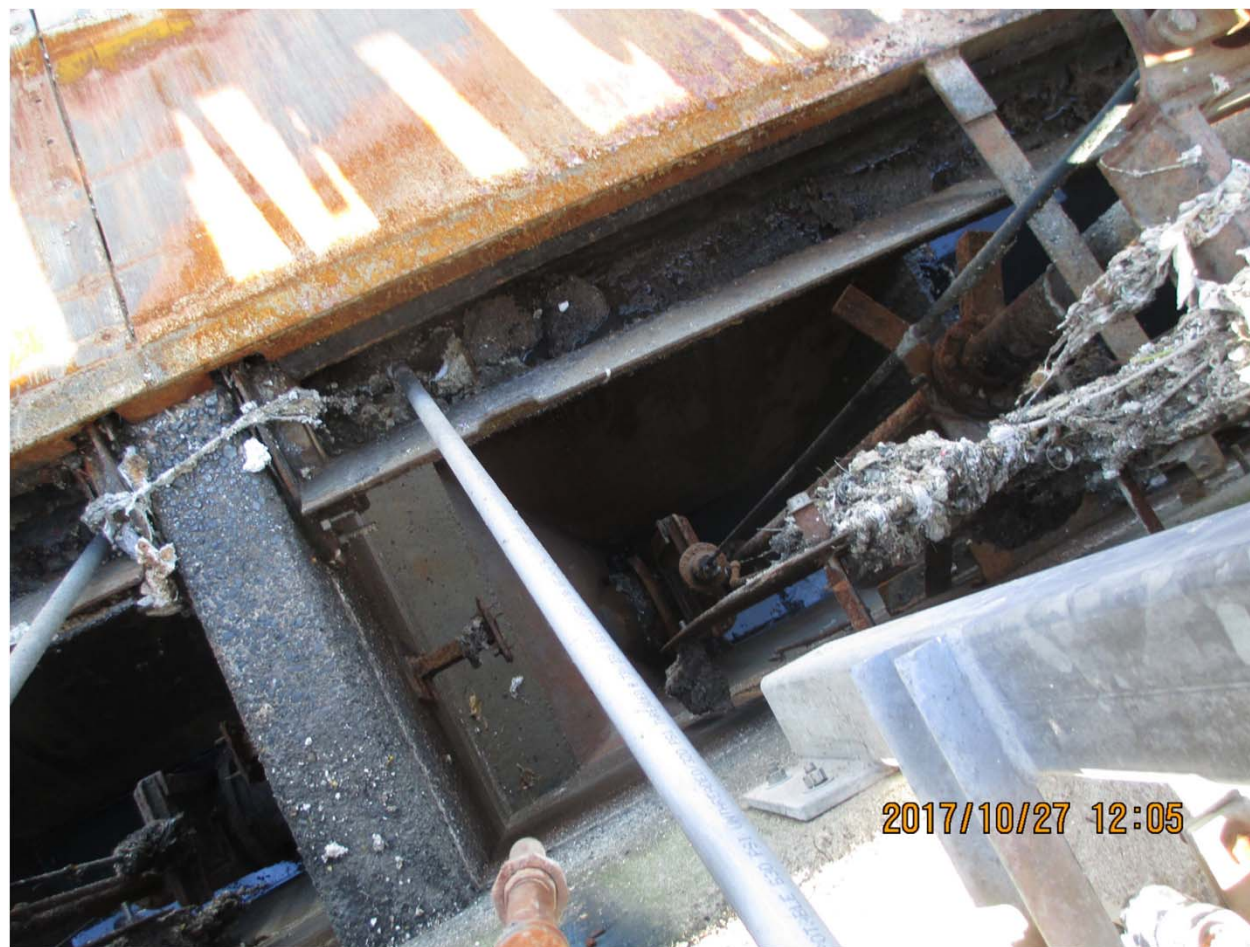
Number	Area	Subject
13	Primary Treatment	Air lift

Solids and grits are collected in eight sumps at one end of the clarifiers. Air lifts are used to pump materials to a trough (Photo 13). Only two of the eight sumps have drains to facilitate maintenance of the air lifts. Following a storm, air lifts are operated at high pressure to remove accumulated solids.

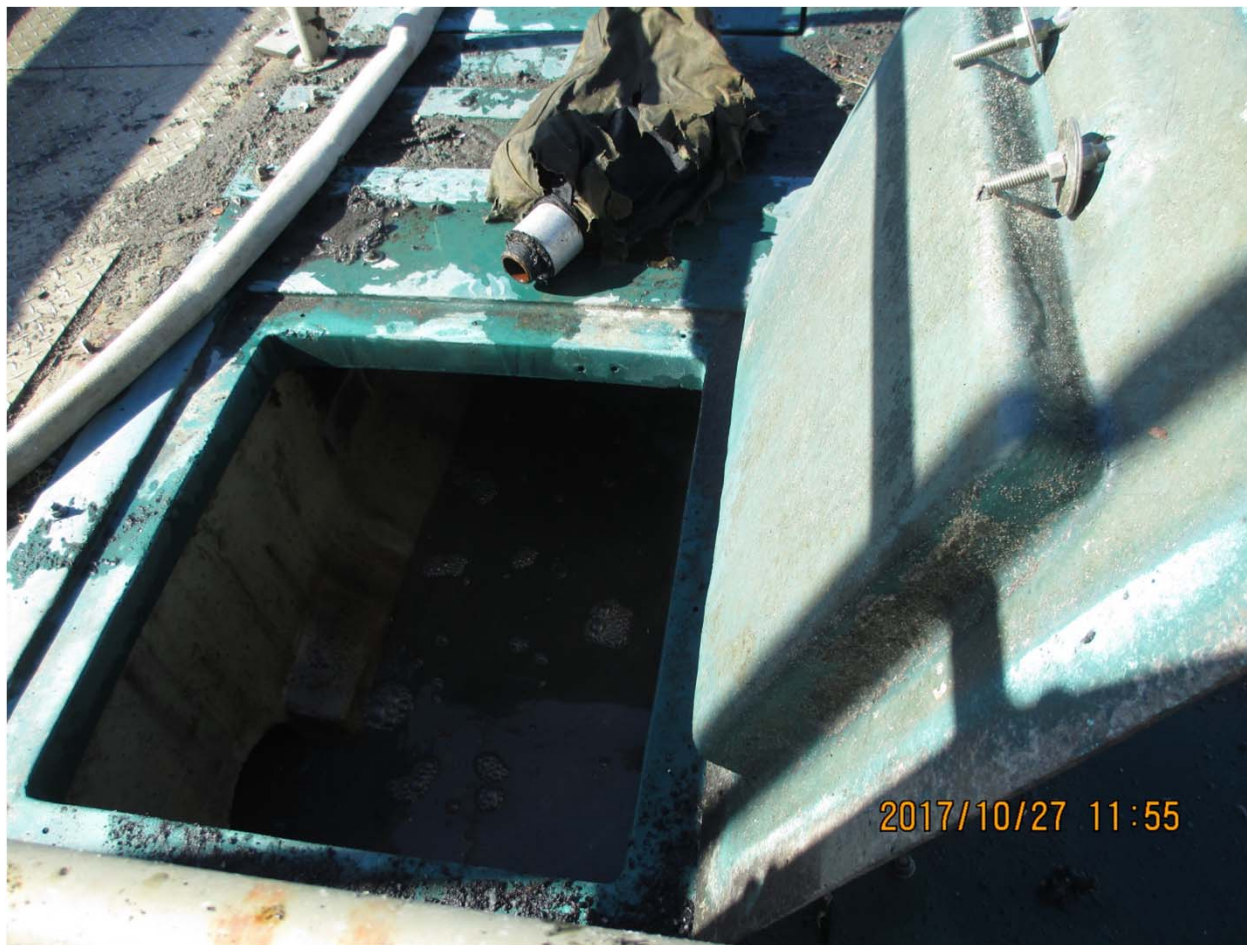
Number	Area	Subject
14	Primary Treatment	Sludge and grit trough

Facility staff were in the process of removing excess grit from the sludge and grit trough (Photo 14). Facility representatives stated that the trough is subject to clogging following high flows.

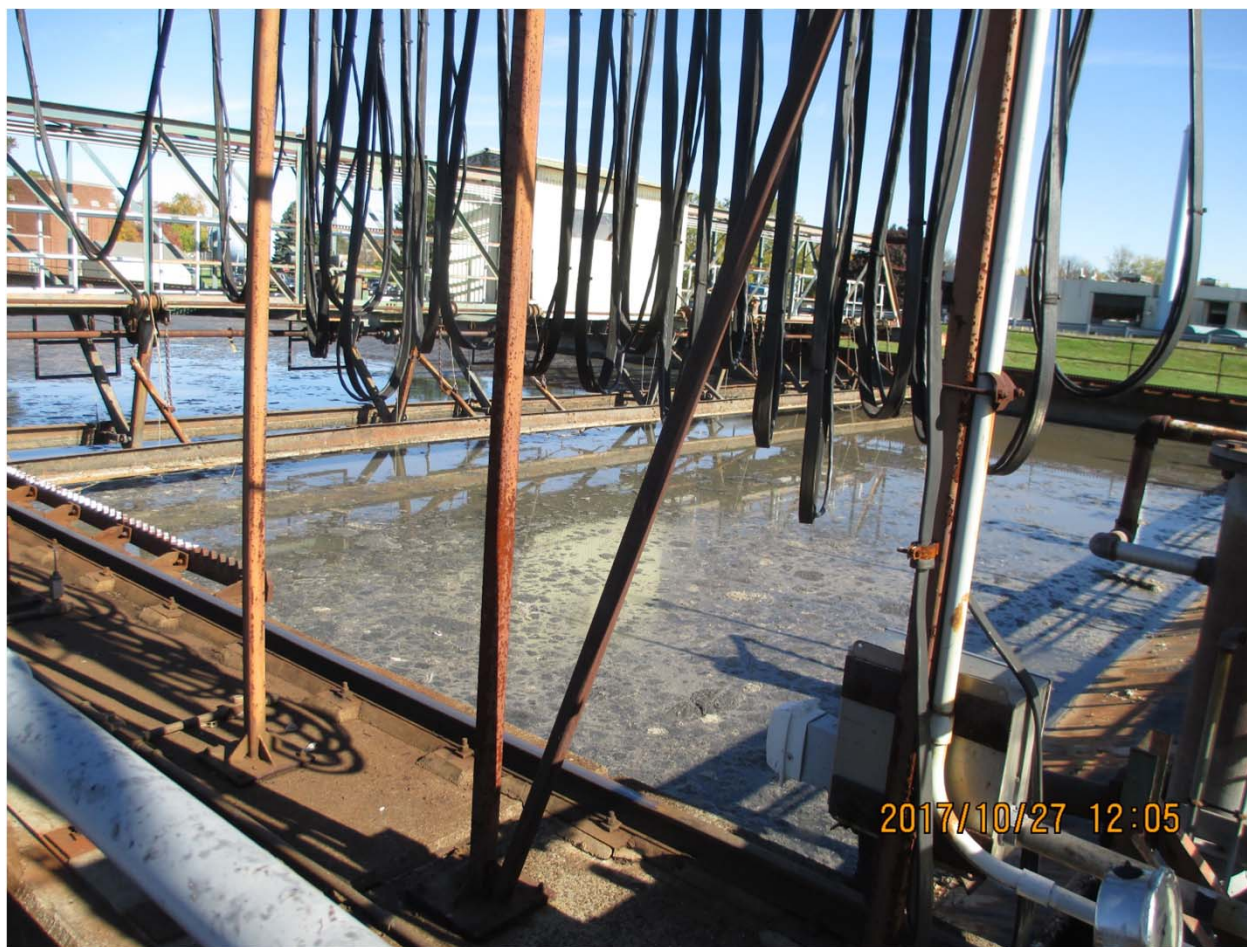
Number	Area	Subject
15	Primary Treatment	Primary basin (in service)

Thick scum was observed on the top of one clarifier (Photo 15). Facility representatives stated that this amount of scum was due to limited motion of the traveling bridge during and following high flows.

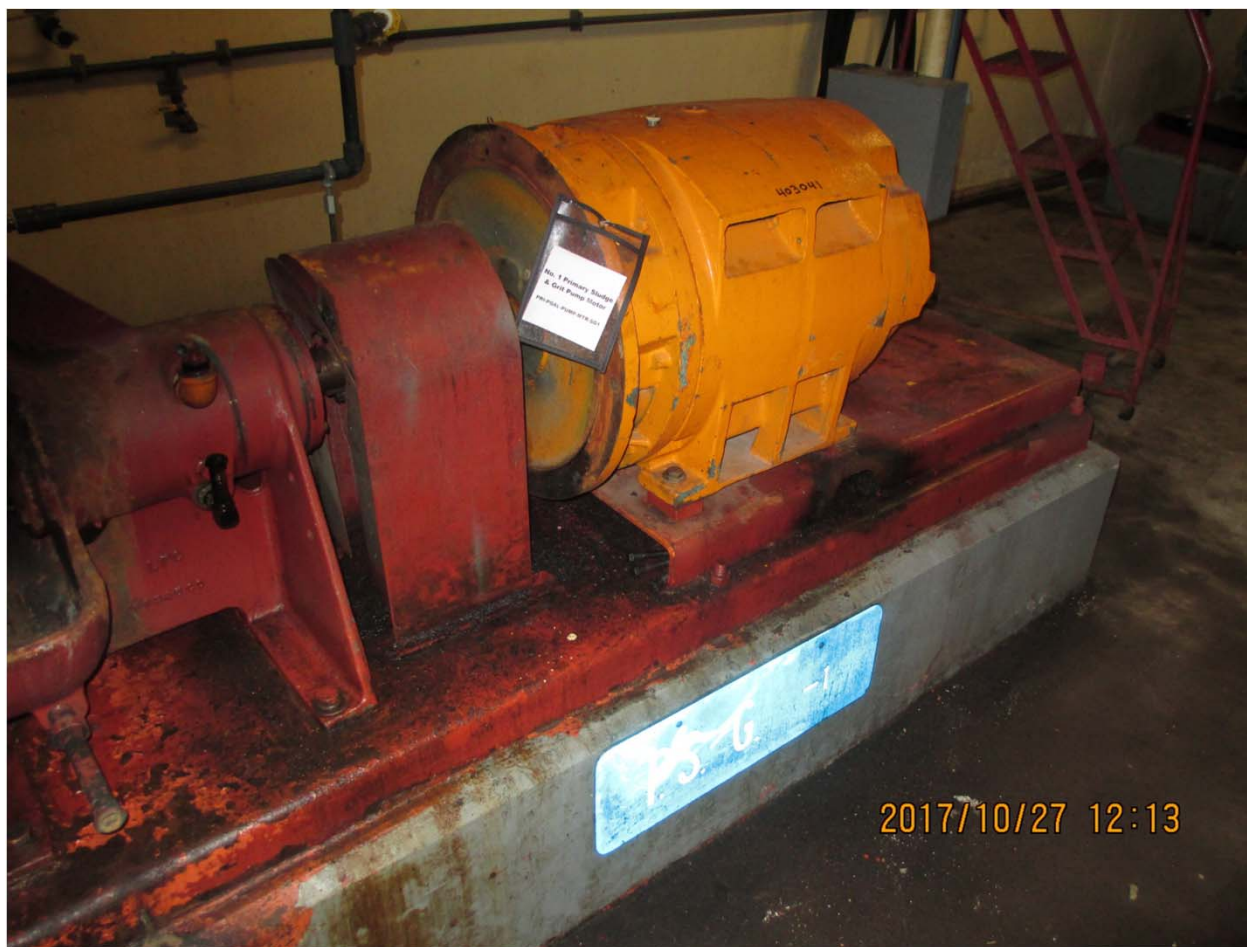
Number	Area	Subject
16	Primary Treatment	Sludge and grit pump

The sludge and grit pumps were observed (Photo 16). There are six sludge and grit pumps to service the four primary clarifiers – three pumps are dedicated to two primary clarifiers and three pumps are dedicated to the other two primary clarifiers.

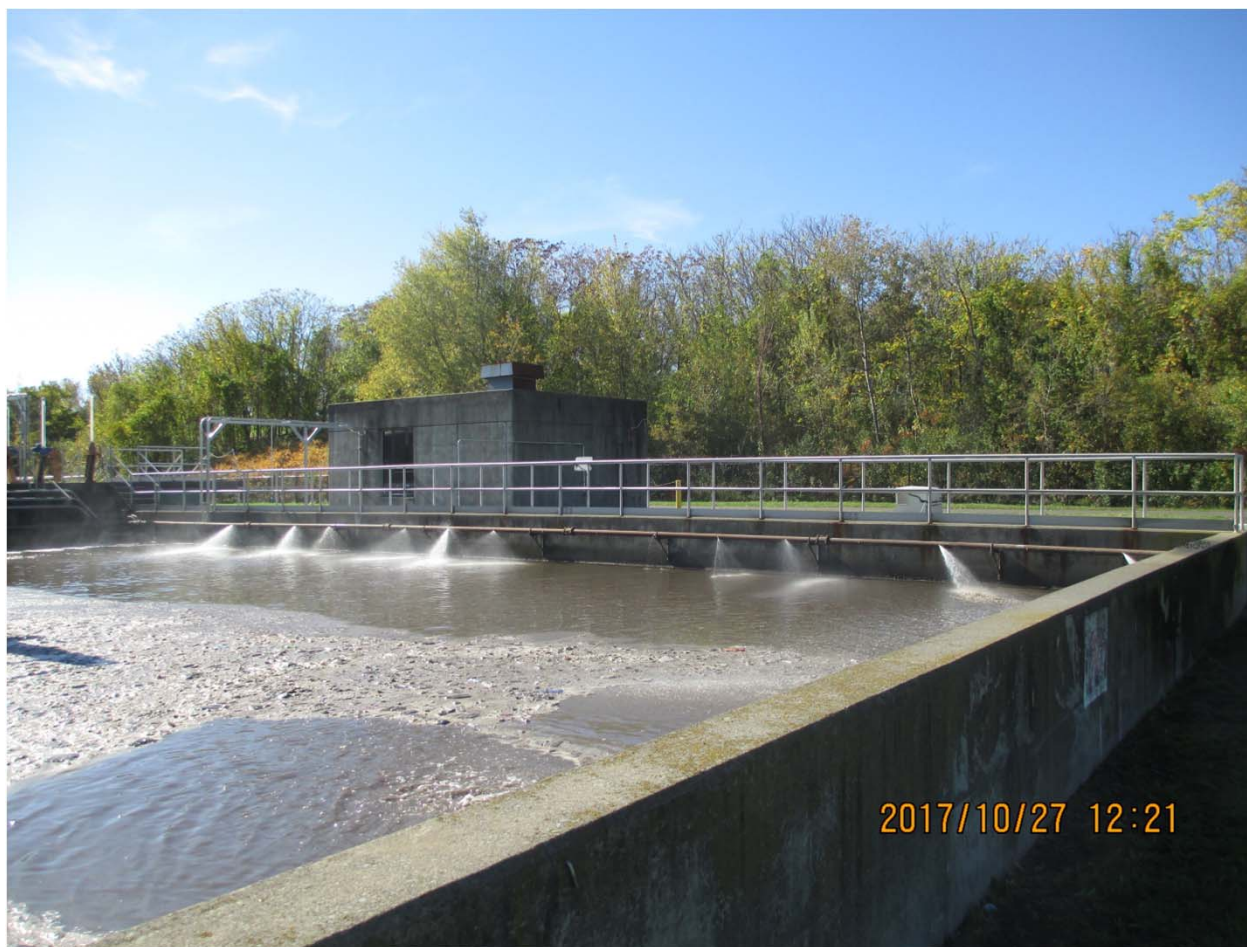
Number	Area	Subject
17	Secondary Treatment	Influent end of secondary aeration basin

Facility representatives explained the operation of the secondary treatment system. The facility employs a Ludzack-Ettinger Process: primary effluent and Return Activated Sludge (“RAS”) from the secondary clarifier are combined in an anoxic zone at the influent end of the secondary aeration basin (Photo 17). Nitrification occurs in the aerated majority of the aeration basin (Photo 19). During normal flows (dry weather), 100% of RAS is recirculated to the anoxic zone for denitrification. The facility’s maximum recycle rate is 60 MGD. During high flows (wet weather), the facility performs a modified step feed of the aeration basin, adding some of the primary effluent to the middle of the aeration basin (in the aerated zone).

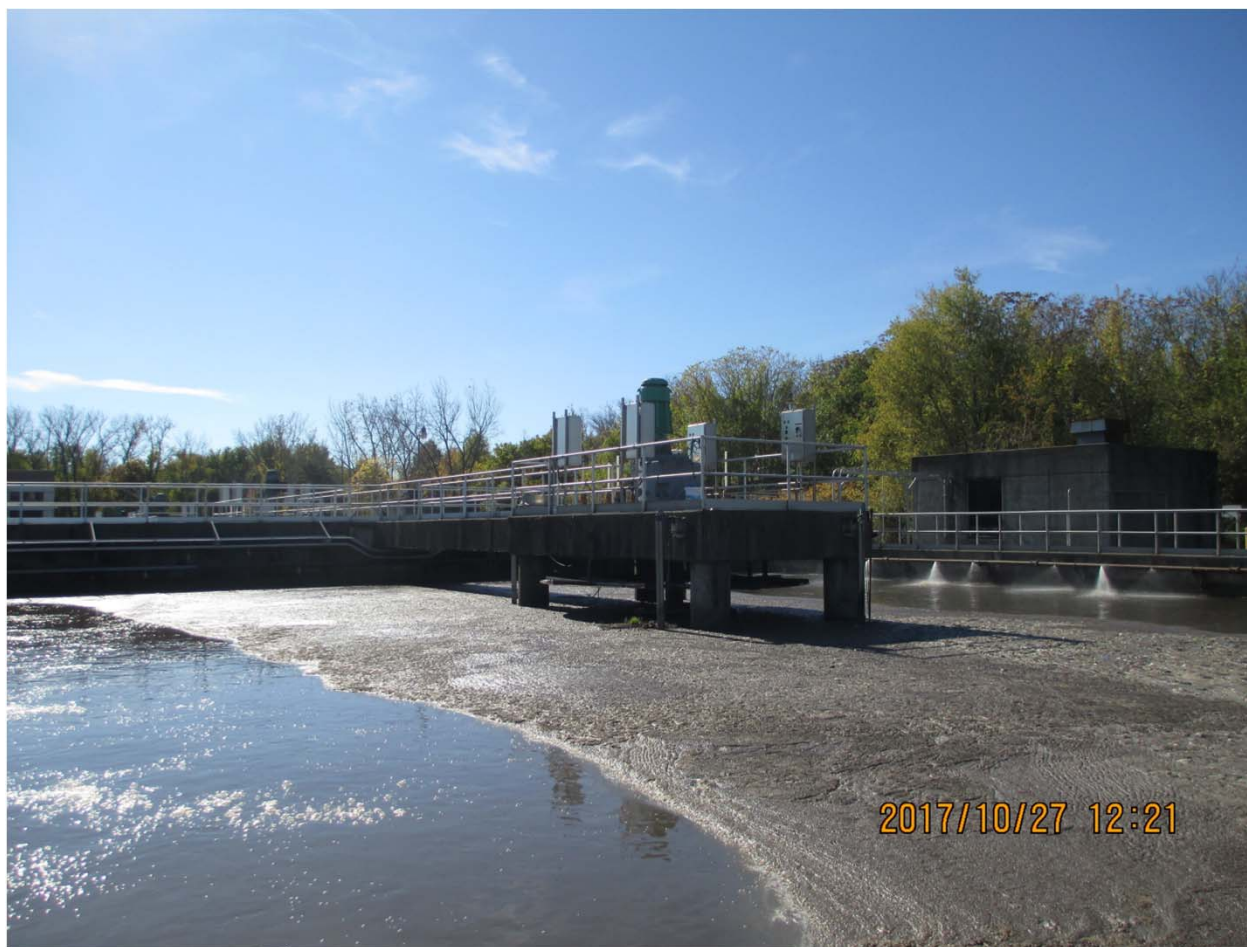
Number	Area	Subject
18	Secondary Treatment	Mechanical aerator platform

A mechanical aeration mixer is present near the influent end of the aeration basin, but is not turned on (Photo 18). The mechanical aeration mixer is seldom used. The facility replaced its mechanical aeration system with air diffusers in the 1990’s; only the influent-end mechanical aeration mixer remains in each aeration basin.

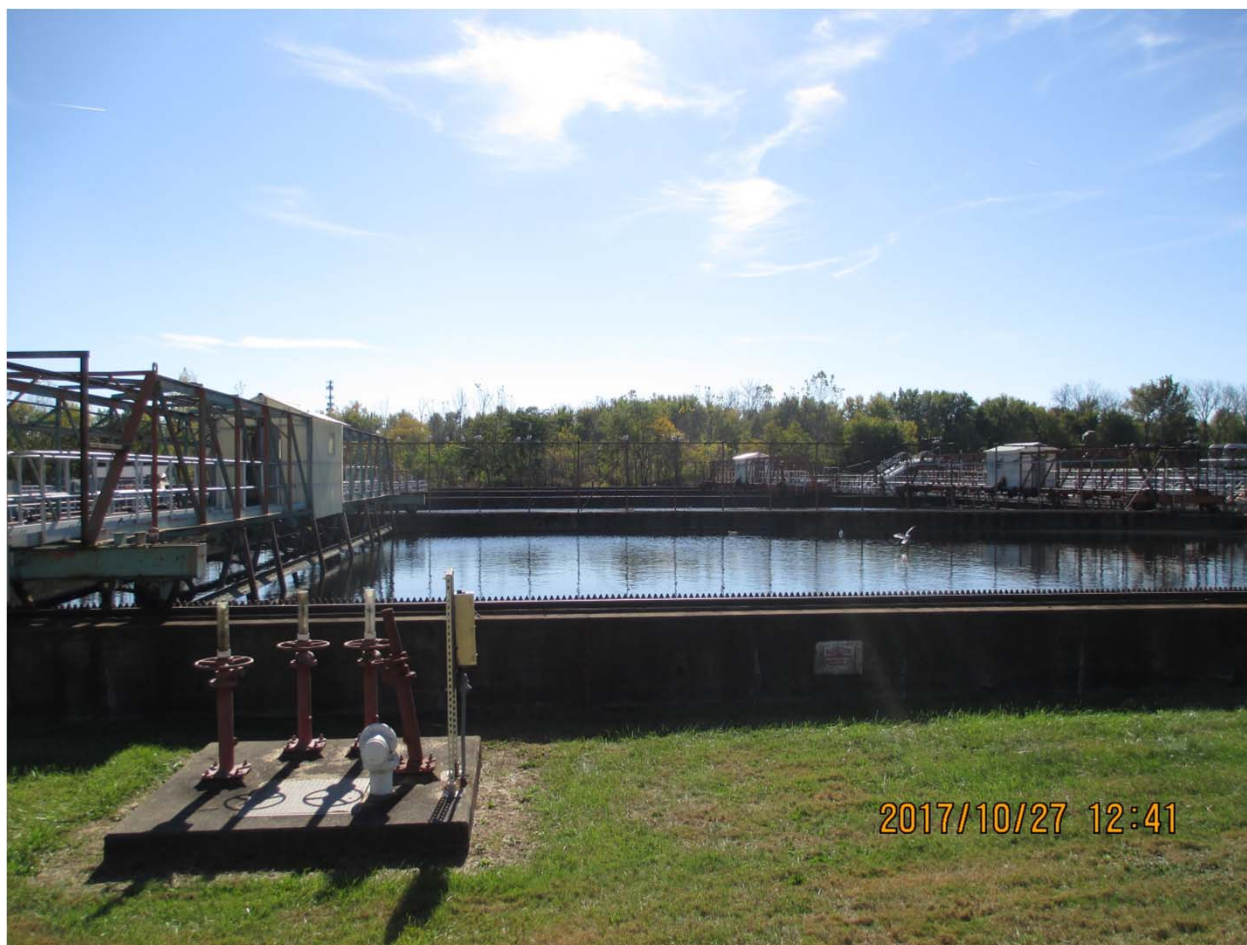
Number	Area	Subject
20	Secondary Treatment	Secondary clarifier influent side

The secondary clarifiers provide physical treatment, settling out solids in two chambers. The first chamber has a traveling bridge (Photo 20), the second chamber has chain and flights (Photos 21 and 22).

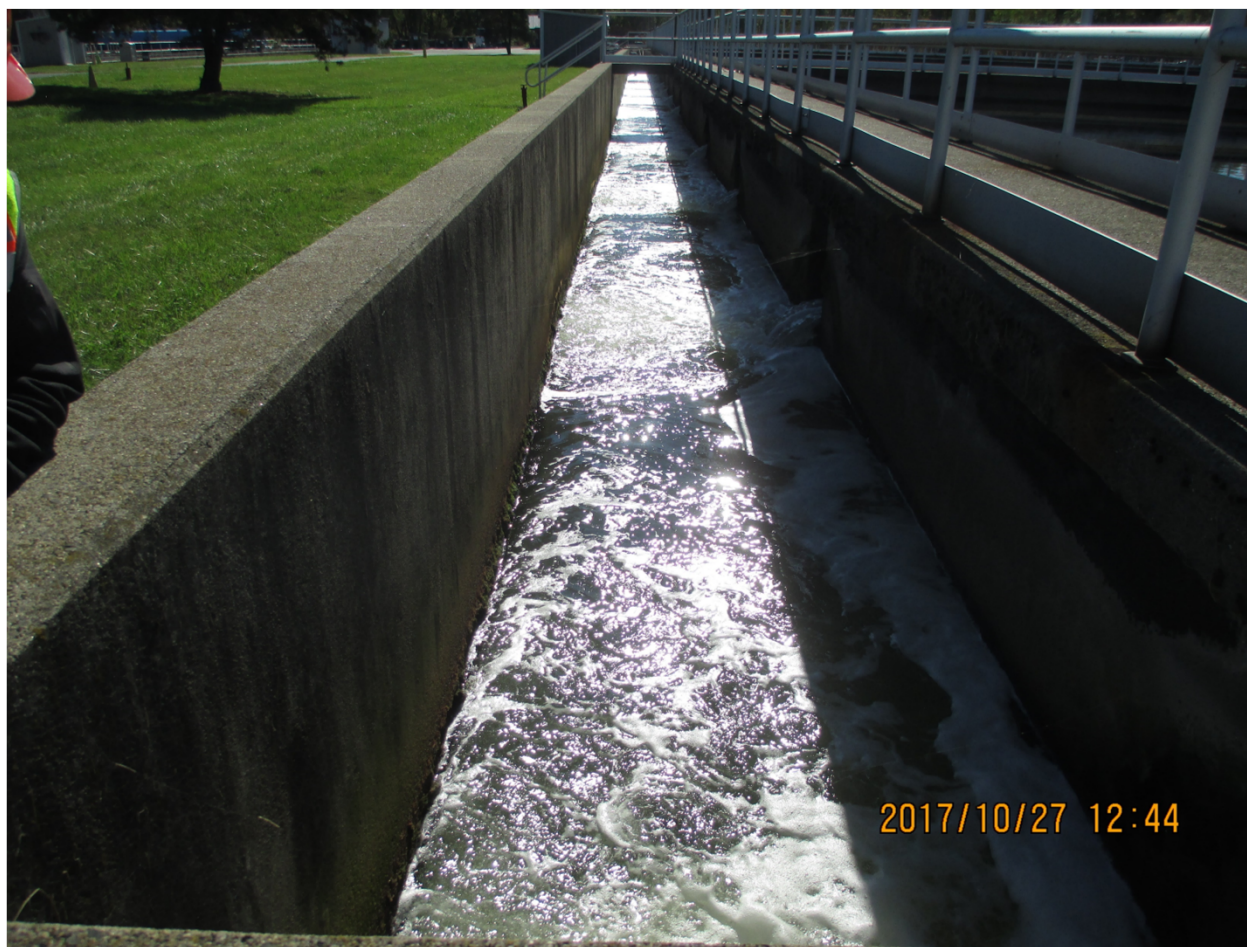
Number	Area	Subject
23	Secondary Treatment	Channel at the end of secondary clarifier

A channel conveys secondary effluent to the disinfection system (Photo 23). Effluent samples for all parameters except fecal coliform bacteria and total residual chlorine are taken in this channel.
