UNITED STATES ENVIRONMENTAL PROTECTION AGENCY

Subj: Inspection Report
Springfield Regional Wastewater Treatment Facility

- A. *Facility Name:* Springfield Regional Wastewater Treatment Facility
- B. *Facility Location:* 190 M St Extension
Agawam, MA 01001
- C. *Facility Contacts:* Josh, Schimmel, Executive Director, Springfield Water and Sewer Commission
(413) 452-1333, josh.schimmel@waterandsewer.org
- Mickey Nowak, Operator, Suez North America
(413) 246-3915, Mickey.Nowak@suez-na.com
- D. *NPDES ID Number:* MA0101613

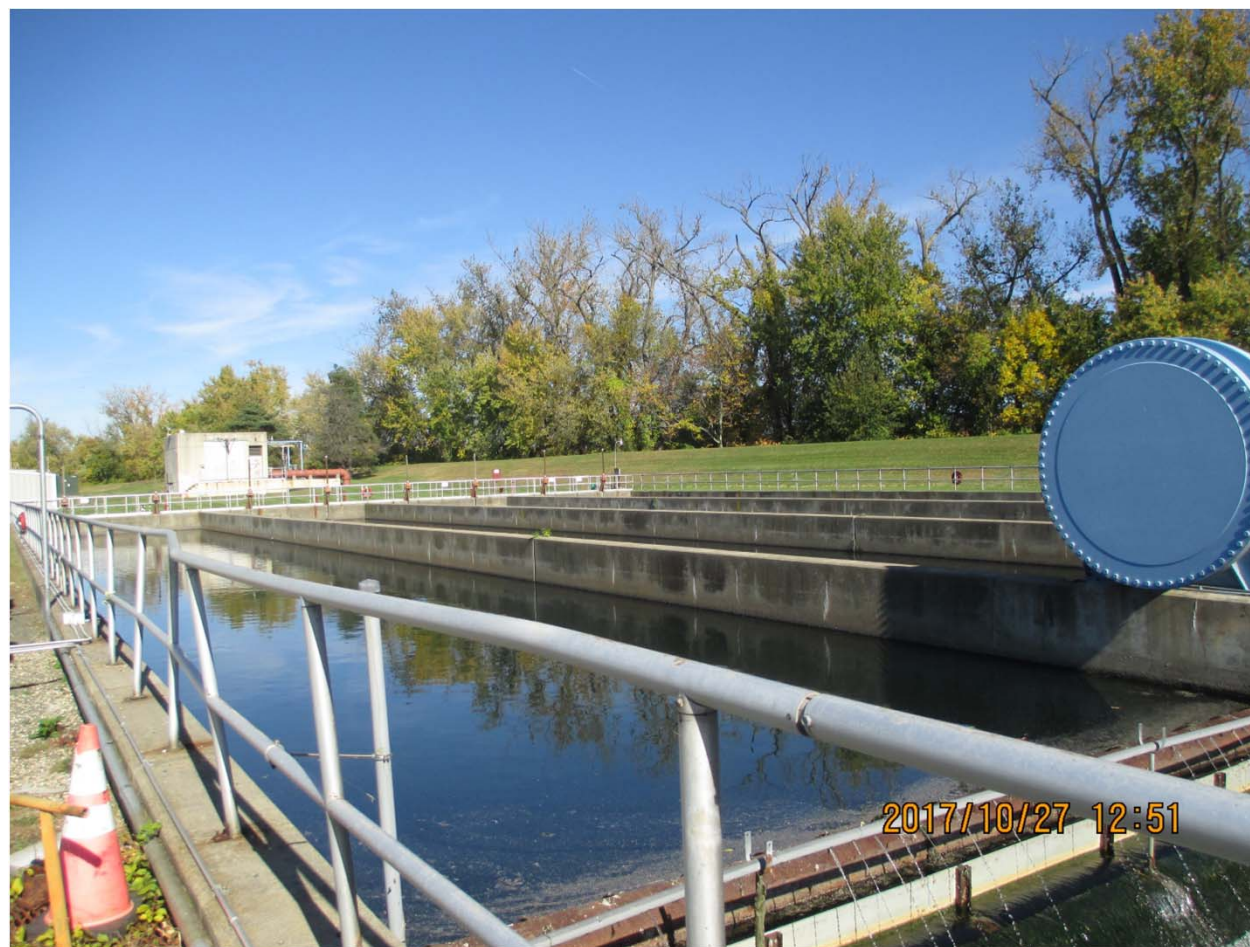
Number	Area	Subject
24	Disinfection and Discharge	Chlorine contact chamber

The inspection team visited the chlorine contact chambers (Photo 24). The facility uses a gaseous chlorination system.

The facility has a target dosing level of chlorine of 0.7 milligrams per liter.

According to the 2000 O&M Manual, the chlorine contact chamber detention time is 13 minutes at flows of 180 MGD.

The facility uses a Hach CL-17 to monitor free chlorine at the influent end of the contact chamber. The Hach CL-17 is tied to the facility's SCADA system. Chlorine dosing is performed automatically based on the observed free chlorine, the flow observed in the influent channels following the bar screens, and an assumption of the chlorine demand in the chlorine contact chamber.

The facility has a chlorine dosing capacity of 3,000 pounds per day (lb/d). The facility has one unit with a 1,000 lb/d capacity and another unit with a 2,000 lb/d capacity. Capacity could be increased by replacing the 1,000 lb/d unit with a 2,000 lb/d unit, but this would result in some loss of precision in dosing.

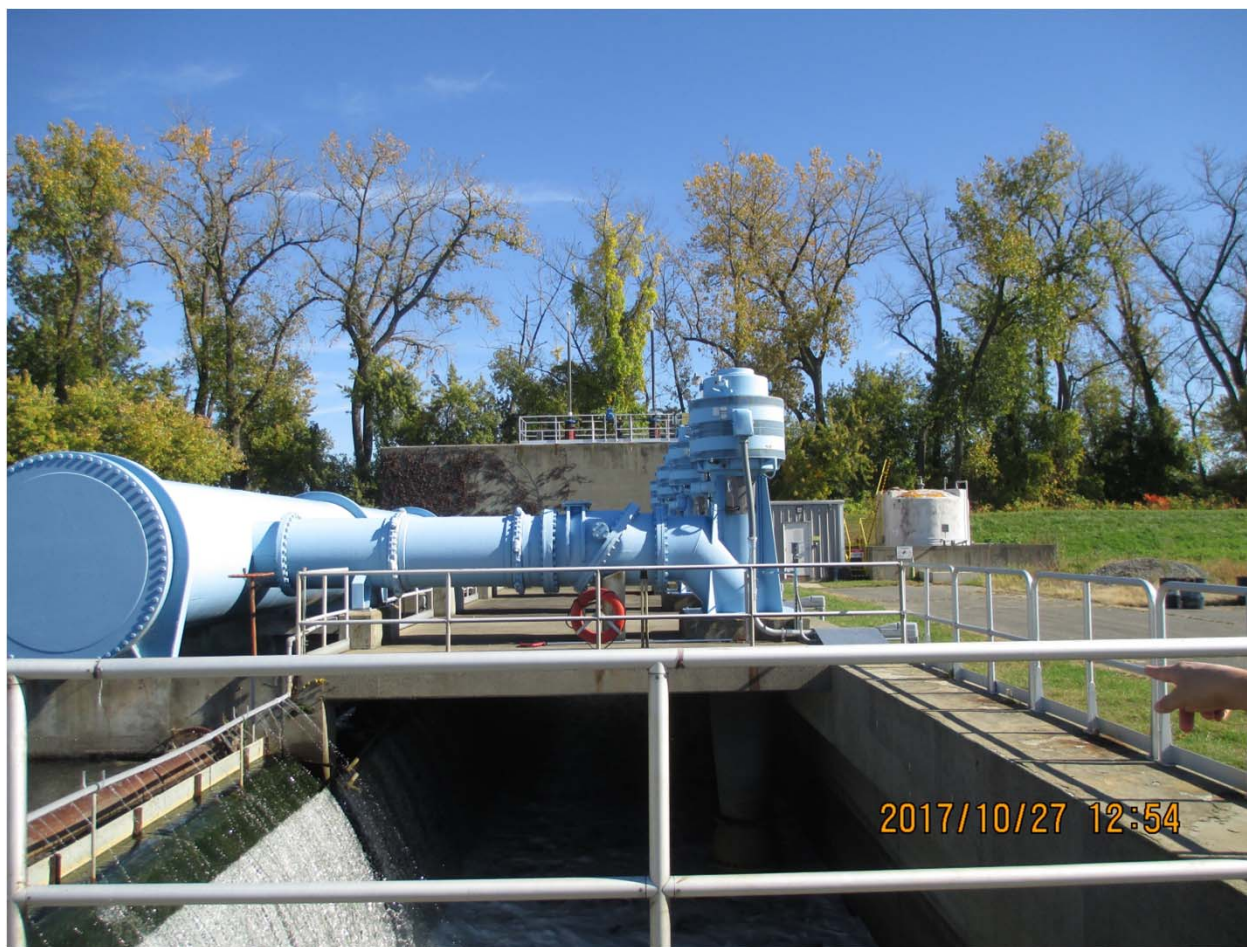
Number	Area	Subject
25	Disinfection and Discharge	Discharge channel and outfall pumps

Sodium bisulfite is added to the discharge of the chlorine contact chamber as it flows into the discharge channel (Photo 25). Sodium bisulfite is not dosed according to the total residual chlorine observed. According to facility representatives, when the facility attempted to meter the sodium bisulfate dose according to the total residual chlorine, the lag between the two led to unacceptable chlorine destruction when sodium bisulfate was under-applied. Now, a constant dose of sodium bisulfate sufficient to destroy the maximum anticipated residual chlorine is added.

Facility representatives stated that the water level in the discharge channel was approximately equivalent to the river water level. When river was levels increase, the facility activates its discharge pumps.

Compliance samples for fecal coliform bacteria and total residual chlorine are taken from the discharge channel. Facility representatives stated that it would be difficult to perform all compliance monitoring in the discharge channel because when the river is high, river water can enter the discharge channel.

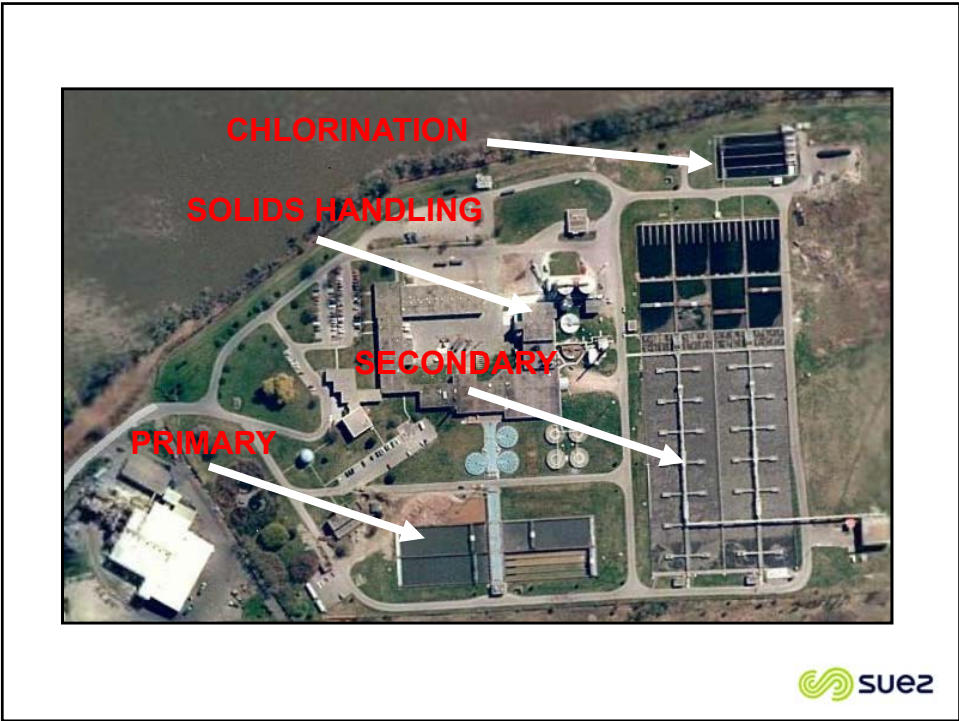
Attachment C - Secondary Bypass Location

The *Changes To The Process Control Strategy In 2015 To Present* presentation provided prior to the inspection was reviewed by Mr. Melcher. The presentation shows the location of the secondary bypass line. An excerpt of the presentation is provided in Attachment C.

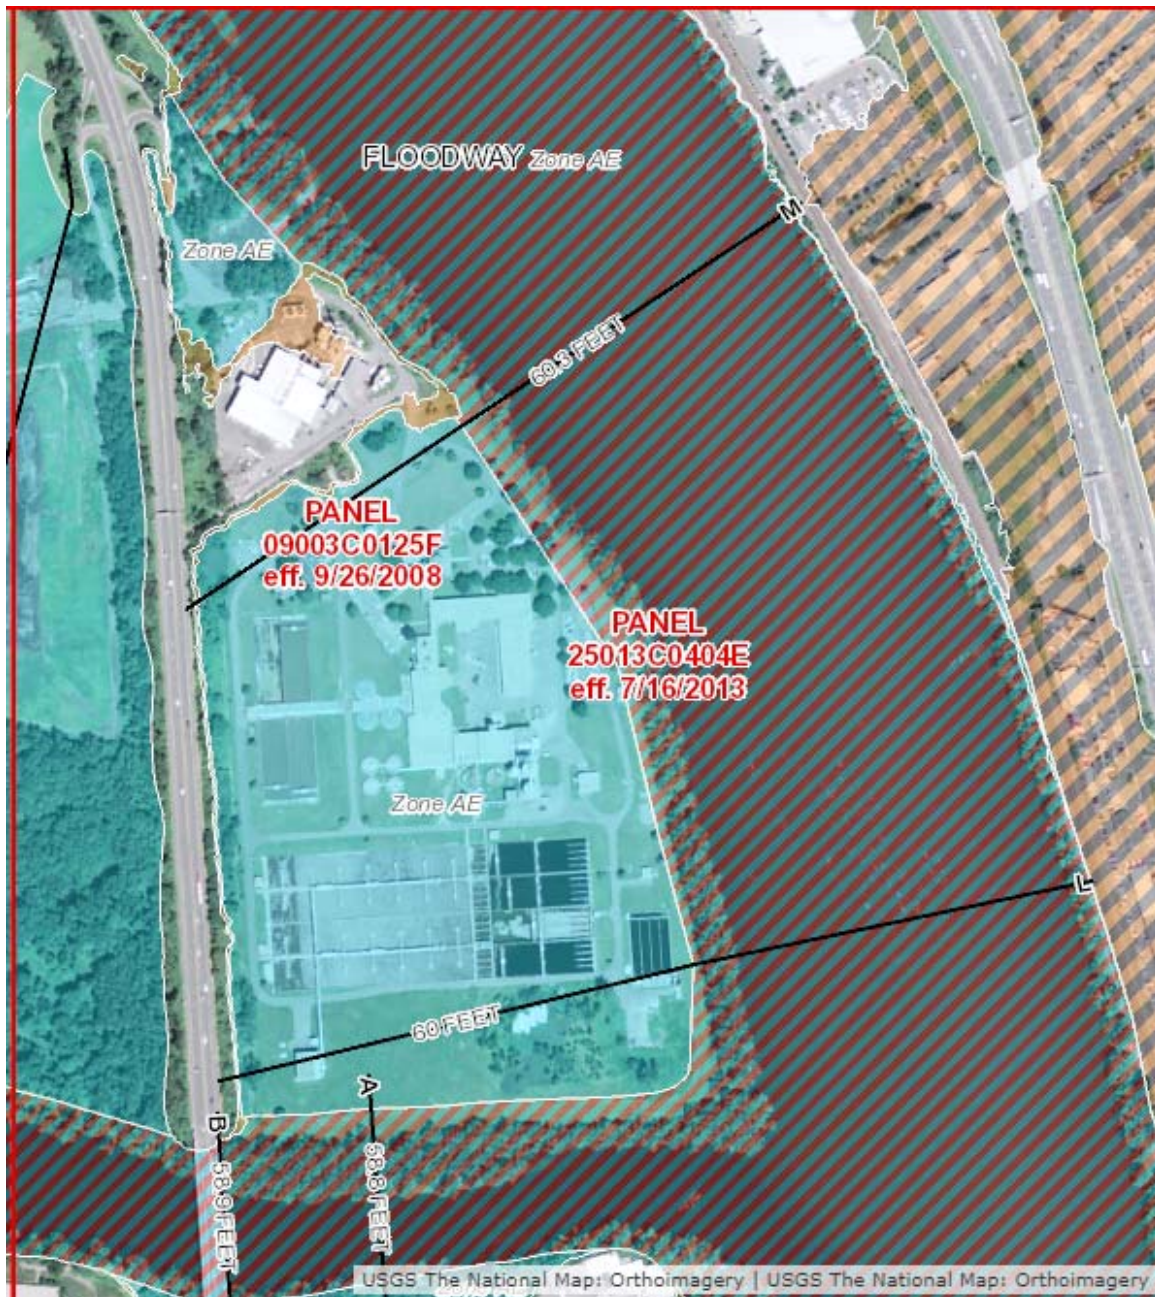
Attachment D - FEMA FIRM

The Flood Insurance Rate Map ("FIRM") prepared by the Federal Emergency Management Agency ("FEMA") for the area of the facility was reviewed by Mr. Melcher (an excerpt of which is provided in Attachment D). The FIRM shows a Special Flood Hazard Area in the area of the facility at an elevation of approximately 60 feet above sea level.

Mr. Nowak stated that a flood control dike was present providing flood protection for the facility. The dike provides protection to an elevation of 26 feet above the Springfield datum, which is 36.5 feet above sea level. The dike is maintained by the facility, not the Army Corps of Engineers.
