Subject: Town of Marion
Update on NPDES Permit Activities

Subject: Update on Marion Actions for Treatment Plant Upgrades

Subject: Progress Update: Marion WWTF Lagoon Water Budget

Re: Summary of Eelgrass MEP Information Aucoot Cove, July 2003.

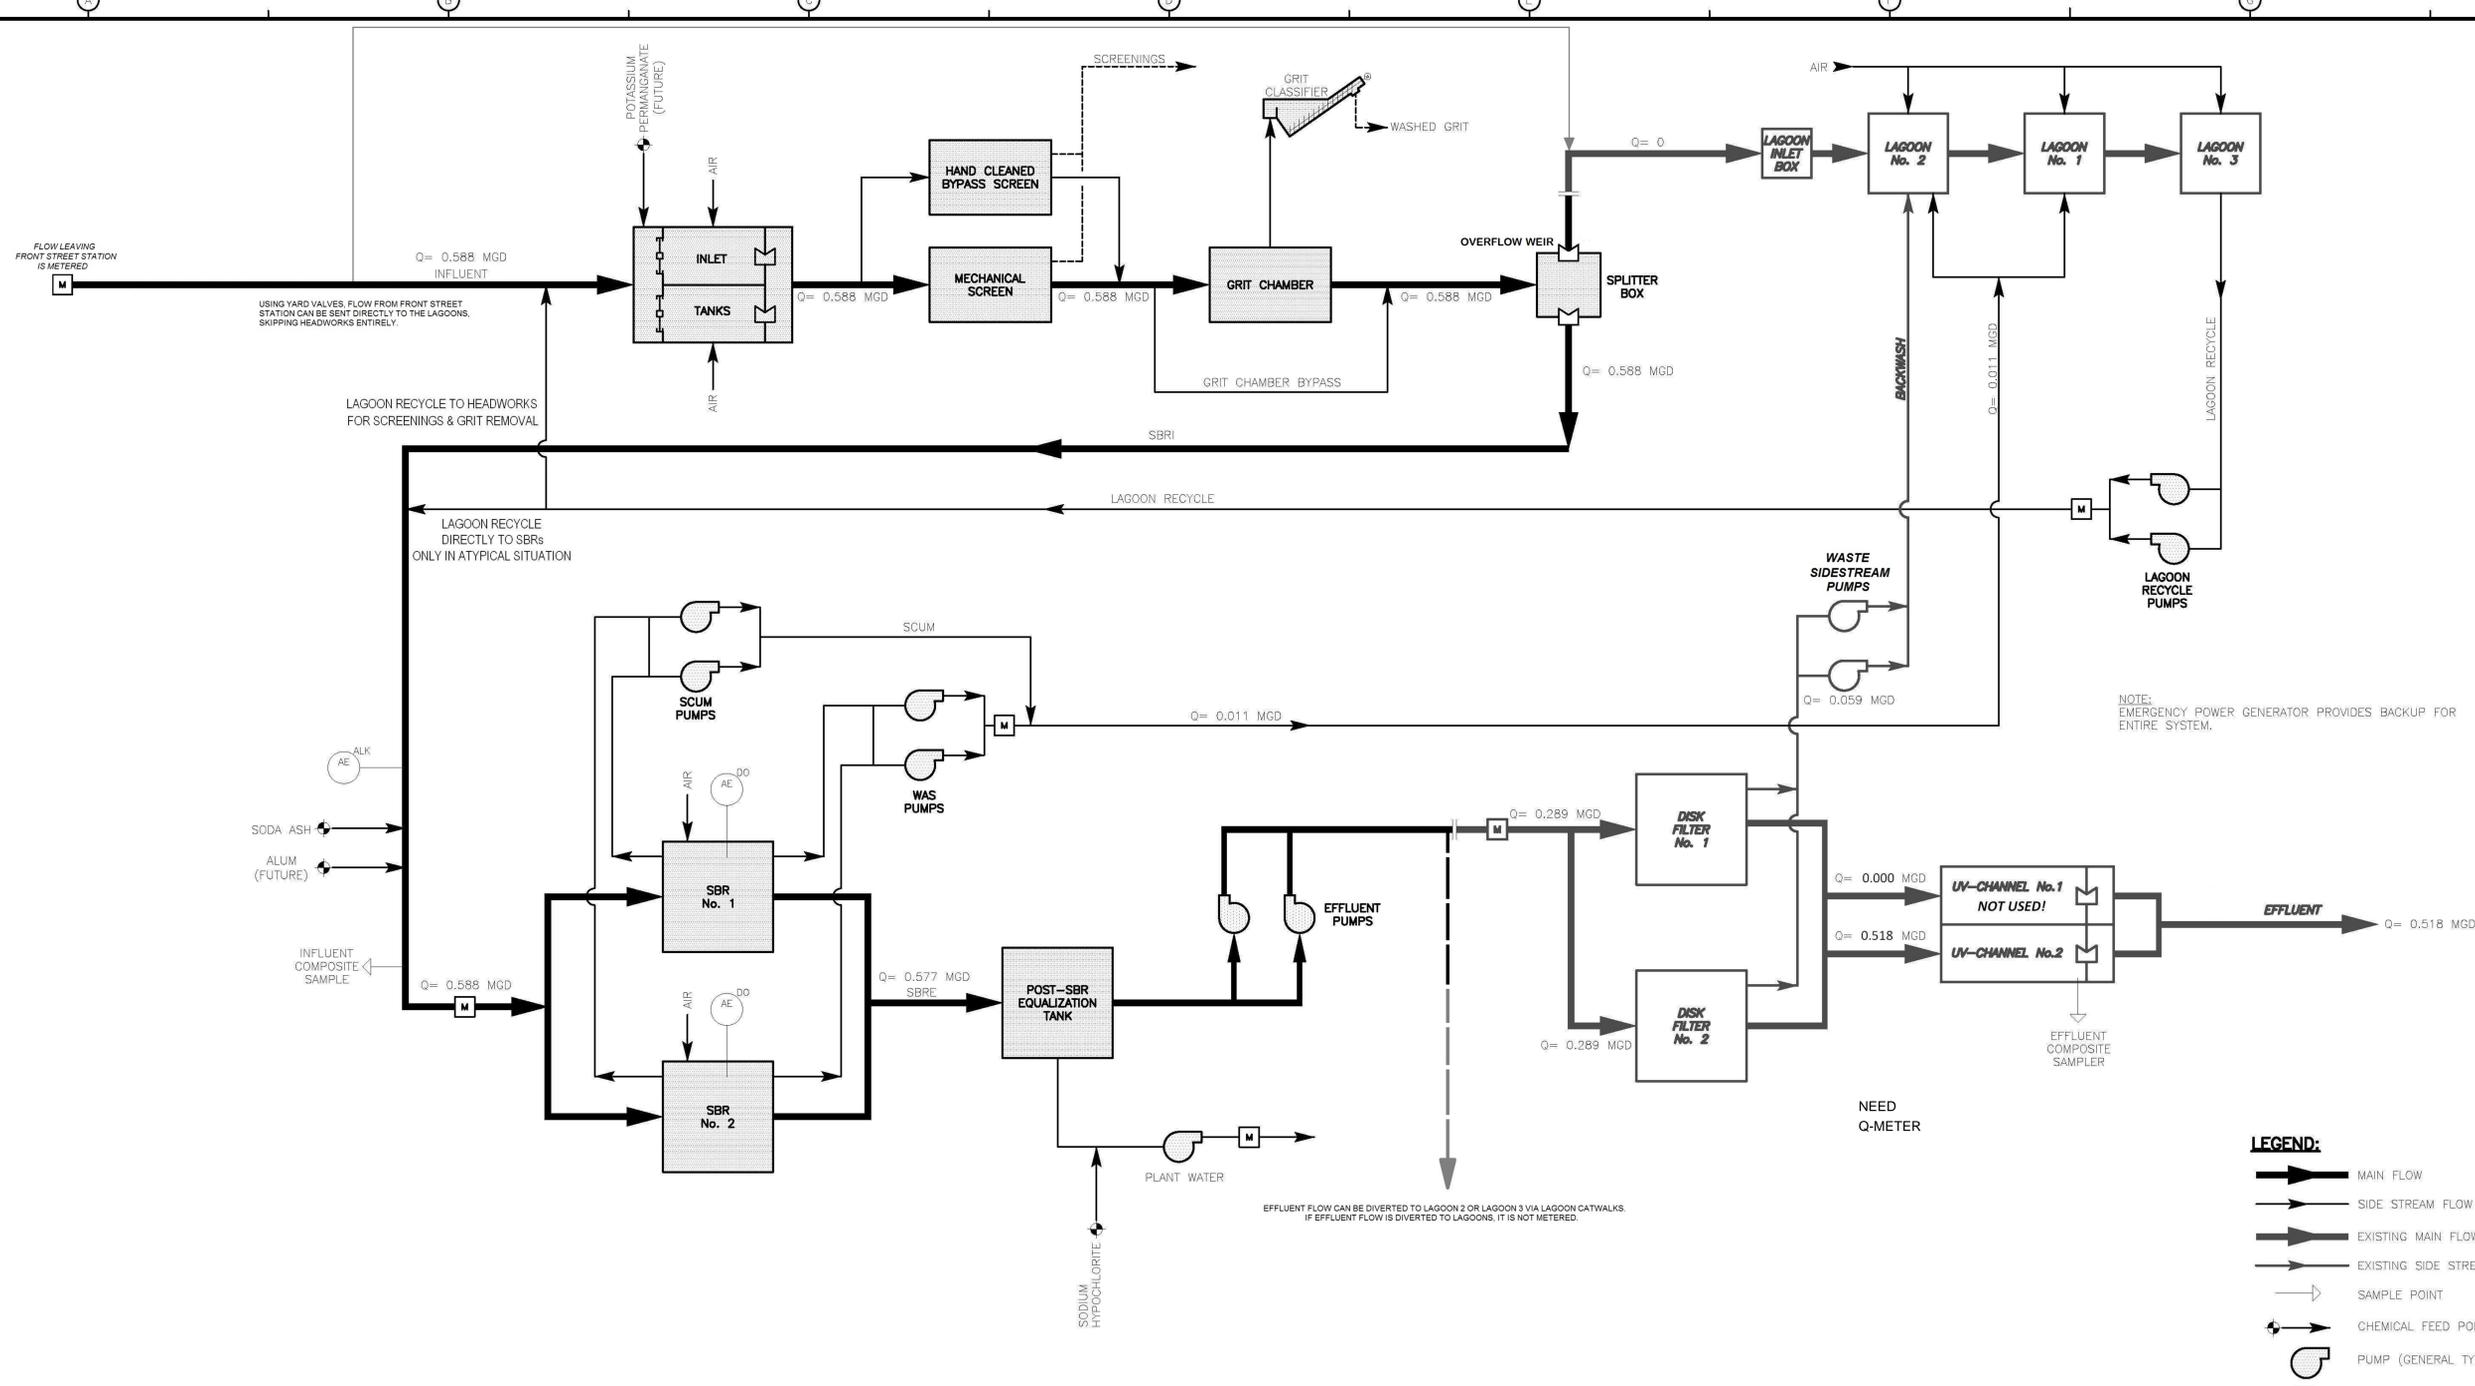
SHEET NO.
G-3

FUTURE PROCESS FLOW DIAGRAM AND DESIGN CRITERIA TABLE

A process diagram of the Marion WWTF is shown in Figure 1. Flow can enter the lagoons in several ways.

- Flow into the WWTF is metered at the Front Street Pump Station, located approximately $\frac{3}{4}$ mile from the headworks. The influent flow passes through the bar screen and grit chamber and then enters a splitter box that can direct flow either into the plant's two SBRs or into the lagoons; flow is directed into the lagoons during wet weather when the influent flow exceeds the treatment capacity at the plant. The volume diverted into the lagoons is unmetered, and is computed as the difference between the daily total at the Front St. Pump Station and the plant's influent flow meter, located immediately before the SBR tanks.

- Waste activated sludge from the SBR tanks is pumped into the lagoons via a metered pump.
- A diversion just prior to the effluent flow meter, the disk filters, and the UV channel can send partially treated effluent back into the lagoons. This is done to maintain volume in the lagoons and to maintain the disk filter and UV treatment apparatus. This diversion is not directly metered; flow sent to the lagoons through this diversion is estimated as the influent minus the WAS pumped flow and the effluent flow.

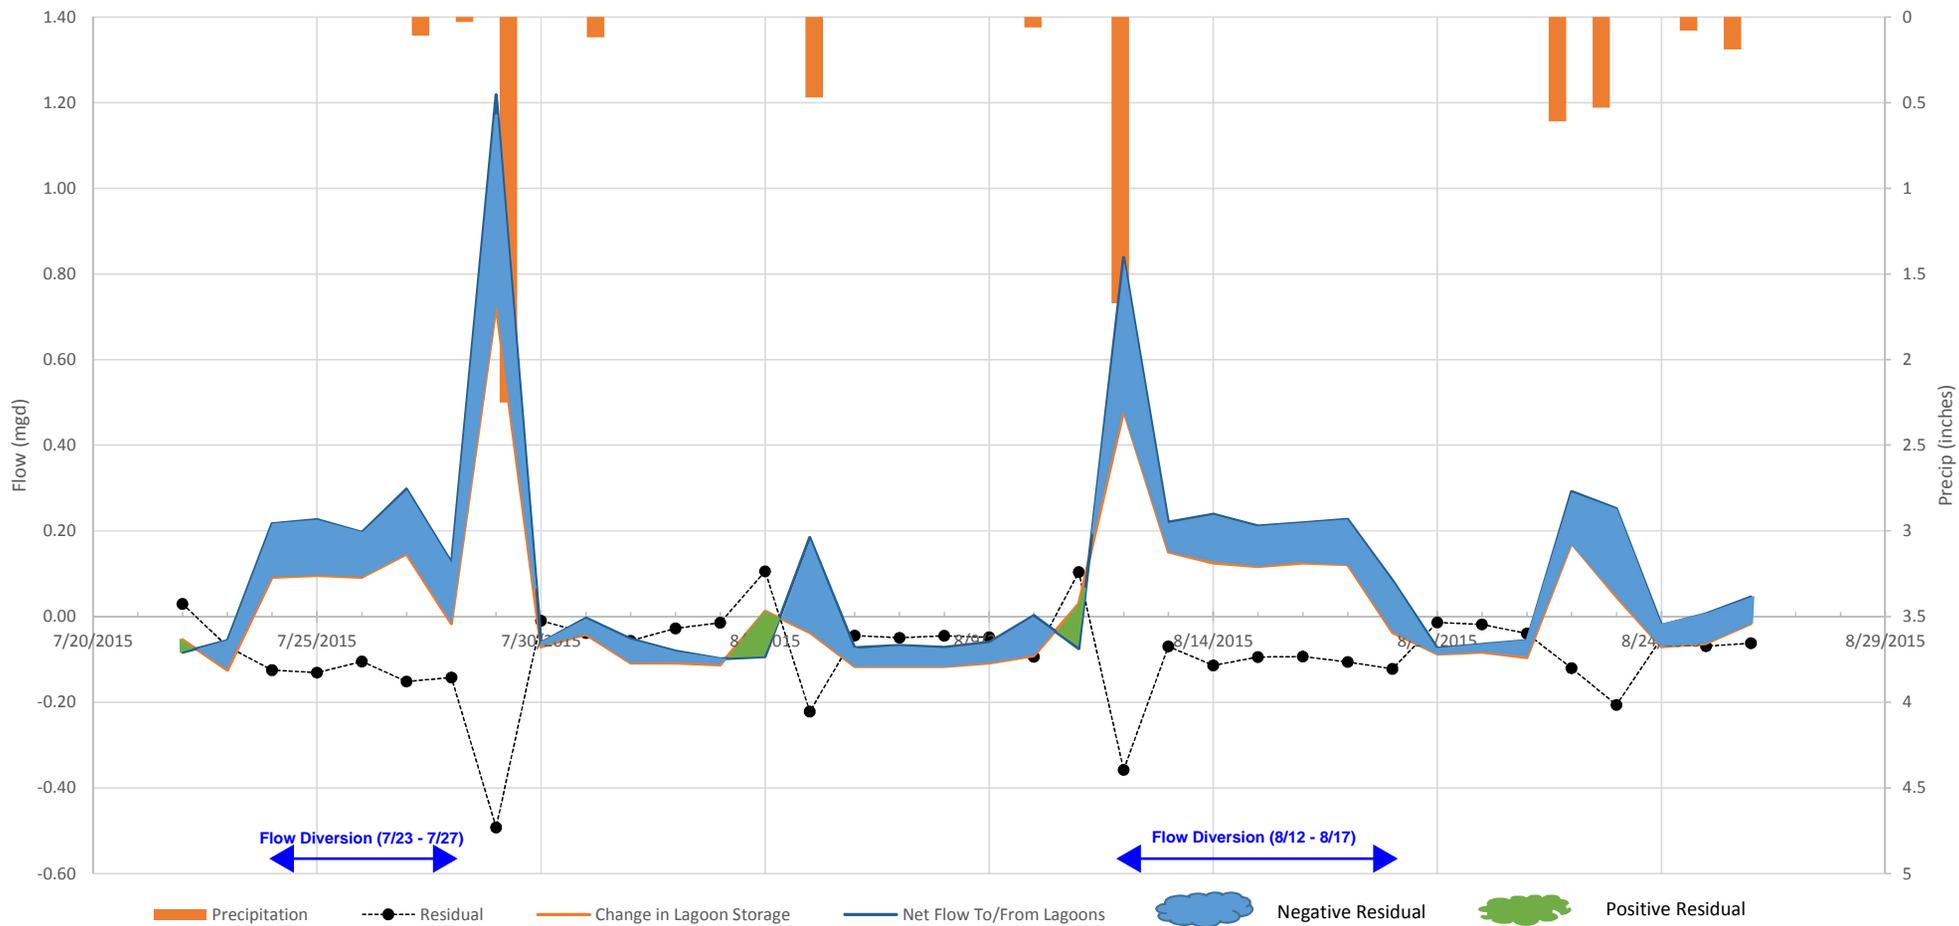
Marion Flow Balance - July - August 2015

The results of the water balance are noisy when examined on a daily basis, but if we look at the trends in the data we can see some general patterns. Figure 2 shows the net flow to or from the lagoons plotted against the change in lagoon storage, and the residual flow, which is the volume that can be attributed to infiltration and error in the precipitation, evaporation, and metering data. The blue shaded areas indicate a negative residual, suggesting infiltration, overestimated precipitation, or underestimated evaporation; the green shaded areas indicate a positive residual, suggesting underestimated precipitation or overestimated evaporation.

The timeseries shown in Figure 2 indicates that the largest negative residual – flow either lost to infiltration or error in the hydrology – occurs during precipitation events. This suggests that the error is caused by inadequate precipitation data. The precipitation falls across a 20 acre area, so it is possible that the geographic distribution of precipitation is not constant across the entire lagoon area. This is especially likely during summer thunderstorms, where intense precipitation can occur over a very small area. The larger errors also occur during the periods when treated effluent is discharged to the lagoons. This could indicate errors due to the timing of the transfer, where the majority of the flow measurements are from 8 AM to 8 AM, whereas the transfer occurs during a subset of a day because it does not start at the beginning of a metering day. Smaller residuals – both positive and negative - occur during periods of no precipitation and no inflow to the lagoons. These are more likely indicative of the actual hydrologic conditions in the lagoons, where the result is separated from the estimated inflow to the lagoons as well as the precipitation measurements.

While the results are preliminary and the time period considered in this analysis is limited, water balance results in Figure 2 during periods where no precipitation falls suggest a relatively consistent negative flow residual. This suggests the following.

- The lagoons may be leaking a small amount of flow. During periods where there is no significant inflow or precipitation, the residual loss term is on the order of 0.01 to 0.05 mgd. This underestimated flow is a relatively small term in the water budget compared to the diverted flows to and from the WWTF. Other potential reasons for this discrepancy are a systematic bias in the evaporation estimates in August or underestimated flow into the lagoons.

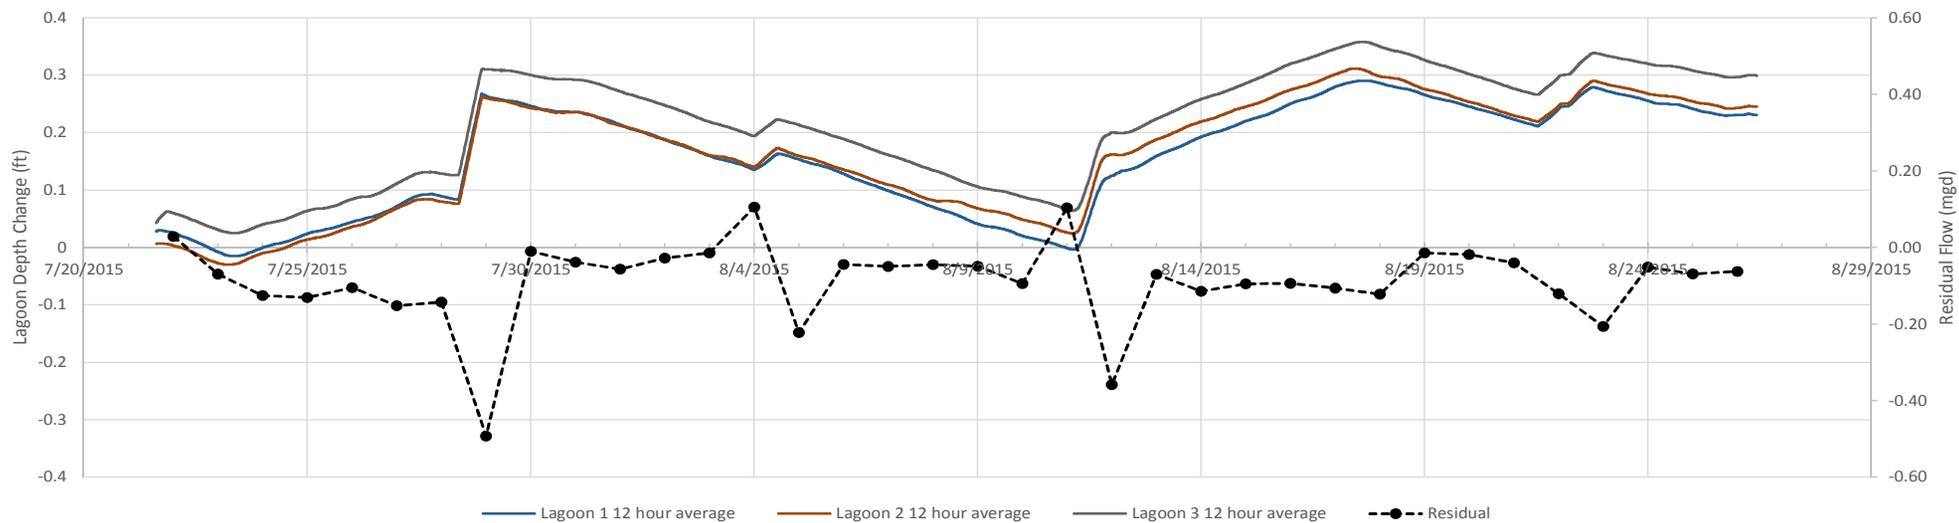
Marion Lagoon Depth

Based on the many sources of uncertainty in the preliminary water balance, we added high-resolution depth sensors to the lagoons to accurately measure the depth change at 10-minute intervals within +/- 0.001 feet, and refined the approach for estimating evaporation from the surface of the lagoons. The three lagoon depth meters were installed on July 21, 2015.

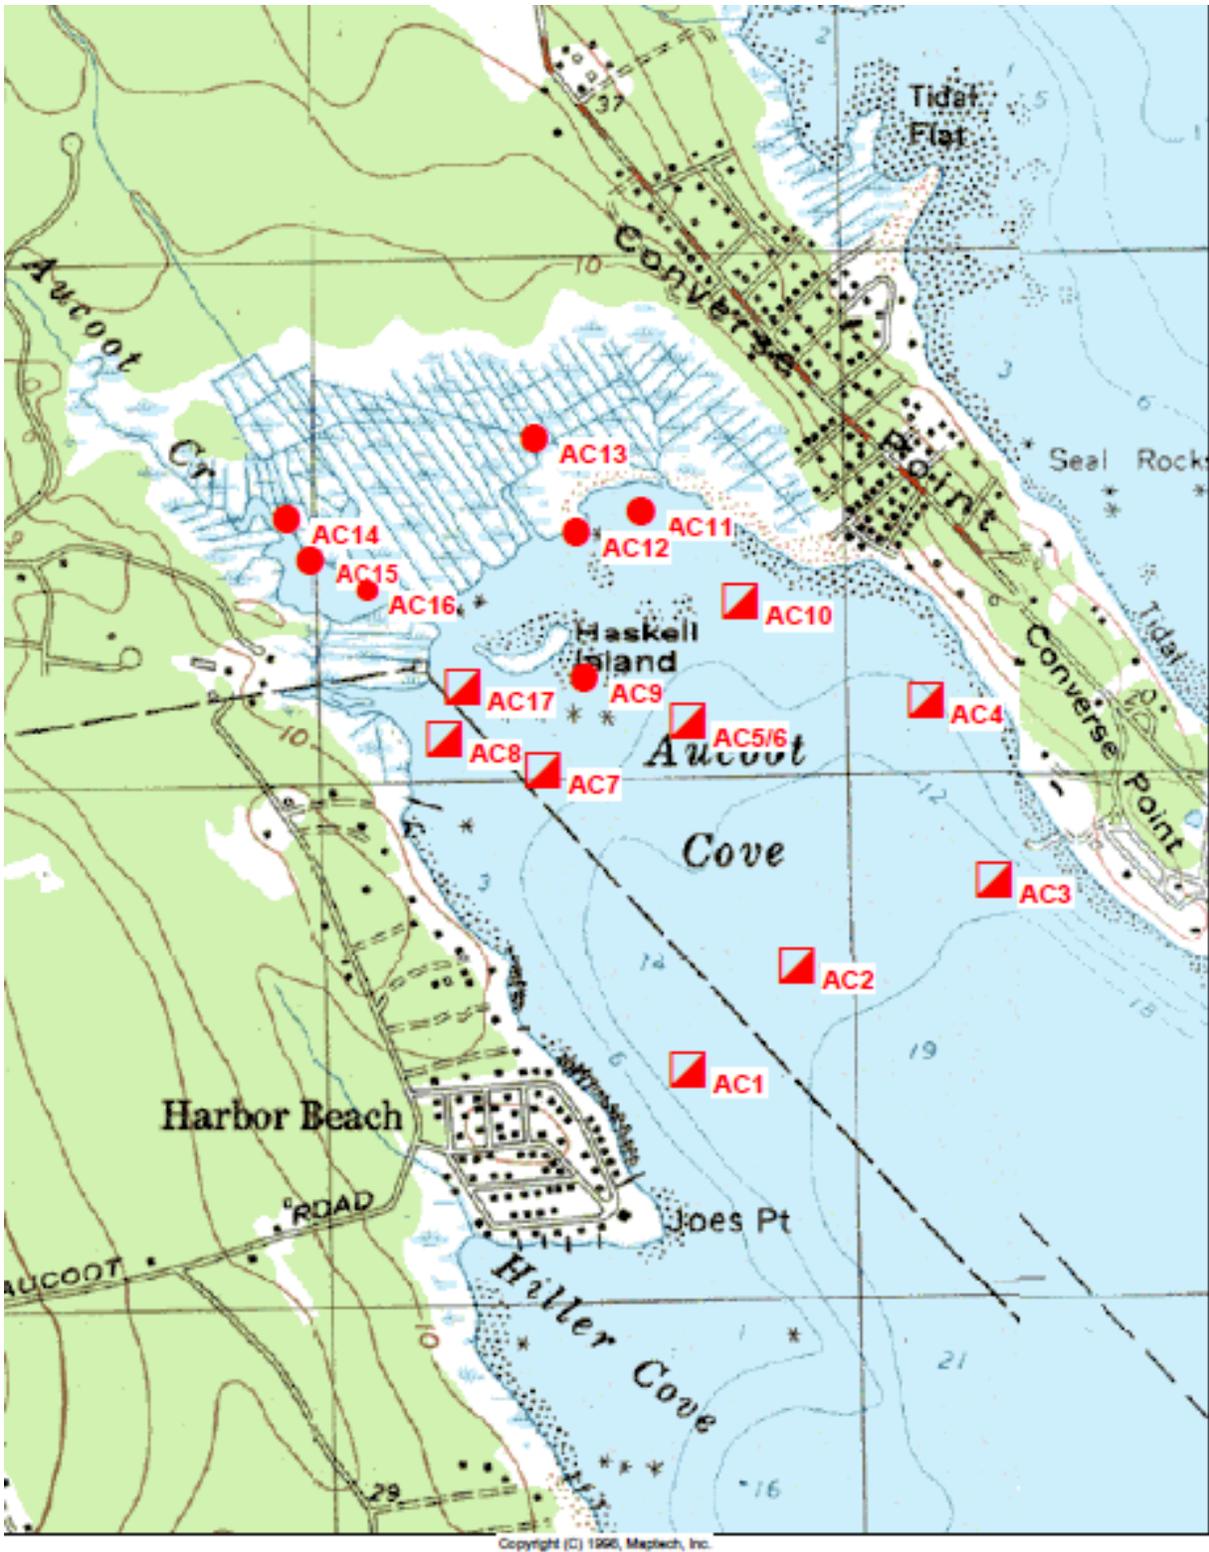
Figure 1. Aucoot Cove sampling locations for sediment survey (all points) and benthic animal survey (boxes) by CSP-SMAST scientists in July and November 2003, respectively.

The field data collection program was part of the SCUBA diver survey for sediment collection and the survey of benthic animal communities. The survey results are “point” surveys, with the divers covering about a 5 meter diameter area. Observations were recorded in the field when the diver’s surfaced. Eelgrass presence/absence was recorded along with the relative density (sparse, medium, high density) and whether epiphytes were present and if the blades were intact, senescing, etc. What follows is a synthesis of these observations. The stations were determined by GPS.

Marsh Associated Sites (AC11 thru AC16): No eelgrass was observed in either survey. This is consistent with MEP observations of the lack of eelgrass habitat associated with salt marsh creeks. For depth reasons, there was not a station between the marsh edge and Haskell Island. However, the proximity of the marsh and lack of eelgrass at AC16, AC12 and AC11 suggest that this is not likely eelgrass habitat. Direct evidence is not available.

Inner Aucoot Cove Sites (AC4 thru AC10, AC17): Most of the eelgrass habitat in Aucoot Cove was found in the main open water basin outside of Haskell Island generally at depths <4 meters with Secchi depths of 3 meters. The exception was AC4 which due to circulation has eelgrass at 5.1 meters and a 5.1 meter Secchi depth.

Outer Aucoot Cove Sites (AC1 thru AC3): No eelgrass was found in the outer basin and water depths were 6.1 meters. The lack of eelgrass may result from the deeper waters and Secchi depths of 2.1 – 2.5 meters.
