Subject: Town of Marion
Update on NPDES Permit Activities

Subject: Update on Marion Actions for Treatment Plant Upgrades

Subject: Progress Update: Marion WWTF Lagoon Water Budget

Re: Summary of Eelgrass MEP Information Aucoot Cove, July 2003.

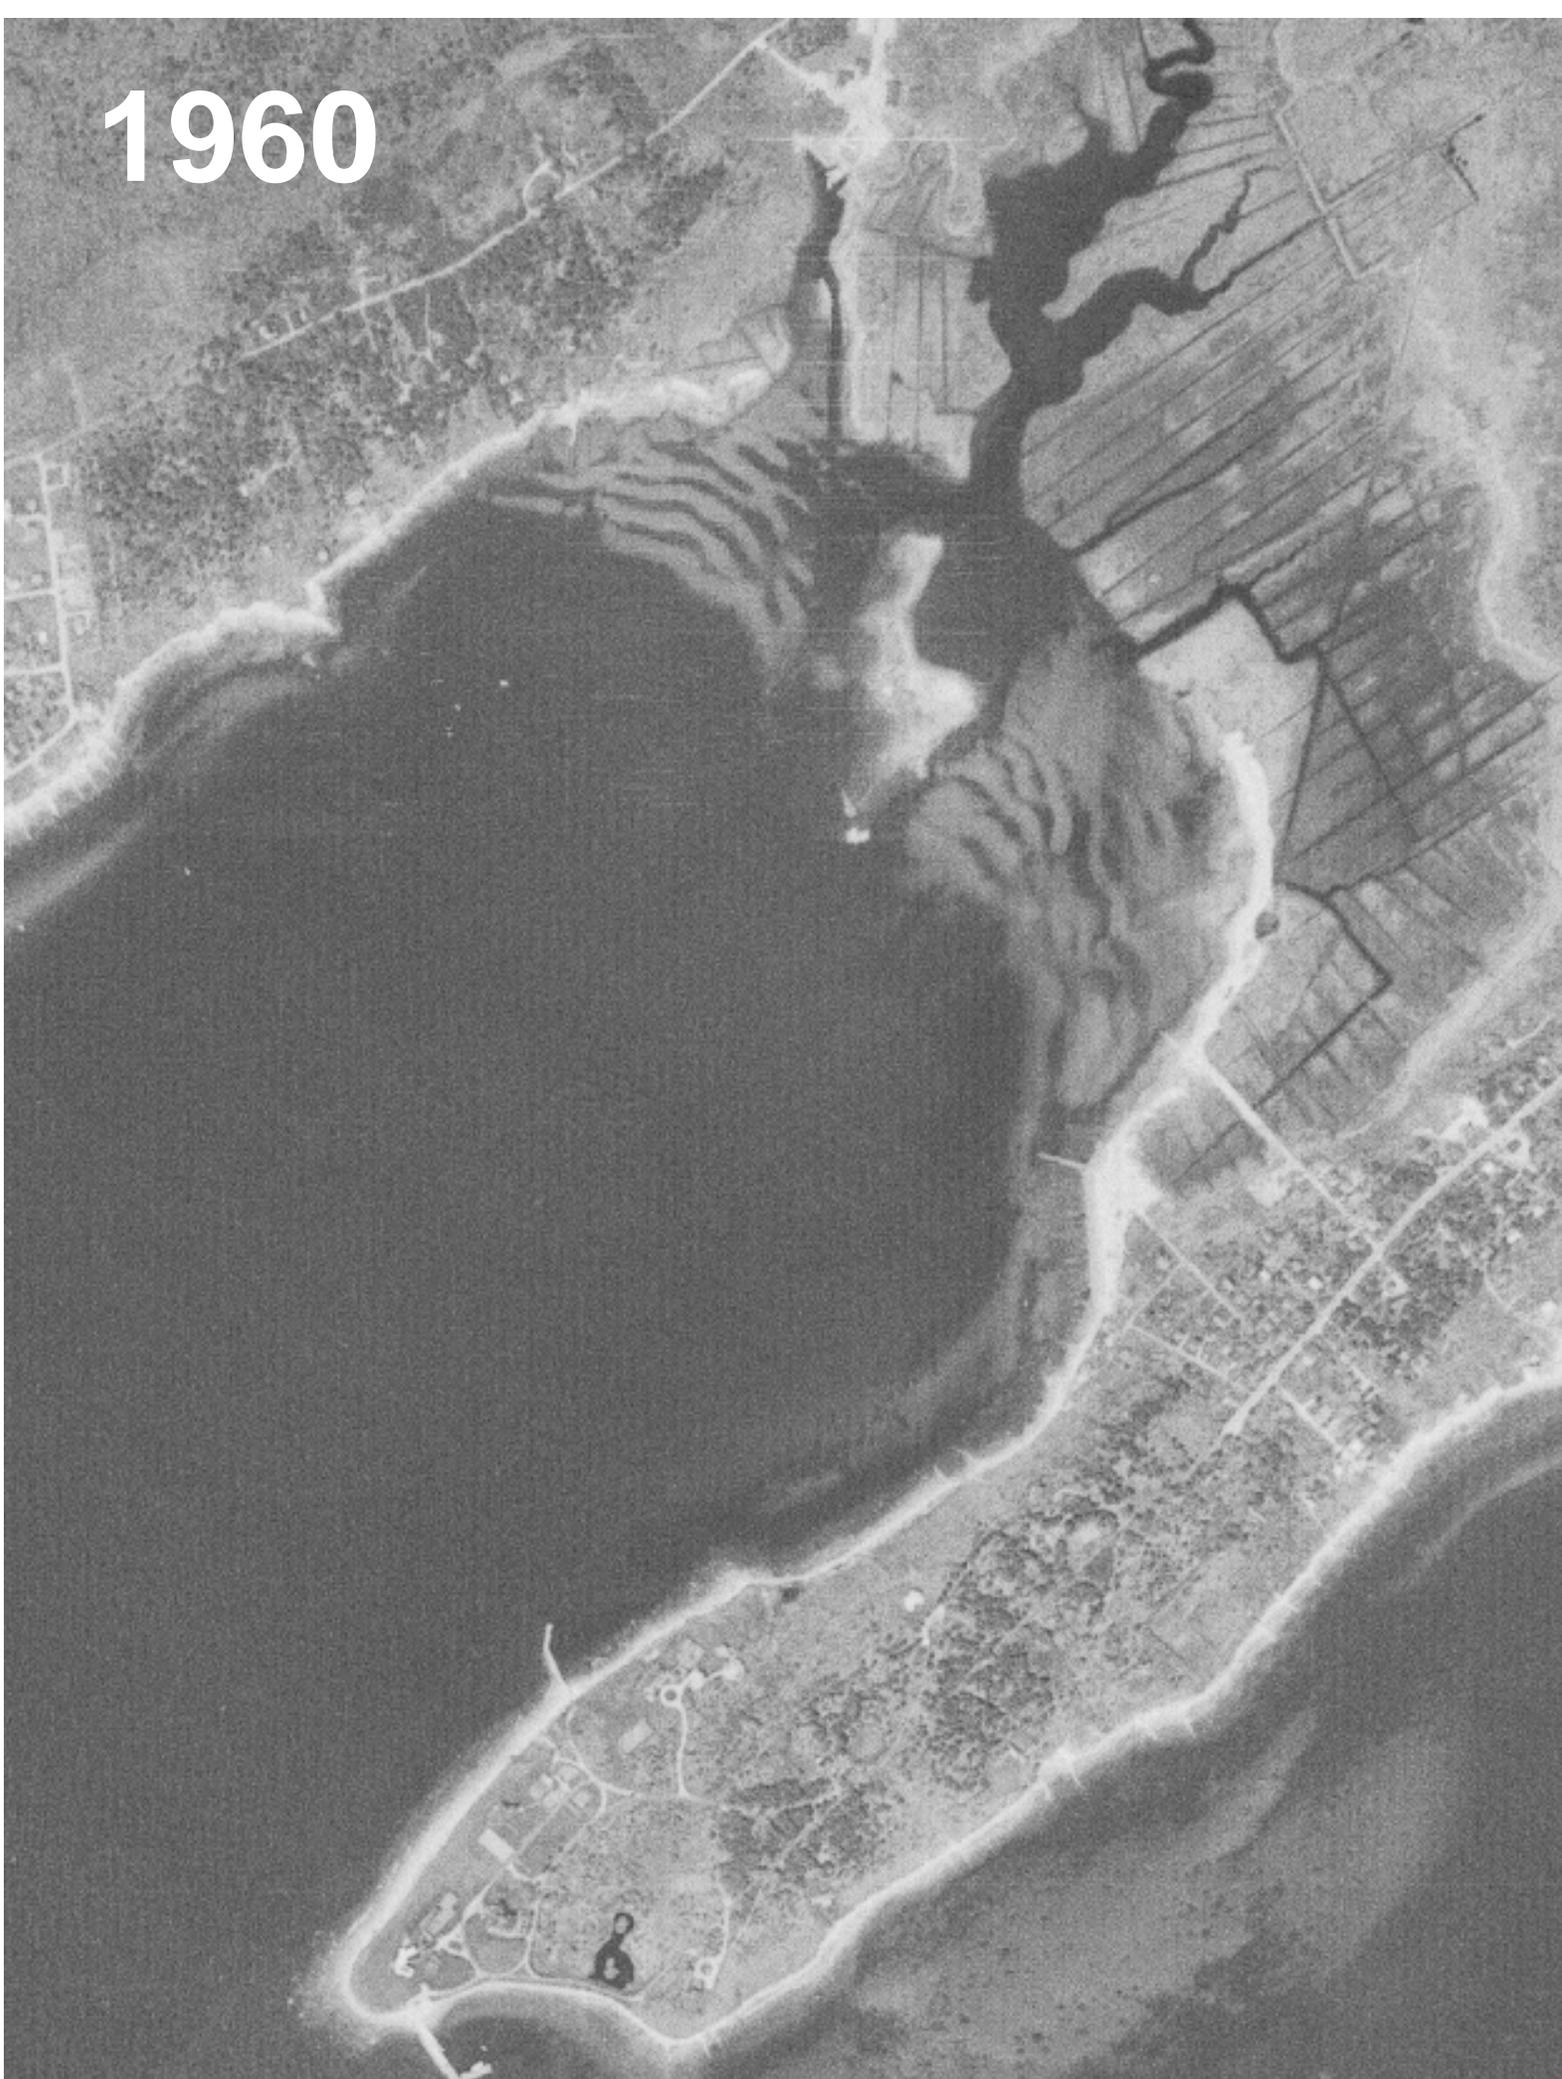
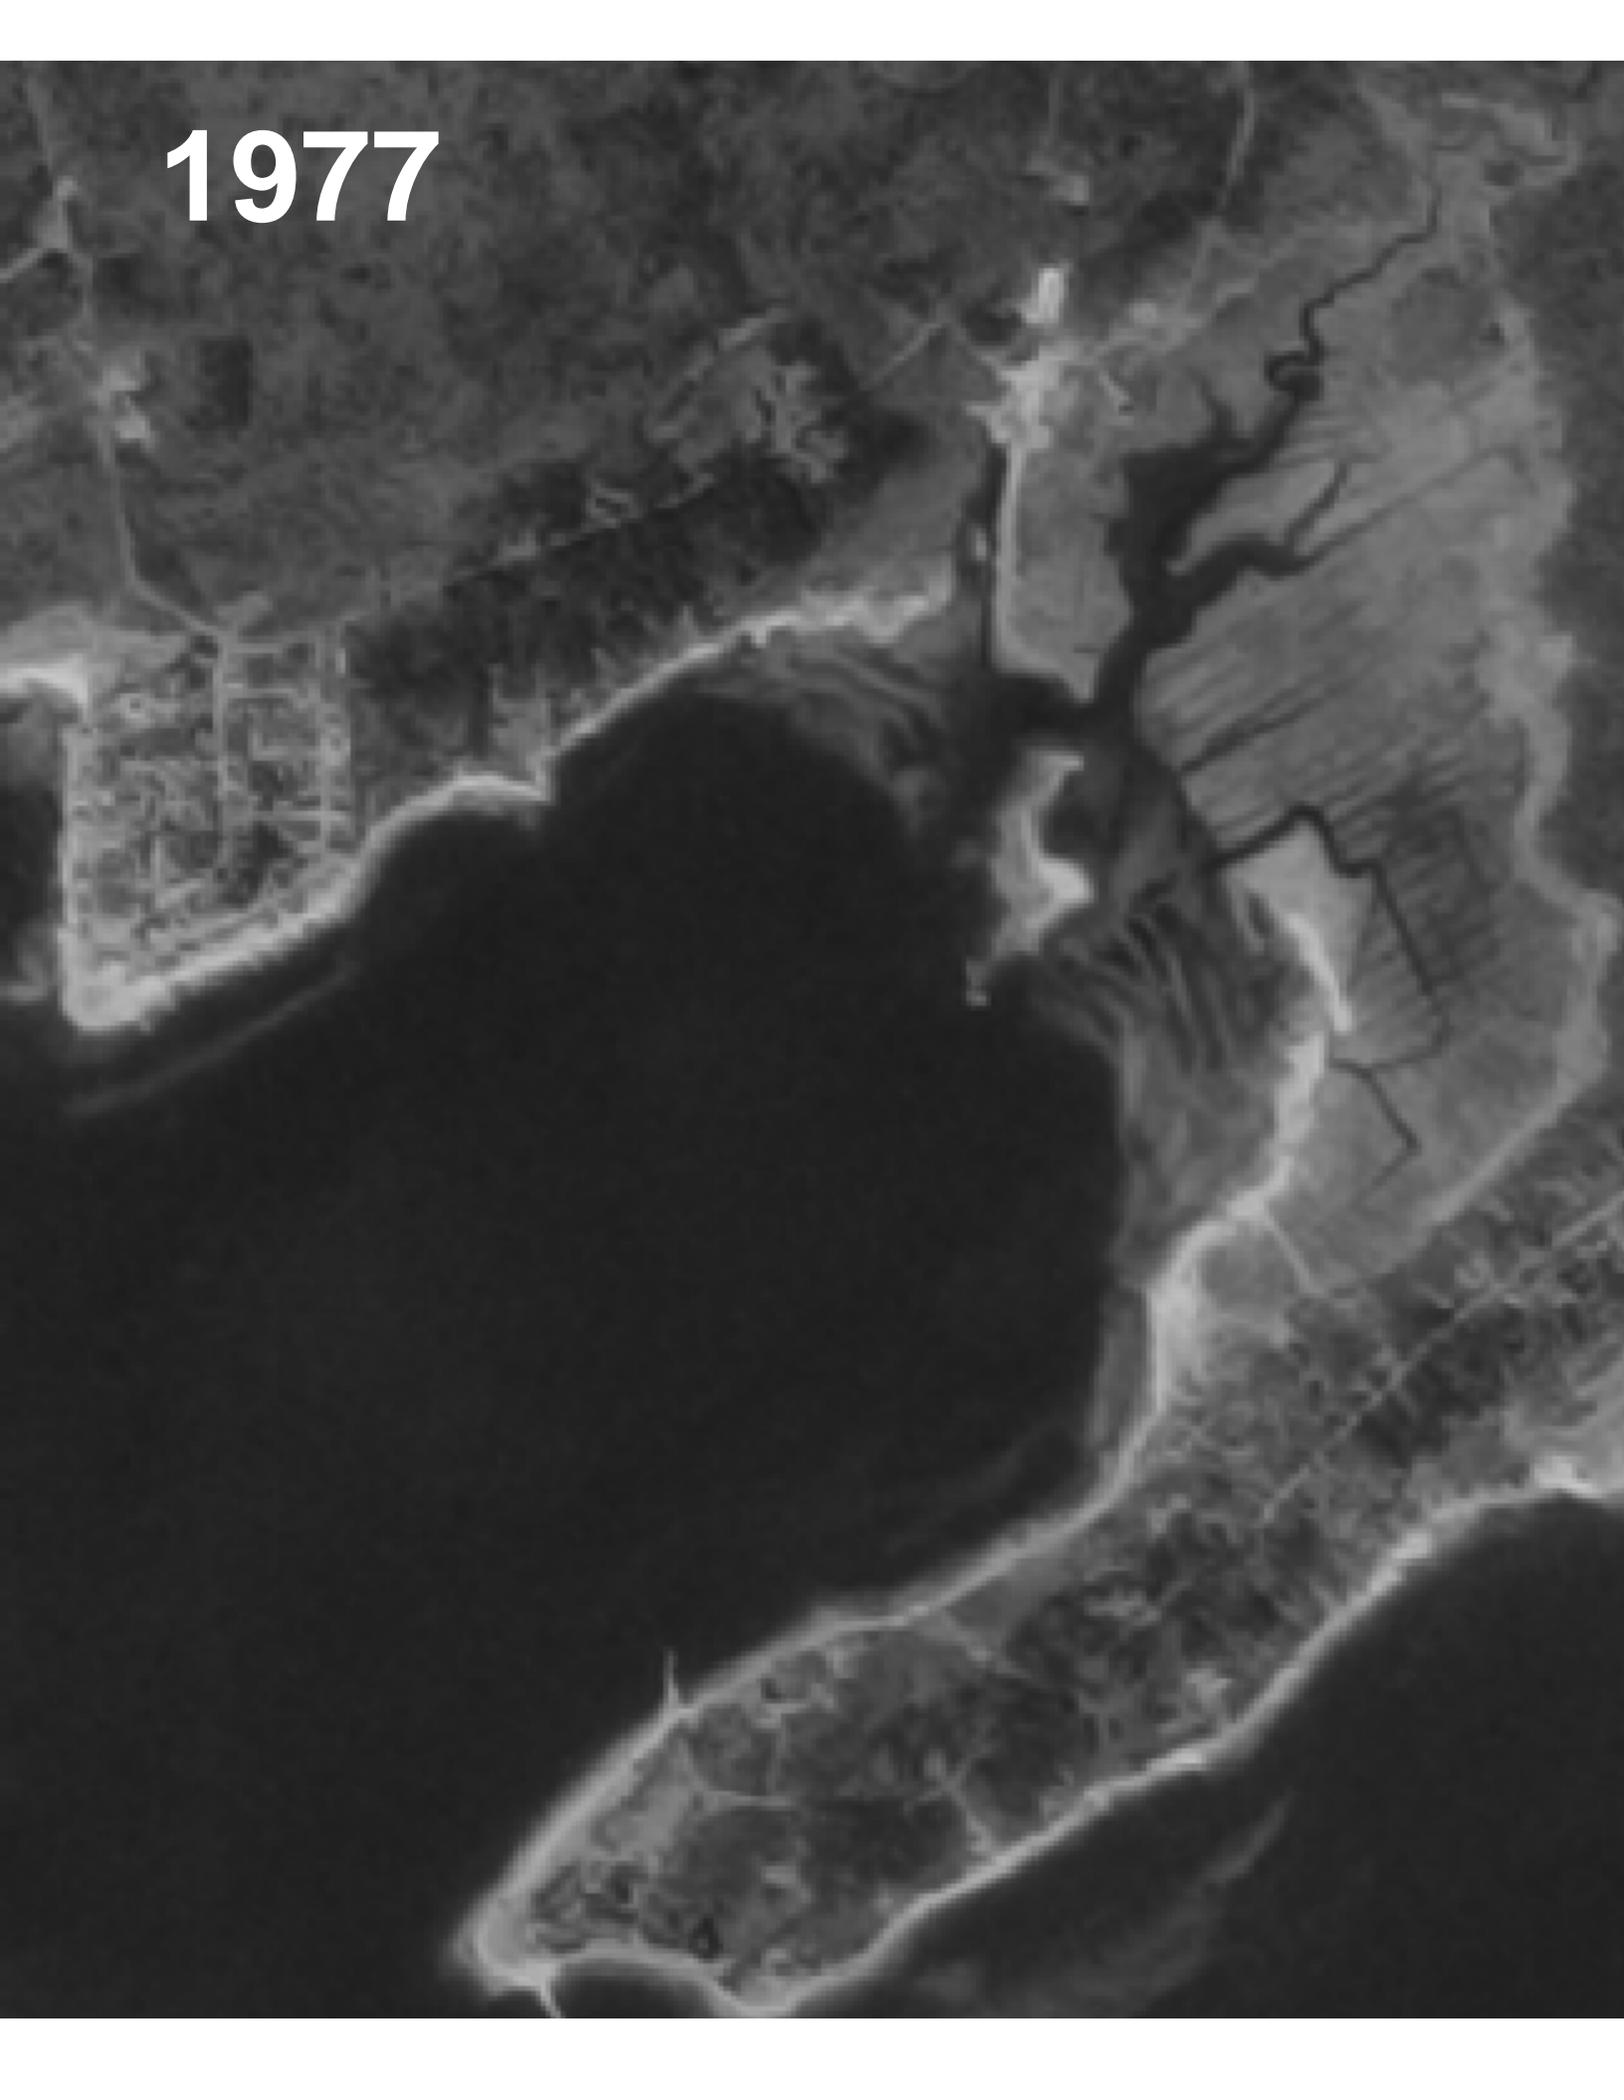
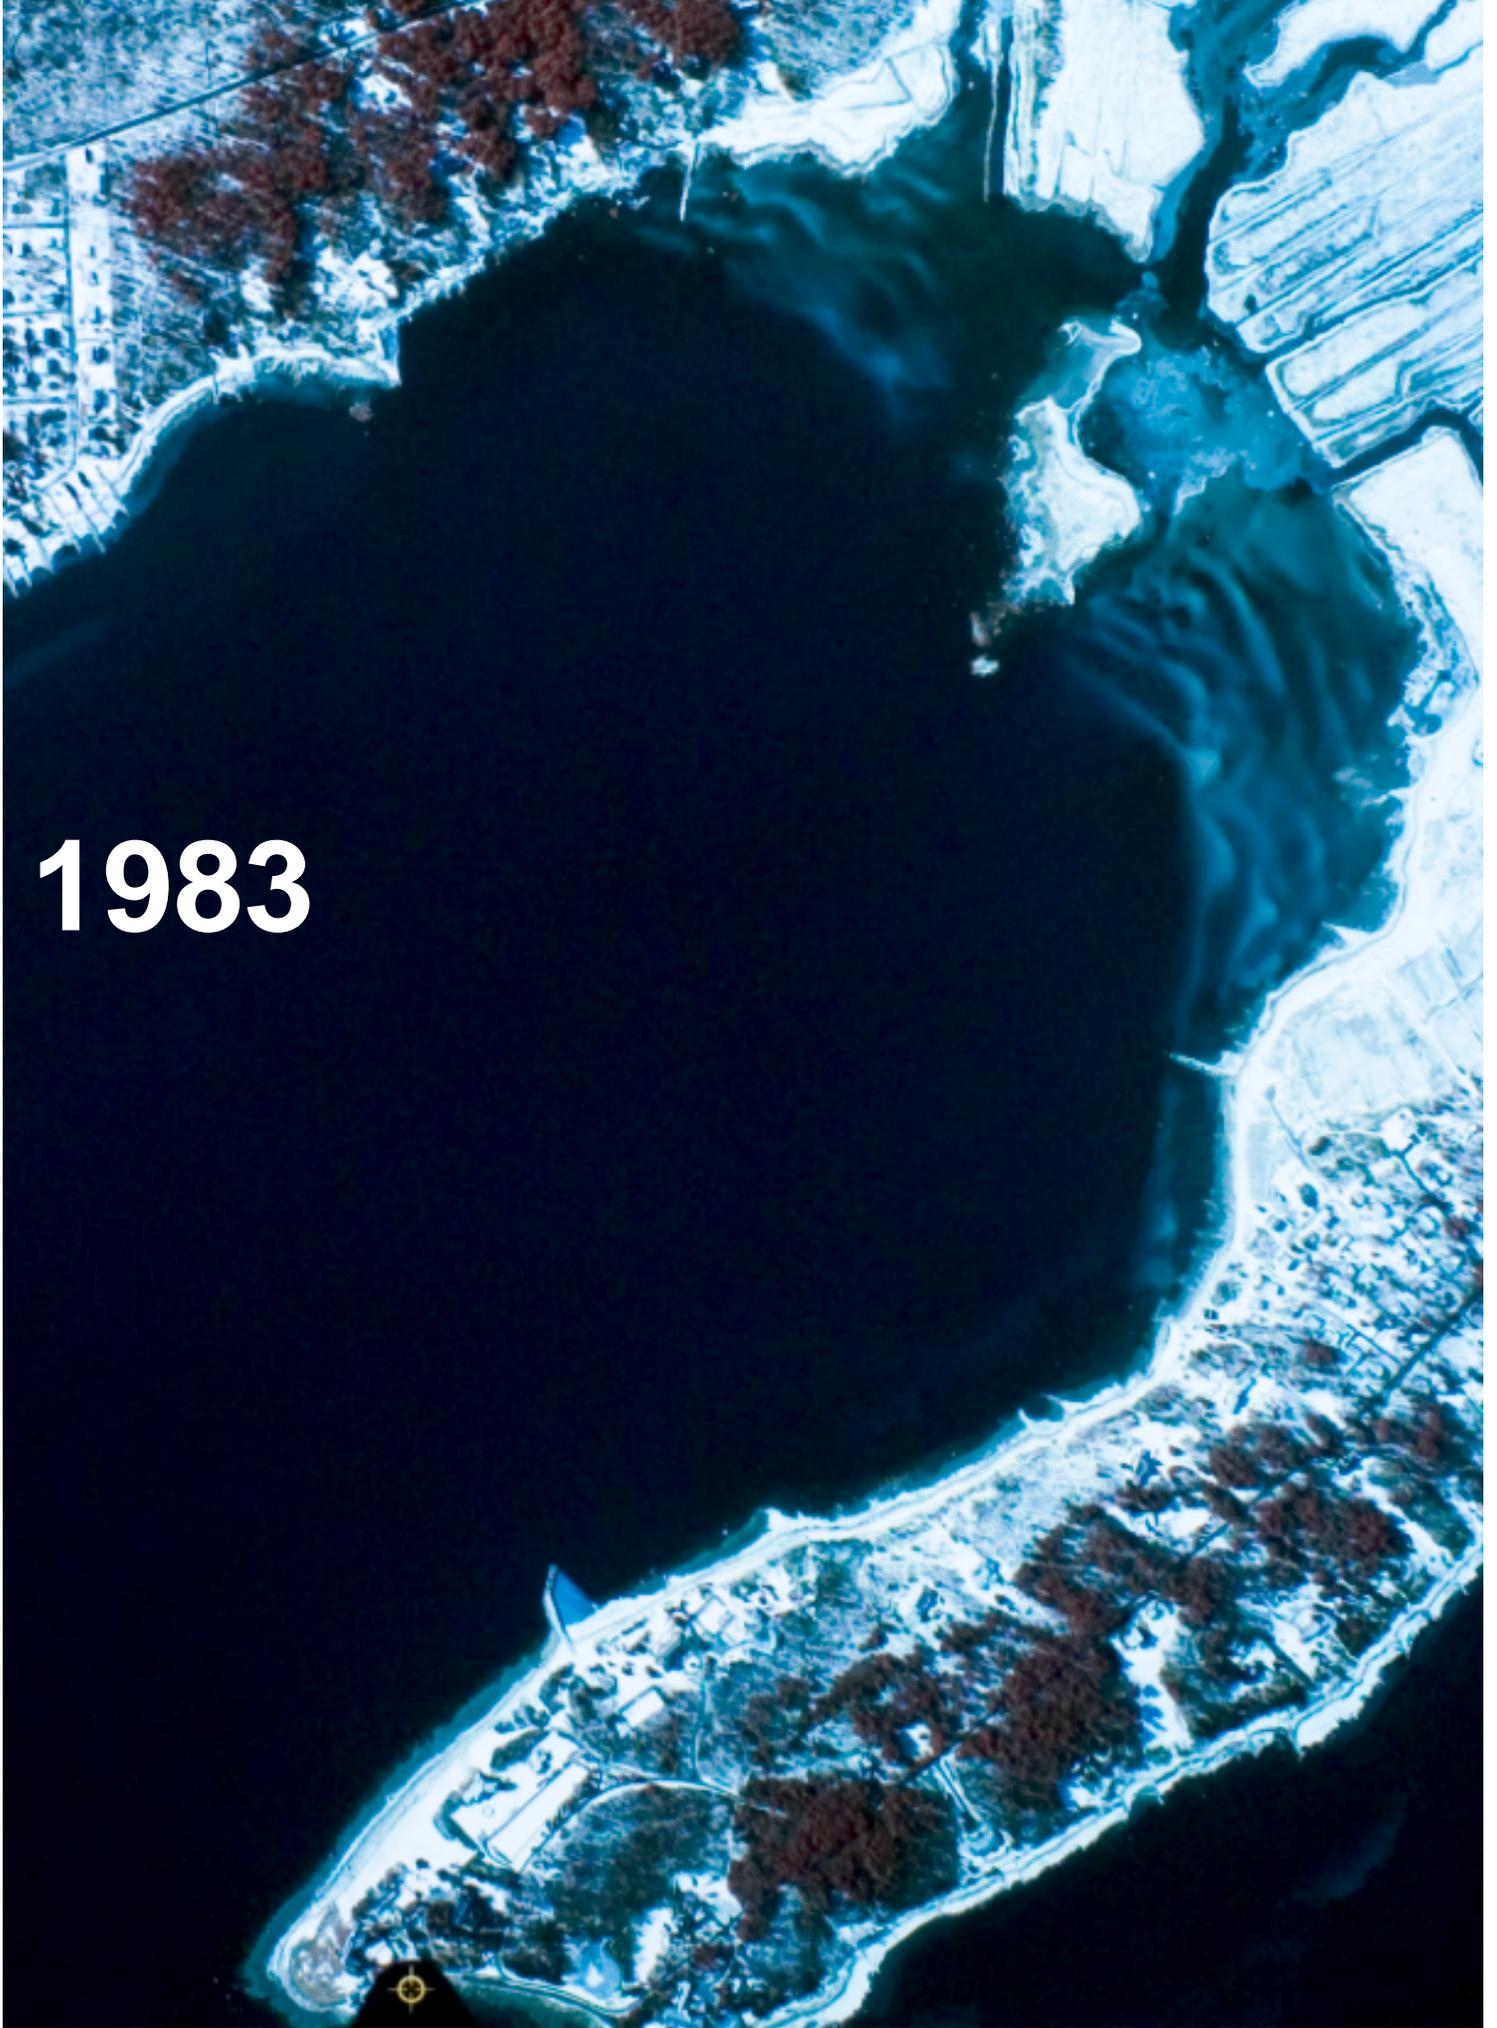
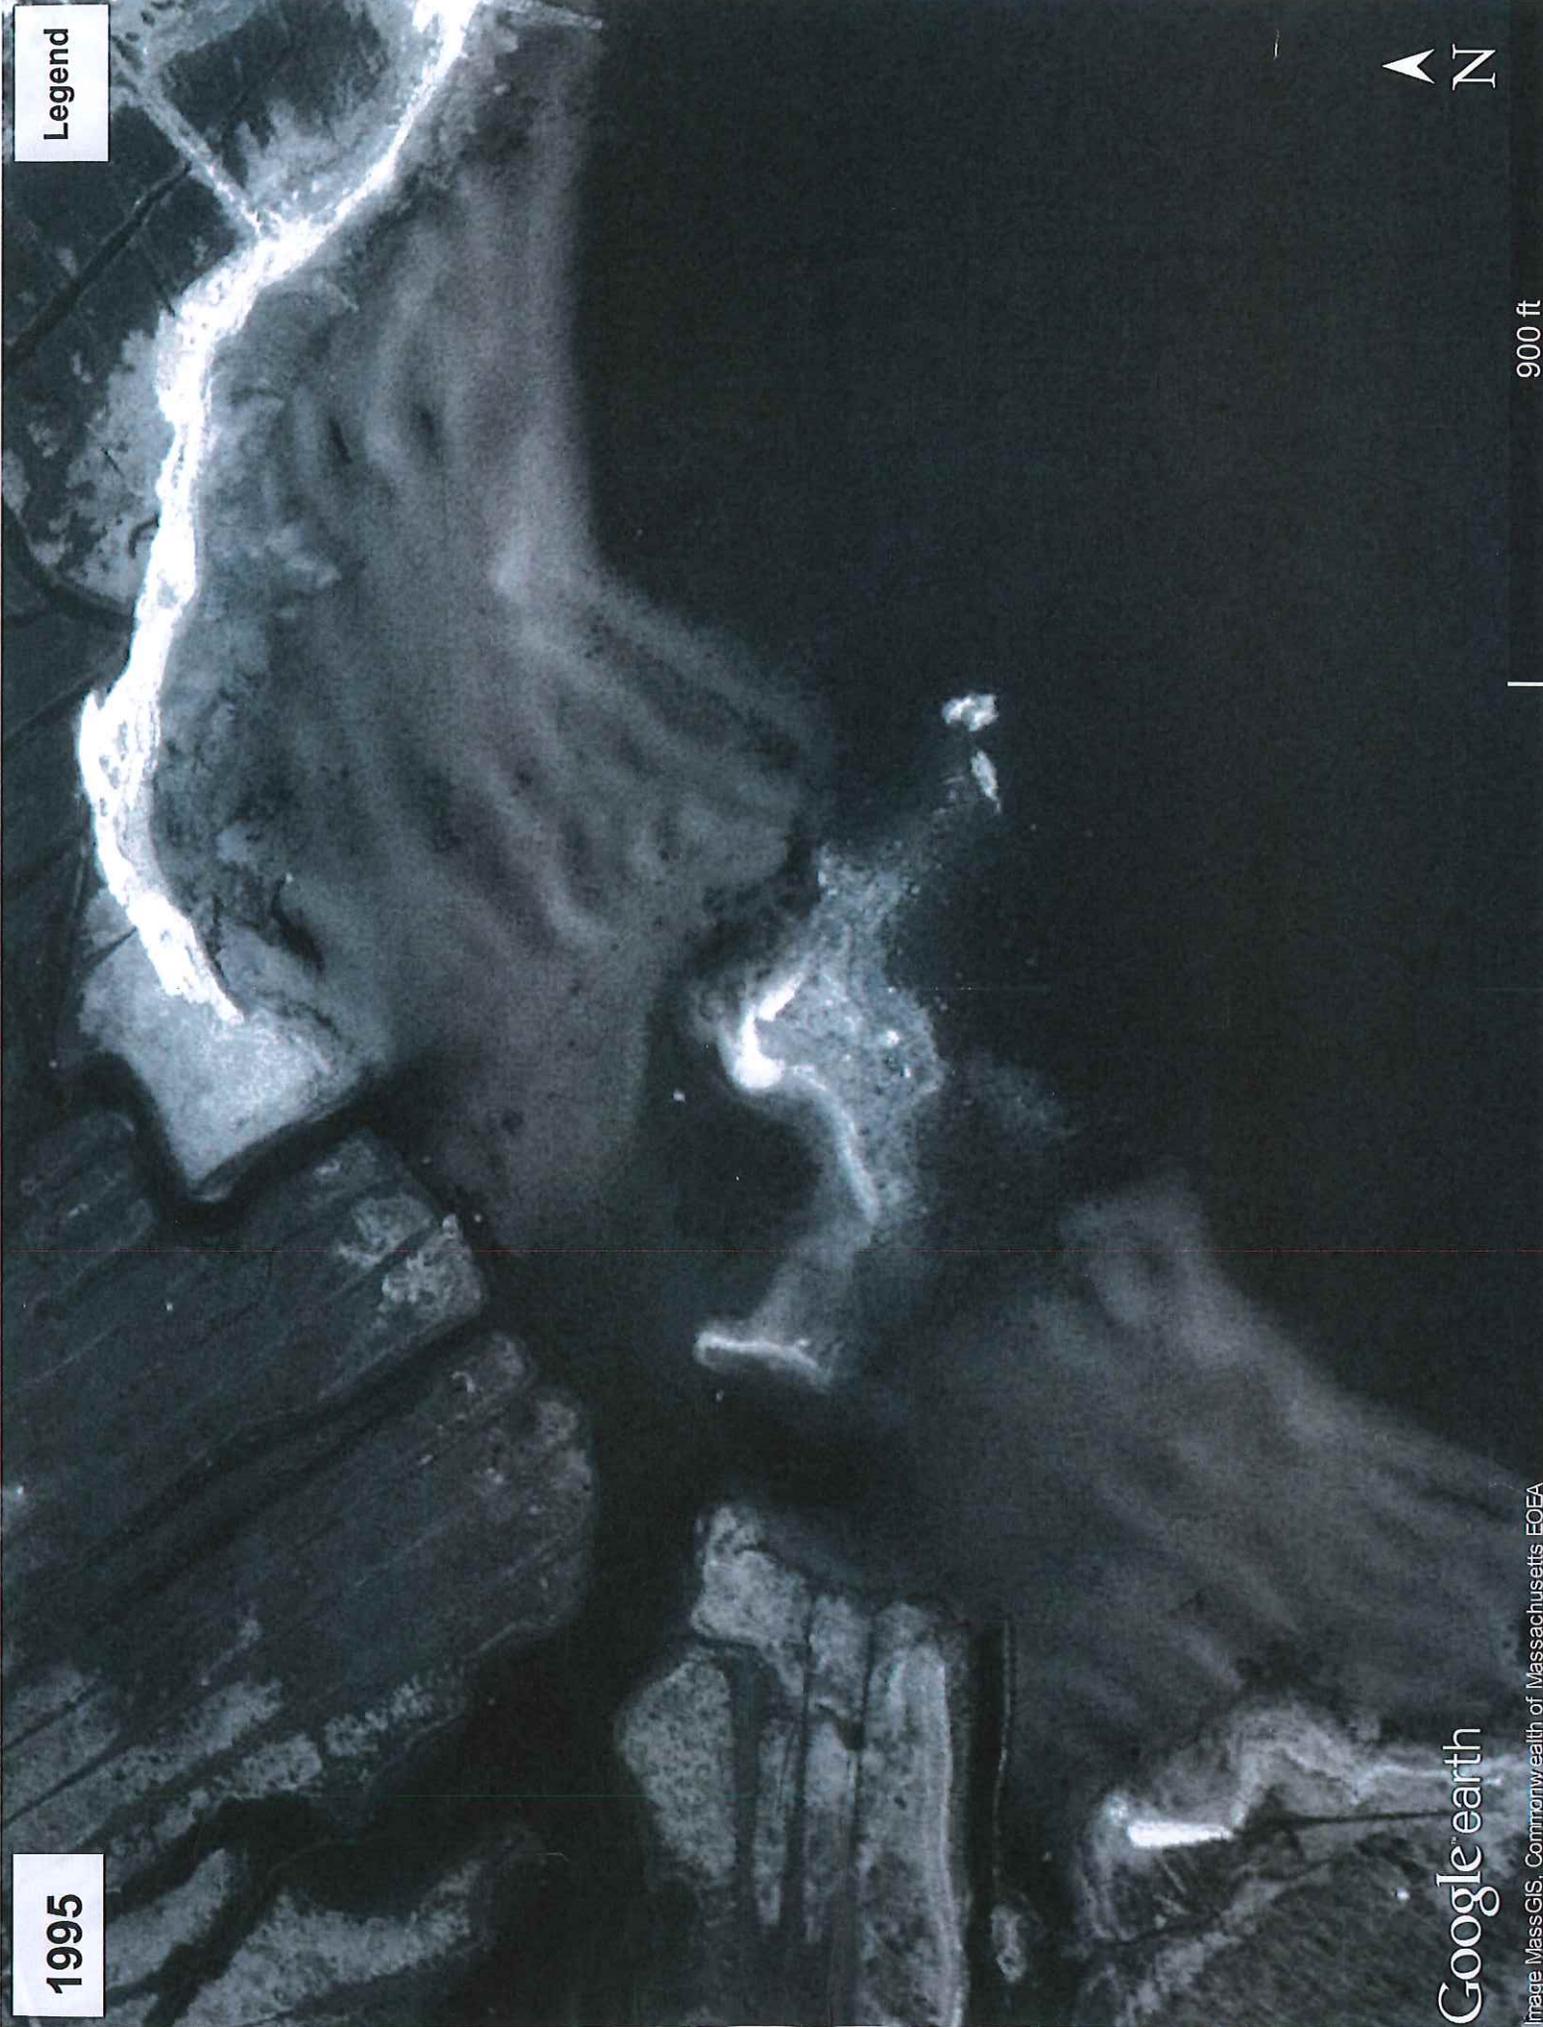
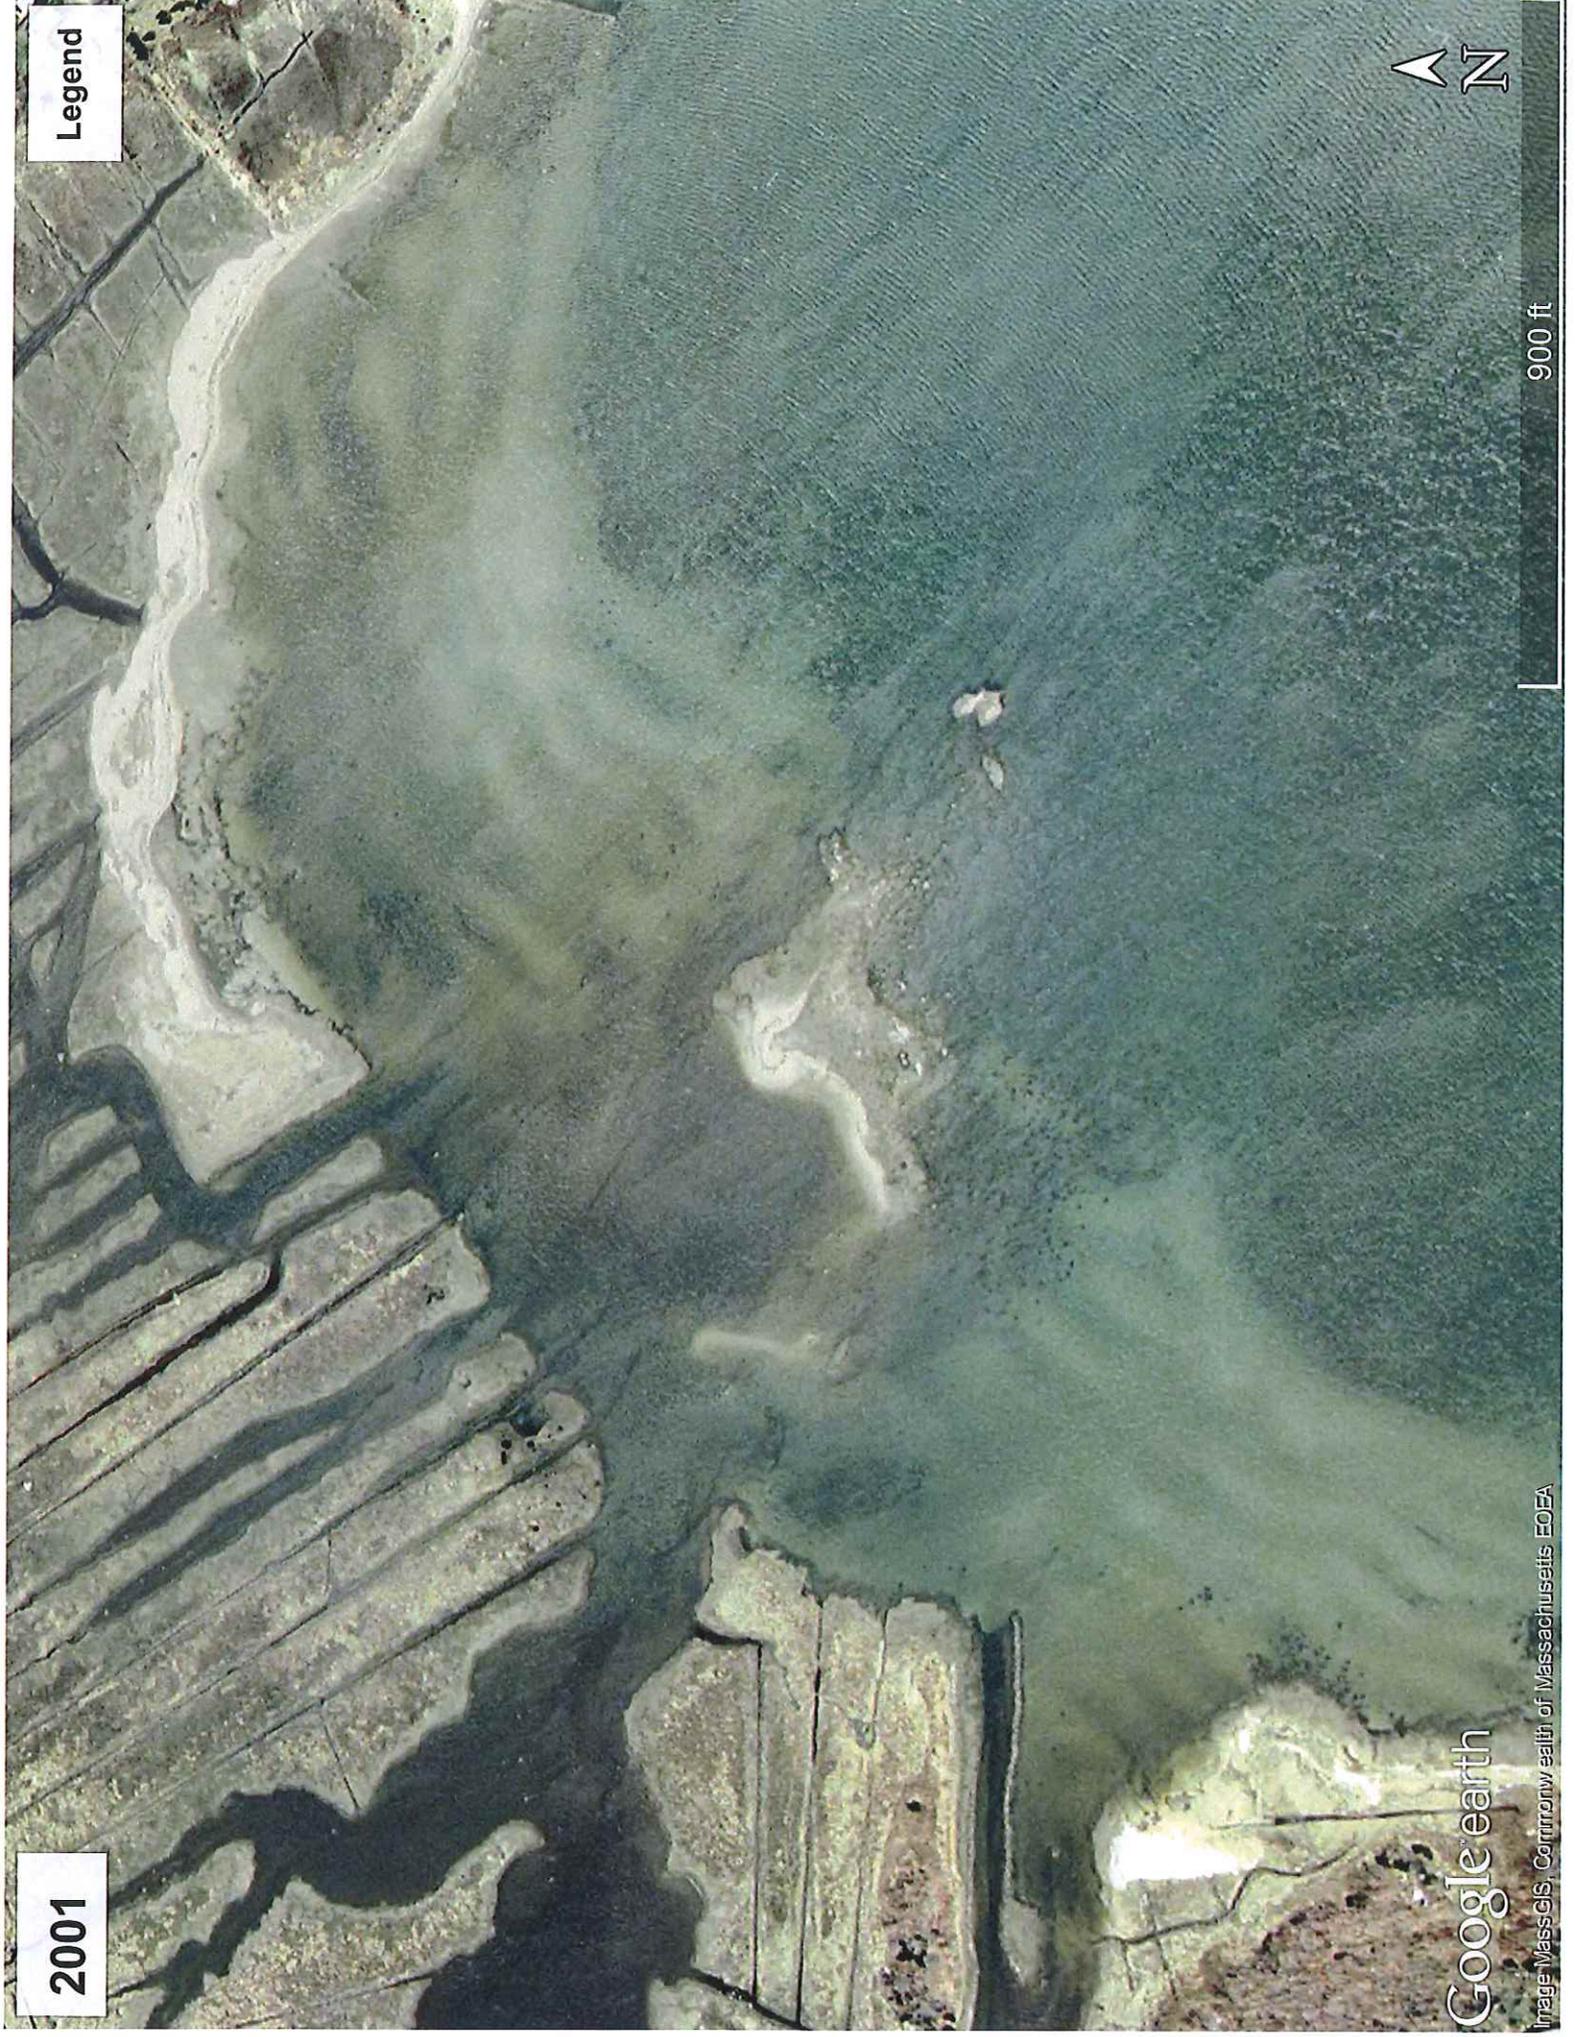
We examined available aerial imagery that could be located of Inner Aucoot Cove and found two primary sources: (1) 1960 to 1983 data from the USGS Earth Resources Observation and Science Center, and (2) 1995 to 2015 data from Google earth. A selection of these images is attached to this letter. All of the images show a relatively stable pattern of sand waves in Inner Aucoot Cove. The origin of the sand is unknown but could have been the Hurricane of 1938. Notable is the passage of Hurricane Bob in 1991, which had its center of impact near Aucoot Cove and does not appear to have significantly altered the sand waves. The lack of visual evidence in the images of vegetation on the bottom of Inner Aucoot Cove does not support EPA's contention that this should be an eelgrass resource area.
