COMPLIANCE EVALUATION INSPECTION REPORT

INSTALLATION NAME: 1810 W. Grace St. LLC
f/k/a E.R. Moore Co.

EPA ID No.: ILD 981 777 998

DATE OF INSPECTION: April 30, 2007

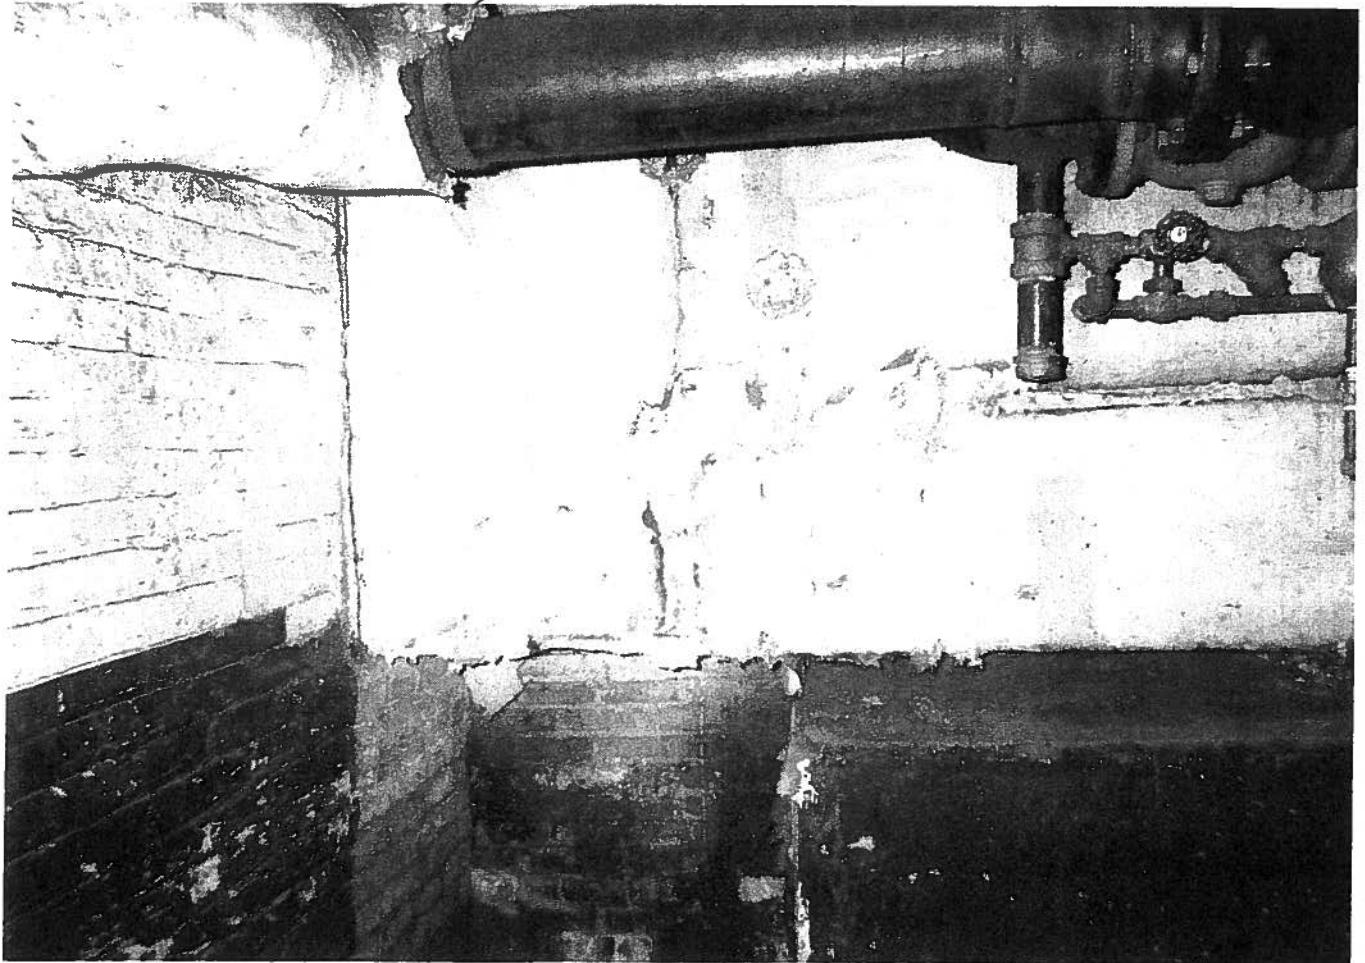
An additional observation during the inspection was the presence of what appeared to be asbestos, hanging in multiple locations throughout the structure. A storage box also contained what appeared to be asbestos which had been removed. I did place a call to Stanley Kaehler and Pete Badilla of Chicago Department of Environment regarding this, and Mr. Badilla arrived at the site that afternoon and took samples as well as ordering the building vacated.

APPARENT ASBESTOS

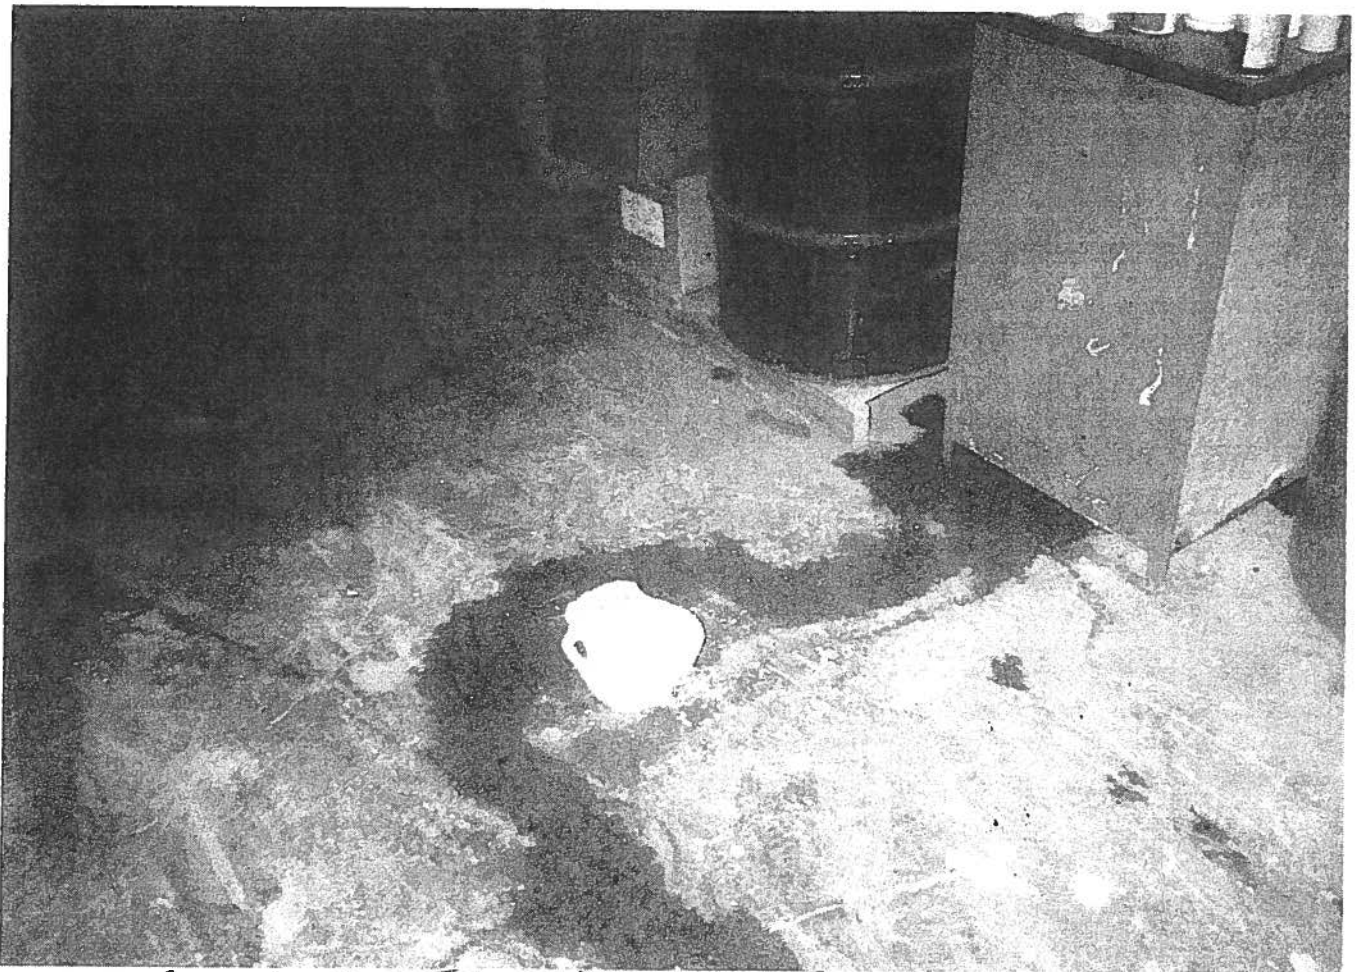
Chester explained that the two structures at the site were in the process of being gutted, and converted to loft condominiums. At the time of the inspection, Chester and his crew were working on the sales office. The inspection began in the north end of the structure on the first floor. I immediately noted the presence of numerous containers, mostly unlabeled, as well as a yellow metal flammables cabinet. A stream of liquid appeared to be originating from the bottom of the cabinet, which was surrounded by containers and not able to be opened.

1ST FLOOR, NORTH SIDE - RED FLAMMABLE STORAGE

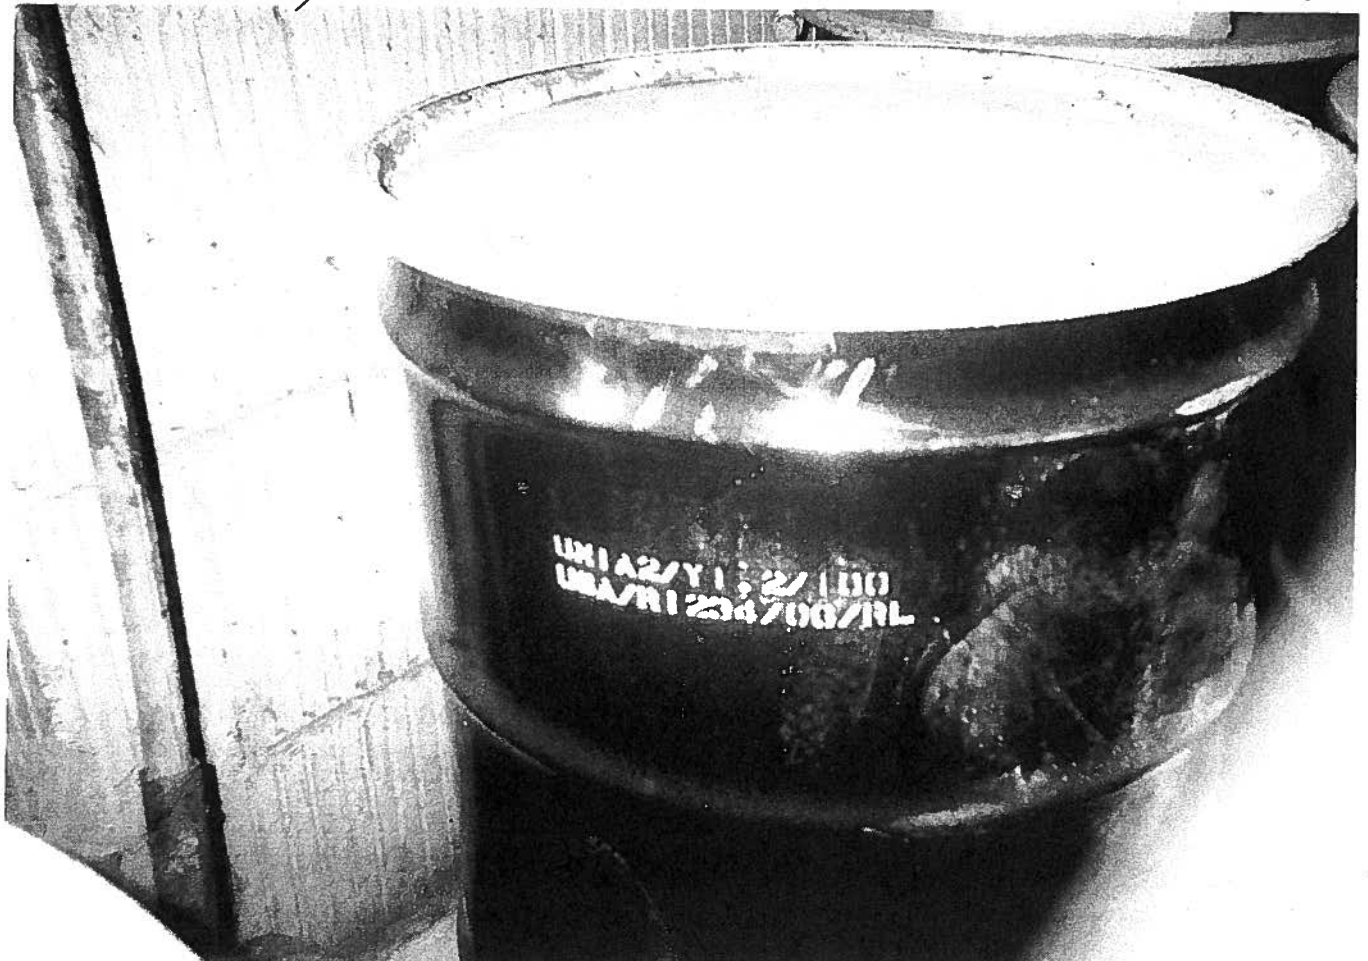
In the northeast corner of the first floor, five black 55-gallon open head drums were noted. These containers allegedly contain the soil from the borings which were done during a Phase 2 investigation prior to the current owner's purchase of the site, which closed on October 31, 2006.

N.E. CORNER, 1ST FLOOR DRUM WITH SOIL CORES

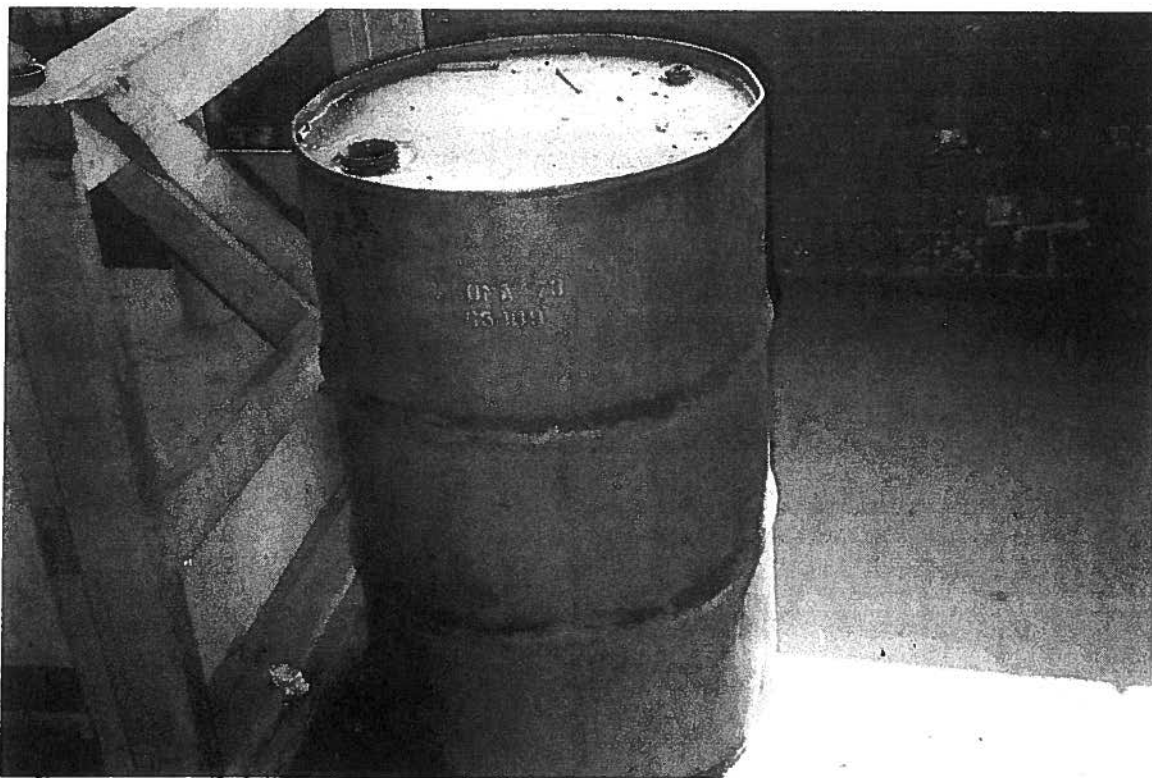
On the east side of the first floor, about 50 apparently empty plastic drums were shrink-wrapped together on pallets, some labeled as perchloroethylene. On the third floor, east side, a single red metal closed-head drum was present, which was unlabeled. Stenciled on the side of the drum was the lettering "Macoma 73, NCC authorized, Bureau of Explosives". Chester did not have knowledge of the contents of this drum. No waste determinations or manifests were kept on-site.

FULL DRUM, 3rd FLOOR

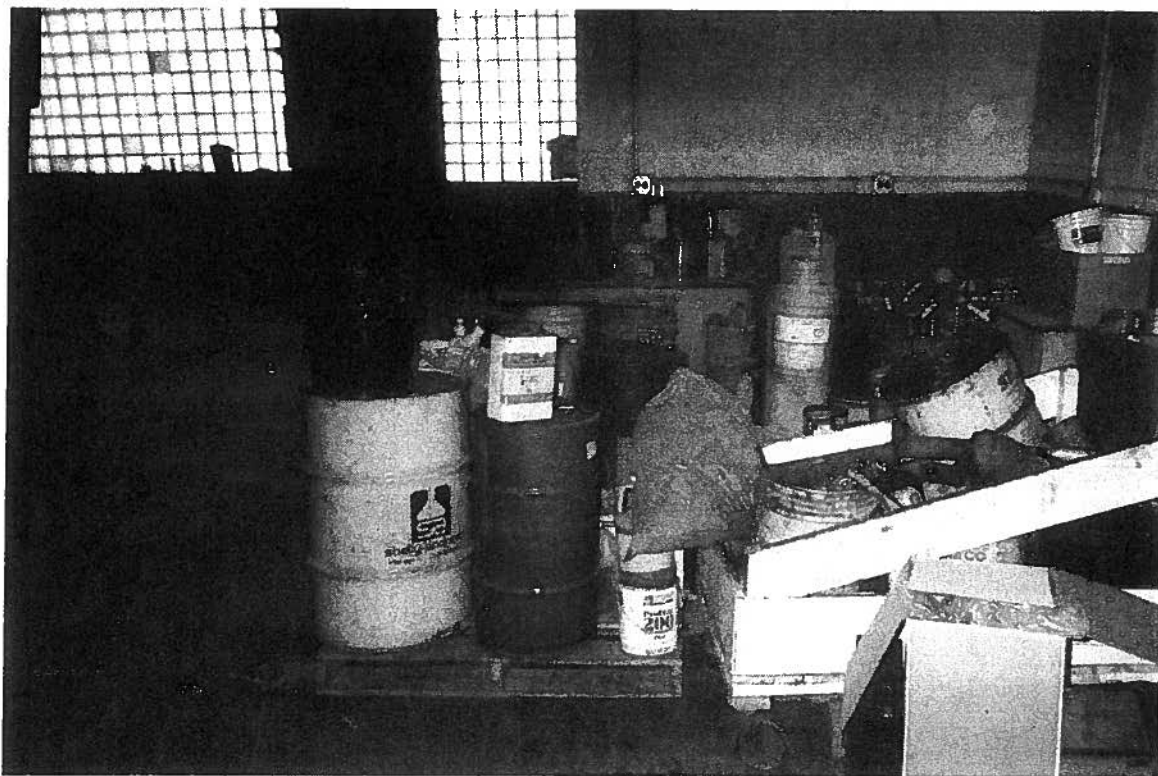
1st FLOOR, NORTH END, UNKNOWN WASTE

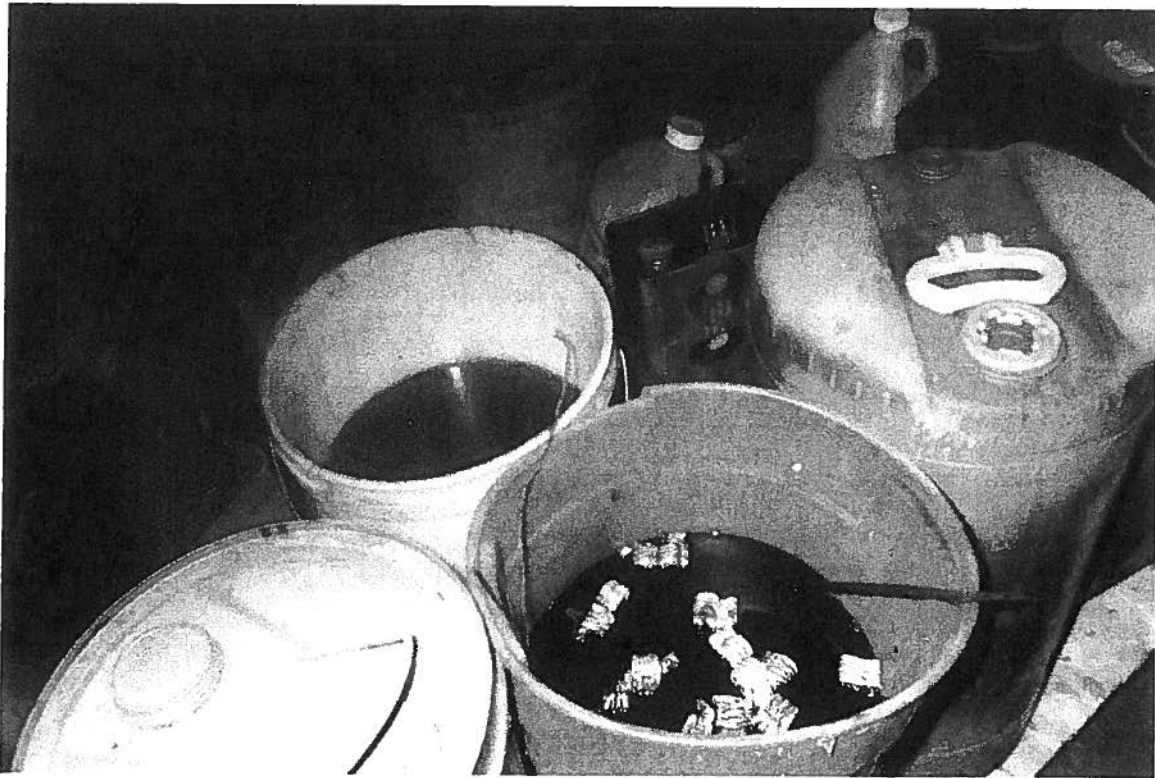
1ST FLOOR NORTH SIDE UNKNOWN WASTE

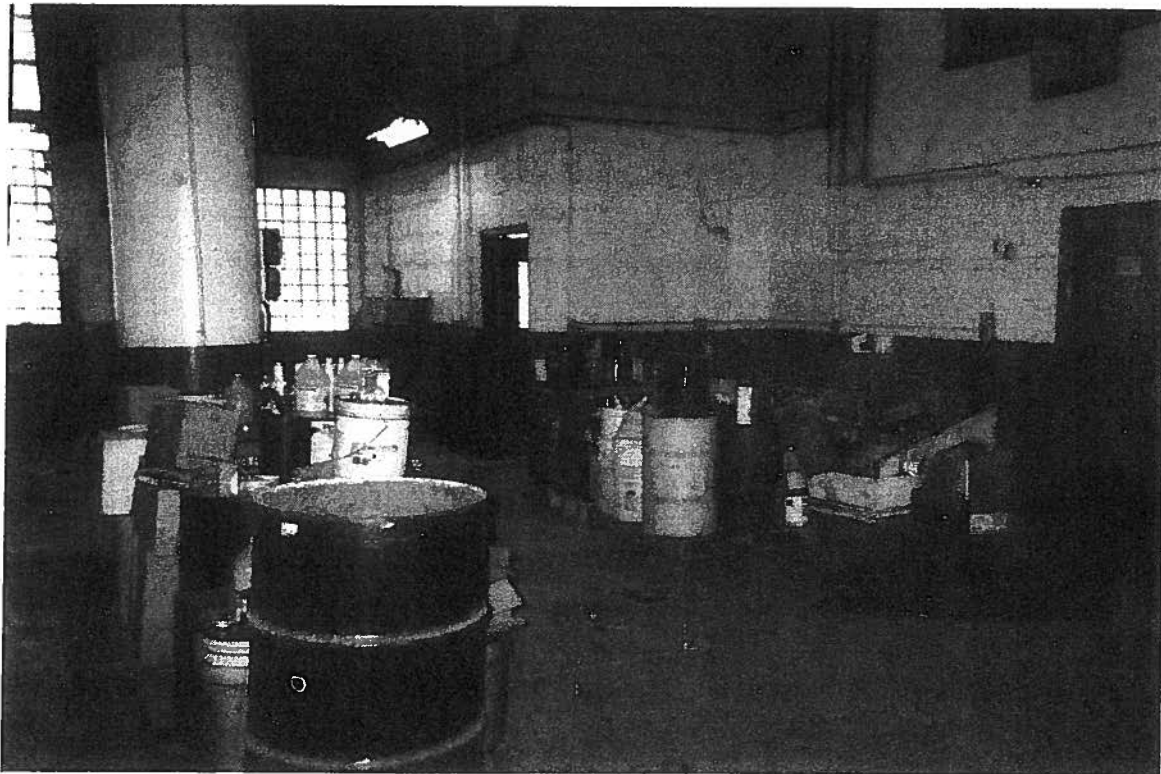
1ST FLOOR N.E CORNER WASTE
CONTAINERS, UNKNOWN CONTENT

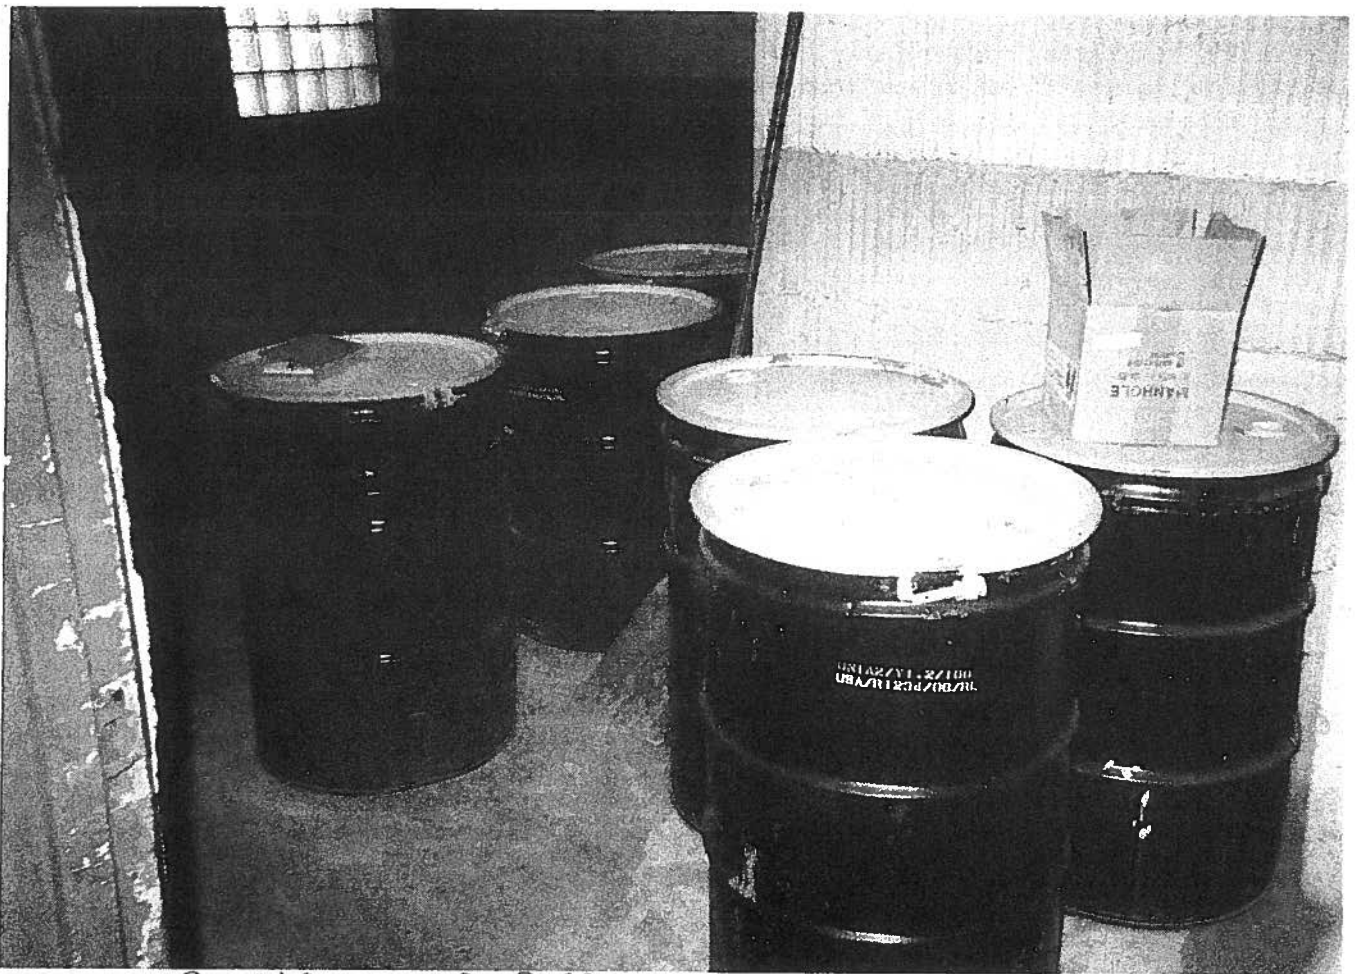
6 DRUMS, NE CORNER 1ST FLOOR
