Phase 1a Brine Gathering System Incident
Remediation Status Report
June 2015

Keitu Engineers & Consultants, Inc.
1403 27th Street NW
PO Box 98
Mandan 58554

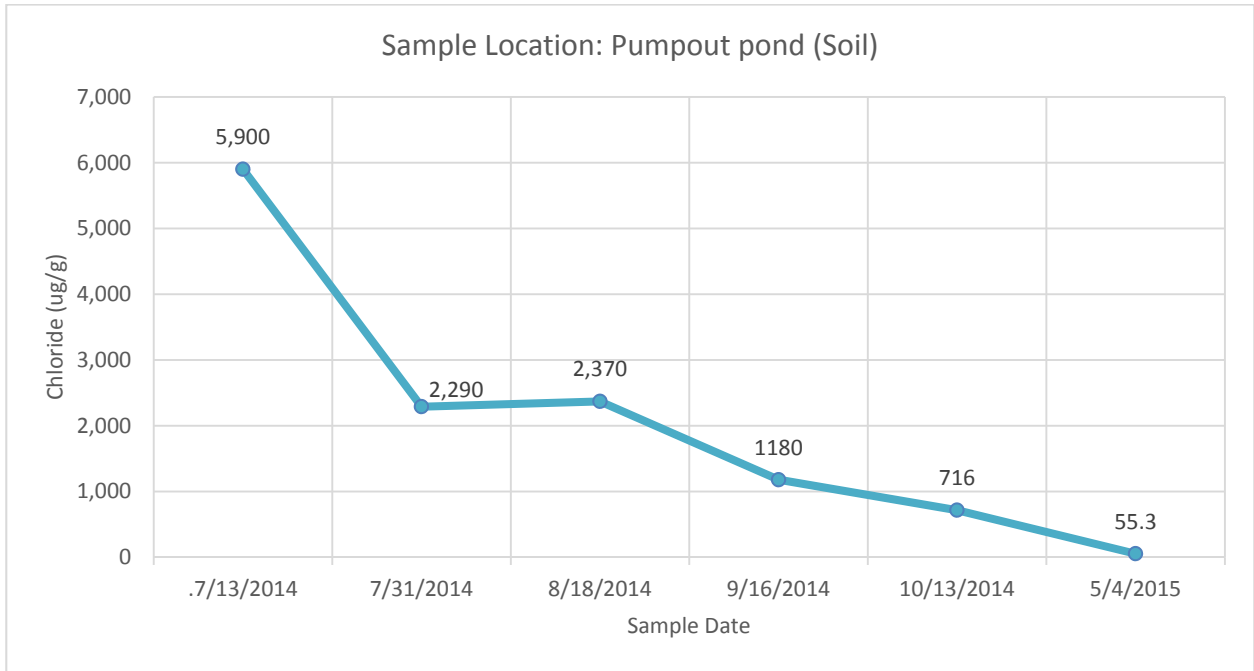
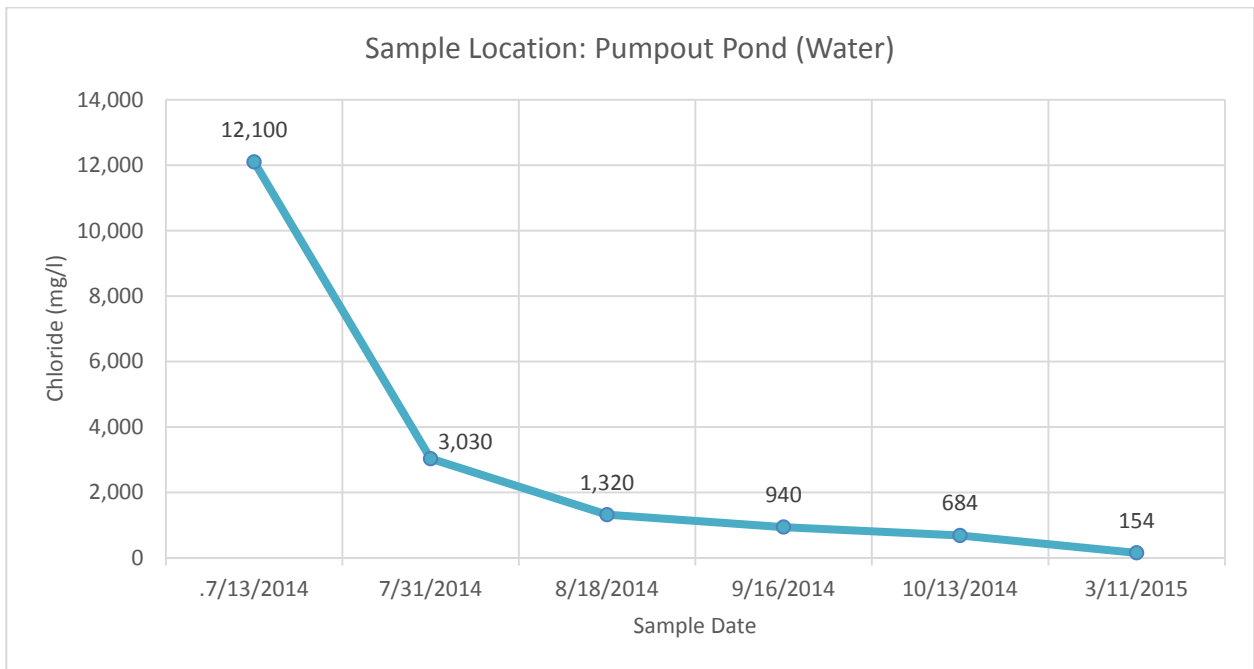
The graphs below display the chloride change since the incident. It is important to note that results can appear cyclical as chloride concentrations are heterogeneous within the small sample locations.

By the end of 2014, the remediation efforts produced a result of 61% chloride level reduction in the first 6" of the soil profile (reduction percentage is based on chloride levels in the days after the release occurred). By the end of 2015, the anticipated result is a reduced chloride level of 75-80% (within the top 12" of soil); by the end of 2016, an 85-90% reduction is expected (within the top 12"); and by the end of 2017, a 95-99% reduction is expected (within the top 18" of soil).

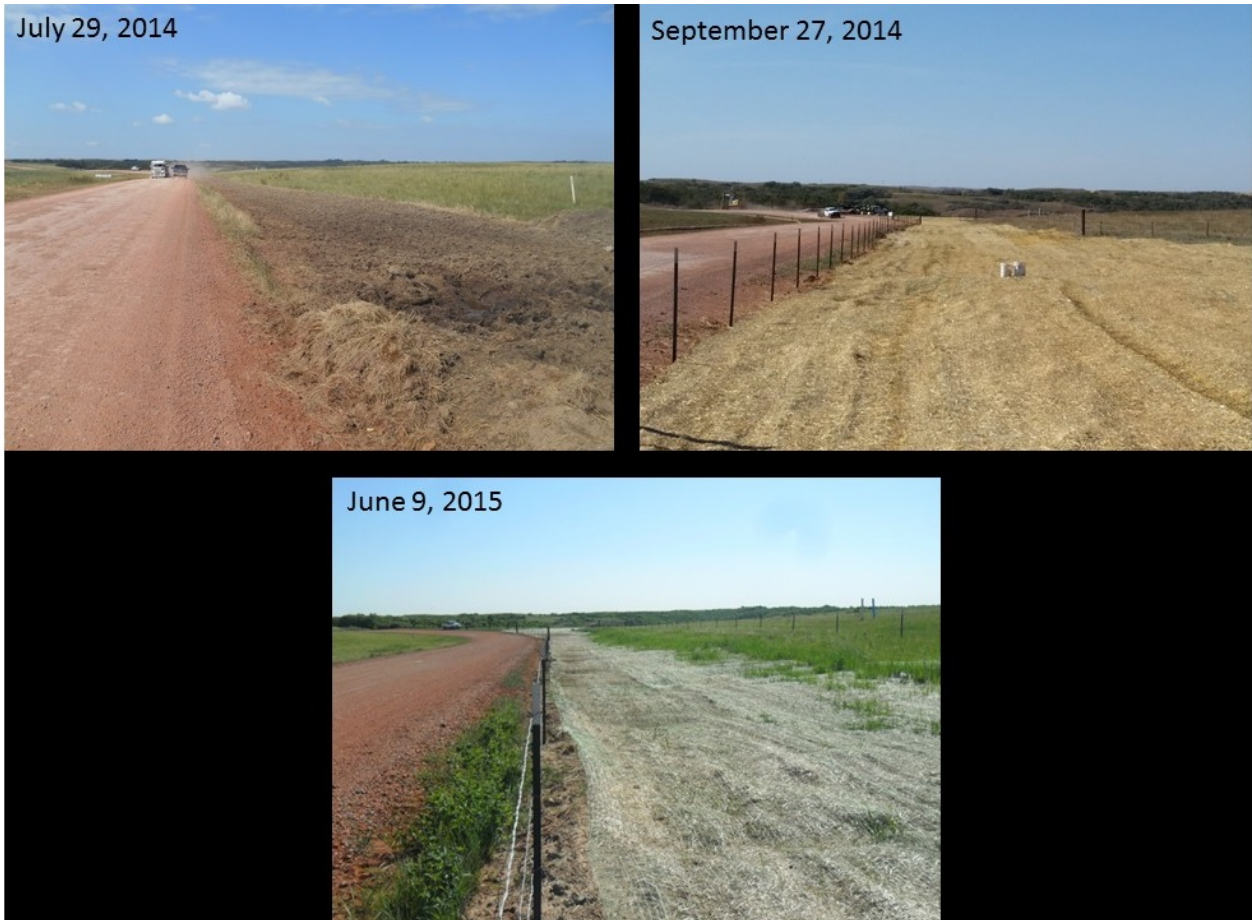
Area A, along Turnuey Ridge Road; looking west southwest.

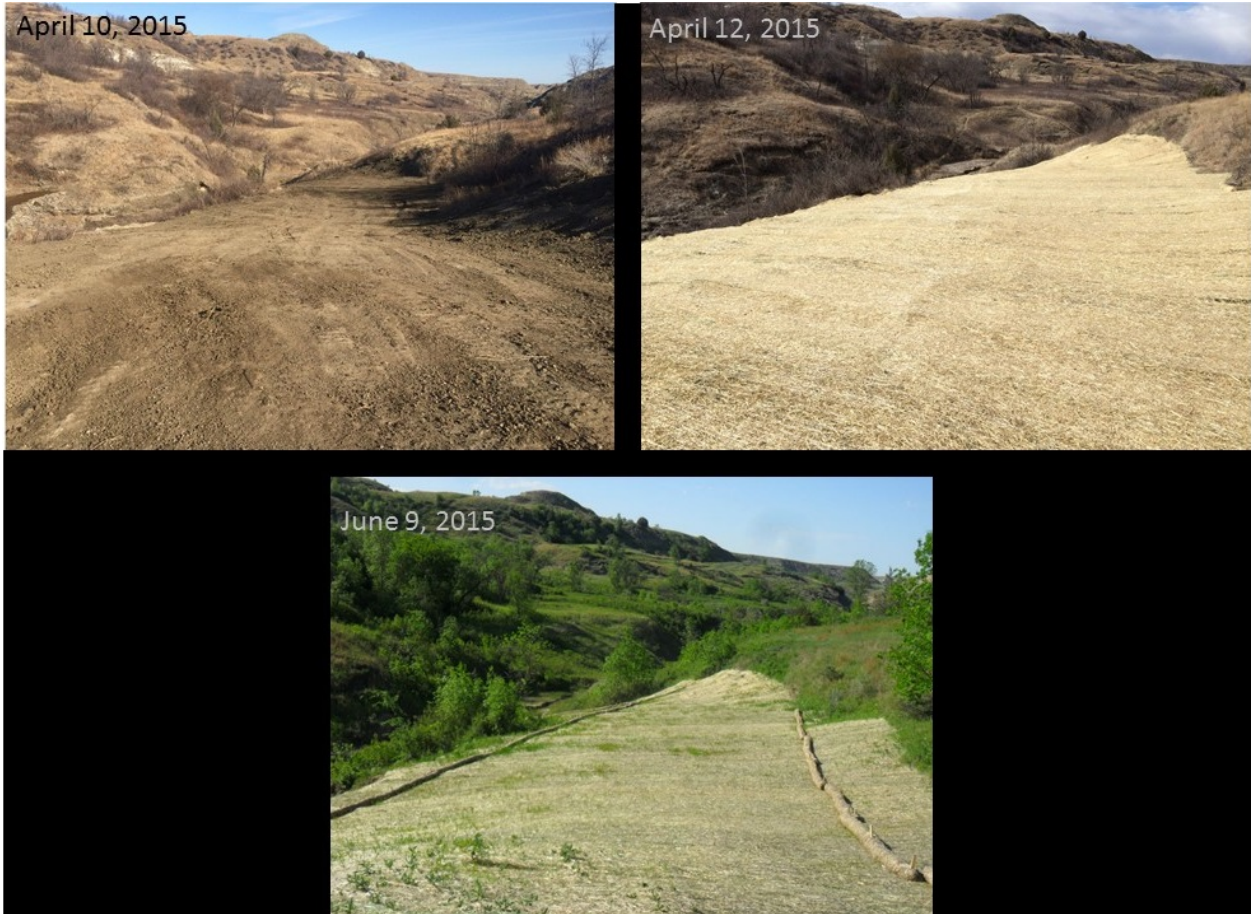
Area D, above pumpout pond; looking north.
