Re: Complaint and Compliance Order      **RCRA-05-2014-0006**  
Summit Inc.  
U.S. EPA ID No.: INX 000028902

**Complaint and Compliance Order**

Photograph Log  
Summit, Inc.  
6901 West Chicago Avenue  
Gary, Indiana 46406

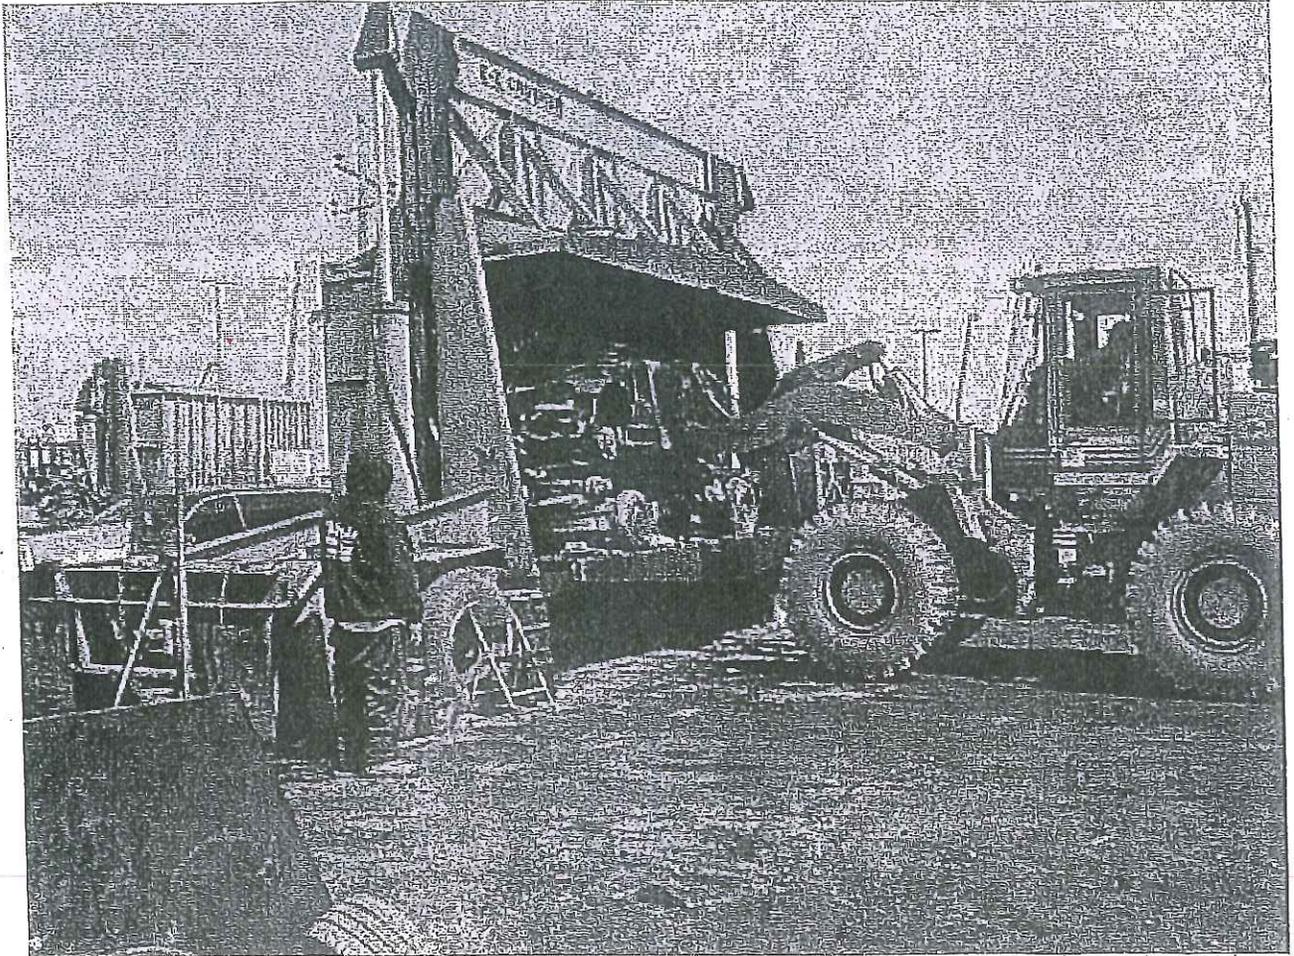
Photograph No.1

Description: One of the two car crushers in operation at the Summit scrap yard. Once the first car is crushed, the loader places a second car in the crusher.

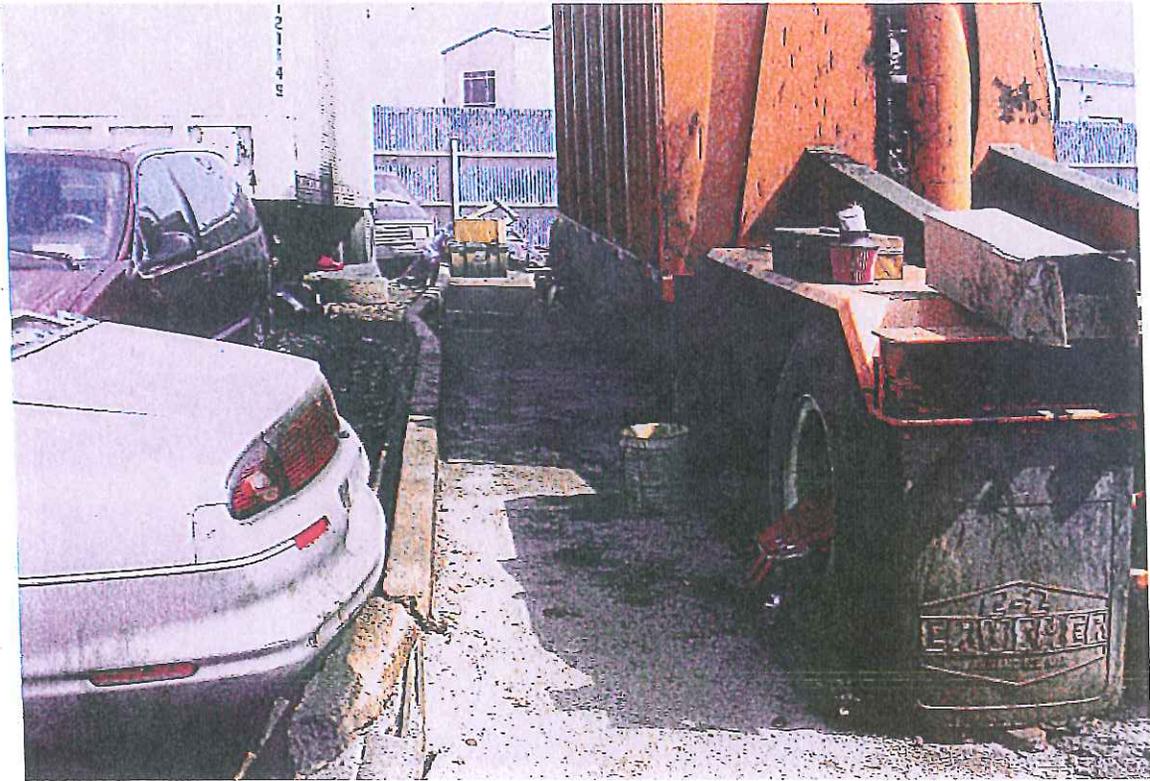
**Exhibit 5**

Description of photograph: This photograph was taken facing northeast. The fence behind the yellow-orange crusher is parallel to Industrial Highway. Note the broken curbing on the crusher pad beneath the rear bumper of the car to the left. Note fresh oil dry and oil staining on the crusher pad floor. The bucket is not labeled "used oil."

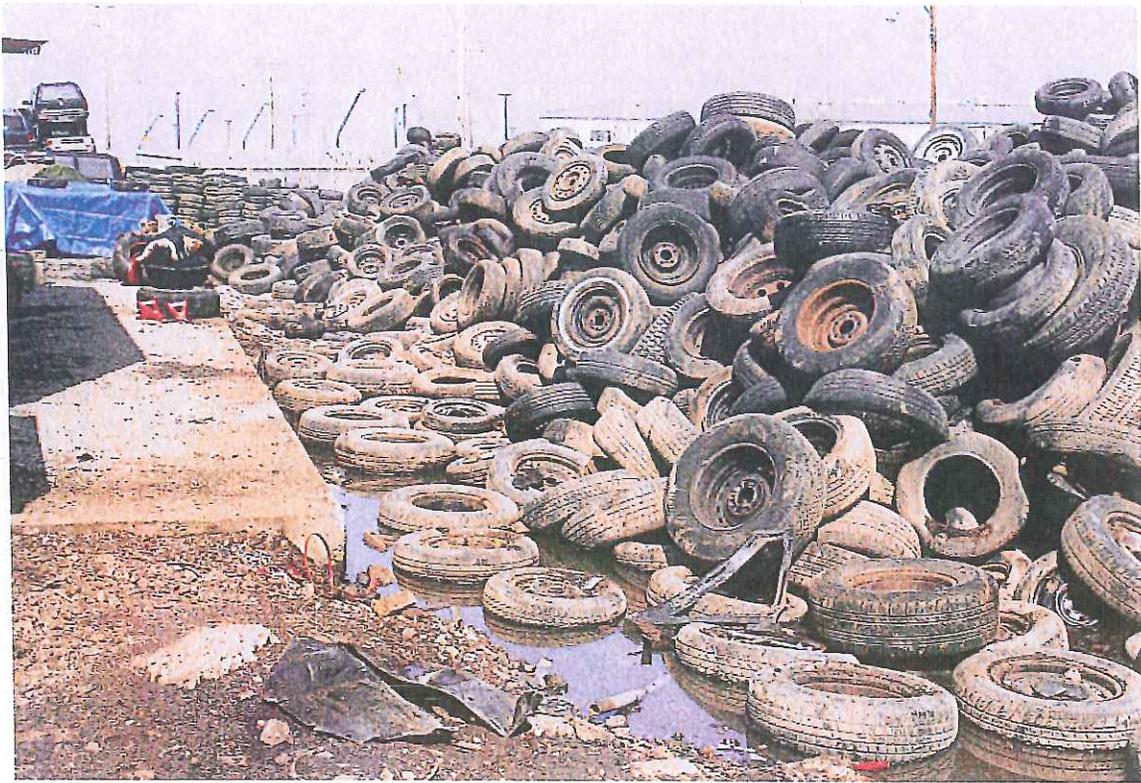
Description of photograph: This photograph was taken looking northwest. The tires are piled between the crusher pad and the Summit Inc fence alongside Industrial Highway. The pooled water has a greenish tinge, as if it is diluted from the liquid in the steel totes (refer to photos 13 and 14) or from fluorescent green antifreeze/coolant. The shadow of the second crusher observed during the inspection is to the left side. Drums of used oil are in a metal tote under the blue tarp weighted down with tires (left side, to the back). These drums had the original product label and were not labeled "used oil."

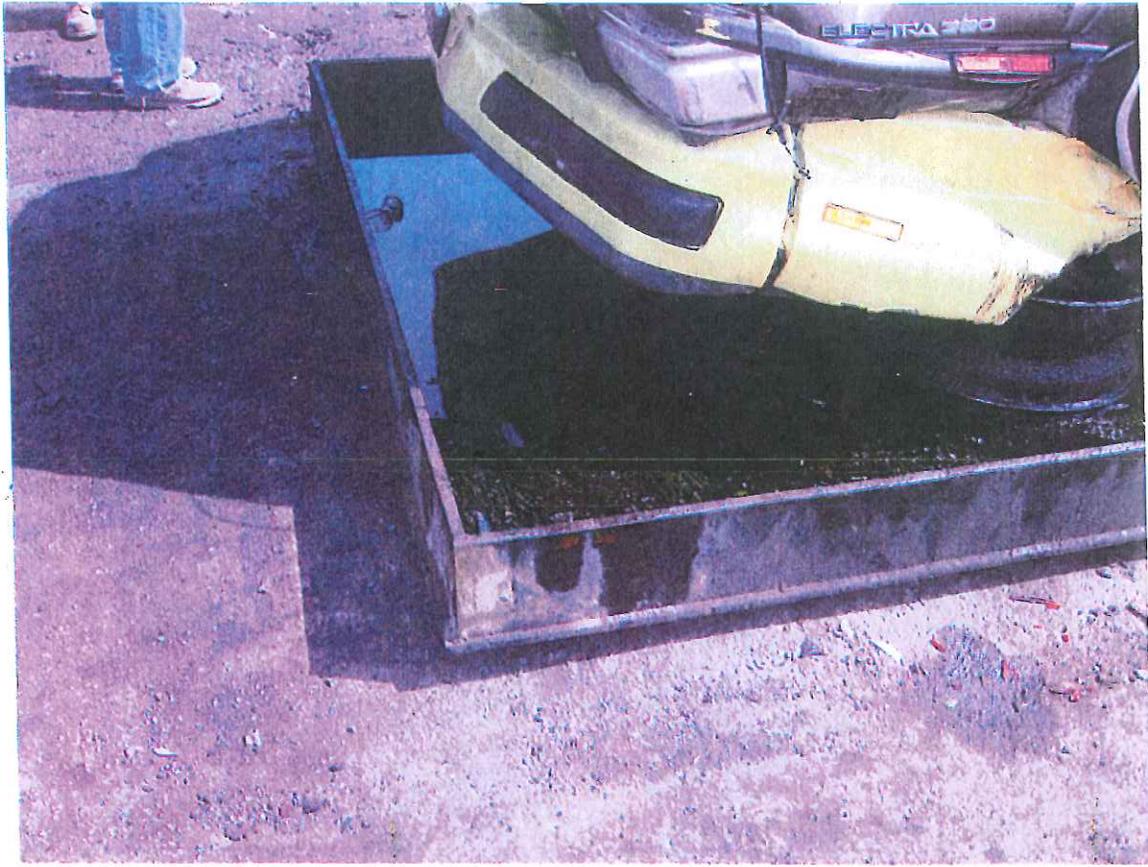
Photograph No.3

Description: Cars placed on a metal pan where car fluids are drained into.

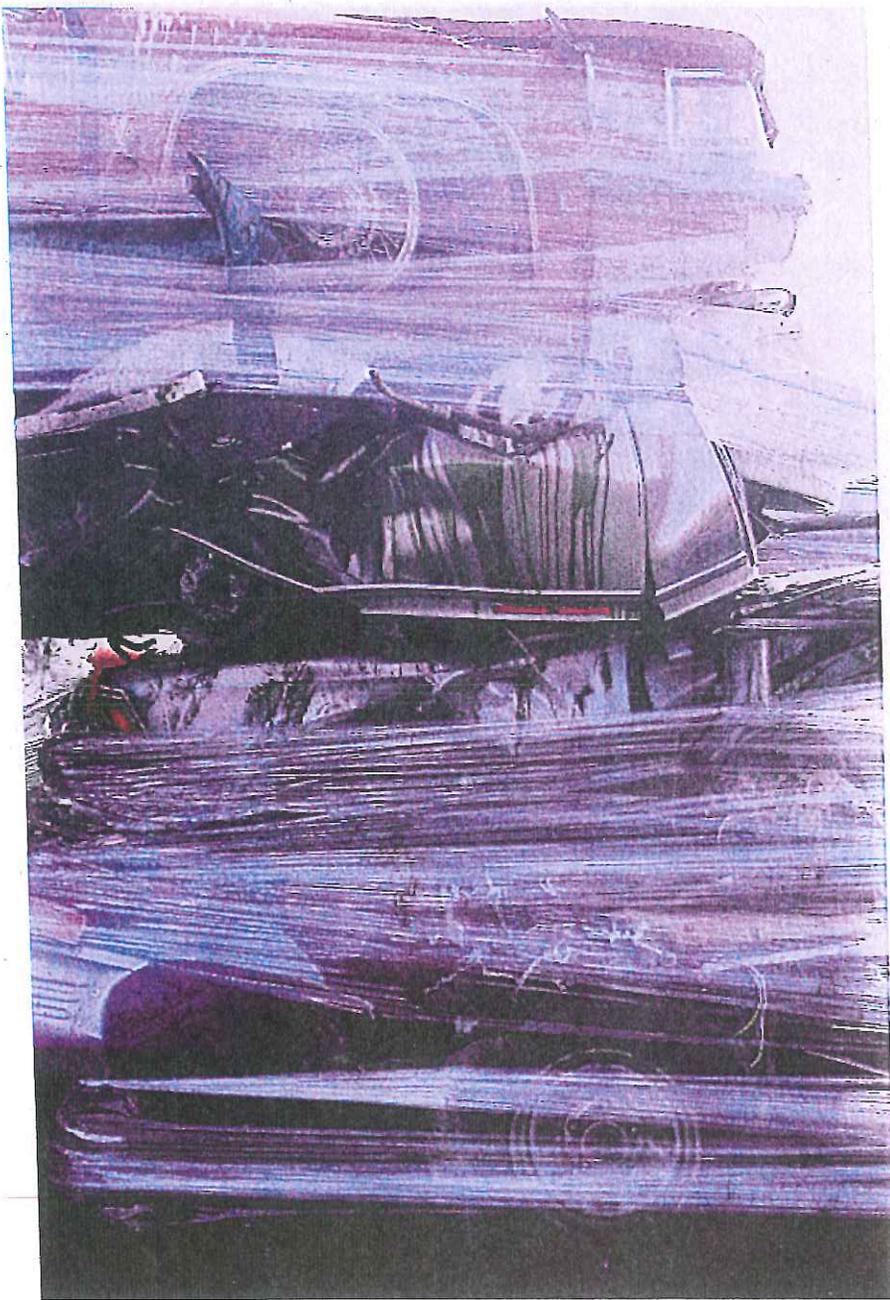
**Exhibit 8**

Description of photograph: Southwest of the crusher pad, hundreds of cars are stacked. The yard is not paved, and drips of used oil form trails. Oil dry had been applied to some such drips. The middle car in this stack exemplifies the need to drain all fluids before crushing the cars. Used oil from the top car has run down the side of the middle car.

36. Crushed cars were shrink wrapped and stacked on-site. During the inspection EPA inspectors observed crushed vehicles with oil dripping on their sides; wooden pallets and the ground beneath the crushed vehicles saturated with oil. See Exhibit 8.

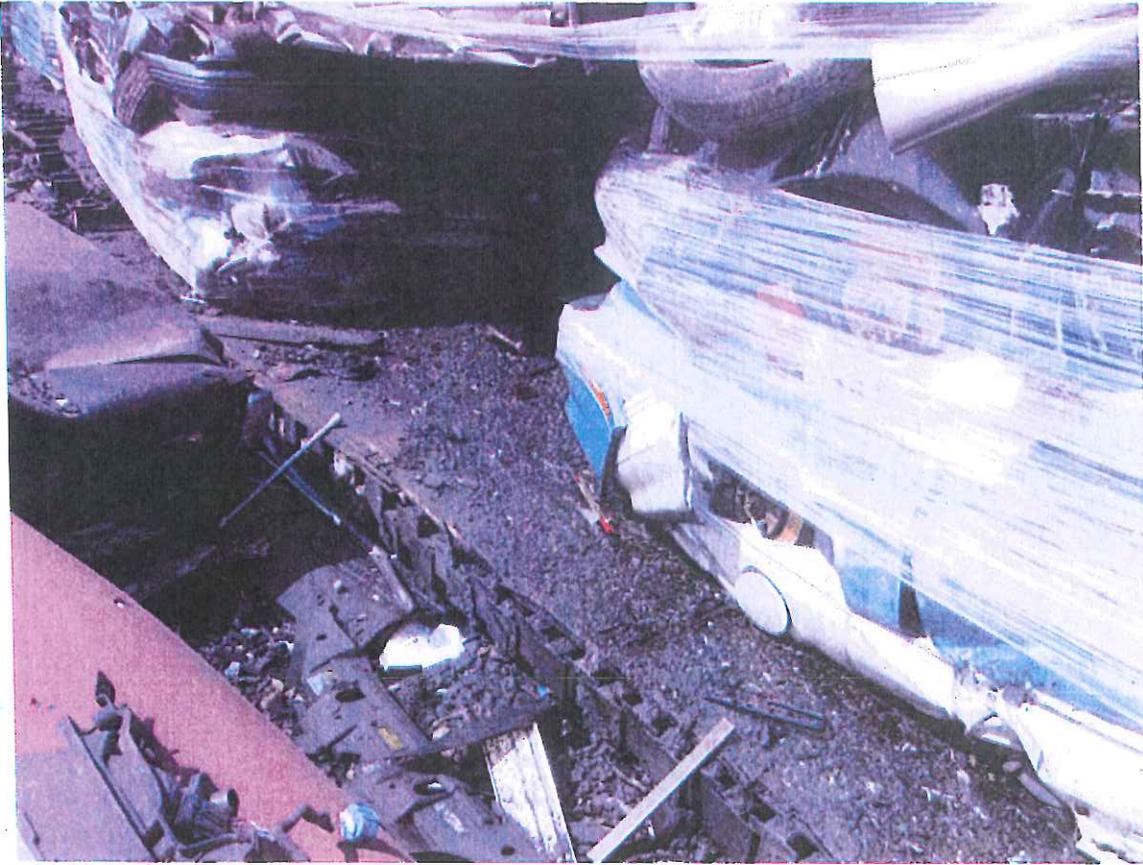
Photograph No.12

Description: Crushed cars rapped in plastic placed on top wooden pallets. The pallets appear to be saturated with oil.

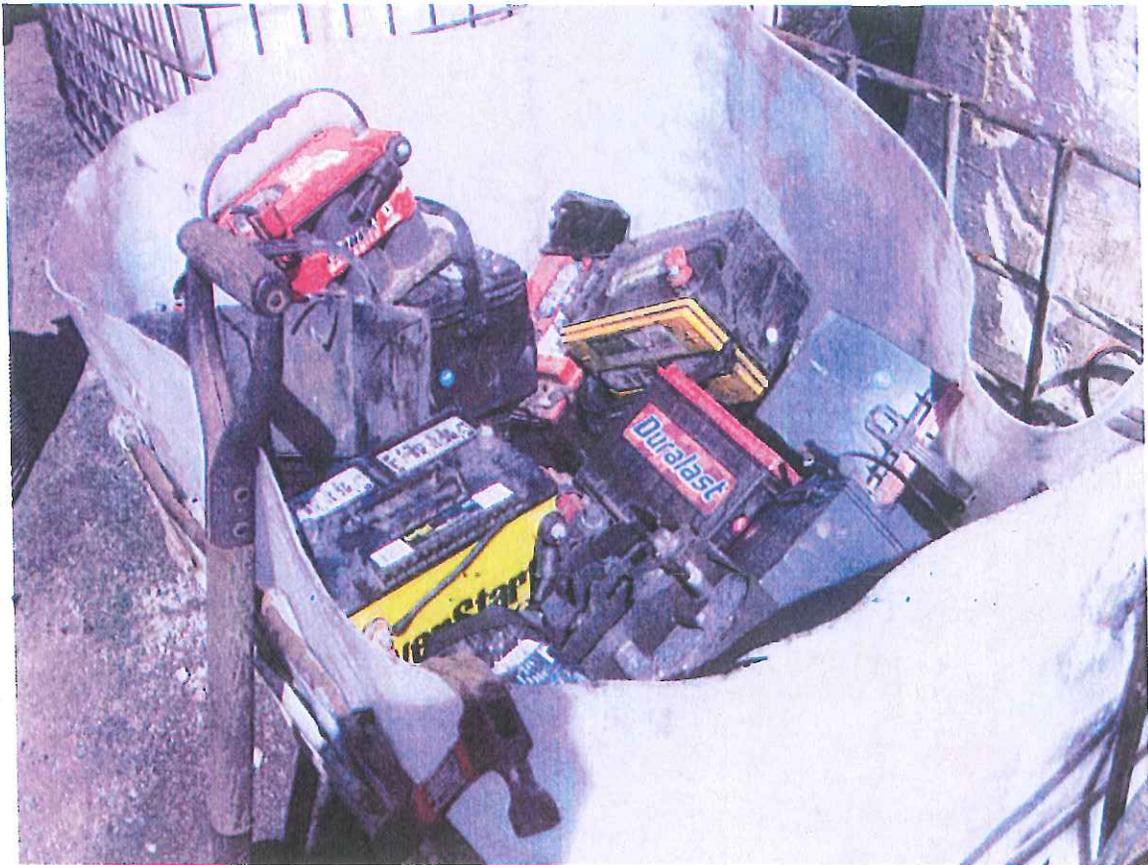
Photograph No.5

Description: Plastic tote containing car batteries.

39. There were plastic totes full of auto batteries located at the Site during the April 2008 inspection. Some of the totes were filled with liquids. One tote had a two inch opening at the bottom. Batteries were also stored in the back of a pick-up truck. Some of these batteries were cracked open. Respondent could not identify the liquids in the tote at that time. These containers were unmarked. See Exhibit 10.

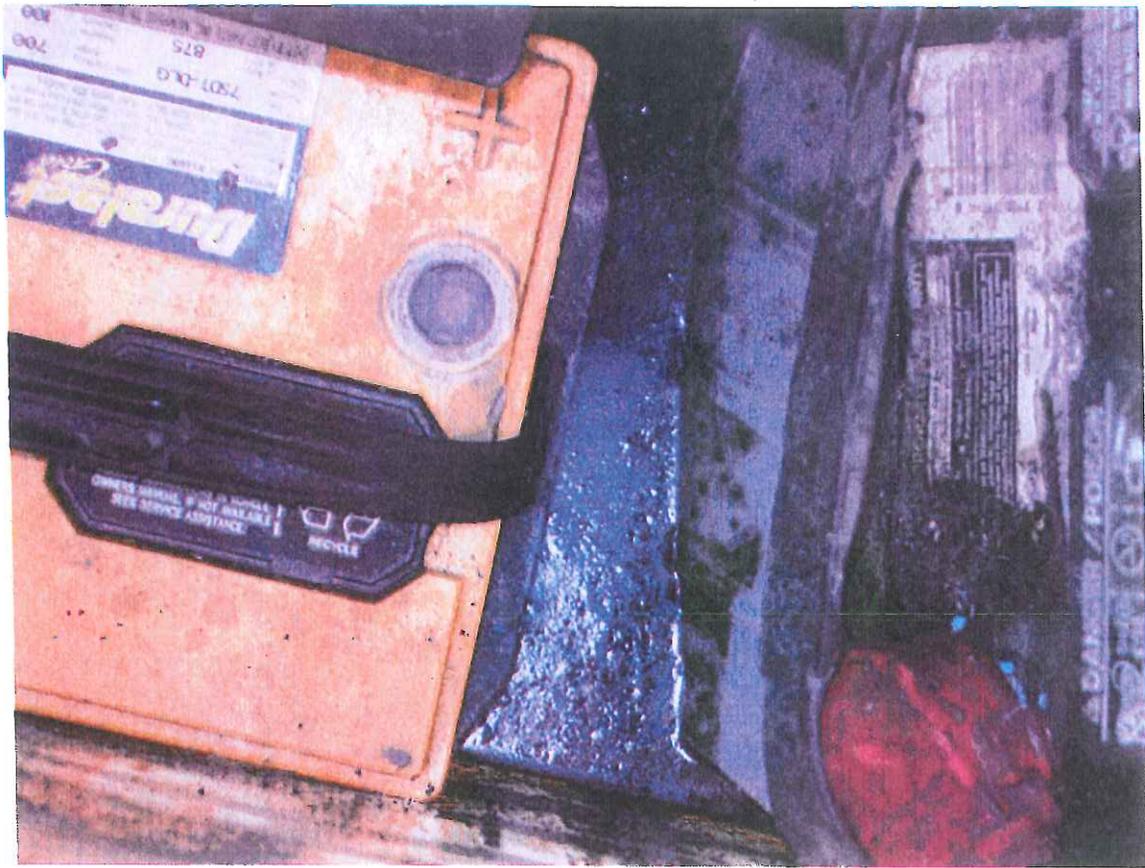
Photograph No.6

Description: Inside of tote shown in Photograph No. 5. The tote was one third full with some type of liquid.

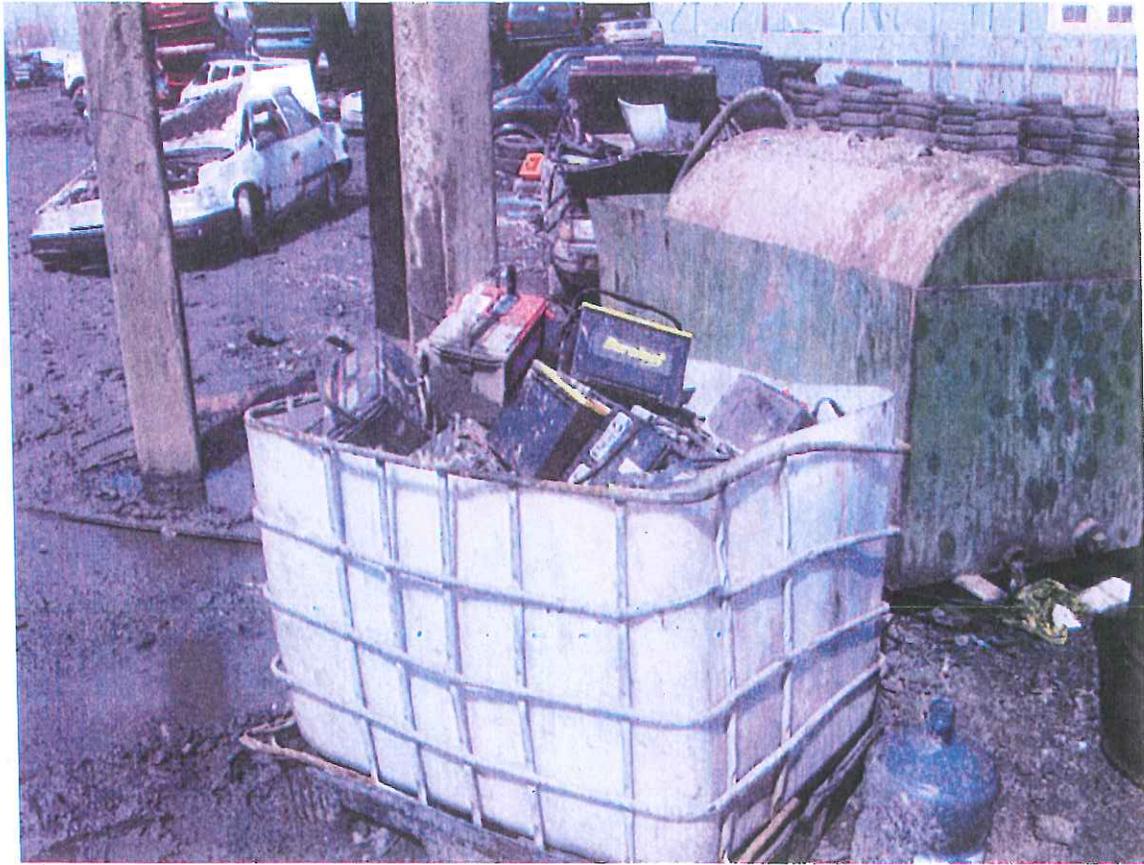
Photograph No.9

Description: Second tote containing car batteries.

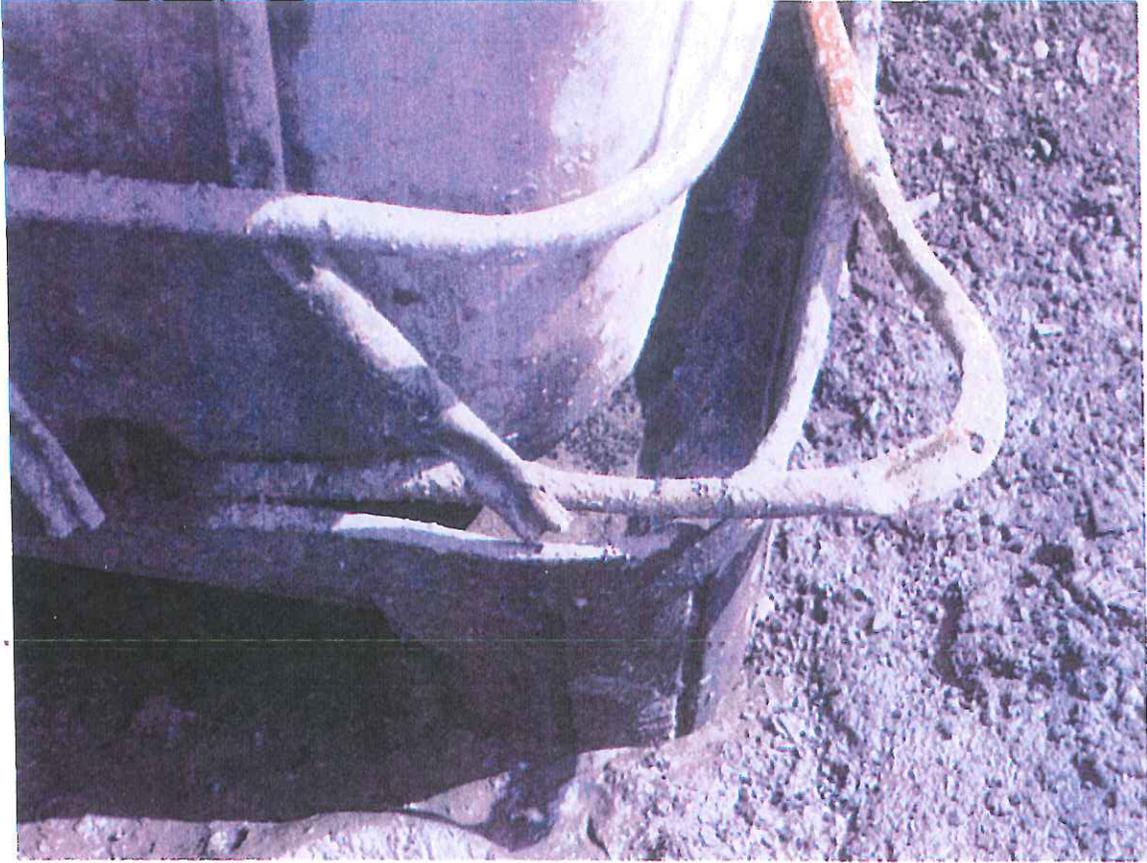
Photograph No.10

Description: Bottom of tote shown in Photograph No. 9 was equipped with a two inch opening.

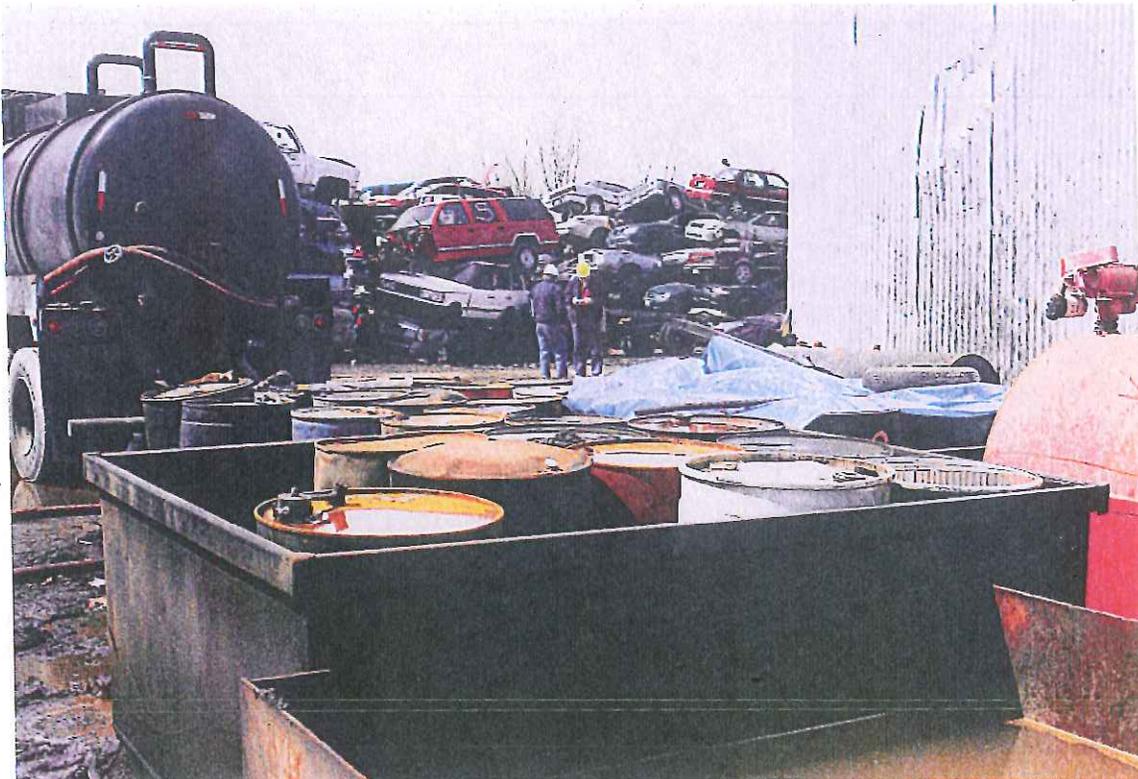
Description of photograph: This photograph was taken facing west with my back to the fence along Industrial Highway and the oil water separator. The metal containers hold drums containing wastewater according to Steve, the Beaver Oil Company truck driver. The truck at the top left of the picture is a one compartment Beaver Oil Company truck, and Steve had pumped used oil from the drums to the left of this picture. The nineteen used oil drums remaining to be emptied are between the truck and the metal totes. This shows the truck backed up onto the pad in order to pump out the drums. Ken Zolnierczyk and Dorel Hunt are standing in front of the stacked cars in the background.

41. Respondent stored several 55 gallon drums located inside and outside the area near the shed. During the April 2008 inspection EPA observed a Beaver Oil Company truck pumping liquids from the unlabelled drums into a tanker truck. The driver informed EPA that he was pumping out used oil and that he had already pumped out 11 drums of used oil. There were 19 more drums remaining. None of the drums were marked. See Exhibit 12.

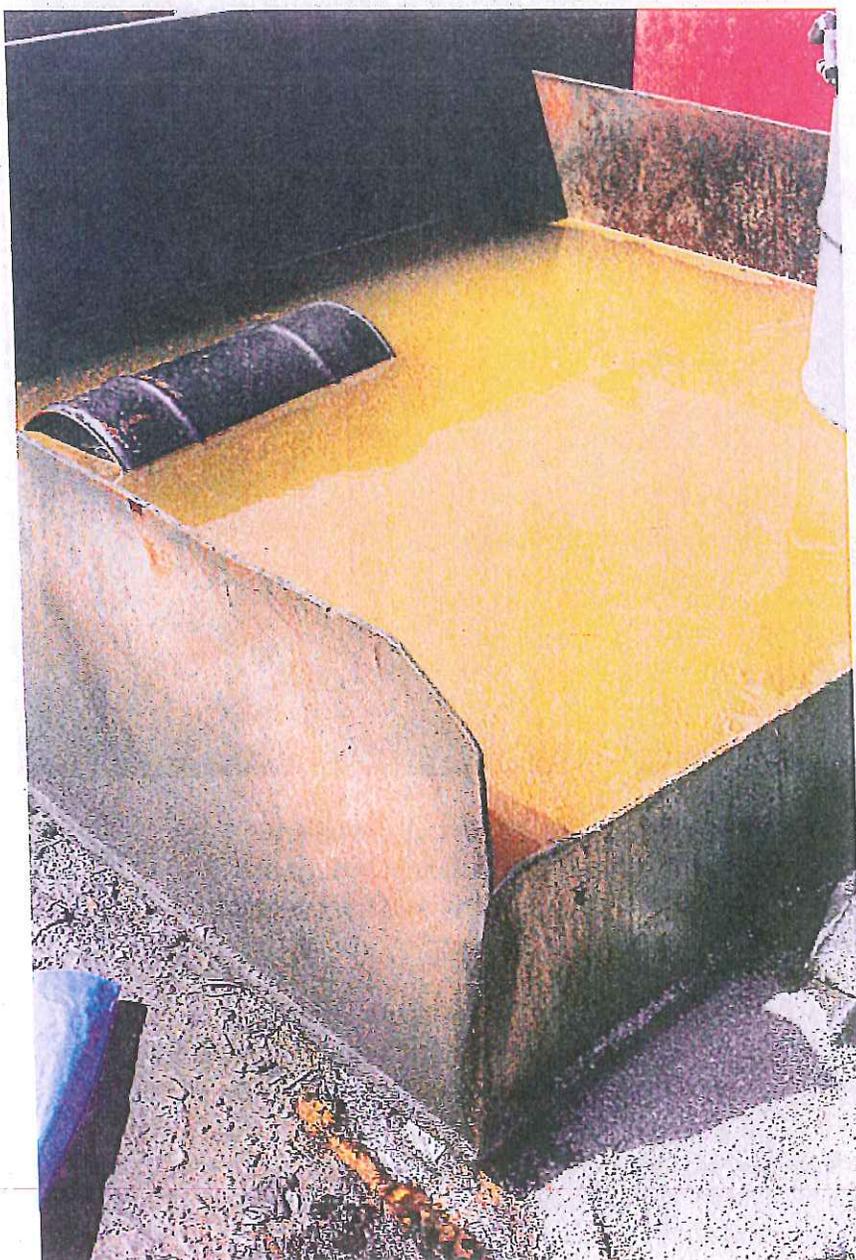
Description of photograph: Steve, the Beaver Oil Company truck driver described the material in this metal tote as wastewater. Note the fresh oil dry between this tote and the northeast edge of the crusher pad.

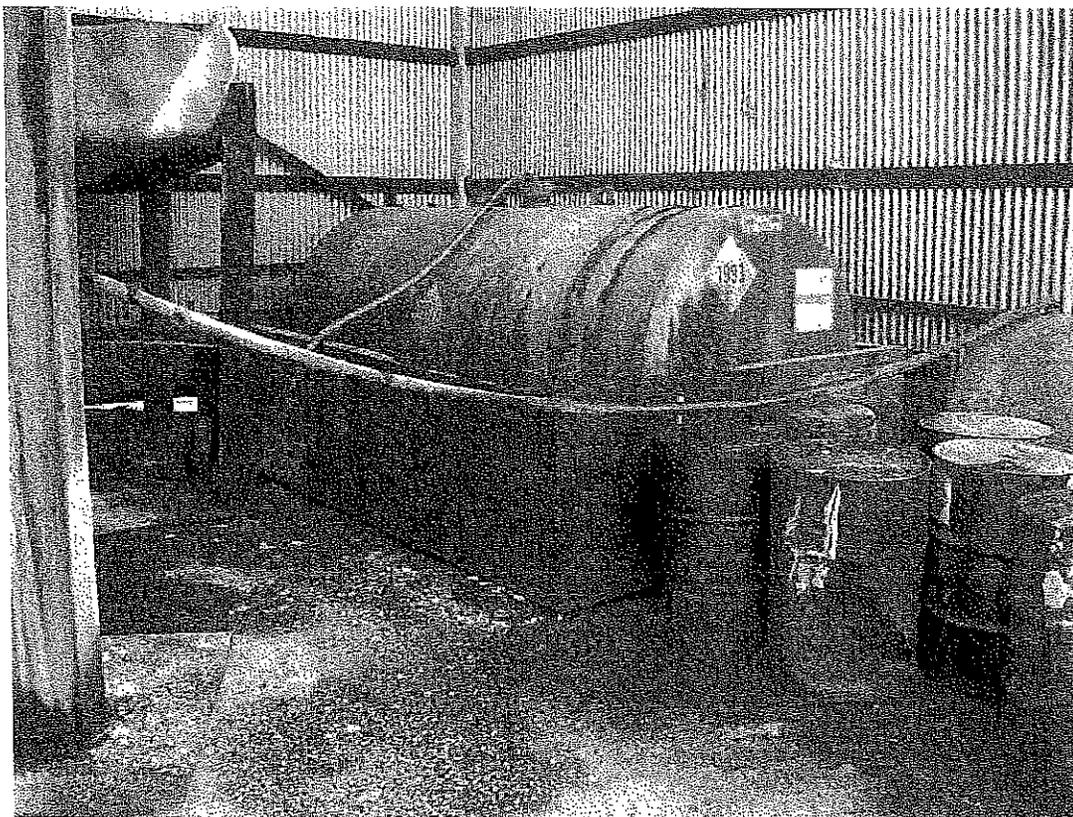
Photograph No. 5

Description: Gasoline storage tank inside a metal box acting as a secondary containment inside the gasoline recovery shed.

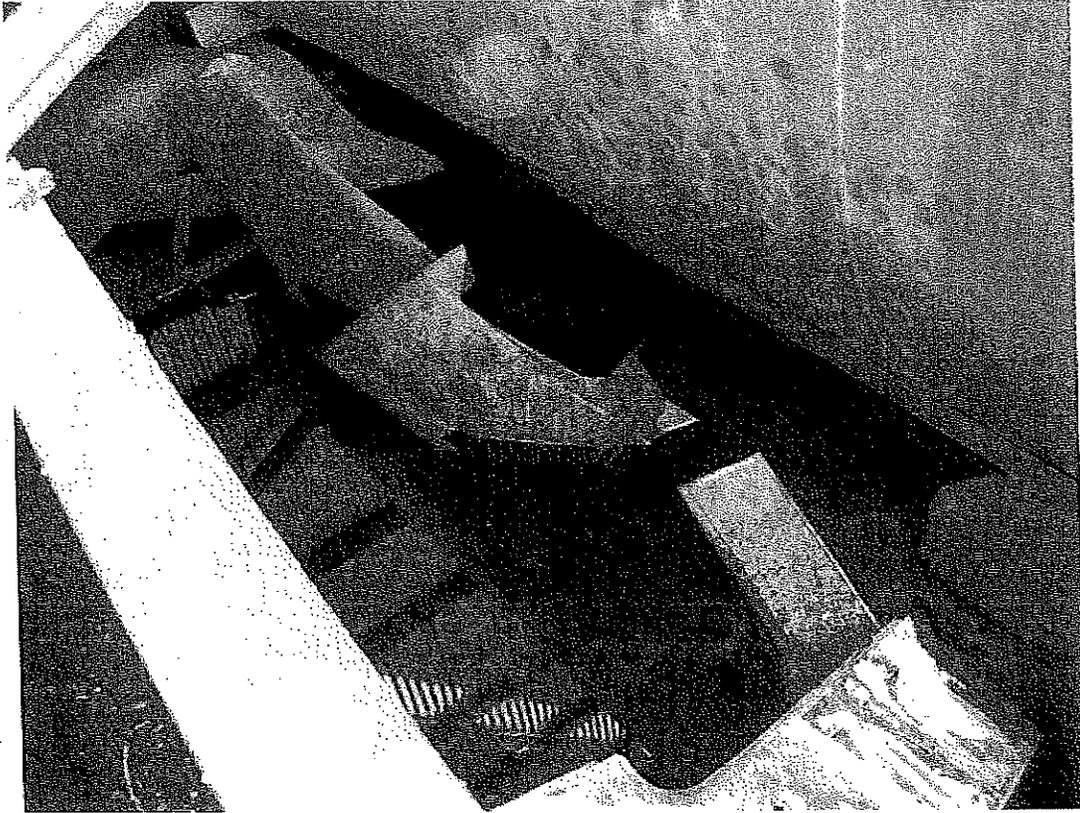
Photograph No. 6

Description: Reddish liquid with metal debris inside the steel box shown in photograph No. 5.

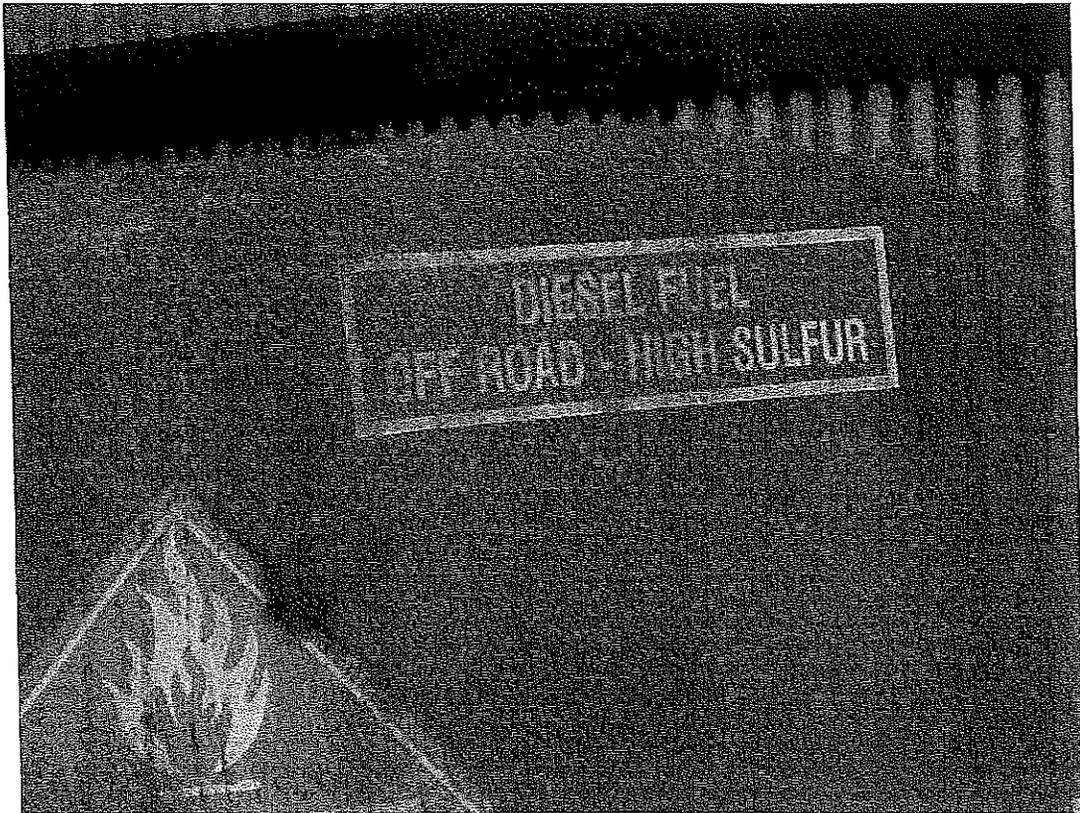
Photograph No. 8

Description: Label on the green gasoline storage tank in the gasoline recovery shed.

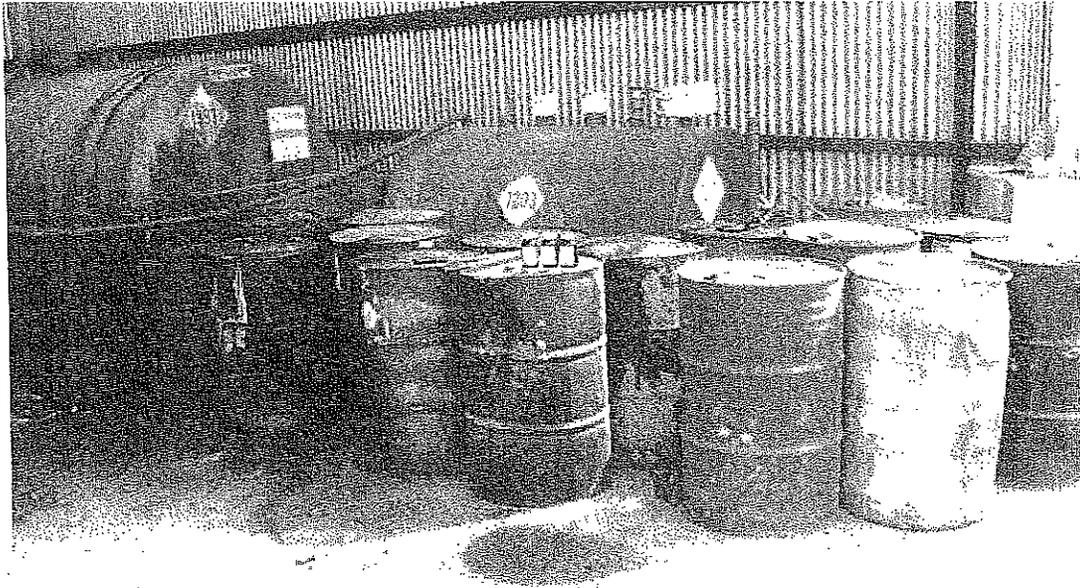
Photograph No. 9

Description: Drums of what appeared to be used oil stored against the east wall of the gasoline recovery shed.

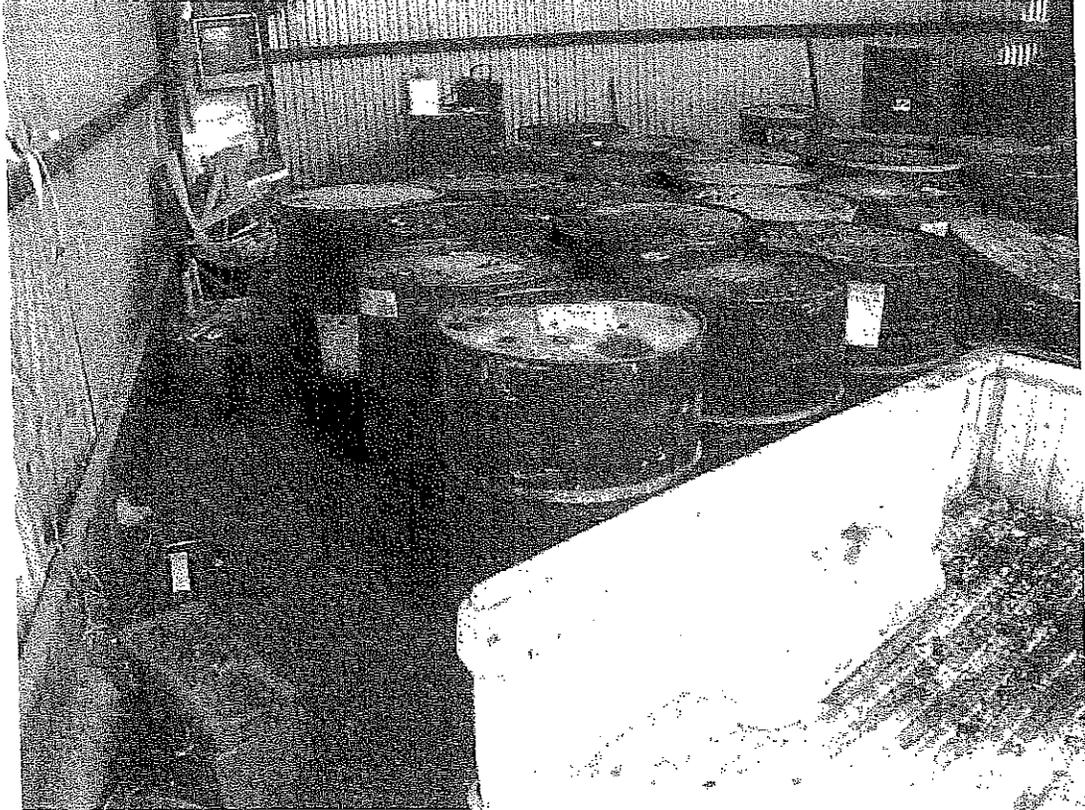
Photograph No. 10

Description: 55-gallon drums of what appeared to be used oil, stored adjacent to the west wall of the gasoline recovery shed.

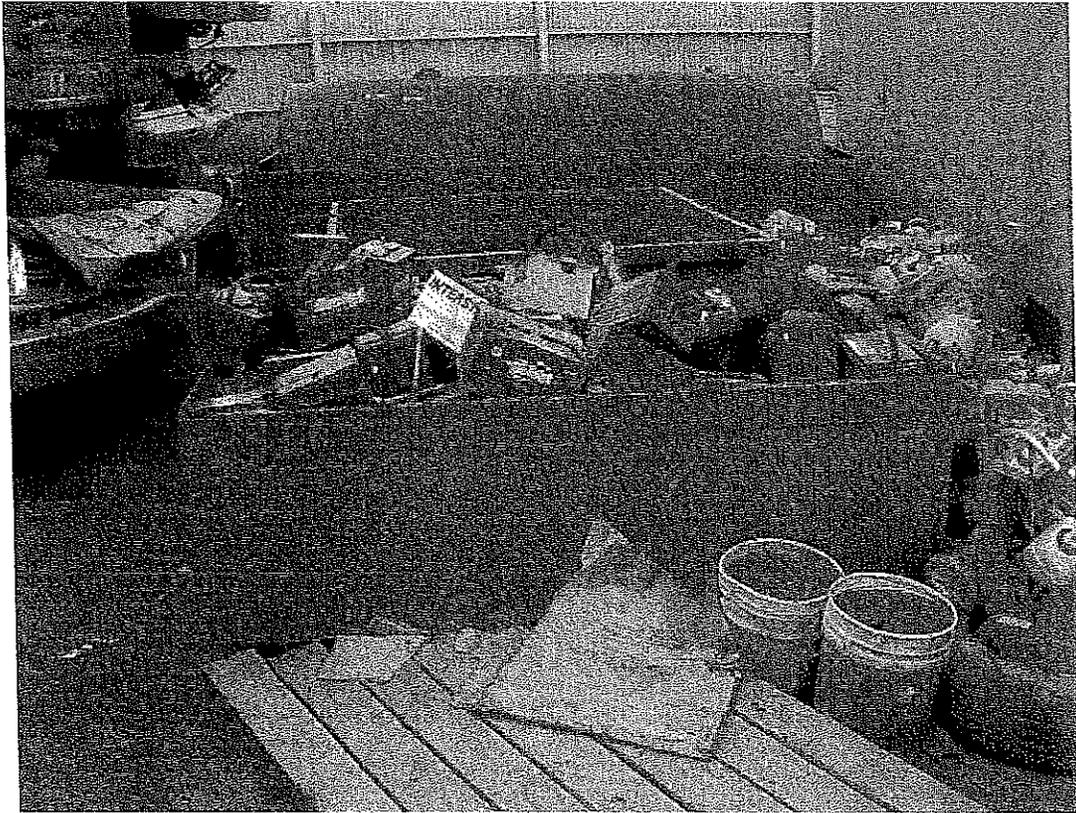
Photograph No. 19

Description: Batteries stored in a steel box west of the gasoline recovery shed.

59. EPA inspectors observed a steel box filled with car batteries near the gasoline recovery shed. Several batteries were broken with the lead plates exposed. There were no markings on the steel box. Exhibit 15.

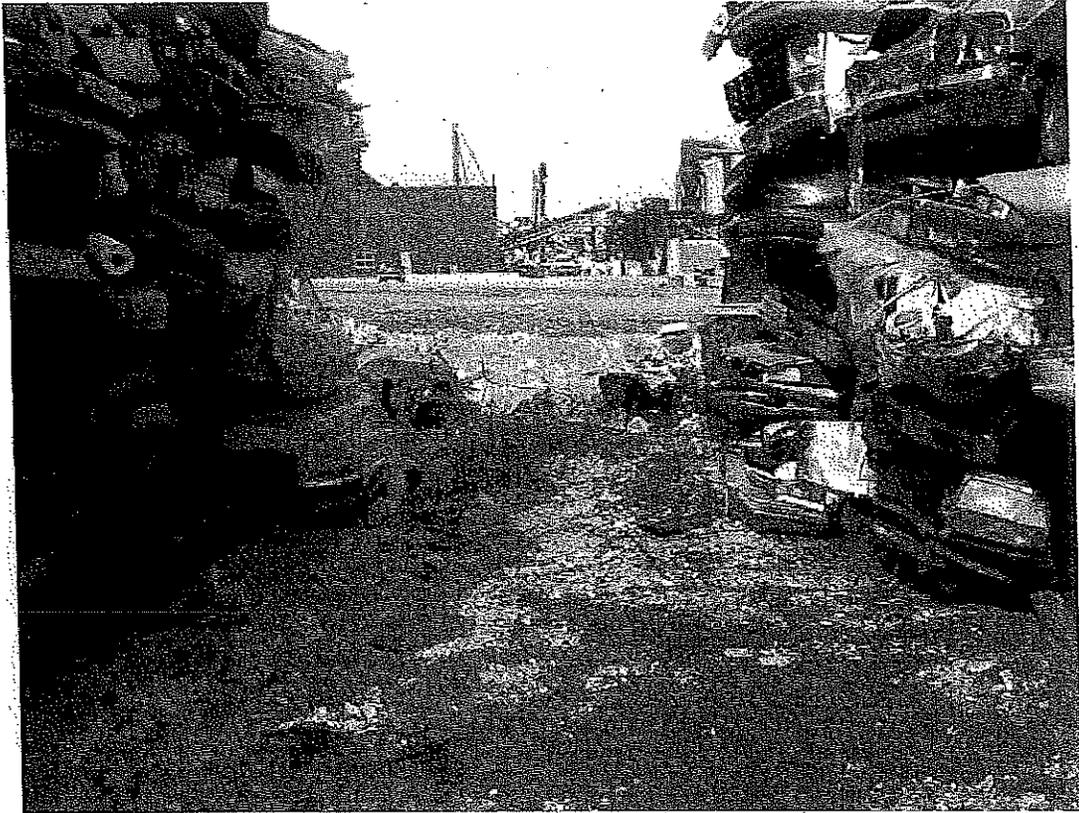
Photograph No. 25

Description: Aisle of crushed cars east of car shredder.

61. In the area between crushed cars and the shredder EPA observed a pool of water with an oil sheen. The soil in front of the water was dark and appeared to be stained with oil. The soils were also saturated with liquids such as automotive oils. EPA collected two soil samples in this area. (31890922 and 23). See Exhibit 16.

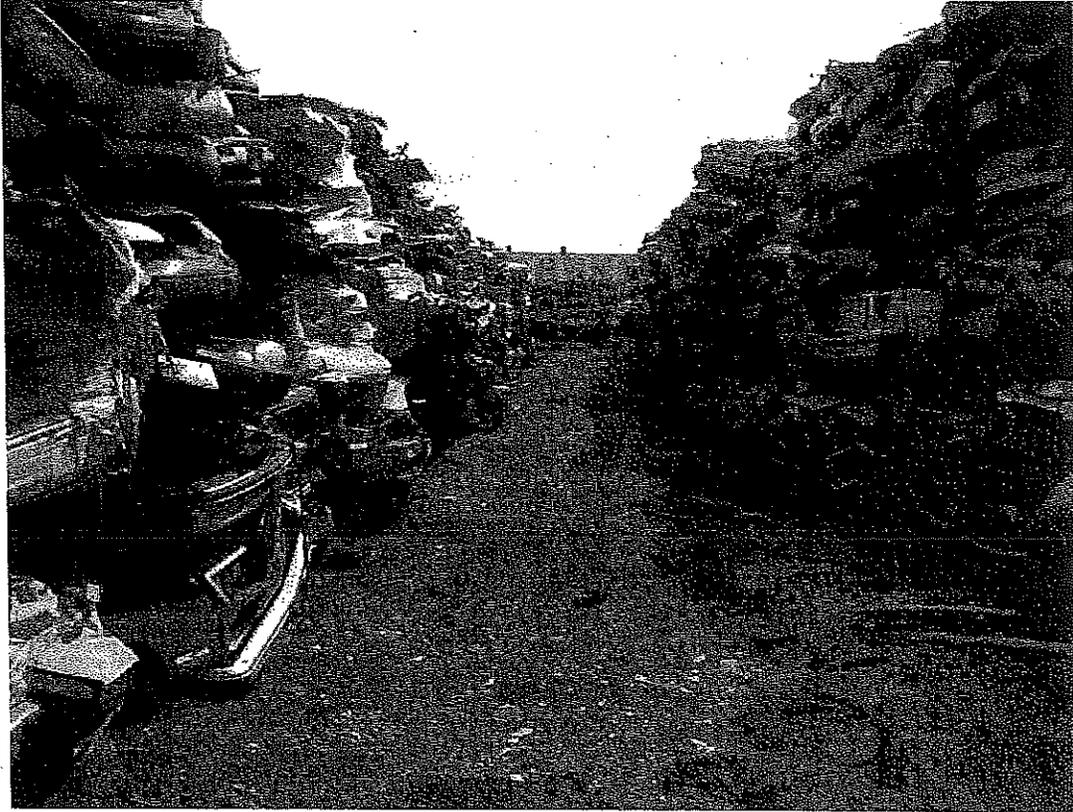
Photograph No. 26

Description: Aisle of crushed cars east of car shredder. This point of view has the car shredder behind us.
