**Re: New Mexico State Police District 7 Headquarters; Construction General Permit (CGP);  
NMU001941; SIC 1592; August 9, 2017**

### NPDES Compliance Inspection Report

**New Mexico General Services Department**  
**Project: NEW MEXICO STATE POLICE, DISTRICT 7 HEADQUARTERS**  
**NPDES Compliance Evaluation Inspection**  
**NPDES Permit NMU001941**  
**Inspection Date: August 9, 2017**

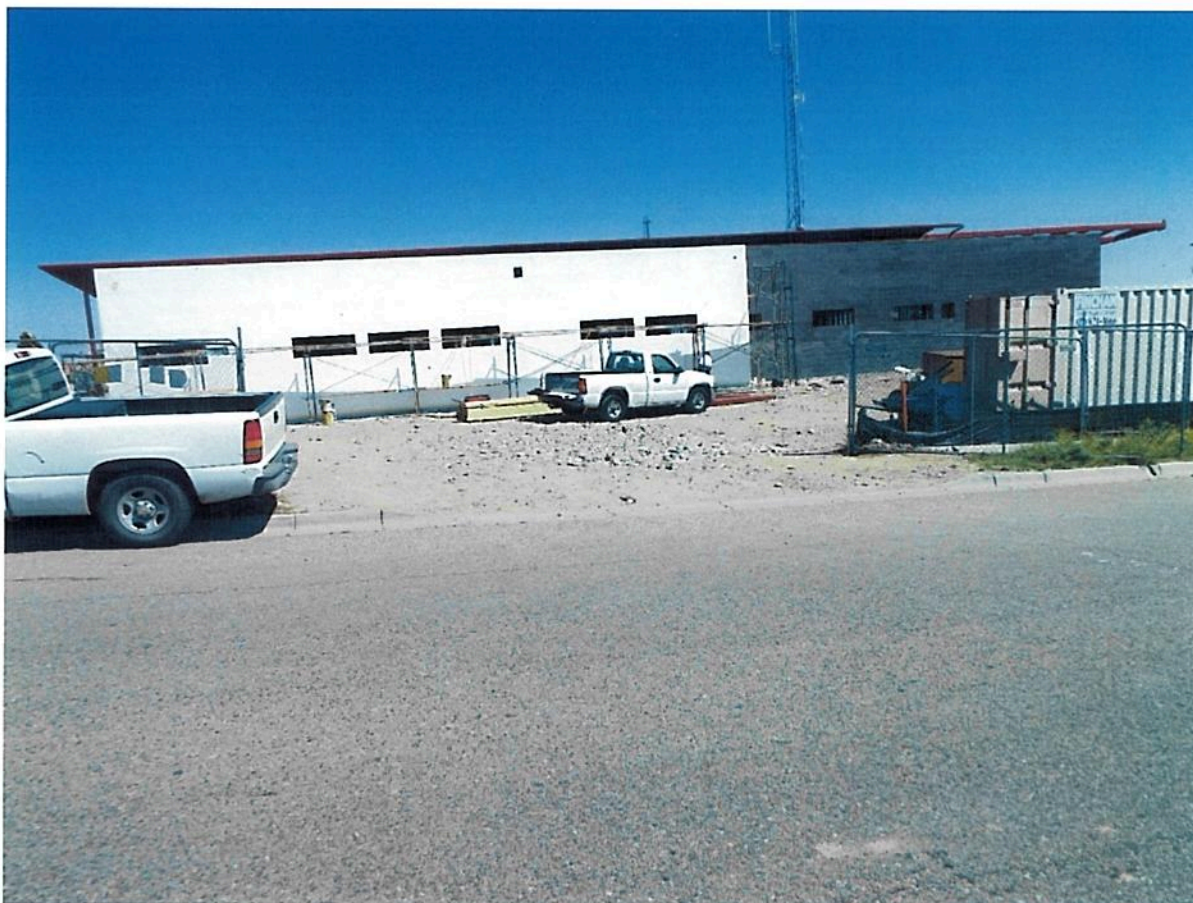
NMED/SWQB  
OFFICIAL PHOTO LOG  
PHOTO #1

Photographer: Daniel Valenta	Date: August 9, 2017	Time: 1046 Hours
City/County: Espanola/Rio Arriba		
Location: New Mexico State Police District 7 Headquarters		
Subject: One of two entrances on site. (southeast side)

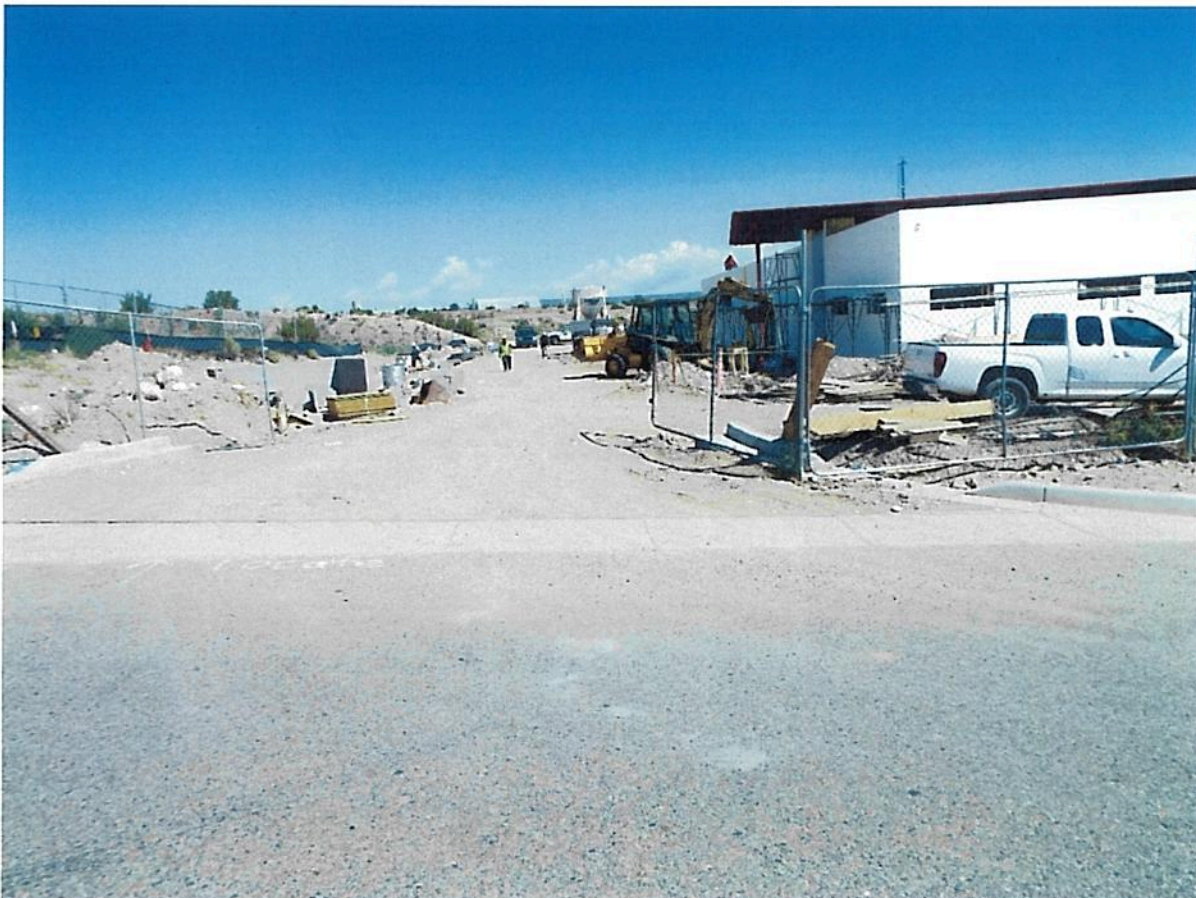
NMED/SWQB  
OFFICIAL PHOTO LOG  
PHOTO #2

Photographer: Daniel Valenta	Date: August 9, 2017	Time: 1046 Hours
City/County: Espanola/Rio Arriba		
Location: New Mexico State Police District 7 Headquarters		
Subject: One of two entrances on site. (southwest entrance) Part 2.2.4/Permit Requirements: Use appropriate stabilization techniques (e.g., use of aggregate stone with an underlying geotextile or non-woven filter fabric, and turf mats) at all points that exit onto paved roads.

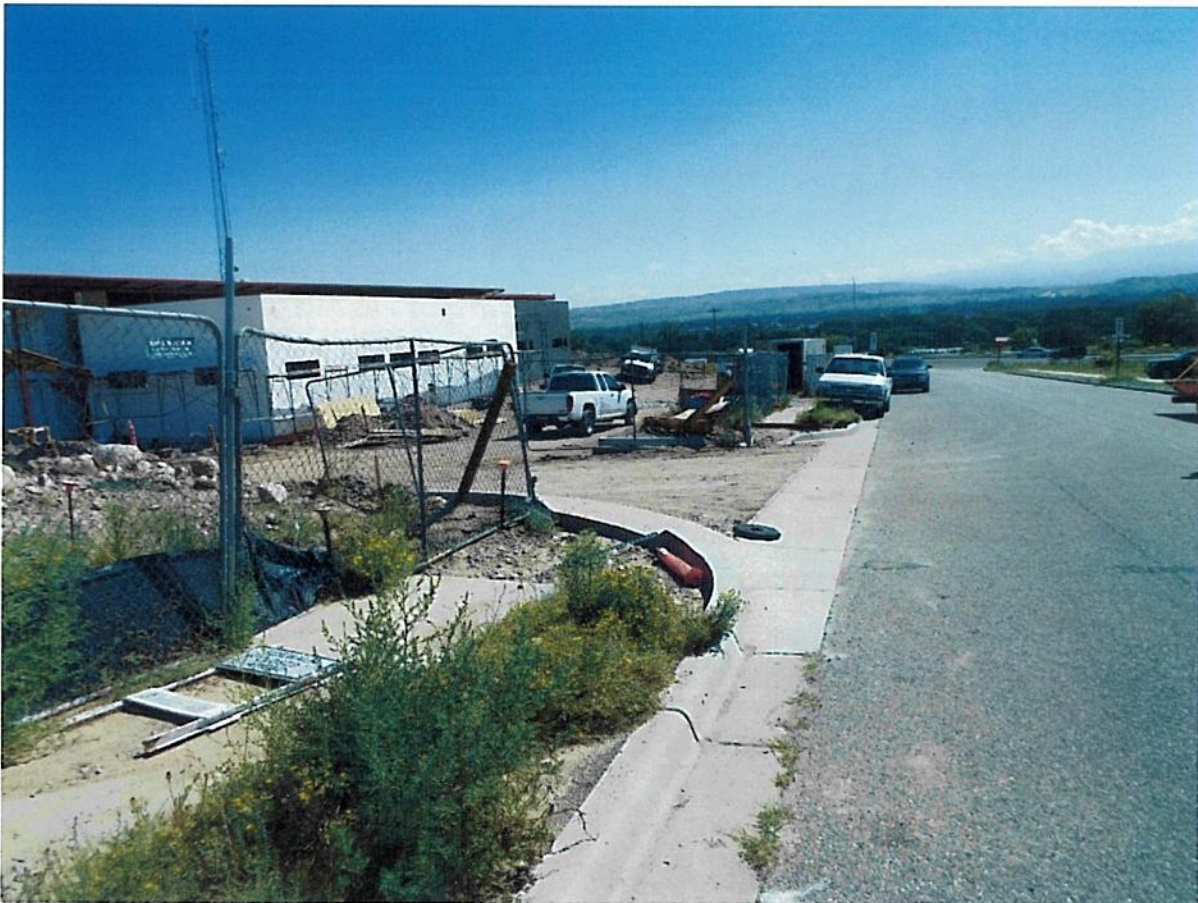
NMED/SWQB  
OFFICIAL PHOTO LOG  
PHOTO #3

Photographer: Daniel Valenta	Date: August 9, 2017	Time: 1046 Hours
City/County: Espanola/Rio Arriba		
Location: New Mexico State Police District 7 Headquarters		
Subject: One of two entrances on site. (southwest entrance) Part 2.2.4/Permit Requirements: Use appropriate stabilization techniques (e.g., use of aggregate stone with an underlying geotextile or non-woven filter fabric, and turf mats) at <b>all points that exit onto paved roads.</b>

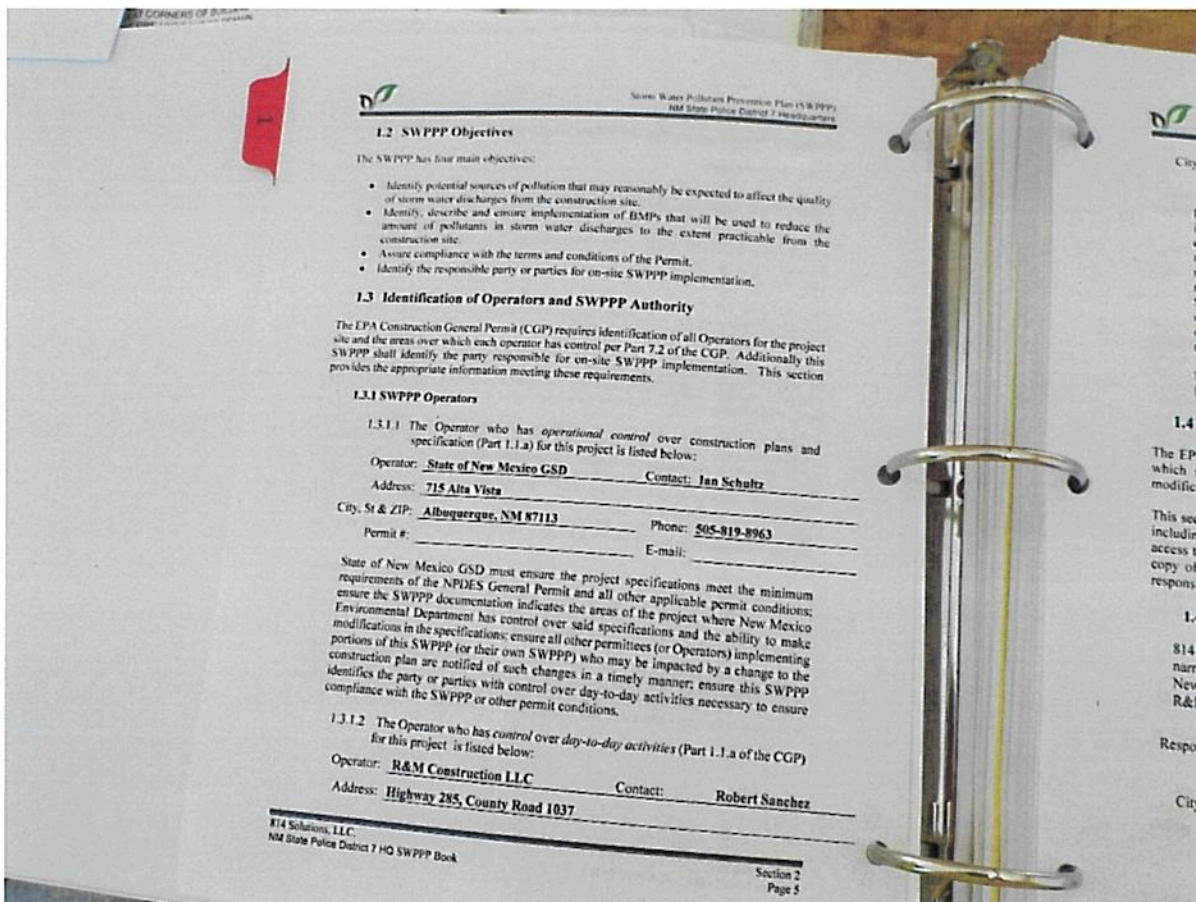
**NMED/SWQB  
OFFICIAL PHOTO LOG  
PHOTO #4**

Photographer: Daniel Valenta	Date: August 9, 2017	Time: 1046 Hours
City/County: Espanola/Rio Arriba		
Location: New Mexico State Police District 7 Headquarters		
Subject: Page 5 of SWPPP – SWPPP Owner (operational control of construction / Contractor (day to day activities at site) listed.

New Mexico General Services Department (Owner), failed to file an Electronic Notice of Intent (eNOI) under the 2017 Construction General Permit (CGP). The New Mexico General Services Department failed to sign the Stormwater Pollution Prevention Plan (SWPPP), which was provided by R & M Construction to NMED at the time of the inspection.

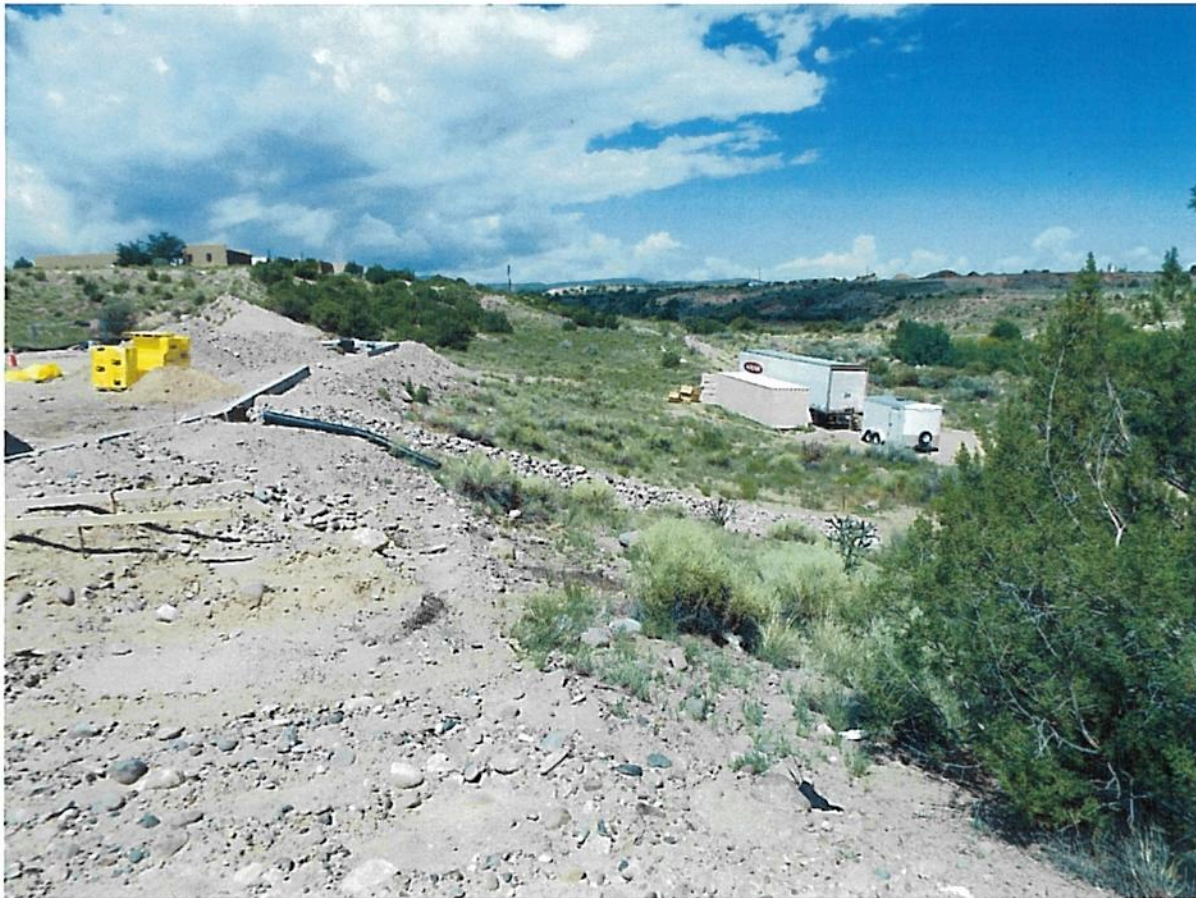
NMED/SWQB  
OFFICIAL PHOTO LOG  
PHOTO #5

Photographer: Daniel Valenta	Date: August 9, 2017	Time: 1046 Hours
City/County: Espanola/Rio Arriba		
Location: New Mexico State Police District 7 Headquarters		
Subject: North side of property looking west. Created spillway with curbing in place.

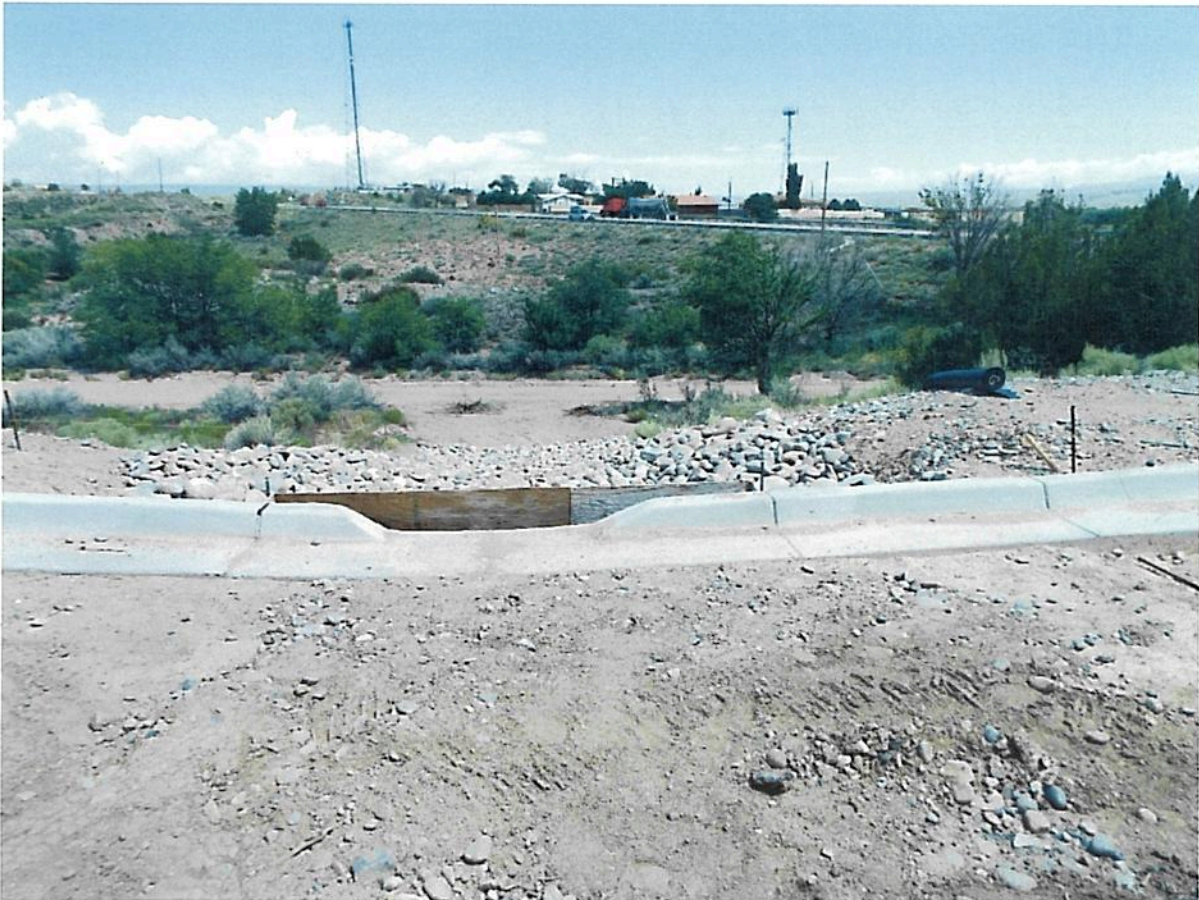
NMED/SWQB  
OFFICIAL PHOTO LOG  
PHOTO #6

Photographer: Daniel Valenta	Date: August 9, 2017	Time: 1138 Hours
City/County: Espanola/Rio Arriba		
Location: New Mexico State Police District 7 Headquarters		
Subject: North side of property looking north. Created spillway with curbing cutout for drainage purposes.

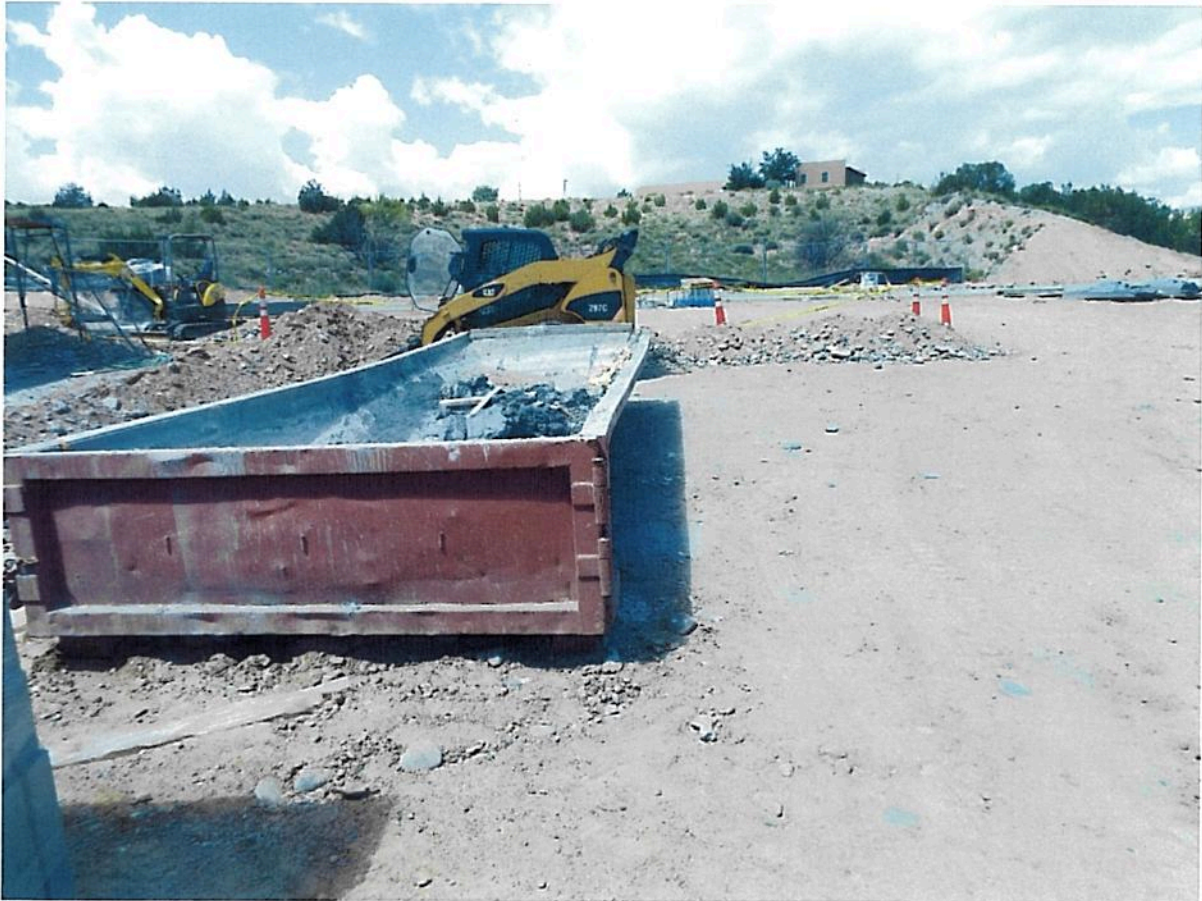
NMED/SWQB  
OFFICIAL PHOTO LOG  
PHOTO #9

Photographer: Daniel Valenta	Date: August 9, 2017	Time: 1138 Hours
City/County: Espanola/Rio Arriba		
Location: New Mexico State Police District 7 Headquarters		
Subject: Concrete washout container.

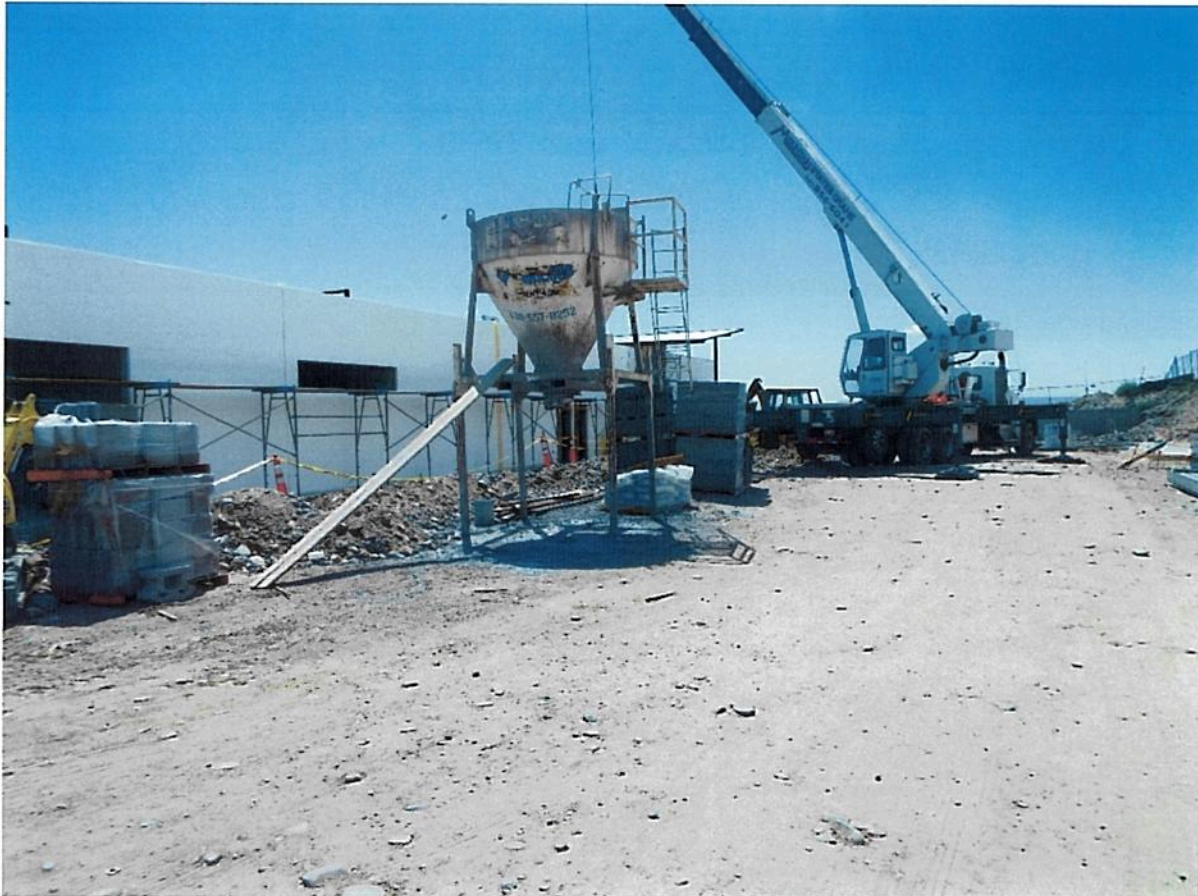
NMED/SWQB  
OFFICIAL PHOTO LOG  
PHOTO #10

Photographer: Daniel Valenta	Date: August 9, 2017	Time: 1143 Hours
City/County: Espanola/Rio Arriba		
Location: New Mexico State Police District 7 Headquarters		
Subject: Temporary Cement Plant west side of property / Part 2.3.4: Applicator and Container Washing Requirements: Direct washwater into a leak-proof container or leak-proof and lined pit designed so that no overflows can occur due to inadequate sizing.

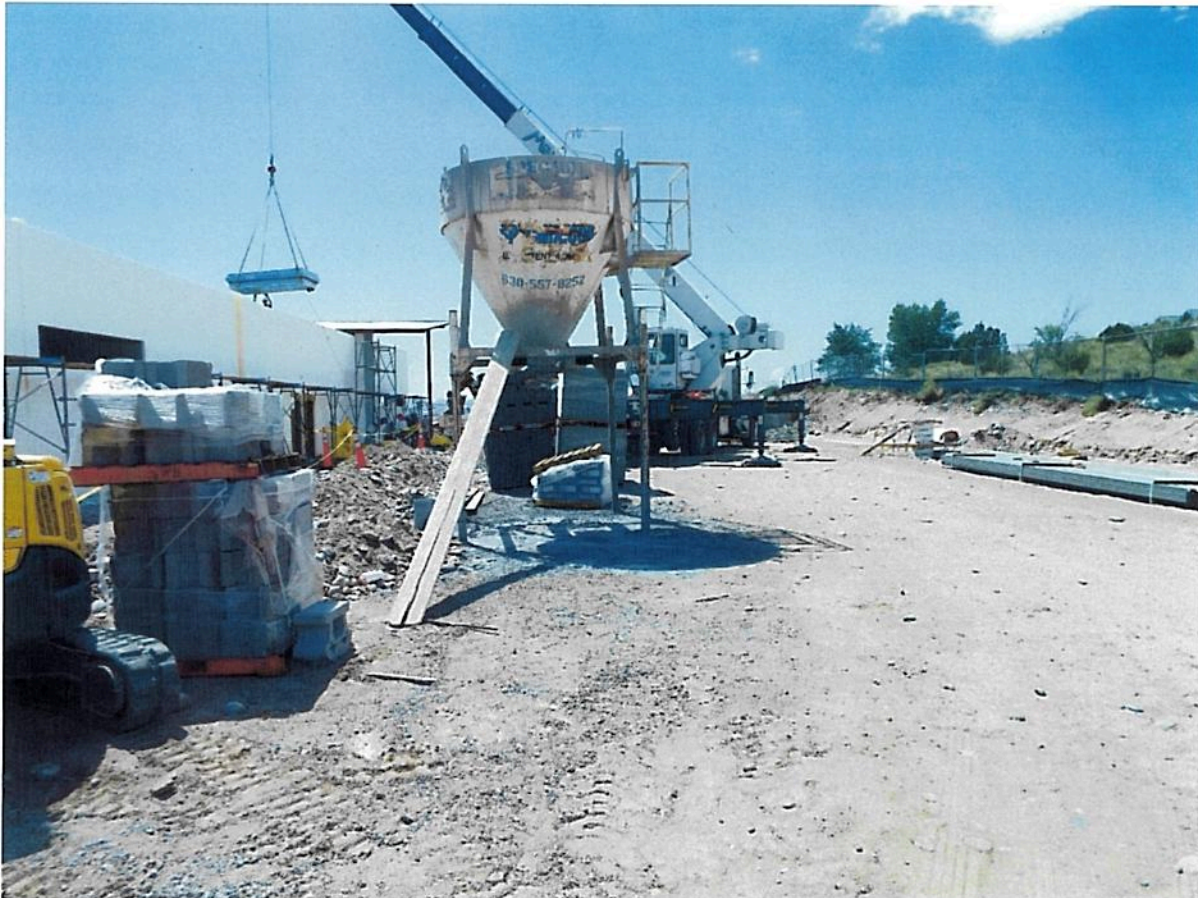
NMED/SWQB  
OFFICIAL PHOTO LOG  
PHOTO #11

Photographer: Daniel Valenta	Date: August 9, 2017	Time: 1143 Hours
City/County: Espanola/Rio Arriba		
Location: New Mexico State Police District 7 Headquarters		
Subject: Temporary Cement Plant west side of property / Part 2.3.4: Applicator and Container Washing Requirements: Direct washwater into a leak-proof container or leak-proof and lined pit designed so that no overflows can occur due to inadequate sizing.

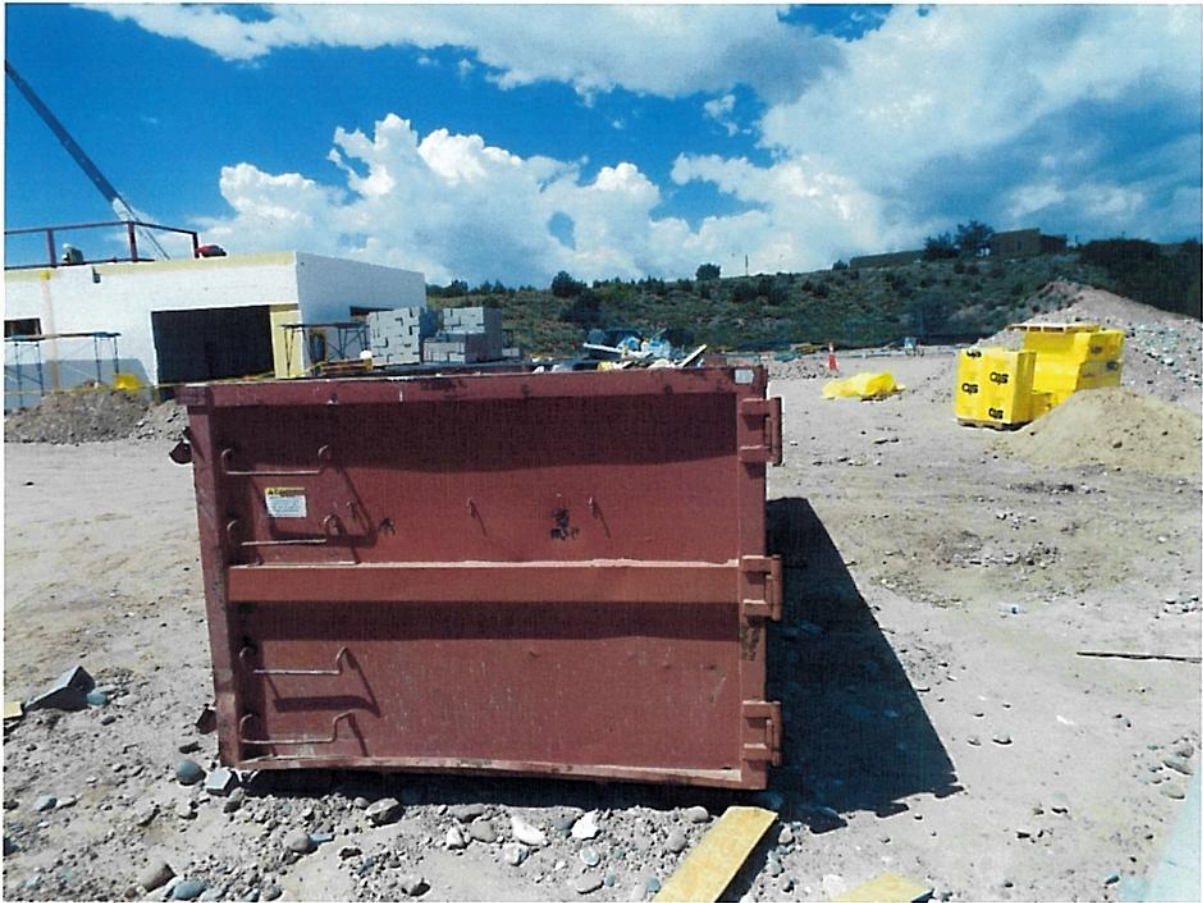
NMED/SWQB  
OFFICIAL PHOTO LOG  
PHOTO #12

Photographer: Daniel Valenta	Date: August 9, 2017	Time: 1137 Hours
City/County: Espanola/Rio Arriba		
Location: New Mexico State Police District 7 Headquarters		
Subject: Construction/Domestic trash dumpster / Part 2.3.3.e Requirements: For construction and domestic waste: Provide waste containers (e.g., dumpster, trash receptacle) of sufficient size and number. Keep waste container <b>lids closed</b> when not in use and close lids <b>at the end of the business day</b> for those containers that are actively used throughout the day.

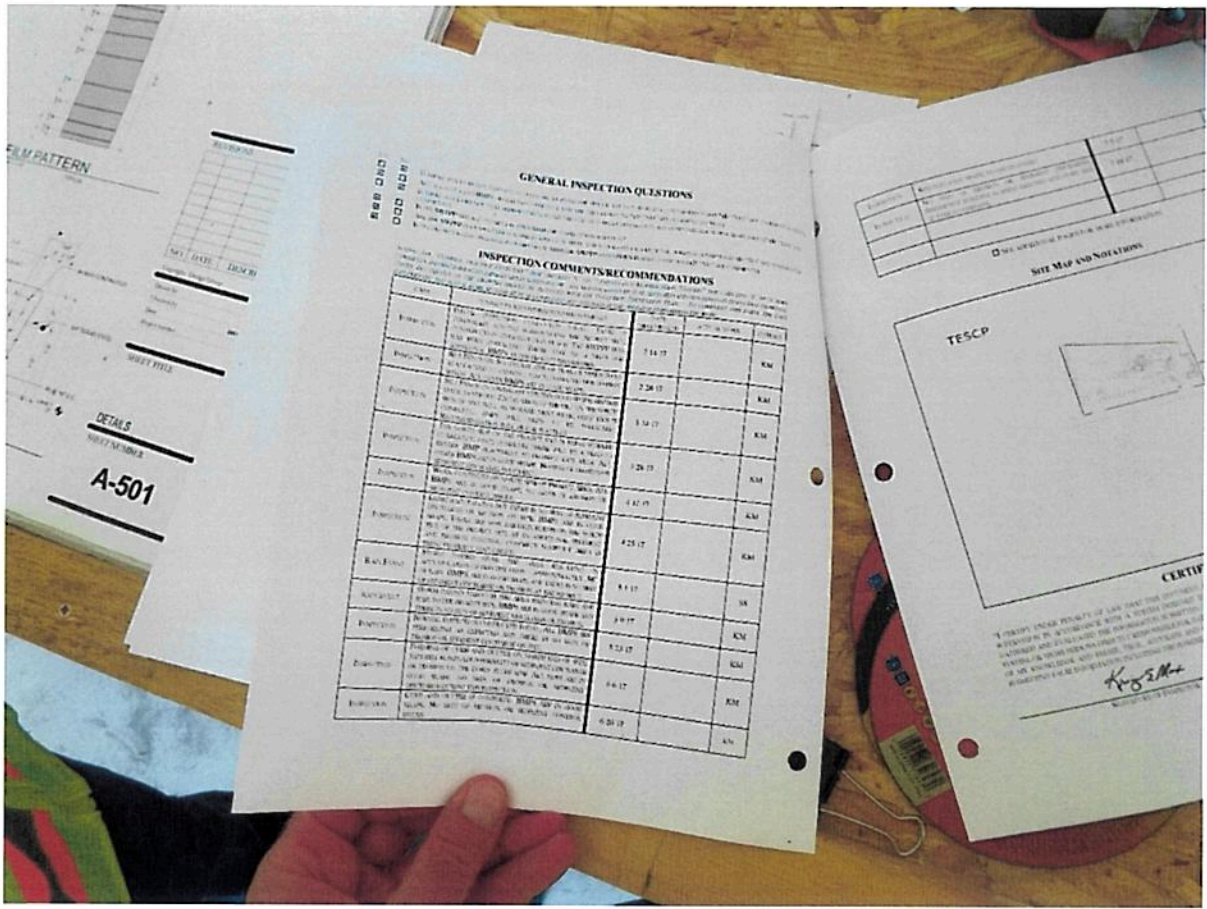
NMED/SWQB  
OFFICIAL PHOTO LOG  
PHOTO #13

The first site inspection by 814 Solutions (sub-contractor), after construction began, was completed on February 14, 2017 by Mr. Craig Max, Environmental Compliance Manager. This site appears to have been active for approximately six months without a permit. Inspections, provided in the SWPPP, indicate that there was a precipitation event that occurred on May 1, 2017, with an accumulation of .58" of rain. There was not an inspection done 24-hours following this event, as required by the permit. The next inspection was dated May 9, 2017 (see photo #13).

Photographer: Daniel Valenta	Date: August 9, 2017	Time: 1132 Hours
City/County: Espanola/Rio Arriba		
Location: New Mexico State Police District 7 Headquarters		
Subject: Inspection report. Part 4.2 of Permit Requires: Inspect <b>within 24 hours</b> of the occurrence of a storm event of 0.25 inches or greater. (Rain event on May 1, 2017 of .58")
