CONCEPTUAL WATER BALANCE MODEL AND FATE ASSESSMENT

Produced Water Spill McKenzie County, North Dakota

Wright Water Engineers, Inc.

October 2015

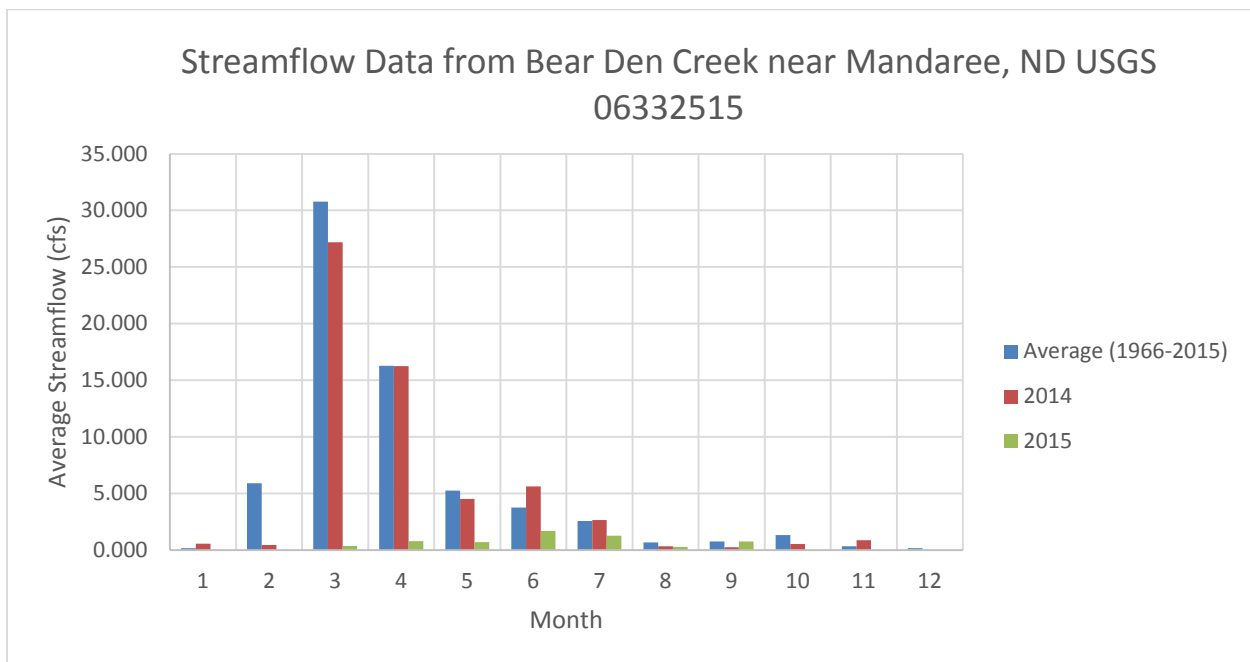
Figure 4-1: Streamflow Data from Bear Den Creek near Mandaree, North Dakota

The nearest USGS streamflow gage is located on Bear Den Creek near Mandaree, North Dakota, approximately 6 miles west of the spill site. The latitude of the stream gage is 47°47'14" N and the longitude is 102°46'05" W. The drainage basin for the Bear Den Creek gage is 74 square miles, or about 60 times larger than the watershed where the spill occurred (thus mandating a basin adjustment factor, as discussed in Section 5.0). The average annual streamflow at the Bear Den Creek gage is 5.7 cfs, or about 0.054 gpm per acre.

The yearly streamflow trend indicates that the highest flows occur in March and decrease throughout the spring and summer. Streamflow is usually very low in the winter months due to freezing temperatures.

The levels of streamflow recorded in 2014 were generally consistent with average historical flows. For example, July 2014 saw an average streamflow of 2.66 cubic feet per second (cfs), which was 3.5% higher than the historical average July streamflow of 2.57 cfs. June 2014 flows were higher than the long-term average, while May flows were lower.

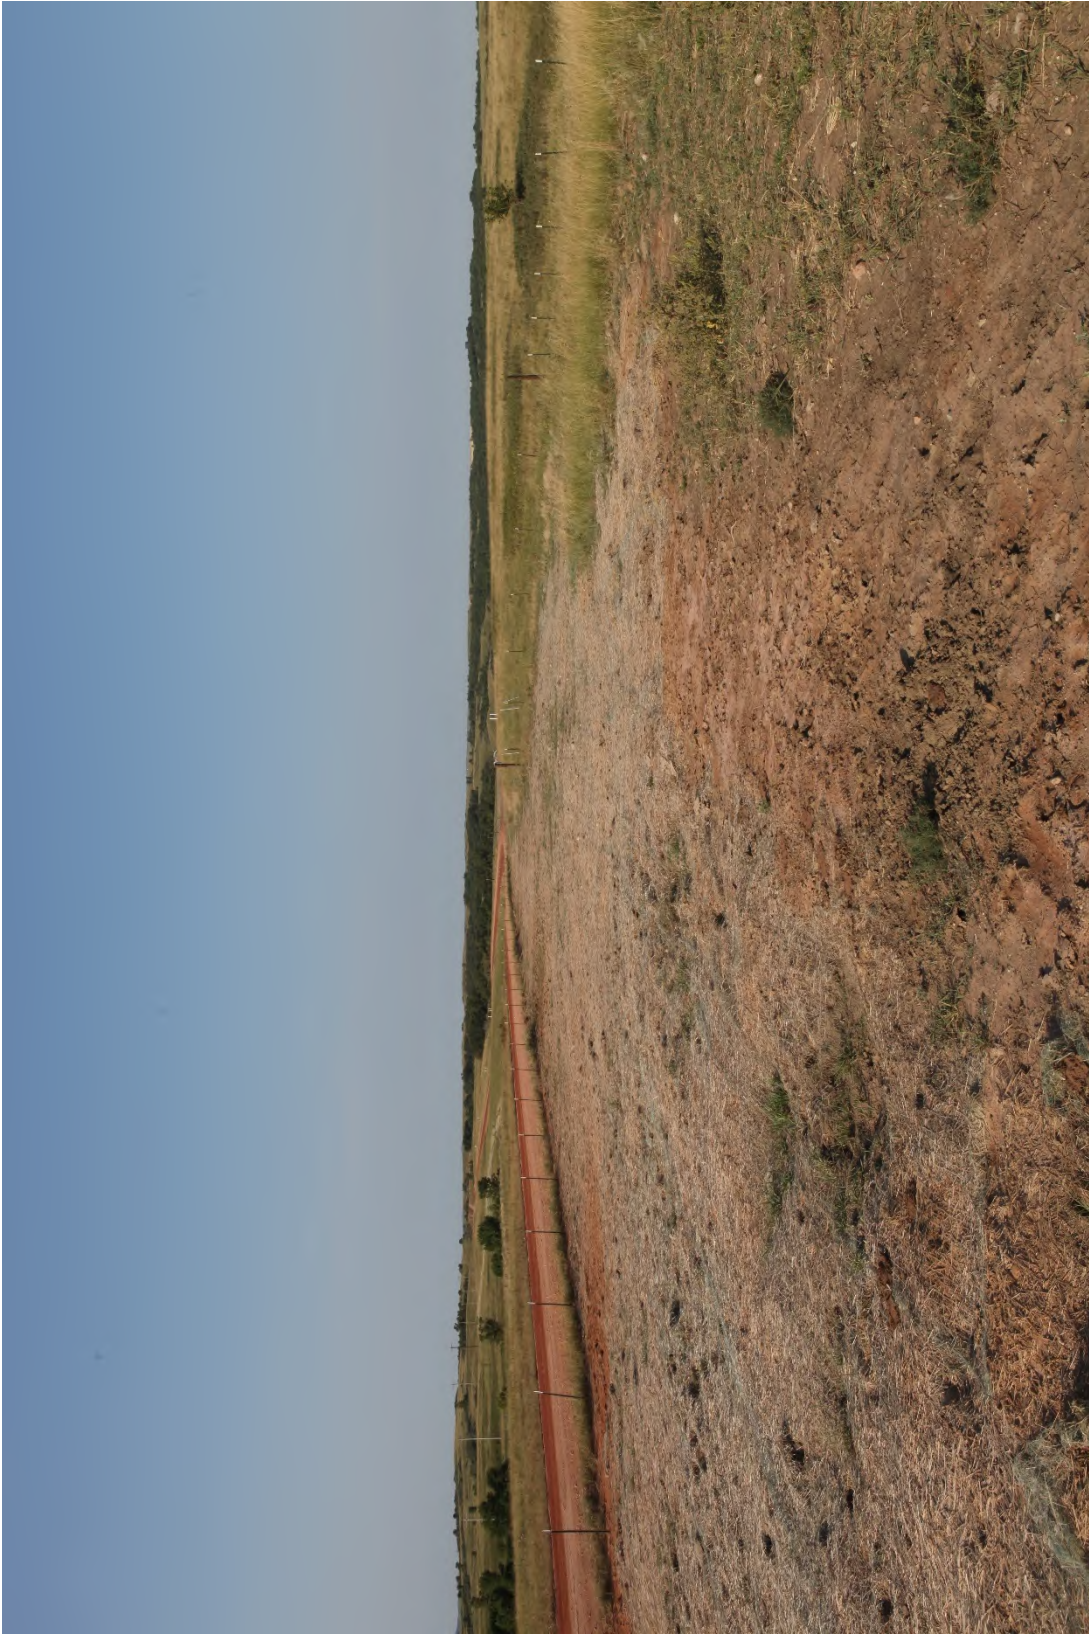
View across spill area north and west of Turnuey Ridge Road
—*looking southwest.*

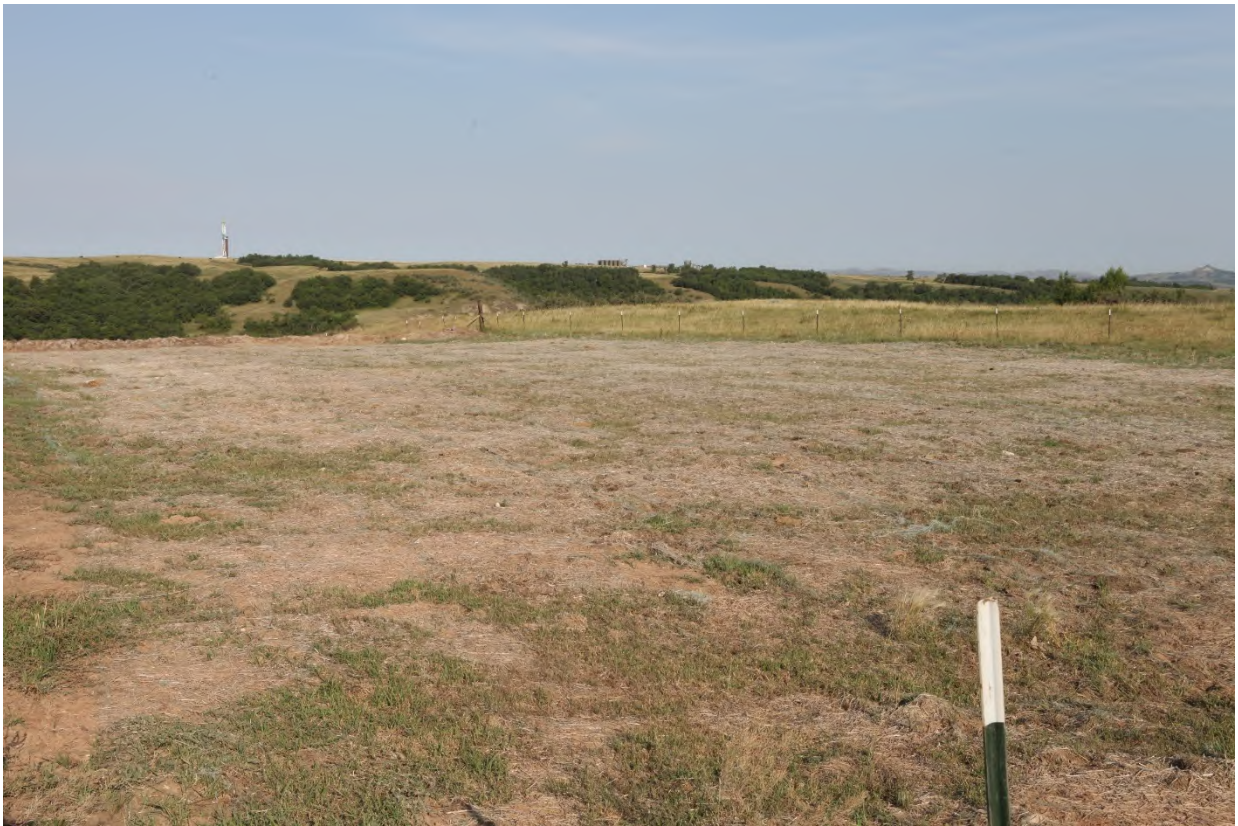
Area adjacent to Turnuey Ridge Road where spilled fluids pooled before dropping into ravine
—*looking northwest.*

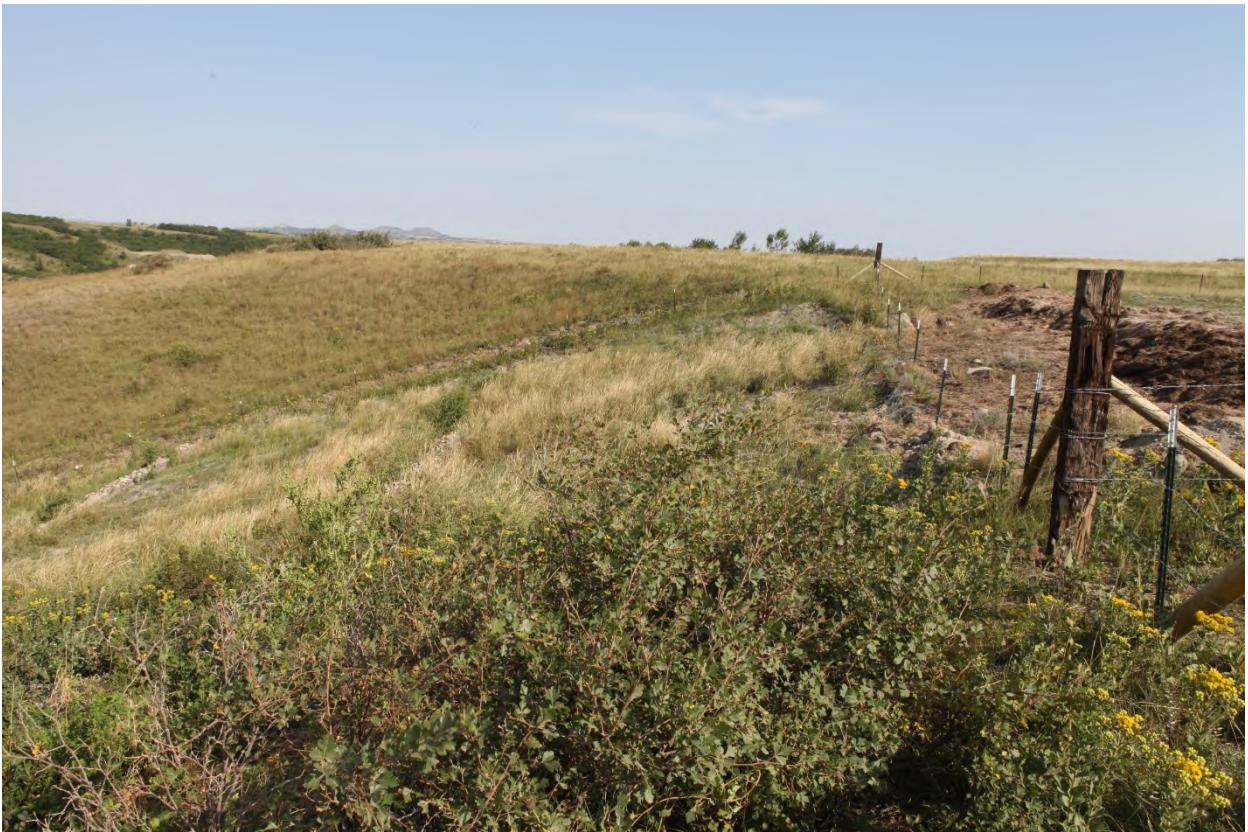
Start of steep drop from road into ravine near
area 58—*looking north.*

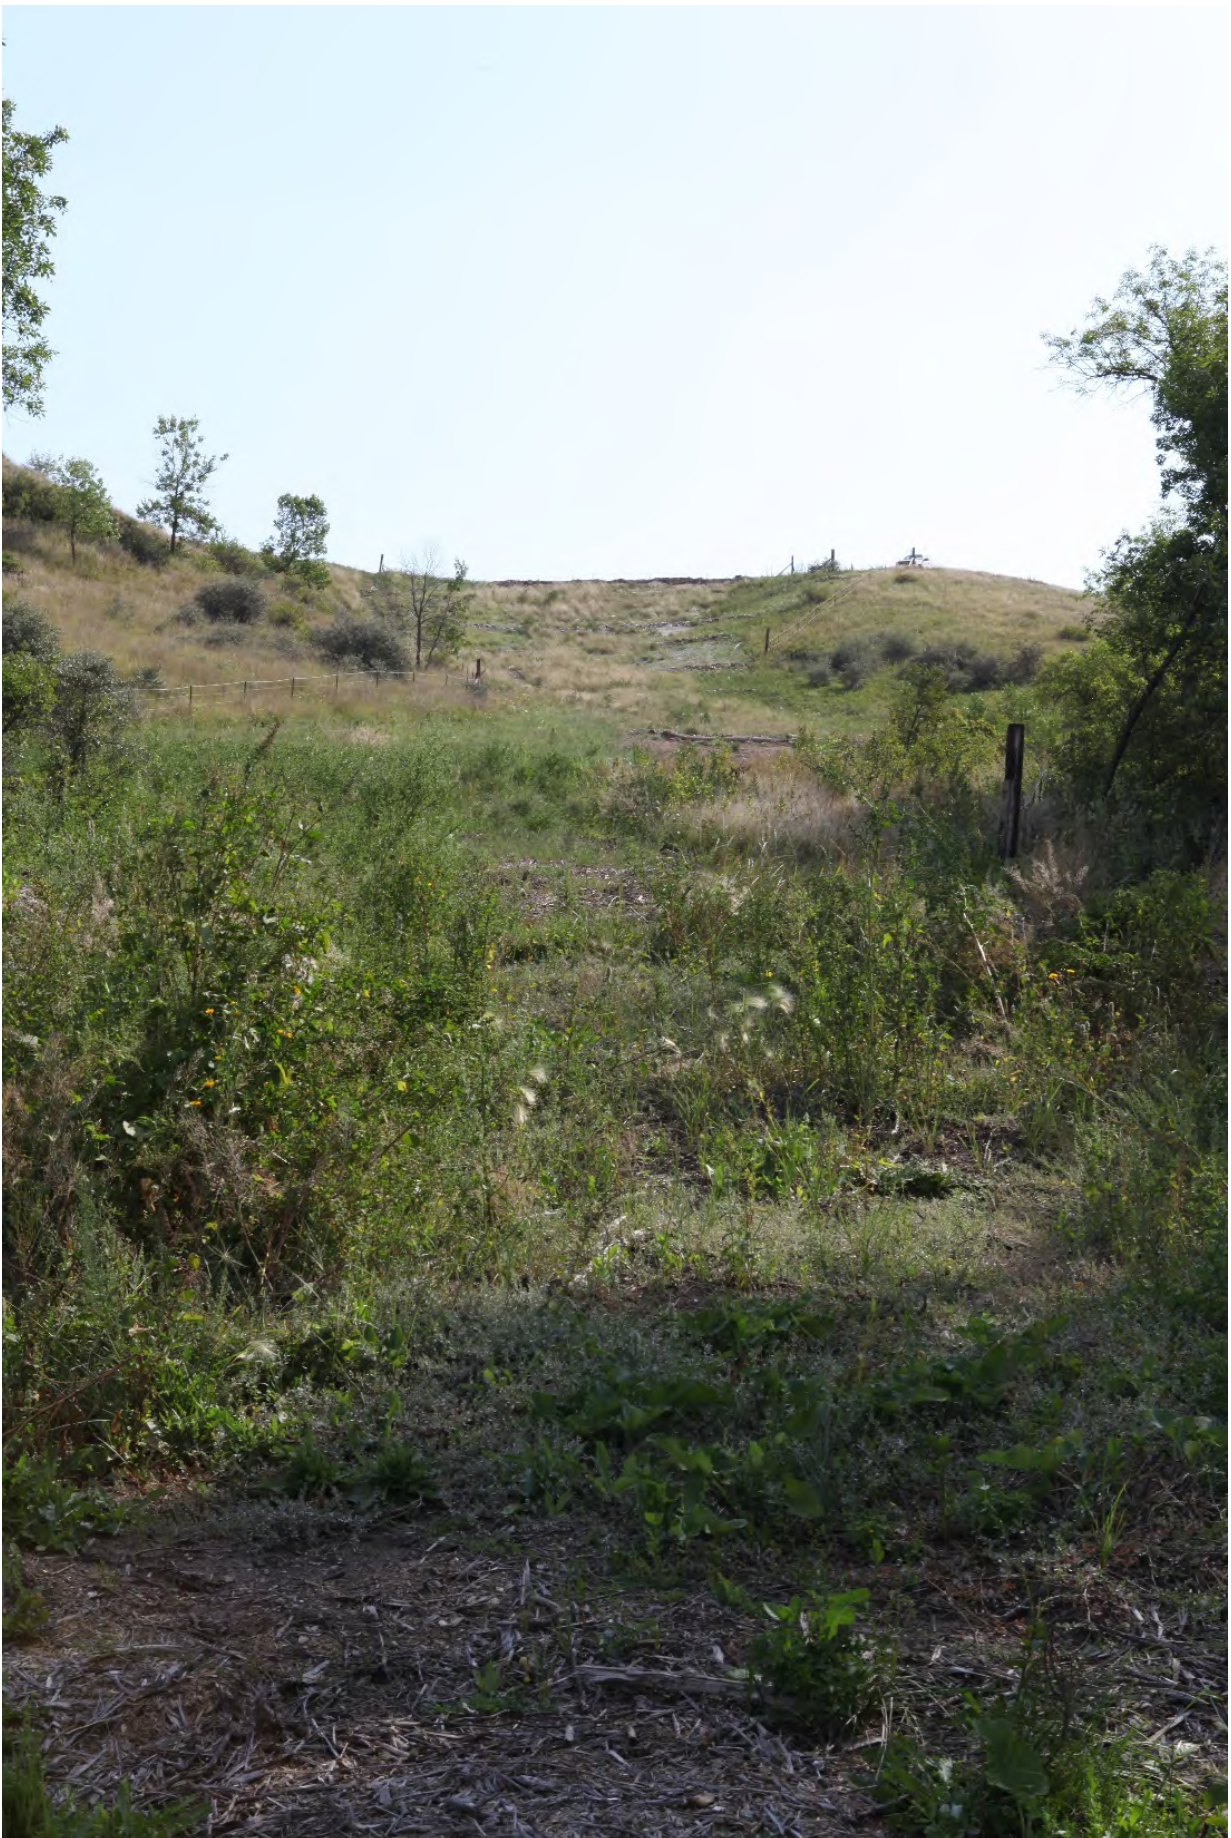
View from Trees (S4) toward Toe of Slope (S3) and Turnuey Ridge Road—*looking northeast*.

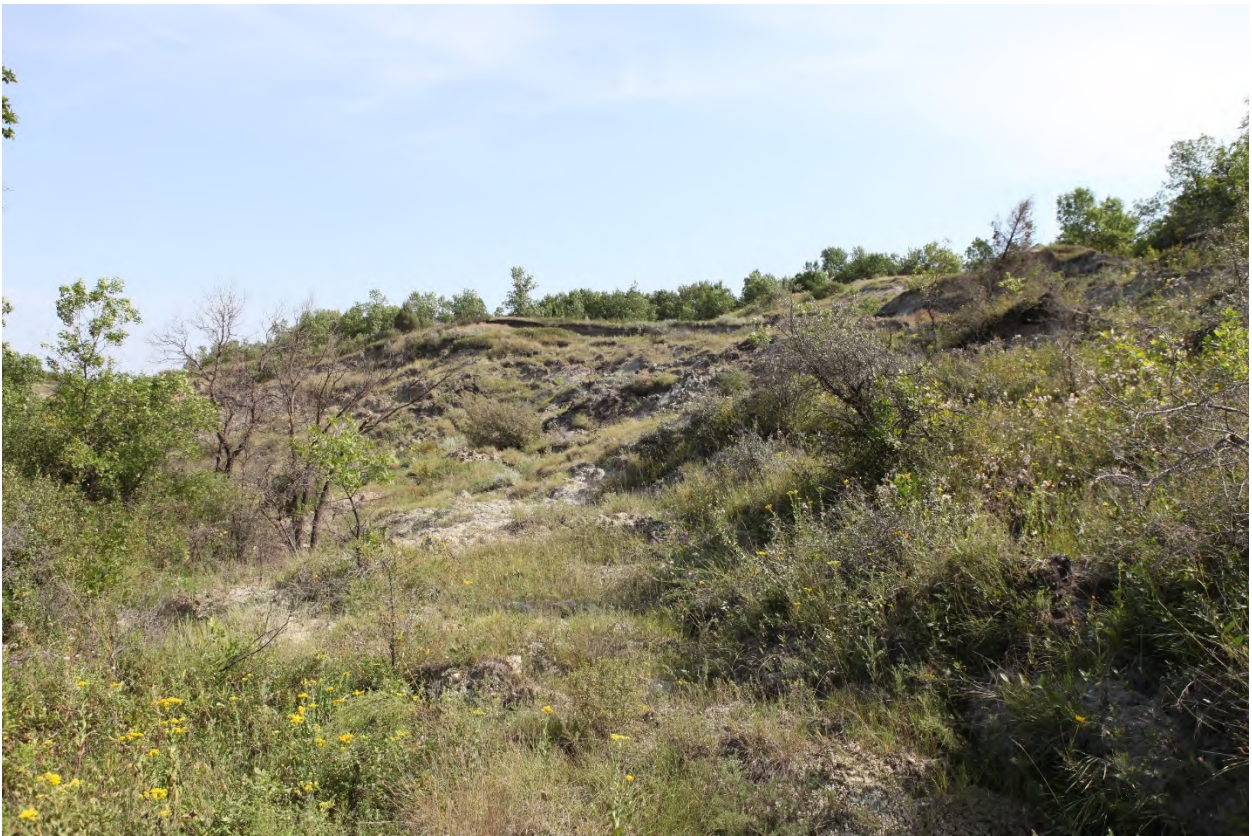
Representative landslide feature on the east side of unnamed drainage near Coulee Start (S6)
—*looking north/northeast.*

Of particular geologic note is that the fine-grained nature of the Sentinel Butte Formation makes it susceptible to landslides particularly in the more deeply incised drainages such as the one in the spill area. A published map (Snsh SW-1) by the NDGS reveals that much of the drainage (including the entire valley bottom along the spilled fluids flow path) is mapped as landslide deposits (see Attachment C). A site visit by WWE in August 2015 confirmed the widespread extent of these landslide features. A photograph of a representative landslide can be found in Attachment A. As noted in Section 2.4, the numerous local slumps/sloughs in the spill flow path promoted temporary surface ponding and infiltration.

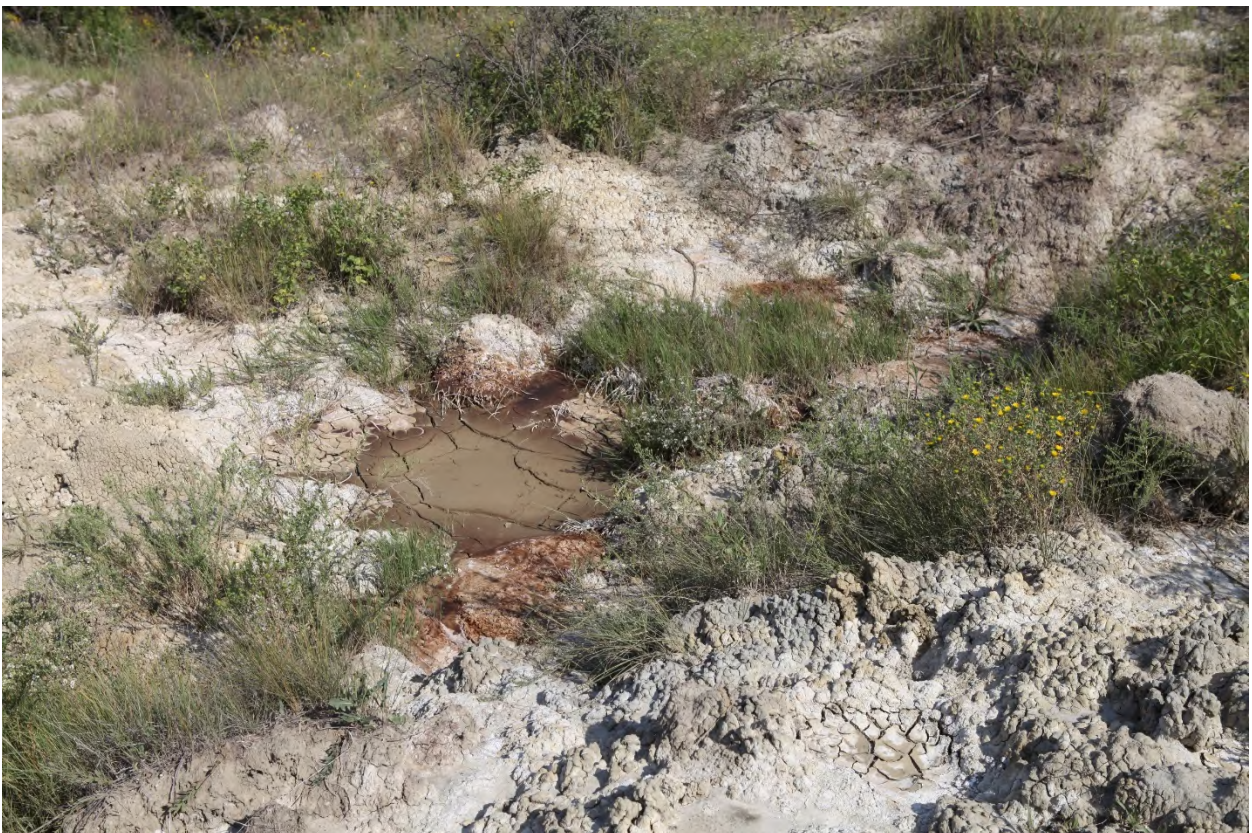
Example groundwater discharge location below landslide uninfluenced by spill—*looking northwest.*

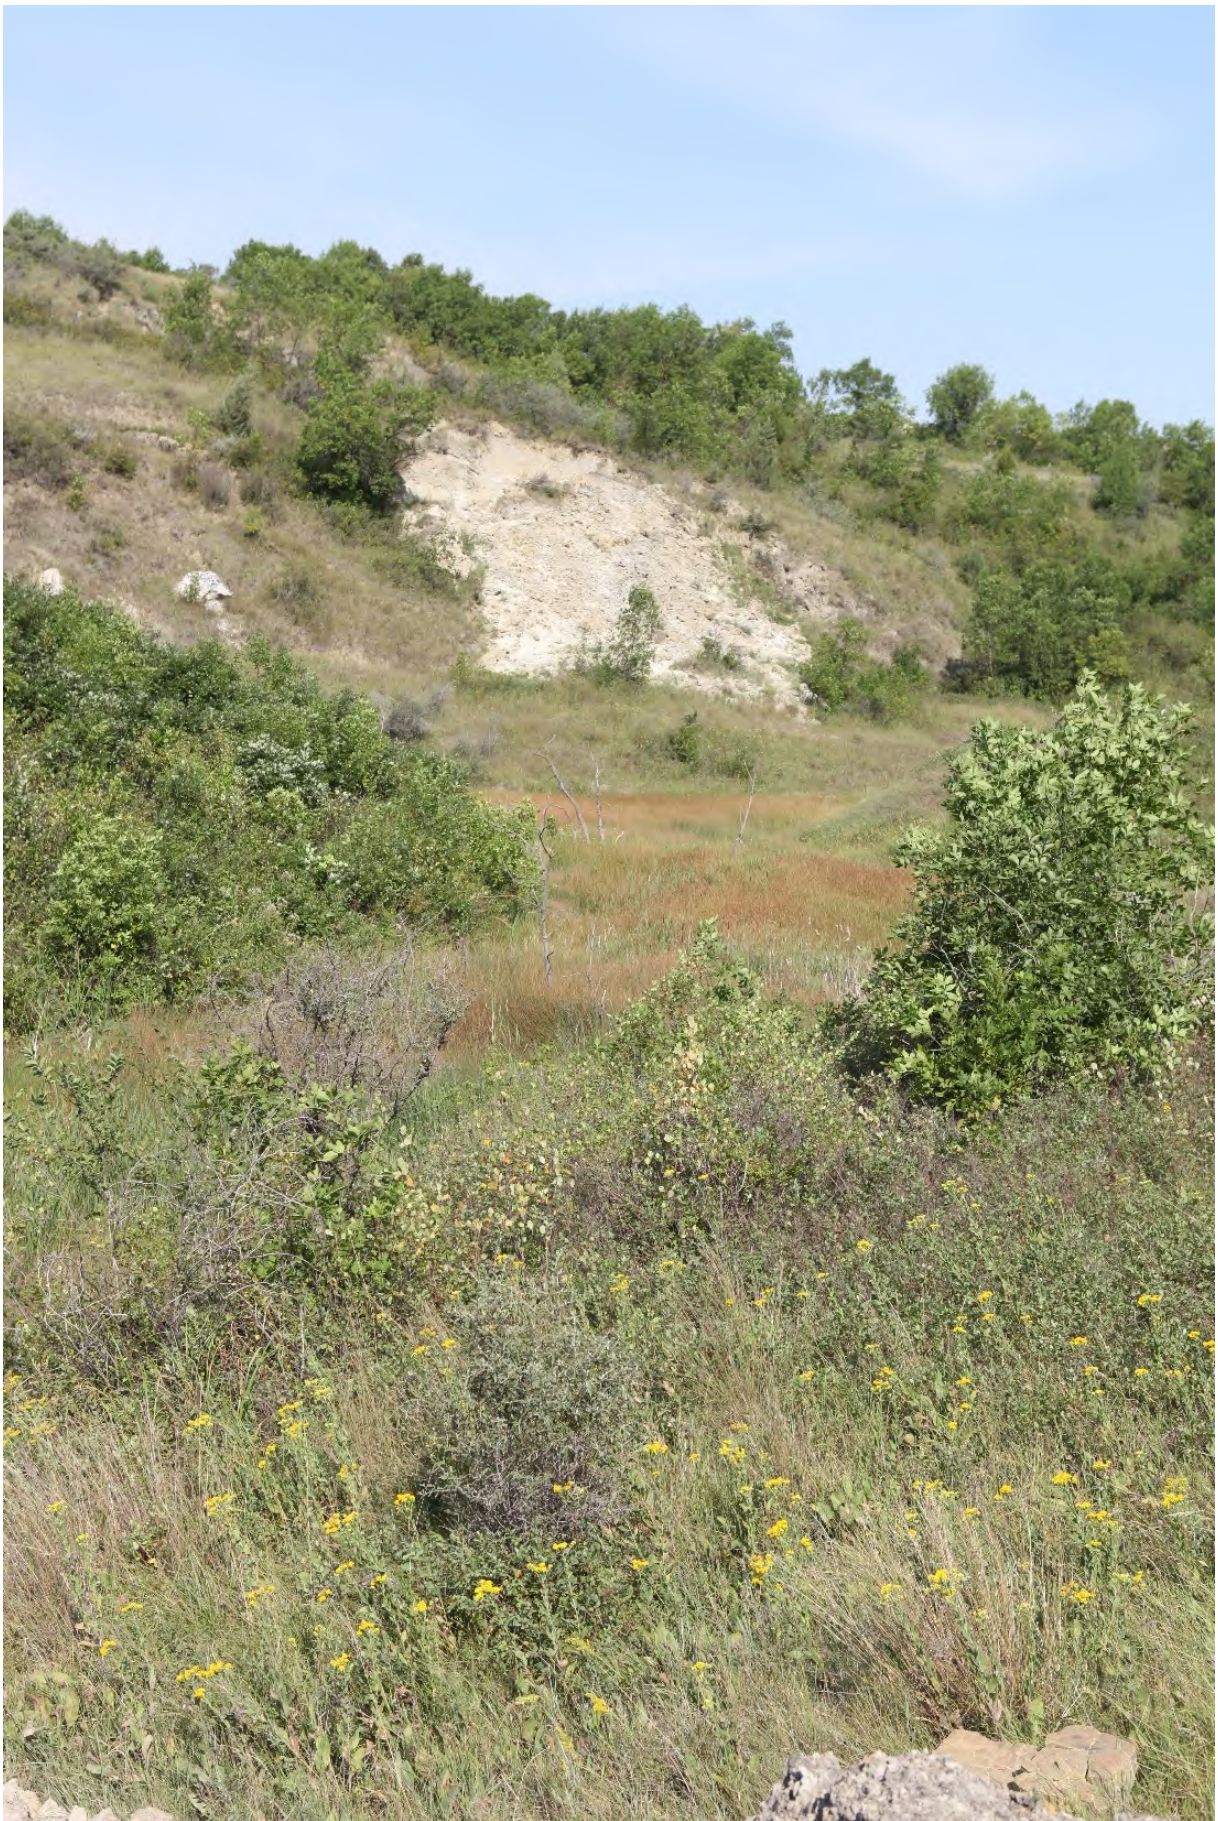
View downstream across Beaver Dam 1 (S9)
—*looking northwest.*

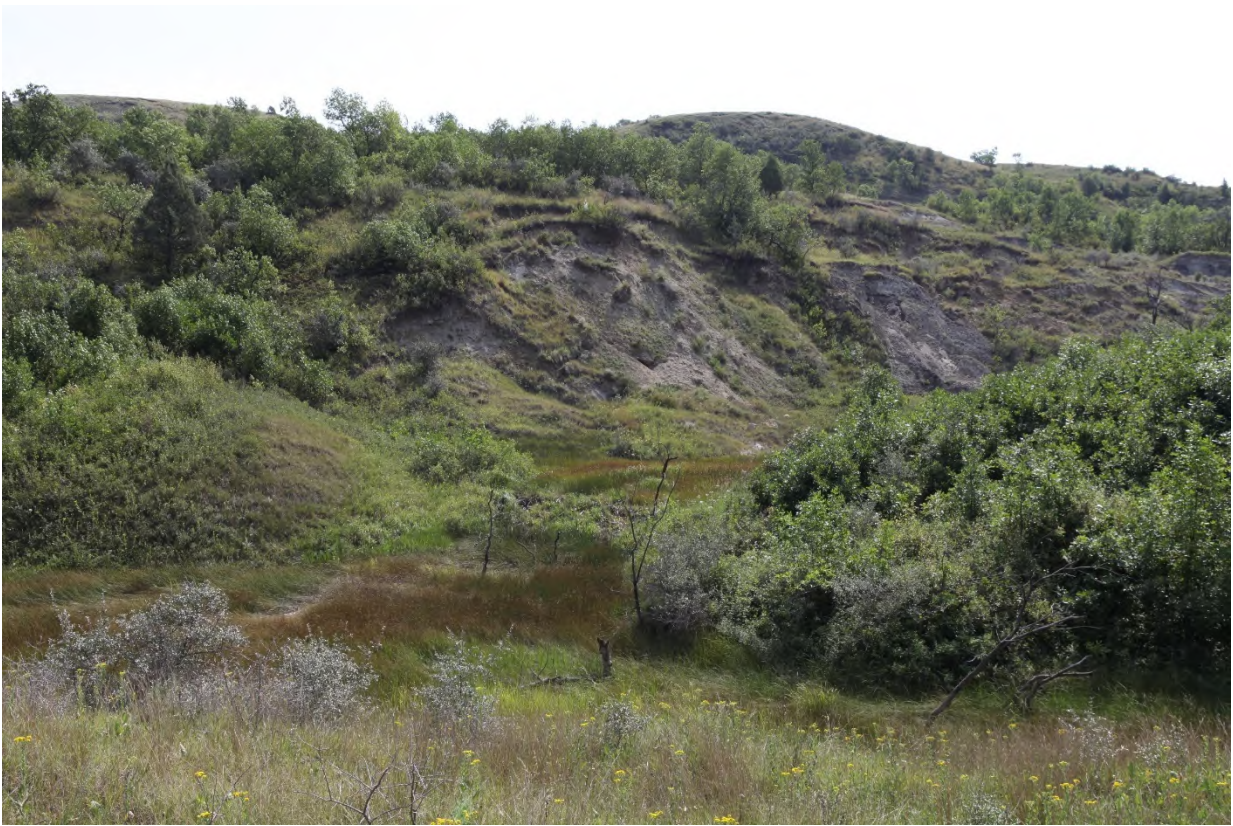
View of a sediment-filled beaver pond from across Beaver Dam 1 (S9)—*looking east.*

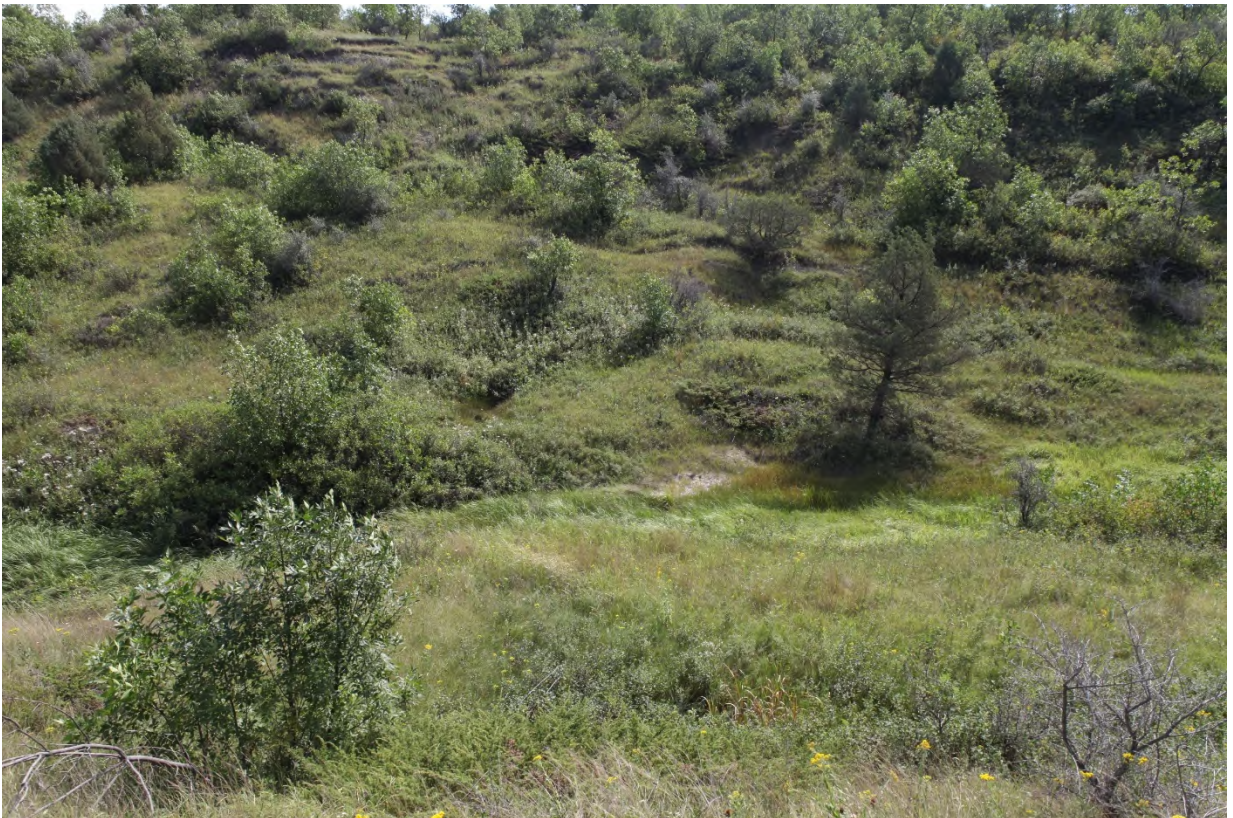
Unnamed drainage channel downstream of Beaver Dam 1 (29)—*looking east/northeast.*

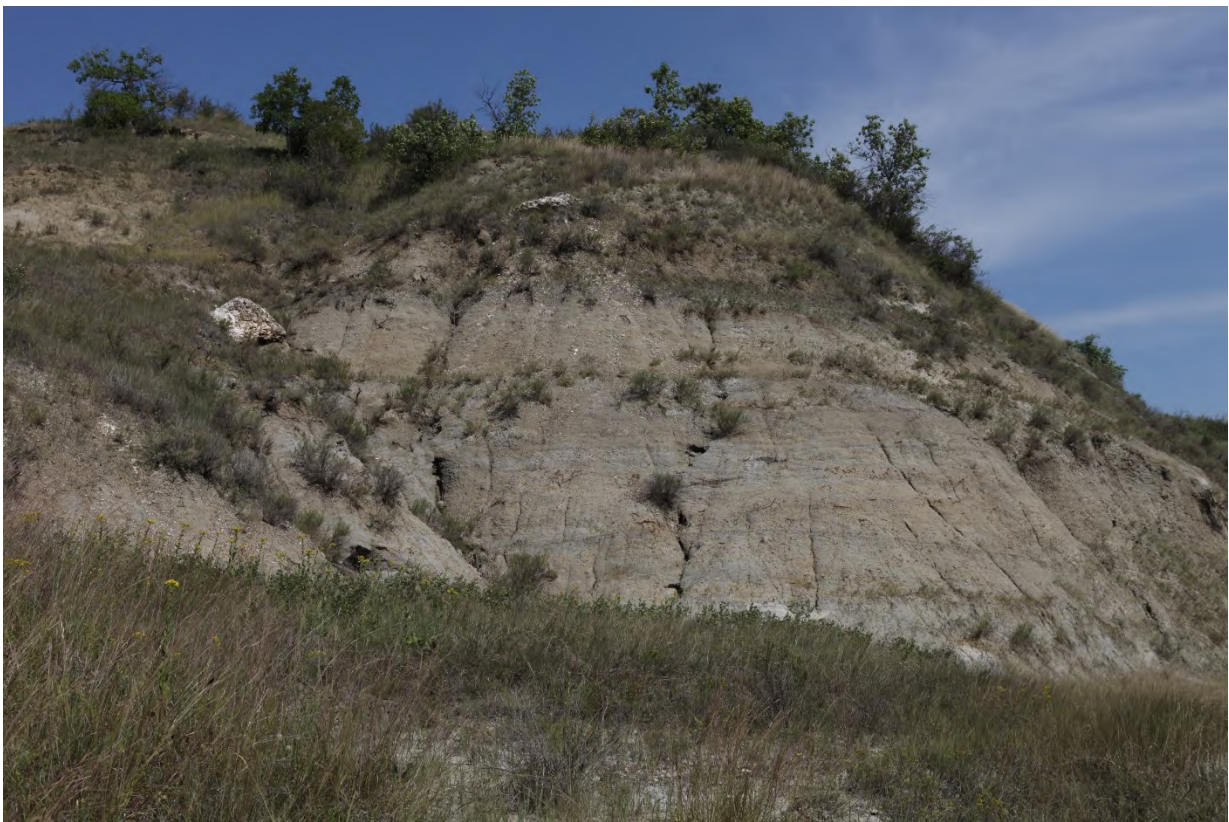
Typical geologic outcrop showing rounded “Badland” topography of easily erodible fine-grained strata
—*looking northwest.*

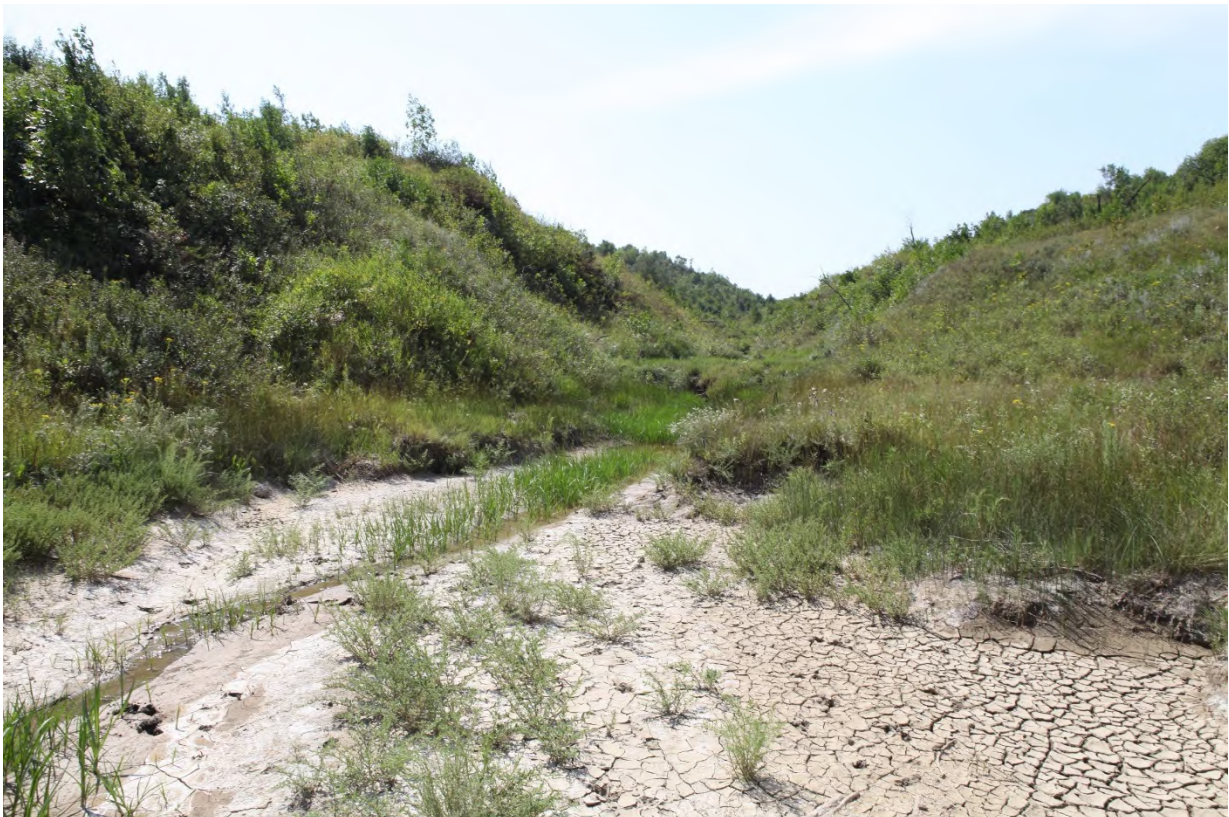
Stream channel above abandoned beaver dam
—*looking upstream.*

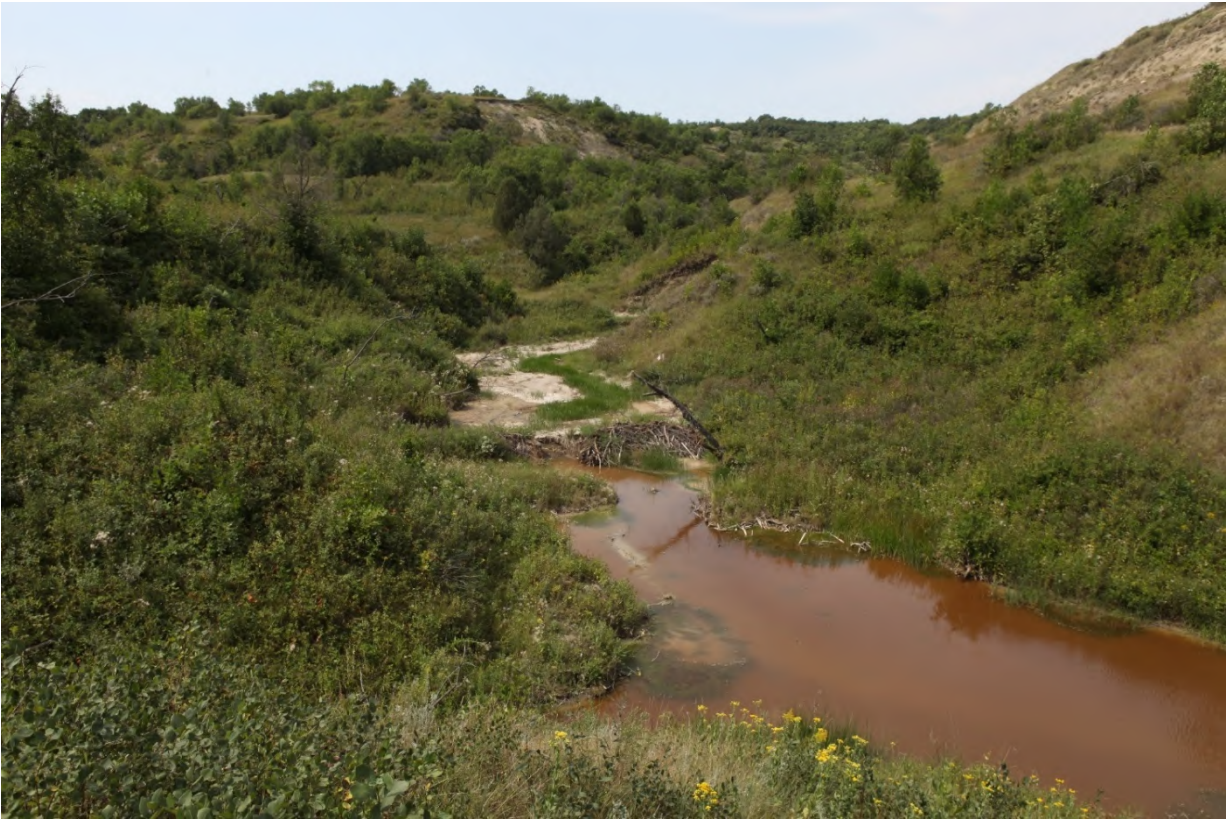
Abandoned beaver dam and pond near Dam 1a
—*looking southwest.*

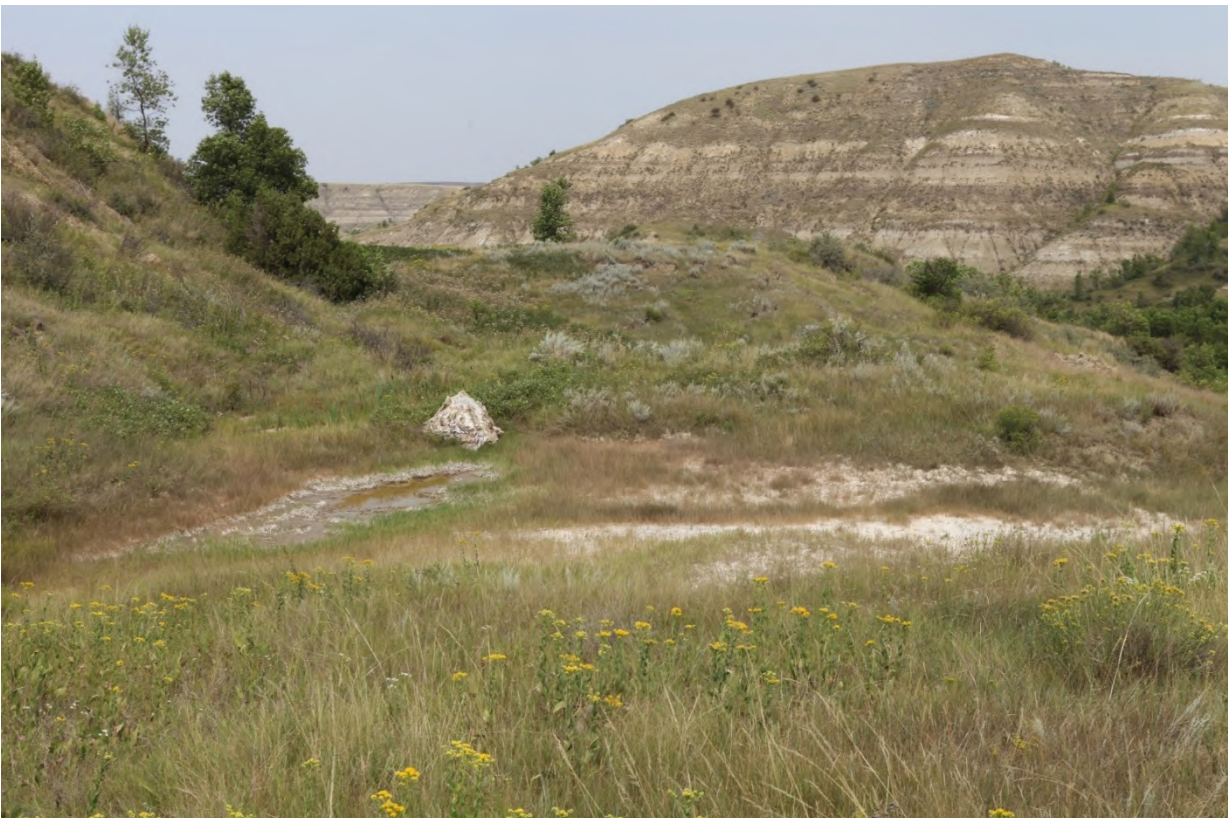
View of common sag pond that collects precipitation
and seepage from west side, above drainage bottom
—*looking north.*

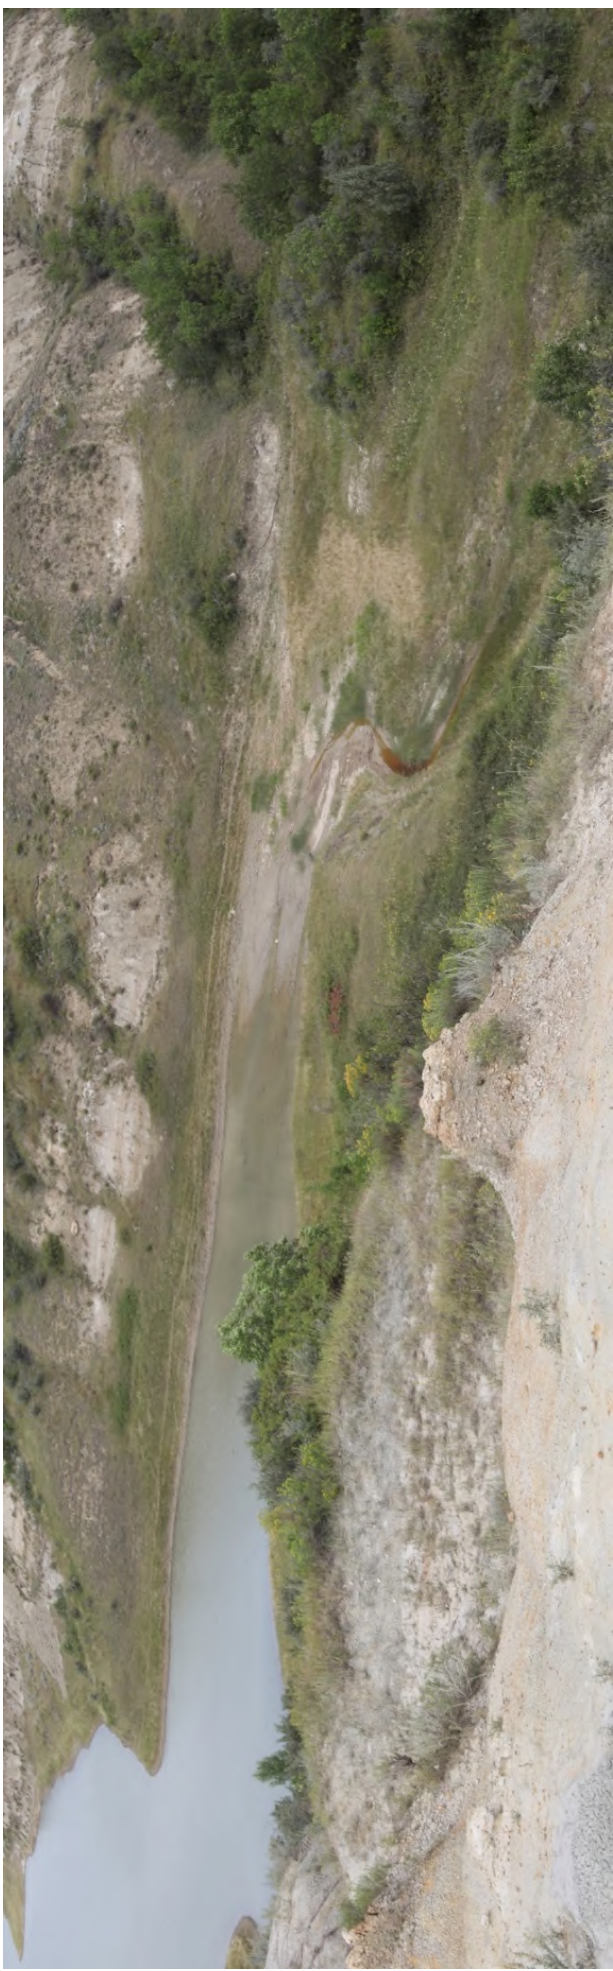
Unnamed drainage at its confluence with Bear Ben Bay (S13)—*looking northeast*.

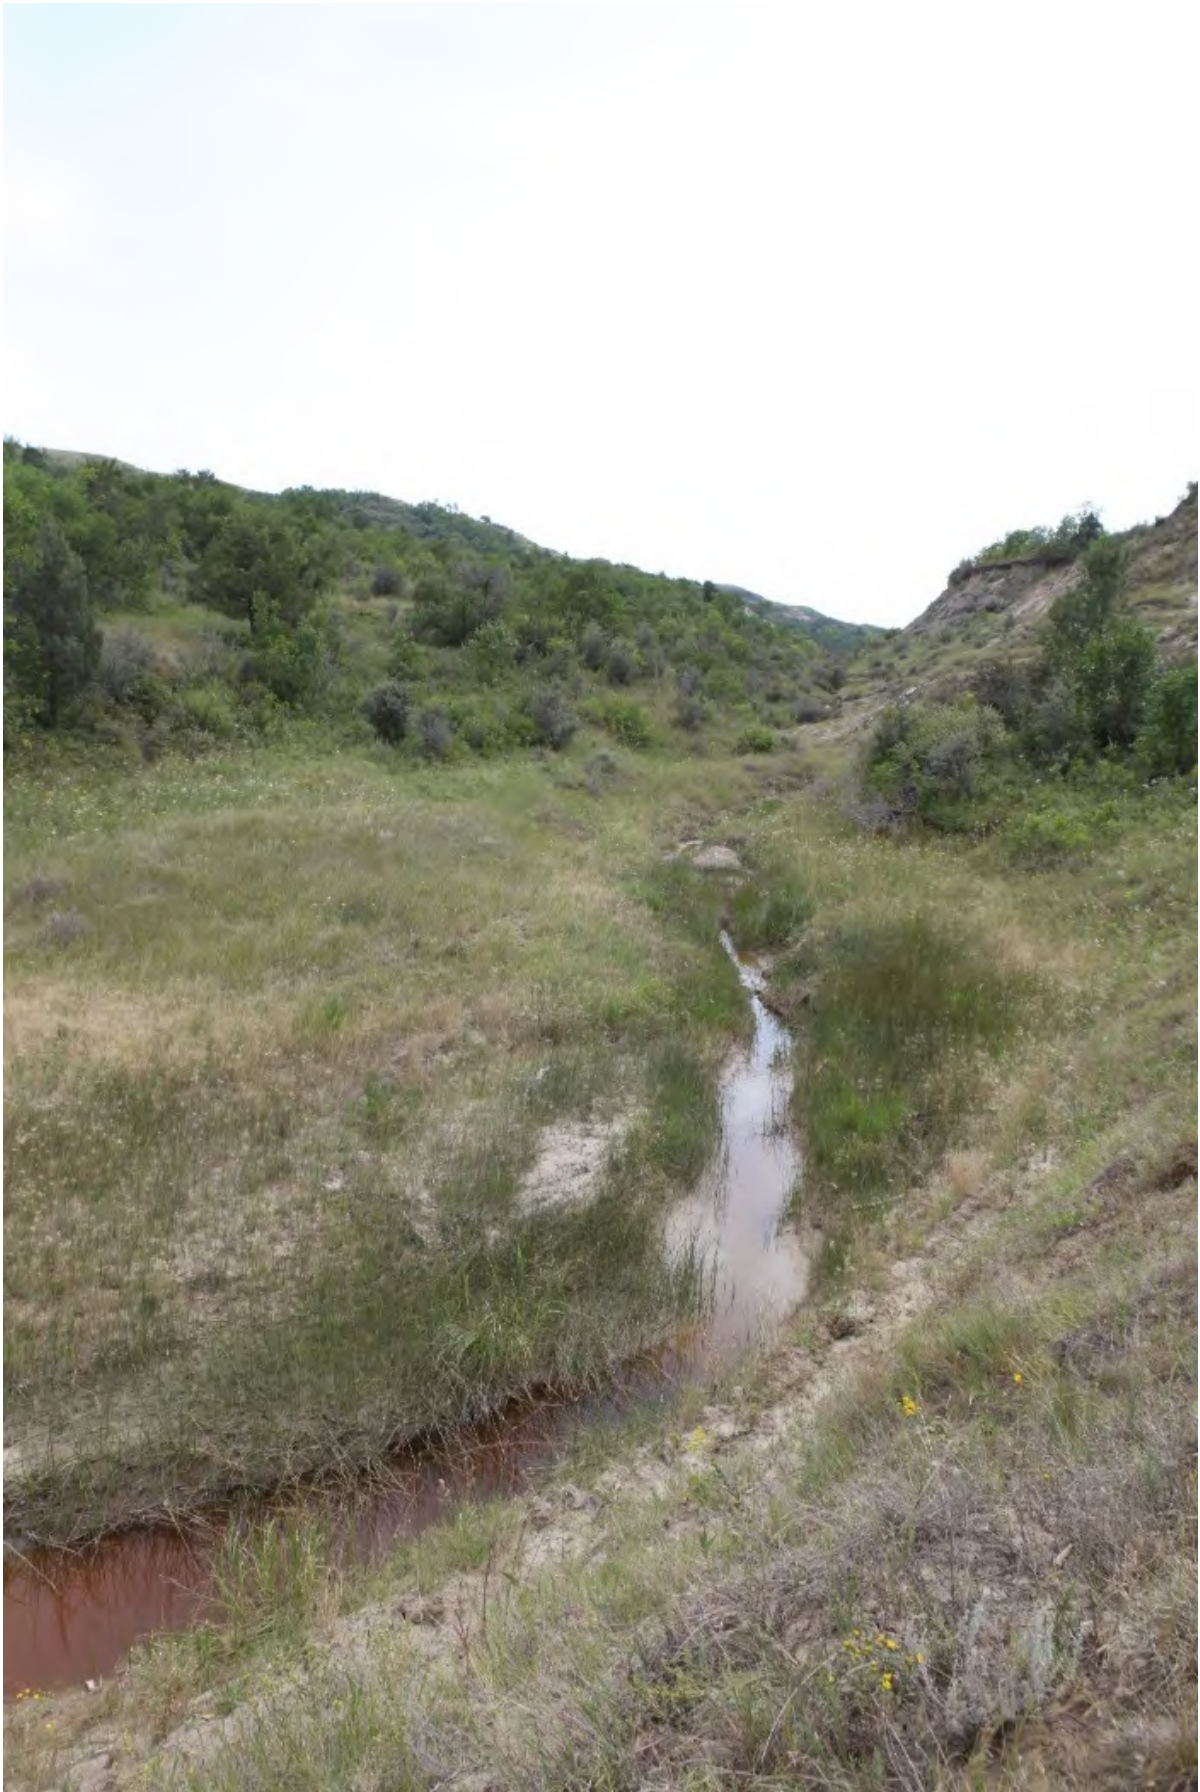
Unnamed channel upstream of Bear Den Bay near
Creek to Bay sample location—*looking south*.
