EXPEDITED SETTLEMENT AGREEMENT

Docket Number: CWA-08-2013-0018, NPDES No. NDR105200

The United States Environmental Protection Agency (EPA) inspected the Shiloh Athletic Complex construction site located at 1915 Shiloh Dr., Bismarck, North Dakota on June 6, 2013 for compliance with Clean Water Act (CWA) storm water control requirements. The inspection determined that Northern Improvement Co. (Northern) had violated the North Dakota Department of Health's North Dakota Pollutant Discharge Elimination System (NPDES) Construction Stormwater General Permit (the Permit) by failing to obtain permit coverage prior to site disturbance, failing to maintain required documents (e.g., permit coverage letter, the Permit, and notice of intent), failing to develop a complete Storm Water Pollution Prevention Plan (SWPP Plan), failing to maintain the SWPP Plan, failing to conduct inspections, and failing to properly install and maintain storm water best management practices (BMPs) to minimize sediment from leaving the site. A copy of the permit is available at <http://www.ndhealth.gov/WQ/Storm/Construction/NDR10per20091001F.pdf>; see also <http://www.ndhealth.gov/WQ/Storm/Construction/Construction

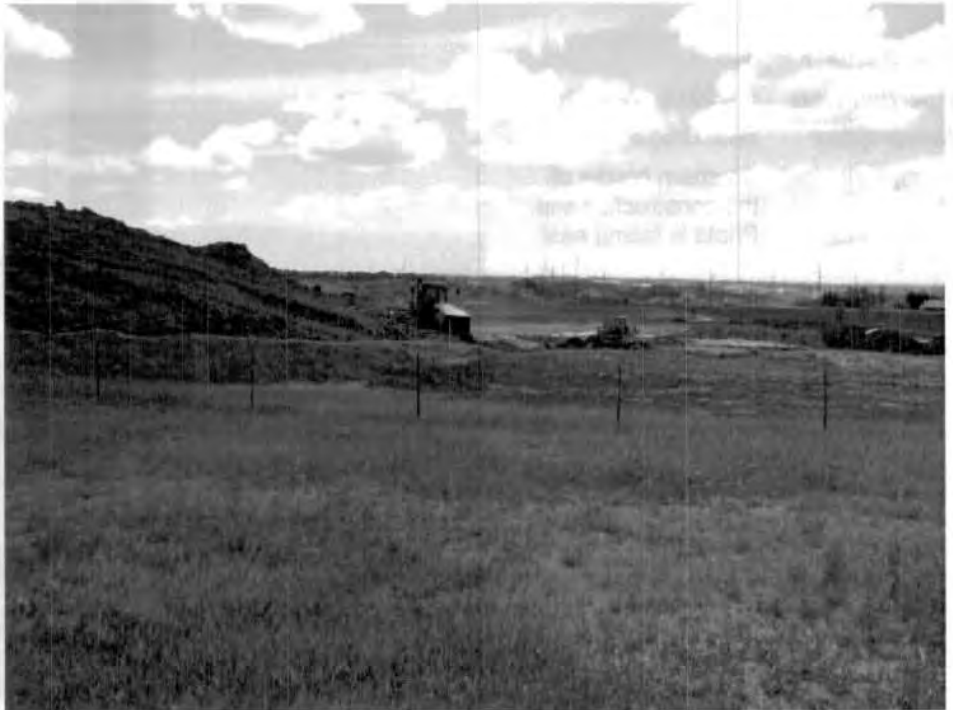
Photo Number 6
Inspection Date 6/6/2013
Photographer Seth Draper
Description Western boundary of the construction site. Photo is facing east.

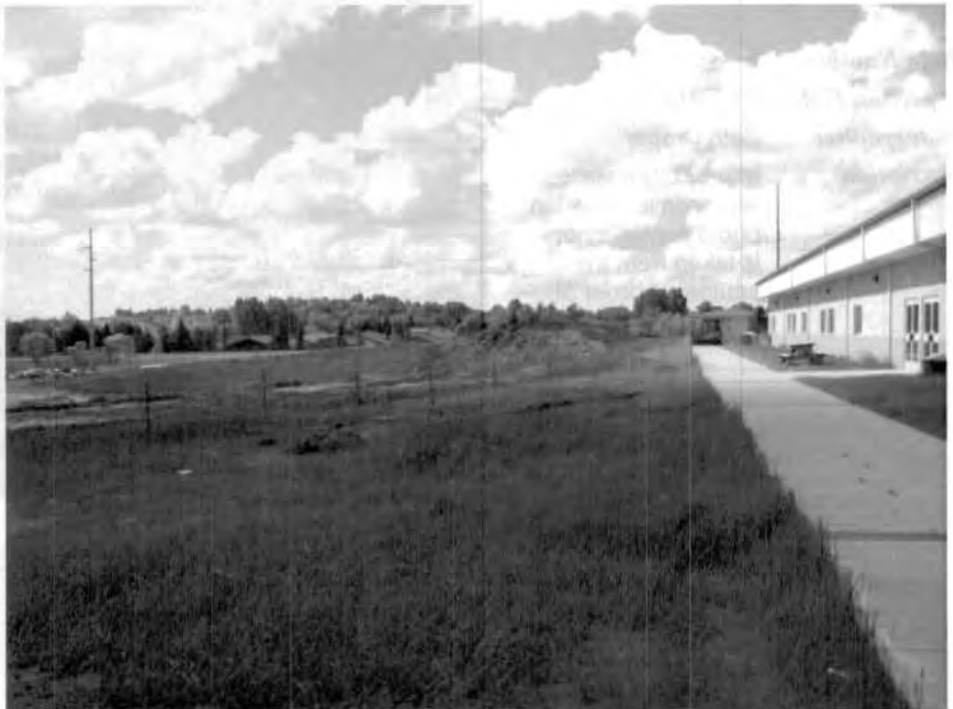
Photo Number 7
Inspection Date 6/6/2013
Photographer Seth Draper
Description Western boundary of the construction site. Photo is facing south.

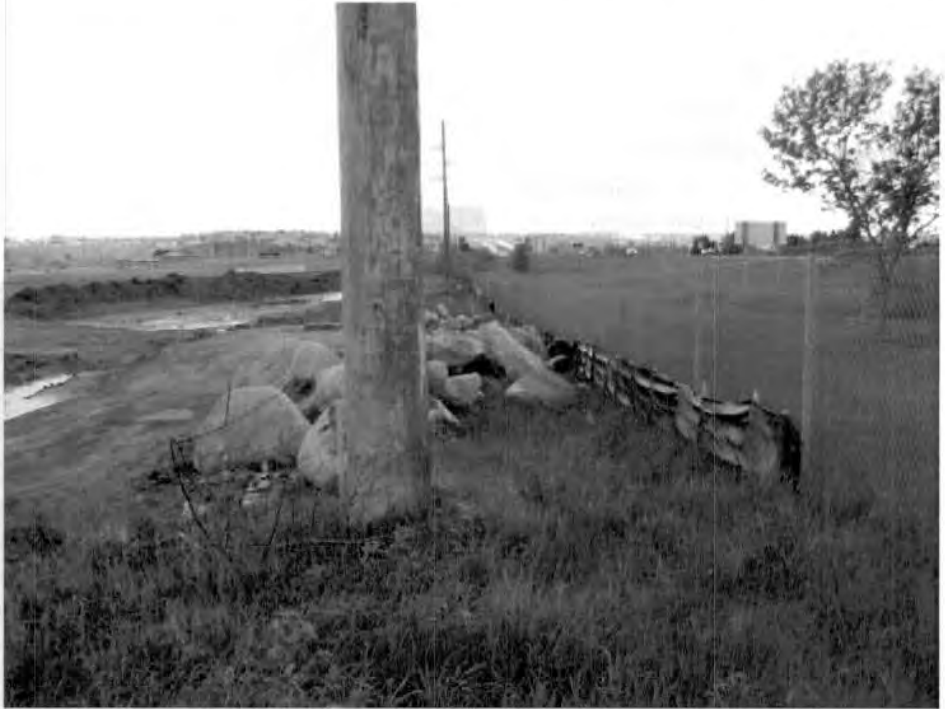
Photo Number 8
Inspection Date 6/6/2013
Photographer Seth Draper
Description Southern border of the construction site. Photo is facing east.

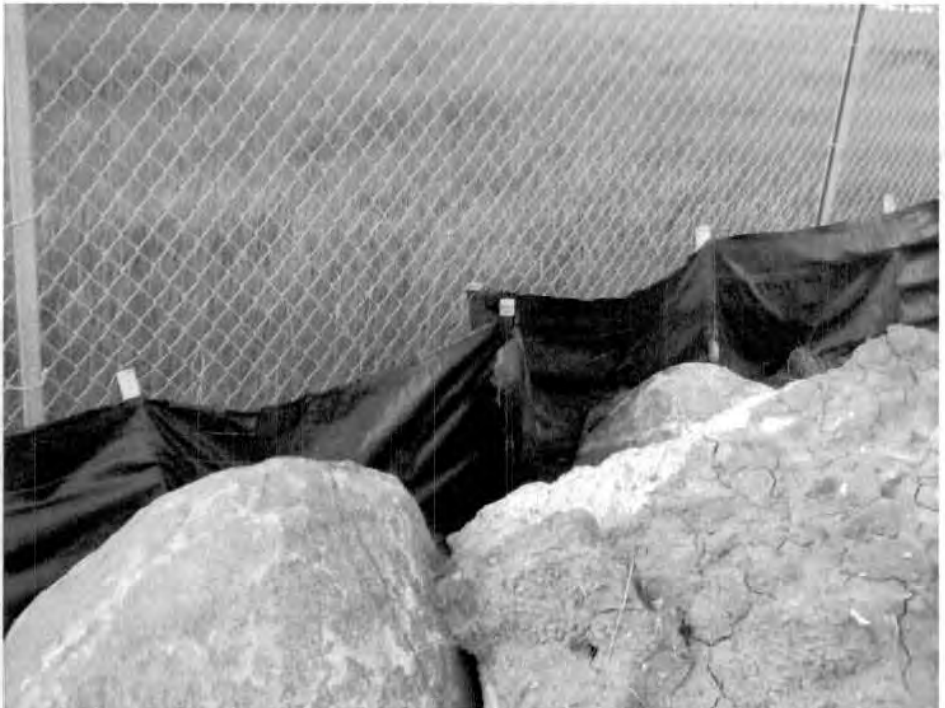
Photo Number 9
Inspection Date 6/6/2013
Photographer Seth Draper
Description Improperly installed silt fence is shown in photo center. Photo is taken from the southern border of the construction site.

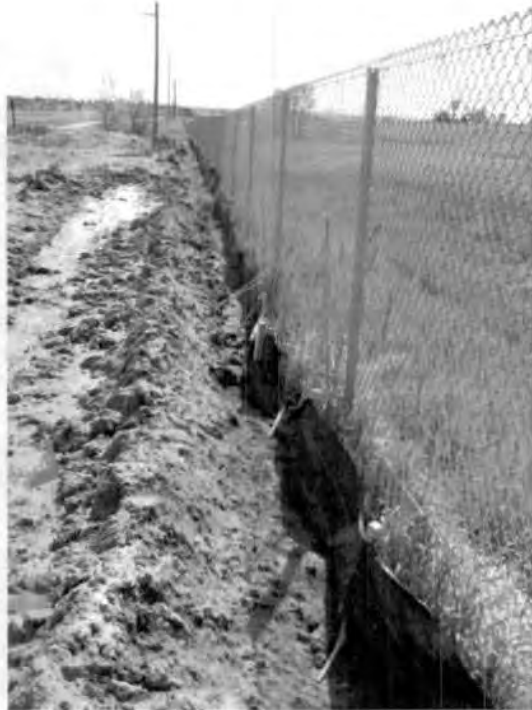
Description Southern border of the construction site. Silt fence along southern border was not maintained at the time of the inspection. Photo is facing east.

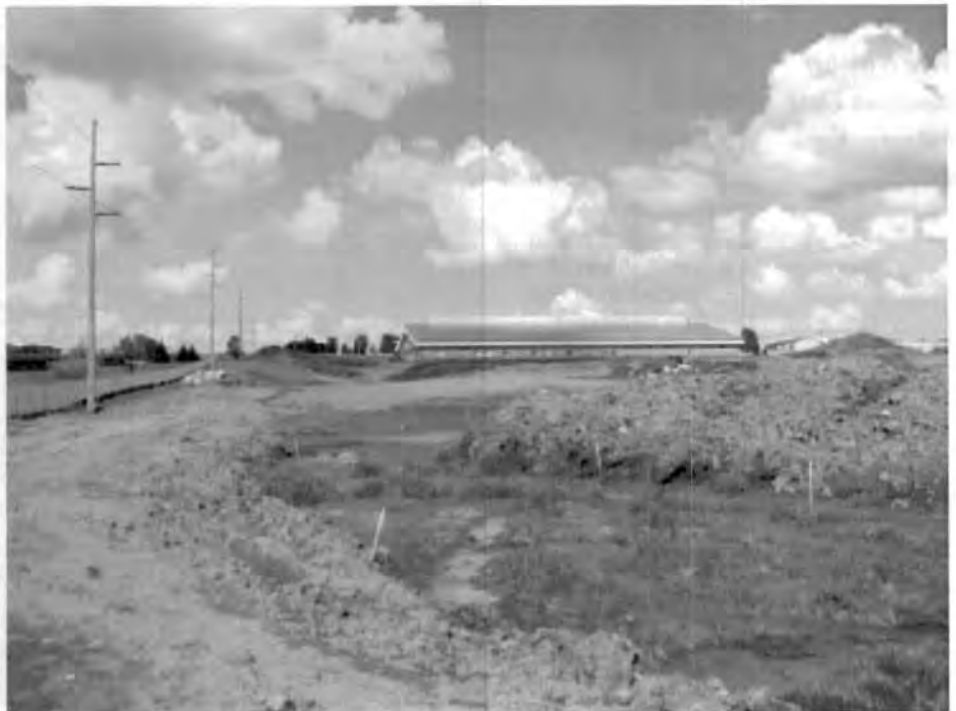
Photo Number 11

Description Upgradient and interior view of the construction site. Majority of the stormwater runoff from the construction site travels directly east, toward photographer. SWPP Plan/Site Map shows a temporary sediment basin should be installed. Photo is facing west.

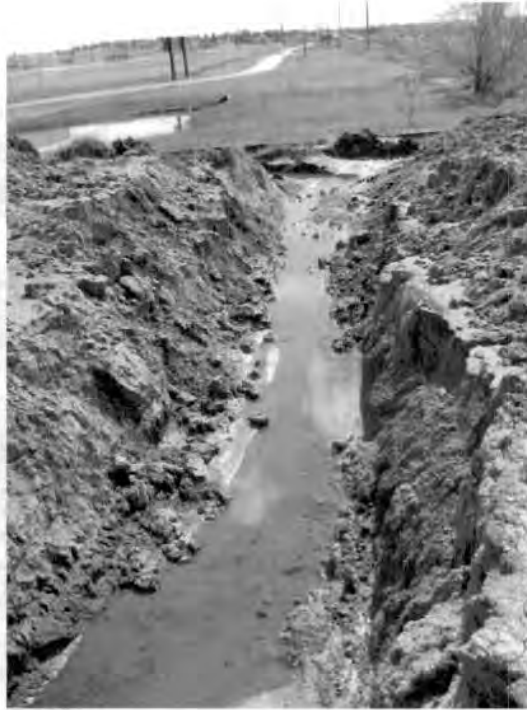
Description Construction ditch shown in photo center conveys majority of the stormwater from the construction site to the eastern border of the site. Construction ditch was not listed on the SWPP Plan/Site Map. Photo is facing east.

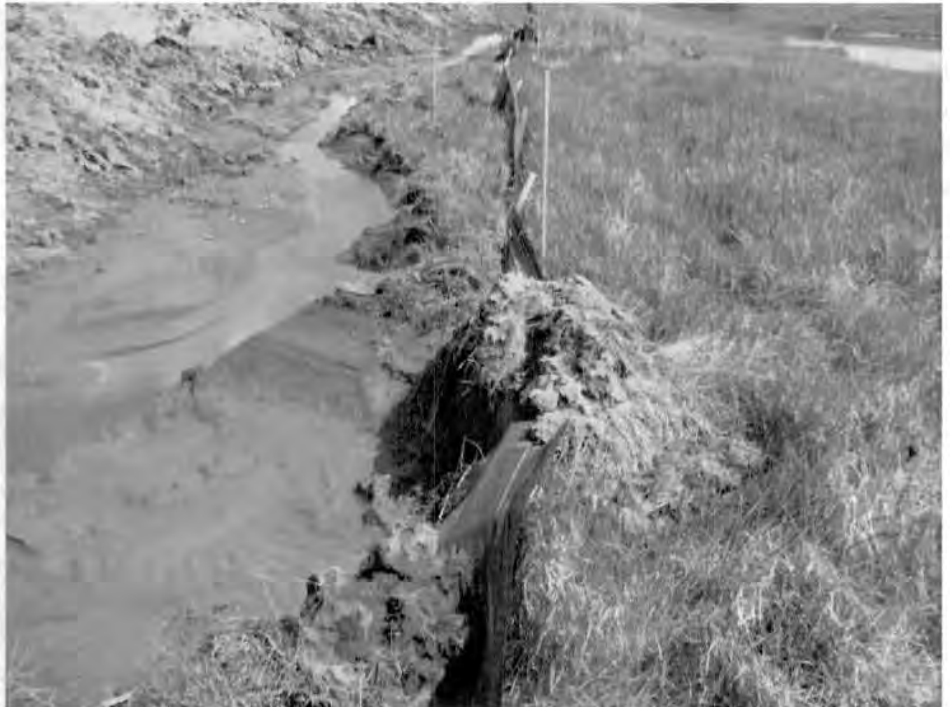
Photo Number 13

Description Eastern border of the construction site. Ditch on left of photo is a continuation of ditch shown in photo 12. Note sediment on top of silt fence. Photo is facing north.

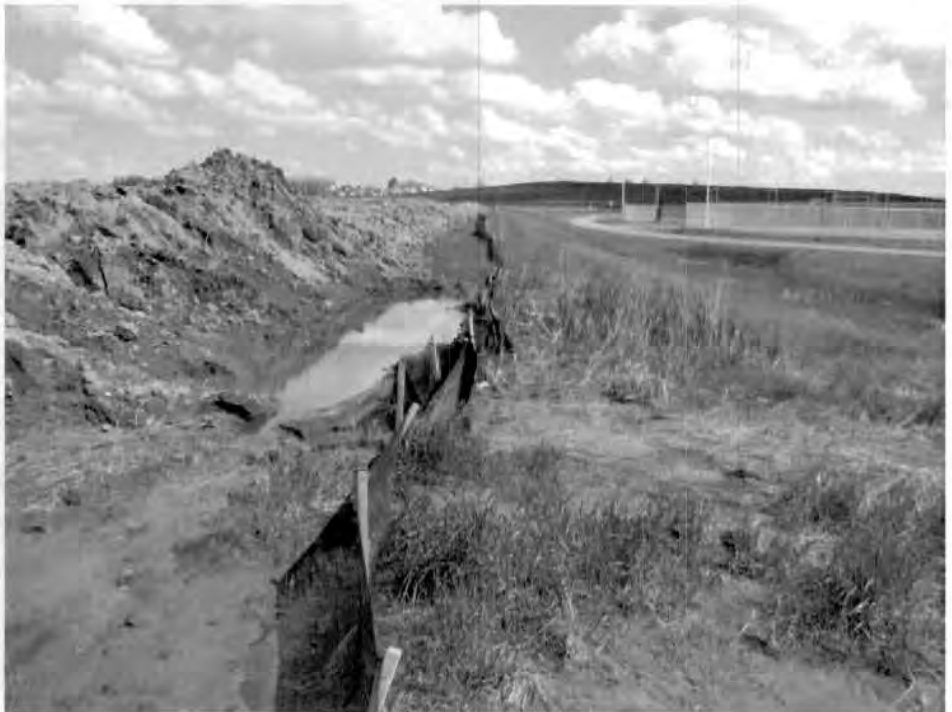
Description Concentration point of stormwater runoff from construction site is shown in photo center. The site recently added a 'sediment pit.' Pooled water left of fence is location of pit. Note grass condition, silt fence has been overwhelmed by storm events.

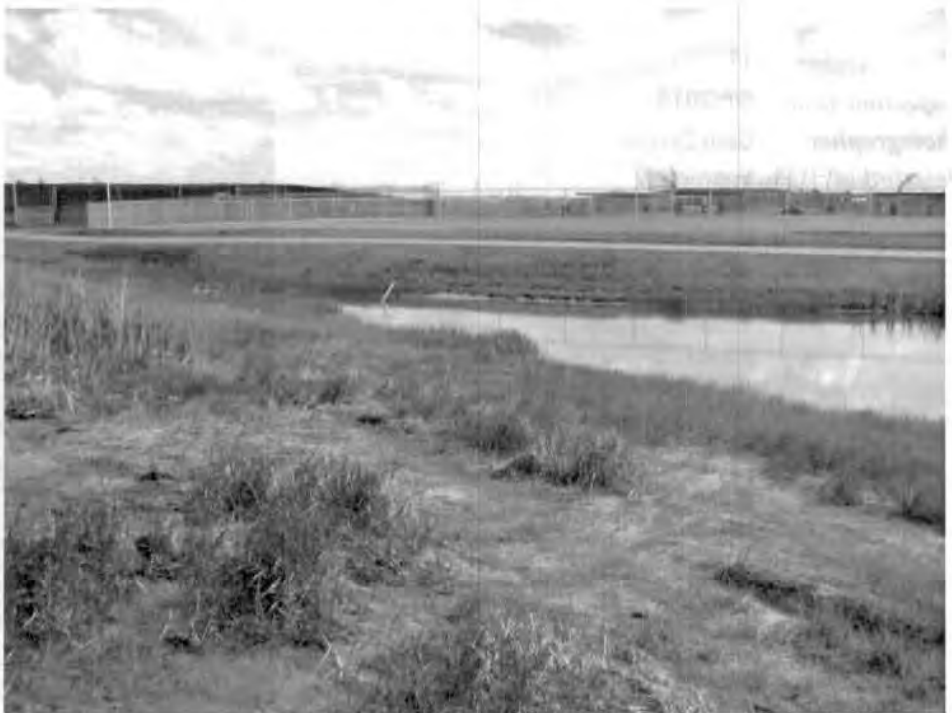
Photo Number 15

Description Stormwater that flows over the silt fence in photo 14 flows into detention basin shown in photo center. Detention basin is not part of the construction site. The detention basin shown in photo is part of the Bismarck MS4. Photo is facing northeast.

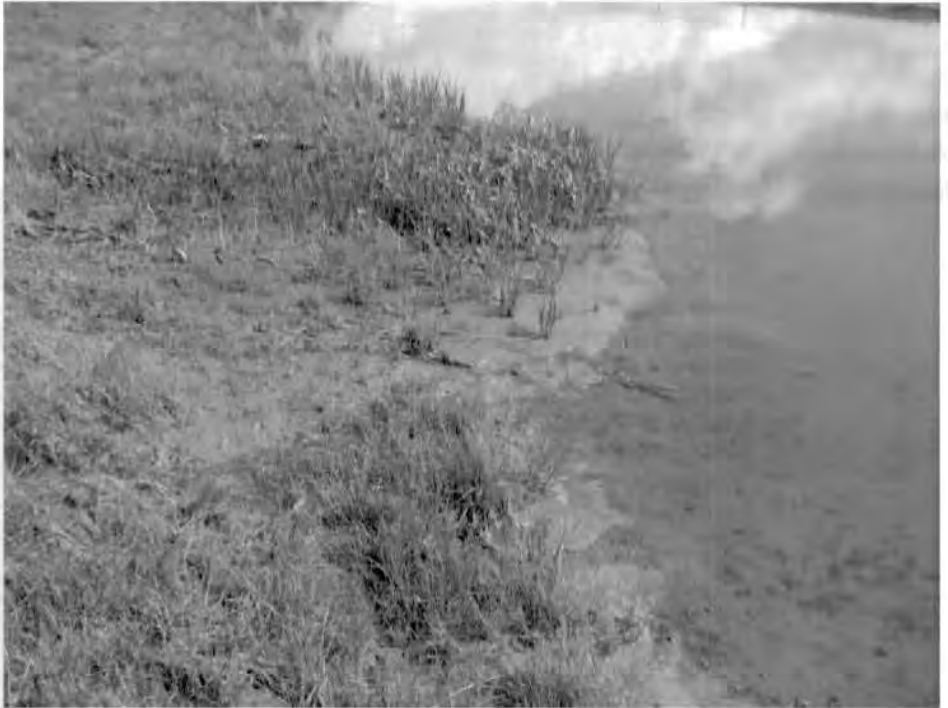
Photo Number 16
Inspection Date 6/6/2013
Photographer Seth Draper
Description Sediment deposition from construction site can be seen on the bank of the detention basin.

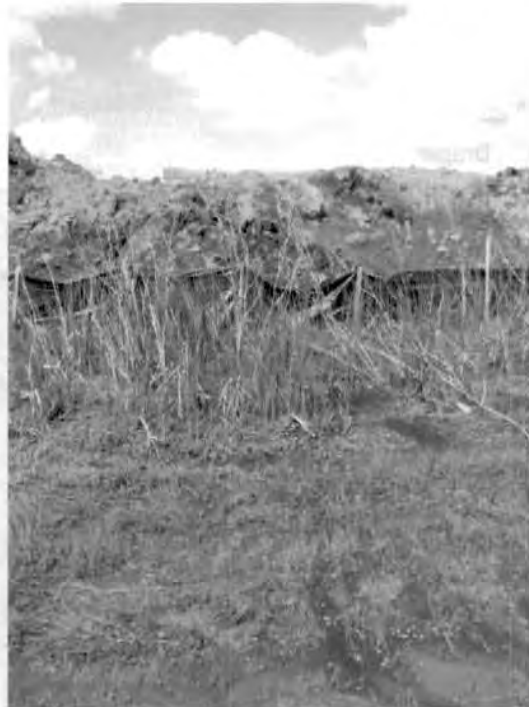
Photo Number 17
Inspection Date 6/6/2013
Photographer Seth Draper
Description Improperly maintained silt fence located on the eastern border of construction site is shown in photo center. Silt fence shown in photo is the upgradient view of the single line of silt fence shown in photo 14. Photo is facing west.

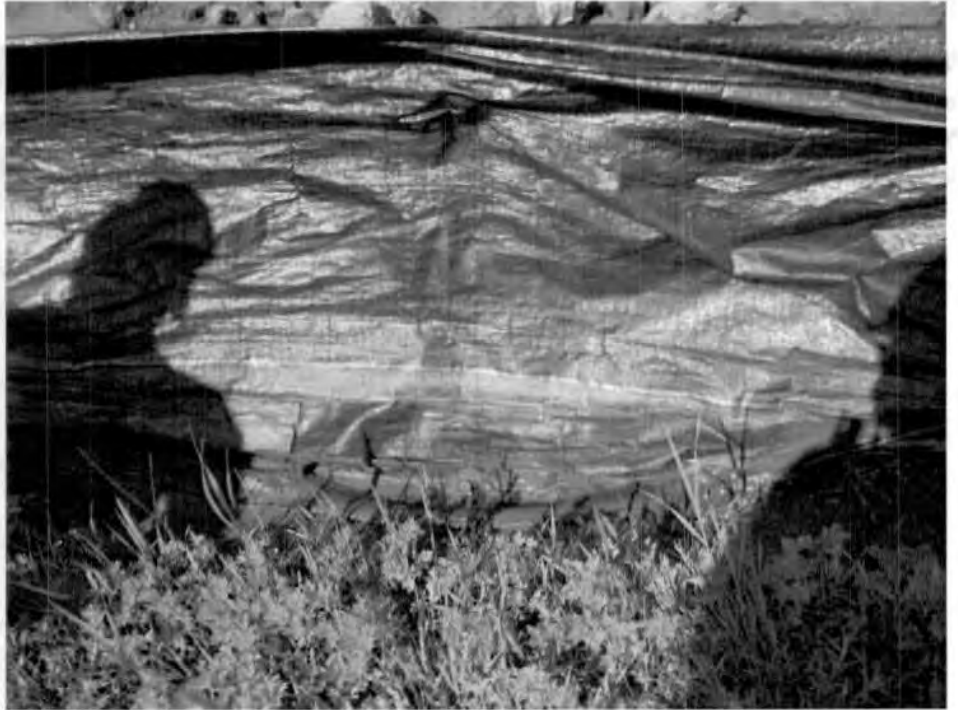
Description Improperly maintained and installed silt fence is shown along the eastern border of the construction site. The bottom of the silt fence has not been trenched in allowing stormwater to flow underneath the BMP.

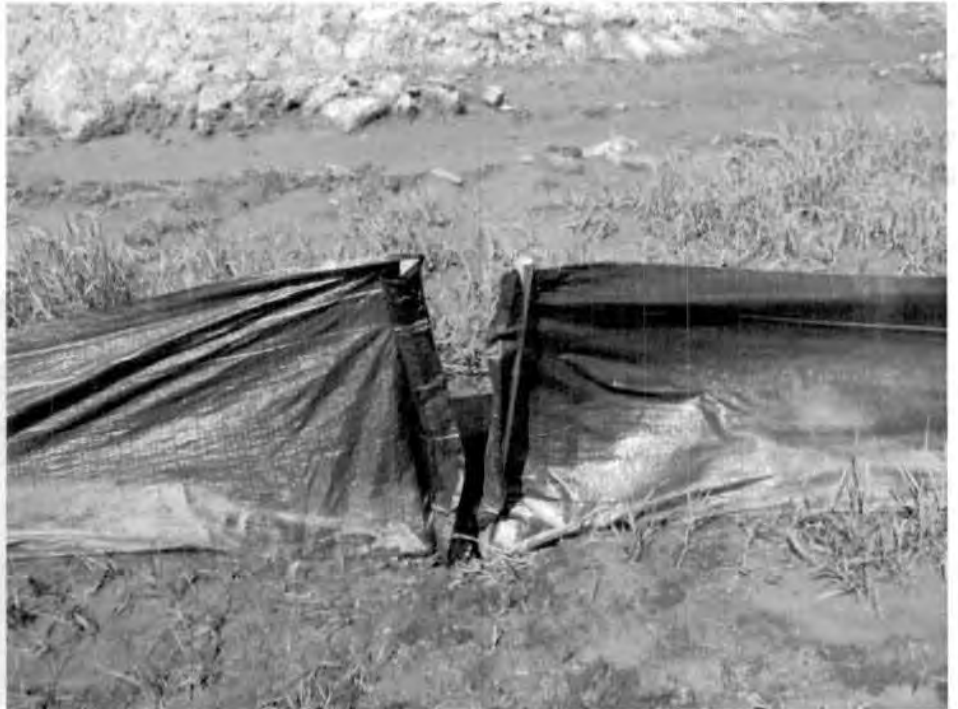
Photo Number 19

Description Improperly installed silt fence is shown in photo center. Photo was taken along the eastern border of the facility.

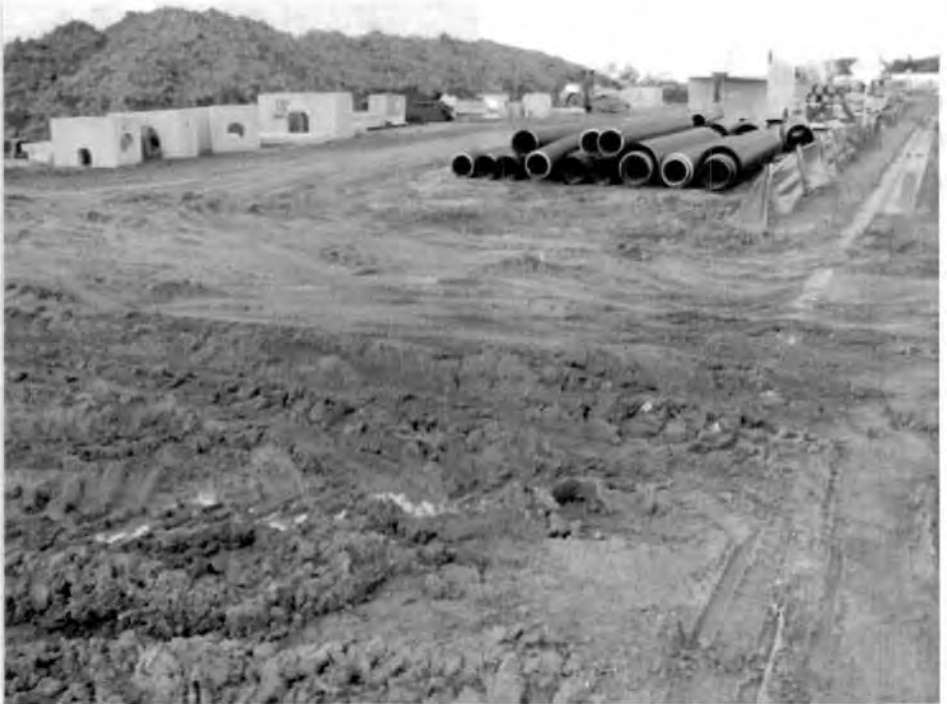
Photo Number 20
Inspection Date 6/6/2013
Photographer Seth Draper
Description SWPP Plan/Site Map detailed that the site would feature a construction entrance/exit at photo location. No construction entrance/exit was installed at time of the inspection. Note trackout from site. Photo is facing southwest.

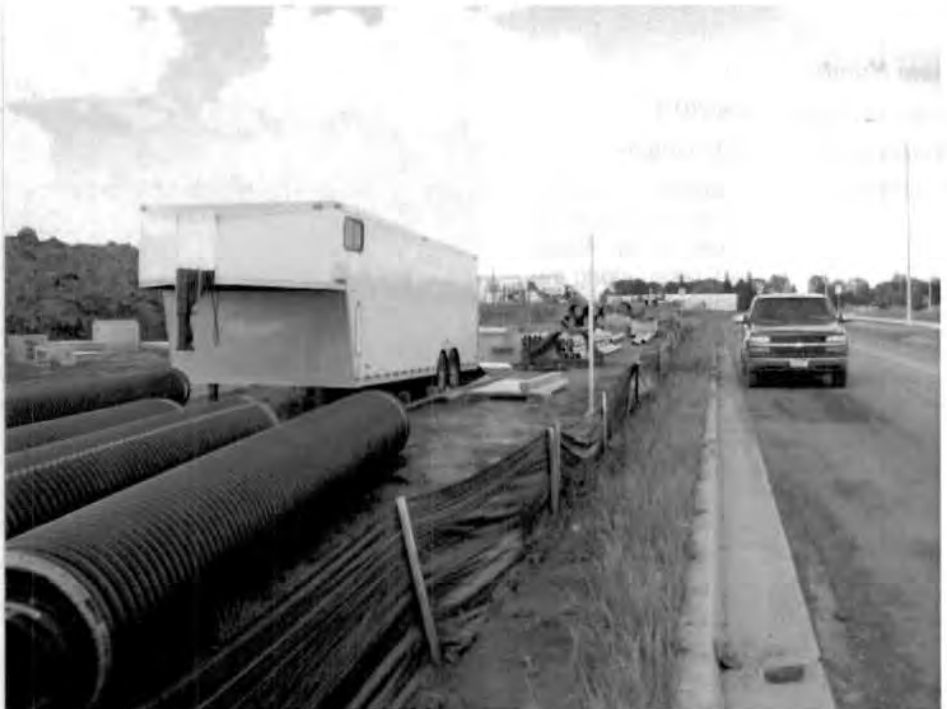
Photo Number 21
Inspection Date 6/6/2013
Photographer Seth Draper
Description Northern border of construction site is shown in photo center. Equipment storage shown in photo not depicted in SWPP Plan/Site Map. Photo is facing west.

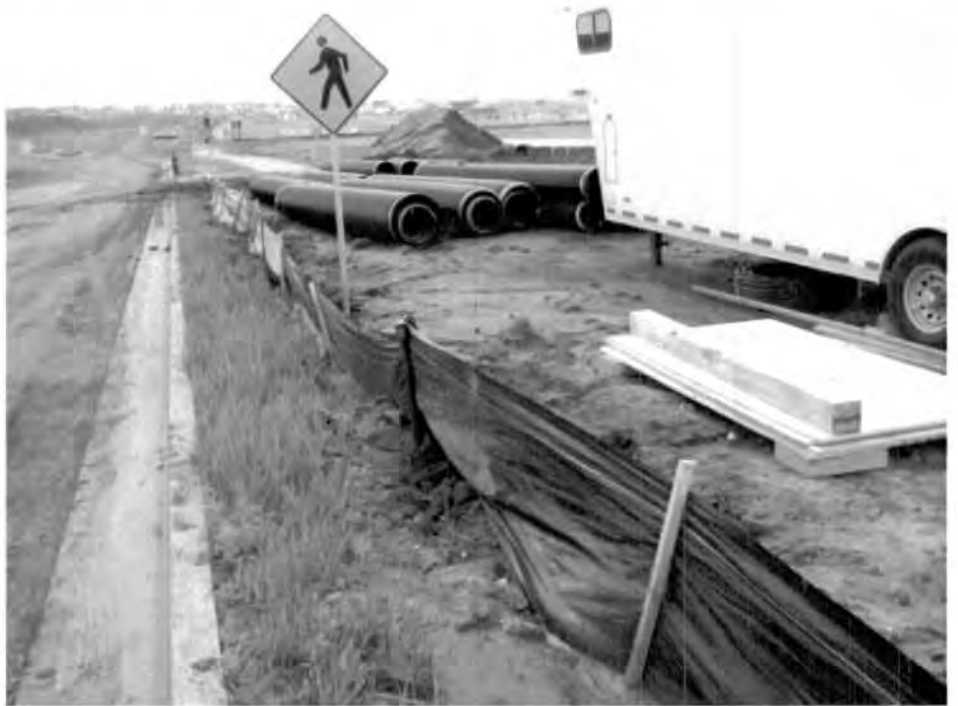
Description Improperly installed/maintained silt fence is shown in photo center. Silt fence bottom has not been trenched into the soil allowing stormwater to flow underneath. Photo is facing east.

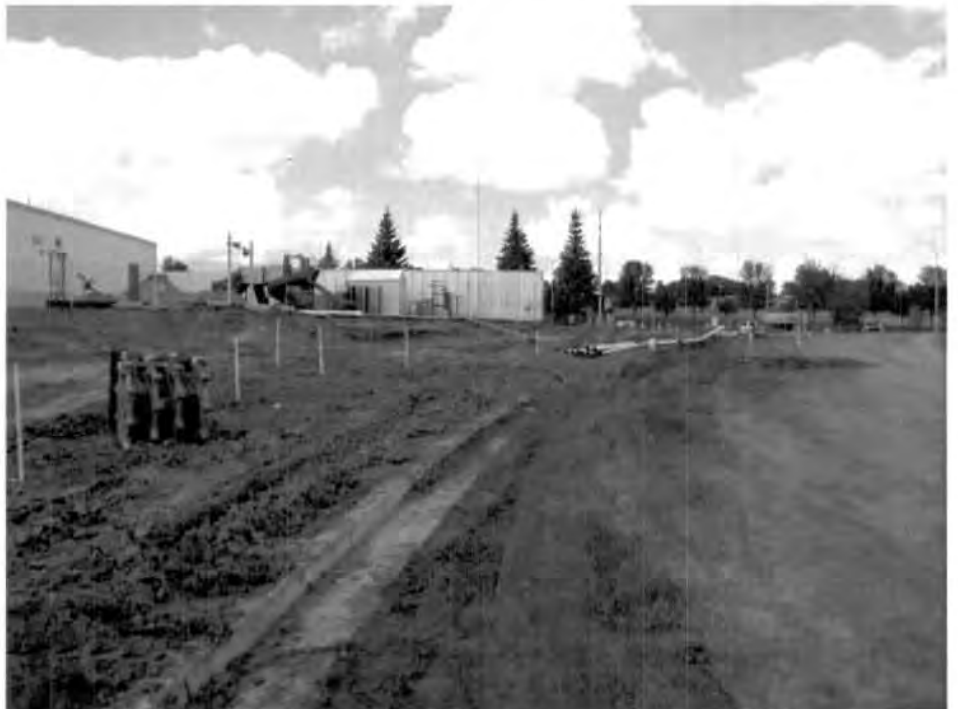
Photo Number 23

Description SWPP Plan/Site Map detailed that the site would feature a construction entrance/exit at photo location. No construction entrance/exit was installed at time of the inspection. Note trackout from site. Photo is facing west.

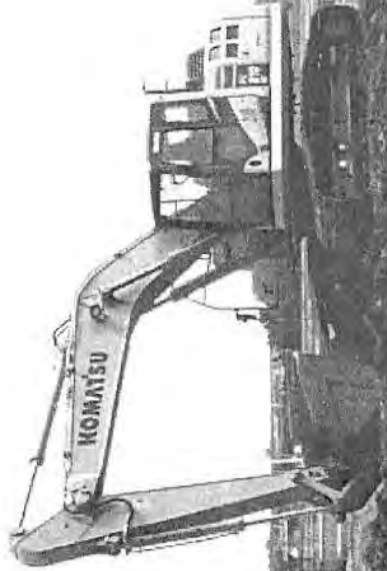
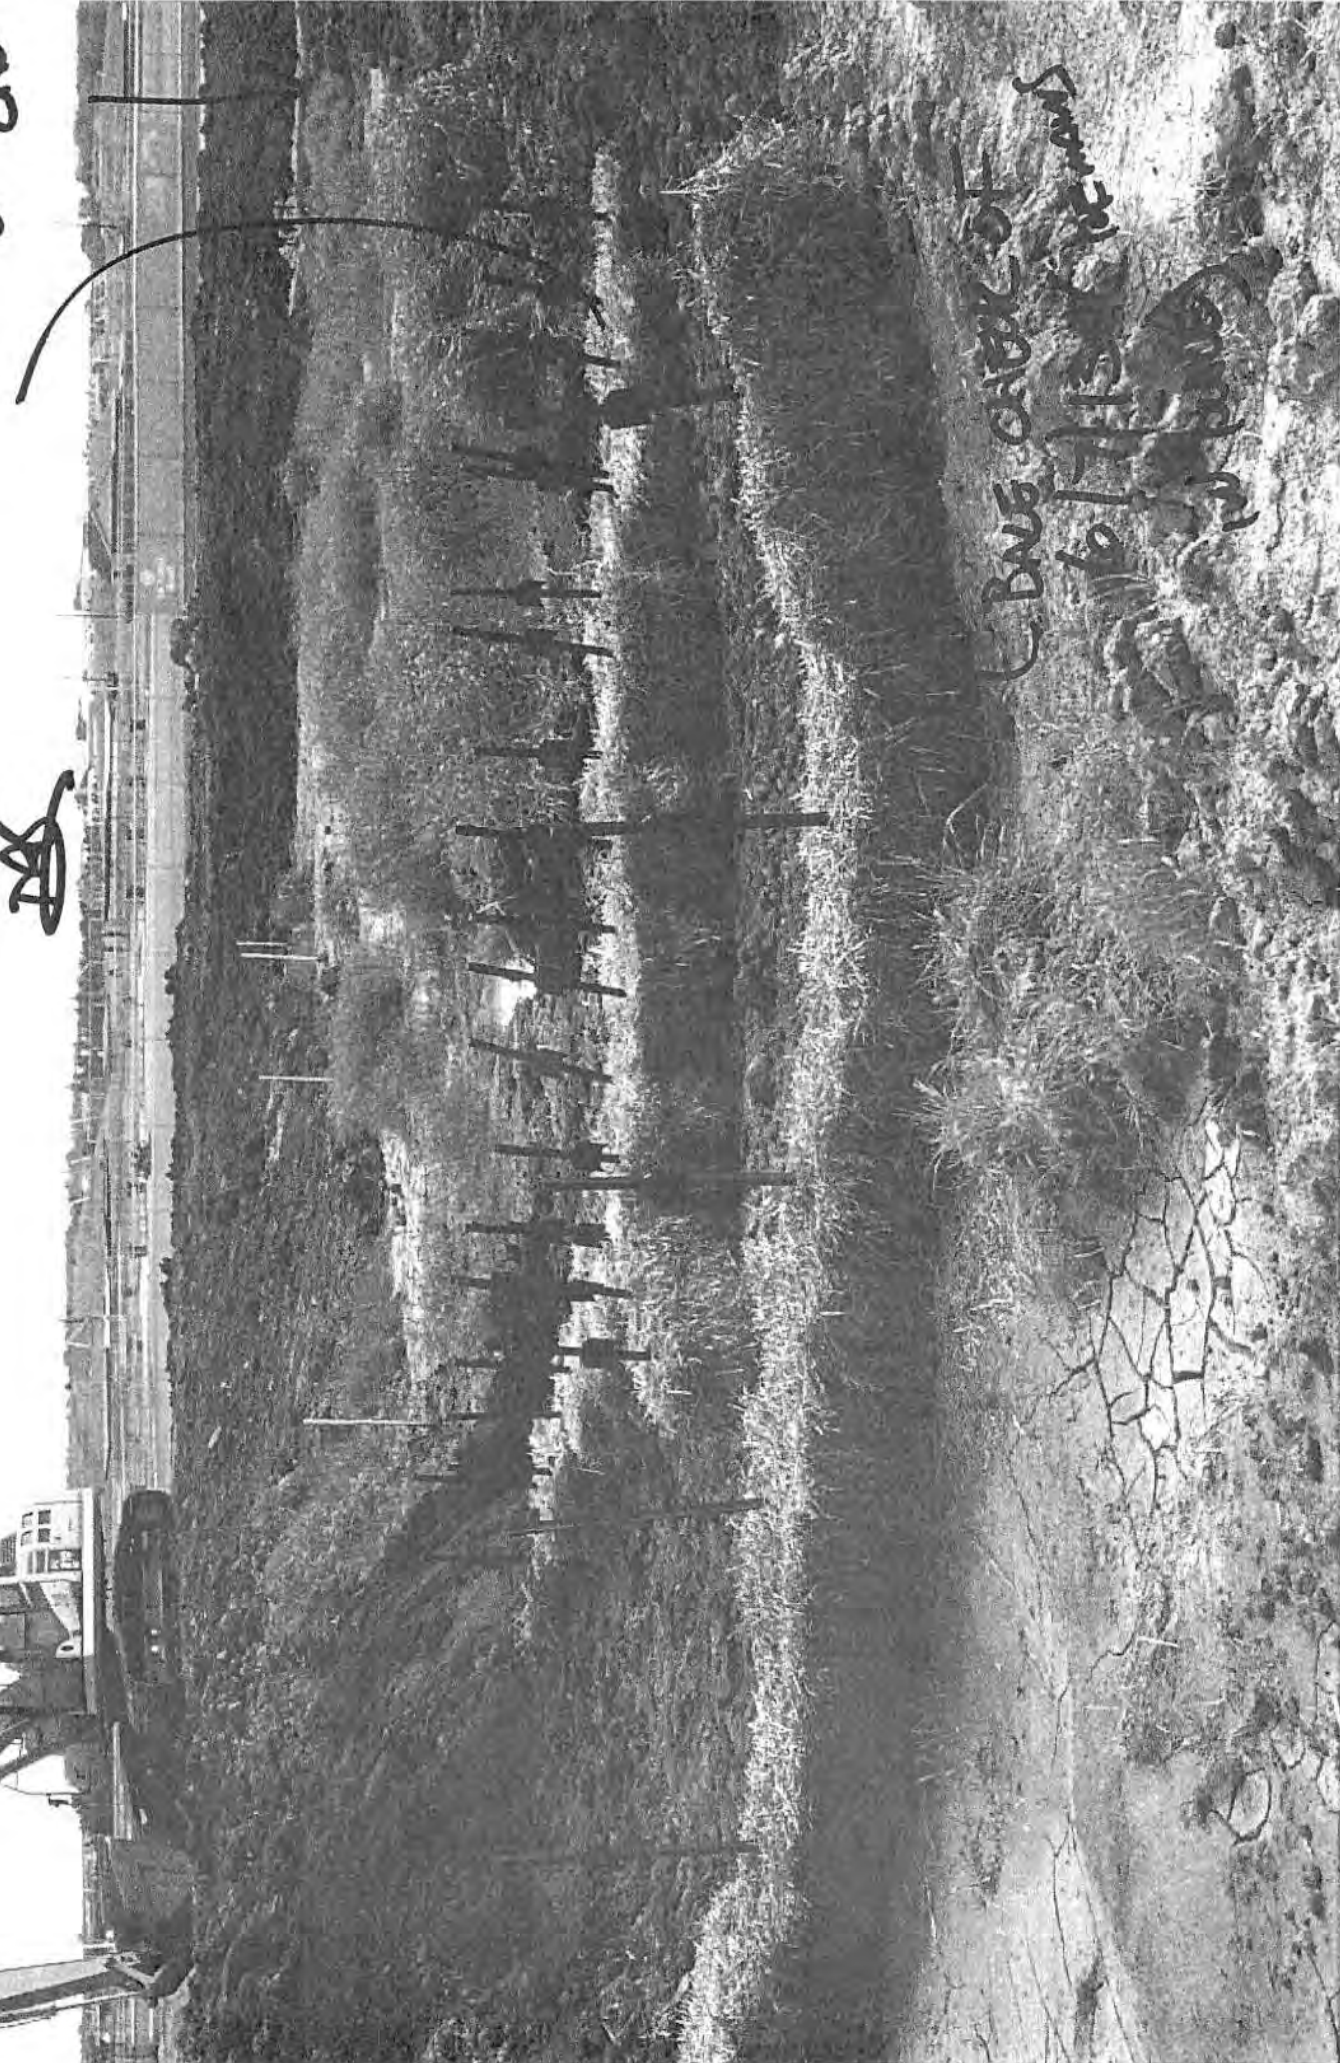
SHILOH - WEST BALE CHECK IN
TEMP. SEEDING POND

EAST BALE
CHECK

← BALE CHECK OF
6/11/13 REMAINS
IN POND
