**UNITED STATES ENVIRONMENTAL PROTECTION AGENCY
REGION 8**

Re: Second Violation of the Rivermeadows Water District Administrative Order, Docket No. SDWA-08-2018-0022, Rivermeadows Water District Public Water System, PWS ID #WY5600786

From: Langenfeld, Matthew
Sent: Monday, June 1, 2020 1:18 PM
To: jryan@ci.jackson.wy.us; Johnny Ryan; jr6111@msn.com
Cc: Minter, Jill; Copeland, Michael; George, Kevin
Subject: FW: Rivermeadow Water District (WY5600786) - Significant Deficiencies Photos of gravity tank and public notice

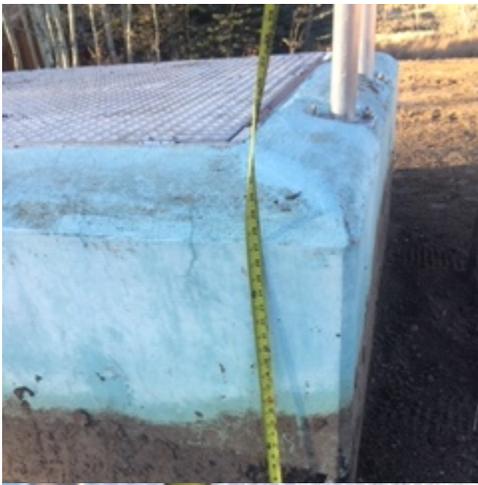
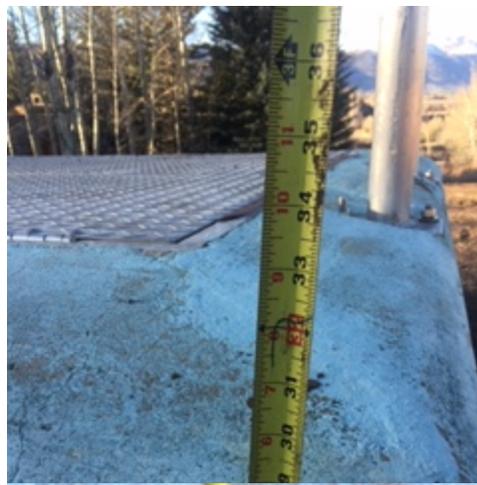
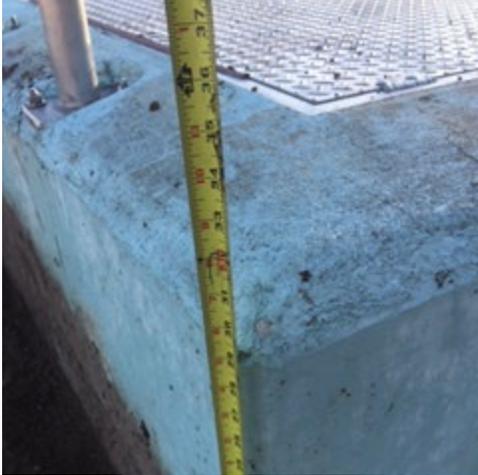
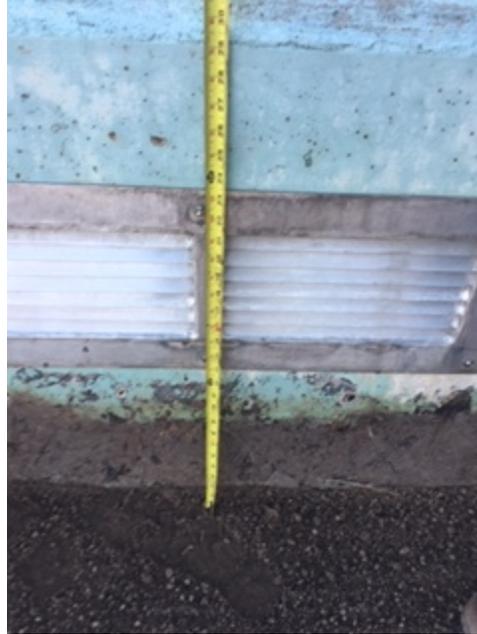
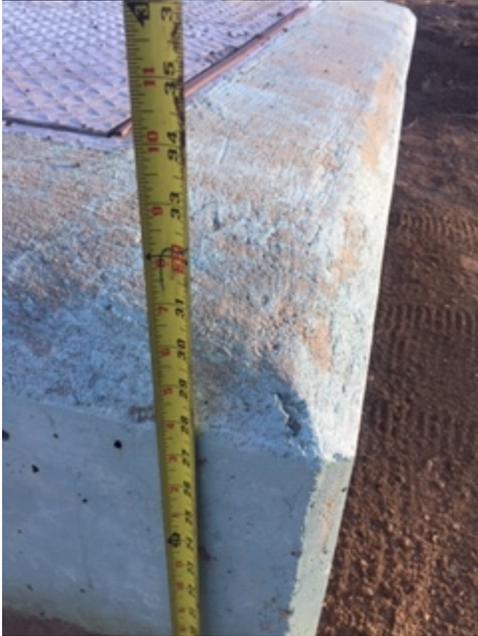
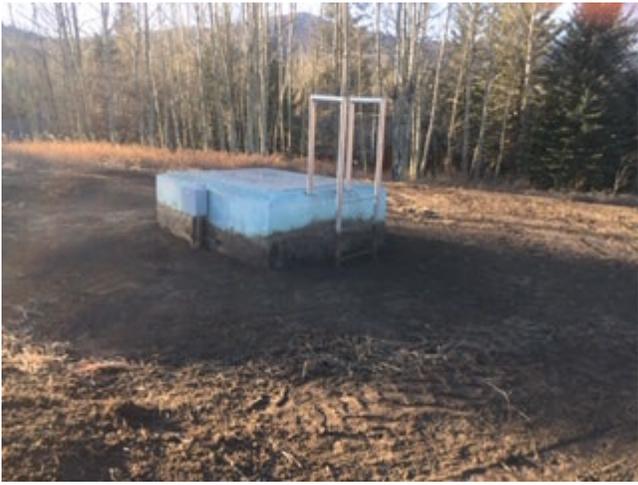
Thank You for clarifying, this morning, that there is not a secondary hatch for Tank ST01 (100K Tank). EPA has evaluated the pictures provided and note that soil was removed from the area around the buried tank where a portion of the tank is above grade and where the hatch is flush with the top of the tank. Removing soil from around the tank does not raise the hatch 2 feet above the top of the tank. These pictures do not demonstrate that these Significant Deficiencies have been corrected as follows.

We believe the lid issue to be corrected by the work performed as seen in the photo's.

(Describe corrective action) We excavated earth around tank lid to distance around entire tank lid greater than 24"

1. The hatch on the partially buried Tank ST01 (110K Tank) must have an elevated hatch that is 24 inches above the top of the tank surface. The hatch is flush with the surface of the tank.
2. Second, the air vent must terminate in an inverted U construction at least 24 inches above the tank surface. There appears to be a vent that is a foot or so below the top of the tank in a flush mount to the side of the tank. This vent should be sealed and replaced with an inverted U construction at least 24 inches above the tank surface.

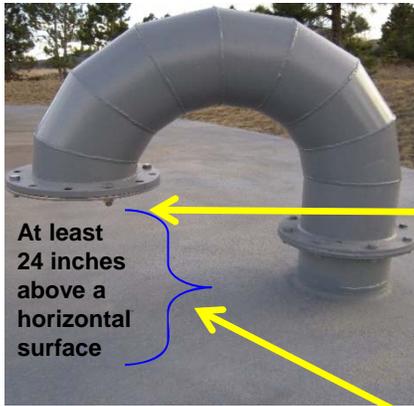
Downturned vent

Protection from contamination entering through the vent.

#24 mesh screen is needed to keep out contamination carried by insects, rodents, and birds. (See Tech Tip on #24 Mesh)

Not having a #24 mesh screen on a vent will trigger a significant deficiency

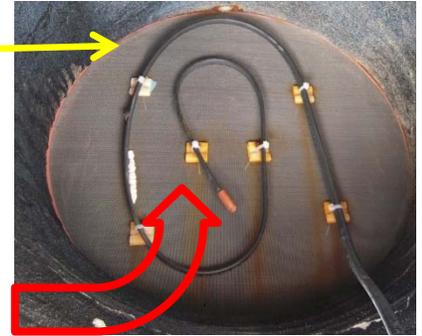
The #24 mesh screen can be installed between two flanges. The flanges allow the #24 mesh screen to set flush, which creates a better seal than wrapping the screen around the pipe and securing it with a band. Also, the flange will place the screen inside the vent to dissuade vandalism. A heating coil can be installed if freezing is a concern.

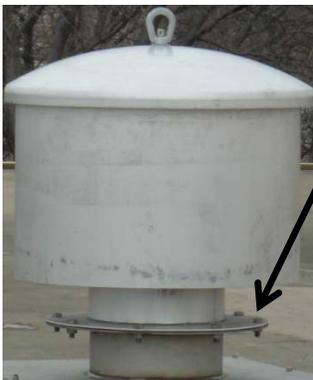
Non-downturned vent (Elevated or Ground Level Tanks Only)

For elevated tanks, having fewer than 8 inches from the bottom of the #24 mesh to a horizontal surface will trigger a significant deficiency

The vent must have a watertight cover that extends down to the bottom of the #24 mesh screen. The cover will prevent the entry of rain and snow as well as minimize the entry of dust.

Not having a solid cover that extends to the bottom of the #24 mesh screen will trigger a significant deficiency

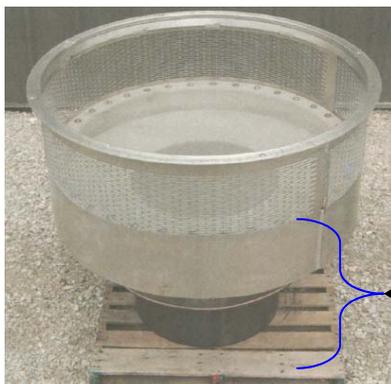
Bird spikes can be added to any intermediate horizontal surfaces. In some cases, the height of the vent should be raised higher than 24 inches to address severe problems with birds or other animals.

Vents not accessible for inspection can trigger a significant deficiency.

Recommendation only: Having the vent opening at least 24 inches above the horizontal surface protects against the inhalation of contamination (dried feces, dust, etc.). In addition to the #24 mesh screen, the vent should also have a bird screen to prevent any birds from nesting on top of a horizontally placed screen.

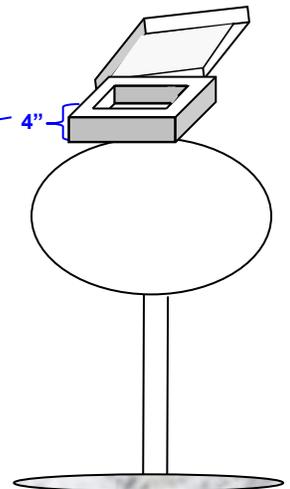
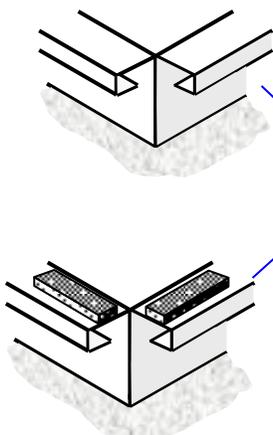
POOR DESIGNS

Insects and spiders can enter the reservoir between the framed section and cover. A seal strip can improve sanitary protection.

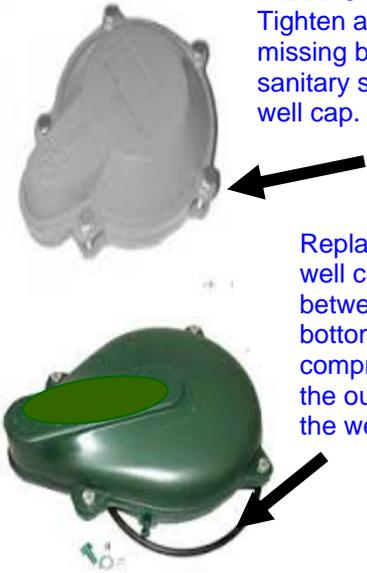
WELL CAP

Tighten and replace any missing bolts to ensure a proper sanitary seal is created by the well cap.

Replace any damaged well cap gaskets between the top and bottom plate and/or the compression seals on the outside diameter of the well casing.

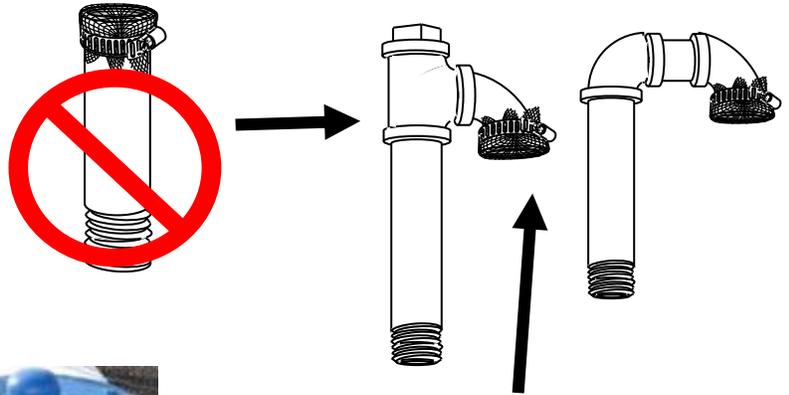
WELL VENTS

Well vents (if applicable) must be at least as high as the well casing or pitless adapter. Replace straight, open well vents with inverted screened vents such as those below. Use non-corrodible 24-mesh screen on all configurations of well vents to exclude insects, rodents and other small animals.

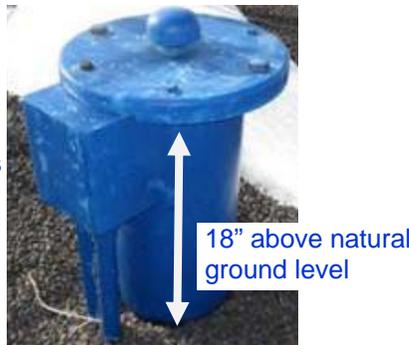
WELL HEIGHT

Permanent casing for all groundwater wells must project at least:

- 12 inches above the concrete floor; or
- 18 inches above natural ground surface.

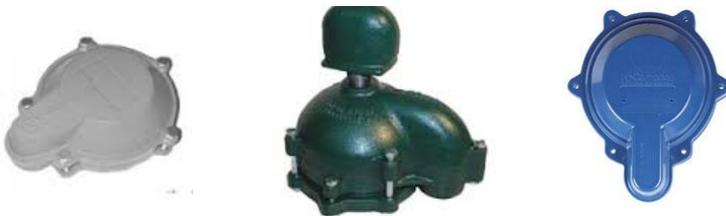
PROPERLY DESIGNED WELL CAPS & SANITARY SEALS

Replace damaged or non-watertight well caps with vermin-proof, premium watertight wellhead caps. Vented caps must use #24-mesh screen.

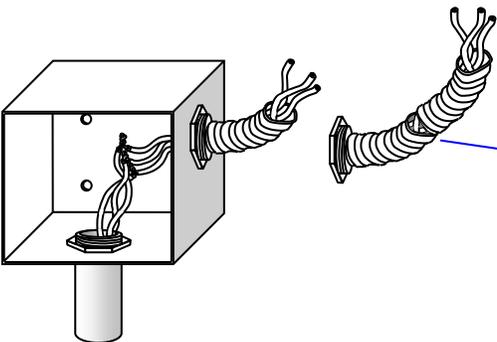
An electrical junction box shall be watertight (including at box attachment to the well casing and electrical conduits attached to the box) to prevent contaminants from entering the well. Replace damaged flexible conduit.
