In the Matter of * Docket No. CWA-06-2012-2710
*
Paco Swain Realty, L.L.C, *
a Louisiana Corporation, *
*
Respondent * RESPONDENT'S
PREHEARING EXCHANGE

WETLAND DELINEATION
58-acre Wetland Delineation
Sections 6 and 7, T-6-S, R-4-E
Livingston Parish, Louisiana

Submitted by:
Gulf South Research Corporation
Baton Rouge, Louisiana

October 2007

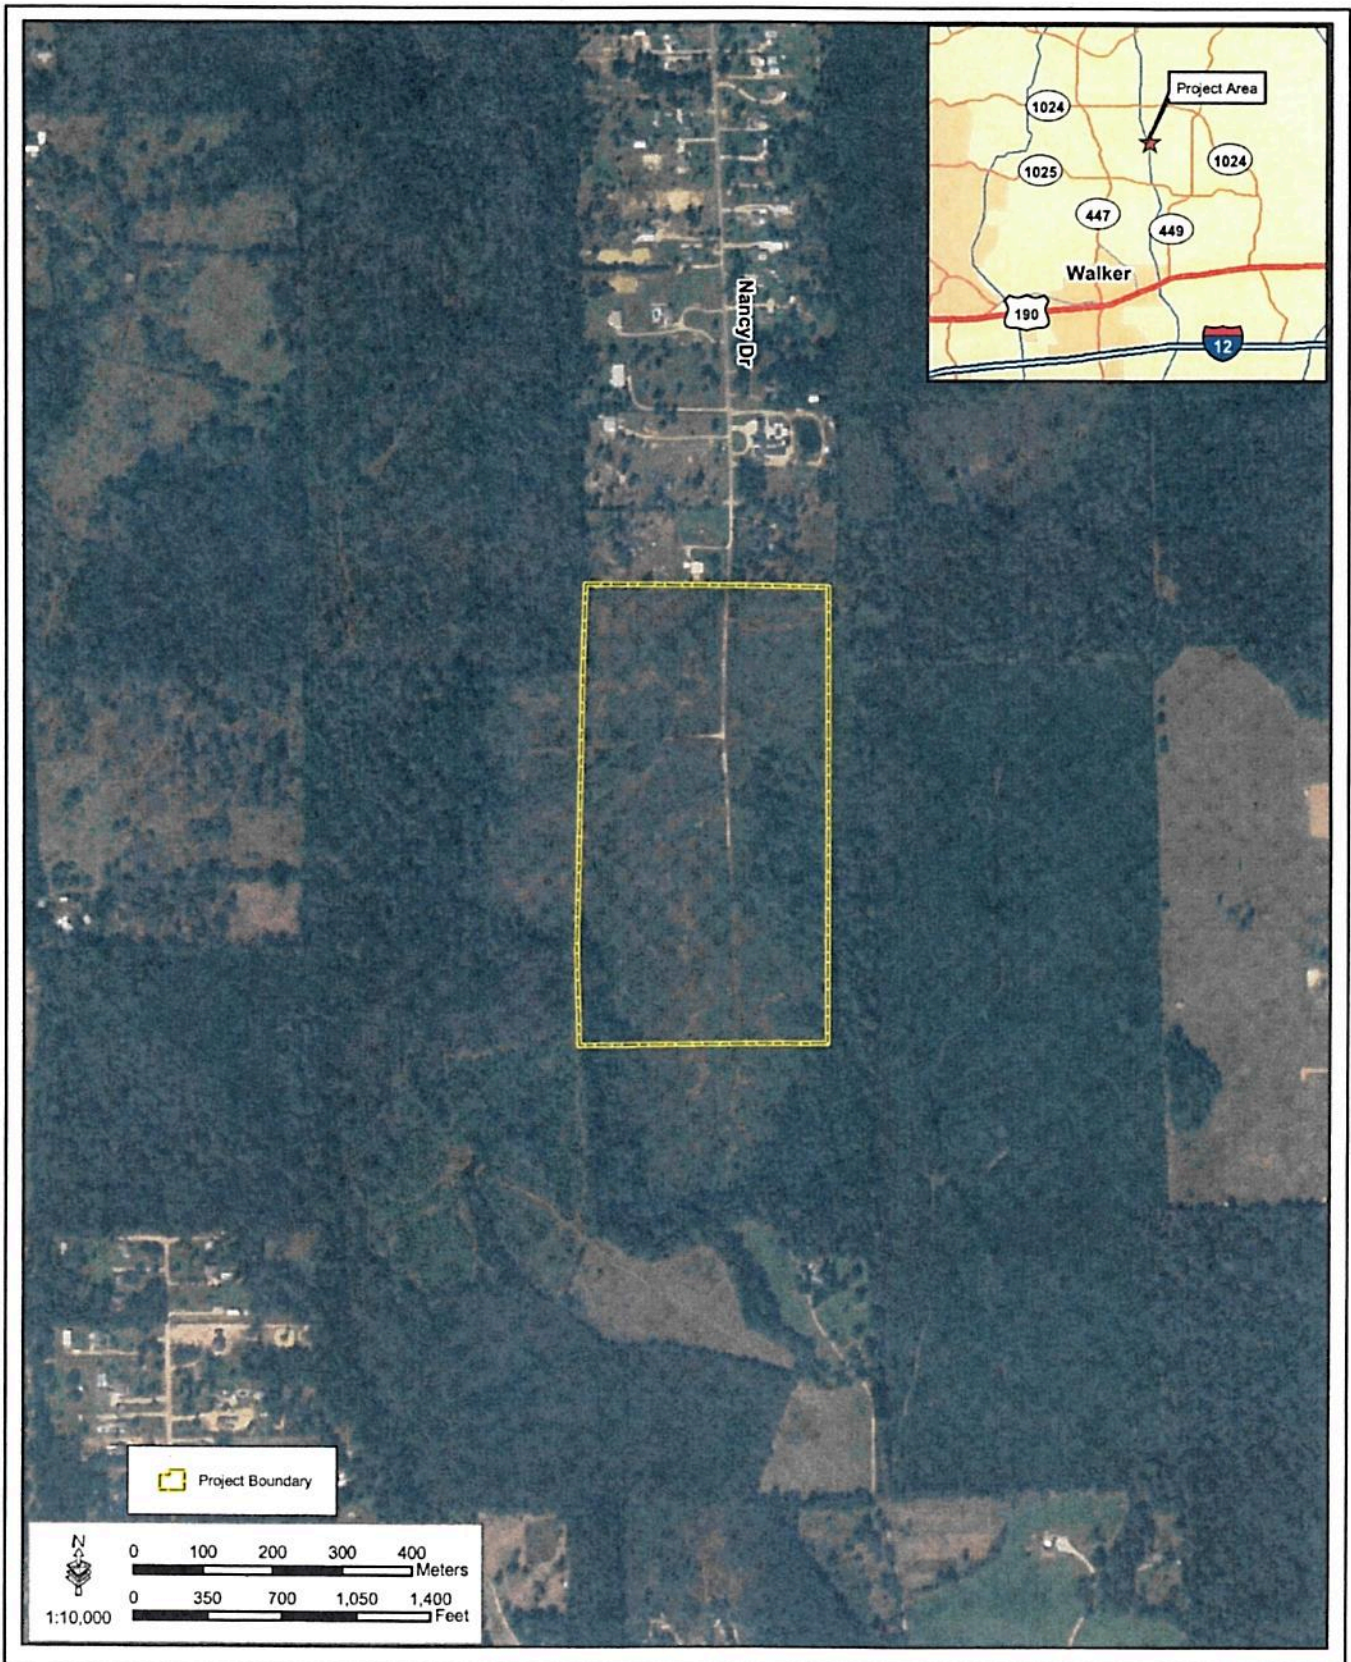
Figure 2: Project Area Map
 Megan's Way Subdivision
 Sections 6 and 7, T6S, R4E

The project site is located on Nancy Drive, south of Louisiana Highway 1024 and east of Louisiana Highway 447 in Walker, Louisiana (Figure 1). More specifically, the property is located in Sections 6 and 7, T-6-S, R-4-E, Livingston Parish, Louisiana. The project site is bordered by residential subdivisions to the north and by forestland to the east, south, and west (Figure 2).

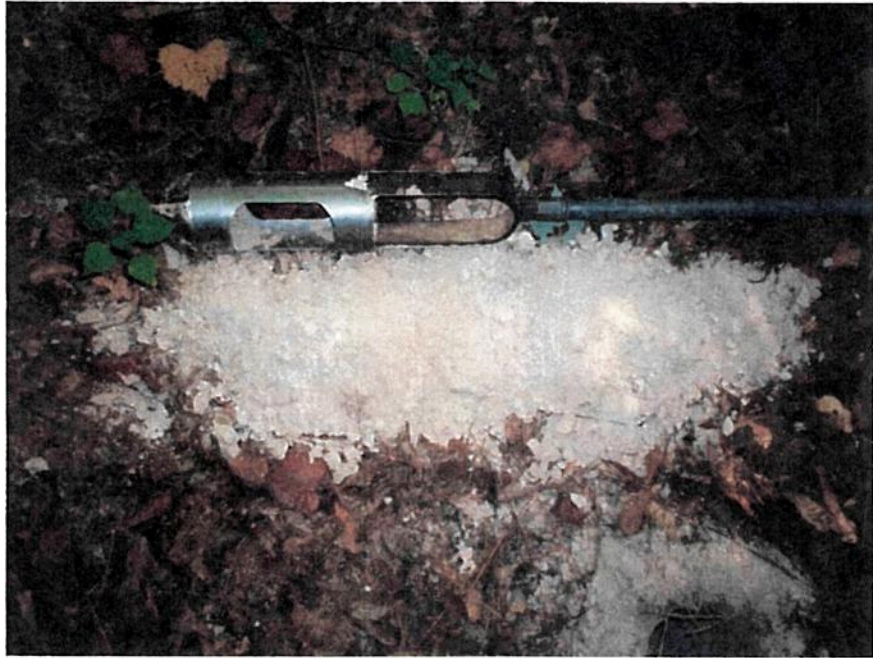
At 14 inches, soil colors in this area were 10YR 7/2 with no mottles. From 14 inches to greater than 16 inches, the soil colors were 10YR 8/2 with no mottles. The soil profile more closely resembles Gilbert silt loams (Gb) than the Encrow soils as mapped. Gilbert soils are listed as hydric soils on both the National and Louisiana Hydric Soils lists; however, field characteristics of the soils sampled at Plot 1 confirmed that the soil is not

functioning as a hydric soil. No primary wetland hydrology indicators and only one secondary wetland hydrology indicator was recorded at Plot 1, local soil survey data. This sample site is not considered to be within a potential jurisdictional wetland due to the lack of wetland hydrology and hydric soils (Appendix A).

Photograph 1. Plot 1: Gilbert soils.

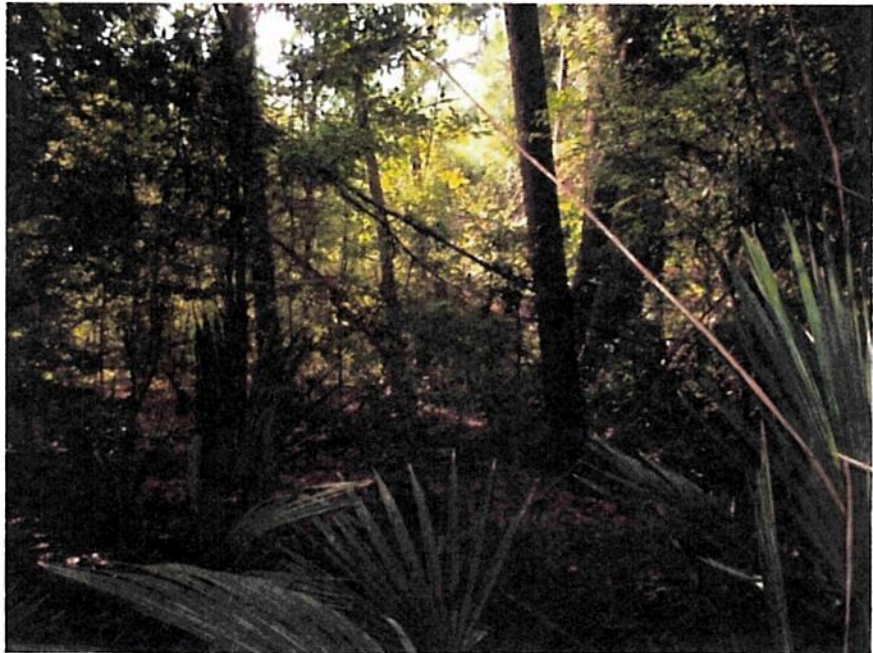
Plot 1 is located within the southwestern corner of project site (Figure 4). This sample site was vegetated with spruce pine, Drummond red maple, persimmon, dwarf palmetto, bluebeech, deciduous holly (*Ilex decidua*), Chinese tallow-tree (*Sapium sebiferum*), and southern dewberry. All (100 percent) of the vegetation observed at the sample site is considered hydrophytic (Appendix A).

Photograph 2. Plot 1: Overview of vegetation, facing southeast.

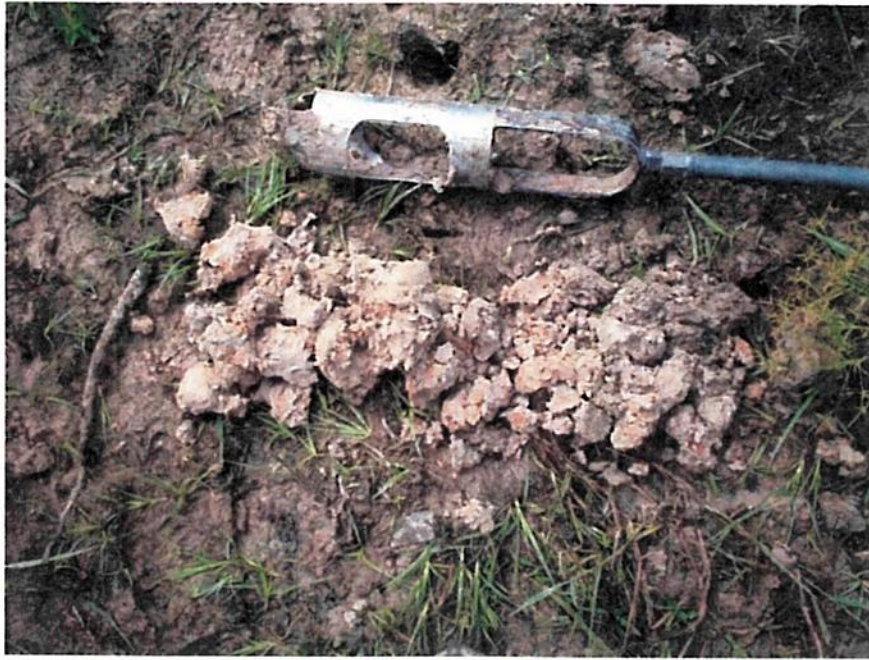
At 4 inches, soil color in this area was 10YR 6/2. From 4 inches to greater than 16 inches, the soil color was 10YR 7/1 with many, medium, prominent 10YR 6/8 mottles. The soil type was confirmed as Encrow silt loam, as mapped. Encrow soils are listed as a hydric soil on the Louisiana and the National Hydric Soils Lists. Field characteristics of the soils sampled at Plot 2 confirmed that the soil is functioning as a hydric soil. Primary wetland hydrology indicators observed at the sample site included inundation, saturation in the upper 12 inches of the soil, and drainage patterns in the wetlands. Secondary wetland hydrology indicators recorded were water-stained leaves and local soil survey data. This sample site is considered to be within a potential jurisdictional wetland (Appendix A).

Photograph 3. Plot 2: Encrow soils.

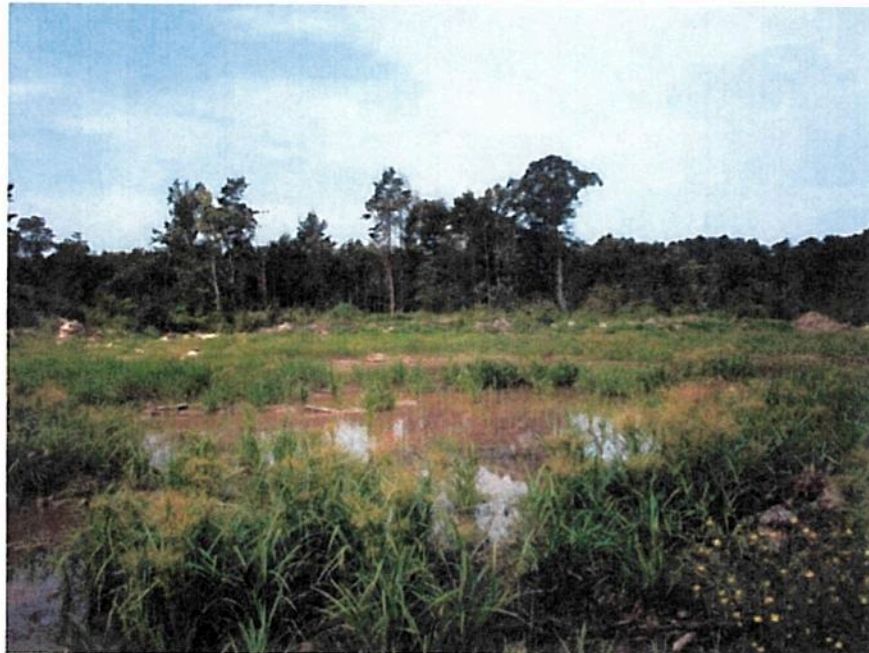
Plot 2 is located in an emergent wetland community in the southwestern portion of the subject property (see Figure 4). Plant species such as beakrush, primrose, marsh flatsedge, and alligator weed (*Alternanthera philoxeroides*) were observed as dominant at the sample site. All (100 percent) of the vegetation observed at the sample site is considered hydrophytic (Appendix A).

Photograph 4. Plot 2: Overview of vegetation, facing southwest.

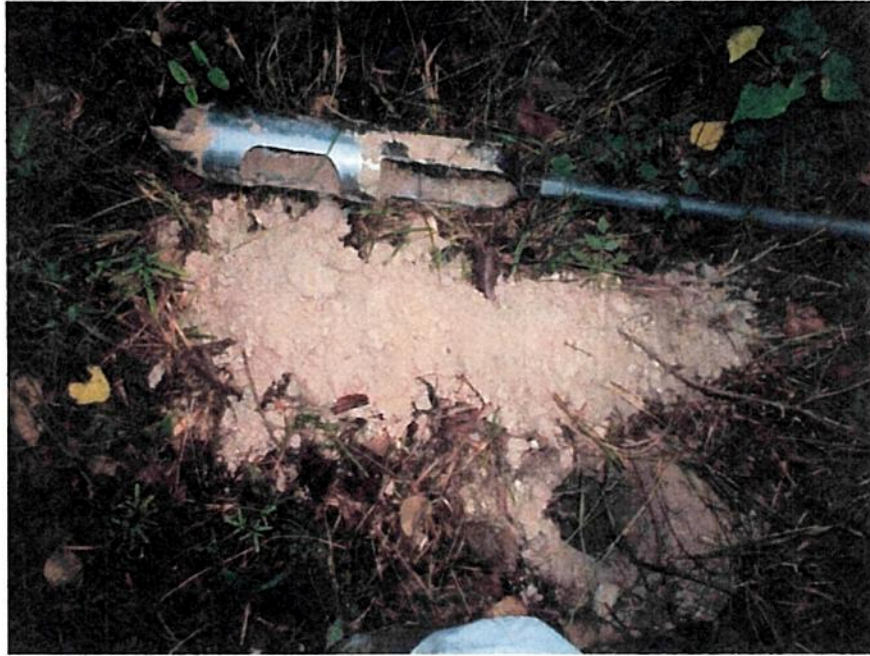
The soil sample was an equal mixture of the colors 2.5Y 7/3 and 2.5Y 6/3 for the complete depth of the sample. There were no visible mottles. The soil profile more closely resembles Deerford soils than the Encrow soils as mapped. Deerford soils are

listed as hydric soils on both the National and Louisiana Hydric Soils lists. Field characteristics of the soils sampled at Plot 3 confirmed that the soil is not functioning as a hydric soil. No primary wetland hydrology indicators and only one secondary wetland hydrology indicator was recorded at Plot 3, local soil survey data. This sample site is not considered to be within a potential jurisdictional wetland due to the lack of wetland hydrology and hydric soils (Appendix A).

Photograph 5. Plot 3: Deerford soils.

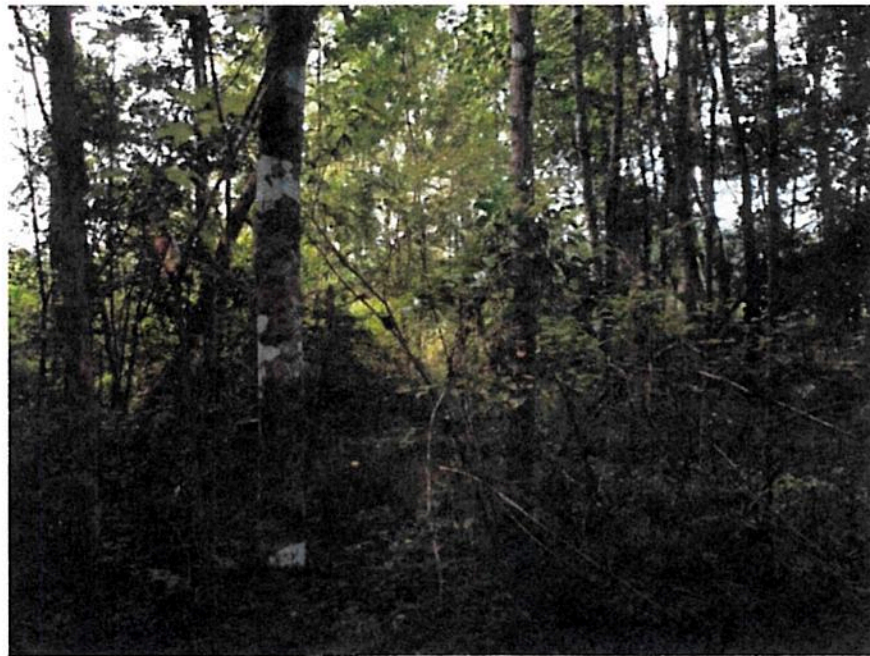
Plot 3 is located within the eastern portion of project site (Figure 4). This sample site was vegetated with sweetgum, Chinese tallow-tree, Drummond red maple, winged elm (*Ulmus alata*), poison ivy (*Toxicodendron radicans*), muscadine (*Vitis rotundifolia*), Japanese climbing fern (*Lygodium japonicum*), cat greenbrier (*Smilax glauca*), Japanese honeysuckle (*Lonicera japonica*), and woodsoats (*Chasmanthium* sp.). The hydrophytic vegetation criterion was met, as 82 percent of the dominant species found at the sample site are considered hydrophytic (Appendix A).

Photograph 6. Plot 3: Overview of vegetation, facing southeast.

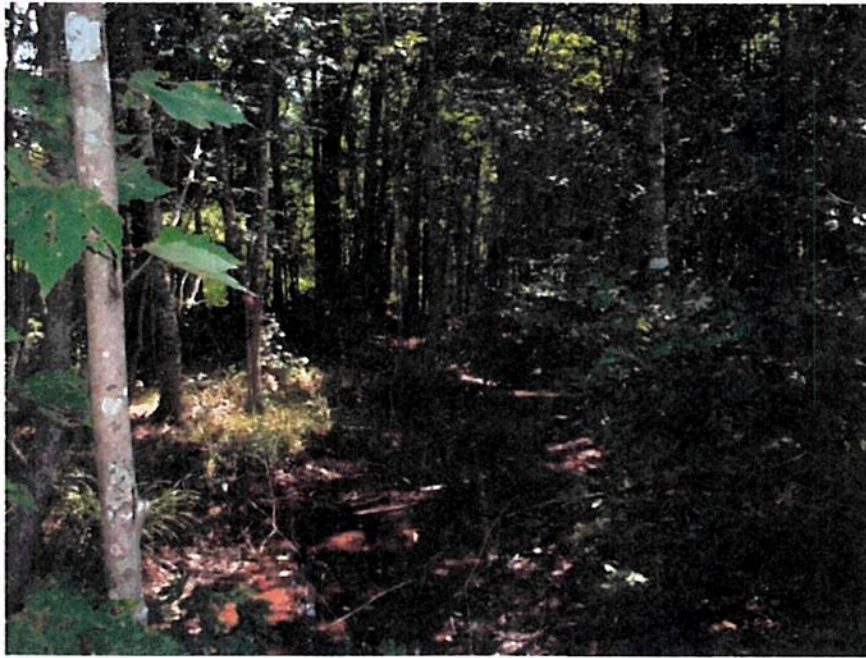
An un-named drain trends through the southeastern portion of the project site. The drain is 6 to 8 feet wide from top bank to top bank and approximately 2 feet deep at its terminus at the road. The drain is less than 12 inches deep at the eastern property boundary. There was approximately 2 to 4 inches of water in the drain at the time of the wetland delineation field survey; however, there was no flow.

Photograph 7. Overview of un-named drain, facing east.

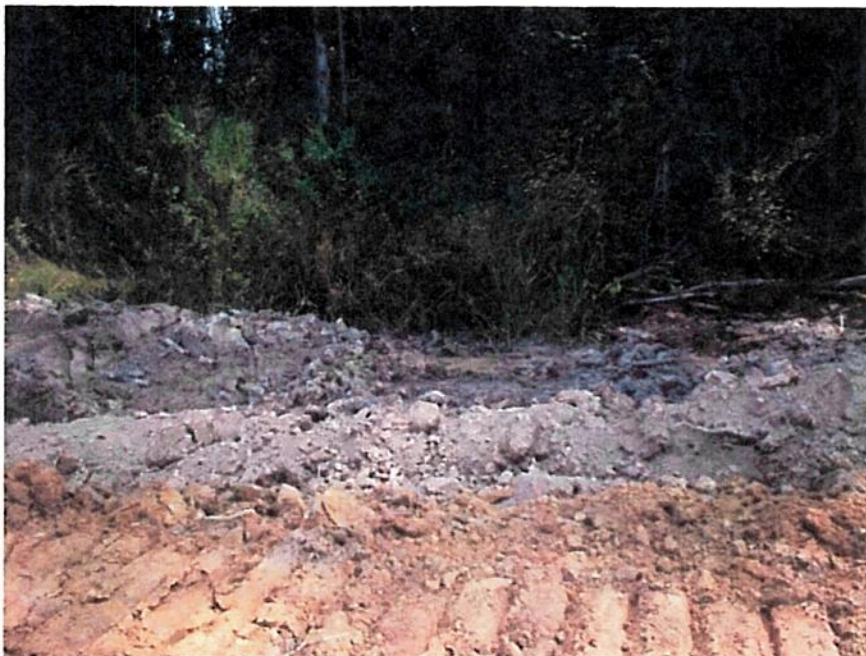
Photograph 8. Overview of un-named drain at terminus at road, facing east.
