## **MEMORANDUM**

**SUBJECT:** Evergreen Place 1<sup>st</sup> Addition Development - Reconnaissance  
Bennet, NE

**FROM:** Delia Garcia, Ph.D.  
Environmental Scientist  
ECAD/Water Branch

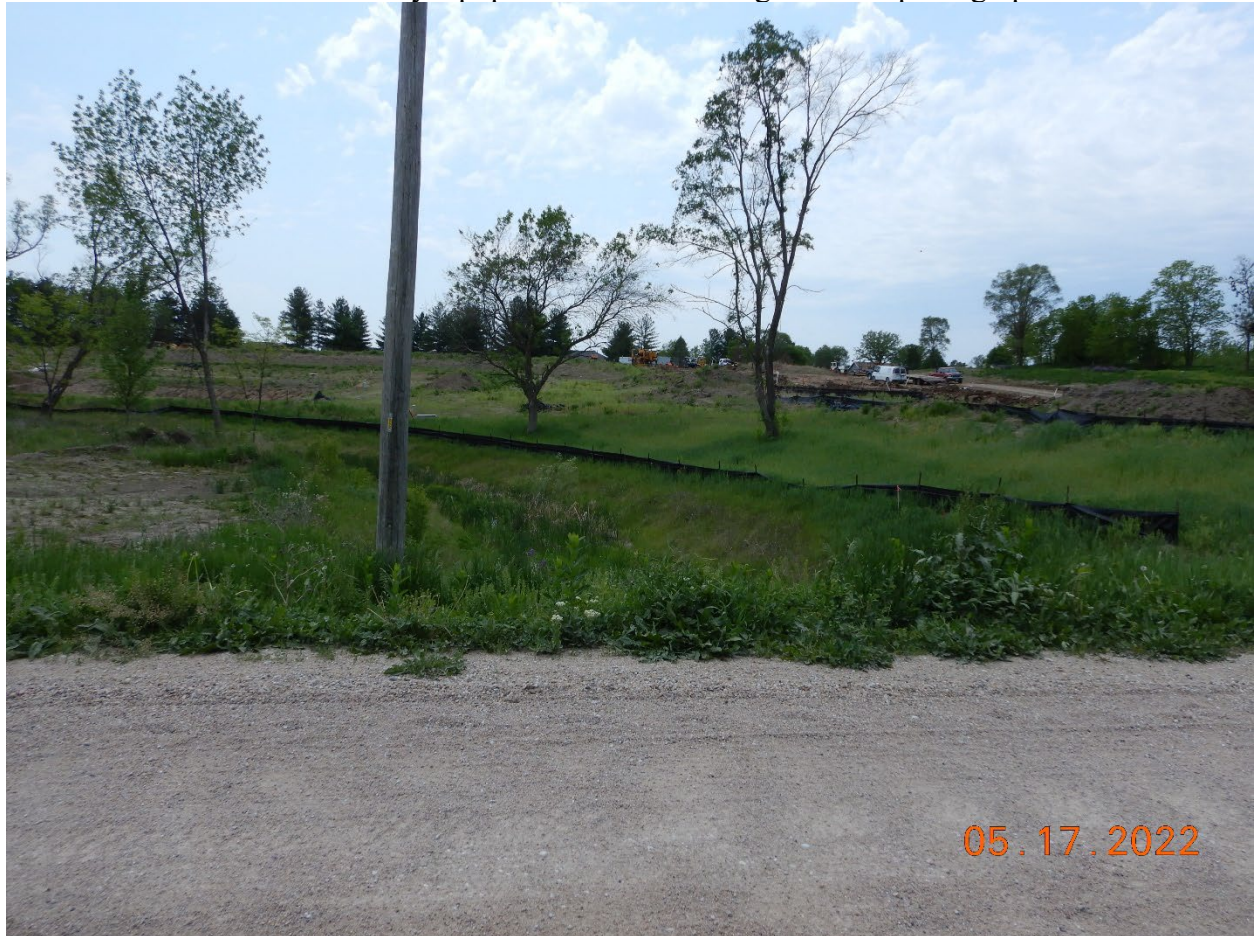
Photo DSCN0009.JPG - Stream and wetland just to the right of the telephone pole in photo. Also note the vehicles and heavy equipment towards the right side of photograph.

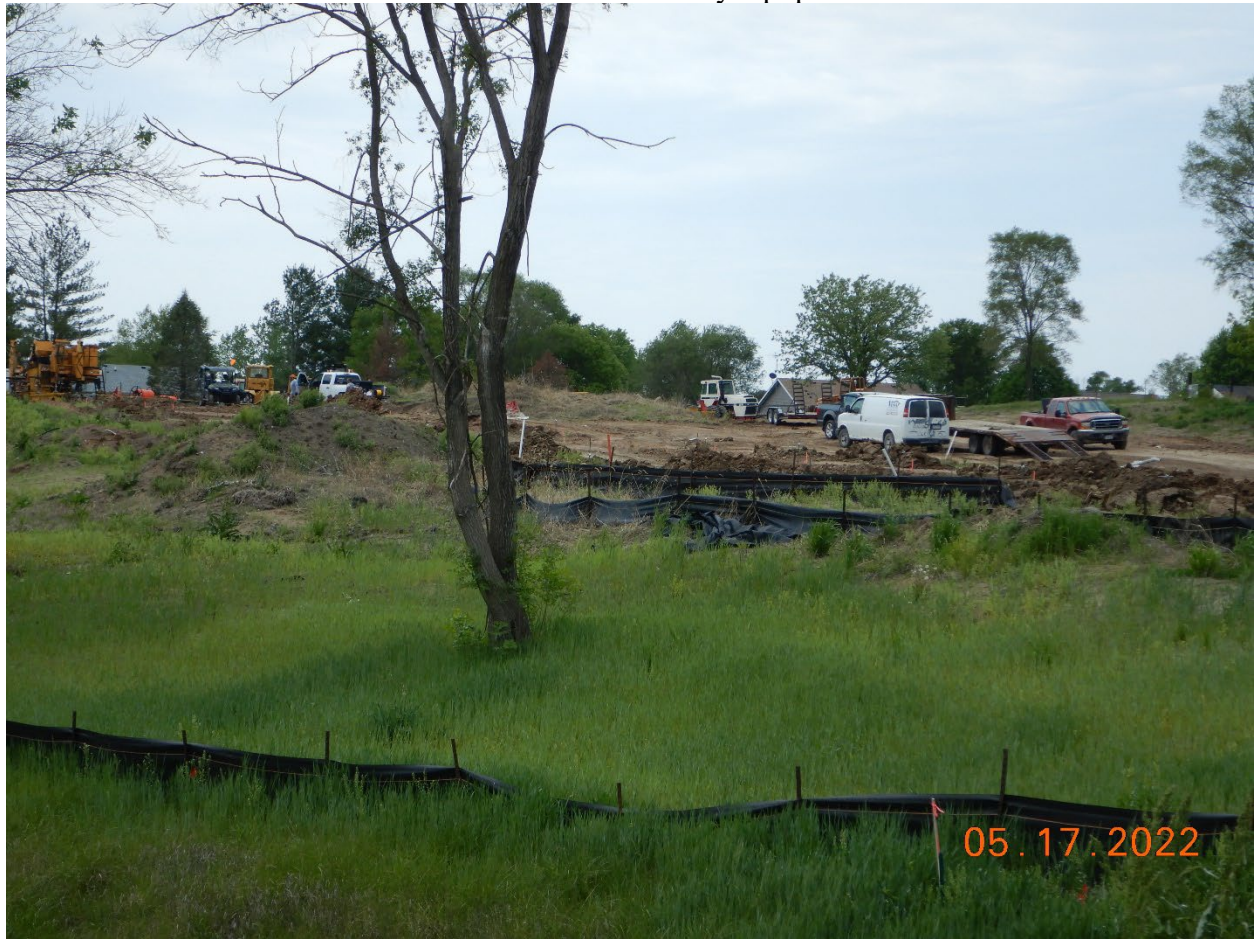
Photo DSCN0010.JPG – Note all the vehicles and heavy equipment on site.

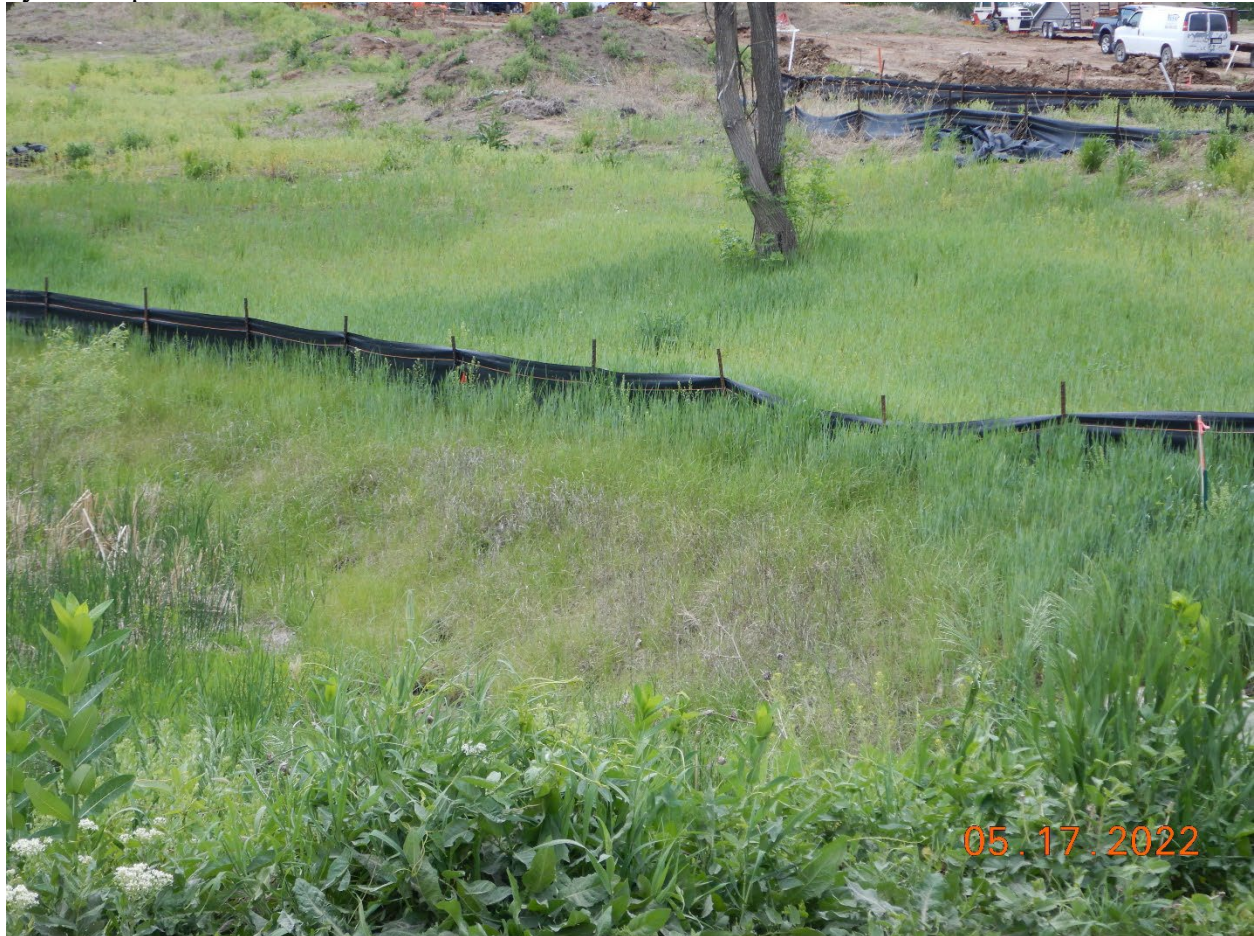
Photo DSCN0011.JPG – Closer view of bed and banks of stream and wetland that were impacted by developer's unauthorized activities.
