Re: Complaint and Compliance Order **RCRA-05-2014-0006**
Summit Inc.
U.S. EPA ID No.: INX 000028902

In the Matter of:)	Docket No. RCRA-05-2014-0006
)	
Summit, Inc.)	Proceeding to Assess a Civil Penalty
6901 West Chicago Avenue)	Under Section 3008(a) of the Resource
Gary, Indiana)	Conservation and Recovery Act,
)	42 U.S.C. § 6928(a)
U.S. EPA ID #: INX 000 028 902)	
)	
Respondent.)

Complaint and Compliance Order

Photograph Log
Summit, Inc.
6901 West Chicago Avenue
Gary, Indiana 46406

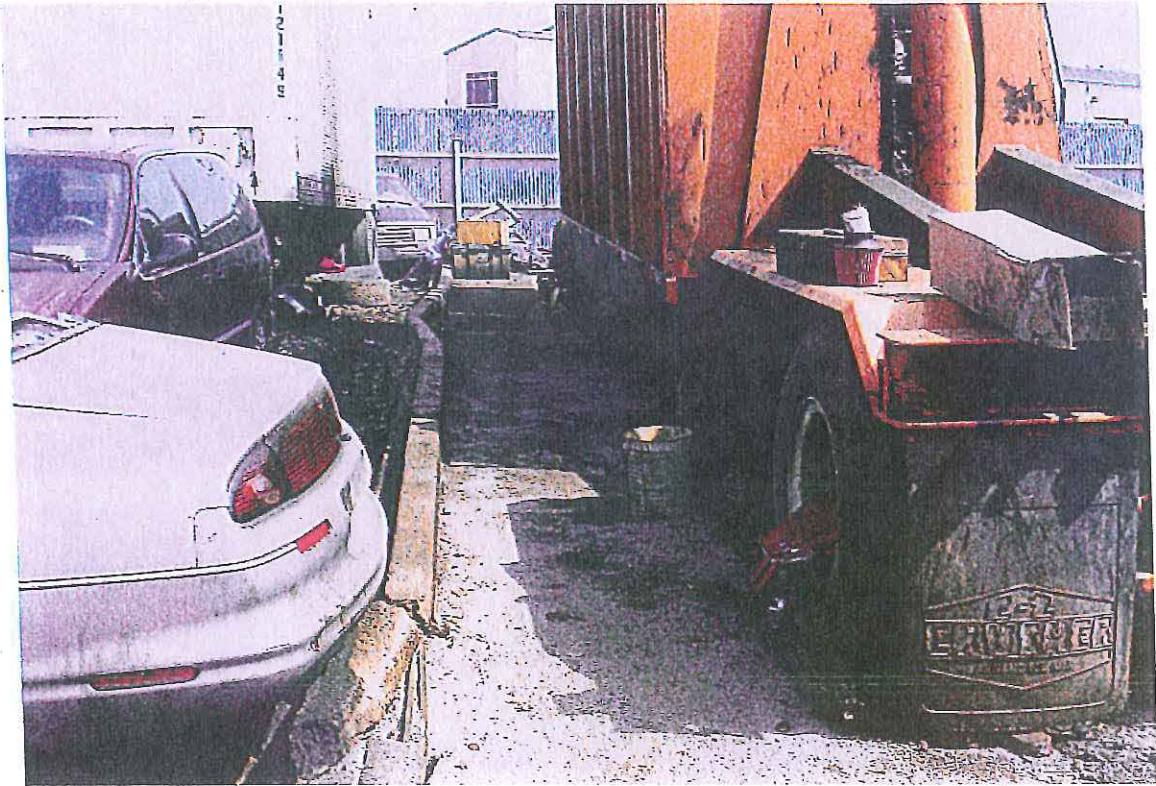
Description of photograph: This photograph was taken facing northeast. The fence behind the yellow-orange crusher is parallel to Industrial Highway. Note the broken curbing on the crusher pad beneath the rear bumper of the car to the left. Note fresh oil dry and oil staining on the crusher pad floor. The bucket is not labeled "used oil."

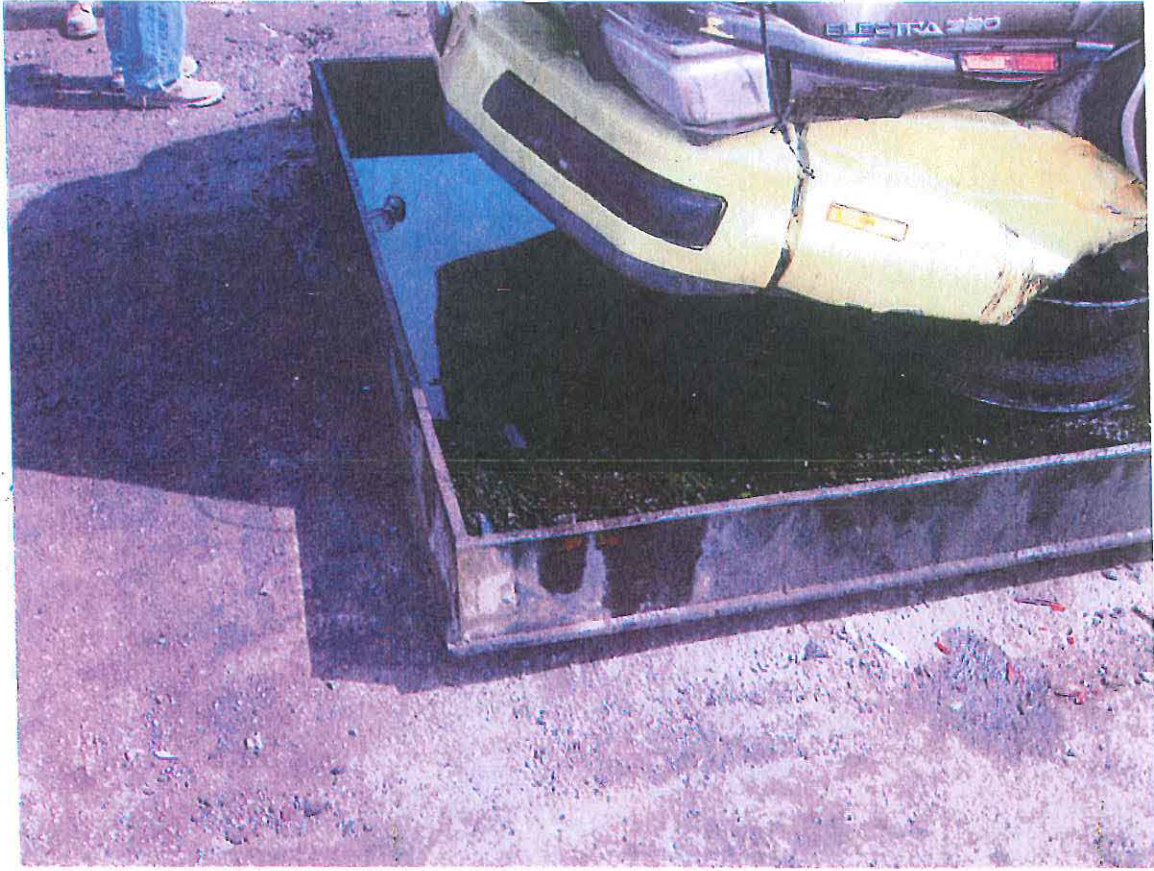
Photograph No.3

Description: Cars placed on a metal pan where car fluids are drained into.

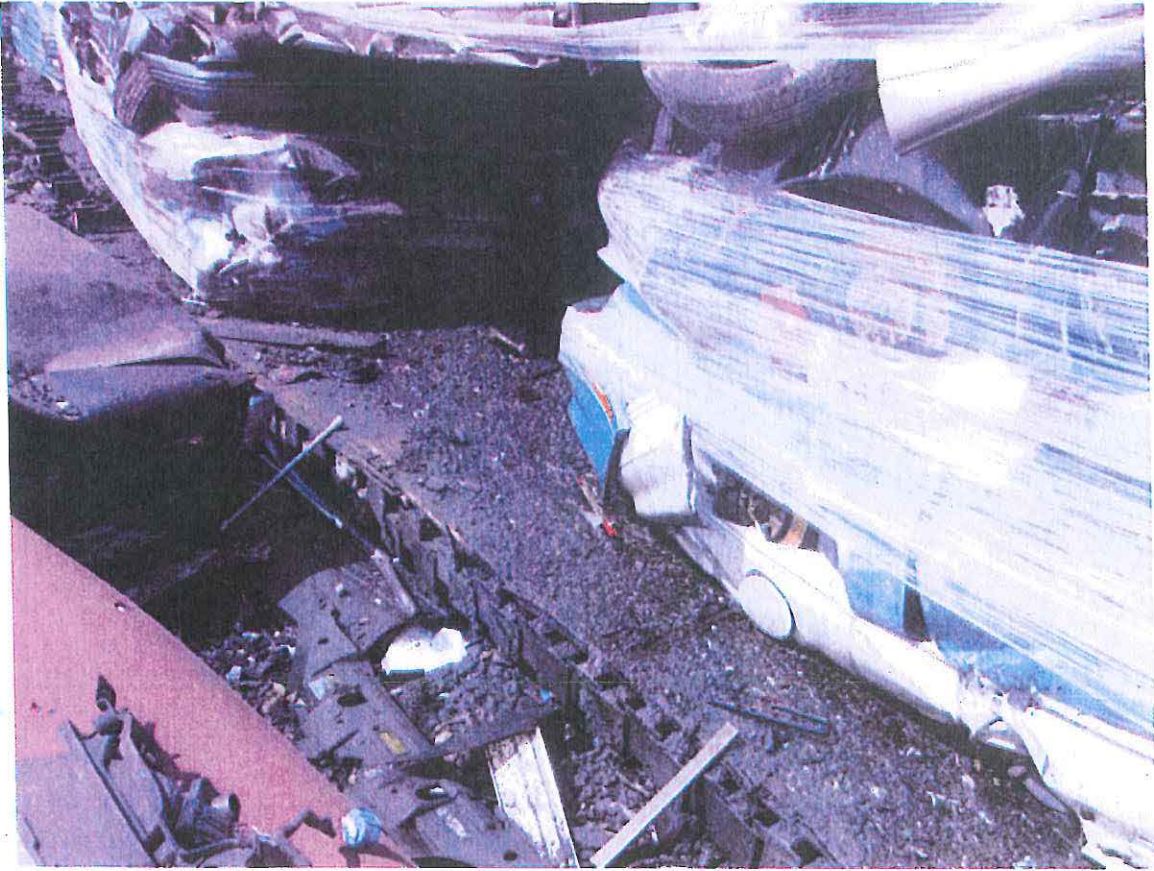
Photograph No.12

Description: Crushed cars rapped in plastic placed on top wooden pallets. The pallets appear to be saturated with oil.

36. Crushed cars were shrink wrapped and stacked on-site. During the inspection EPA inspectors observed crushed vehicles with oil dripping on their sides; wooden pallets and the ground beneath the crushed vehicles saturated with oil. See Exhibit 8.

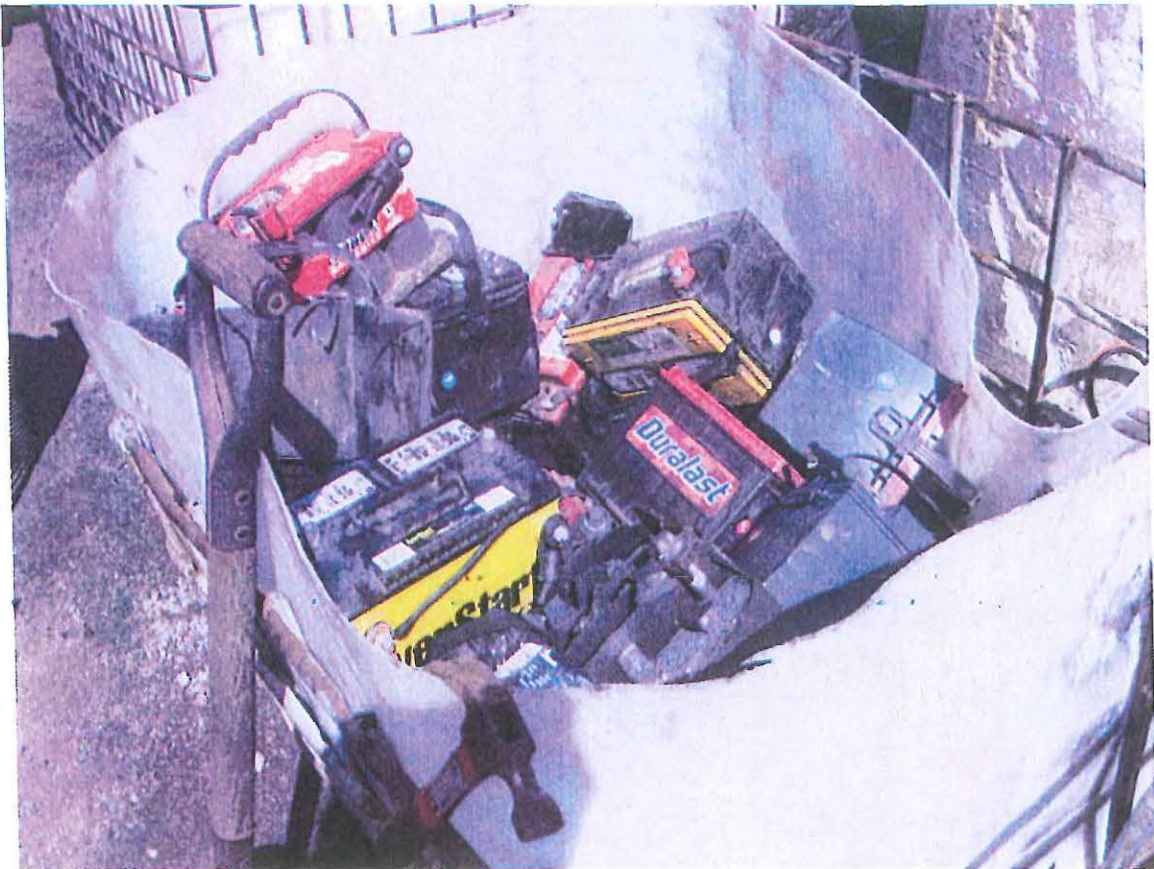
Photograph No.5

Description: Plastic tote containing car batteries.

39. There were plastic totes full of auto batteries located at the Site during the April 2008 inspection. Some of the totes were filled with liquids. One tote had a two inch opening at the bottom. Batteries were also stored in the back of a pick-up truck. Some of these batteries were cracked open. Respondent could not identify the liquids in the tote at that time. These containers were unmarked. See Exhibit 10.

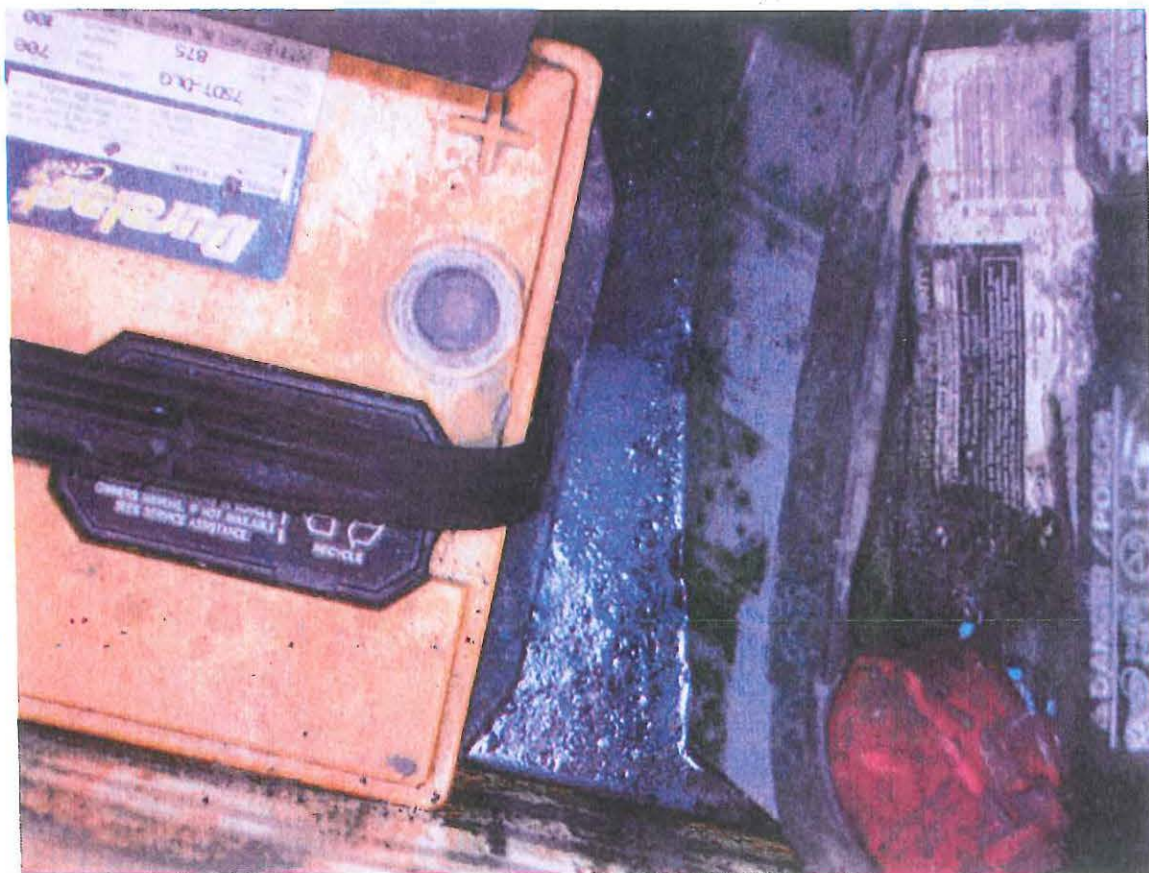
Photograph No.6

Description: Inside of tote shown in Photograph No. 5. The tote was one third full with some type of liquid.

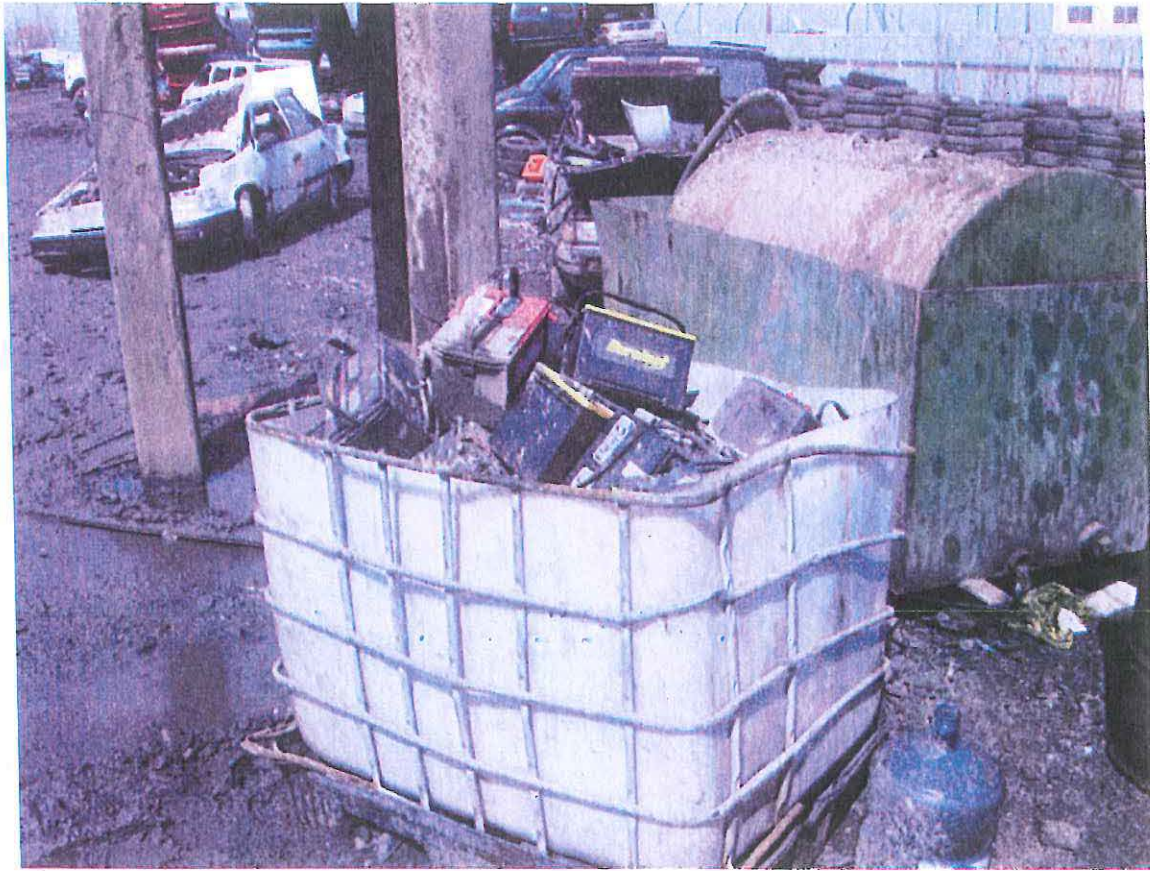
Photograph No.9
Date: April 2, 2008
Site: Summit, Inc., 386901 West Chicago Avenue, Gary, IN 46406
Description: Second tote containing car batteries.

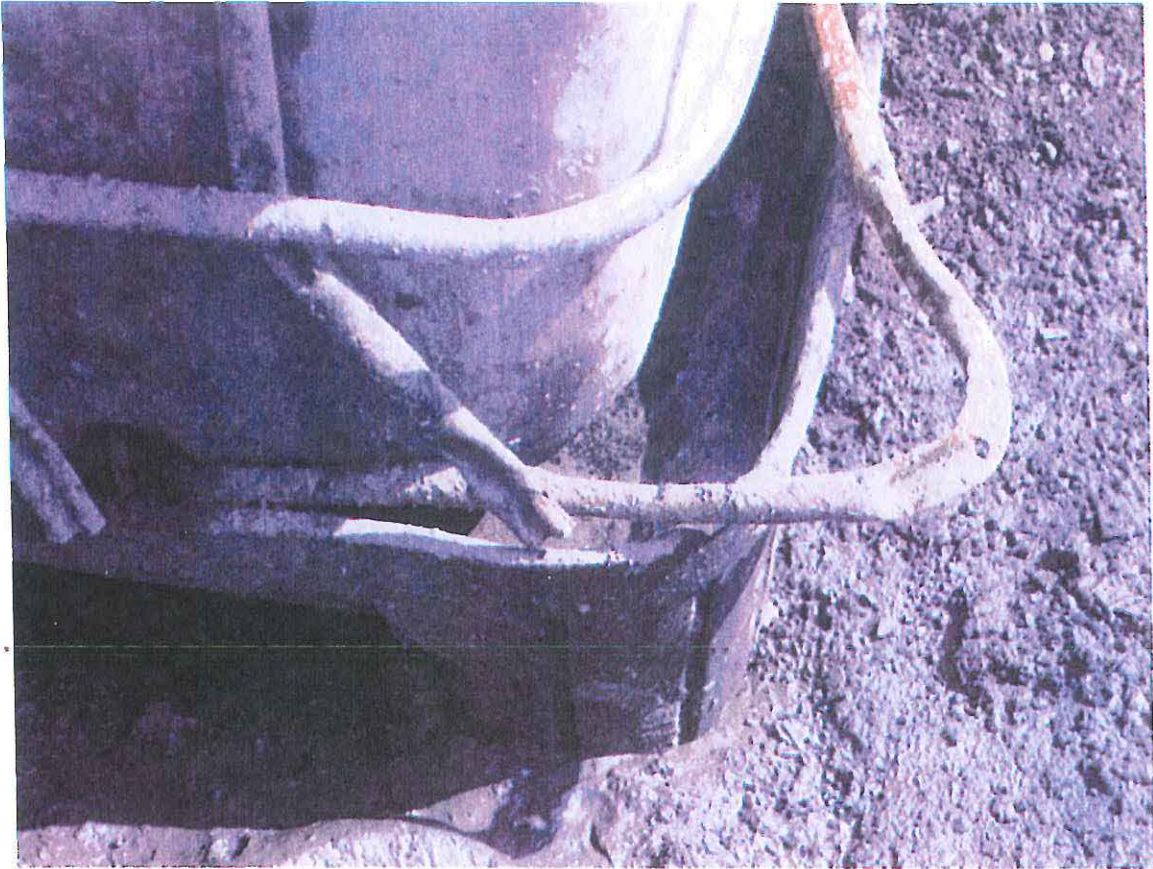
Photograph No.10

Description: Bottom of tote shown in Photograph No. 9 was equipped with a two inch opening.

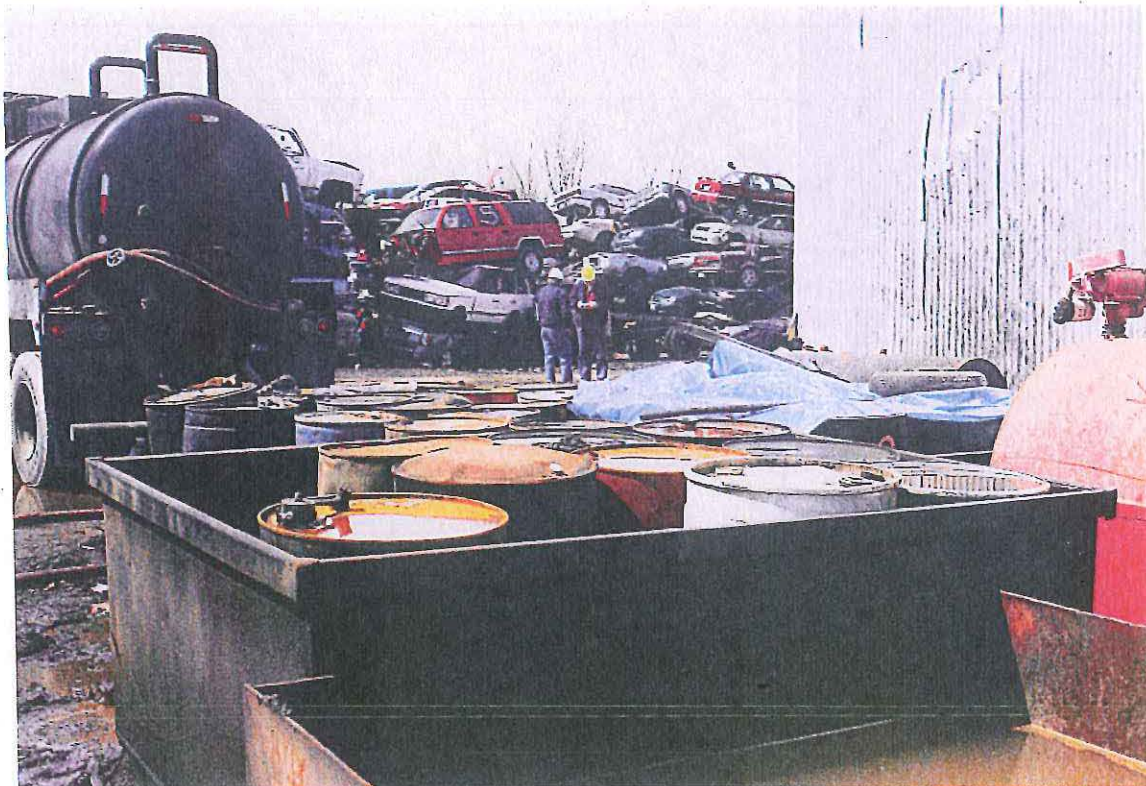
Description of photograph: This photograph was taken facing west with my back to the fence along Industrial Highway and the oil water separator. The metal containers hold drums containing wastewater according to Steve, the Beaver Oil Company truck driver. The truck at the top left of the picture is a one compartment Beaver Oil Company truck, and Steve had pumped used oil from the drums to the left of this picture. The nineteen used oil drums remaining to be emptied are between the truck and the metal totes. This shows the truck backed up onto the pad in order to pump out the drums. Ken Zolnierczyk and Dorel Hunt are standing in front of the stacked cars in the background.

41. Respondent stored several 55 gallon drums located inside and outside the area near the shed. During the April 2008 inspection EPA observed a Beaver Oil Company truck pumping liquids from the unlabelled drums into a tanker truck. The driver informed EPA that he was pumping out used oil and that he had already pumped out 11 drums of used oil. There were 19 more drums remaining. None of the drums were marked. See Exhibit 12.

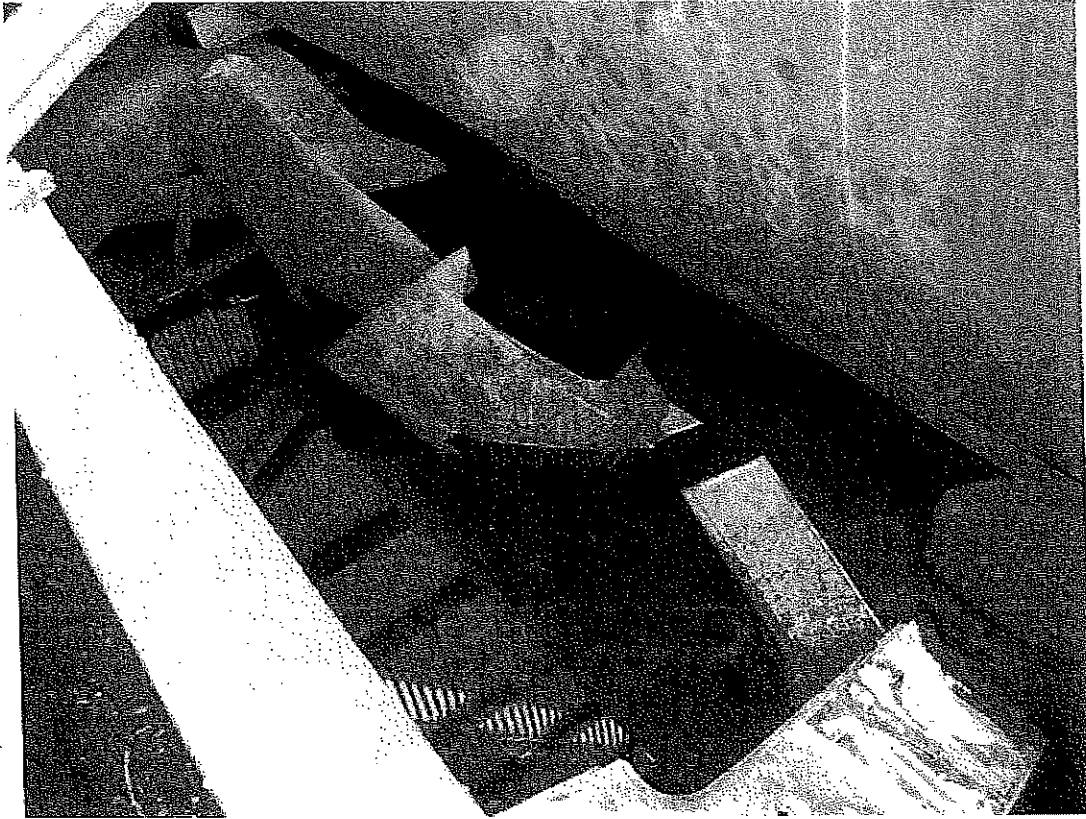
Photograph No. 6

Description: Reddish liquid with metal debris inside the steel box shown in photograph No. 5.

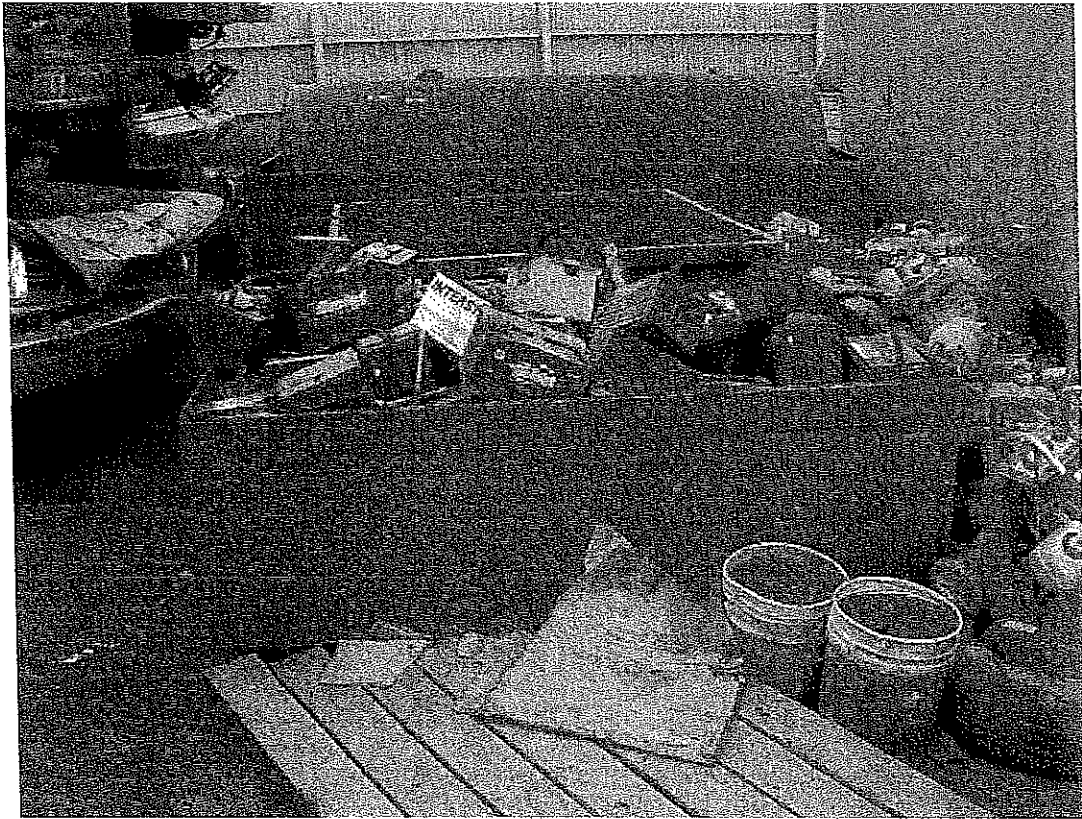
Photograph No. 19

59. EPA inspectors observed a steel box filled with car batteries near the gasoline recovery shed. Several batteries were broken with the lead plates exposed. There were no markings on the steel box. Exhibit 15.

Description: Batteries stored in a steel box west of the gasoline recovery shed.

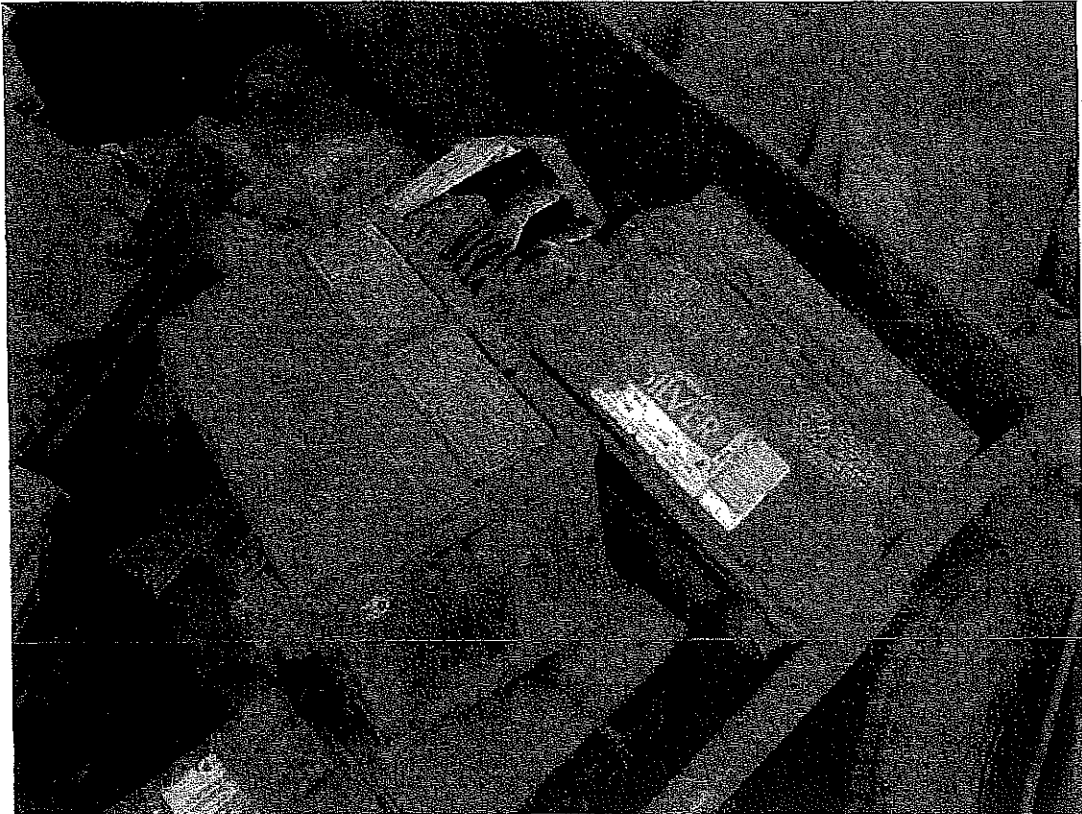
Photograph No. 20

Description: Batteries stored in a steel box west of the gasoline recovery shed.

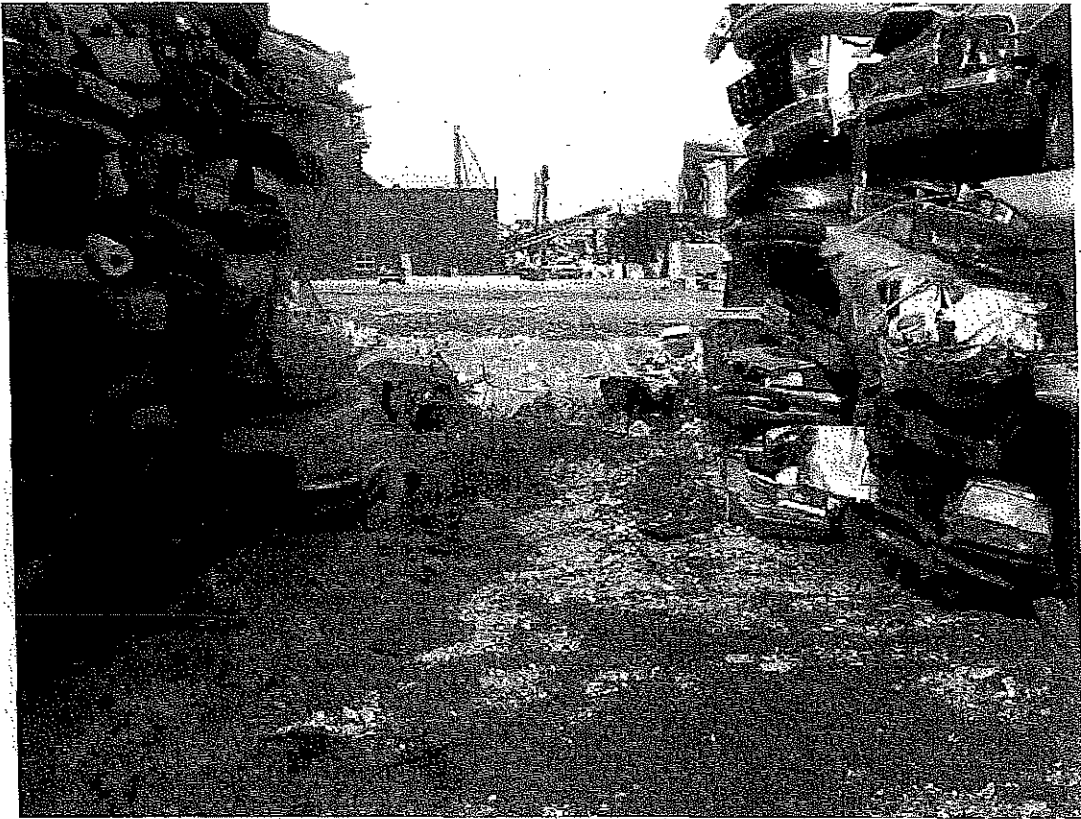
Photograph No. 25

Description: Aisle of crushed cars east of car shredder.

61. In the area between crushed cars and the shredder EPA observed a pool of water with an oil sheen. The soil in front of the water was dark and appeared to be stained with oil. The soils were also saturated with liquids such as automotive oils. EPA collected two soil samples in this area. (31890922 and 23). See Exhibit 16.

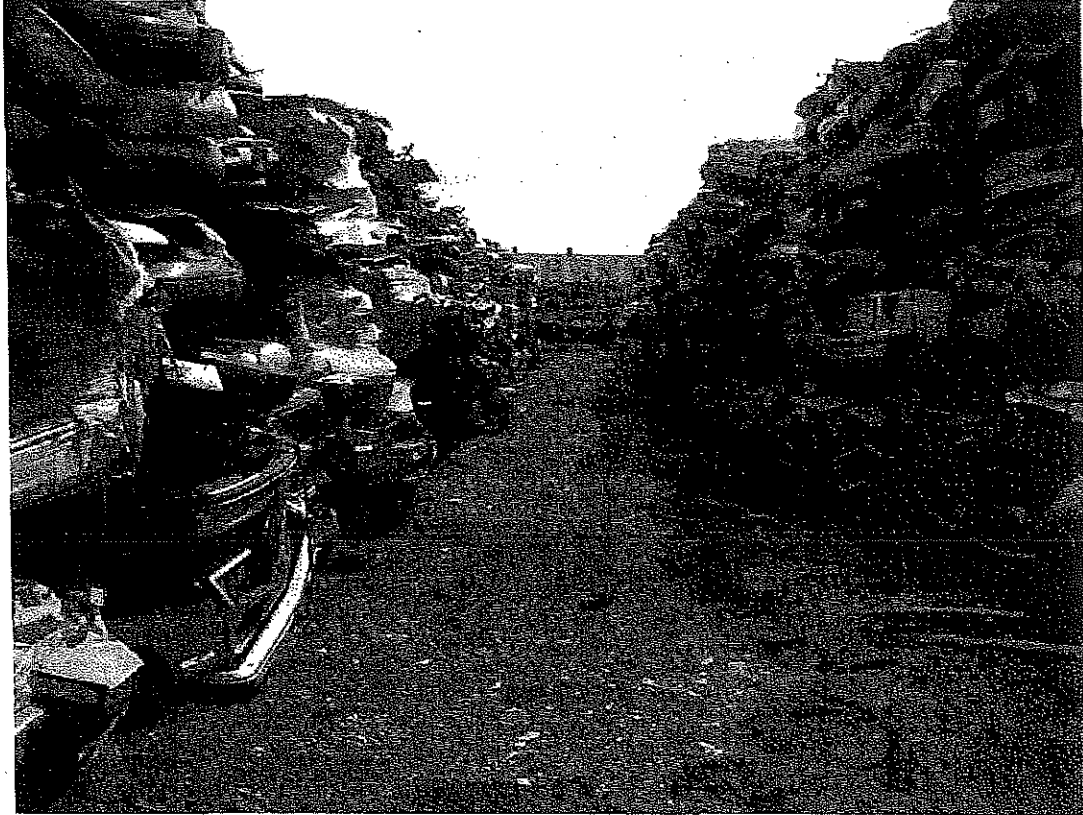
Photograph No. 26

Description: Aisle of crushed cars east of car shredder. This point of view has the car shredder behind us.
