**Subject:** Results of Year 1 Operation, Maintenance and Monitoring Plan Sampling  
Head of the Thea Foss Waterway Remediation, Tacoma, WA

# RESULTS OF YEAR 1 OPERATON, MAINTENANCE AND MONITORING PLAN SAMPLING

## Head of Thea Foss Waterway Remediation Project

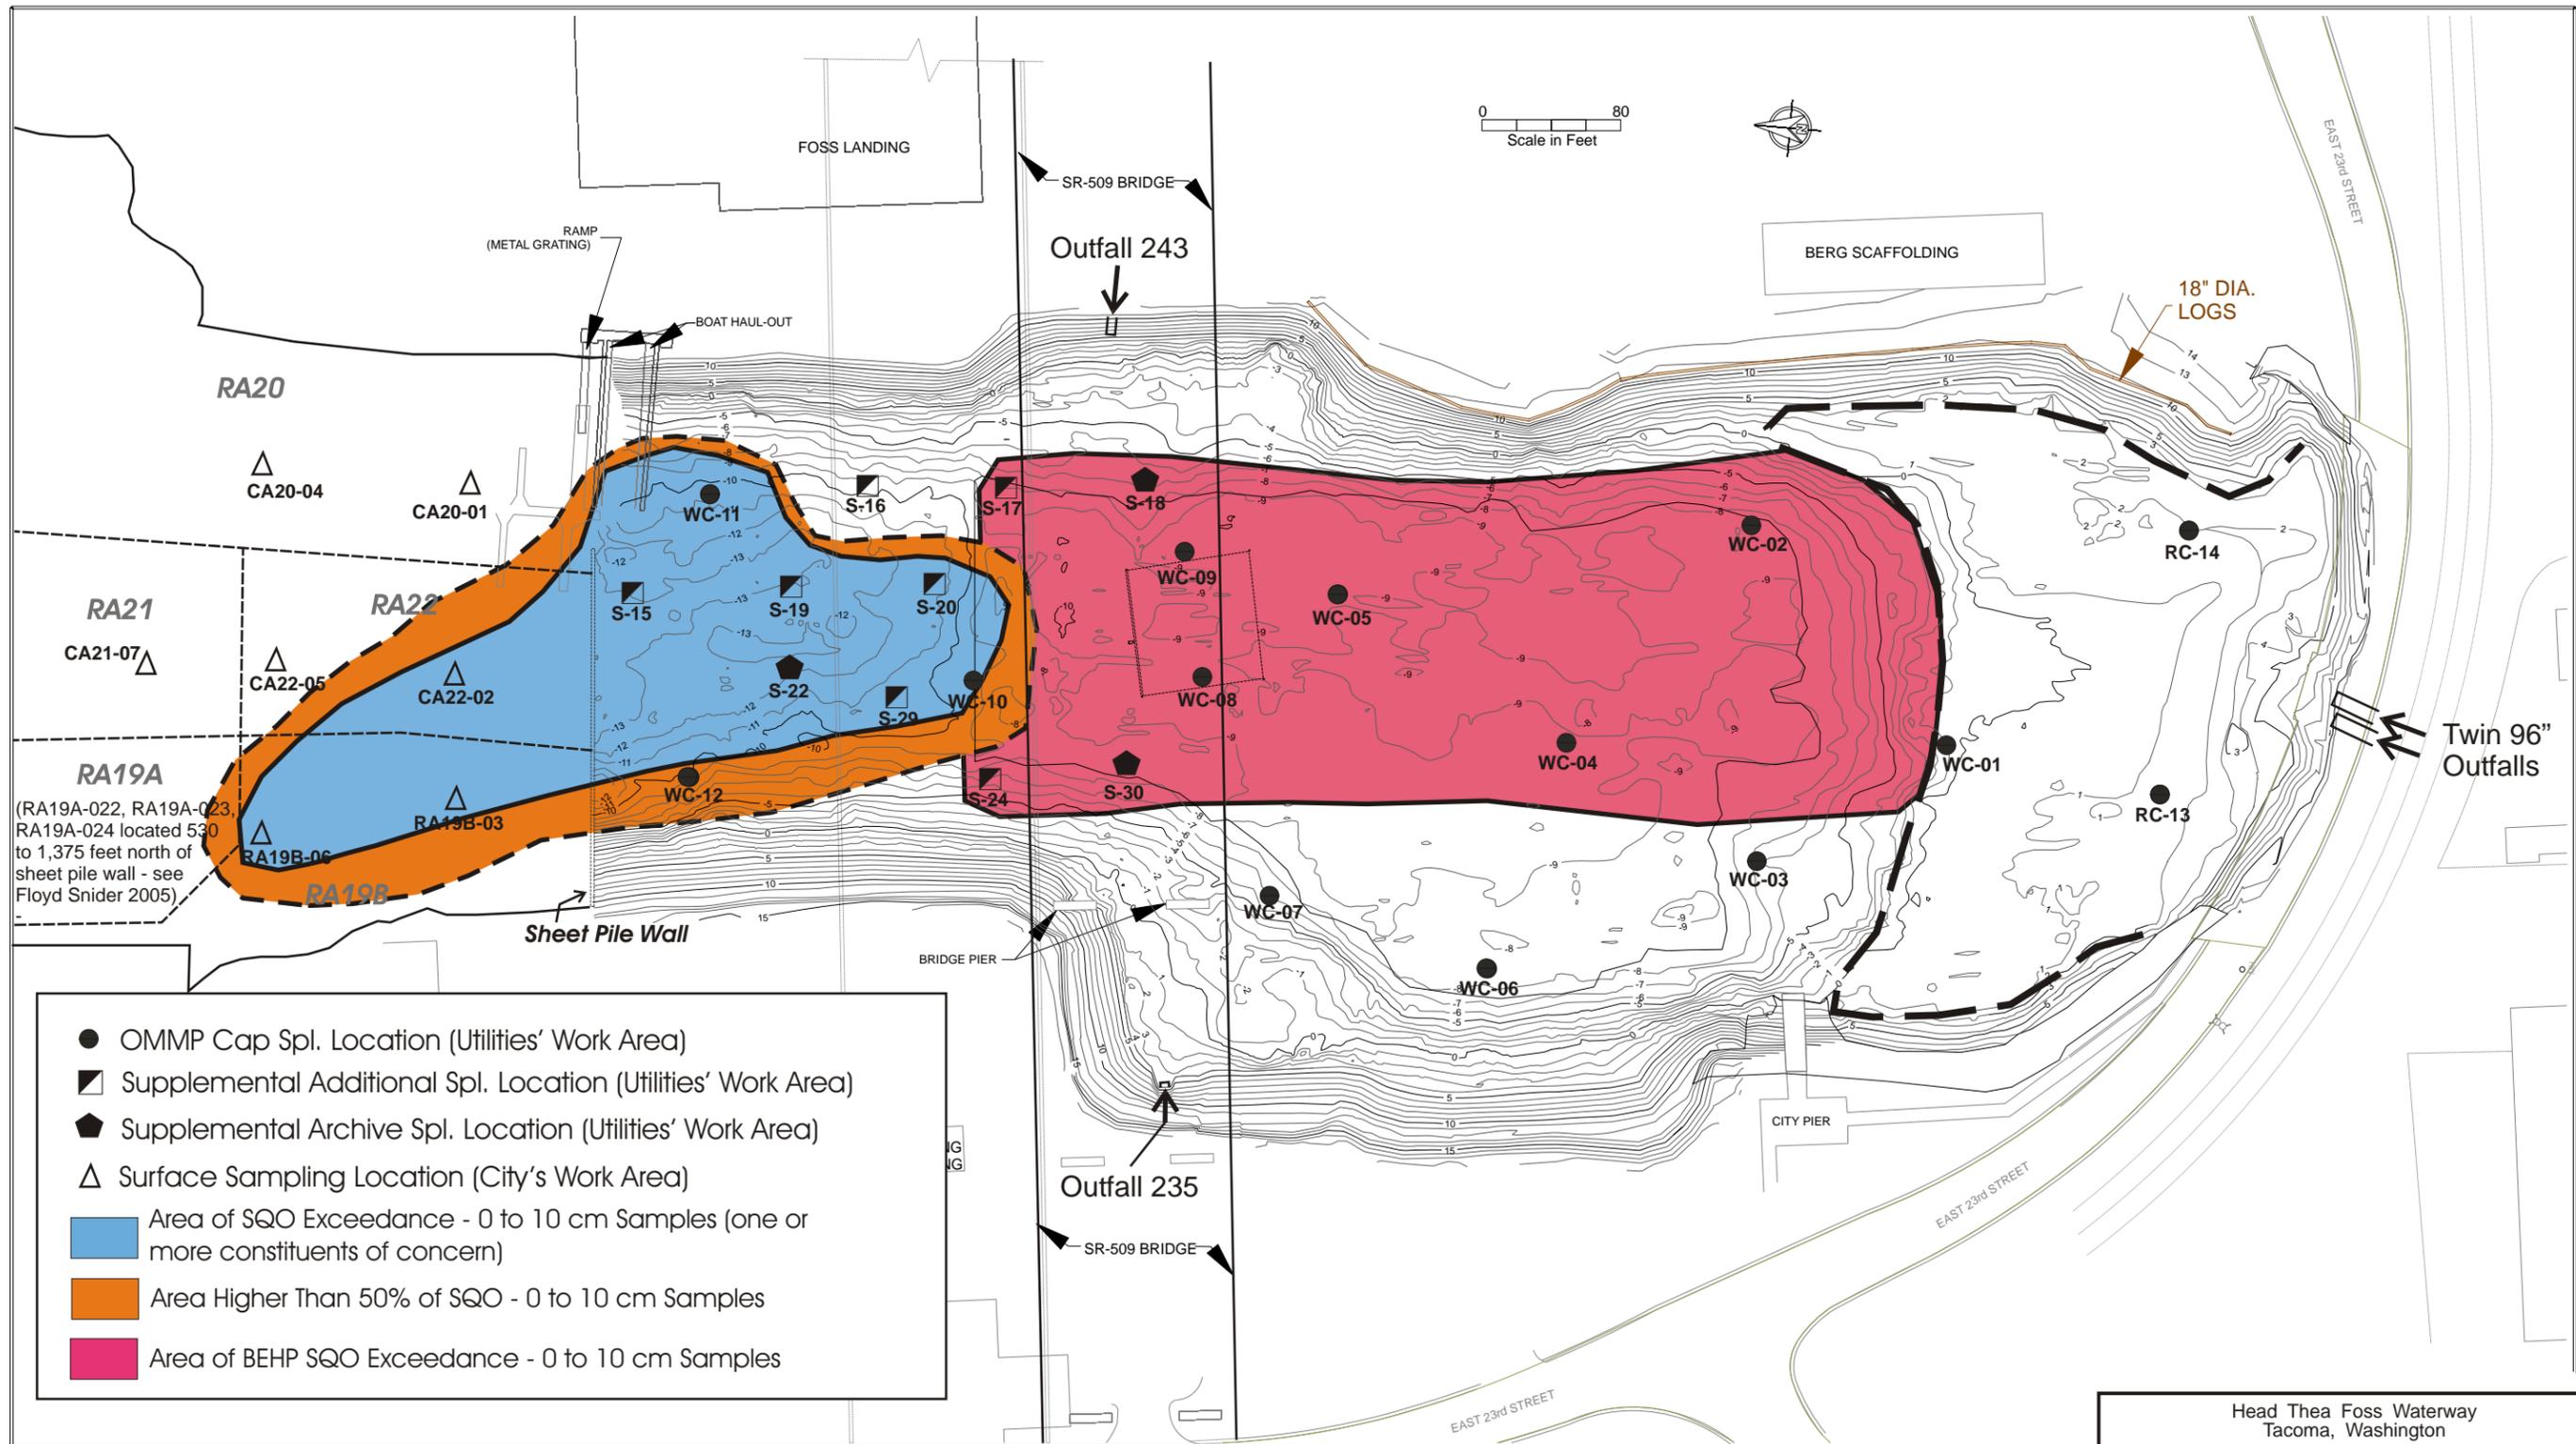
Figure 19 shows the general area where the SQOs are exceeded in 0 to 10 cm sediment for one or more constituents. The area north of the SR509 Bridge was recontaminated by City dredging in 2004. This conclusion was based on the timing of recontamination, comparison of pre-dredge and post-dredge sediment sample analyses, core data, and construction methods. The basis for this conclusion is presented in DOF and TetraTech (2005). The portion of the Utilities' Work Area generally north of the SR509 Bridge is the same area where the City identified the cause of SQO exceedances to be City dredging, based on their recontamination corrective action proposal submitted to EPA (Tacoma 2005).

Head Thea Foss Waterway  
Tacoma, Washington  
**Area of SQO Exceedance  
0 to 10 cm Sediment  
May 2005**  
PAP-001-04 **FIGURE 19** Sept. 2005  
Dalton, Olmsted & Fuglevand, Inc.

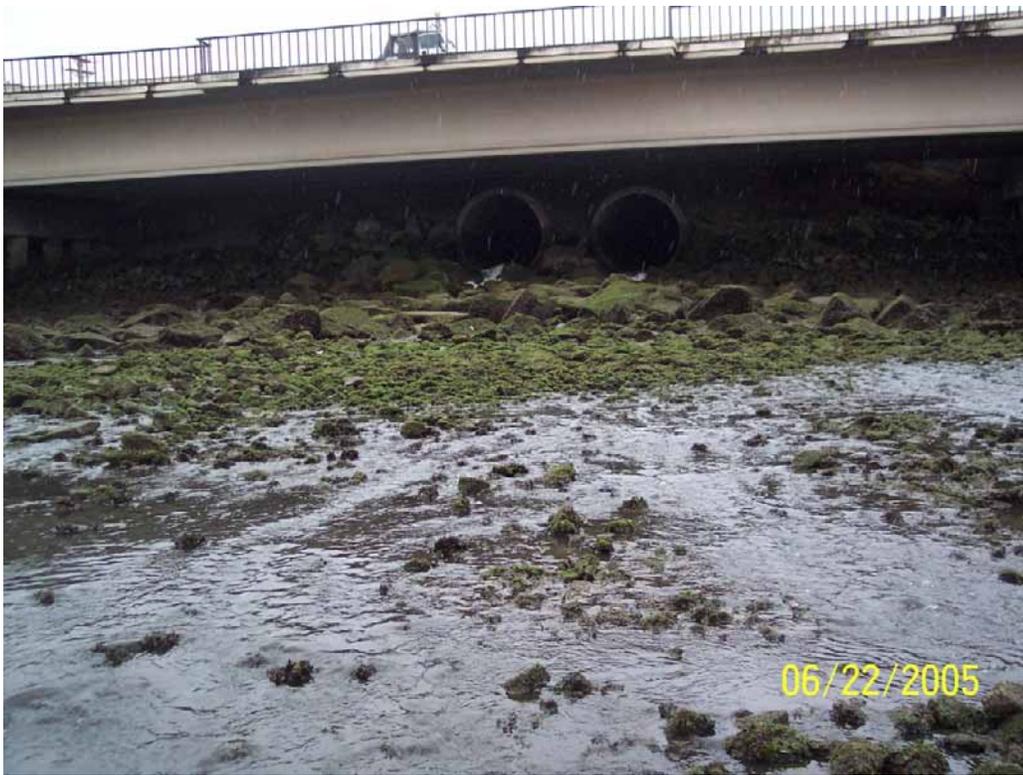
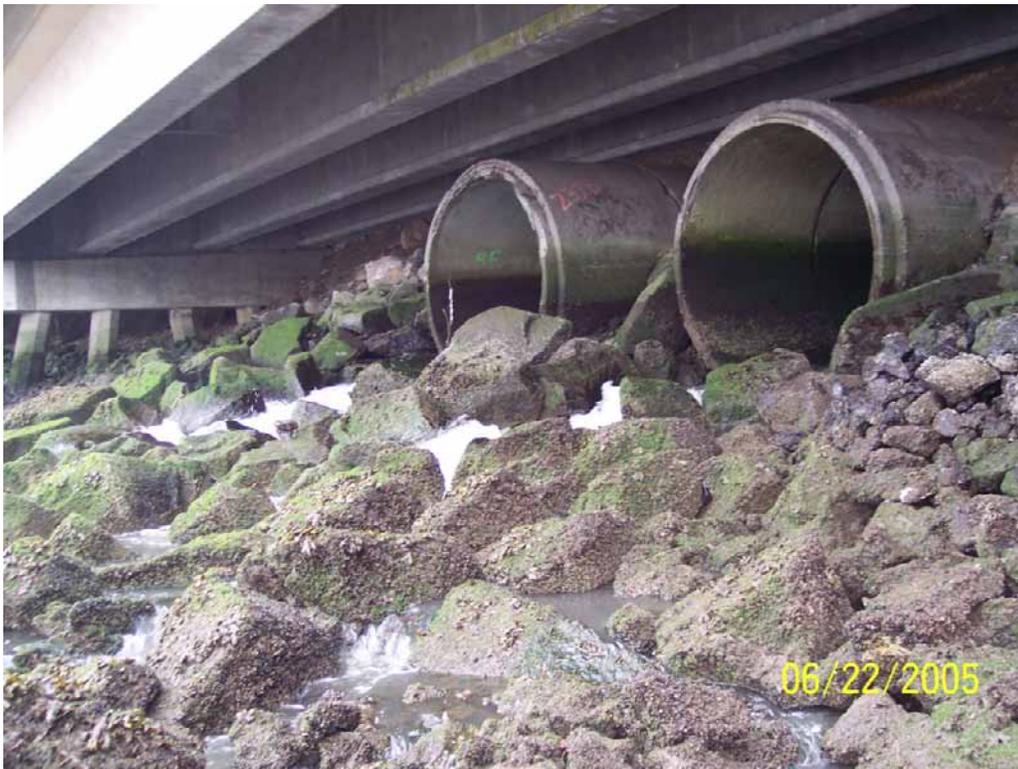
PAP-001-01 **FIGURE 3** July 2005  
Dalton, Olmsted & Fuglevand, Inc.

The condition of the apron was similar to that observed during several visits by DOF staff in 2004 and April 2005. Digital photographs of the Twin 96” outfalls and scour protection apron are shown on Figures 3 to 6a. Water discharge from the Twin 96” outfalls during a rainfall event was spreading out over the apron (as intended) and migrating in a northward direction to the waterway channel. No erosional channels were observed on the apron and most of the water infiltrated into coarser materials near the north end of the apron.

*Figure 3a -  
Discharge From  
Outfalls 237a and  
237b - View  
to South*

*Figure 3b -  
Discharge from  
Outfalls 237a and  
237b - View  
to Southeast*

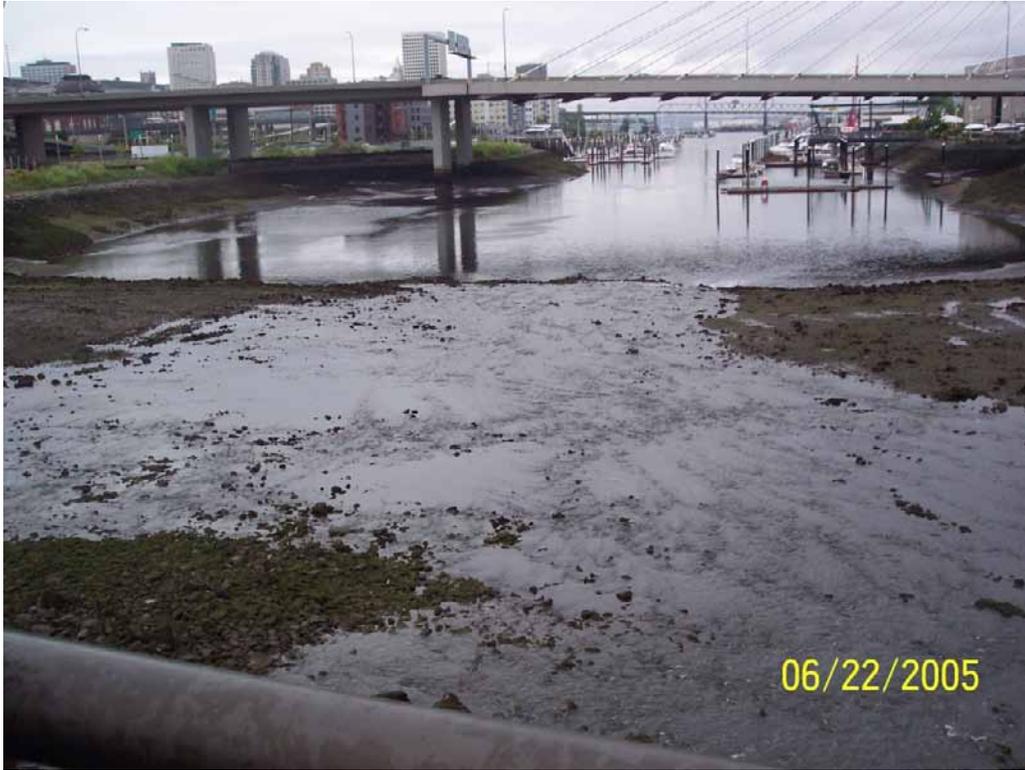
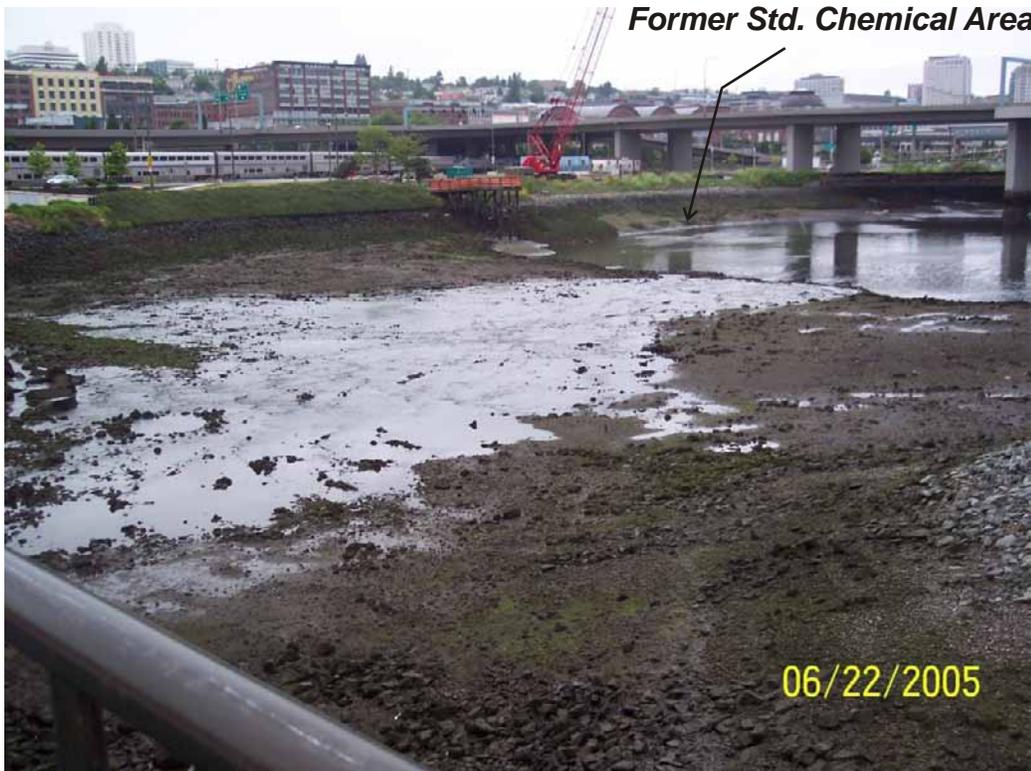
PAP-001-01b **FIGURE 4** July 2005  
Dalton, Olmsted & Fuglevand, Inc.

Exposed waterway slopes are shown on the photographs presented in Figures 4 to 6 and Figures 8 to 13. During the site visits in June 2005, barnacles and algae covered the coarser capping materials. No visible evidence of slope erosion, sloughing etc. was observed.

*Figure 4a -  
Scour Protection  
Apron - View to  
North (towards  
Commencement  
Bay)*

*Figure 4b -  
Scour Protection  
Apron - View to  
Northwest (towards  
City Pier and former  
Std. Chemical Area)*

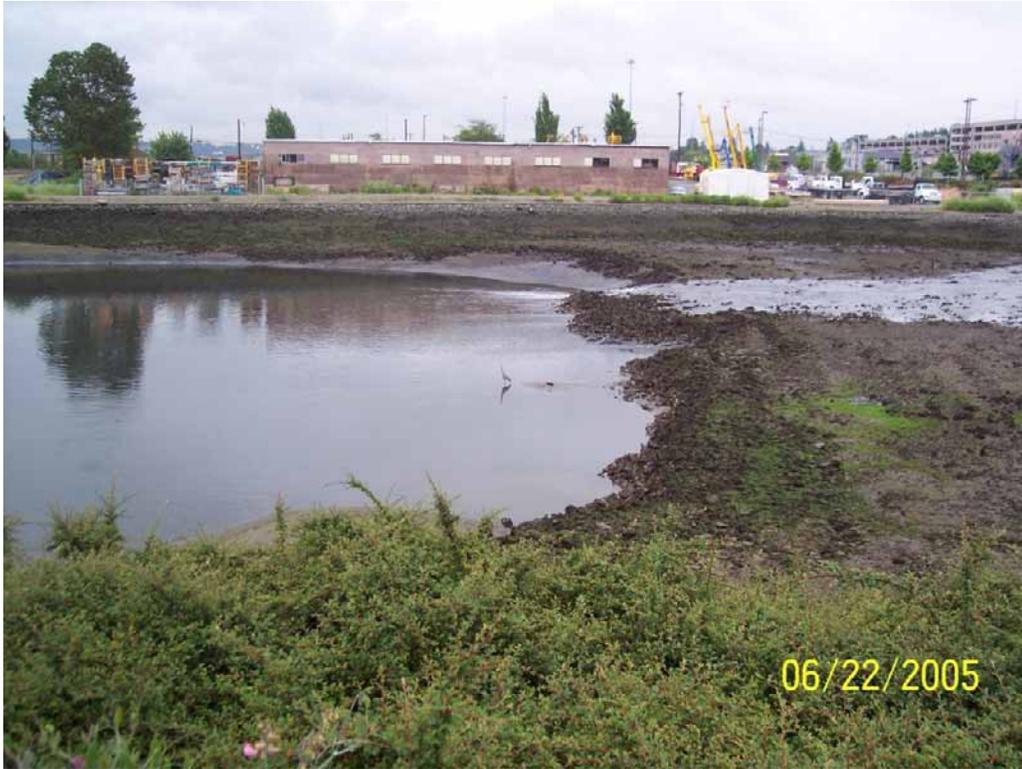
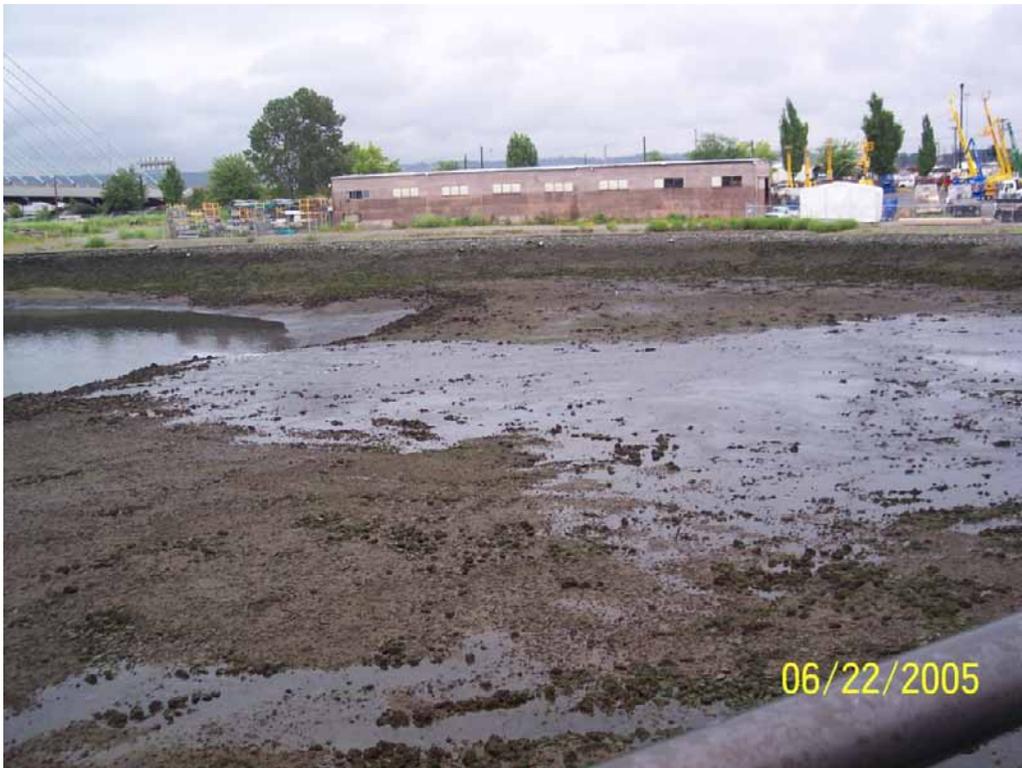
PAP-001-01b **FIGURE 5** July 2005  
Dalton, Olmsted & Fuglevand, Inc.

*Figure 5a -  
Scour Protection  
Apron - View to  
East (towards Berg  
Scaffolding)*

*Figure 5b -  
Scour Protection  
Apron - View to  
Northeast (towards  
Berg Scaffolding)*

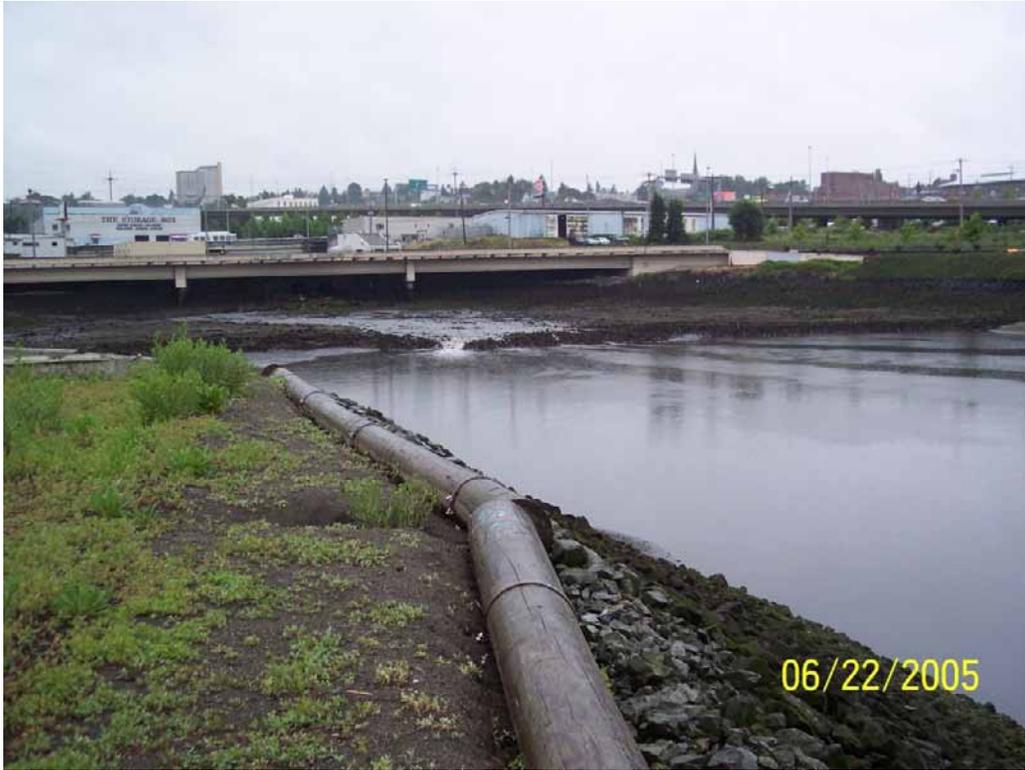
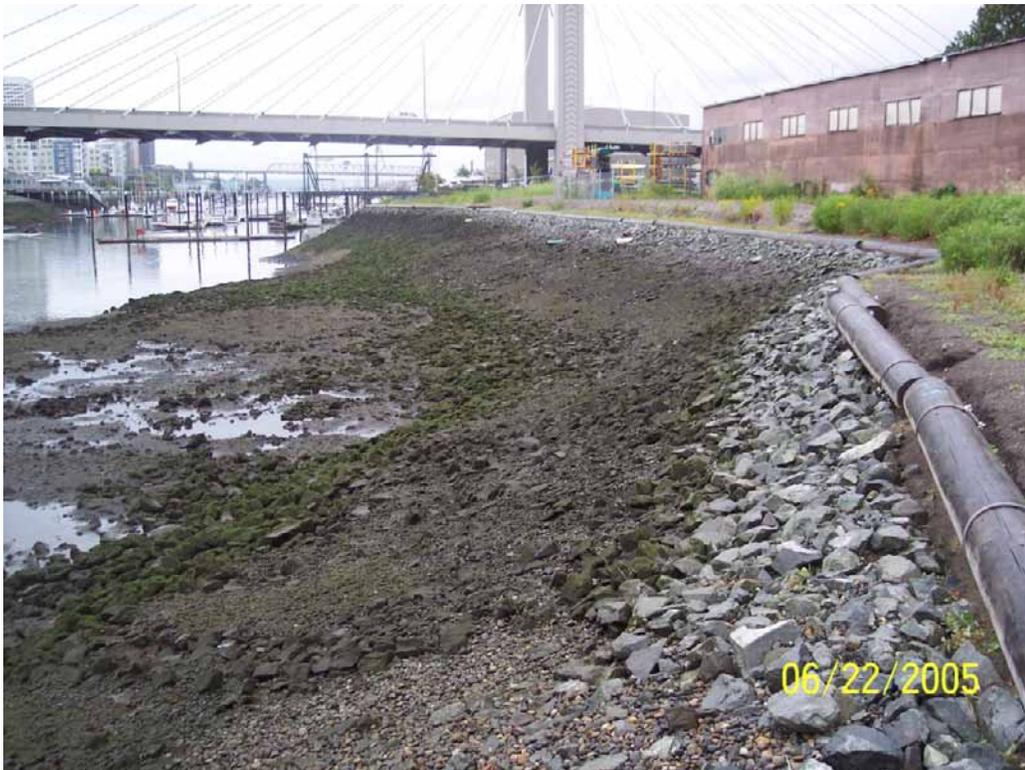
PAP-001-01 **FIGURE 6** July 2005  
Dalton, Olmsted & Fuglevand, Inc.

*Figure 6a -  
South End of  
Waterway - View to  
Southwest*

*Figure 6b -  
South End of  
Waterway - View to  
Southwest*

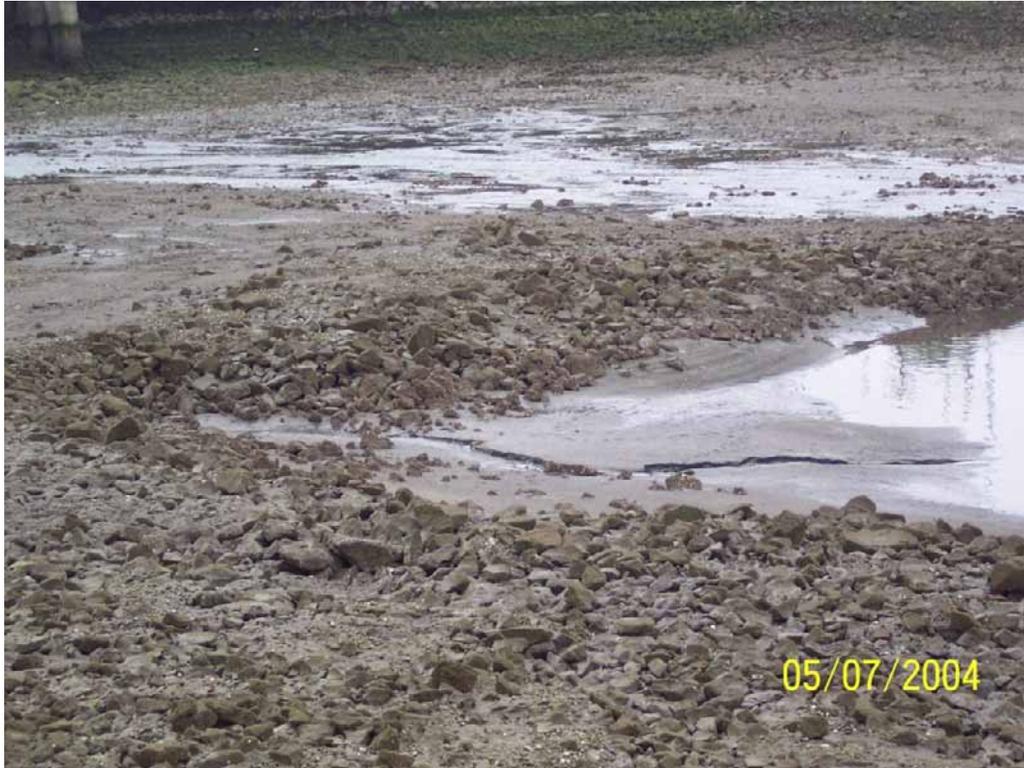
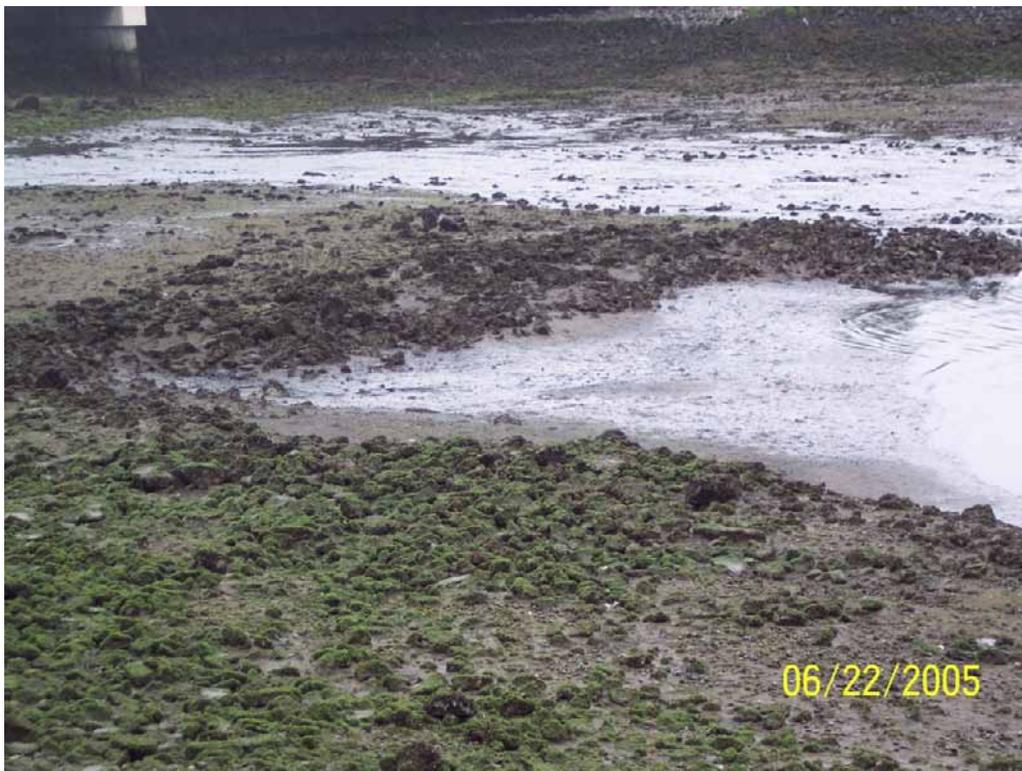
PAP-001-01 **FIGURE 7** July 2005  
Dalton, Olmsted & Fuglevand, Inc.

In May 2004, a small, shallow erosional channel was observed on the north side of the apron near the southeast corner of the waterway (Figure 7a). This portion of the waterway bottom would only be exposed during the lowest tides (estimated to be less than -2 feet MLLW). The small channel was visually less pronounced as compared to the May 04 observations (Figure 7b). The bottom of the channel appeared to be “*self armoring*” in that coarser materials were observed in the bottom of the channel. The minor erosion is very local in nature and does not appear to have adversely impacted the overall integrity of the cap. No corrective action is warranted at this time other than to monitor this feature during other low tide events.

*Figure 7a -  
Scour Protection  
Apron - View to  
Southwest  
(May 04)*

*Figure 7b -  
Scour Protection  
Apron - View to  
Southwest  
(June 05)*

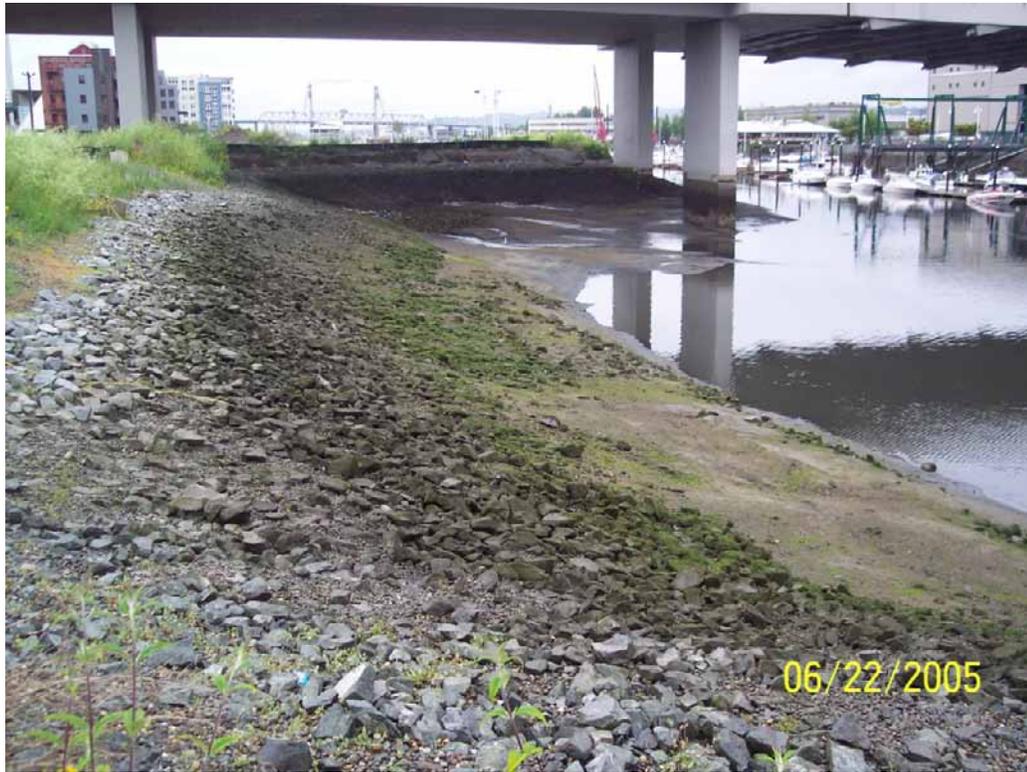
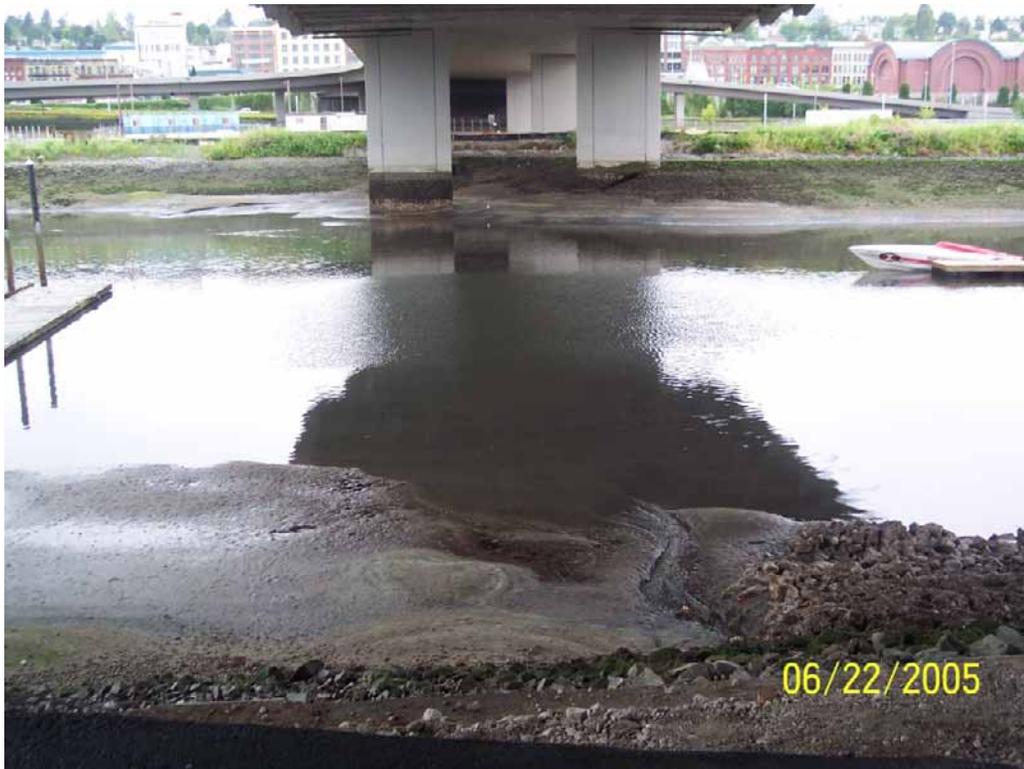
PAP-001-01 **FIGURE 8** July 2005  
Dalton, Olmsted & Fuglevand, Inc.

No sheens were observed in the area of the former SR509 seep (Figures 8, 9 and 10b) or elsewhere in the waterway, during our June 2005 site visits when the predicted low tides ranged between -3.29 feet and -3.85 feet MLLW. Naturally occurring gas bubbles were observed throughout the head of the waterway.

*Figure 8a -  
West Bank Slope  
in Former Std.  
Chemical Co.  
Area - View to  
North*

*Figure 8b -  
Former SR509  
Seep Area -  
View to West  
Under SR509  
Bridge*

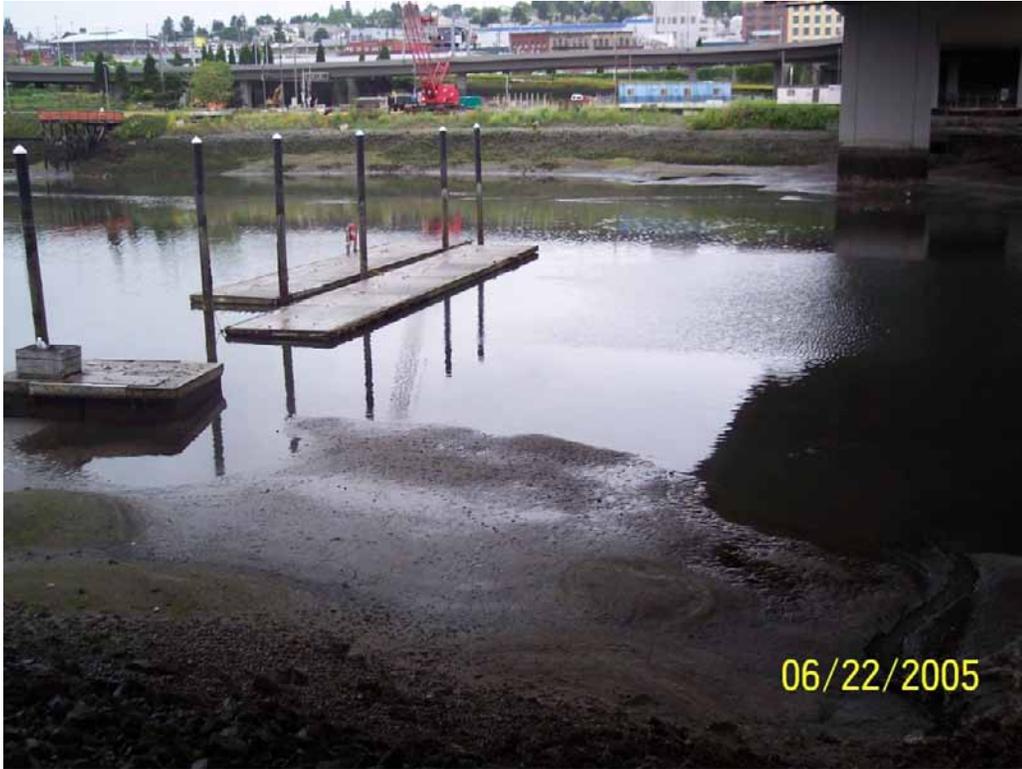
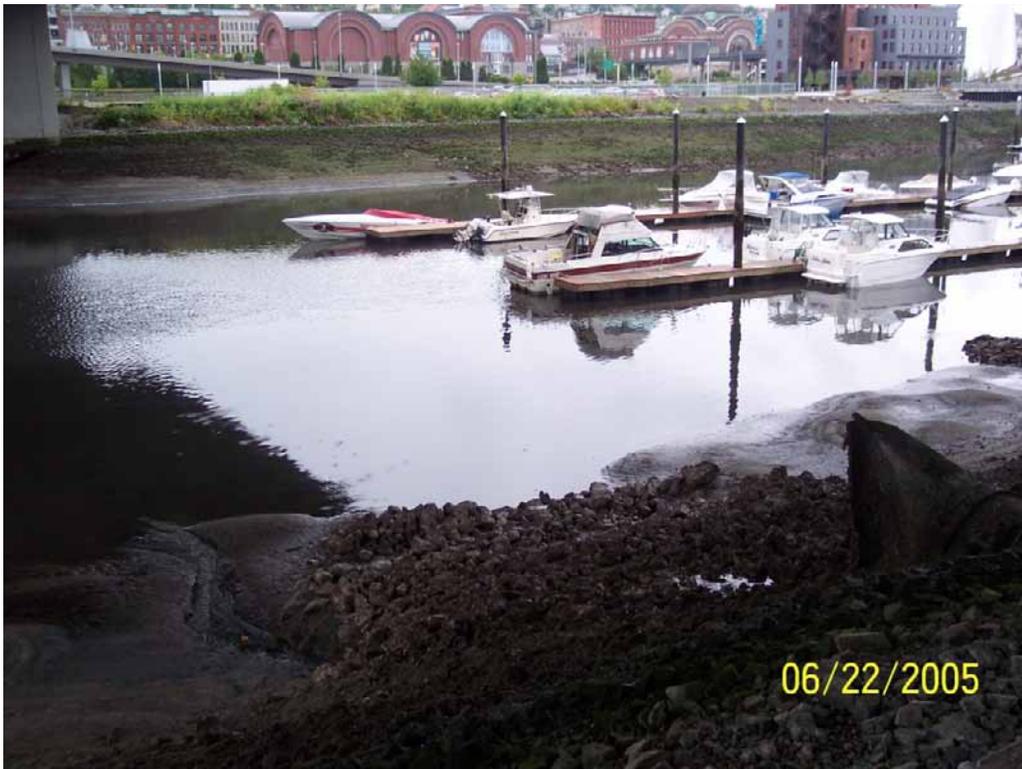
PAP-001-01 **FIGURE 9** July 2004  
Dalton, Olmsted & Fuglevand, Inc.

*Figure 9a -  
Sr509 Seep Area-  
View to Southwest*

*Figure 9b -  
SR509 Seep Area-  
View to Northwest  
(Foss Landing  
Marina)*

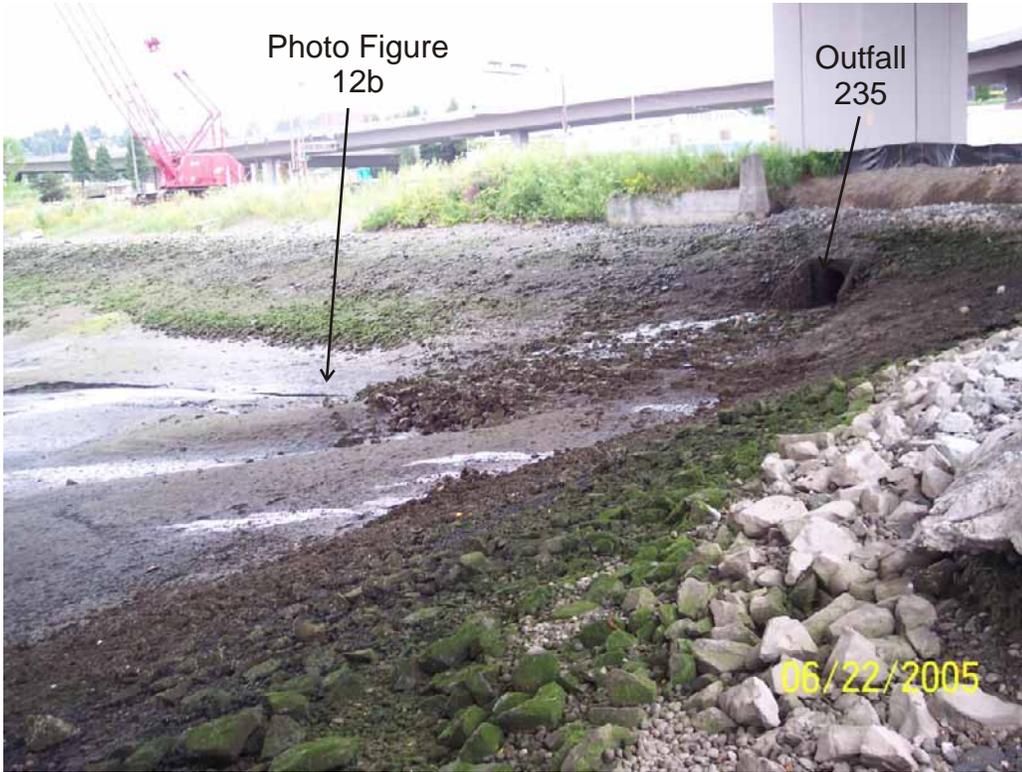
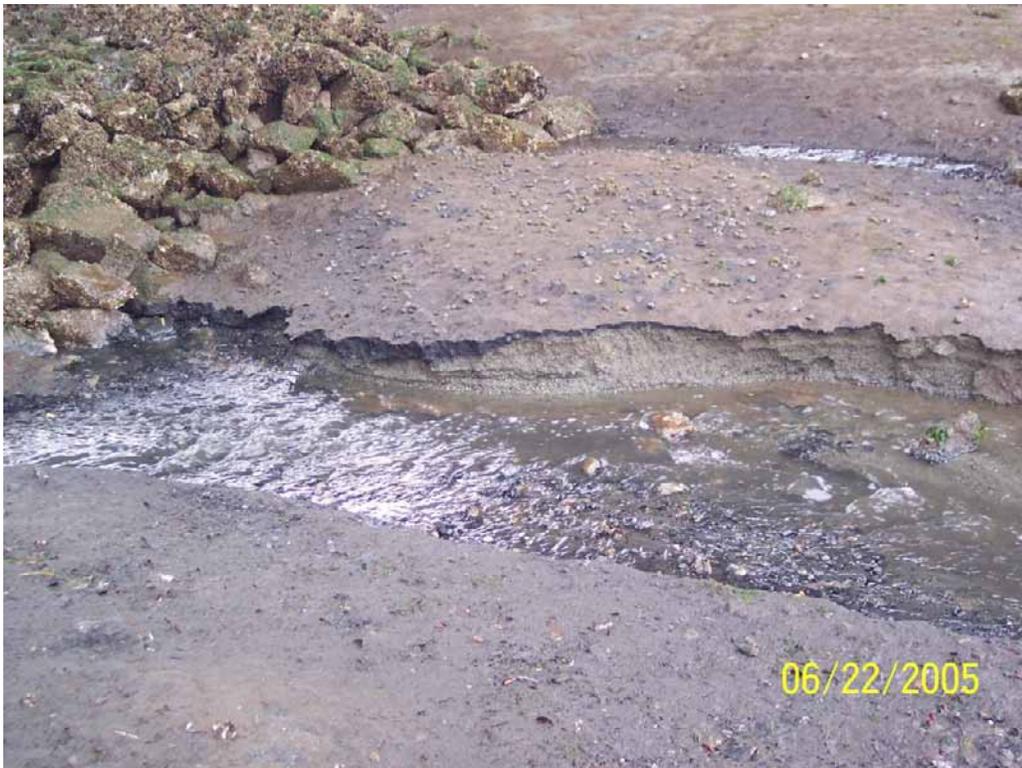
PAP-001-01 **FIGURE 12** July 2005  
Dalton, Olmsted & Fuglevand, Inc.

Several small channels were observed at the toe of outfall scour protection material associated with Outfall 235 near the west side of the SR509 bridge (Figures 12 and 13). The bottom of the channel appeared to be “*self armoring*” in that coarser materials were observed in the bottom of the channel (Figure 12b). The minor erosion is local in nature and does not appear to have adversely impacted the overall integrity of the cap. No corrective action is warranted at this time other than to monitor this feature during other low tide events.

**Figure 12a -  
Discharge From  
Outfalls 235 - View  
to Southwest**

**Figure 12b -  
Small Erosional  
Channel Outfall  
235 - View  
to Northeast**

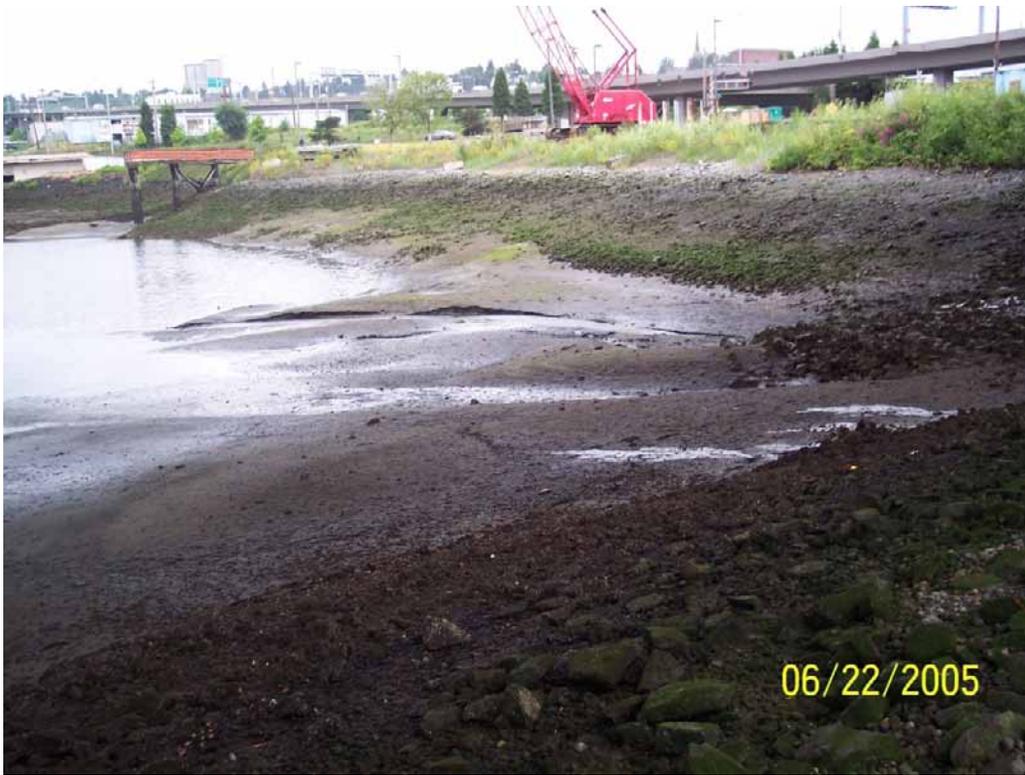
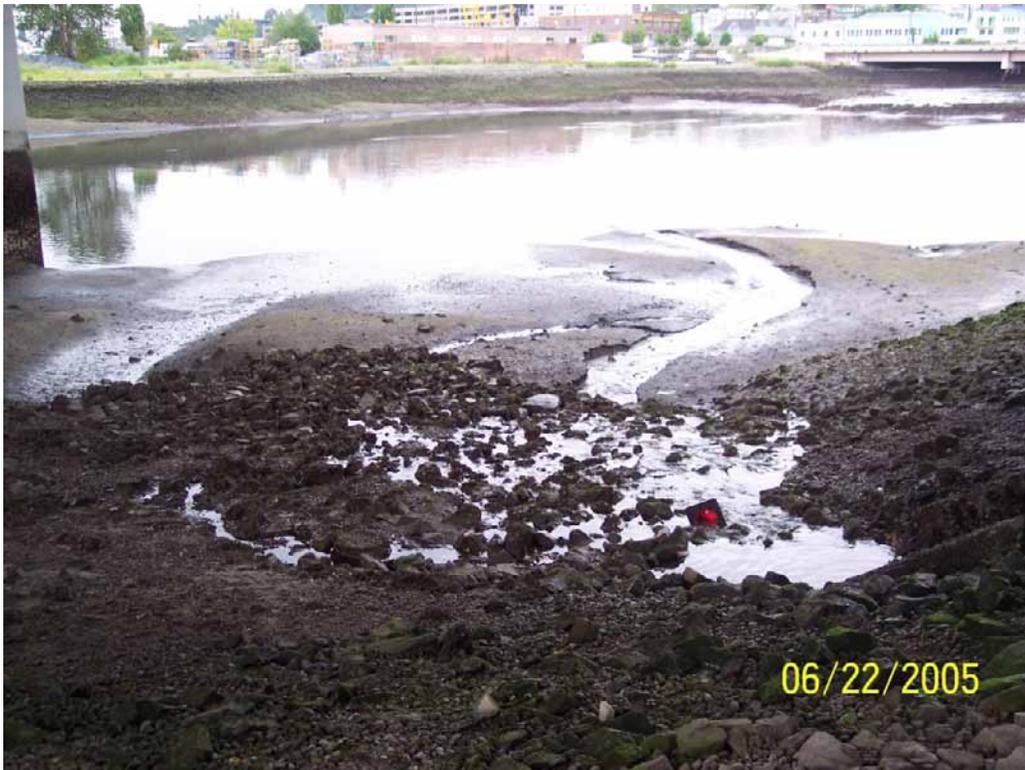
Figure 13 – Discharge Area Outfall 235

*Figure 13a -  
Discharge From  
Outfall 235 - View  
to South*

*Figure 13b -  
Discharge from  
Outfall 235 - View  
to Southeast*

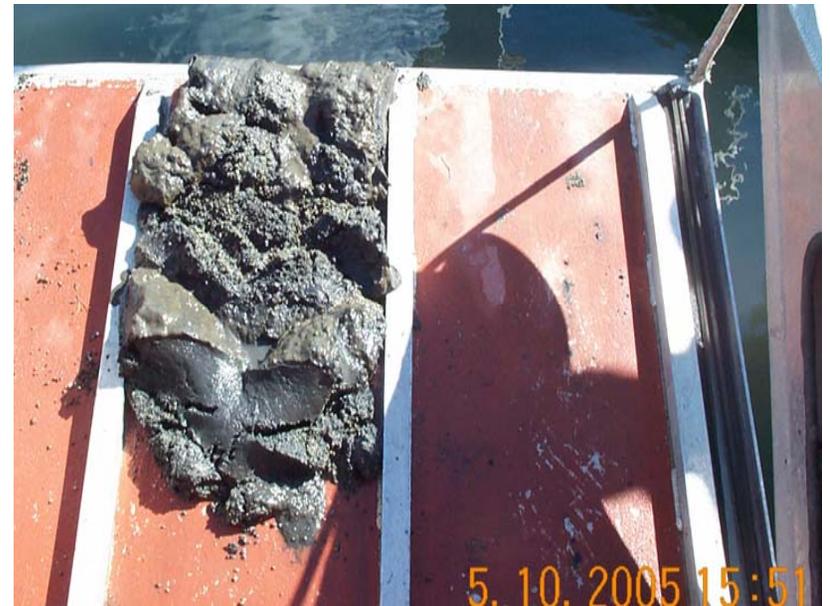
CA-19-06 on back of boat after sampling. Silt is mixed in sand layer more than other samples from the City Project Area.

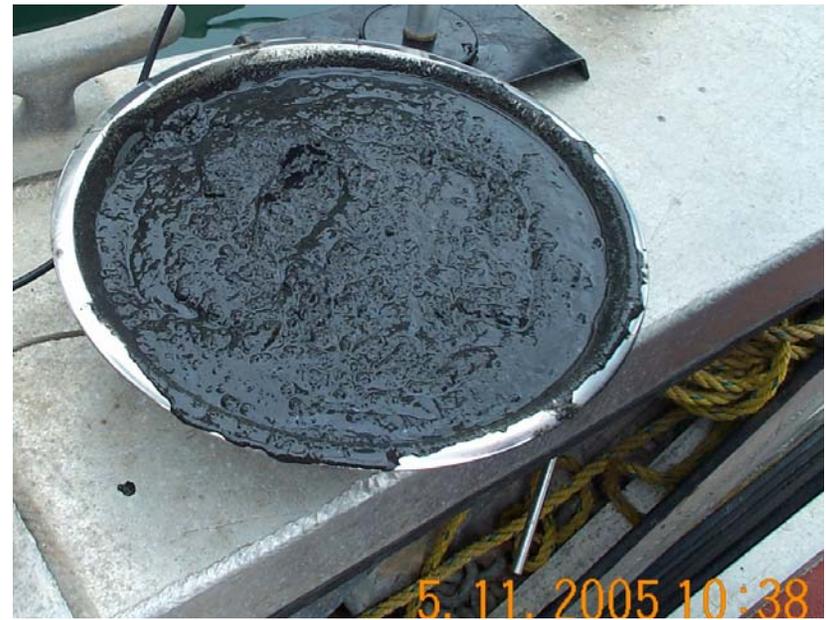
WC-07 (0 – 10 cm) in bowl, showing sheen spots.

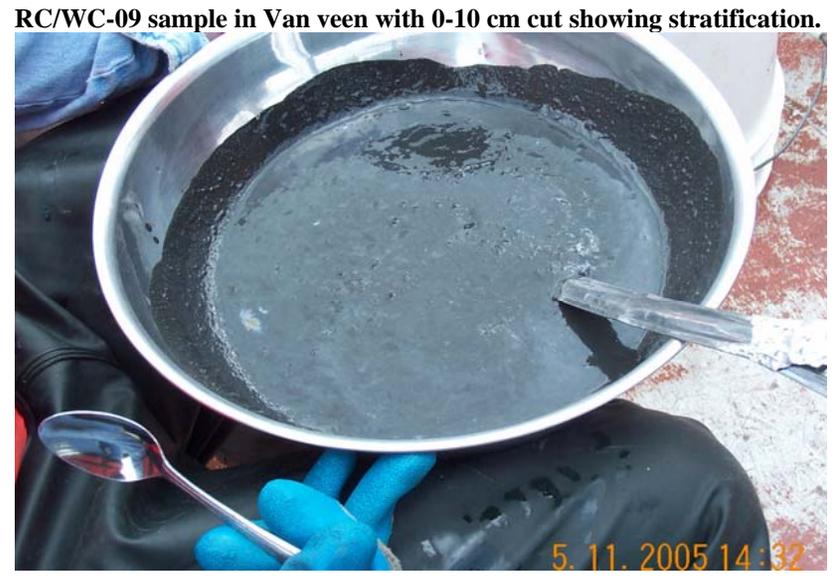
RC/WC-09 sample in Van veen with 0-10 cm cut showing stratification.

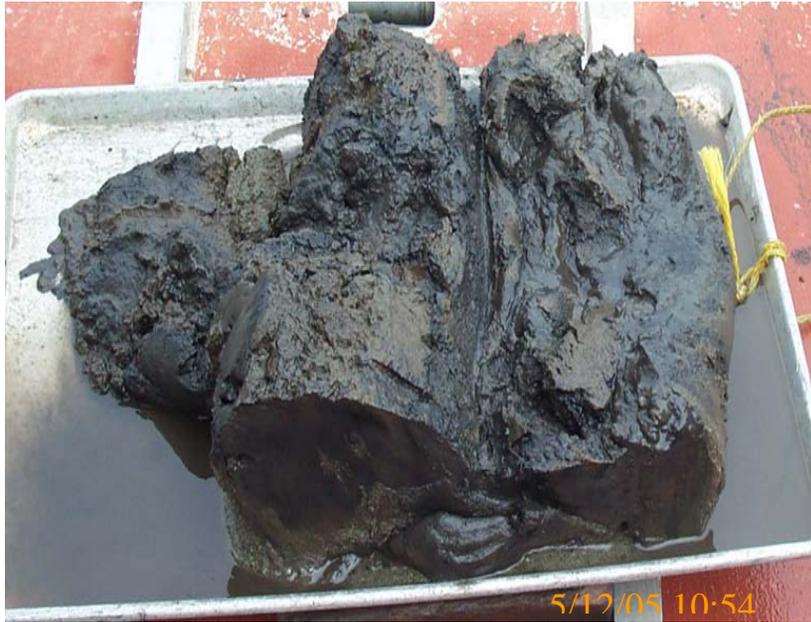
Stratification of RC-03 in tray.

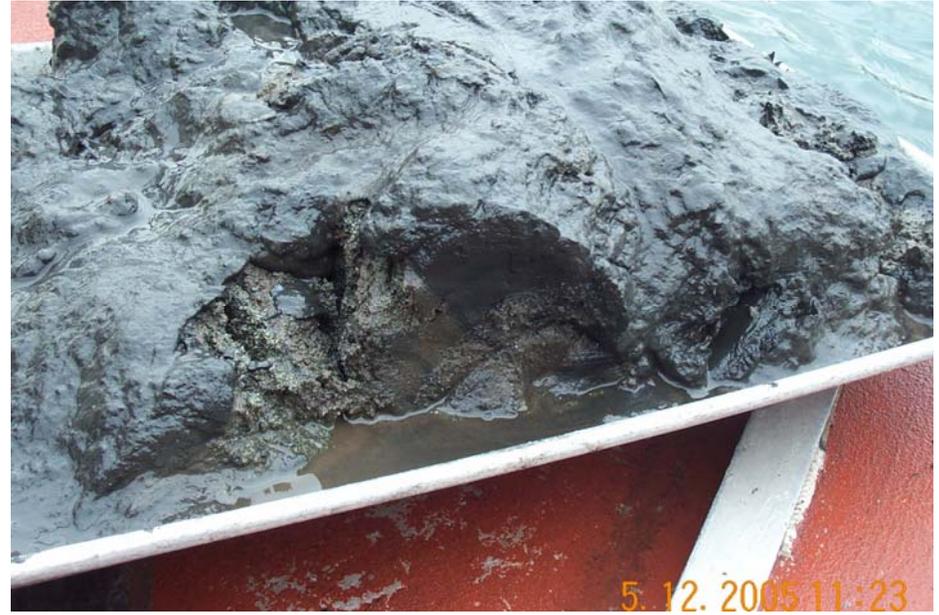
Stratification of RC-04 in tray.
