Re: Contract Number: EP-S7-06-02; Technical Direction Document Number: 07-08-0011
Swift Creek Asbestos Site Time-Critical Removal Action Report

**Swift Creek Asbestos
Site Time-Critical
Removal Action Report
Everson, Washington**

TDD Number: 07-08-0011

April 2008

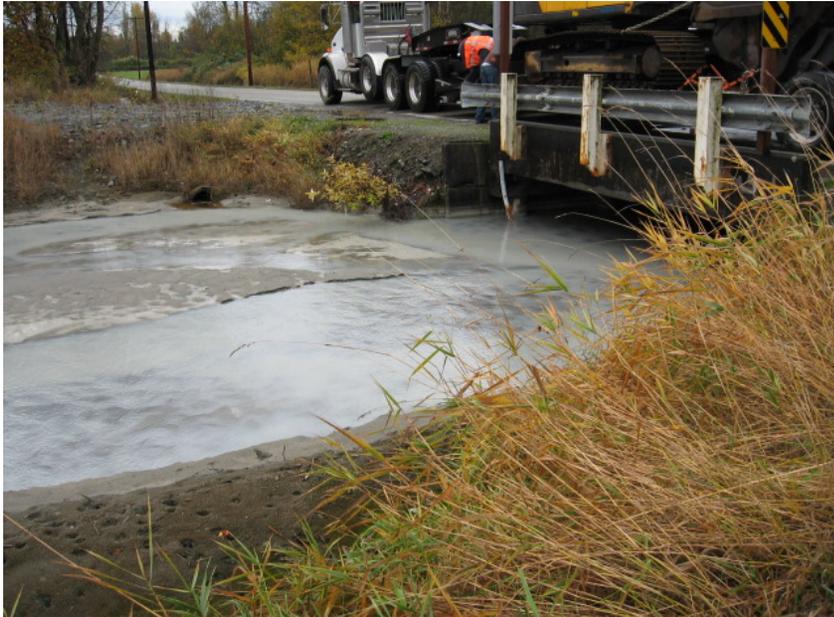
Description: Swift Creek flowing under western bridge.

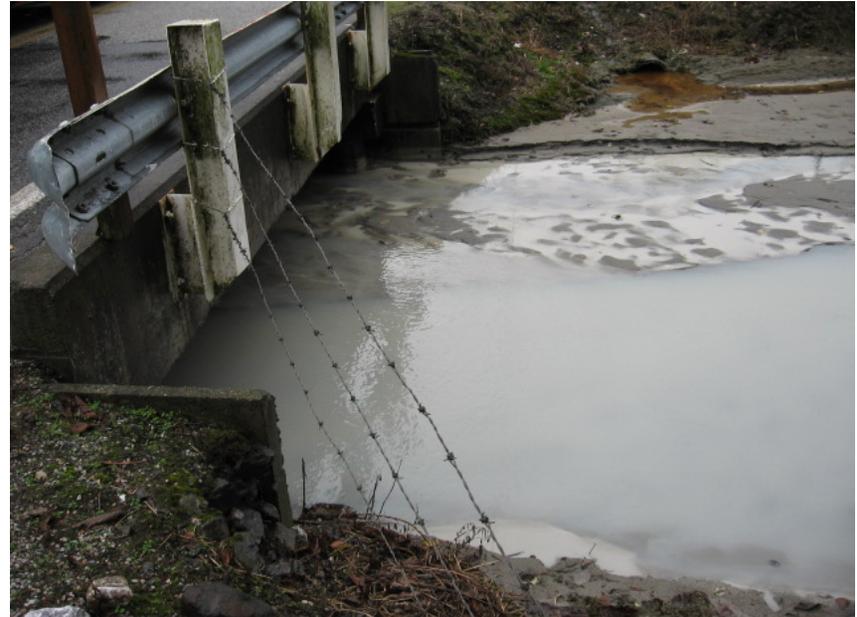
Photo No: 1377

Description: Swift Creek flowing under Oat Coles Road bridge.

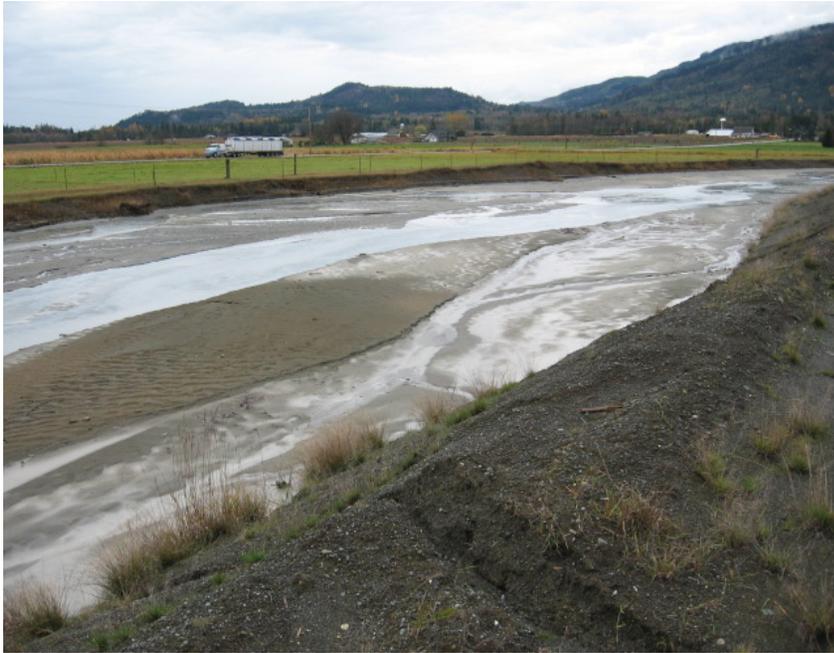
Description: Swift Creek at the south bank near Oat Coles Road.

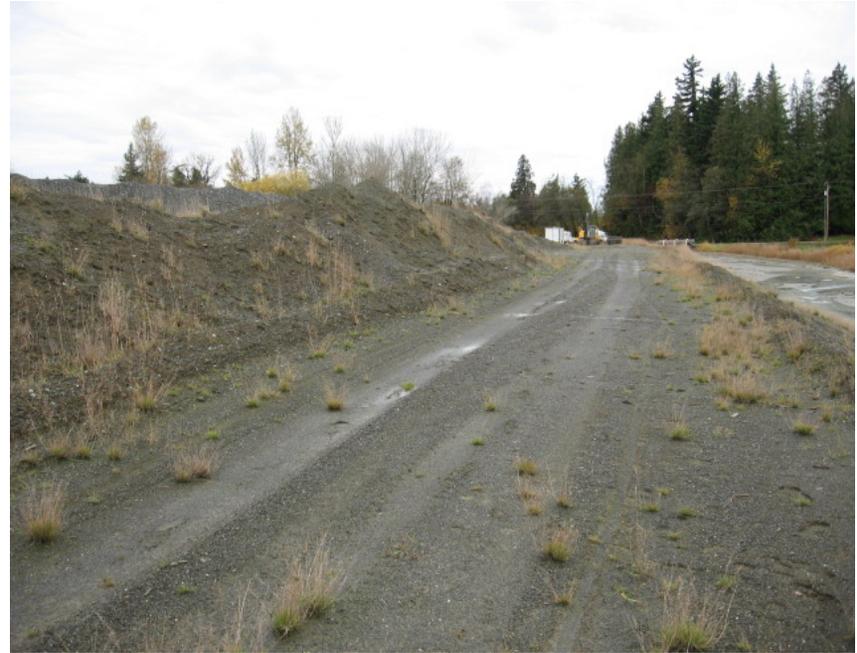
Date: 11/8/2007 **Photo No:** 1381

Description: Dredge stockpiles on south bank at Oat Coles Road.

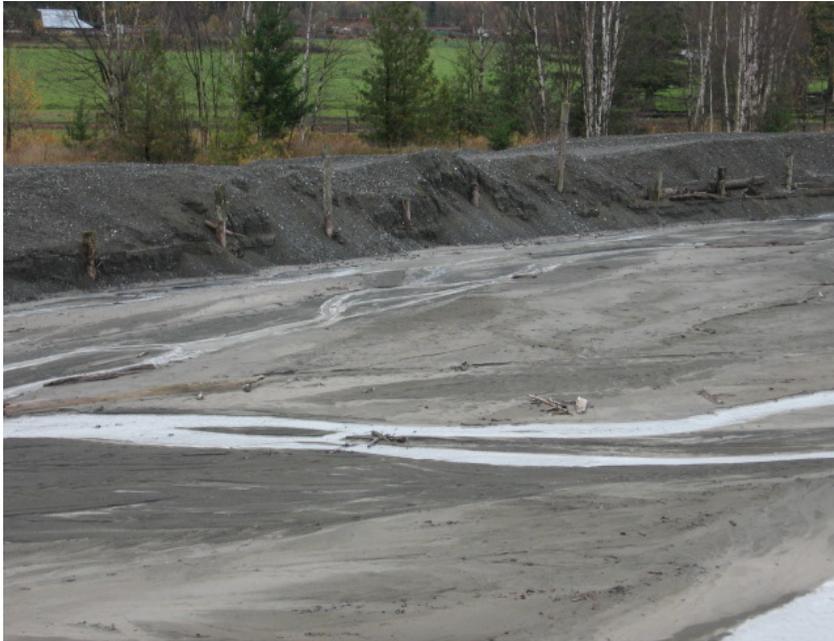
Description: Elevated creek grade in channel midway between Goodwin and Oat Coles Road.

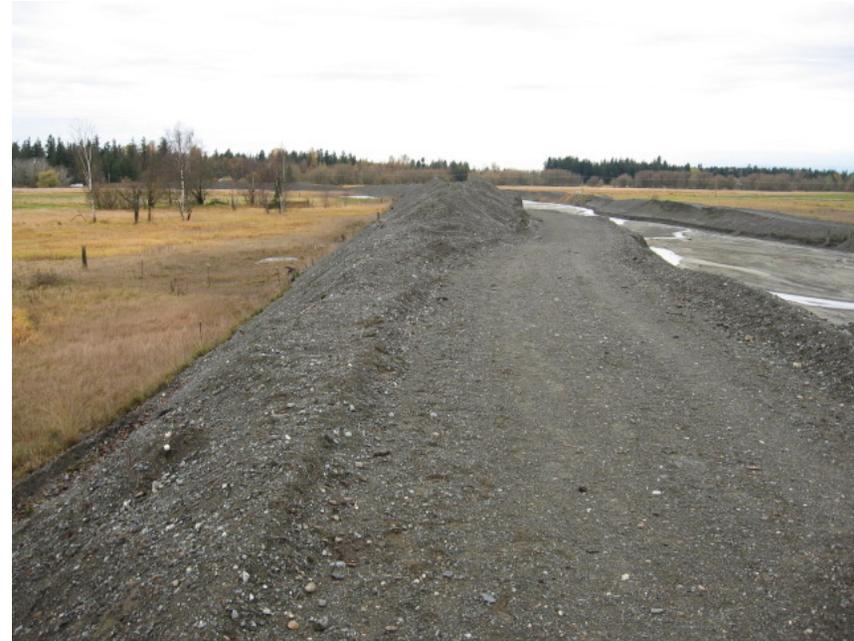
Date: 11/8/2007 **Photo No:** 1383

Description: Dredge stockpile configuration on south bank prior to any site stabilization efforts.

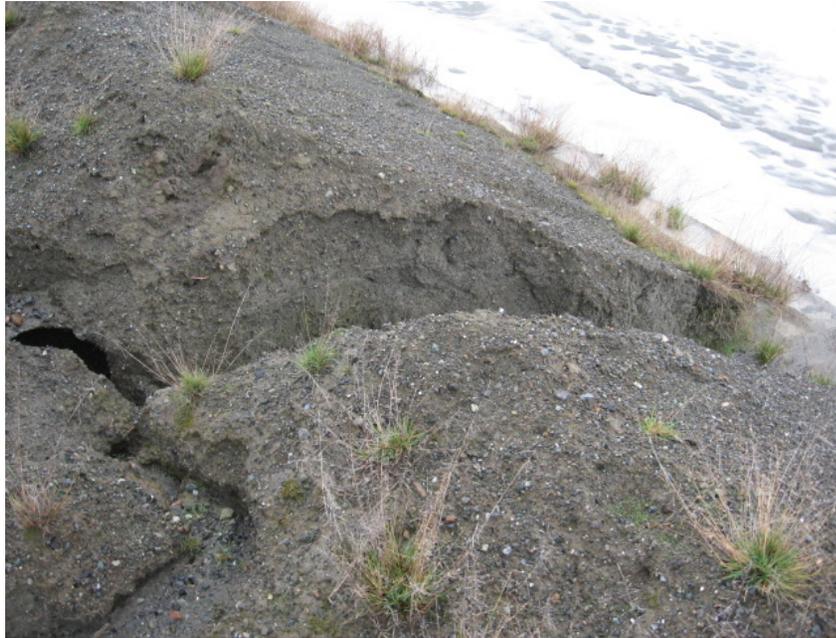
Description: Surface runoff erosion on south bank of Swift Creek prior to any site stabilization efforts.

Paul Pittman pointed out that since 2005, when Whatcom County rebuilt the banks at a 2:1 slope using native dredged material, there had been excessive erosion on both the slopes and along the banks of the creek during the several large winter storms. During the site walk, it was apparent that a majority of these banks had been eroded, thereby resulting in many areas with a vertical creek bank. The erosion of the banks and the deposition of sediments along this relatively flat section of Swift Creek had increased the elevation of the creek bed by approximately eight feet over the elevation at the conclusion of the 2005 dredging event. In some areas, the creek bed and the Swift Creek water level were higher than the adjoining pasture land. Paul Pittman explained the ways in which the creek had flooded adjacent pasture land in the past, by seeping through the banks and breaching them at thinner points, rather than by overtopping them.

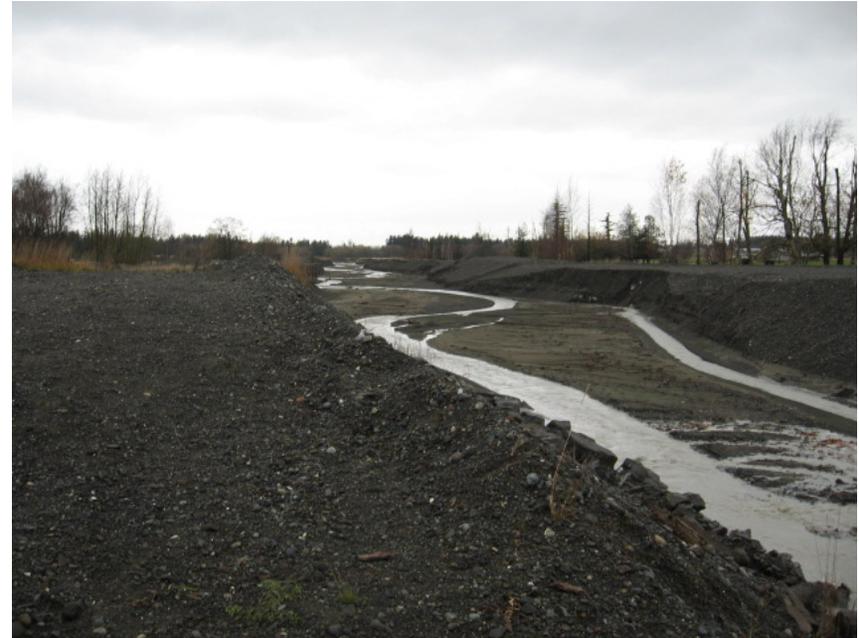
Photo No: 1385

Description: Swift Creek channel erosion apparent along entire length of dredged areas.

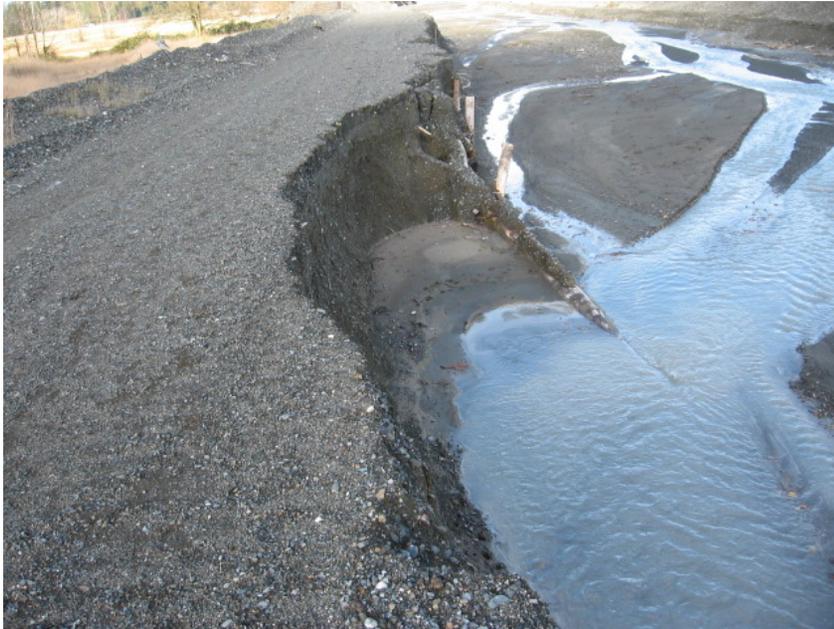
Description: Severely eroded south bank of Swift Creek near the crossing site.

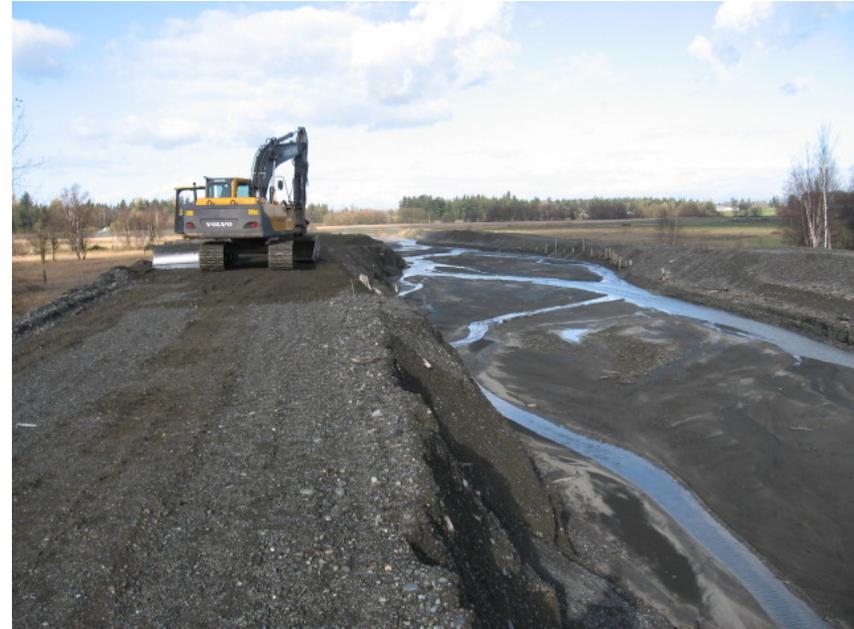
Photo No: 1394

Description: ERRS beginning stabilization of stockpiled materials on south bank of Swift Creek.

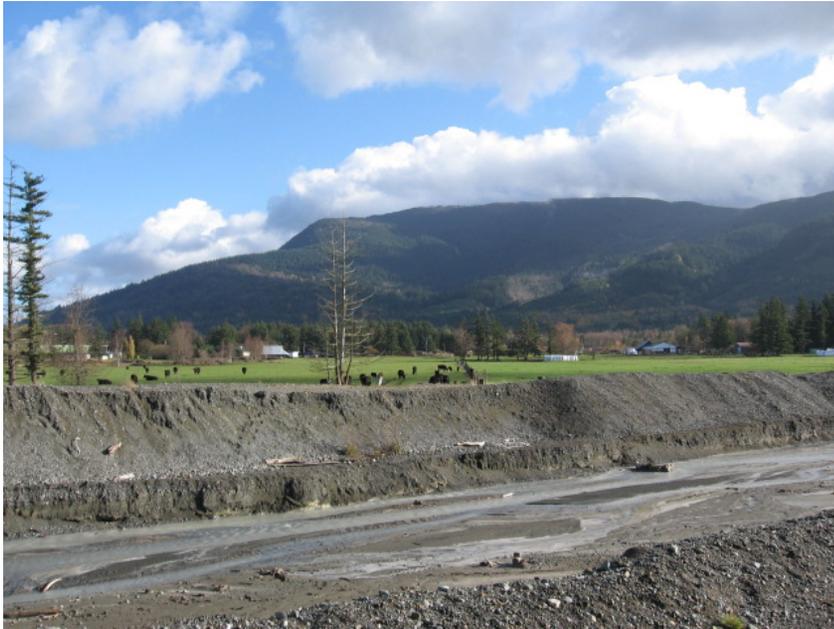
Description: Initial condition of Swift Creek (foreground) and the eroding source deposit on Sumas Mountain (background).

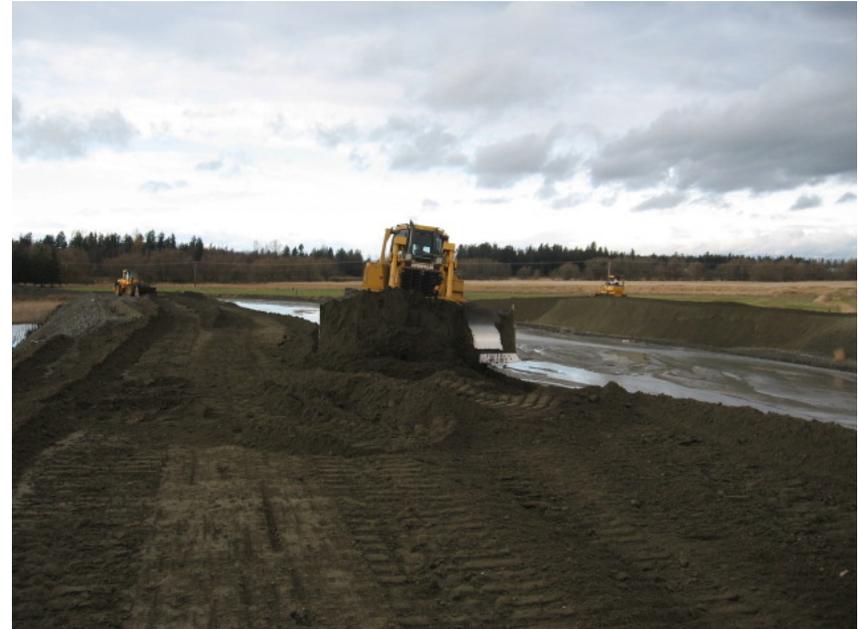
Photo No: 1400

Description: Large ERRS bulldozer making quick work of grading and leveling material along south bank of Swift Creek.

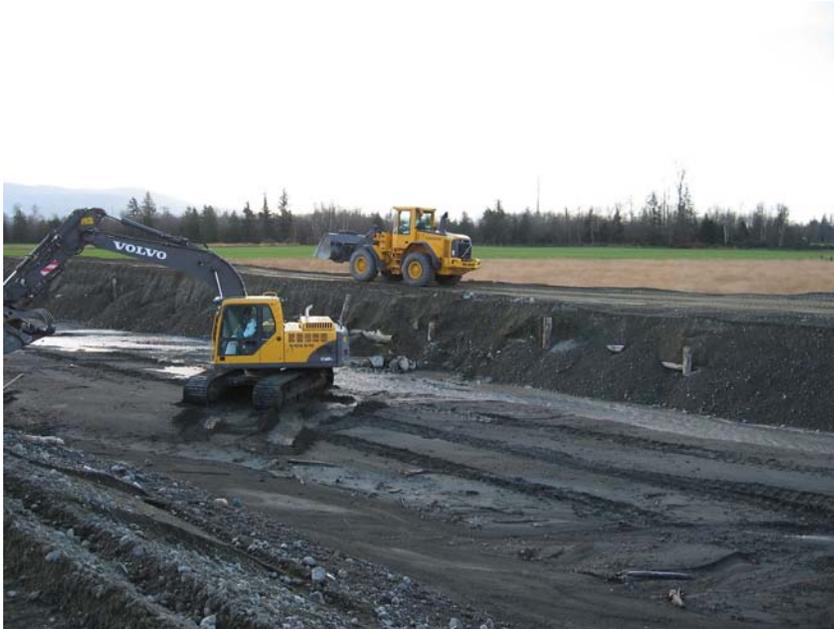
Description: ERRS armoring stream channel with new aggregate material and existing piles.

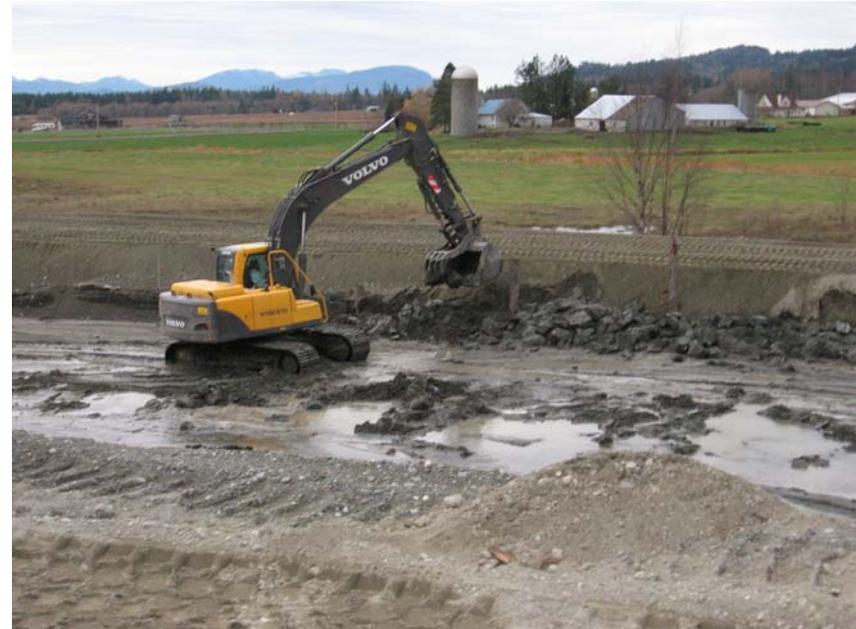
Photo No: 1426

Description: ERRS continued armoring creek channel with larger rocks and other available materials.

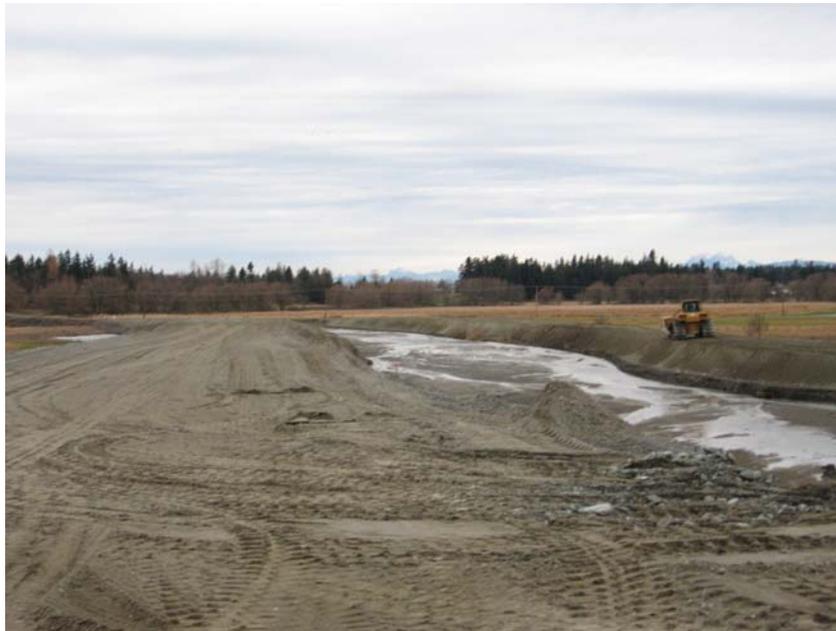
Description: South bank of Swift Creek near the end of the stabilization efforts.

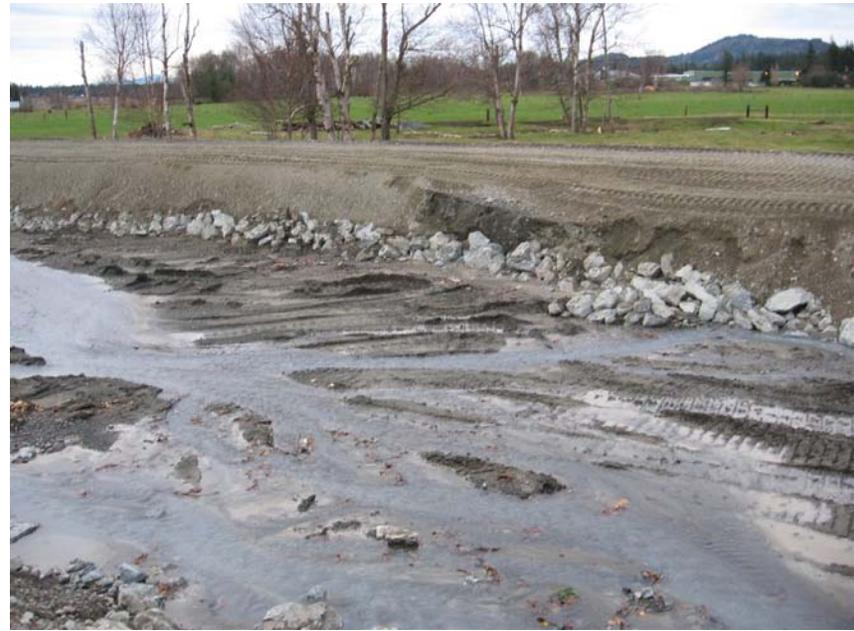
Photo No: 1430

Description: View of completed aggregate and rock armoring on the north bank of Swift Creek.

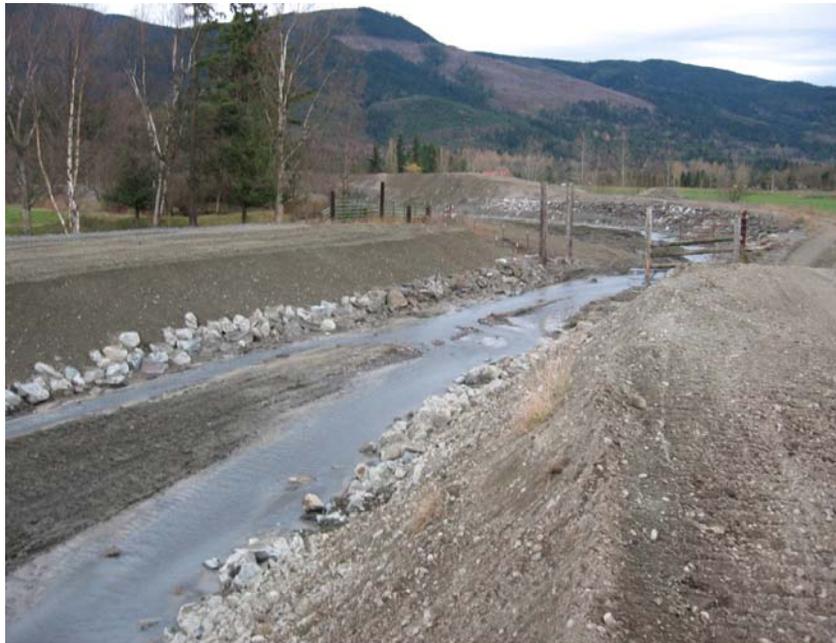
Description: Completed armoring and stockpile grading at crossing site of Swift Creek.

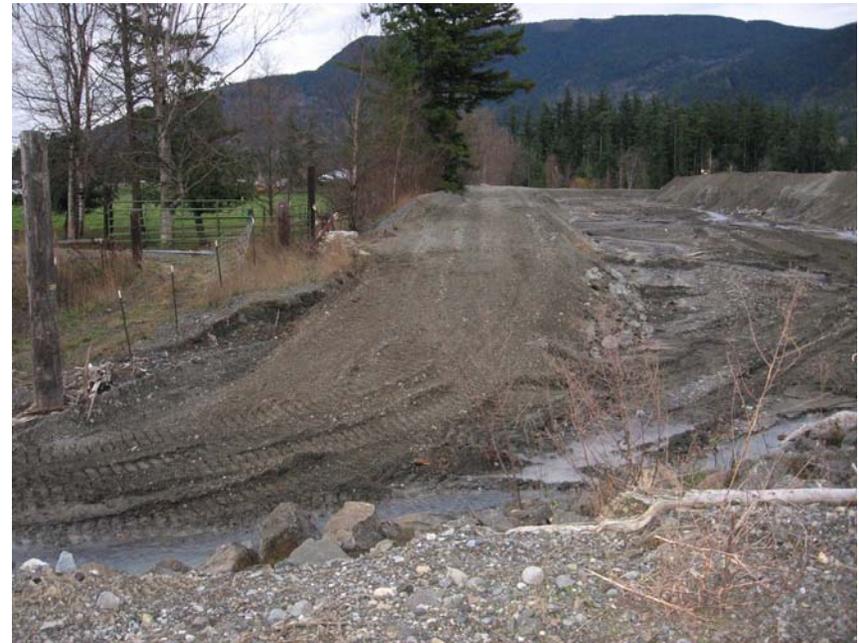
Photo No: 1436

Description: Grading and leveling completed on north side of Swift Creek.

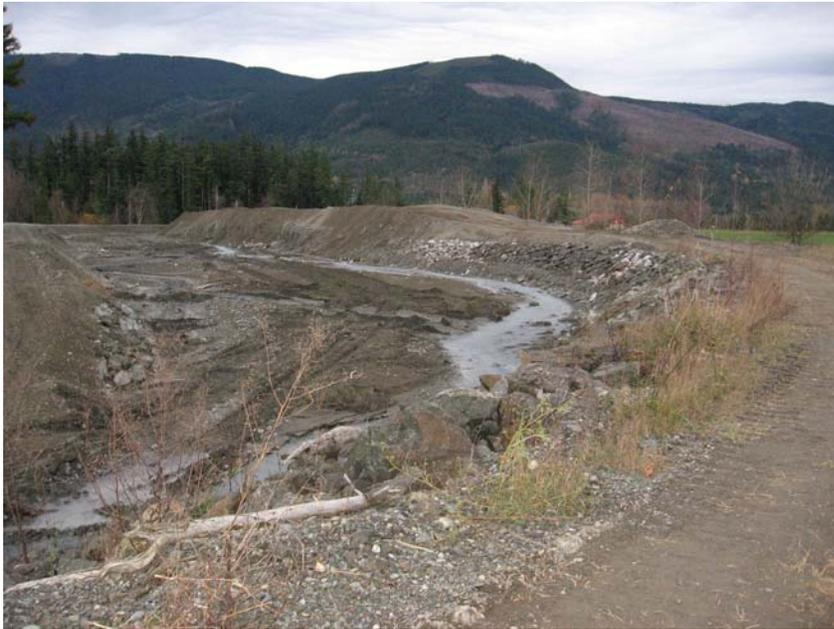
Description: View of armoring placed along channel bend east of crossing site and material regraded upon completion.

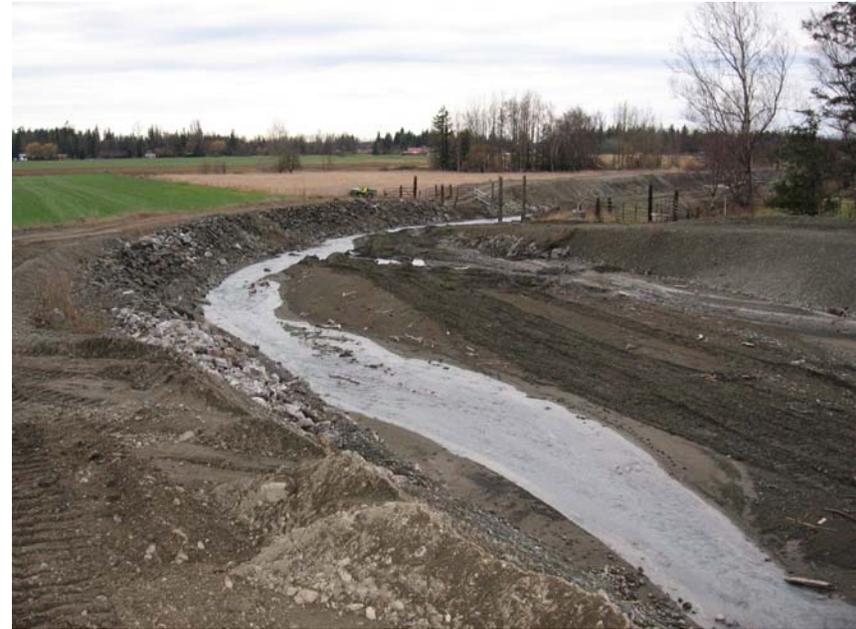
Date: 11/14/2007 **Photo No:** 1440

Description: Reverse view of previous photo, looking back at the crossing site after regrading both banks.

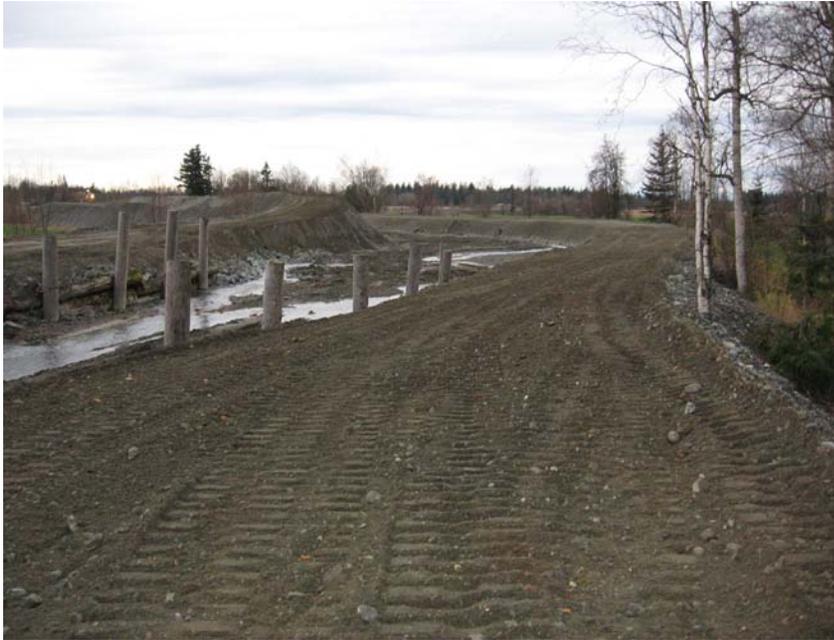
Description: View of north bank on east side of site near Goodwin Road after grading.

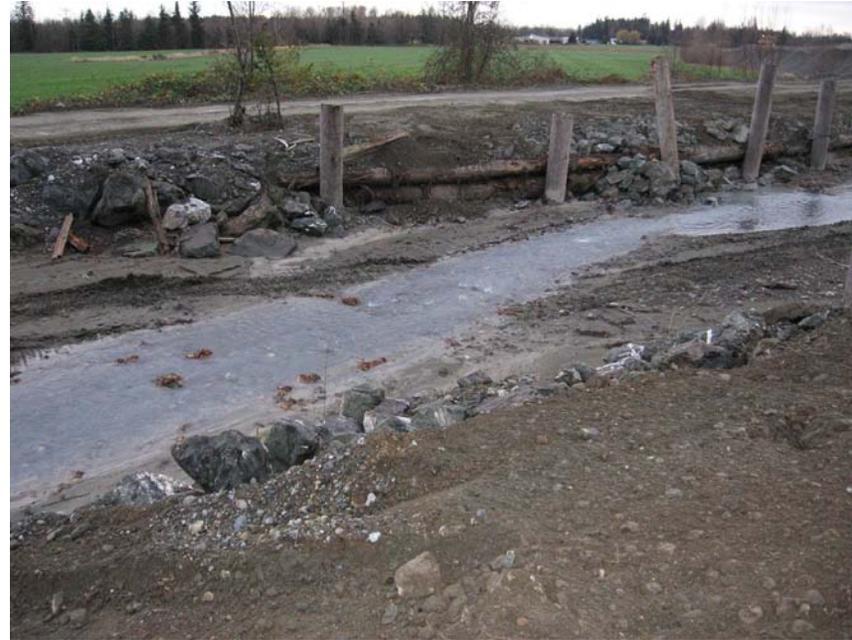
Date: 11/12/2007 **Photo No:** 1442

Description: View of channel armoring and erosion control measures installed near Goodwin Road.

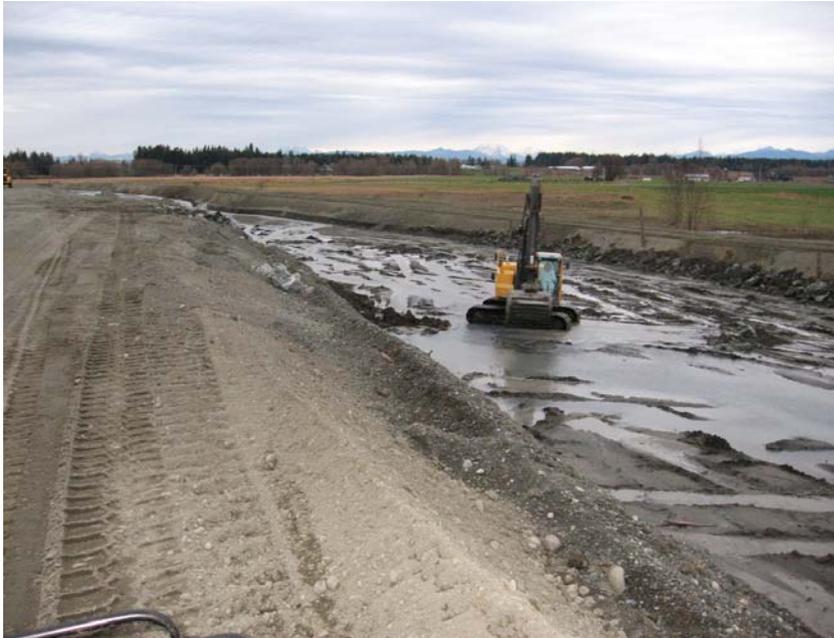
Description: Installation of final aggregate and rock armoring throughout channel before applying dust suppressant to banks.

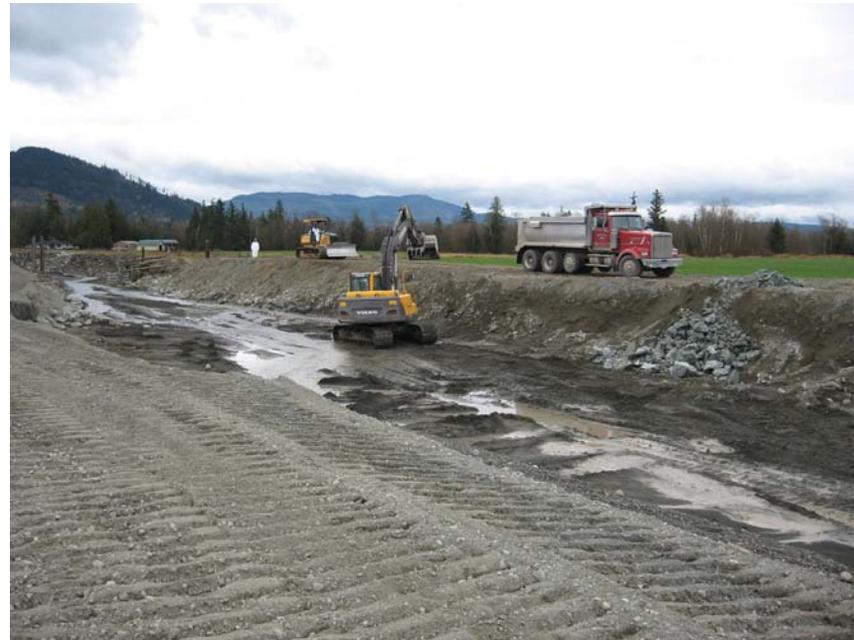
Date: 11/15/2007 **Photo No:** 1461

Description: ERRS offloading rock and creating additional erosion control features in channel of Swift Creek.

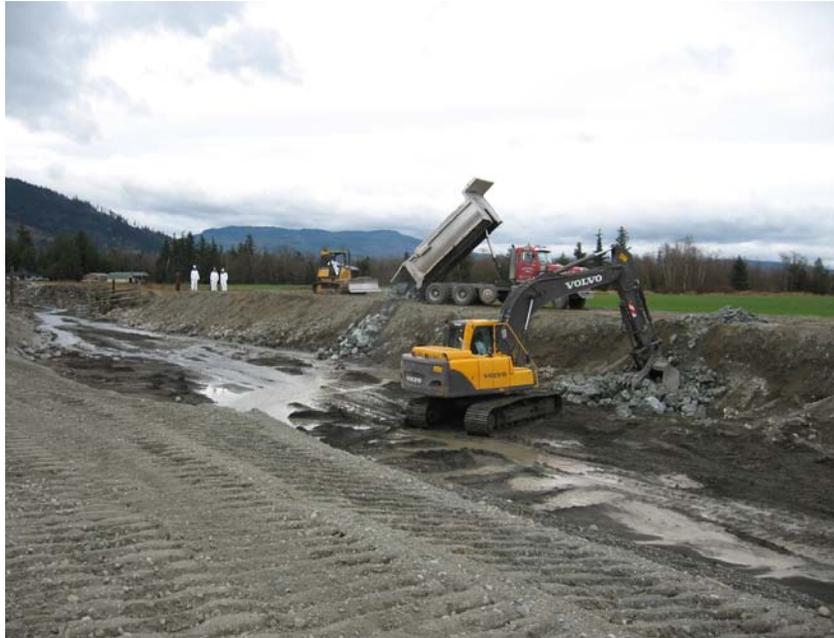
Description: ERRS completing erosion control features in Swift Creek using delivered rock material.

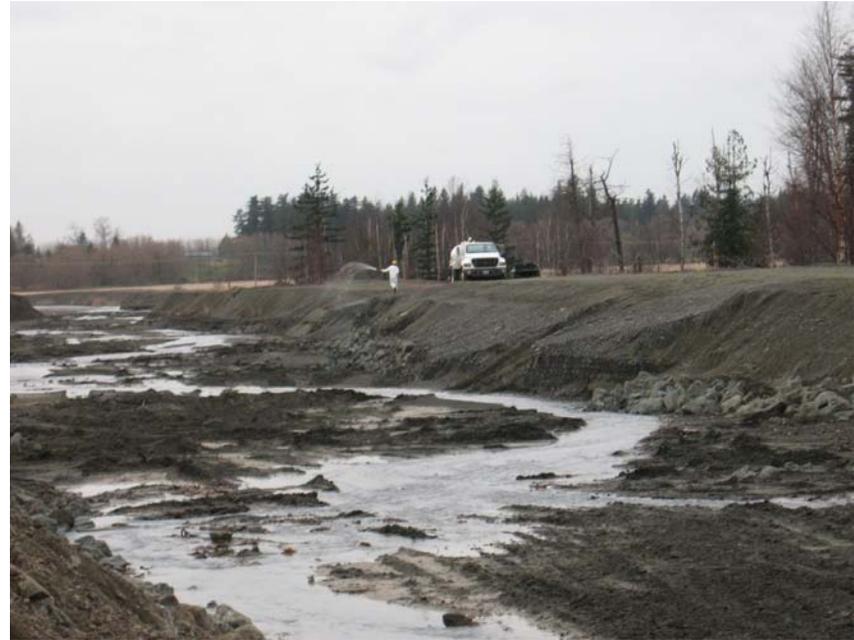
Date: 11/15/2007 **Photo No:** 1468

Description: ERRS applying dust suppressant to the north bank of Swift Creek downstream of crossing site.

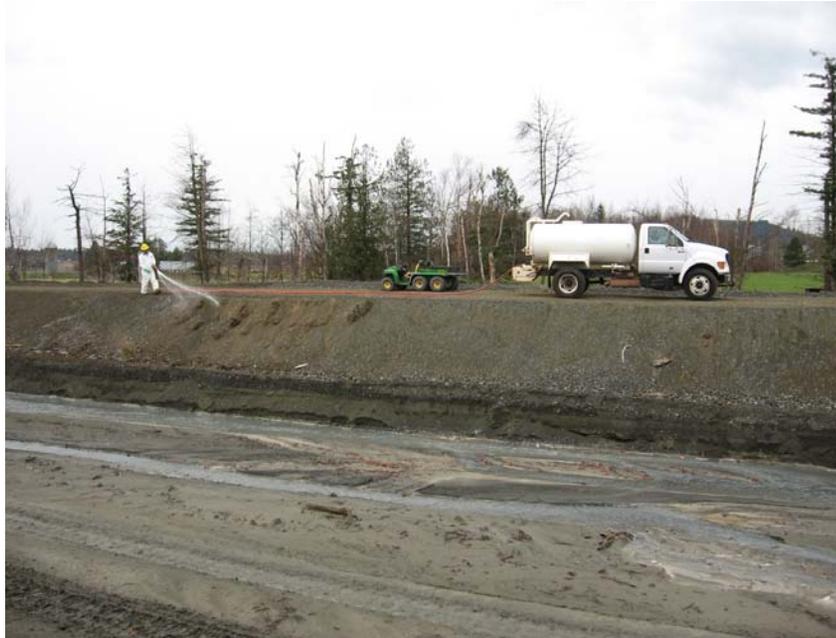
Description: ERRS applying dust suppressant to the spots on the bank following a pass by the water truck.

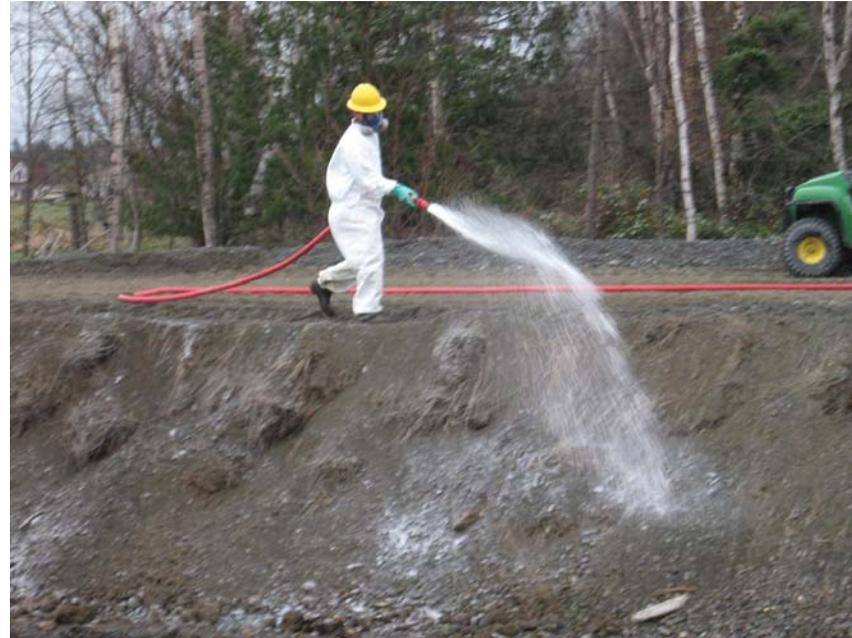
Date: 11/15/2007 **Photo No:** 2486

Description: ERRS spraying dust suppressant to ensure uniform coverage over entire site.
