APPENDIX F
SAND LAYER DIVE SURVEY REPORT

Project: T-4 Removal Action Project
Work Scope: Dive survey of the sand cover layer placed at slip #3 for
Client: Anchor Environmental, LLC
Date: September 17th, 2008

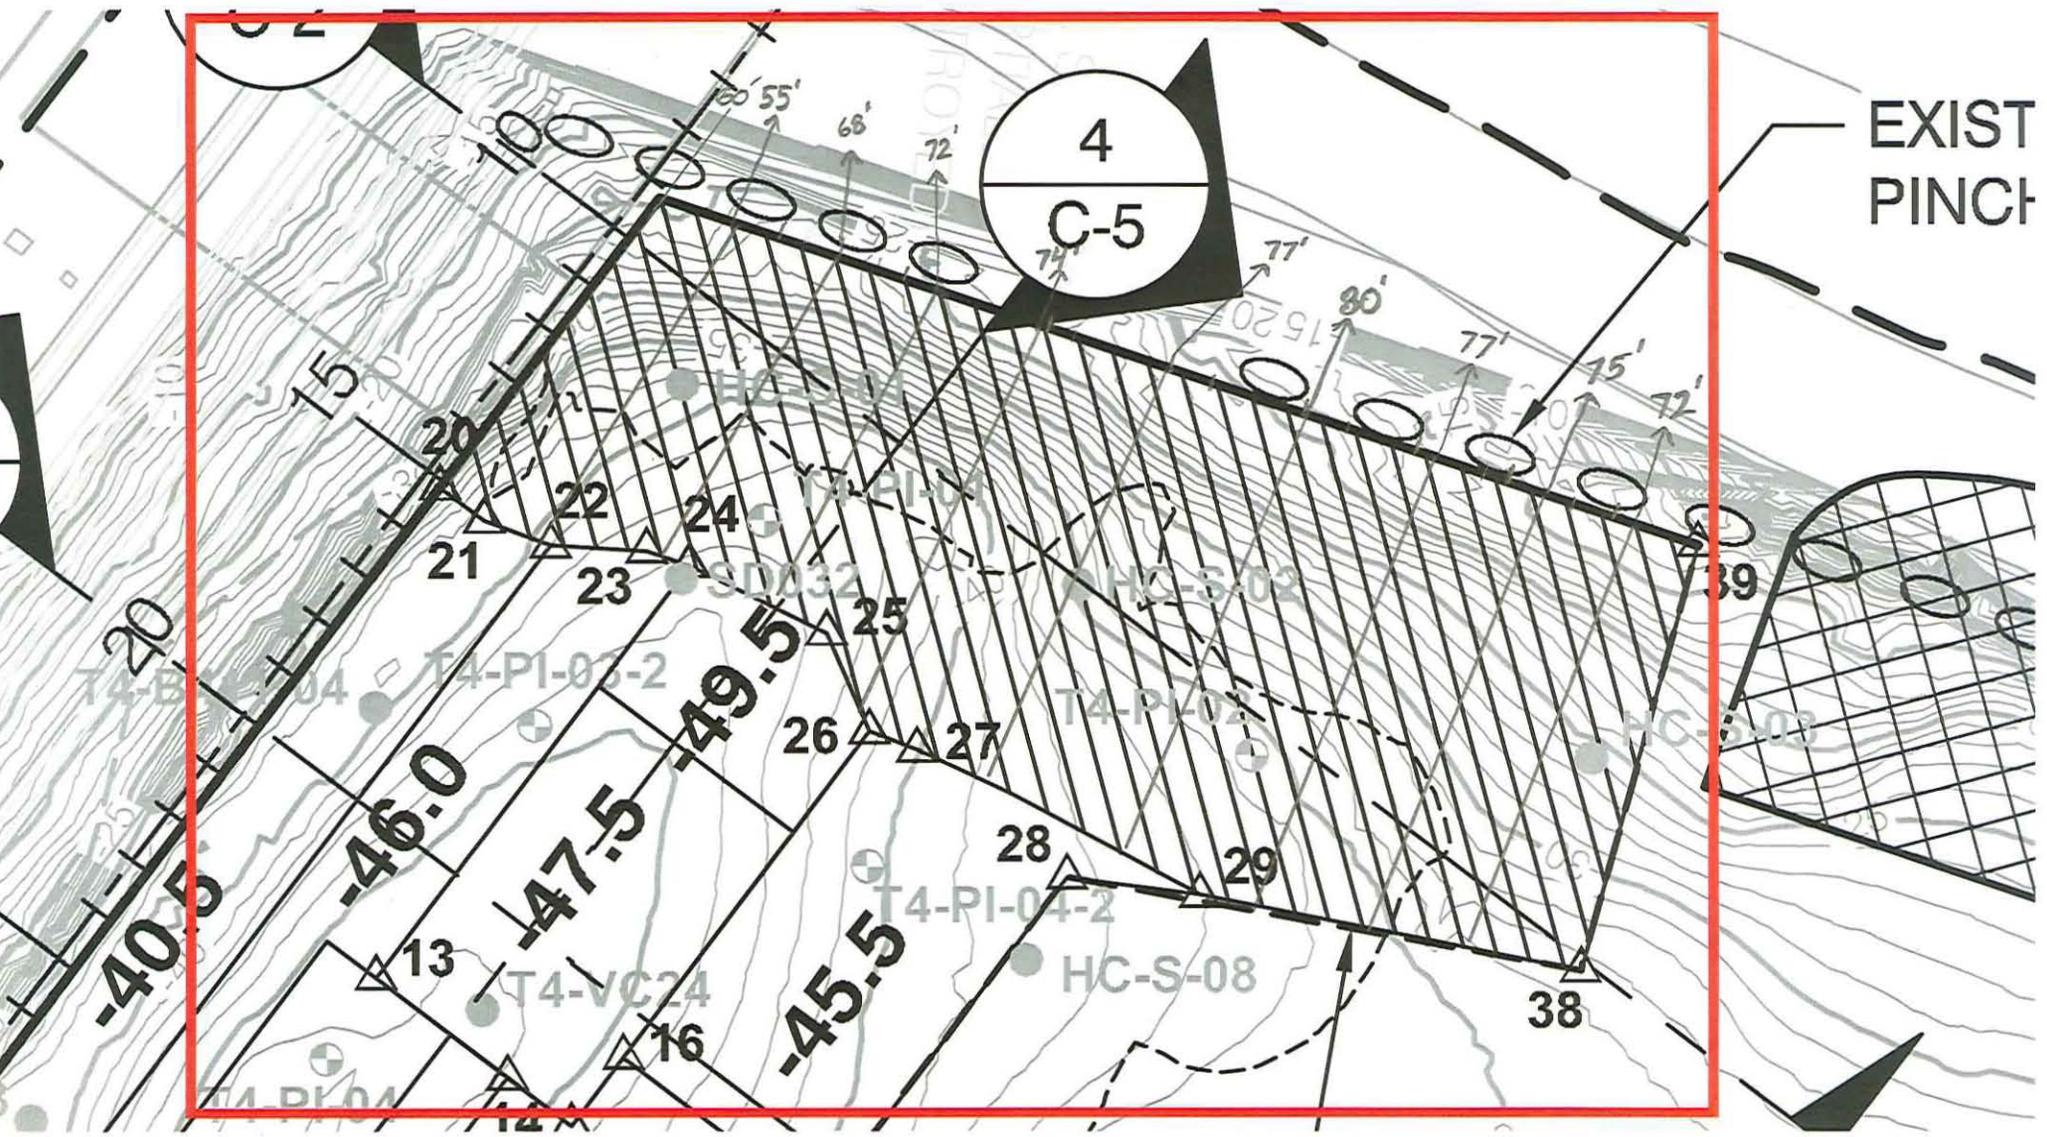
NUC marked the adjacent seawall longitudinally in 20' increments. Using a weighted down line and a search line the diver swam away from the wall inspecting the sand cap in a radial manner. Once an area was adequately surveyed the weighted down line was moved to the next station on the seawall and the search was repeated. In this manner the search patterns overlapped and the entire sand cap area was surveyed. Please refer to the actual design drawing included with this report for actual paths that the diver swam during the inspection.

In the course of the visual survey the Northwest Underwater Construction diver found no areas that were not covered by the sand cap. Additionally the toe of the slope adjacent to the seawall was covered. Therefore, it can be concluded that the placed sand cap covered the entire area (as shown on attached drawing).
