RESULTS OF YEAR 2 OPERATIONS, MAINTENANCE, AND MONITORING PLAN SAMPLING

**Head of the Thea Foss Waterway Remediation,
Tacoma, WA**

**PacifiCorp Environmental Remediation Company
and
Puget Sound Energy**

November 2006

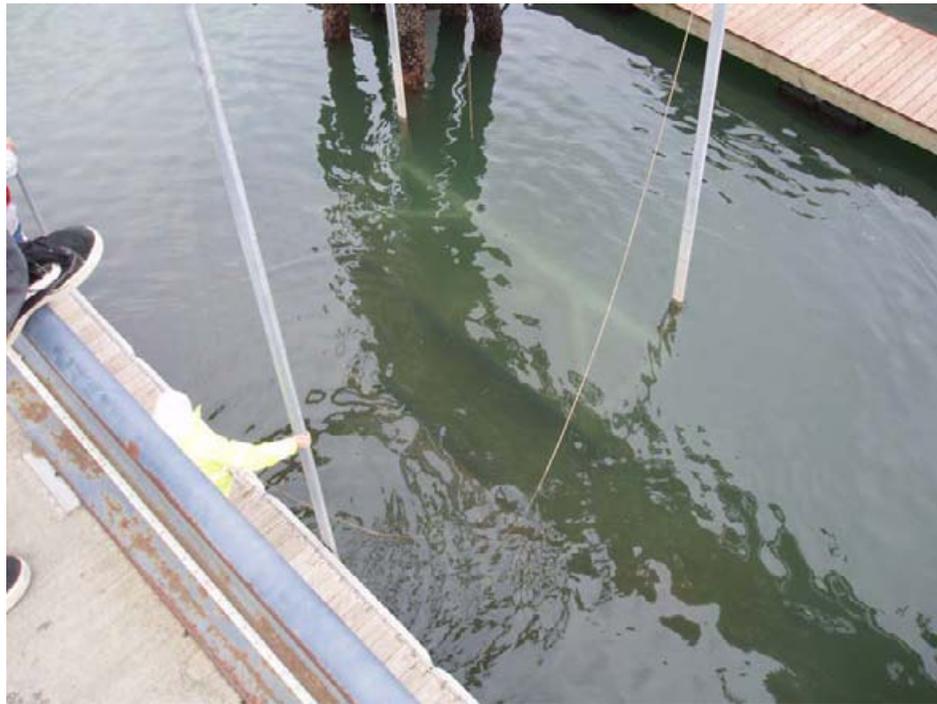
Figure 2 Sediment Smoothing

At several times, the operation was paused to complete leadline measurements to gauge smoothing progress and to allow the diver to inspect the work. The diver reported that the slope toward the channel appeared fairly uniform and that there was not a mound of sediment building up at the west end of the cradle's movement limit. He also reported that the shoreward slope appeared smooth as well.

Smoothing was completed at approximately 1114. At this time the measurement at the west end of the lift was -8.5 feet, and Bill Conley and John O'Loughlin estimated that approximately 2 feet of sediment from the middle part of the hump beneath the boat lift had been removed. Prior to the diver exiting the water he reported that a 6-inch hump had built up at the western limit of the smoothed area. He was able to smooth this area by hand.

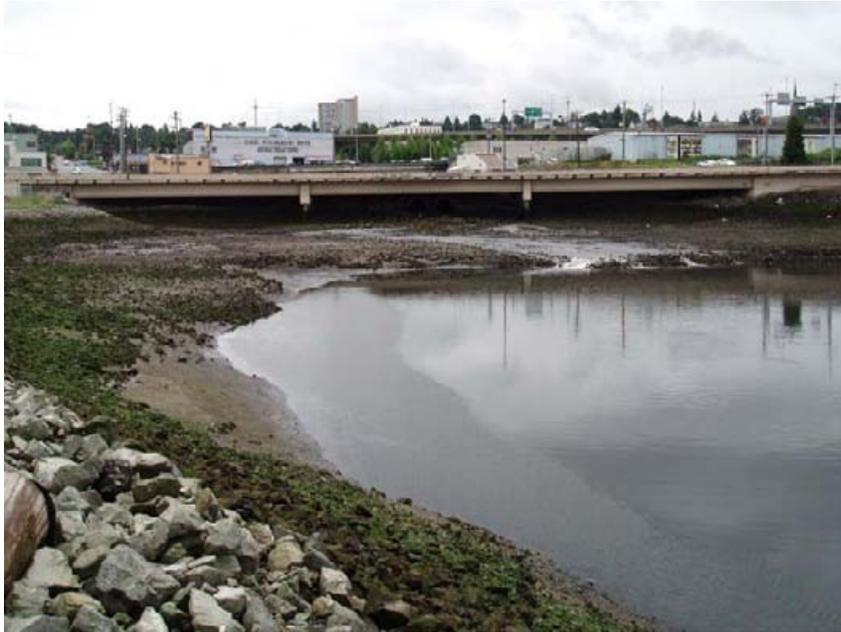
Figure 3 – Scour Protection Apron
Looking South Along East Bank

The condition of the scour protection apron at the south end of the waterway are shown in Figures 3 to 6. Water was flowing out of outfalls 237a and 237b during the site visit (Figure 7). The discharge from these outfalls was spreading out over the apron and flowing northward towards the turning basin. As previously noted in the Year 0 and Year 1 low tide site observations, a small, shallow channel is present in the apron near the southeast corner of the waterway (Figure 3). The configuration and shallow depth of this channel appear unchanged from previous observations and the overall integrity of the cap has not been adversely impacted

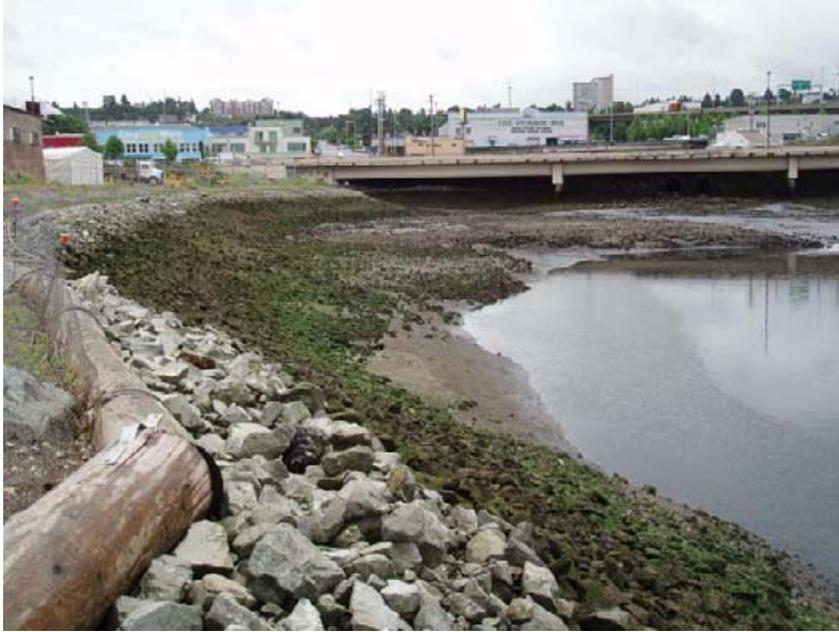
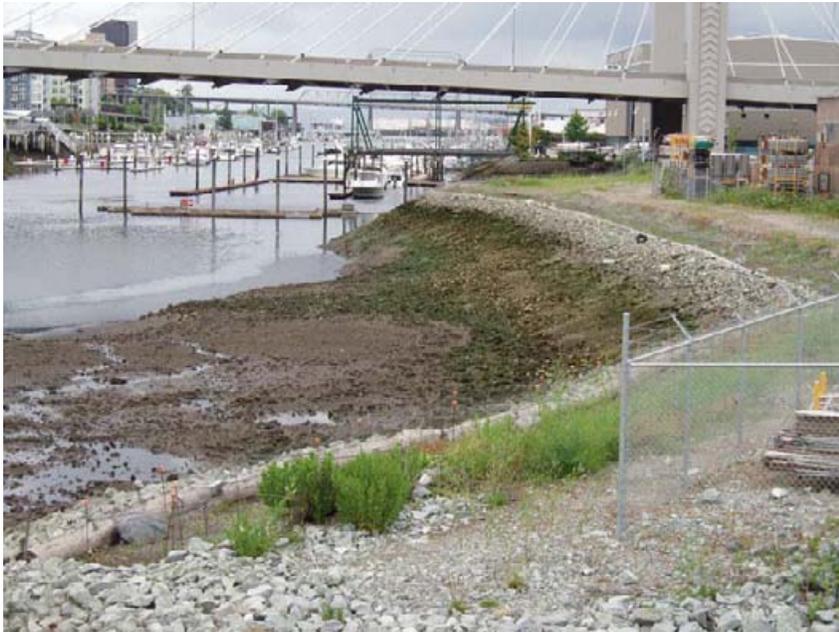
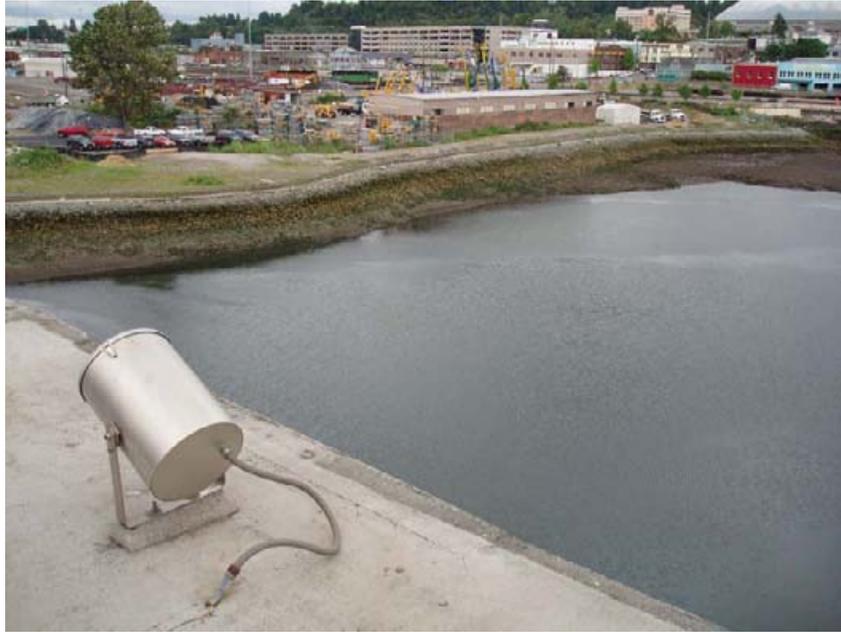
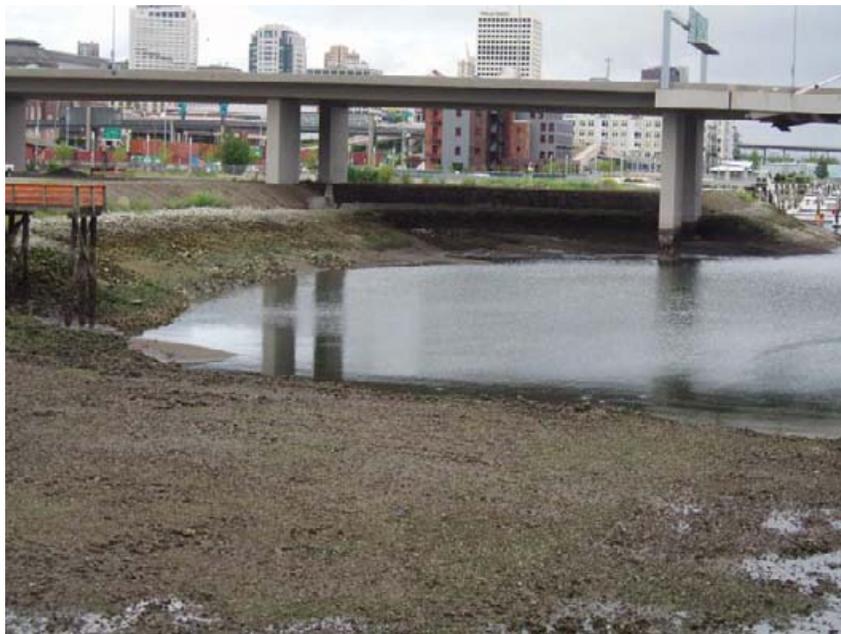
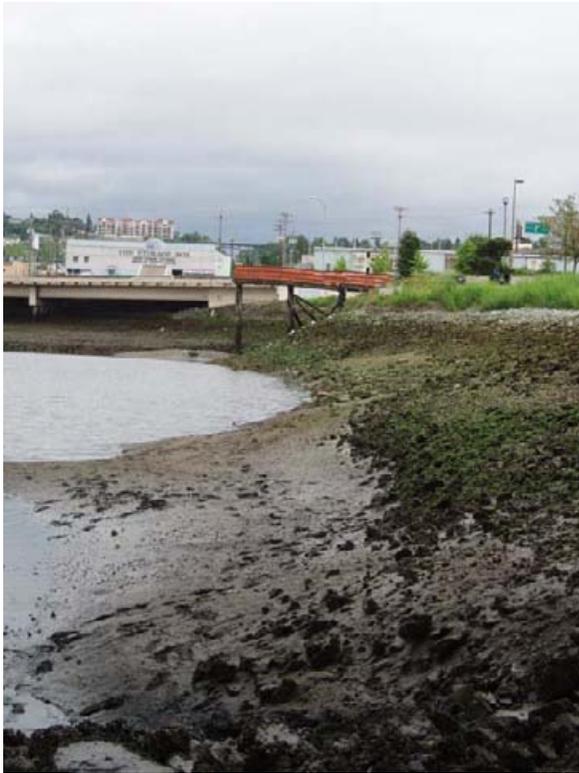
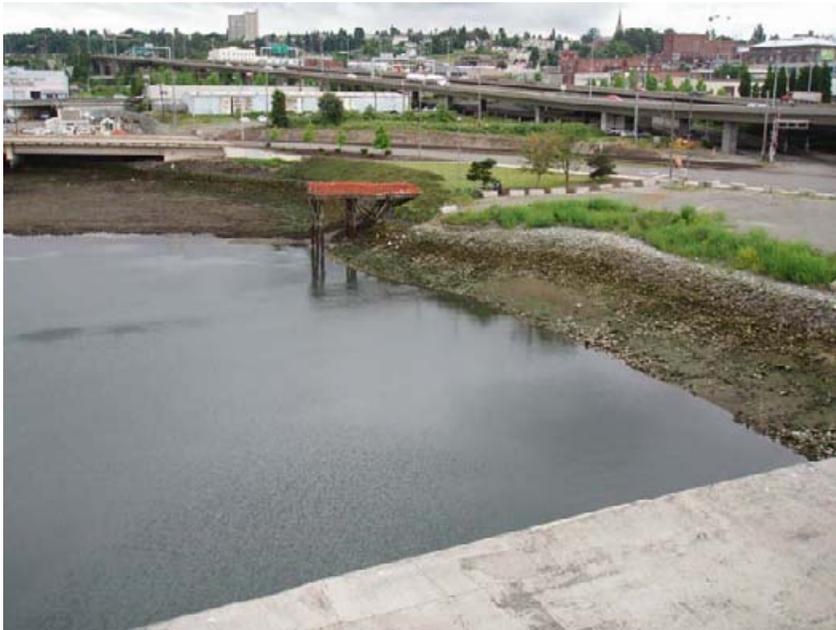
Photographs of the east and west bank slopes exposed during low tide are shown in Figures 8 to 13. No slope erosion or sloughing was observed. As previously noted in the Year 0 and Year 1 site observation memoranda, the coarser slope cap materials are covered with algae and barnacles. A layer of olive and gray silt is present over capping material on the lower portions of the east and west bank slopes.

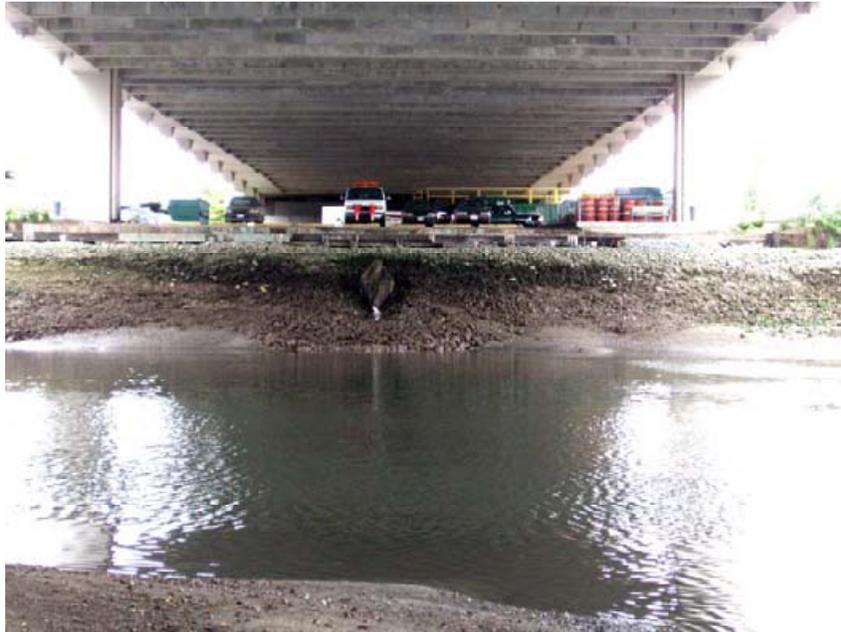
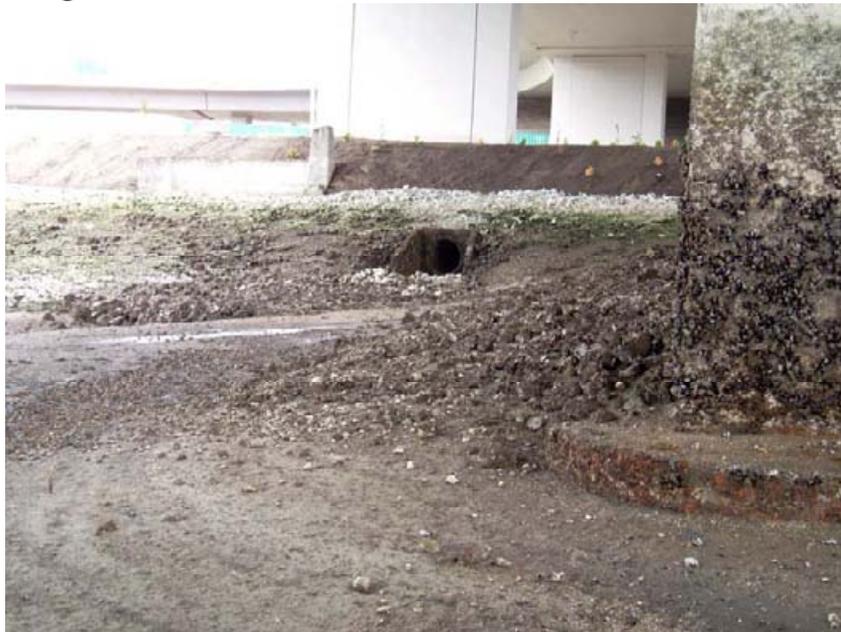
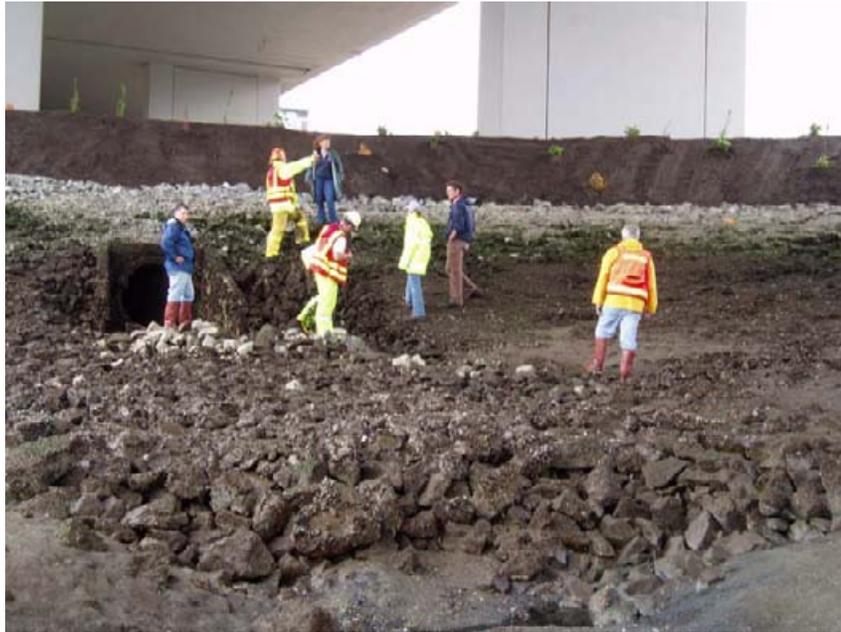
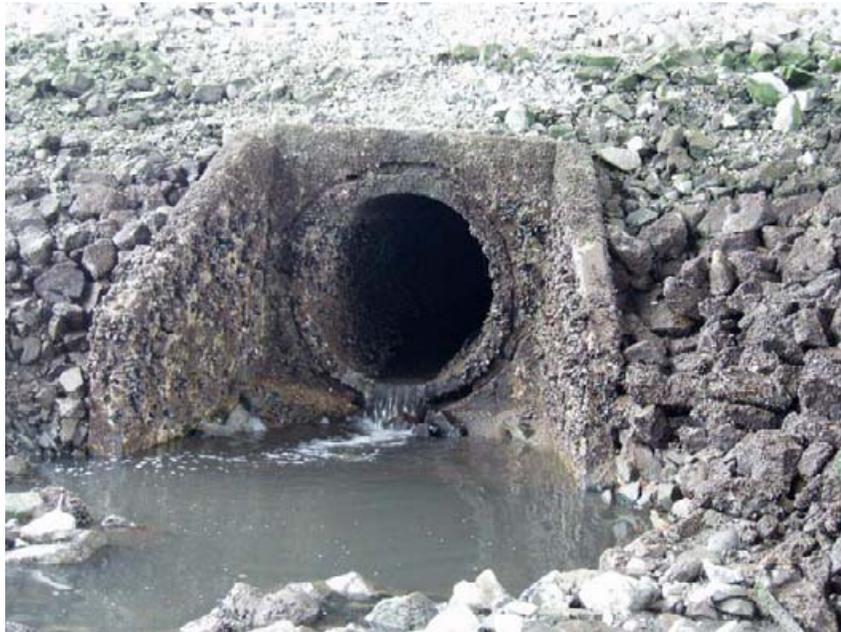
The weather was overcast with intermittent showers and light winds during this field visit. Gas bubbles were observed throughout the head of the waterway but no sheens were observed in this area. Algae and barnacles are present on coarser slope cap and scour protection materials. The scour protection adjacent to outfalls 243 (at Station 73+40 on the east side of the waterway under the SR-509 bridge) and 235 (at Station 73+20 on the west side of the waterway under the SR-509 bridge) shows no signs of erosion or displacement (Figures 17 to 20). Water was flowing out of both these outfalls during the site visit.

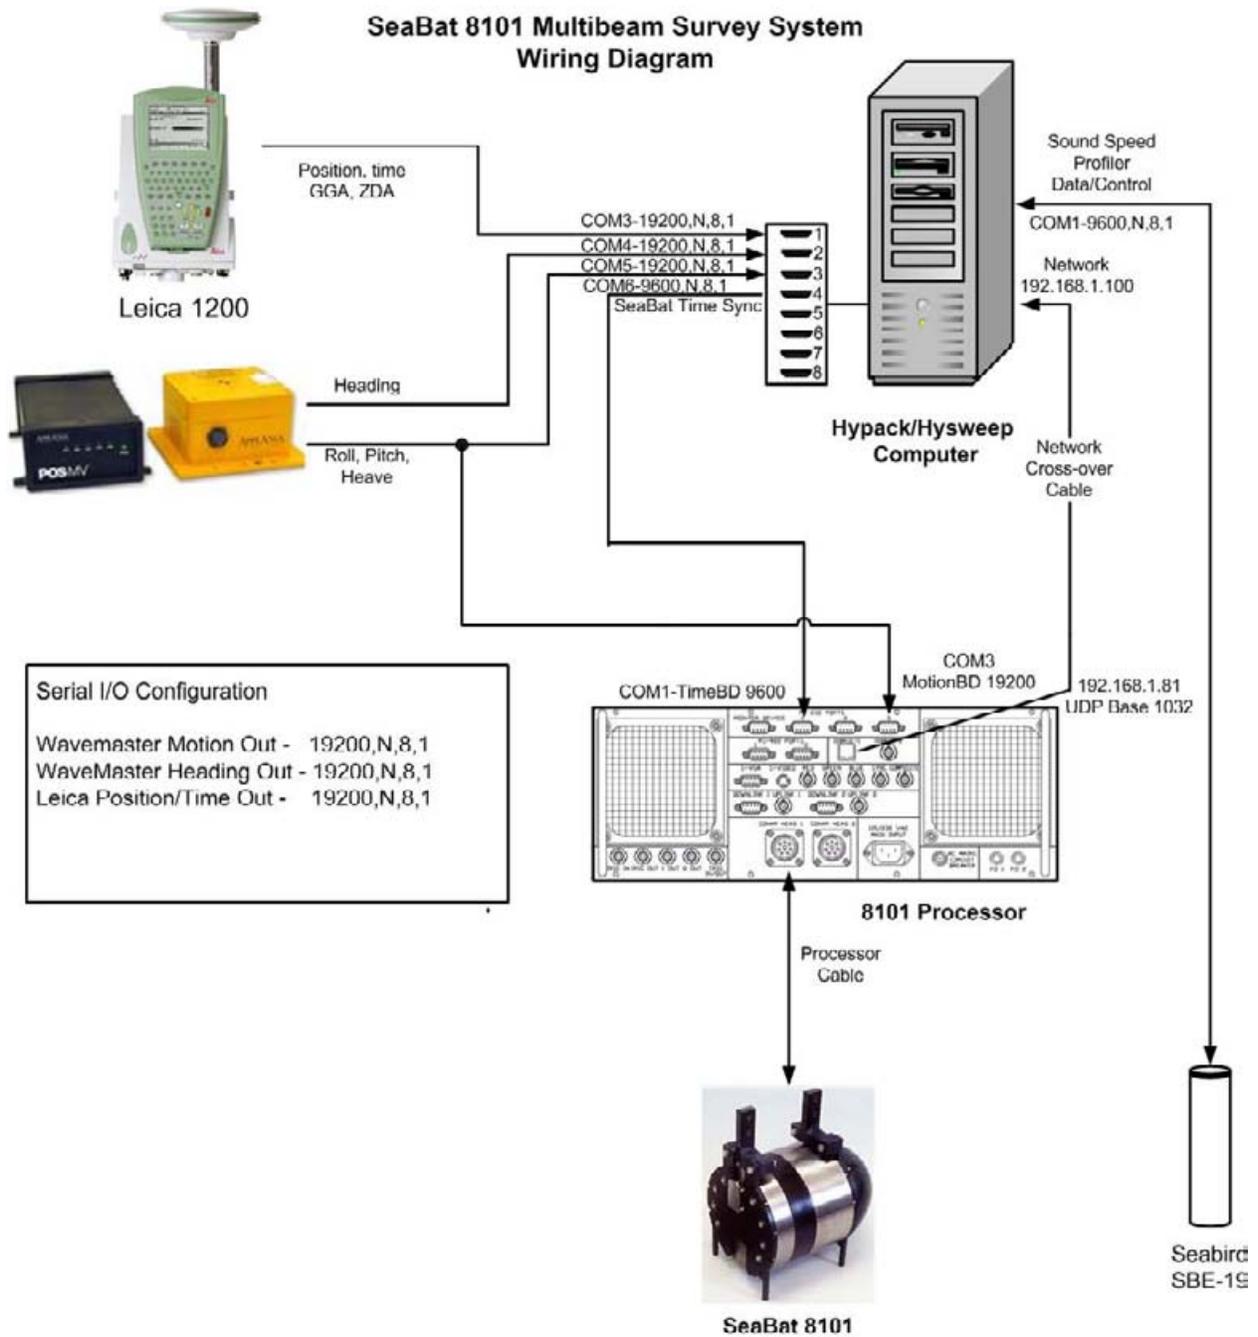
Figure 2 – 8101 Multibeam Survey System

Figure 2 shows the data flow and communications setup for the devices which make up the survey system. Table 3 lists the settings for each of the data communication links.

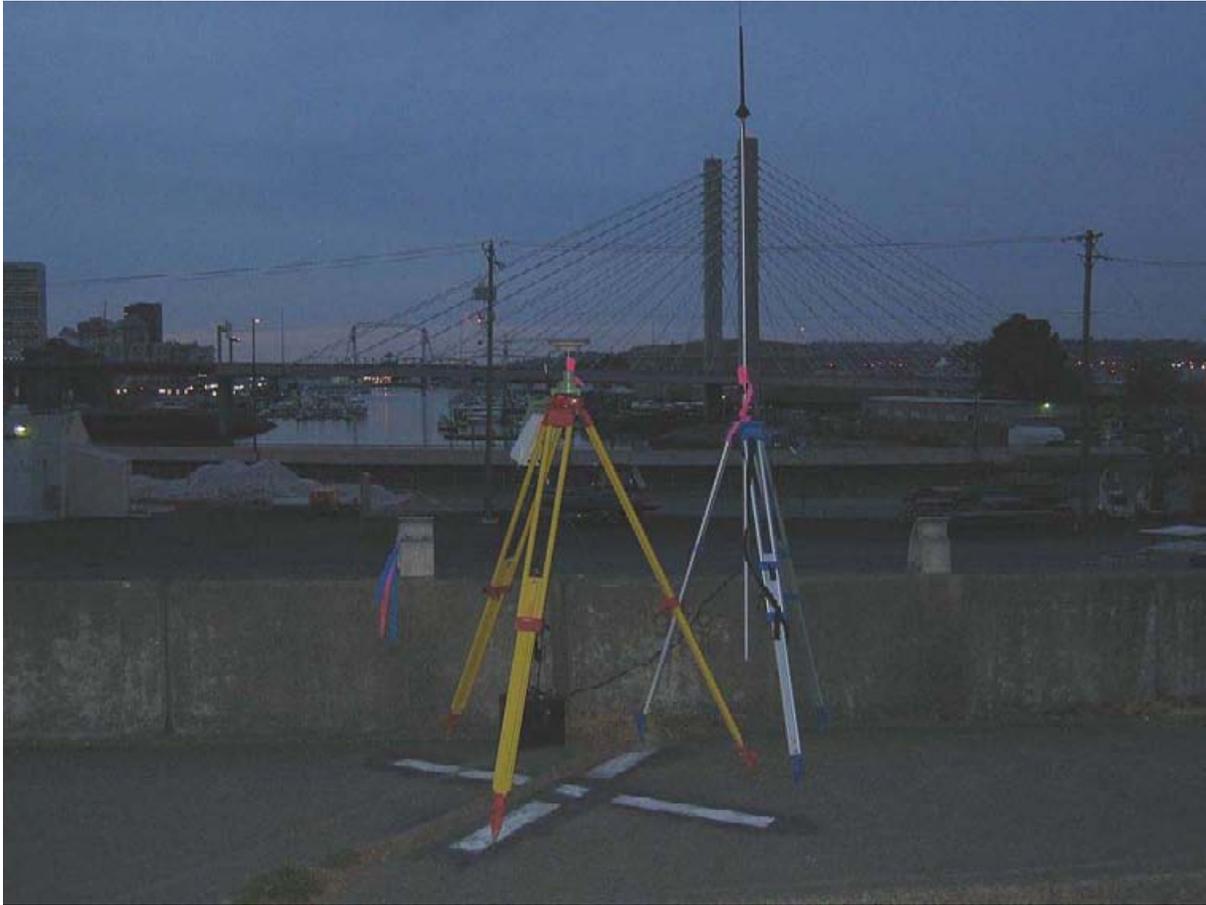
Figure 3 - RTK GPS Base Station

A GPS RTK base station was set up at the benchmark on Puyallup Ave., as shown in Figure 3. This system provided vertical positioning which was used to correct sounding data to MLLW, Epoch 1960 – 1978 (i.e. the RTK GPS was used as a tide gauge).

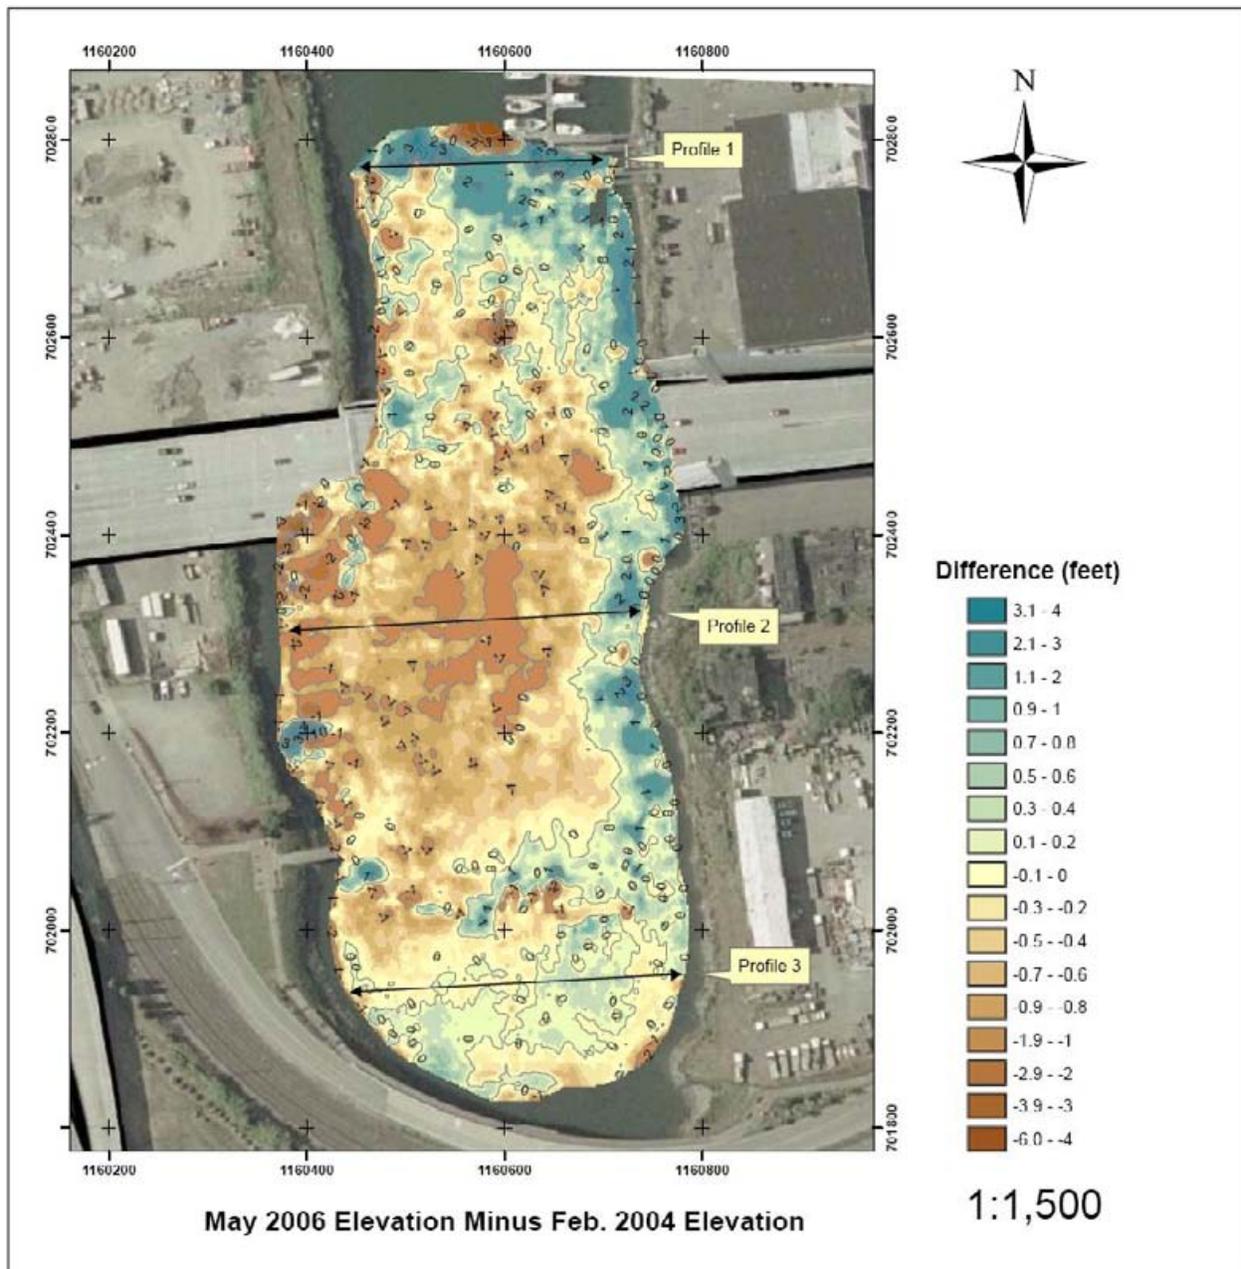
Figure 5 - Elevation Change Plot

Figure 5 shows a plot, color coded for changes in elevations of the bottom, for the southern section of the Thea Foss Waterway. Figure 6 shows the cross section profile results for the cross section lines shown in Figure 5.

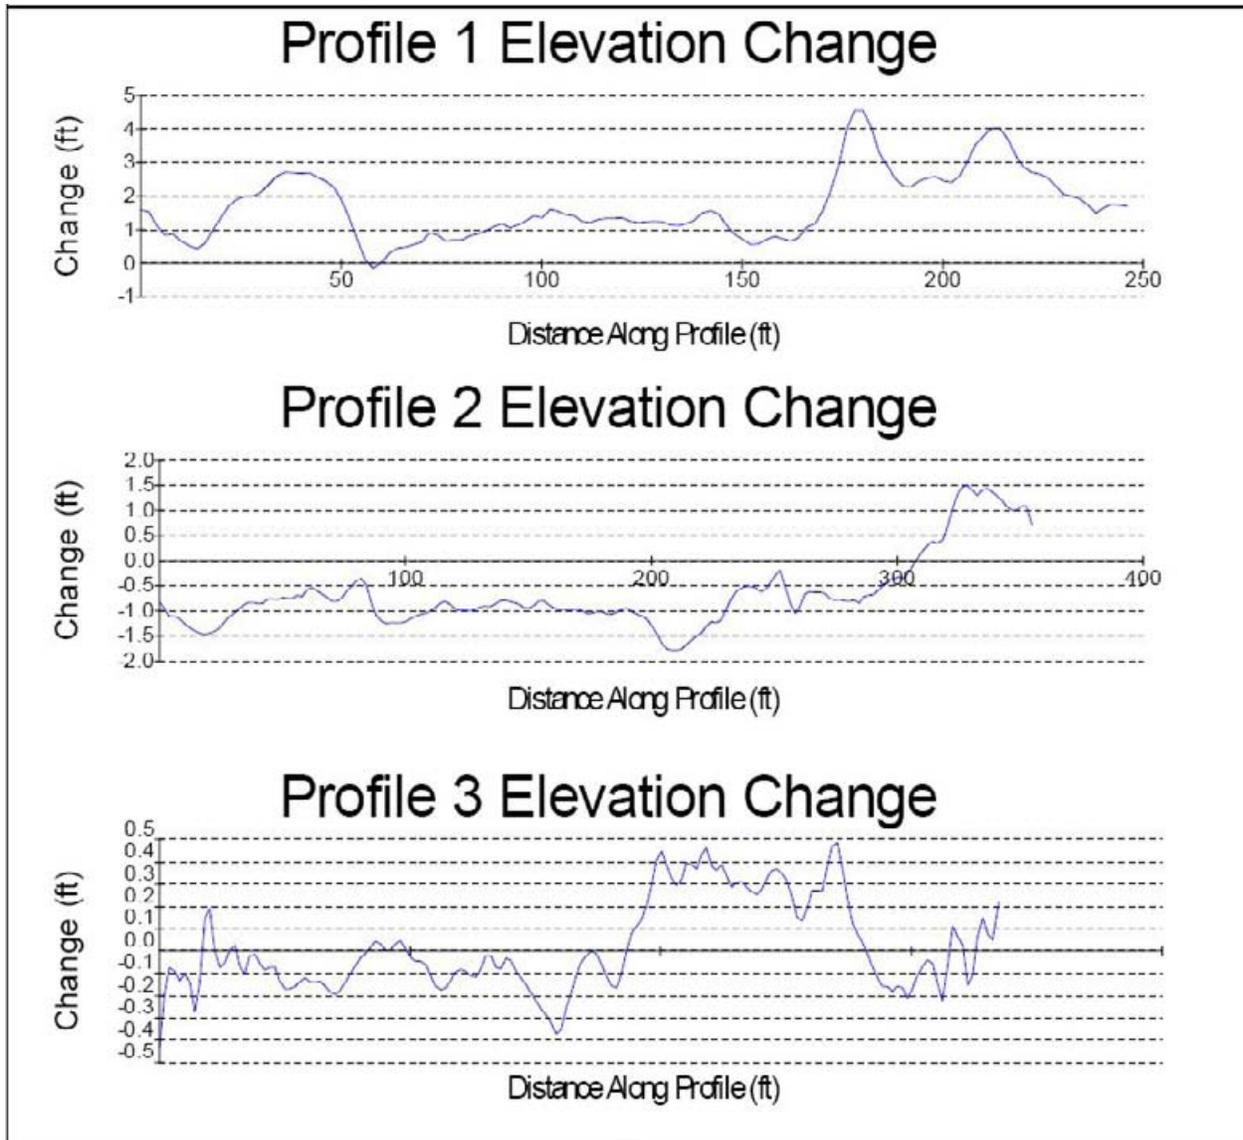
Figure 6 - Elevation Difference Profiles

consolidation calculations made during design. Profile 3 is in an area where capping material and slope armor material (e.g. rock) were placed to the design grades. Consolidation calculations during design in this area predicted < 3 in of consolidation. This is consistent with the bathymetry results. The minimal differences along the western half of the profile are probably due to the differences in the equipment and procedures between the surveys (refer to Section 4.2). The increase in elevation just east of center in Profile 3 may be a result of sediment deposit from the outfall at the south end of the waterway.

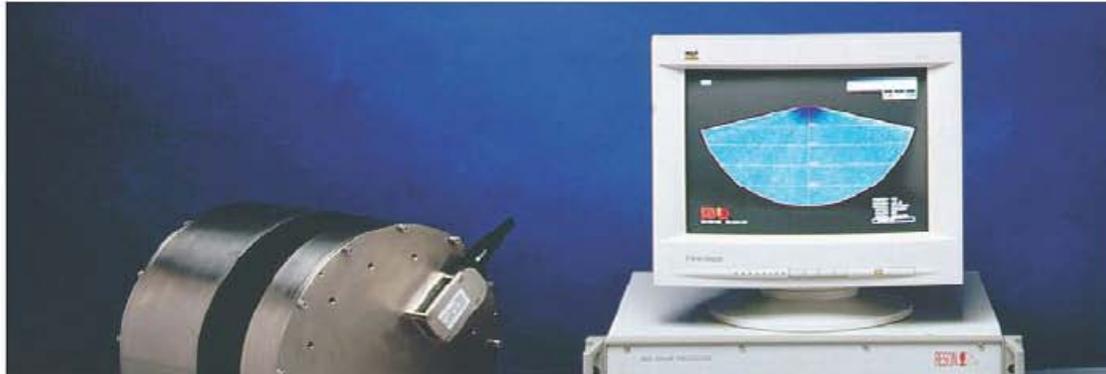
SeaBat 8101

- Phase and amplitude bottom detection
- Circular array: all beams 1.5°
- 150° swath coverage (upgradeable to 210°)
- 240kHz frequency
- Up to 600m swath width (with Option 040)
- Meets IHO & USACE Class 1 standards

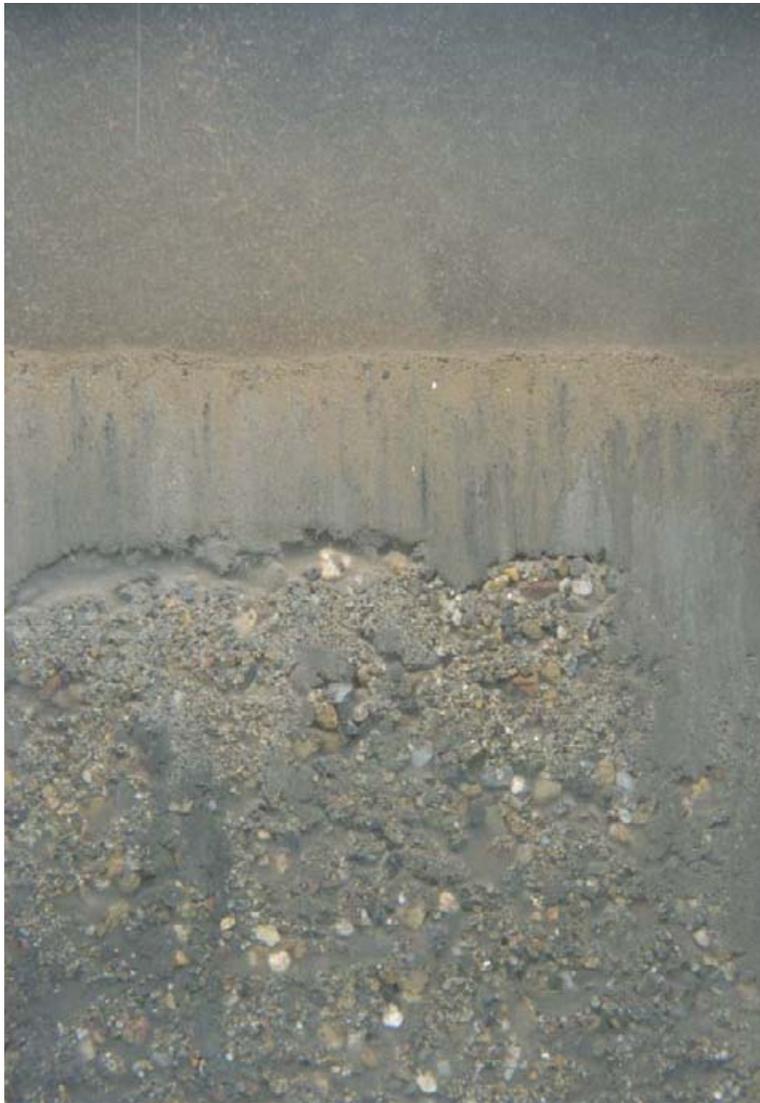
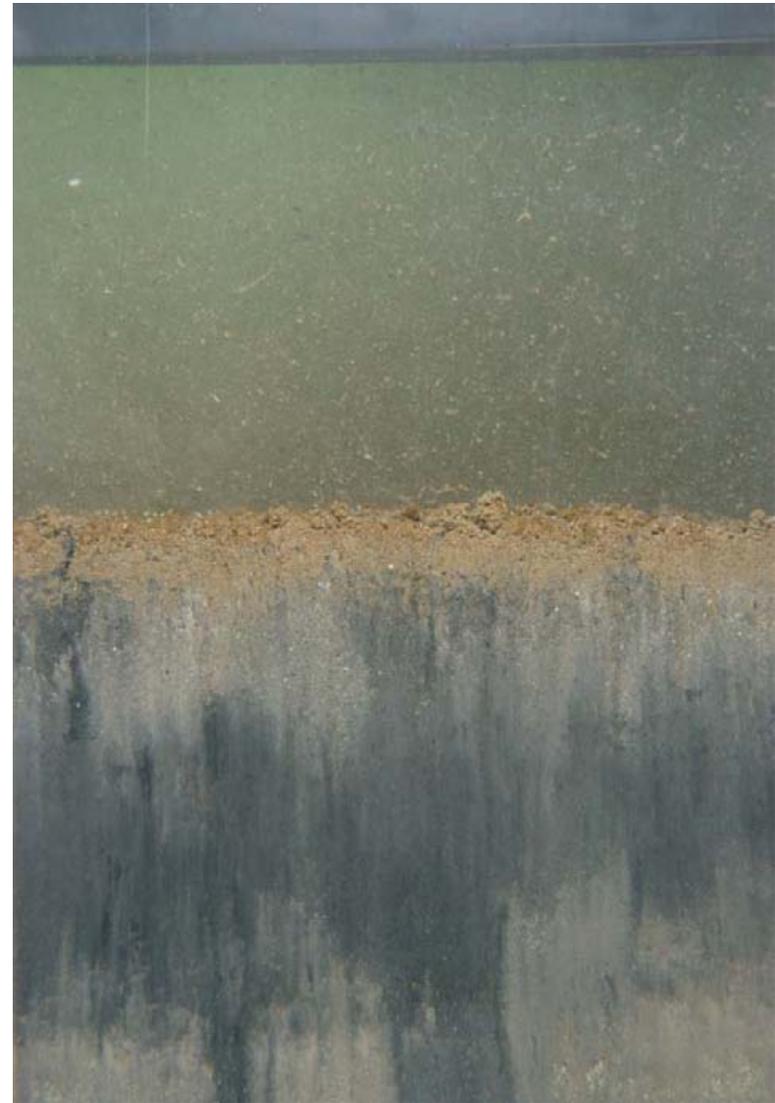
Figure 3: These profile images from Station S19 (left) and WC-06 (right) show different textural characteristics for depositional strata. The left image shows a distinct grain-size difference in the surface layer, while the right image shows a surface layer with similar grain-size deposited on top what used to be the sediment surface (buried oxidized horizon). SCALE: Width of image = 14.3 cm.

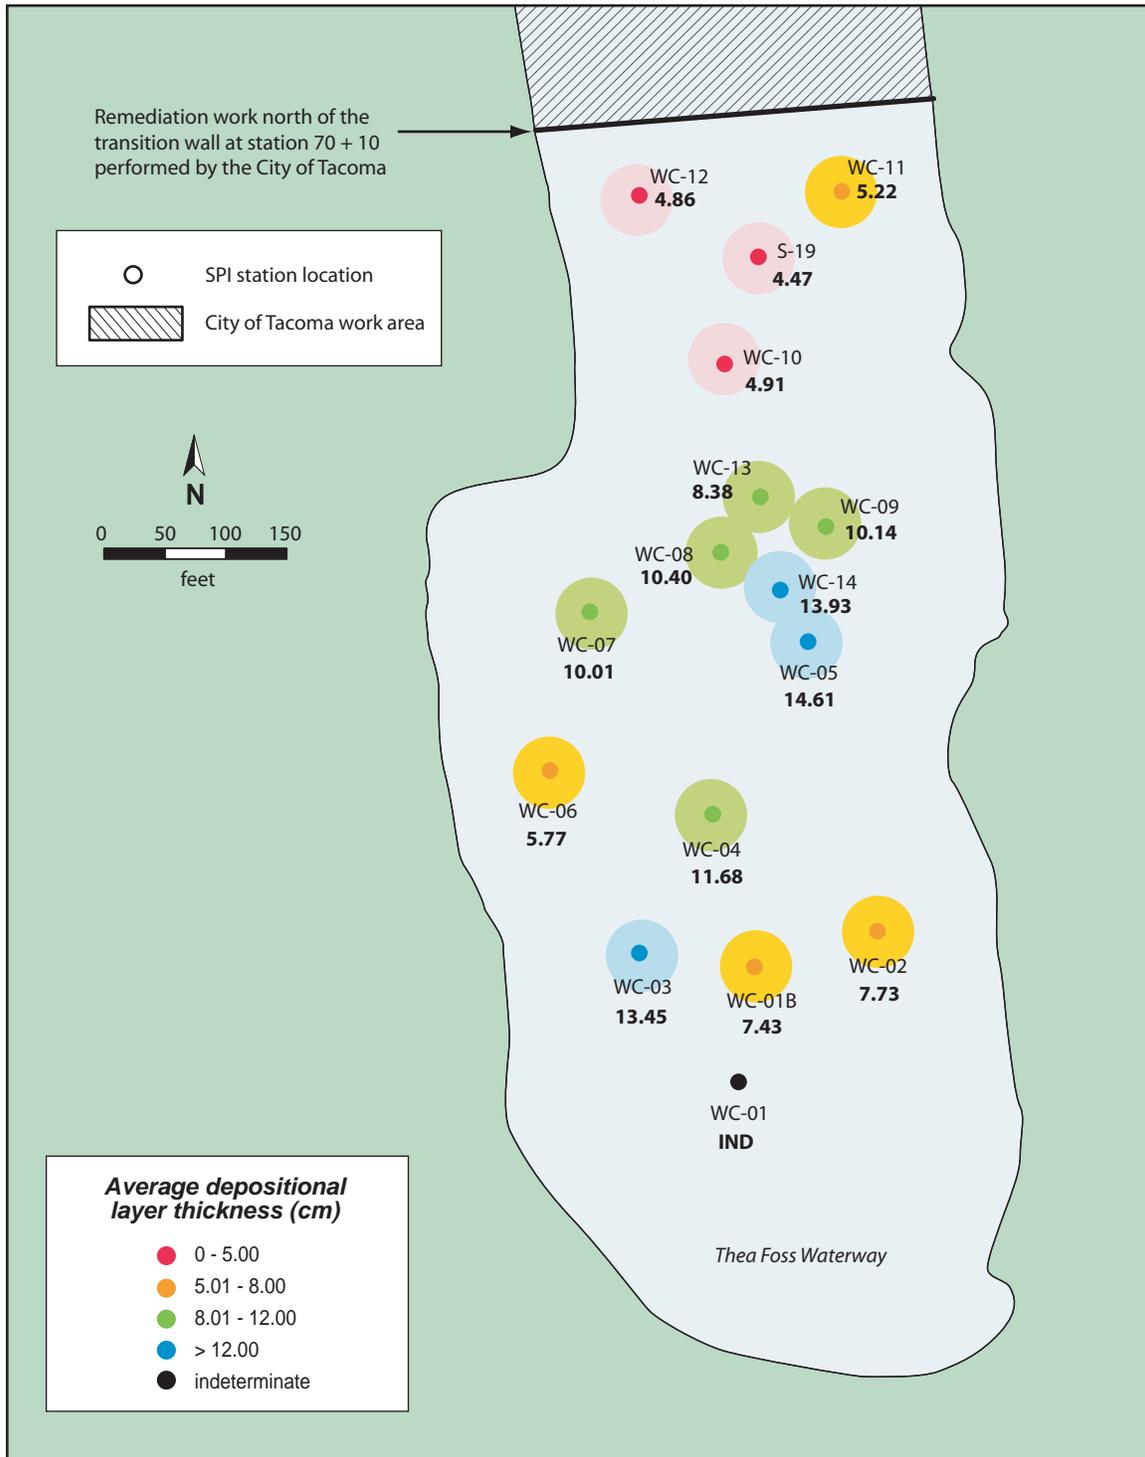
Figure 4: Average surface depositional layer thickness (cm) at SPI stations in the Thea Foss Waterway.

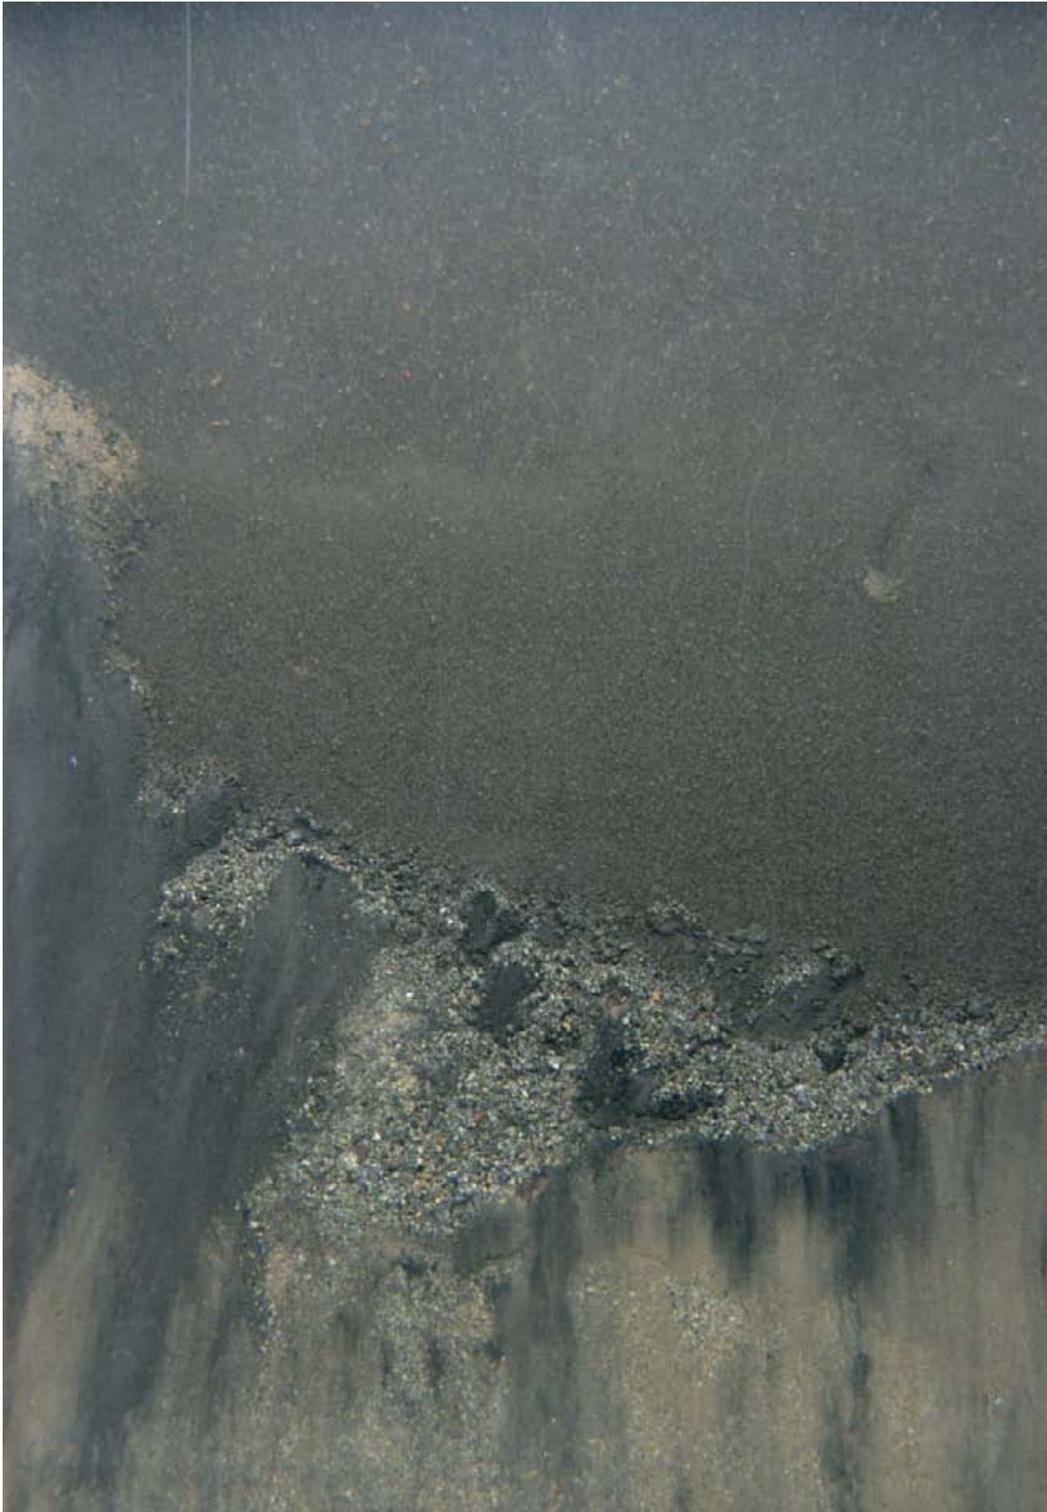
Figure 5: The large surface boundary roughness value (9.9 cm) measured in this image from Station WC-14 is caused by a sampling artifact; this replicate image was taken in the same location as the previous image, showing the "divot" carved out of the bottom by the camera prism in the previous deployment. SCALE: Width of image = 14.3 cm.

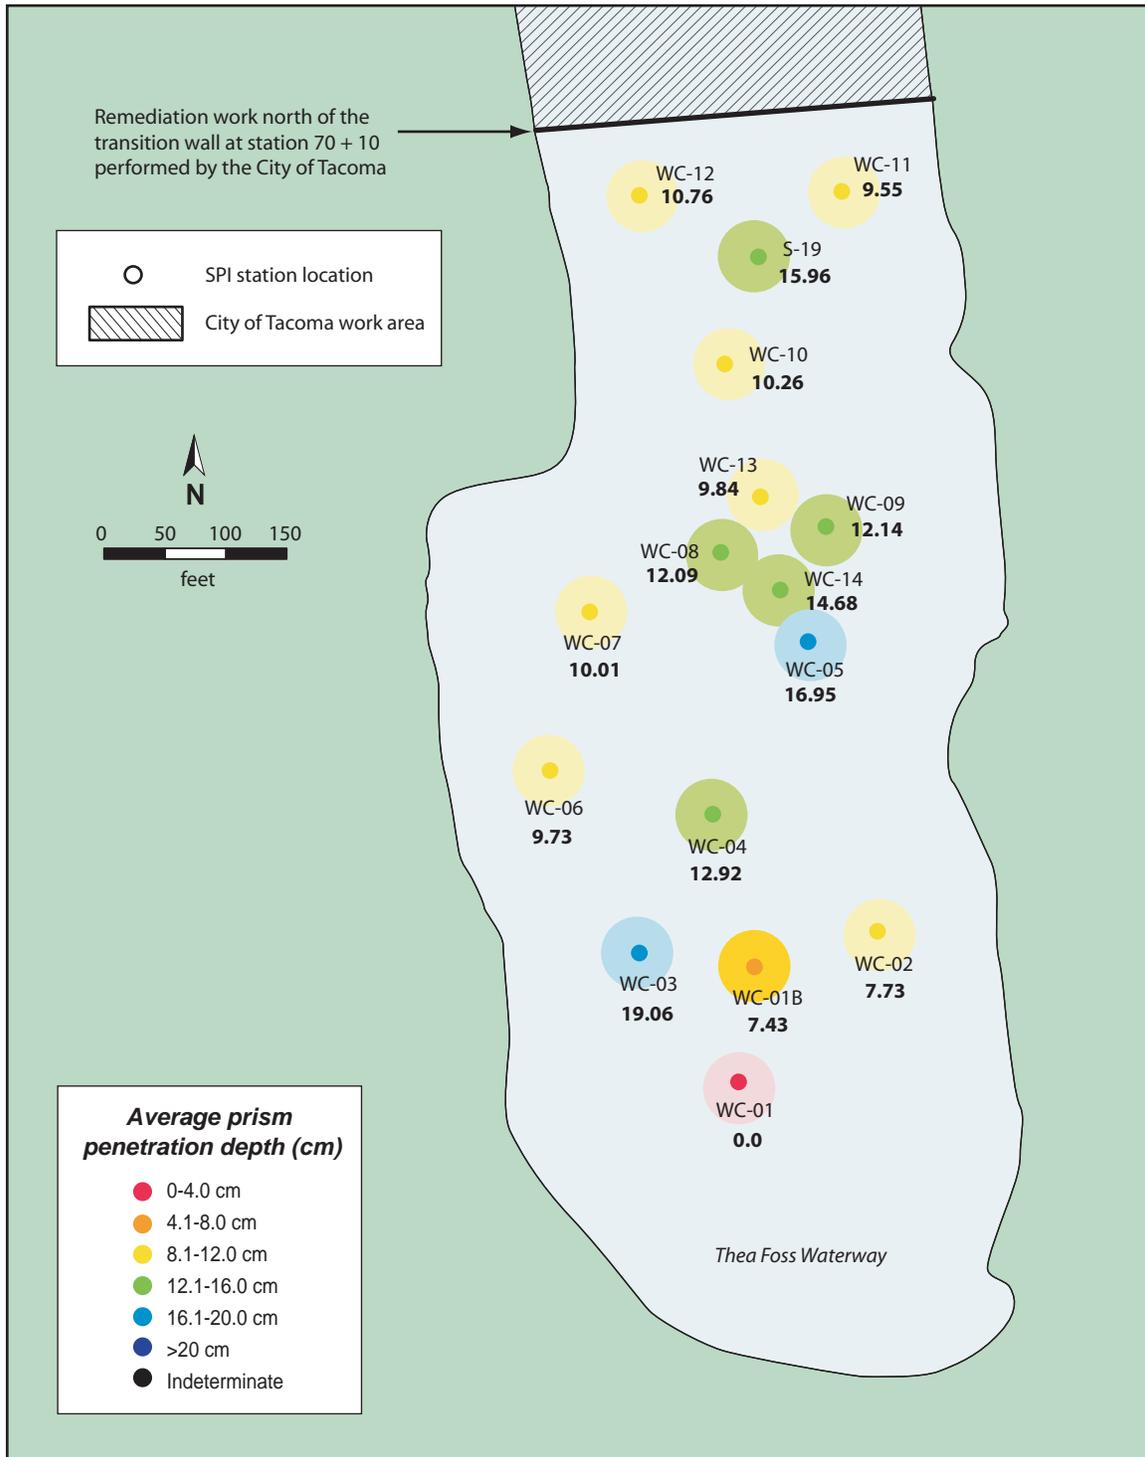
Figure 6: Spatial distribution of average camera prism penetration depth (cm) in the Thea Foss Waterway.

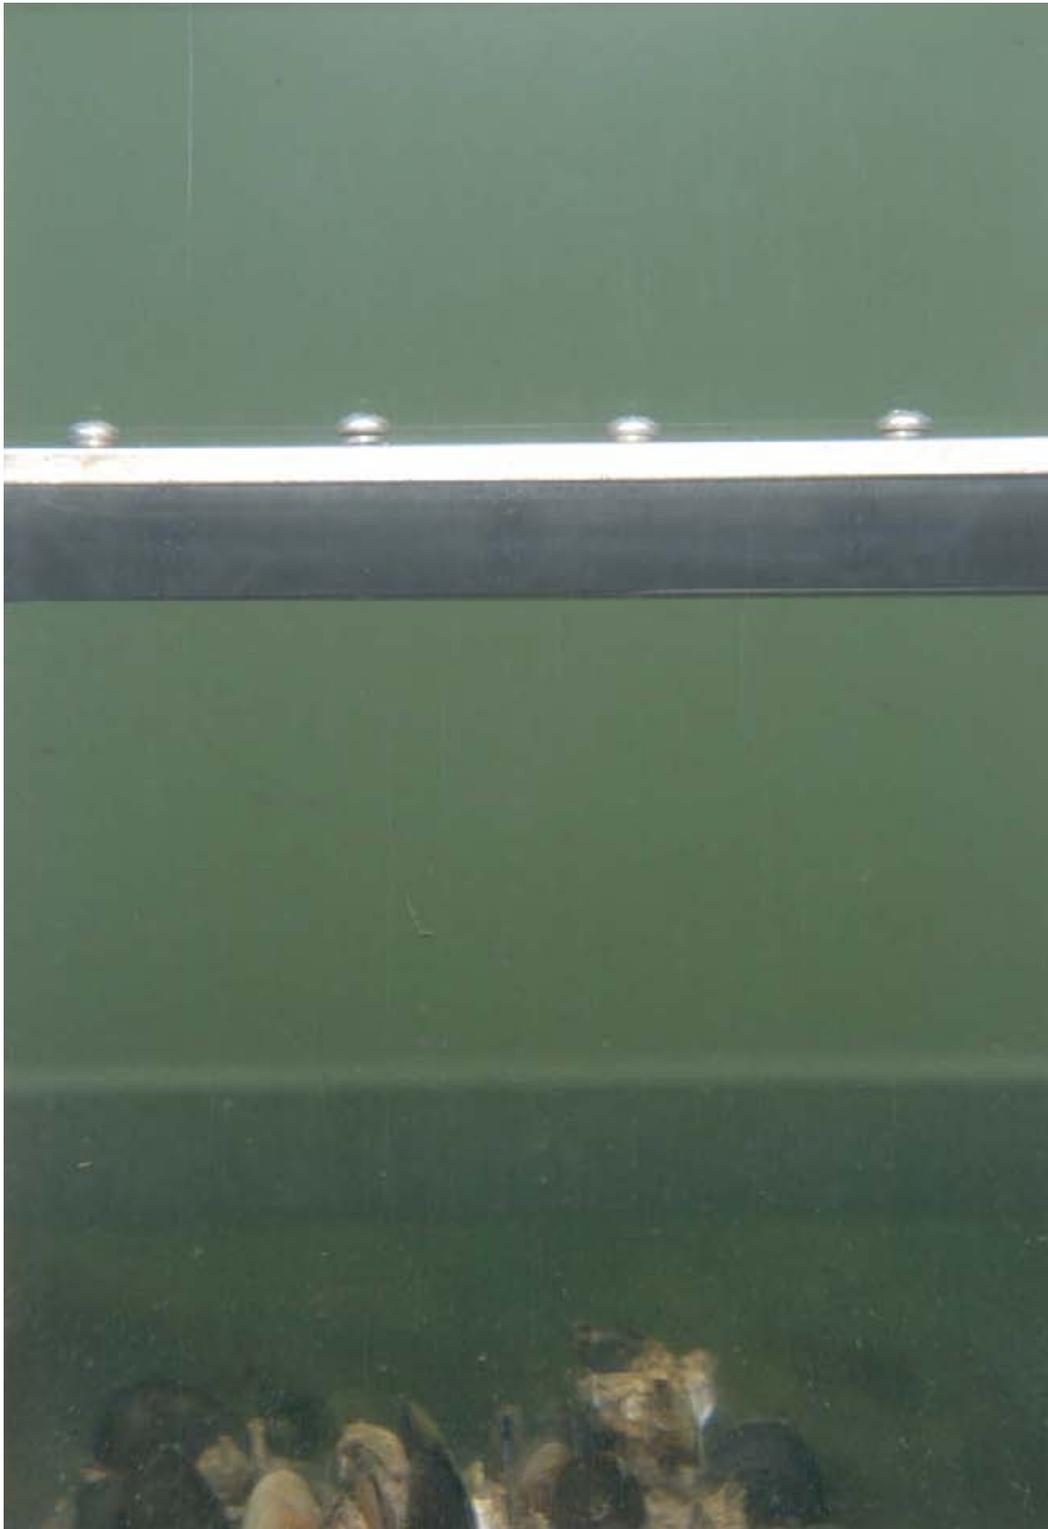
Figure 7: The mussel bed shown in this profile image from Station WC-01 prevented camera prism penetration as well as measurement of any other SPI parameters at this particular location. SCALE: Width of image = 14.3 cm.
