RESULTS OF YEAR 2 OPERATIONS, MAINTENANCE, AND MONITORING PLAN SAMPLING

**Head of the Thea Foss Waterway Remediation,
Tacoma, WA**

**PacifiCorp Environmental Remediation Company
and
Puget Sound Energy**

November 2006

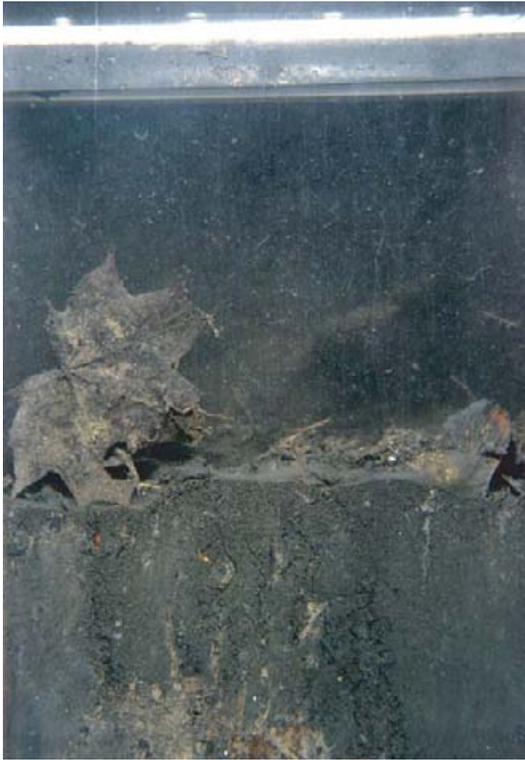
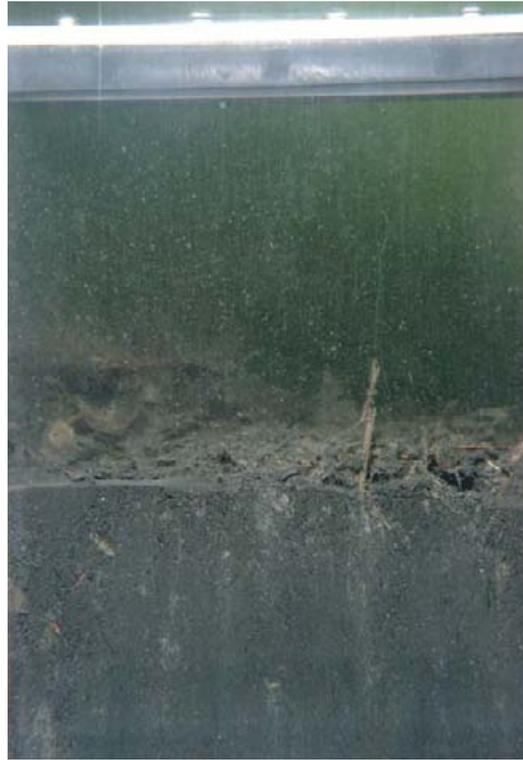
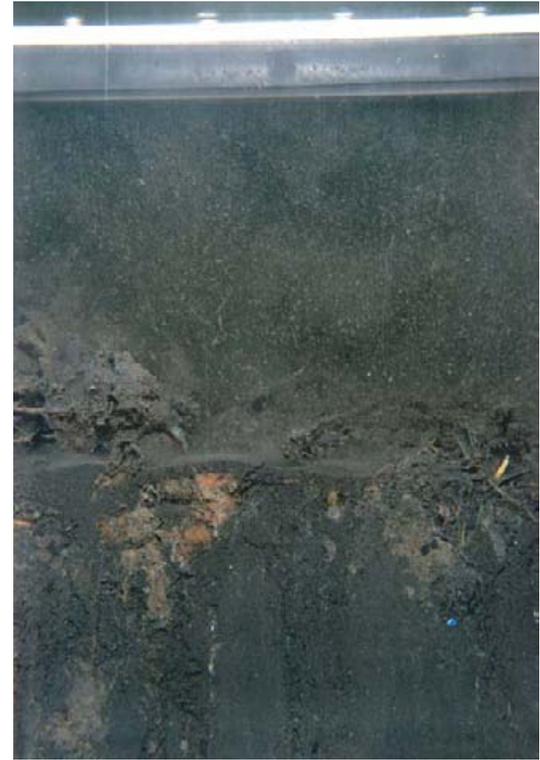
Figure 9: These profile images from Station WC-02 show anoxic mud throughout the entire vertical sediment profile, indicative of high sediment oxygen demand. SCALE: Width of image = 14.3 cm.

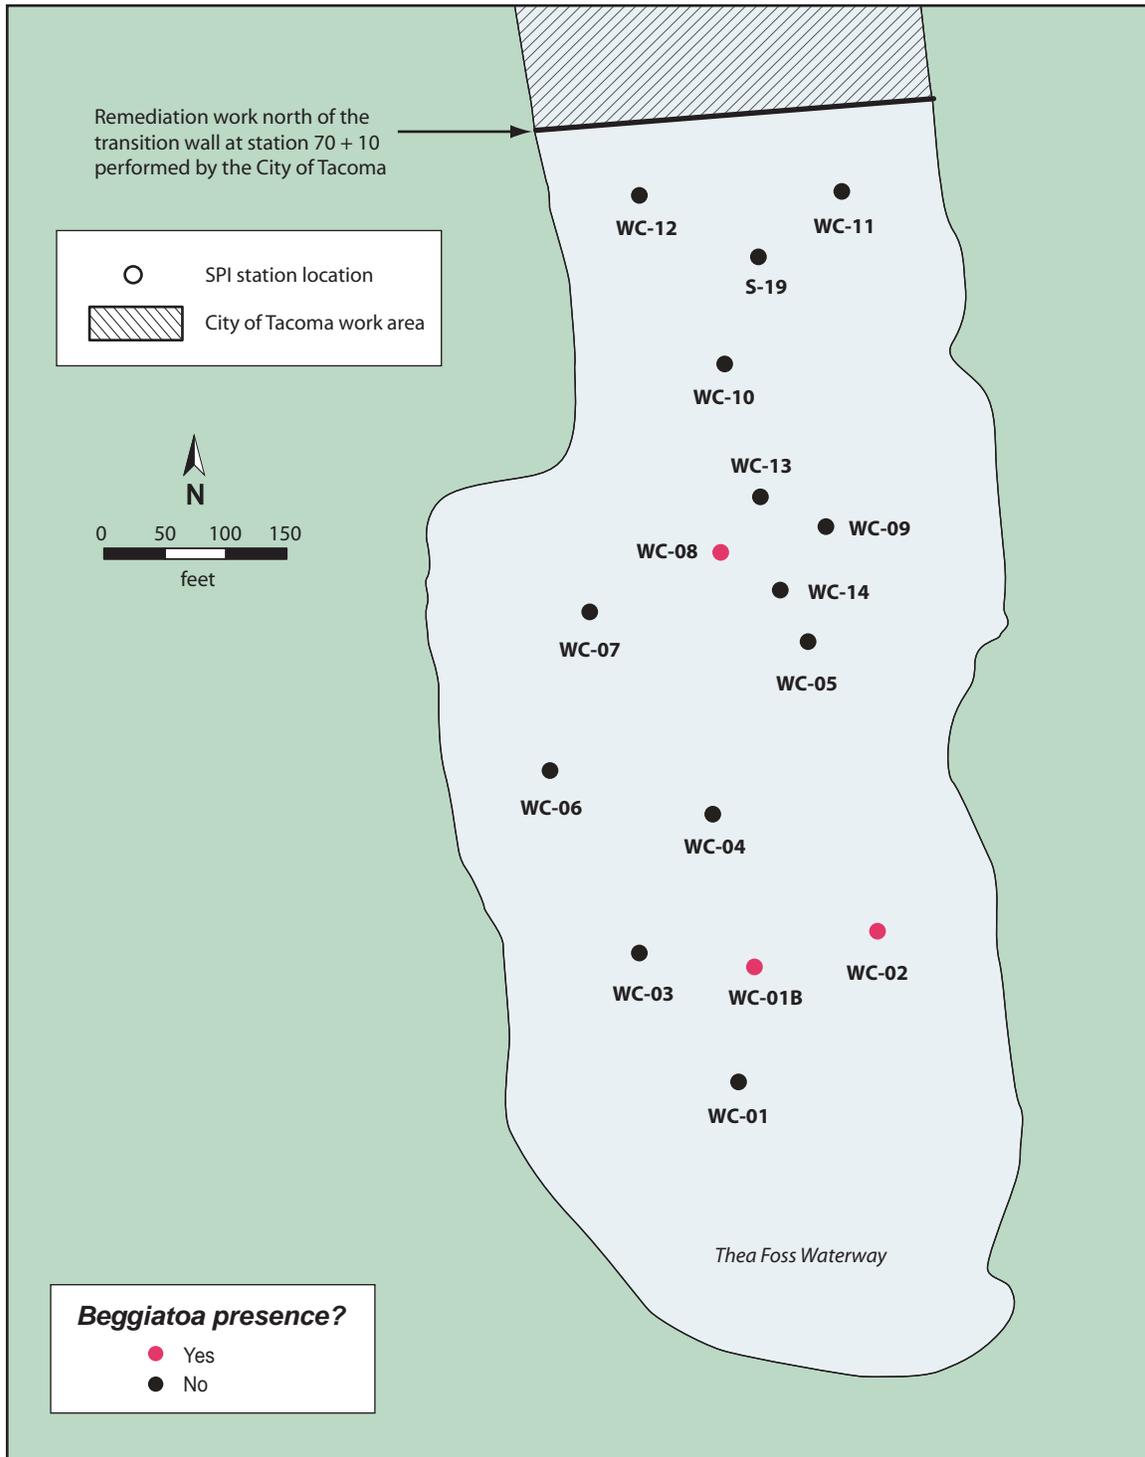
Figure 10: Locations where *Beggiatoa* colonies were found in surface sediments in the Thea Foss Waterway, indicative of low dissolved oxygen concentrations in the benthic boundary layer.

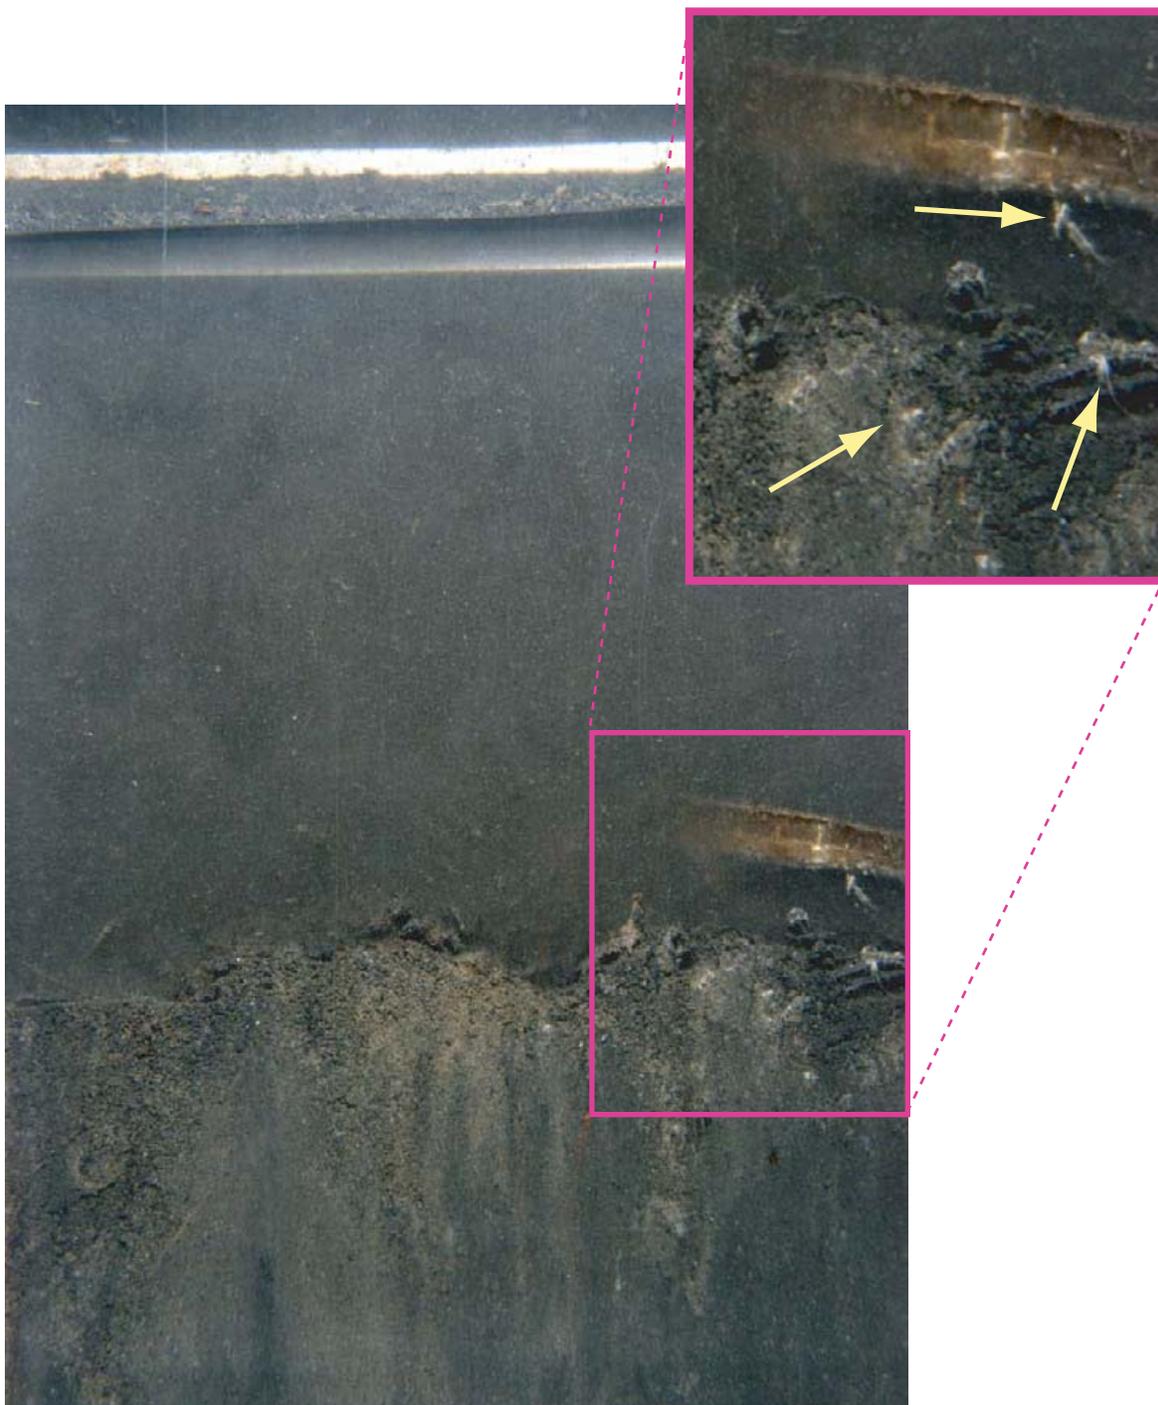
Figure 11: The white patches with string-like wisps at the sediment surface in this profile image from Station WC-01B are colonies of the sulfur-reducing bacteria *Beggiatoa*.

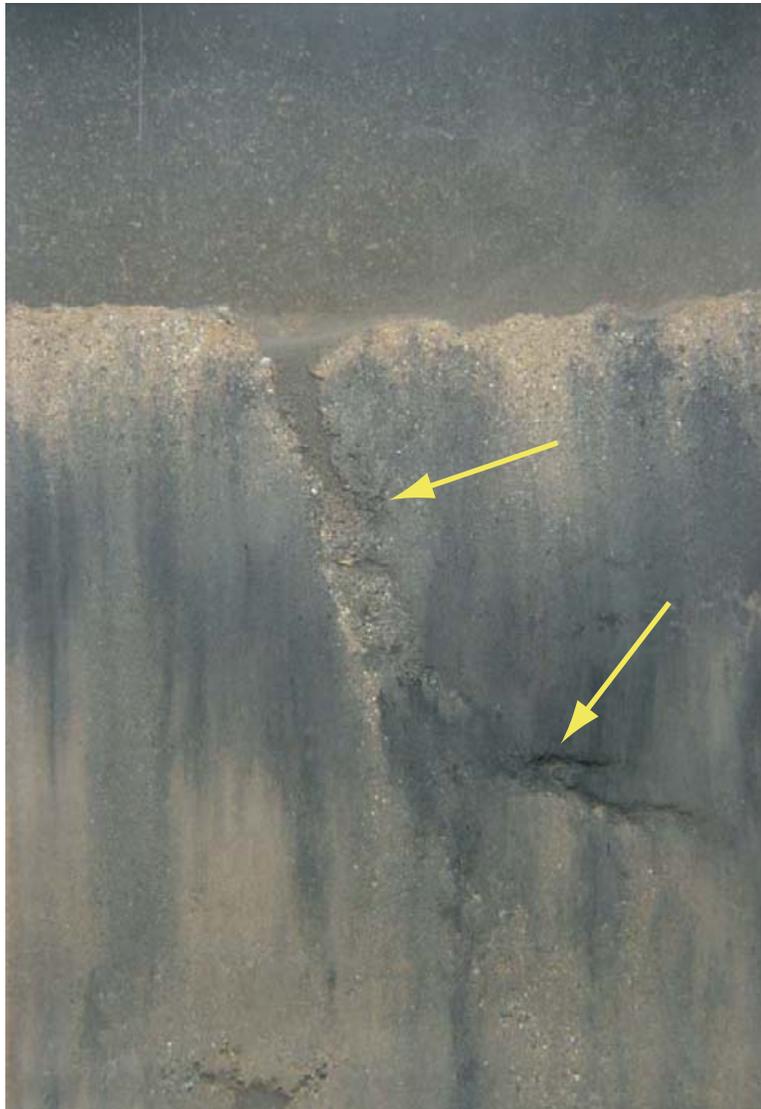
Figure 13: These profile images from Station WC-03 (left) and WC-04 (right) show evidence (arrows) of deposit-feeding infauna (burrows and sub-surface feeding voids). SCALE: Width of image = 14.3 cm.

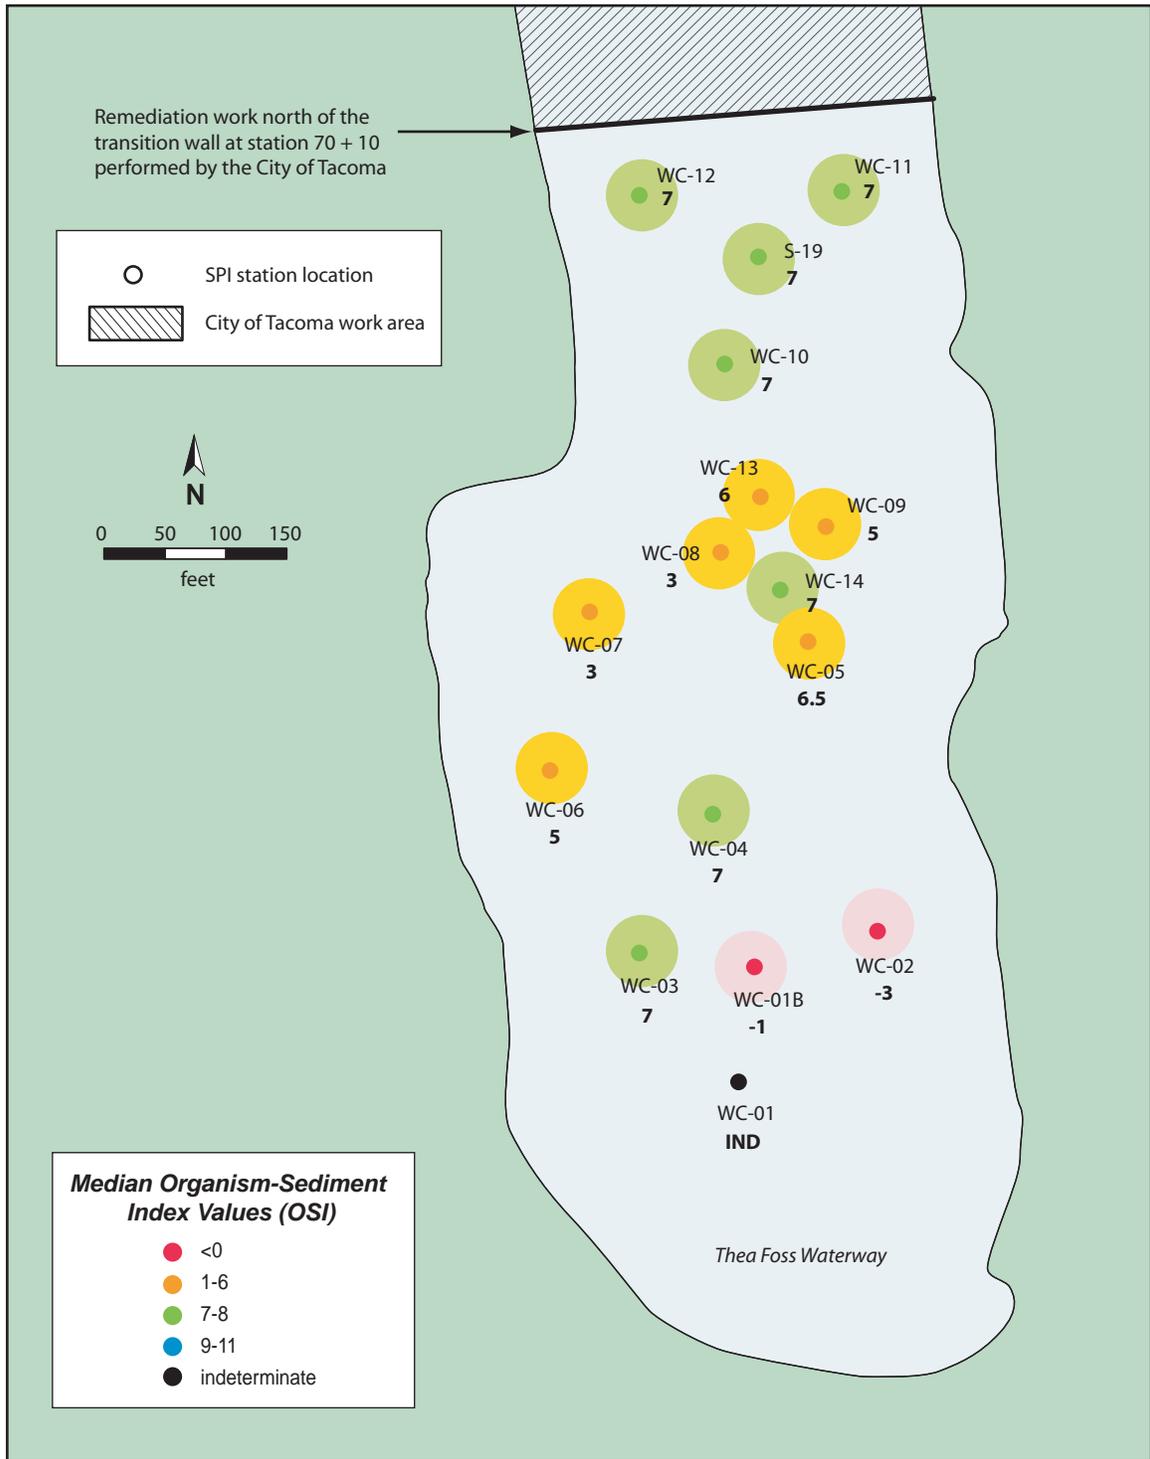
Figure 14: Distribution of median OSI values in the Thea Foss Waterway.

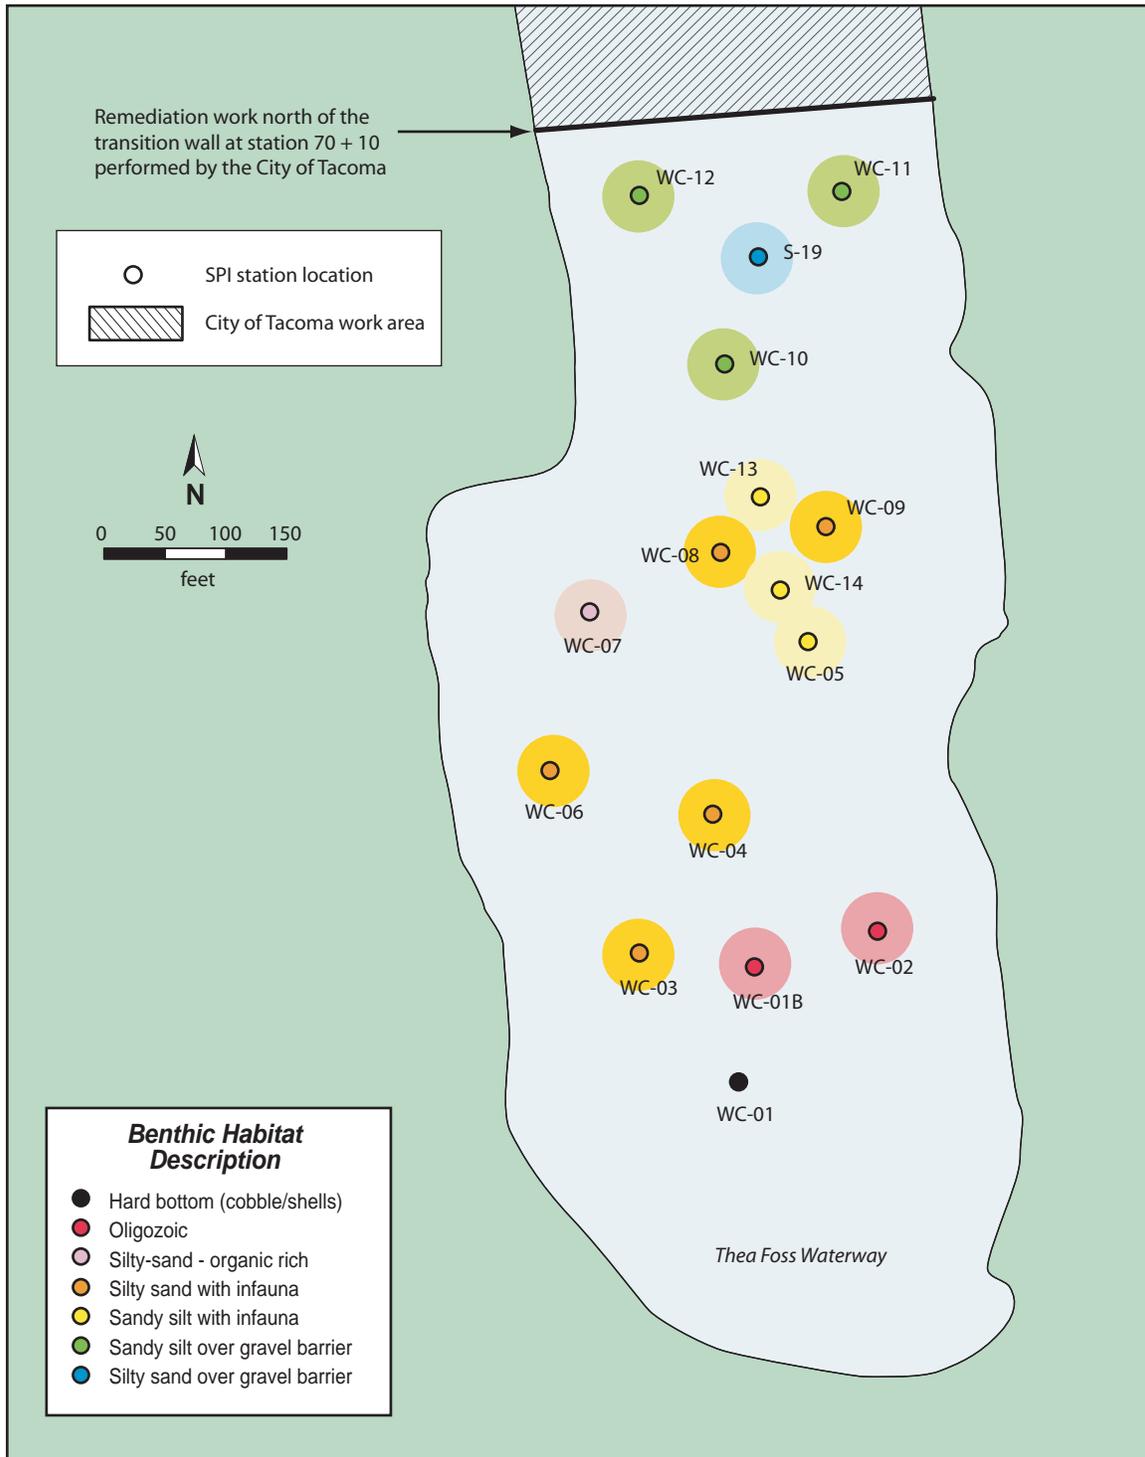
Figure 15: Spatial distribution of benthic habitat based on SPI classification in the Thea Foss Waterway.

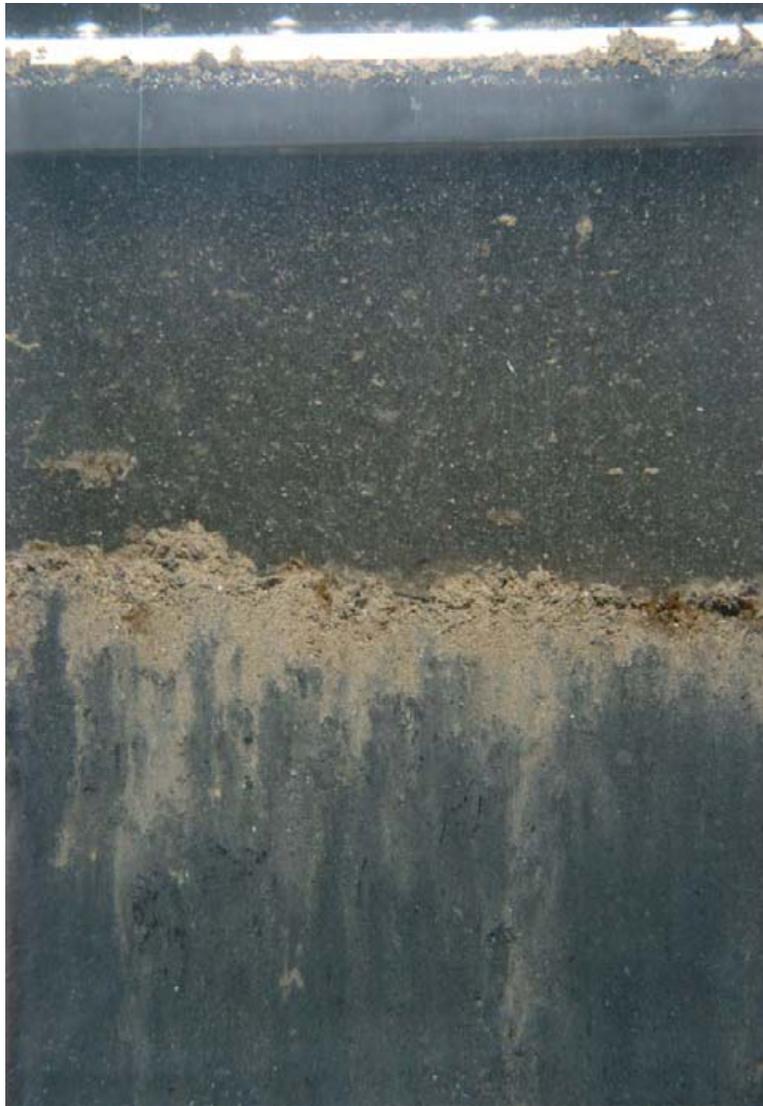
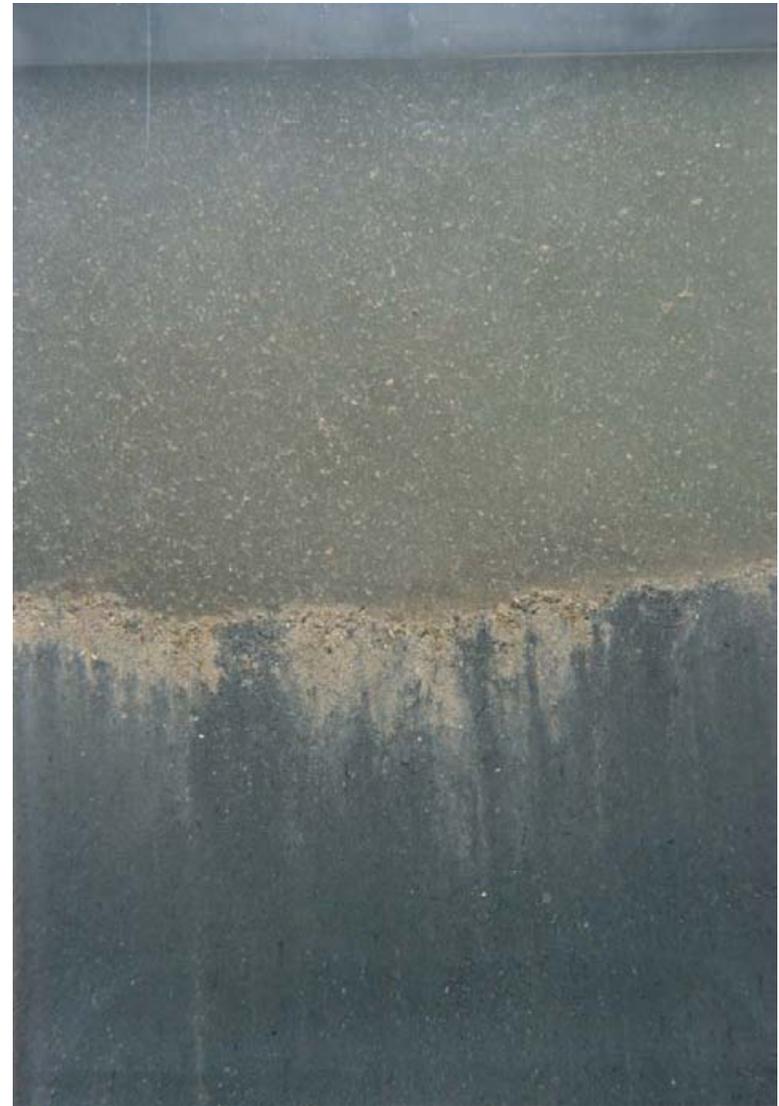
Figure 16: The relatively thin oxidized surface layers and dark subsurface sediments seen in these two profile images from Station WC-07 are indicative of either excessive organic enrichment or high sulfide inventories. SCALE: Width of image = 14.3 cm.

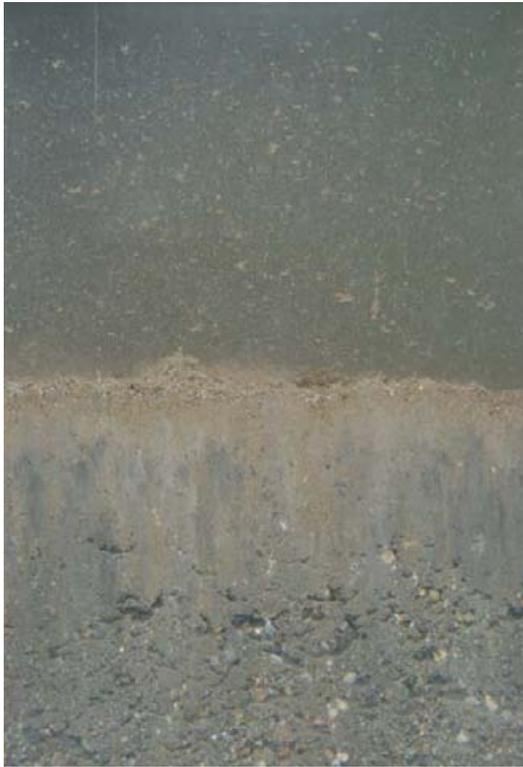
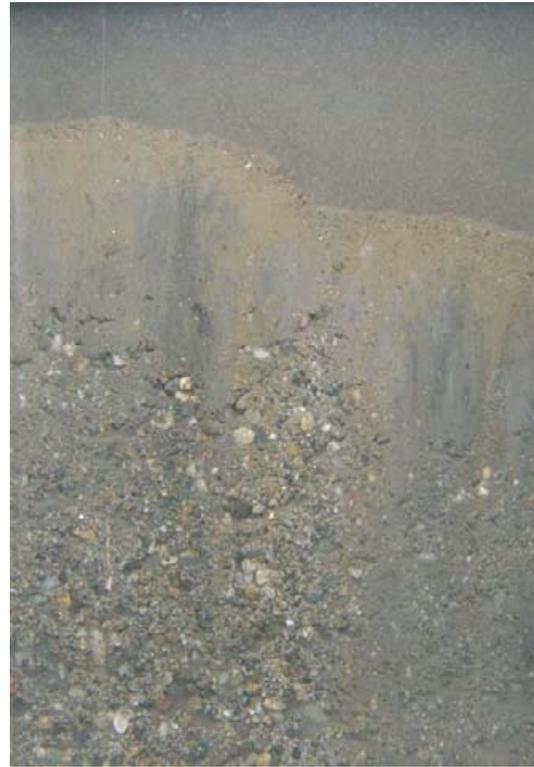
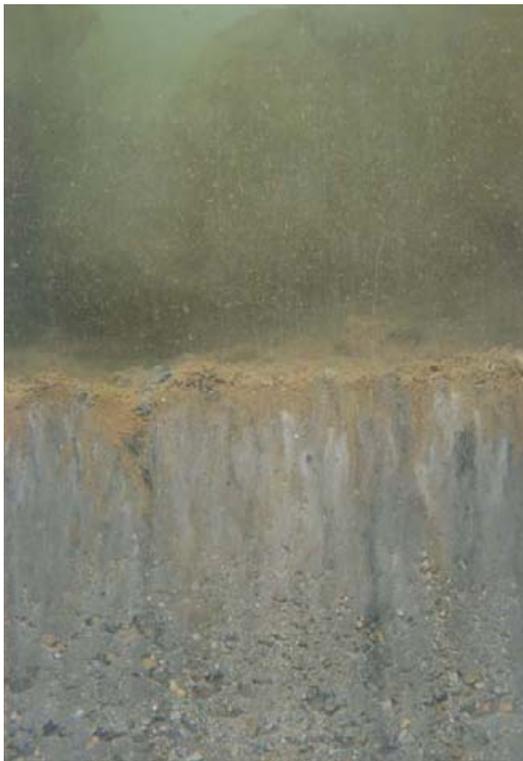
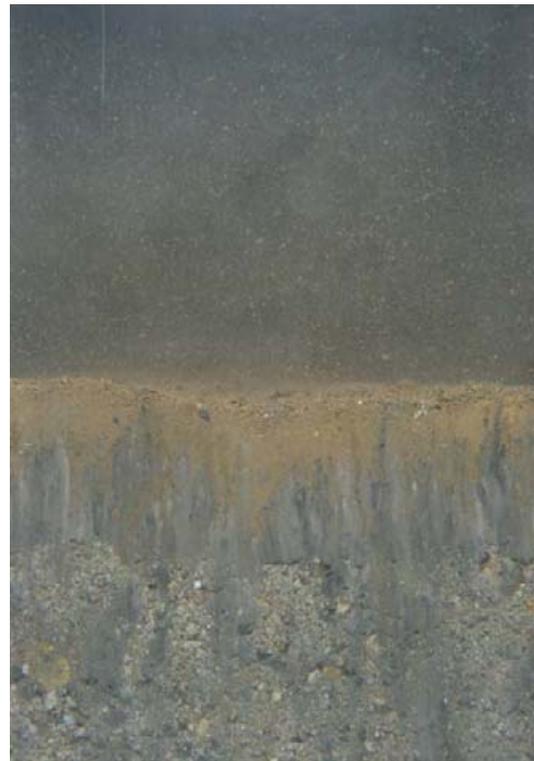
Figure 17: These profile images from the four northernmost stations have the common distinguishing feature of the Thea Foss capping material visible in the bottom half of the image. SCALE: Width of image = 14.3 cm.
