**Re: *Addendum to the Additional Vapor Intrusion Evaluation Report
Former Synertek Building No. 1 Facility
3050 Coronado Drive, Santa Clara, California***

2015 Addendum to the Additional
Vapor Intrusion Evaluation Report,
Former Synertek Building No. 1,
3050 Coronado Drive,
Santa Clara, California

Former Synertek Building No. 1
3050 Coronado Drive
Santa Clara, California

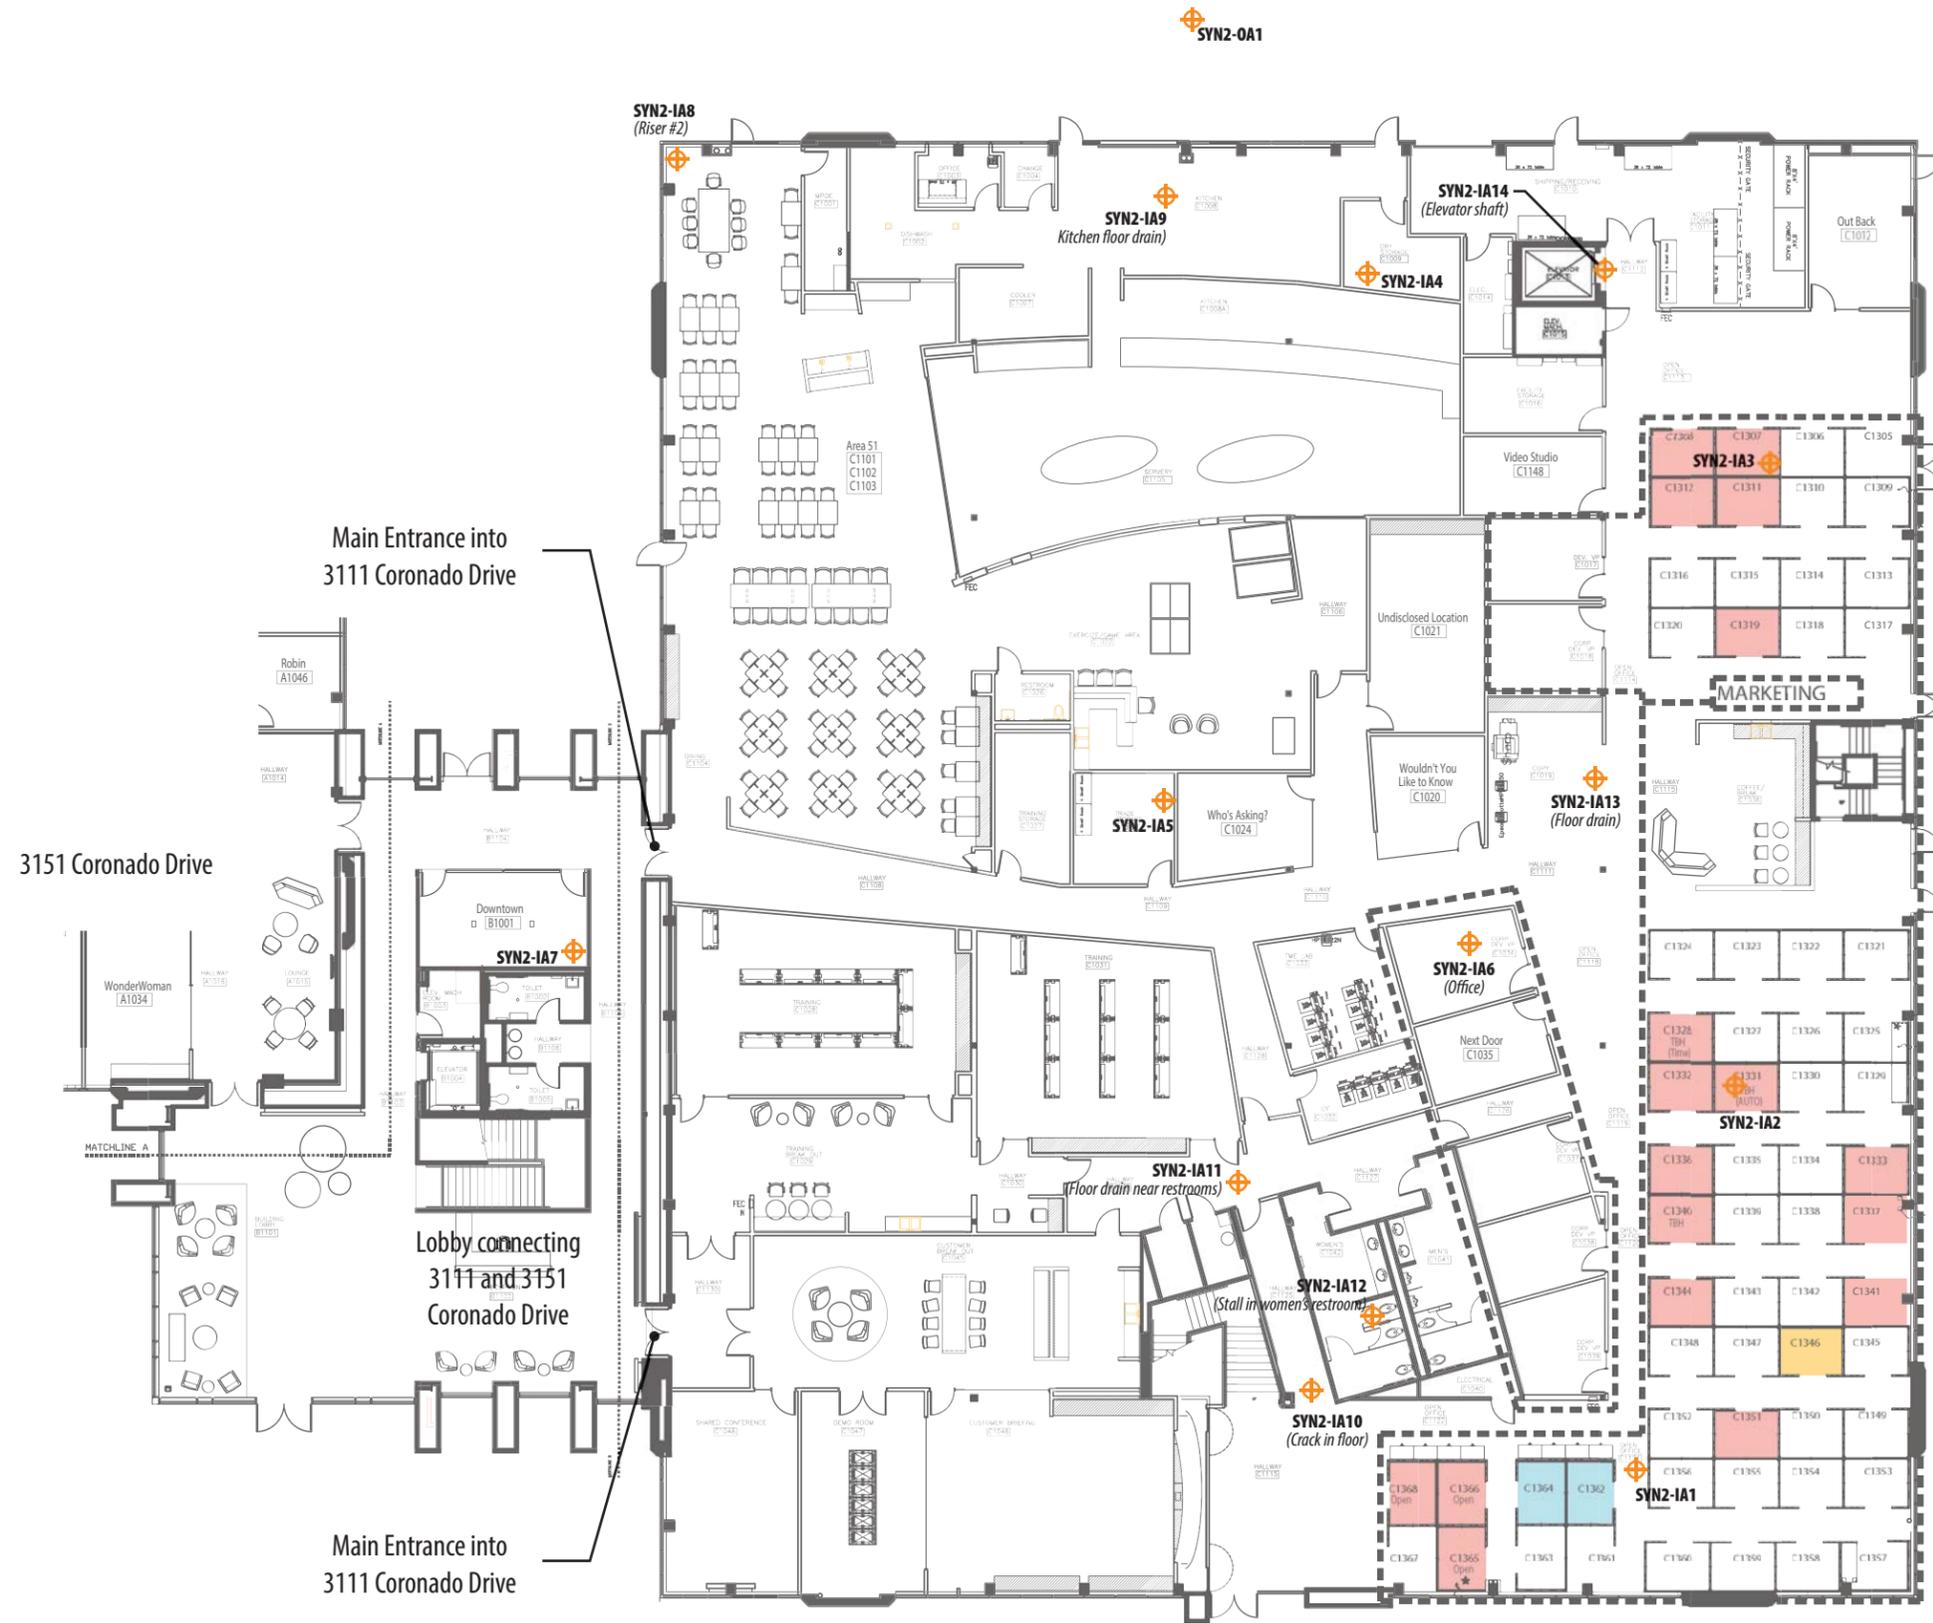
FIGURE 3
Off-site Building (3111 Coronado Drive) –
HAPSITE Sampling Locations, June 2015
 Former Synertek Building 1
 3050 Coronado Drive
 Santa Clara, California

A preliminary HAPSITE screening and pathway sampling with HVAC on was conducted at the 3111 Coronado Drive building on June 30, 2015. Fourteen locations within the Infoblox building were sampled using the HAPSITE in quantification mode (quant mode) (Figure 3). HAPSITE quant mode samples were taken at points that were established as preliminary USEPA Method TO-15 indoor air sample locations. Additionally, pathway samples were taken in locations such as confined areas or rooms that contained conduits, cracks, or penetrations that may have provided a route for VI, as mentioned previously. The USEPA Project Manager approved the locations during a walkthrough of the site while HAPSITE screening was in process. The HVAC-on HAPSITE results are presented in Table 1.

There were no detects of chlorinated VOCs in any of the HAPSITE samples. Following discussion of the sampling results with the Water Board and USEPA, seven sampling locations were identified as shown on Figure 4. A second HAPSITE survey was performed during the HVAC-off sampling event on August 16, 2015. Seven quant mode samples were collected during this event. The samples were co-located with the indoor sample locations (Figure 4) and an outdoor air sample was taken north of the Infoblox building. The HVAC-off HAPSITE results are presented in Table 2. As with the HVAC-on event, there were no detections of chlorinated VOCs in any of the HAPSITE samples.

◆ HAPSITE Air Sampling Location

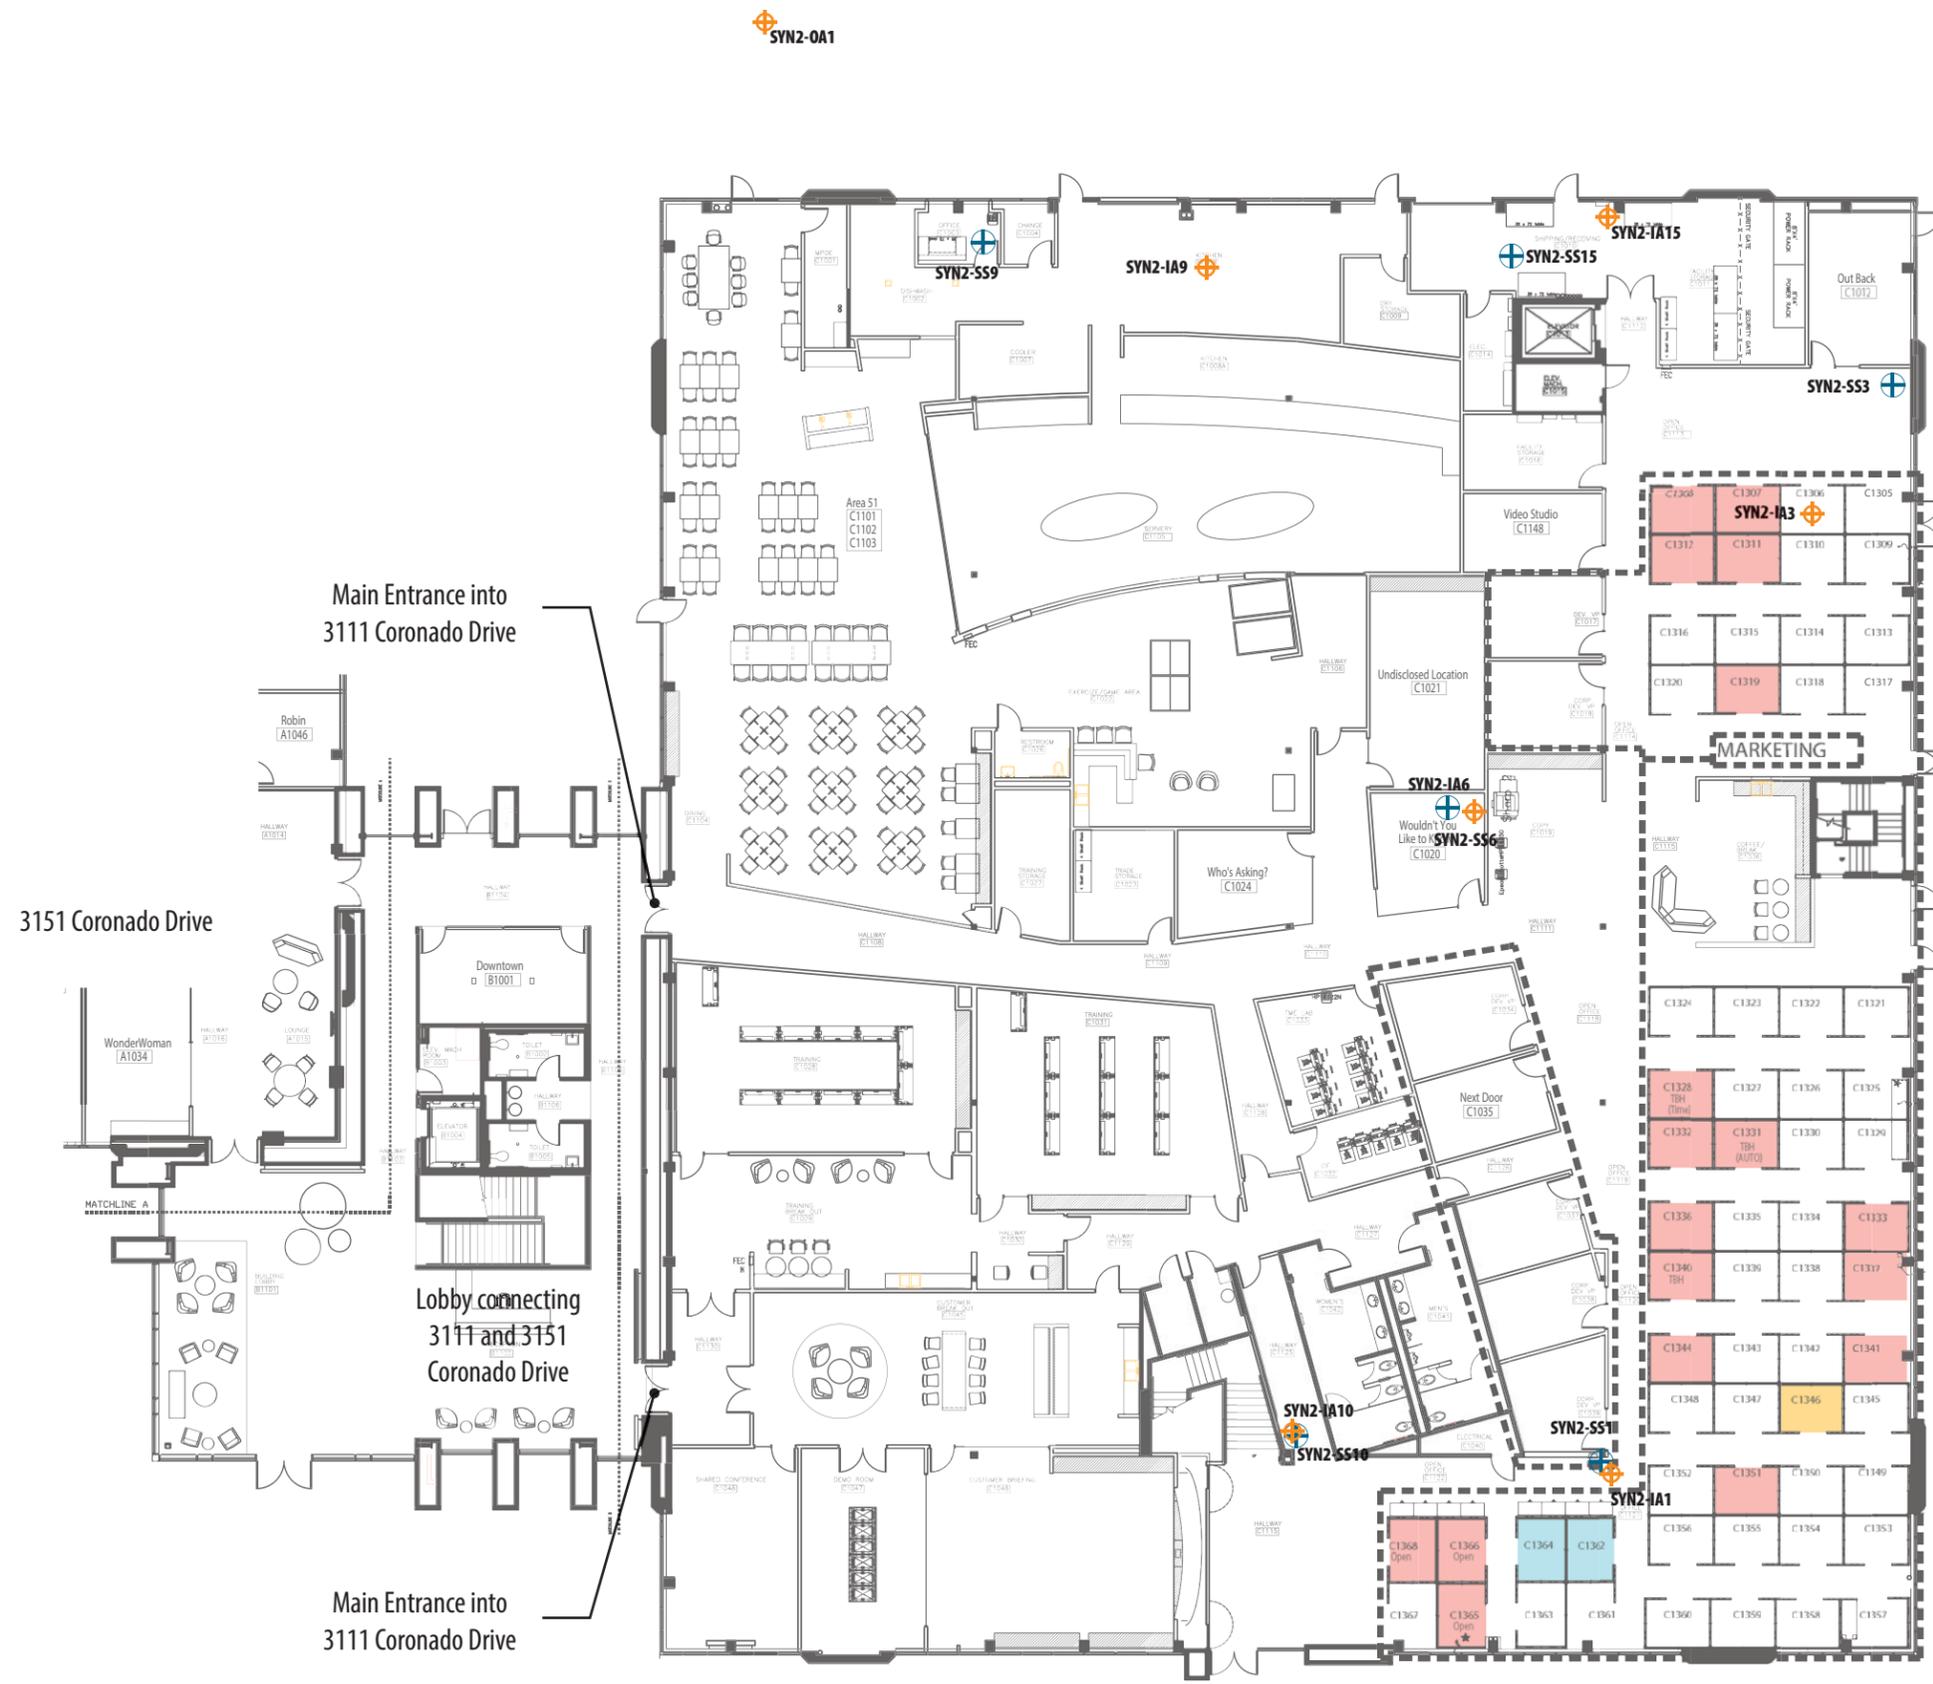
On August 11, 2015, six temporary subslab probes (SYN2-SS1, SYN2-SS3, SYN2-SS6, SYN2-SS9, SYN2-SS10, and SYN2-SS15) were installed, leak tested, and completed with flush-mount covers in the offsite building (Figure 4).

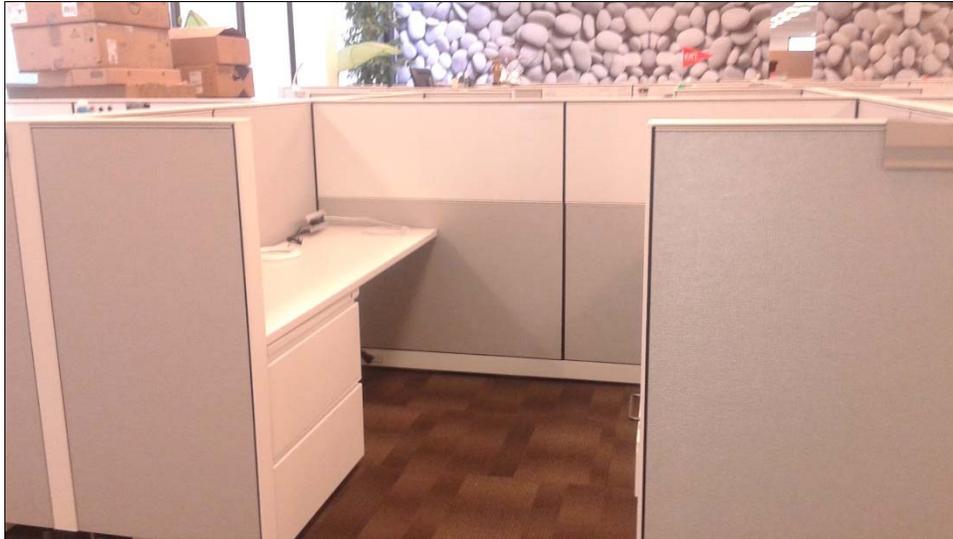
Photo No.	3	Date	06/30/15	View Direction	South
Location of SYN2-IA3, inside a cubicle on northeast corner of building.

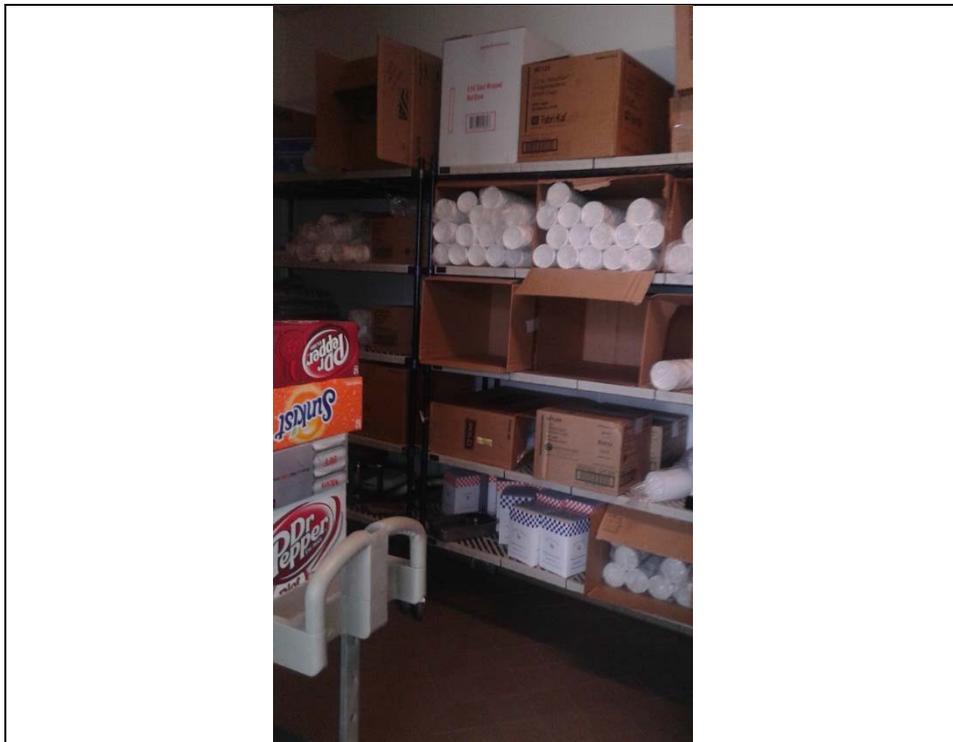
Photo No.	4	Date	06/30/15	View Direction	South
Location of SYN2-IA4, inside storage area near kitchen on north side of building.

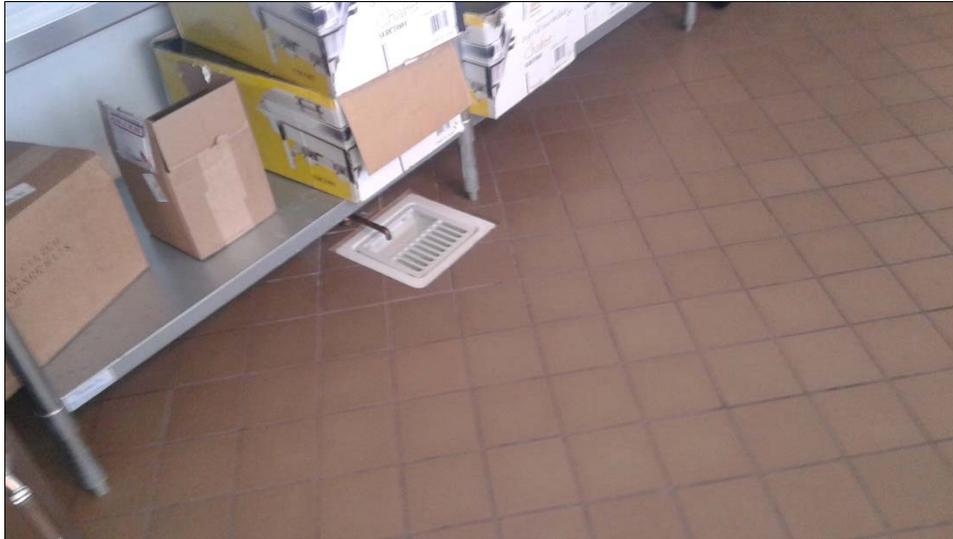
Photo No.	9	Date	06/30/15	View Direction	South
Location of SYN2-IA9, floor drain in kitchen.

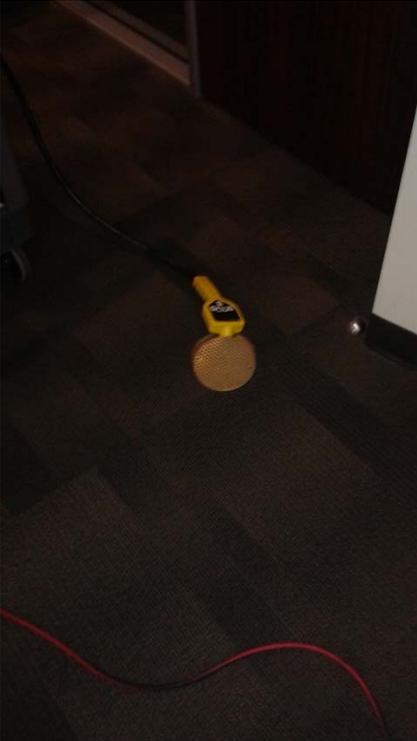
Photo No.	11	Date	06/30/15	View Direction	Northwest
Location of SYN2-IA11, floor drain near restrooms in central part of building.

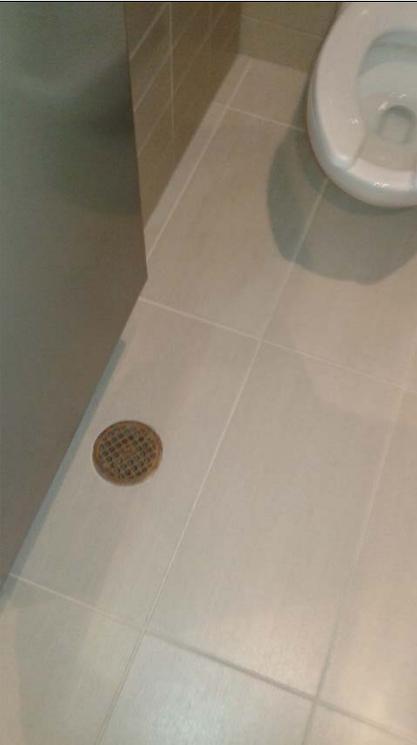
Photo No.	12	Date	06/30/15	View Direction	East
Location of SYN2-IA12, floor drain inside a stall in women's restroom on south side of building.

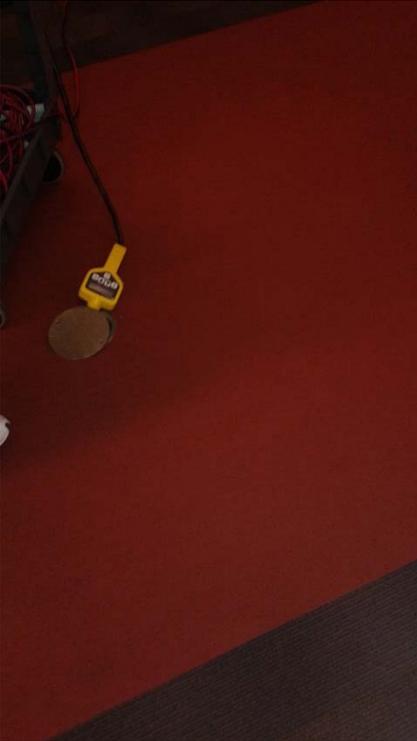
Photo No.	13	Date	06/30/15	View Direction	Northwest
Location of SYN2-IA13, floor drain in office space on east side of building.

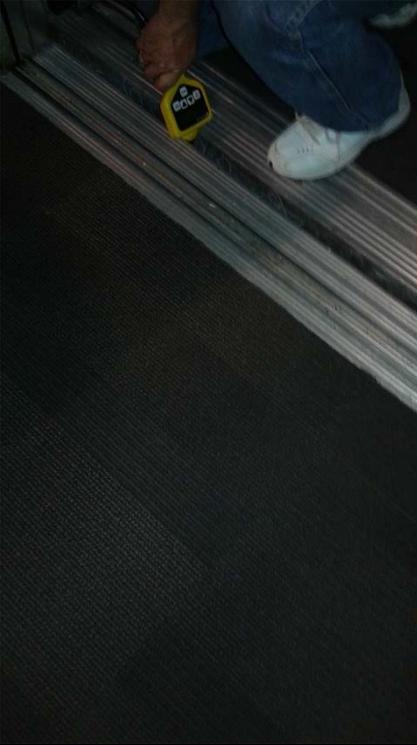
Photo No.	14	Date	06/30/15	View Direction	Southwest
Location of SYN2-IA14, elevator shaft at northeast corner of building.
