# Halaco Engineering Co. Superfund Site: EPA Update

**September 24, 2007**

# Halaco: EPA Update

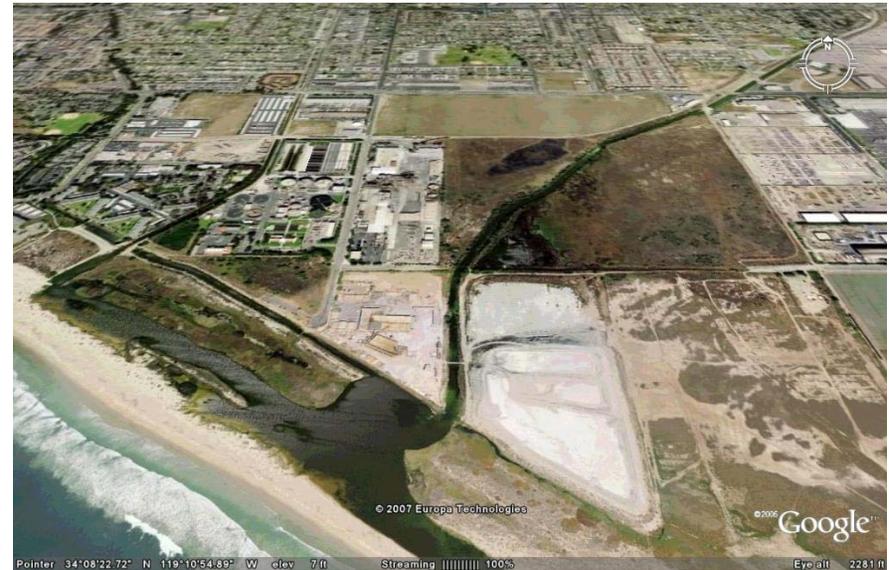
- Halaco operated a metal smelter from 1965 to 2004
- Halaco processed scrap metal to recover aluminum, magnesium, and zinc

- Oxnard Industrial Drain divides the site

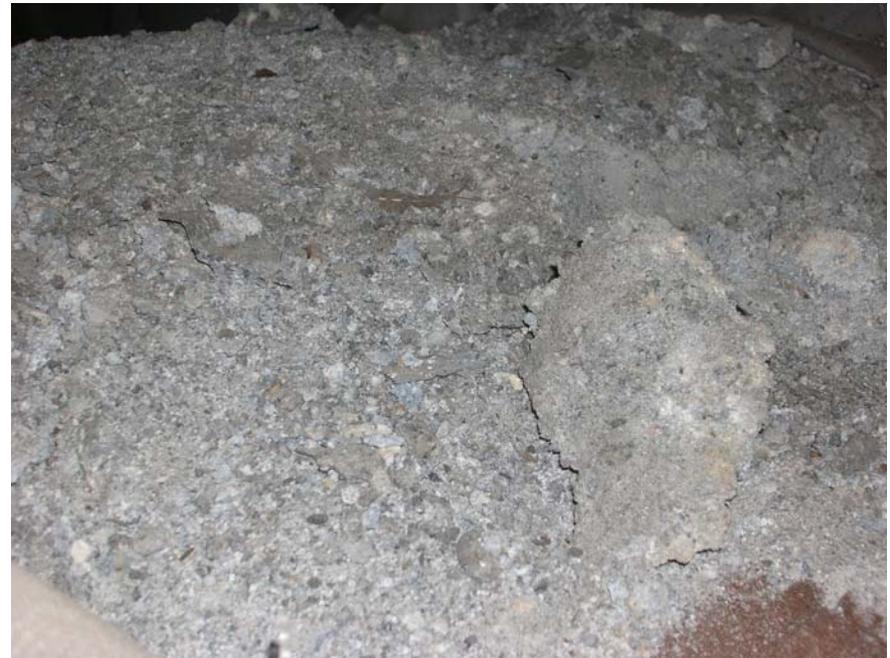
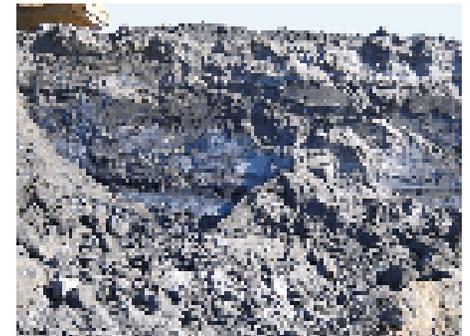
- Halaco generated more than 700,000 cubic yards of waste
- Waste has elevated levels of metals, radioactive thorium
- *Elevated levels do not necessarily mean unsafe levels*

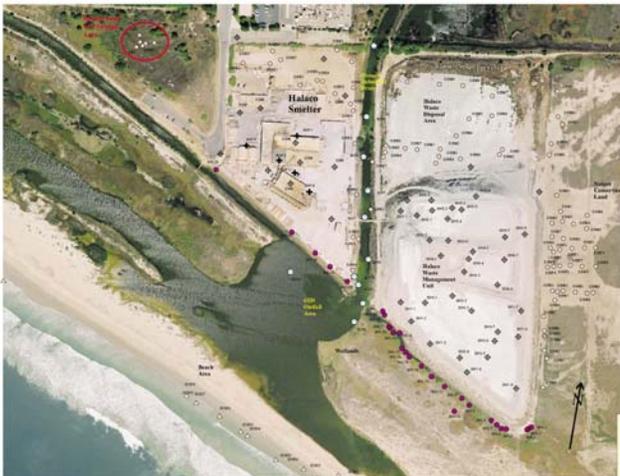
Figure 3-2: Solid Matrix Sample Locations Near Site  
Halaco Engineering Company  
Integrated Assessment Draft Report  
January 2007

- Surface Sediment Sample (SSF)
- Residential (SR) and Agricultural (SA) Samples
- Soil Sample (SSH)
- ◇ Soil Boring Location (SBL)
- Wetlands Sediment Sample (SWL)
- △ Beach Sediment Sample (SDB)
- Marine Sediment Sample (SOM)
- ✦ Waste Samples from Smelter Area

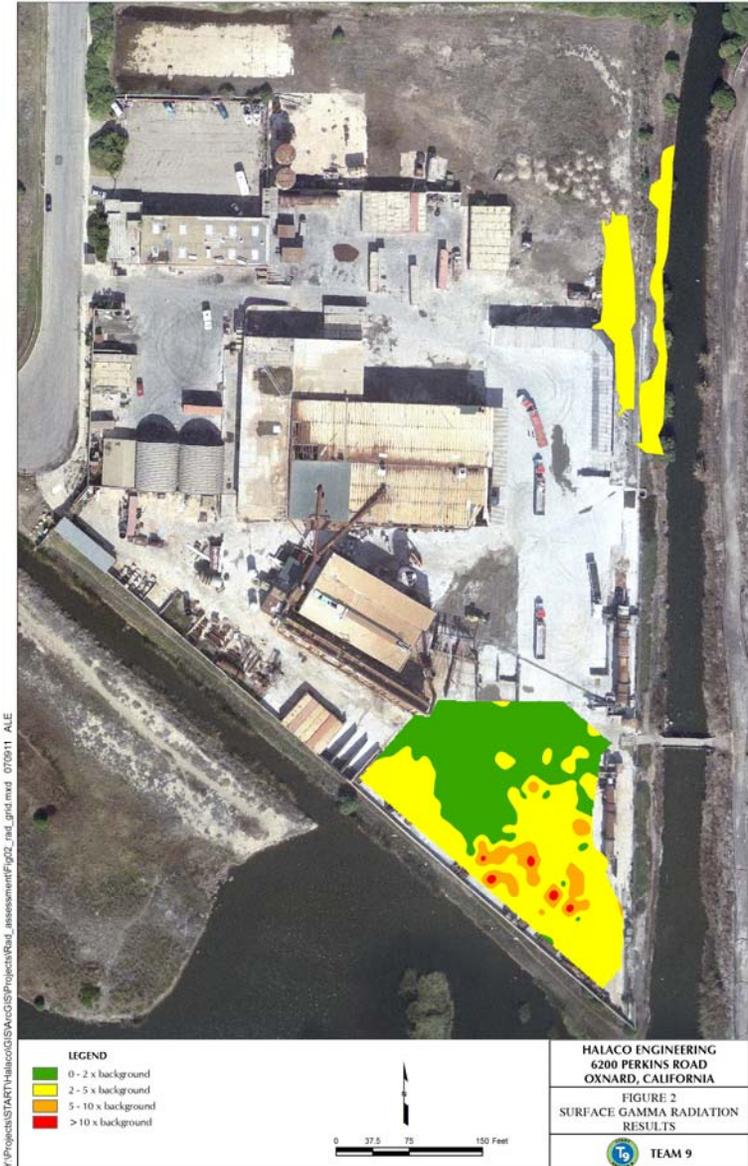
FIGURE 2  
SURFACE GAMMA RADIATION  
RESULTS

- LEGEND
- 0 - 2 x background
  - 2 - 5 x background
  - 5 - 10 x background
  - > 10 x background

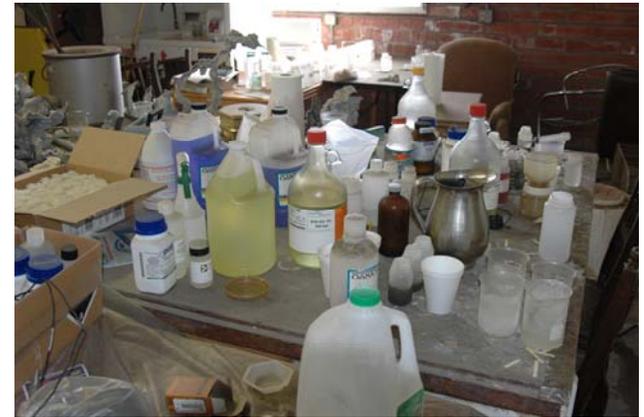
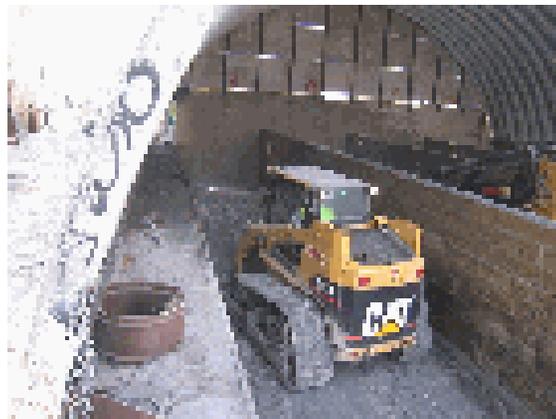
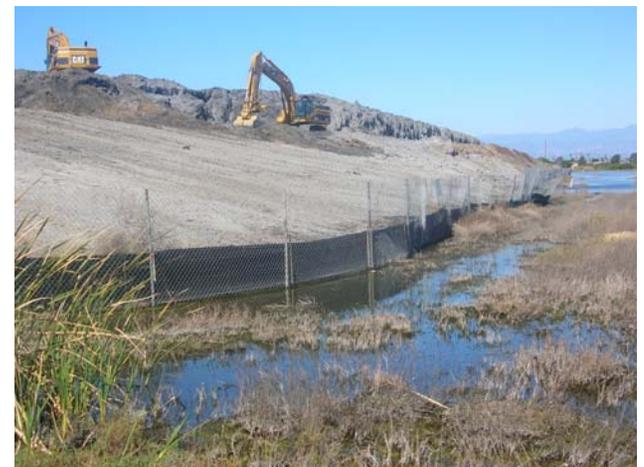
- In 2006, site owners removed drums and chemicals
- In 2007, EPA took further action to:
  - stabilize the waste pile
  - remove wastes from wetlands
  - improve site security
