2008 ANNUAL PROGRESS REPORT

**Former Fairchild Building 19
369/441 Whisman Road
Middlefield-Ellis-Whisman Study Area
Mountain View, California**

Schlumberger Technology Corporation
225 Schlumberger Drive
Sugar Land, TX 77478

June 15, 2009

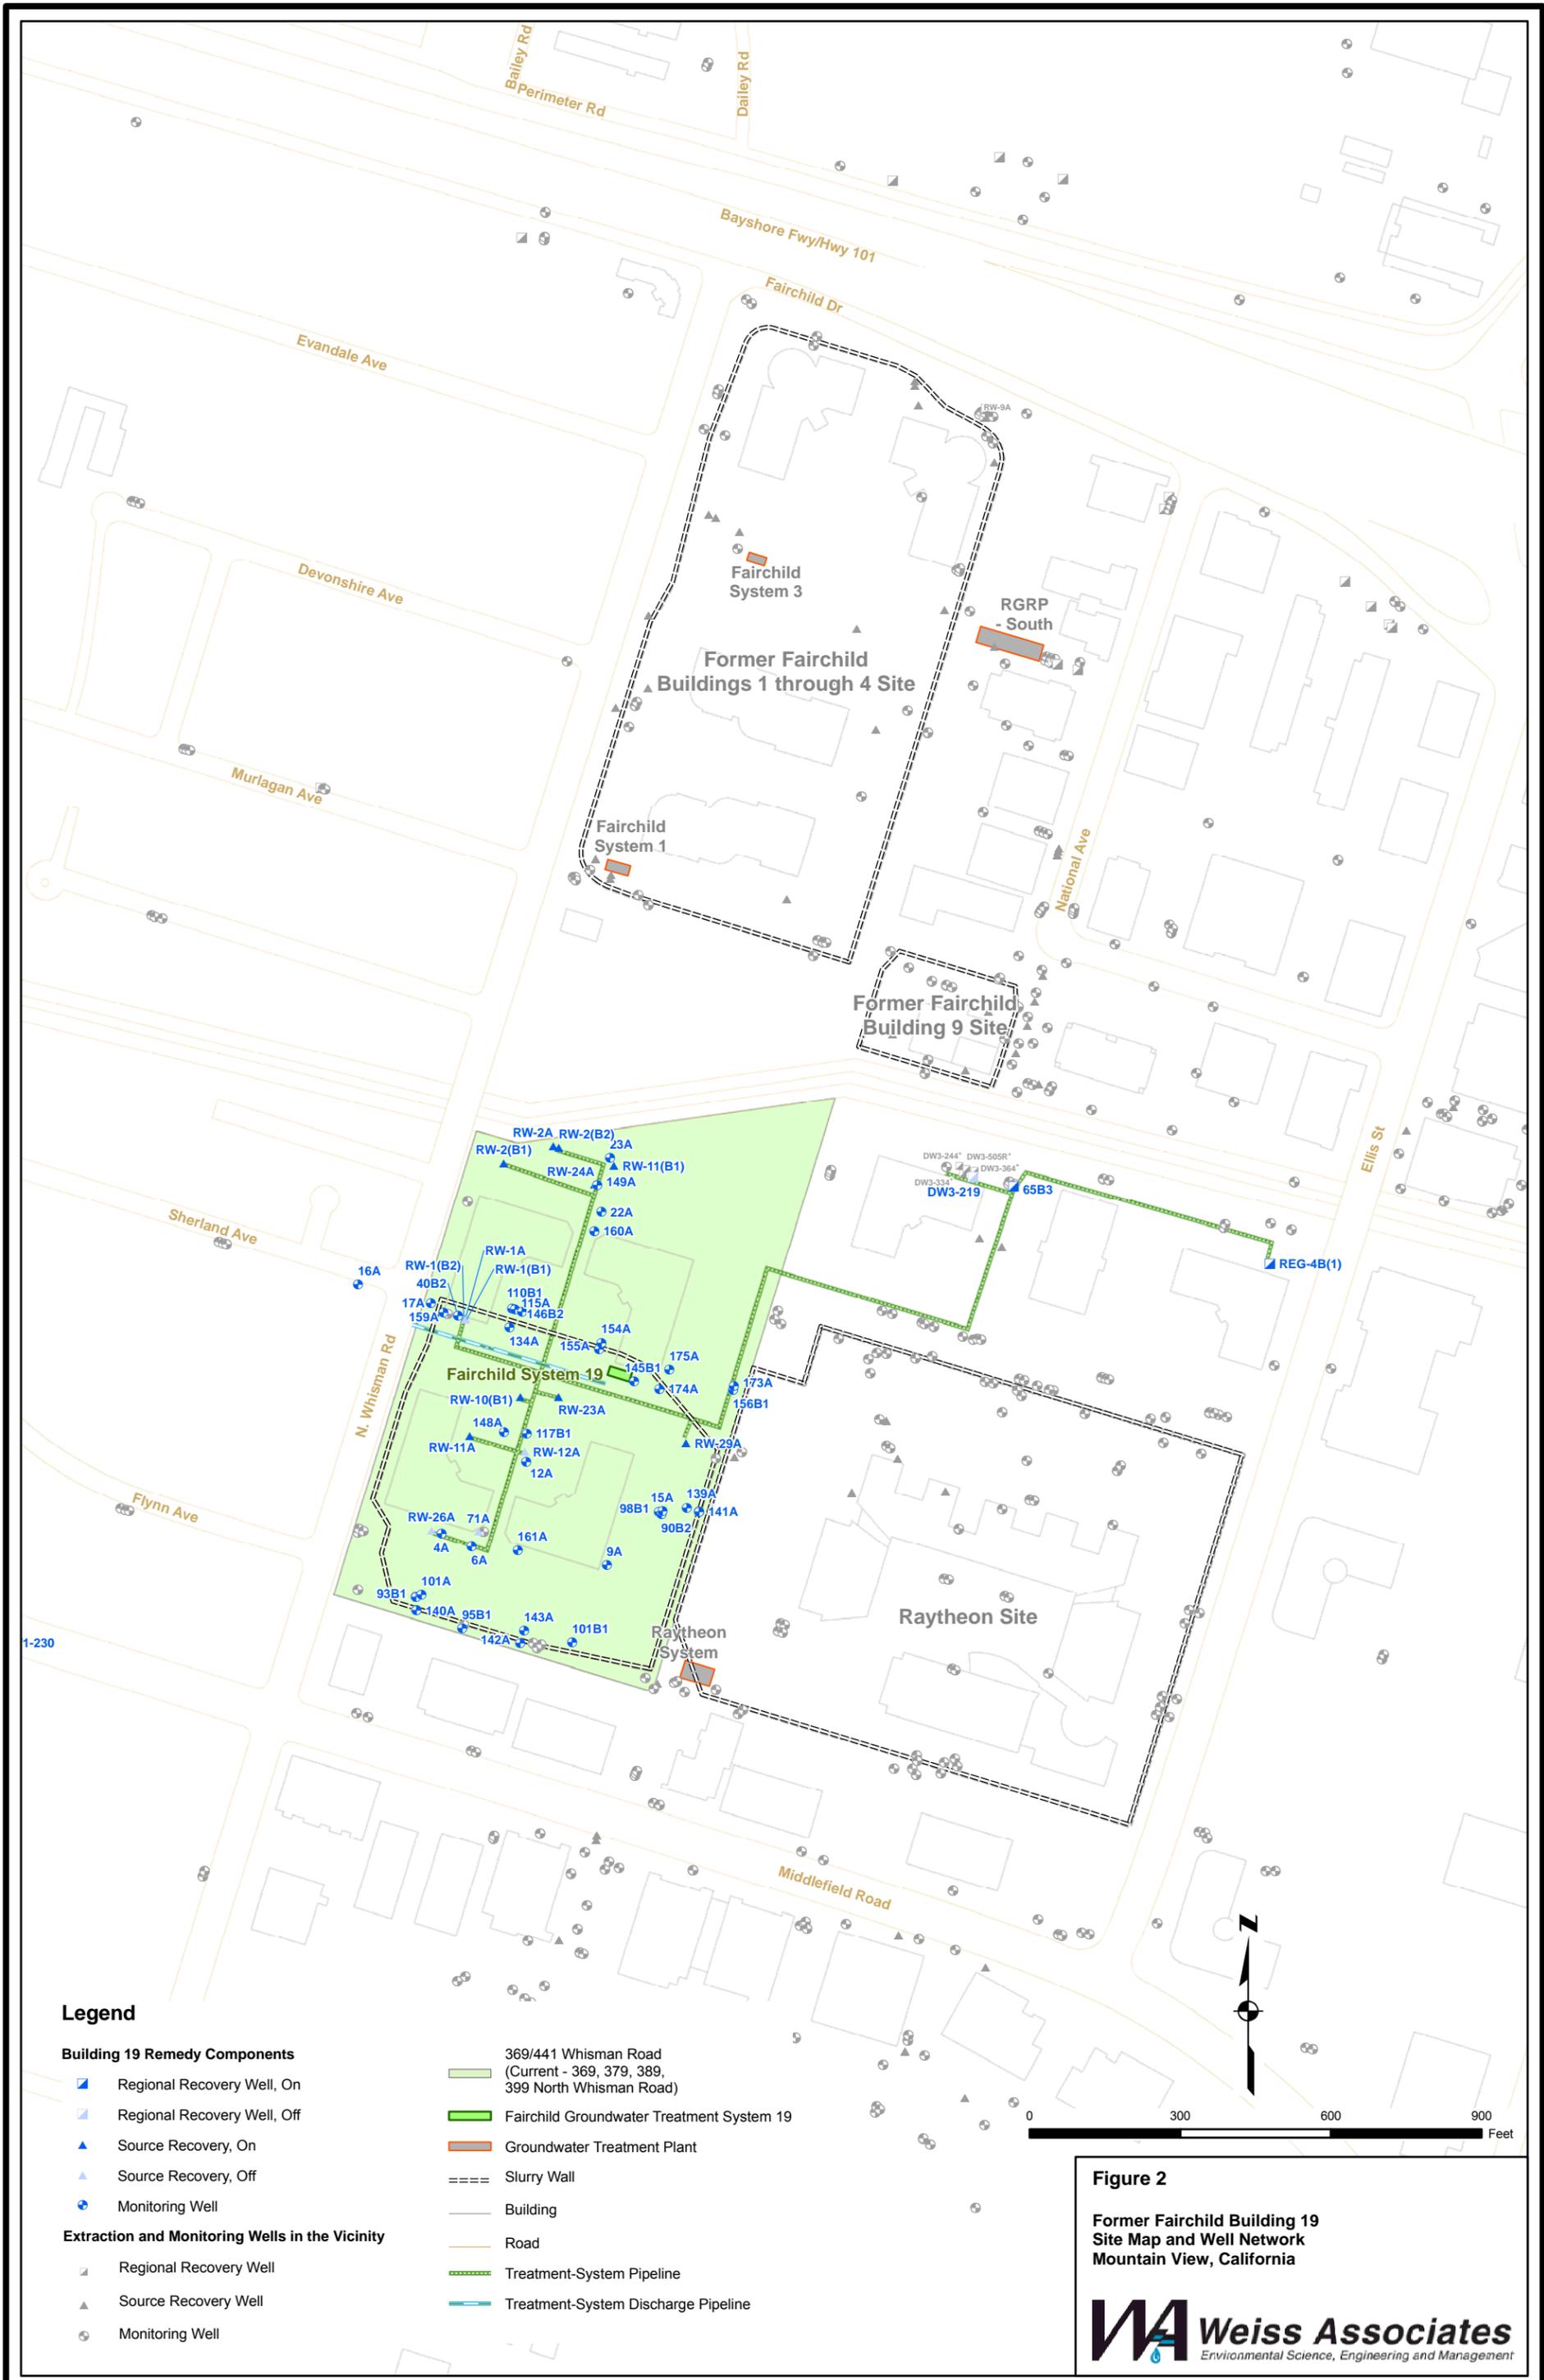
Figure 2

**Former Fairchild Building 19
Site Map and Well Network
Mountain View, California**

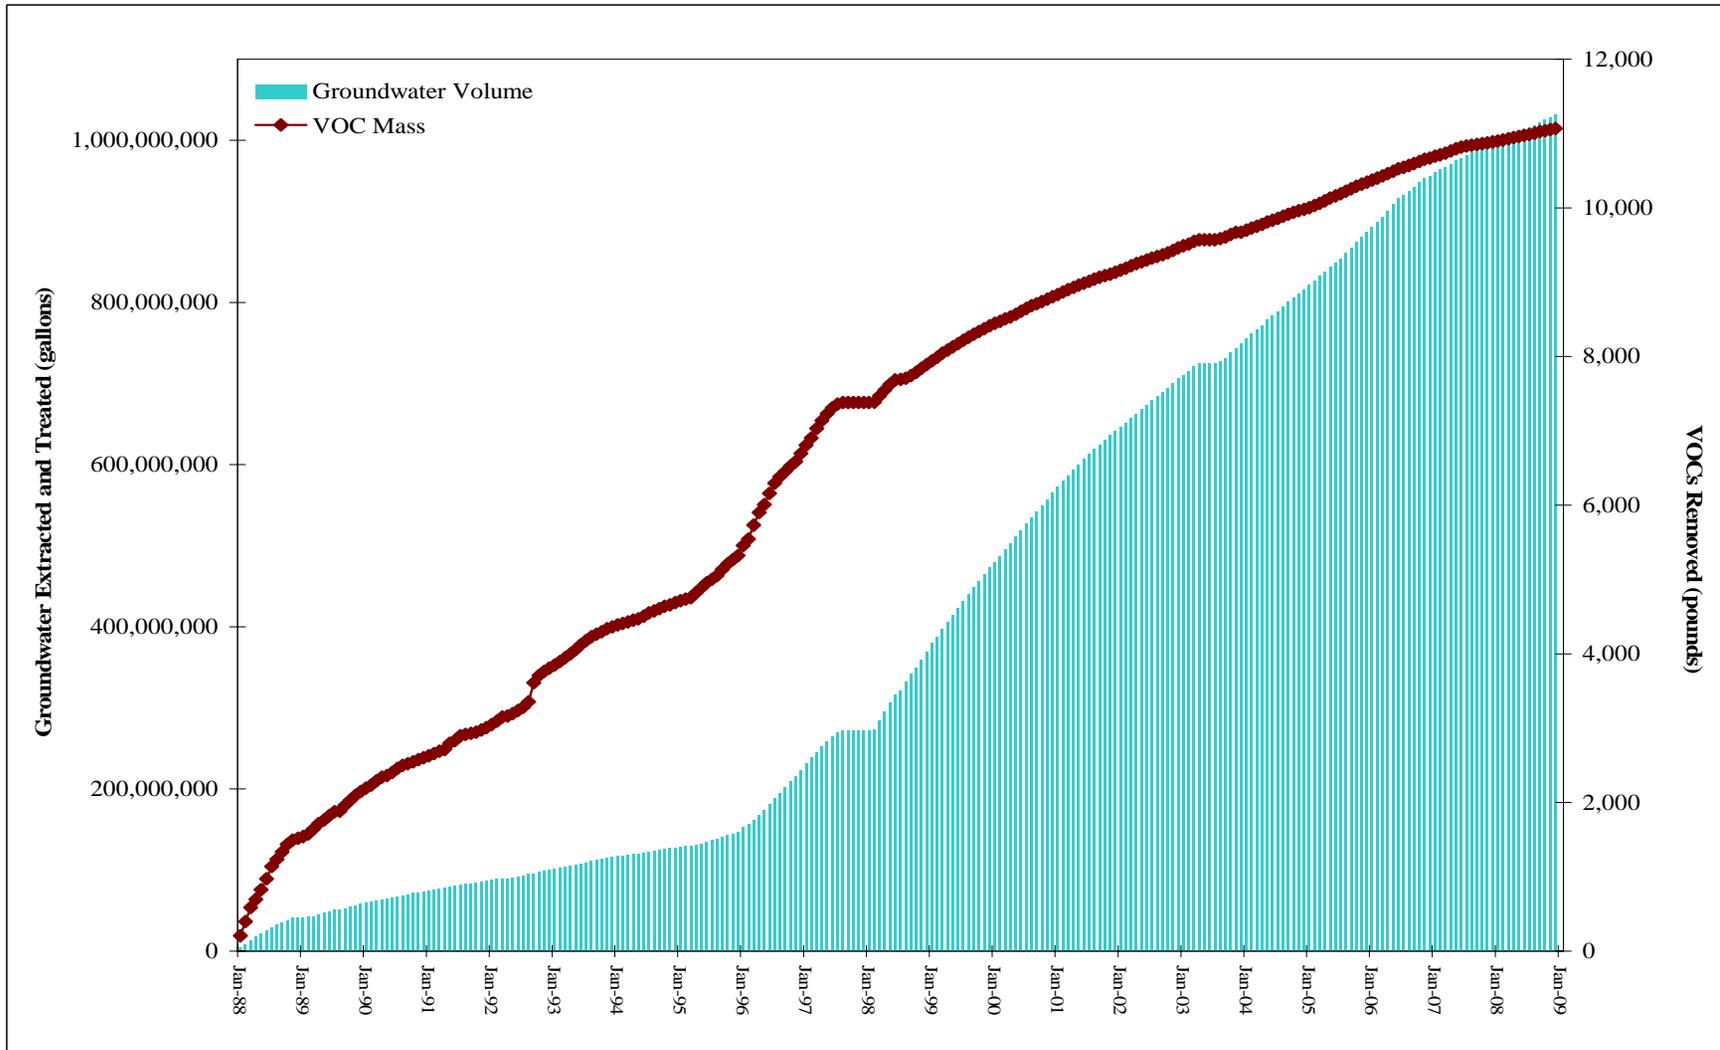
Figure 3. Cumulative Groundwater Extracted and VOC Mass Removed, System 19, 369 Whisman Road, Mountain View, California

Groundwater Treatment: During 2008, System 19 treated approximately 35.6 million gallons of groundwater, and 180 pounds of VOCs removed from groundwater. System 19 operated in full compliance with the permit discharge limitations specified in Regional Water Quality Control Board, San Francisco Bay Region Order Number R2-2004-0045, permit number CAG912003. From January 1 through December 31, 2008, the groundwater treatment system operated 96% of the time. Extraction wells RW-1A, 71A, RW-12A and RW-26A were shut down with approval from USEPA in August 2007¹ as part of the Fairchild Building 1-4 slurry wall evaluation (Northgate; 2006, 2007a, 2007b, 2008a) and remained offline in 2008.

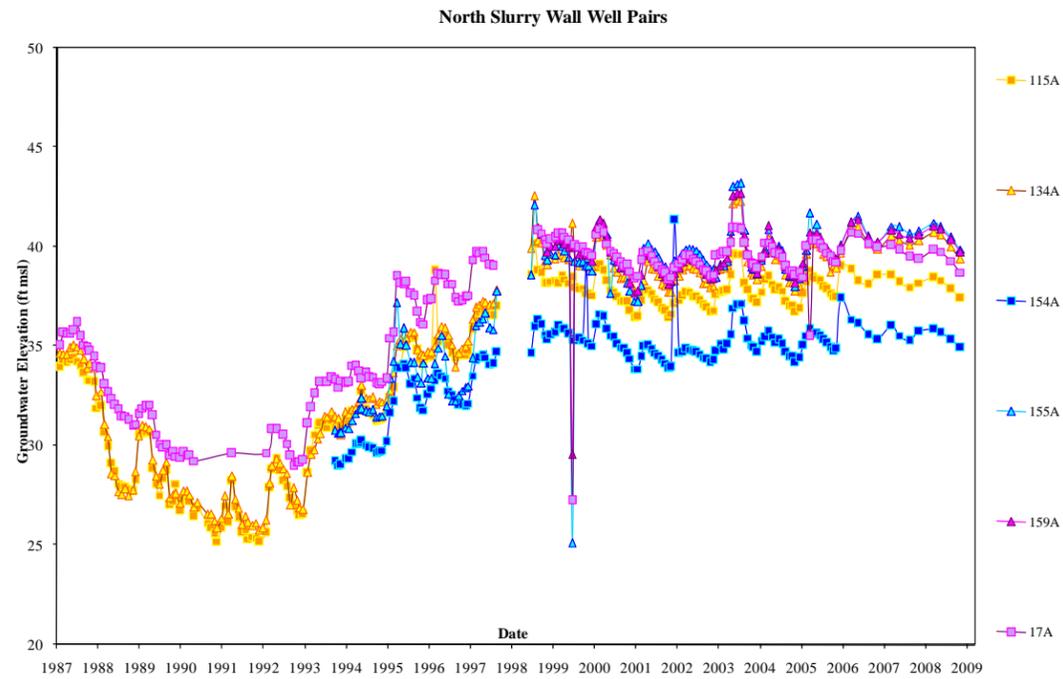
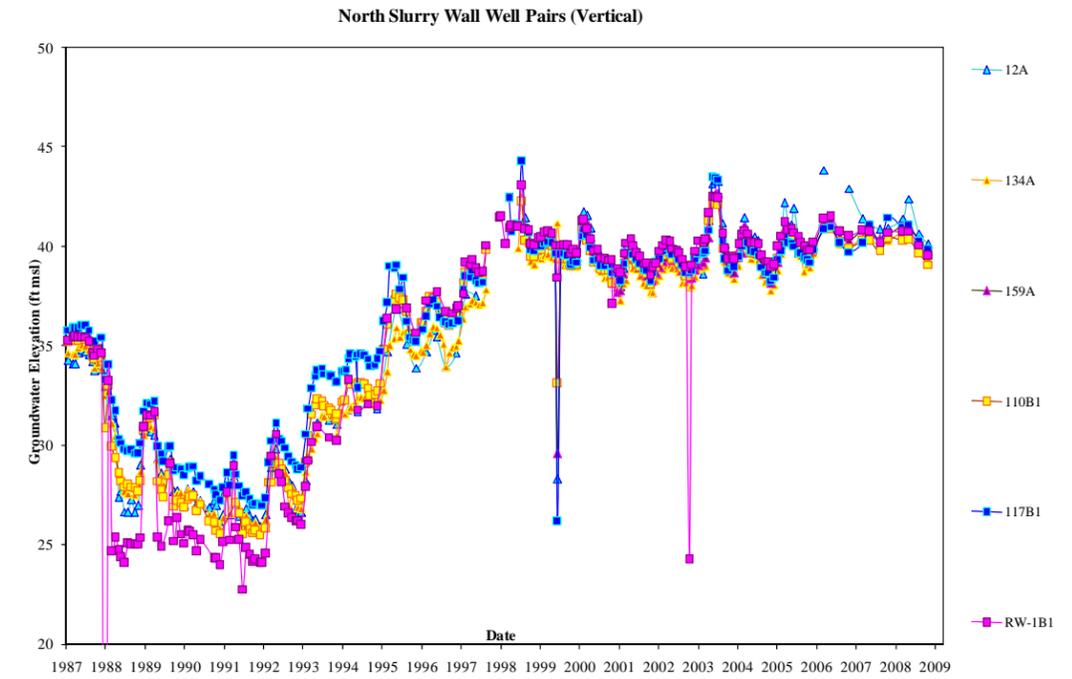
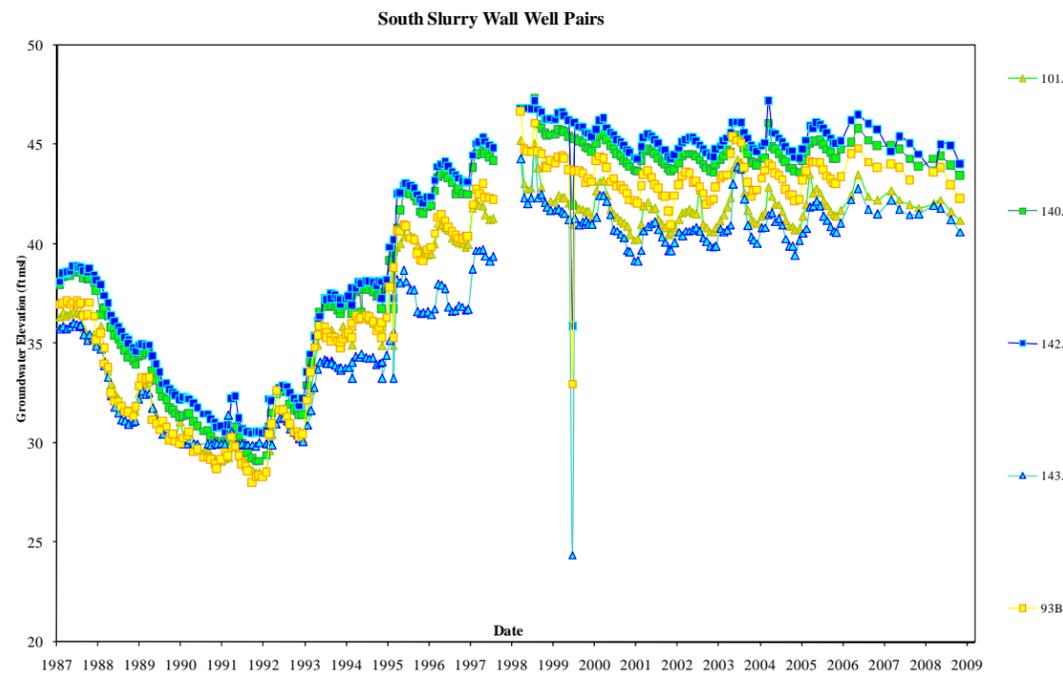
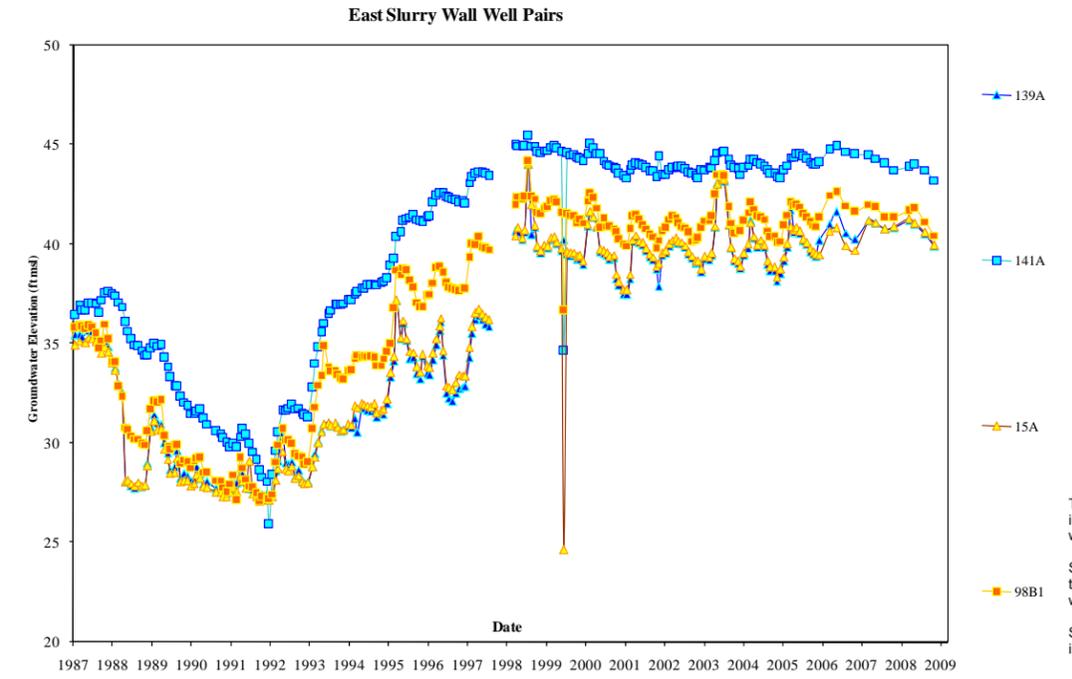
Note:
 Triangular data points indicate well is inside slurry wall or is an A zone well.
 Square data points indicate that well is outside slurry wall or is a B1 zone well.
 Slurry wall pairs are shown in similar colors.

Figure 4. Building 19 Hydrographs – Groundwater Elevation Measurements

Horizontal Gradients: During this reporting period, inward gradients were consistently observed at well pairs, (142A/143A, 140A/101A, and 141A/139A) on the upgradient and cross gradient sides of the slurry wall. Groundwater elevations in the downgradient (northern side of the slurry wall) wells 134A, 155A, 159A, and 134A (inside slurry wall) were higher than in wells 110B1, 154A, 17A, and 115A (outside slurry wall), respectively, indicating an outward gradient throughout 2008.

Step	2008 Status
Step 3b: Water level pairs	<p>Table 6 and Figure 4 present data for the slurry wall well pairs. Currently an outward hydraulic gradient exists at the western (cross gradient) and northern (downgradient) sections of Building 19 slurry wall (17A/159A, 115A/134A, and 154A/155A).</p> <p>Both upward and downward hydraulic gradients are observed across the A/B1 aquitard. Upward gradients continue to be observed at most times at 98B1/15A, and 93B1/101A.</p>
Step 4: Perform capture zone width calculations	<p>Calculated capture zone width are provided in Table 8.</p> <p>Graphical flow net analysis was performed based on potentiometric surfaces, with consideration given to calculated capture zone widths based on estimated hydraulic parameters. The estimated hydraulic capture zone widths encompass the target capture areas in the A-zone, B1-zone and B2-zone.</p>
Step 5: Concentration trends	<p>In 2008, long term trends are generally stable to decreasing based on time concentration plots in Appendix D.</p> <p>Some downgradient wells indicate slight TCE increases (i.e. 115A, 160A, and 173A); however the changes are within fluctuations within the past five years, and are well below historical maximums.</p>

- Slurry wall gradients are variable. During this reporting period, inward gradients were consistently observed in well pairs along the southern (upgradient) and eastern (cross gradient) slurry walls. Slurry wall pairs along the northern (downgradient) slurry wall indicated an outward gradient throughout 2008.

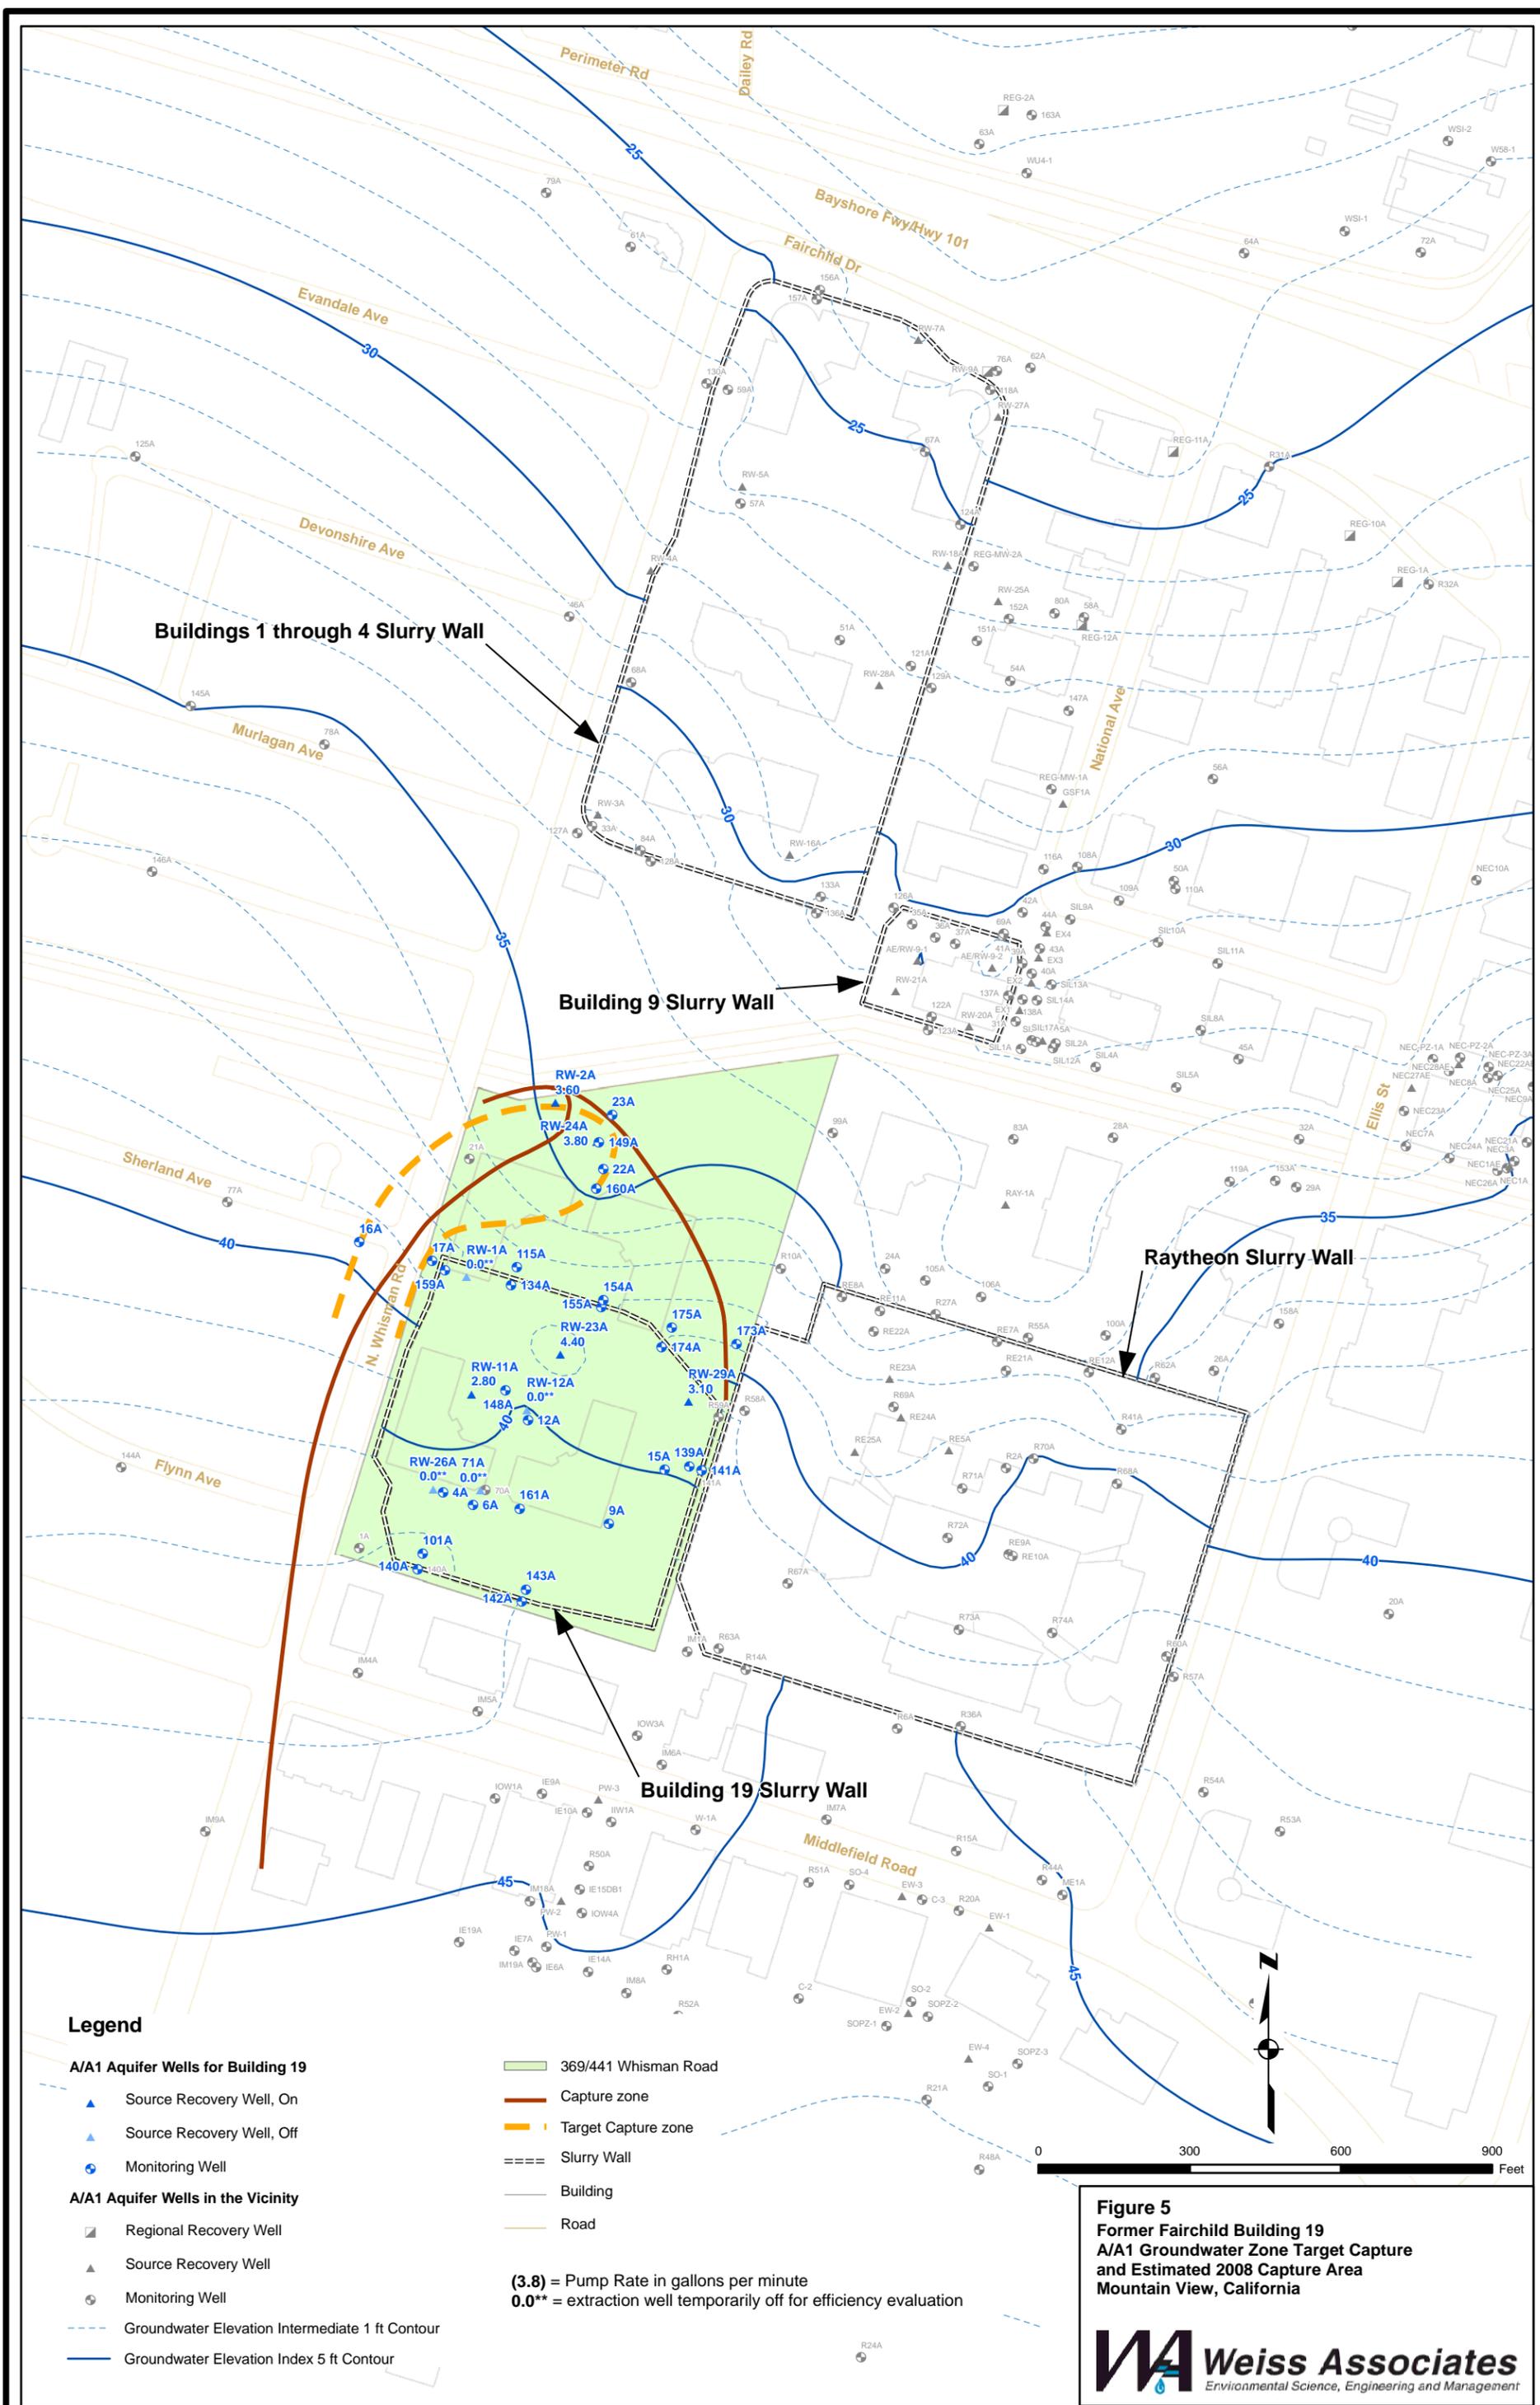
Figure 5
 Former Fairchild Building 19
 A/A1 Groundwater Zone Target Capture
 and Estimated 2008 Capture Area
 Mountain View, California

The target capture and November 2008 estimated hydraulic capture based on graphical flow net evaluation for the SCRWs in each aquifer, A/A1, B1/A2 and B2 (Figures 5 through 7). The capture zone width calculations presented in Table 12 are based on site estimates of hydraulic conductivity, thickness and 2008 pumping rates. As noted previously, the calculated capture zone widths were the starting point for the capture evaluation, with primary emphasis placed on the graphical flow net evaluation of capture and not the calculated capture.

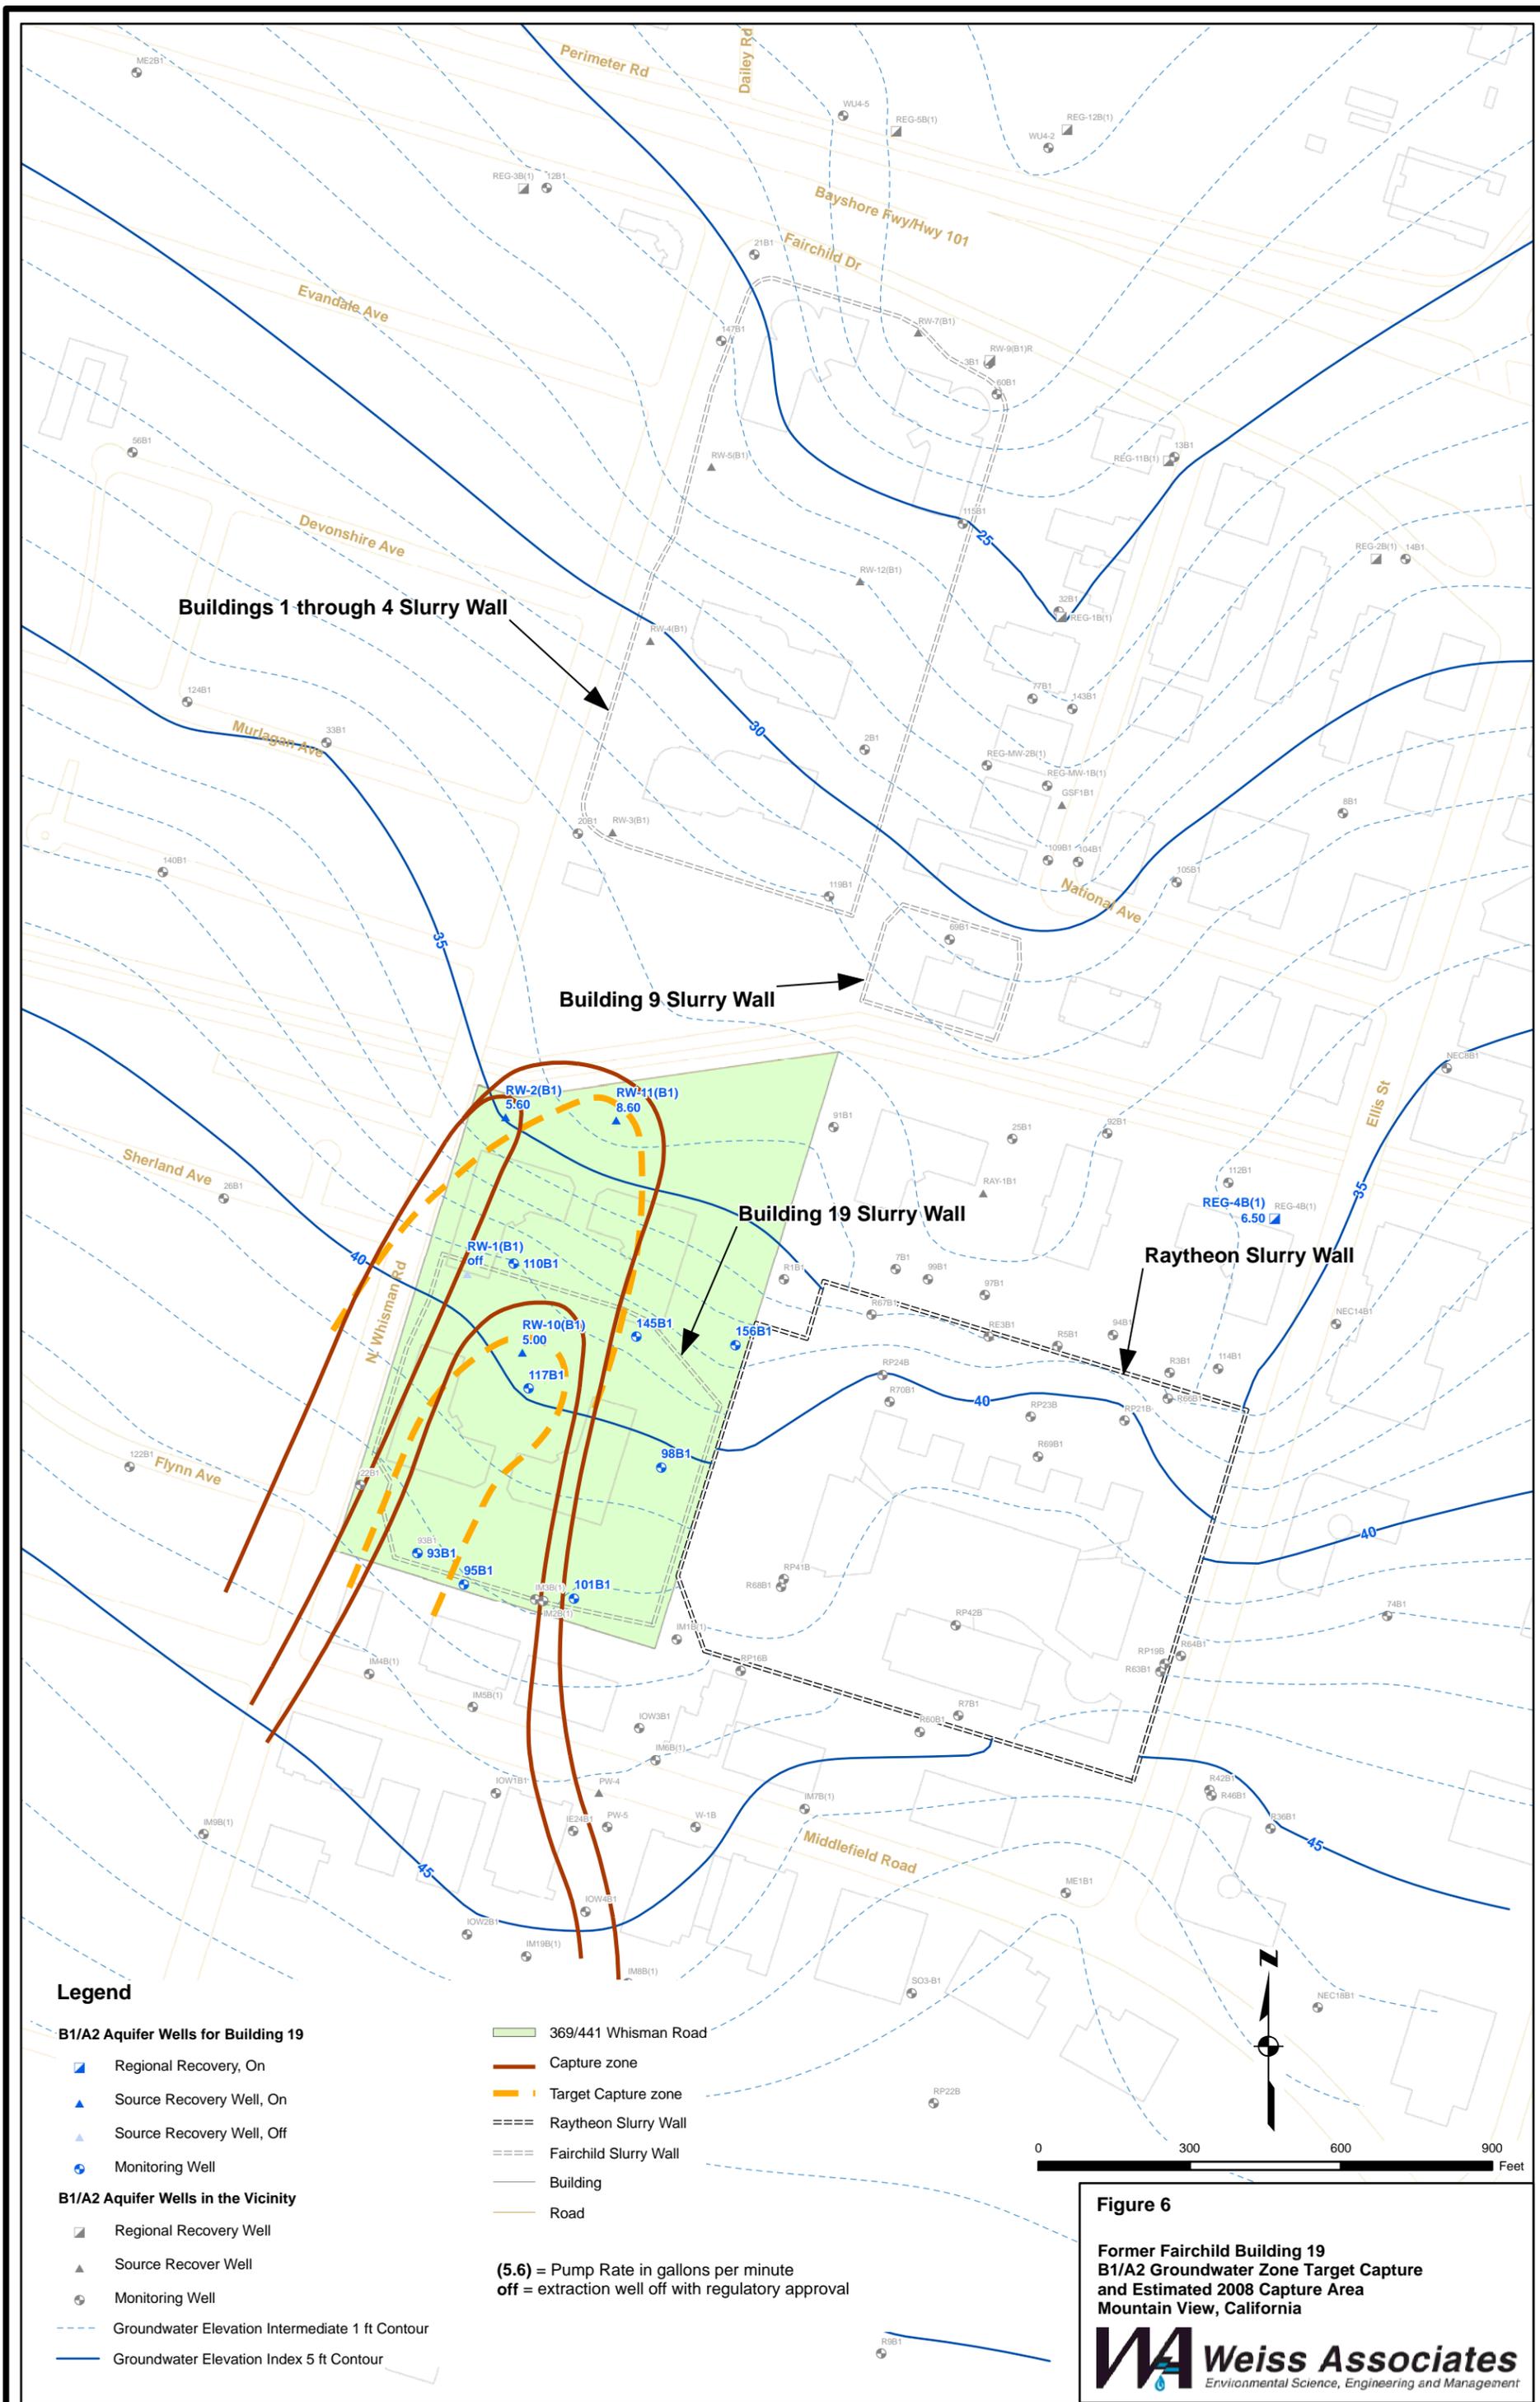
**Former Fairchild Building 19
 B1/A2 Groundwater Zone Target Capture
 and Estimated 2008 Capture Area
 Mountain View, California**

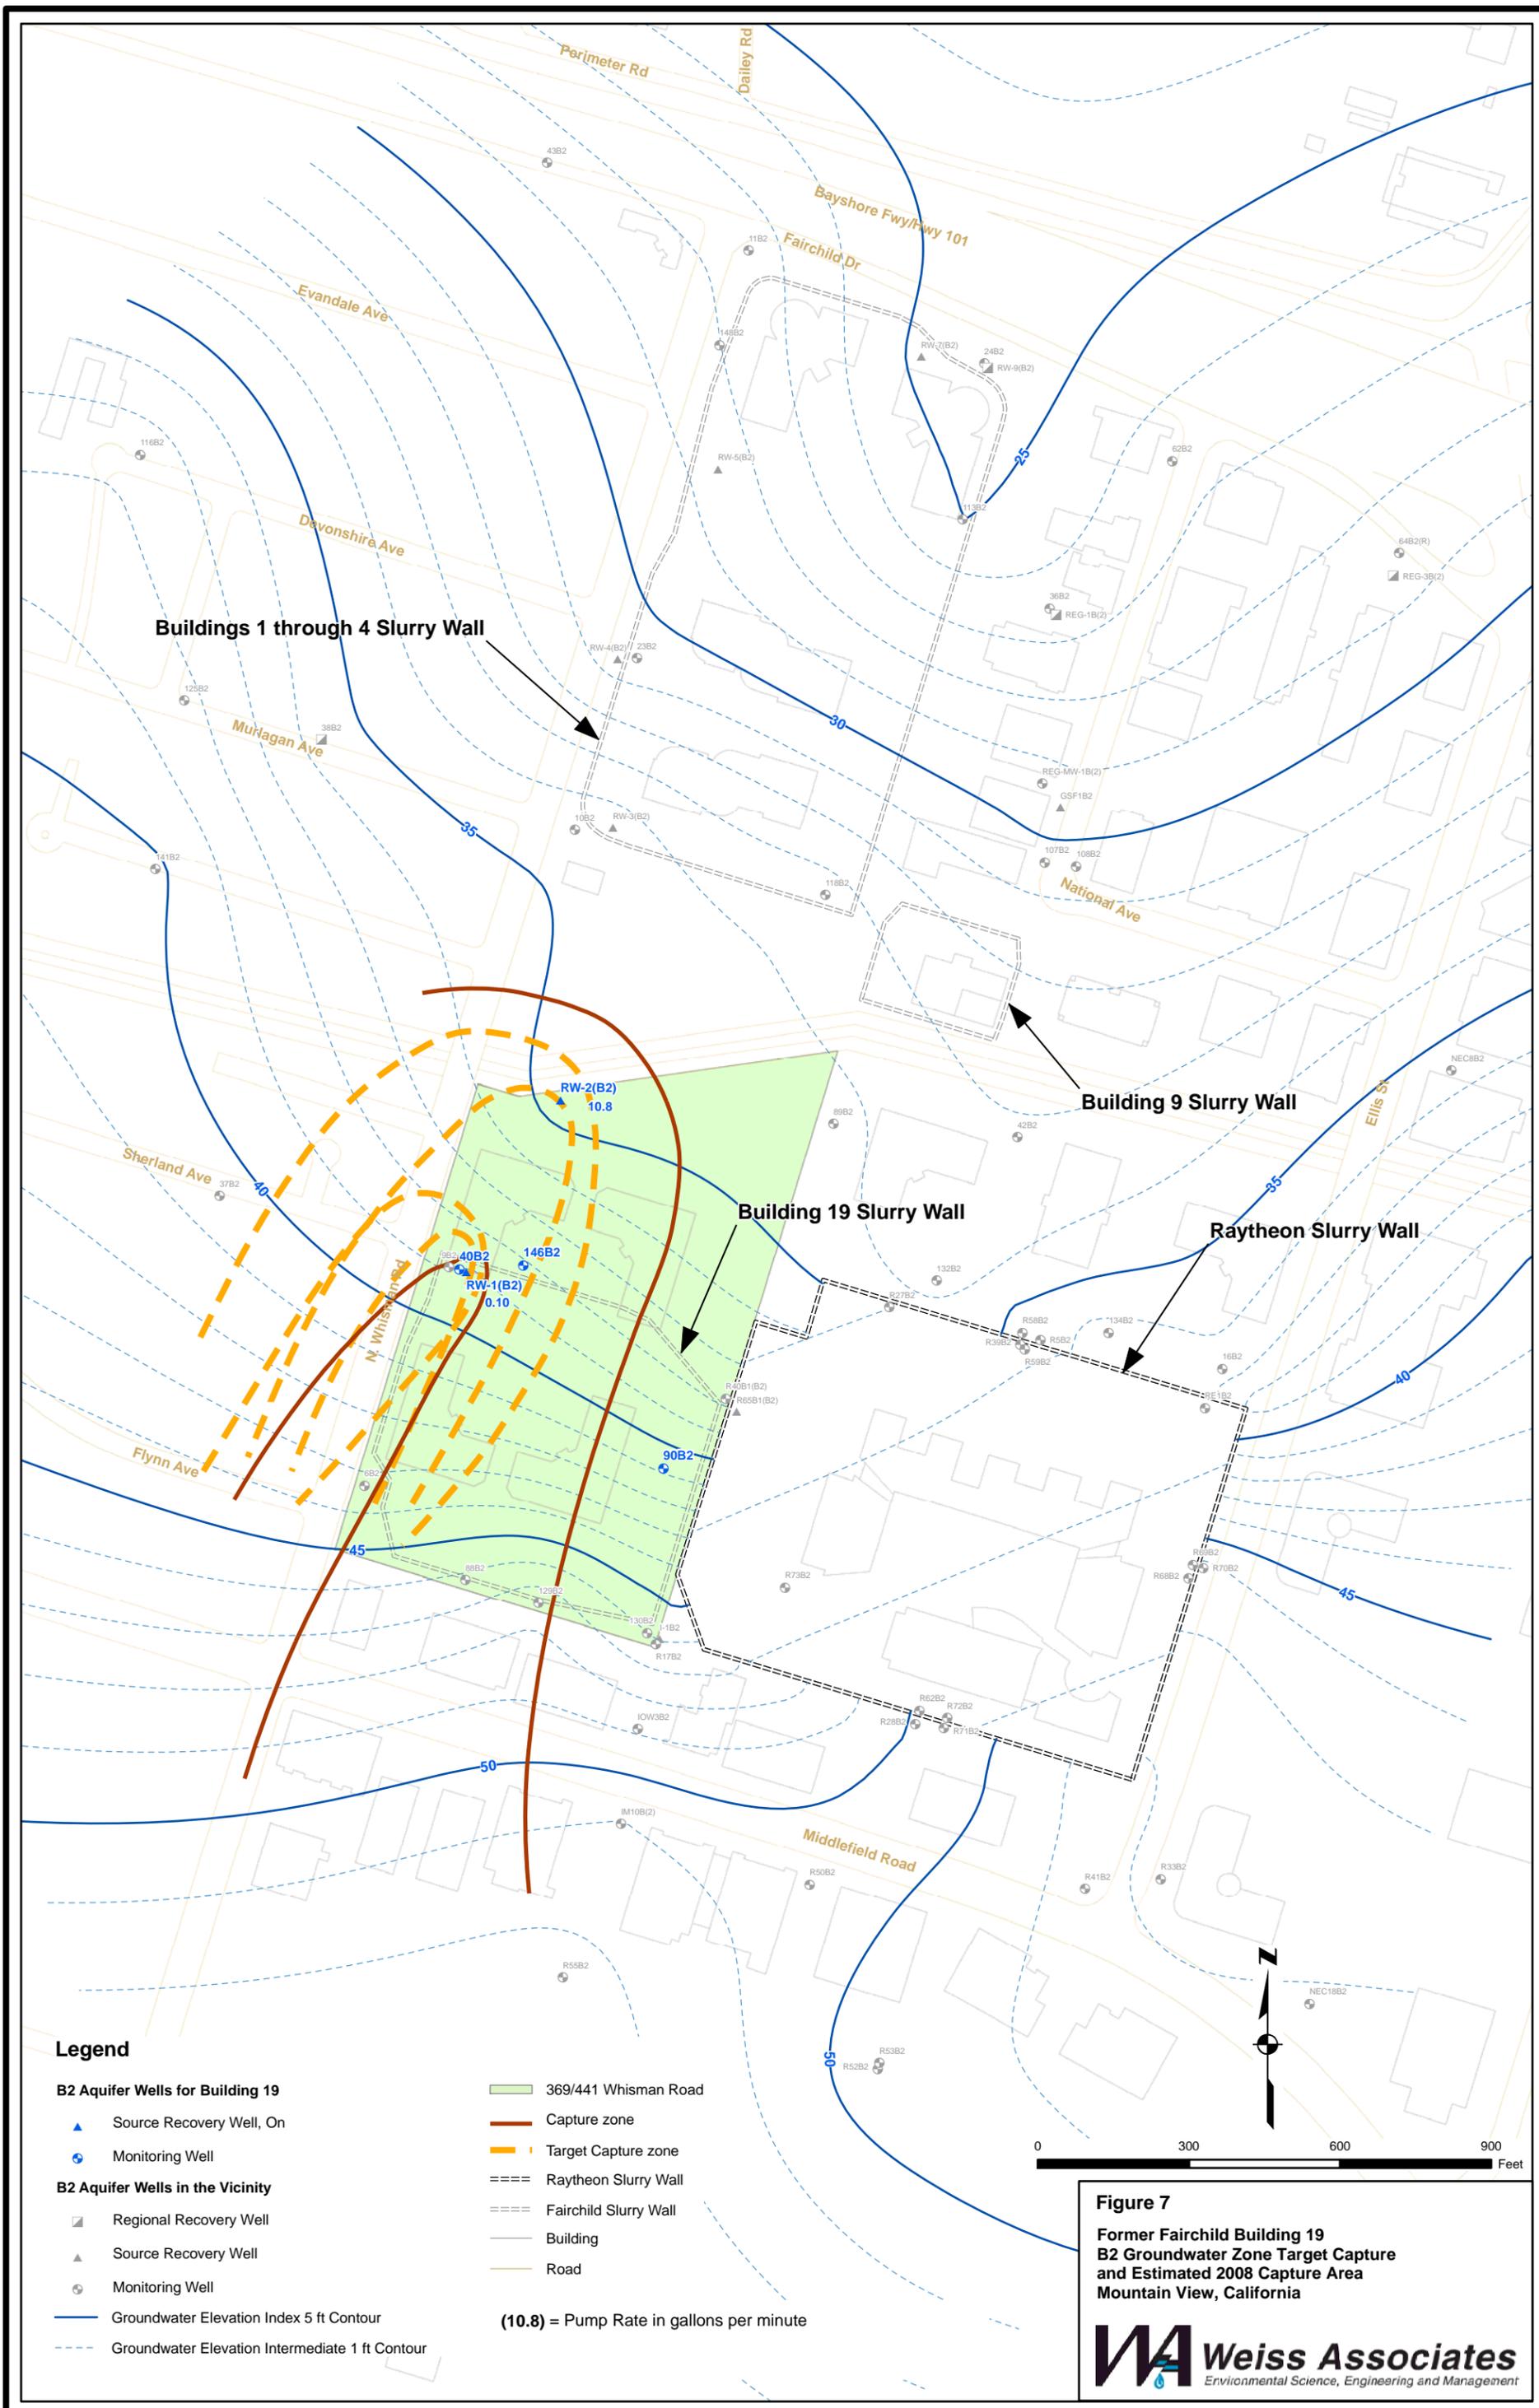
Figure 7
Former Fairchild Building 19
B2 Groundwater Zone Target Capture
and Estimated 2008 Capture Area
Mountain View, California
