Five-Year Review Report

Second Five-Year Review Report McCormick and Baxter Superfund Site Stockton, San Joaquin County, California

United States Army Corps of Engineers

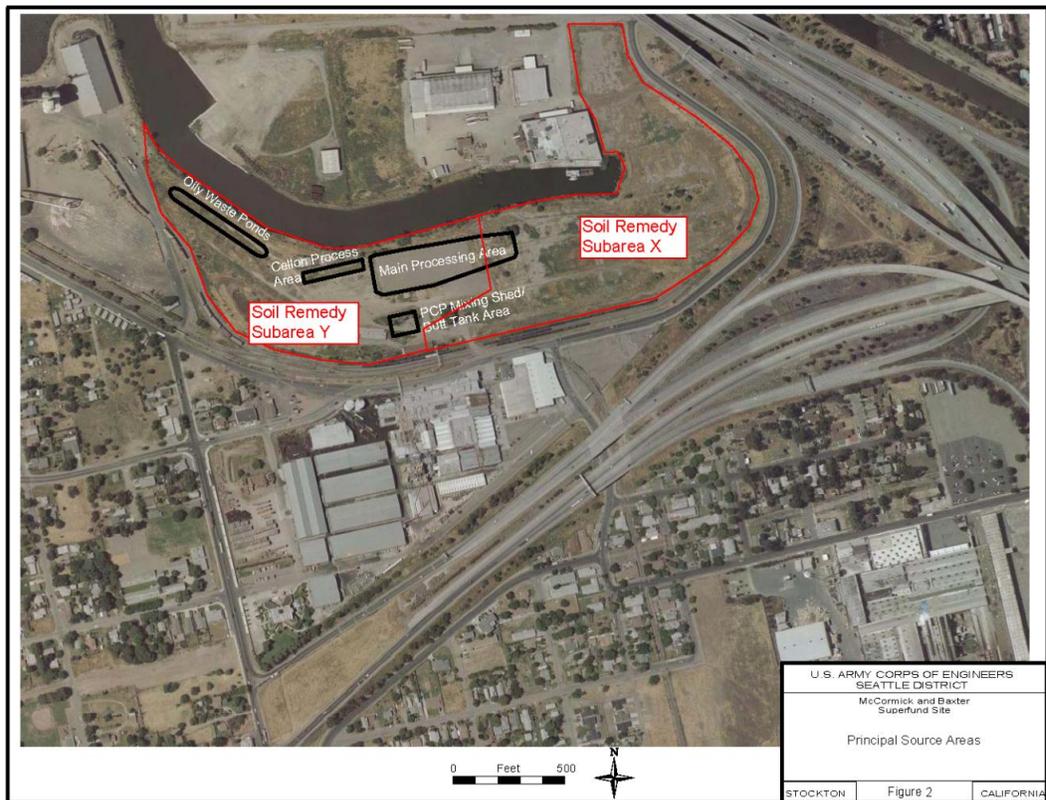
Figure 2. Principal source areas of the McCormick and Baxter Superfund Site

The primary facility areas identified as principal sources of contamination include the main processing area (MPA), oily waste ponds area (OWPA), Cellon process area (CPA) and PCP mixing shed/butt tank area (Figure 2).

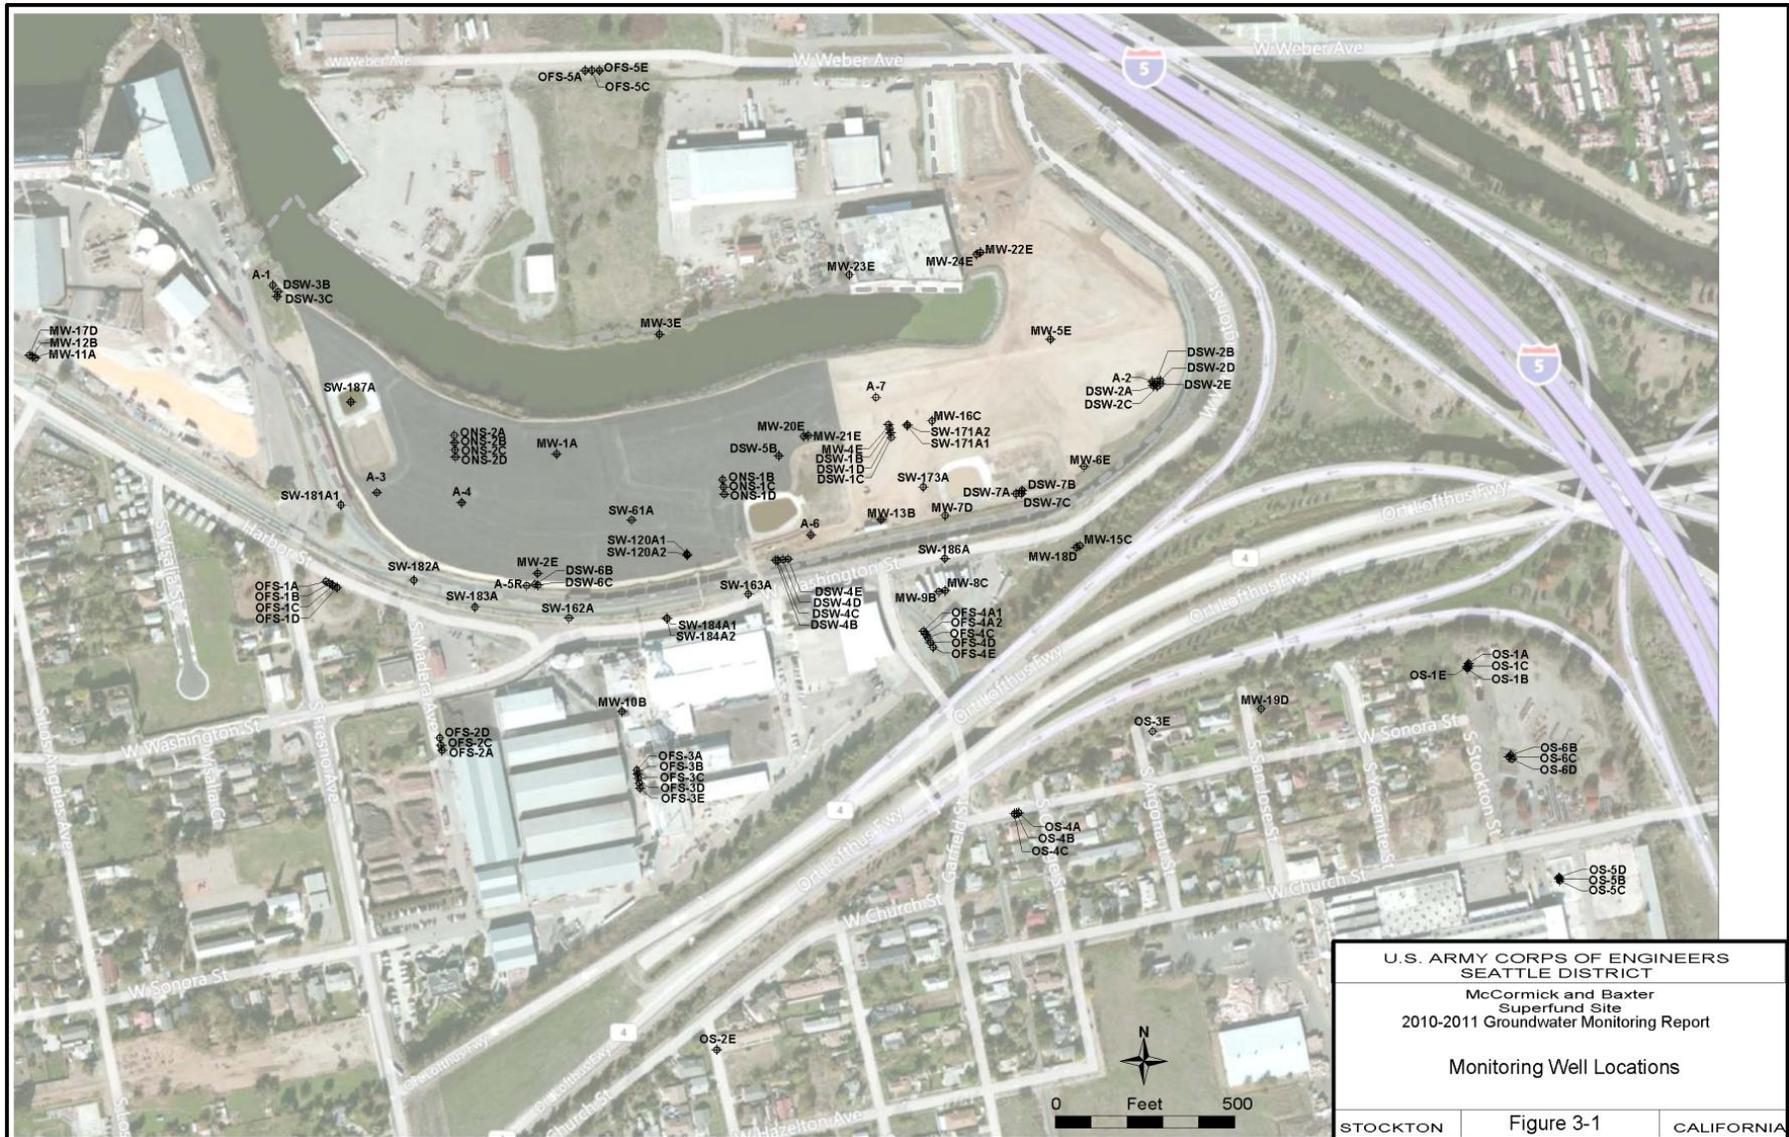
Figure 3. Monitoring well location map.

Groundwater level measurements are collected semi-annually from approximately 100 monitoring wells (Figure 3). Measurements collected between December 2010 and May 2012 revealed that, notwithstanding slight differences in horizontal gradient magnitudes, vertical gradient magnitudes and horizontal and vertical flow directions remained consistent with past results prior to uplands soil capping. This suggests that capping has not altered groundwater flow and that there are no offsite hydraulic influences that could shift contaminant migration. As part of the FFS, the potential impact of infiltration from the stormwater detention basins will be assessed.

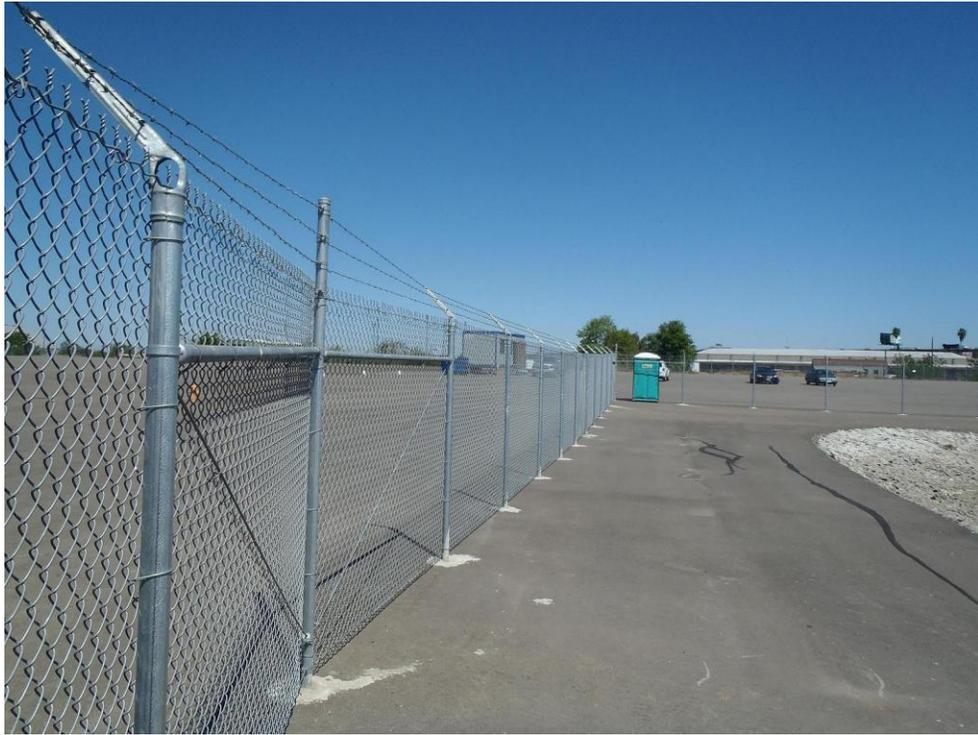
Photo 1: Fence surrounding detention basin #2. The facility is in excellent condition but note the long crack in the asphalt cap parallel to the basin. This type of cracking may be a geotechnical concern

- Keep the asphalt cap maintained by repairing cracks
- Perform a slope stability analysis to determine if the long cracks in the asphalt cap are evidence of slope failure
- Keep fencing repaired, and routinely check for signs of damage or vandalism
- Replace warning signs when damaged or illegible
- Continue progress toward the goal of developing a final remedy for the groundwater OU

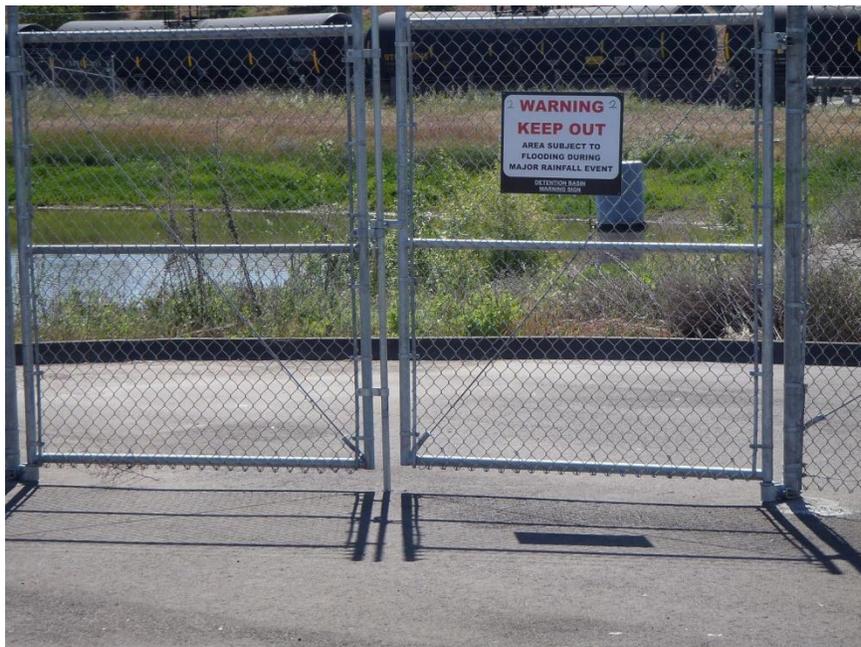
Photo 2: Access gate to detention basin #2 with flood hazard warning sign

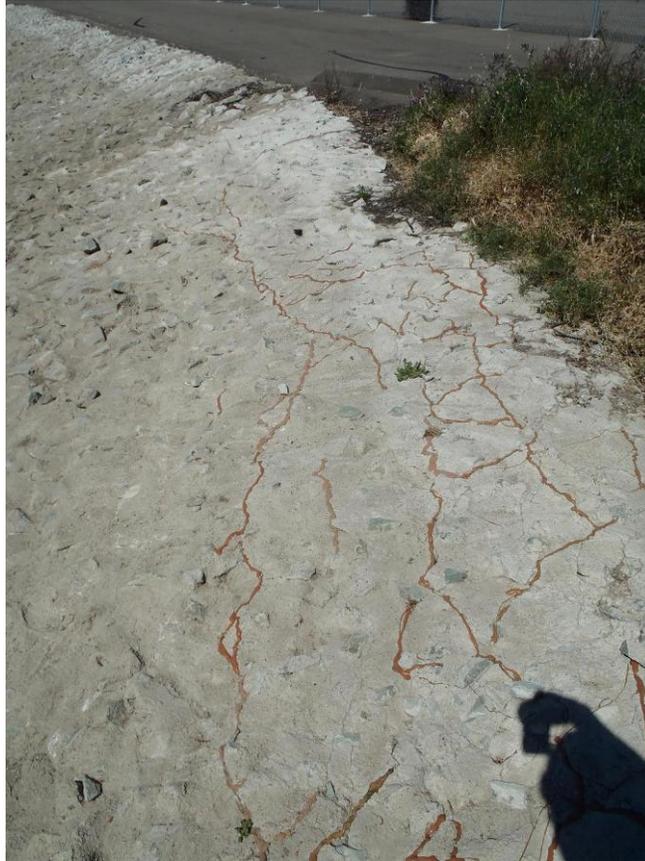
Photo 3: Cracking in detention basin #2 forebay is being repaired with a sealant

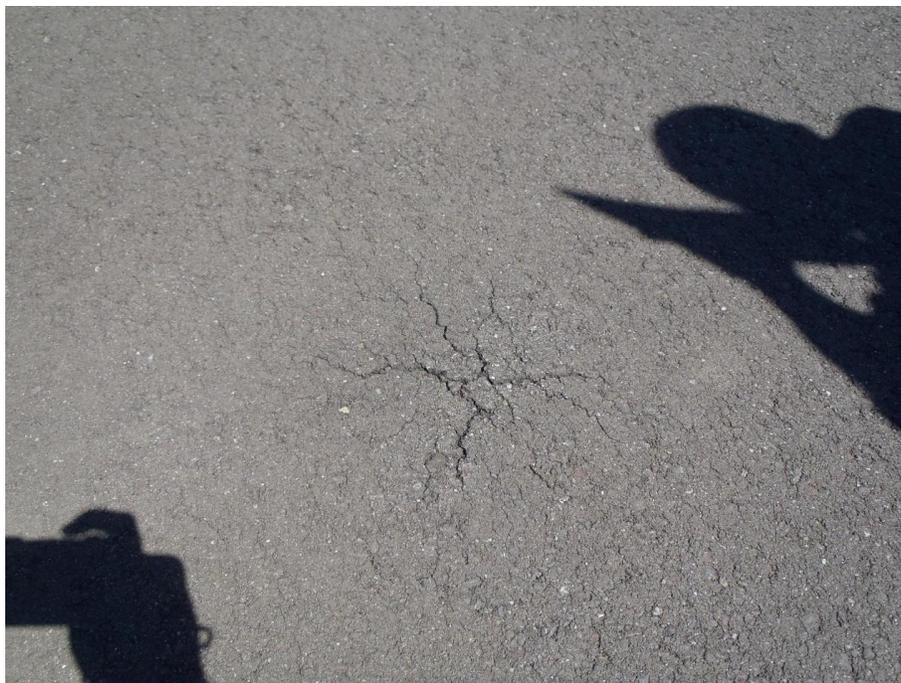
A. Landfill Surface			
1.	Settlement (Low spots) Areal extent _____ Remarks <u>very minor settlement on south side causing bulges + radial cracking</u>	G Location shown on site map _____ Depth _____	<input checked="" type="checkbox"/> Settlement not evident

Photo 5: Shallow radial cracking in bulge in the asphalt cap, probably due to differential soil settlement over rocks, bricks, or other debris.

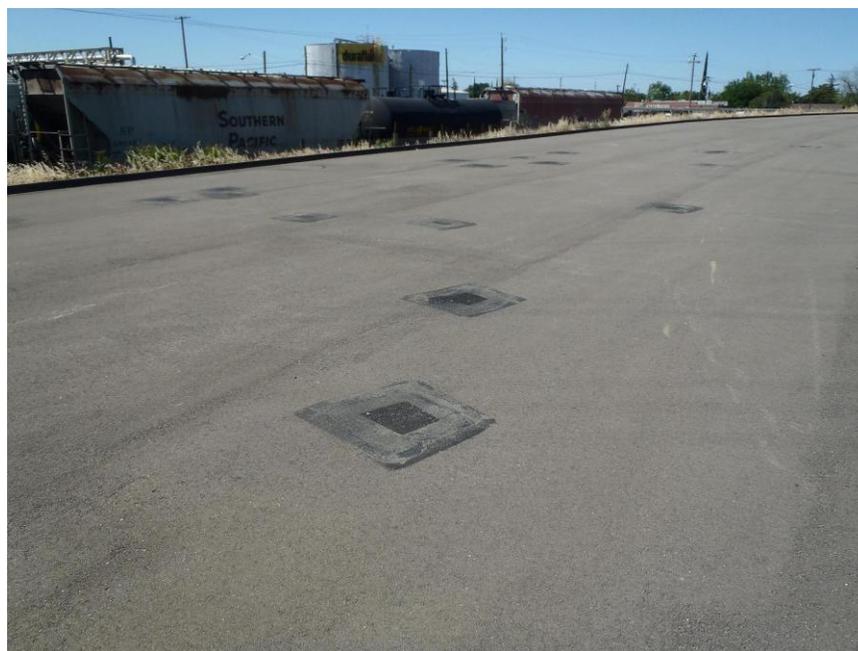
Photo 6: Radial cracking is being patched.

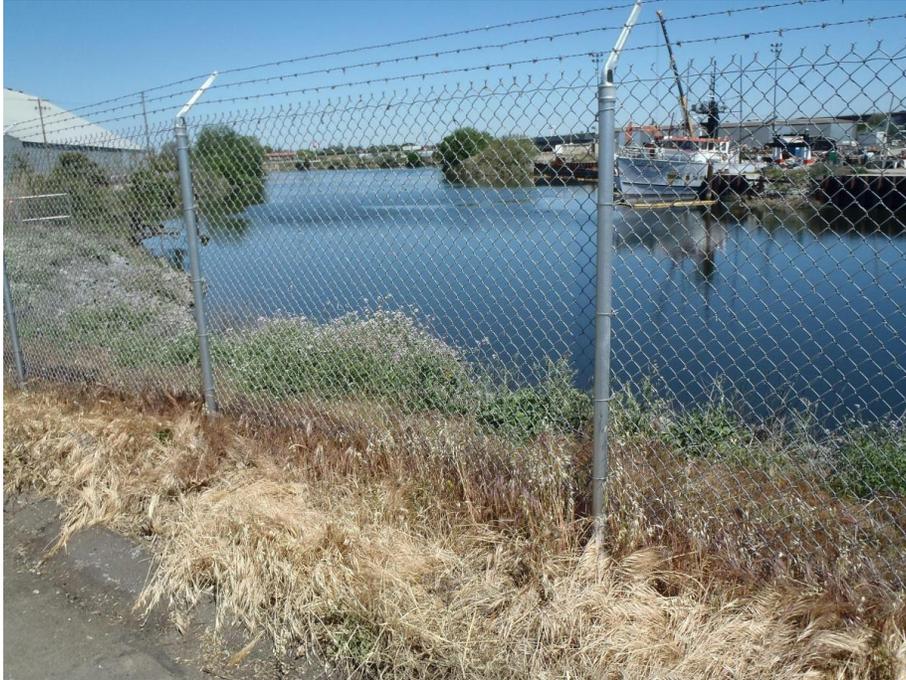
Photo 7: The log boom for the sediment OU remedy in Mormon Slough is missing (replacement is planned).

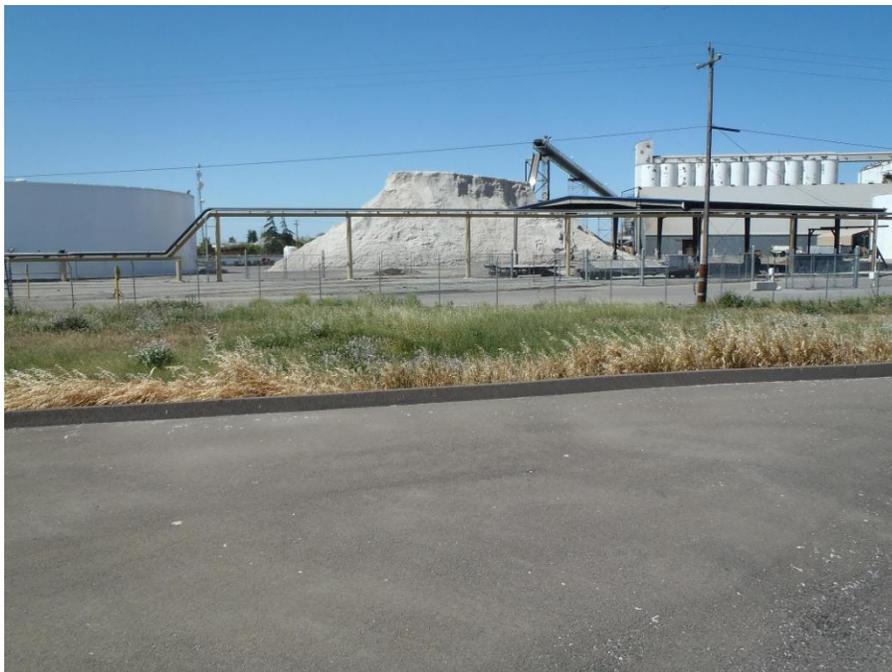
Photo 8: The material stockpile on the adjacent property is blown by the wind onto the site creating a nuisance. The San Joaquin Valley Air Pollution Control District might be able to do some sort of nuisance abatement enforcement order.

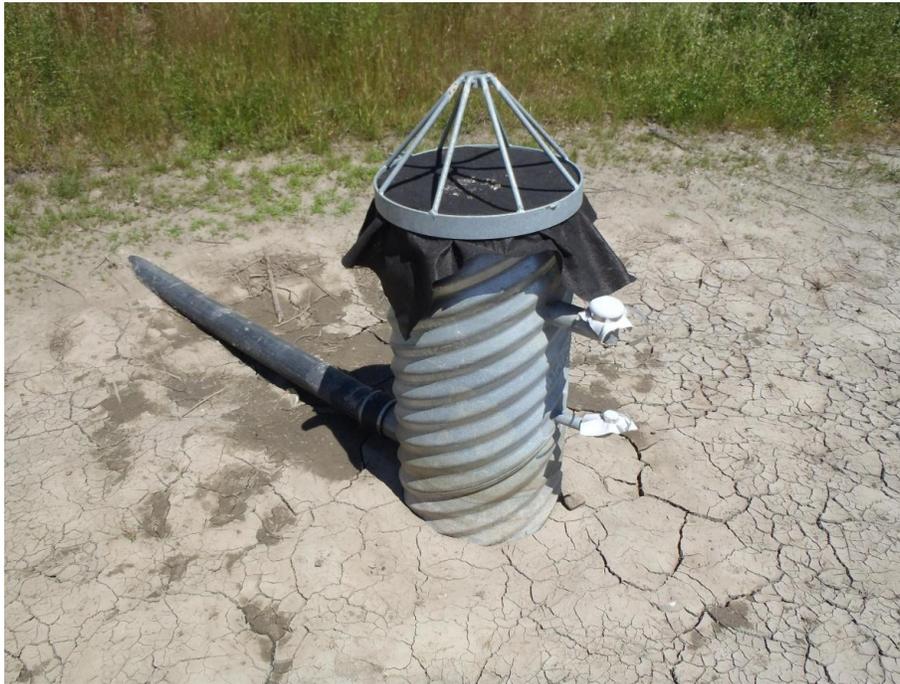
Photo 10: The main basin of Detention Basin #4 may be due for cleanout of accumulated fine sediment.

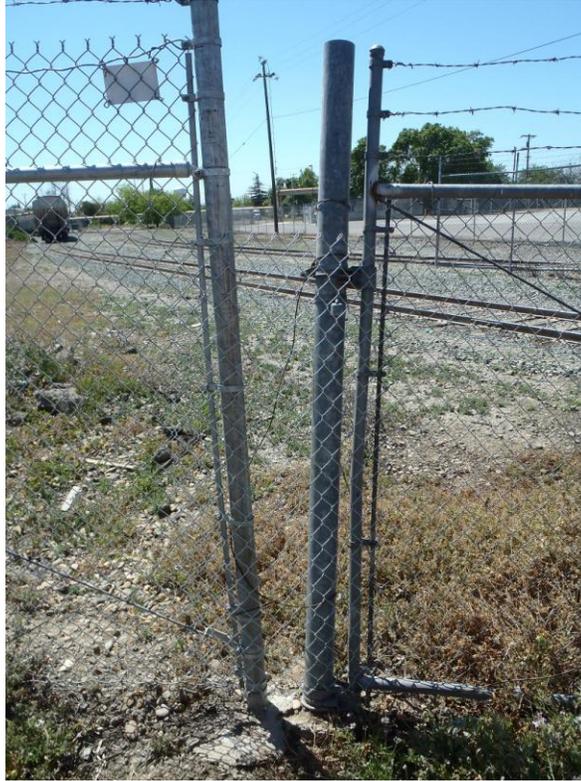
Photo 11: Trespasser damage to perimeter fence in M&B subarea Y has a temporary repair.

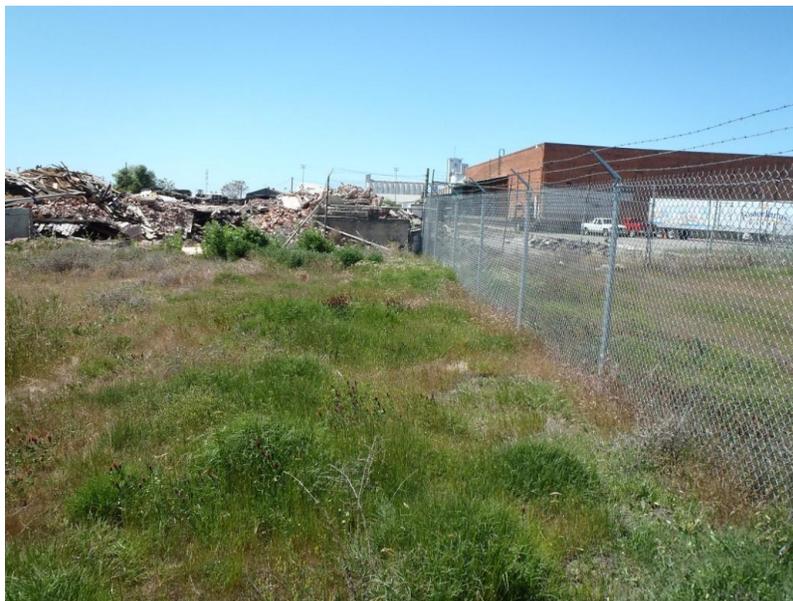
2. Land use changes on site			
Remarks	<input checked="" type="radio"/> N/A		
3. Land use changes off site			
Remarks	<input type="radio"/> N/A		
cold storage facility being torn down. new fence needed			
VI. GENERAL SITE CONDITIONS

Photo 12: The demolition of the cold storage building north of the slough has created a gap in the perimeter security fence in M&B Subarea X next to detention basin #4.

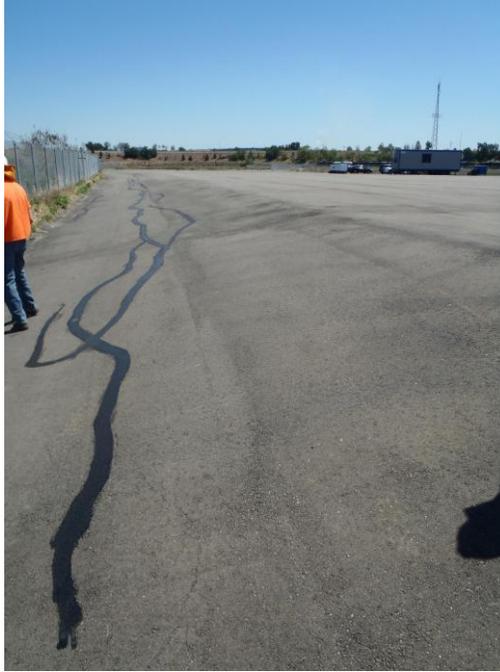
The cap is in good shape and being maintained properly. It has been noted that there are some long cracks parallel with the slough that should be filled with sealant, not just patched over, and it is recommended that a slope stability analysis be performed to assure that these are superficial, and not evidence of a deeper-seated failure plane. In addition, there were cracks that appear to be caused by weed growth. Although many of these crack have been patched, ongoing maintenance efforts to address these cracks is needed.

Photo 15: Lengthy cracking parallel to slope along the edge of asphalt cap should be examined by geotechnical engineer for slope stability

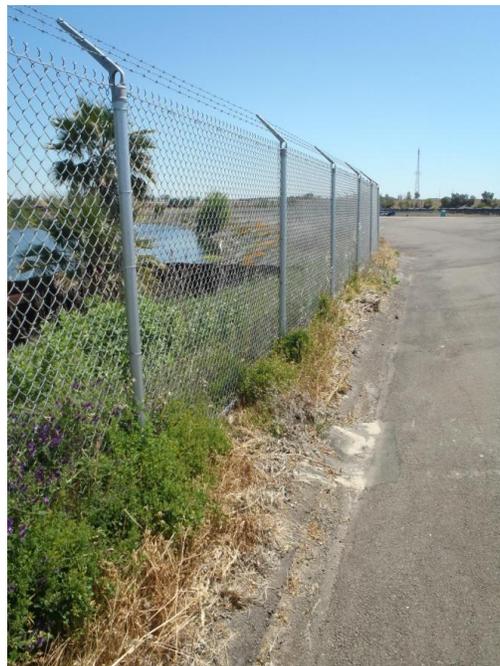
Photo 16: Sheet pile wall and stone rip-rap, sediment OU. Consider removing the Washington (fan) Palm behind the sheet pile before it grows larger

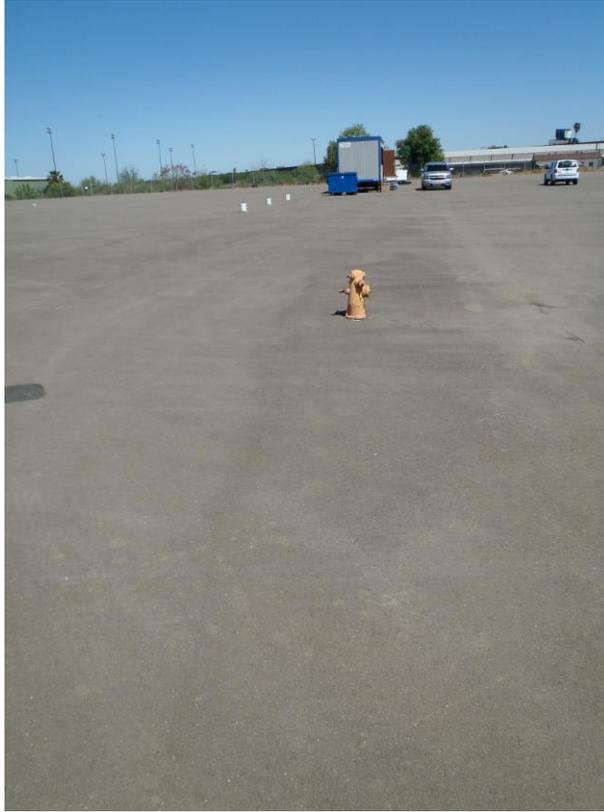
The grass is not being cut, both causing a fire hazard and obstructing clear view of some well heads. Many well heads have been damaged and need maintenance. It is suggested that they be locked, and marked with bollards.

Photo 17: White monitoring well cap stickups visible near top of photo are vulnerable to vehicles and should be changed to flush mount or protected with bollards.

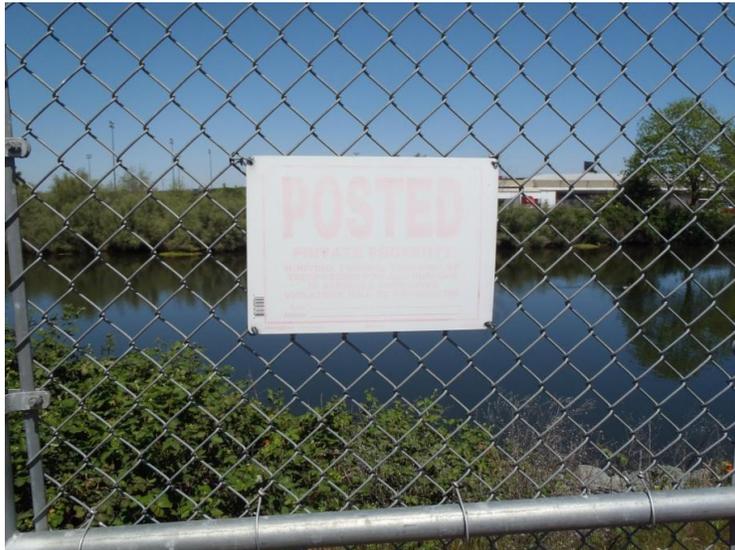
The inspection included a thorough walk of the site to inspect site condition and ICs in place. It is noted that the UPPR fencing is in poor shape, and a new fence on the eastern boundary of the Site is suggested. Signage is faded, and does not warn of toxic danger at the site. More visible signs, written in both English and Spanish, would increase the understanding of the hazards at the site.

Photo 18: Signs are old and faded and sometimes face the wrong way. Recommend replacement with new bilingual warning signs.

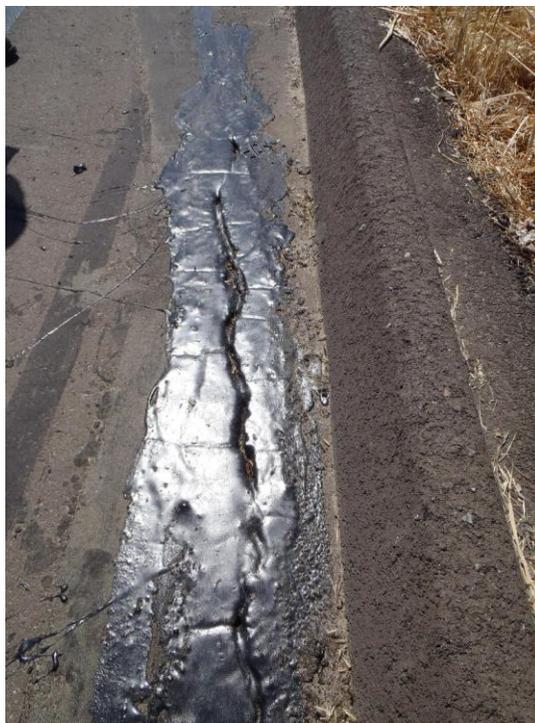
2.	Cracks Lengths _____ Widths _____ Depths _____ Remarks <u>long cracks developing; a seam on top are parting, need sealant to fill them</u>	G Location shown on site map _____	<input type="checkbox"/> Cracking not evident

Photo 19: This crack is not sealed properly; the crack should be completely filled with sealant. Or perhaps the crack is actively widening?

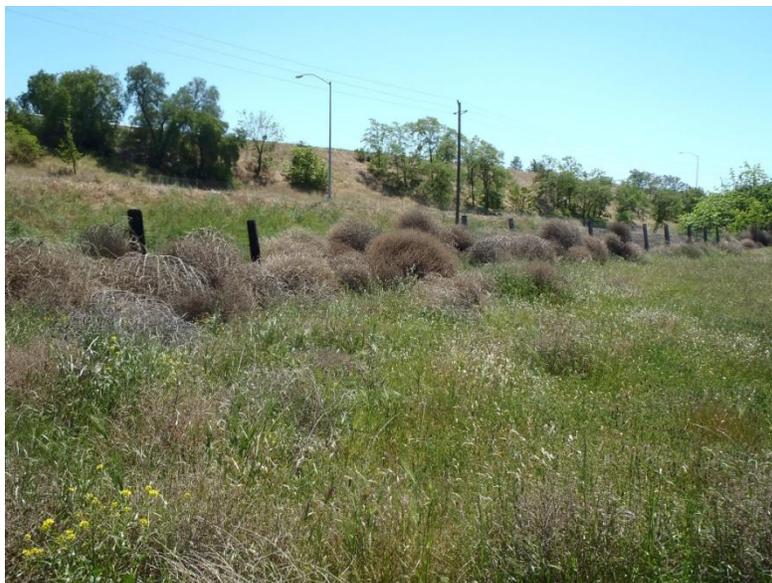
1. Vandalism/trespassing			
Remarks	<input type="radio"/> Location shown on site map	<input type="radio"/> No vandalism evident	
fence is being repaired on M&B (EPA) site but not on UPRR property

Photo 20: The perimeter fence around the UPRR property and along the railroad tracks on M&B Subarea X is in very poor condition and is not being maintained. Tumbleweed (Russian thistle) accumulation on the fence is a fire hazard and precludes inspection of the perimeter soil berm.
