FINAL FIVE-YEAR REVIEW FOR OPERABLE UNITS 1 THROUGH 5, MARINE CORPS BASE CAMP PENDLETON, CALIFORNIA

Document Control Number: SW-2014-0001

FIVE-YEAR REVIEW REPORT

**OPERABLE UNITS 1 THROUGH 5
MARINE CORPS BASE
CAMP PENDLETON, CALIFORNIA**

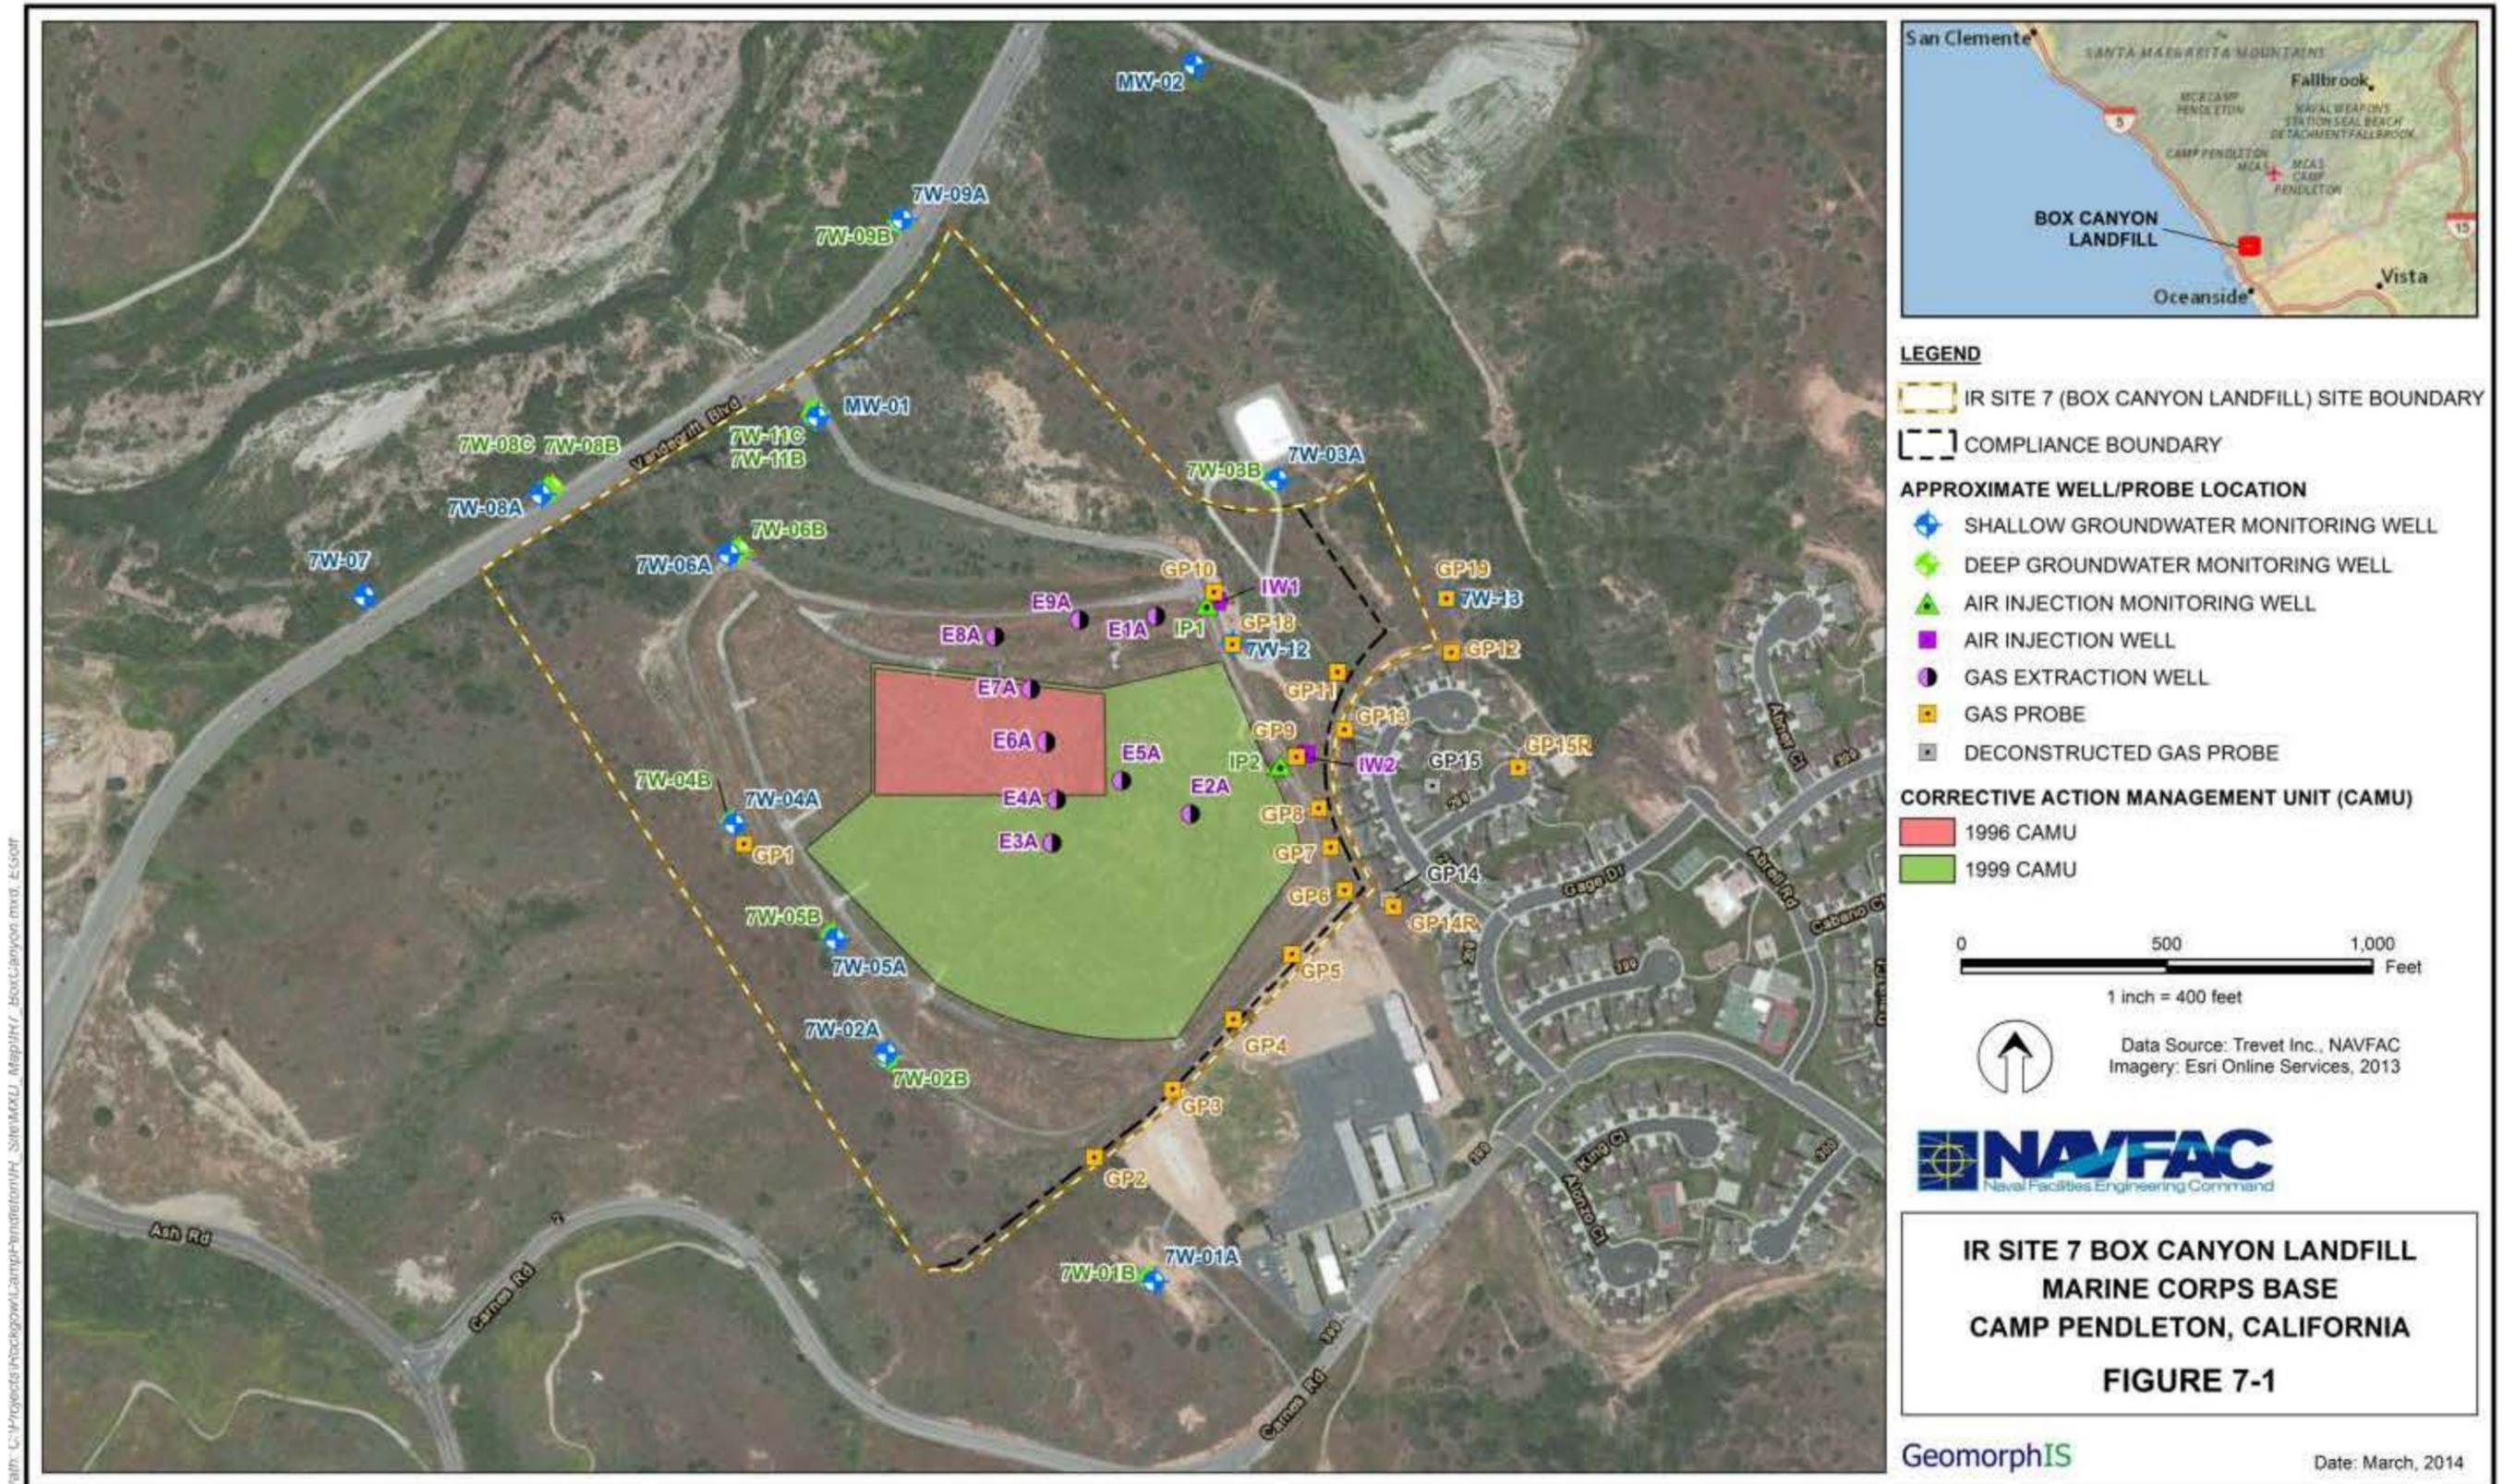
Figure 7-1: Box Canyon Landfill Layout

- Installation of an evapotranspiration (ET) cover consisting of a vegetated topsoil layer (minimum thickness of 12 inches), a minimally compacted middle soil layer (minimum thickness of 48 inches), and a compacted low-permeability bottom layer (minimum thickness of 12 inches).
- Installation of lined surface water drainage structures and erosion control measures.
- Construction of an access road.
- Implementation of a post-construction monitoring and maintenance plan.
- Documentation of the remedial action process, quality control confirmation test data, and final as-built conditions.

The final remedy and associated land use control requirements for IR Site 7 were issued under the ROD for OU-3 in January 1999. The site began closure construction in July 2001. A 6-foot-thick (minimum) earthen closure cover was completed and the site was revegetated in December 2002. Final closure of the landfill was completed by the installation of the permanent perimeter fence, and post-closure monitoring activities were initiated in February 2003.

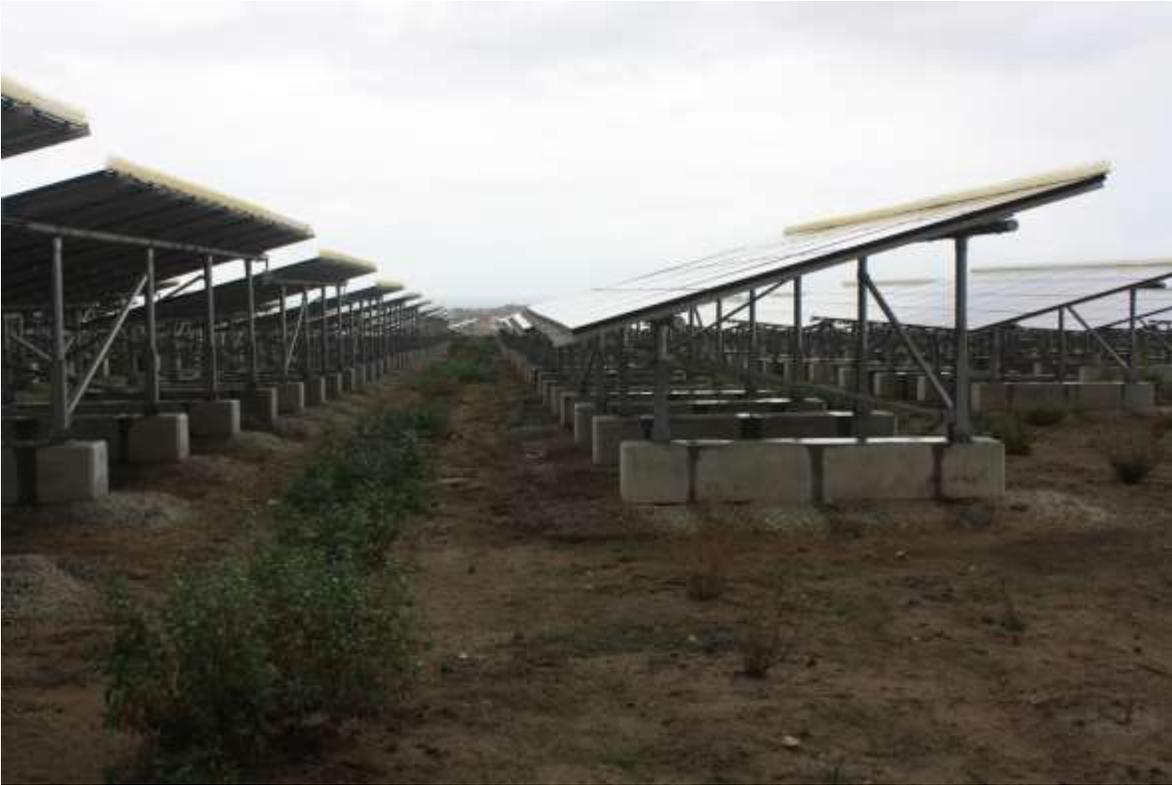
Site 7 (Box Canyon Landfill) PV Panels Phase I

- Vegetation in the Phase I area of the PV panels was replaced in the winter of 2012, and continues to mature. Phase II is currently undergoing re-vegetation. Both areas will need several years of biological monitoring and vegetation maintenance to ensure establishment of a successful ET cover.

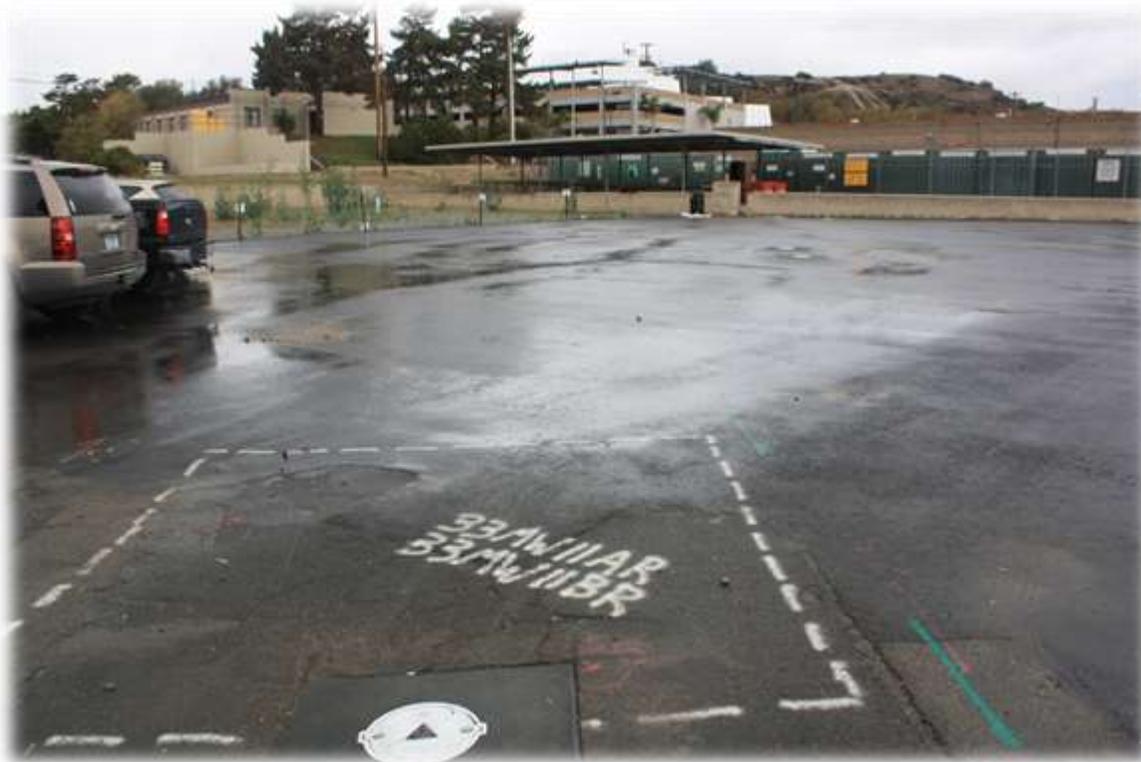
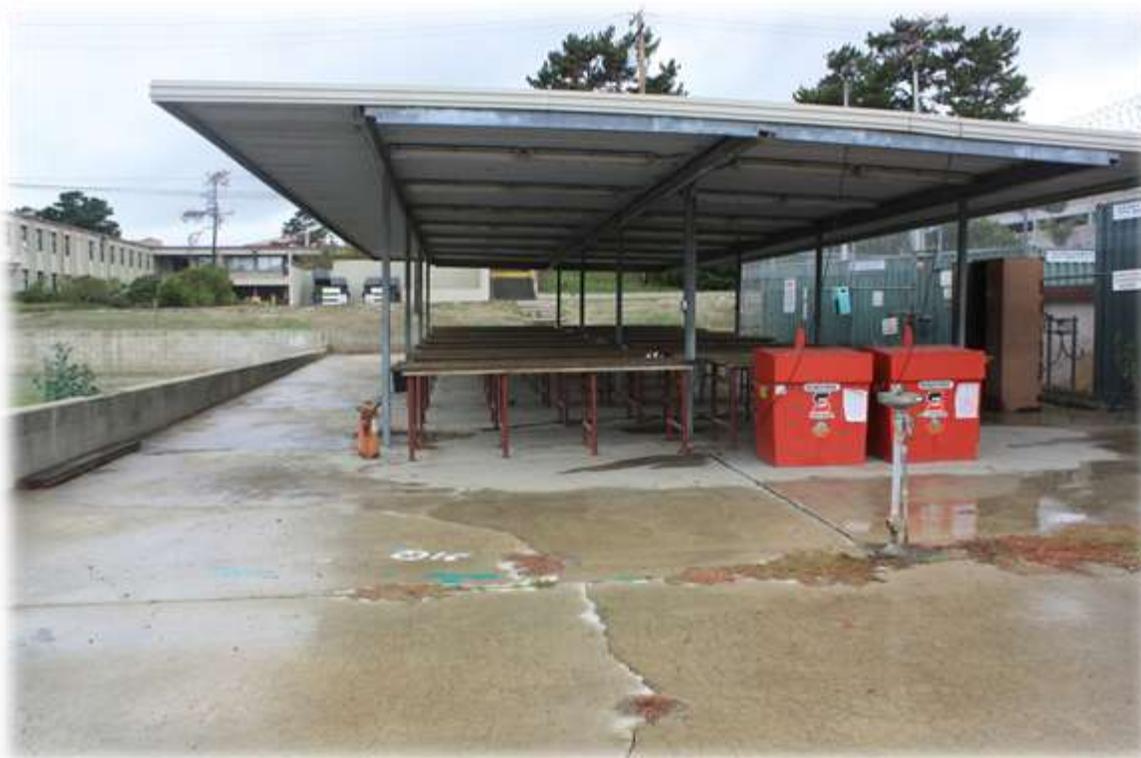
Site 33 (52 Area Armory)

Pilot studies are being conducted at 12 Area Site 13, 21, 22/23 Area groundwater and will begin soon at Site 1115. The first phase of a Removal Action (excavation) has been completed at Site 33 and a second phase is schedule to begin in early 2014. No concerns were noted.

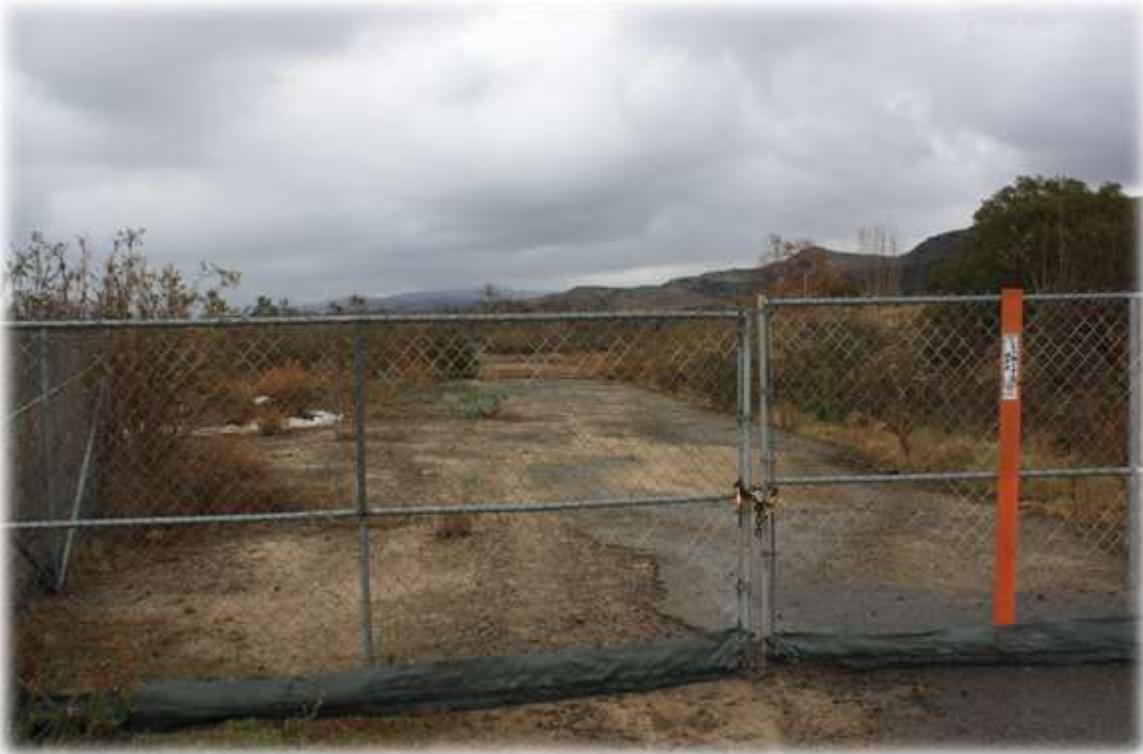
Site 62 (Asphalt Batch Plant)

Site 62 is not undergoing any active remediation. Photos in Appendix B show the current conditions of these sites. No concerns were noted.

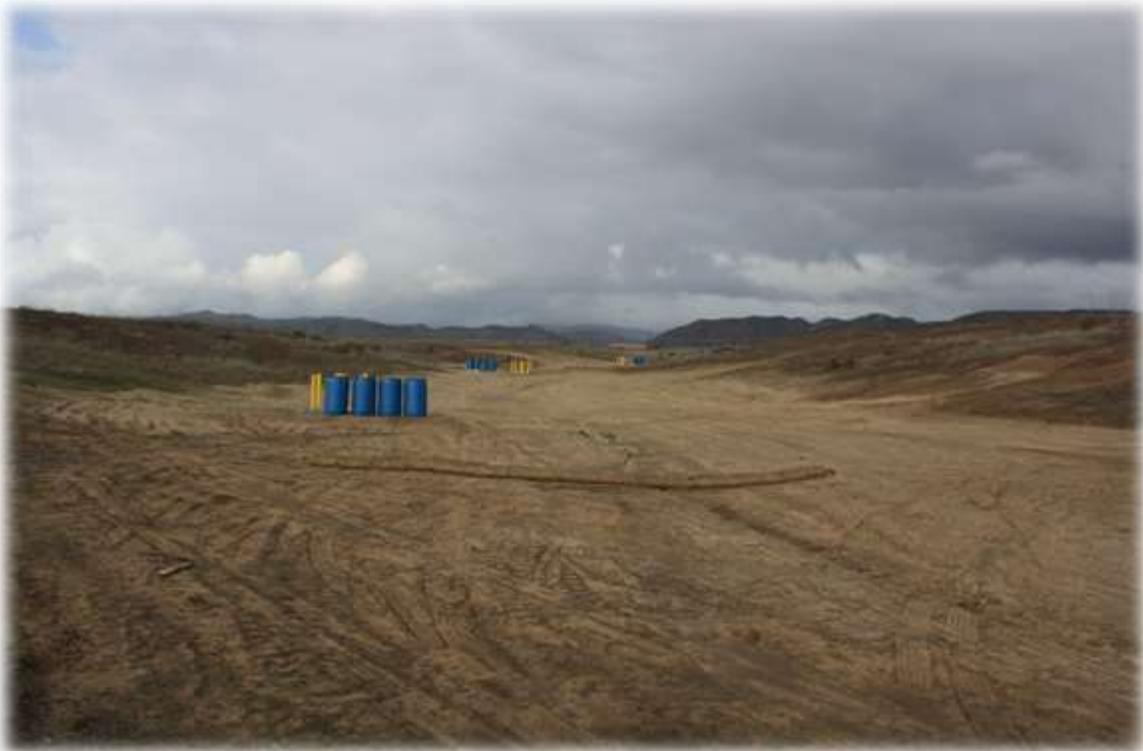
Site 1114 (41 Area Arroyo)

A Removal Action has been completed at Site 1114, the excavation has been backfilled, and bioremediation substrate was placed into the excavation before it was backfilled. Groundwater monitoring has been instituted at the site. The first phase of a Removal Action (excavation) has been completed at three of the nine subsites that comprise Site 1116; pilot studies are scheduled to begin at two of the three subsites in early 2014. Sites 1117 through 1122 were not undergoing any active remediation. No concerns were noted.
