Second FIVE-YEAR REVIEW REPORT FOR
T H Agriculture & Nutrition Site
SUPERFUND SITE
FRESNO COUNTY, CALIFORNIA

United States Environmental Protection Agency
Region 9
San Francisco, California

Executive Summary

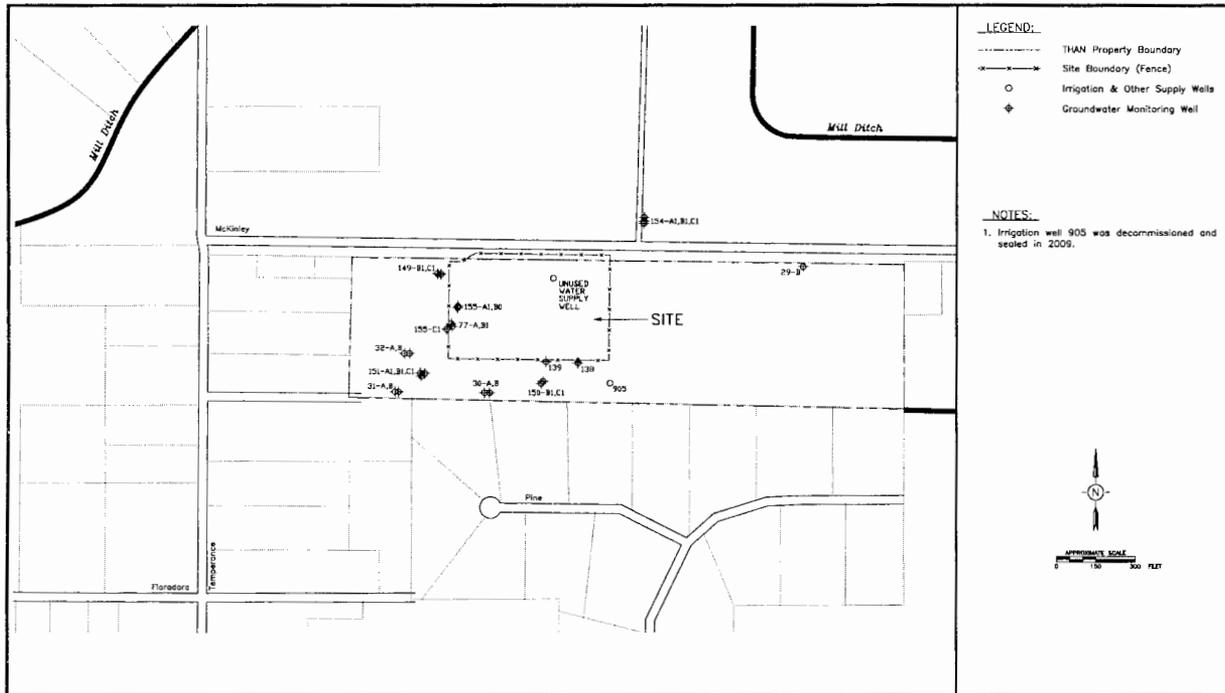
ON-SITE AND NEAR-SITE WELL LOCATION MAP
T H Agriculture & Nutrition Site
Fresno County, California
FIGURE 2

On-site and near-site groundwater monitoring well locations are shown on Figure 2. The water-bearing zones (B-, C-, and D-zones) appear to be in hydraulic communication, with preferential horizontal flow paths dominating groundwater movement. The groundwater flow direction is generally toward the southwest in all three water-bearing zones. No significant vertical gradients between the three zones have been observed, indicating that they are hydrologically interconnected.

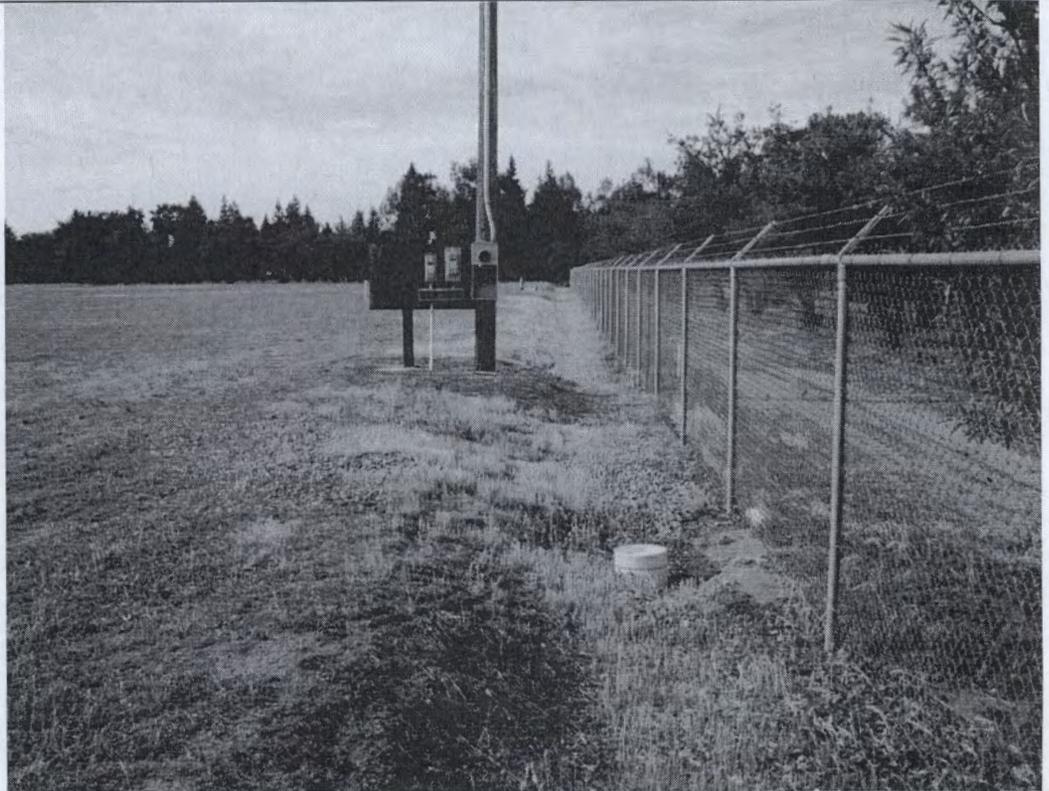
View of the infiltration
trench on west side of
containment cover. Note
infiltration-trench
inspection port in
foreground. Note utility
pole and electrical panel
located approximately 60
feet south and 8 feet east
of northwest corner of
Site.

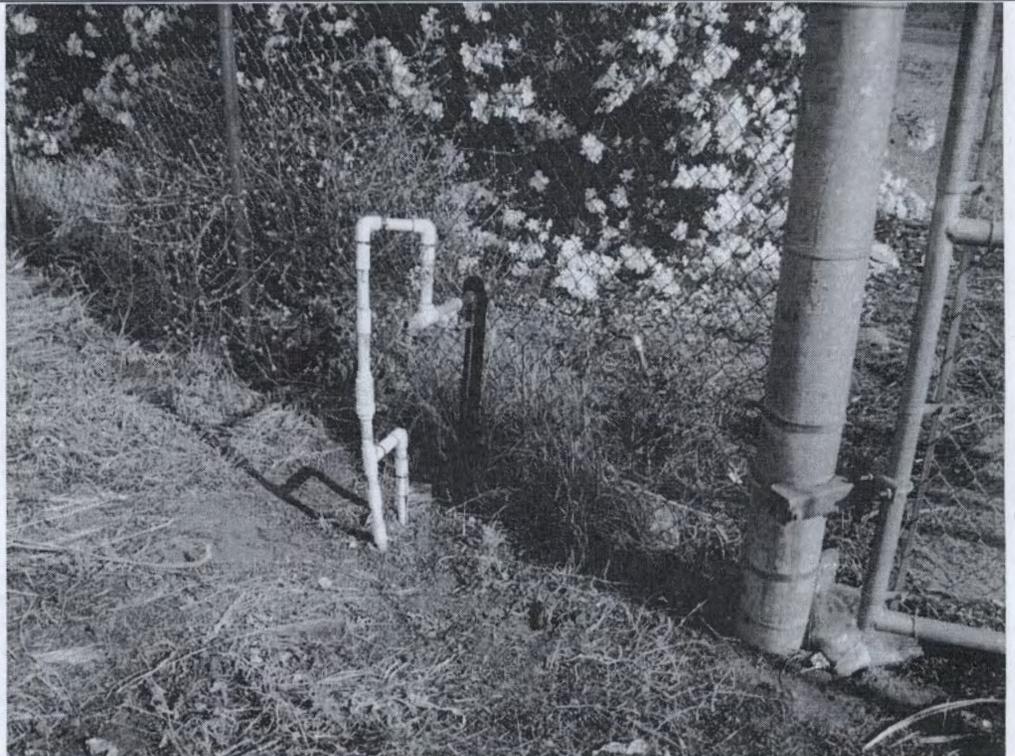
2

View of water supply
hose bib faucet located
approximately 1 foot
south and 12 feet east
of northwest corner of
Site.

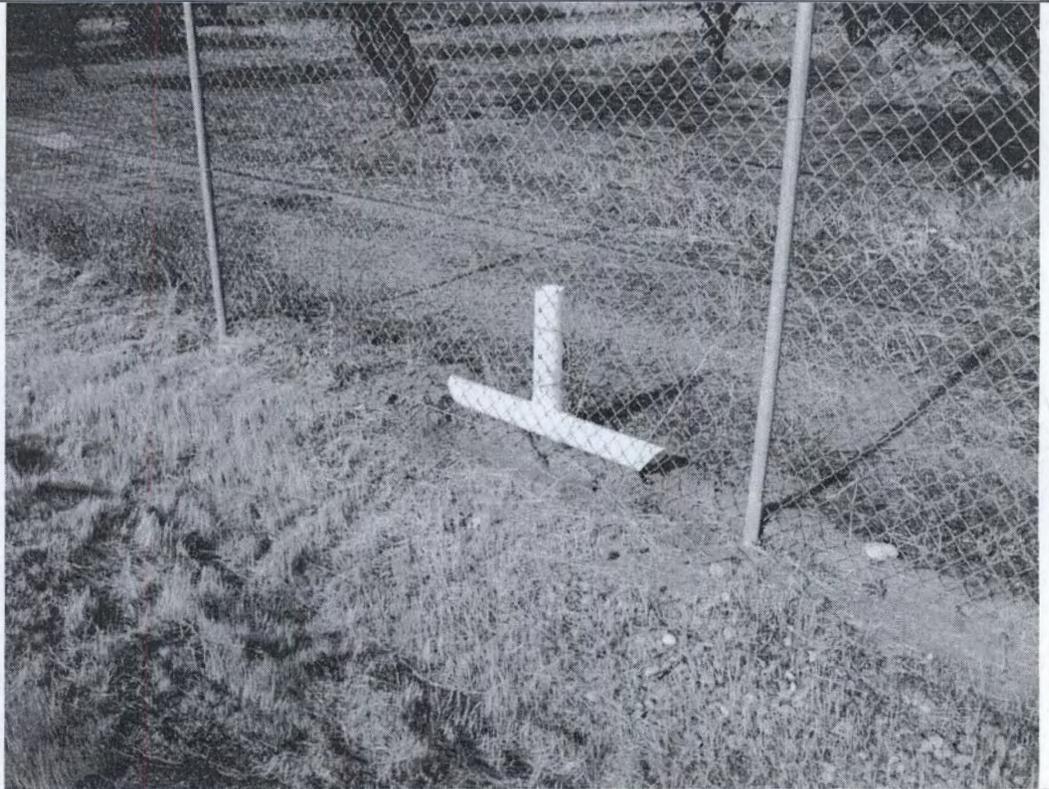
View of rodent poison bait station just outside western fence at Site.

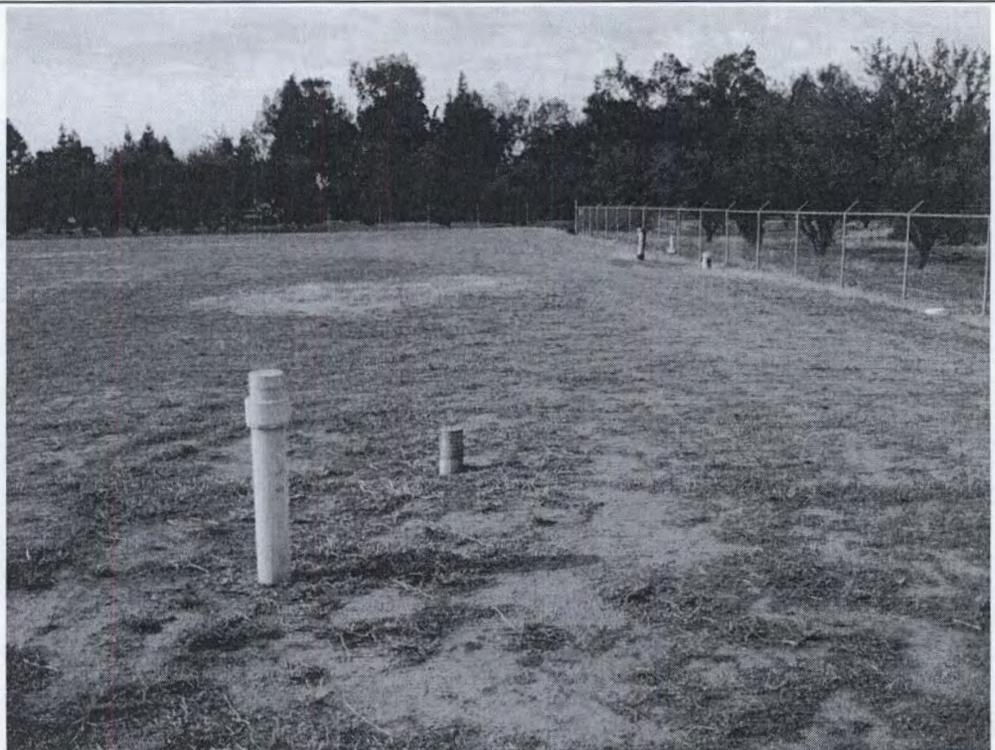
4

View of groundwater monitoring wells 155-A1 and 155-B0, in foreground, and monitoring wells 77-A and 77-B1, in background, located in southwest quadrant of the Site.

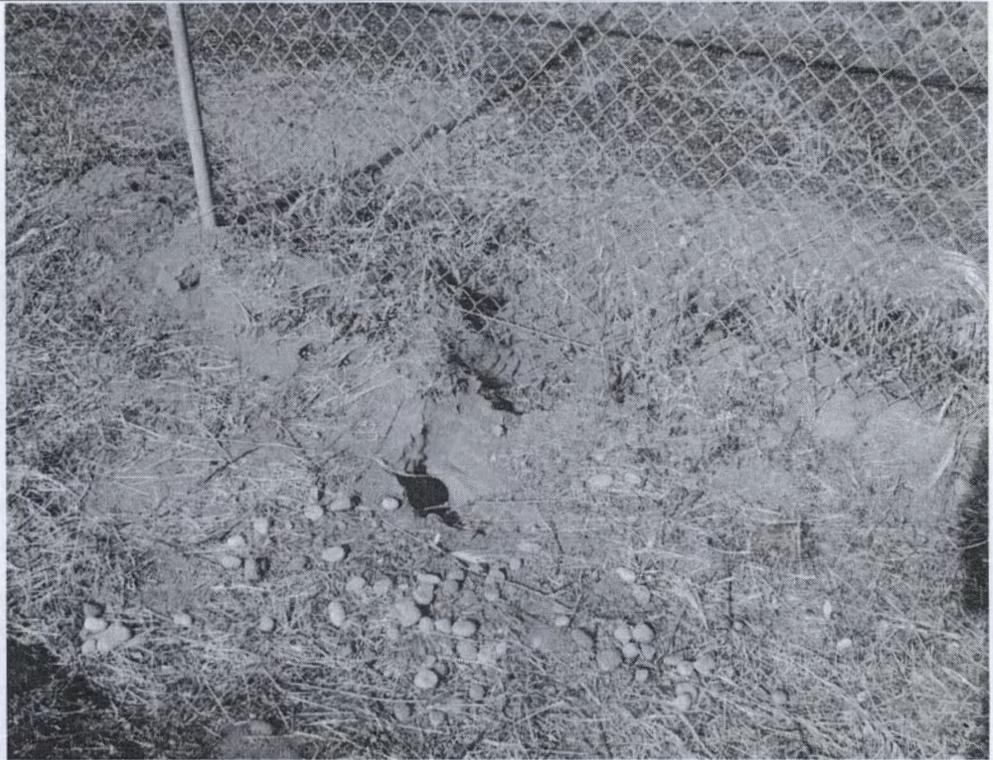
- The chainlink fence and gates are in good condition. At a few locations, rodent burrows (approximately 6-inch diameter) under the fence are present and need to be filled with top soil from the adjacent orchard. Some of the warning signs on the fence have deteriorated, are nearly illegible, and need to be replaced.

View of typical rodent burrow (approximately 6-inch diameter) under western fence at Site.

- A field person visits the Site at least every two weeks to check for vandalism or other issues.
- There are no major O&M problems or issues at the Site.
- Rodent burrows under the fence, and in the vegetative layer of the containment cover, are filled in with top soil from the adjacent orchard, as they are found.
- Rodent poison bait is placed in bait stations, and scattered in active burrows, on a monthly basis.
- A few years ago, vandals cut a hole in the fence and stole the electrical wire that ran from the utility pole to the on-site water supply well. The hole in the fence was repaired, and no further intrusion inside the fence has occurred.

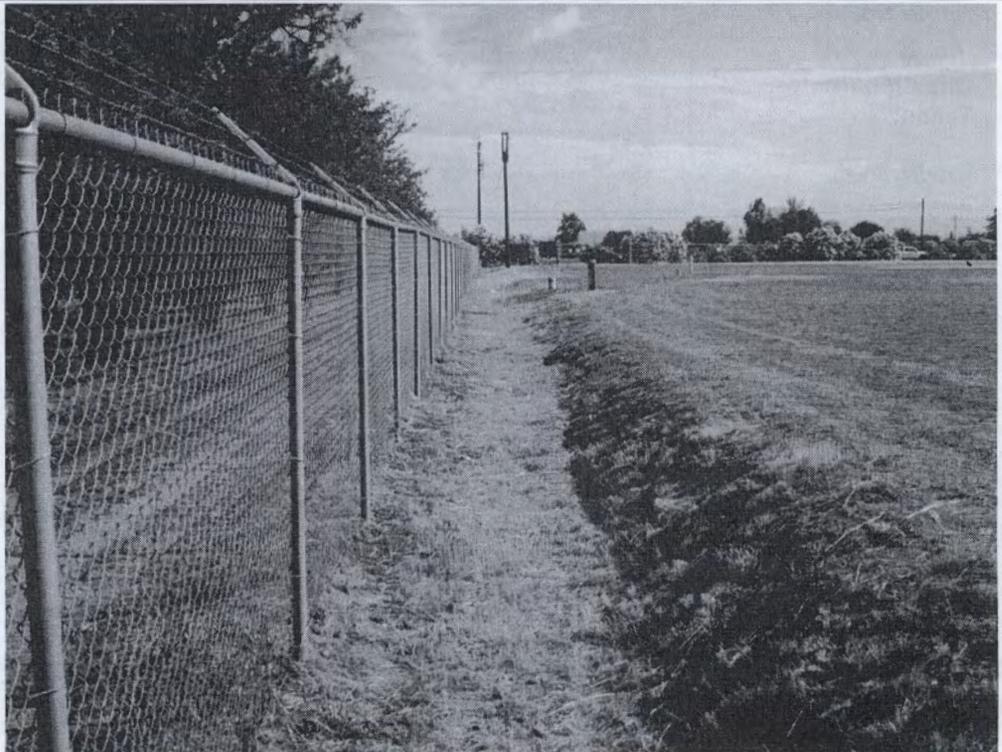
**Photo No.
6**

View of the infiltration trench on west side of containment cover.

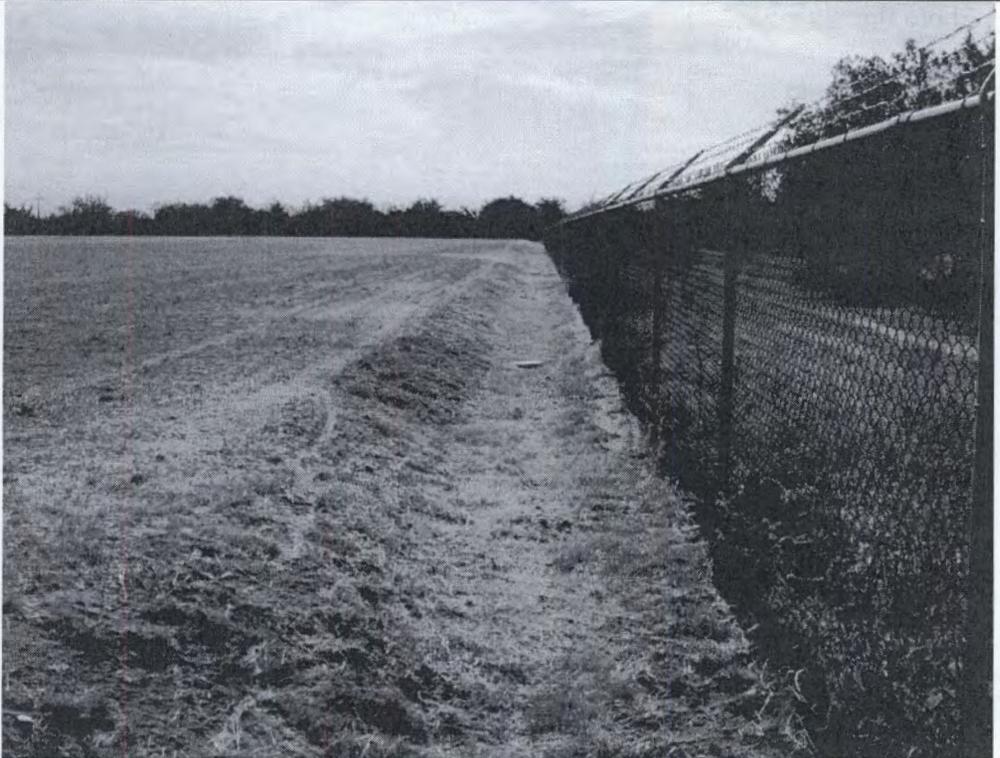
View of the infiltration
trench on south side of
containment cover.

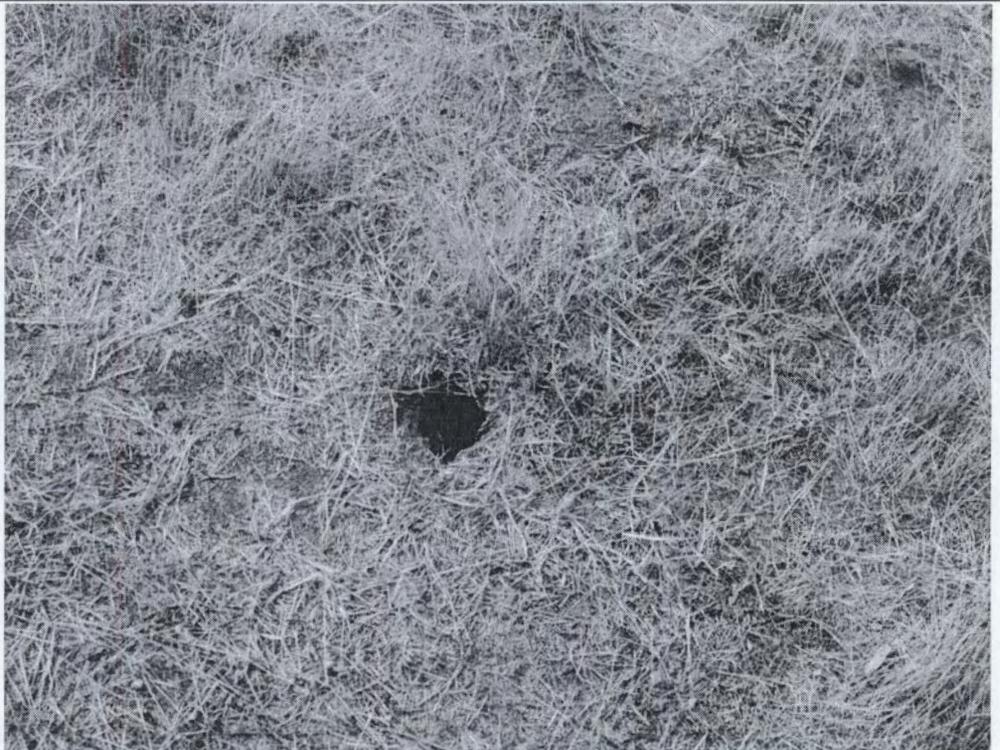
8

- The containment cover is in good condition. No significant vegetative growth or erosion damage was observed. A few small rodent burrows (approximately 6-inch diameter and 6-inch deep) were observed in the vegetative top layer of the containment cover. These burrows need to be filled with top soil from the adjacent orchard.
- The monitoring wells are in good condition.
- The stormwater infiltration trench on the west and south sides of the containment cover is in good condition.
- No accumulations of litter or debris, or signs of vandalism or unauthorized entry to the Site, were observed.
- In the northeast quadrant of the Site, there is an unused water well that should be properly destroyed, because it has not been used in over one year, and THAN does not intend to use it in the future. The well location is shown on Figure 2.

View of typical rodent
burrow (approximately 4-
inch diameter) in the top
layer of the containment
cover near the southern
edge.

| 4. | Holes Areal extent <u>6" dia. (typical)</u> Remarks <u>A few rodent burrows observed. Site O&M contractor fills holes with top soil from adjacent orchard as found, and places poison bait periodically.</u> | Location shown on site map _____ Depth <u>6" (typical)</u> | Holes not evident |

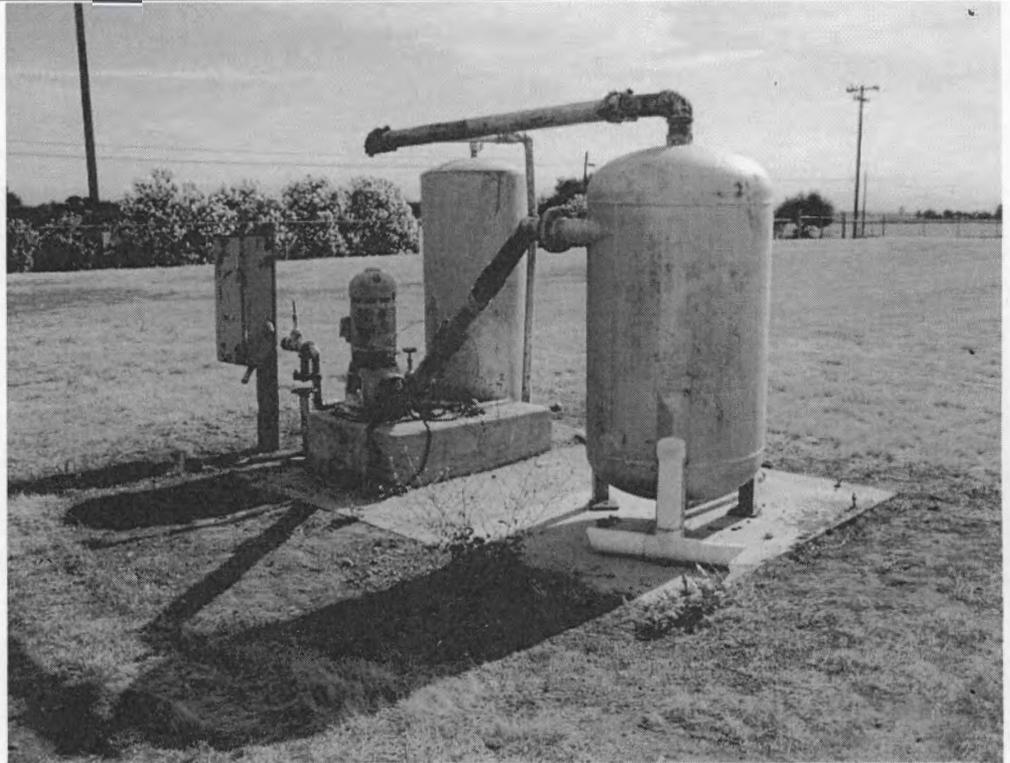
View of the approximately 7-foot by 15-foot concrete pad with a water well, two water tanks, and electrical panel, located approximately 70 feet south and 230 feet west of northwest corner of Site.
