FINAL REMOVAL SITE EVALUATION (RSE) REPORT FOR QUIVIRA SITE EVALUATION FOR CHURCH ROCK (CR-1) AND (CR-1E) MINE SITES

Rio Algom Mining LLC

SENES Consultants Limited

September 2011

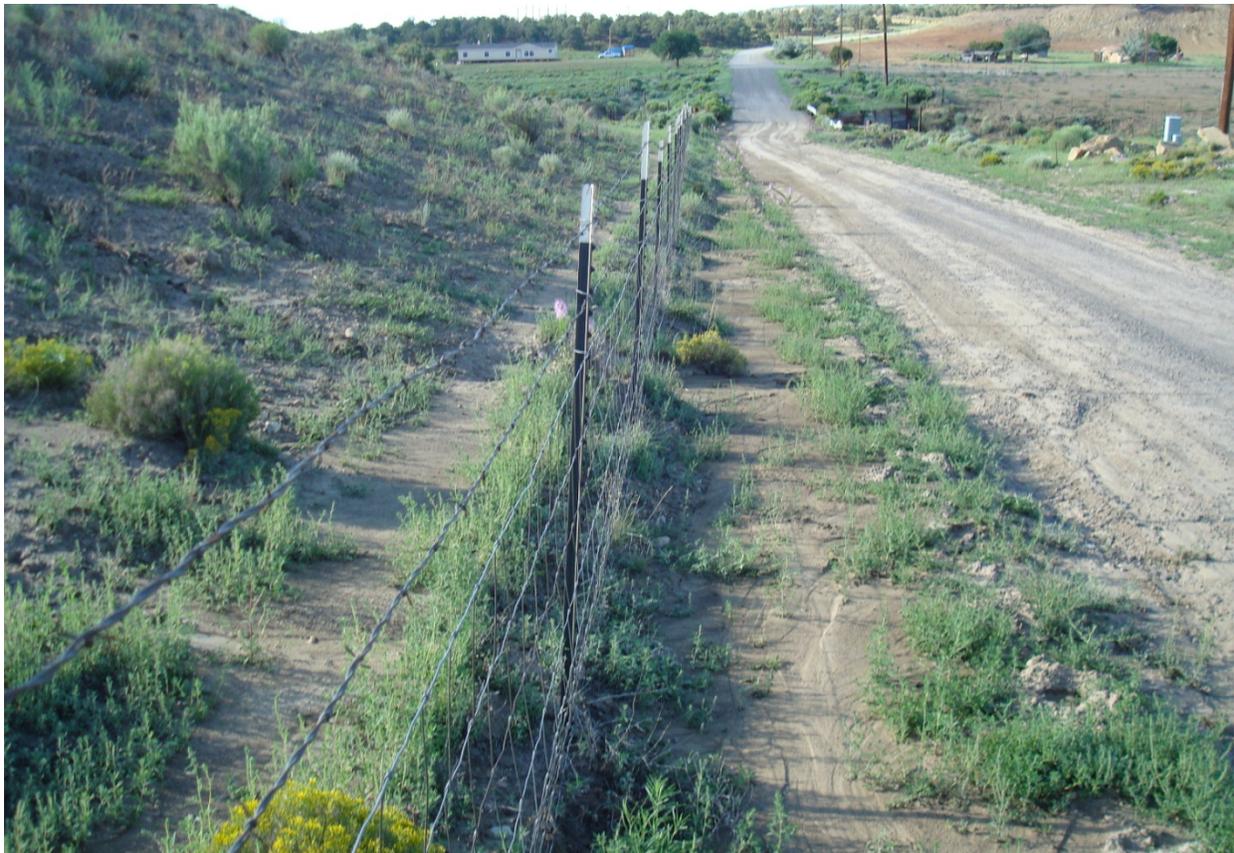
Plate 3.3-1 West Slope of Waste Rock Pile Prior to Mitigation

Erosion rills in the soil cover were repaired on a portion of the reclaimed slope, which was further stabilized with straw wattles. To reduce the migration of sediment, straw wattles were installed in select locations along runoff channels, and silt fencing was installed in selected areas of potential sheet flow along the perimeter of the facility. RAML will continue to conduct inspection and maintenance activities, as required under the AOC.

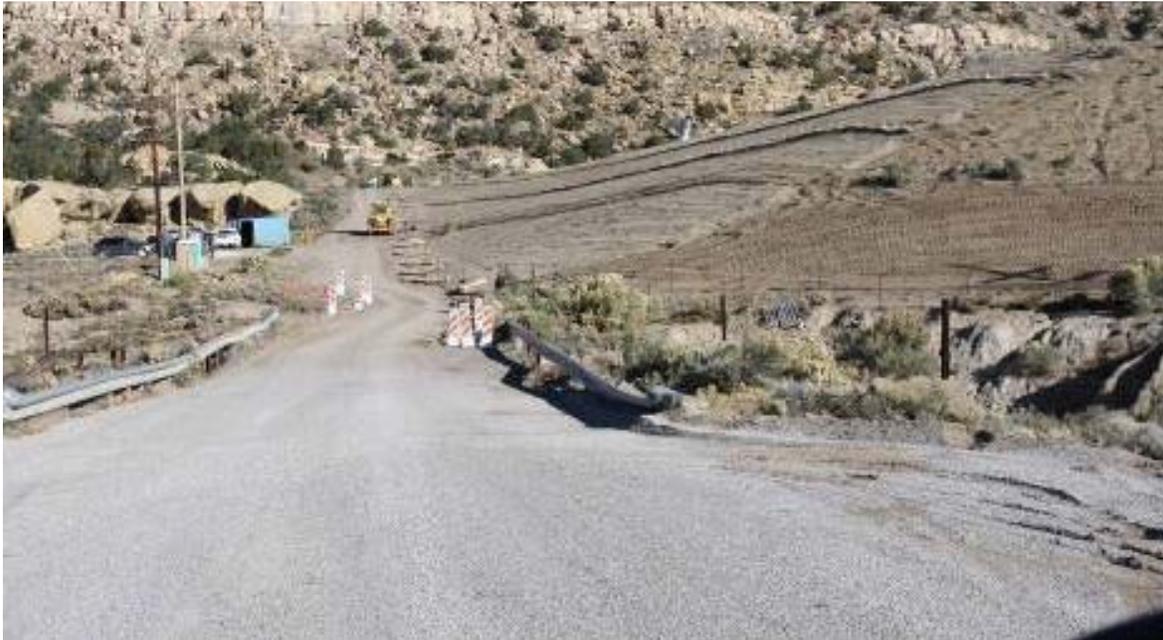
Plate 3.3-2 View of Entrance Ramp Showing Road and Waste Rock Pile Mitigation

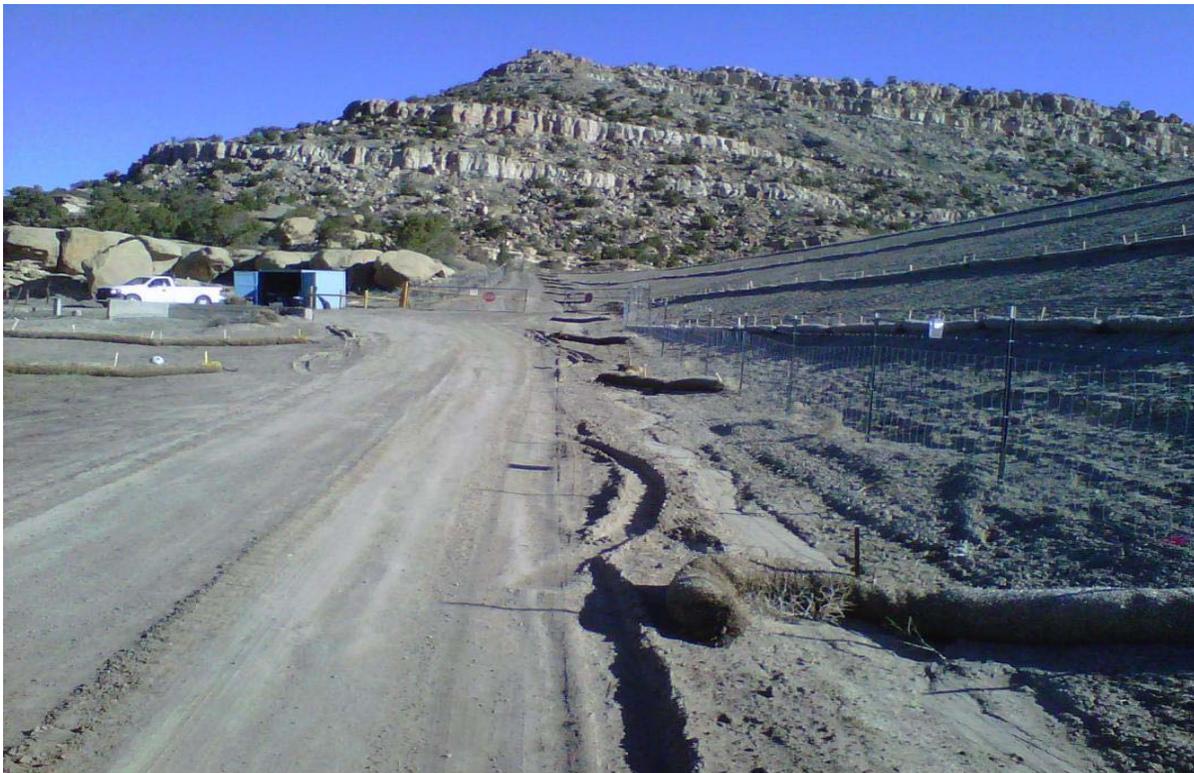
Plate 3.3-3 West Slope of Waste Rock Pile with Erosion Controls

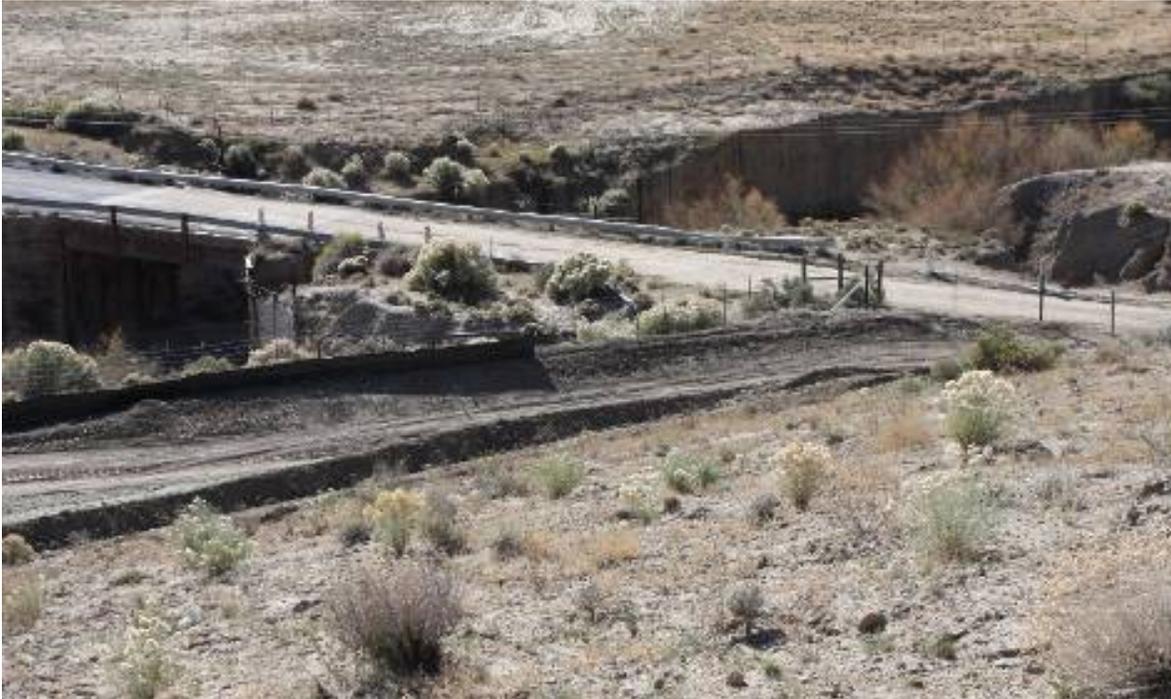
Plate 3.3-4 Berm Storm Water Control at South End of Waste Rock Pile

Several thousand feet of earthen berms were repaired and extended to better direct “run-on” storm water safely around the facility and to direct potentially impacted “run-off” storm water to sediment traps and evaporation basins located onsite. One new trap was installed while others were deepened or enlarged to increase capacity. A 25-foot section of channel was excavated west of the mine entrance ramp that would allow storm water from the mountain ridge to be diverted off the ramp and to discharge as un-impacted water. Upon completion of the grading of the west slope of the waste rock pile, straw wattles were immediately installed at the toes of the slope.

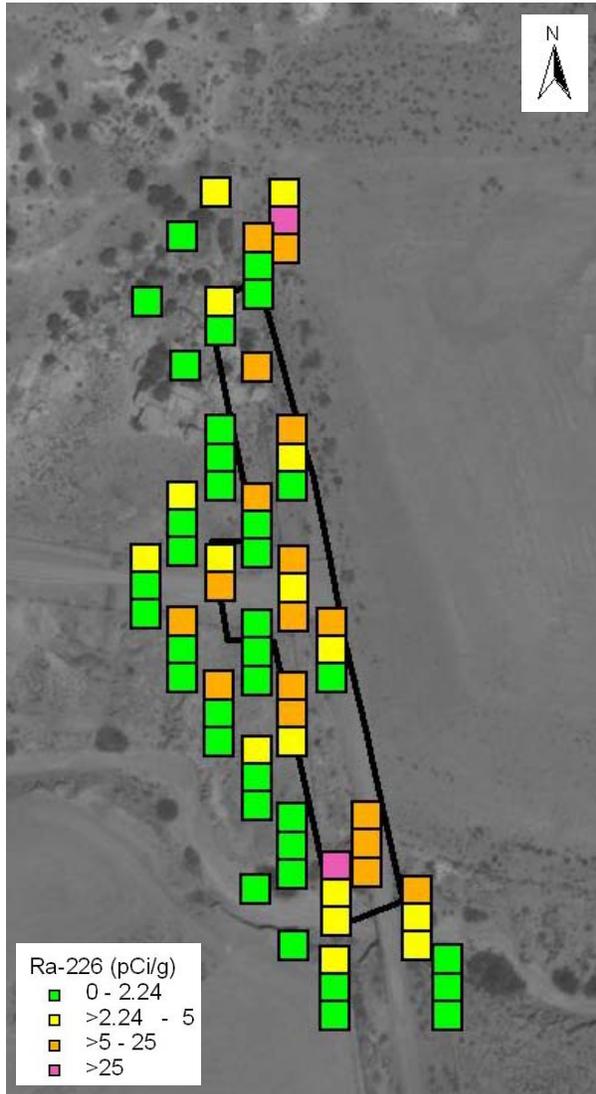
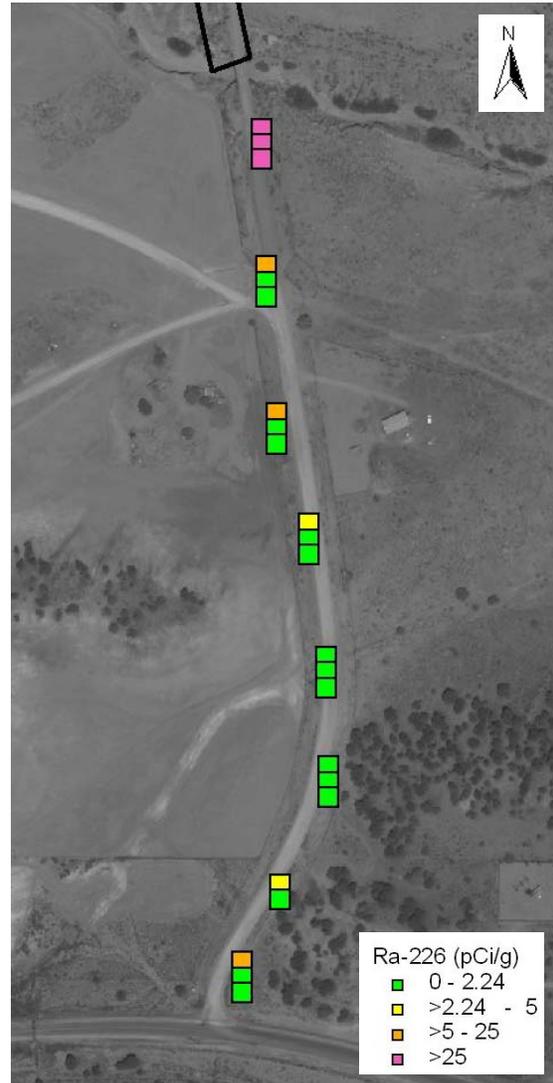
Plate 4.2-1 RWPR Ra-226 Soil Concentrations (pCi/g)

Sampling of the area north of the bridge at Arroyo #2 found higher concentrations generally along the road and near shoulders of the road.

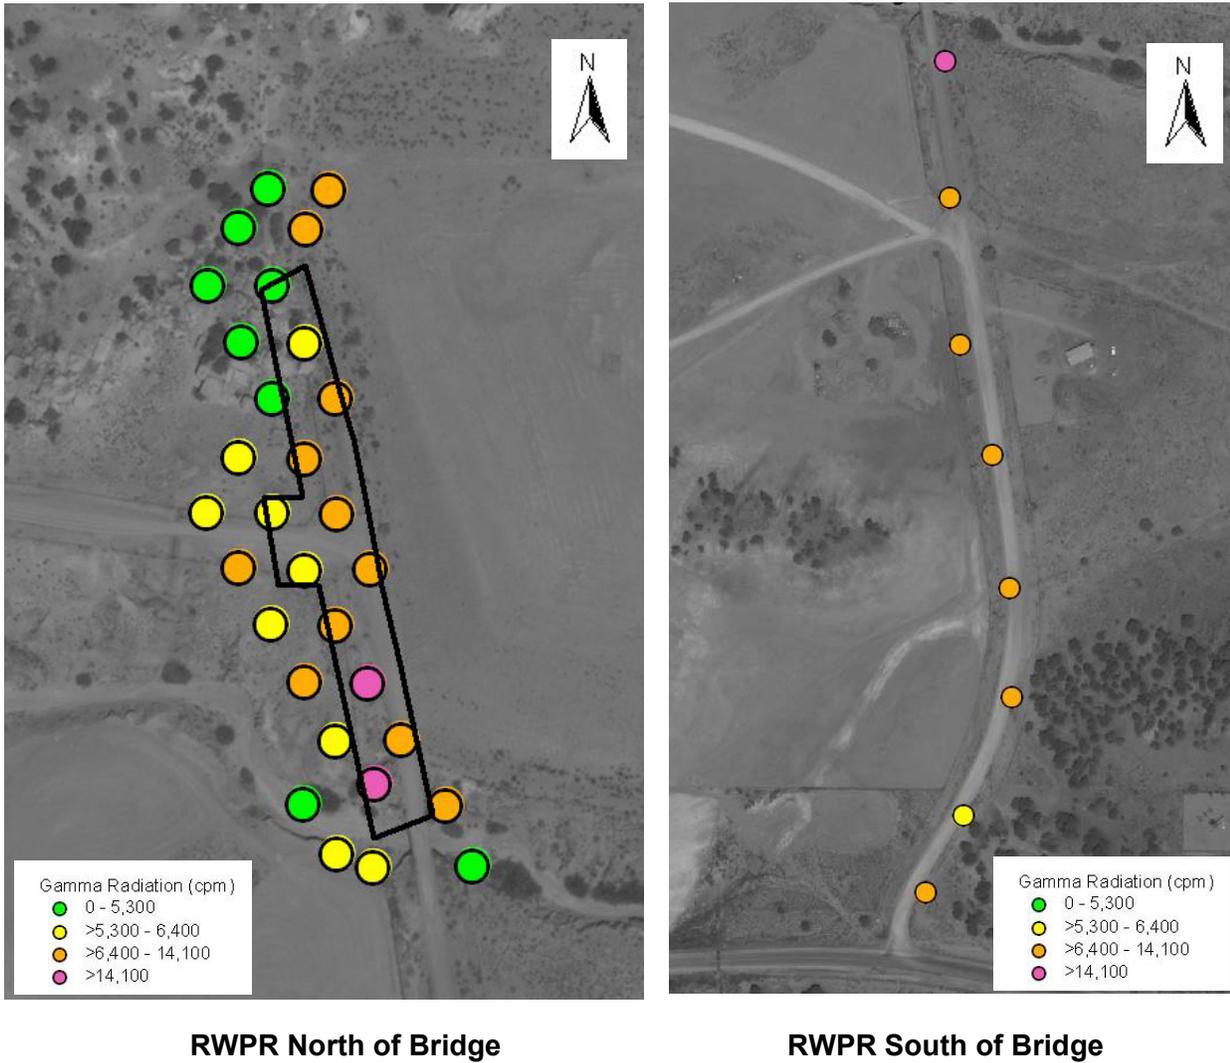
**Plate 4.2-2 RWPR Collimated Gamma Radiation Measurements (cpm)
at Static Locations**

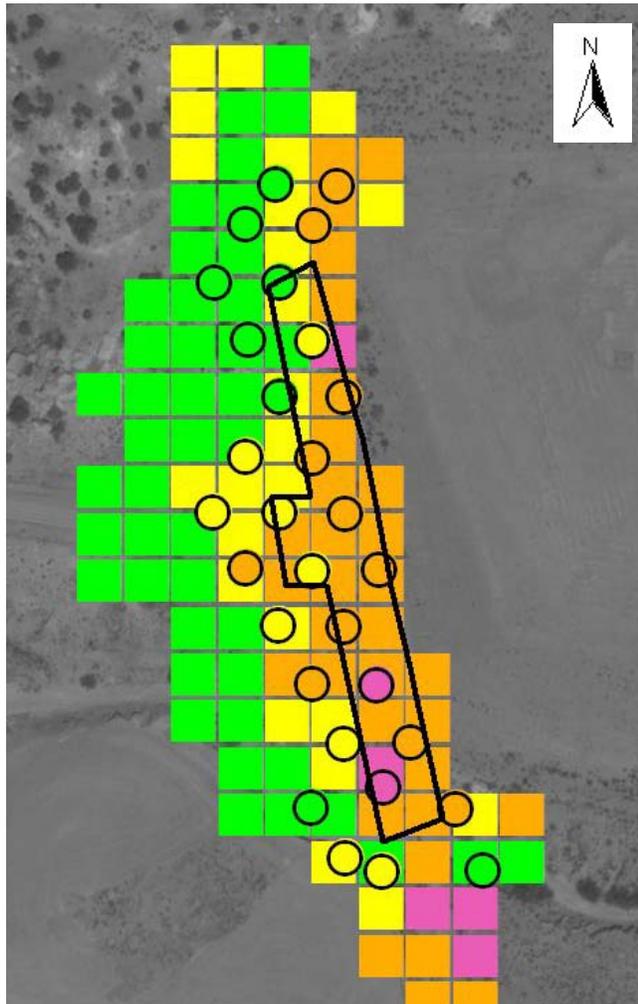
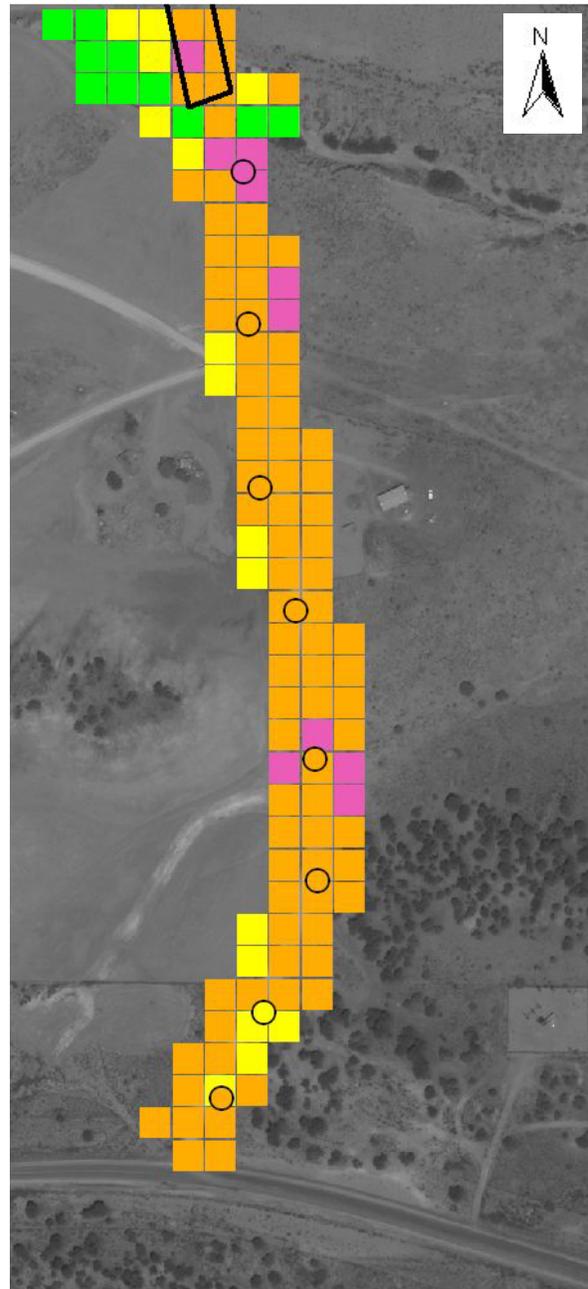
Plate 4.2-3 RWPR Static and Scanning Gamma Radiation Measurements

- 0 - 5,300
- >5,300 - 6,400
- >6,400 - 14,100
- >14,100

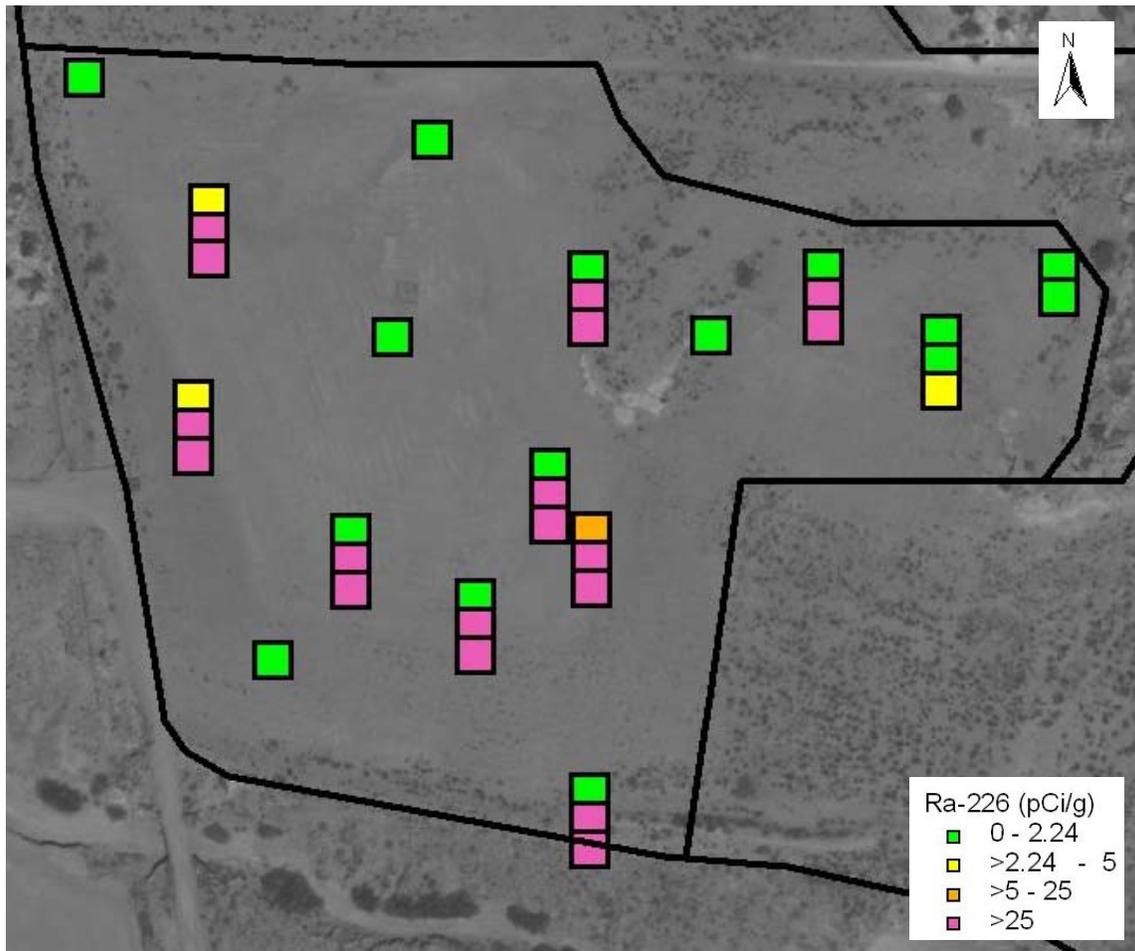
Plate 4.3-1 CR-1 Ra-226 Soil Concentrations Measured with Shallow Sub-Surface Program-Site Wide

Top block is 0-6 inches; second block is 18-24 inches; third block is 30 to 36 inches soil horizon.
In some cases, a target zone was only partially measured due to refusal during sample collection.

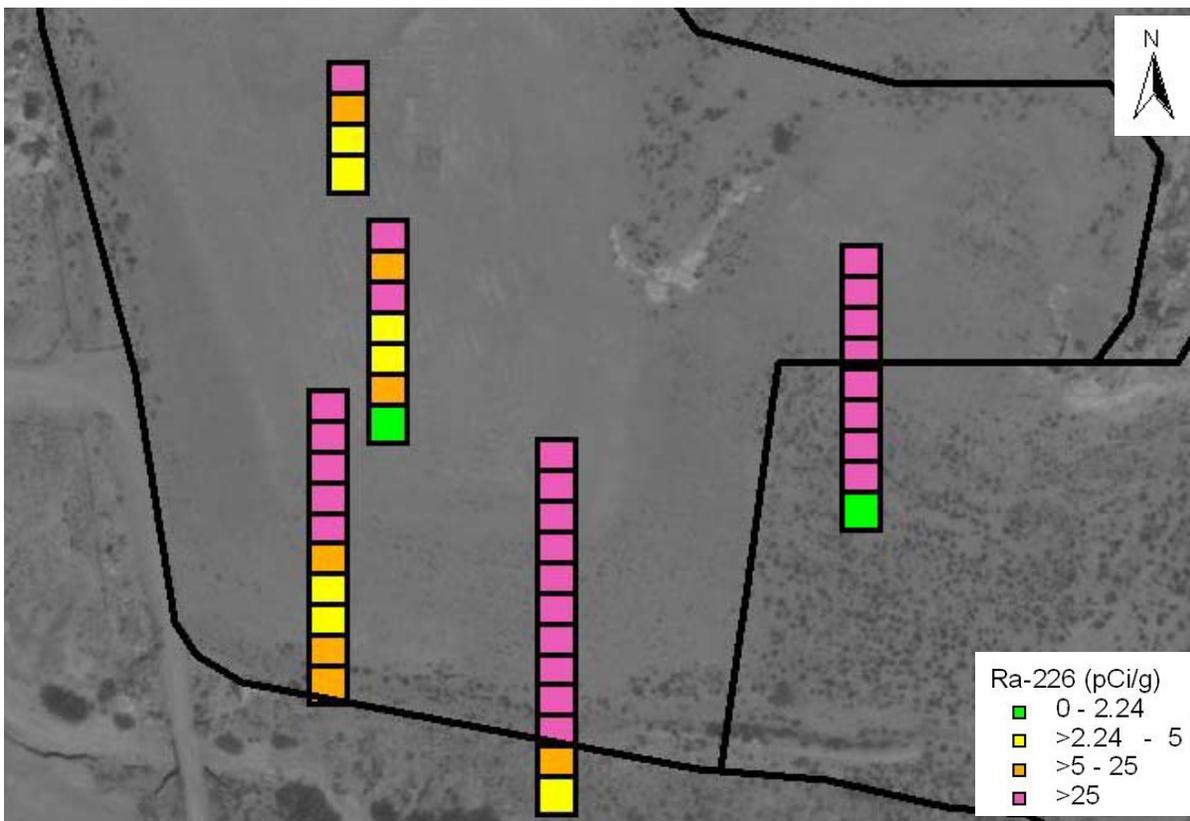
Plate 4.3-2 CR-1 Ra-226 Soil Concentrations Measured with Deep Drilling Program on Waste Rock Area

Sampling conducted by 5 foot increments with a composite over 1.5 foot.
Top block begins at a 5 foot depth

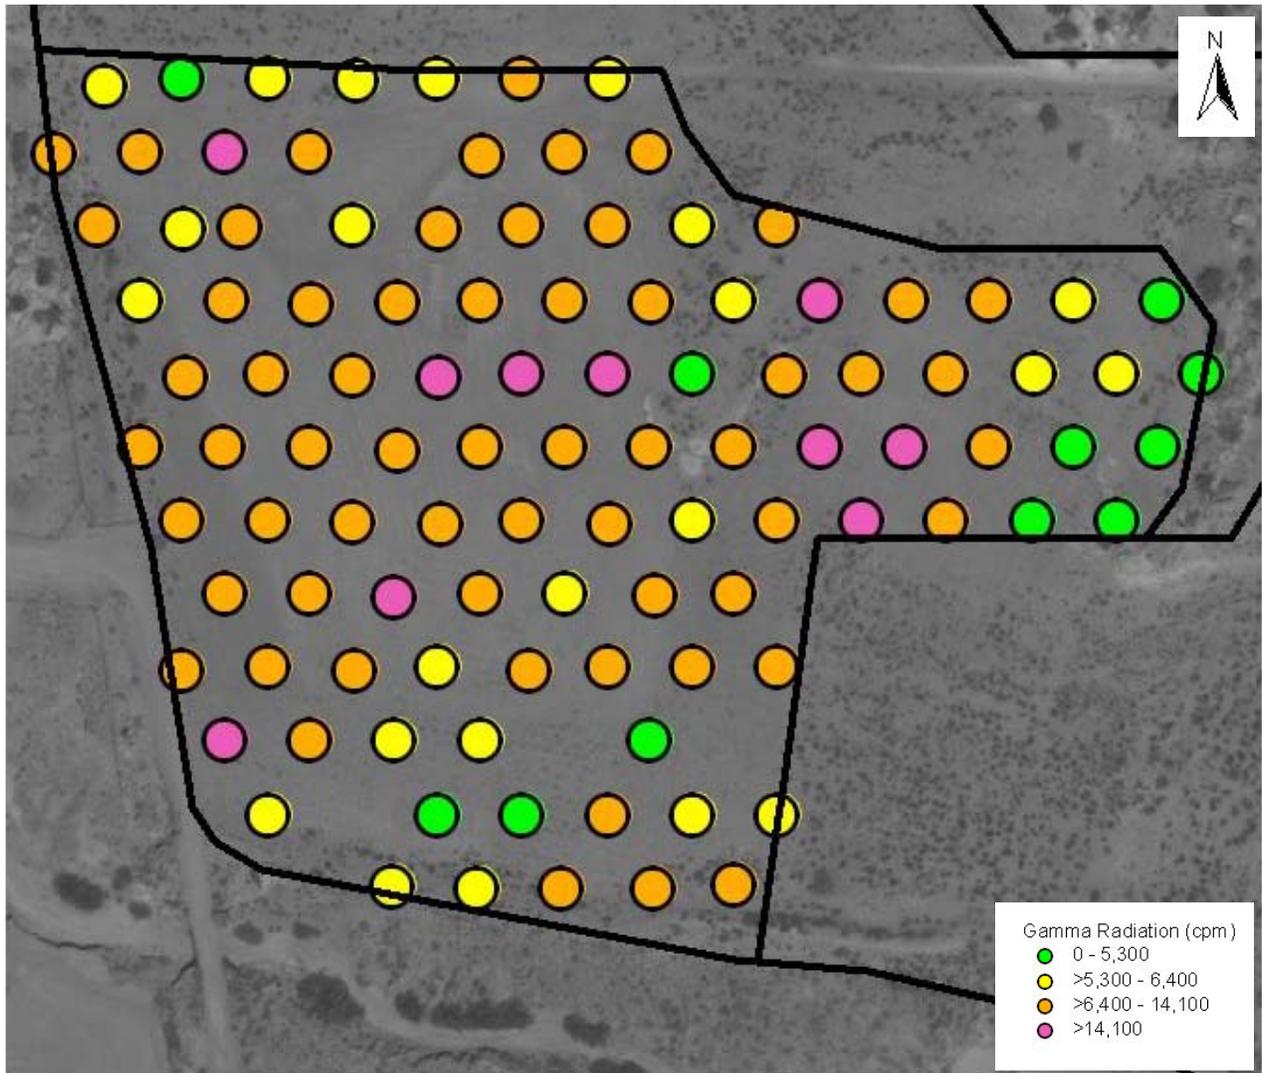
Plate 4.3-3 CR-1 Static Gamma Radiation Levels (cpm) Measured on Waste Rock Area

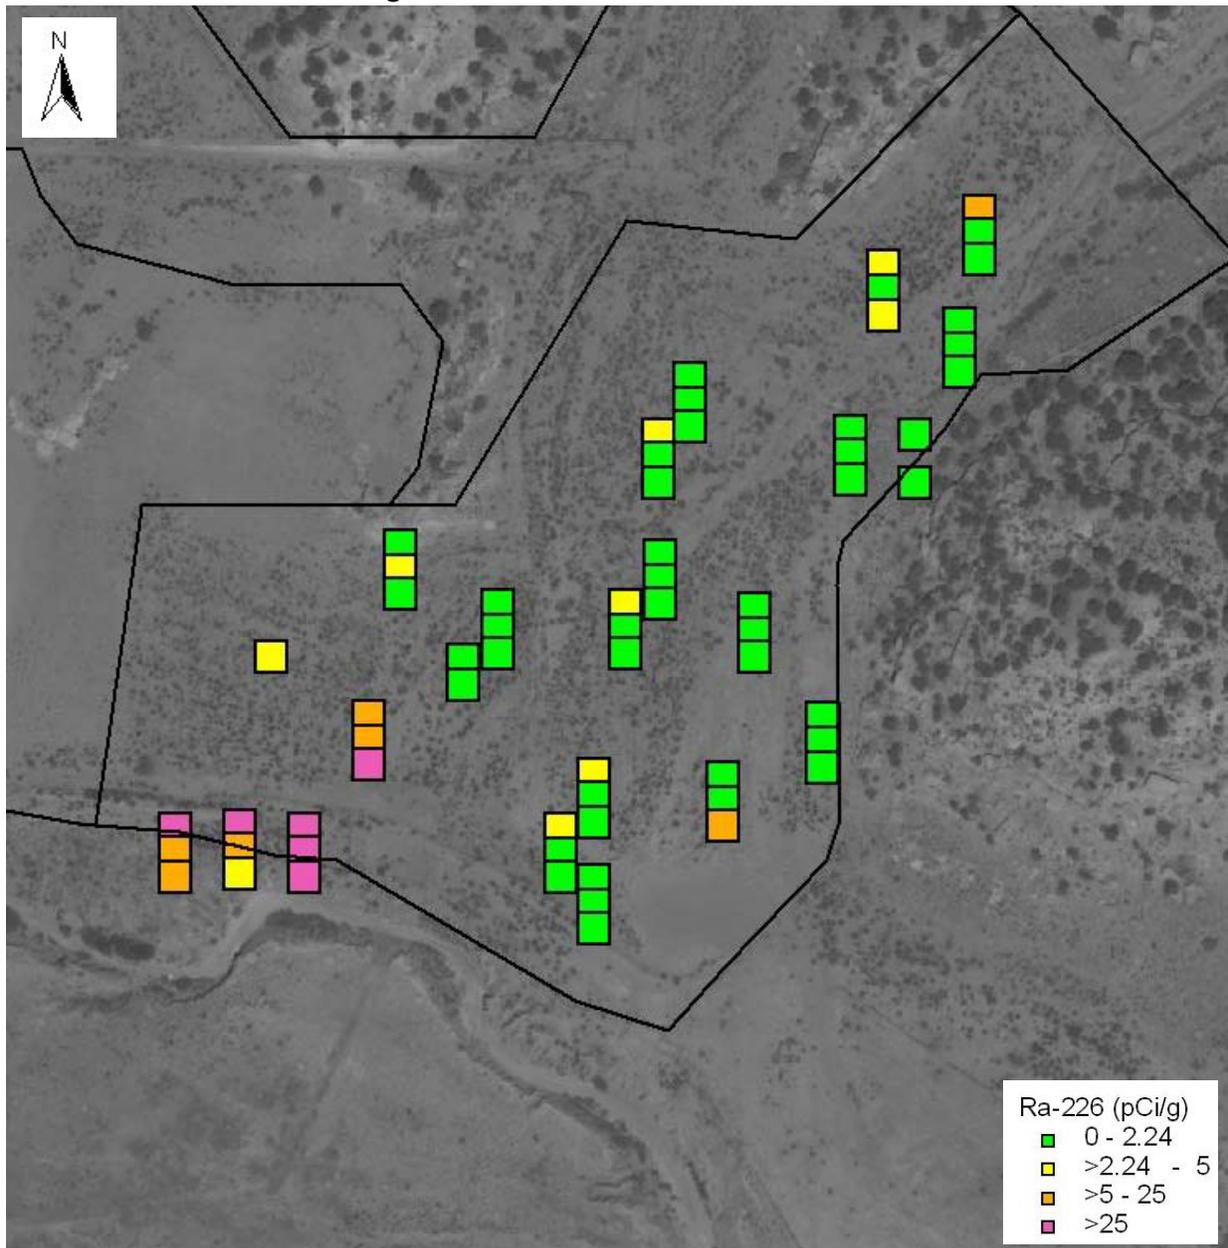
Plate 4.3-4 CR-1 Ra-226 Soil Concentrations Measured with Shallow Sub-Surface Program on Former Sediment Pond Area

Notes: Top block is 0-6 inches; second block is 18-24 inches; third block is 30 to 36 inches soil horizon.
In some cases, a target zone was only partially measured due to refusal during sample collection.

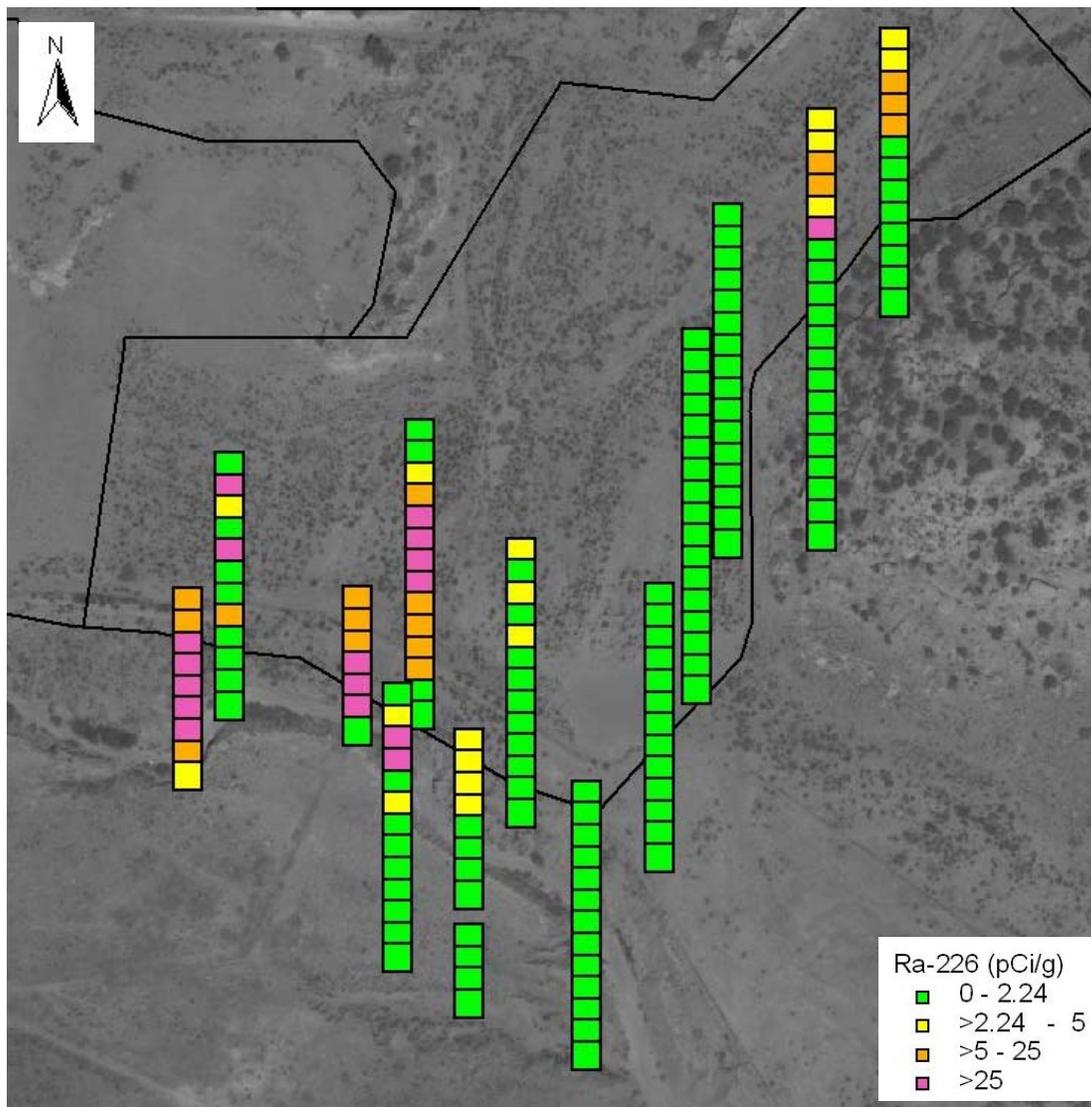
Plate 4.3-5 CR-1 Ra-226 Soil Concentrations Measured with Deep Drilling Program on Former Sediment Pond Area

Plate 4.3-5 graphically illustrates the results of the deep drilling Ra-226 soil concentration data from the former sediment pond areas with summary statistics provided in Table 4.3-5. The majority of deep drilling occurred in this area with sampling from 13 locations. Consistent with the shallow sampling, results from the deeper sampling program found many of the surface concentrations to be below the PAL. The 16.5-18 foot sample interval at C1LP-402 had the highest Ra-226 concentration. These targeted samples are not intended to be statistically representative of the entire pond location and the resulting statistics may not be reliable indicators of concentrations at each depth. Ra-226 surface soil concentrations exceeded the PAL in the southwest and northeast part of the former sediment pond area.

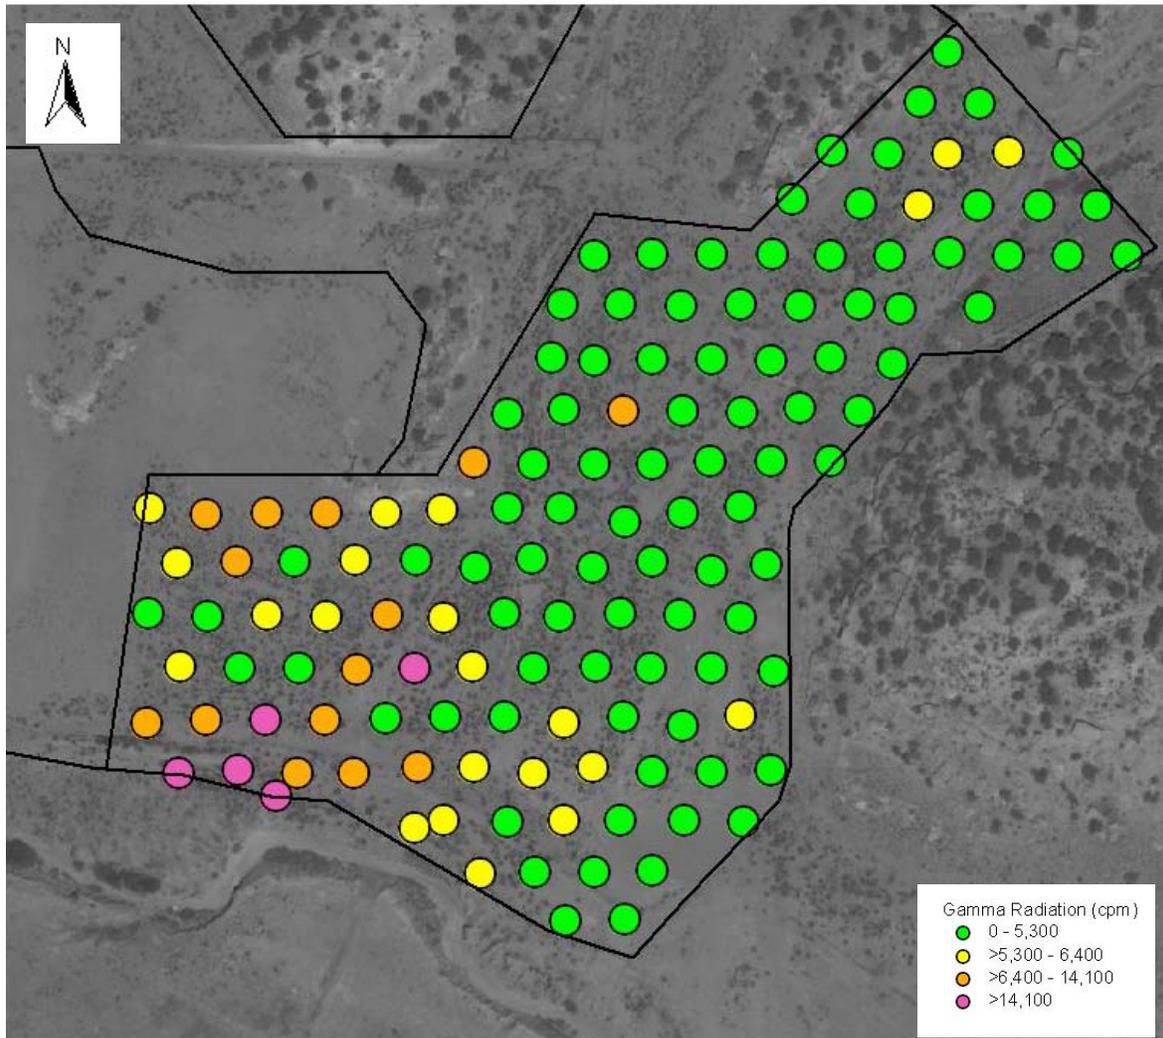
Plate 4.3-6 CR-1 Static Gamma Radiation Levels (cpm) Measured on Former Sediment
Pond Area

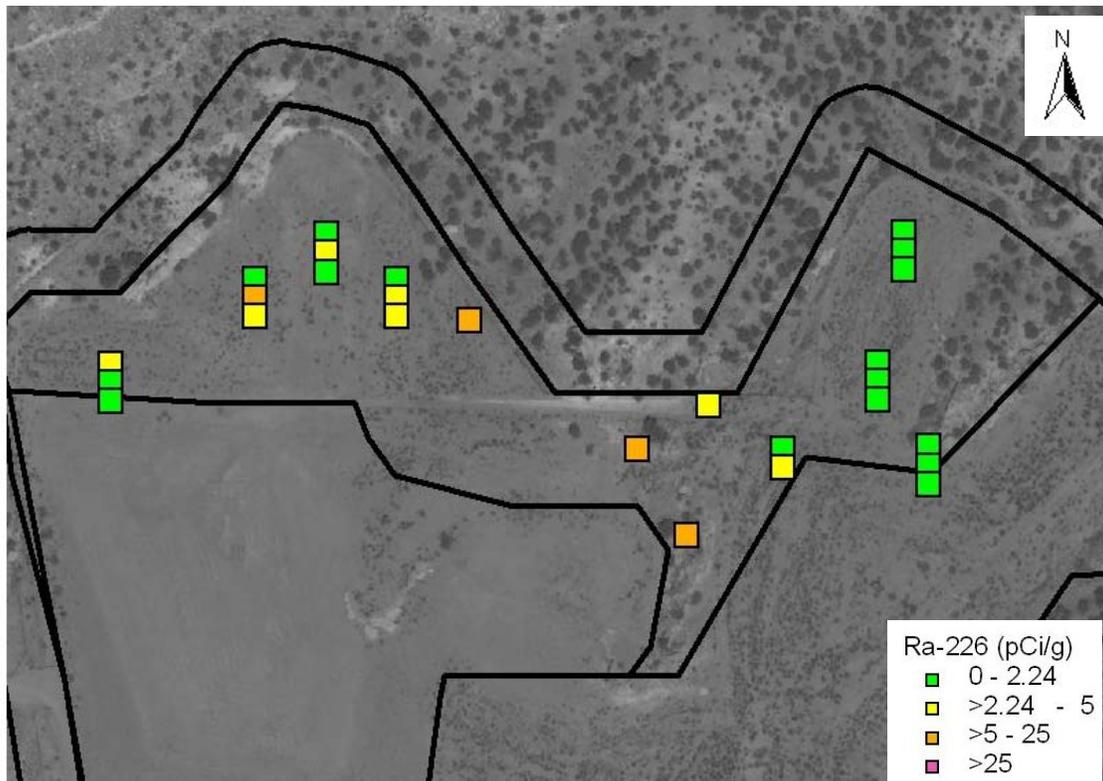
Plate 4.3-7 CR-1 Ra-226 Soil Concentrations Measured with Shallow Sub-Surface Program on Former Industrial Area

Sampling conducted by 1.5 foot increments
Top block is from 0 to 1.5 foot depth

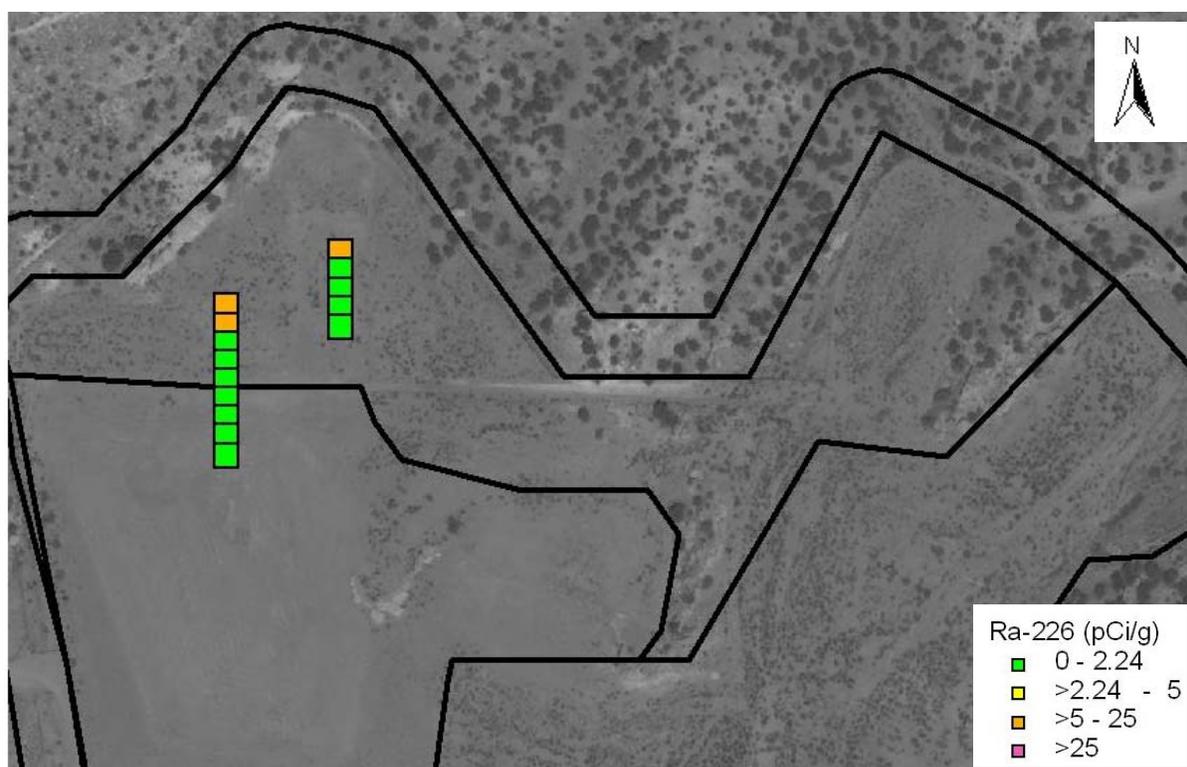
Plate 4.3-8 CR-1 Ra-226 Soil Concentrations Measured with Deep Drilling Program on Former Industrial Area

Sampling conducted by 5 foot increments with a composite over 1.5 foot.
Top block begins at a 5 foot depth

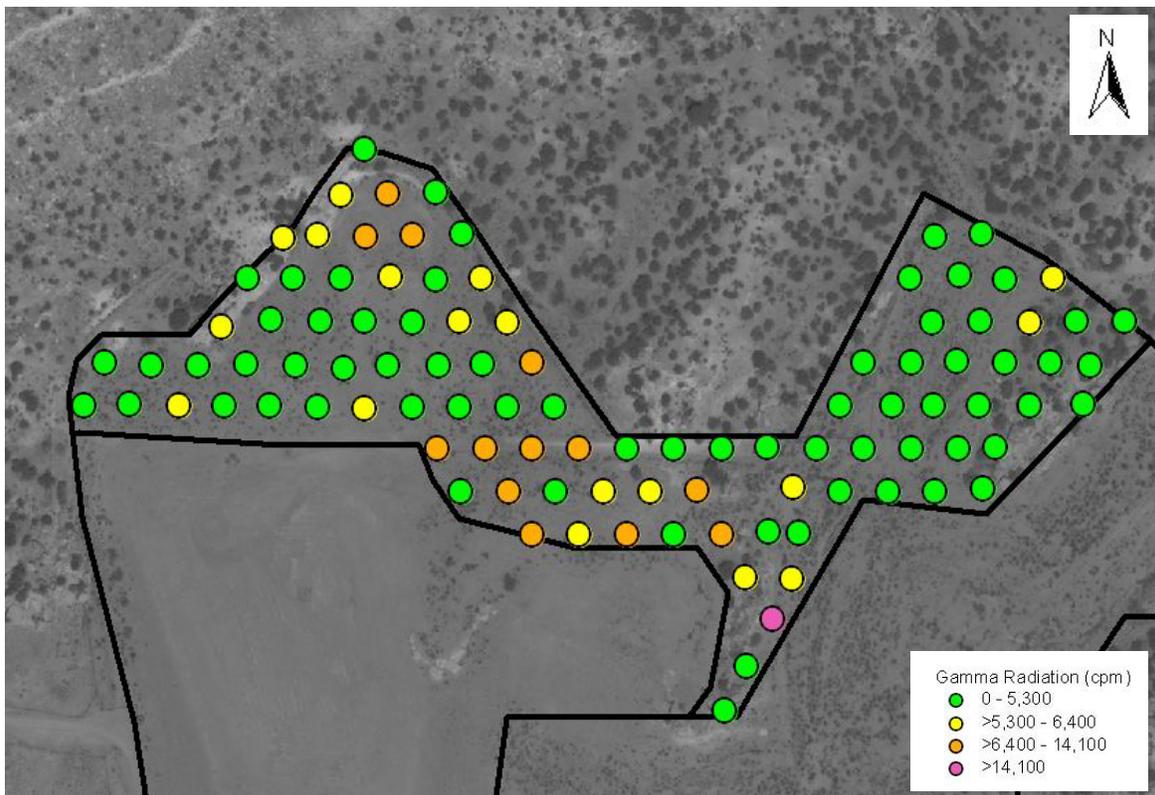
Plate 4.3-9 Static Gamma Radiation Levels (cpm) in Former Industrial Area

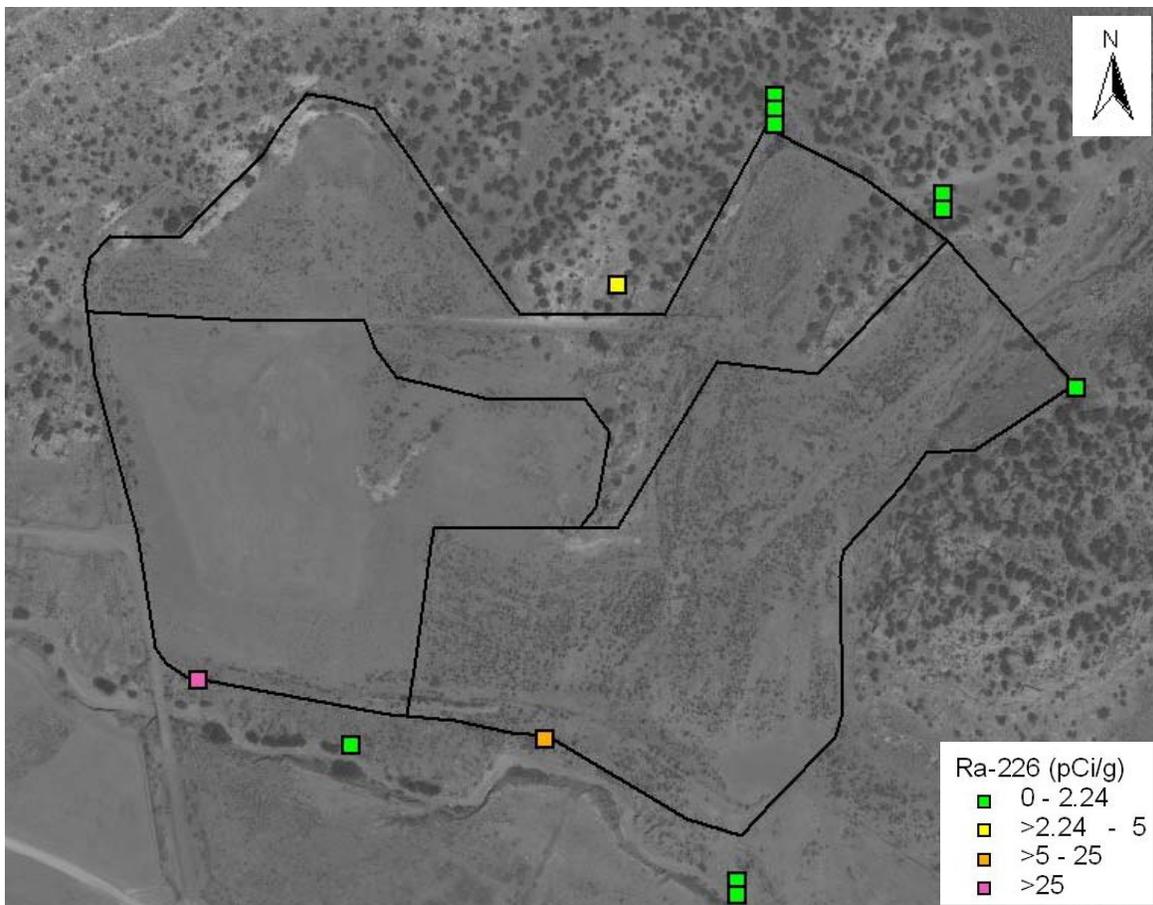
Plate 4.3-10 CR-1 Ra-226 Soil Concentrations Measured with Shallow Sub-Surface Program on Step-out Area

Top block is 0-6 inches; second block is 18-24 inches; third block is 30 to 36 inches soil horizon.
In some cases, a target zone was only partially measured due to refusal during sample collection.

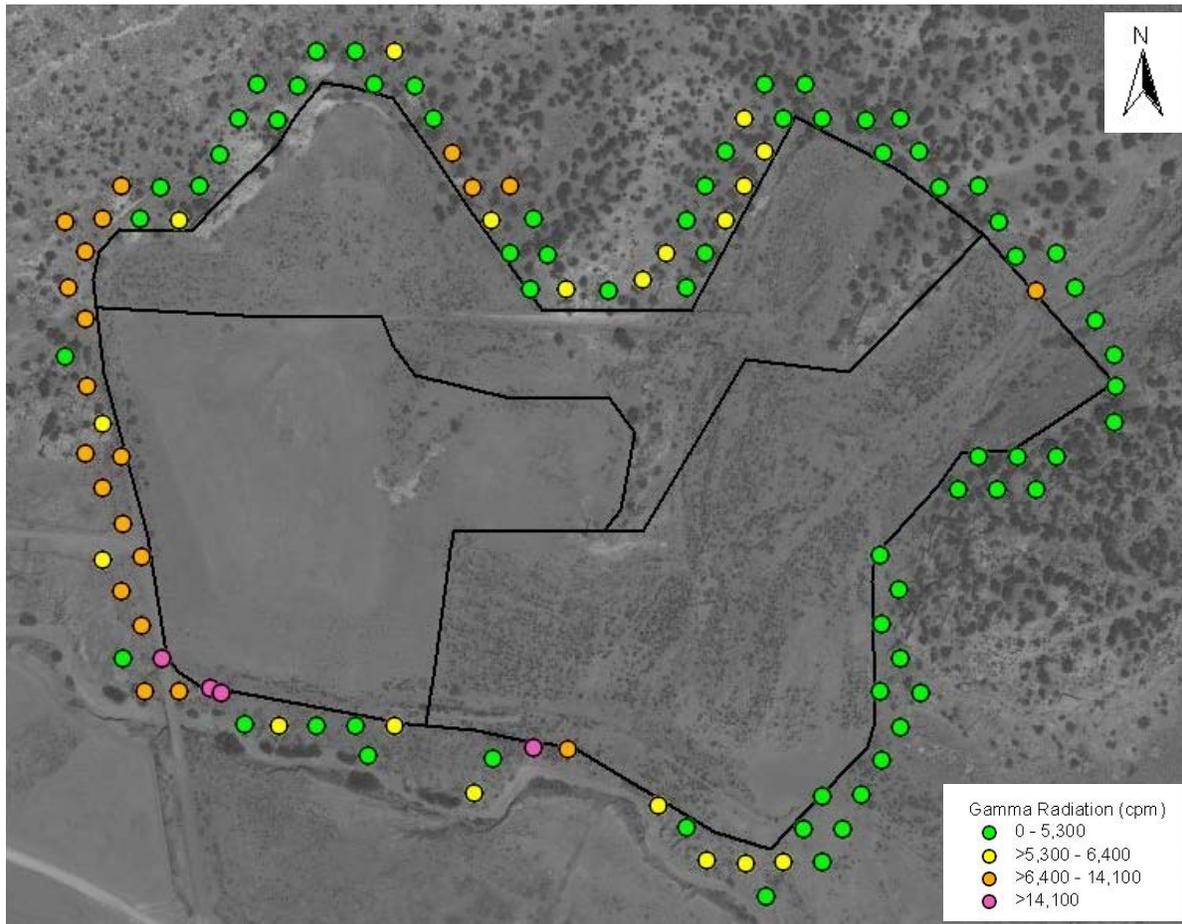
Plate 4.3-11 CR-1 Static Gamma Radiation Levels (cpm) Measured on Step-out Area

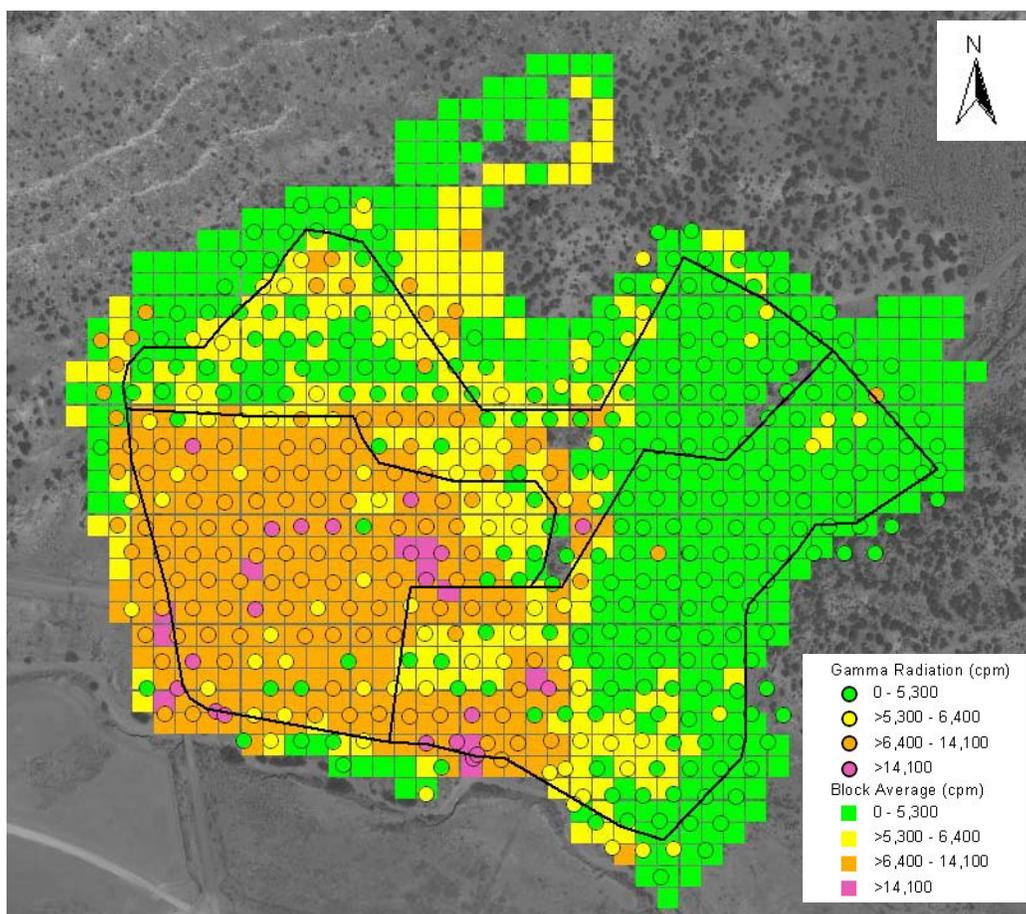
Plate 4.3-12 CR-1 Scanning Gamma Radiation Measurements

- Circles are static gamma radiation results
- Squares indicate averages of scanning gamma radiation data
- No data in areas not colored.

The scanning gamma radiation measurements were averaged to a grid area corresponding to the area represented by the 80 ft triangular grid used for static measurements. These averages are shown in Plate 4.3-12 along with the static point measurements.

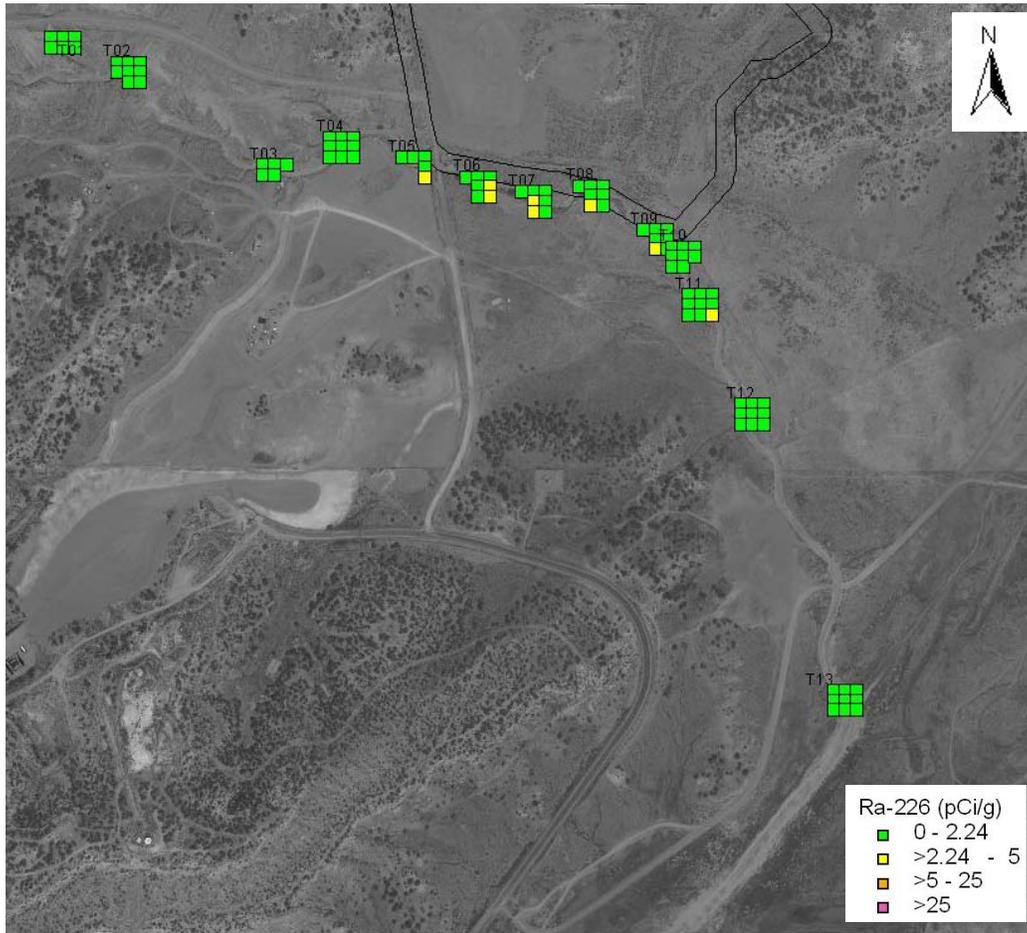
Plate 4.3-13 CR-1 Ra-226 Soil Concentrations Measured with Shallow Sub-Surface
Program on Unnamed Arroyo #2

Top block is 0-2 inch, Second Block is 2-6 inch and Third Block is 30-36 inch
Some concentrations shown that only partially cover a depth increment of interest
