FINAL REMOVAL SITE EVALUATION (RSE) REPORT FOR QUIVIRA SITE EVALUATION FOR CHURCH ROCK (CR-1) AND (CR-1E) MINE SITES

Rio Algom Mining LLC

SENES Consultants Limited

September 2011

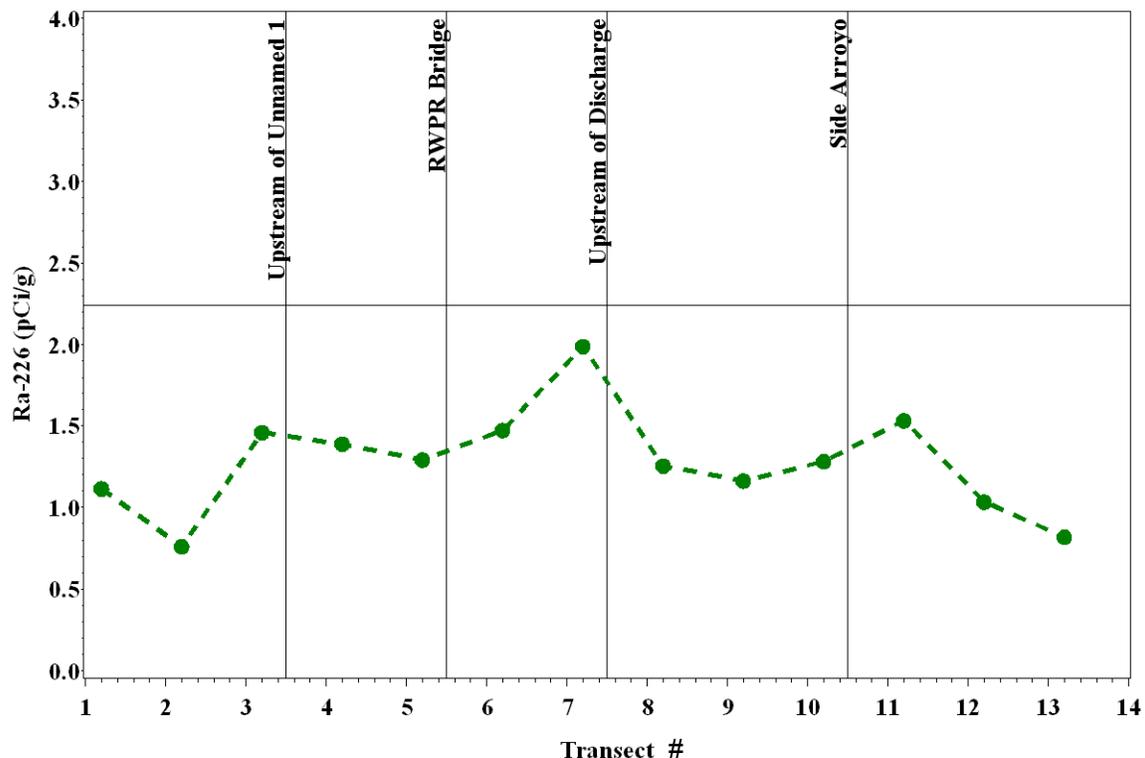
**Plate 4.3-14 CR-1 Ra-226 Soil Concentration Profile Along Unnamed Arroyo #2
(0 to 6inch)**

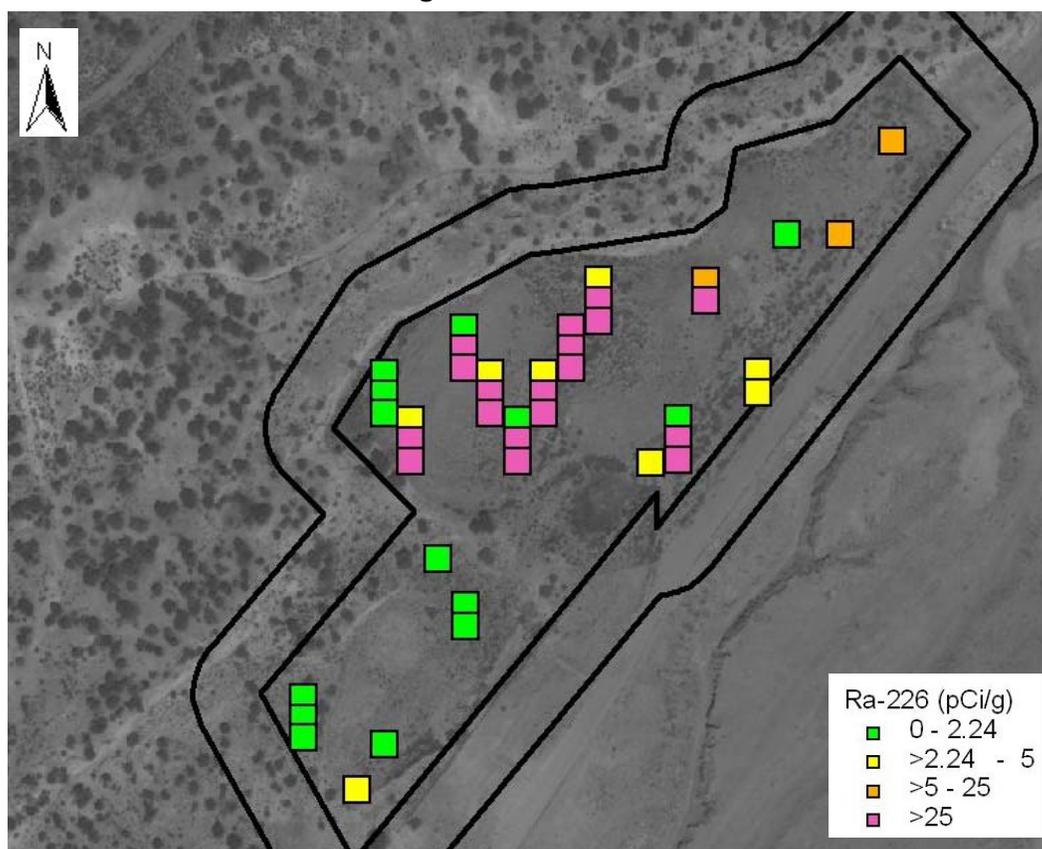
Plate 4.4-1 CR-1E Ra-226 Soil Concentrations Measured with Shallow Sub-Surface Program on Lease Area

Notes: Top block is 0-6 inch; second block is 18-24 inch; third block is 30 to 36 inch soil horizon. In some cases, a target zone was only partially measured due to refusal during sample collection.

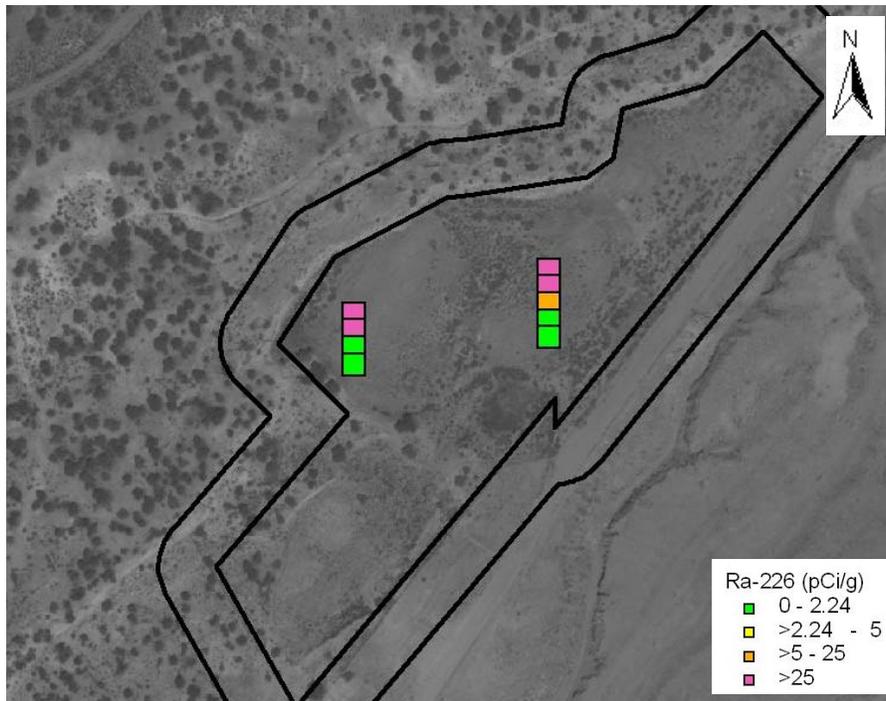
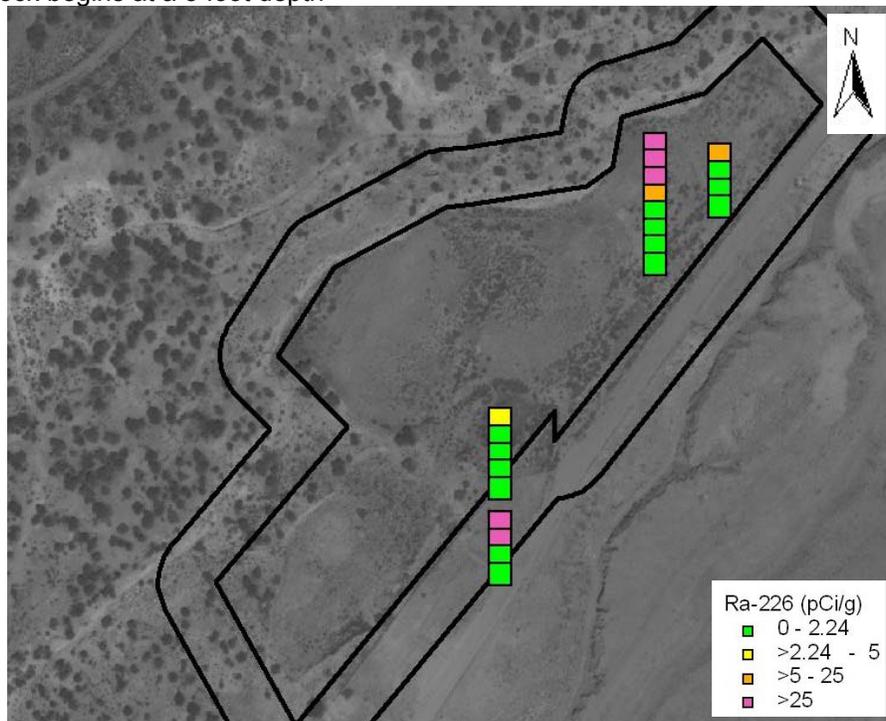
Plate 4.4-2 CR-1E Ra-226 Soil Concentrations Measured with Deep Drilling Program on Lease Area

Notes: Sampling conducted by 5 foot increments with a composite over 1.5 foot. Top block begins at a 5 foot depth

Notes: Sampling conducted by 1.5 foot increments. Top block represents 0-1.5 feet

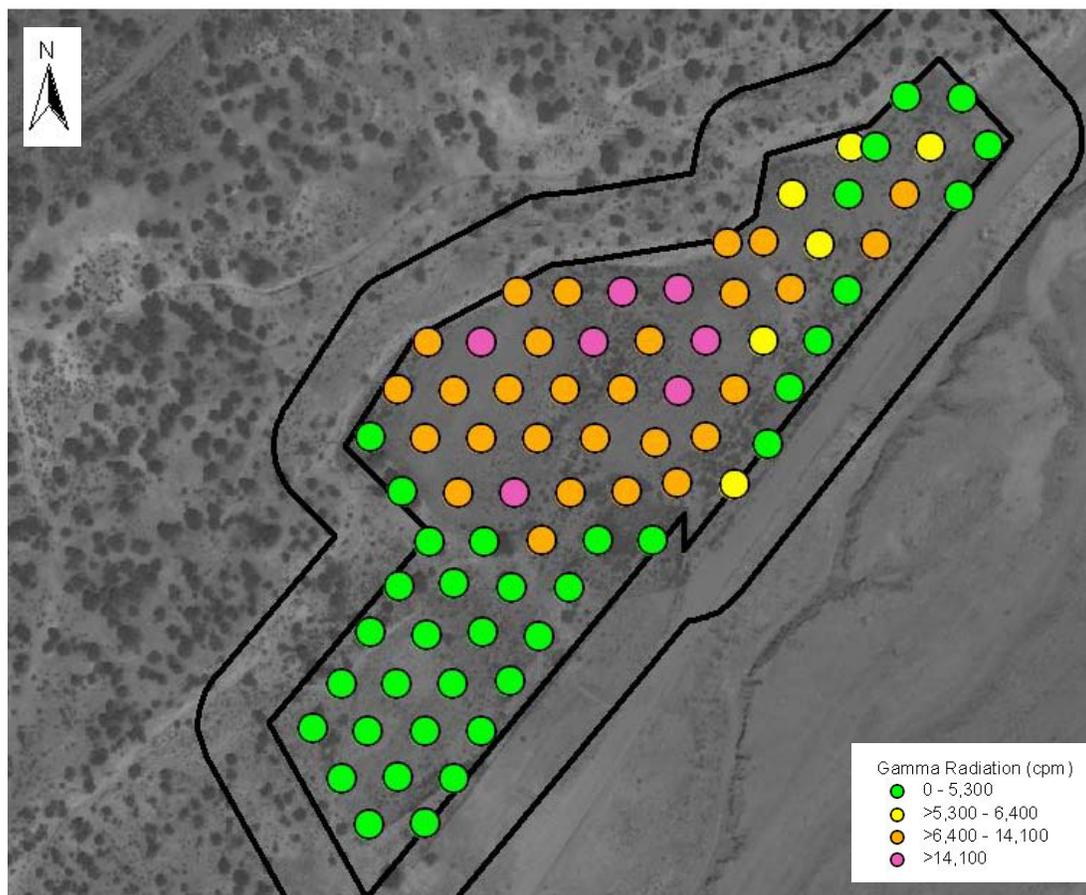
Plate 4.4-3 CR-1E Static Gamma Radiation Measurement (cpm) on Lease Area

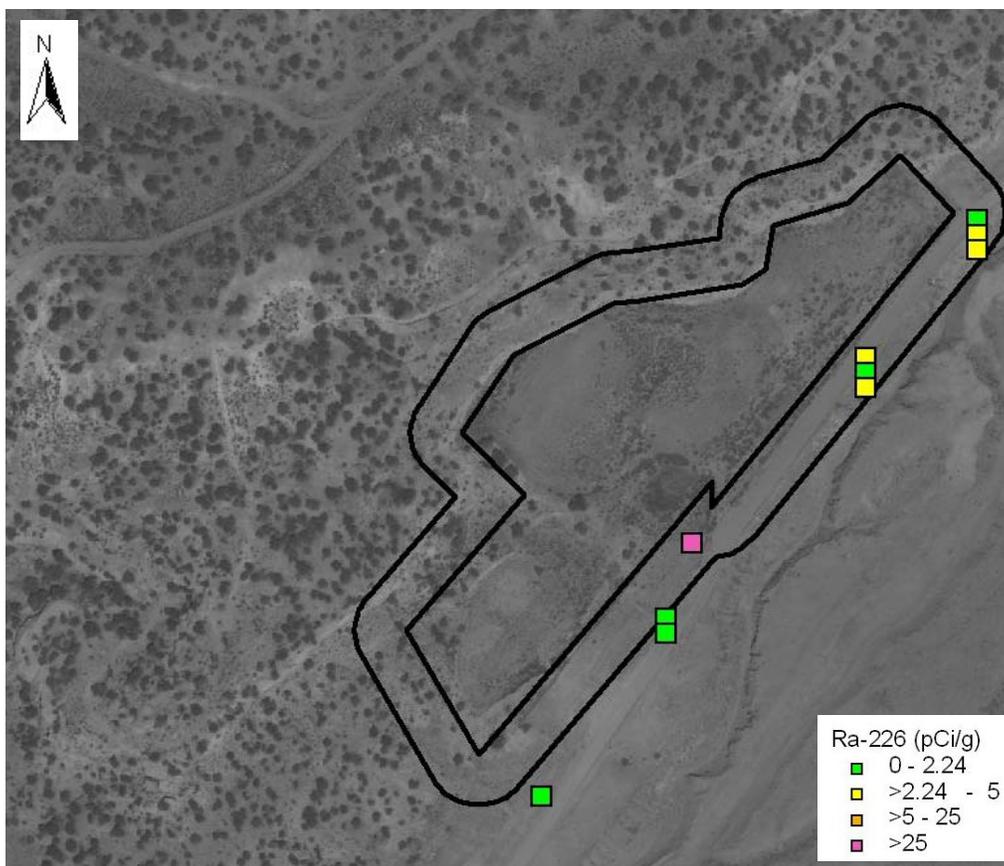
Plate 4.4-4 CR-1E Ra-226 Soil Concentrations Measured with Shallow Sub-Surface Program on Step-out Area

Top block is 0-6 inches, second block is 18-24 inches, third block is 30 to 36 inches soil horizon.
In some cases, a target zone was only partially measured due to refusal during sample collection.

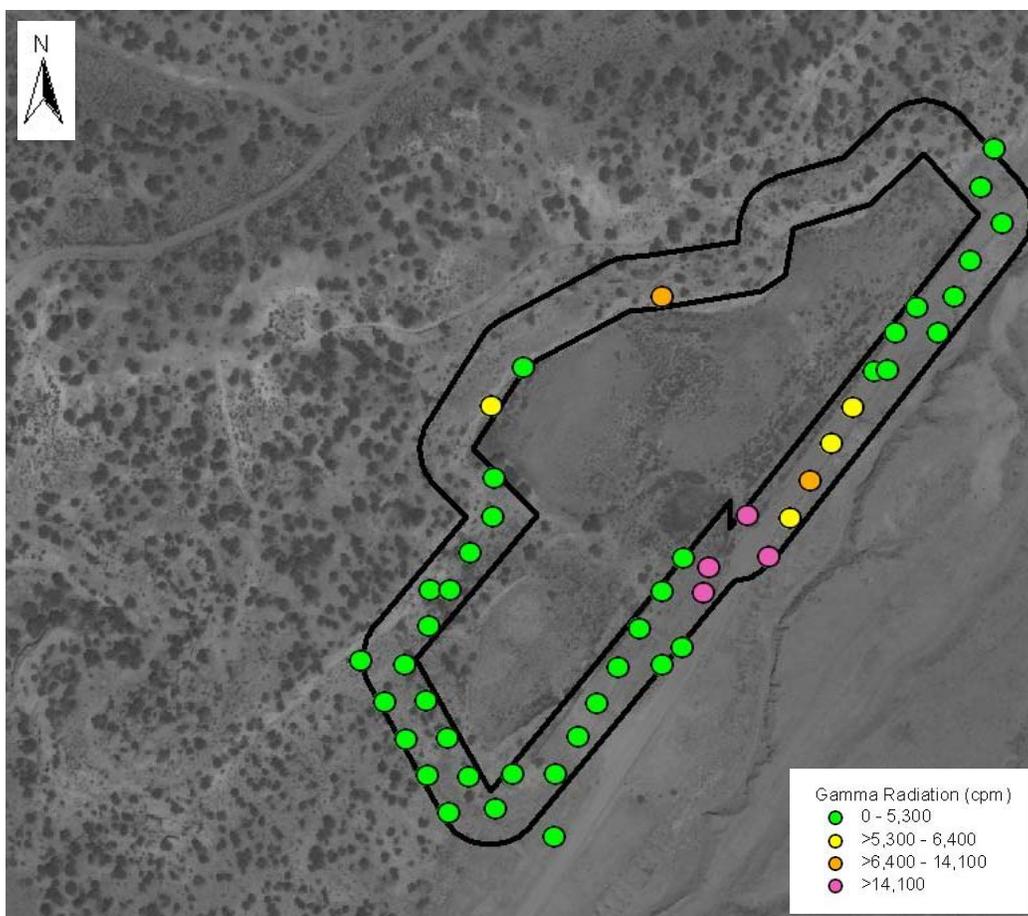
Plate 4.4-5 CR-1E Static Gamma Radiation Measurements (cpm) on Step-out Area

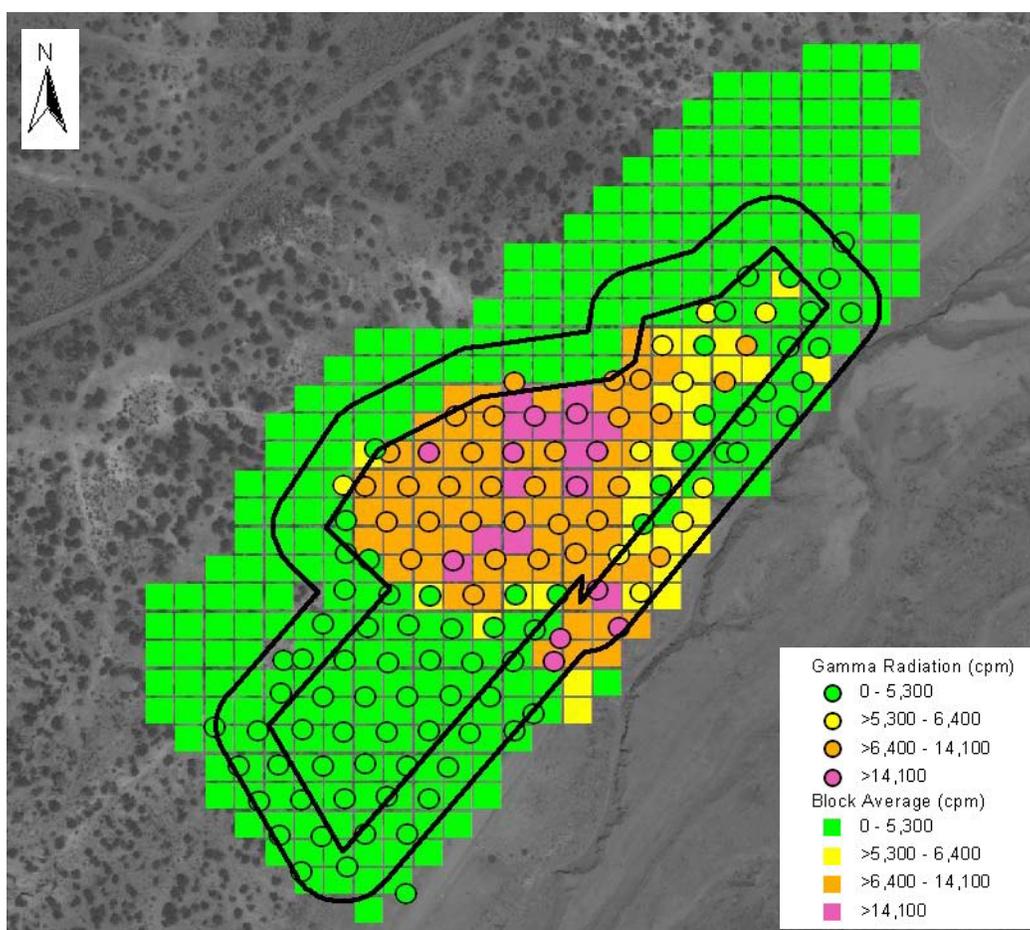
Plate 4.4-6 CR-1E Scanning Gamma Radiation Measurements Site Wide

Scanning gamma radiations were automatically recorded and averaged to areas considered representative by the 80 ft triangular grid and these are illustrated in Plate 4.4-6. The static gamma radiation measurements and the scan averages agree well. The Step-out areas generally indicate soil concentrations below the PAL with the exception of the area on the east central part of the CR-1E site. Summary statistics on the scan averages are provided in Table 4.4-6.

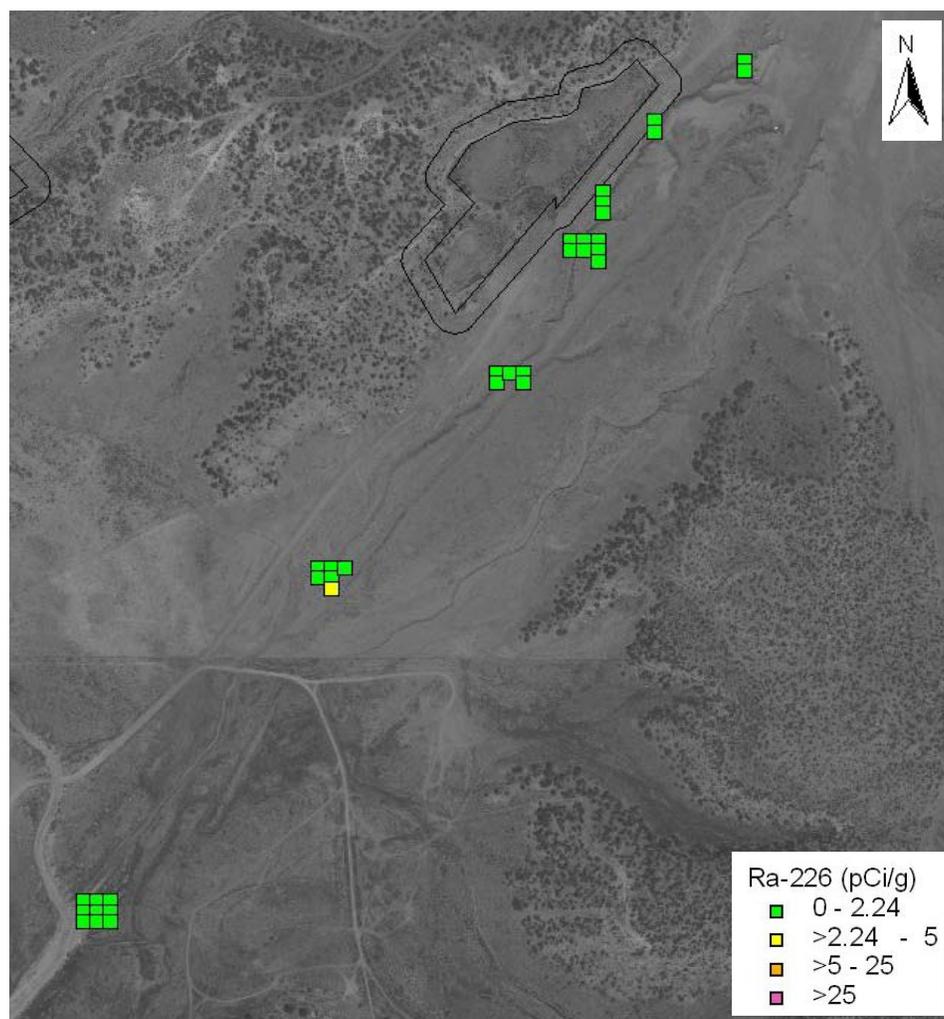
Plate 4.4-7 CR-1E Ra-226 Soil Concentrations Measured with Shallow Sub-Surface Program on Pipeline Arroyo

Soil samples were collected from seven transects of the Pipeline Arroyo and the results are shown on Plate 4.4-7 for the three intended locations per transect. The measured concentrations were all below the PAL in the 0 to 6 inch horizon along the length of the arroyo. Only one sample at the 30 to 36 inches depth horizon in Transect 6 was slightly elevated.

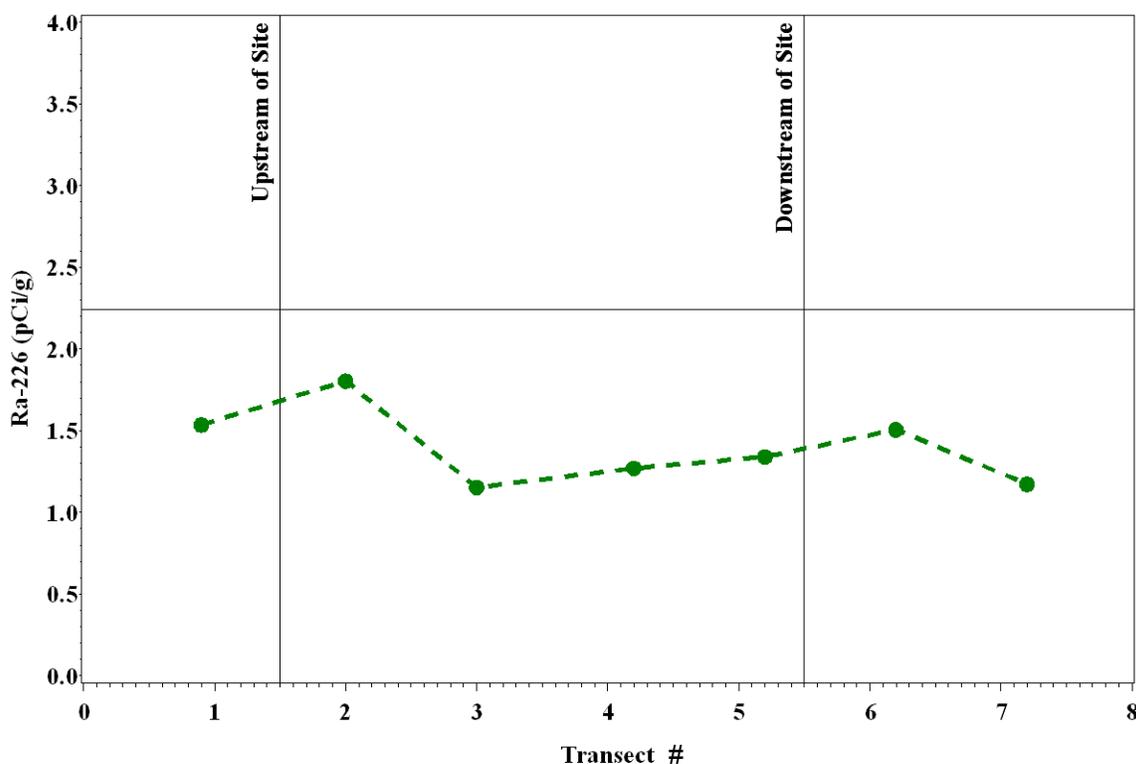
Plate 4.4-8 CR-1E Ra-226 Concentrations Profile for Pipeline Arroyo

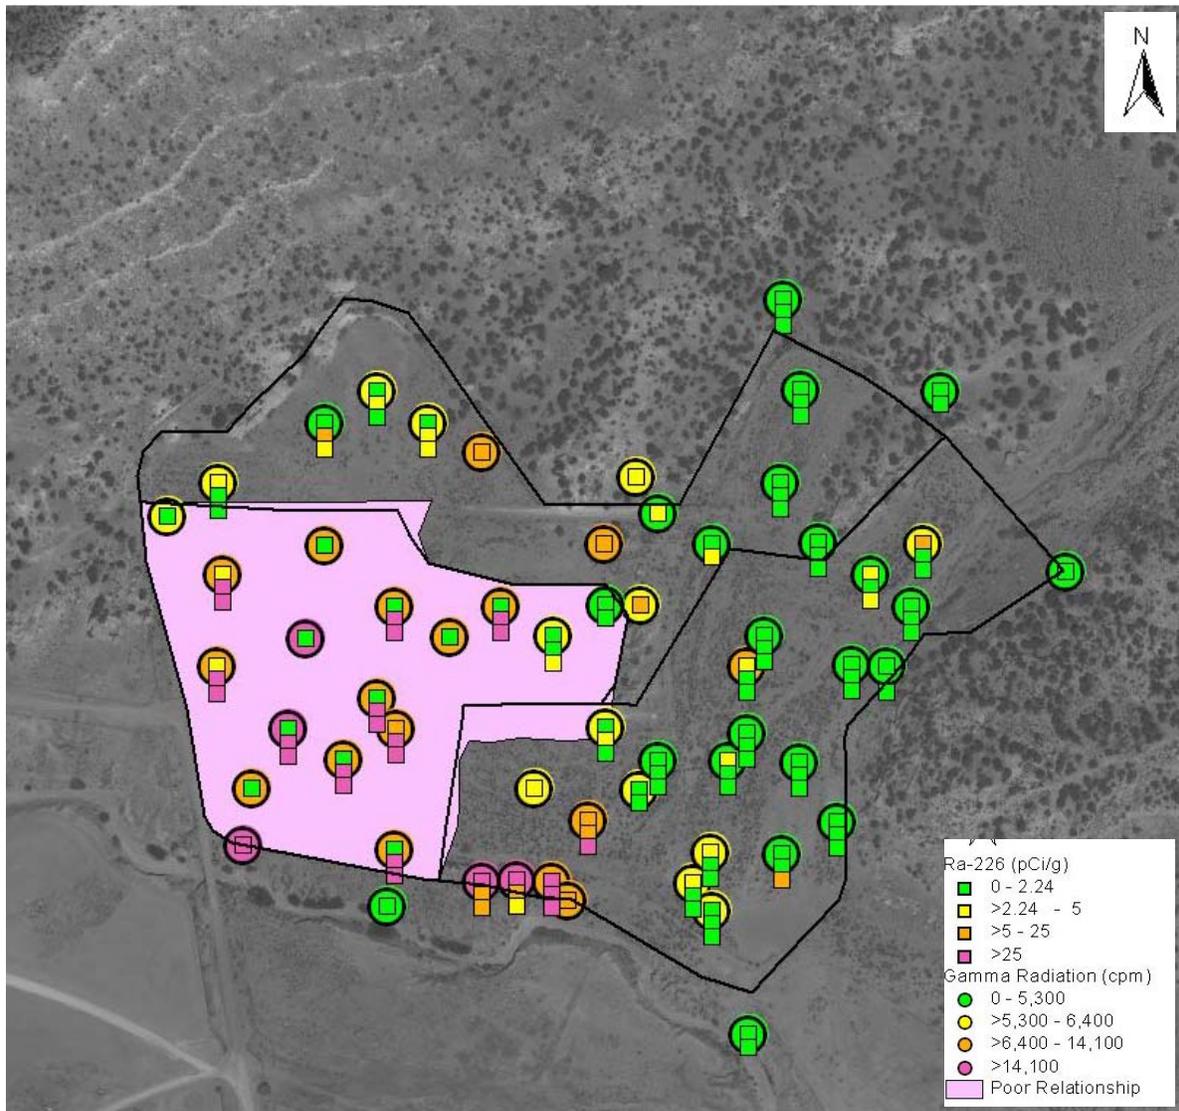
Plate 4.5-1 CR-1 Surface Gamma Radiation Measurements (cpm) and 0-6 inch Soil Concentrations (pCi/g)

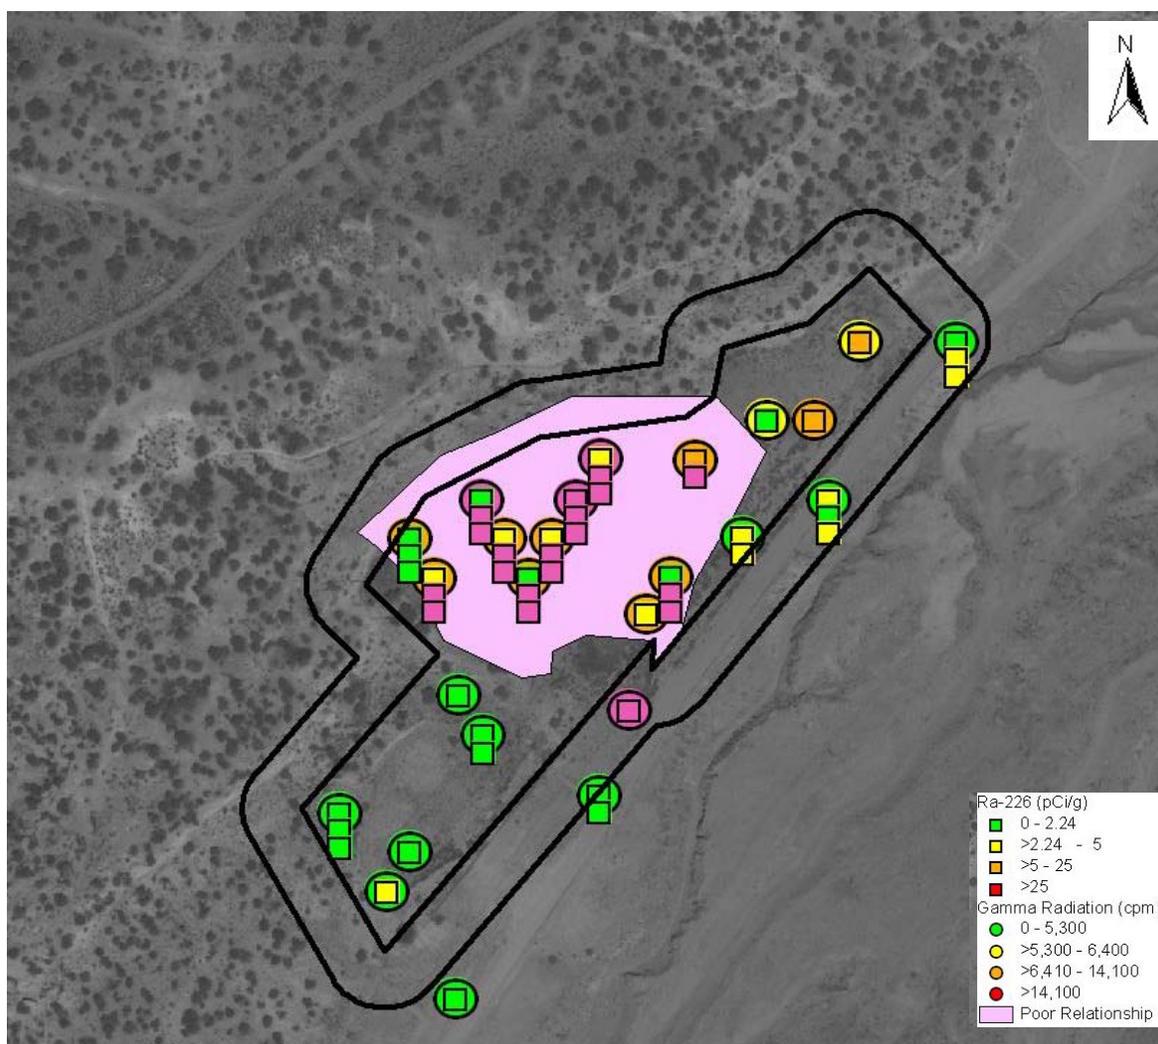
Plate 4.5-2 CR-1E Surface Gamma Radiation Measurements (cpm) and 0-6 inch Soil Concentrations (pCi/g)

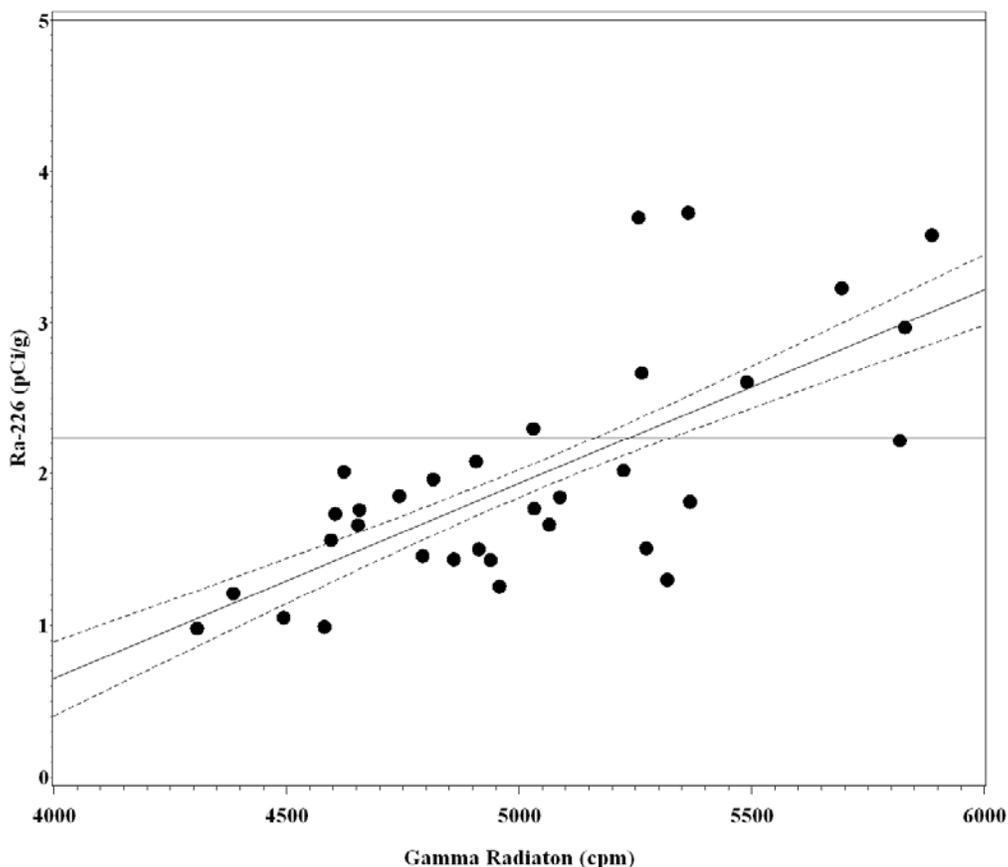
Plate 4.5-3 Regression Between Gamma Radiation Measurements (cpm) and Soil at Low Ra-226 Concentrations

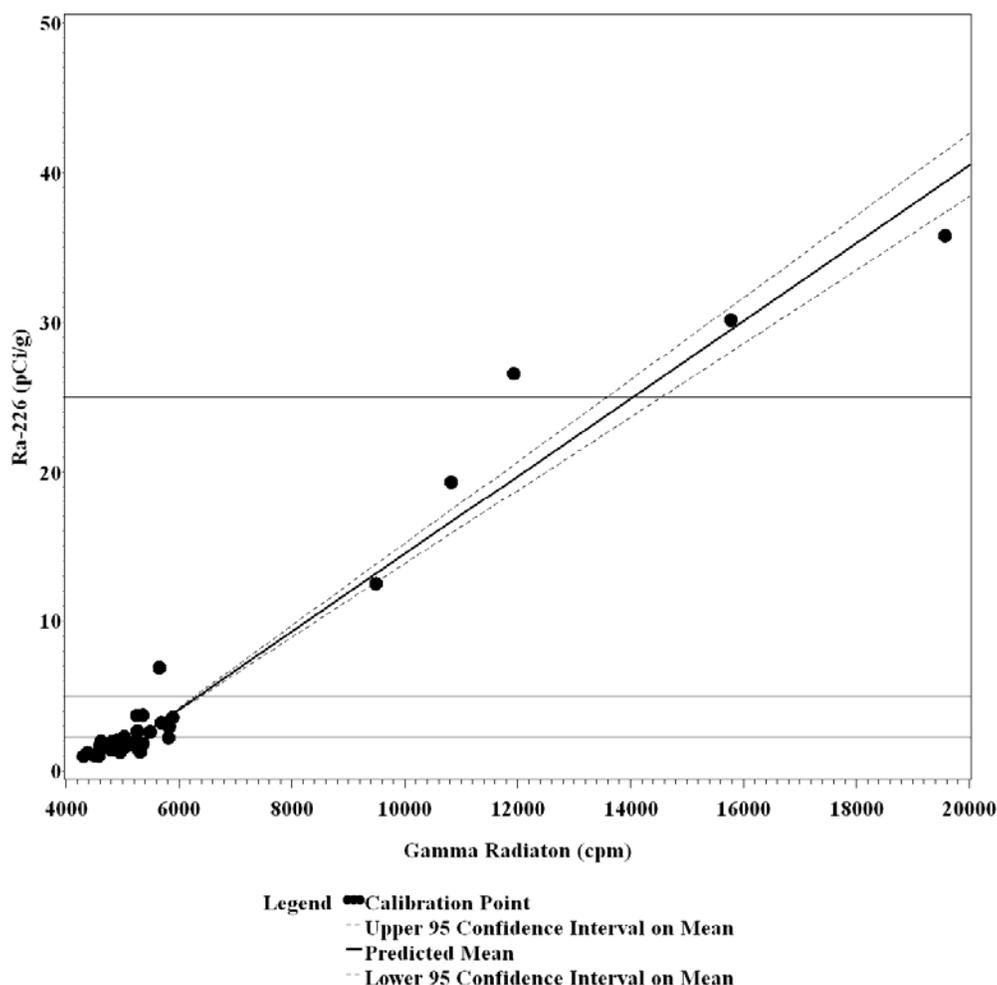
Plate 4.5-4 Relationship Between Gamma Radiation and Soil Ra-226 Concentration over the Range of Calibration Samples

The performance has been assessed in Appendix A3 and it appears suitable for the range of interest and can be extended to higher gamma radiation measurements. The relationship can be used to estimate the gamma radiation measurements corresponding to the soil Ra-226 concentrations of interest. Table 4.5-1 shows the gamma radiation measurements corresponding to the soil Ra-226 concentrations in the 0-6 inch soil horizon. The gamma radiation measurements have been rounded to two significant figures for the table.

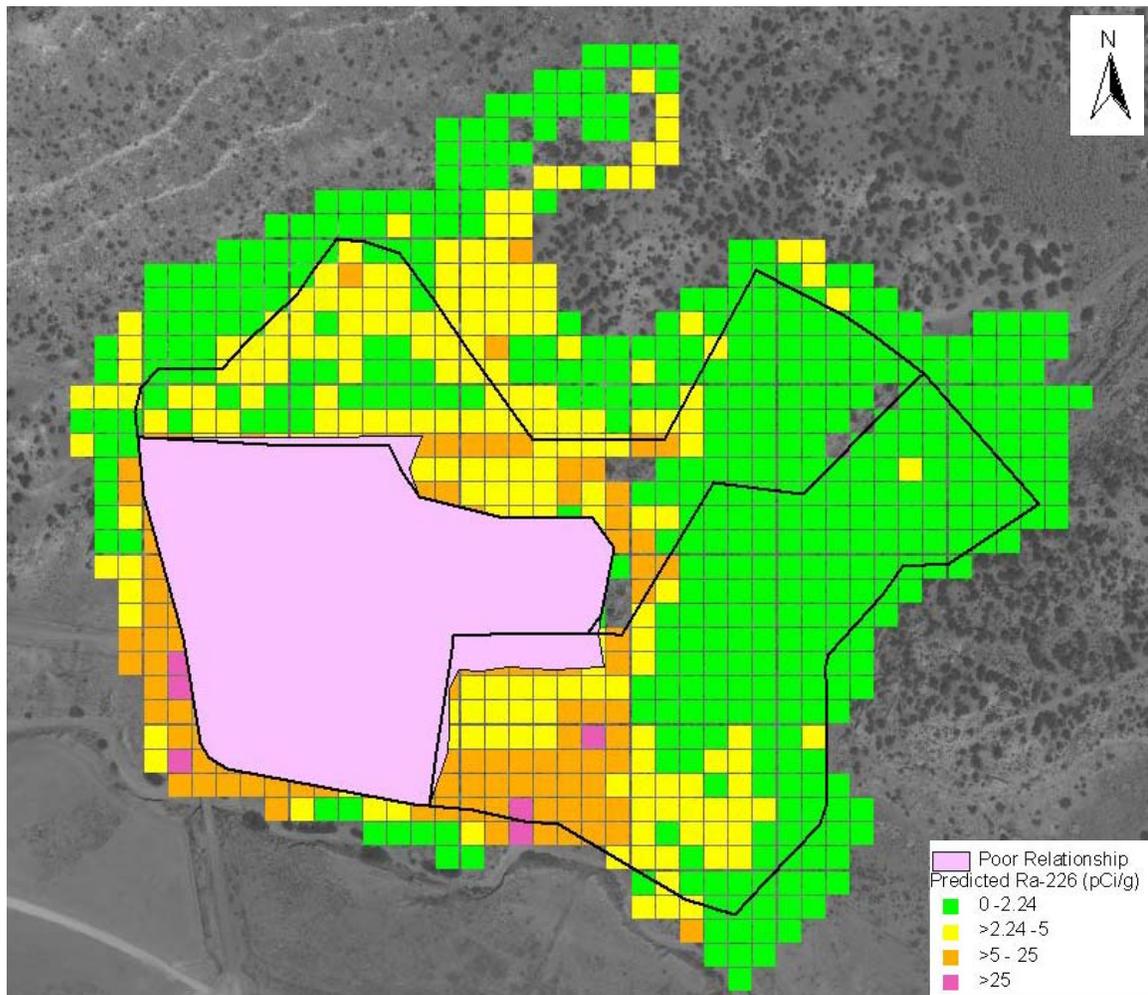
Plate 4.5-5 CR-1 Ra-226 Concentration from Scanning Gamma Radiation

Note: no data collected in open blocks

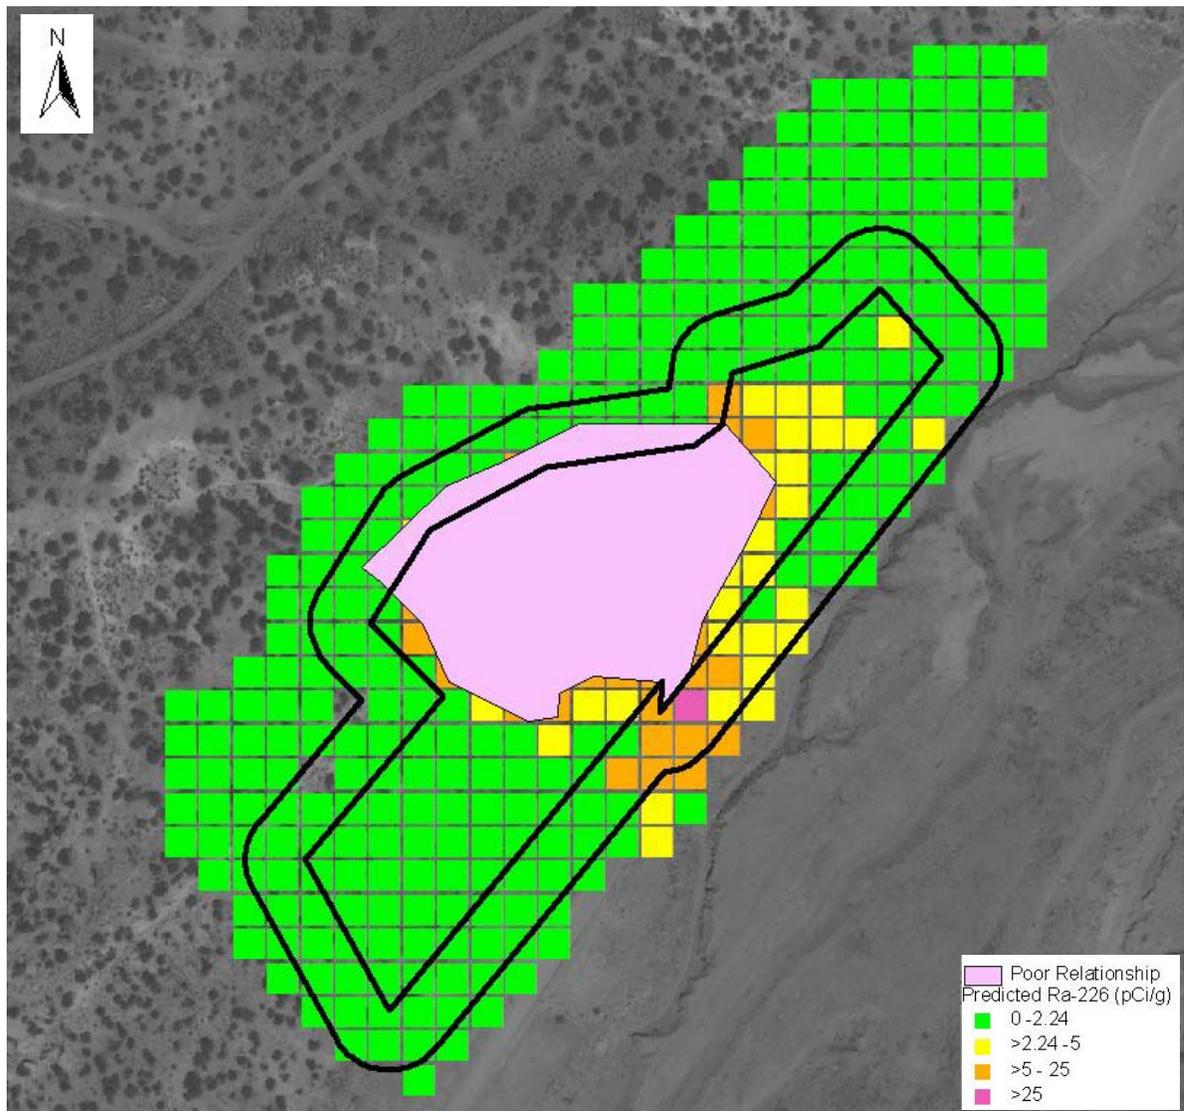
Plate 4.5-6 CR-1E Ra-226 Concentration Prediction from Scanning Gamma Radiation
