**RECORD OF DECISION FOR SITES 41, 42, & 43**

**MARBO ANNEX**

**ANDERSEN AIR FORCE BASE, GUAM**

**May 2010**

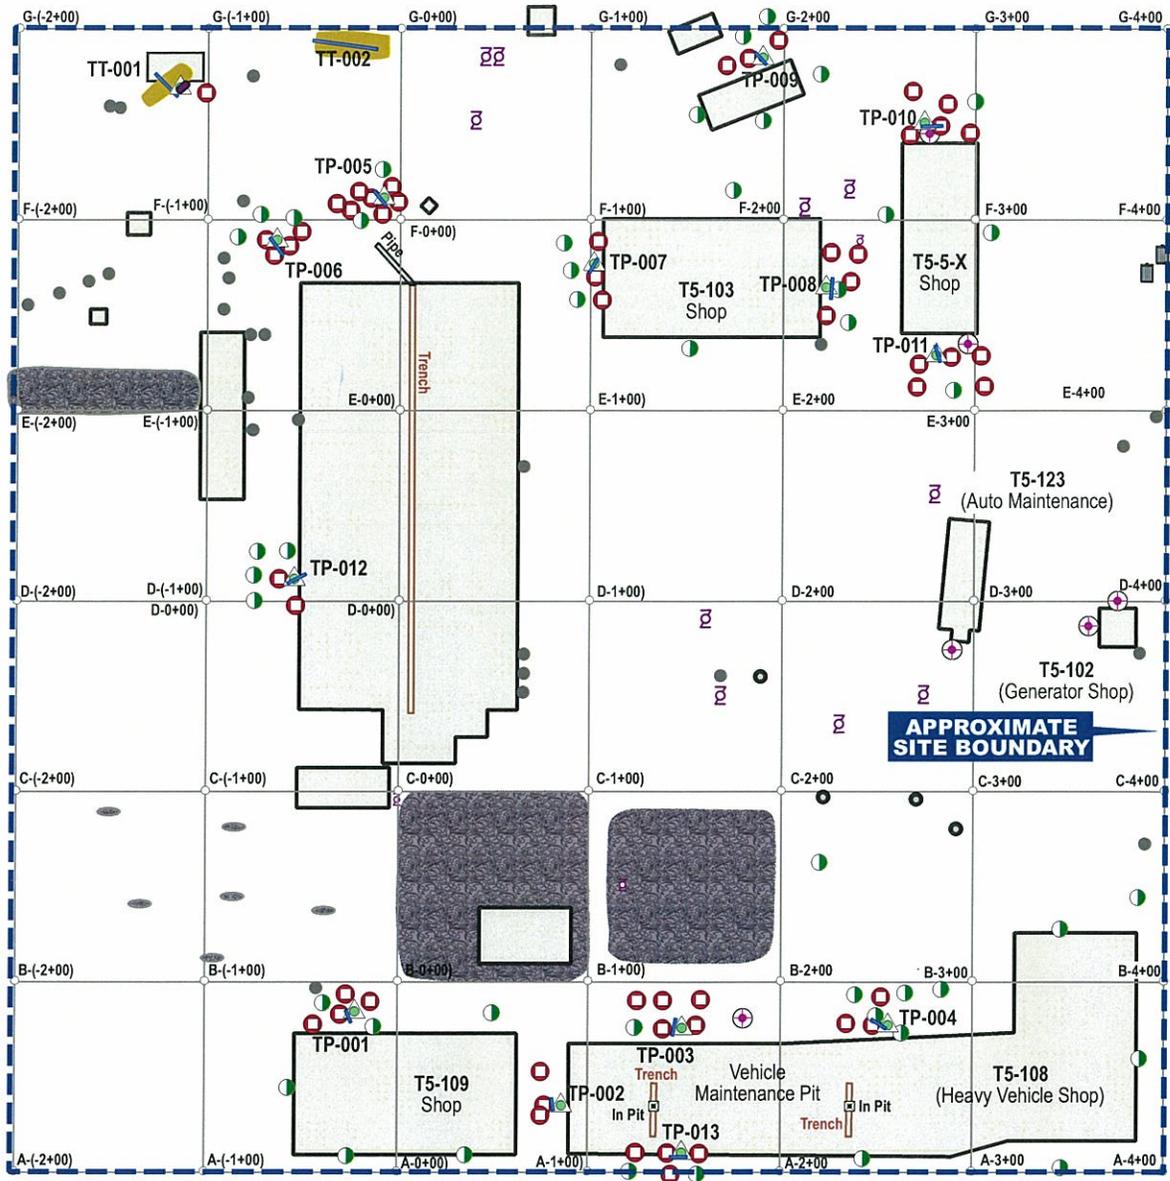
**FIGURE 2-3**

- Tar/asphalt area
- Surface soil sample locations above regulatory limits
- Surface soil sample locations below residential remedial goal
- Subsurface soil sample locations below residential remedial goal
- Soil gas and surface soil composite sample location
- Deteriorated 55 gallon drum or suspected drum remnants
- Miscellaneous debris including household waste
- Test pits/trenches
- Metal waste /debris
- Tire debris
- Asphalt debris area
- Mounded area
- Wooden utility poles on the ground
- Existing wooden utility pole
- Concrete pad
- Existing trench

**ANDERSEN AIR FORCE BASE  
GUAM**  
**Map of Site 41  
MARBO Annex**

Site 41 comprises approximately 8 acres of land with relatively flat to gently sloping topography. Site 41 consists of the concrete foundations of former operational buildings including: the tool shop, carpenter shop, generator shop, heavy vehicle shop, and vehicle maintenance shops (**Figure 2-3**). In addition, a vehicle maintenance pit associated with the former location of the heavy vehicle shop was located at the site. Due to past operations at the former shops, potentially hazardous materials were suspected to be discharged to the soils (EA, 1998a and ICF Technology, Inc [ICF], 1995). Although the area was once developed, the site is not currently maintained.

- Initial surface soil samples collected at Site 41 were composited from groups of 4 to 6 samples. The analytical results were then compared to screening levels (preliminary remediation goals [PRGs] and background threshold values [BTVs]) and discrete surface soil samples were collected from within five feet of building foundations to further characterize the areas with exceedances. Nine composite surface soil samples were collected from around the building foundations at depths of 0 to 6 inches bgs, and analyzed for semi-volatile organic compounds (SVOCs), polychlorinated biphenyls (PCBs), and Target Analyte List (TAL) metals. No SVOCs or PCBs were detected in any of these samples at concentrations exceeding screening levels. However, lead was detected at concentrations exceeding the risk-based screening level in four composite surface soil samples near the foundations of the T5-103 Shop, the T5-5-X Shop, the T5-108 Heavy Vehicle Shop, and the T5-109 Shop (**Figure 2-3**).

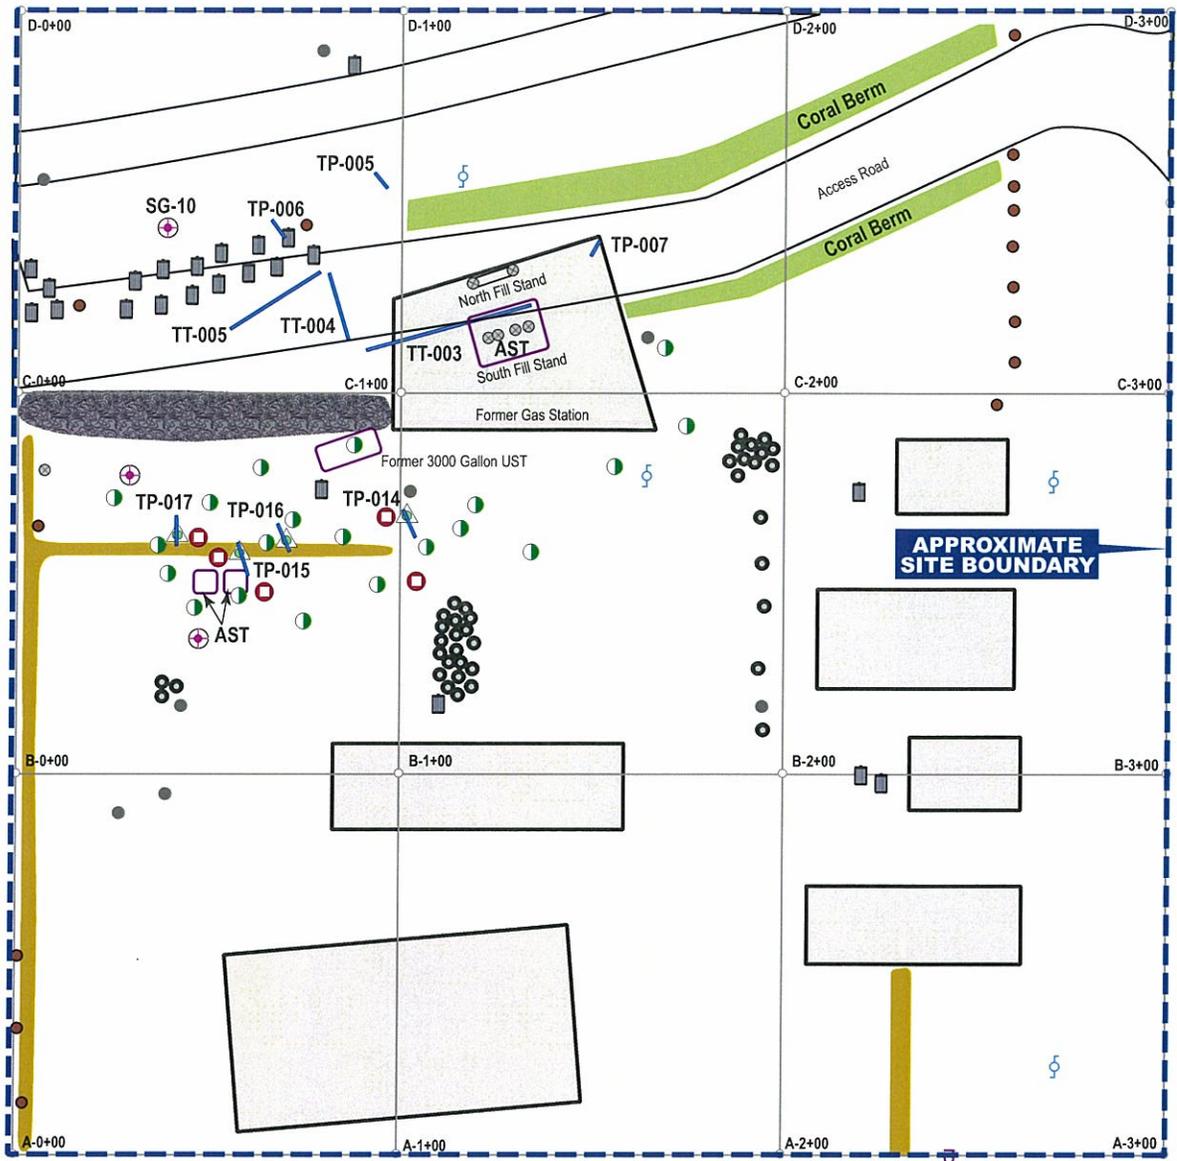
**FIGURE 2-4**

- Tar/asphalt area
- Surface soil sample locations above regulatory limits
- Surface soil sample locations below residential remedial goal
- Subsurface soil sample locations below residential remedial goal
- Soil gas and surface soil composite sample location
- Miscellaneous debris including household waste
- Test pits/trenches
- Metal waste /debris
- Tire debris
- Mounded area
- Unknown pipe stub-up
- Wooden utility poles on the ground
- Existing wooden utility pole
- Fence post
- Concrete pad
- Storage Tanks

Site 42 comprises approximately 1.5 acres of land with relatively flat to gently sloping topography. Site 42 is a former gas station with two associated rusted above-ground storage tanks (ASTs) and one UST (**Figure 2-4**) (EA, 1998a and ICF, 1995). Due to past operations, discharge of fuel-related constituents to the soils may have occurred. The UST was discovered during test trenching activities and no historical records, plans, or maps for this UST have been found. The liquid content of the UST was analyzed and characterized as non-hazardous waste. The 3000-gallon UST and associated piping was excavated and removed in March 2008 (EA, 2008). The tank was found to be in good condition with no visible damage.

- Fifteen surface soil samples were collected from the perimeter of the concrete pad in the vicinity of the UST, and the mounded area near the two ASTs (**Figure 2-4**). Lead was detected at concentrations exceeding the residential PRG in four surface soil samples. Eleven additional surface soil samples were collected in the area surrounding the four surface soil samples found to contain lead at concentrations exceeding the residential PRG. Lead was detected at a concentration exceeding the residential PRG in one surface soil sample.
- Four subsurface soil samples were collected during test pitting activities. None of the subsurface soil samples contained lead or VOCs at concentrations

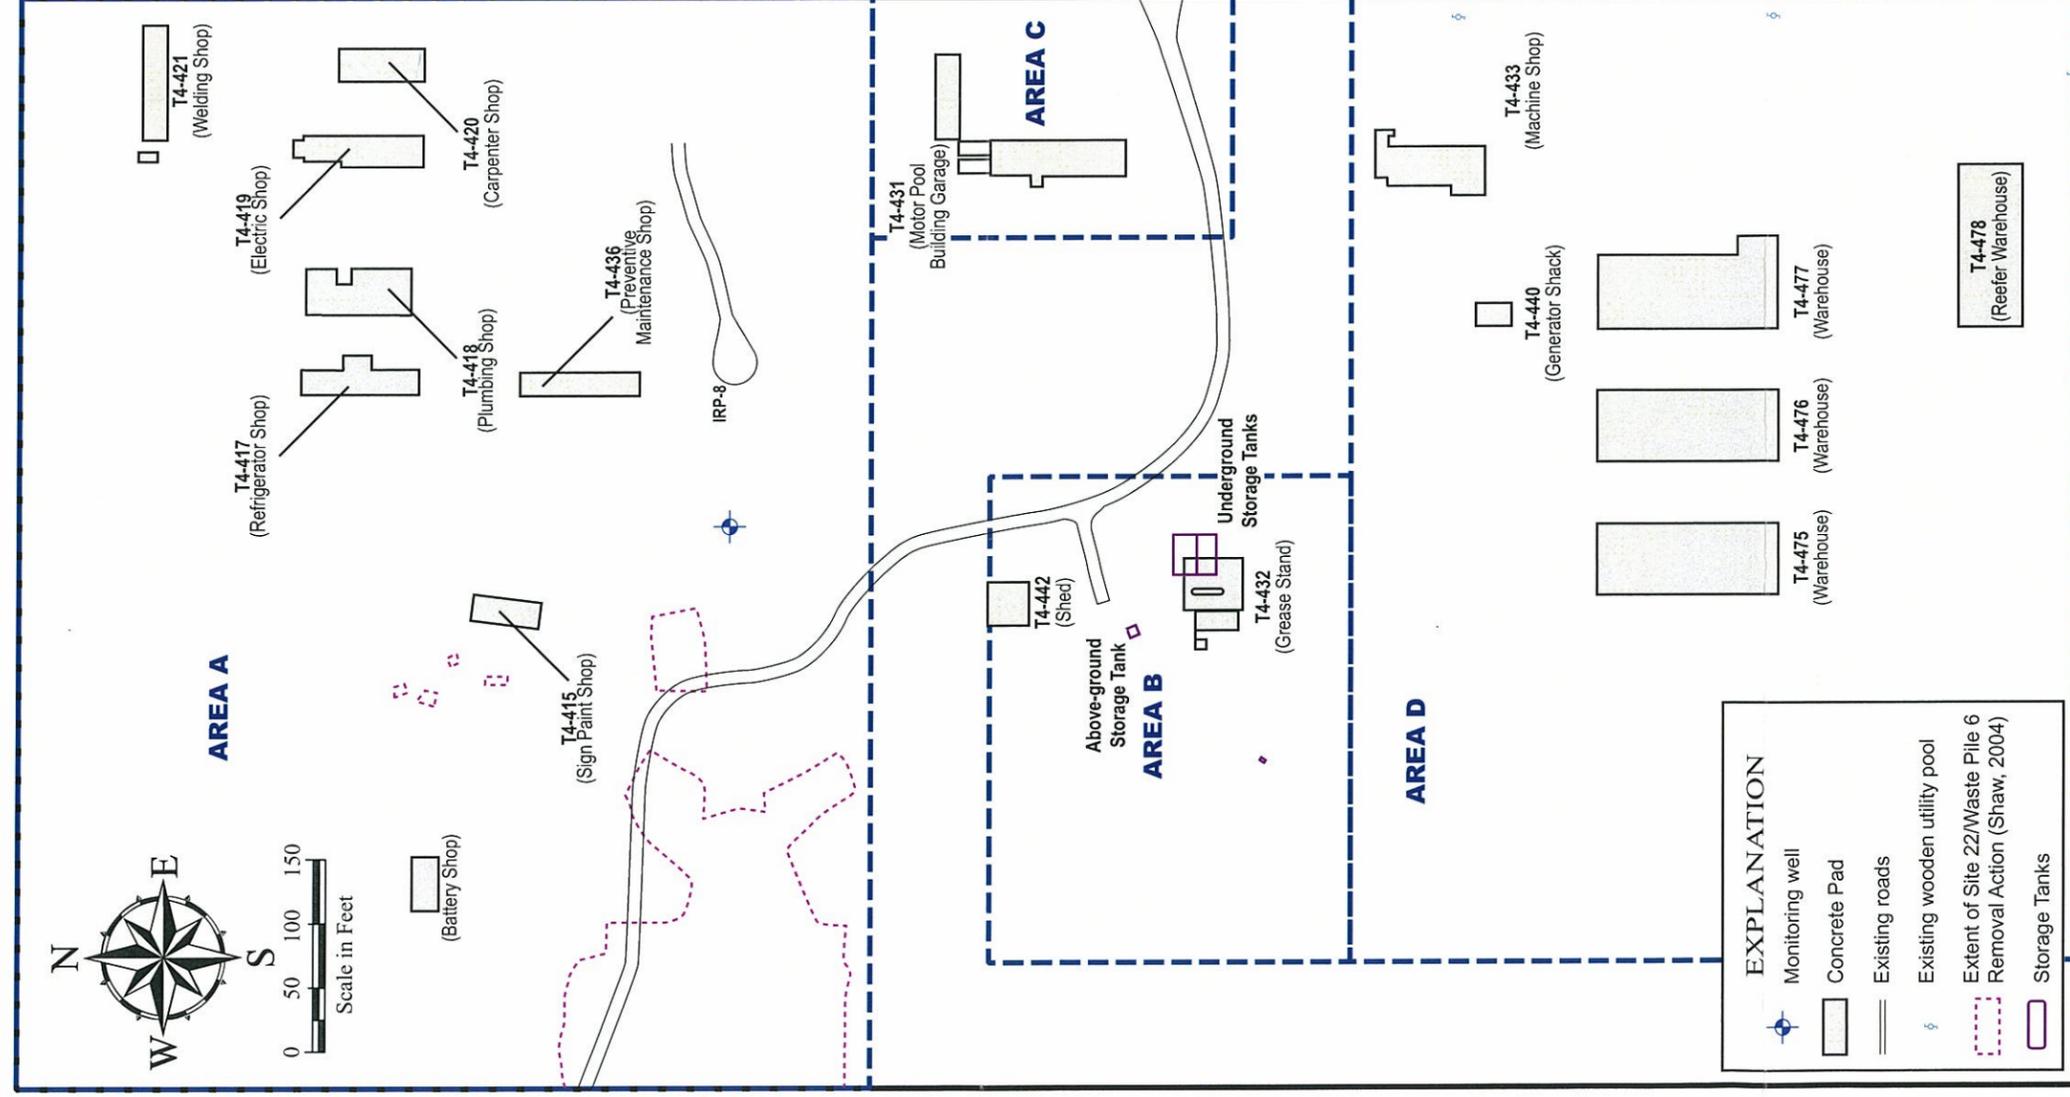
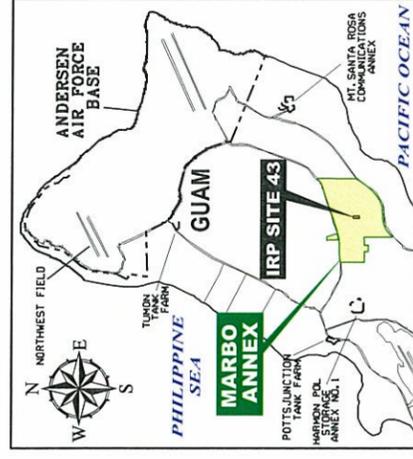
Fig 2-5 MARBO Area 43 Location map2.ai

Map of Site 43,  
Areas A, B, C, and D,  
MARBO Annex

<ul style="list-style-type: none"> <li>▲ Surface Soil Sample Locations</li> <li>■ Subsurface Soil Sample Locations</li> <li>▲ Surface Soil Sample Locations above Regulatory Limit</li> <li>— Test Trench</li> <li>▲ Soil Gas and Soil Sample Locations</li> <li>--- Approximate Site Boundary</li> <li>— Edge of Asphalt Road</li> <li>○ Deteriorated 55 Gallon Drum or Suspected Drum Remnants</li> <li>○ Wooden Utility Poles on the Ground</li> <li>○ Steel Pipe on the Ground</li> <li>○ Existing Wooden Utility Pole</li> </ul>	<ul style="list-style-type: none"> <li>■ Miscellaneous Debris Includes Large and Small Metal Containers, Sheet Metals, Wires, Cables, Auto Parts, Engine Parts, Glass Bottles, Concrete Slabs, Food Cans, Soda Cans, and Household Trash</li> <li>⊖ Deteriorated 5 Gallon Drum</li> <li>○ Mounded Area</li> <li>○ Debris Area</li> <li>○ Monitoring Well</li> <li>○ Tarr/Asphalt and Asbestos Debris Area</li> <li>○ Tire Debris</li> <li>○ Asbestos Area</li> <li>○ Concrete Pad/Building Location</li> </ul>

Site 43 comprises approximately 35 acres and is relatively flat, with a gentle slope to the south and southwest. Site 43 includes the foundations (concrete pads) of former operational support buildings (**Figure 2-5**). Due to past operations at the former shops, potentially hazardous materials were suspected to have been discharged at the site (EA, 1998a and ICF, 1995).

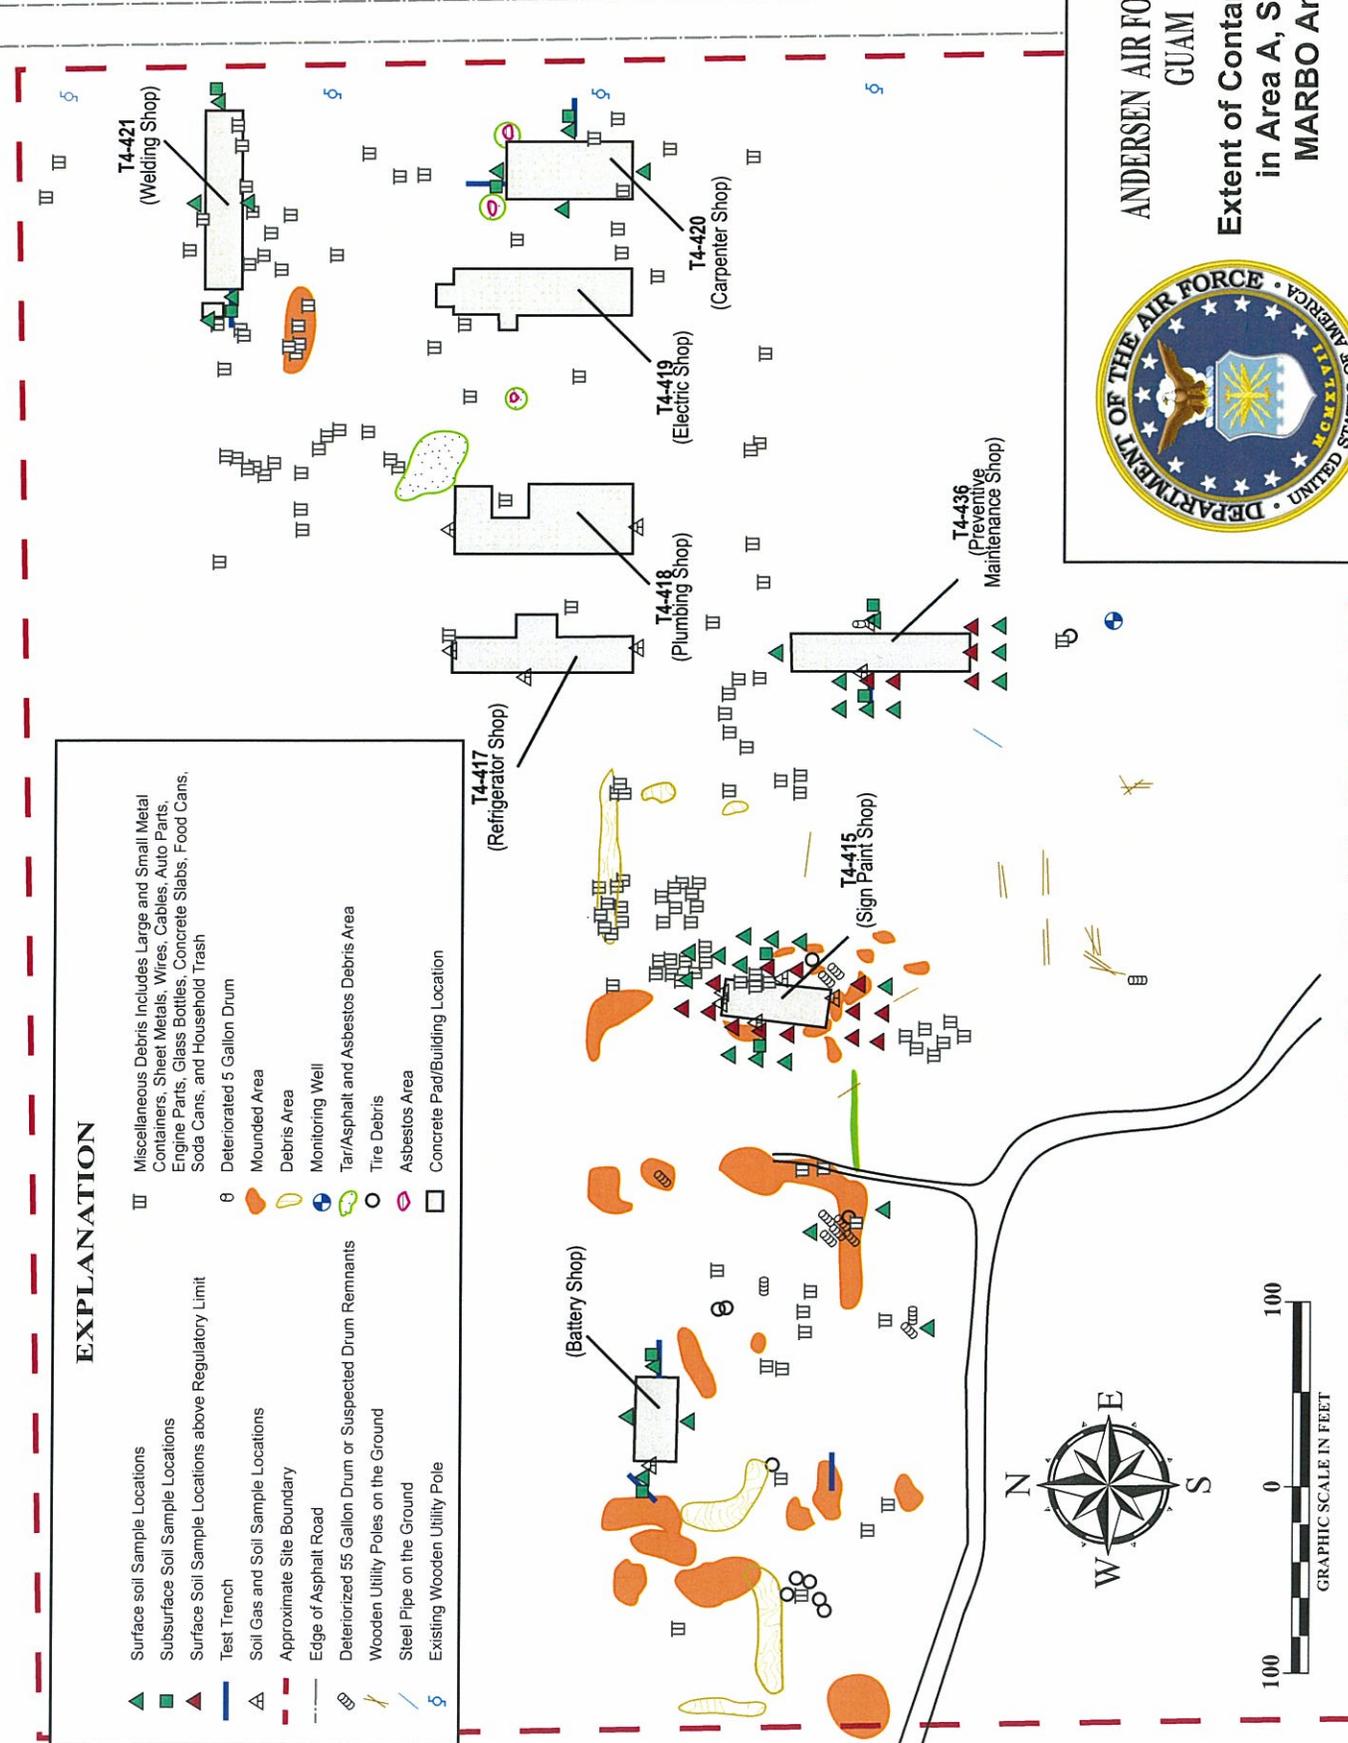
FIGURE 2-6

**Extent of Contamination  
in Area A, Site 43  
MARBO Annex**

- A total of 173 surface soil samples (including duplicates) were collected from Areas A, B, C, and D (**Figures 2-6 through 2-9**, respectively), and analyzed for a variety of parameters including PAHs, PCBs, and TAL metals. The sample

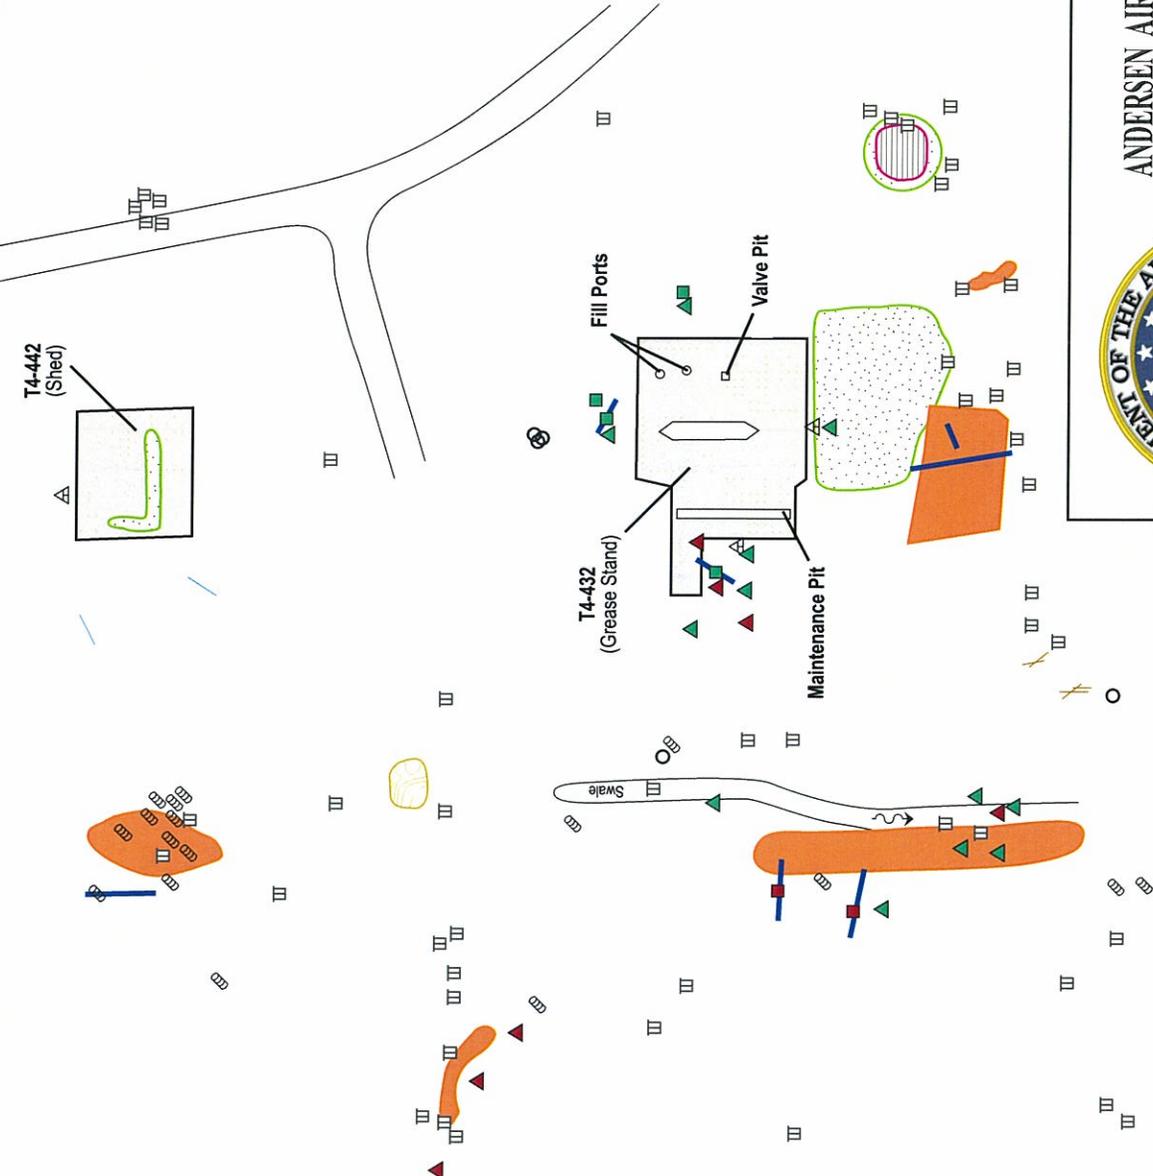
EXPLANATION	
	Surface Soil Sample Locations
	Subsurface Soil Sample Locations
	Surface Soil Sample Locations above Regulatory Limit
	Subsurface Soil Sample Locations above Regulatory Limit
	Test Trench
	Soil Gas and Soil Sample Locations
	Deteriorated 55 Gallon Drum or Suspected Drum Remnants
	Wooden Utility Poles on the Ground
	Steel Pipe on the Ground
	Miscellaneous Debris Includes Large and Small Metal Containers, Sheet Metals, Wires, Cables, Auto Parts, Engine Parts, Glass Bottles, Concrete Slabs, Food Cans, Soda Cans, and Household Trash
	Mounded Area
	Debris Area
	Tar/Asphalt and Asbestos Debris Area
	Tire Debris
	Asbestos Area
	Flow Direction
	Concrete Pad/Building Location

ANDERSEN AIR FORCE BASE  
GUAM  
Extent of Contamination  
in Area B, Site 43  
MARBO Annex  
FIGURE 2-7
