FIGURE 25
SHALLOW SOIL GAS SAMPLING LOCATIONS WITH THRESHOLD EXCEEDANCES
 Soil and NAPL RI
 Del Amo Superfund Site
URS

FIGURE 26
TOTAL VOC CONCENTRATIONS
AT SHALLOW SOIL GAS
SAMPLING LOCATIONS
 Soil and NAPL RI
 Del Amo Superfund Site

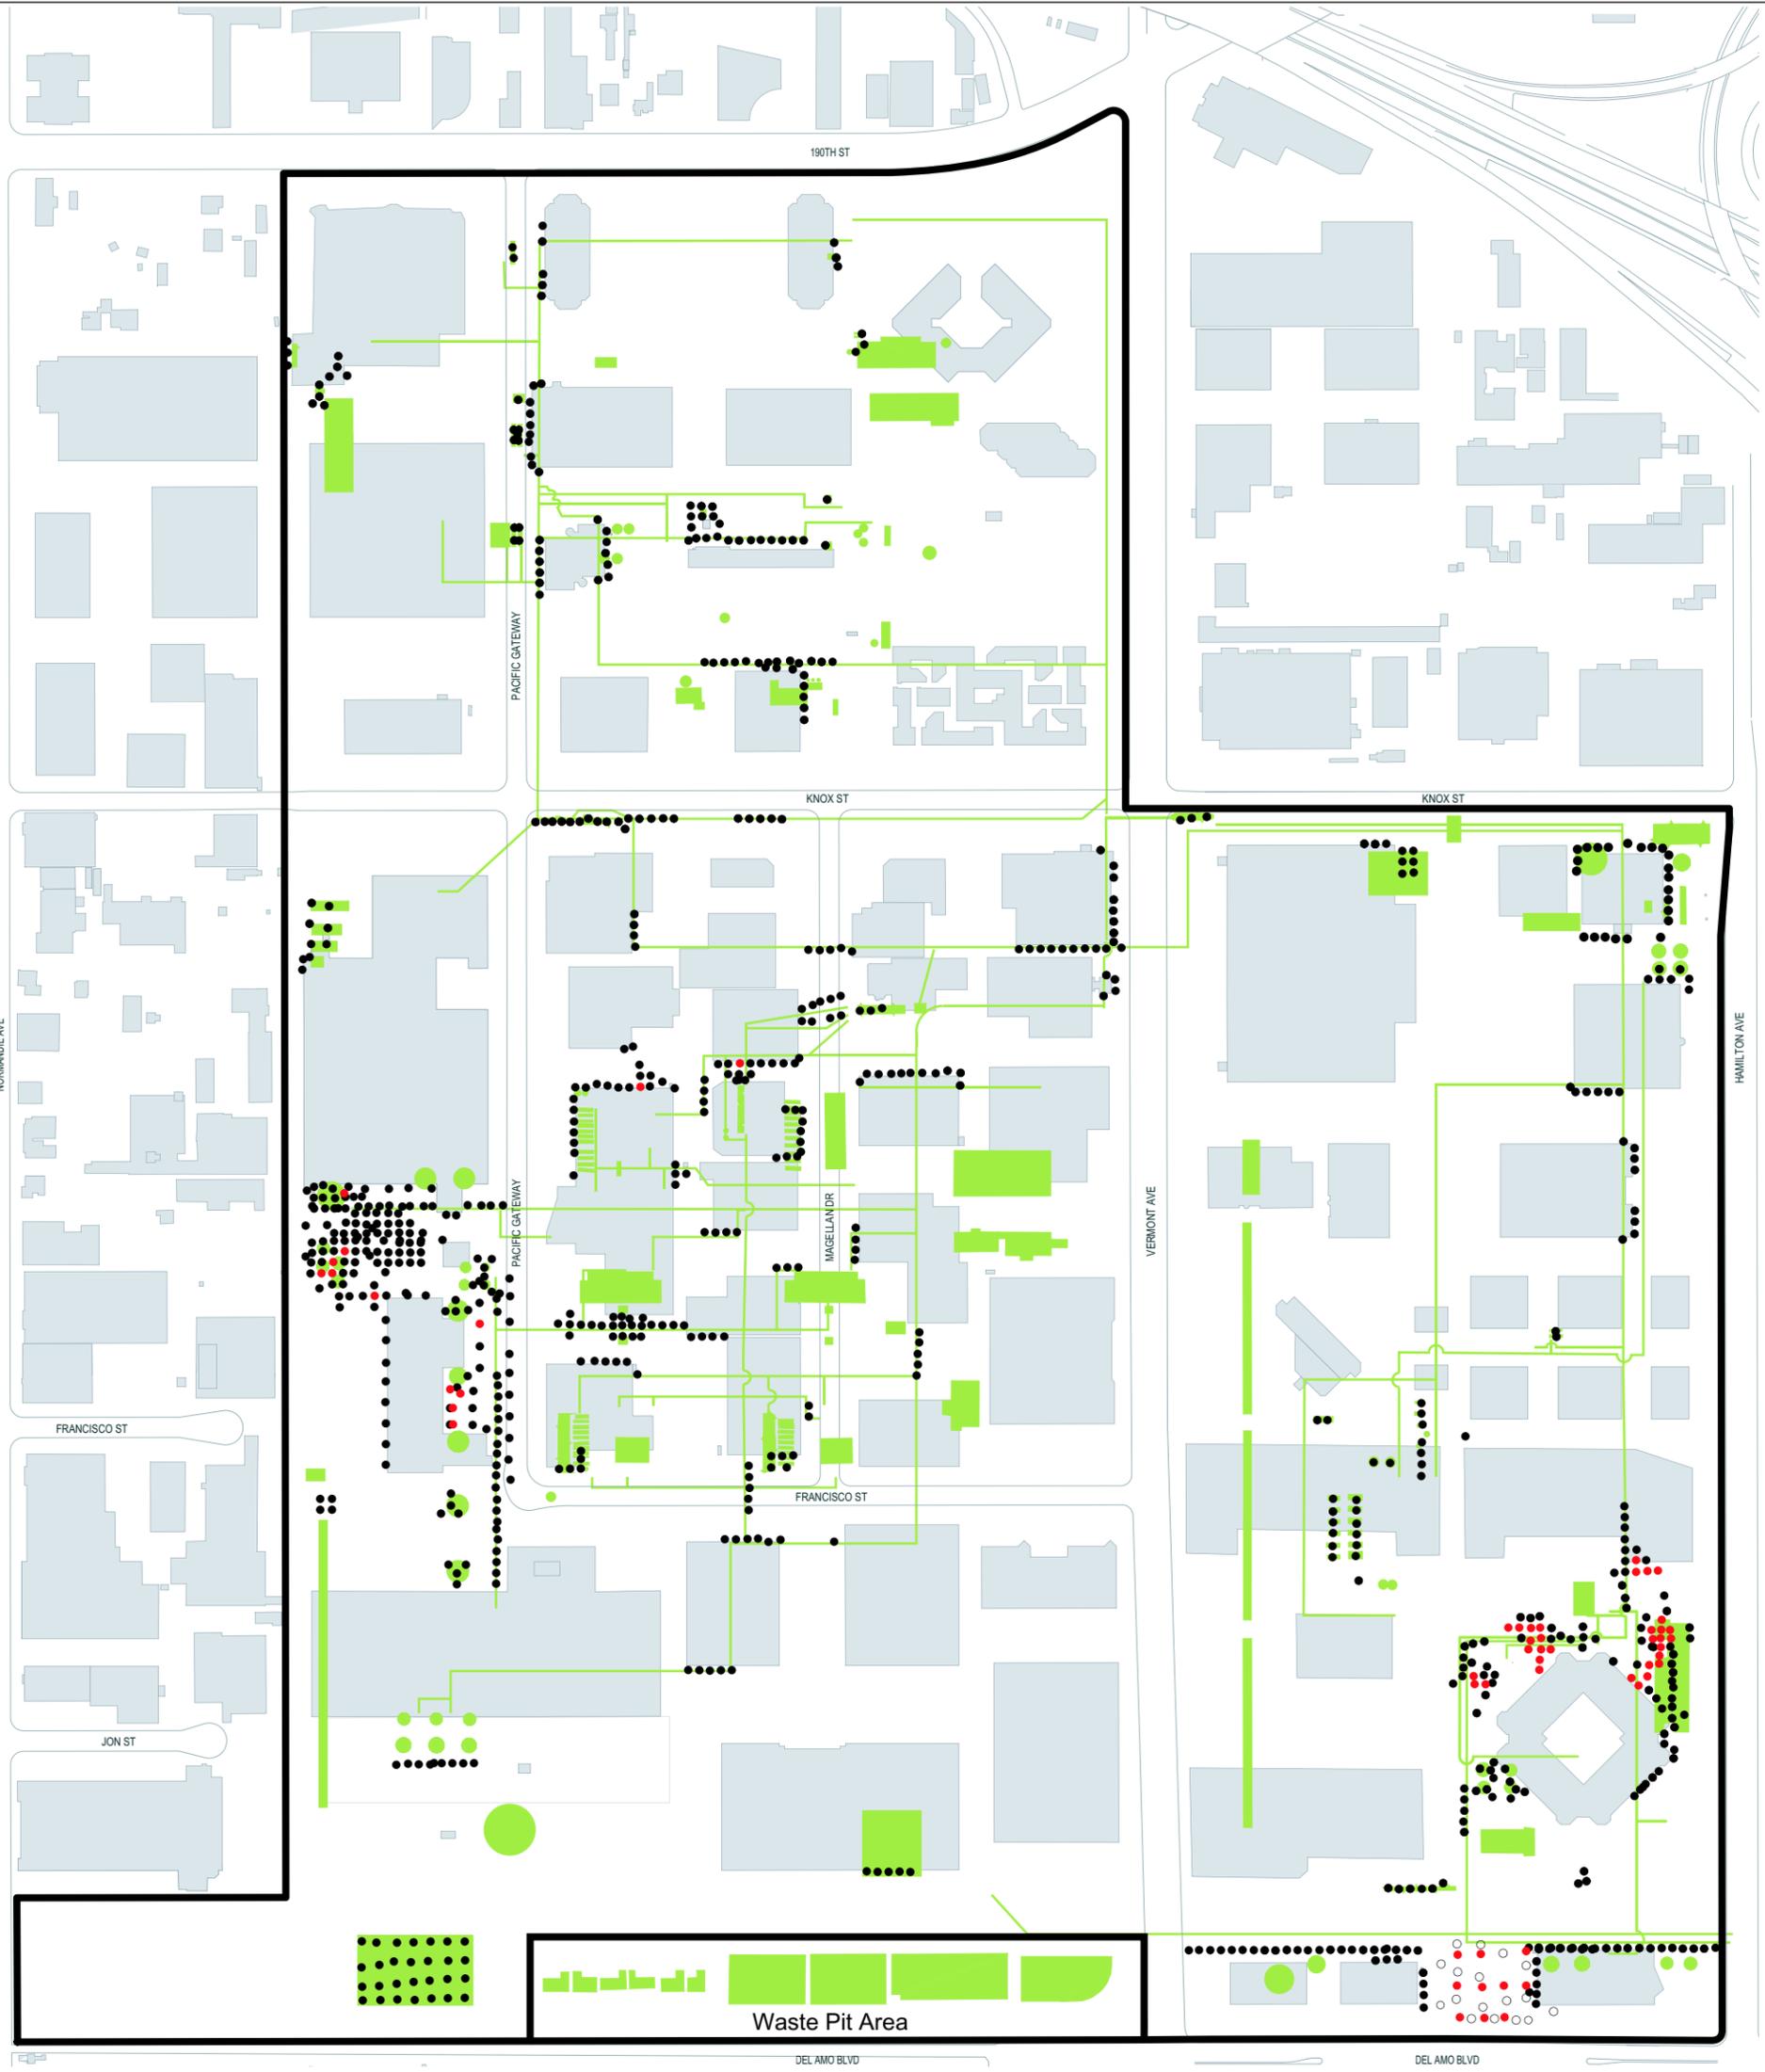
Note: RI and non-RI shallow soil gas sampling completed between 1991 and 1997

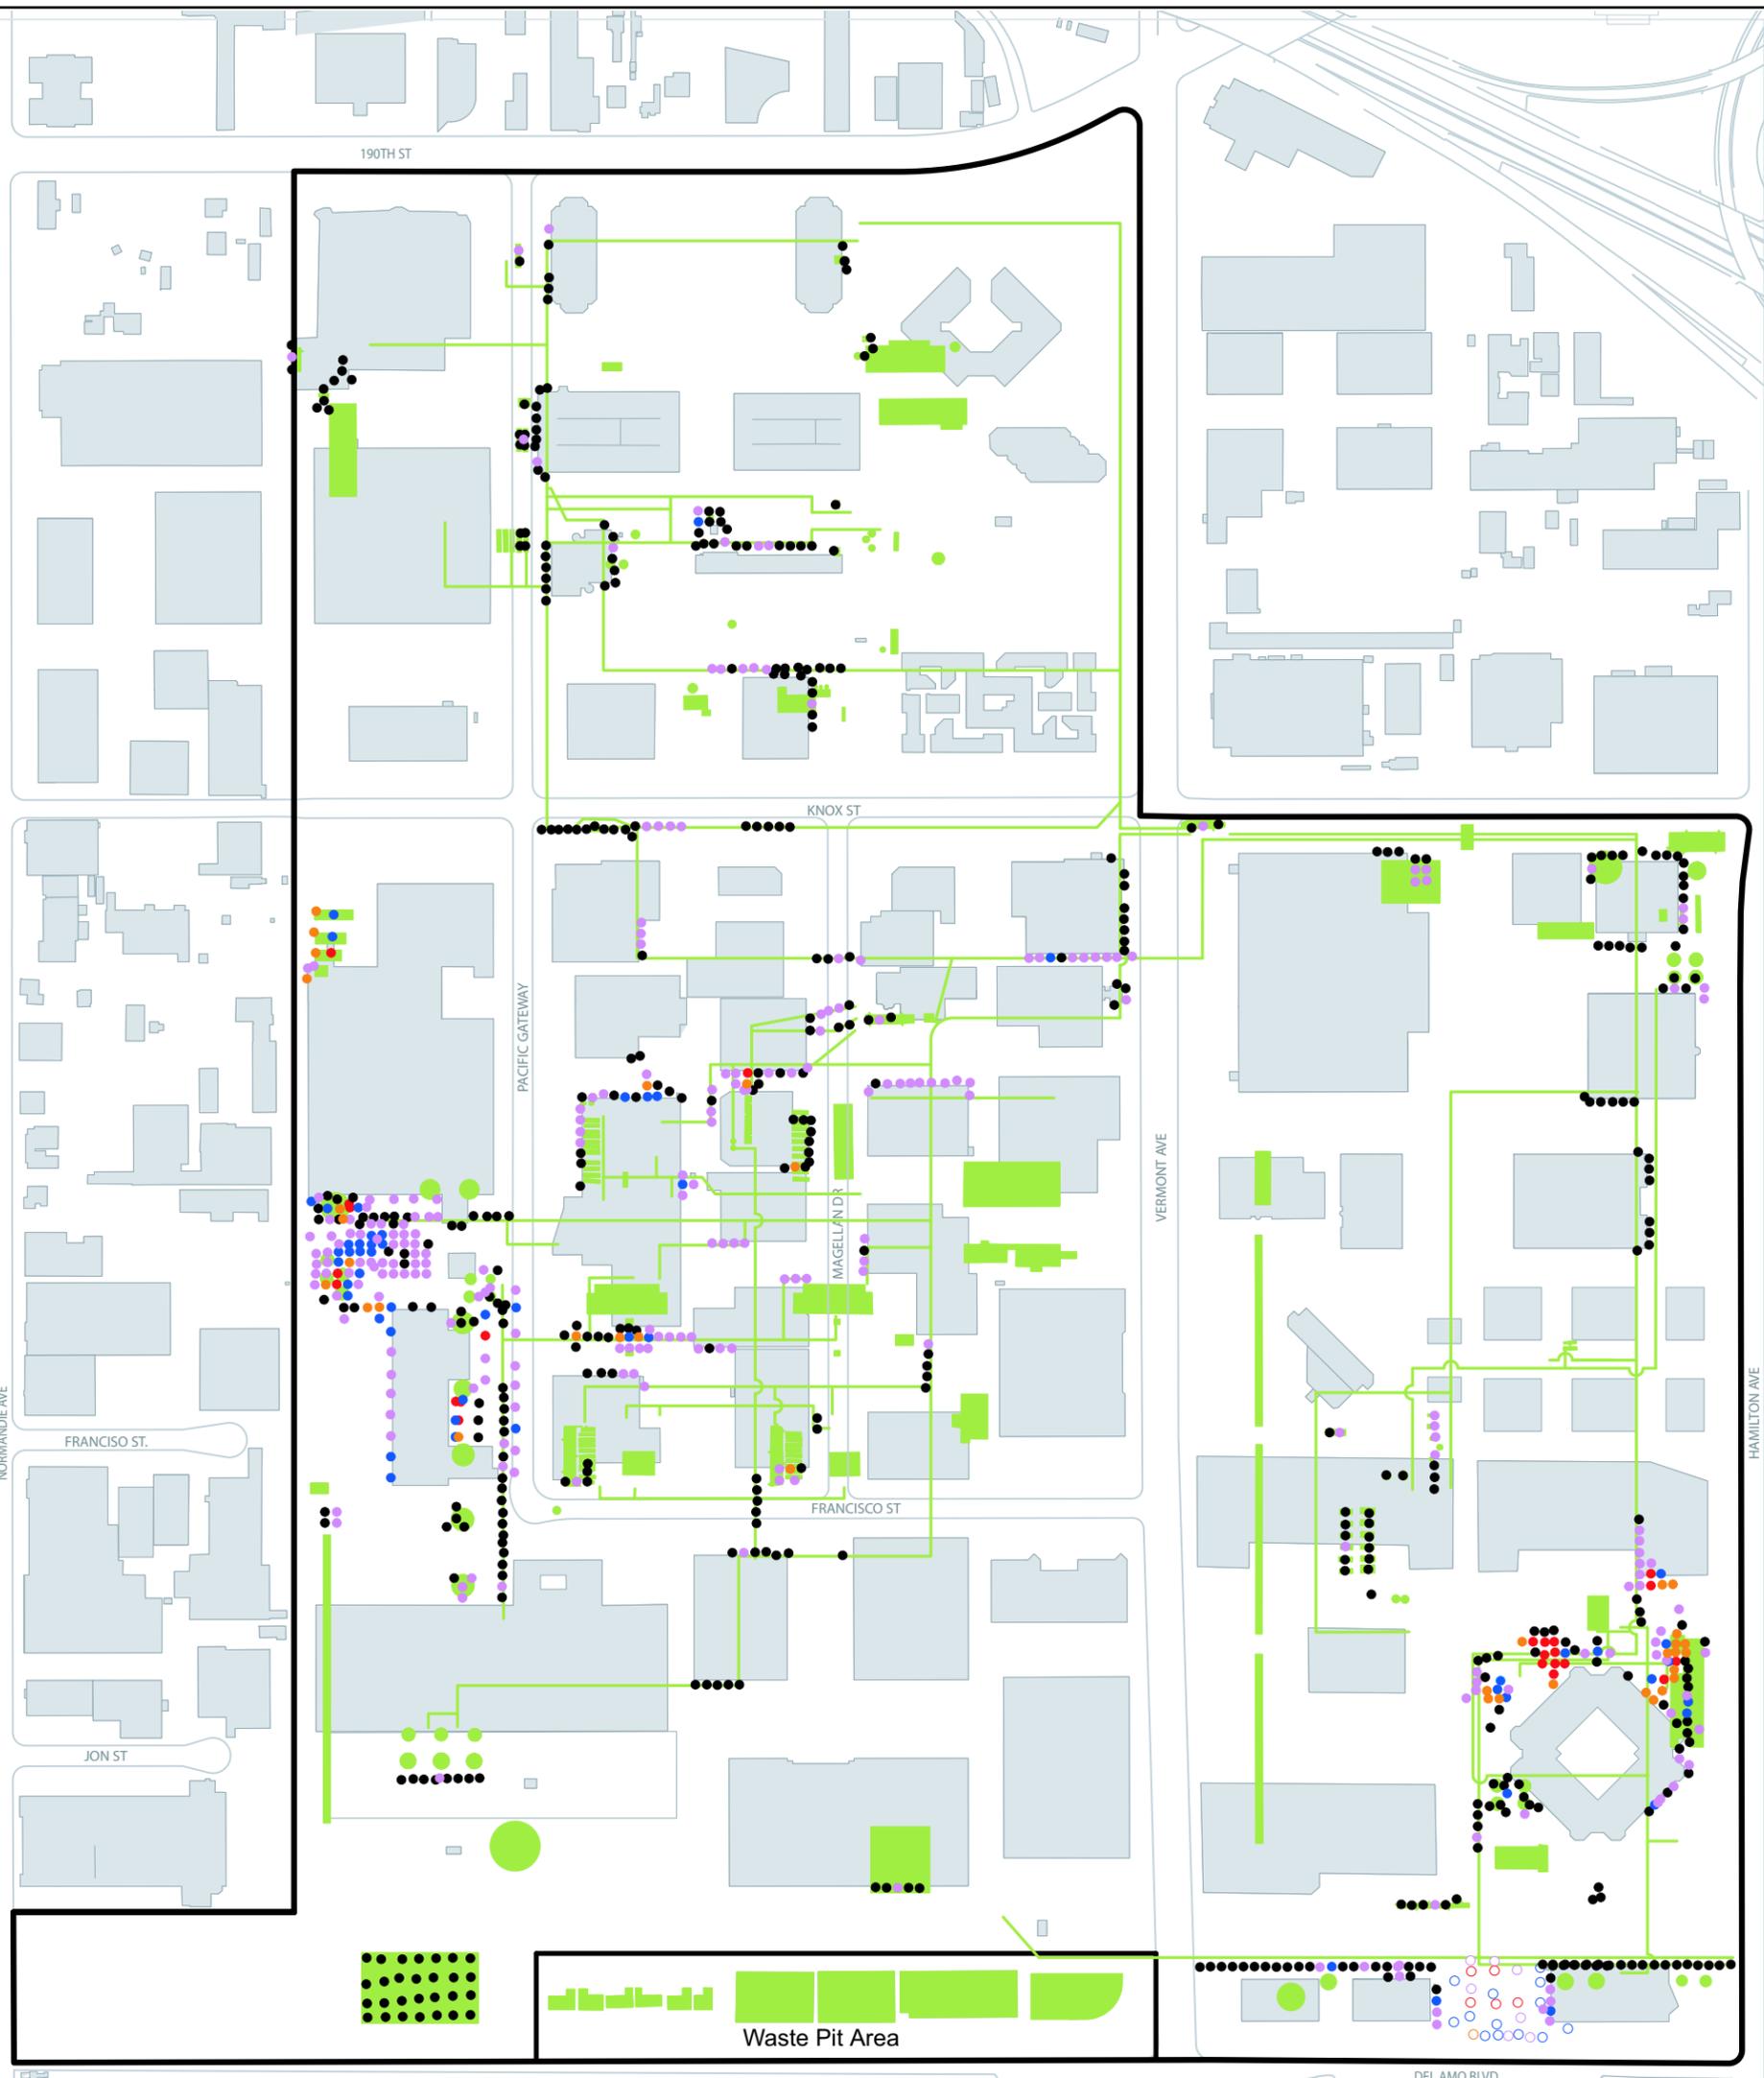
Note: RI and non-RI shallow soil gas sampling completed between 1991 and 1997

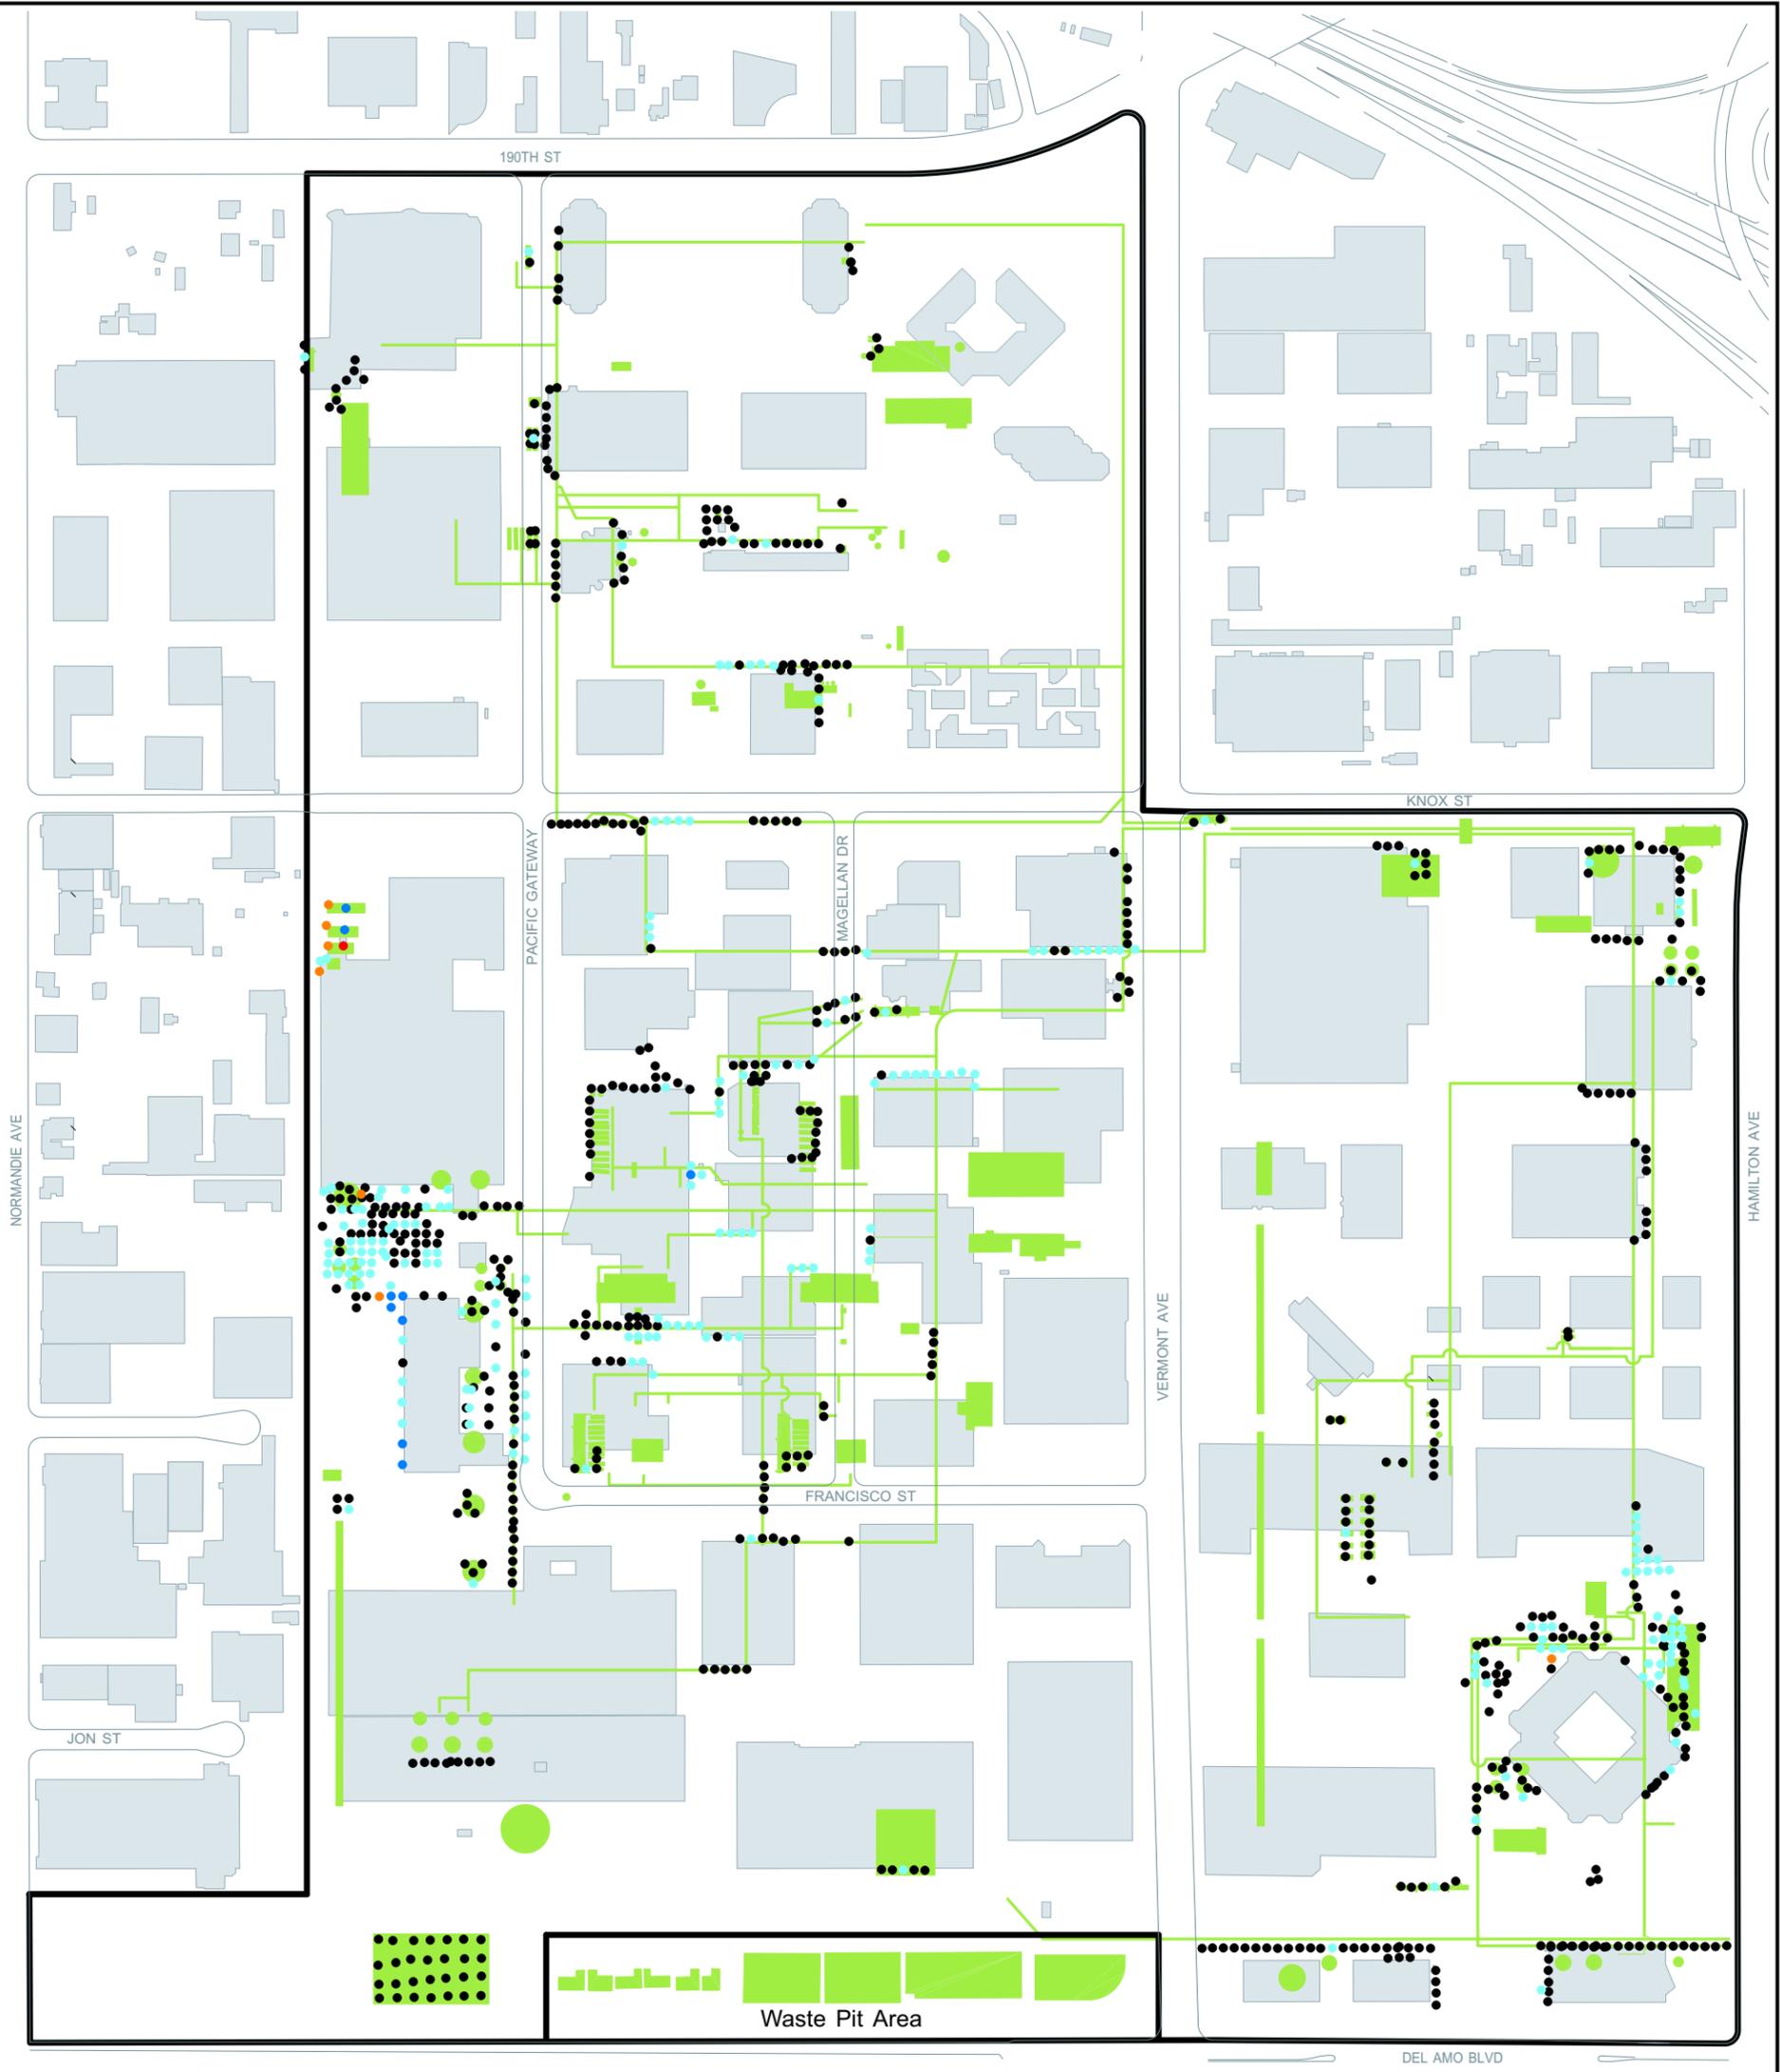
Note: RI and non-RI shallow soil gas sampling completed between 1991 and 1997

FIGURE 27
TOTAL CHLORINATED VOC CONCENTRATIONS IN SHALLOW SOIL GAS
 Soil and NAPL RI
 Del Amo Superfund Site
URS

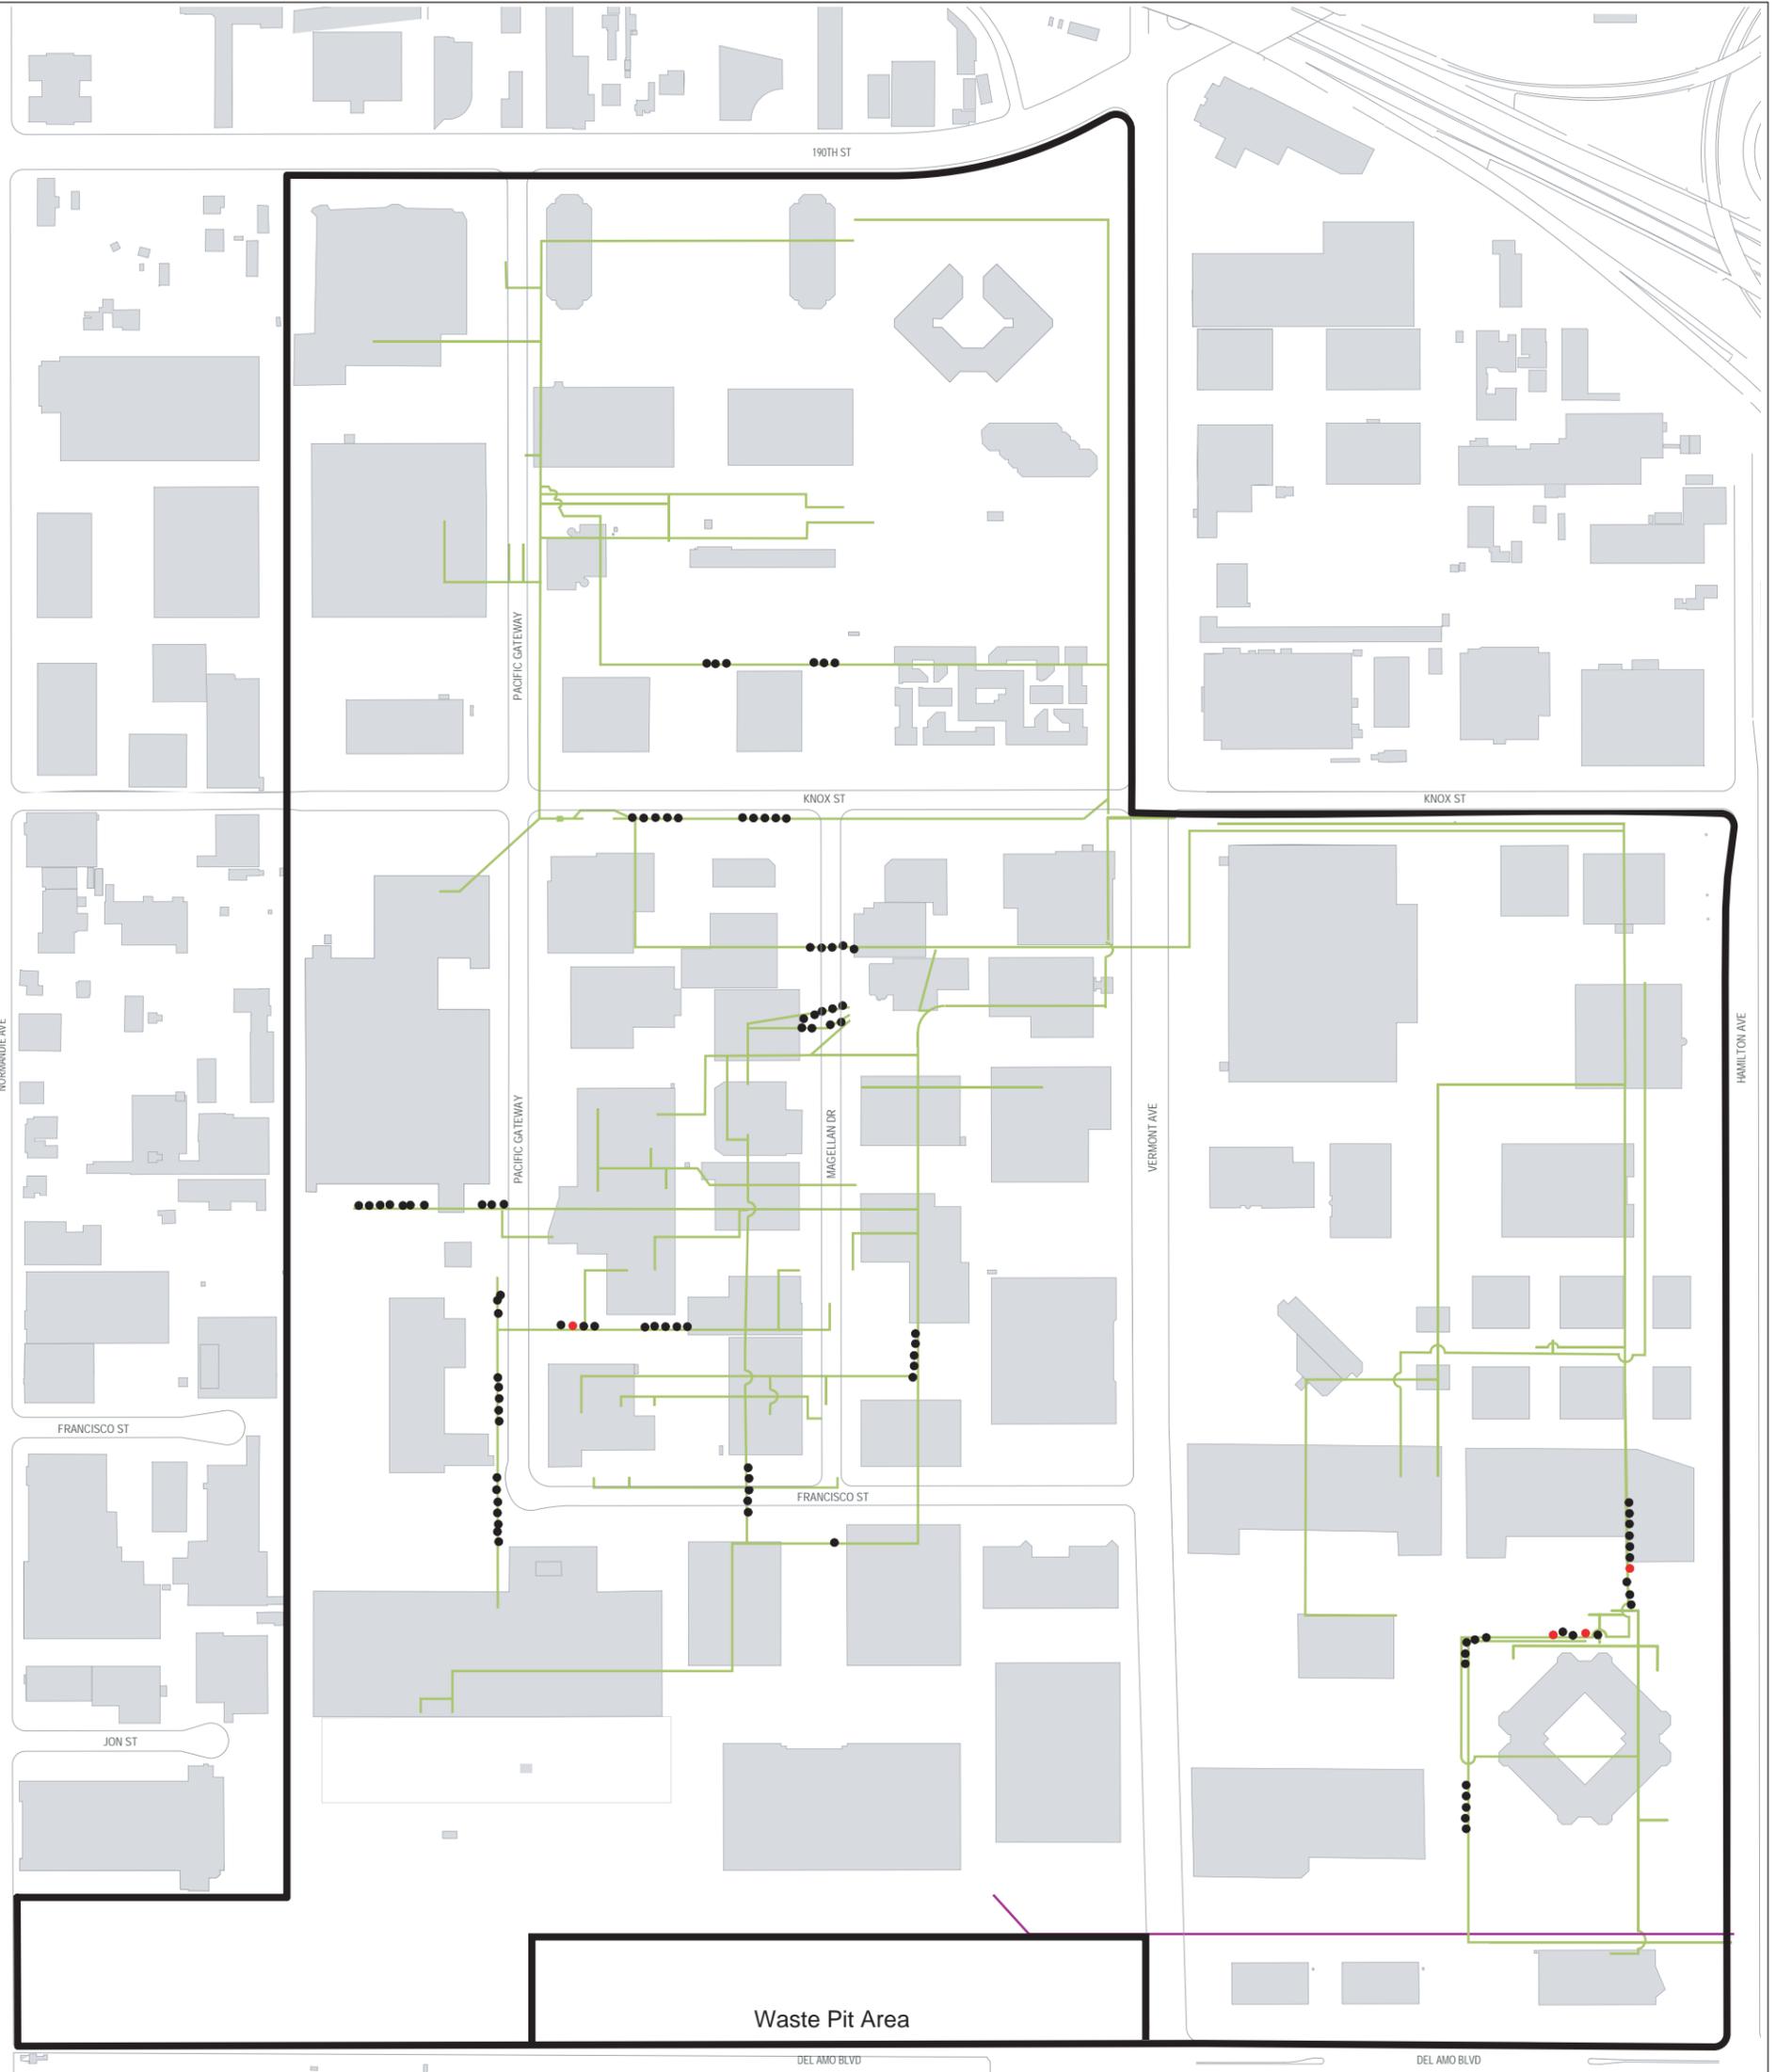
Note: Pipeline soil gas sampling completed between 1994 and 1995

FIGURE 28
**NON-PRIORITY PIPELINE & TRENCH
 TRANSMISSION SYSTEM
 SHALLOW SOIL GAS SAMPLING
 LOCATIONS**
 Soil and NAPL RI
 Del Amo Superfund Site

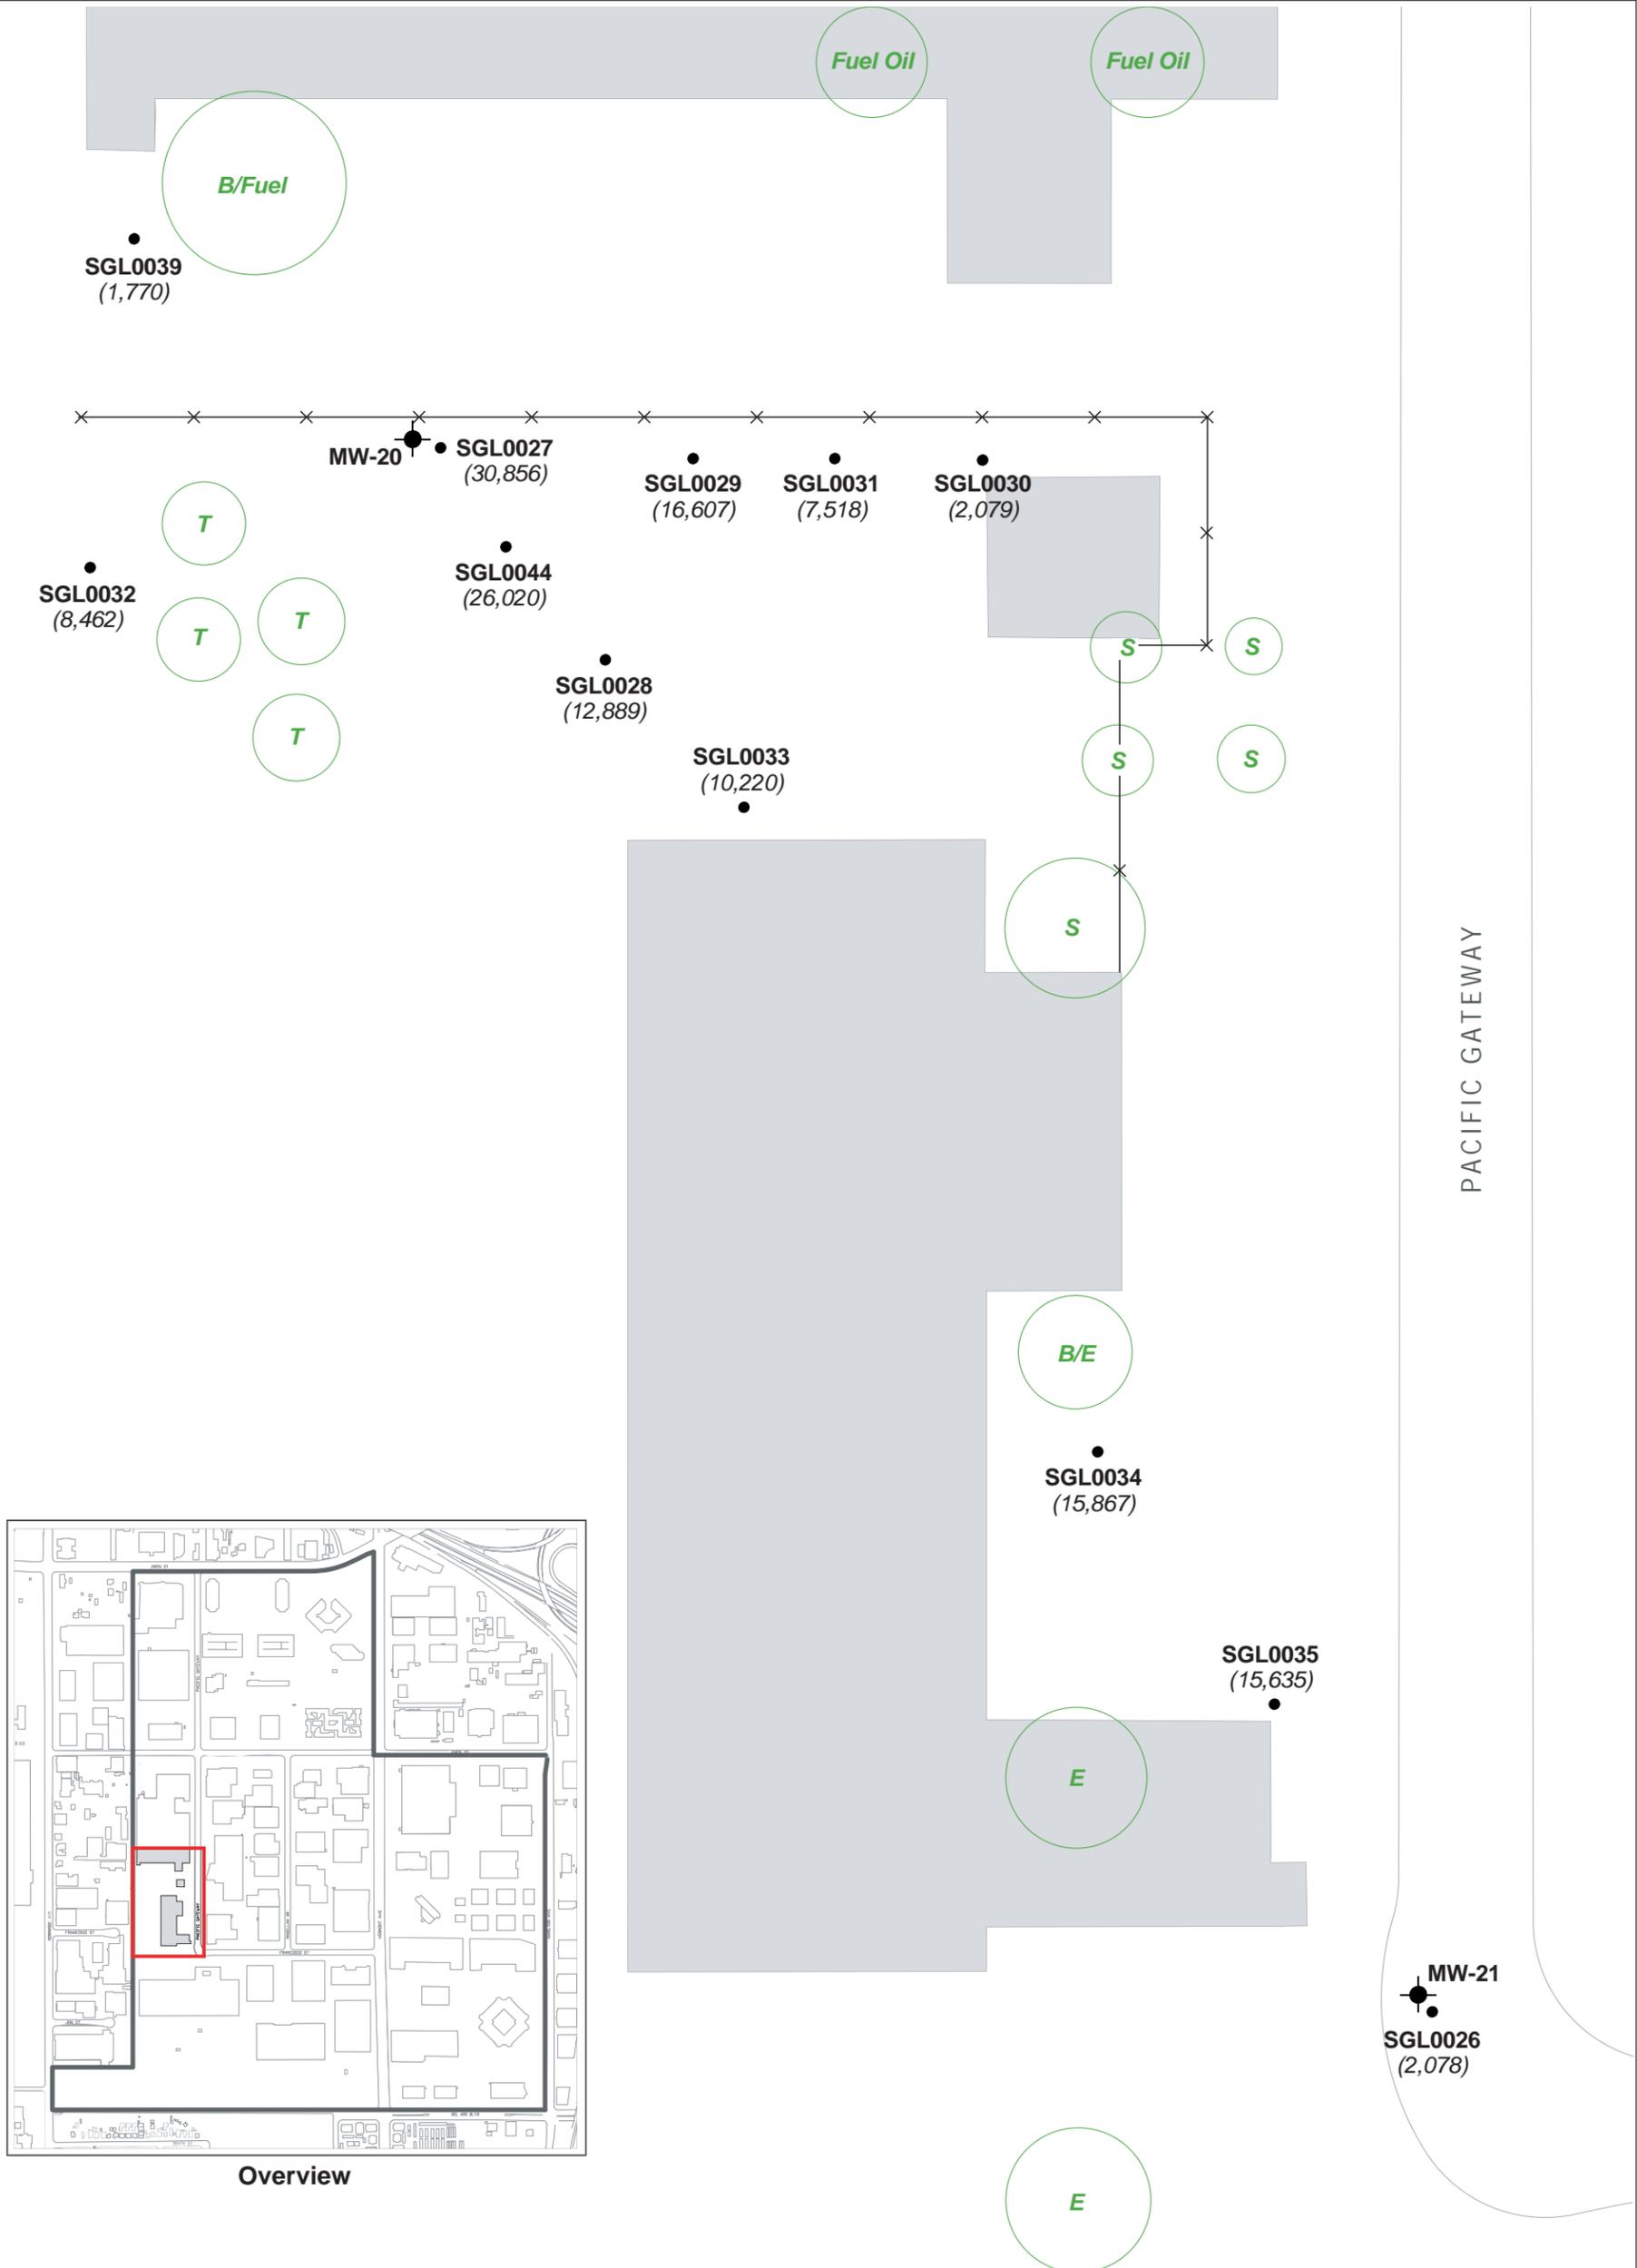
FIGURE 29

Note: Soil gas samples collected at depths ranging from 47 to 59 feet below ground surface
 Deep soil gas sampling completed in 1992

TOTAL VOC CONCENTRATIONS IN DEEP SOIL GAS SAMPLES

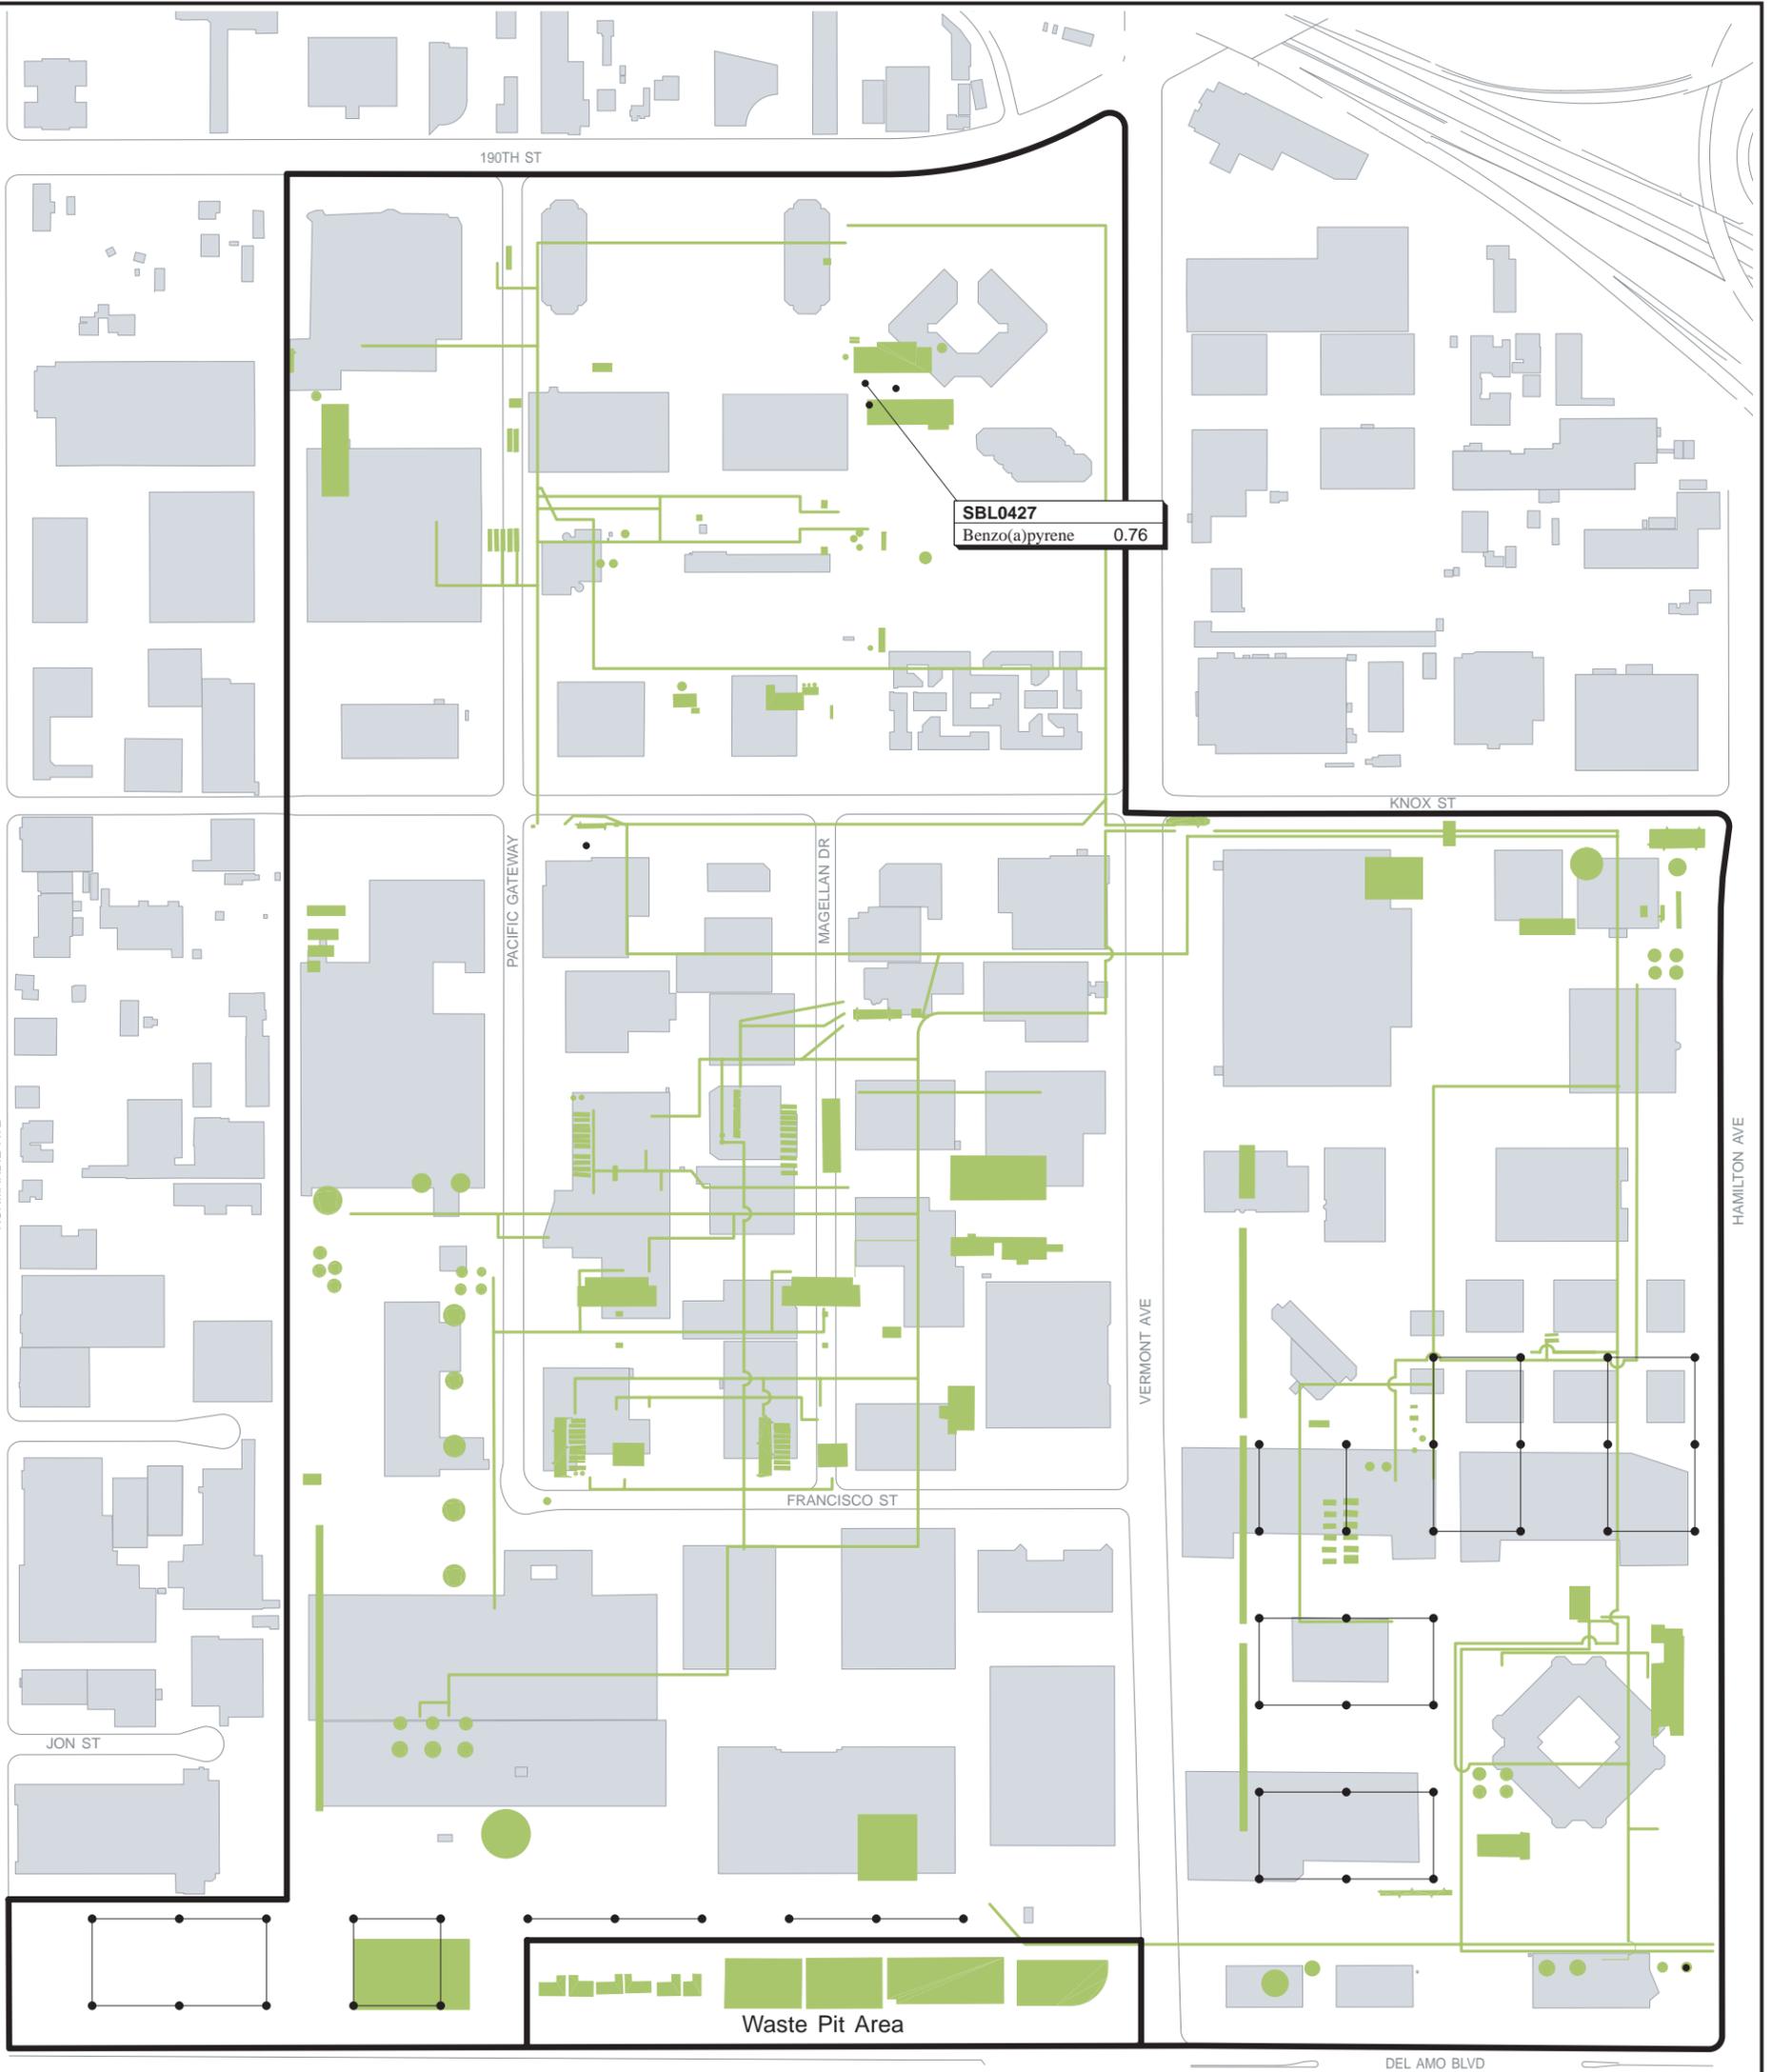
Note: Data collected between 1993 and 2003

FIGURE 30
**SVOC/PAH SAMPLING
 LOCATIONS IN SURFACE SOIL**
 Soil and NAPL RI
 Del Amo Superfund Site
