FIGURE 25
SHALLOW SOIL GAS SAMPLING LOCATIONS WITH THRESHOLD EXCEEDANCES
 Soil and NAPL RI
 Del Amo Superfund Site
URS

FIGURE 26
TOTAL VOC CONCENTRATIONS
AT SHALLOW SOIL GAS
SAMPLING LOCATIONS
 Soil and NAPL RI
 Del Amo Superfund Site

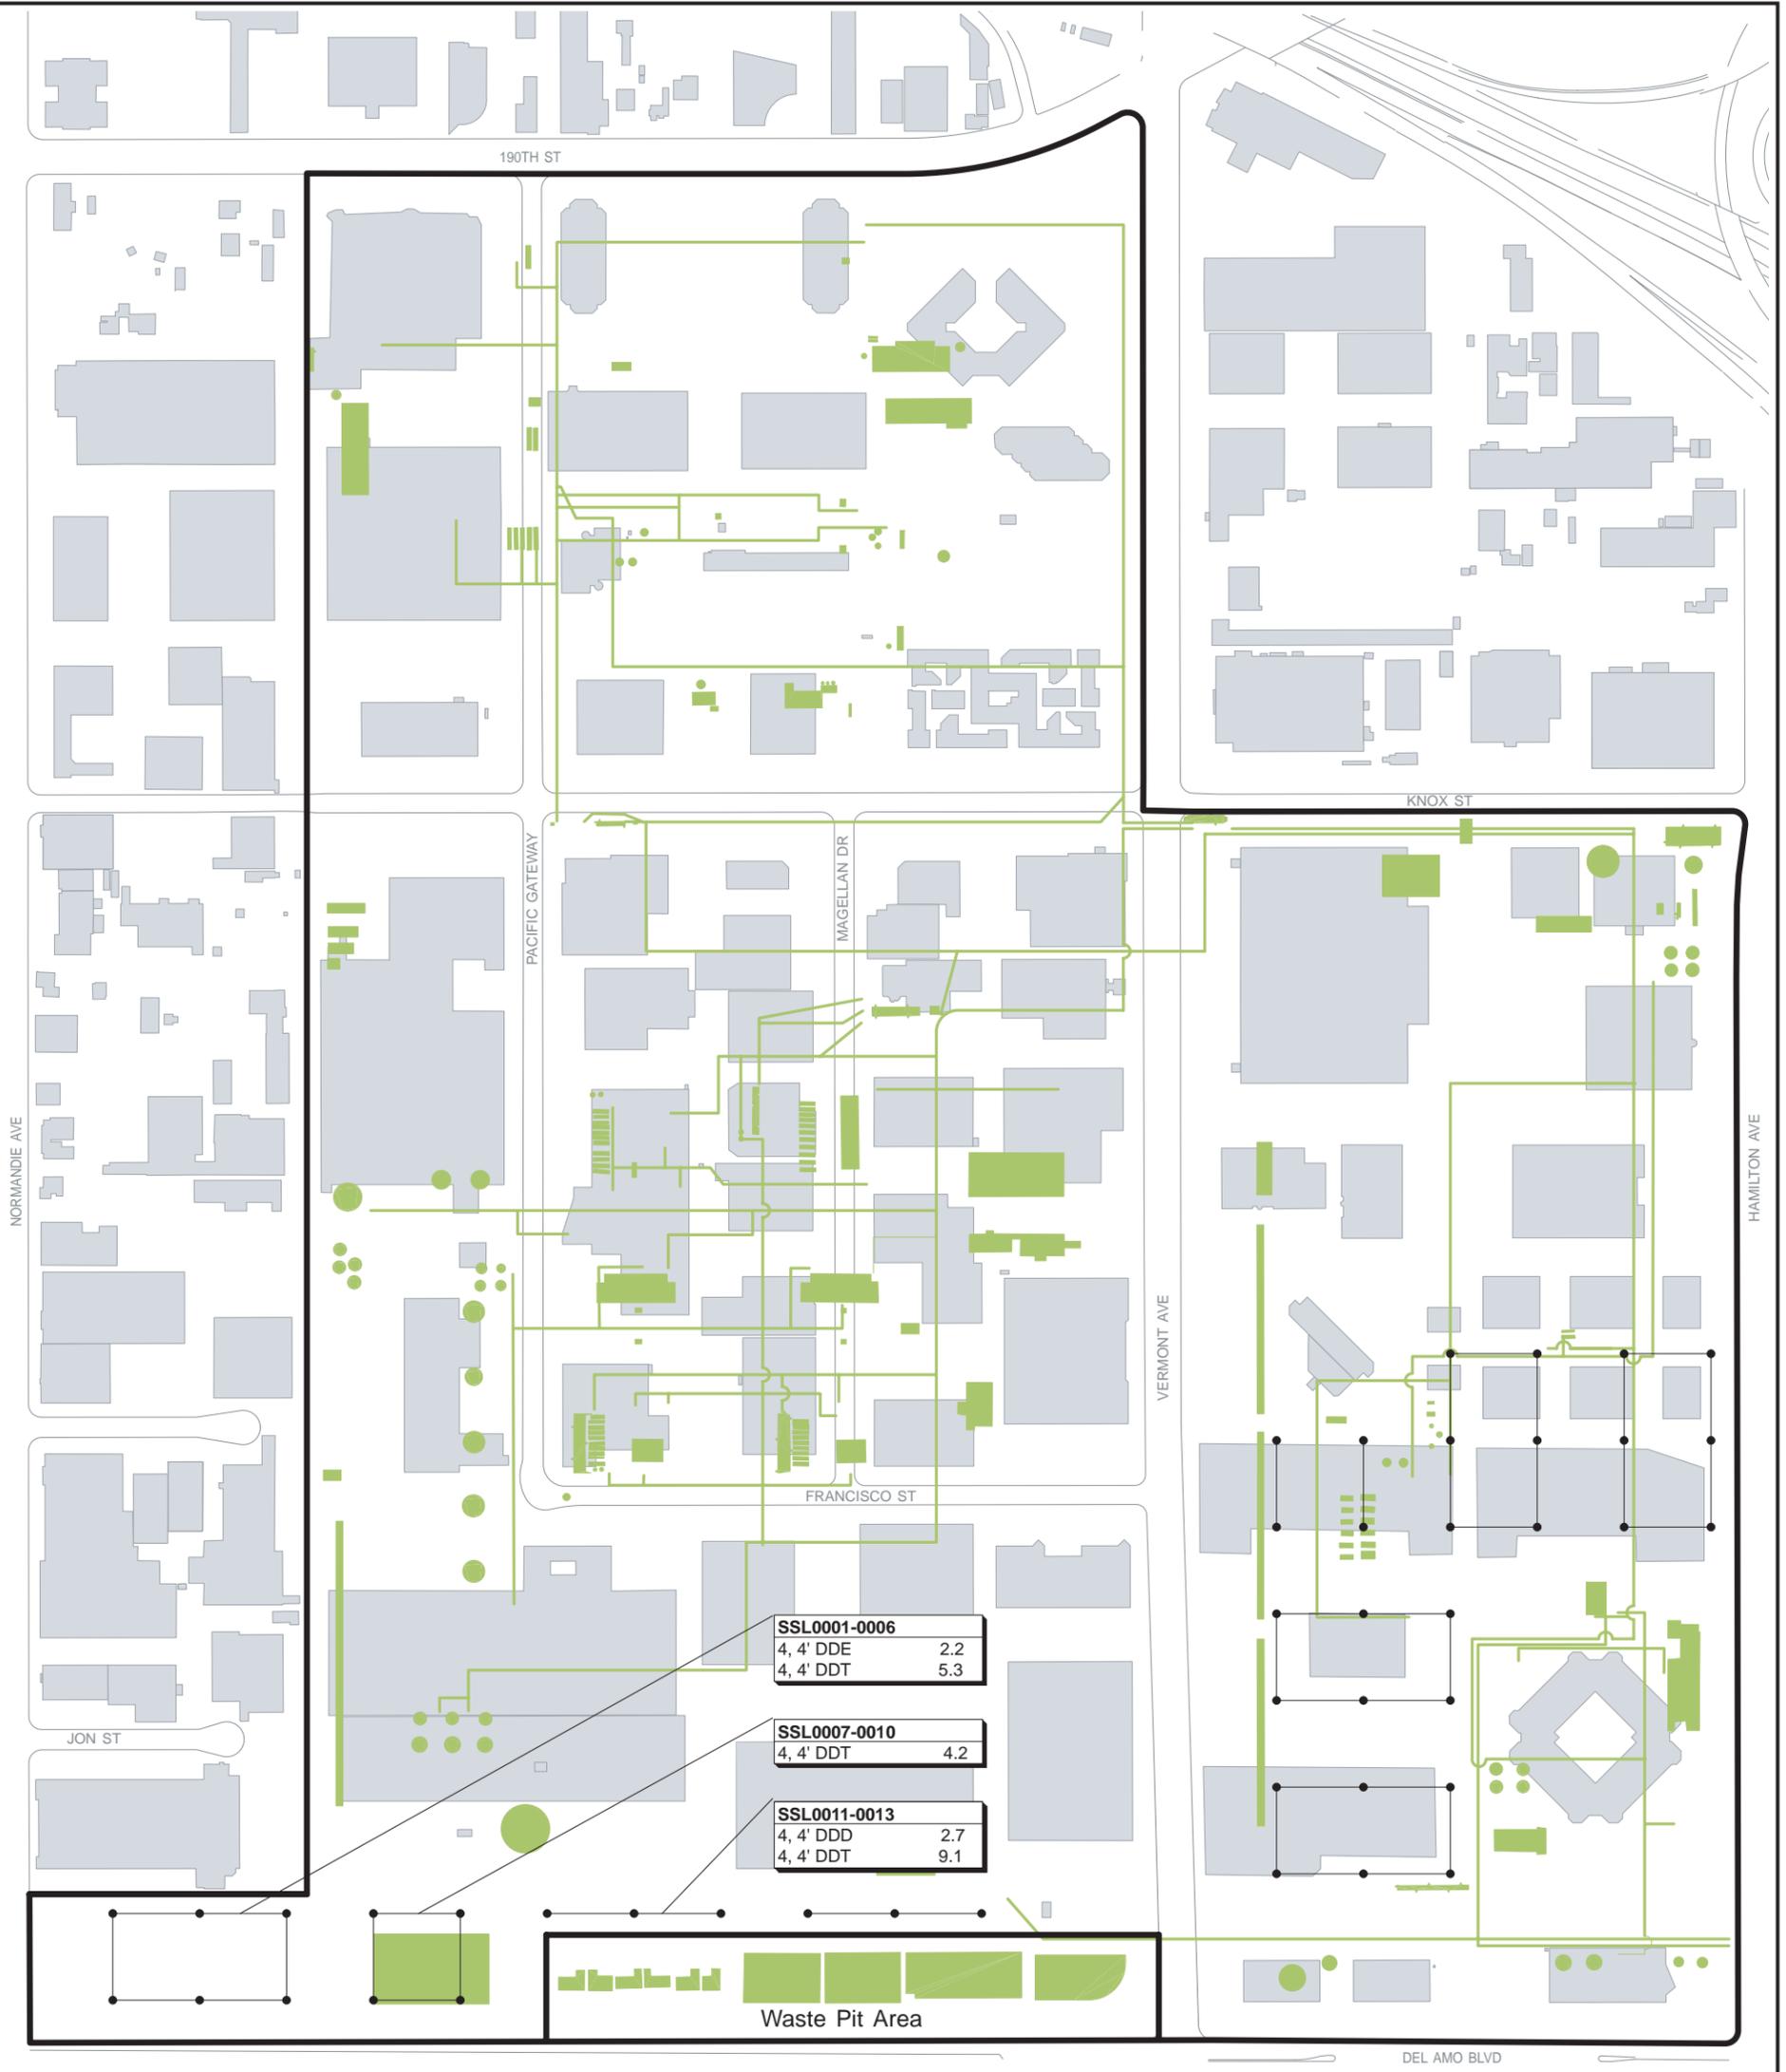
Note: Data collected in 1993

FIGURE 31
PESTICIDE/PCB SAMPLING LOCATIONS IN SURFACE SOIL
 Soil and NAPL RI
 Del Amo Superfund Site

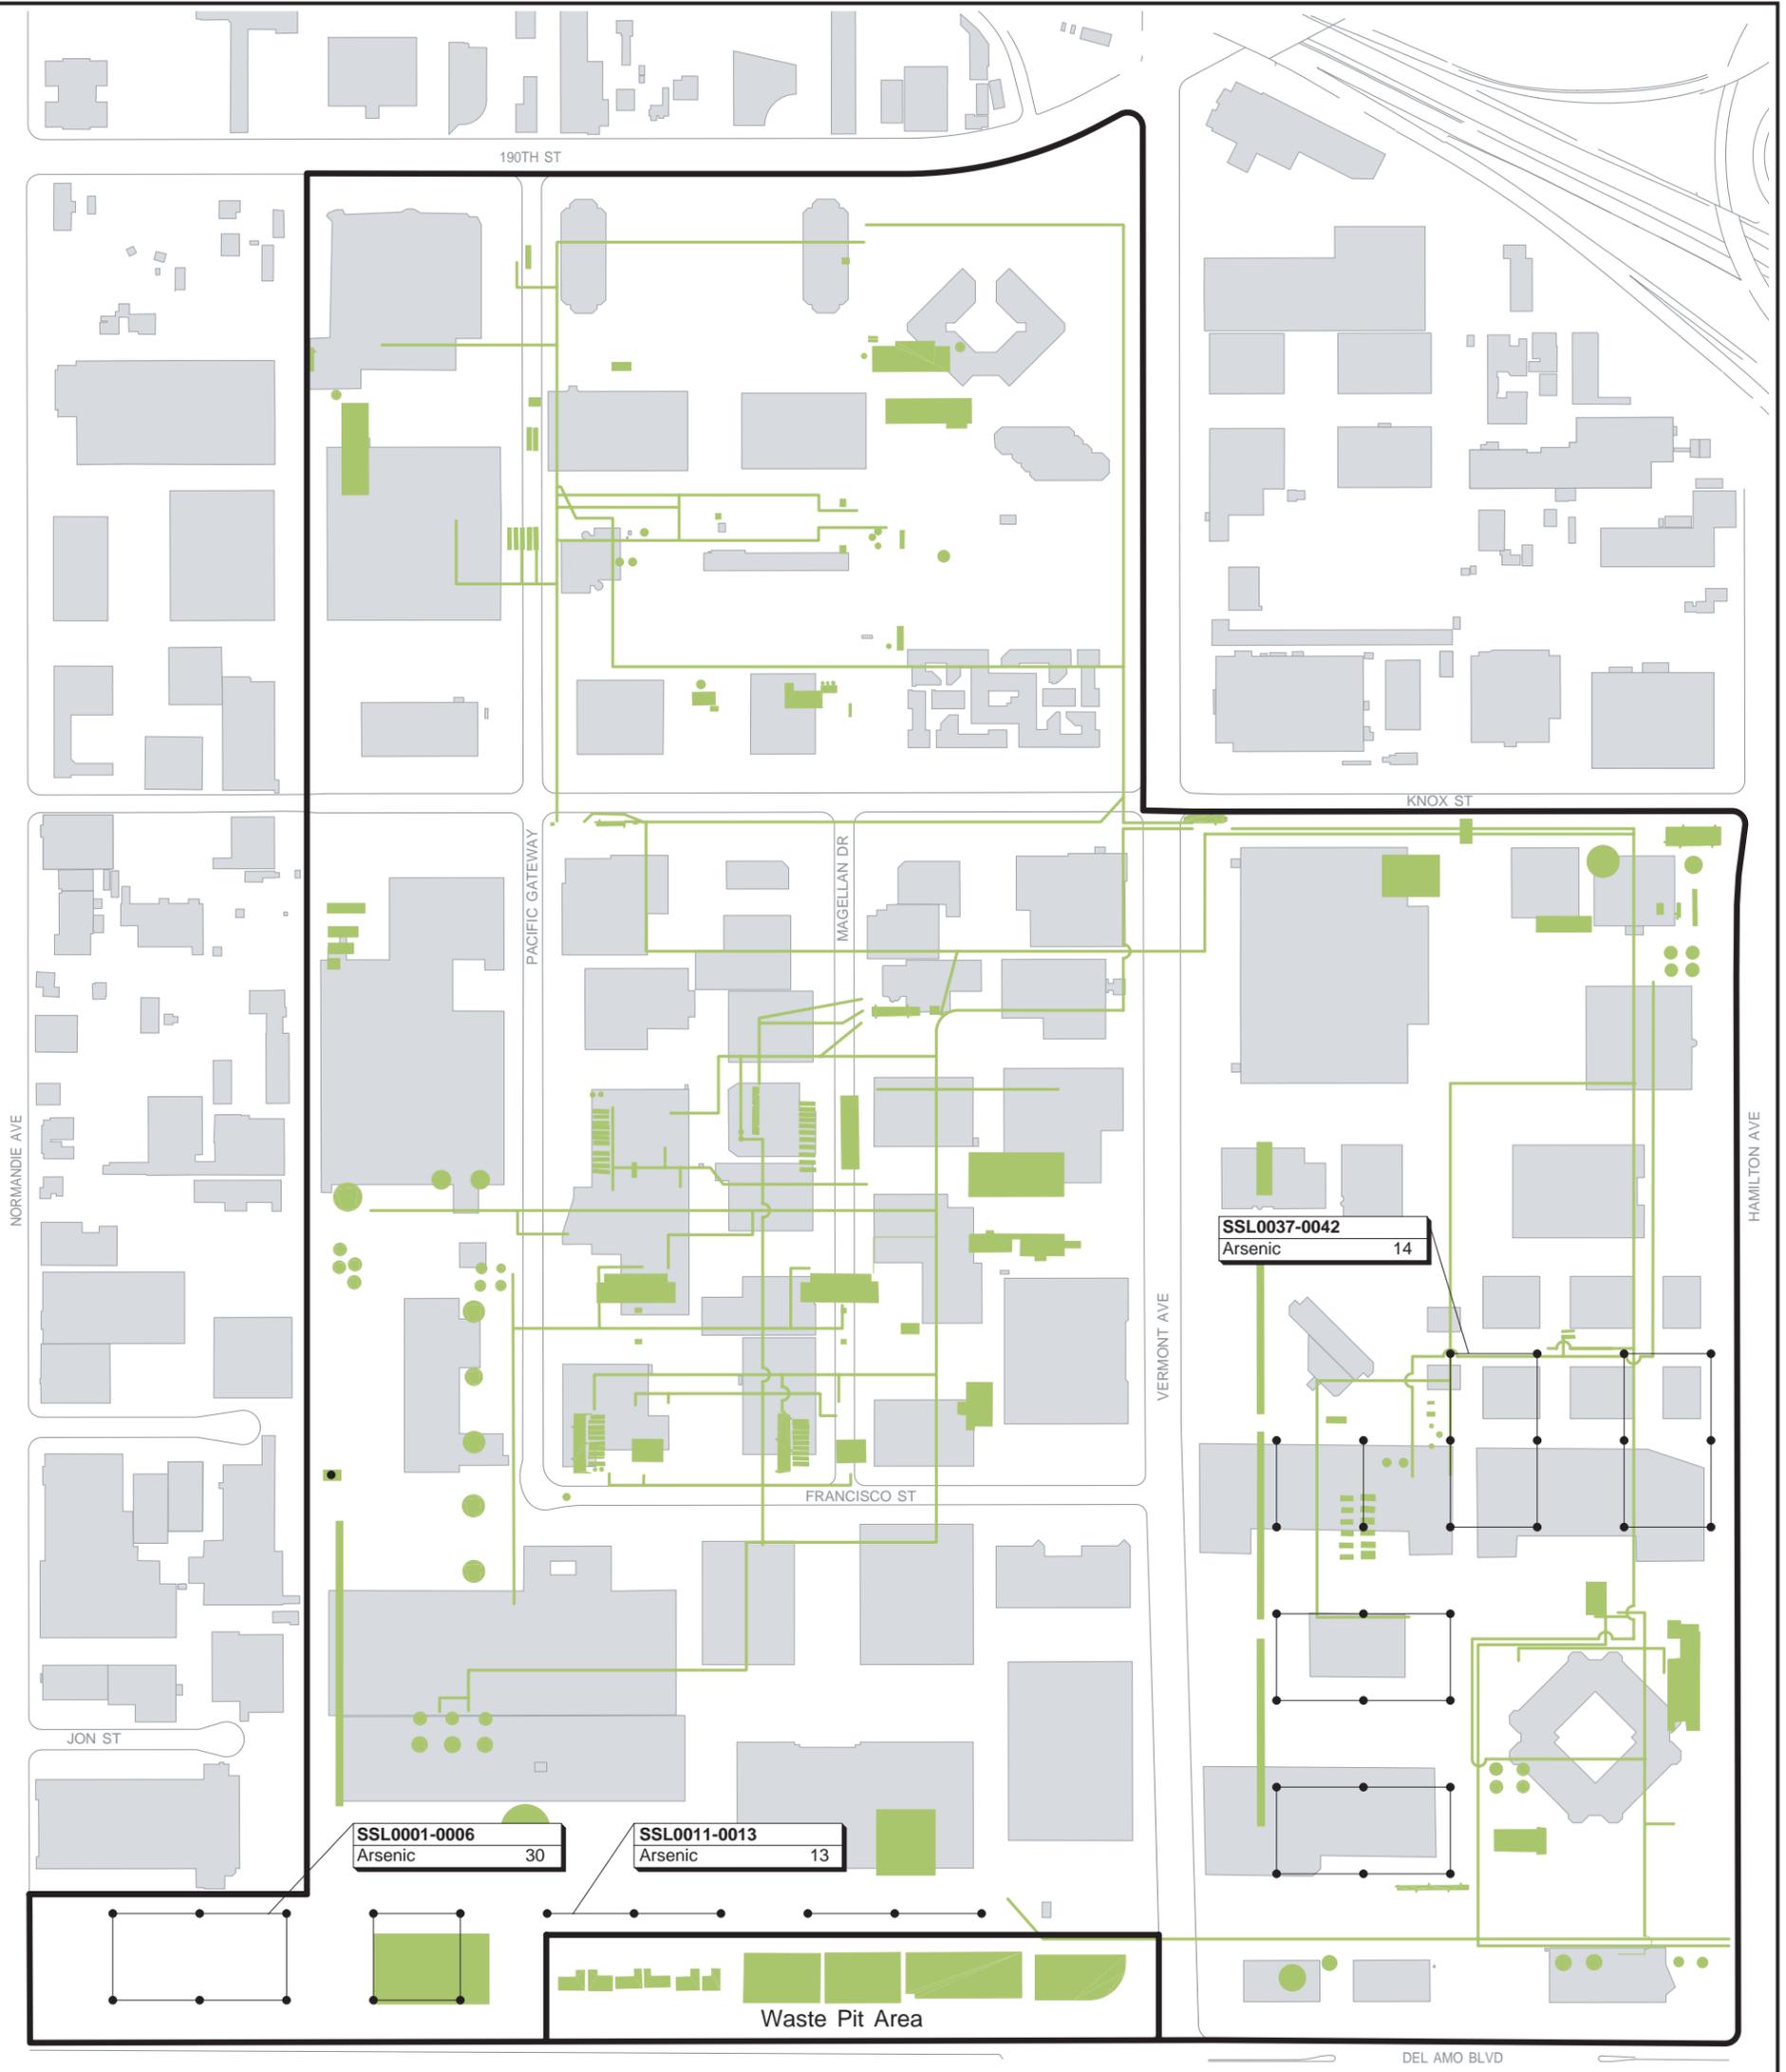
Note: Data collected in 1993

FIGURE 32
METALS SAMPLING LOCATIONS IN SURFACE SOIL
 Soil and NAPL RI
 Del Amo Superfund Site

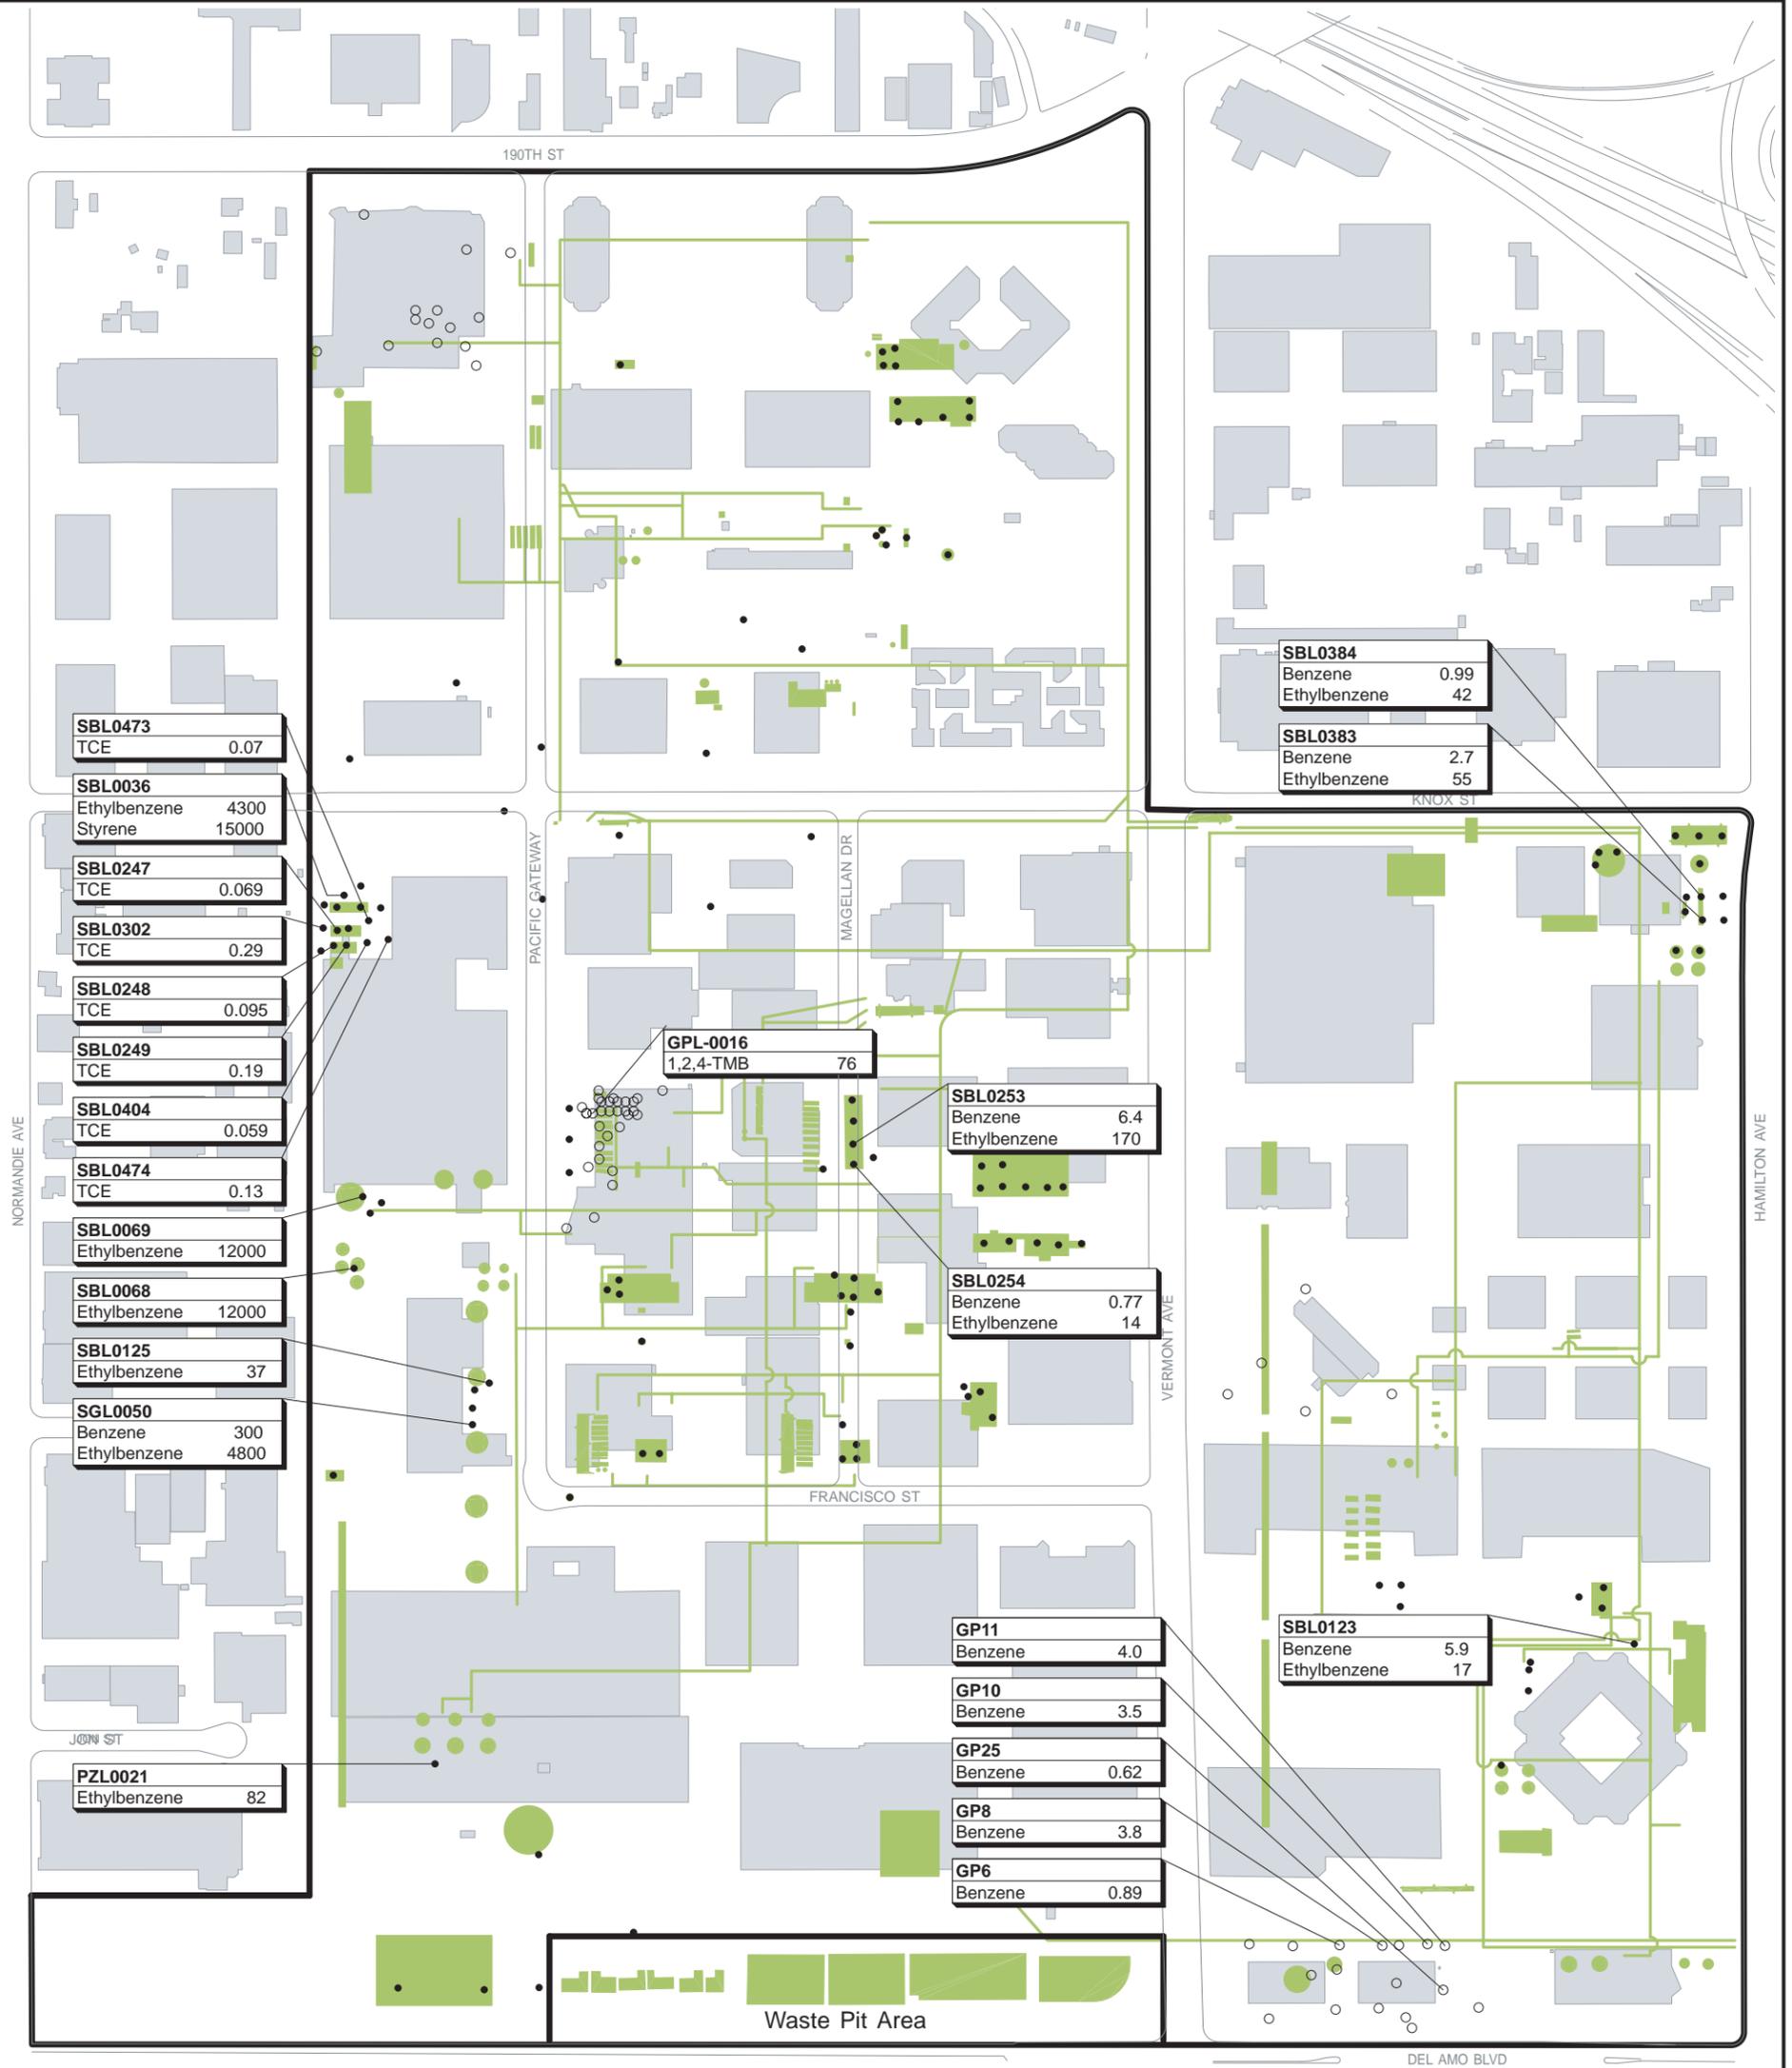
Note: Data collected between 1990 and 2003

FIGURE 33
VOC SAMPLING LOCATIONS
IN SHALLOW SOIL
 Soil and NAPL RI
 Del Amo Superfund Site

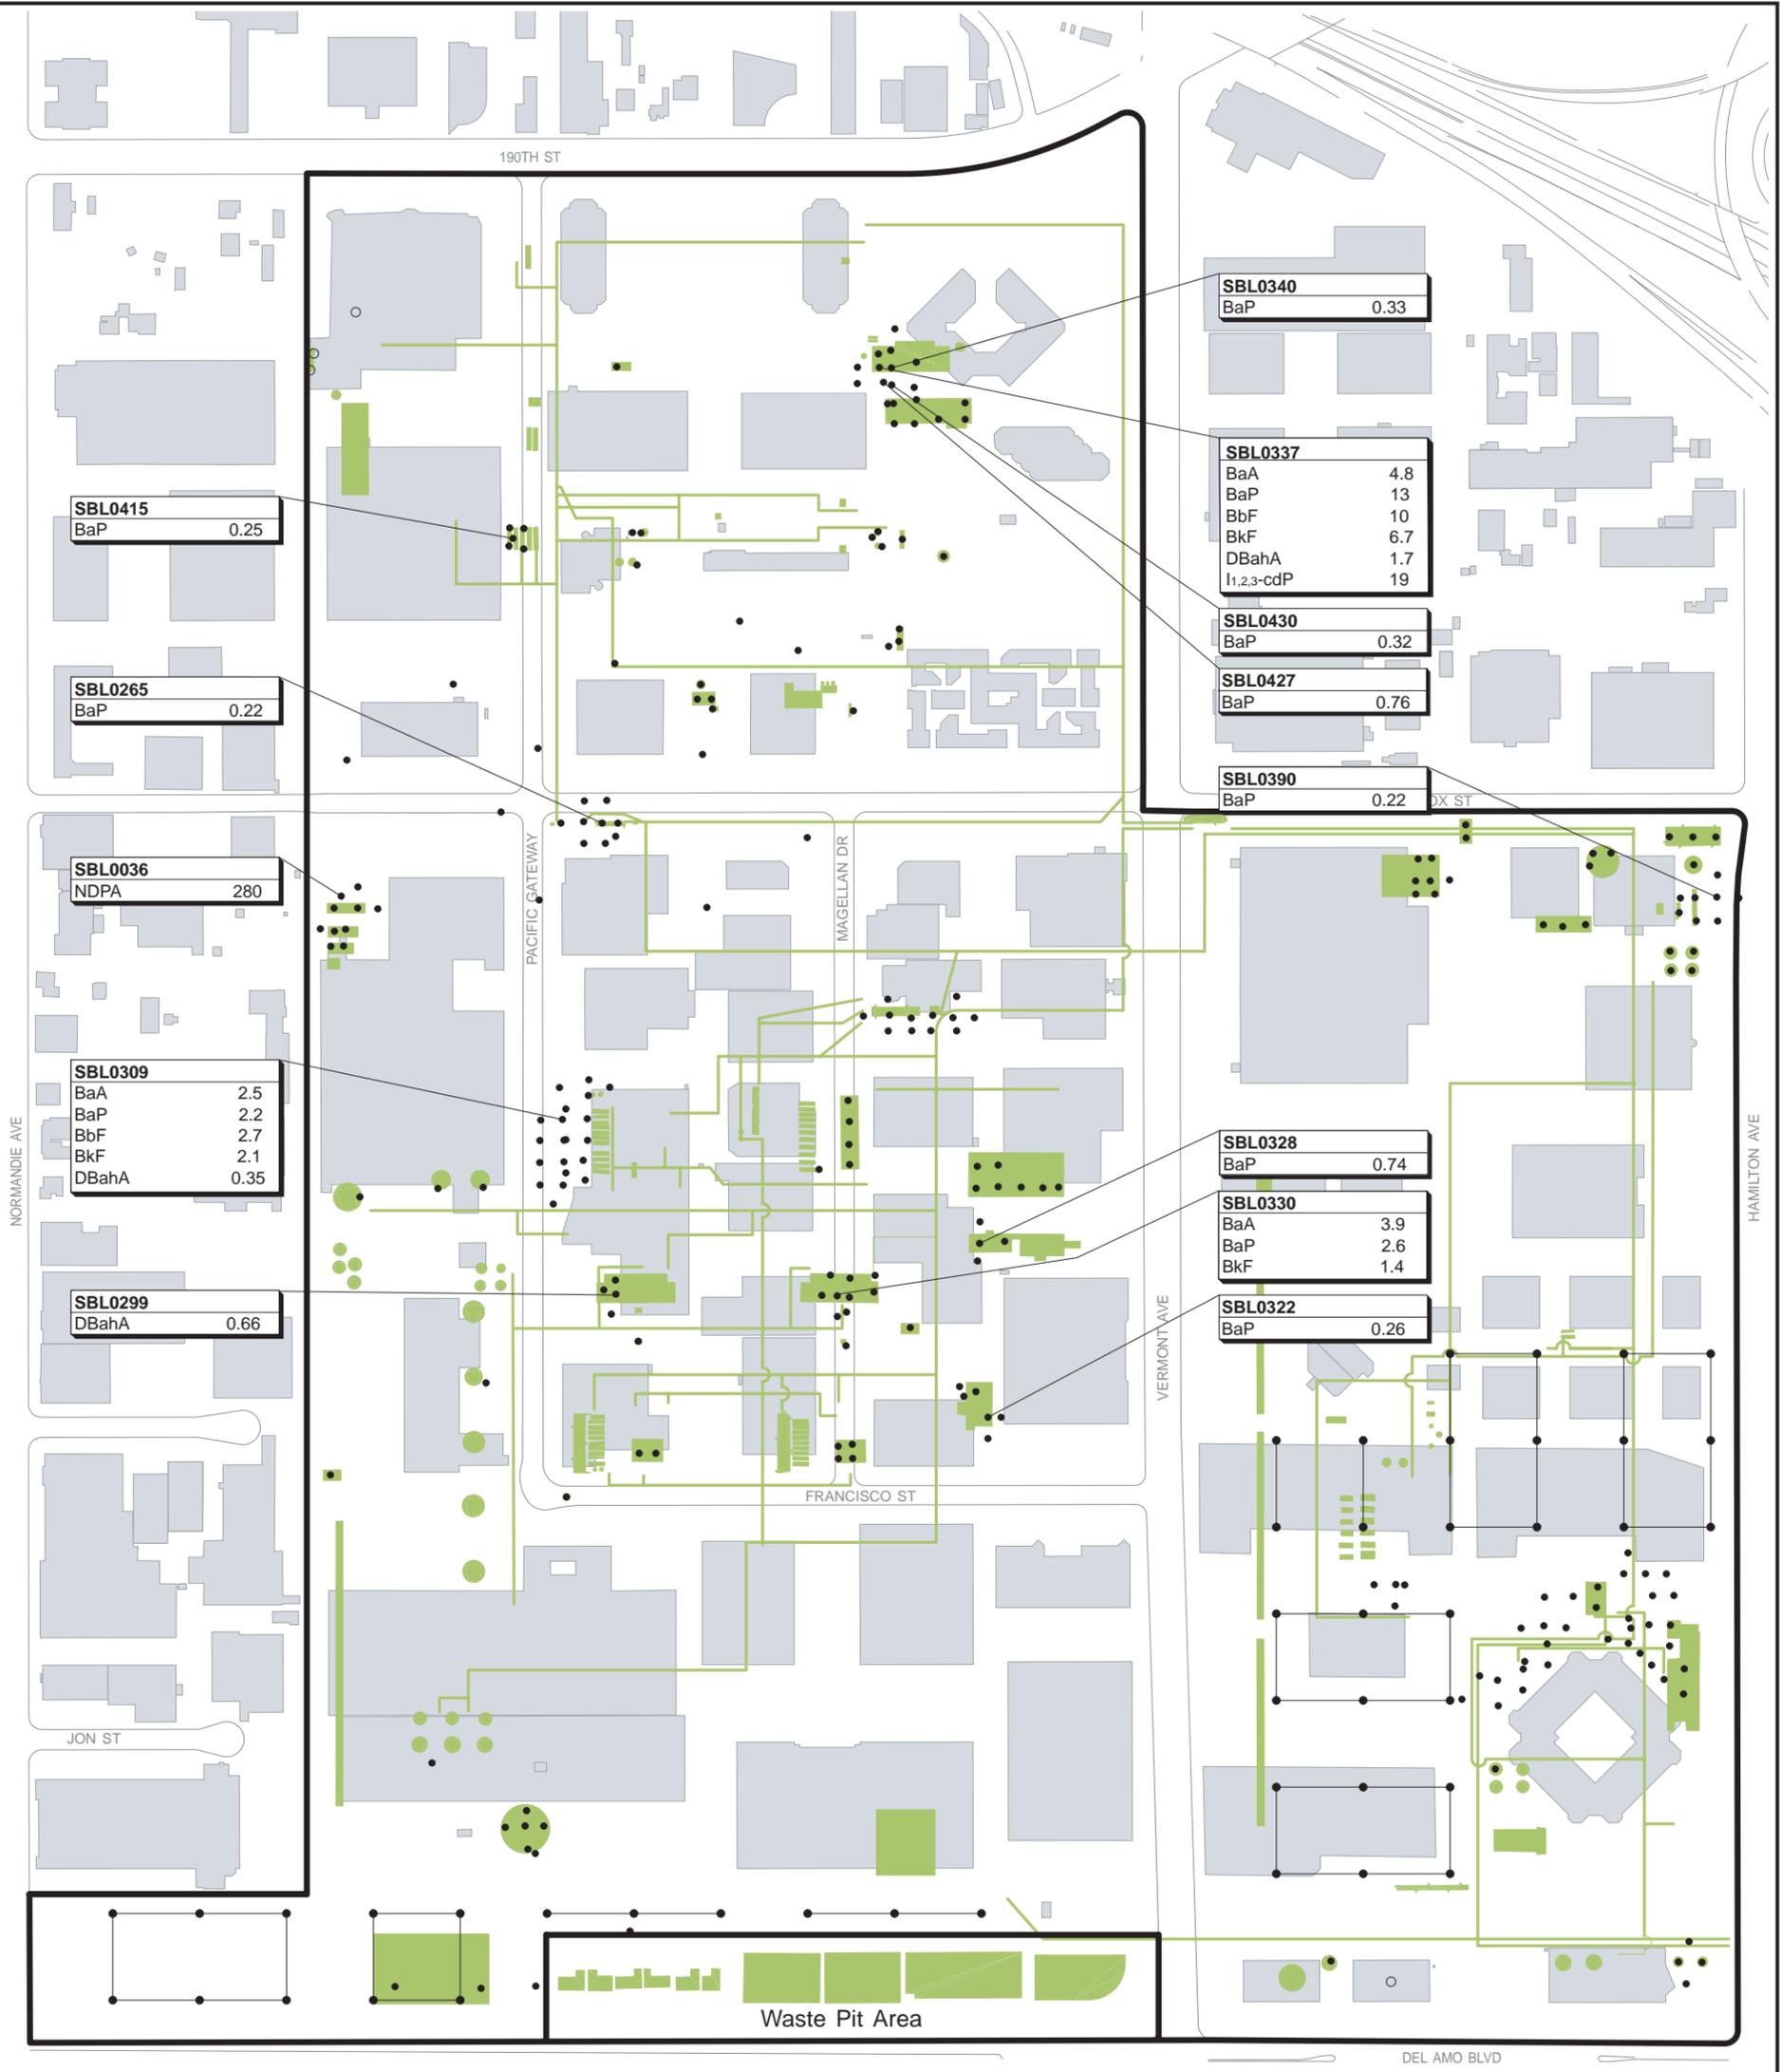
Note: Data collected between 1990 and 2003

FIGURE 34
SVOC/PAH SAMPLING LOCATIONS IN SHALLOW SOIL
 Soil and NAPL RI
 Del Amo Superfund Site

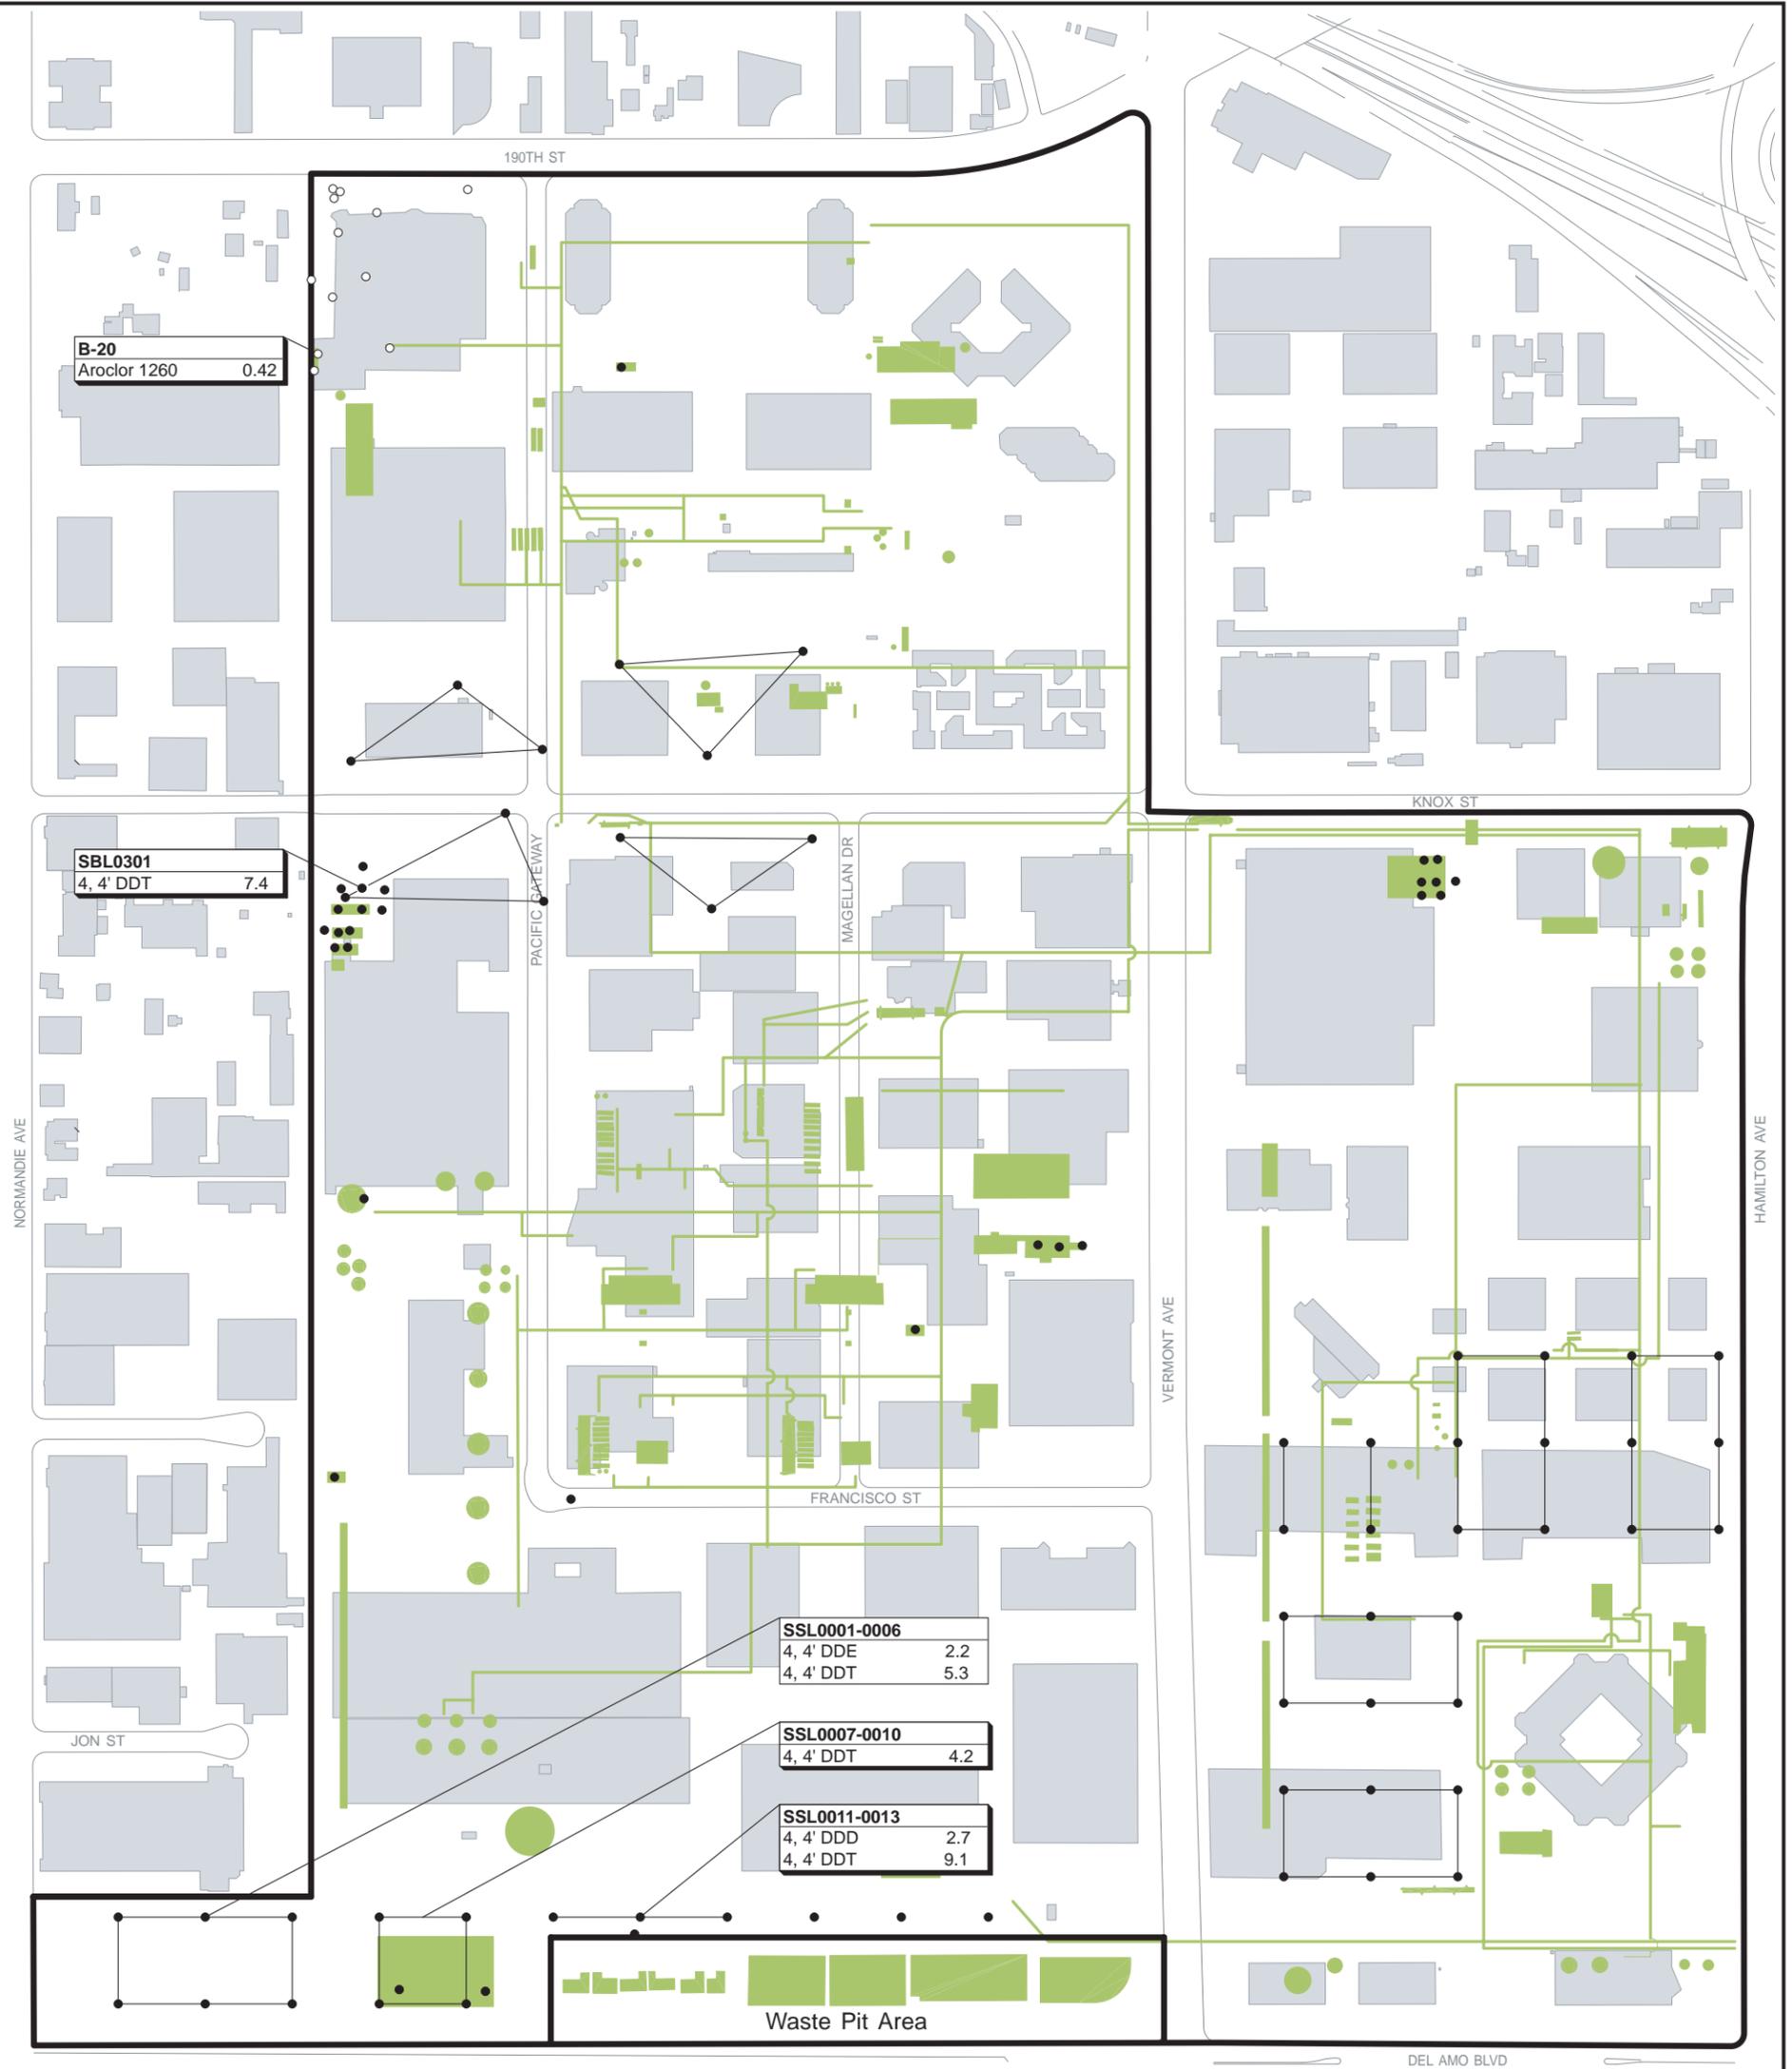
Note: Data collected between 1993 and 2003

FIGURE 35
PESTICIDE/PCB SAMPLING LOCATIONS IN SHALLOW SOIL
 Soil and NAPL RI
 Del Amo Superfund Site

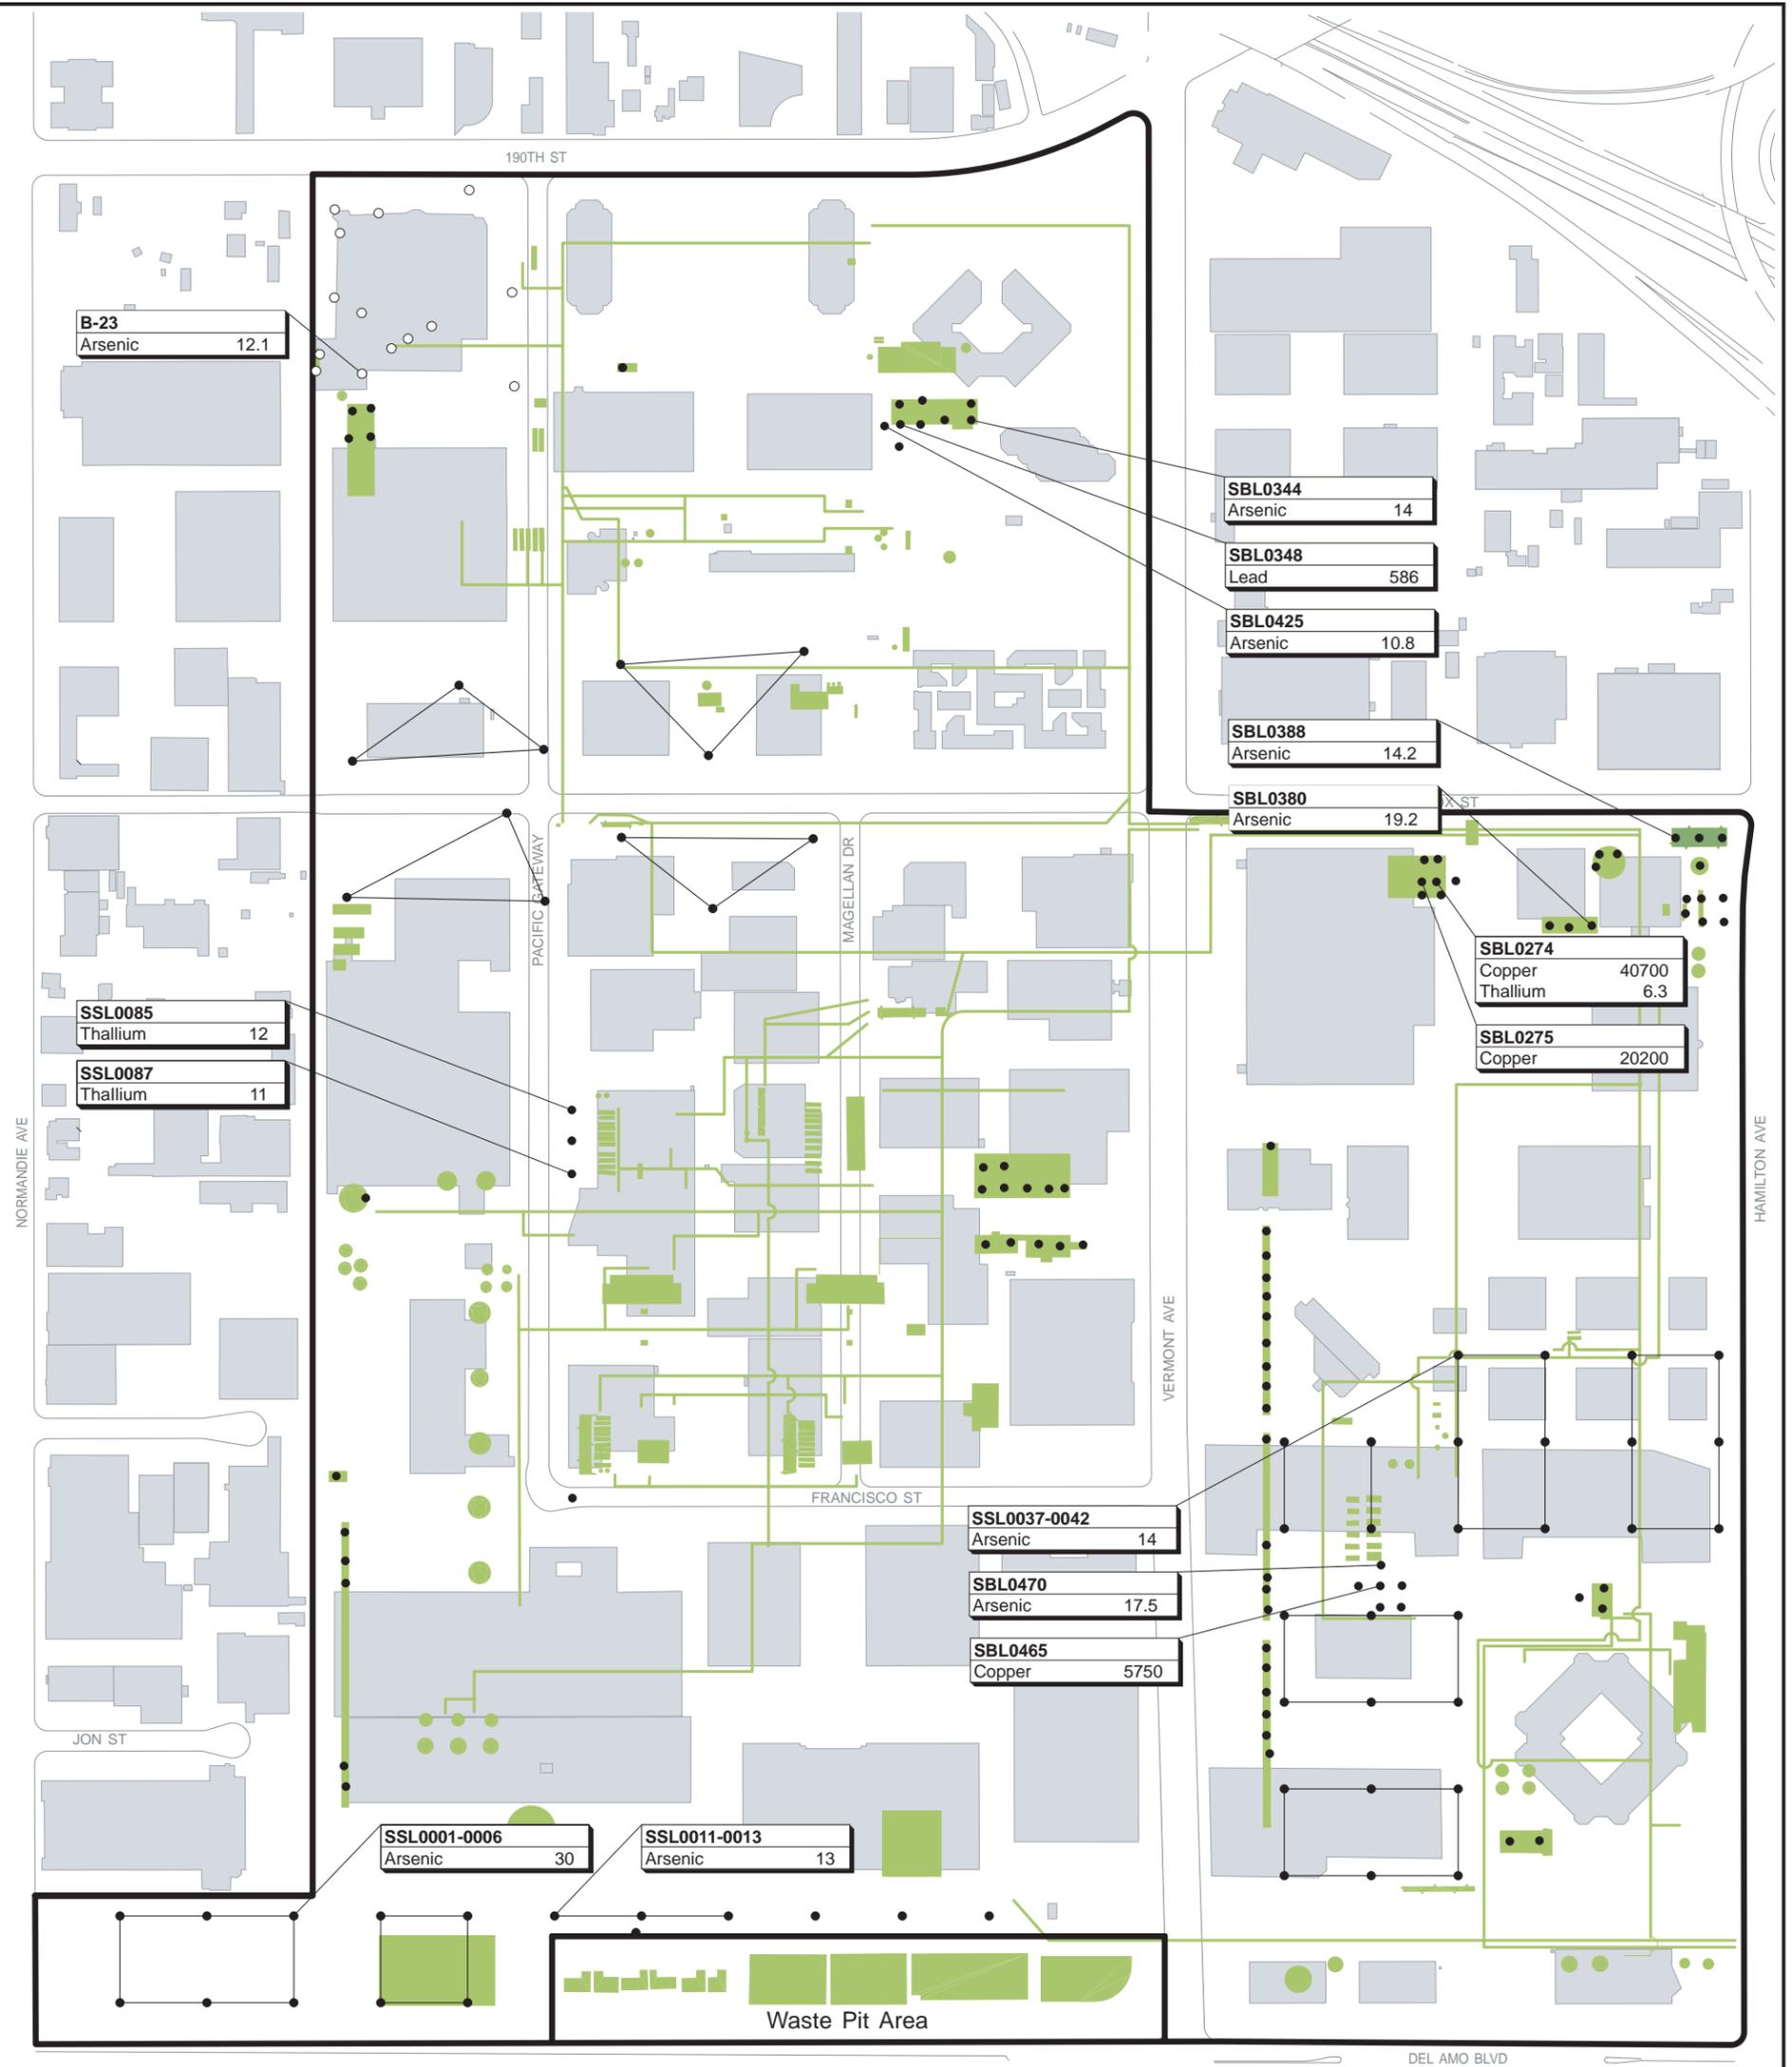
Note: Data collected between 1993 and 2003

FIGURE 36
METALS SAMPLING LOCATIONS IN SHALLOW SOIL
 Soil and NAPL RI
 Del Amo Superfund Site
