FIGURE 25
SHALLOW SOIL GAS SAMPLING LOCATIONS WITH THRESHOLD EXCEEDANCES
 Soil and NAPL RI
 Del Amo Superfund Site
URS

FIGURE 26
TOTAL VOC CONCENTRATIONS
AT SHALLOW SOIL GAS
SAMPLING LOCATIONS
 Soil and NAPL RI
 Del Amo Superfund Site

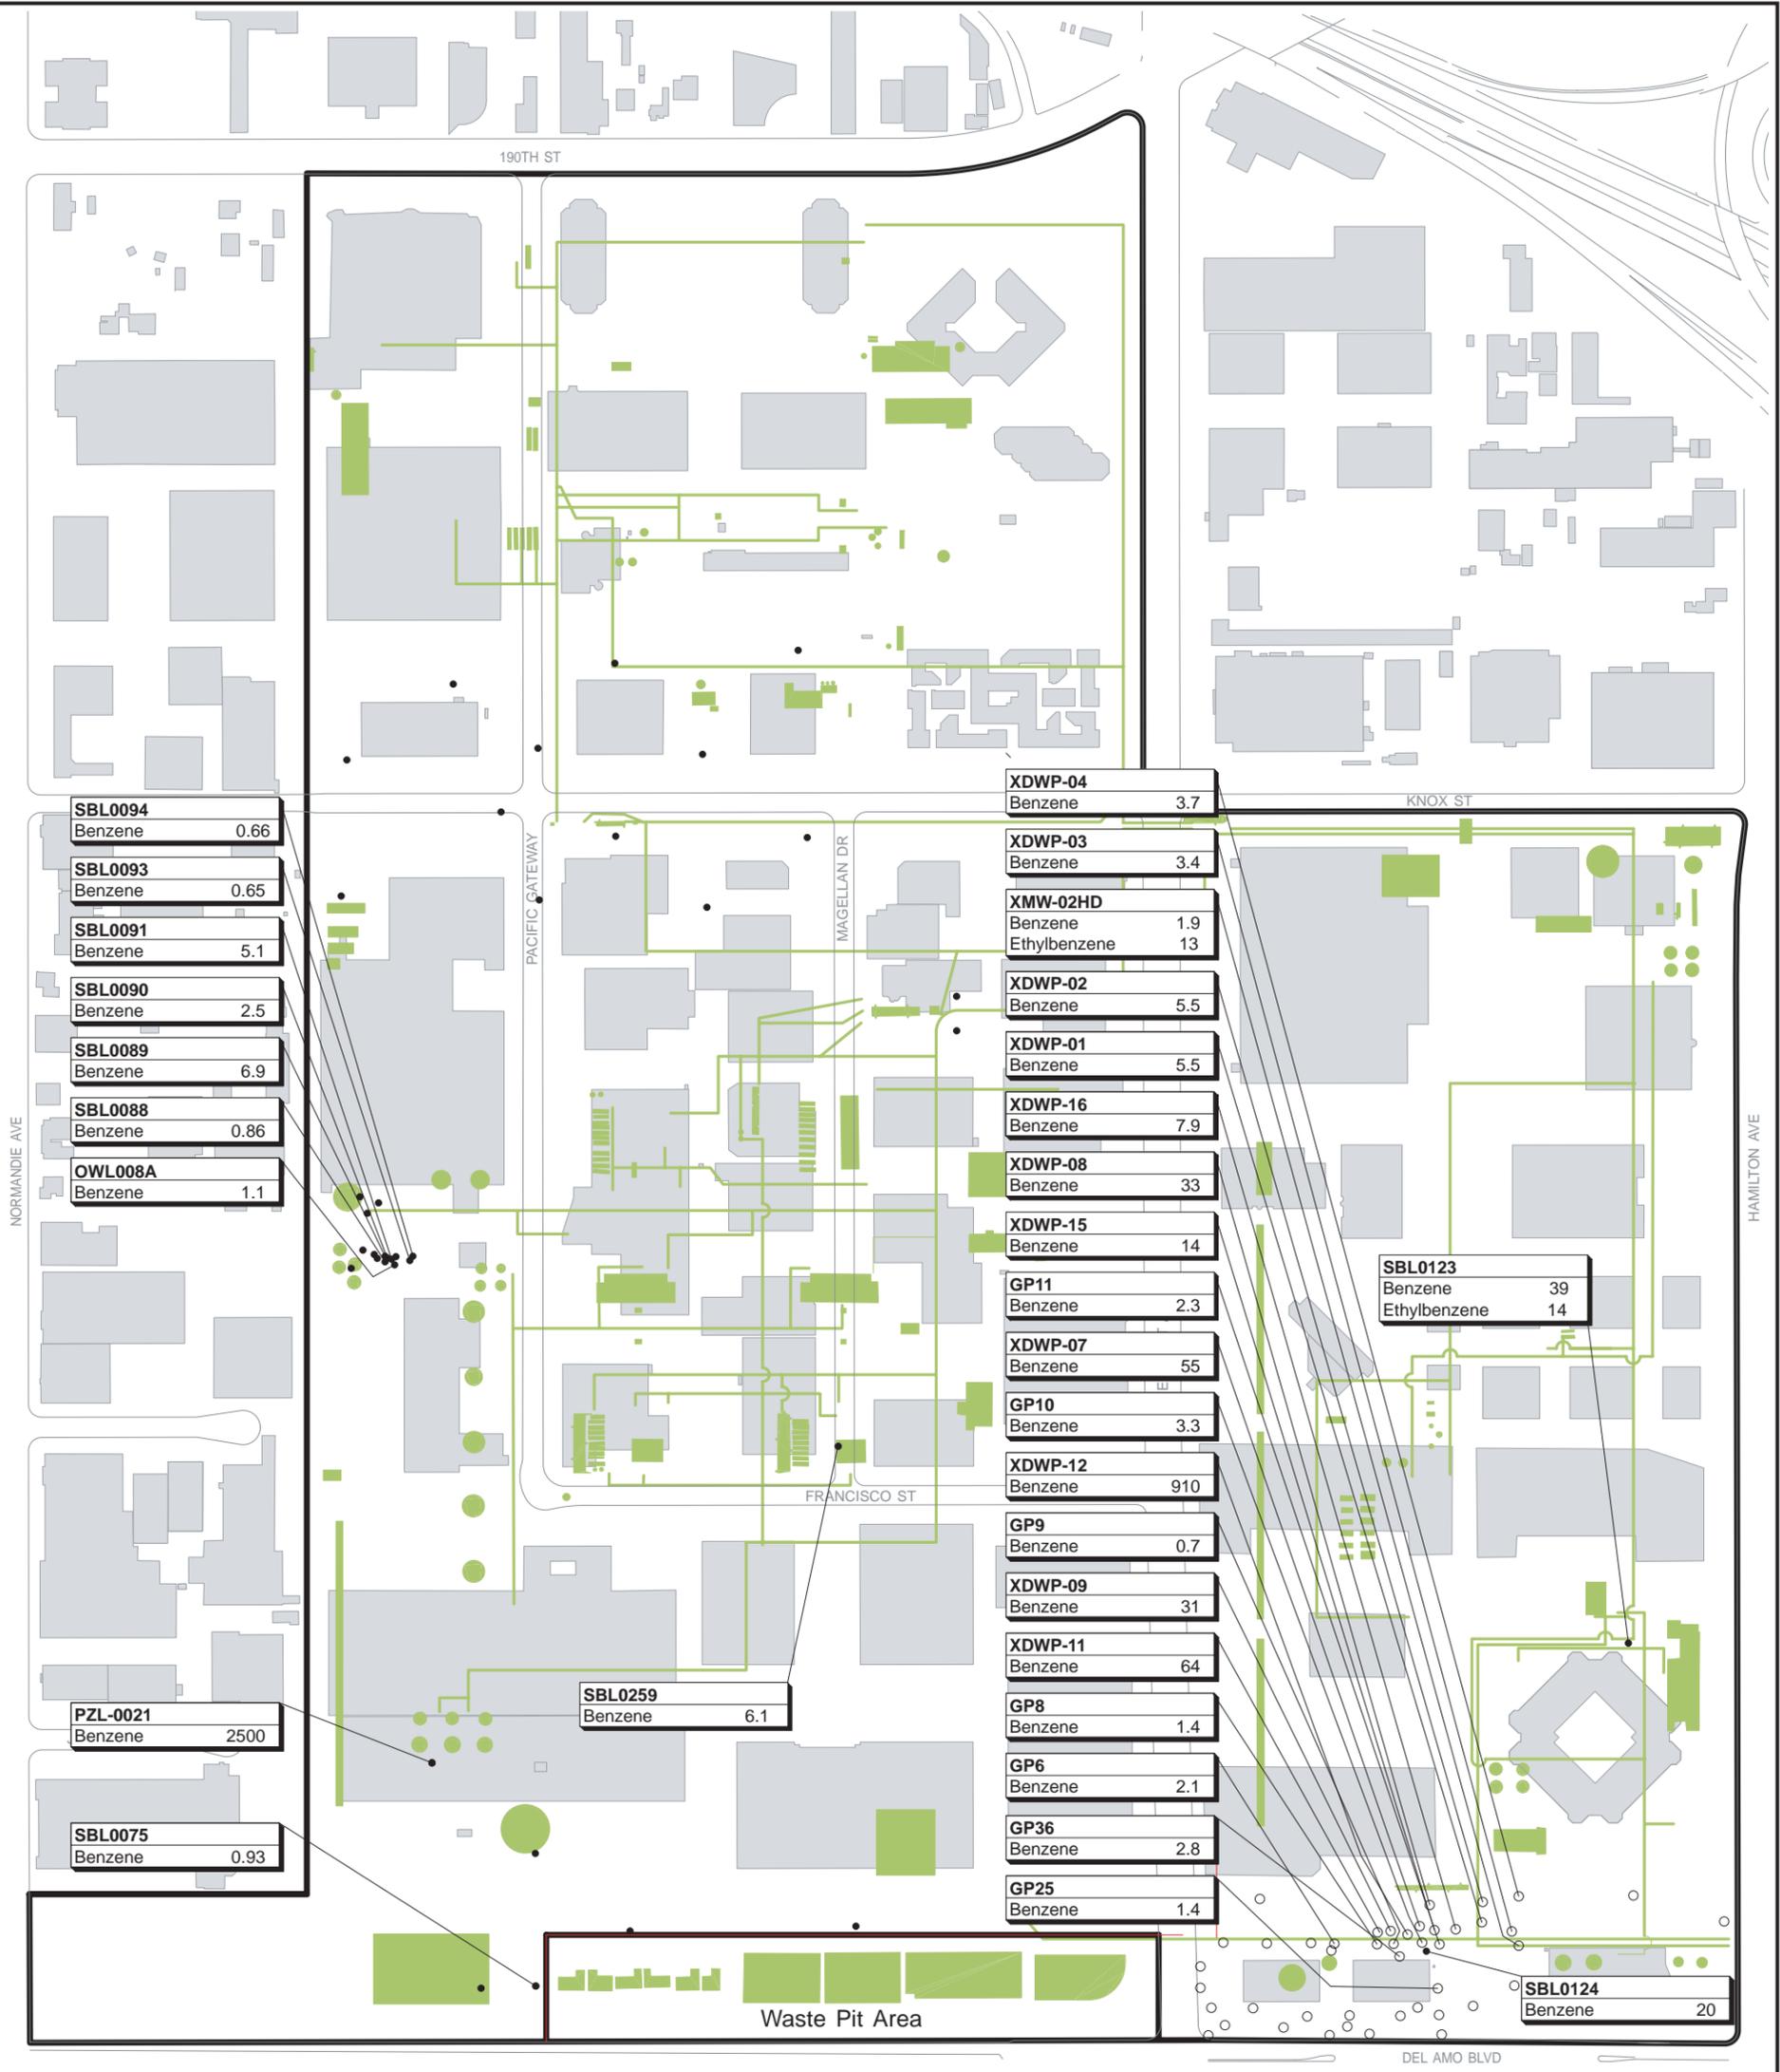
Note: Data collected between 1993 and 2003

FIGURE 37
VOC SAMPLING LOCATIONS
IN DEEP SOIL
 Soil and NAPL RI
 Del Amo Superfund Site

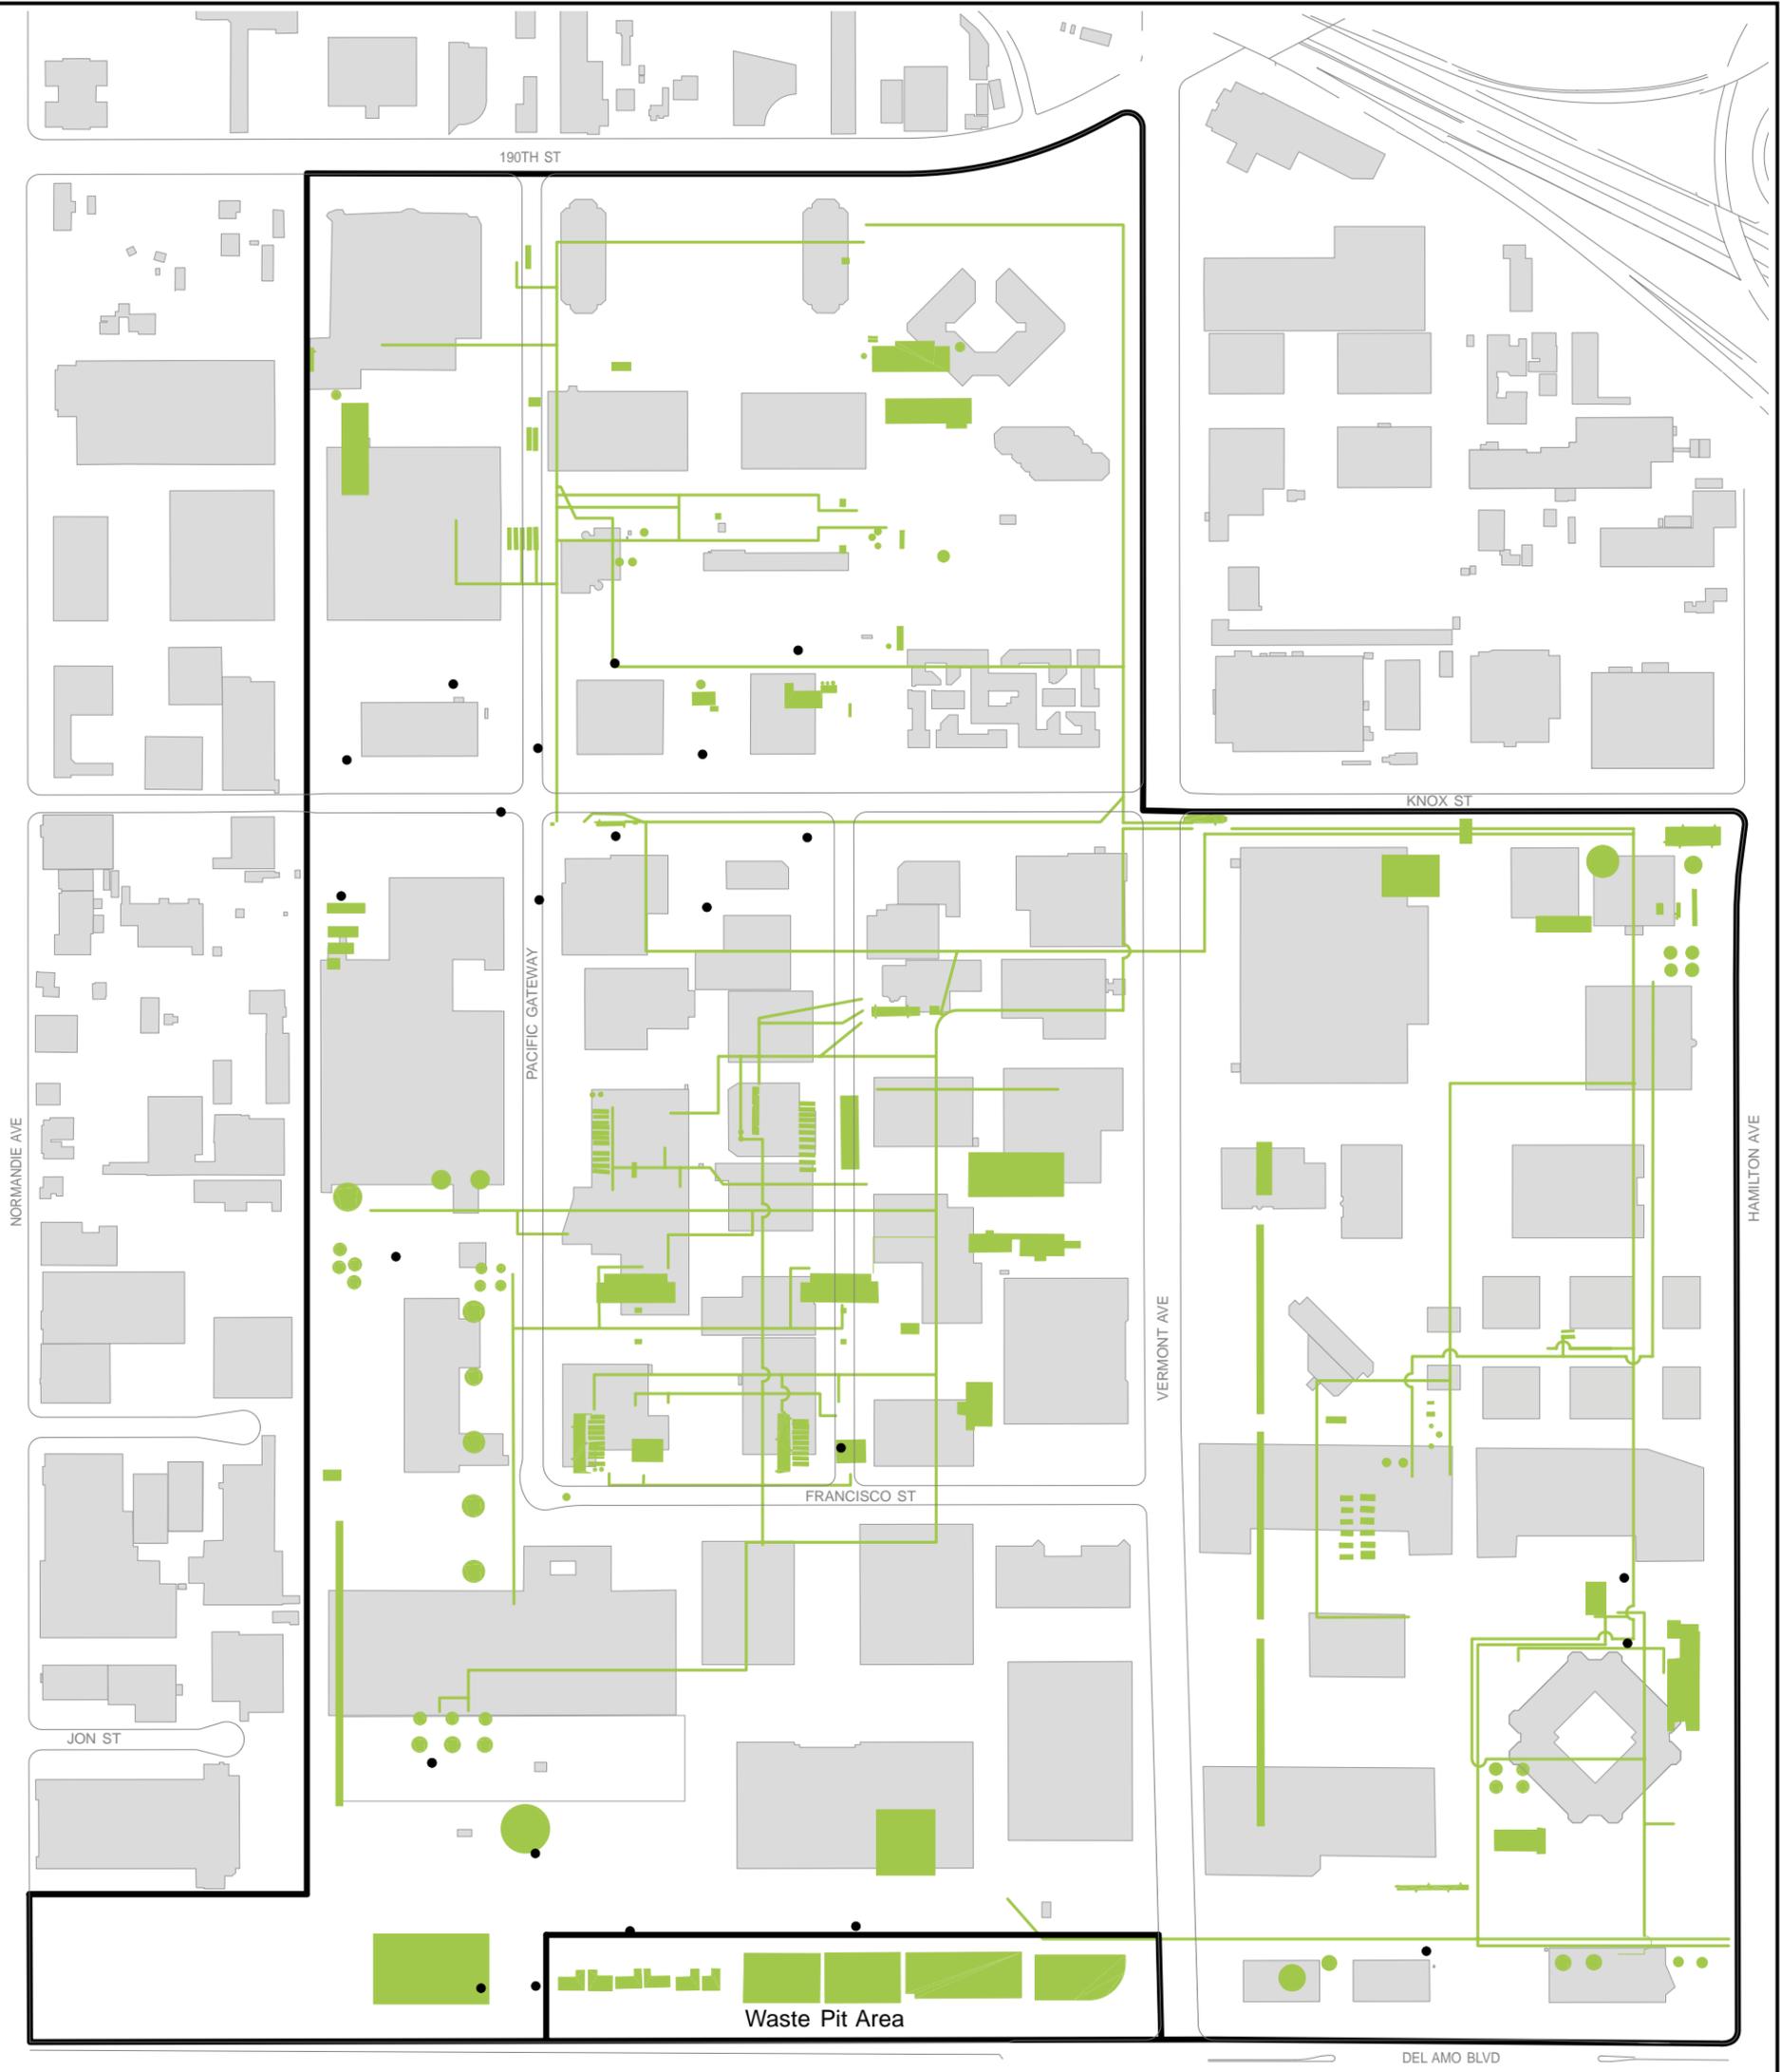
Note: SVOCs/PAHs were not detected at concentrations in excess of screening criterial at any deep soil sampling locations. Data collected between 1993 and 2003

FIGURE 38
SVOC/PAH
SAMPLING LOCATIONS
IN DEEP SOIL
 Soil and NAPL RI
 Del Amo Superfund Site

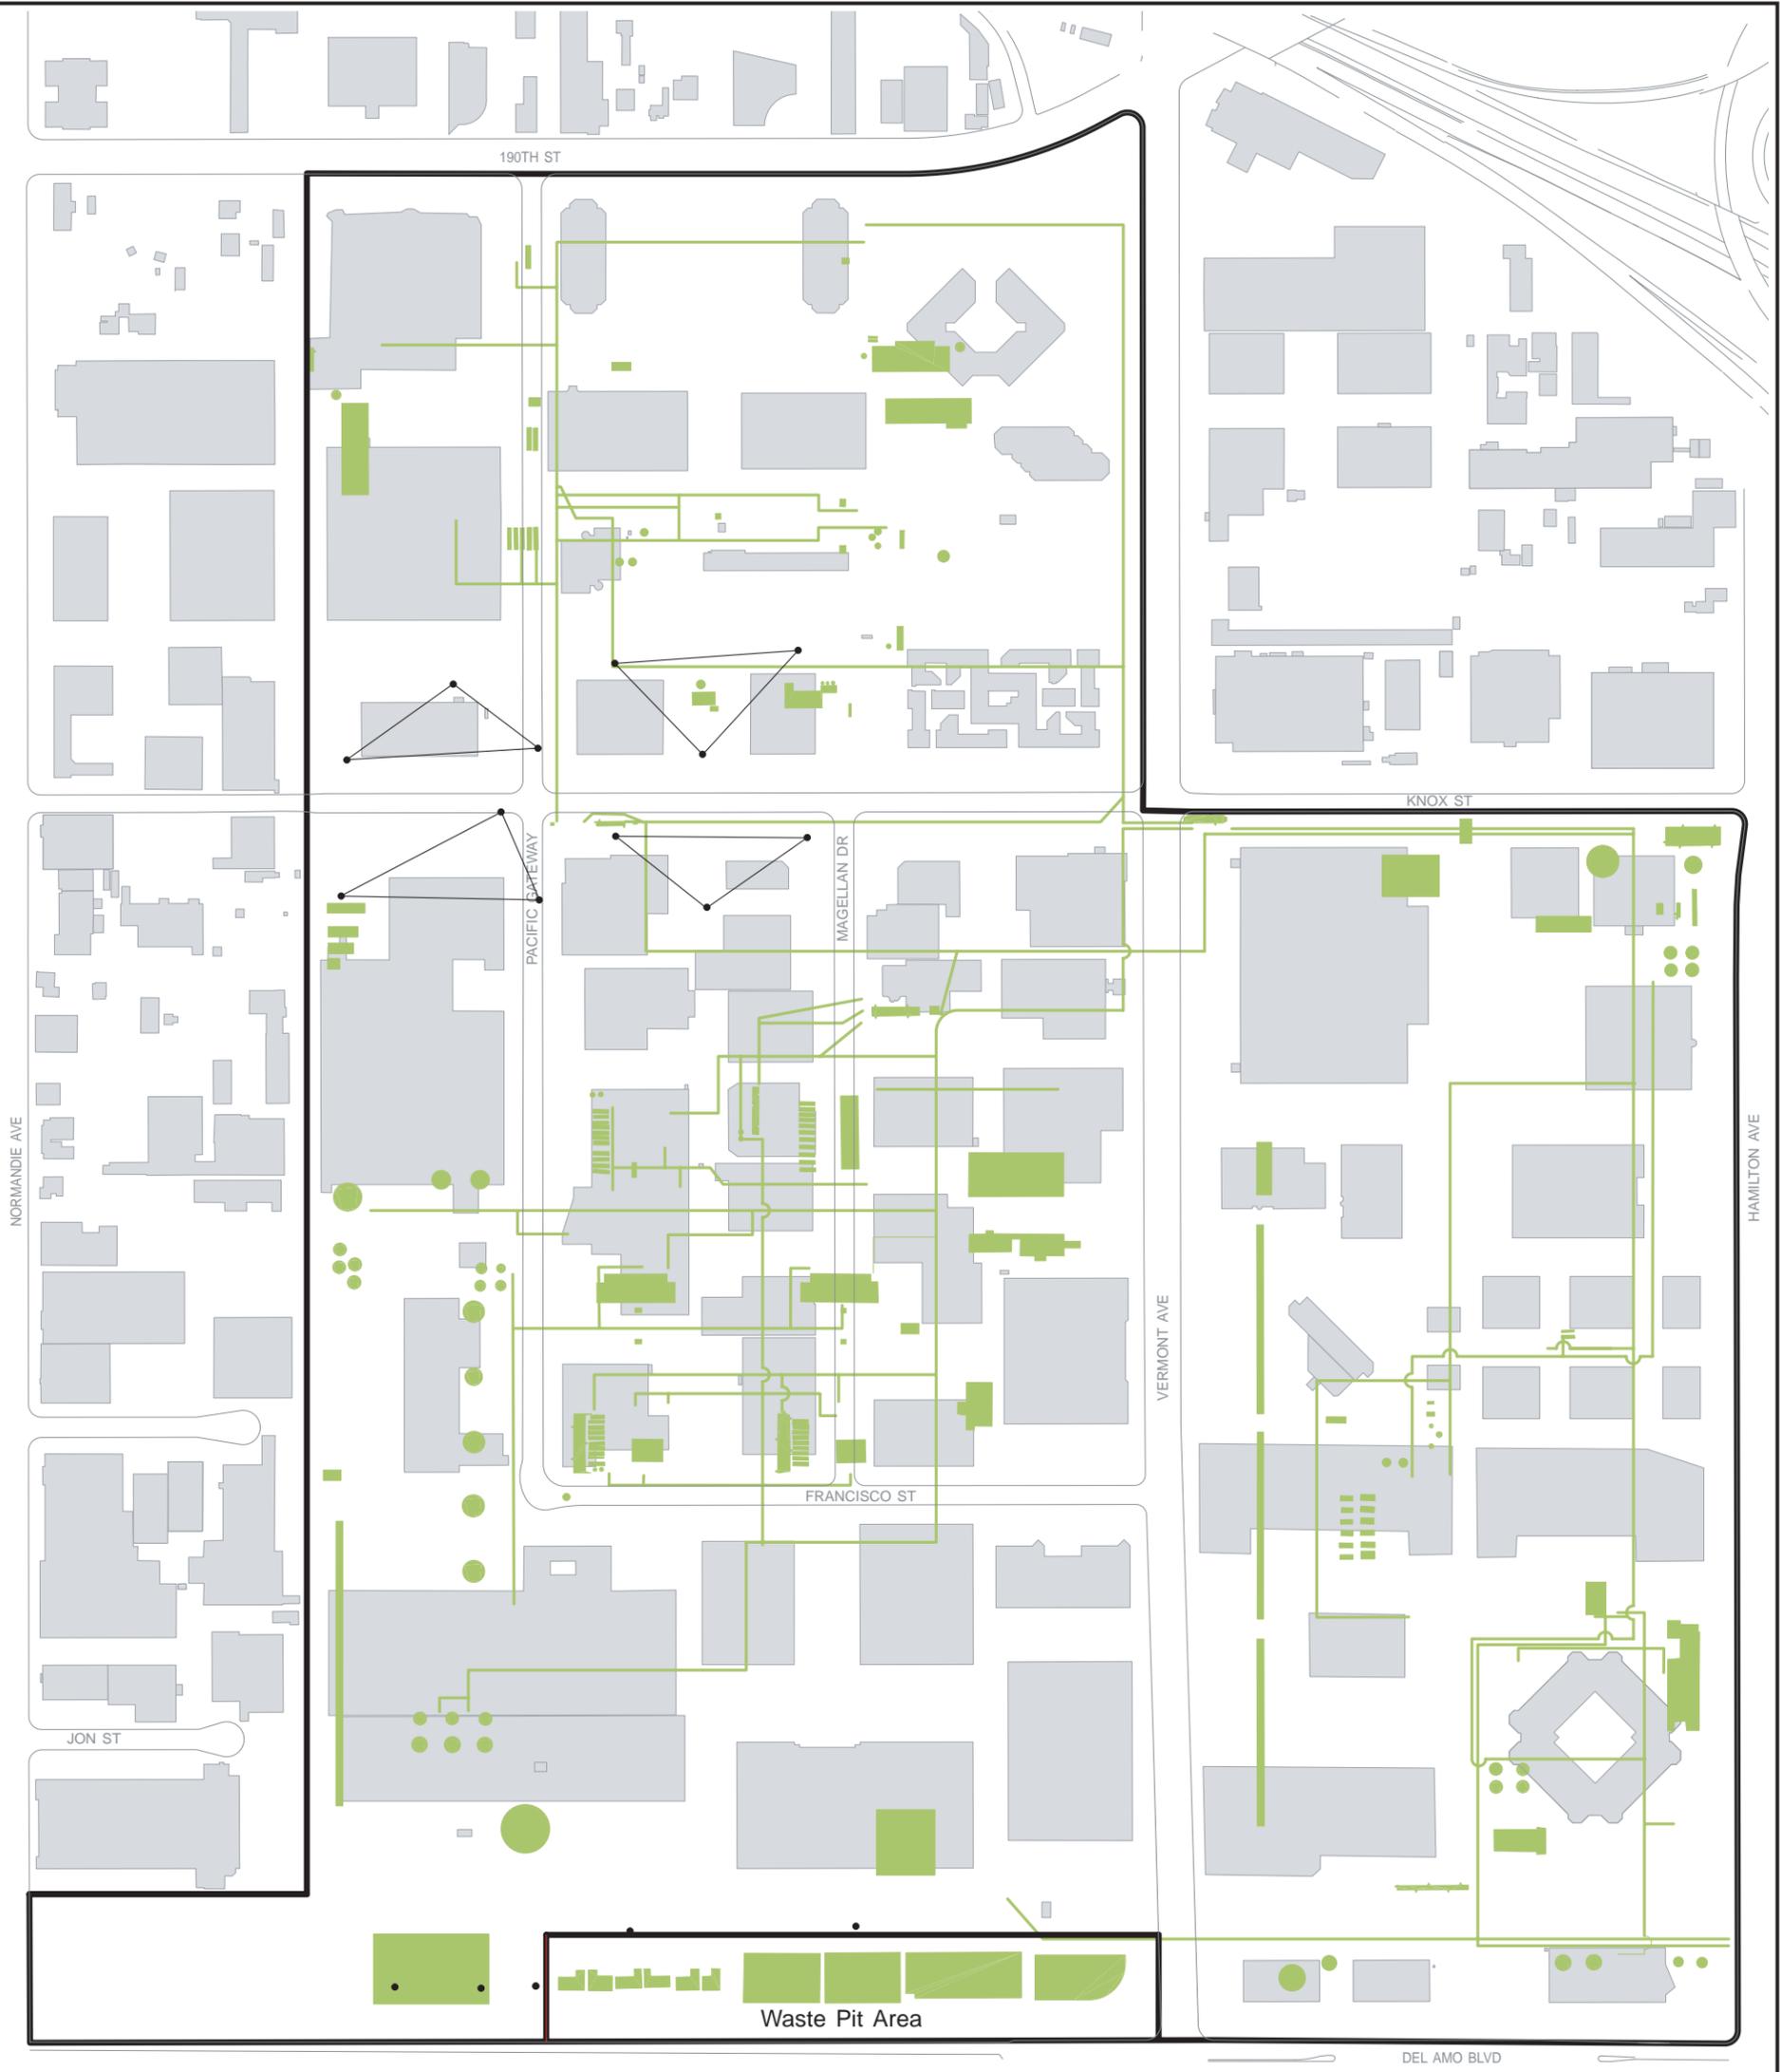
Note: Pesticides/PCBs were not detected at concentrations in excess of screening criteria at any deep soil sampling locations
Data collected between 1993 and 2003

FIGURE 39
PESTICIDE/PCB SAMPLING LOCATIONS IN DEEP SOIL
 Soil and NAPL RI
 Del Amo Superfund Site
URS

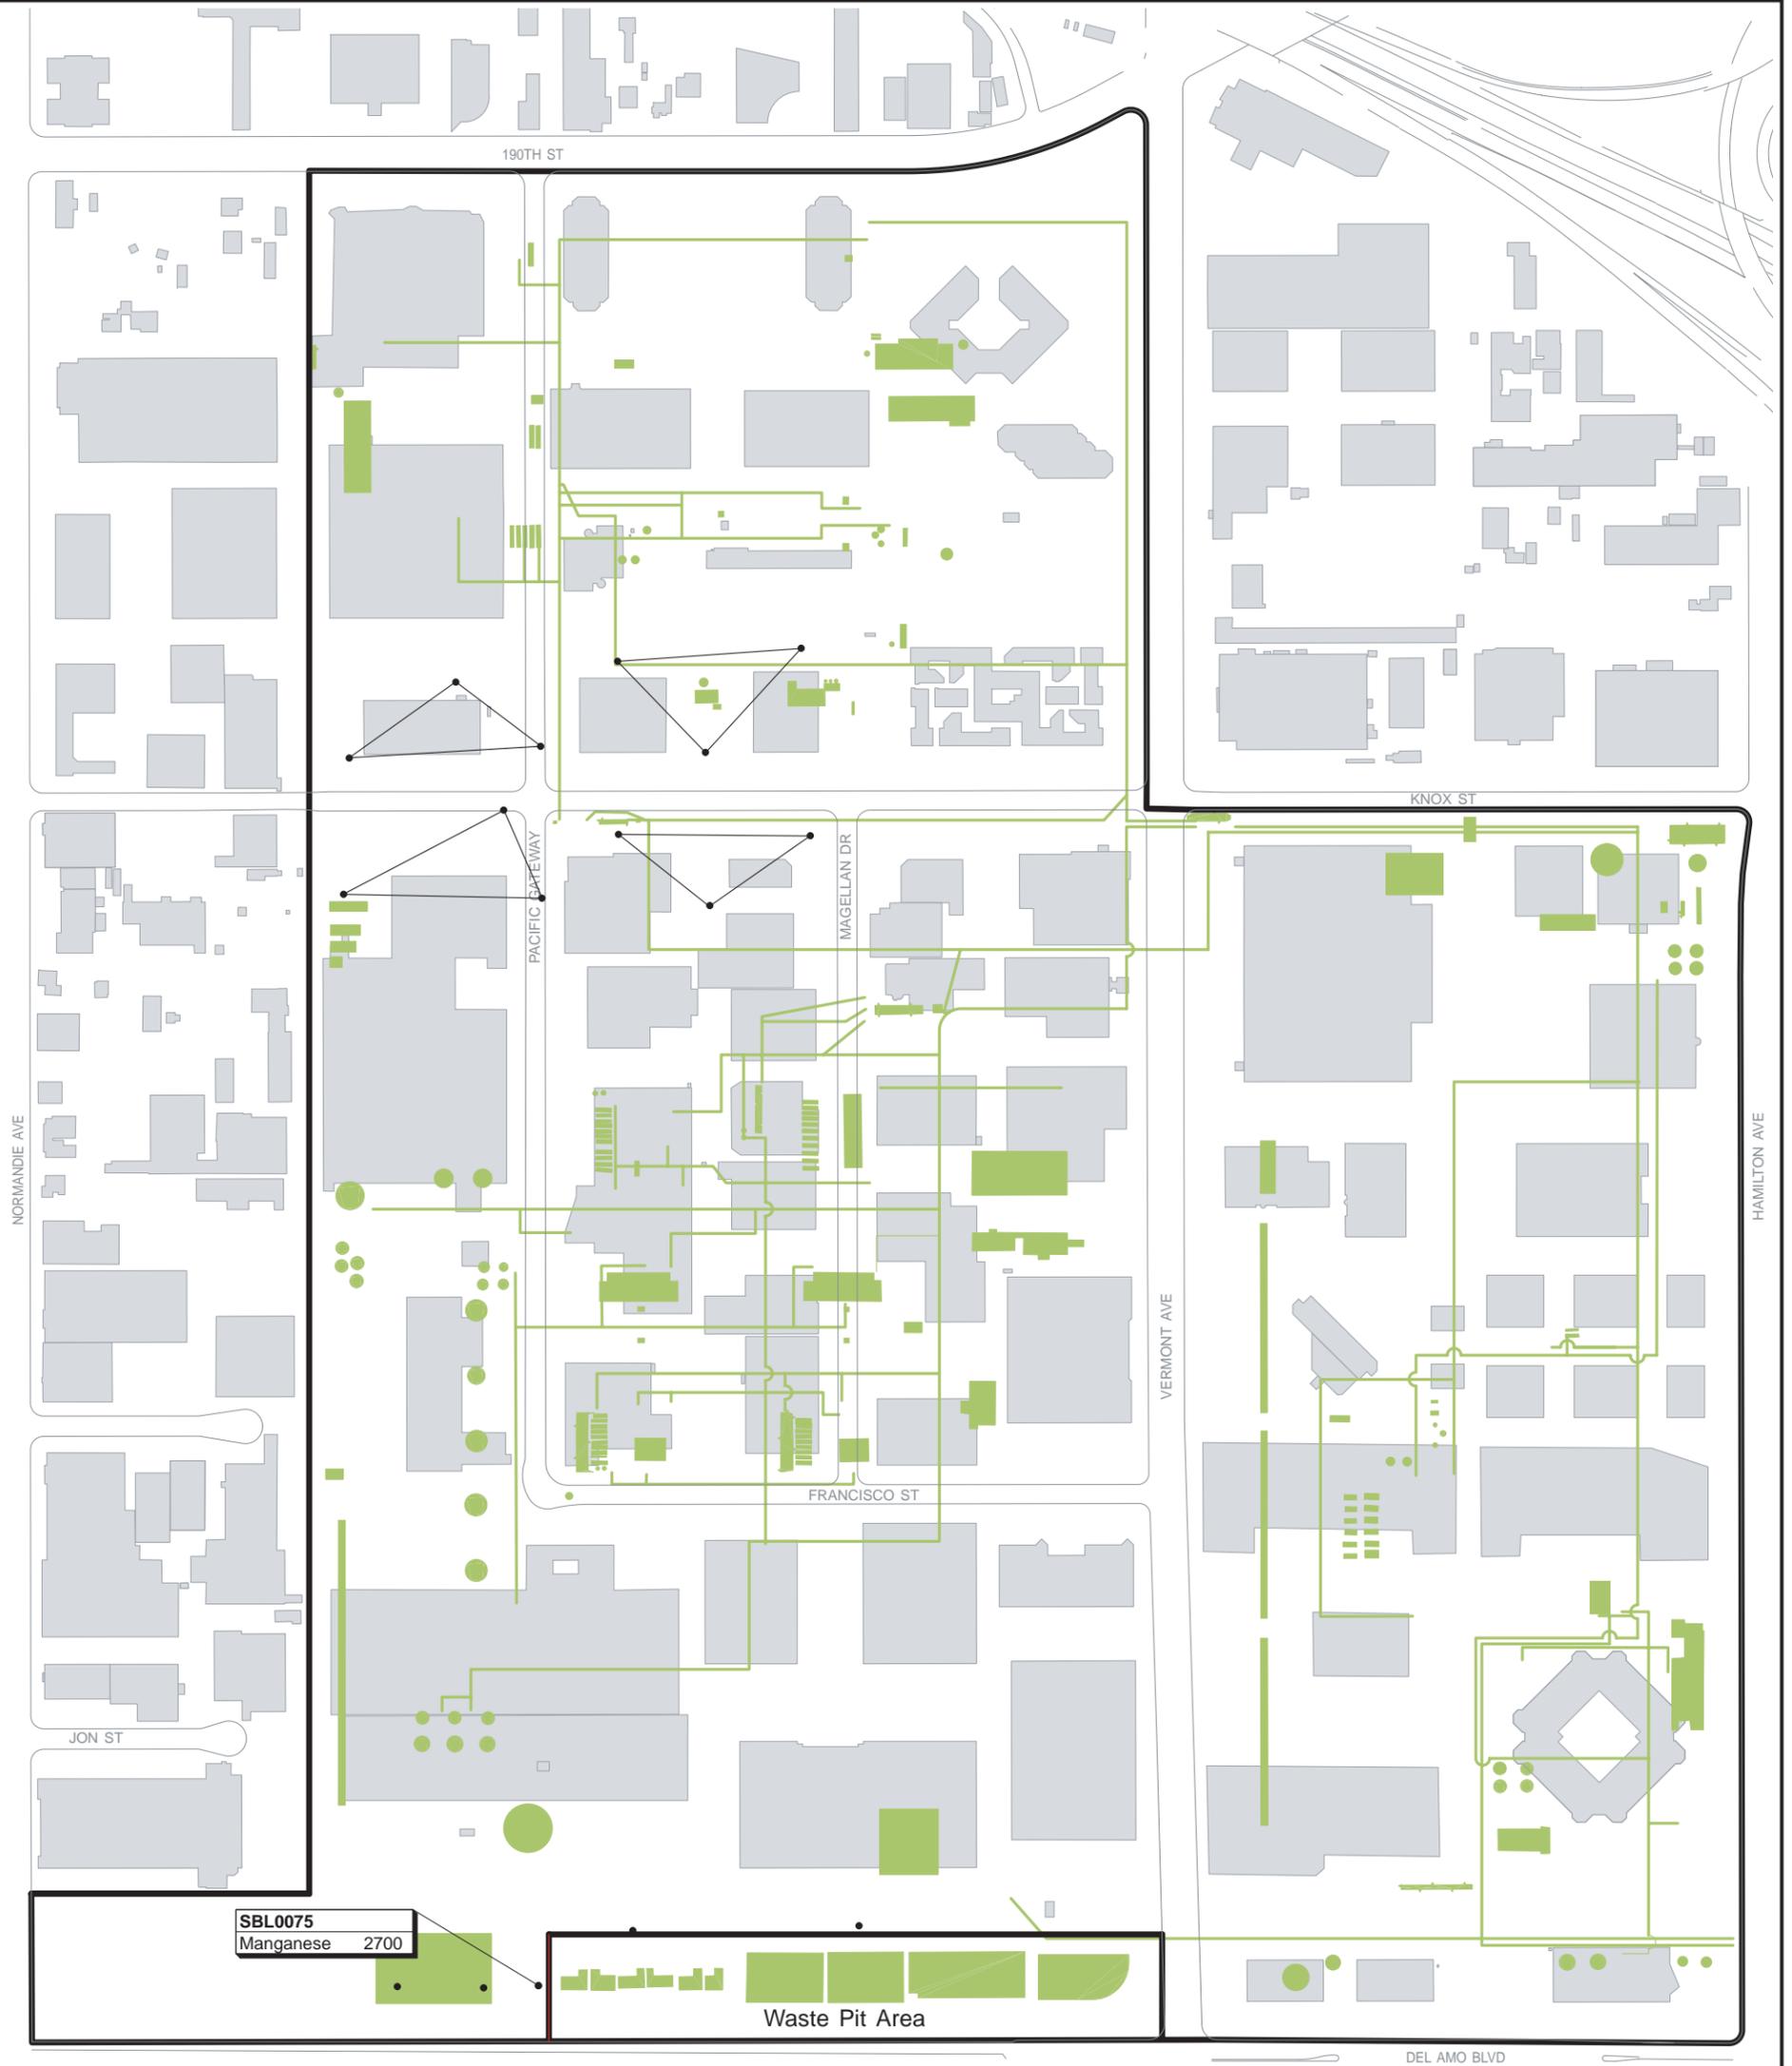
Note: Data collected in 1993

FIGURE 40
**METALS
 SAMPLING LOCATIONS
 IN DEEP SOIL**
 Soil and NAPL RI
 Del Amo Superfund Site

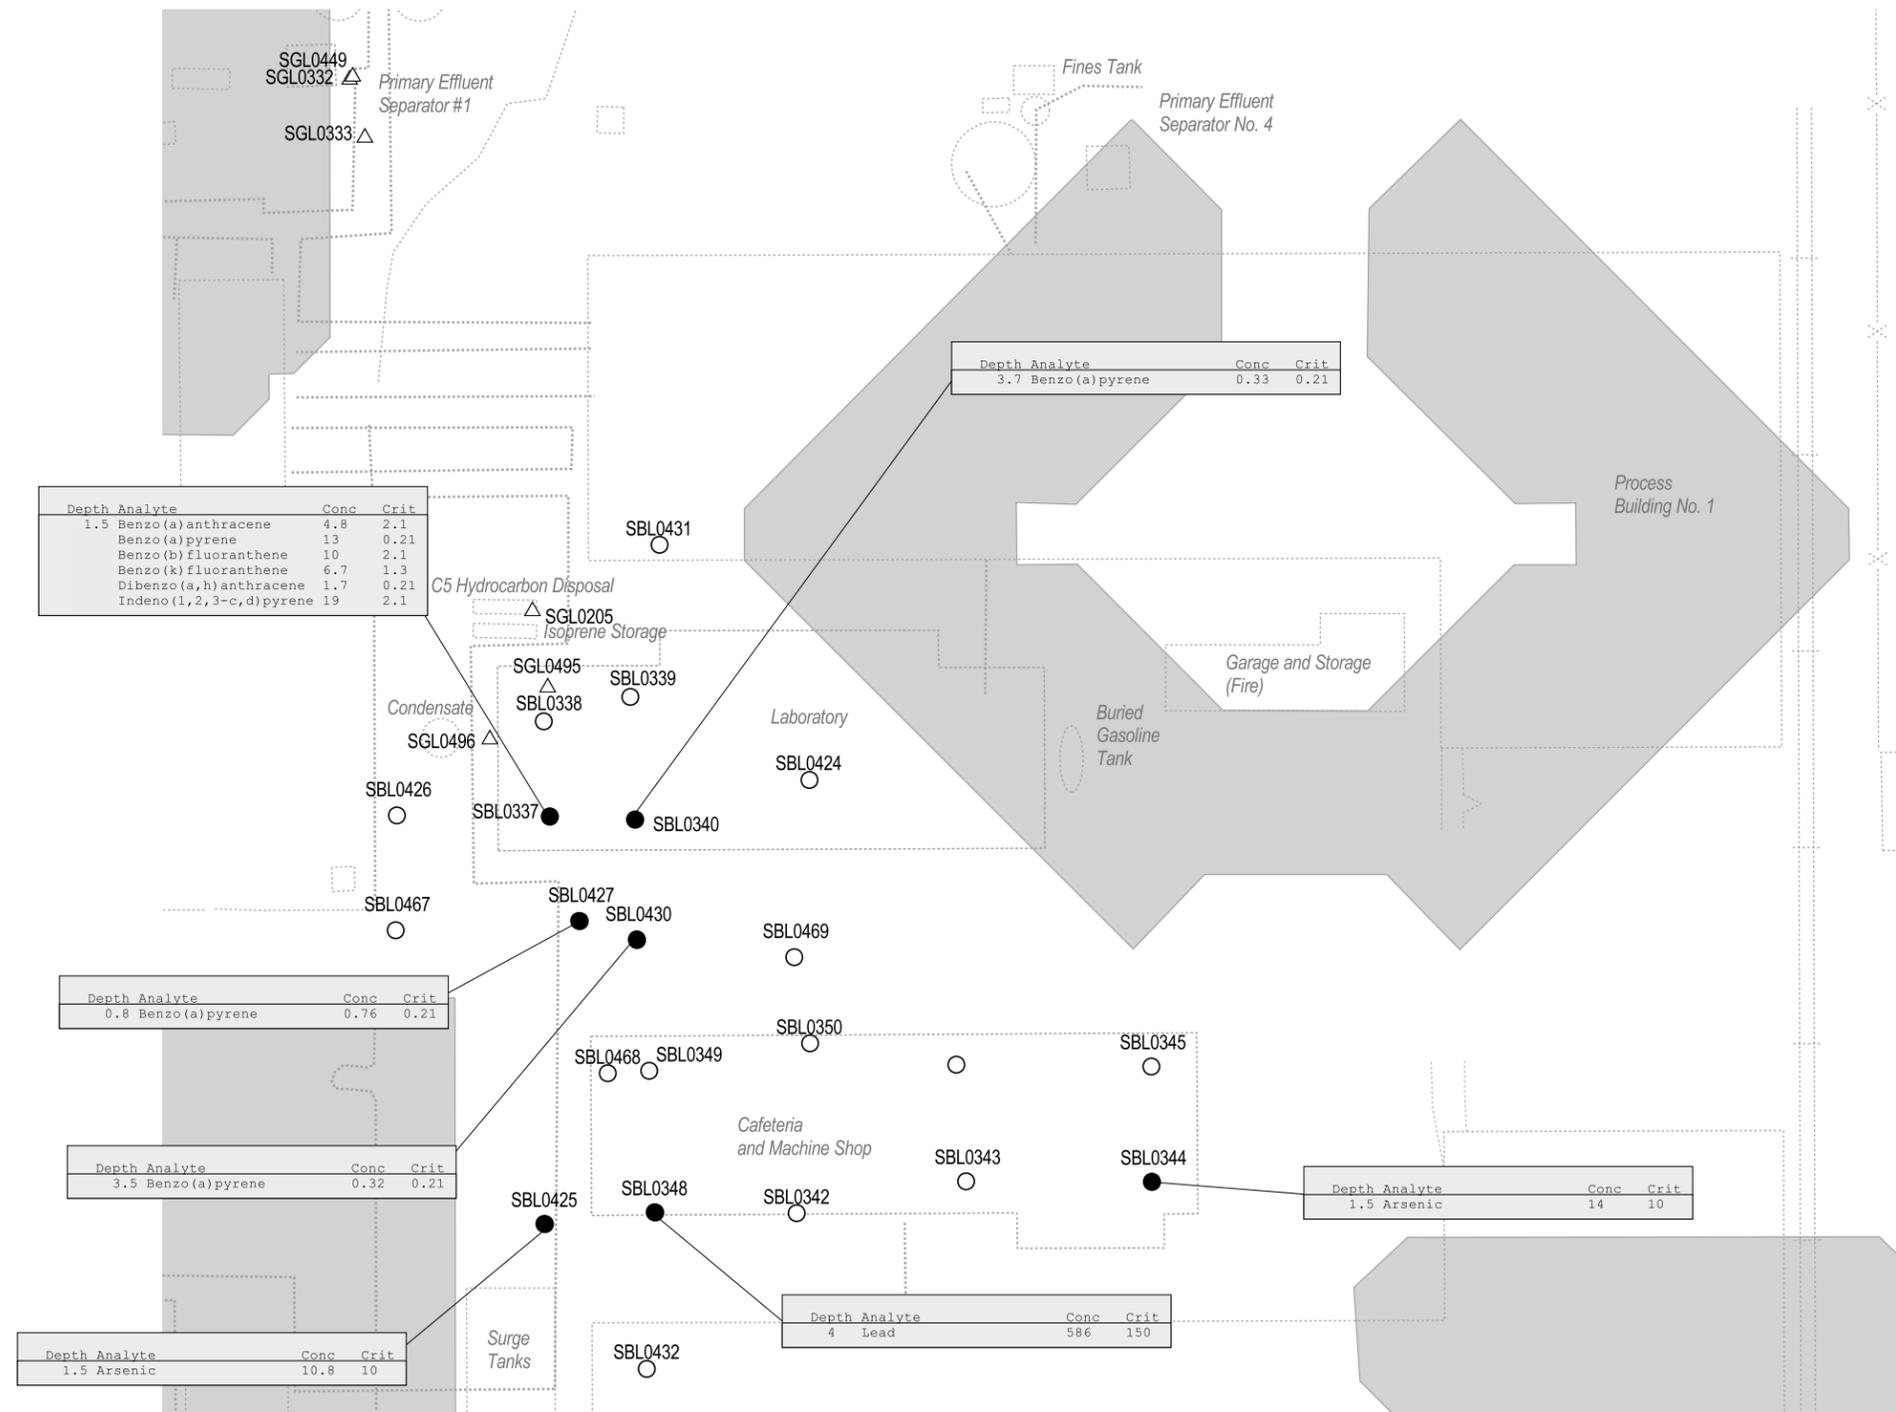
Note: Chemical concentrations at the depicted soil gas sampling locations did not exceed screening criteria. See Section 5 and Table 10 for further explanation of screening criteria.

Figure 41
SHALLOW SOIL AND SOIL GAS SCREENING CRITERIA EXCEEDANCES
Laboratory and Machine Shop
 Soil and NAPL RI
 Del Amo Superfund Site

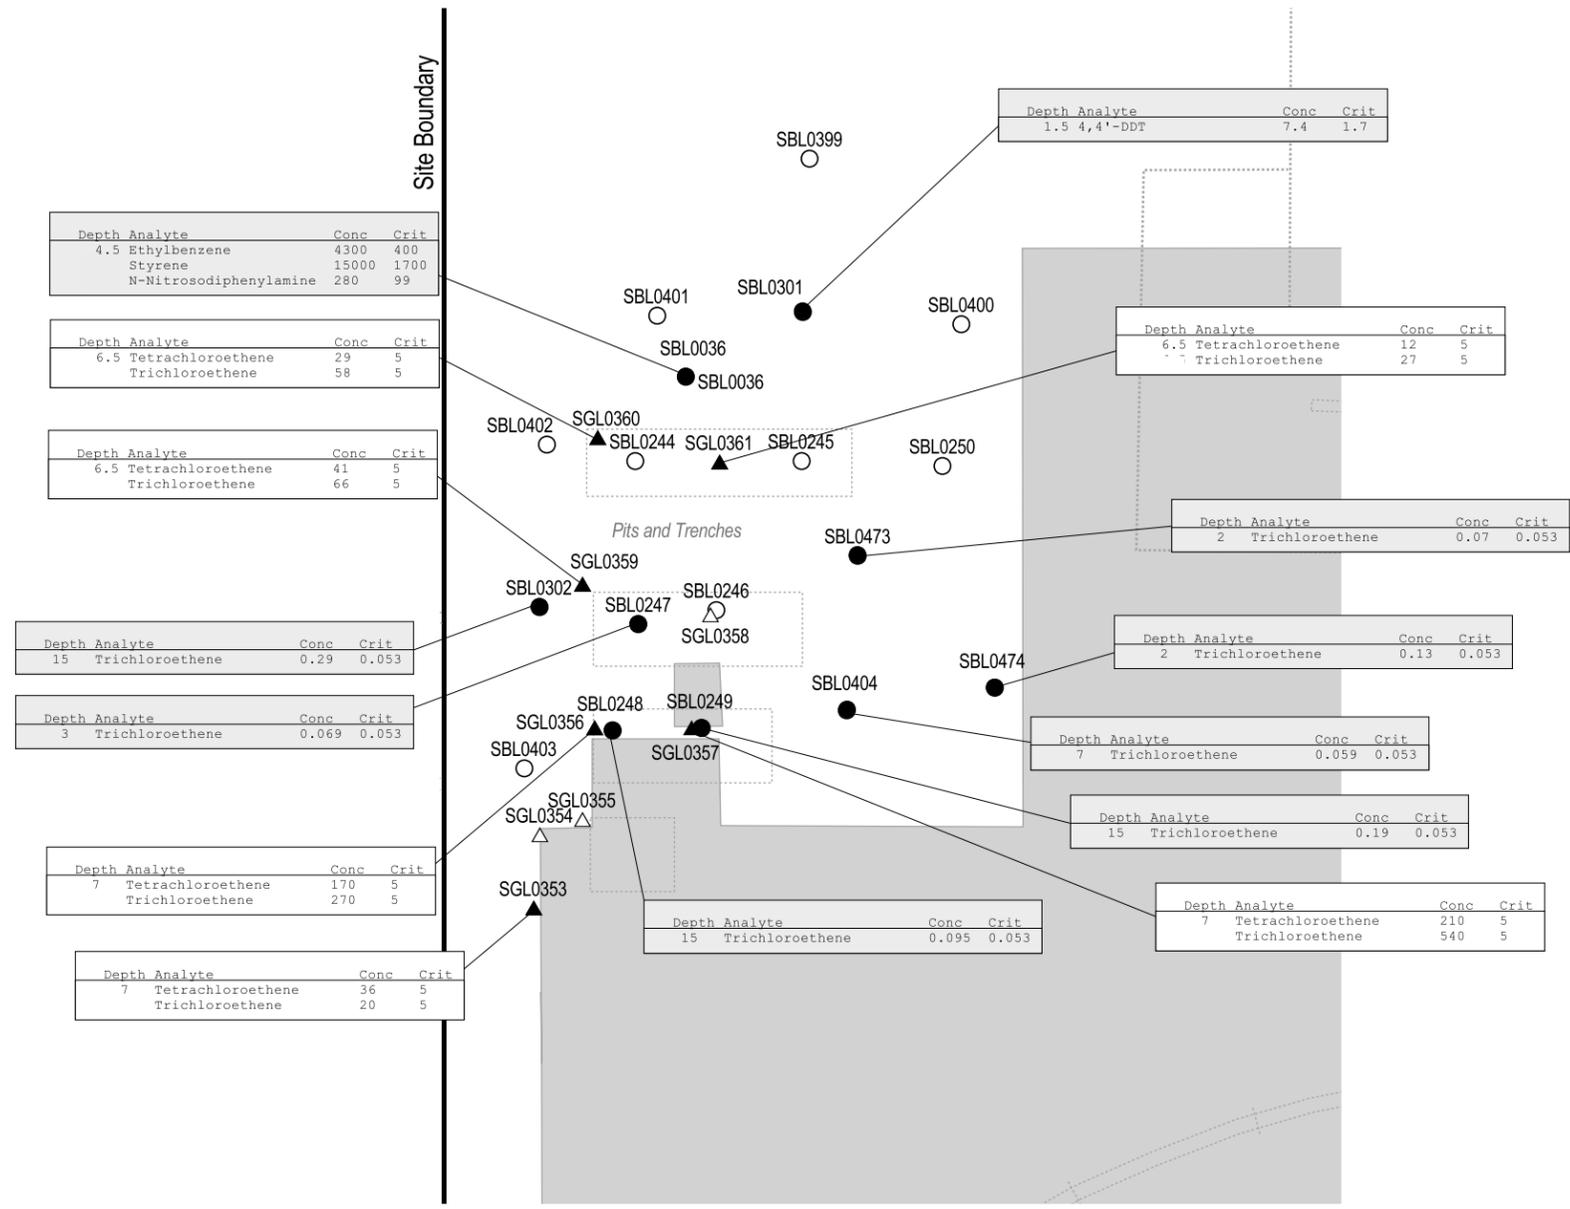
Depth	Analyte	Conc	Crit
15	Trichloroethene	0.29	0.053

Depth	Analyte	Conc	Crit
6.5	Tetrachloroethene	12	5

Figure 42
SHALLOW SOIL AND SOIL GAS SCREENING CRITERIA EXCEEDANCES
Pits and Trenches
 Soil and NAPL RI
 Del Amo Superfund Site
