FIGURE 25
SHALLOW SOIL GAS SAMPLING LOCATIONS WITH THRESHOLD EXCEEDANCES
 Soil and NAPL RI
 Del Amo Superfund Site
URS

FIGURE 26
TOTAL VOC CONCENTRATIONS
AT SHALLOW SOIL GAS
SAMPLING LOCATIONS
 Soil and NAPL RI
 Del Amo Superfund Site

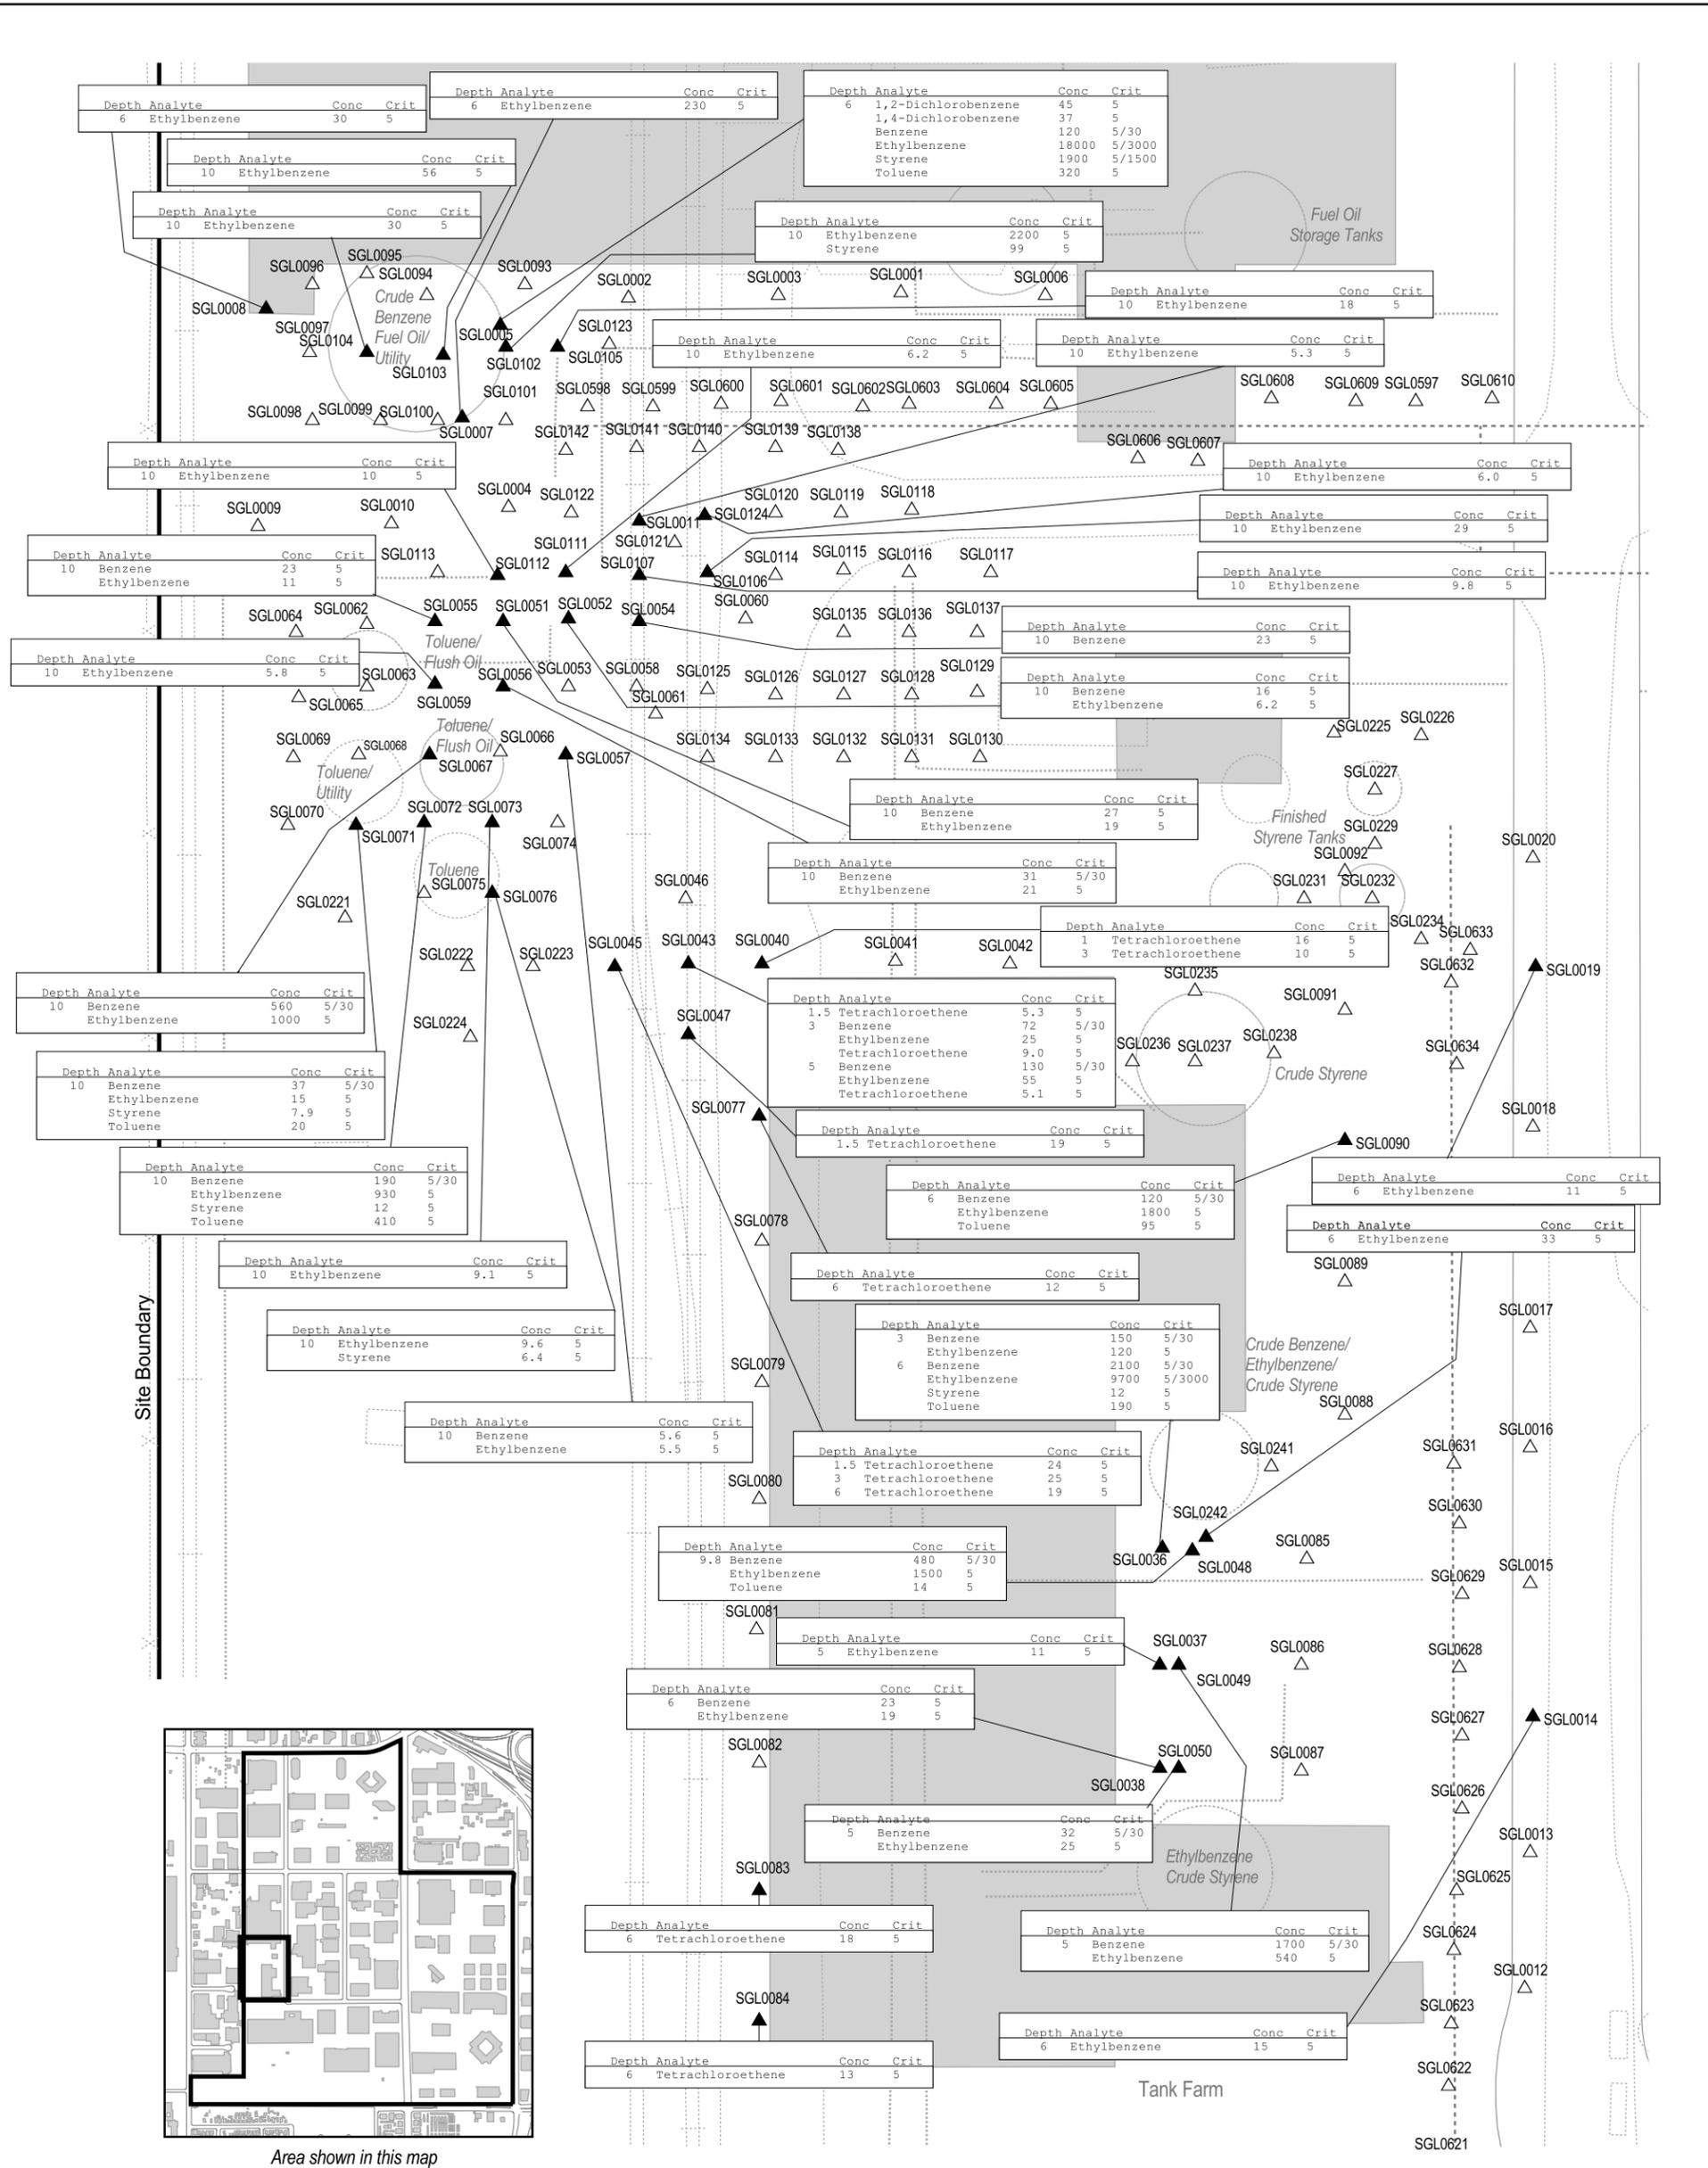
Depth	Analyte	Conc	Crit
6	Tetrachloroethene	18	5

Figure 43
SHALLOW SOIL GAS SCREENING CRITERIA EXCEEDANCES
MW-20 and Tank Farm
 Soil and NAPL RI
 Del Amo Superfund Site

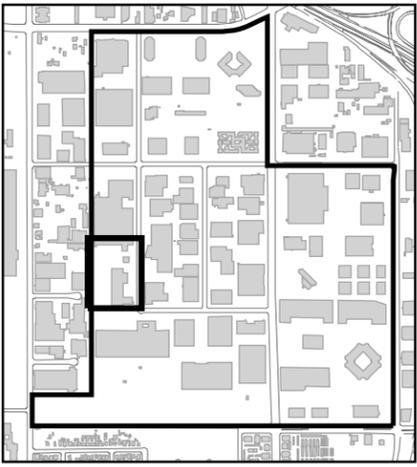
Figure 44

Depth	Analyte	Conc	Crit
7	Ethylbenzene	31	8.9
10	Ethylbenzene	12000	8.9

Depth	Analyte	Conc	Crit
5	Benzene	300	0.60
5	Ethylbenzene	4800	8.9

SHALLOW SOIL SCREENING CRITERIA EXCEEDANCES
MW-20 and Tank Farm

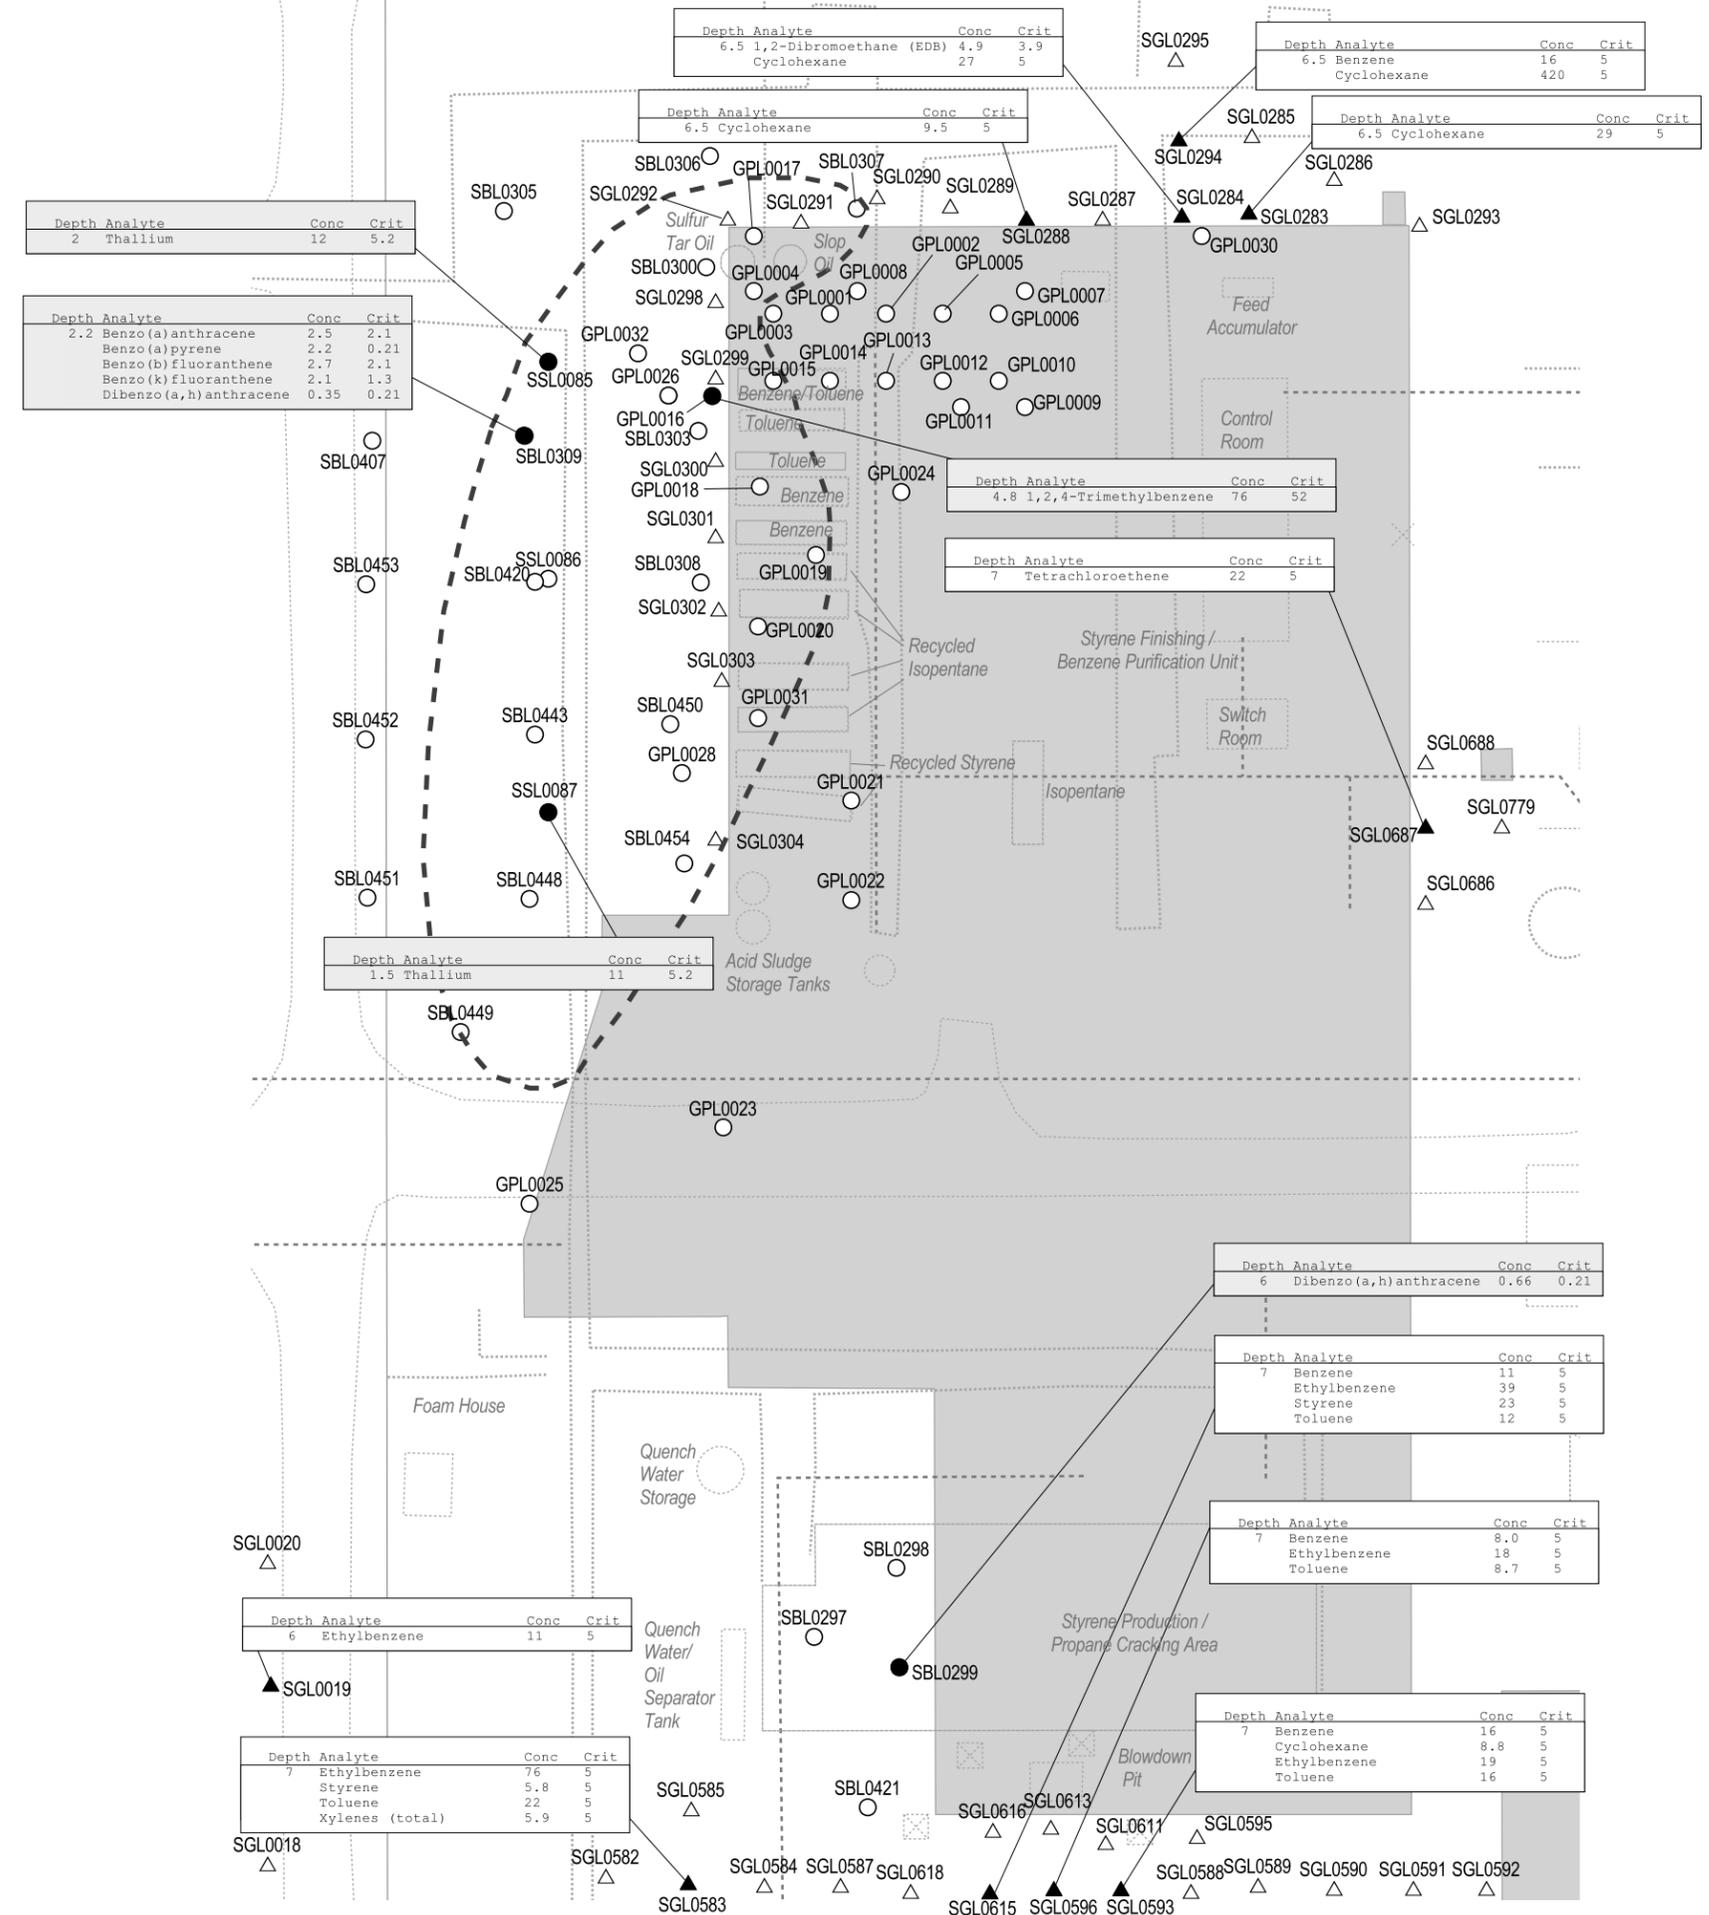
Depth	Analyte	Conc	Crit
2	Thallium	12	5.2

Depth	Analyte	Conc	Crit
6	Ethylbenzene	11	5

Approximate area of soil staining and/or chemical odors

Figure 45
SHALLOW SOIL AND SOIL GAS SCREENING CRITERIA EXCEEDANCES
Styrene Finishing/Benzene Purification and Styrene Production/Propane Cracking Units
 Soil and NAPL RI
 Del Amo Superfund Site
