**AEROJET**  
Environmental Remediation

**FIGURE 1-1**  
Location of Sites Included  
in PGOU Solls RI/FS

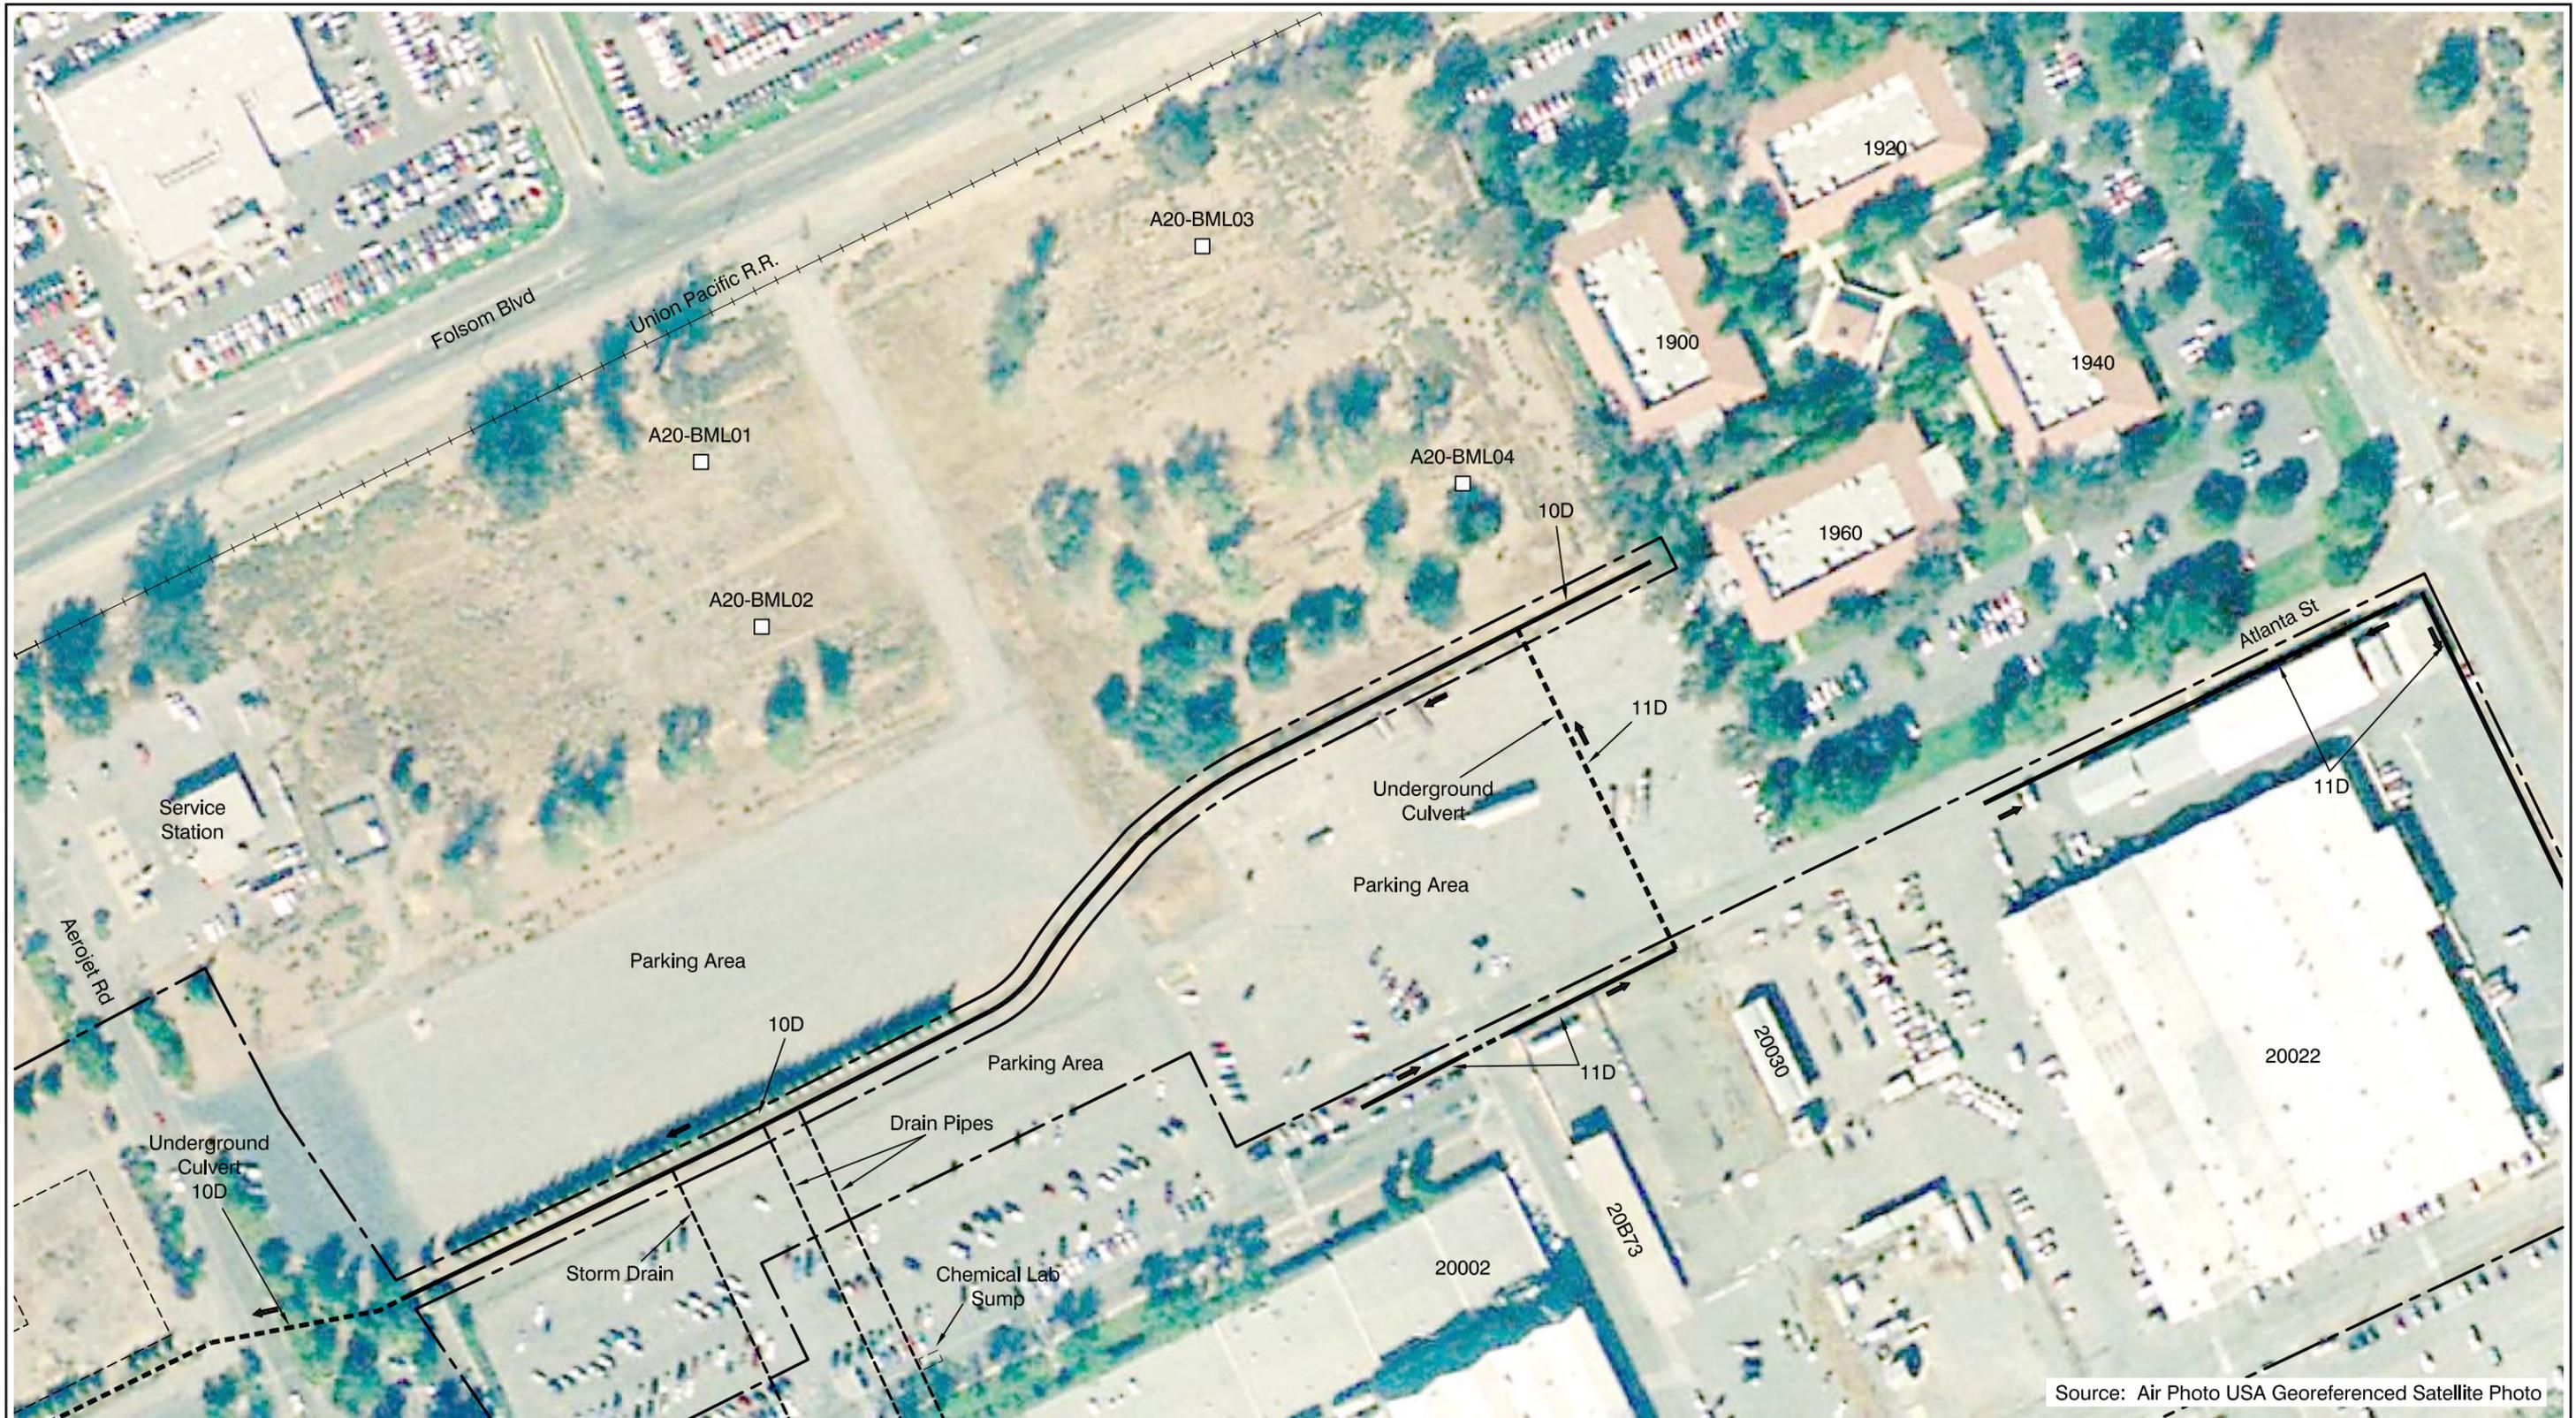
**FIGURE 3-1**  
**Background Metals Leachate**  
**Sampling Locations**  
**Area 20**

- Ditch Included in PGOU Soils RI/FS
- - - - - Underground Culvert Included in PGOU RI/FS
- Background Soil Leachate Sample Location
- ← Surface Water Flow Direction (2002)
- - - - - Superfund Site Boundary

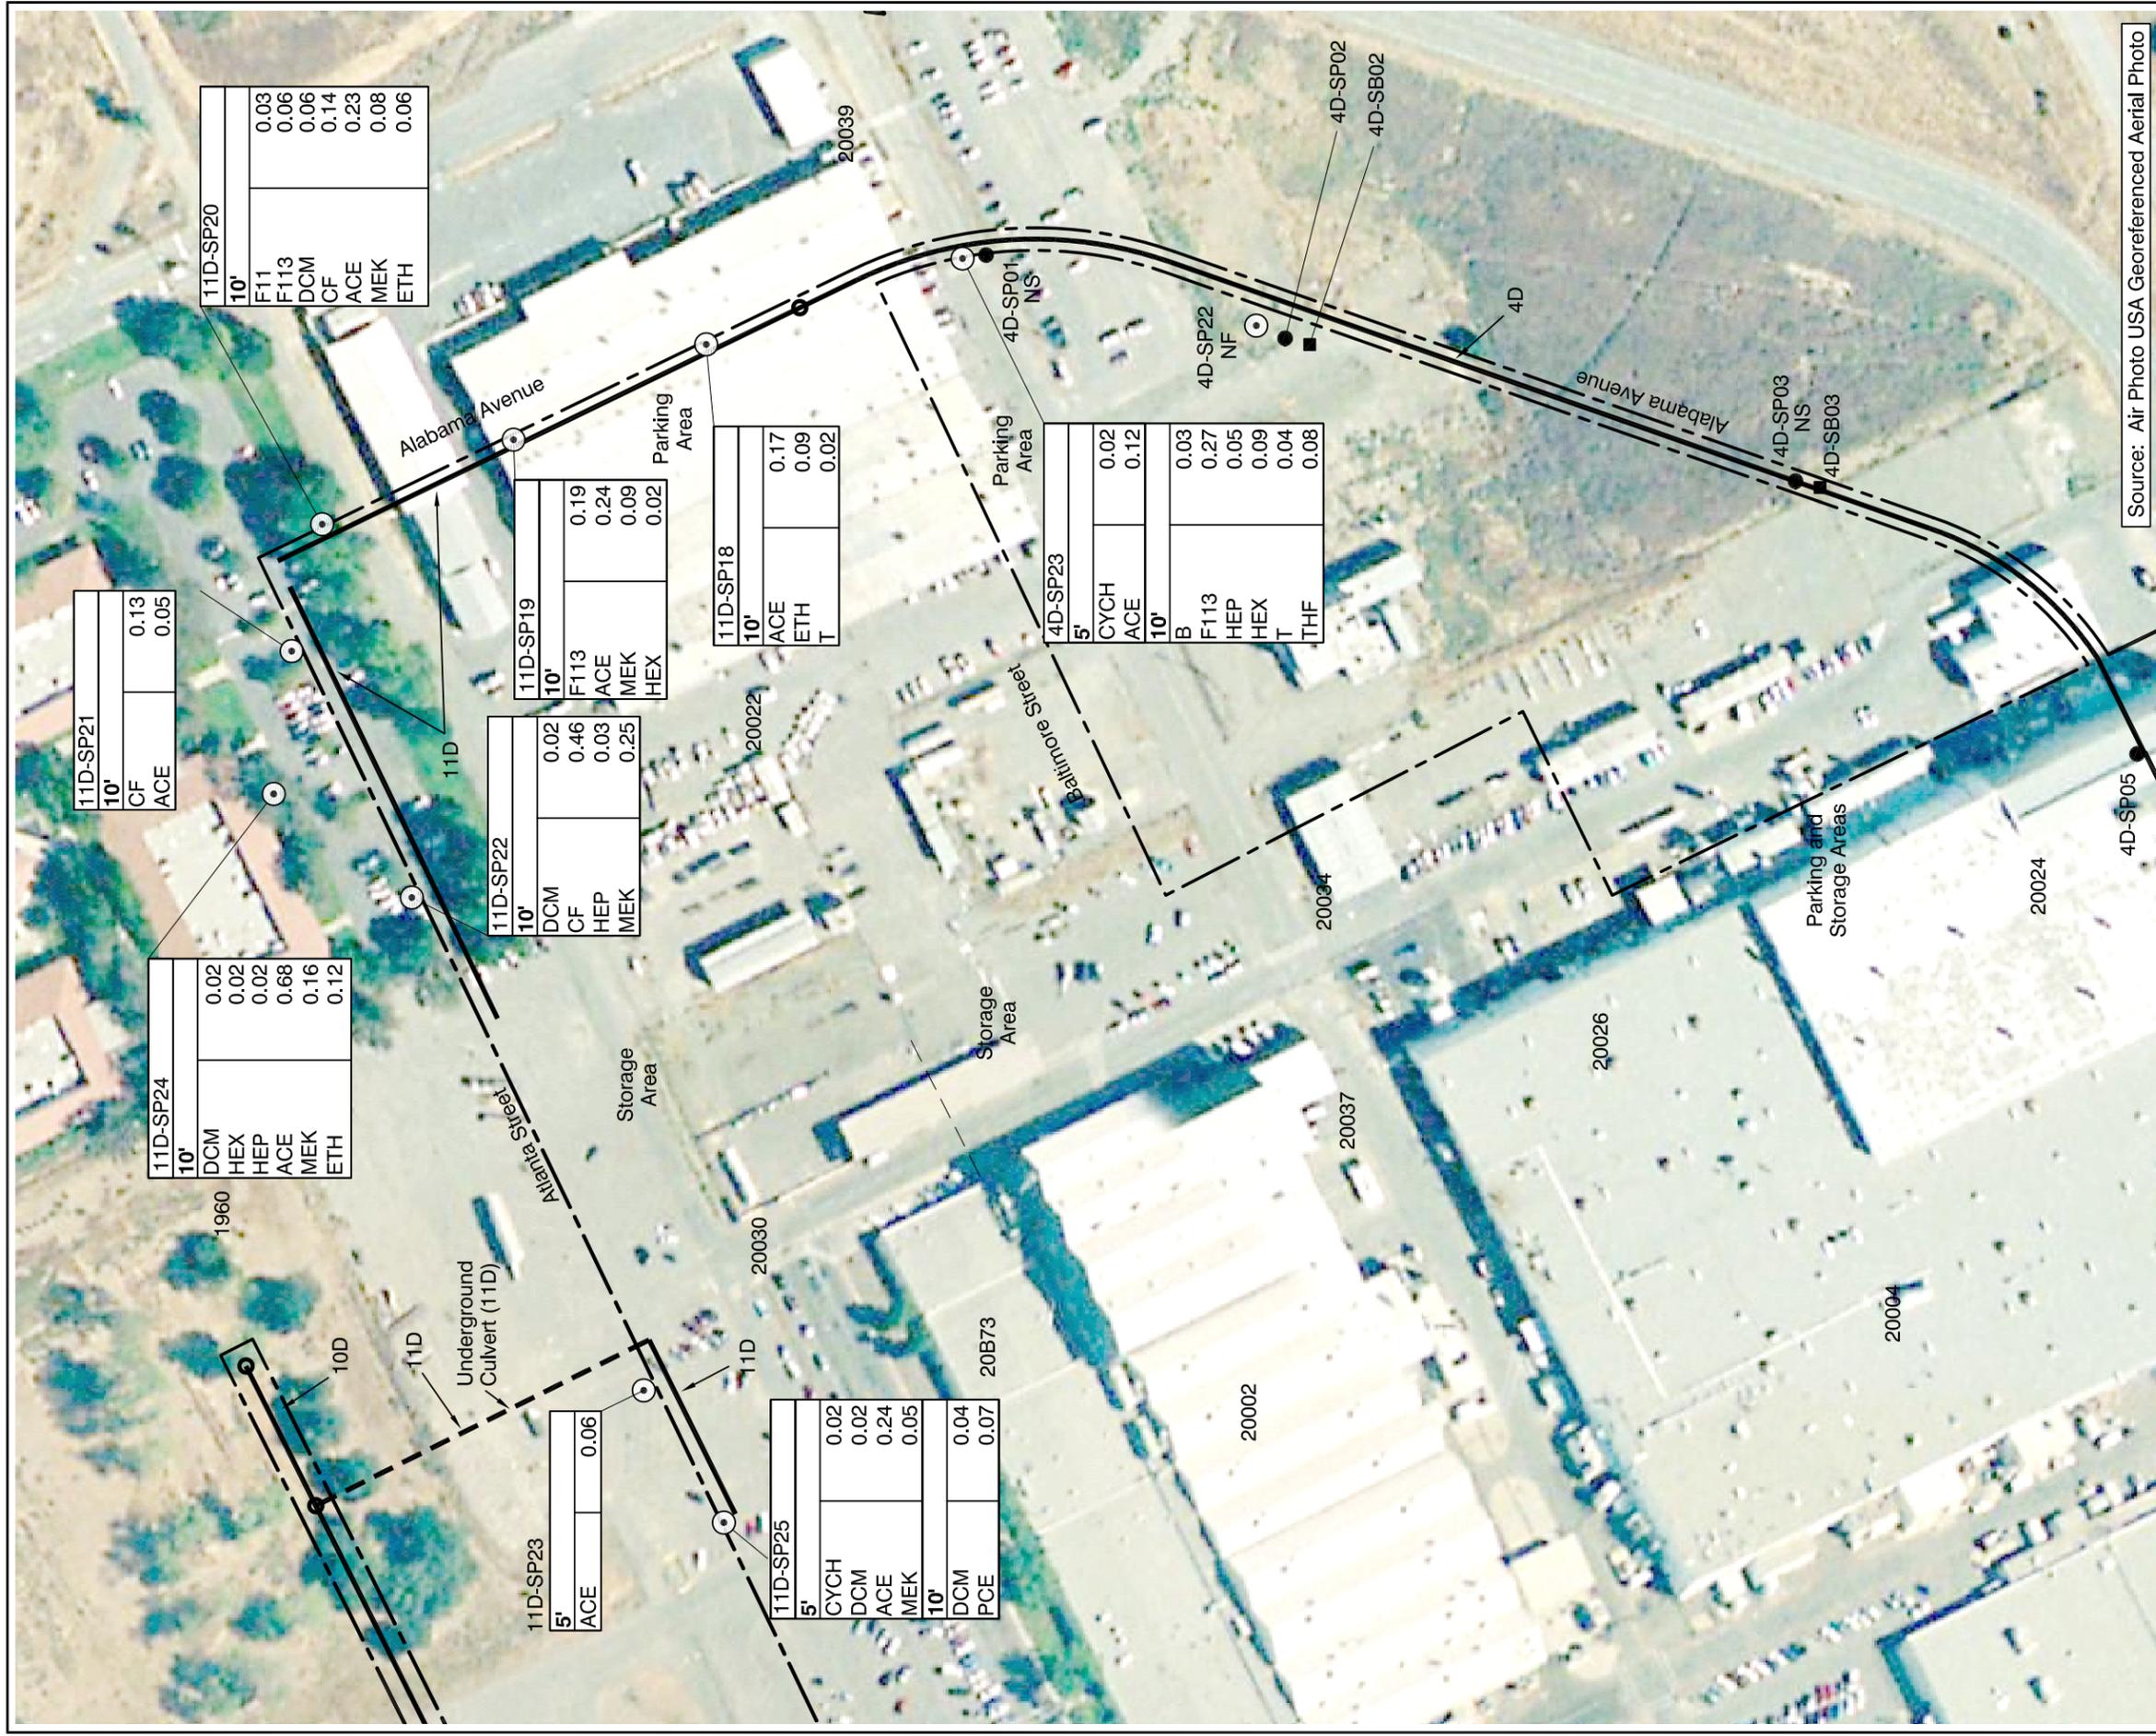
- ⊙ Soil Vapor Sample Location & ID
- Stage 1 RI Soil Vapor Sample Location
- Stage 1 RI Soil Sample Location
- Ditch Included in POU RI/FS
- - - Underground Culvert Included in POU RI/FS
- ← Surface Water Flow Direction (2002)
- - - Superfund Site Boundary
- NF No Flow
- NS Not Sampled
- Start/End of Potential Source Site Ditches

**Concentrations Above Screening Level are in Boldface**  
 Concentration in Milligrams per Cubic Meter (mg/m<sup>3</sup>)

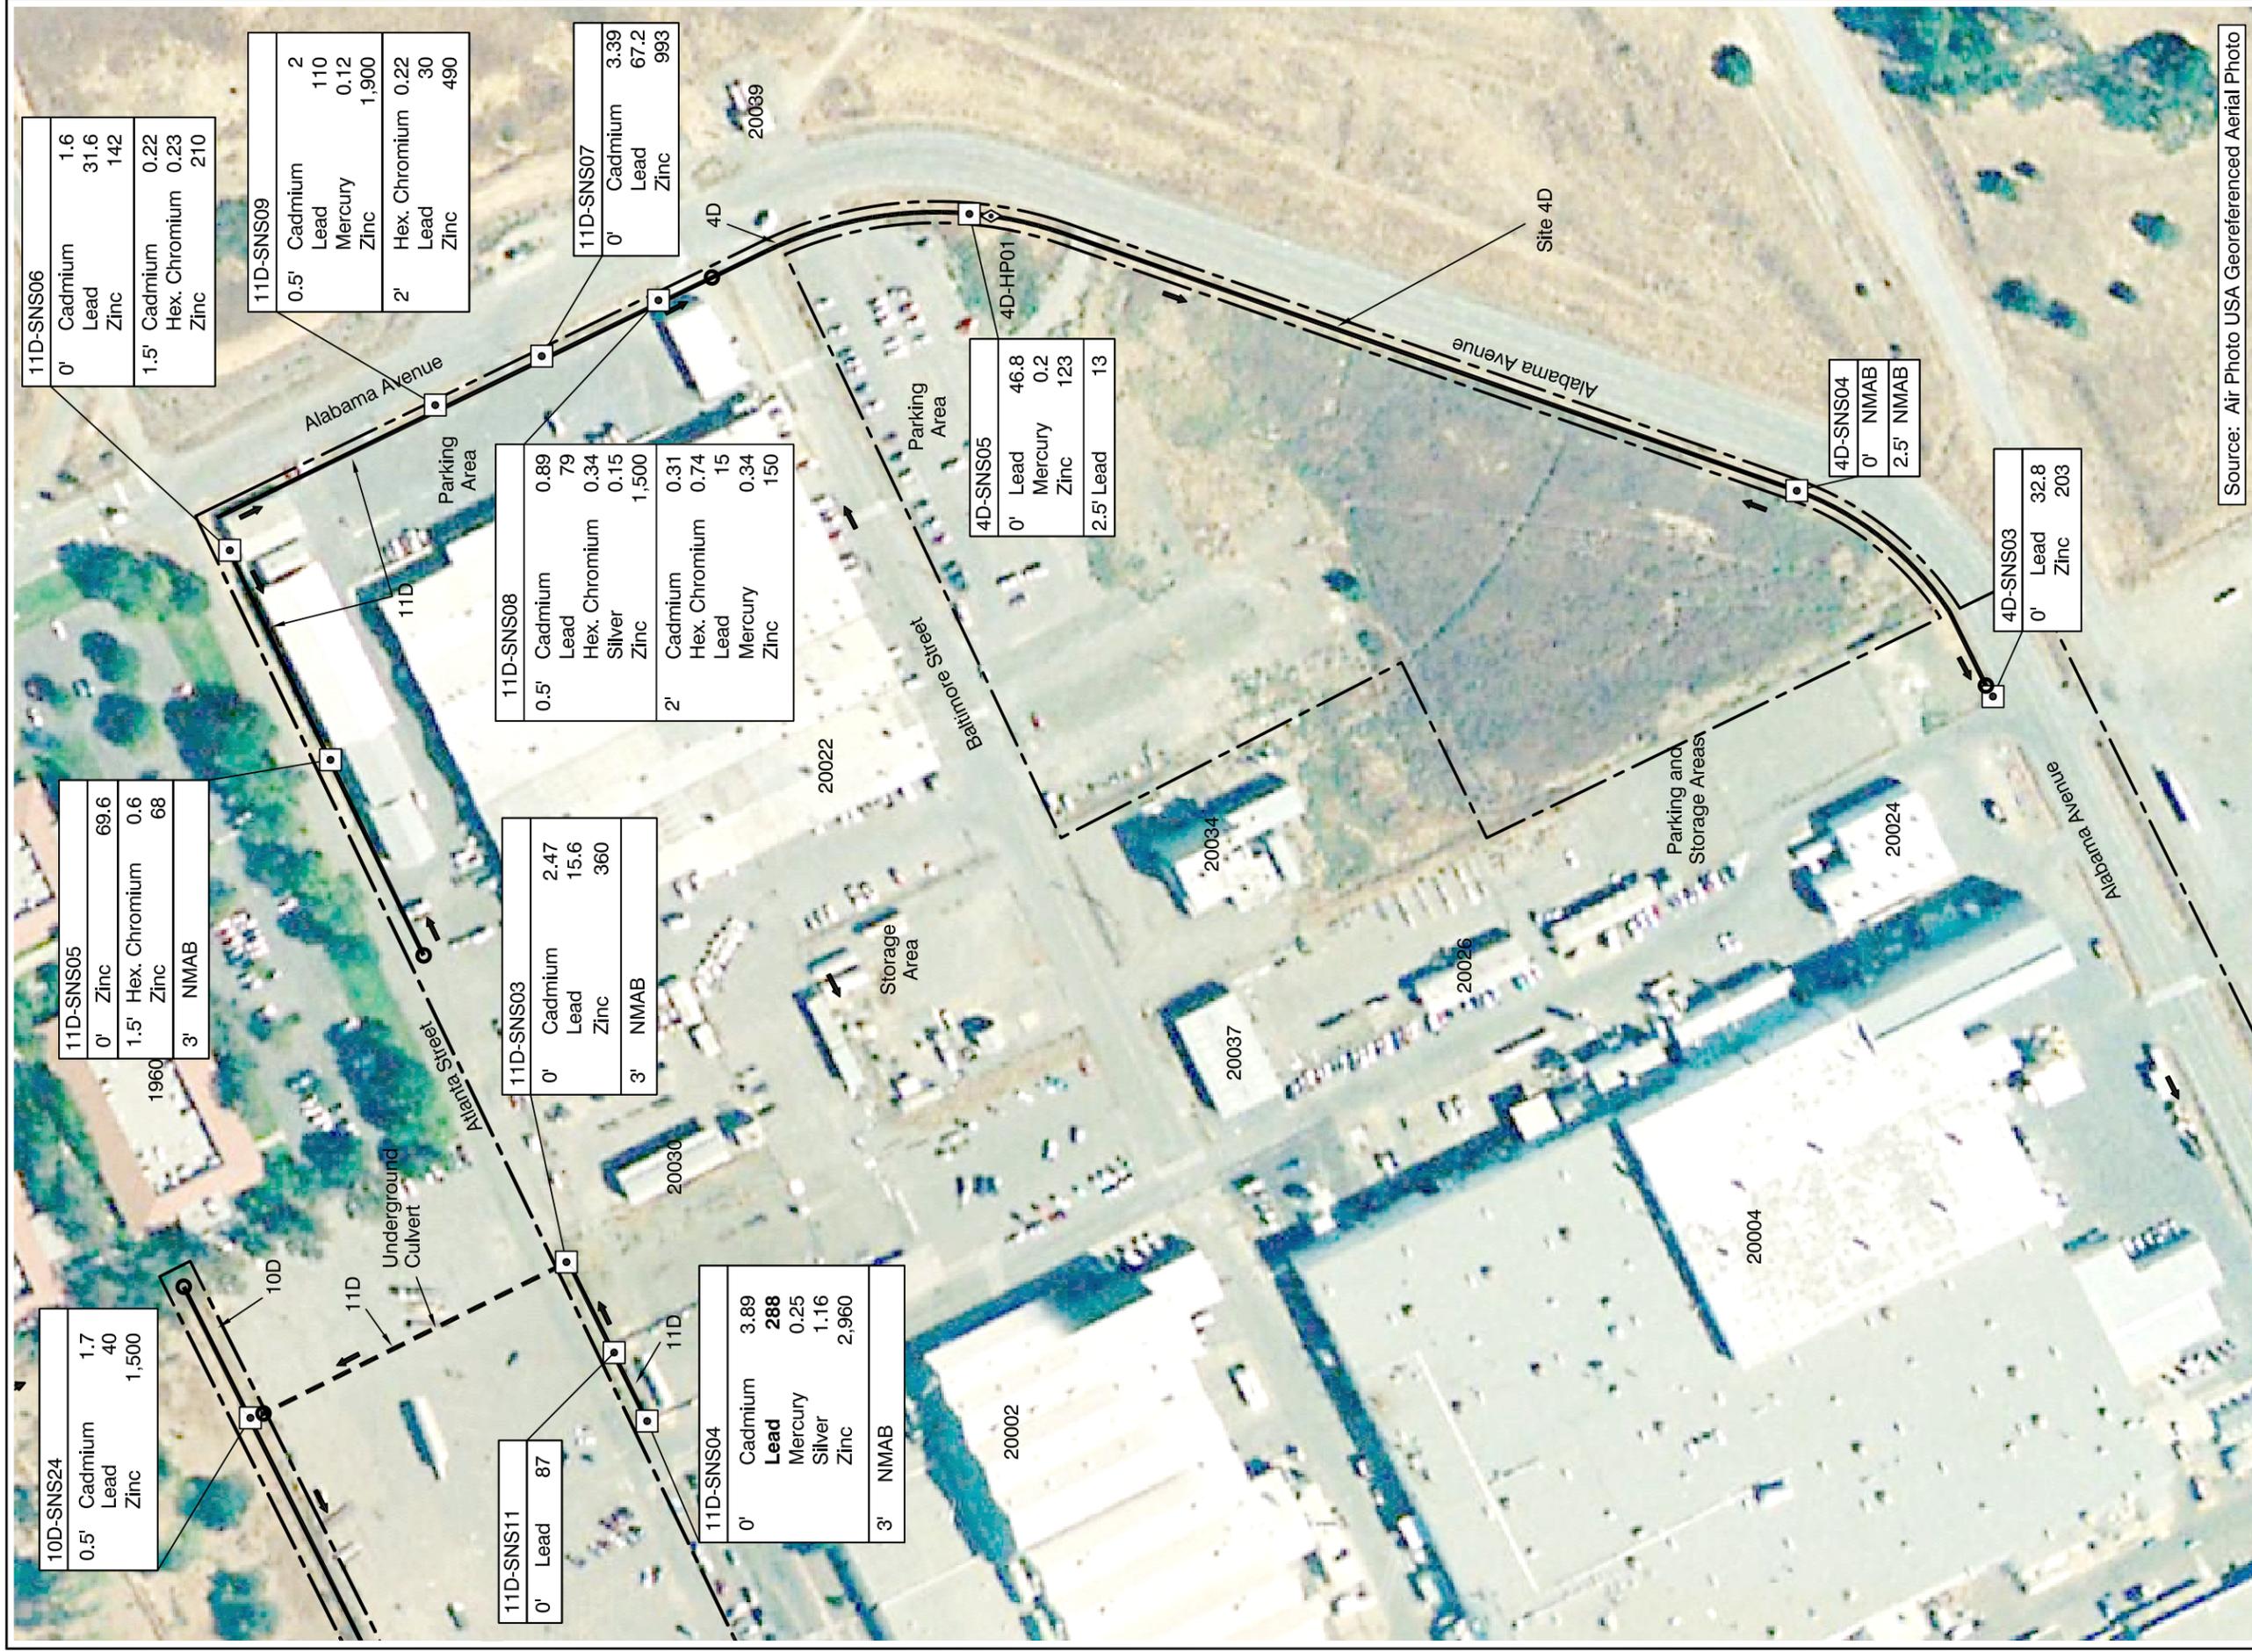
**FIGURE 4-4**

Concentrations reported in milligrams per kilogram (mg/kg). Concentrations above residential PRG are shown in boldface. NMAB = No Metals Above Background

**Metals Detected Above Background in Surface Soil Samples Potential Source Sites 4D and 11D**

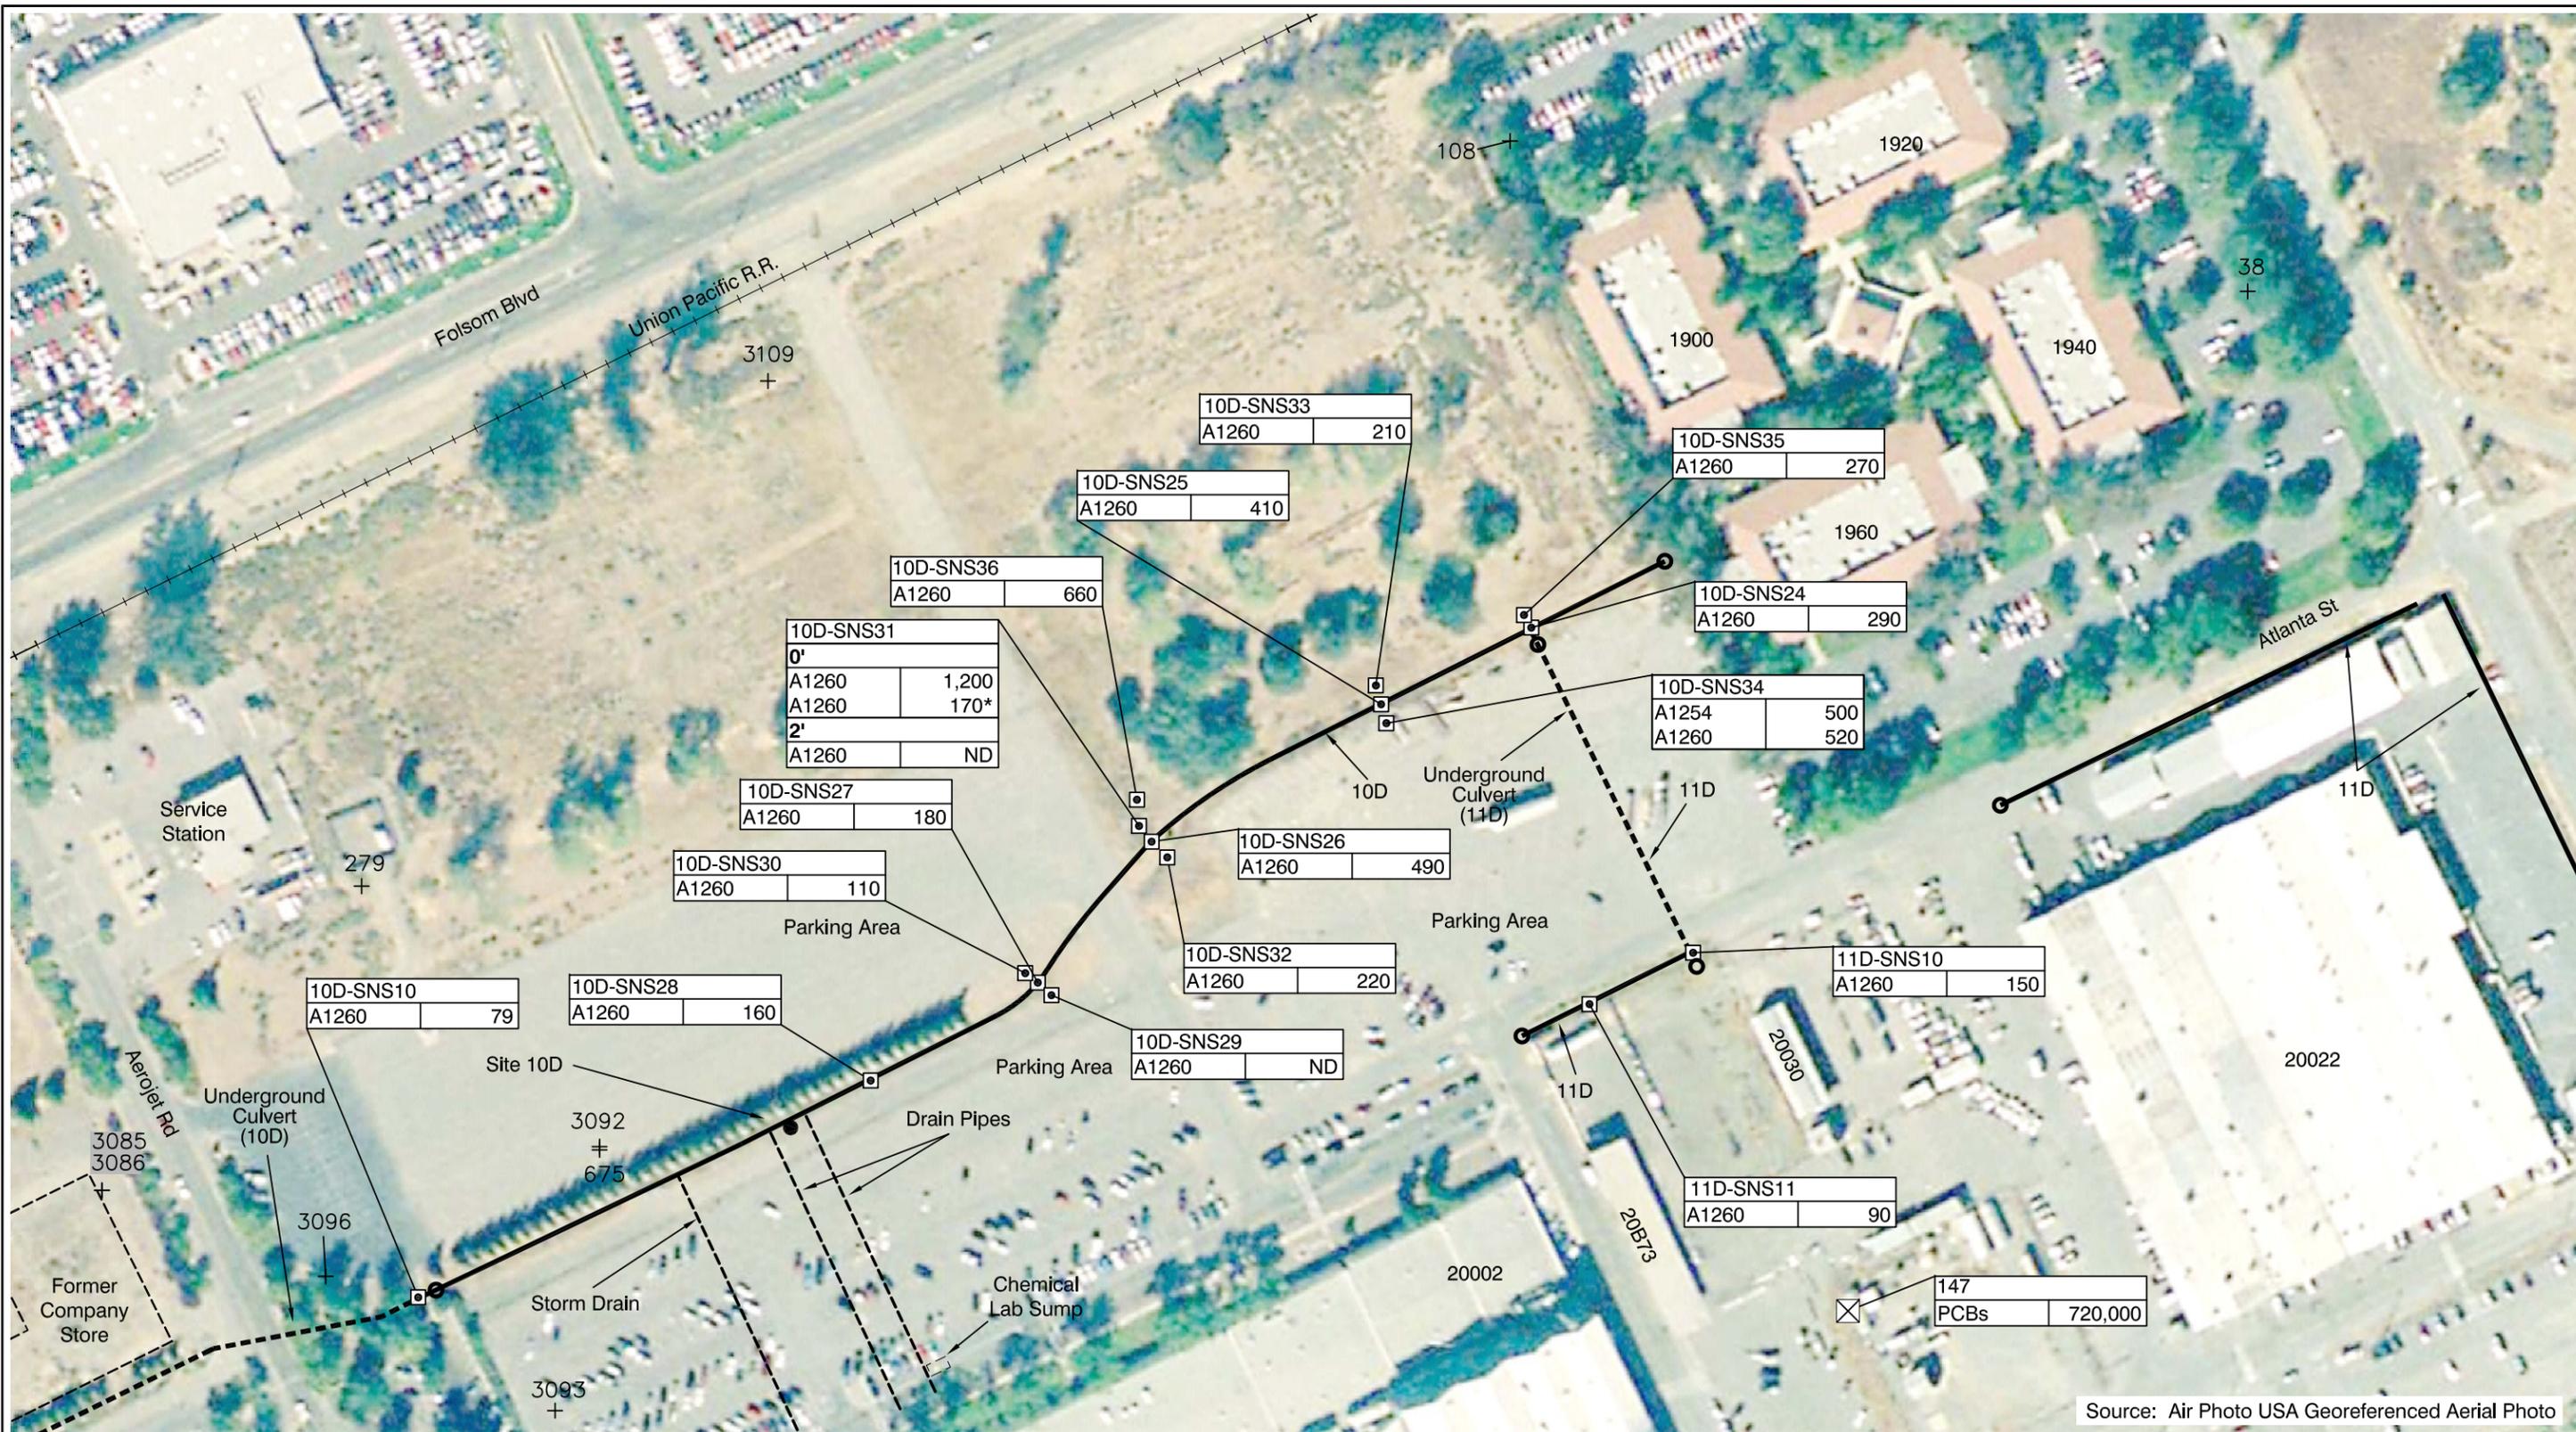
**FIGURE 4-5**  
**PCBs Detected in Surface Soil and Bank Samples**  
**Potential Source Sites 10D and 11D**

Concentration in Micrograms per Kilogram (µg/Kg)  
 A1254: Aroclor 1254  
 A1260: Aroclor 1260

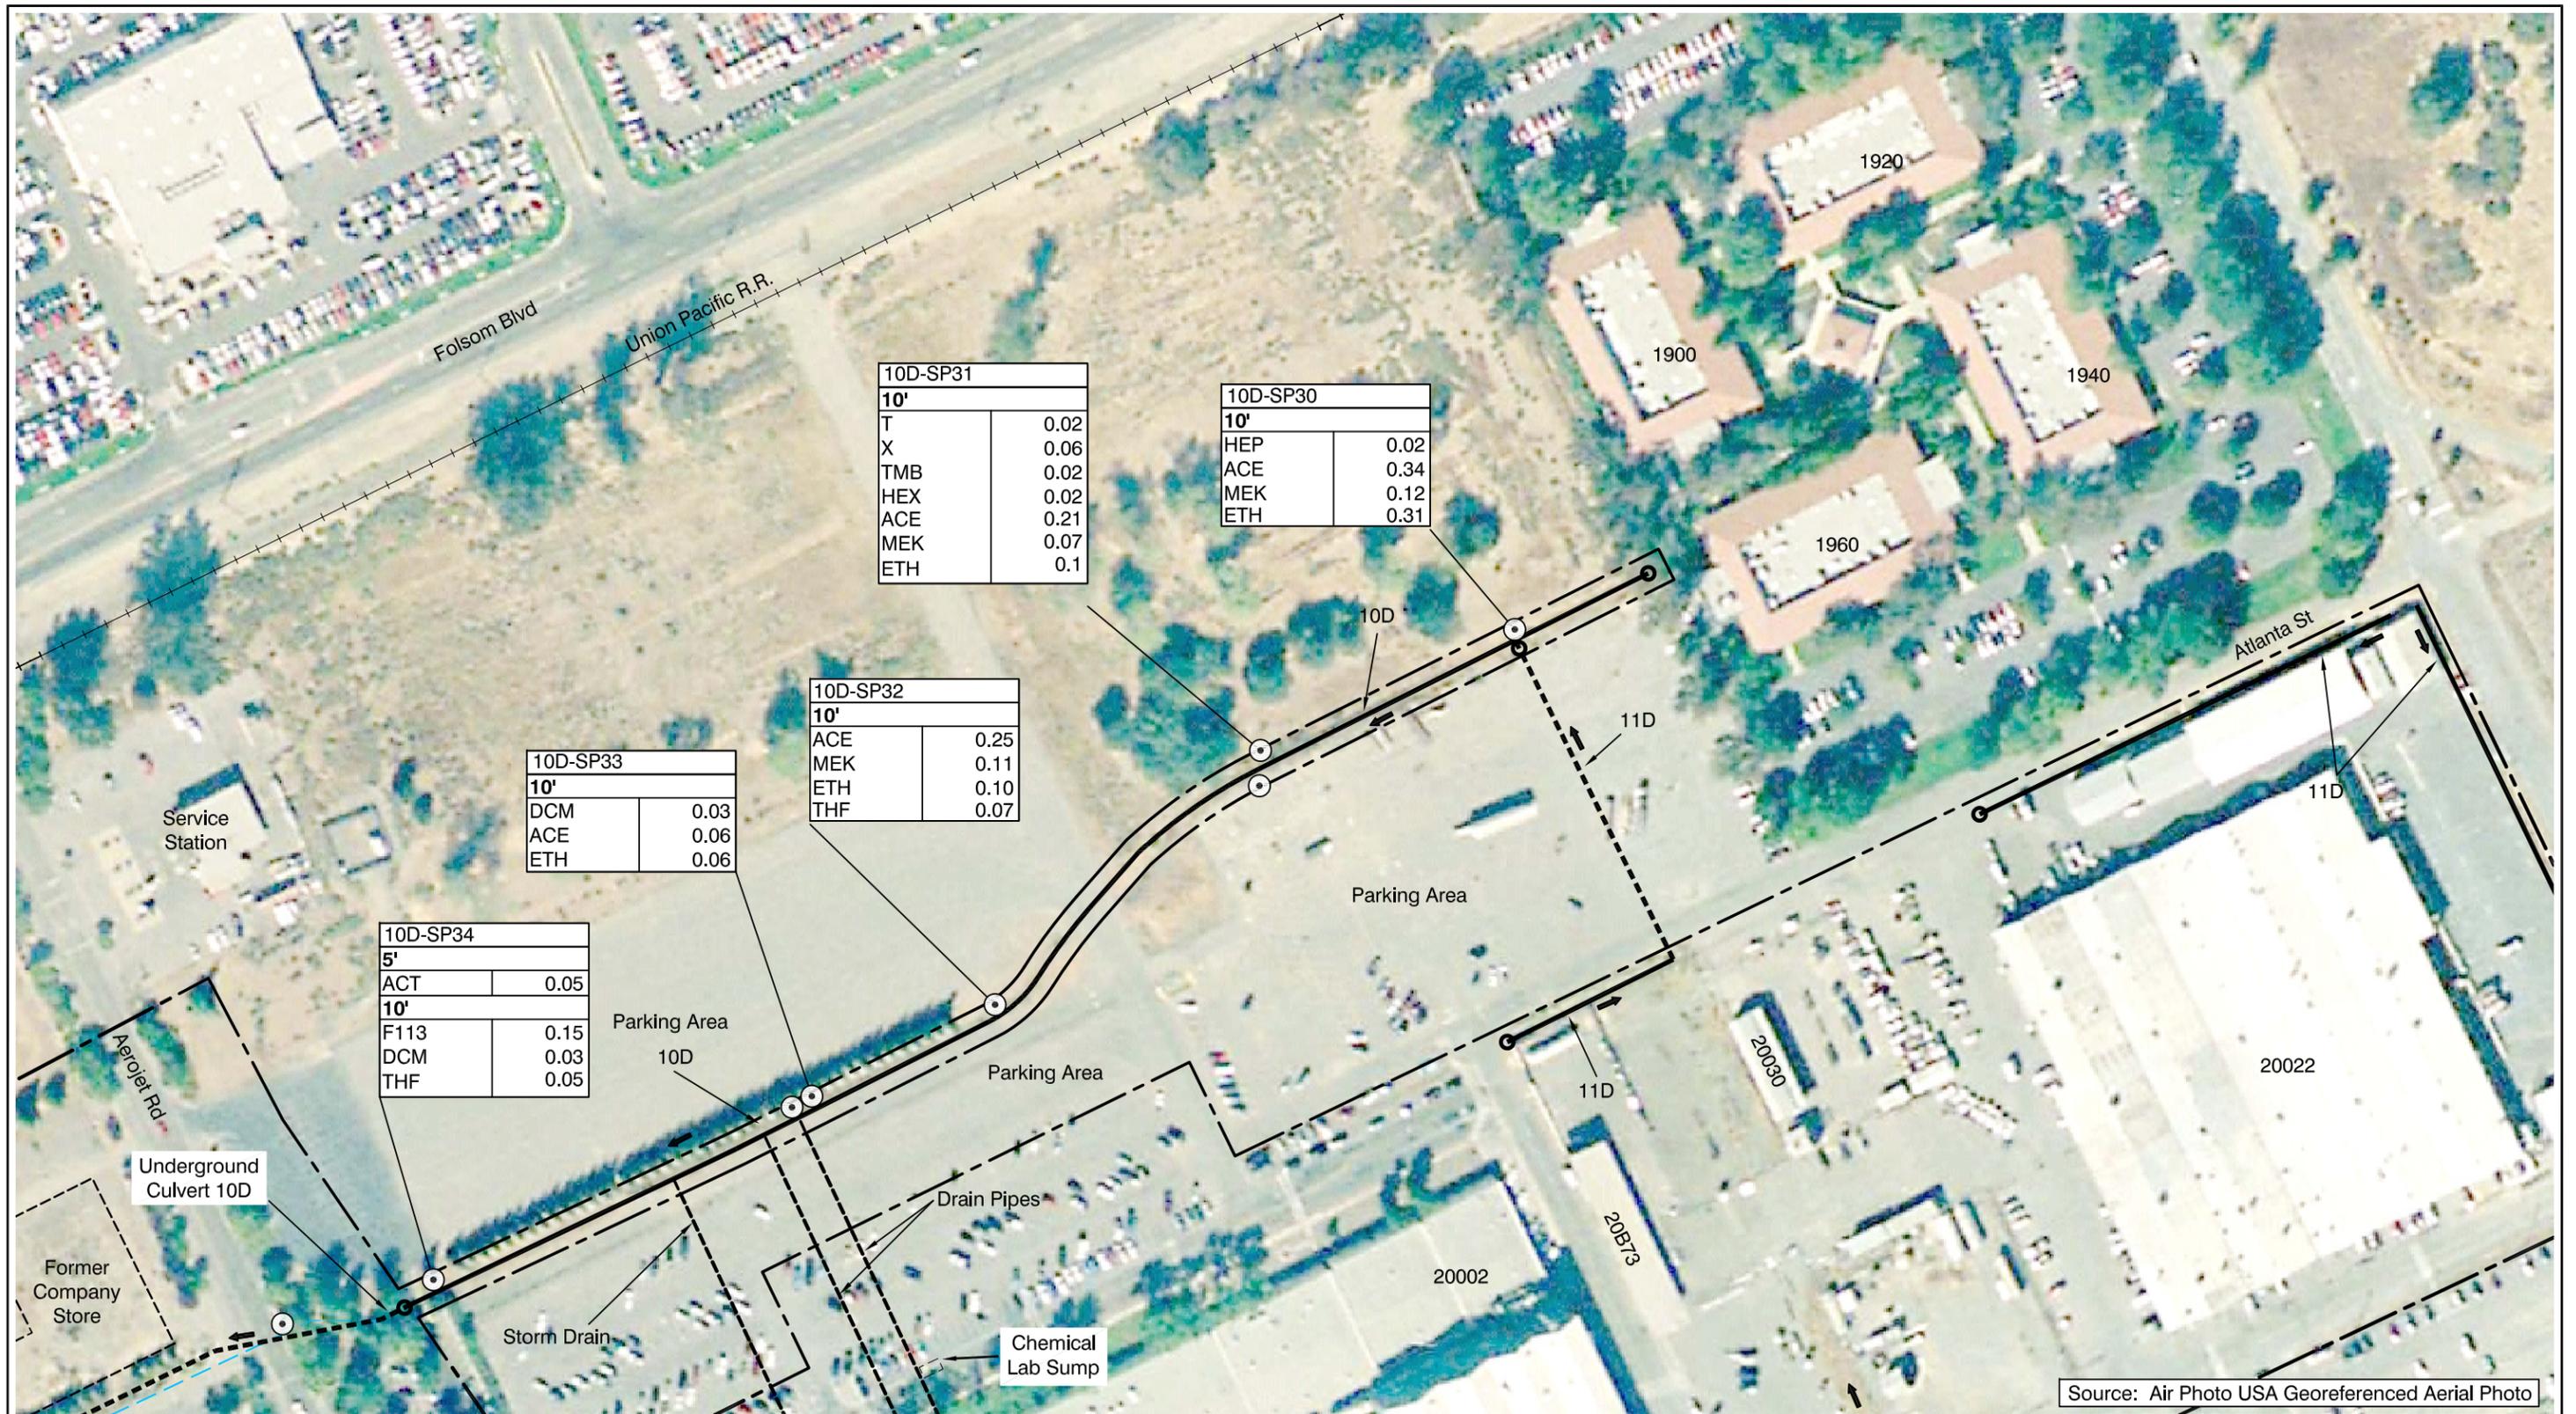
**FIGURE 4-7**  
**VOCs Detected in Soil Vapor Samples**  
**Potential Source Site 10D**

Concentration in Milligrams per Cubic Meter (mg/m<sup>3</sup>)  
**Concentrations Above Screening Level are in Bold.**

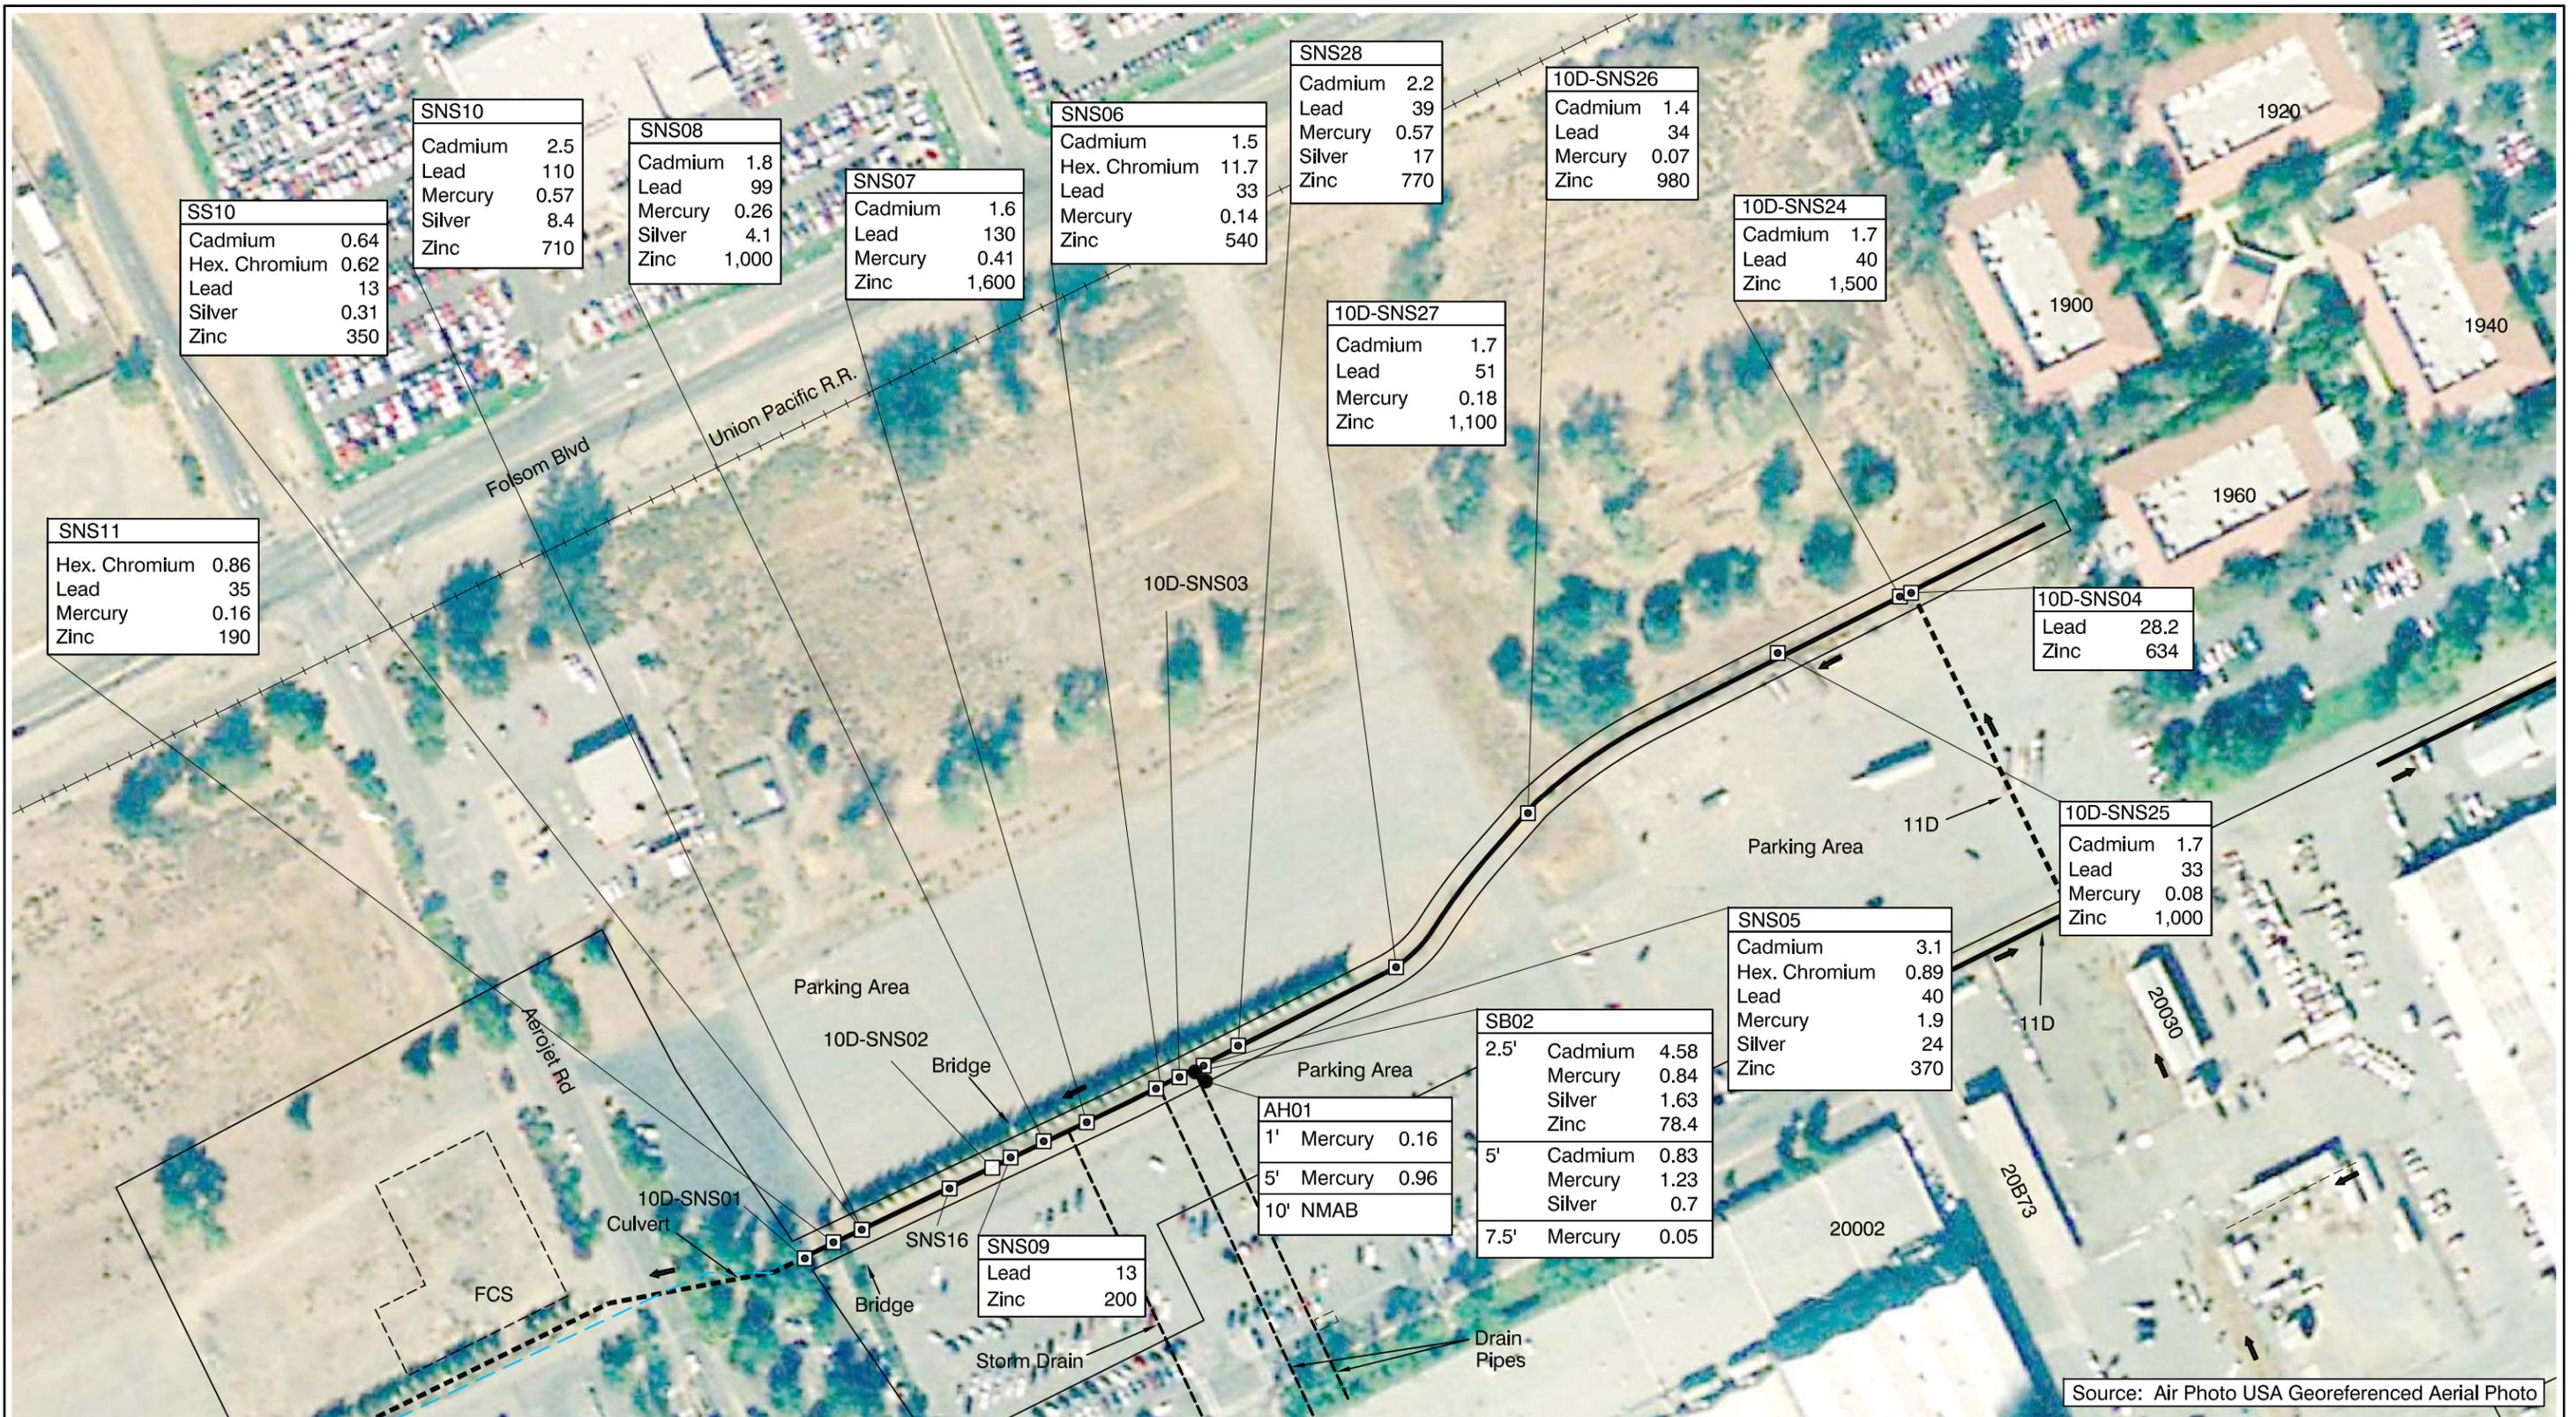
**FIGURE 4-8**  
**Metals Detected**  
**Background in Soil Samples**  
**Potential Source Site 10D**

Concentrations Reported in Milligrams per Kilogram (mg/Kg)  
**Concentrations Above Residential PRG are in Boldface**
