**AEROJET**  
Environmental Remediation

**FIGURE 1-1**  
Location of Sites Included  
in PGOU Solls RI/FS

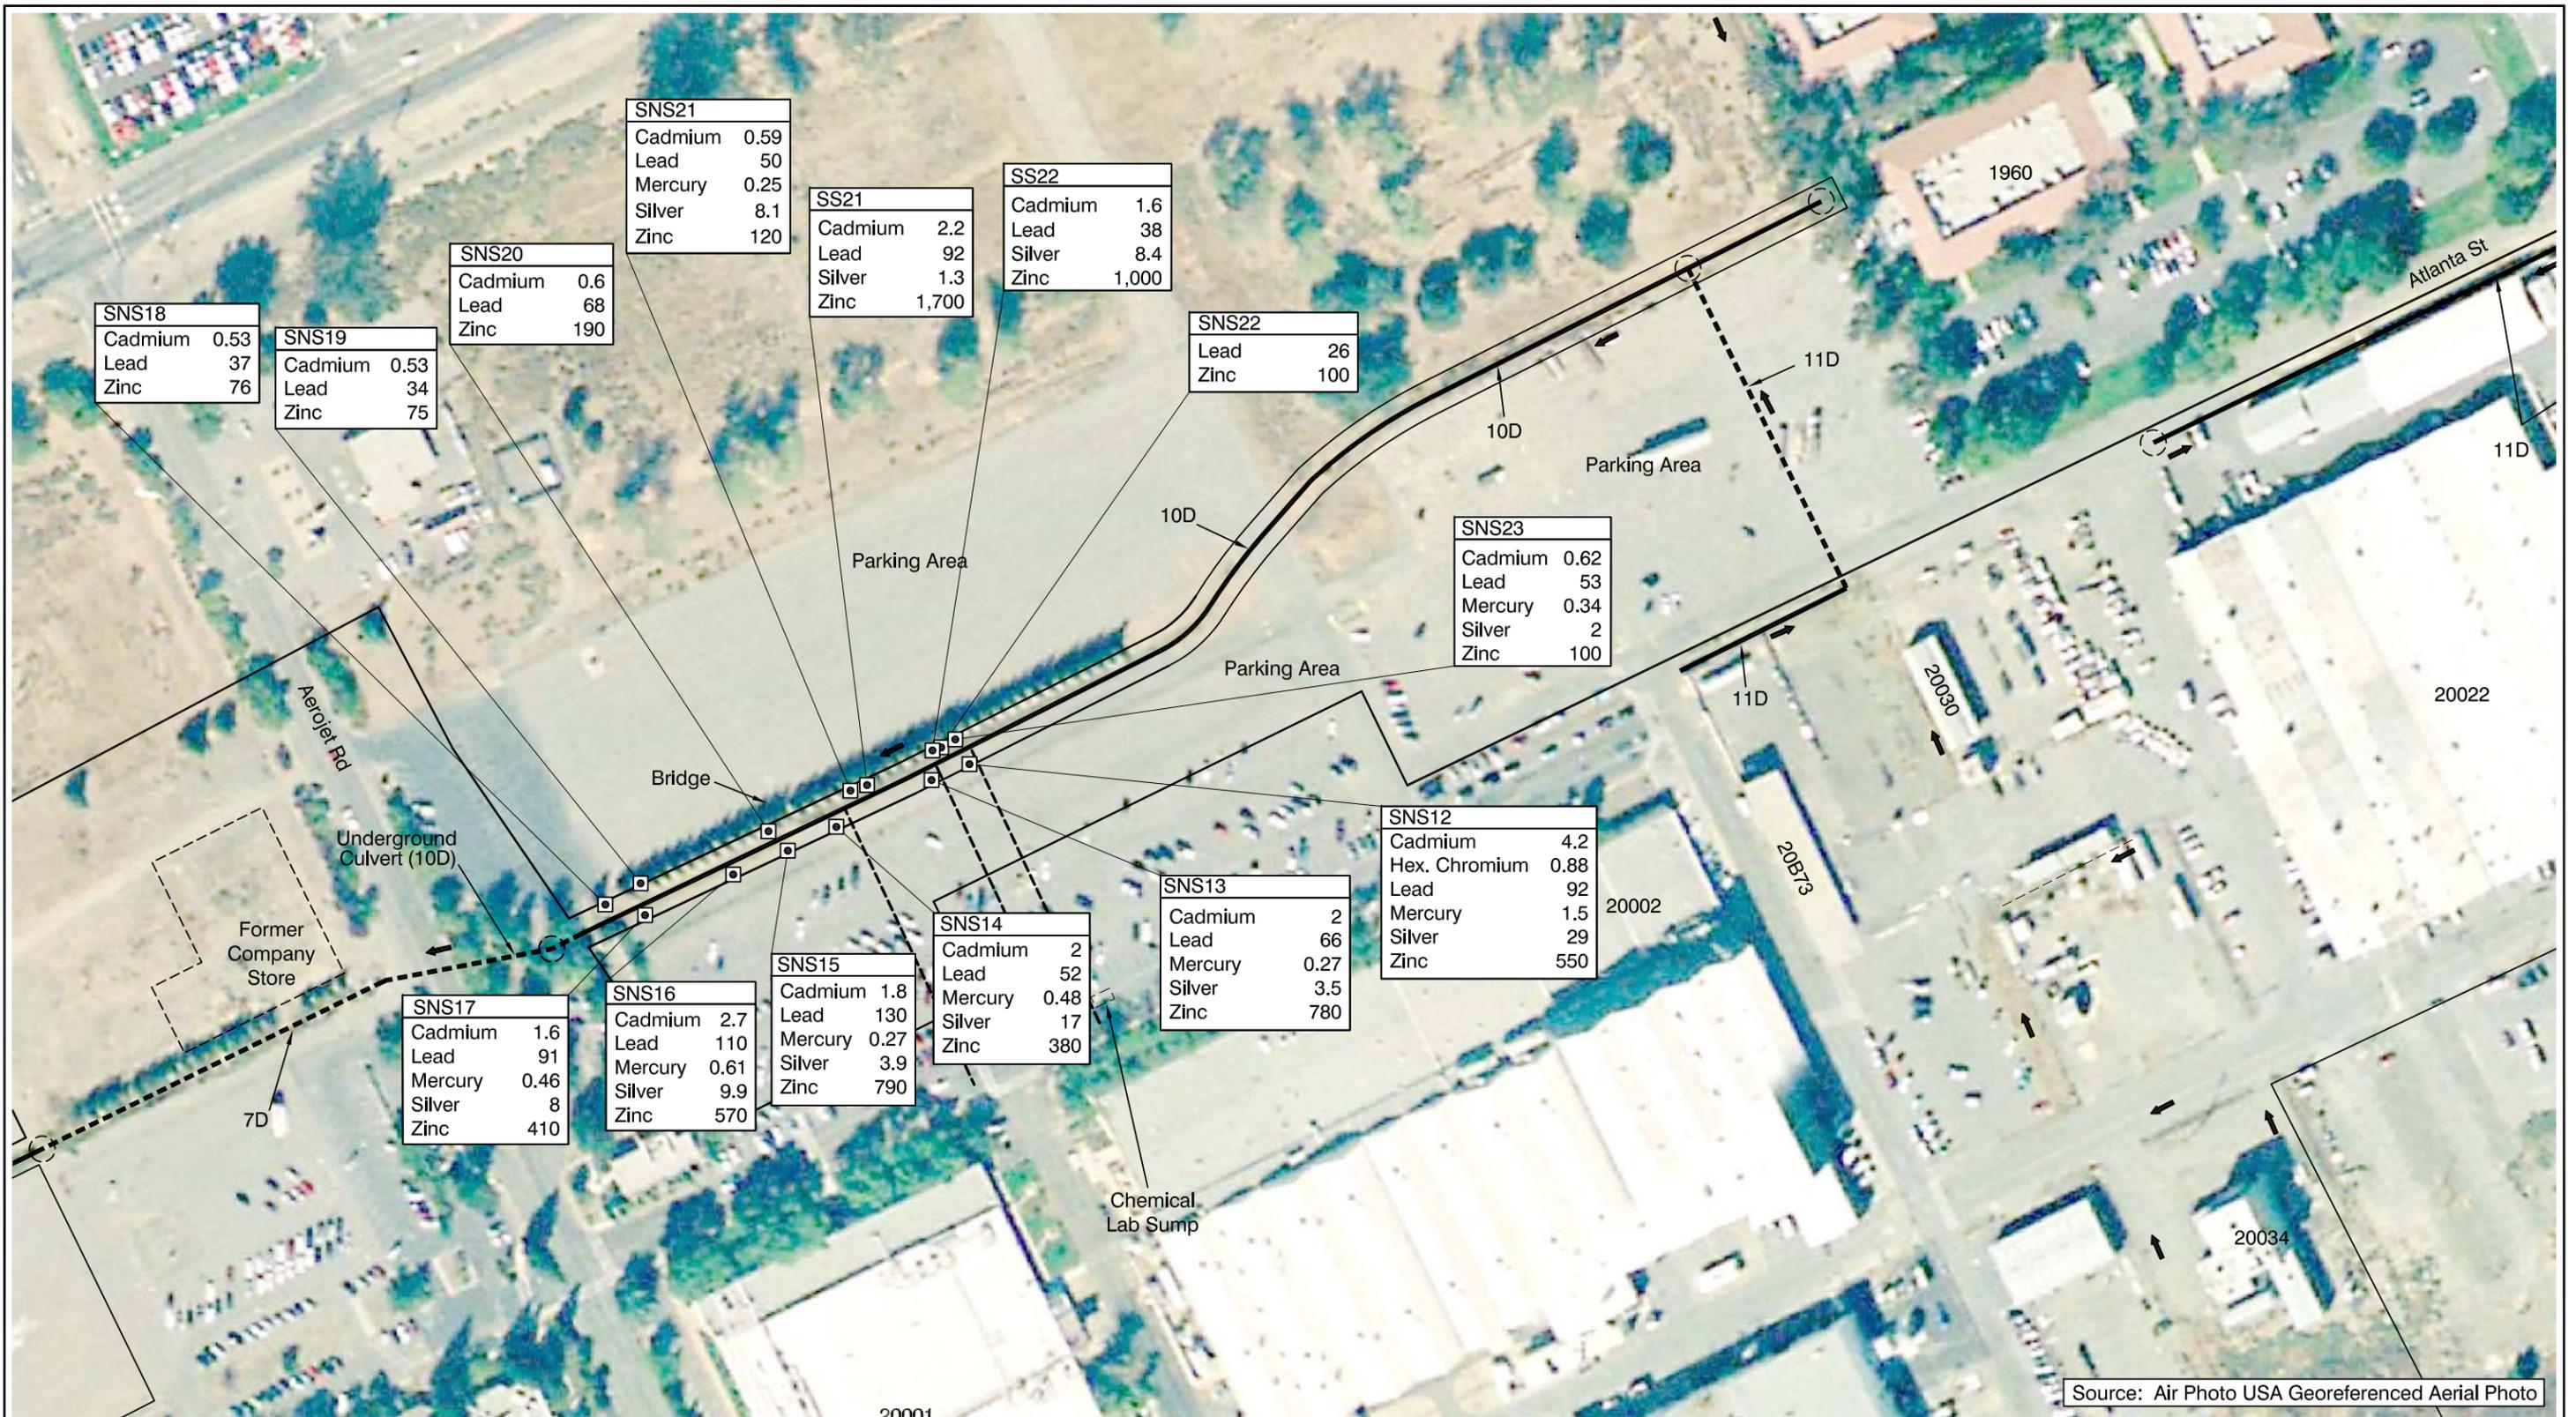
**FIGURE 4-9**  
**Metals Detected Above**  
**Background in Bank Soil Samples**  
**Potential Source Site 10D**

Concentrations Reported in Milligrams per Kilogram (mg/Kg)  
**Metals Concentrations Above Residential PRG are in Boldface**

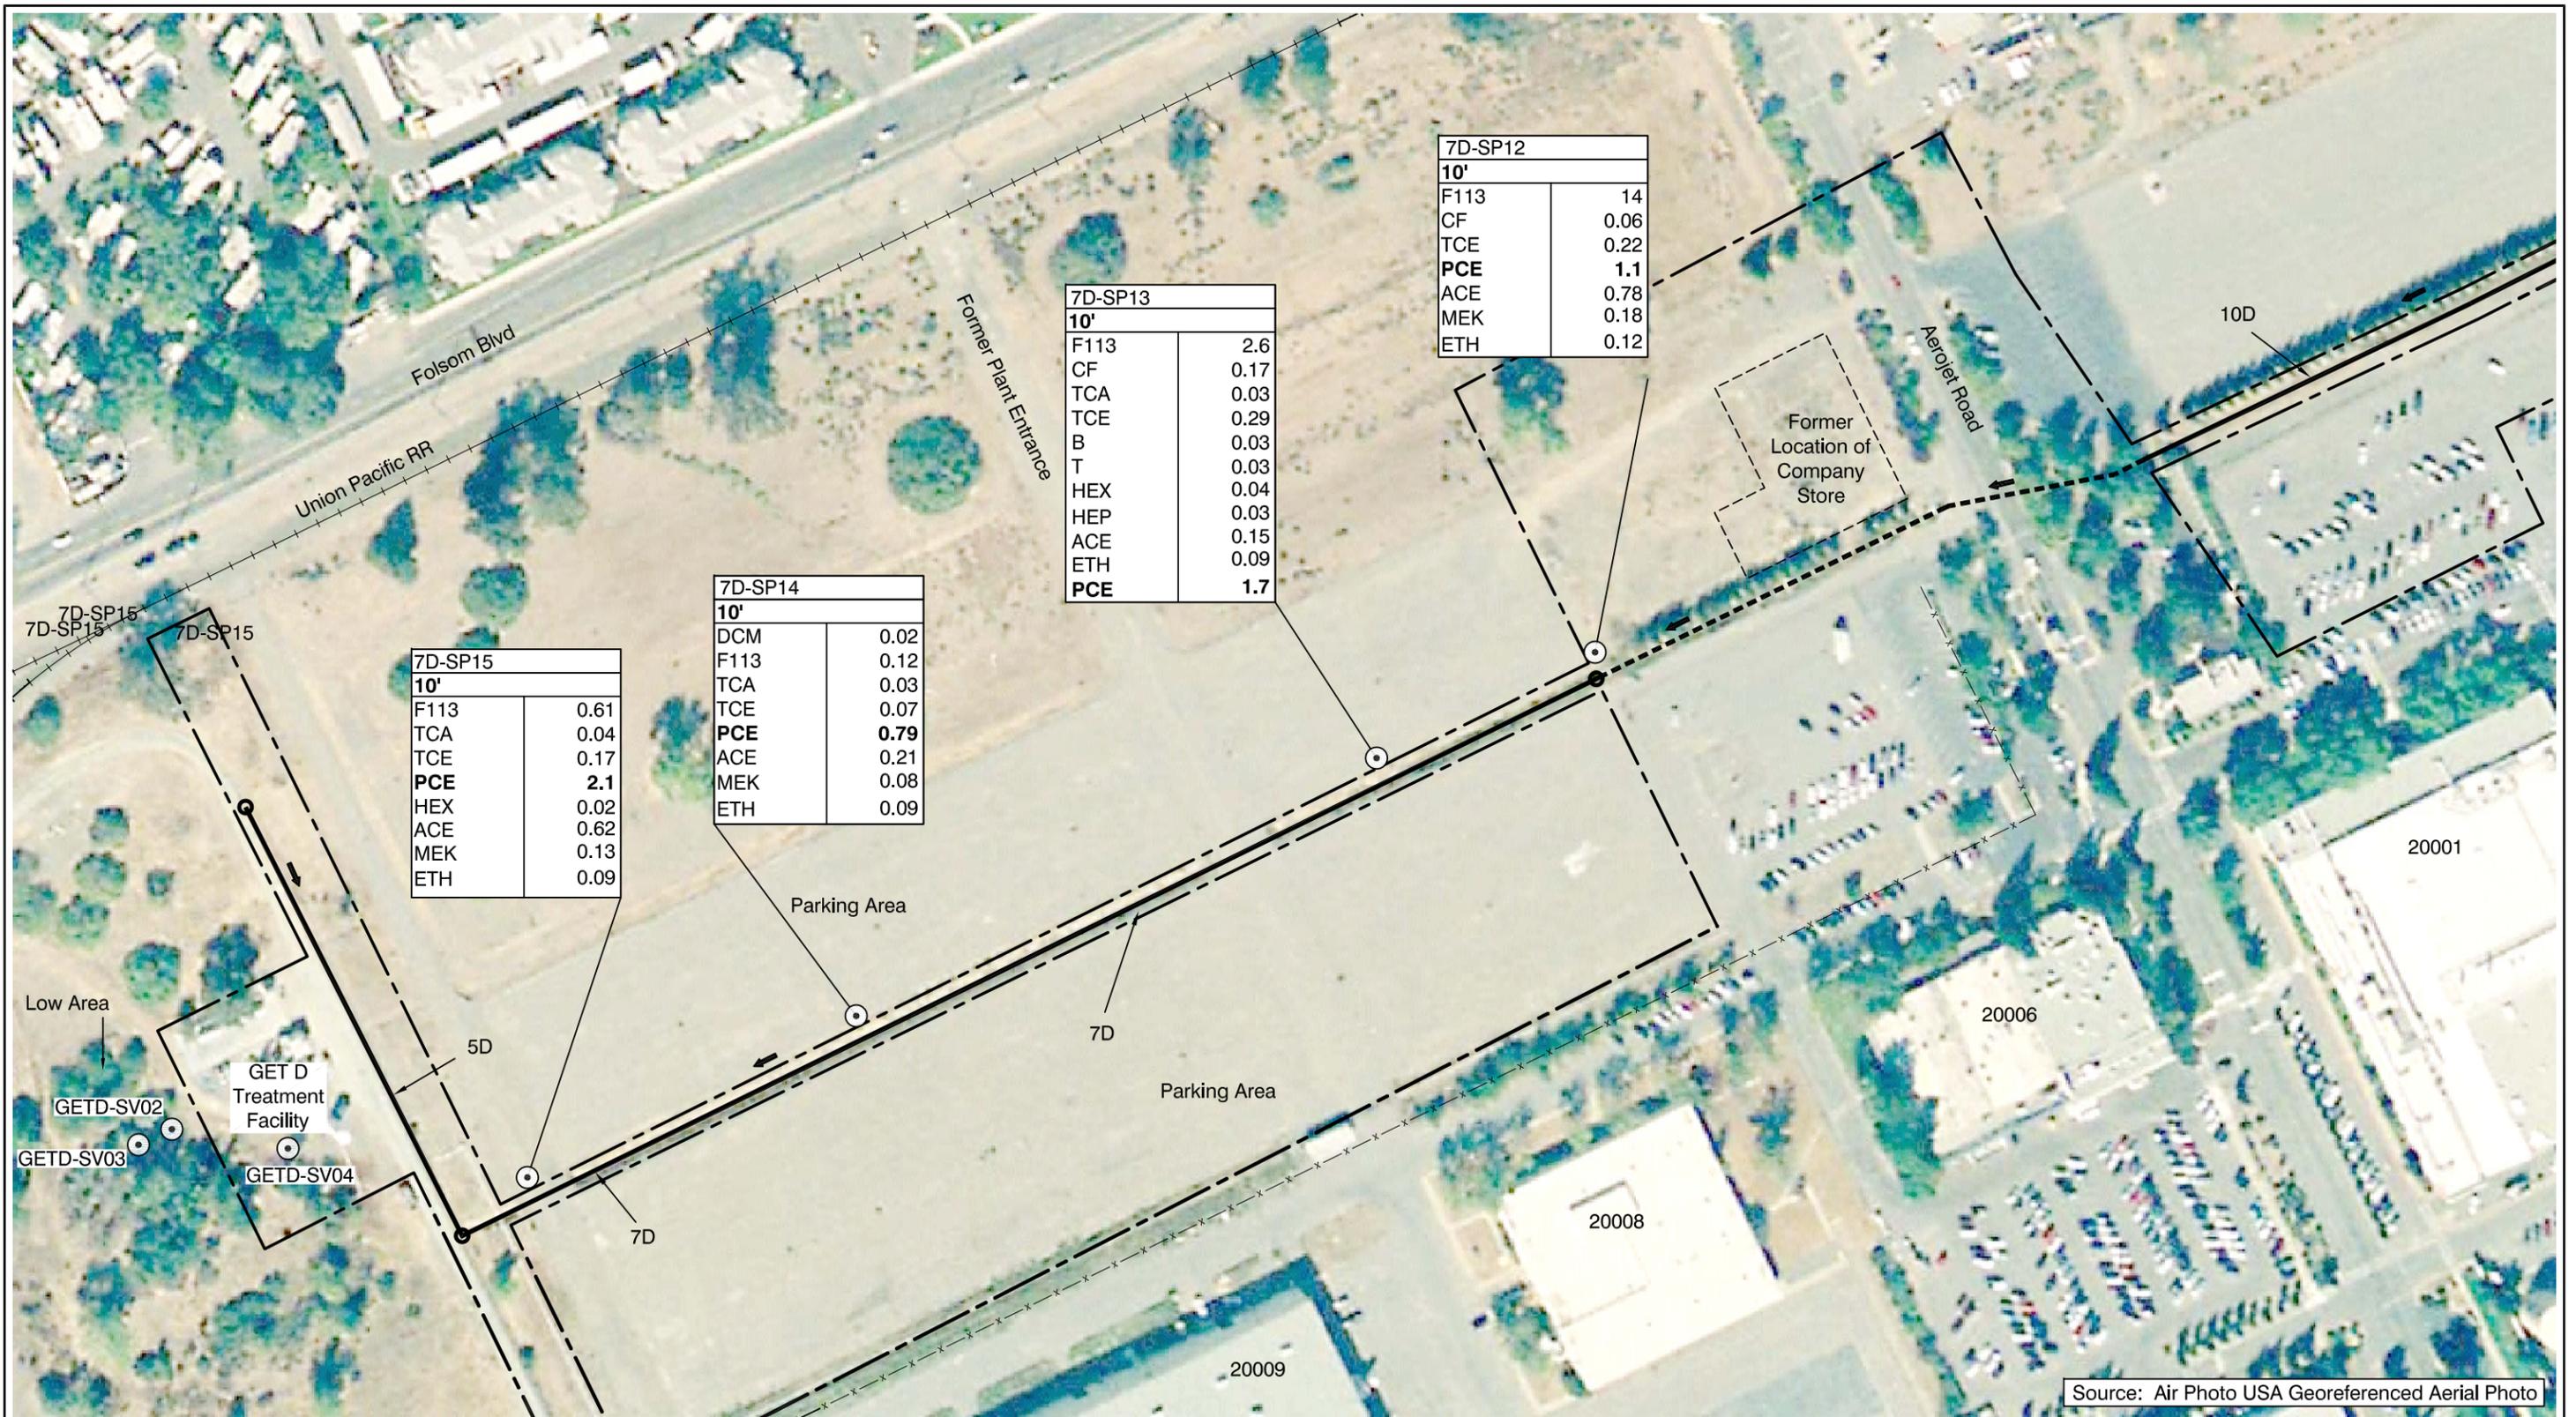
**FIGURE 4-11**  
**VOCs Detected in Soil Vapor Samples**  
**Potential Source Sites 5D, 7D and GET D**

**Concentrations Above Screening Level are In Bold**

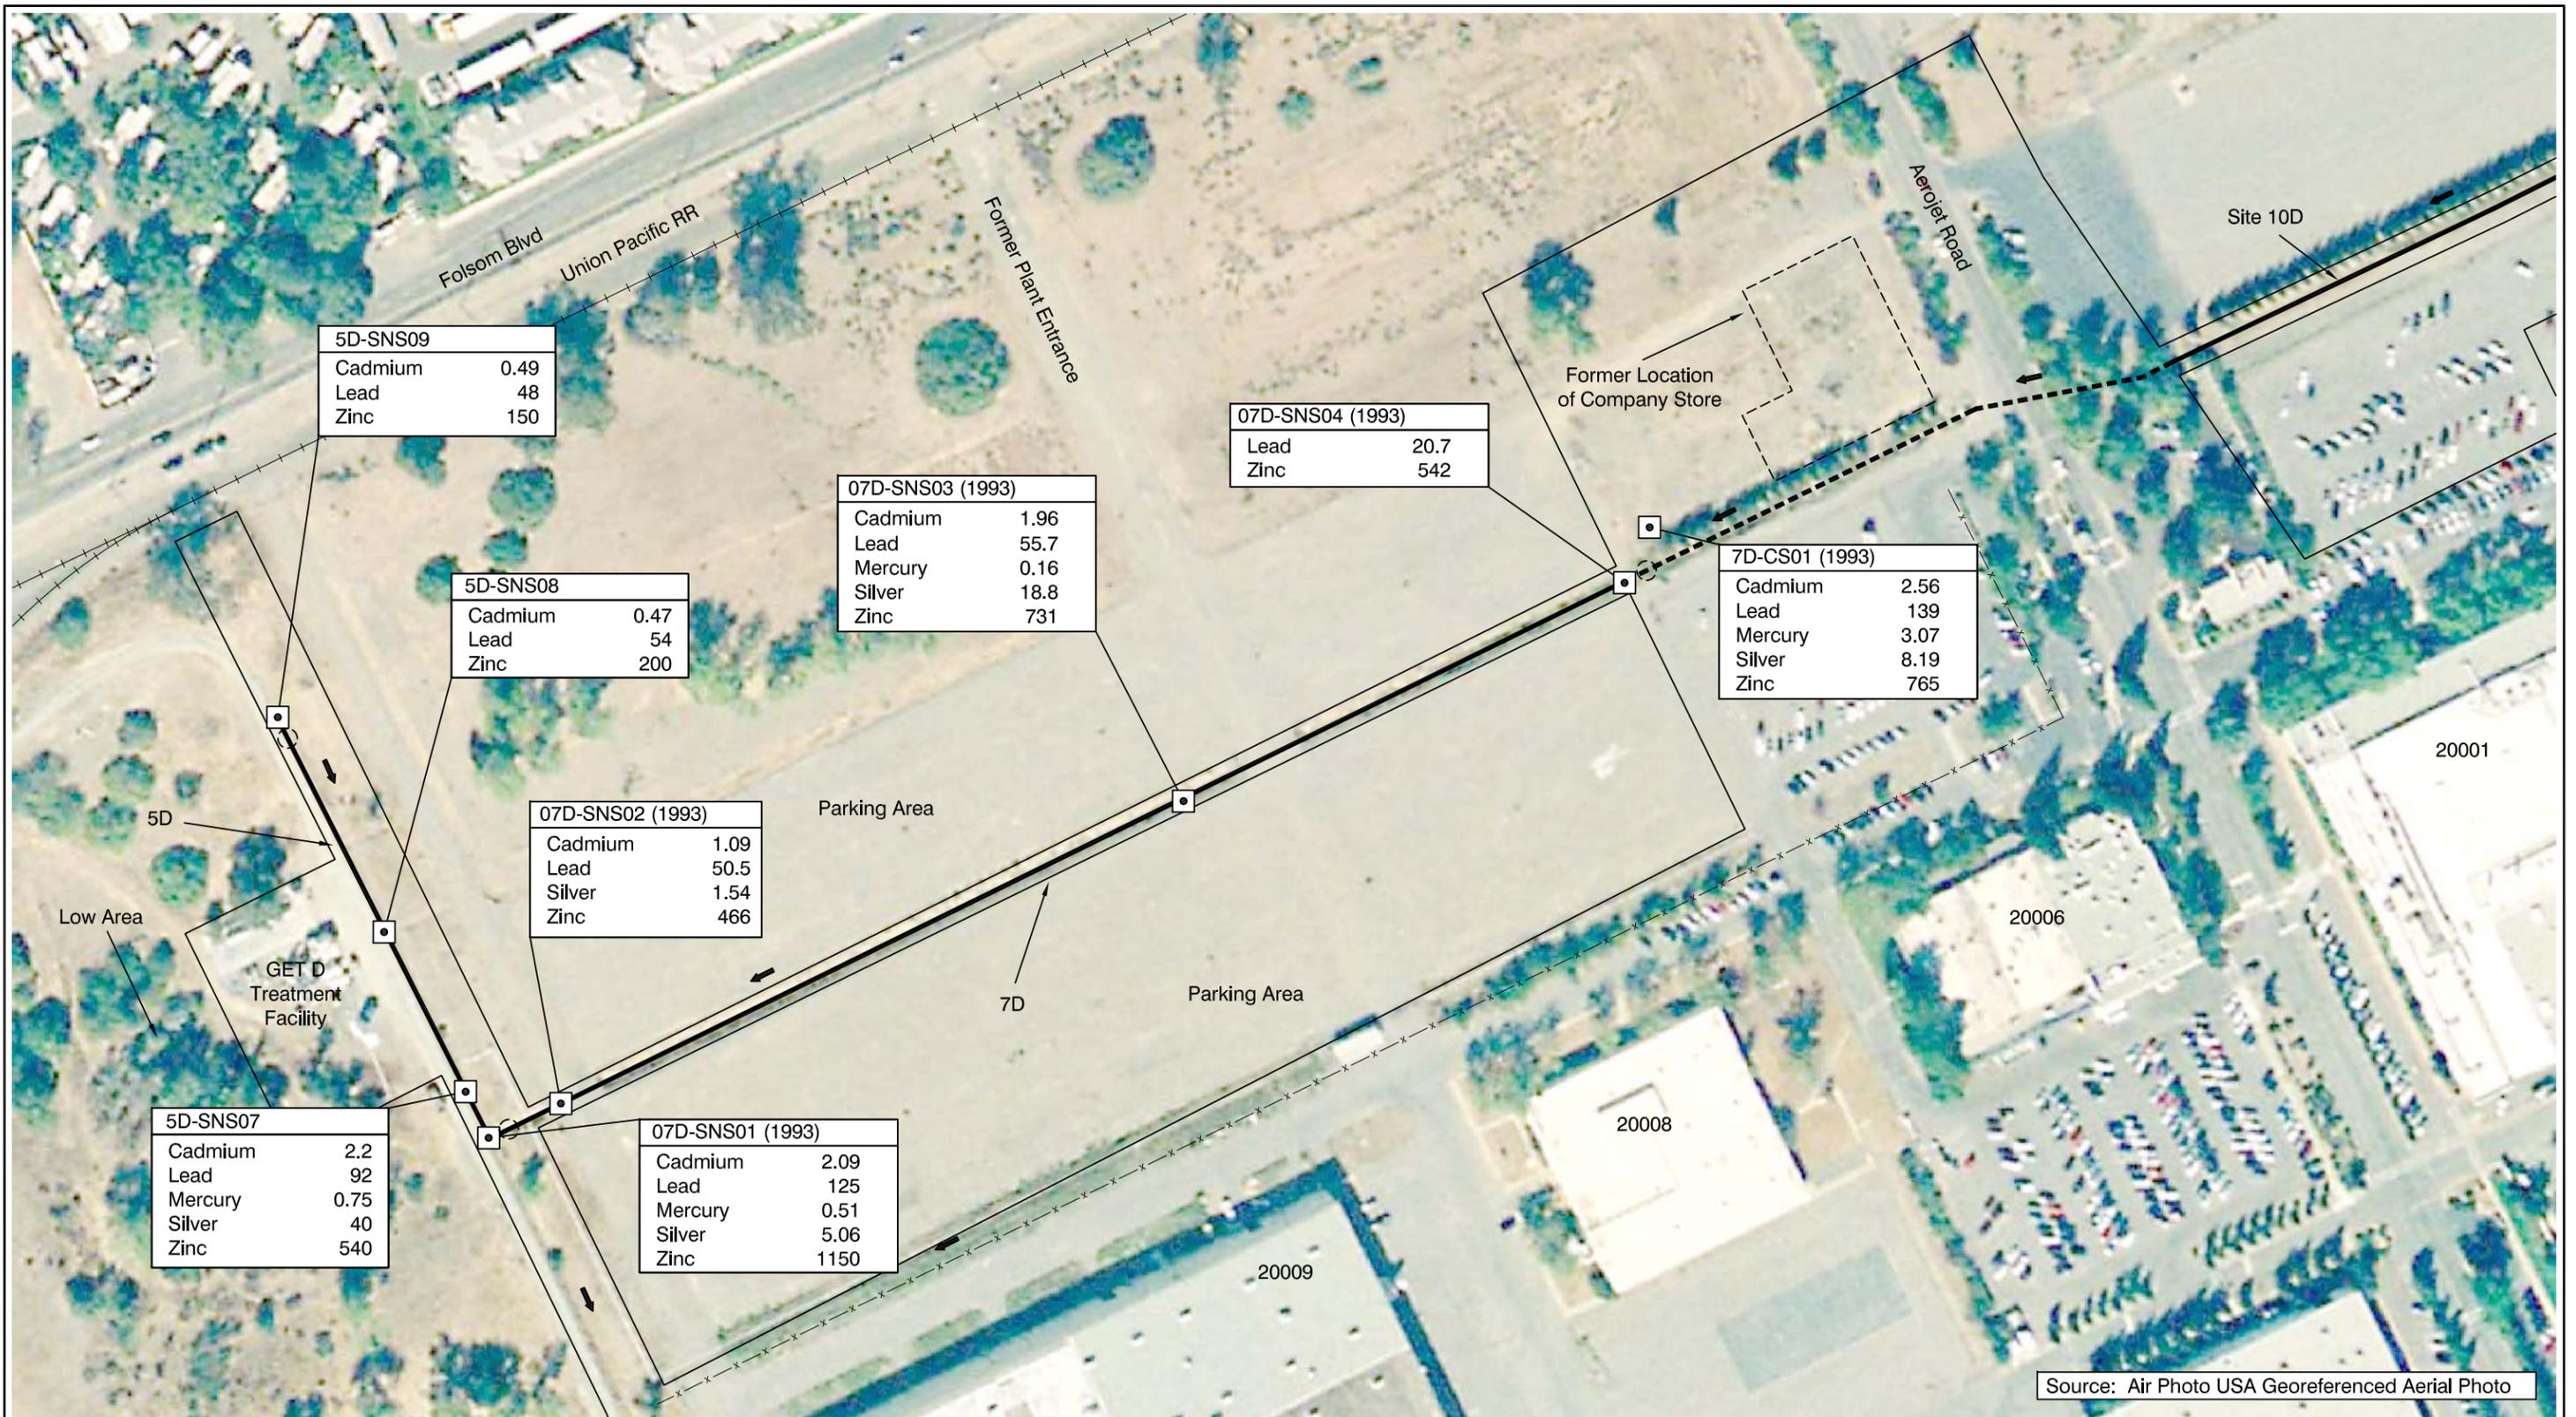
**FIGURE 4-12**  
**Metals Detected Above**  
**Background in Soil Samples**  
**Potential Source Sites 5D and 7D**

Concentrations Reported in Milligrams per Kilogram (mg/Kg)  
 Concentrations Above Residential PRG are in Boldface

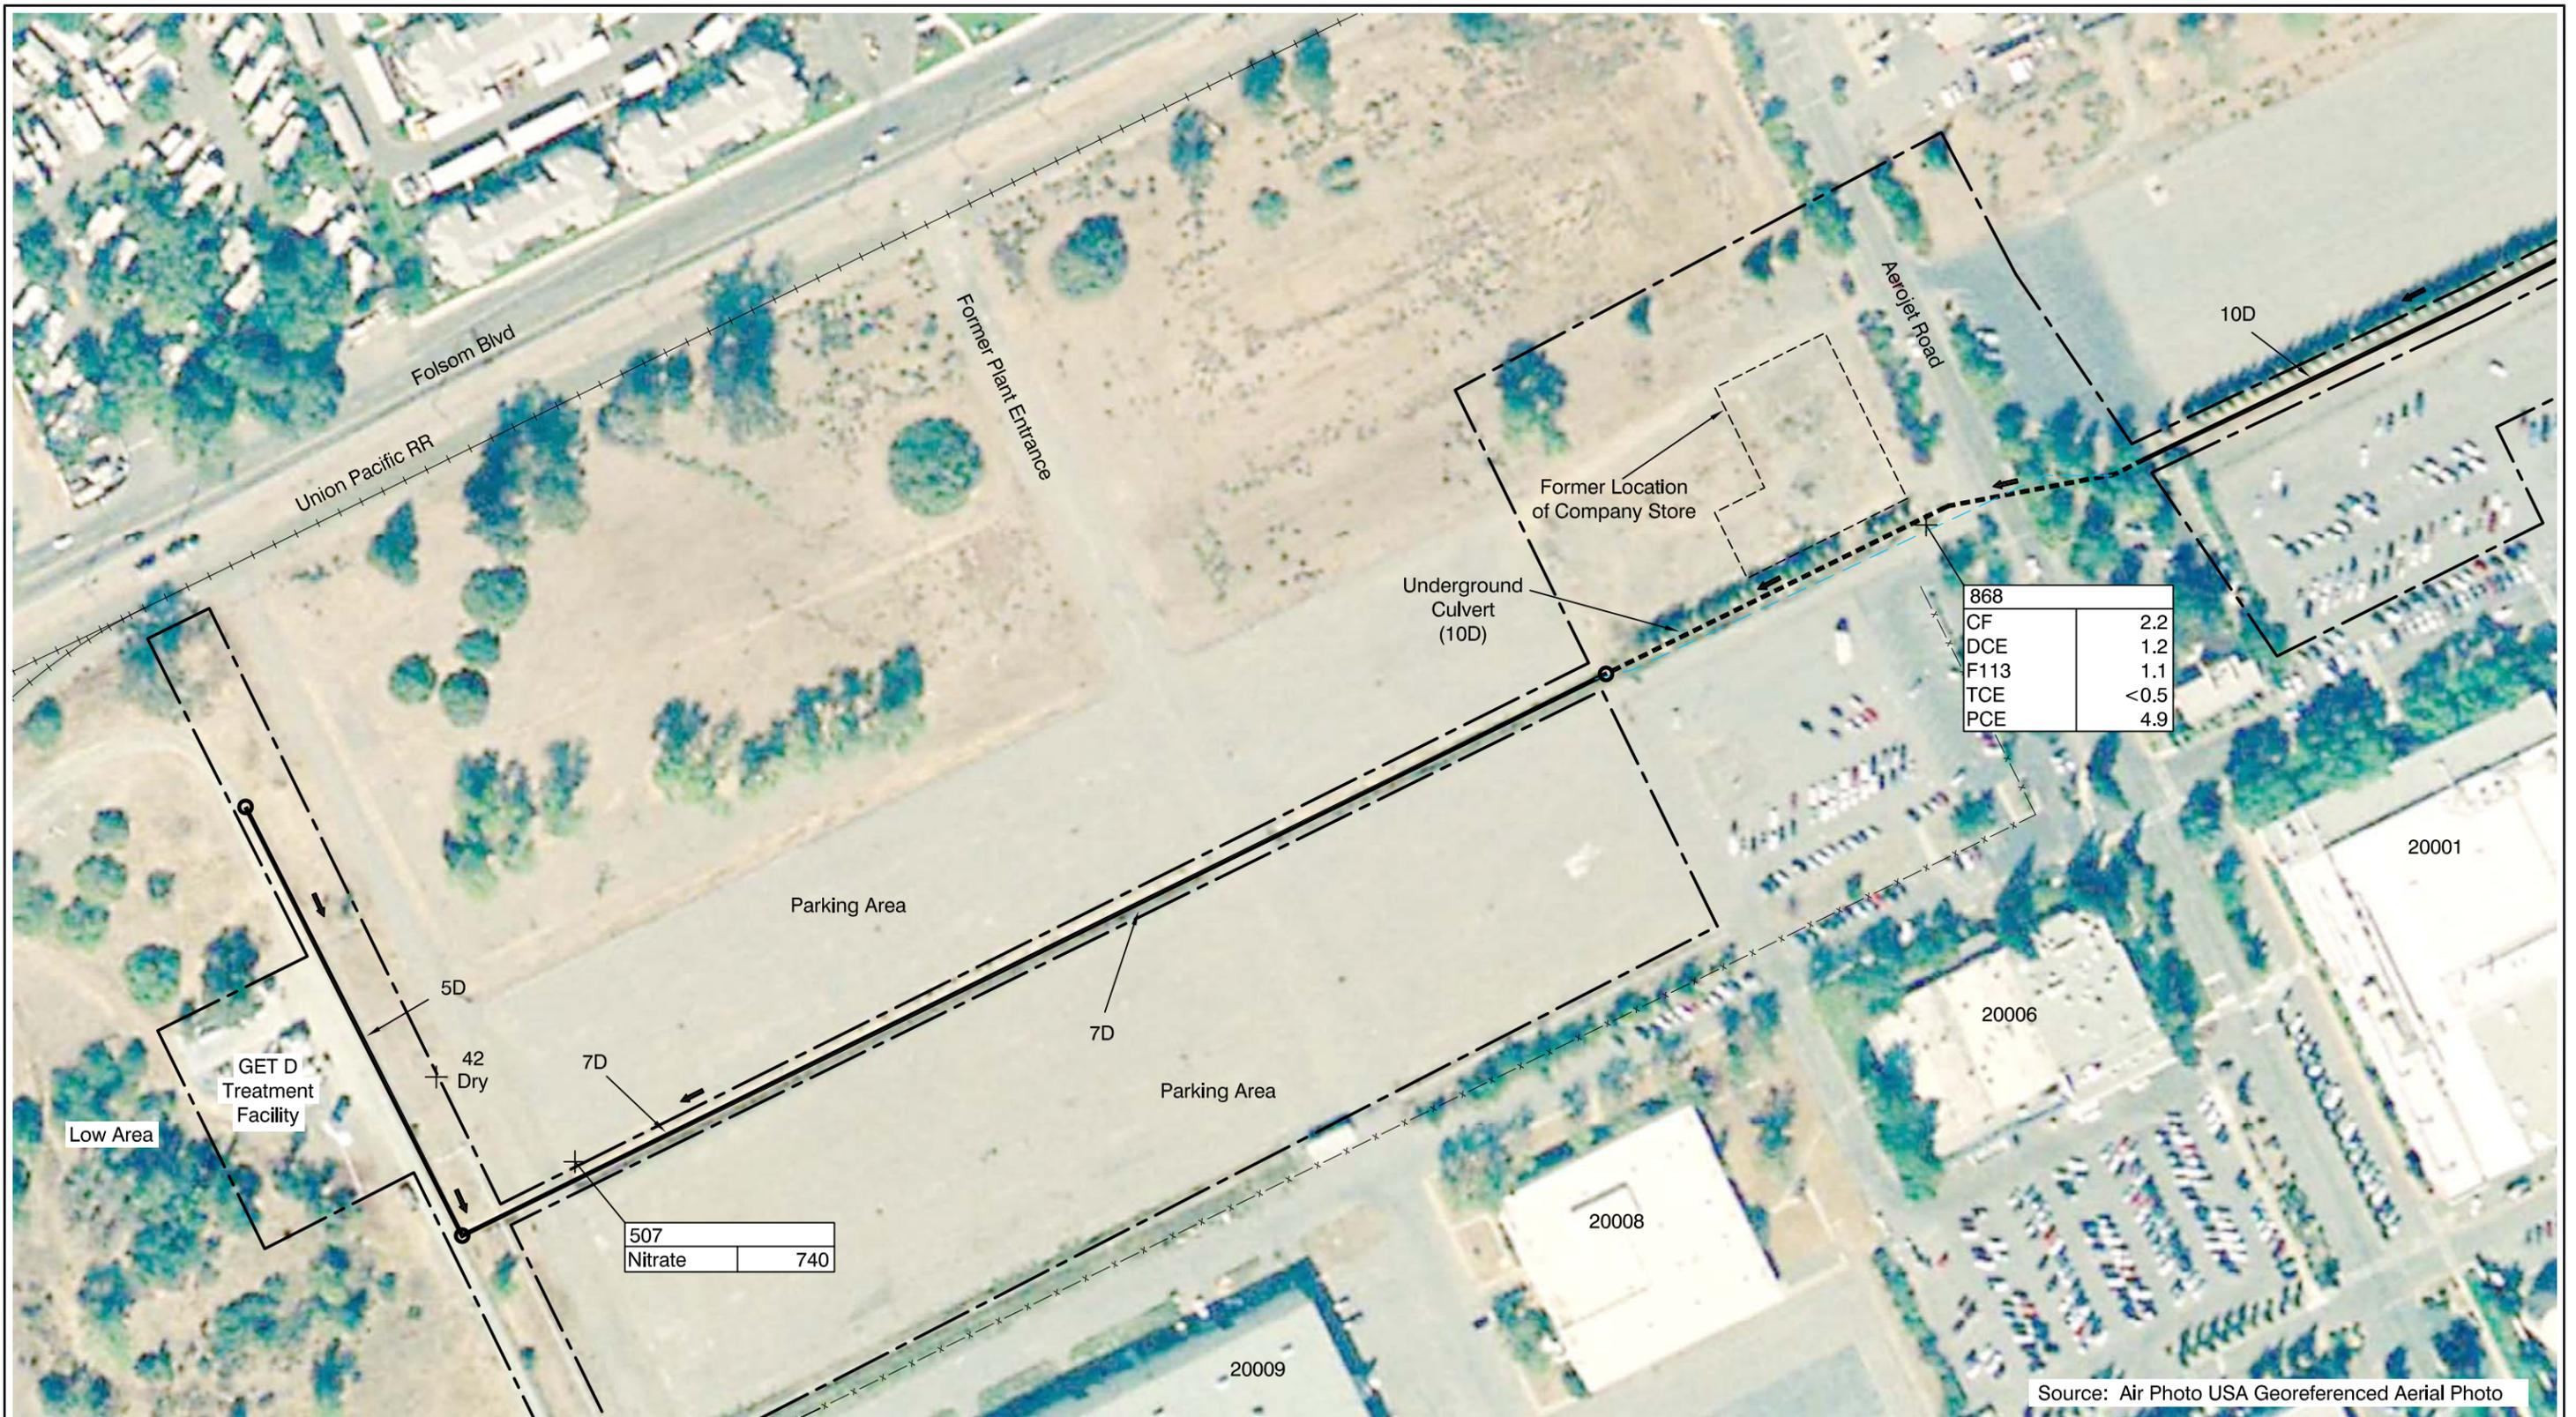
**FIGURE 4-13**

Concentrations Reported in Micrograms per Liter (µg/L)

**Constituents Detected In Perched Groundwater Samples Sites 5D, 7D and Former Company Store**

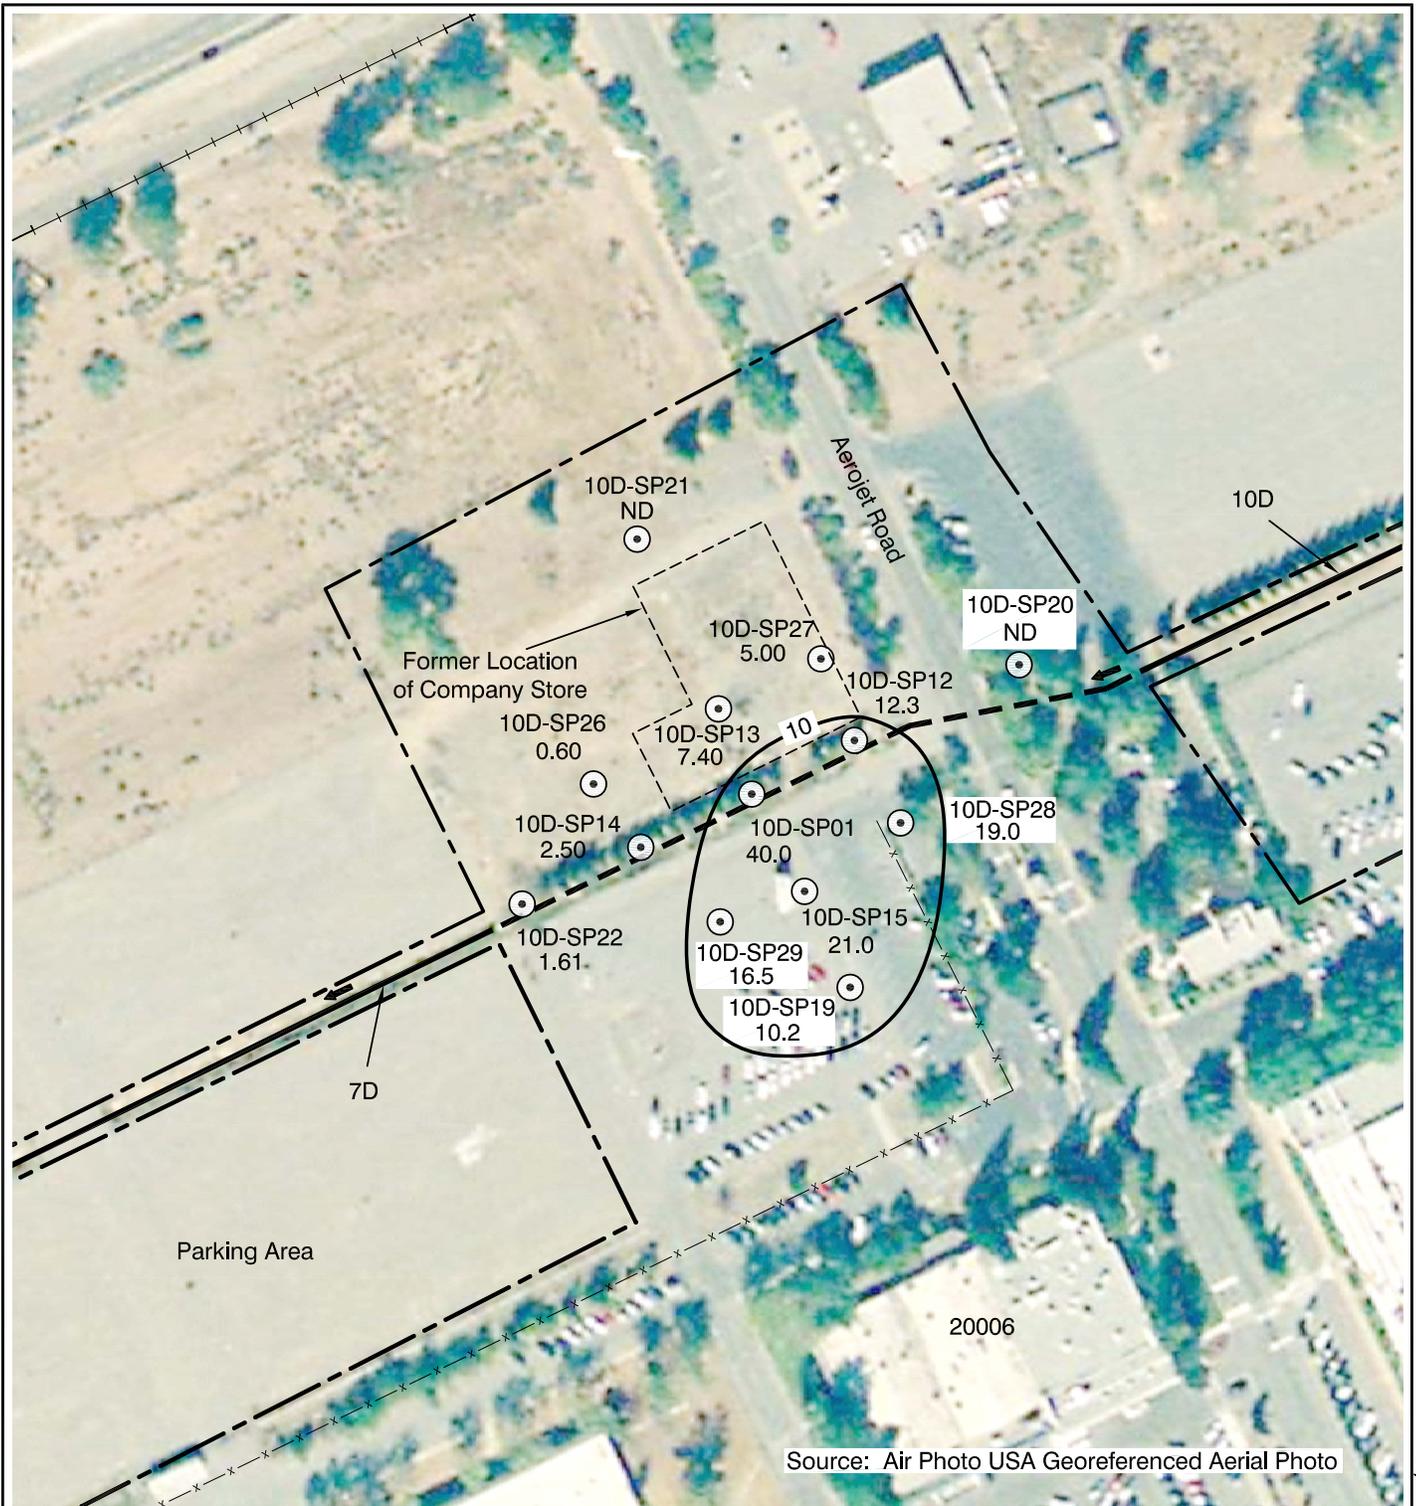
**FIGURE 4-15**  
**Total VOC Concentrations (Less Freon 113)**  
**in 1992 Intermediate Soil Vapor Samples**  
**Former Company Store**

- 10 Soil Vapor Concentration Isopleth in Milligrams per Cubic Meter (mg/m<sup>3</sup>)
- 10D-SP26 Soil Vapor Sample Location
- 0.60 Total VOC Concentration (mg/m<sup>3</sup>) (ND = Not Detected)

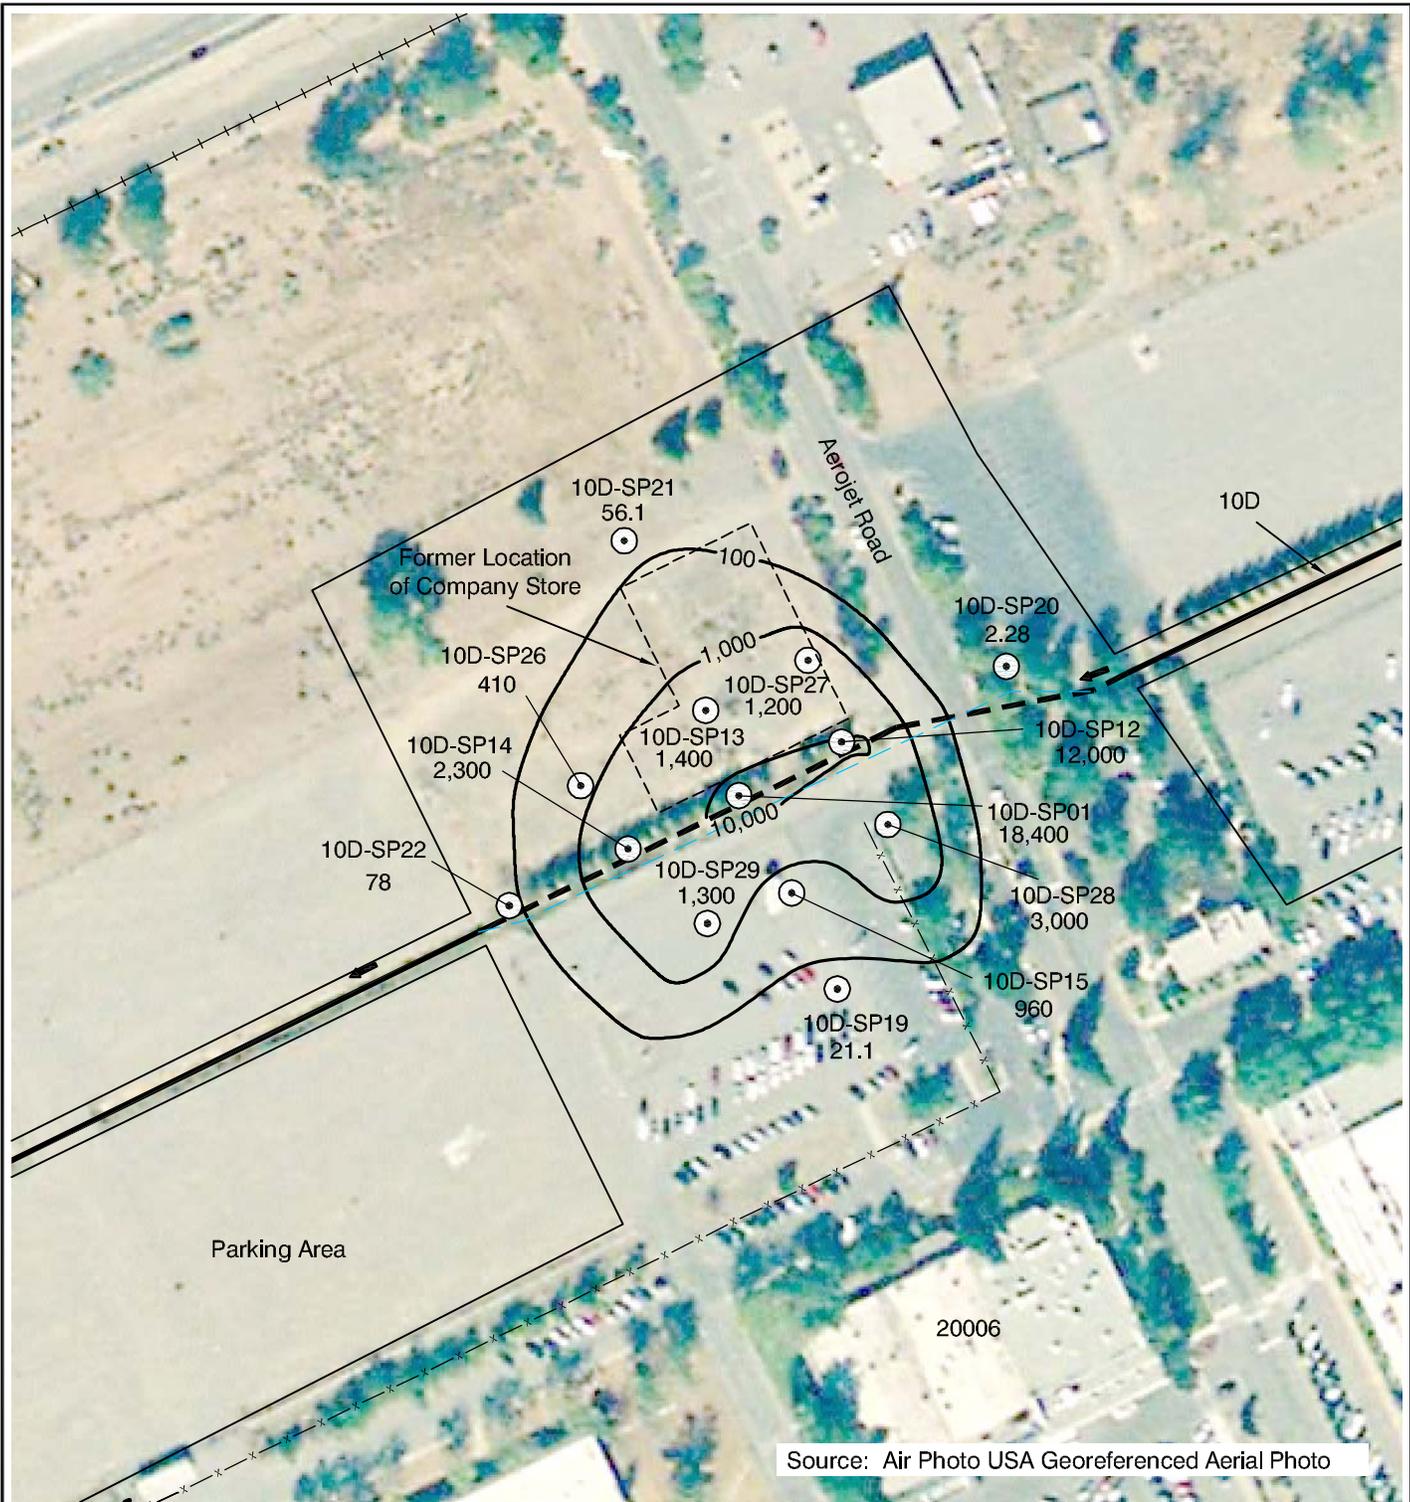
**FIGURE 4-17**  
**Freon 113 Concentrations in**  
**1992 Intermediate Soil Vapor Samples**  
**Former Company Store**

- 100 — Freon 113 Concentration Isoleth in Milligrams per Cubic Meter ( $\text{mg}/\text{m}^3$ )
- 10D-SP26 — Soil Vapor Sample Location
- 410 — Freon 113 Concentration ( $\text{mg}/\text{m}^3$ )

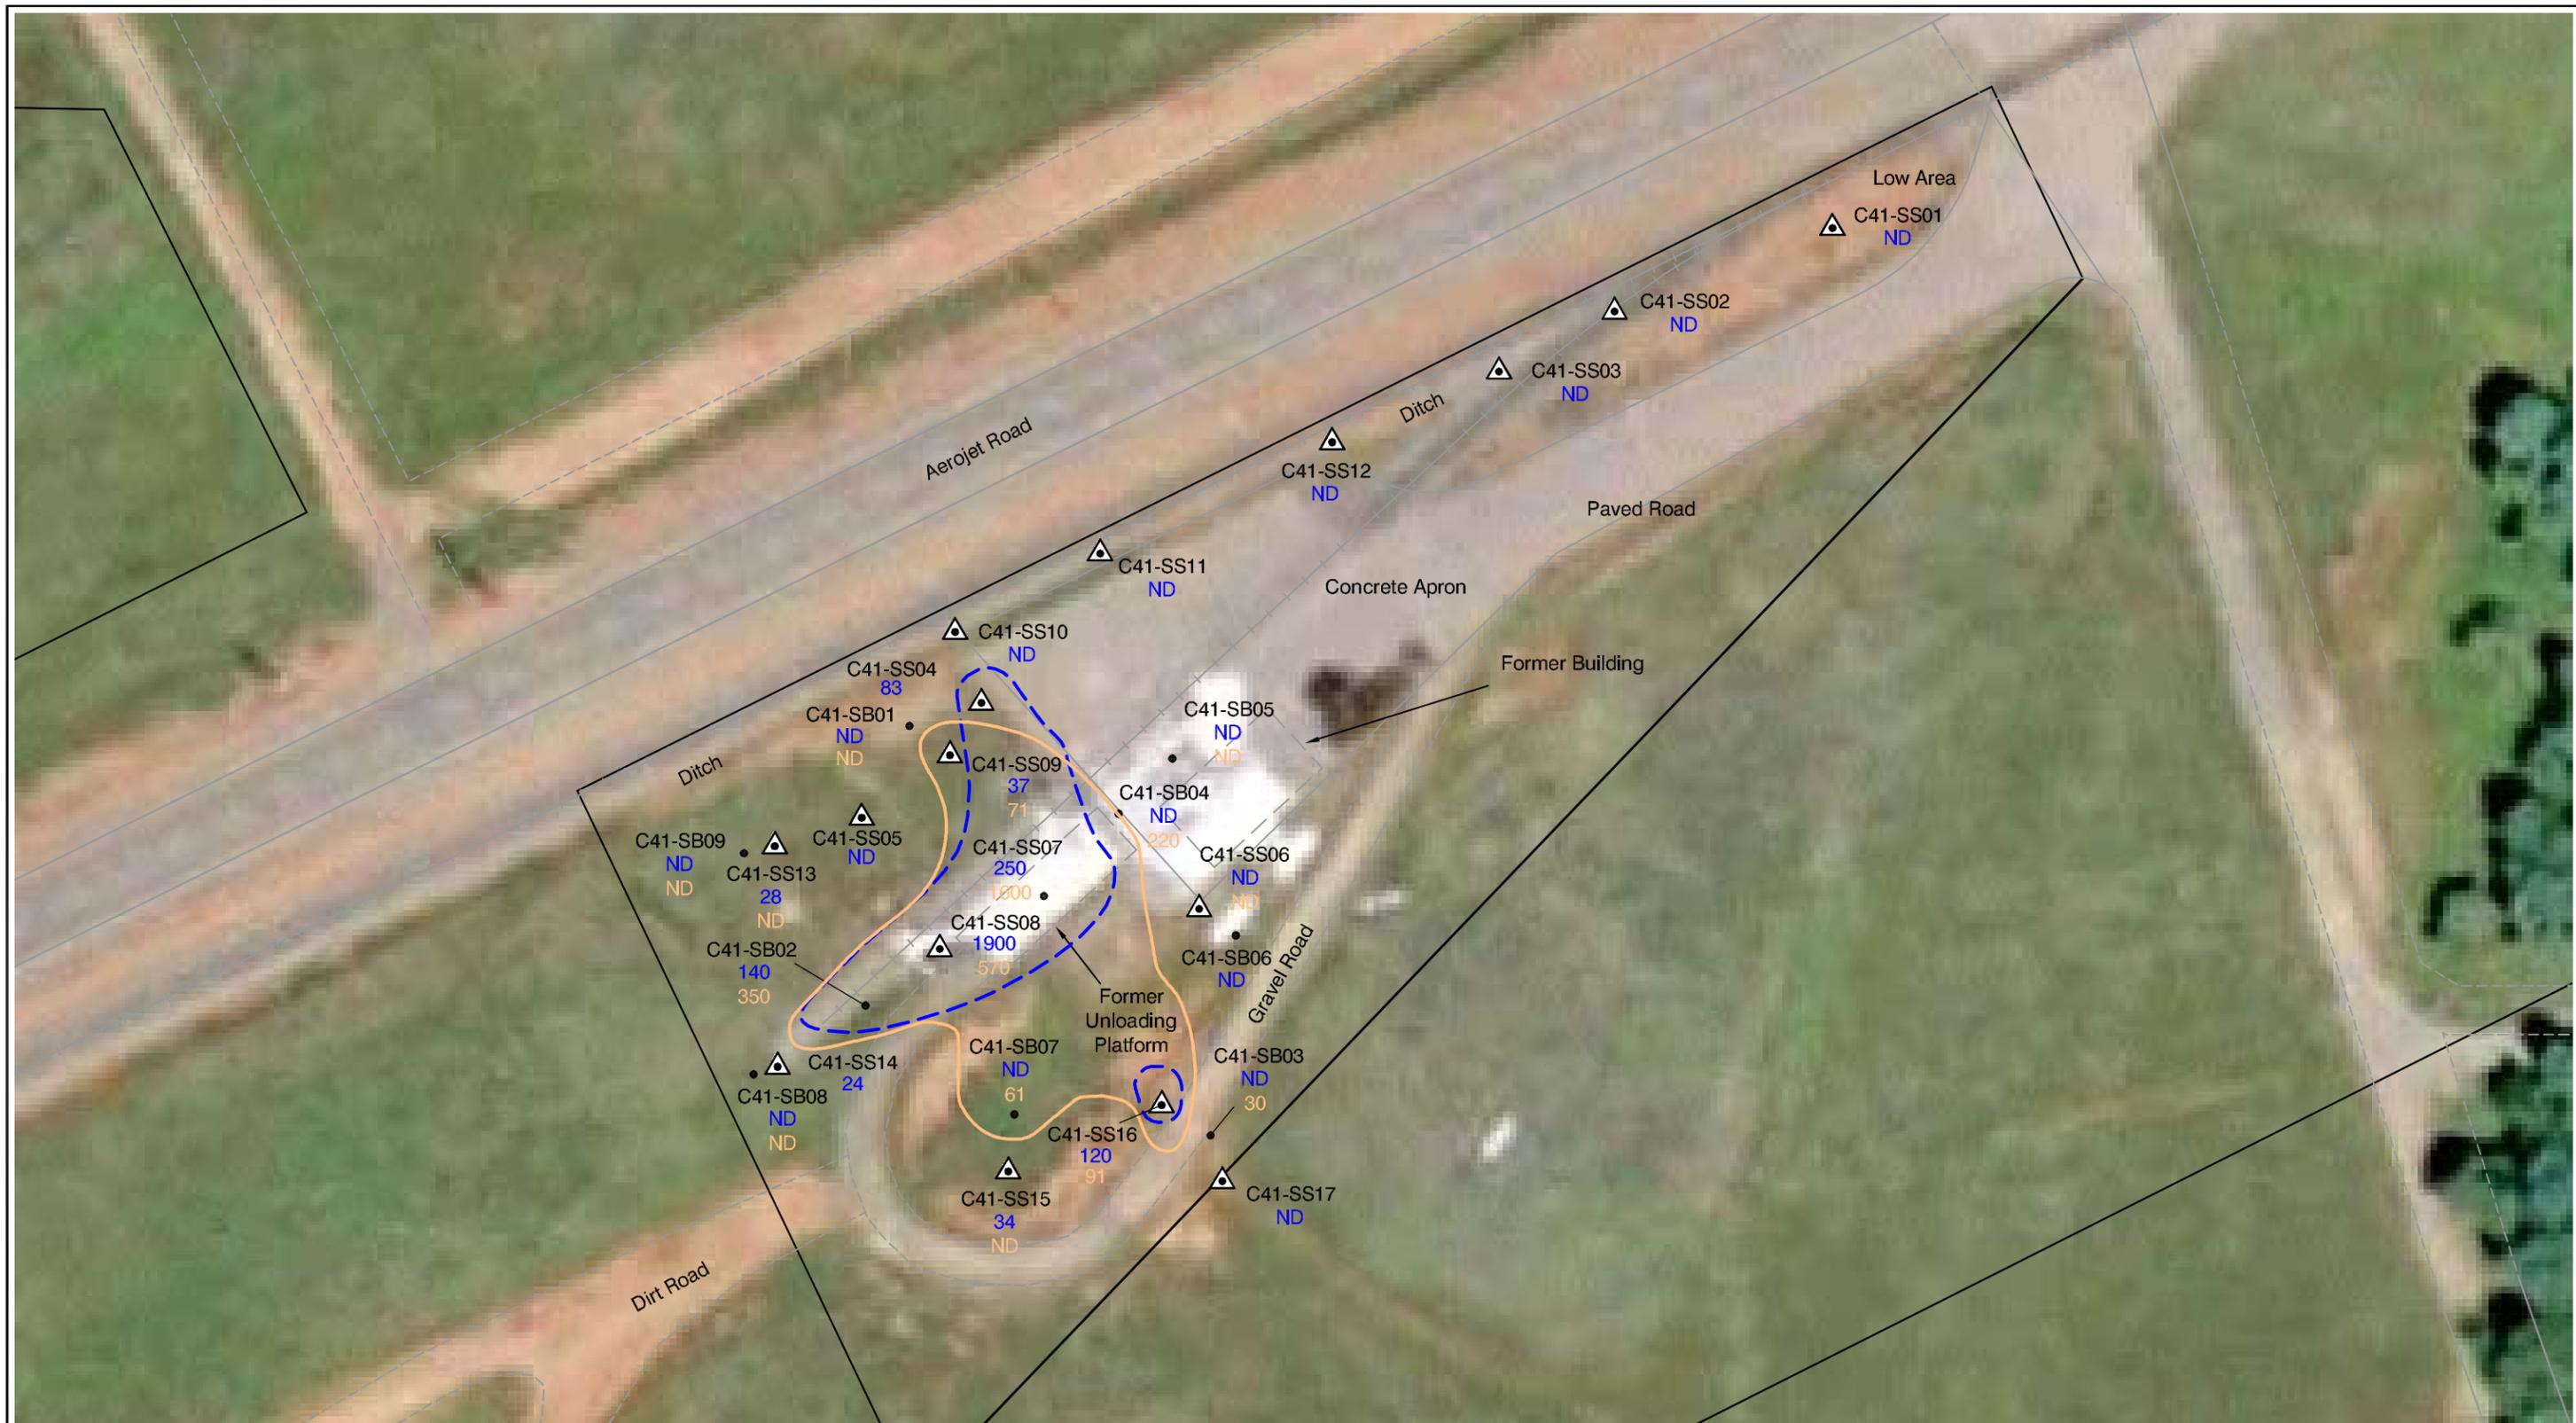
**FIGURE 4-33**  
**Perchlorate in Soil**  
**0 to 5 Feet BGS**  
**Site C41**

- ▲ Soil Sampling Location
- Soil Boring Location
- 140 Perchlorate Concentration at 0 to 2 ft Below Ground Surface
- 570 Perchlorate Concentration at 5 ft Below Ground Surface
- ND Not Detected
- Extent of Perchlorate >60 µg/Kg at 0 to 2 ft Below Ground Surface
- Extent of Perchlorate >60 µg/Kg at 5 ft Below Ground Surface
